AFWAL - TR - 80 - 2112

FIRE RESISTANT AIRCRAFT HYDRAULIC SYSTEM

BOEING MILITARY AIRPLANE COMPANY
ADVANCED AIRPLANE BRANCH
P.O. BOX 3707
SEATTLE, WASHINGTON 98124

FINAL REPORT FOR PERIOD MAY 1976 - MAY 1980

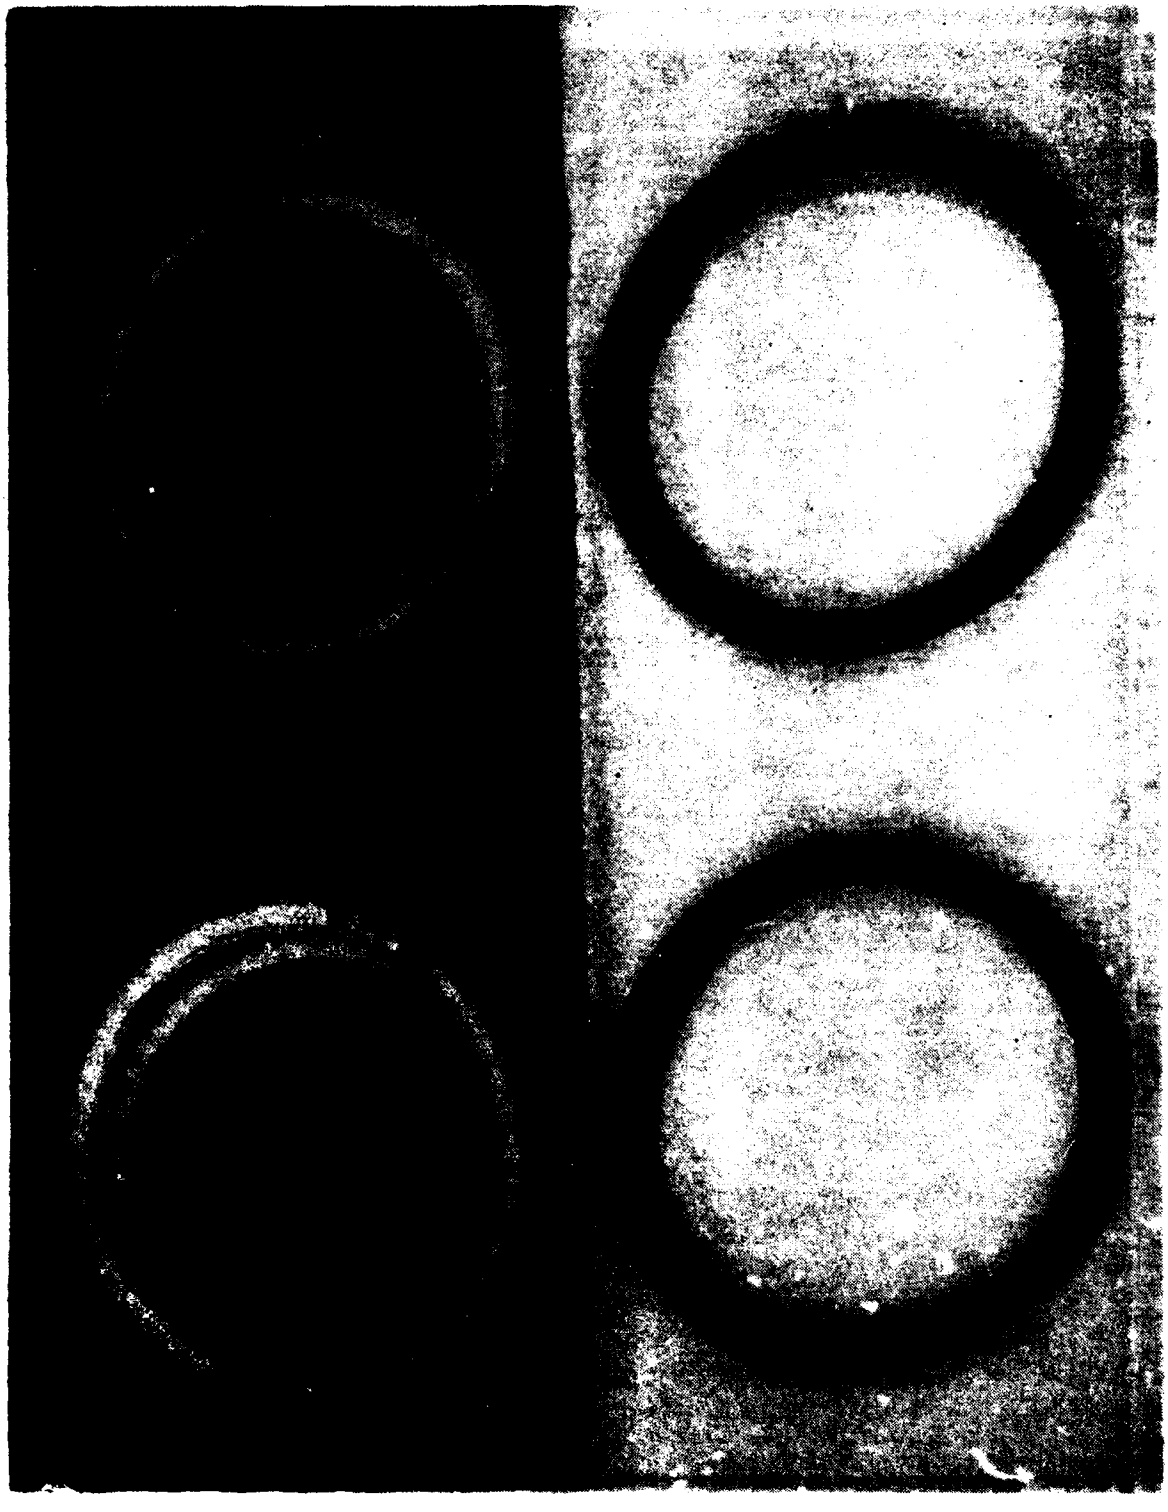
Figure 44. Military-standard internal static seals (AO-8 fluid)

On the larger AS568-330 size static seals (Figure 44), minimal deterioration was noted. Each O-ring had a radial cut in its side where the bias-cut end of the dual-turn backup ring was located. The backup ring seemed excessively short for this groove as there was approximately one-half inch underlap of the end bias when installed in the grooves.

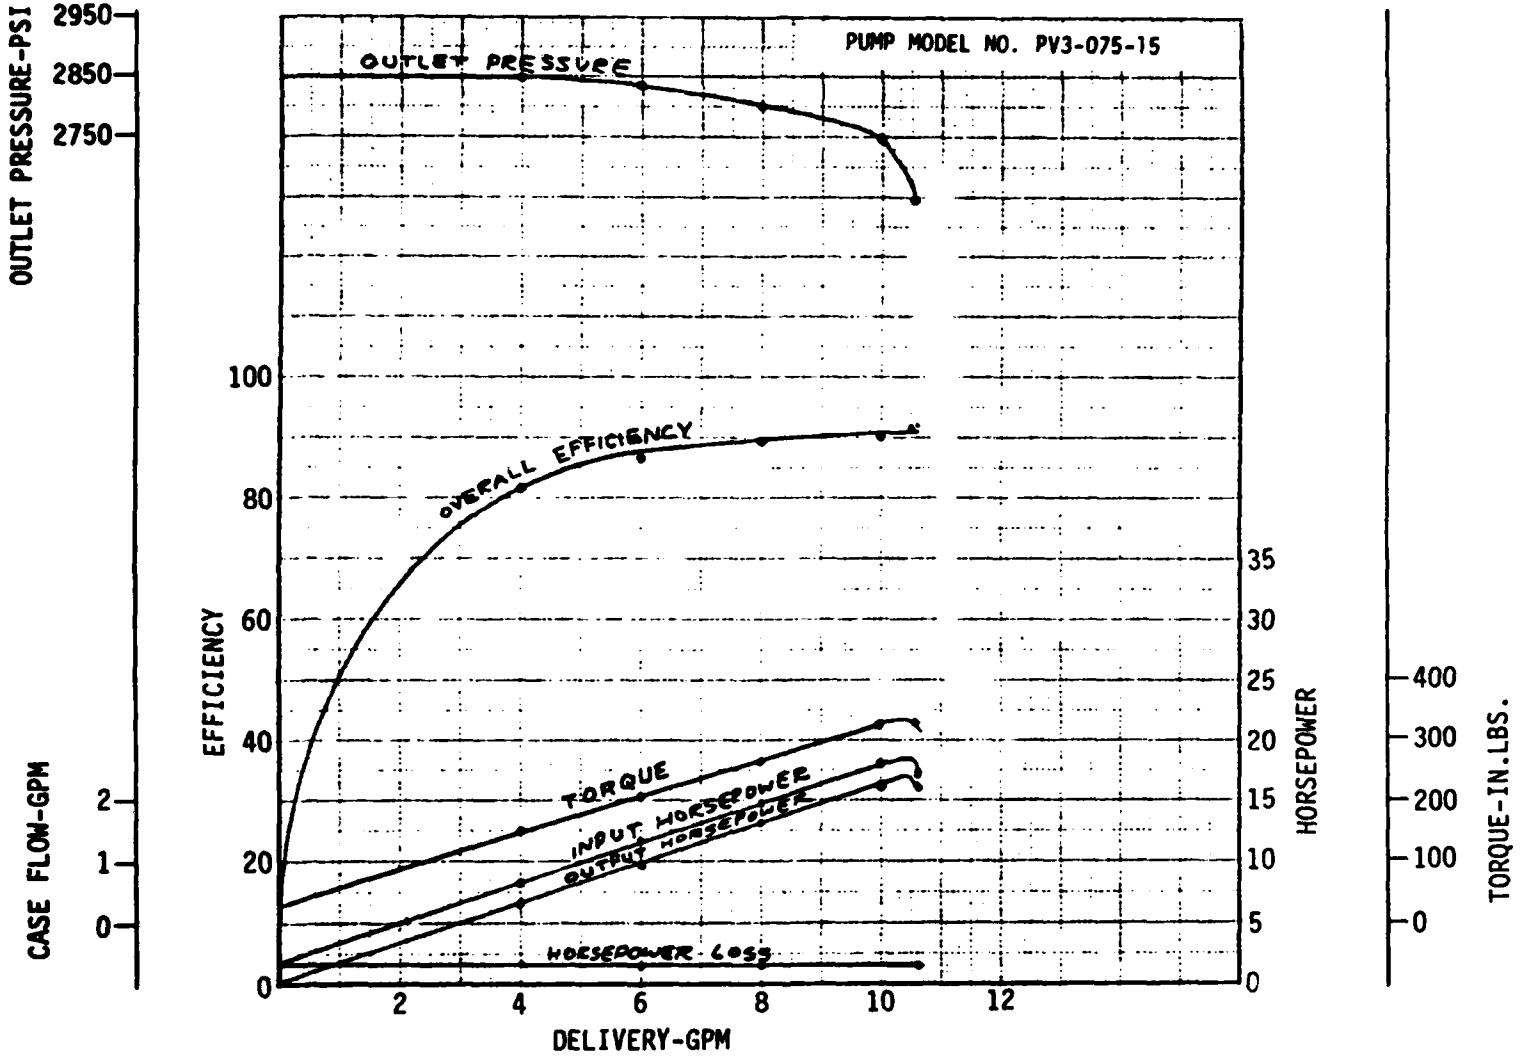
Figure 49. Fifty-hour pump partial-flow performance at 3500 rpm

c. At the 3500-rpm speed condition (50% of rated speed), the AO-8 pump had lower power loss and higher overall efficiency in the cutout flow regime (zero flow to full flow at full-flow pressure). As seen in Figure 49, the peak efficiency for the AO-8 pump with inlet fluid temperature of 180F was 91.51% compared to 86% for the 5606 pump with inlet fluid temperature of 240F (see Figure D-2). In the full-flow regime at lower pressures, the volumetric efficiencies for the two pumps were nearly identical at each respective data point, but the peak overall efficiency for the AO-8 pump was slightly higher, eg. 92% comapred to 90%.

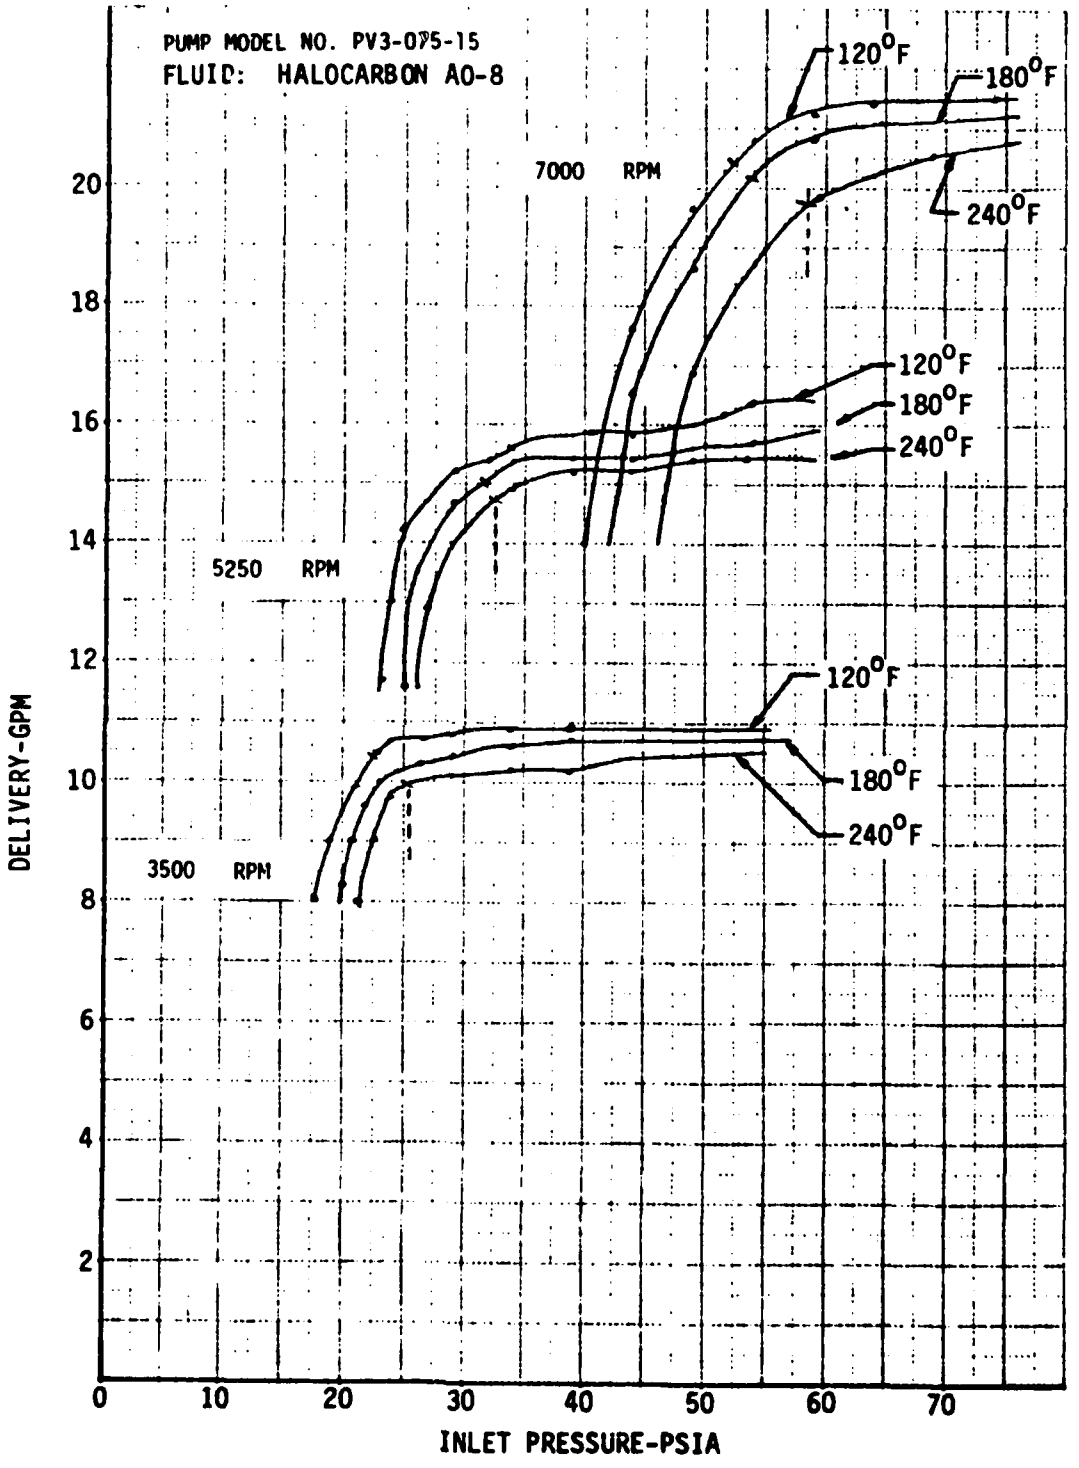
Figure 55. Fifty-hour pump critical inlet pressures

The data for each of the three inlet fluid temperature conditions at each of the three pump speed conditions, 3,500, 5,250, and 7,000 rpm, are shown in the curves in Figure 55. In each case, the delivery flow decreased gradually as inlet pressure was reduced until a pressure was reached where a sharp dropoff in delivery, indicating the onset of cavitation, occurred. The following tabulation indicates the approximate critical inlet pressure for each speed and inlet fluid temperature condition as selected from the curves in Figure 55 as the pressures where a five percent drop in the maximum measured delivery flow occurred.

Pump Speed	Critical Inlet Pressure (psia)		
(rpm)	@ 120F	@ 180F	@ 240F
3,500	22.5	24.5	22.5
5.250	33.5	31.5	32.5
7,000	52.5	53.5	58.5

By comparison, the critical inlet pressure measured with the PV3-075-1 pump operating with MIL-H-5606 fluid at 7,000 rpm and 240F inlet fluid temperature was 24.5 psia. See Figure D-7 in Appendix D.

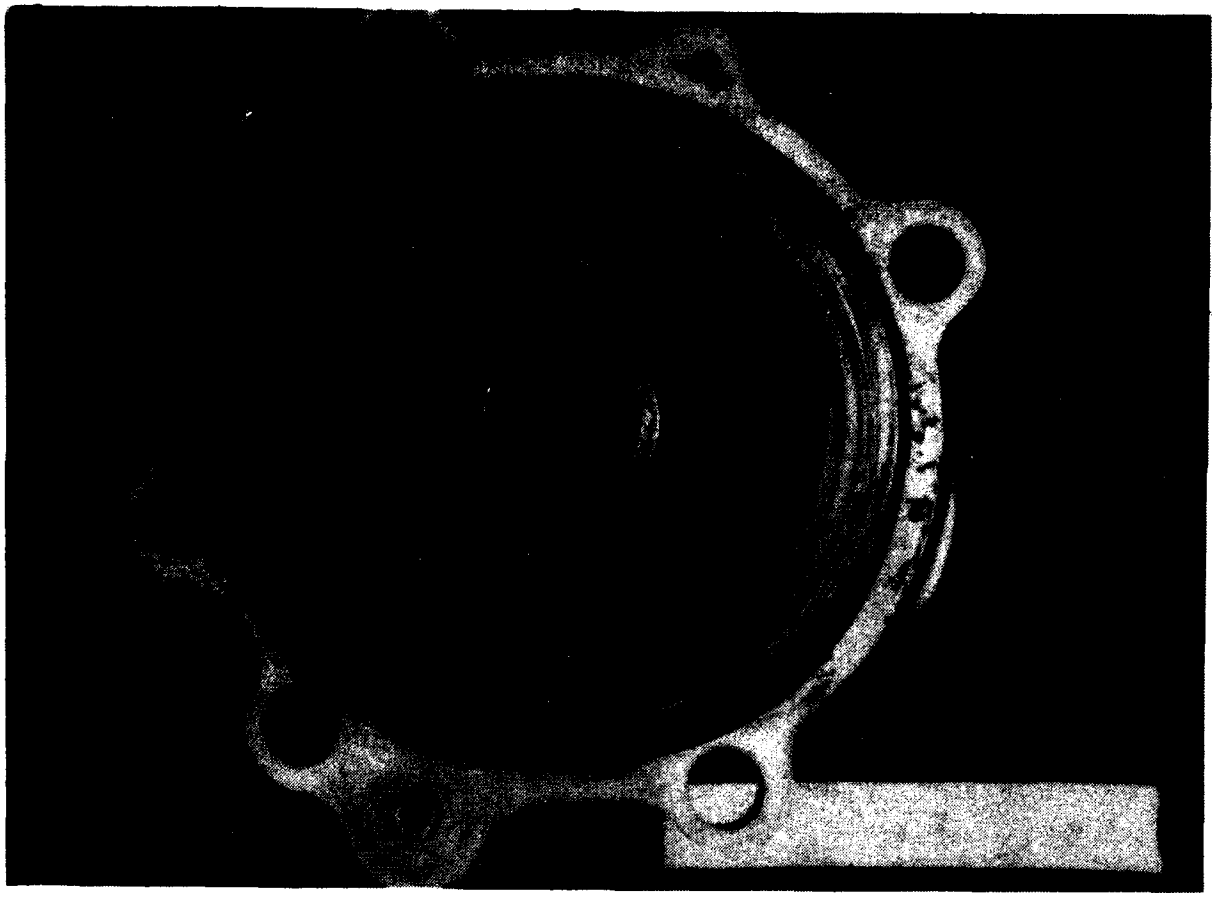
Figure 67. Long-term pump valve block after break-in run

The valve block face and all interior passages in contact with the fluid were discolored. Considerable bronze was transferred from the cylinder block Kingsbury pads (see Figure 67).

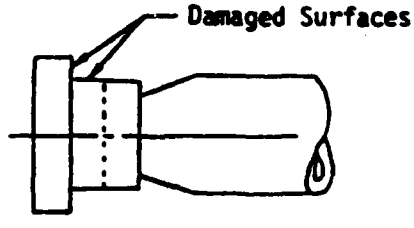
The rear surfaces of the bronze shoes (see sketch) appeared to have imbedded particles of steel in the center of polished "spots" implying that the imbedded particles had upset the softer bronze which had subsequently been worn off. Sperry-Vickers personnel suspected that the silver colored particles were free lead in the bronze which had been exposed by erosion.

Piston barrel diameters had increased by as much as 0.0002 inch. The cause of the coating has not been determined.

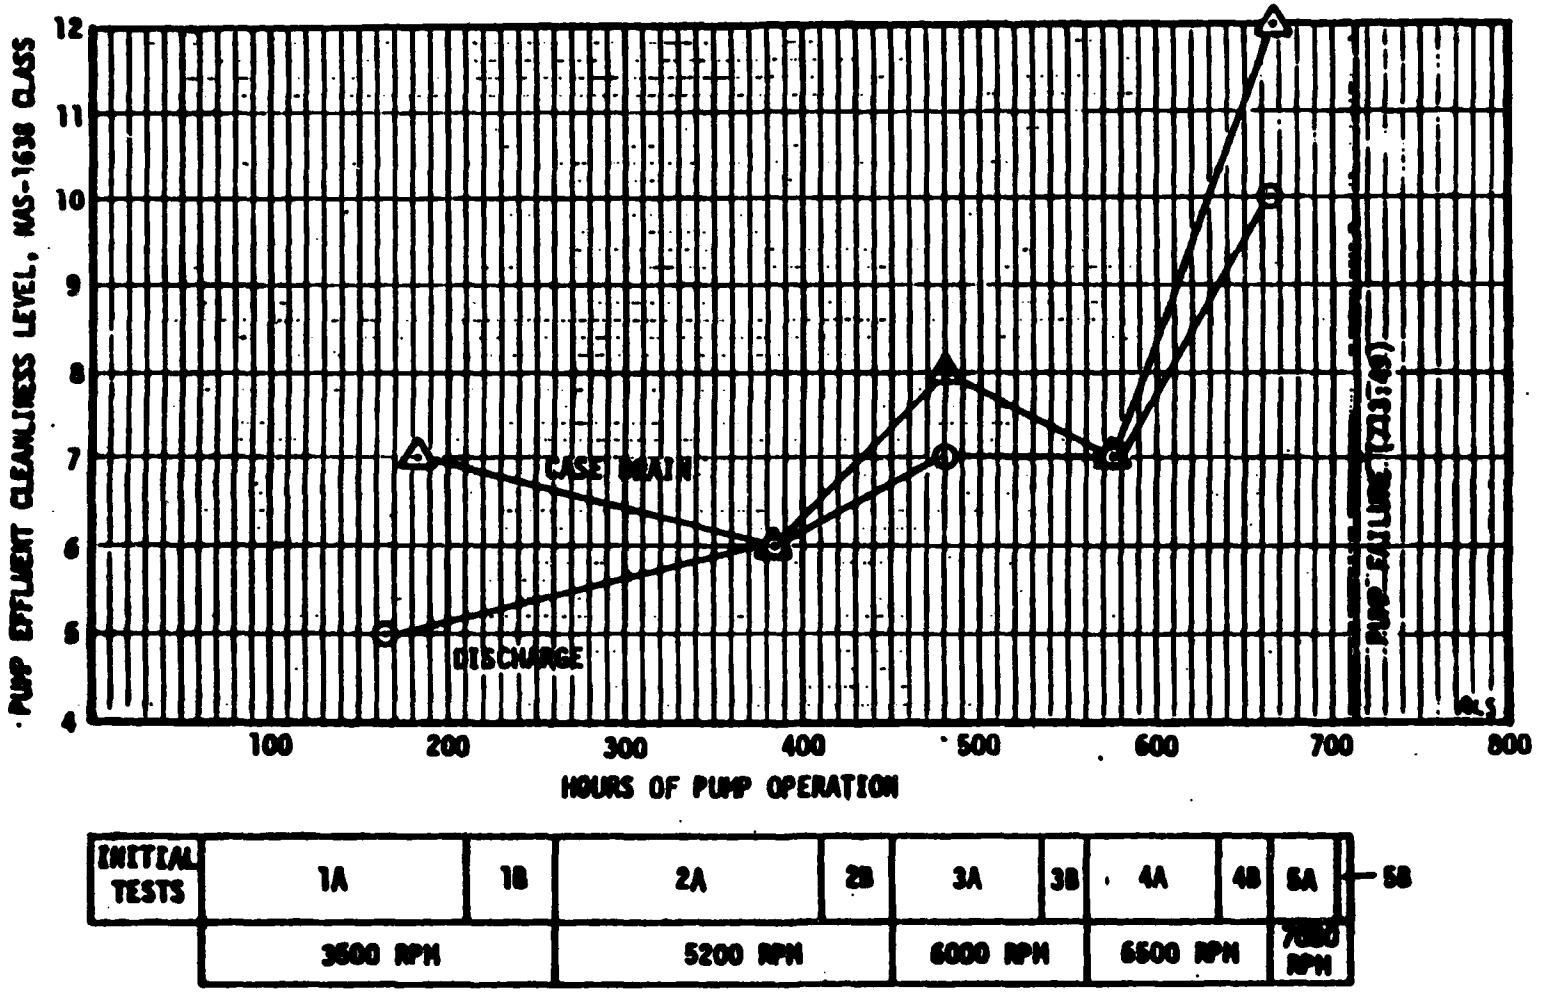
Figure 93. Long-term pump effluent cleanliness levels

As shown in Figure 93, the pump case drain effluent worsened near the end of testing. The pump discharge effluent cleanliness appears to be a function of pump speed, with wear occurring at all speeds. Obviously a 20 to 25 percent decrease in the rated speed of the pump will not produce an infinite life. Additional testing would be required to estimate pump life as a function of speed.

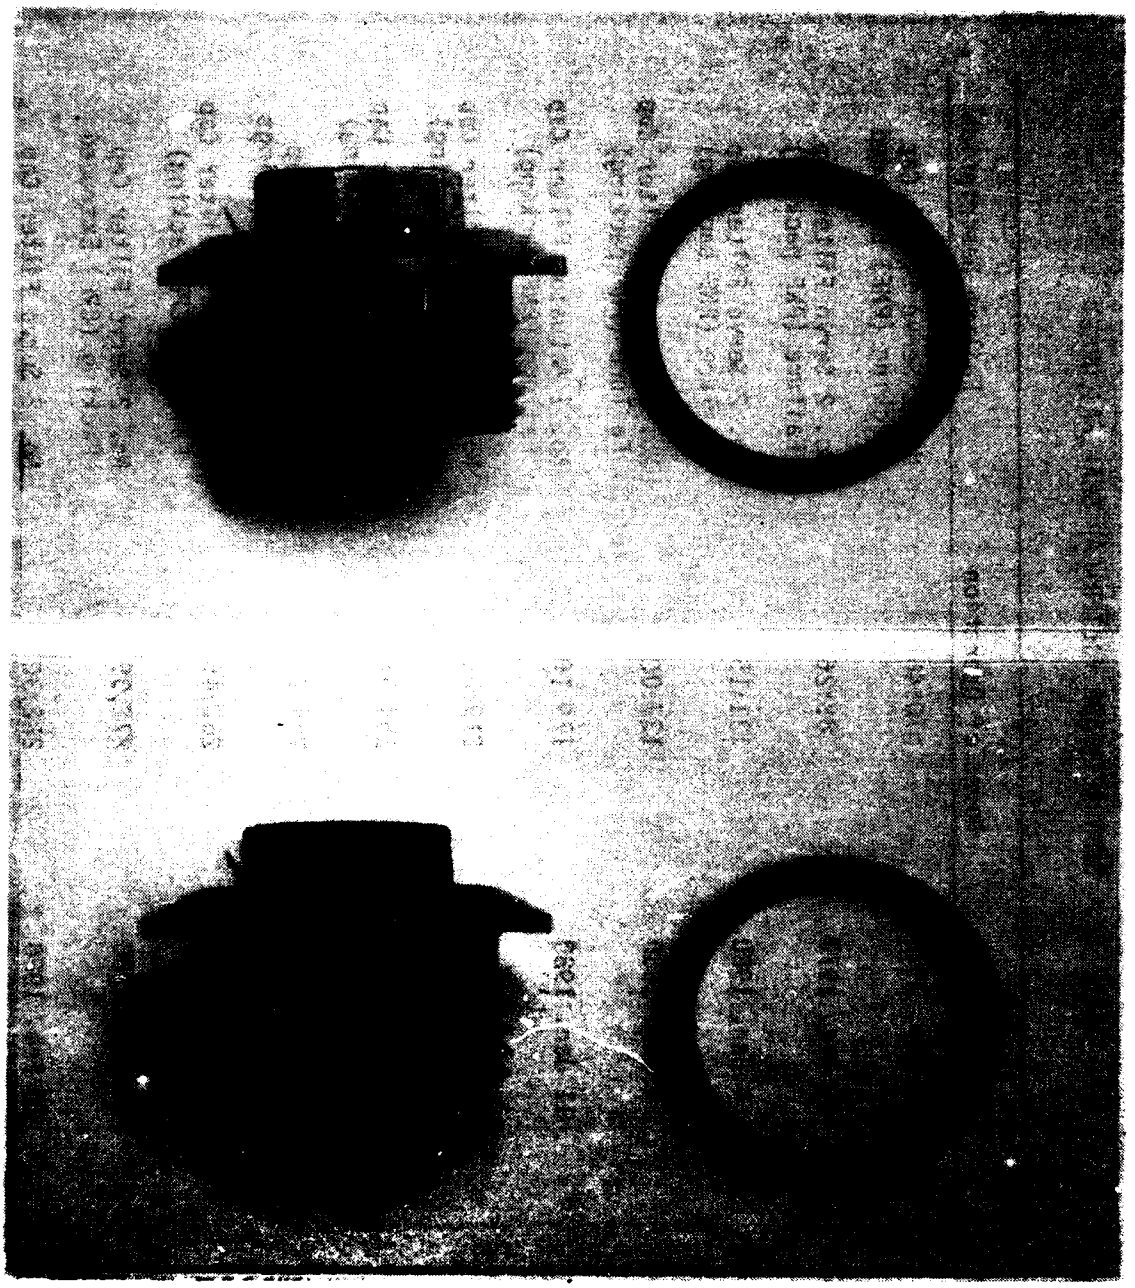
Figure 104. Typical servoactuator filter cap failures

Failure No.	Date	Hours of Operation	Failure Description
1.	30 Nov. 1979	70:46	No. 2 Servo Filter Cap Packing (PNF) Extruded
2.	18 Dec. 1979	88:26	No. 2 Servo Filter Cap Failure (PNF packing)
3.	4 Jan. 1980	131:15	No. 2 Servo Filter Cap Failure (PNF packing)
4.	4 Jan. 1980	137:00	No. 1 Actuator Filter Cap Failure (PNF packing)
5.	11 Jan. 1980	179:10	No. 1 Actuator Filter Cap Failure (PNF packing)
6.	16 Jan. 1980	219:04	No. 1 Actuator Filter Cap Failure (Viton packing)
7.	18 Jan. 1980	254:01	No. 1 Actuator Filter Cap Failure (Viton packing)
---	12 Feb. 1980	254:01	Changed all Filter Cap Packings to CPE O-rings
8.	12 Feb. 1980	260:45	No. 2 Actuator Filter Cap Failure (CPE Packing)
9.	14 Feb. 1980	272:09	No. 2 Servo Filter Cap Packing (CPE) Extruded
10.	20 Feb. 1980	282:30	No. 2 Servo Filter Cap Failure (CPE Packing)

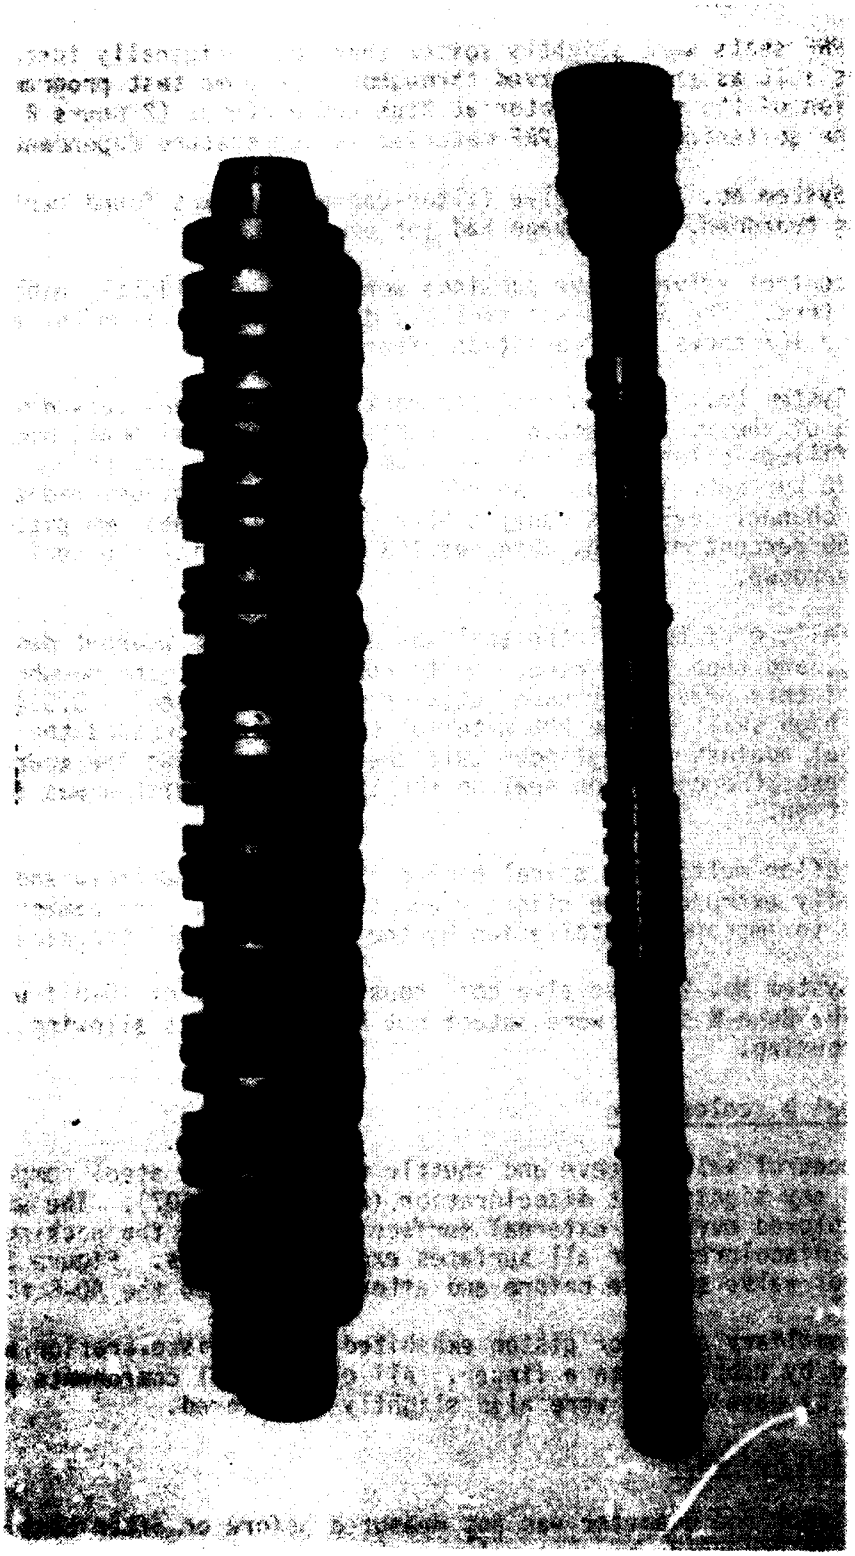
Figure 107. Control valve spool and sleeve

The control valve sleeve packings were soft and slightly nibbled on the outer diameters. The damage was probably due to removal from the actuator housing. Figure 107 shows seal condition after removal.

The control valve sleeve and shuttle were the only steel components which exhibited any significant discoloration (Ref. Figure 107). The steel sleeve was discolored over its external surface except under the packings, and the shuttle was discolored over all surfaces except the lands. Figure 110 shows the control valve shuttle before and after exposure to the AO-8 fluid.

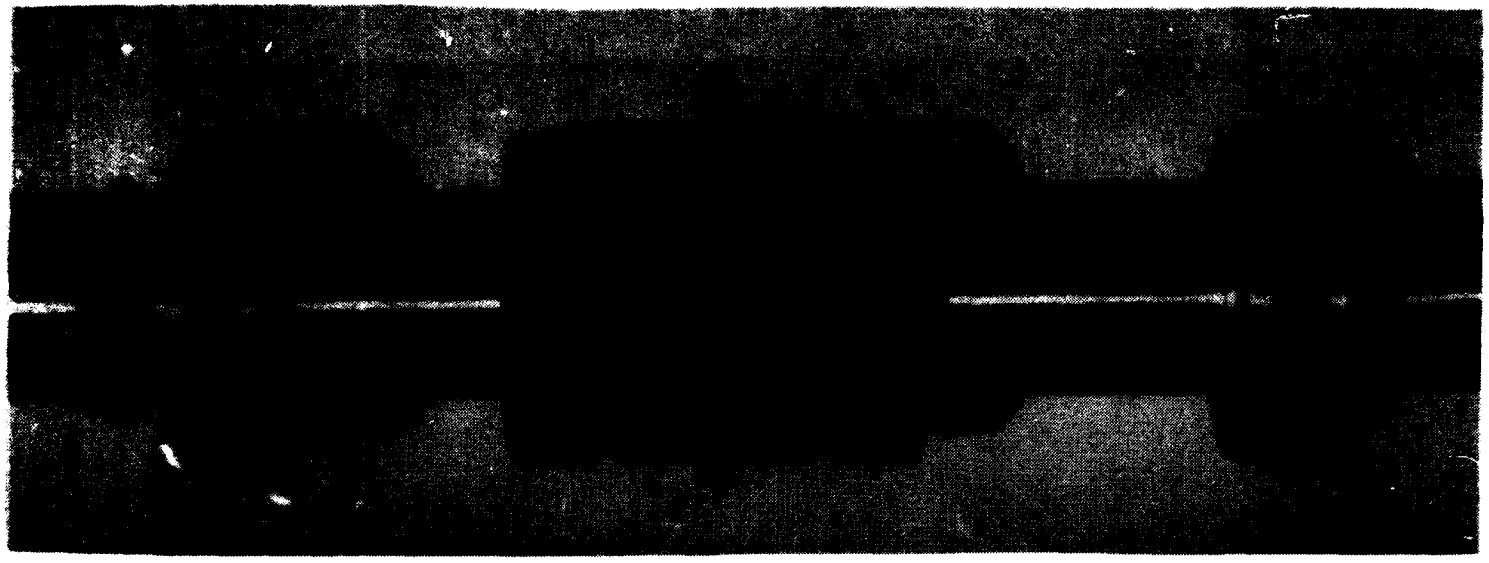
Figure 108. Piston and center-dam seals (No.2 on left)

The System No. 2 piston seal and packing were extensively damaged. The sealing web of the W. S. Shamban Co. Double Delta Channel Seal, made of their Turcon (filled-Teflon) material, was completely worn through and was approximately 70 percent missing. The PNF O-ring, which provides radial support to the channel seal, was badly nibbled, separated into two pieces, and approximately 50 percent missing. Figures 108 and 109 depict the seal condition at teardown.

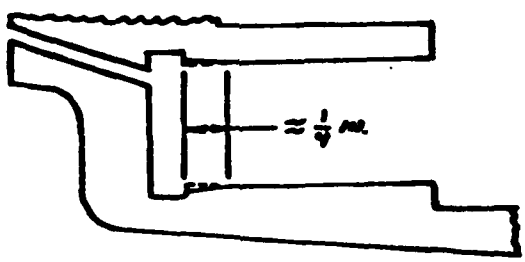
The actuator piston bore appeared "belled" out at the bottom end - see sketch. The defect was apprently not detrimental and was probably due to manufacturing since a worn hard-coat would also have damaged the piston.

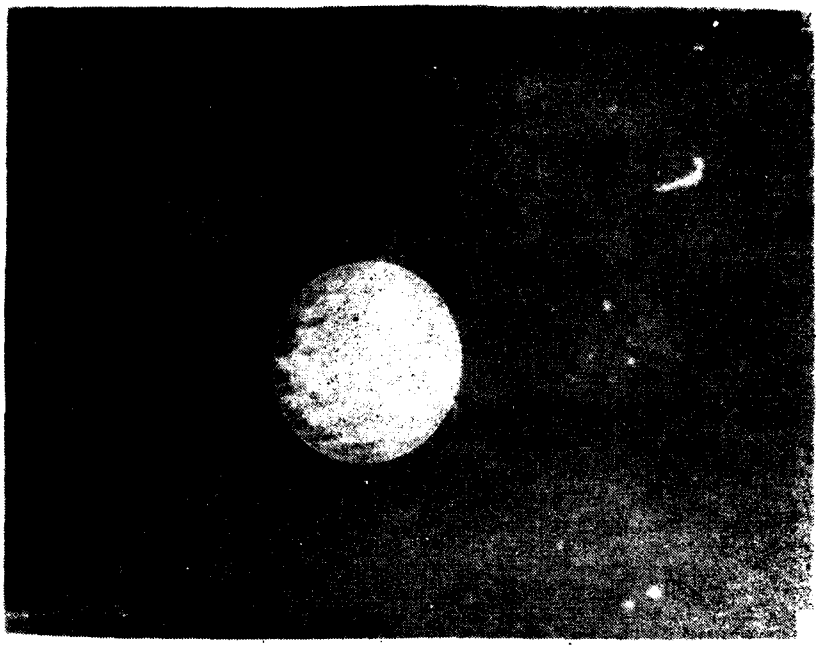
317084 ACTUATOR PISTON AFTER
656.24 HOURS OF OPERATION IN
AO-8 FLUID

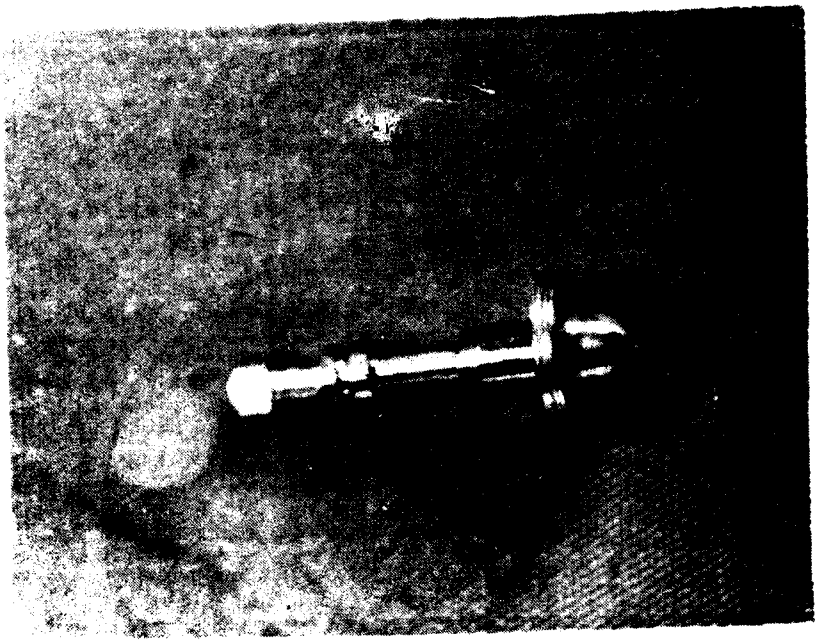
314445 PILOT VALVE AFTER
713:49 HOURS OF OPERATION
IN AO-8 FLUID
