TECHNICAL REPORT ARPAD-TR-81007

INCREASING THE CLARITY OF ULTRASONIC CRACK DETECTION SIGNALS FROM BASES MOUNTED ONTO LOADED 155-MM M483A1 PROJECTILES

HENRY HARTMANN

JANUARY 1983

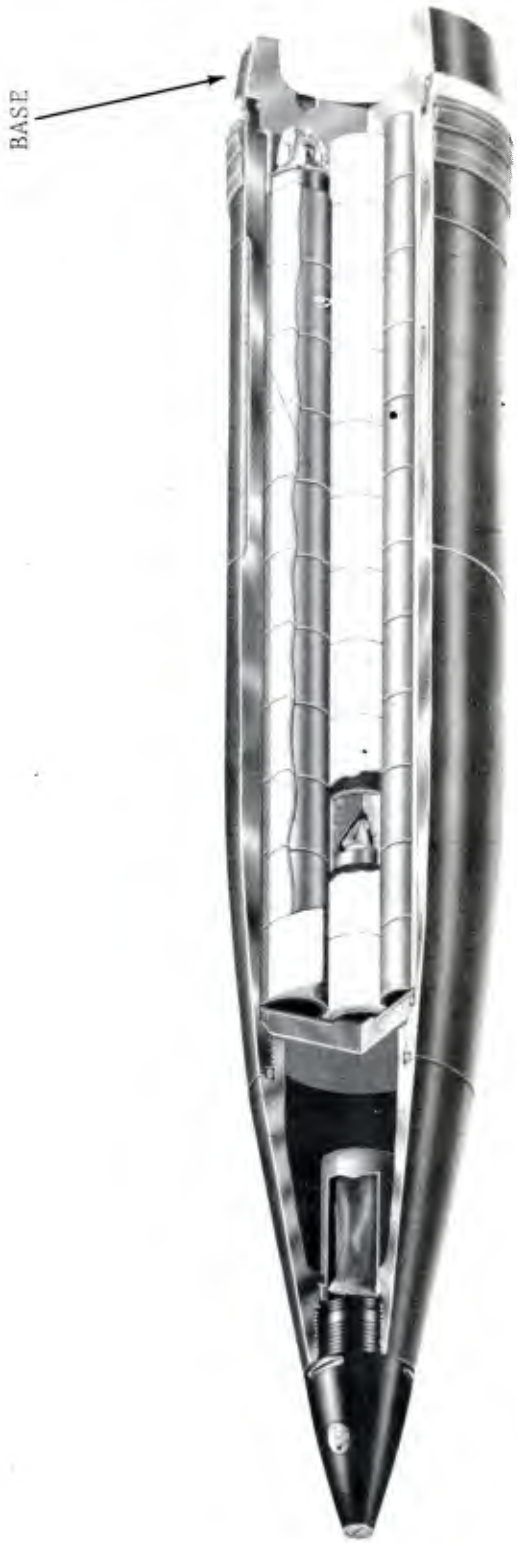
Cracked bases have been found on loaded 155-mm M483A1 projectiles (fig. 1). A nondestructive inspection technique is needed to screen the involved portion of stockpile. Ultrasonic inspection provides the best capablity for inspecting bases that are still attached to loaded projectiles.

Figure 1. 155-mm M483A1 projectile

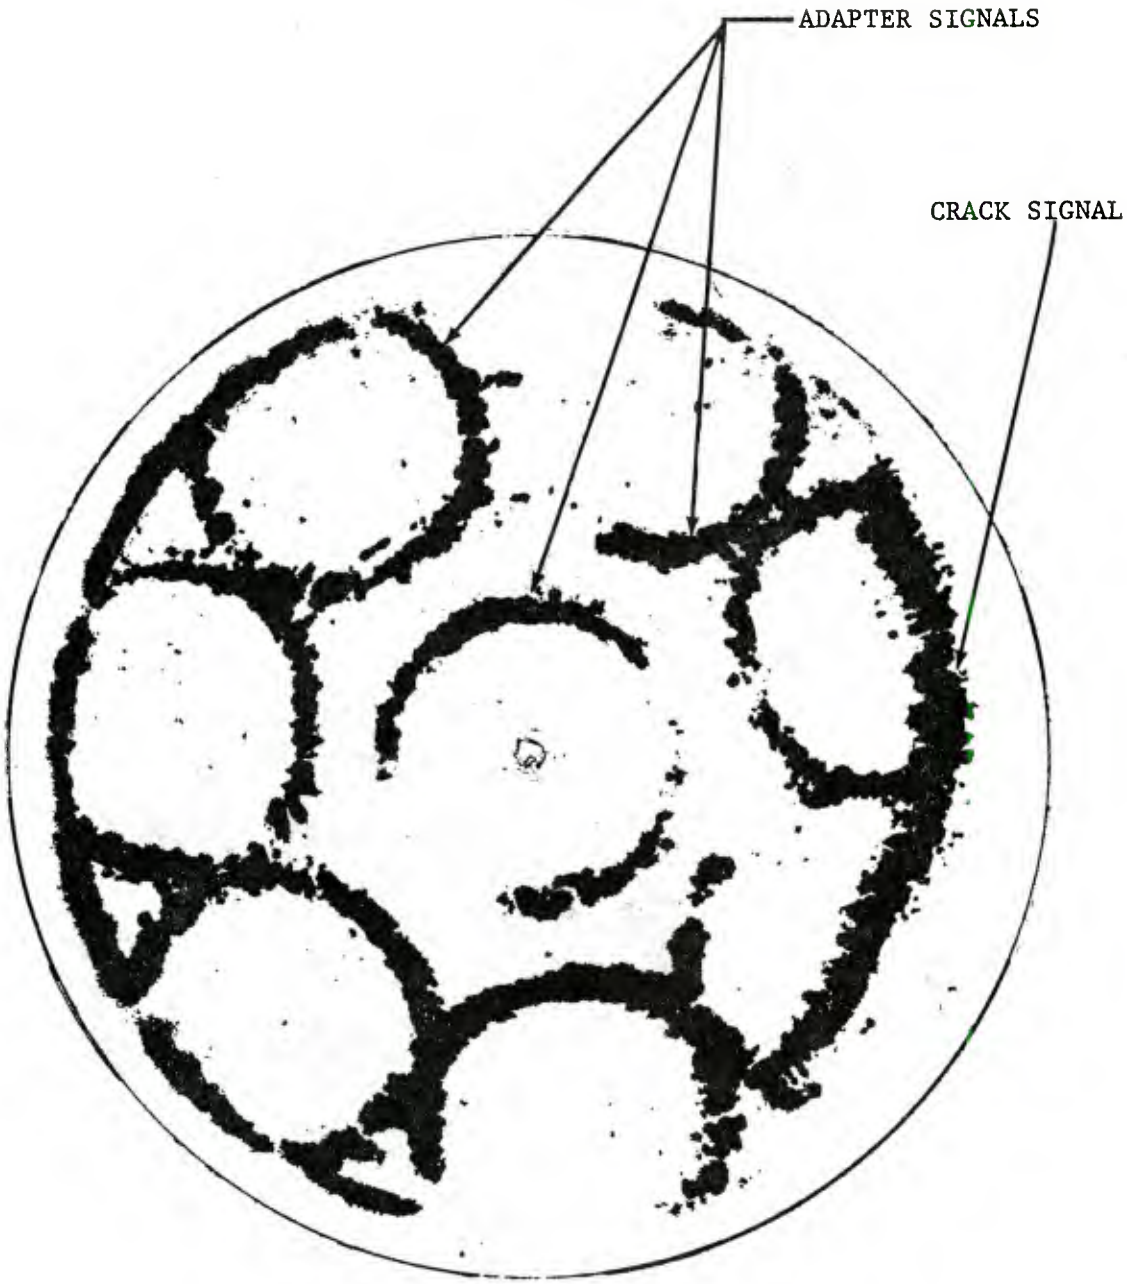
Four locations on the base were selected for monitoring. Two of these locations were where the adapter signals were most intense; the other two were where the crack signals were greatest. (The distribution of adapter signals is called "pressure patterns.") For the various conditions imposed, peak ultrasonic signals were recorded from these four locations. Several of the parameters were evaluated, one at a time, and data were recorded (table 1).

Figure 3. Ultrasonic C-scan showing distribution of crack and adapter signals

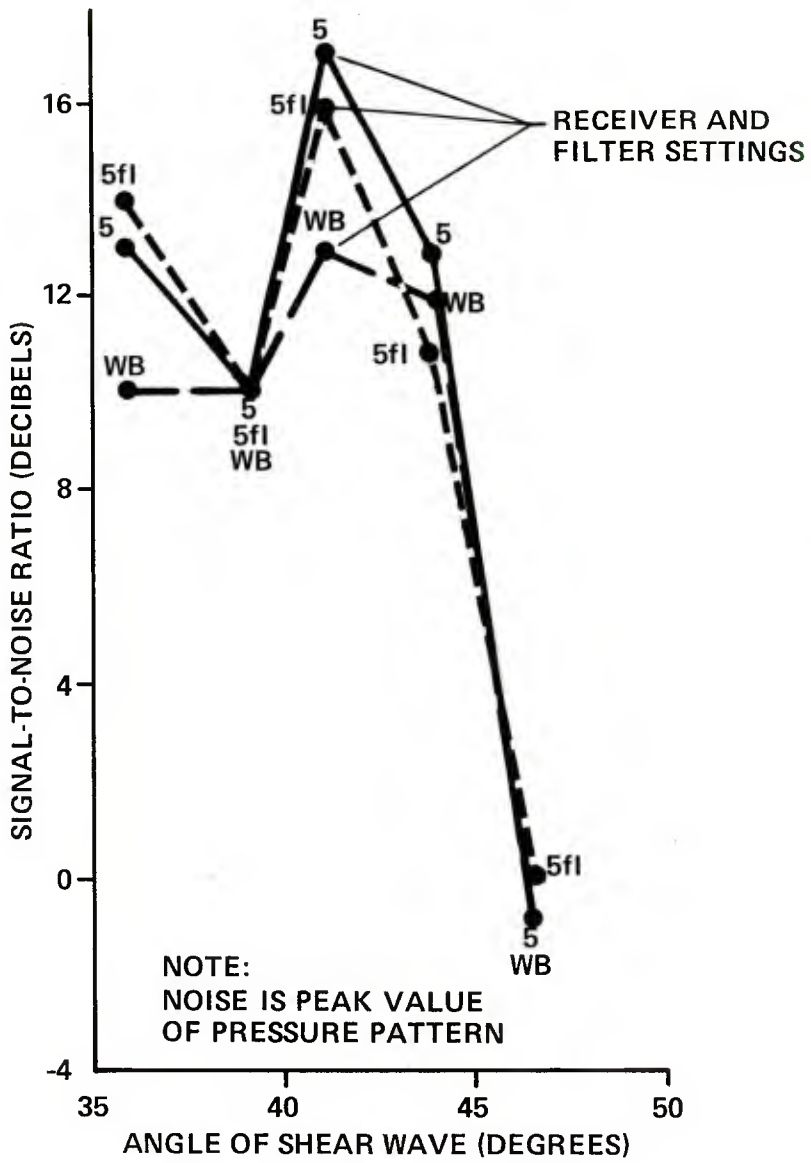
One of the top performances was accomplished by transducer A (fig. 5). Transducer A was quite selective in its shear wave angle-of-refraction. Peak performance occurred at a refracted angle-of-shear of 41 degrees.

Figure 5. Clarity of ultrasonic echoes from a natural crack by use of transducer A (5 MHz, narrowband, 19-mm diameter active element, cylindrically focused at 102 mm)

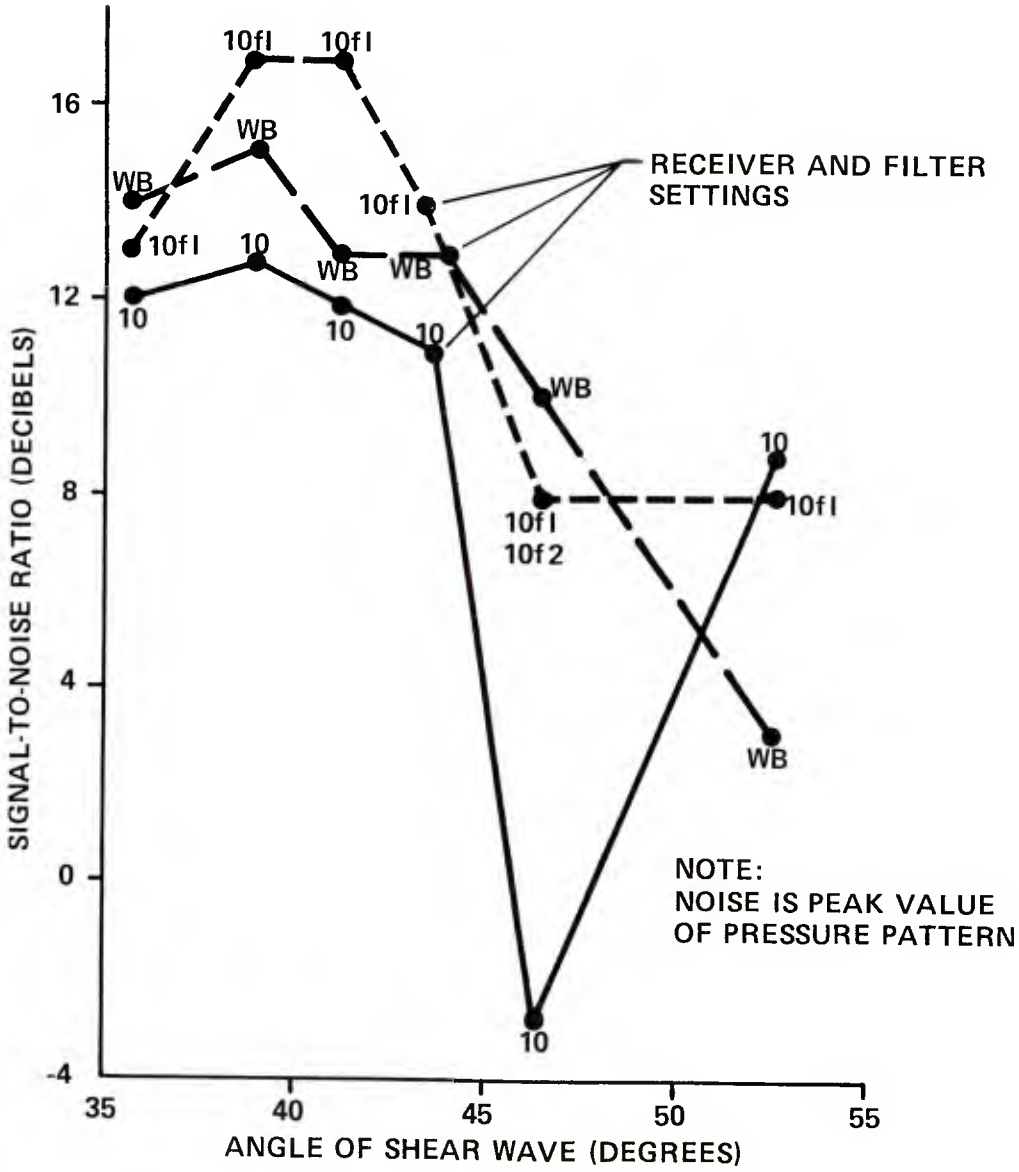
An even better shear wave angle-of-refraction was evident in the performance of transducer B (fig. 6). The peak performance occurred at a refracted angle-of-shear between 39 and 41 degrees.

Figure 6. Clarity of ultrasonic echoes from a natural crack by use of transducer B (10 MHz, wideband, 6.4-mm diameter active element, flat lens)

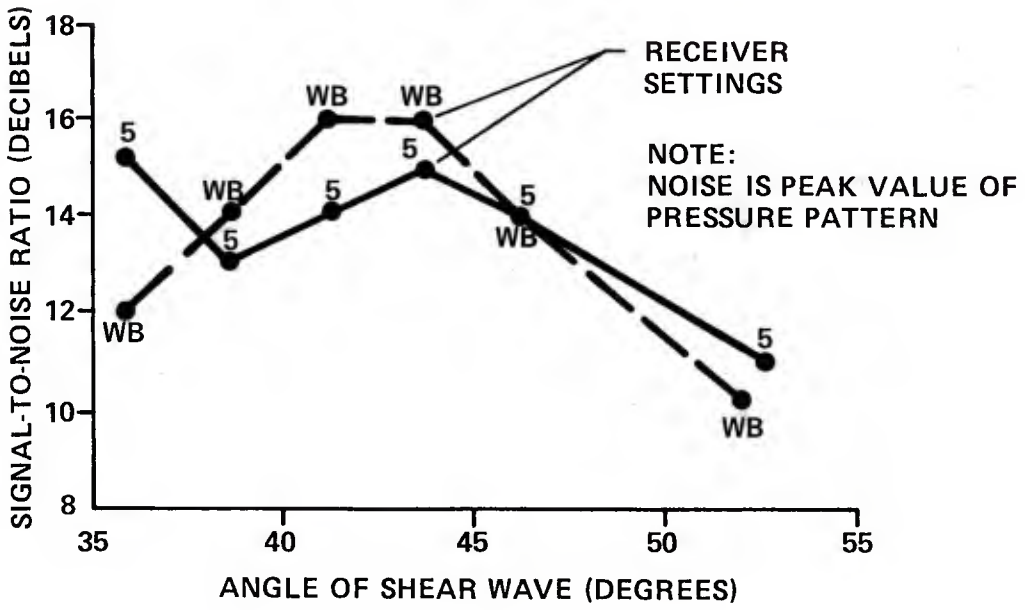
Figure 7. Clarity of ultrasonic echoes from a natural crack by use of transducer C (5 MHz, narrowband, 6.4 mm diameter active element, flat lens)

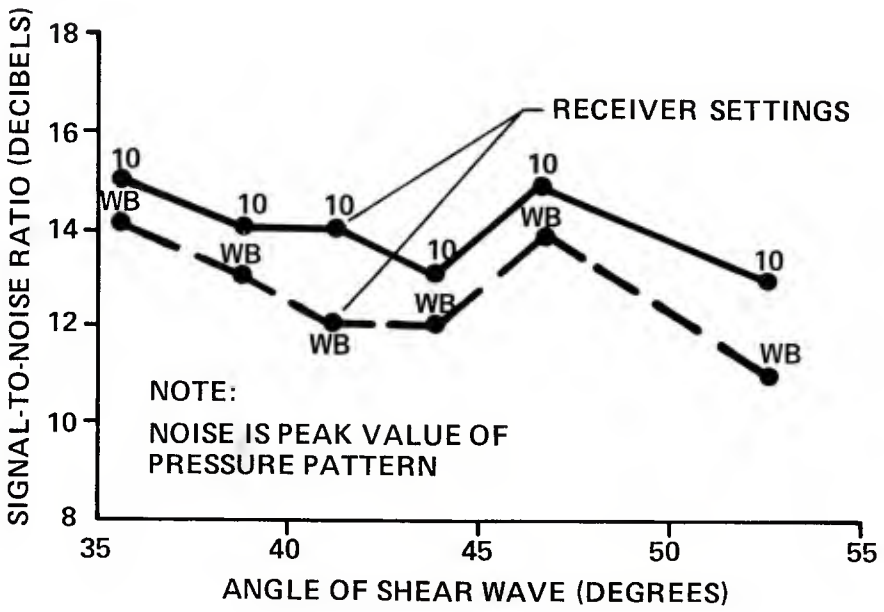
Figure 8. Clarity of ultrasonic echoes from a natural crack by use of transducer D (10 MHz, narrowband, 19 mm diameter active element, cylindrically focused at 102 mm)

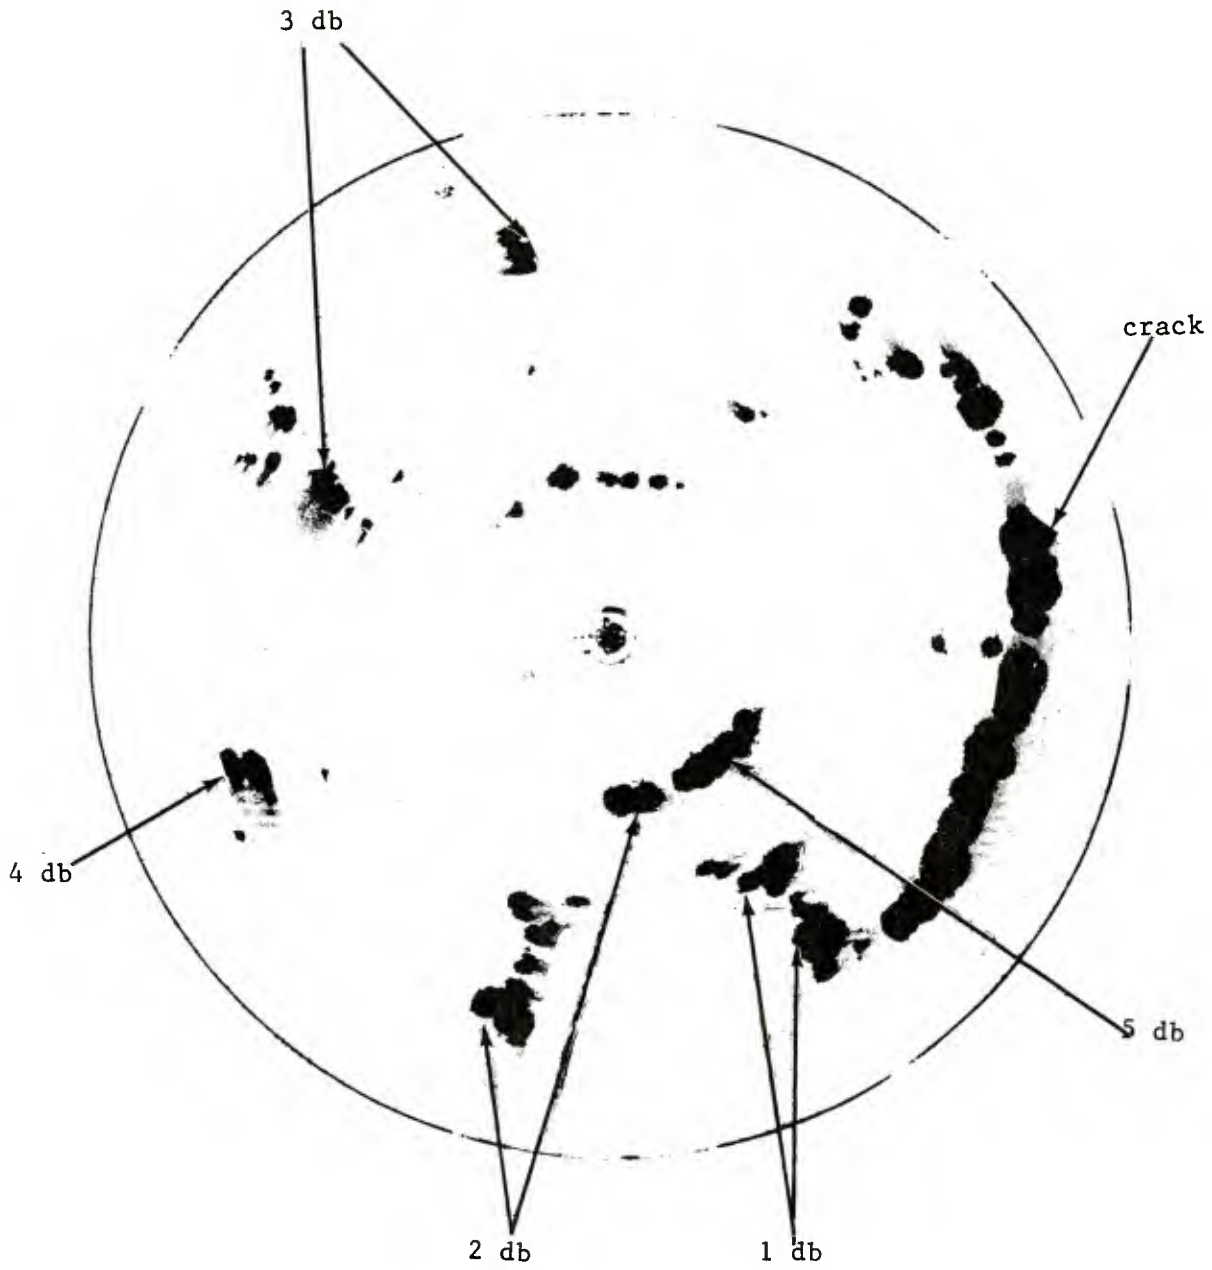
Using figure 10 as a reference, when an additional offset of the transducer of only 1 mm (0.04 in.) was induced and another C-scan recorded (fig. 11), adapter signals decreased rapidly. The greatest reduction occurred toward the center of the base where the strongest signal (5 db on the center adapter) disappeared. Further out towards the perimeter, a portion of only a 1-decibel adapter signal still remains. This occurrence reveals that the inspection orientation with the metal machining ridges on the forward surface of the base affect the intensity of the adapter signals. If these tiny machined ridges were not present, chances are that ultrasonic signals from the pressure of the adapters would not be a problem. Since the orientation of most deep cracks is circumferential, a radial crack detection position of a transducer (which will be normal to these cracks) is the best orientation.

Figure 10. Ultrasonic C-scan showing peak signals from a cracked base mounted in the simulated projectile body by use of a transducer B offset 0.5 mm to the right

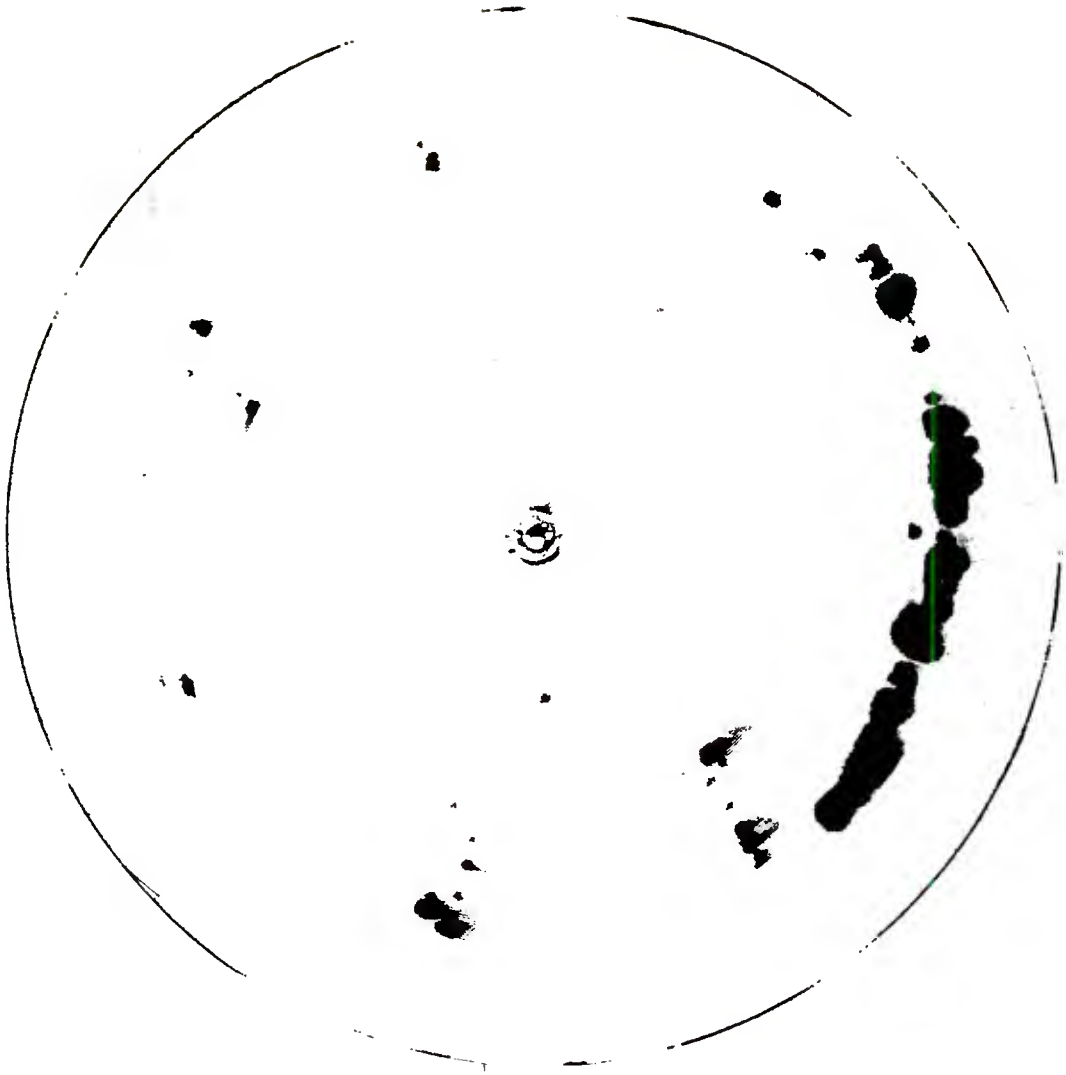
Figure 11. Ultrasonic C-scan of cracked base mounted in the simulated projectile body by use of transducer B offset 1.5 mm to the right
