VERMILION HARBOR, OHIO

DETAILED PROJECT REPORT ON SECTION 111 SHORE EROSION STUDY

STAGE 3 DOCUMENTATION

U.S. ARMY CORPS OF ENGINEERS
BUFFALO DISTRICT
1776 NIAGARA STREET
BUFFALO, NEW YORK 14207

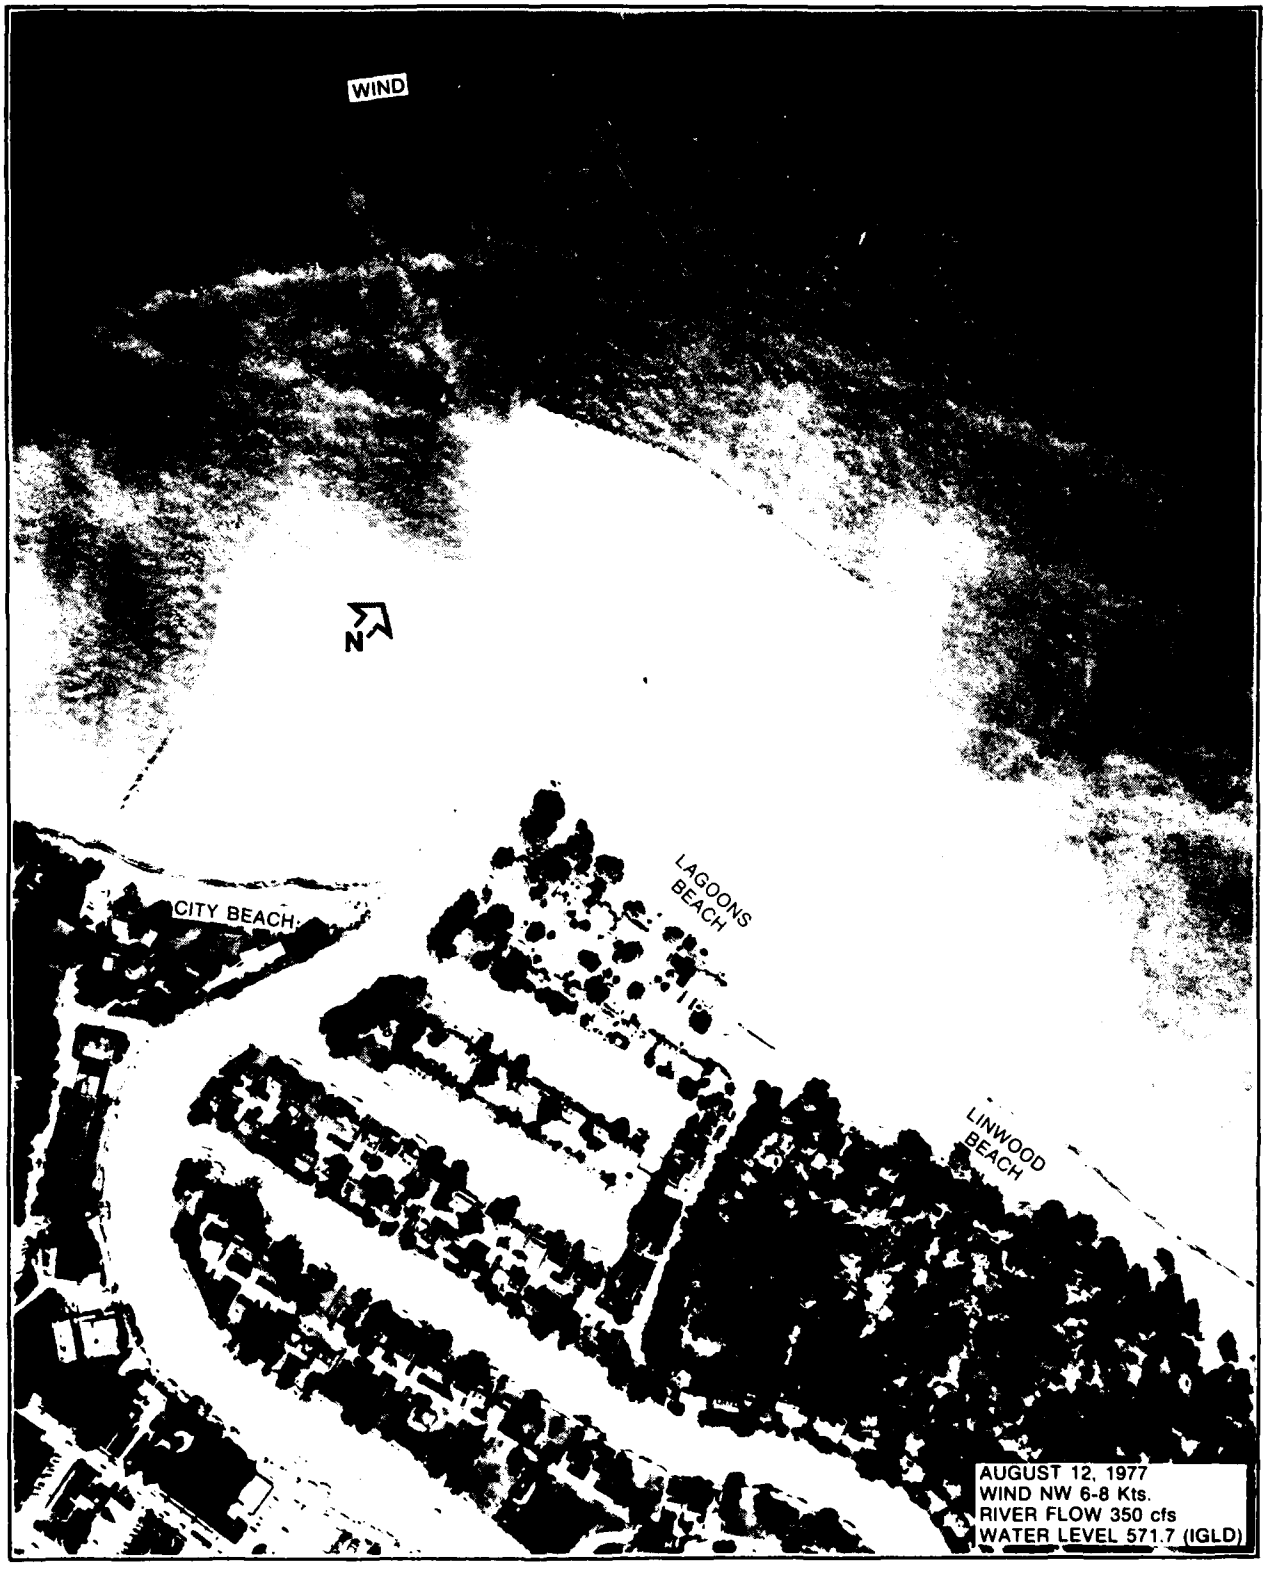
In recent years, however, the accretion has been greater east of the East Pier. (Photo 3.1). Prior to construction of the breakwater in 1973, the Lagoons Beach immediately to the east of the East Pier was about 200 feet wide. Since construction of the breakwater, this beach has accreted an additional 300 feet, apparently due to the shadowing effect of the breakwater.

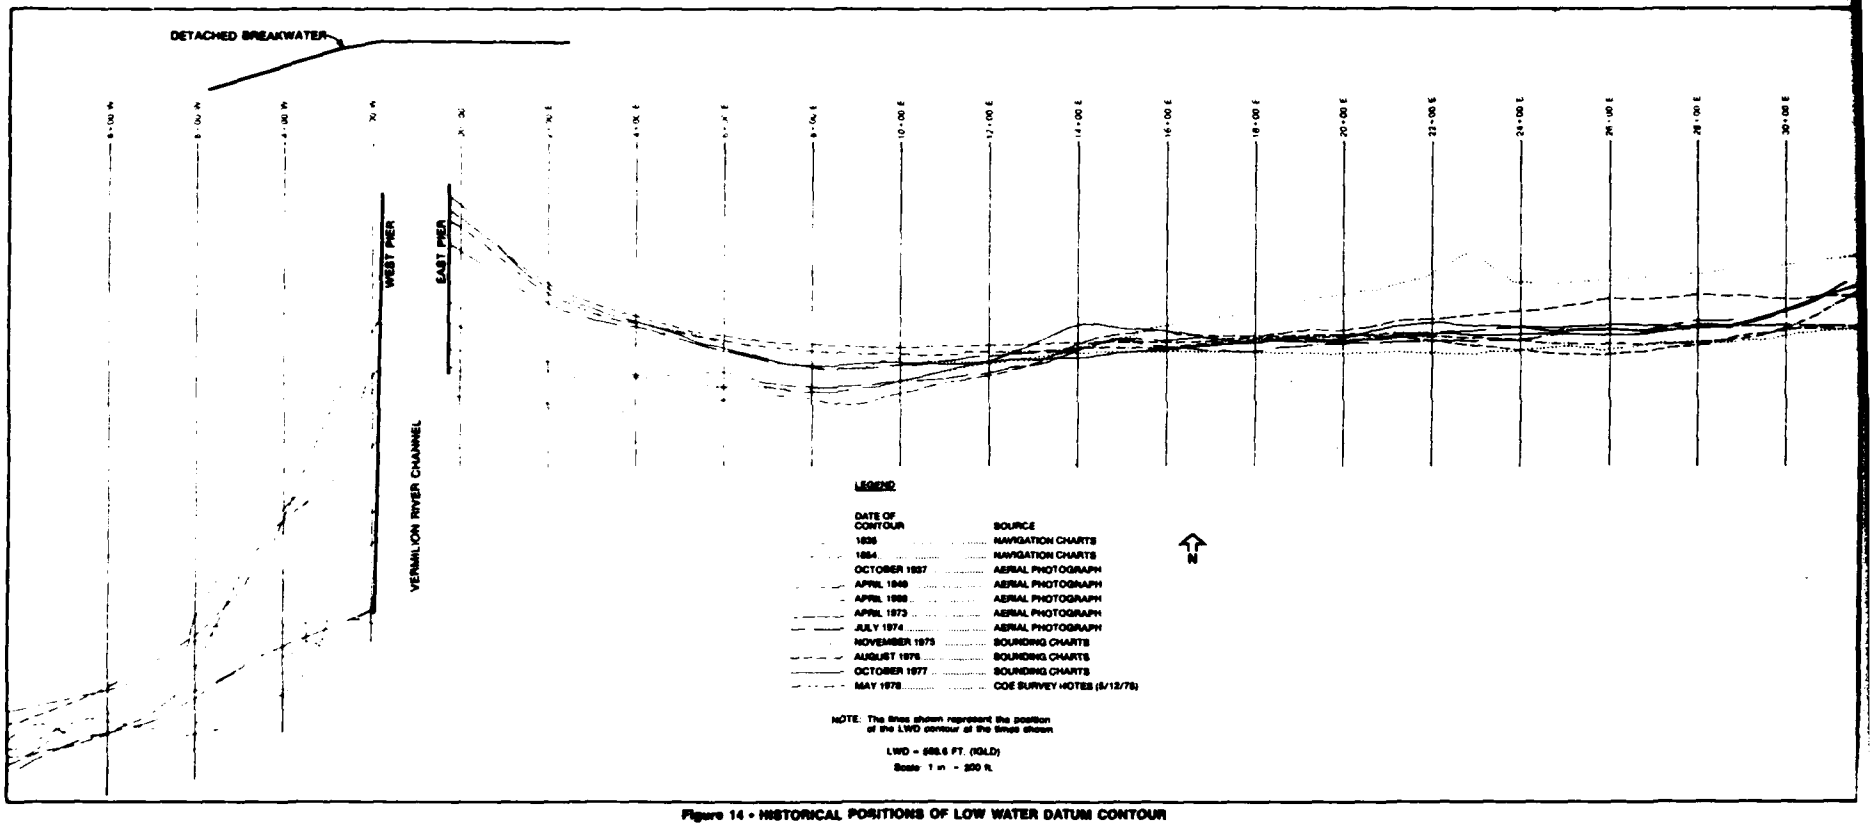
Figure 14 • HISTORICAL POSITIONS OF LOW WATER DATUM CONTOUR

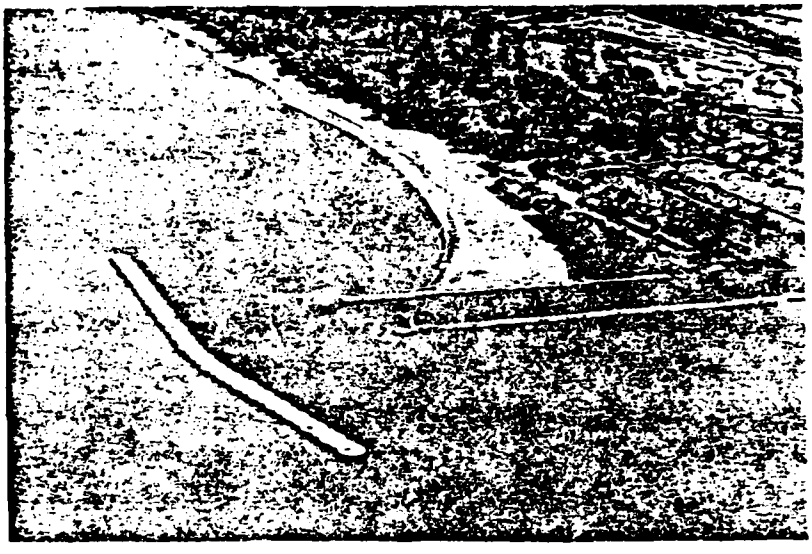
No. 1 - Aerial photo showing mouth of Vermilion River and Lagoons Beach before sand pumping demonstration

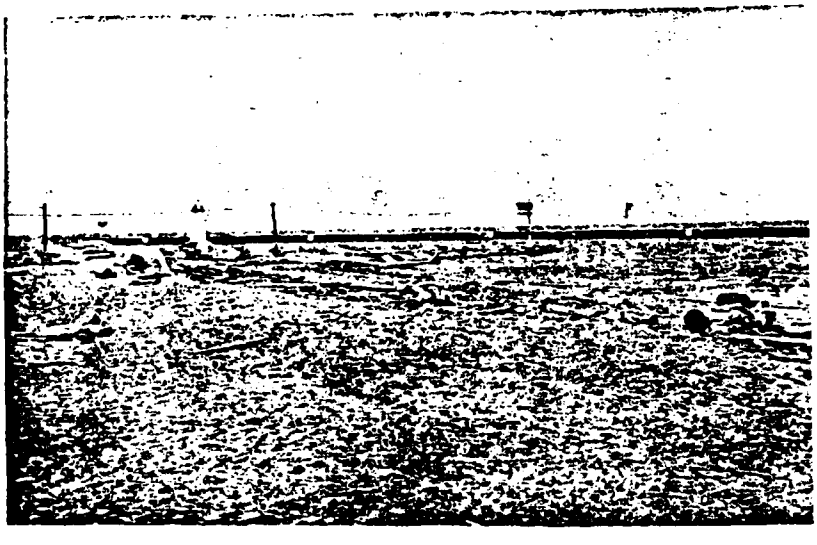
No. 2 - Lagoons Beach before sand pumping demonstration looking offshore towards east and west piers, respectively, and the detached breakwater

10. As originally planned, this project entailed the dredging of approximately 15,000 cubic yards of sand from Area A at Lagoons Beach (Photos No. 2, 3, and 4), and depositing it along the Linwood Beach (Photo No. 5) at Area B, as shown on Plate 3. The amount was selected for the following reasons: (a) an estimated 15,000 cubic yards of sand deposited at Linwood Beach would provide the Linwood Park residents a suitable beach for the summer while having a minimal adverse impact upon the Lagoons Beach; and (b) due to the initially perceived time constraints (approximately 1 month to perform the work), no more than 15,000 cubic yards could be pumped, even with excellent working conditions, and that this amount would be a sufficient amount of sand to monitor its movement downdrift back to Lagoons Beach.

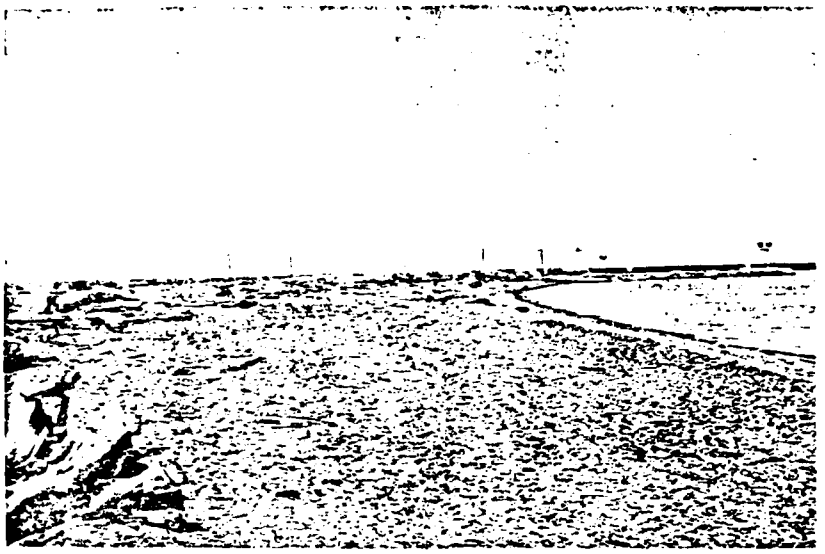
No. 3 - Lagoons Beach before sand pumping demonstration; same view as Photo No. 2 but further away from piers

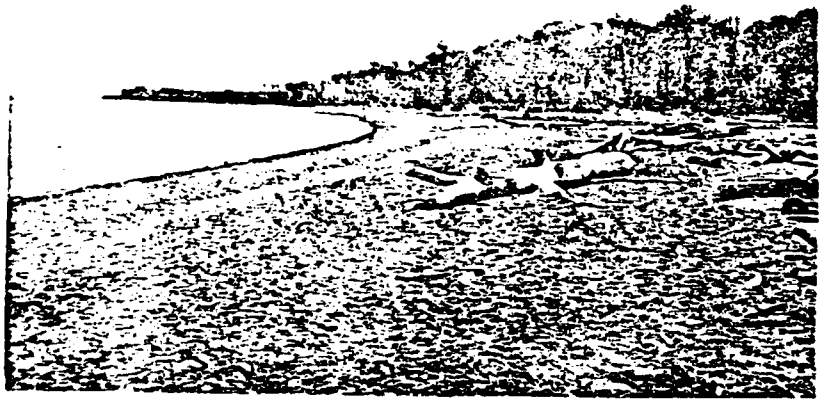
No. 4 - Lagoons Beach before sand pumping demonstration looking away from piers towards Linwood Beach which is in the far background

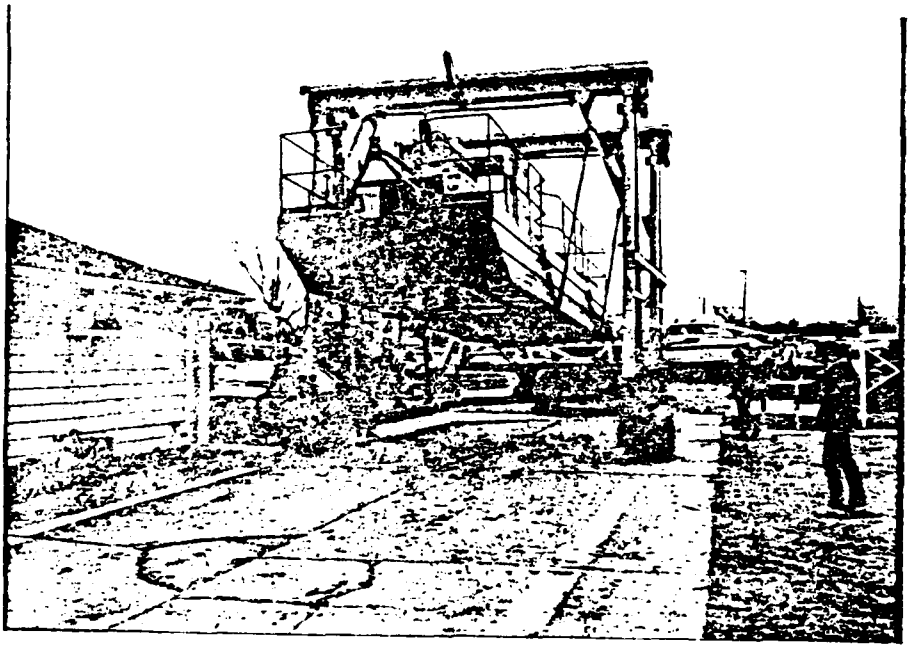
No. 5 - Linwood Beach before sand pumping demonstration
