LAKE GAILLARD DAM
CT. 00387

PHASE I INSPECTION REPORT
NATIONAL DAM INSPECTION PROGRAM

Identification Number:	CT 00387
Name:	Lake Gaillard Dam
State Location:	Connecticut
County Location:	New Haven
Stream:	Branford River
Date of Inspection:	August 1, 1978

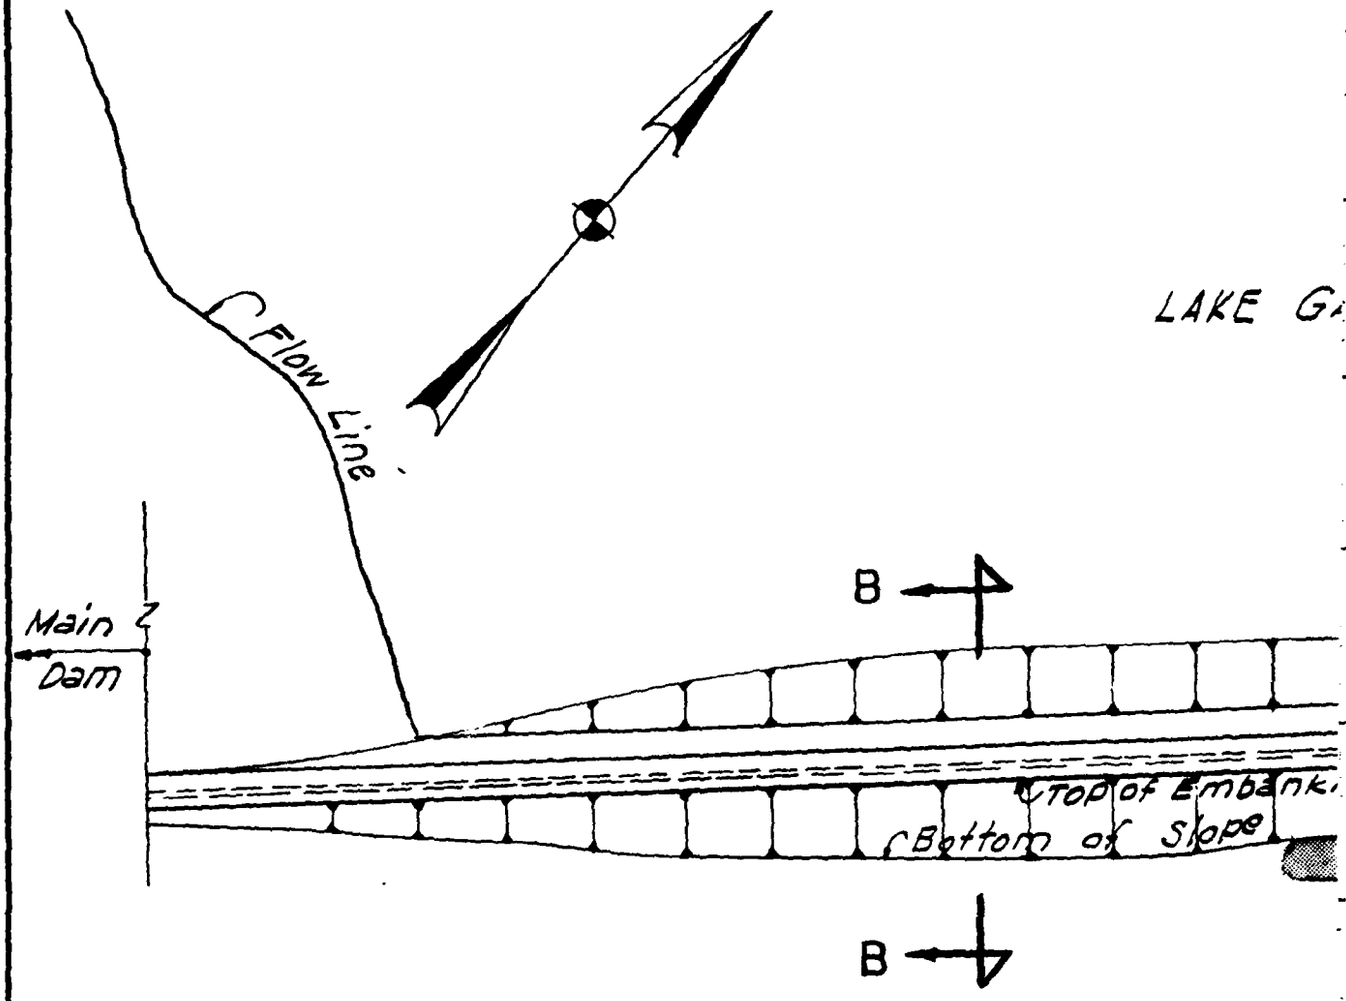
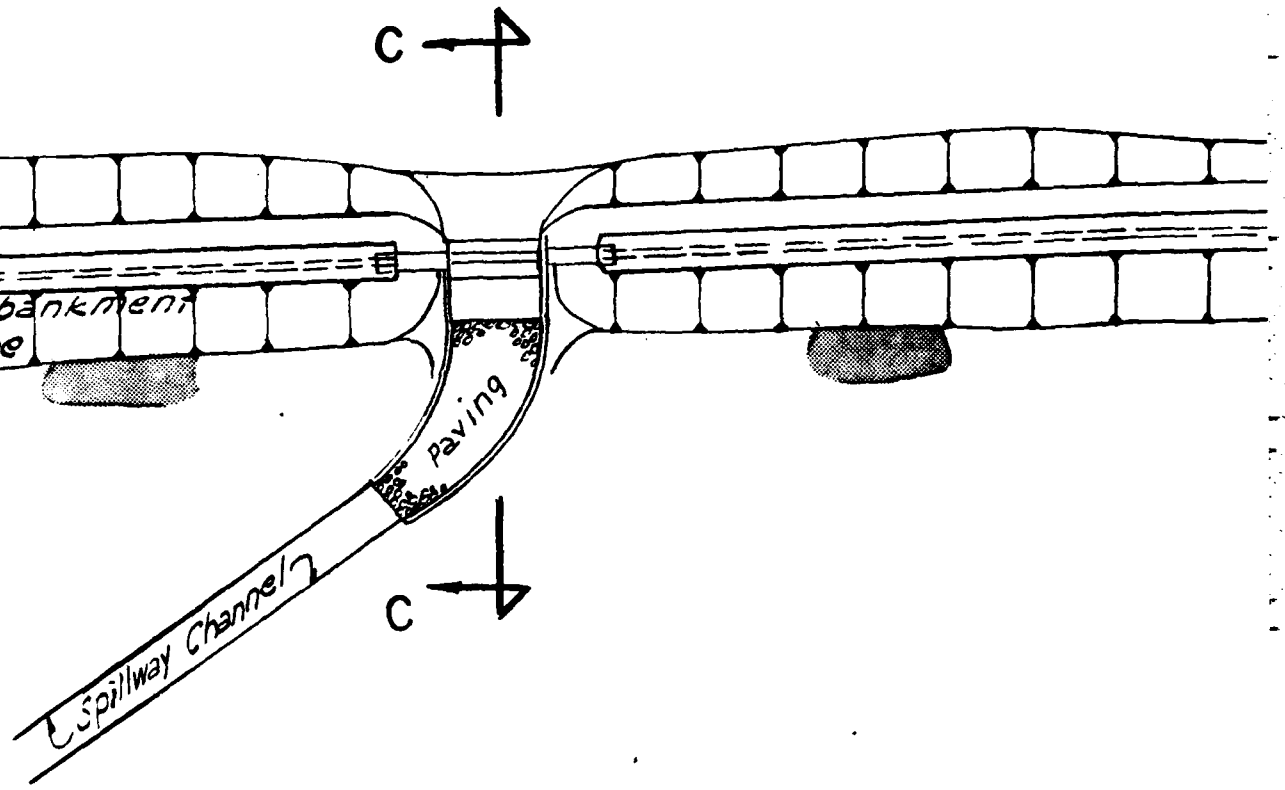
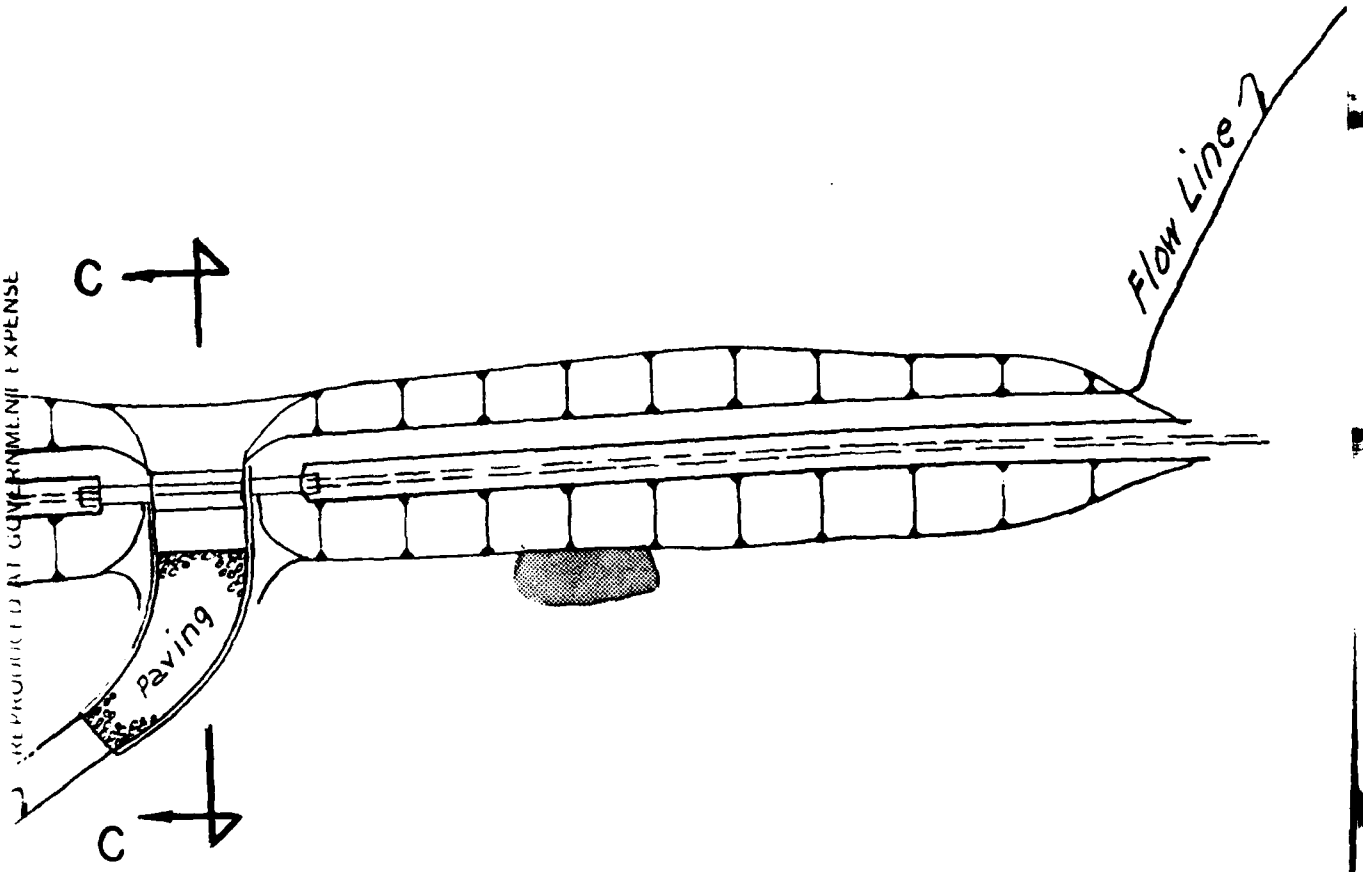
PLATE-2

The east dike where the water level is approximately 3 to 5 feet below the spillway crest has a straight alignment with no signs of movement or distress. In two spots that are delineated on Plate 2, Appendix B, there are wet or soft areas which are usually dry only during the month of August. Although these spots are spongy, there is no visible sign of any seepage.

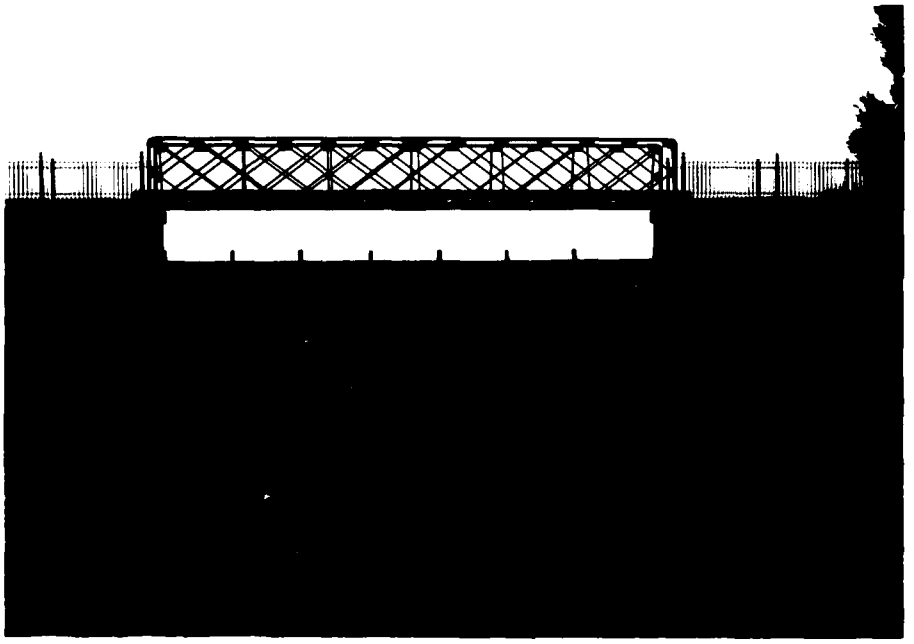
PHOTO 2
DOWNSTREAM FACE OF SPILLWAY

The spillway on the east dike is made of reinforced concrete and appears very sound. A steel truss pedestrian bridge with a wooden walkway spans the spillway width. The decking of the walkway has rotted and it is in need of repair.
