GEOPHYSICAL SEEPAGE DETECTION STUDIES MILL CREEK DAM WALLA WALLA, WASHINGTON

Dwain K. Butler, Ronald E. Wahl,
Michael K. Sharp

August 1984
Final Report

REPORT DOCUMENTATION PAGE		READ INSTRUCTIONS BEFORE COMPLETING FORM
1. REPORT NUMBER Miscellaneous Paper GL-84-16	2. GOVT ACCESSION NO. AD-A146409	3. RECIPIENT'S CATALOG NUMBER

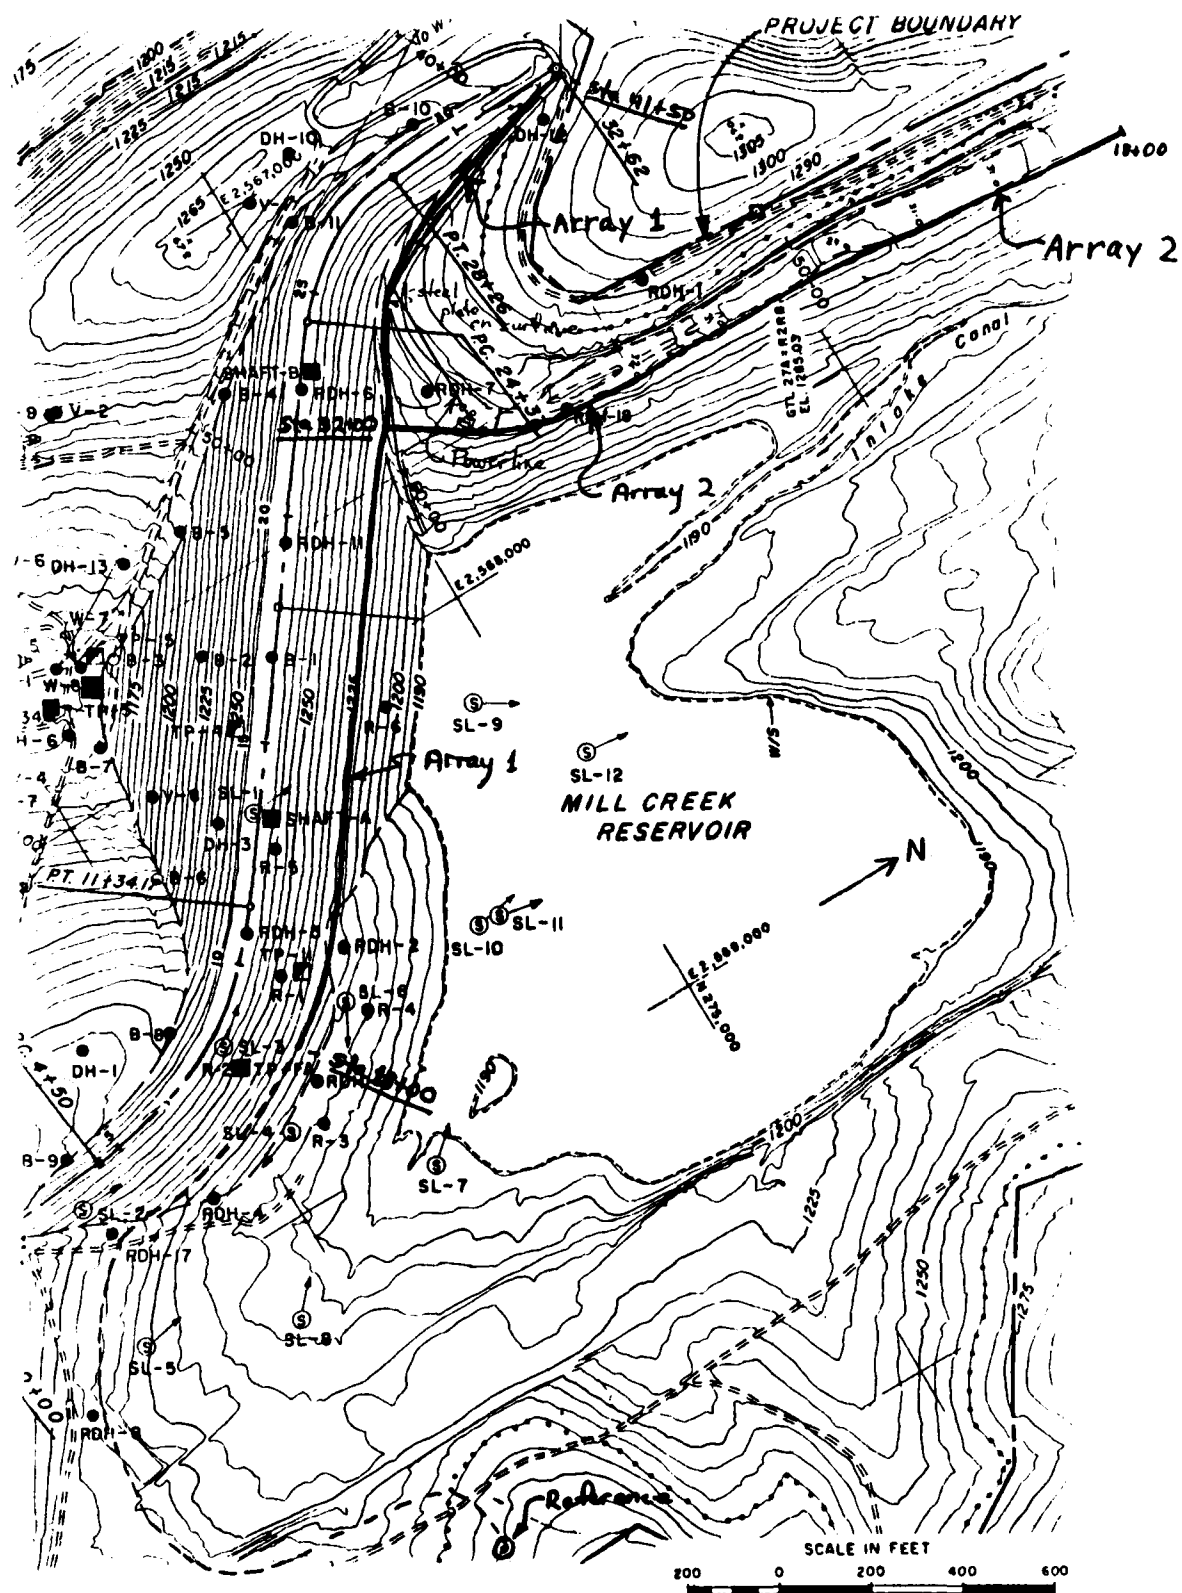
Figure 1. Mill Creek Dam site map showing locations of SP Arrays 1 and 2.
(Drill hole designations and other symbols on site maps used in
this report are explained in the August 1979 General Design
Memorandum No. 5, Walla Walla District.)

4. Two SP electrode arrays were installed by WES and Walla Walla District personnel as shown in Figure 1. Array 1 was installed from Station 18+00 to Station 41+50 along the elevation 1225 ft contour on the upstream face of the dam, slightly downstream of the location of the cutoff wall. Array 2 ties in to Array 1 at Station 32+00 and proceeds approximately perpendicular to Array 1 from 0+00 to 18+00 (separate stationing scheme from Array 1). Electrode spacing along both arrays is 50 ft. A reference electrode was located approximately 1200 ft east of Station 18+00 of Array 1 (upstream of dam).

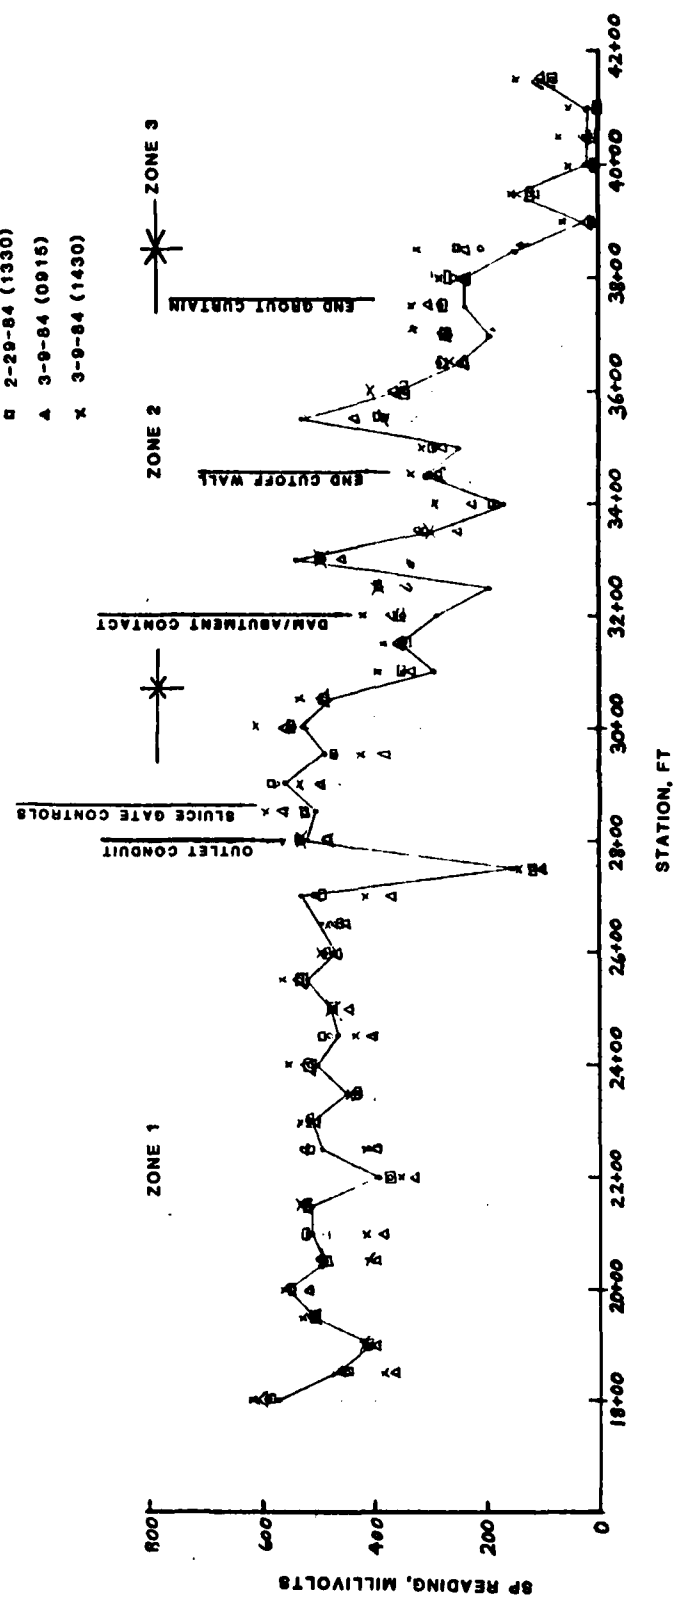
Figure 2. Unprocessed Array 1 SP Data (Pre-Test Fill) showing identification of three zones based on the data and location of selected features along the array. Pool elevation—118- ft.

10.   Figure 2 is a summary plot of unprocessed Array 1 data for 3 days (prior to the test filling). The data in Figure 2 illustrate two features of the results: (1) the data vary considerably along the length of the array; (2) for a given station, the SP values vary with time. The individual station values vary by as much as 100 millivolts. Examination of Figure 2 as well as the plots in Appendices B and D reveals that plots for a given day are generally parallel to plots for other days along the arrays, i.e., the average value for the arrays shifts (e.g., a reference shift). Figures 3 and 4 show array averages versus time. Since the array average versus time trend as well as the individual electrode versus time trends (Appendices C and E) are qualitatively similar, it seems that the predominant cause for time variations are reference level shifts which affect an entire array similarly. Thus the array averages seem to be good reference level indicators.

11.   Examination of the plots in Figure 2 reveal 3 zones along the dam; these zones were also noted in the original SP data collected by WES personnel in December 1983. The zones are characterized by apparent changes in average value along the array; for example, the average value changes from approximately 500 mv for Zone 1 to 300 mv for Zone 2 to 50 mv for Zone 3. This same pattern of zones is observed for the array profiles during the test filling, and the array averages as well as the zonal averages generally decrease with time during the test filling. Several features are worth noting in Figure 2: (1) the large anomaly at Station 27+50 of Array 1 nearly coin- cides with the outlet conduit; (2) the Zone 1/Zone 2 boundary approximately coincides with the dam/abutment contact; (3) the Zone 2/Zone 3 boundary approximately coincides with the end of the grout curtain. Possible explana- tions for observations (2) and (3) above are that the Zone 1/Zone 2 boundary is due to a lateral change in material type and that the Zone 2/Zone 3 boundary is due to a lateral change in groundwater flow regimes caused by the presence of the cutoff wall and grout curtain.

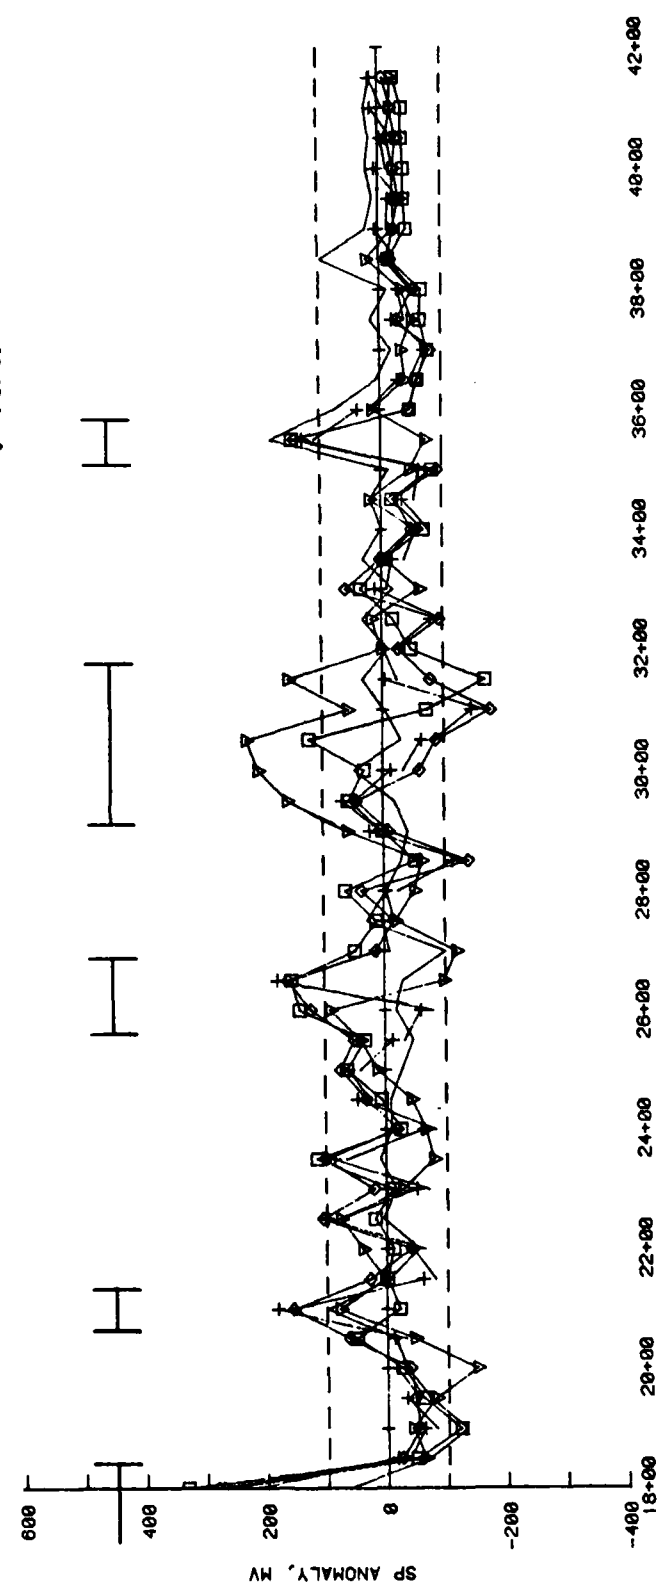
Figure 6. SP anomaly profiles for Array 1, referenced to the 4-5-84 data.

13. For Array 1, processed SP anomaly plots were generated using both the pre-test fill 9 March data and the 5 April (first day of test fill) as baseline profiles. Figures 5 and 6 contain summary plots of several Array 1 SP profiles referenced to 9 March and 5 April respectively. Figure 7 presents anomaly plots for several Array 2 profiles referenced to the 5 April profile.

15. In order to interpret the SP anomaly plots, a 100 millivolt threshold will be used for attaching significance to an anomaly. This procedure may be overly conservative, but at least spurious anomalies caused by time variations or variations in contact potential at individual electrodes will be eliminated. The 100 millivolt threshold is shown in Figures 5-8. Anomalous zones which exceed the threshold are indicated on the figures.

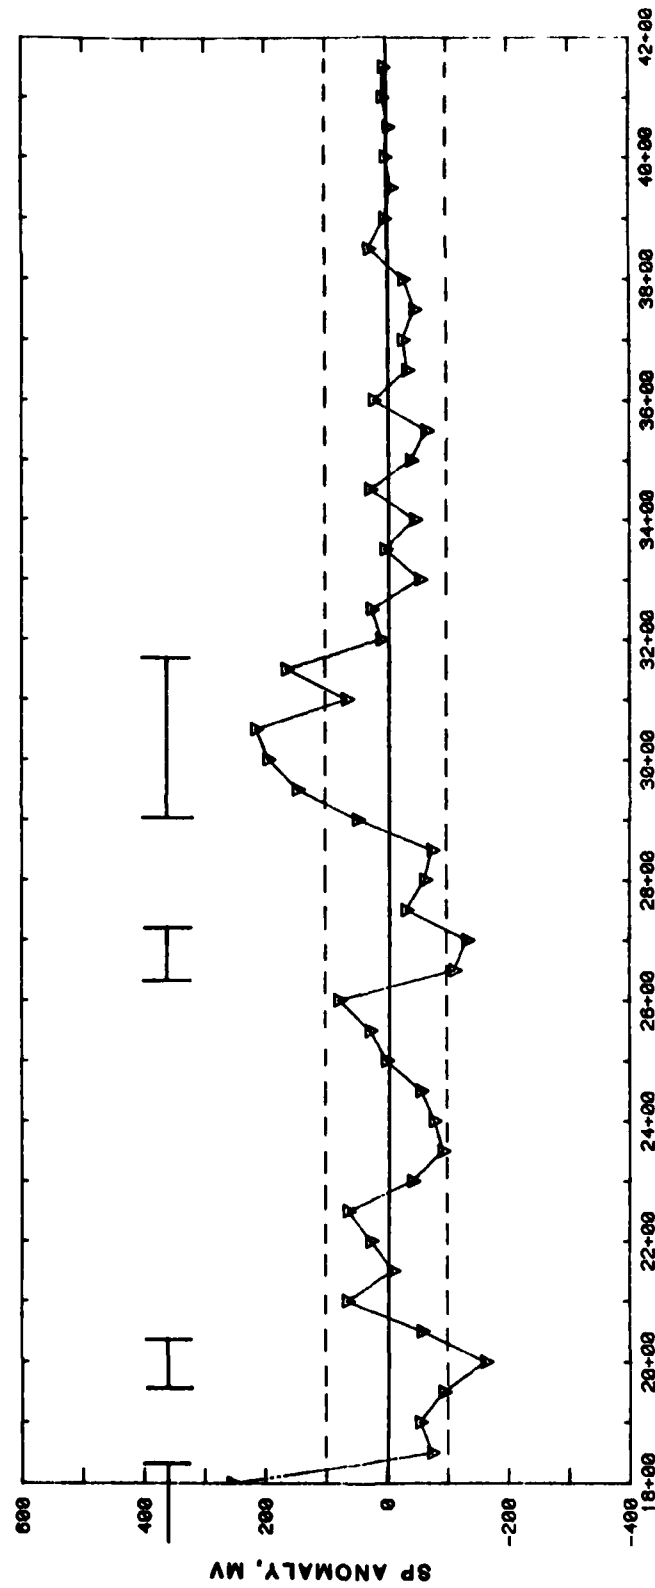
Figure 8. SP anomaly profile for 4-20-84 referenced to the 4-5-84 data using zonal averages.

14. For Array 1, a second type of processed anomaly plot was generated. Zone averages, for the three zones along the array, were computed for 5 April and 20 April, and an anomaly plot was produced using the zone averages instead of the array averages. Figure 8 is the zone average anomaly plot for Array 1.

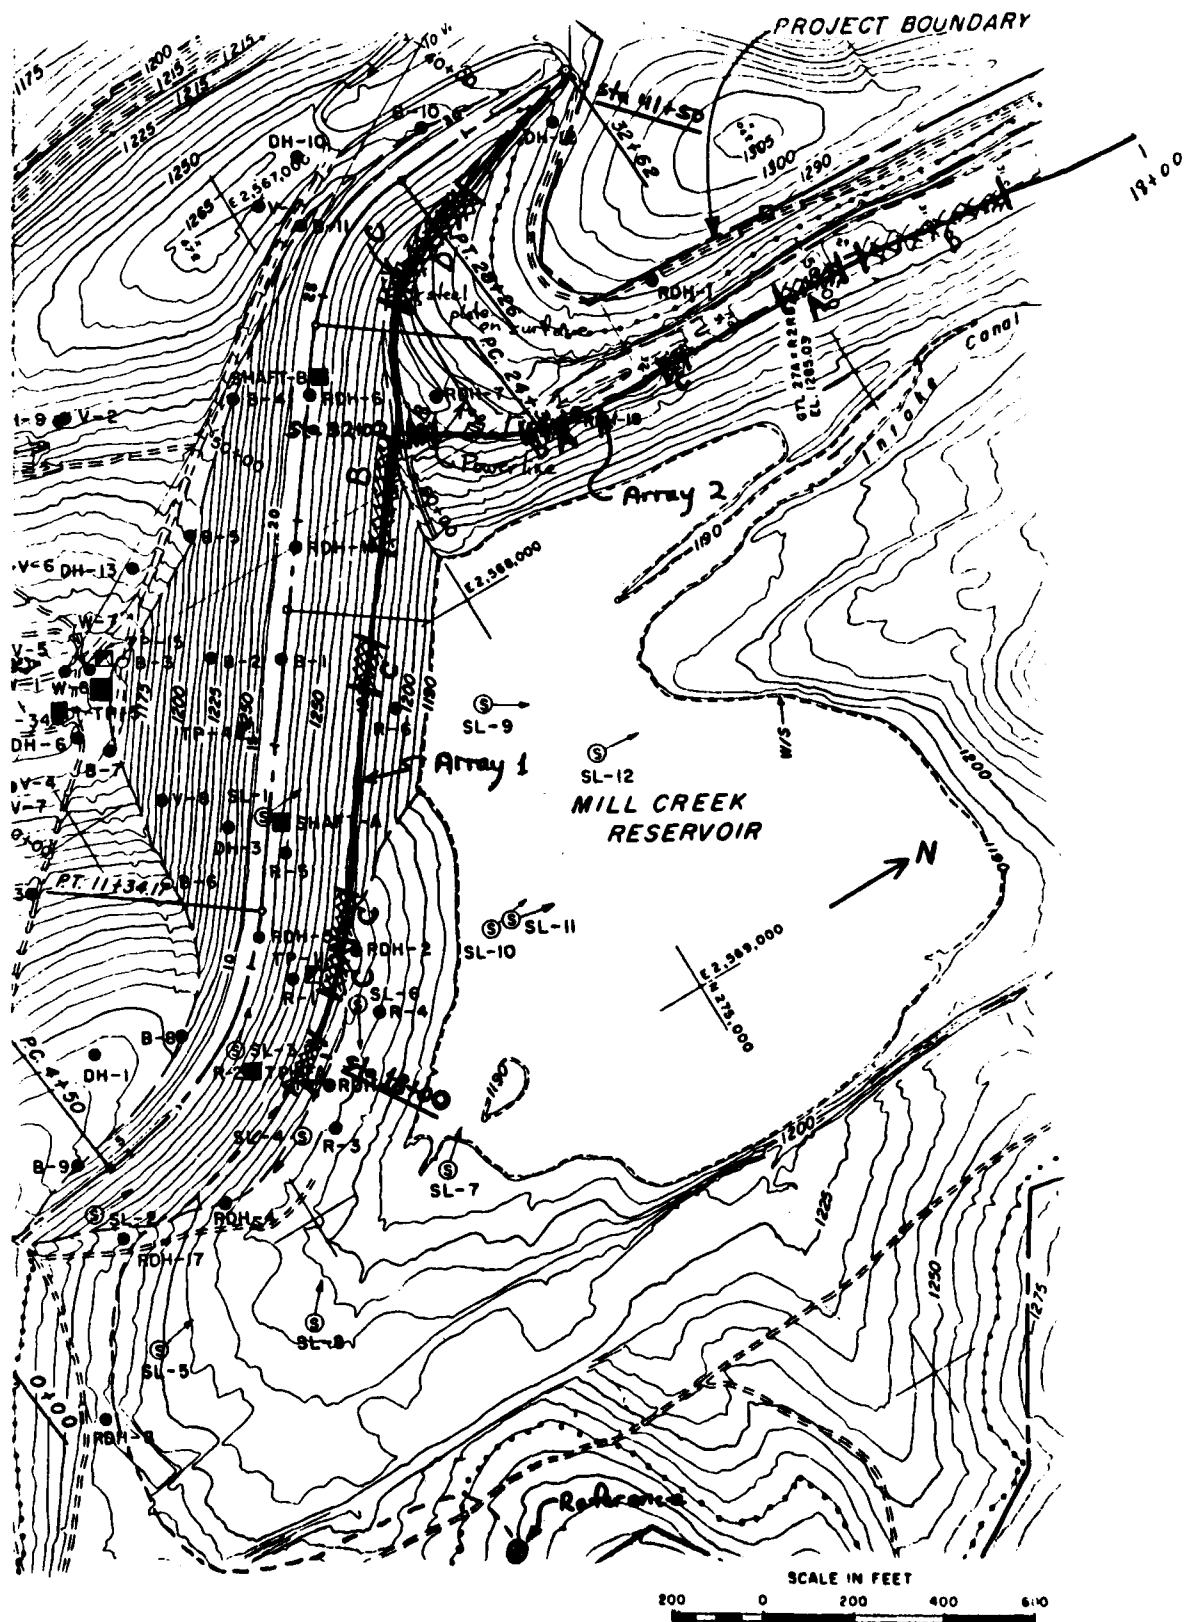
Figure 9. Interpreted SP anomalous zones. See text for explanation of significance ranking.

These anomaly zones are shown as cross-hatched segments along the two arrays in Figure 9. The interpreted anomalies and associated significance ranking should be utilized in conjunction with known geology, construction history and details, and piezometer data in making the final seepage assessment.

18. Conclusions are presented with reference to Figure 9. The field arrays were designed for a monitoring function during the test fill and not a mapping function, hence it is not possible to predict seepage directions unambiguously from the interpreted SP anomalous zones in Figure 9. The key conclusions are as follows:

a. Only two highly significant SP anomalies are interpreted along Array 1, 17+00 to 18+25 and 29+25 to 31+75;

b. Two highly significant anomalies are interpreted along Array 2, 3+25 to 3+75 and 9+25 to 10+75;

c. Array 1 anomaly 29+25 to 31+75 and Array 2 anomaly 00+25 to 00+75 occur in the vicinity of the dam/right abutment contact;

d. The anomaly indicated from 35+00 to 38+00 on Array 1 is poorly defined and is the only anomalous zone from 32+00 to 41+50 of Array 1, hence possible correlation of anomalous zones on Array 2 with this section of Array 1 is not well justified;

e. The anomaly from 17+00 to 18+25 of Array 1 apparently coincides with an area identified by District personnel as exhibiting anomalous piezometer response and as the most likely area of a "deficiency" in the cutoff wall.

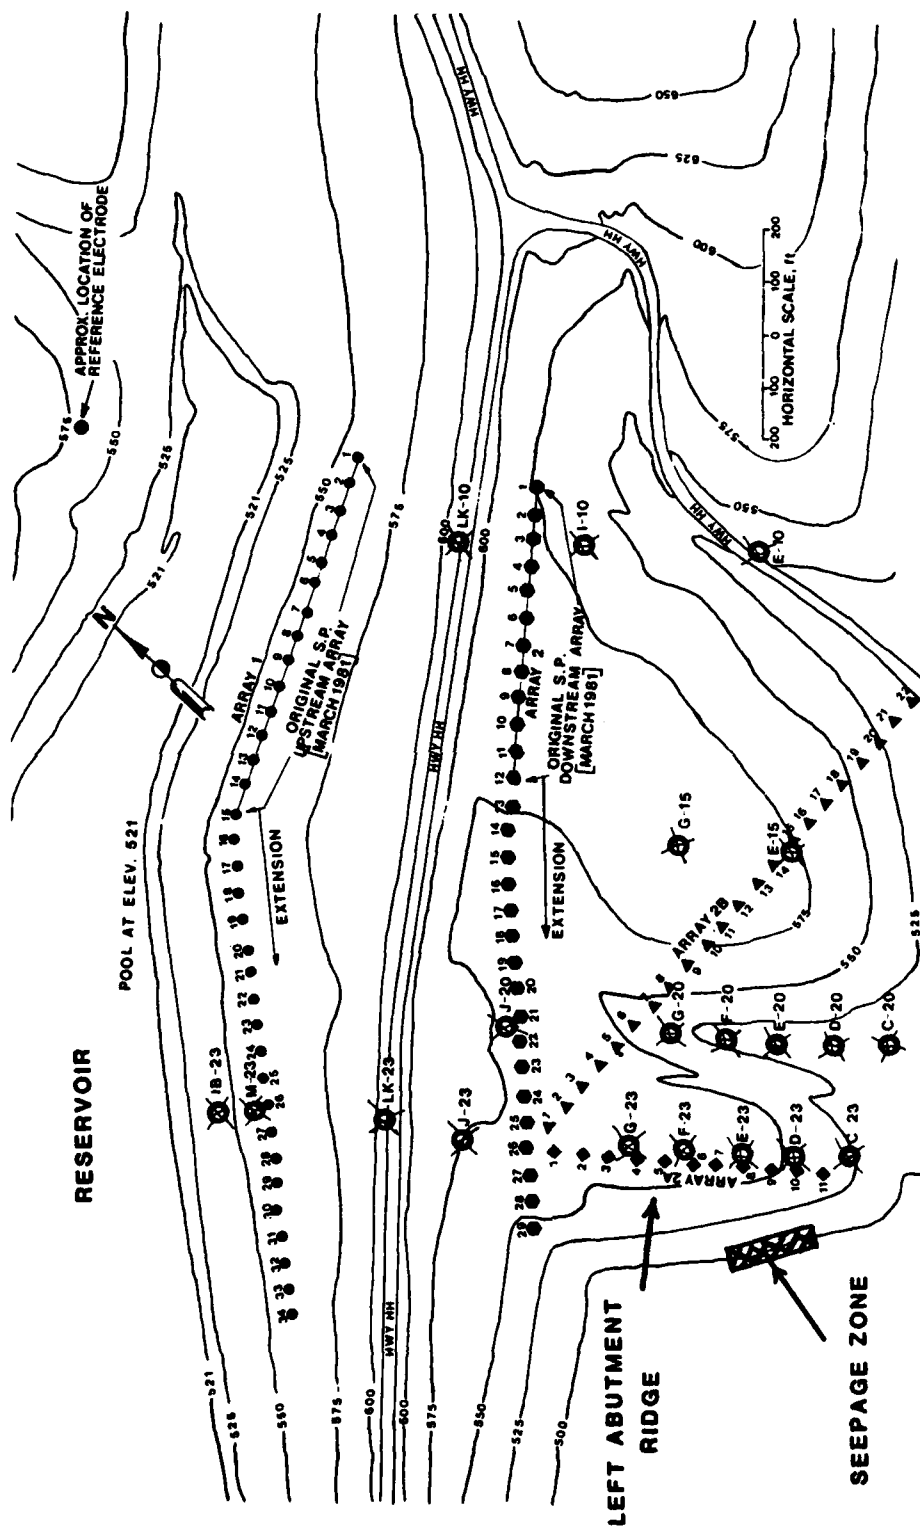
Figure Al. Site map showing seepage zone and the SP array installed to map and monitor seepage paths; Figures A2 And A3 present results of surveys conducted along the smaller of the two left abutment ridges.

Figure 1 illustrates a portion of the dam and left abutment, showing a zone where seepage emerges during high reservoir levels. Rock below the floodplain and abutments is a dolomitic limestone which is cherty, intensely fractured, and highly weathered, particularly in the abutments. The top of the limestone is pinnacled, and air-, water-, and clay-filled cavities exist below the rock surface. Top of rock is typically about 50 ft below the surface of the smaller of the two left abutment ridges.

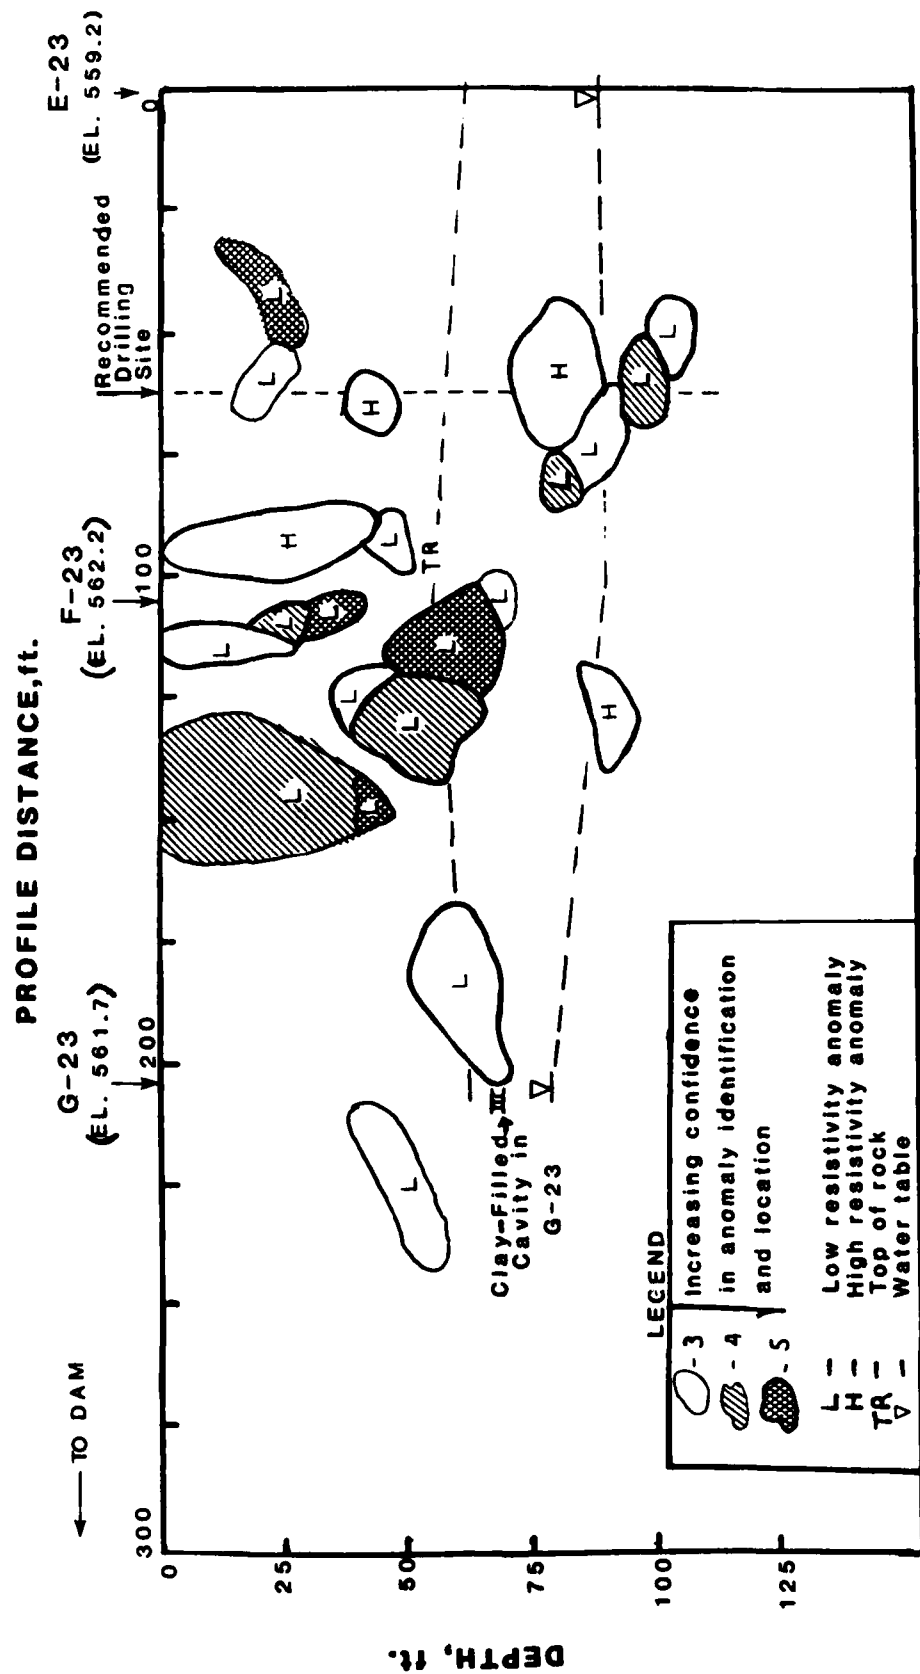
Figure A2. Interpreted results of pole-dipole resistivity survey along the left abutment ridge.

Geophysical surveys were conducted along both the base and crest of the left abutment ridge as shown in Figure 1. Results of two types of surveys along the crest of the ridge are shown in Figures 2 and 3. The pole-dipole survey results are interpreted to identify low (L) and high (H) resistivity anomalous zones beneath the profile line (Figure 2). The cluster of high and low anomalies at the water table below the 60 to 65 ft profile position in Figure 2 is particularly significant. A possible interpretation of the anomaly cluster is a solution feature which is partially air-filled (H) and partially water- and/or clay-filled (L). A verification of the interpretation shown in Figure 2 is provided by a clay-filled cavity intercepted in boring C-23, coinciding with the boundary of a low resistivity anomaly.

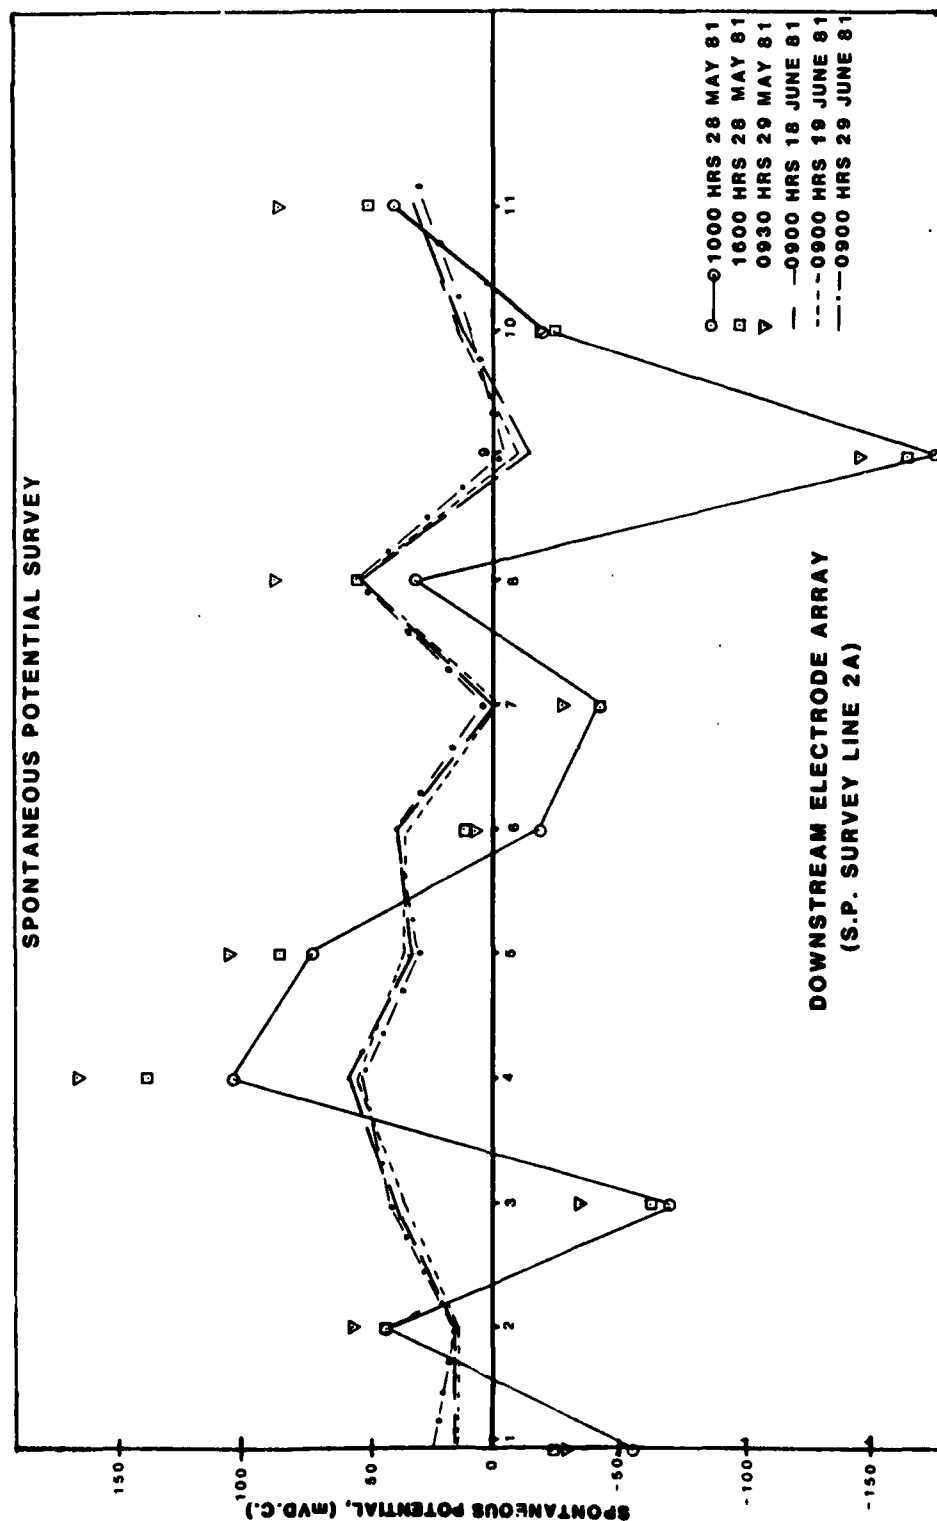
Figure A3. Results of SP survey along the left abutment during low (18-19 June 1981) and high (28-29 May 1981) reservoir levels.

SP array 2A, shown in Figure 1, was monitored as a function of time during both high and low reservoir levels. The results of this series of surveys are shown in Figure 3. The low pool level surveys are very repeatable, mainly positive, and show only small variation about a mean value of ~25 mv. The high pool level surveys are less repeatable, show considerably greater

variability, and a substantial portion of the survey line has negative SP values or is negative relative to the low pool level baseline. The broad SP anomaly centered at electrodes 5 and 6 coincides in location with the resistivity anomaly cluster discussed previously, and suggests that the interpreted air-filled portion of the cavity system may now be an active seepage path. The large amplitude SP anomaly at electrode 9 is beyond the extent of the pole-dipole survey line.
