HILL AFB, UTAH
INSTALLATION RESTORATION PROGRAM
PHASE IIB IRP SURVEY
FINAL REPORT

VOLUME I: TEXT

TR 03-542-027

11 September 1984

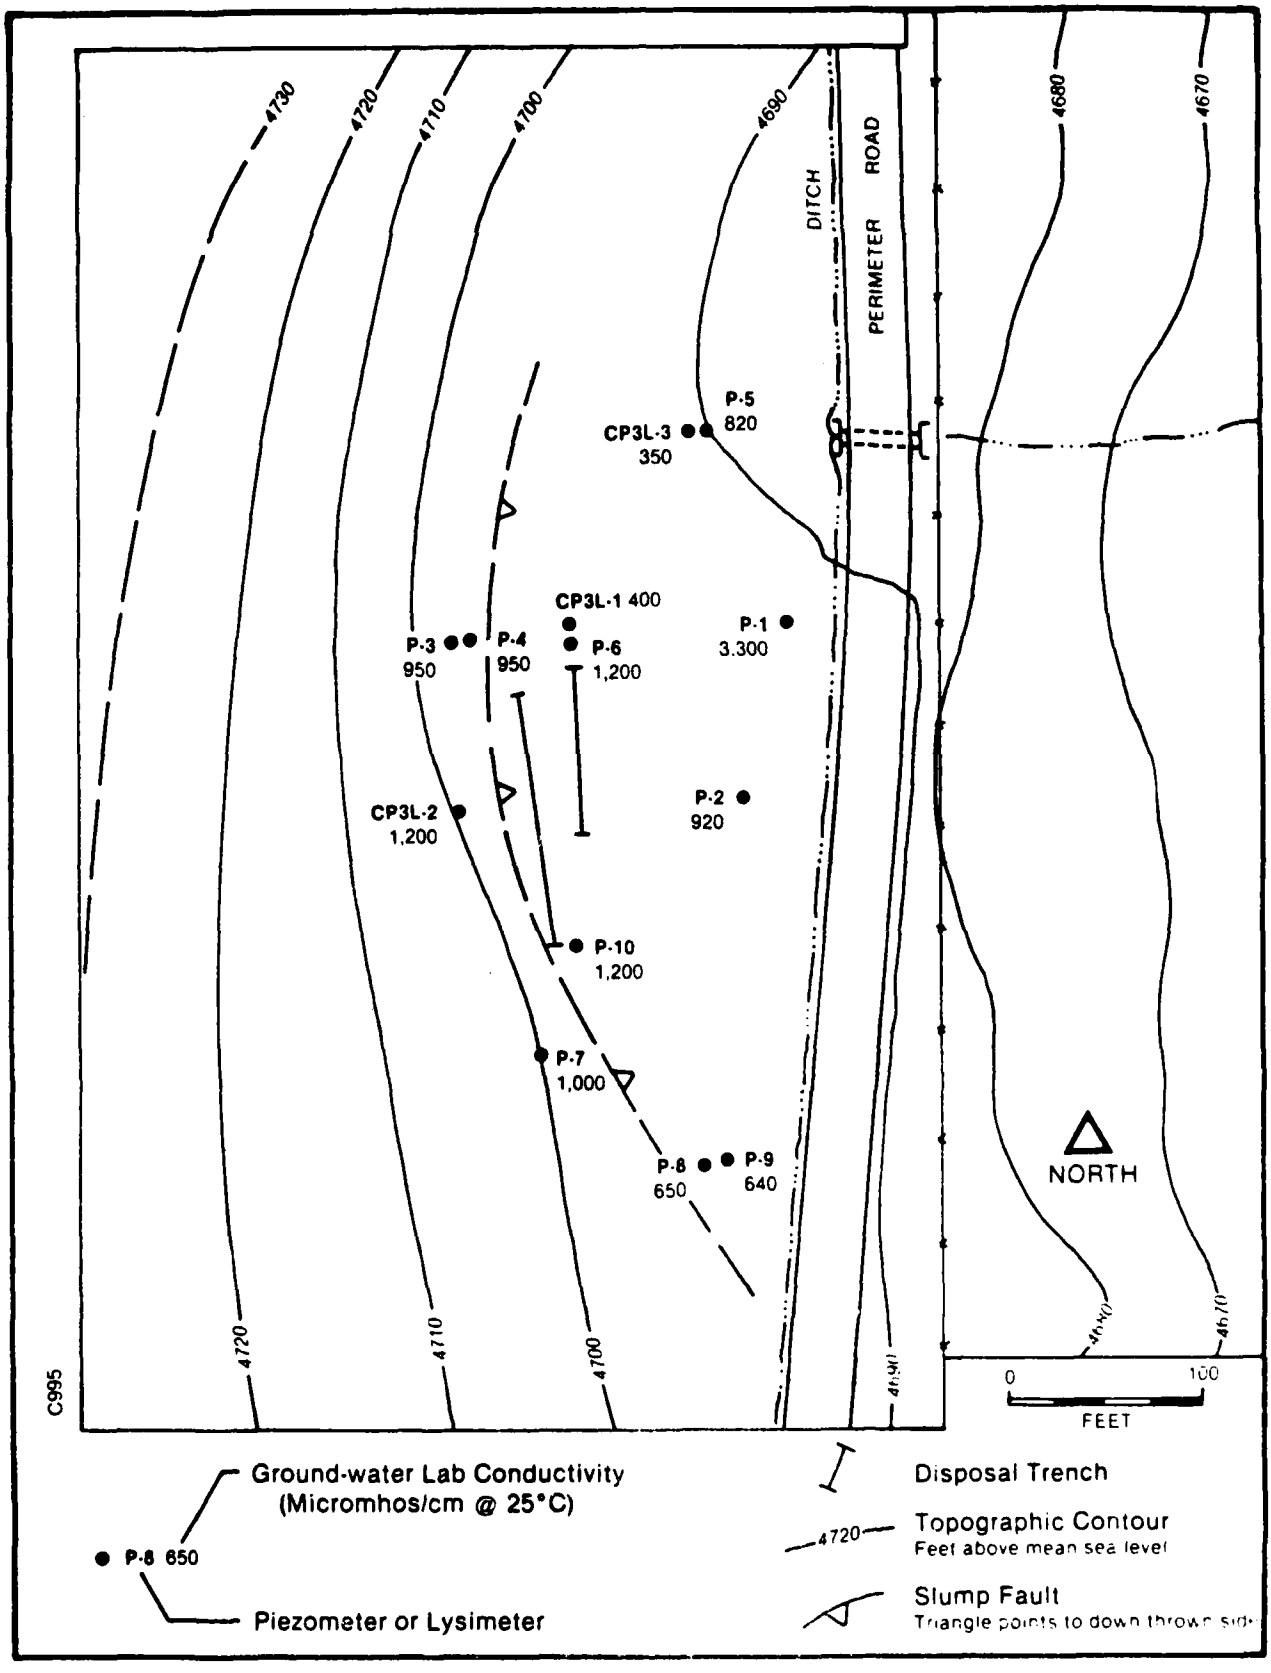
Figure 2-21. Ground-Water Conductivity Data, Chemical Disposal Pit No. 3.

conductivity decreased from February 1983 to April 1983 throughout the site, with the exception of Piezometer P-1, which showed an increase. The general decrease in conductivity is attributed to winter precipitation and groundwater recharge. The measurements provide qualitative insight into the possible rapid chemical changes during recharge. Lysimeter CP3L-1, which is only about two feet below the ground, had a laboratory conductivity of 400 micro-mhos/cm, which represents conductivities associated with winter precipitation and snow melt. The relatively higher conductivity values associated with the deeper lysimeters and piezometers indicate that some mineralization is occurring over short distances as the water moves down and through the ground. This mineralization can be caused by factors such as natural lithologic and hydrologic conditions or ground disturbances as well as a contamination source. Piezometer P-1 was the only in-situ measurement on Table 2-8 that showed an increase in field conductivity value. This is believed to be due to the upgradient subsurface disturbances of the aquifer and solvent product at Piezometers P-6 and P-10 due to augering and development activities. There is also a possibility that the measurement is the result of field meter error.

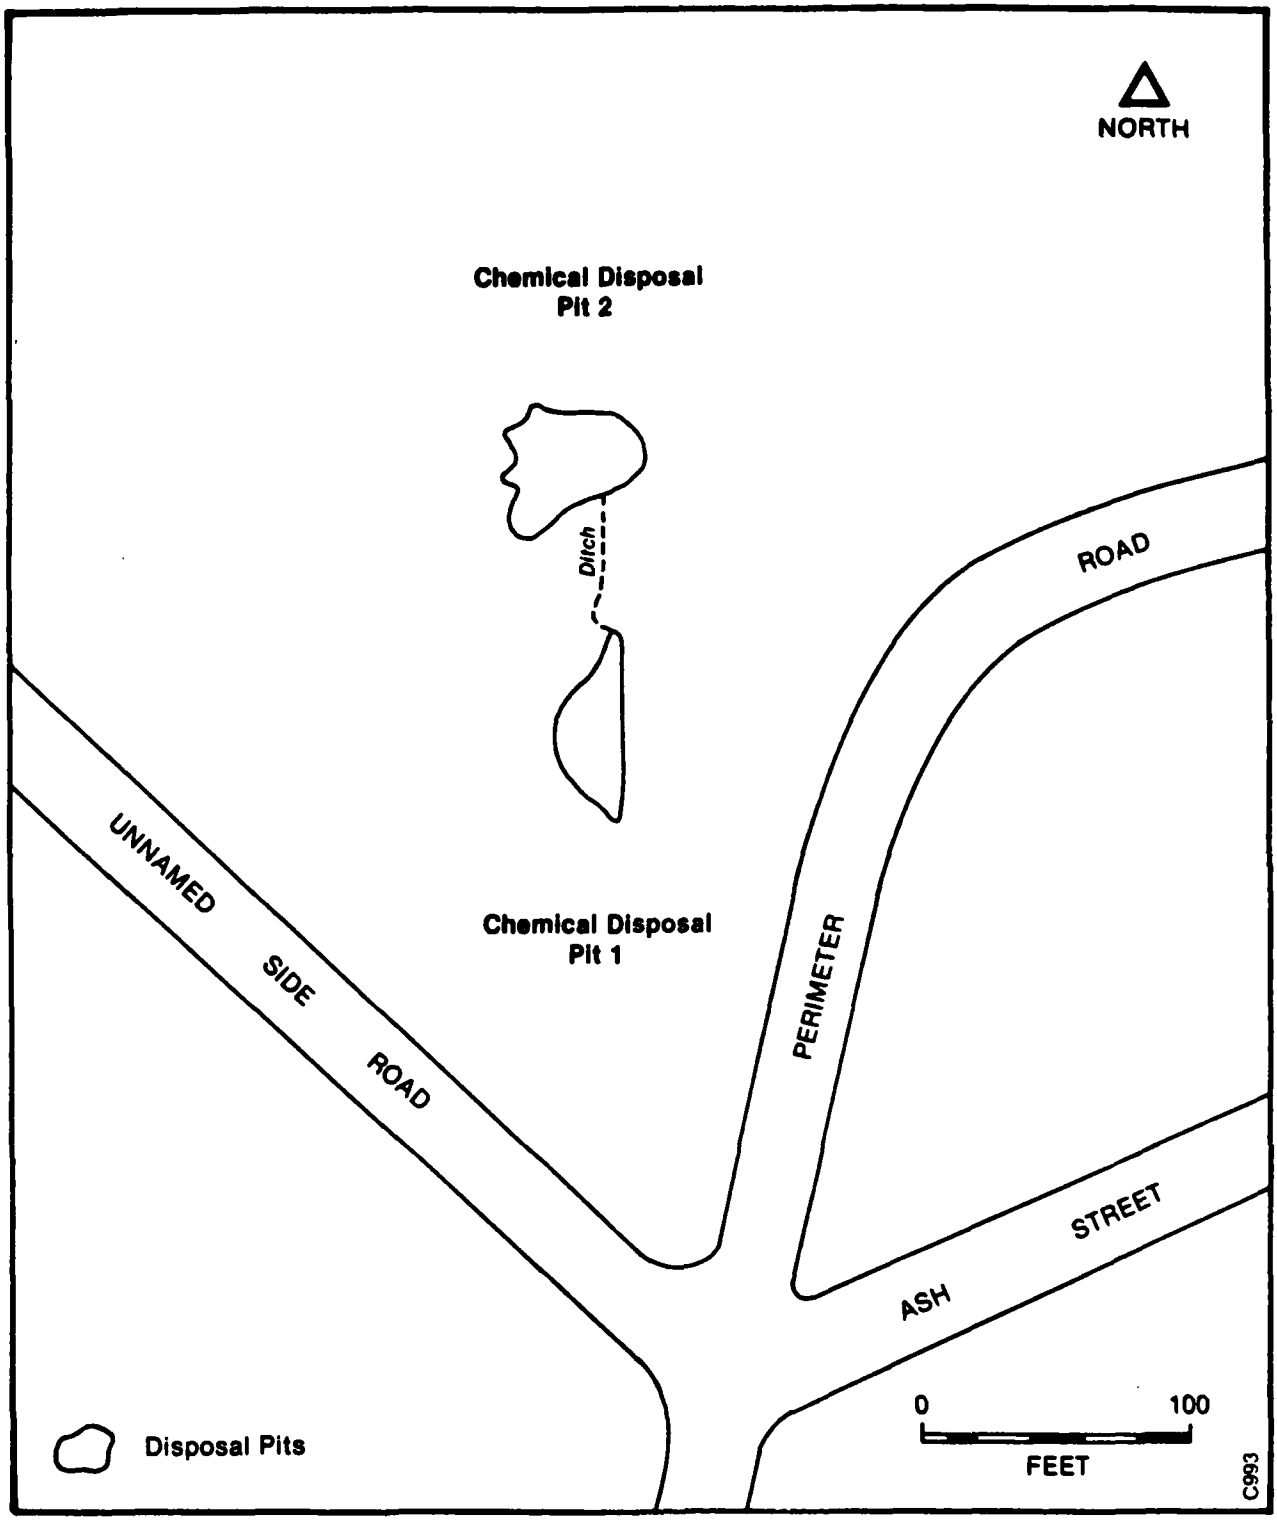
Figure 4-1. Chemical Disposal Pits Nos. 1 and 2, General Locations, 1971.

The pit locations and configurations are shown on Figure 4-1. It should be noted that the pit configurations on Figure 4-1 are from 1971 aerial photgraphy and the extent and depths at the time of closure in 1973 are not known, although it appears reasonable that they were probably not significantly different from those in 1971. Figure 4-2 depicts the results of soil coring used to locate the pits. The figure shows the locations of hand augered samples in which obvious hydrocarbon waste material was found. Some difficulty was encountered in correlating the 1971 aerial photography with the field sampling results because several roads visible in the photographs obscure the reference points for auger locations. However, it is judged that the pits have been positively identified and located. No other pits are known to exist in this area.

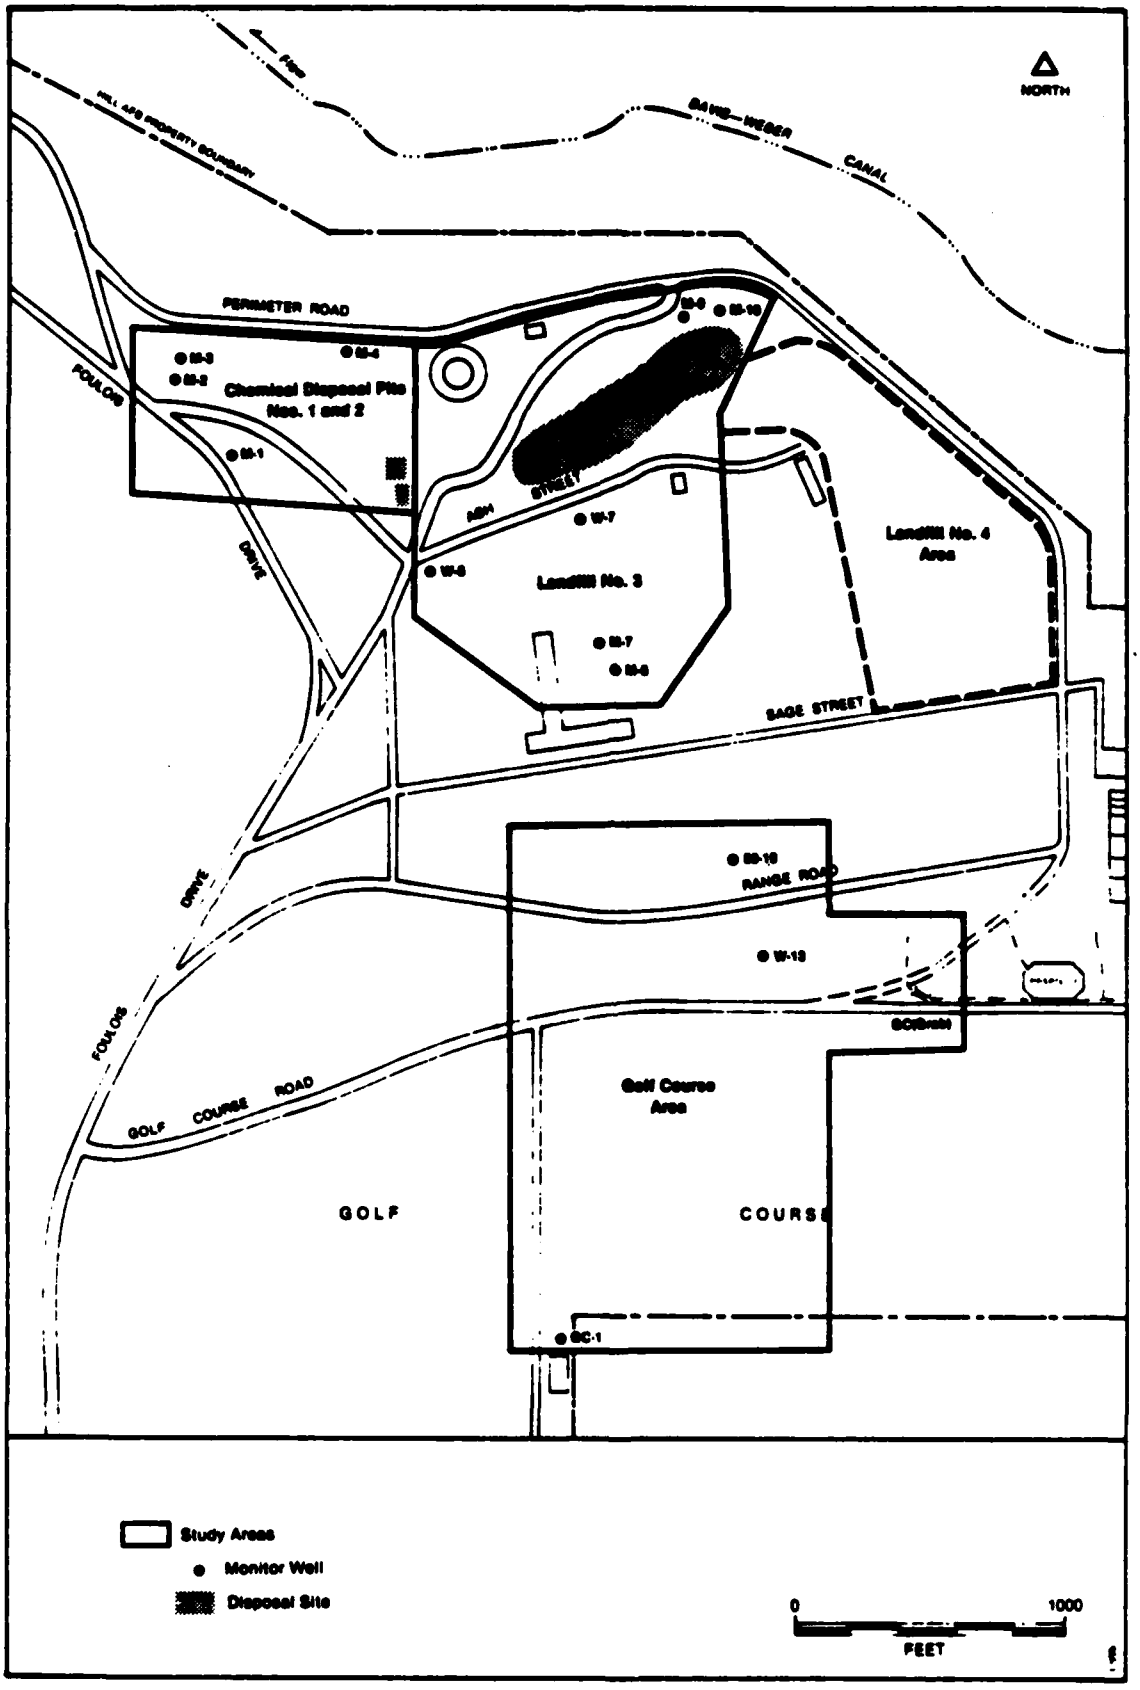
Figure 4-3. Study Sites and Associated IRP Phase II Monitor Wells.

shallow aquifer and the lower artesian aquifer under the clay. The locations of four new IRP Phase II monitor wells (M-1, M-2, M-3 (deep), and M-4) associated with the disposal pits and the corresponding study sub-area are depicted on Figure 4-3. This figure also depicts the other study sub-areas and monitor wells for this field investigation to be discussed later in this section.

Although additional data would be required to define the configuration of the clay surface between the monitoring points used in this study, present data are judged to be sufficiently reliable to make the hydrogeological assessments for this investigation.

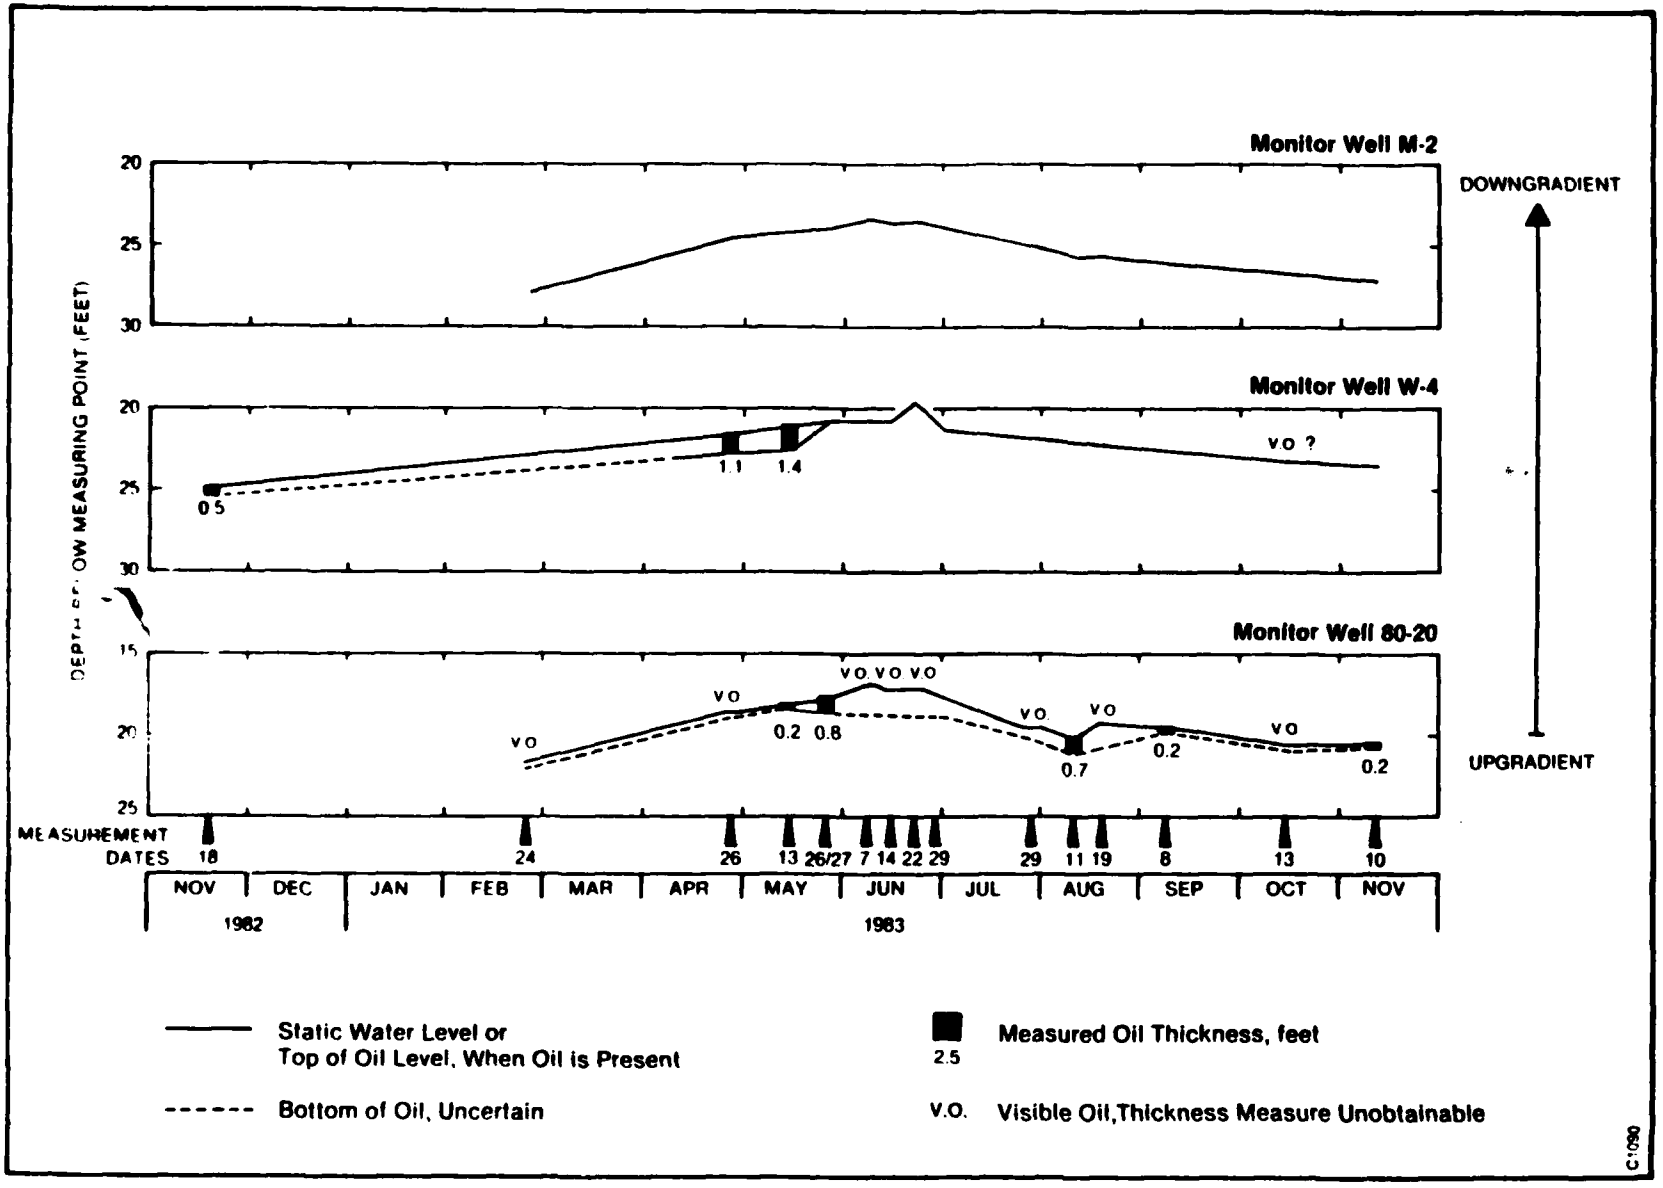
Figure 4-5. Selected Hydrographs of Monitor Wells in the Vicinity of Chemical Disposal Pits Nos. 1 & 2.

There were 14 sets of measurements taken under the initial IRP and extended oil and groundwater measuring programs. Figure 4-5 depicts the measurement dates. Also shown is a single measurement at Monitor Well No. 4 in November 1982, which was collected at the beginning of the IRP field program. The periods of field measurements were tailored to the expected changes in oil and water levels. Water levels and oil thickness data were collected principally by Radian personnel, with periodic assistance by Hill AFB Bioenvironmental and Civil Engineer personnel. The measurements were obtained at Monitor Wells M-1, M-2, M-3, M-4, W-4 and 80-20 (Figure 4-4).

Oil thicknesses were difficult to measure due to local precipitation effects and the generally dirty aspects of the oil. Generally, a good measurement could only be obtained under ideal conditions on the first try. Subsequent readings were difficult to obtain because the first measurement disrupted the static oil, mixing it with the groundwater. Measuring activities also coated the inside of the casing making additional readings difficult.

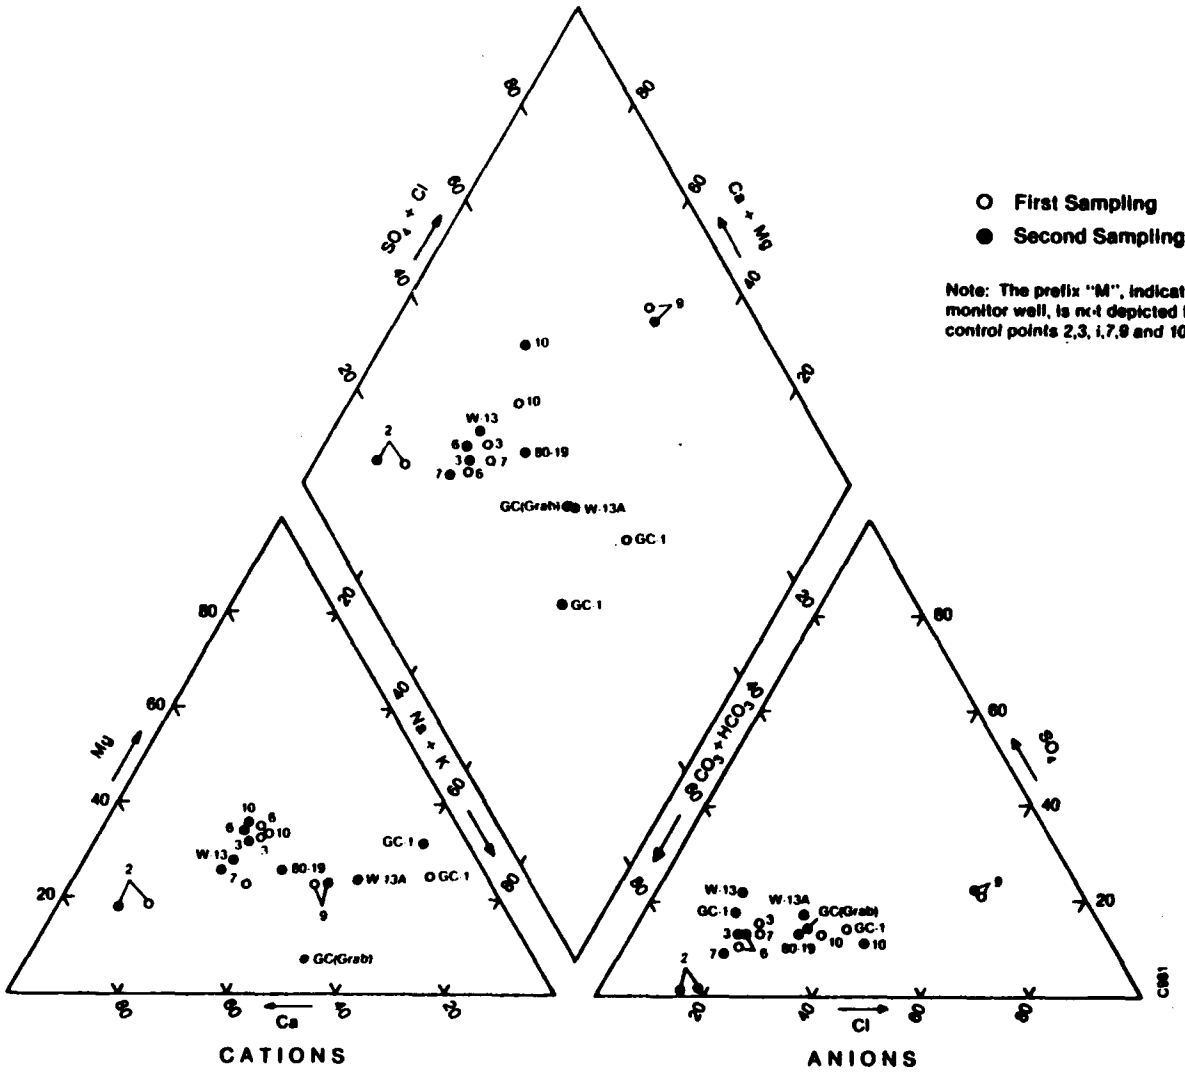
Figure 4-6. Golf Course Study Trilinear Piper Diagram

Figure 4-6 suggests that groundwater recharge from the Golf Course may flow beneath the waste areas. The elongated clustering of data points on Figure 4-6 shows on one end water from Well GC-1 and at the other end water from the downgradient monitor wells M-2, M-3, M-6, and M-7. Samples from Monitor Wells 80-19, and W-13 plot in the intermediate area of the diagram along with the parking lot runoff sample. This diagram, although not conclusive, suggests that the water in the Golf Course Area is not significantly different chemically from groundwater to the north but it does generally show a gradual transition in water chemistry from south to north.

An additional observation from the trilinear diagram analysis is that water from monitor wells M-2 and M-9 generally plot away from water in the other wells. These wells are downgradient from Chemical Disposal Pits No. 1 & 2 and Landfill No. 3, respectively. The differences in water chemistry evident on the diagram are most likely the result of impacts from the disposal sites.

Groundwater in the shallow and lower aquifers appears to be essentially the same as evidenced by the common grouping of water from wells in both zones on the diagram. This further indicates hydraulic connection and common recharge sources for the two aquifers.

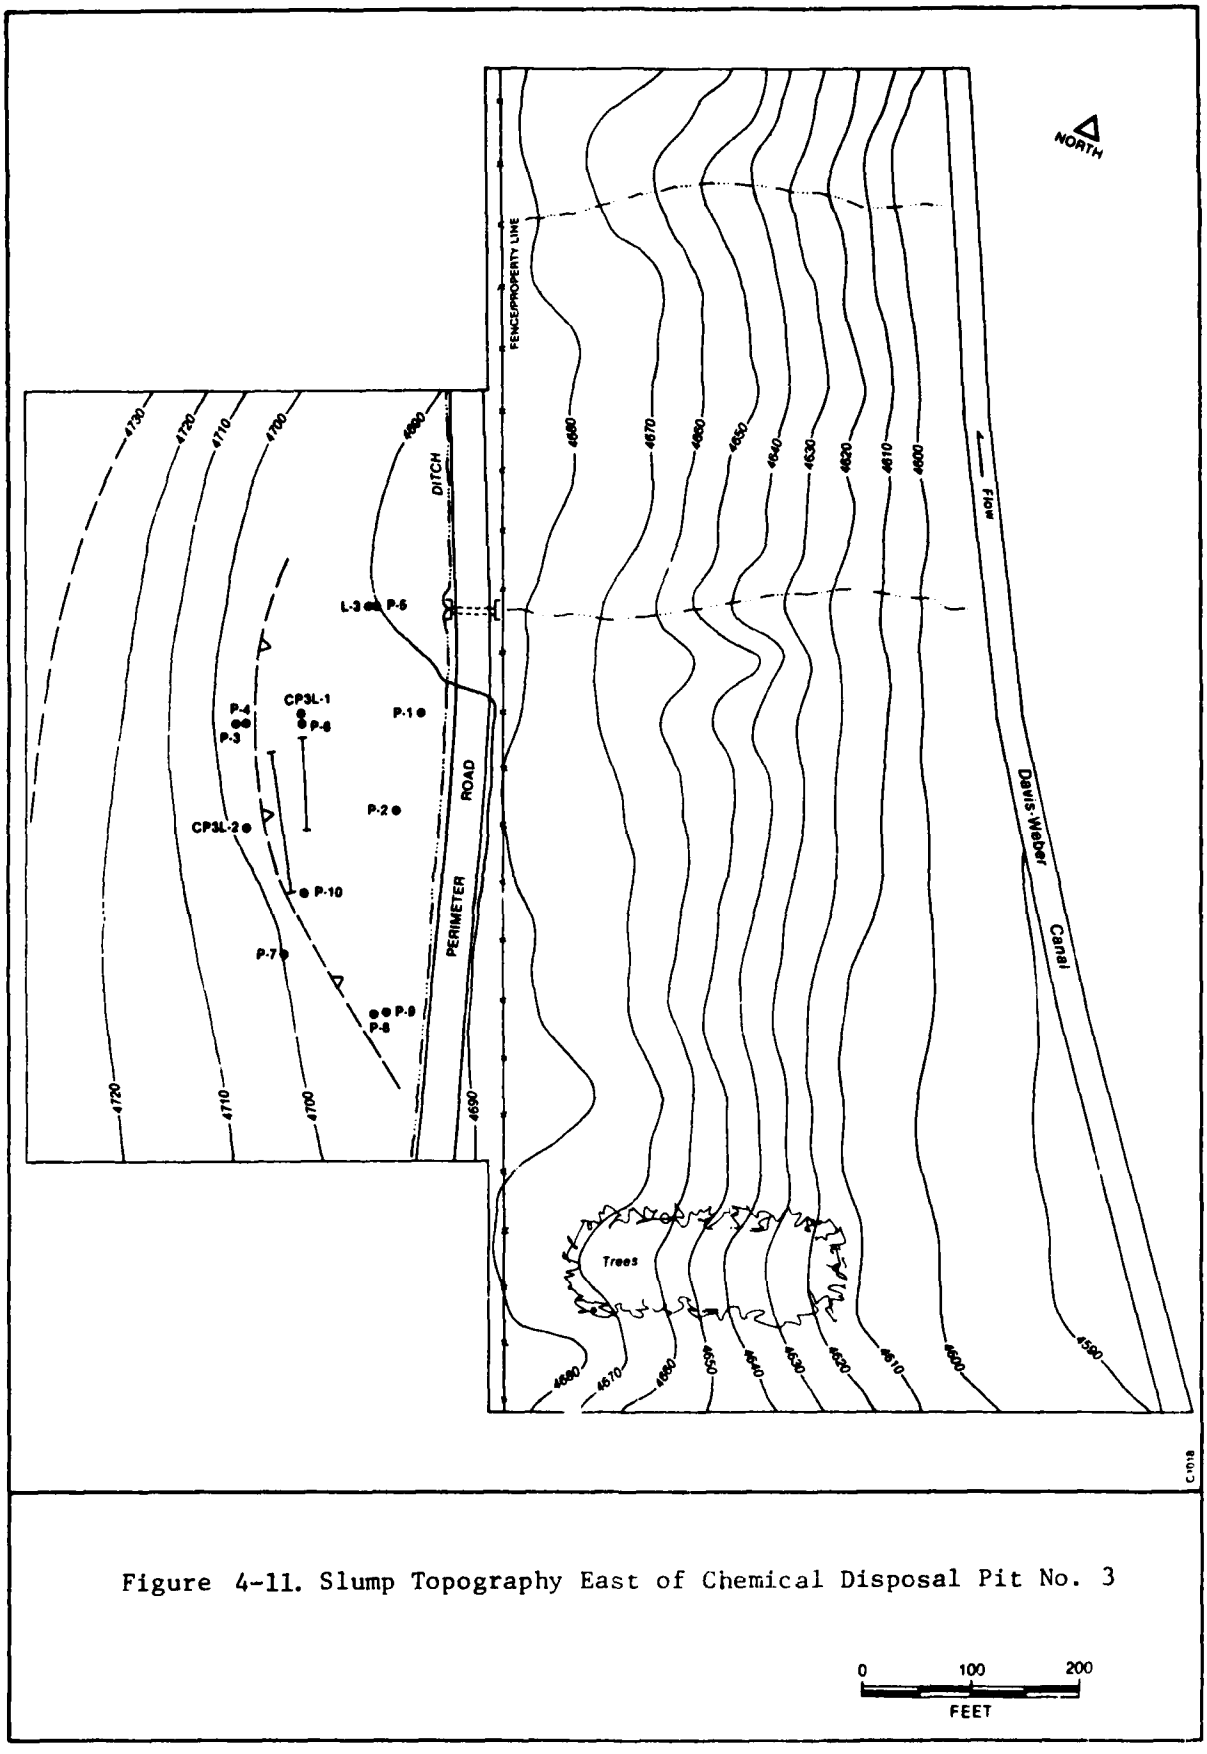
Figure 4-11. Slump Topography East of Chemical Disposal Pit No. 3

configuration of the slump. The resulting topographic contours are depicted on Figure 4-11 which is estimated to bracket the north and south extent of the slump of interest. Further detailed studies off-base at Chemical Disposal Pit No. 3 and potentially in the area east of the Davis Weber canal will be needed to fully characterize the site. Assuming that the area shown is the extent of the hydraulic system of the slump then that area noted would be expected to encompass the possible lateral limits of solvent migration. The east-west cluster of trees on the south side and the intermittent drainage on the north side may well reflect the lateral areas of slippage from the slump.

The intermittent drainage in the middle and downslope from the drainage culvert under the Perimeter Road may be a minor slip plane. However, it is more likely related to surface water flows from the uphill drainage areas west and south of the Perimeter Road which pass through the culvert under the road (Figure 4-11). Solvents flowing at or near the surface as well as leachate could have exited from the disposal pit via this culvert or possibly along the old topographic surface under the Perimeter Road (Figure 2-15).
