R84AEB592

HIGH TEMPERATURE ELECTRONICS TECHNOLOGY

LIFE TEST REPORT
FINAL REPORT - CDRL Item A003

Aircraft Engine Business Group
Advanced Technology Programs Dept.
Cincinnati, Ohio 45215

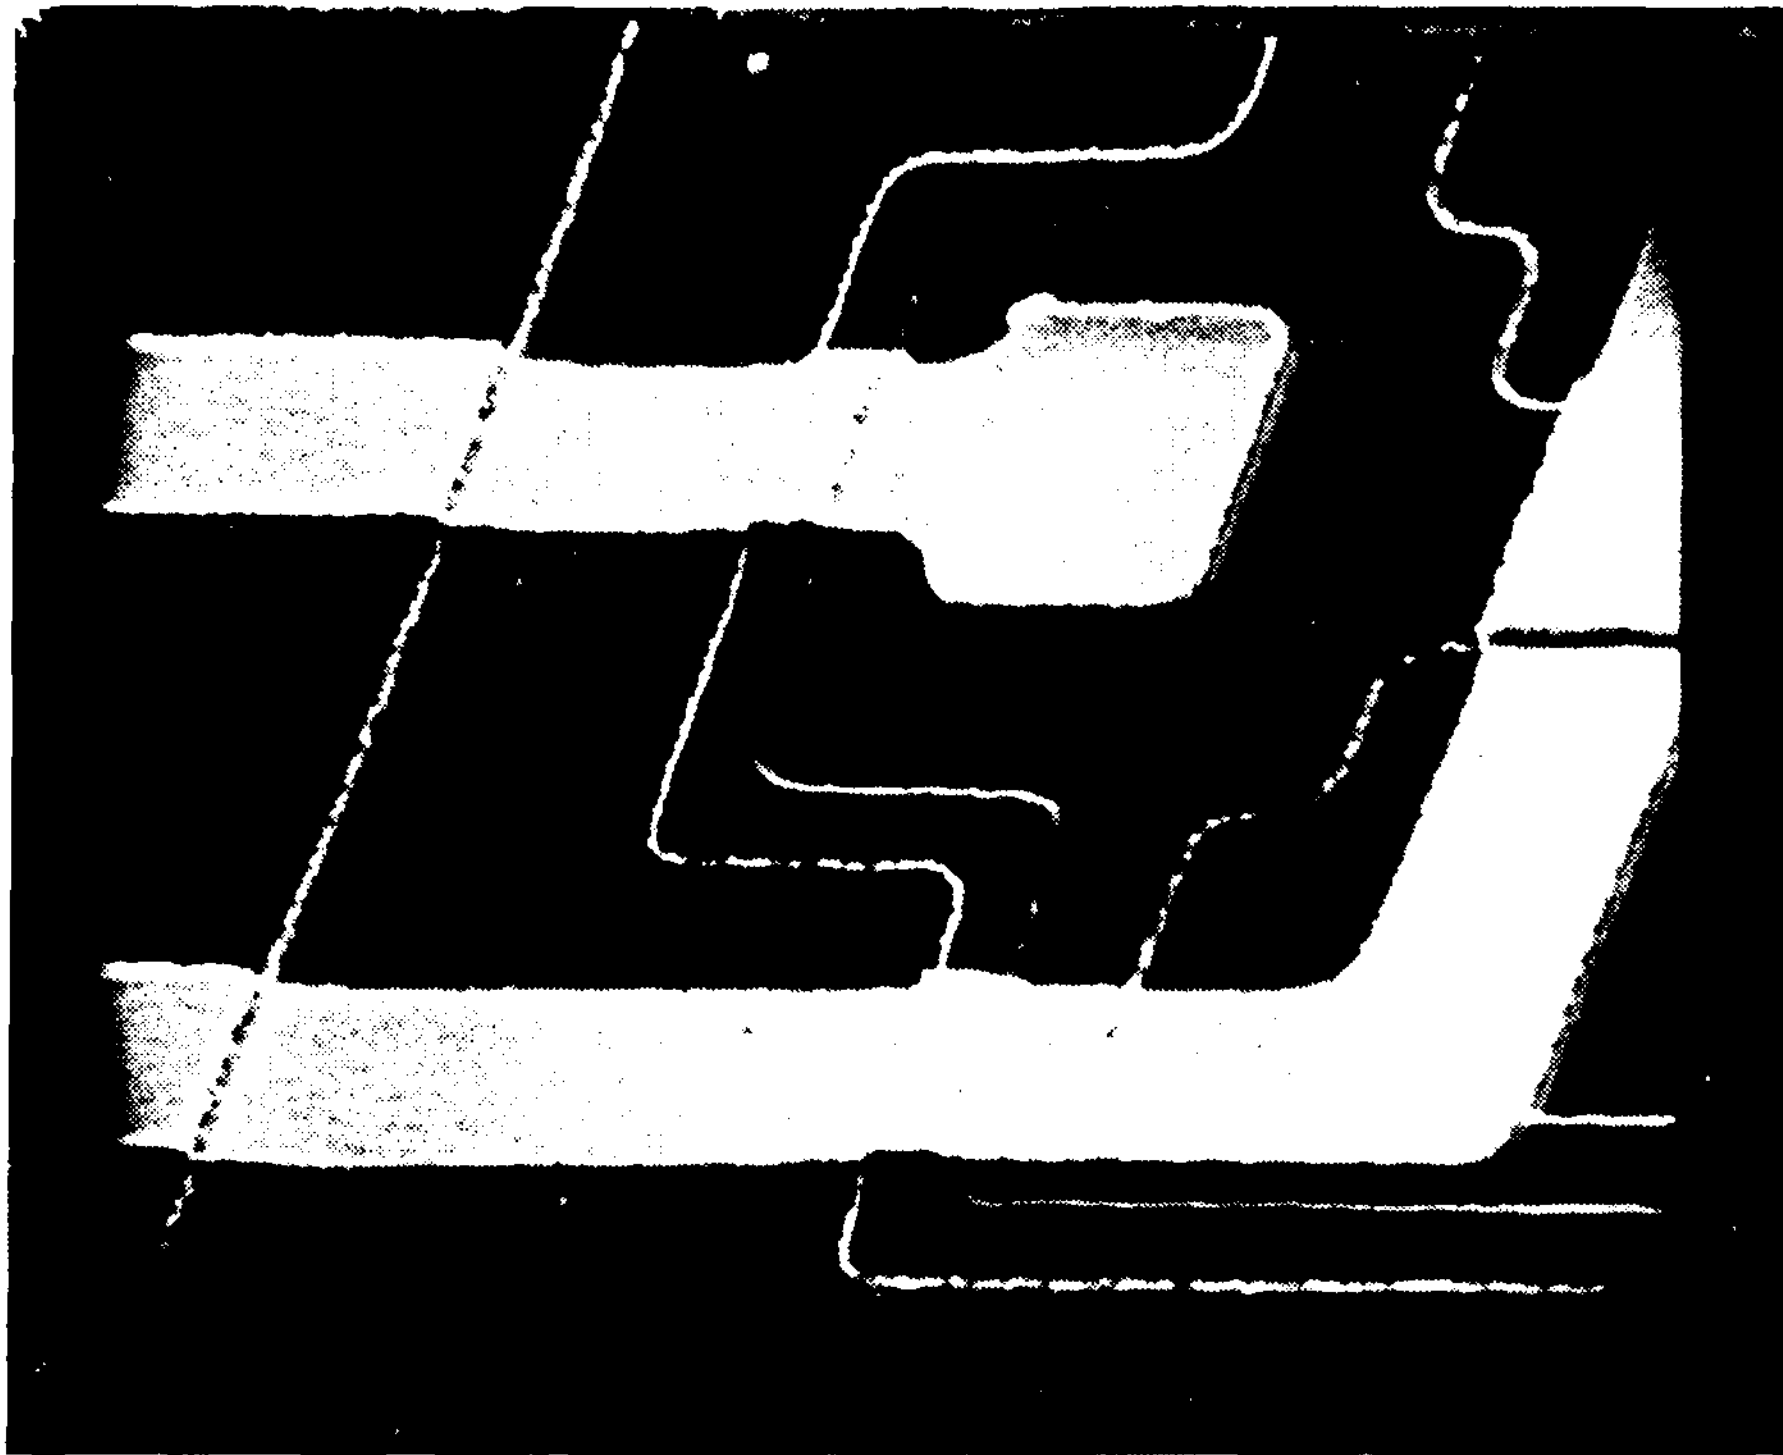
02-09-84-8 2000X

Two more wafers were metallized with high-temperature gold and annealed immediately following ion milling. Probing indicated that there was gross leakage between the transistor elements. These wafers were examined in a scanning electron microscope (SEM) to search for the cause of the leakage. Residıal metal was observed along the edges of oxide steps, and the leakage was ›robably due to this metal. Apparently, the ion milling had not been con-:inued long enough to remove all of the metal from the vertical steps where :he effective thickness of the metal is greater. Figure 3 is a SEM photograph showing the residual metal.

Figure 3. SEM Photograph Showing Residual Metal at Oxide Steps.

An attempt was made to remove the residual metal by chemical etching, but :his resulted in undercutting of the gold. The one remaining undamaged wafer was then subjected to further ion milling after a new photoresist mask was ıpplied. After probing and SEM inspection indicated that the residual metal was gone, the wafer was annealed to remove ion-milling damage, and the life :est circuits were probed. The yield was still zero. Further probing of the I^2L evaluation transistor indicated that the remaining problem was due to excess contact resistance. Figure 4(a) is a curve tracer photograph of a :ransistor showing the resistive nature of the contact. When a sufficiently large current is forced through the contact, the contact resistance is reduced,

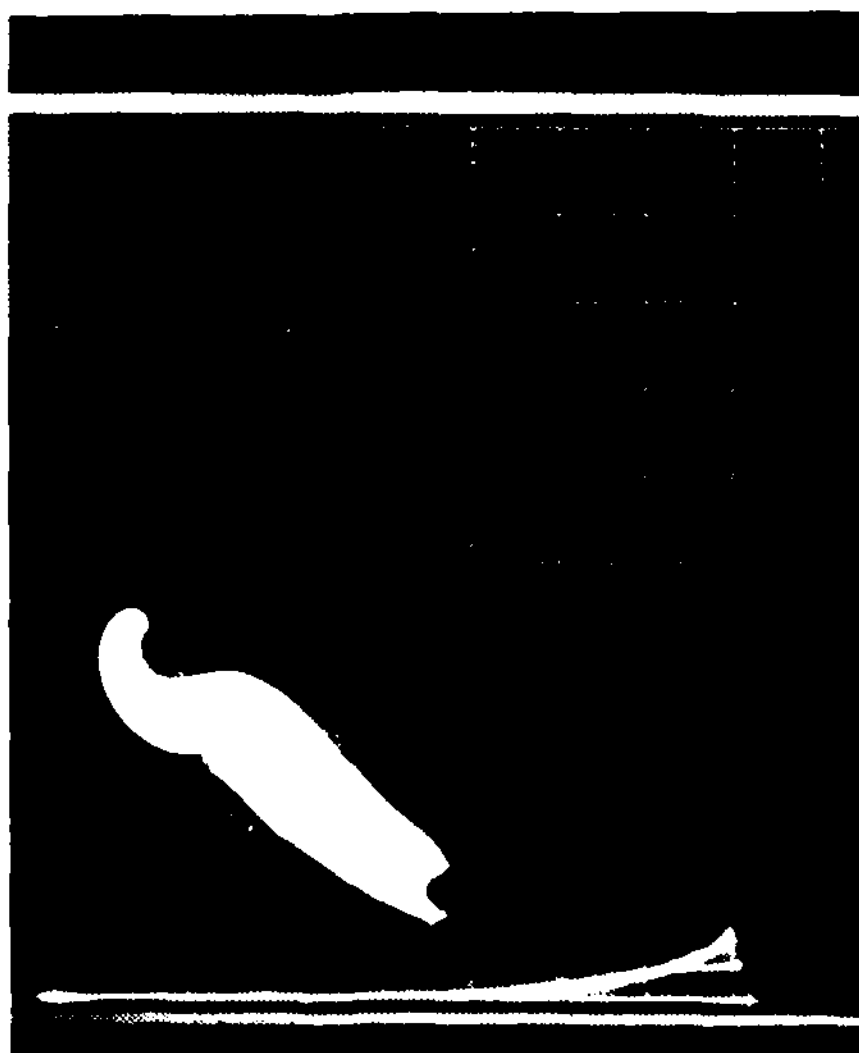
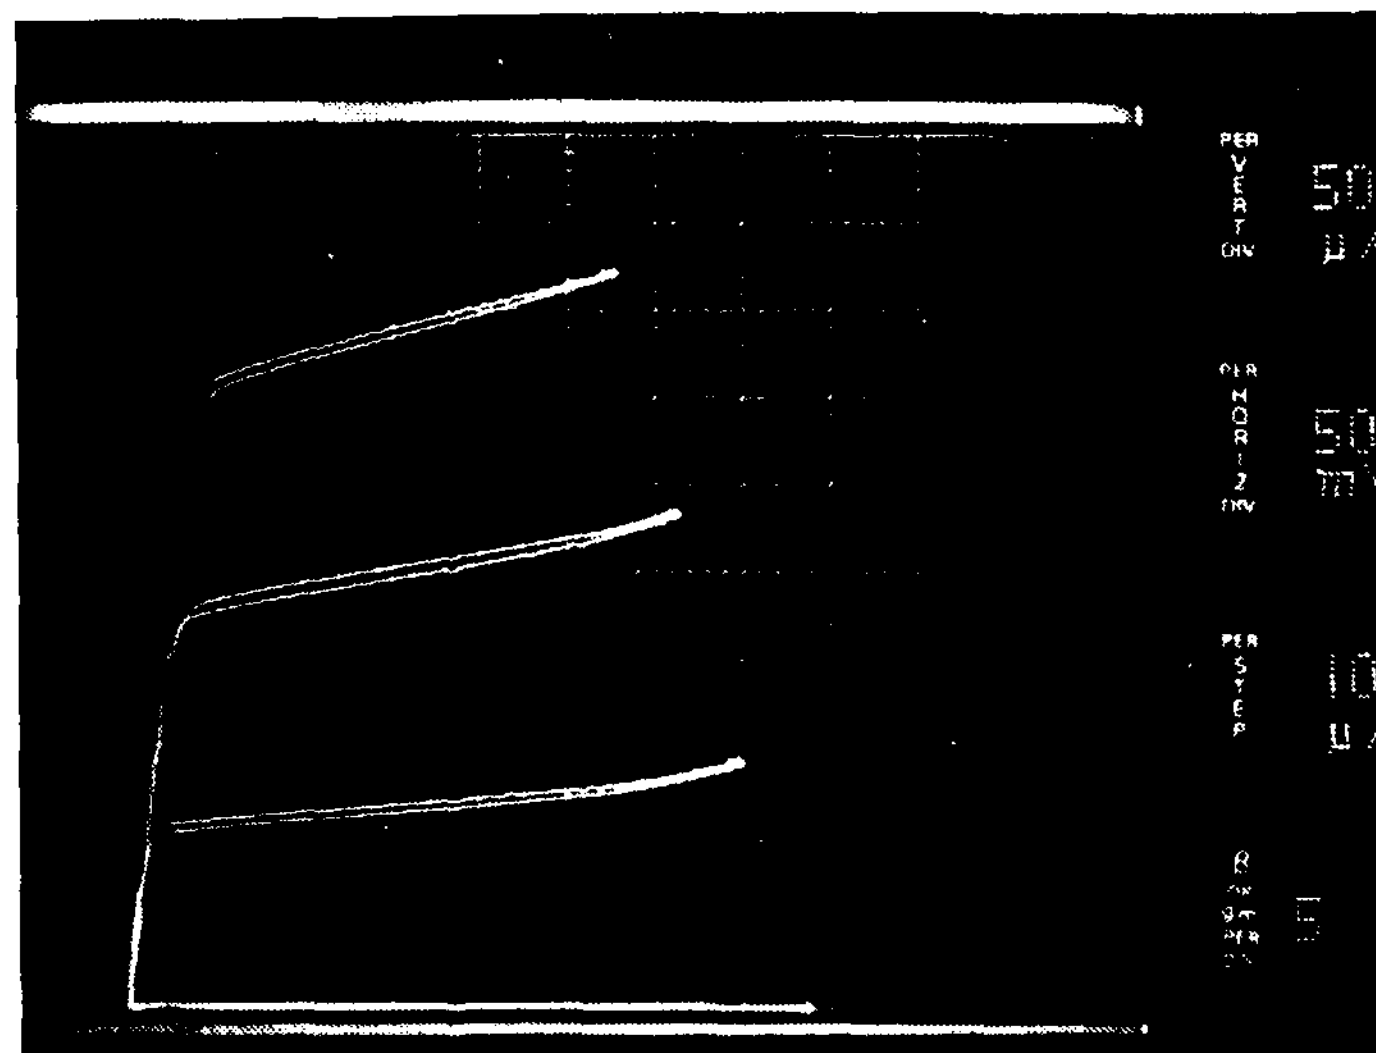
Figure 4. Curve - Tracer Photographs of Transistor Characteristic, Before and After Forcing Current, Indicative of Barrier Layer at Contact.

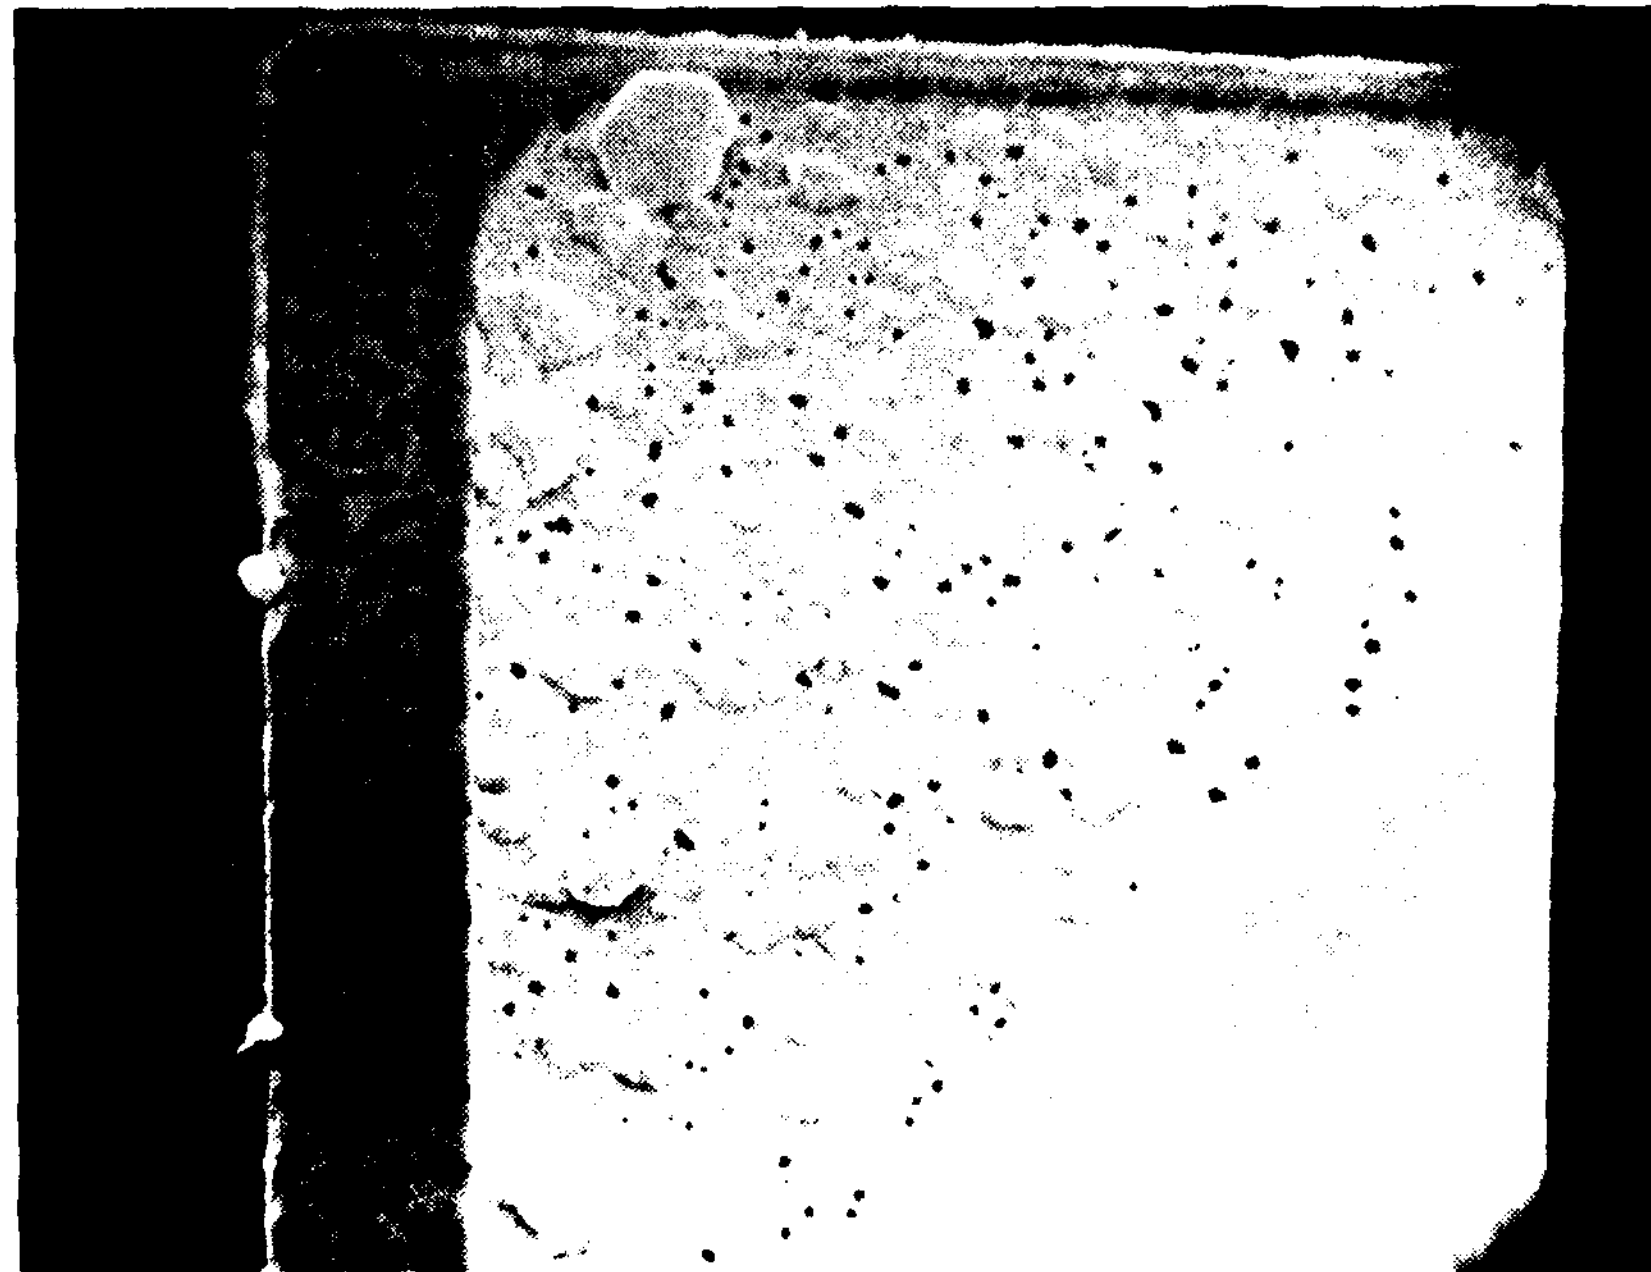
Figure 15. Bond Pad Area on Sample 19-9 (Normal Gold Metallization).

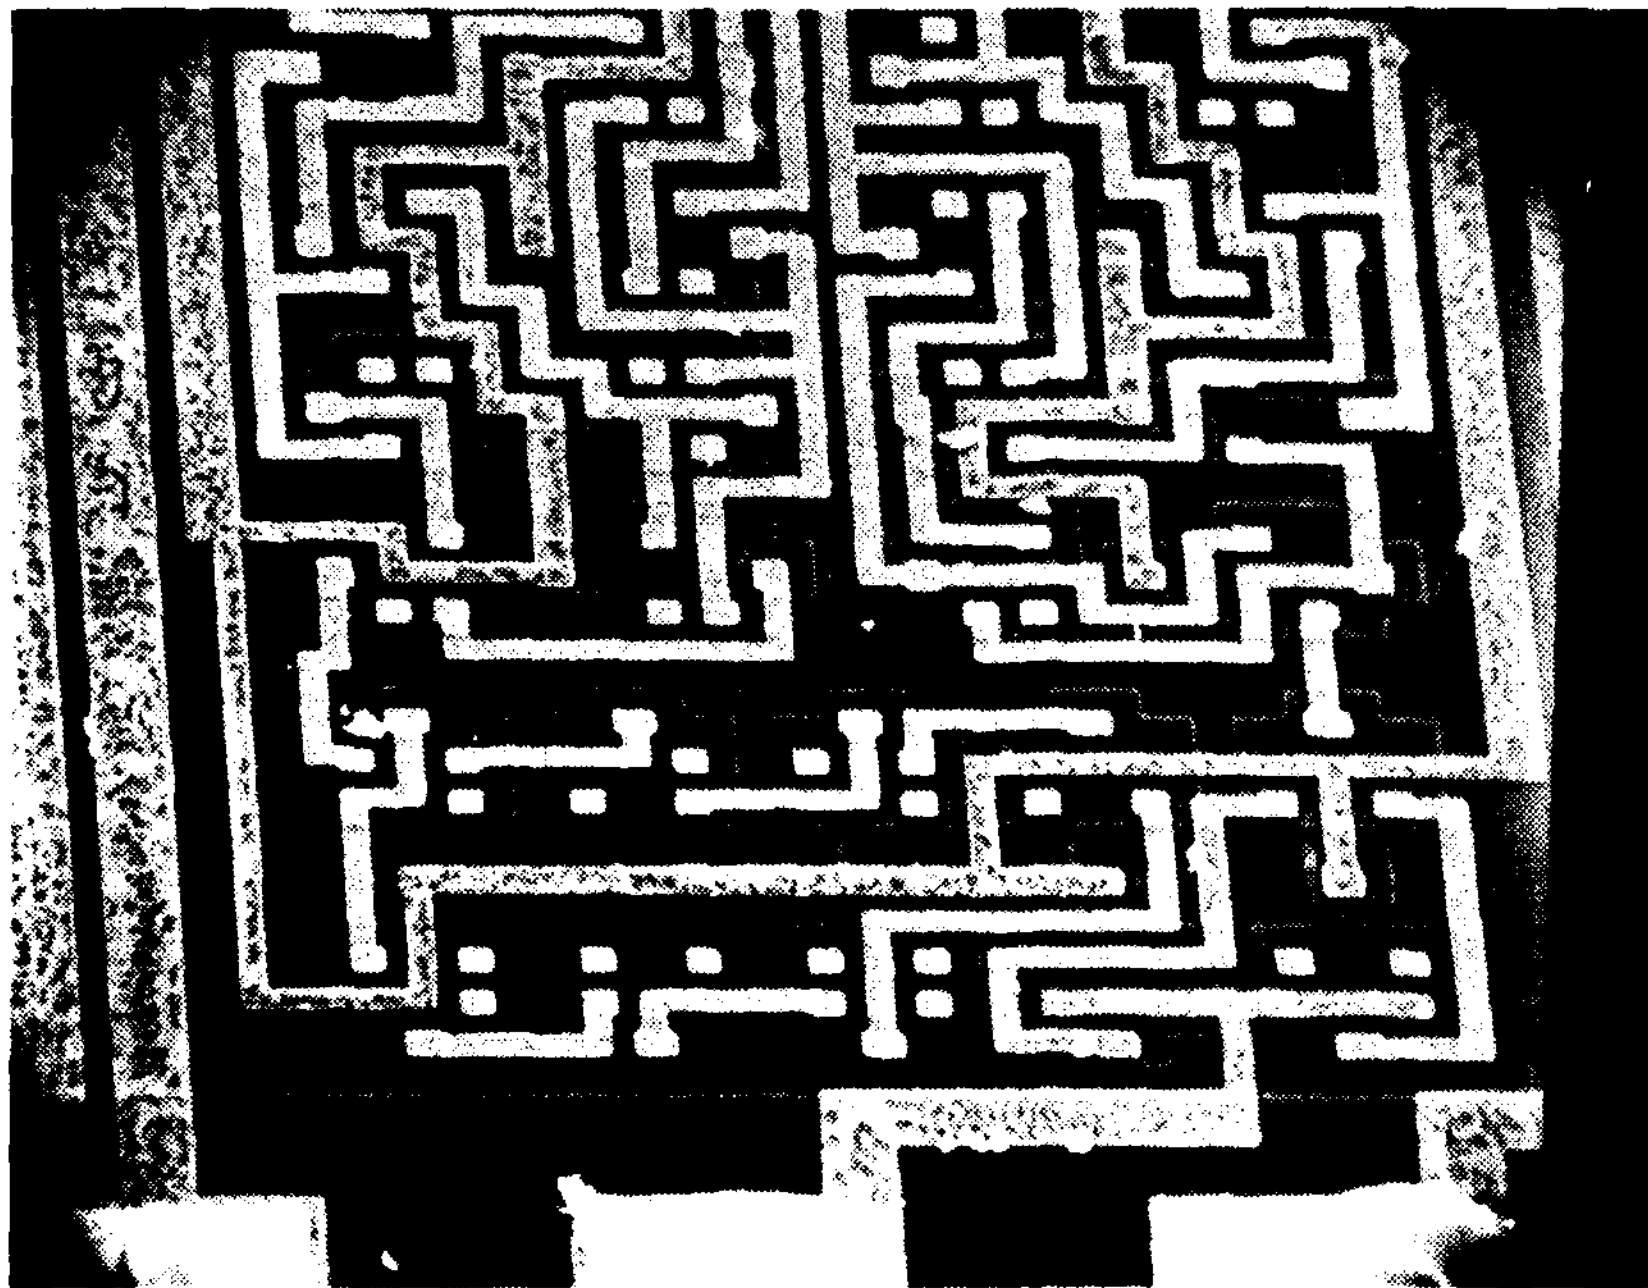
5-22-84-6 200X

Figure 12. Gross Voiding on Sample 22-9 (Hydrogen Doped).

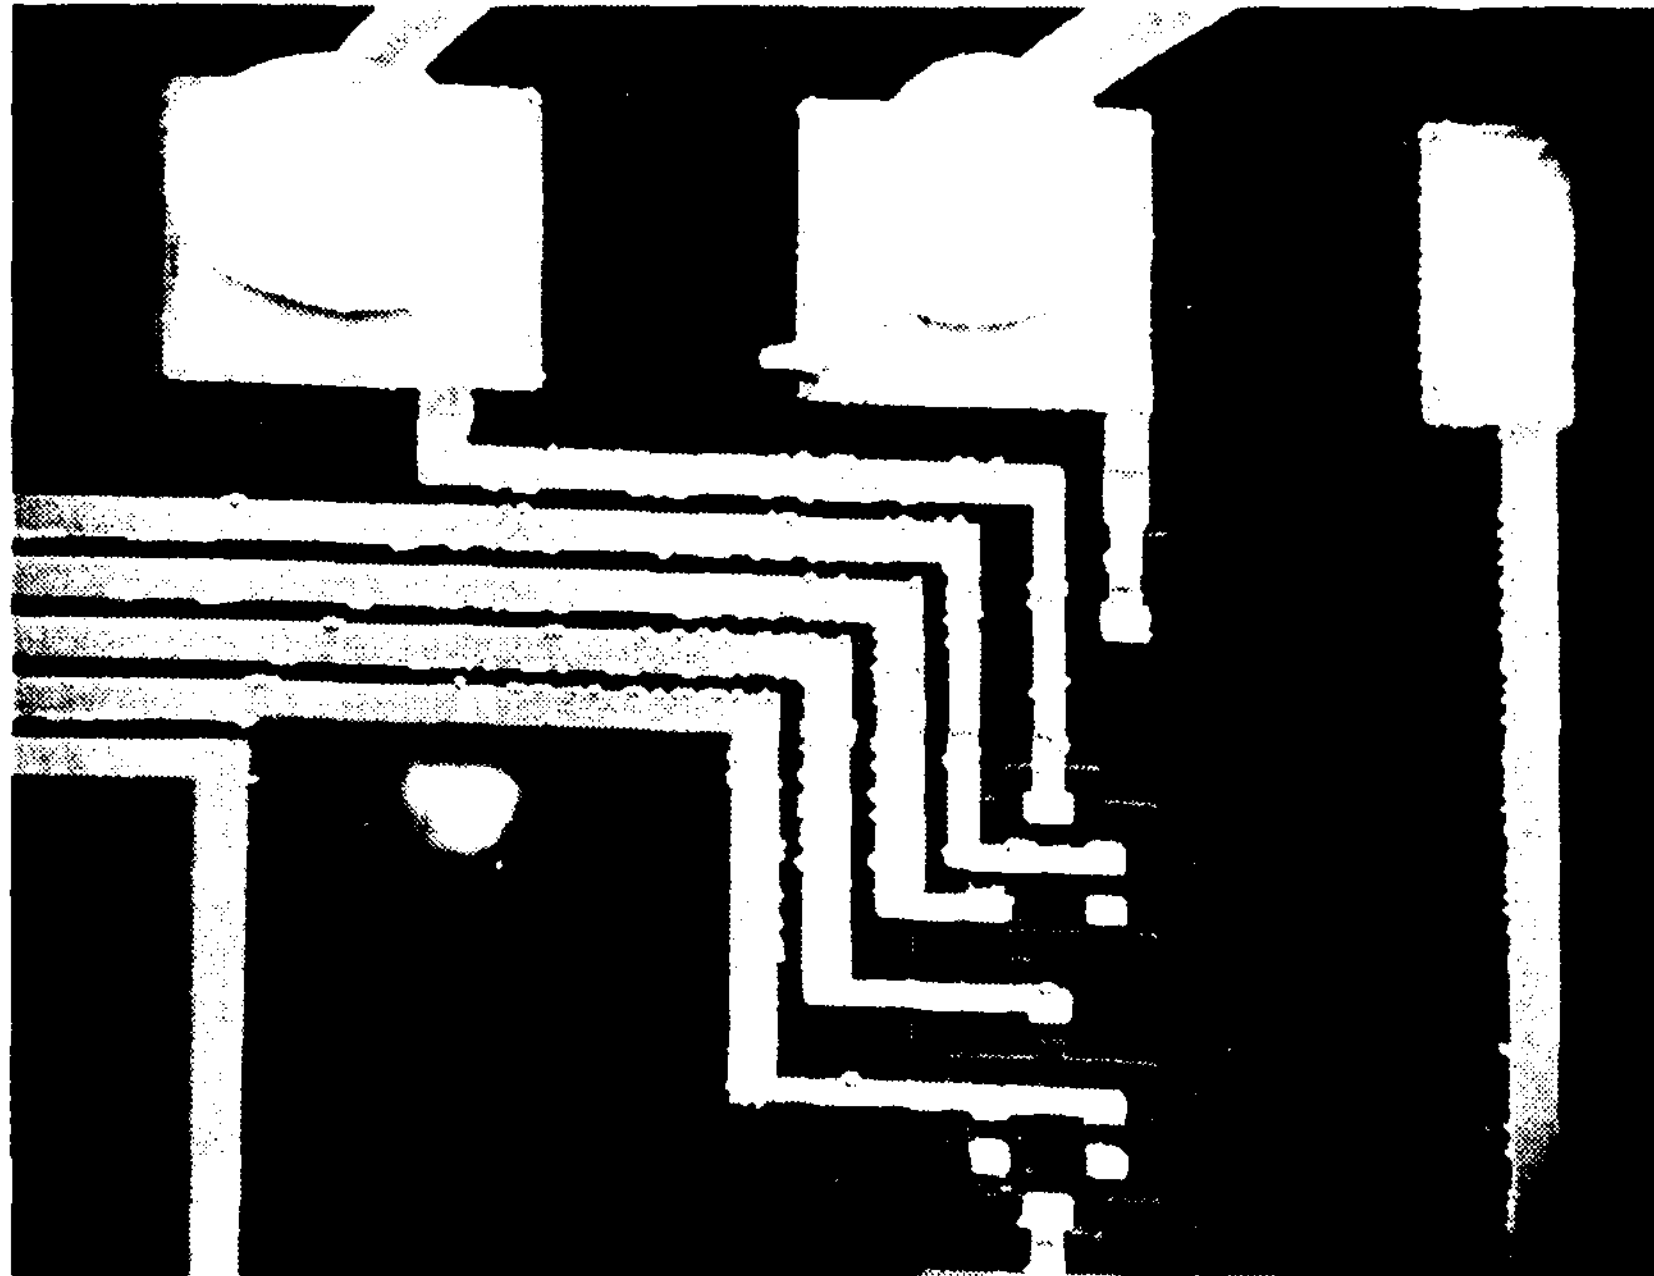
4-18-84-4 200X

The crystal growths at the edges of the lines are known to be related to compressive stresses that build in the gold film when the sample is raised to the test temperature. (Both the silicon substrate and the nitride coating have a much smaller thermal expansion coefficient than the gold.) If the nitride coating on the edges of the metal lines is sufficiently weak it can crack, and the gold can be extruded or diffused through the crack, forming crystal growths, as observed. The greater tendency for the hydrogen-doped gold samples to form crystal growths may be related more to the relative thickness and integrity of the nitride on the two wafers than to the nature of the gold.

Figure 10. Gold Crystal Growth on Sample 22-1 (Hydrogen Doped).

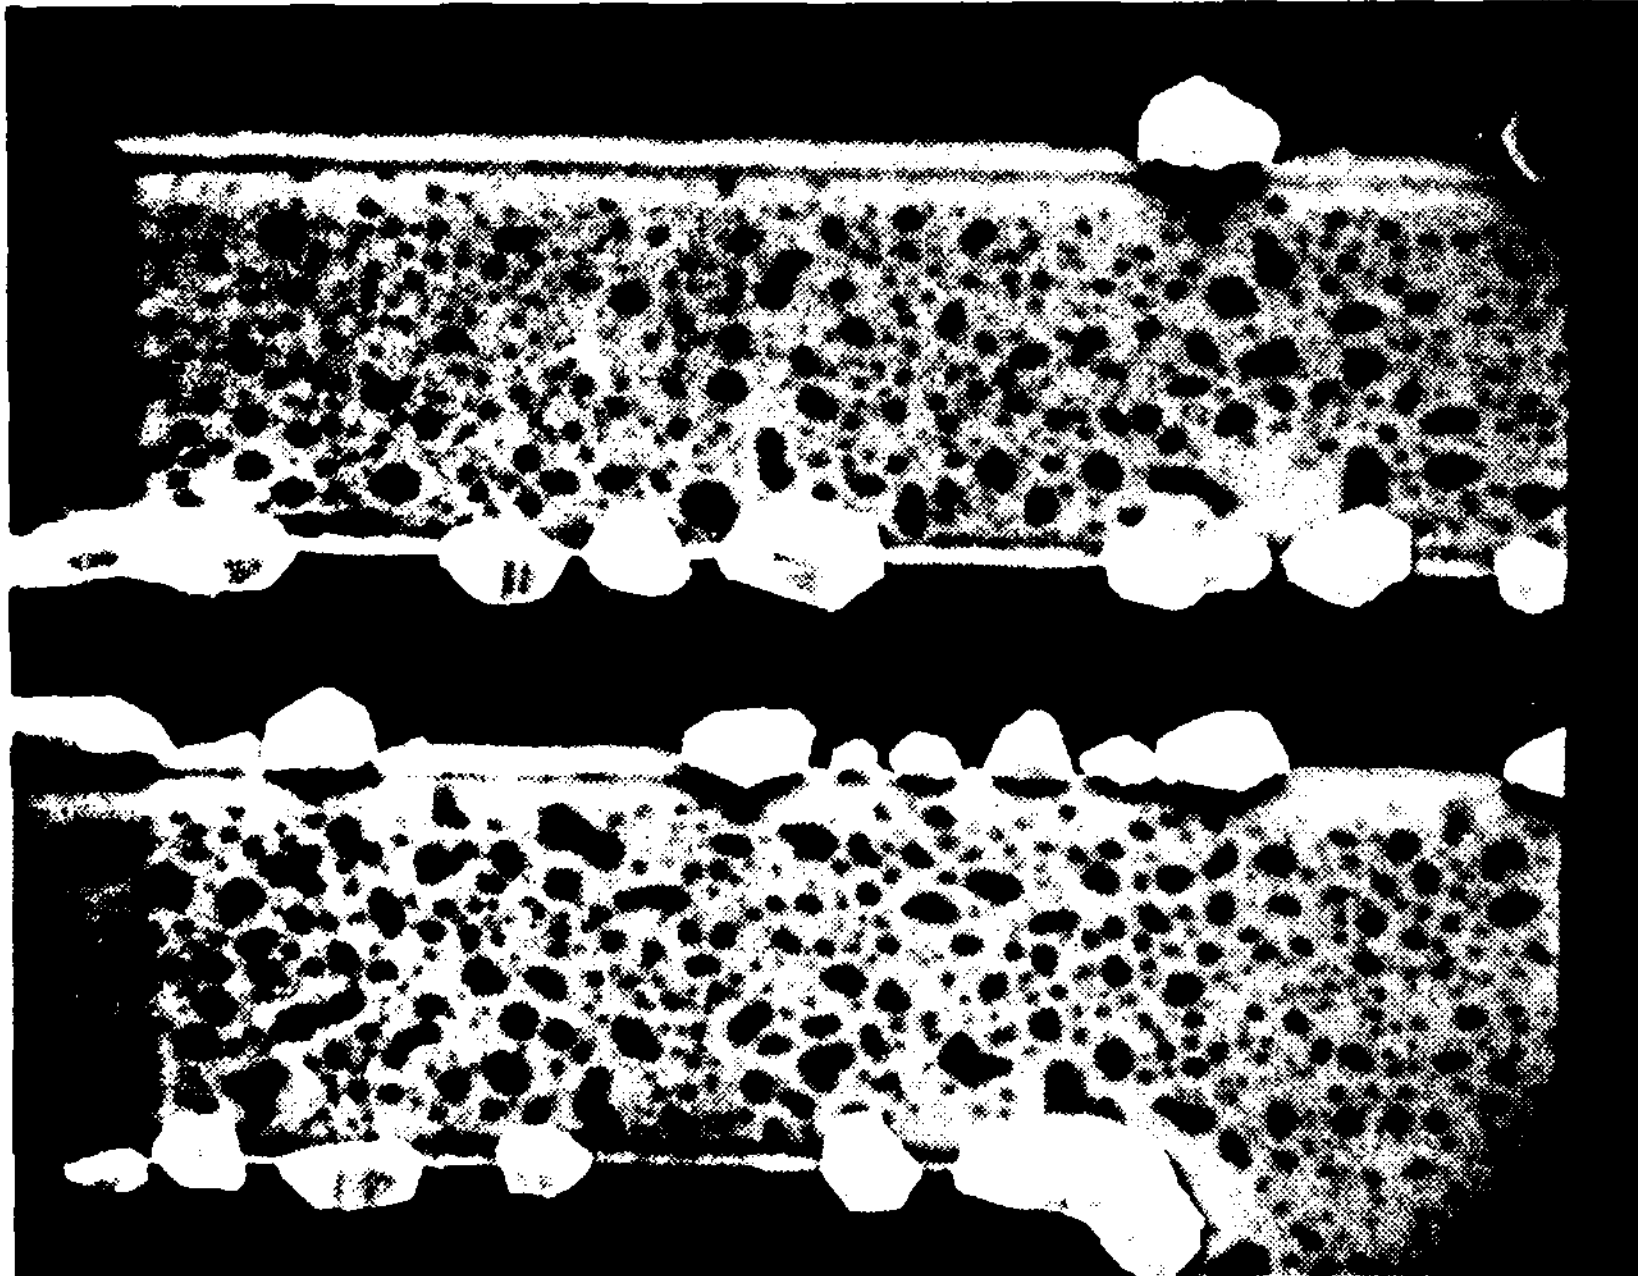
4-18-84-6 2000X

Figure 11. Holes in Gold Runs Adjacent to Crystal Growth (Sample 22-1).

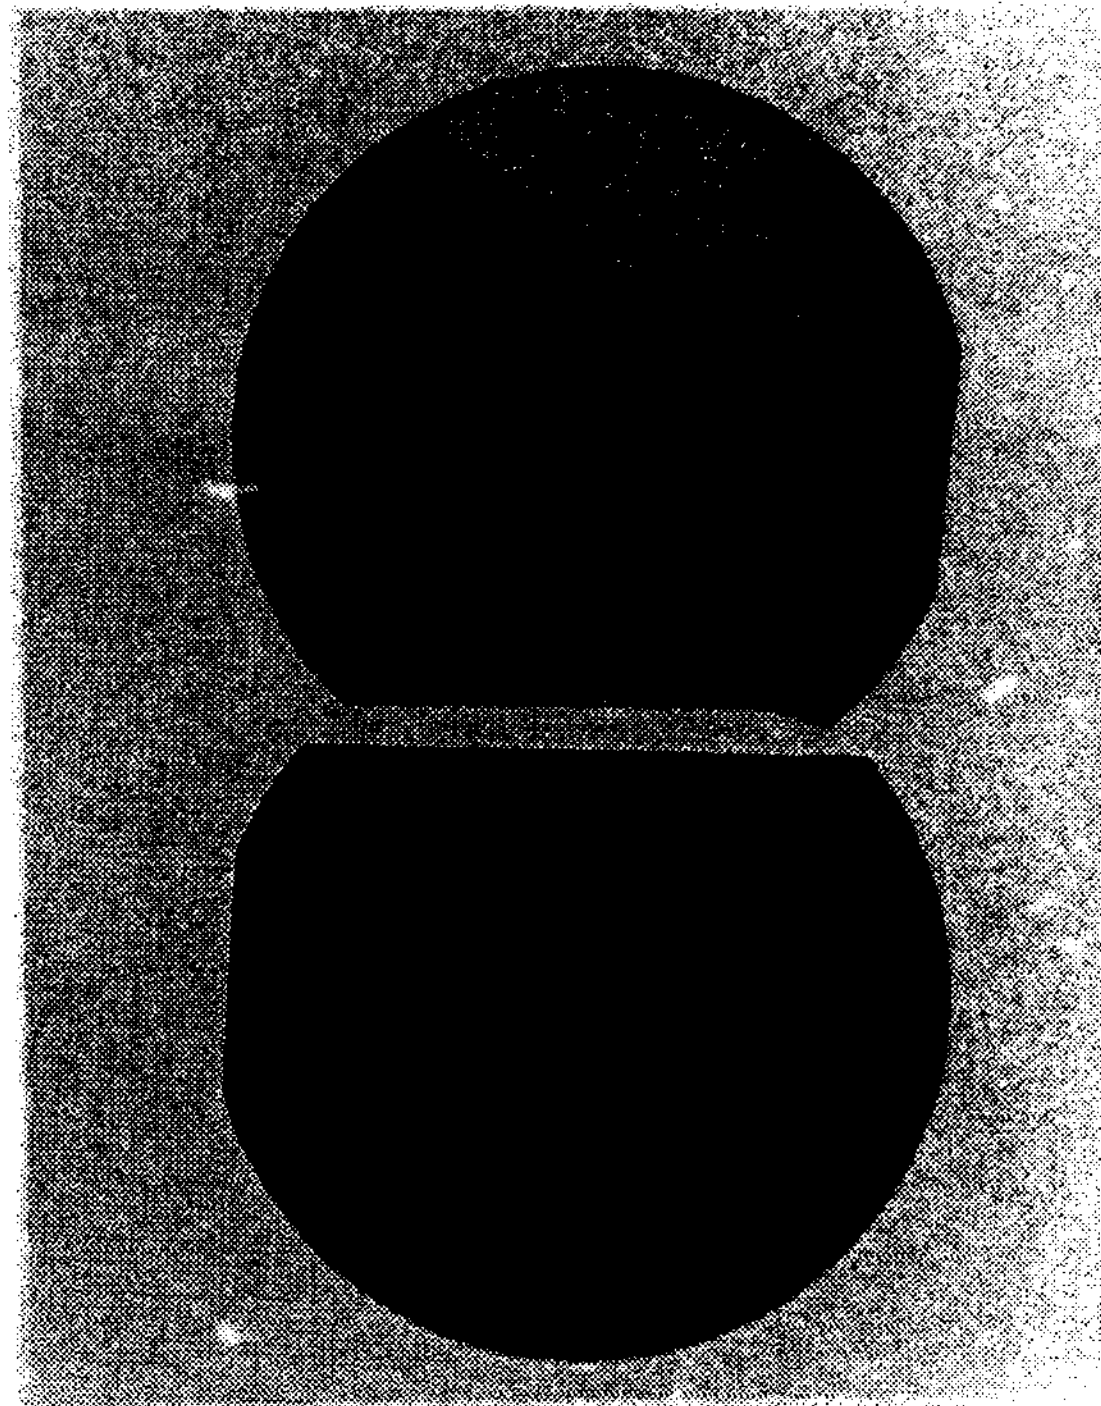
Ti-W was chosen as a preliminary diffusion barrier since it is a commonly used barrier with gold metallizations. A diffusion barrier of "as sputtered" Ti-W was found to fail after times as short as 100 hours at 350°C (see Figure 2). Without an effective barrier the silicon semiconductor material and the gold metallization can interdiffuse as shown in Figure 3. Silicon dissolving into the gold would be supplied from the device contact regions. Gold dissolving into the silicon in the contact regions can leave voids and open circuits in the interconnect lines. Finally, gold doping in the silicon will shorten minority carrier lifetimes and cause transistor gains to degrade.

Fig. 2 Evaluation of undoped Ti-W diffusion barriers for separating gold and silicon. Both samples have been annealed for 100 hours at 350°C in nitrogen.

The addition of a nitrogen "stuffing"[1] to the Ti-W layer transforms it into an excellent diffusion barrier. The nitrogen doping was introduced into the Ti-W diffusion barrier during the sputtering process by mixing about 10% nitrogen to the argon atmosphere inside the chamber. The nitrogen doped diffusion barrier provides good protection against the interdiffusion of silicon and the gold metallization but the nitrogen doping changed the adhesion properties of the Ti-W barrier layer. Tape tests and pull tests indicated that the adhesion between the Ti-W and the wafer oxide and between the Ti-W and the gold layer were about 1000 psi in "nitrogen stuffed" samples. Failures in life tests due to lifting metal lines, shown in Figure 4, and problems during the bonding operation of chip packaging, as shown in Figure 5, were attributed to reduced adhesion resulting from the nitrogen doping in the diffusion barrier. The addition of an undoped Ti-W layer on the top and bottom of the nitrogen doped layer restored the adhesion level to greater than 8000 psi.

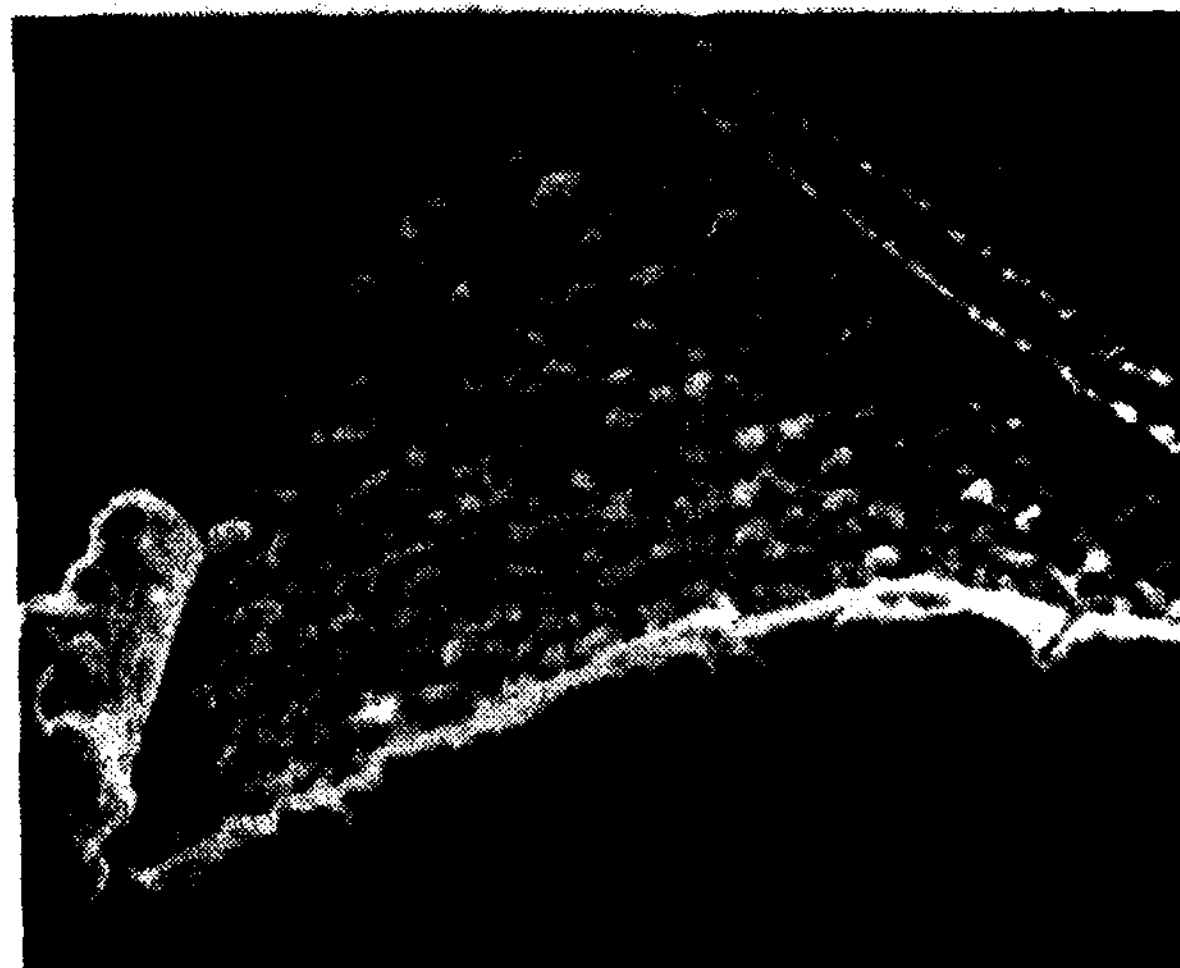
Fig. 5 A heavily nitrogen doped Ti-W diffusion barrier caused the reduction in adhesion between itself and the top gold layer. The reduced adhesion was discovered at the bonding operation as shown in the top photograph. The bottom photograph shows a close-up of the corner bonding pad with the gold lifting from the Ti-W layer.

- Adhesion of Ti-W to gold or silicon oxides is degraded by barrier "stuffing". Good adhesion can be achieved by using as unstuffed Ti-W layer at the interfaces.

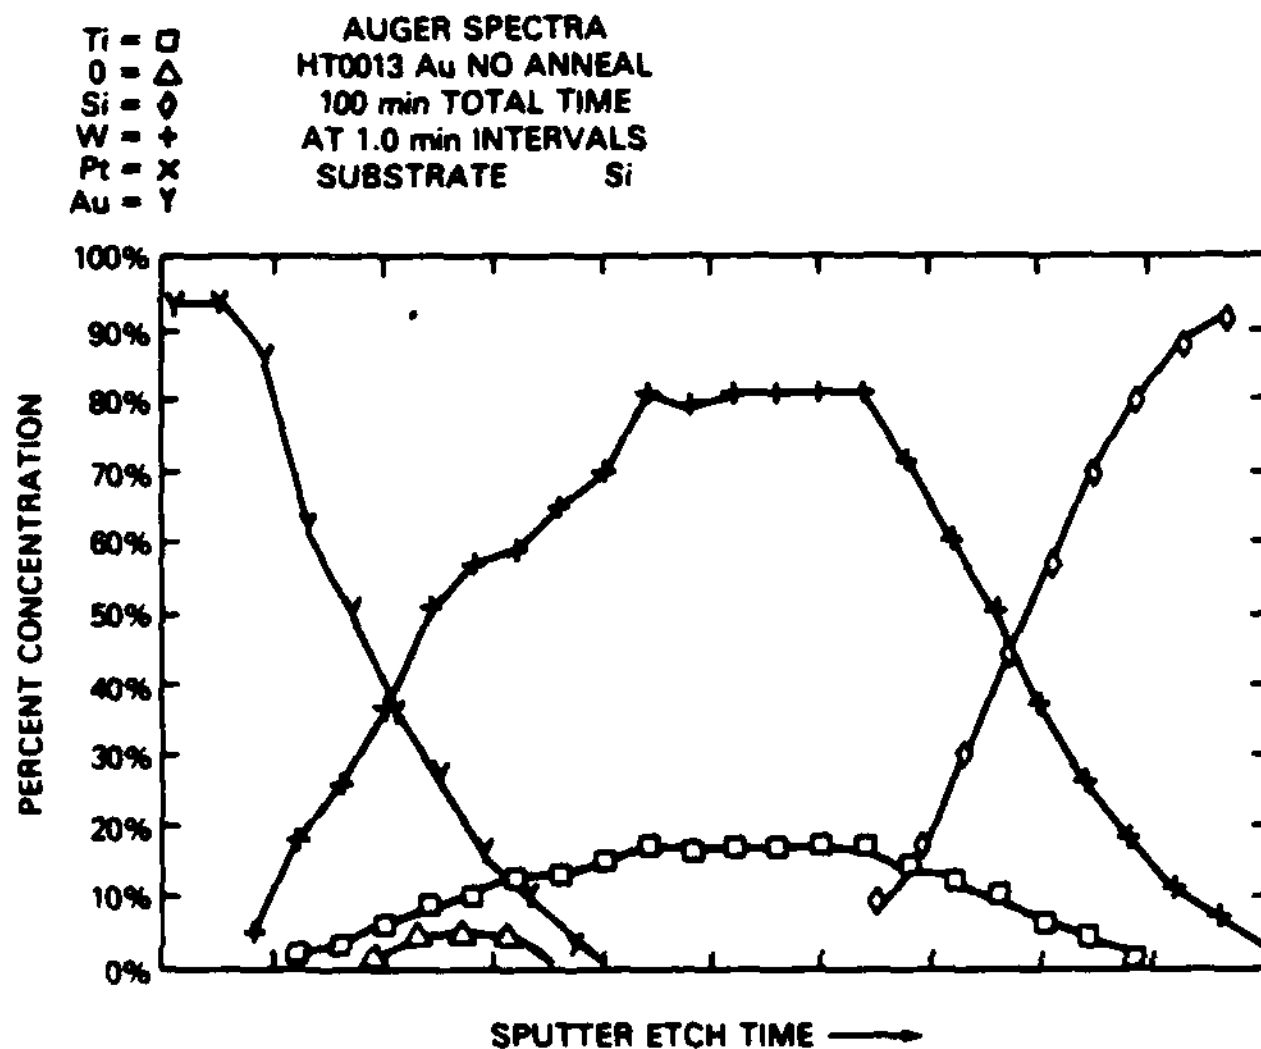
over 3500 hours while the other half was stored at room temperature. An Auger profile of the as deposited structure is shown in Figure 6. A well defined nitrogen doped Ti-W diffusion barrier is shown. Some oxygen at the Au/Ti-W interface is observed due to the gettering action of Ti-W. After annealing, the degree of interdiffusion increased, as shown in the Auger profile in Figure 7. In particular, the tungsten and titanium have penetrated into the bulk of the gold film and have moved into the silicon. There is some indication of a pending barrier breakdown since the gold and silicon are in close proximity of each other after annealing. However, the diffusion barrier remains effective even though metal migration occurs during the anneal process. Tests indicate that lifetimes will exceed the desired goal for any reasonably expected acceleration factors.

Fig. 6 The Auger profile of the as deposited metallization system shows the abrupt interfaces between the layers.

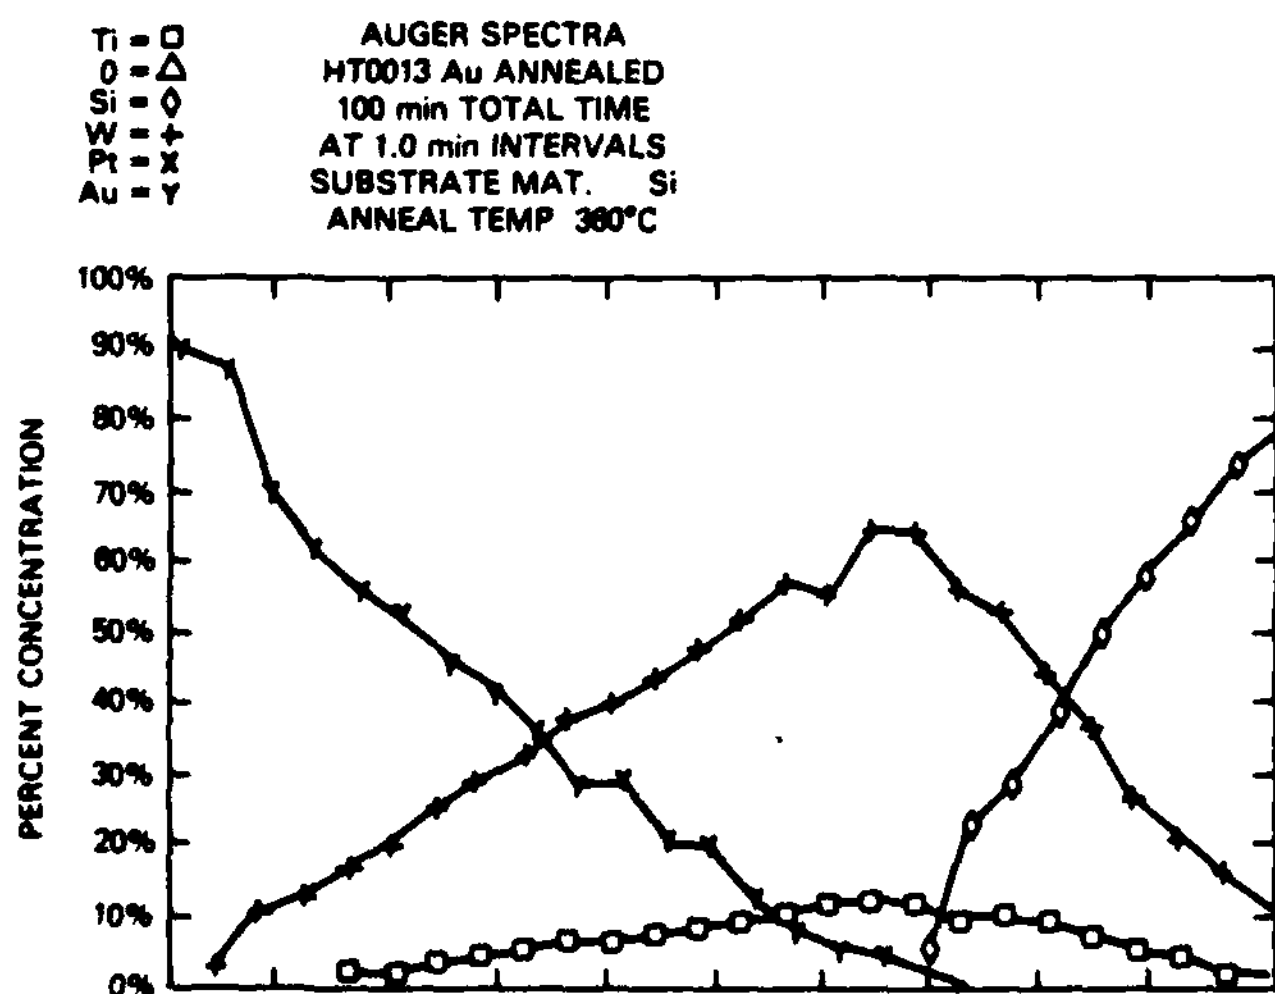
Fig. 7 The Auger spectra profile of the sample after annealing for over 3500 hours at 360°C shows some movement in the Ti-W layer.

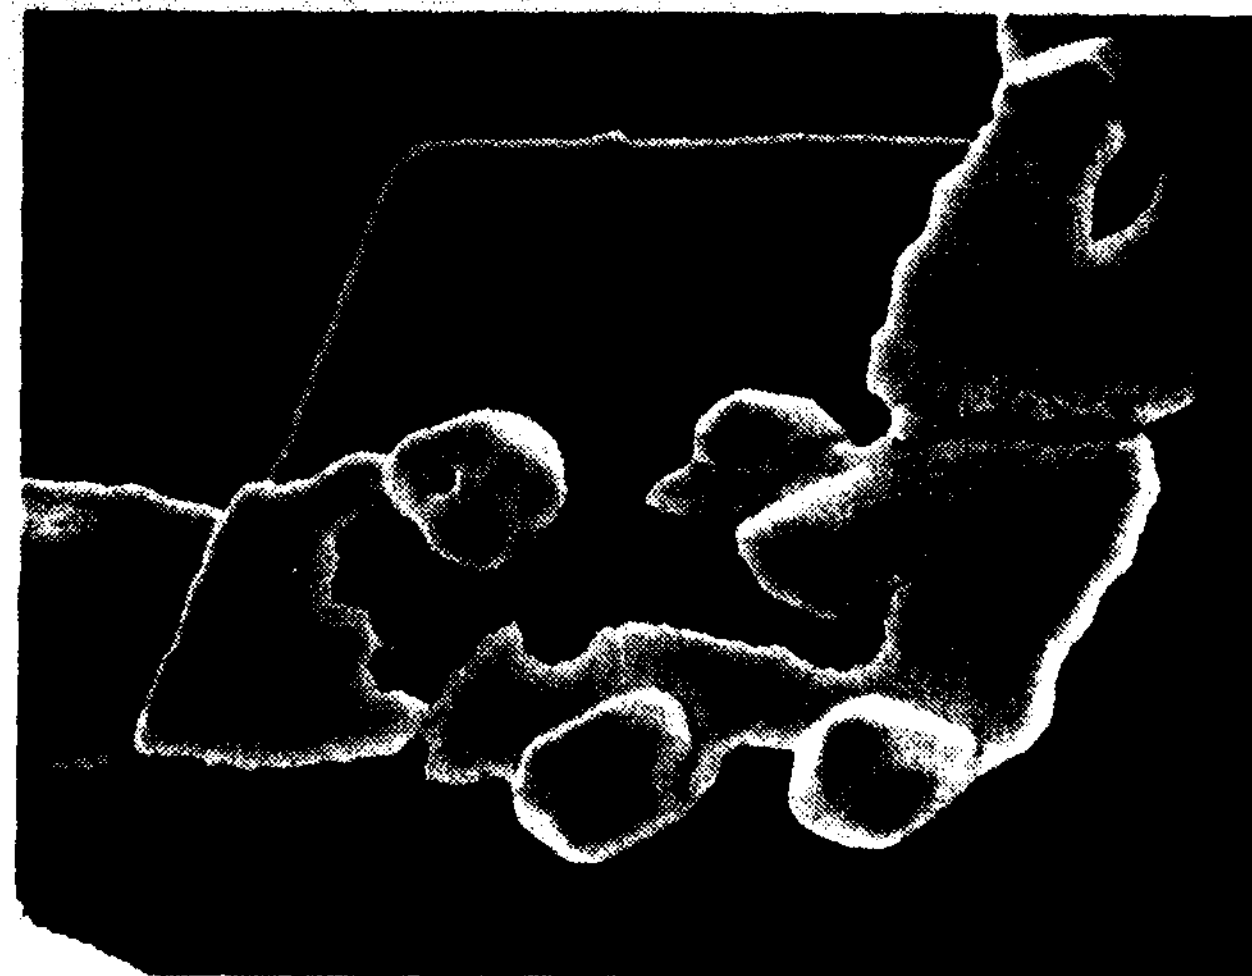
One of the discoveries in the failure analysis of the initial life test samples was the presence of hillocks and voids in the unpassivated metallization layers [2]. Single crystals were observed growing from the top and sides of the metal runs (see Figure 8). SEM microprobe analysis of the crystals indicated that they were composed of pure gold within the limits of the measurements.

The cause of the gold crystal growth was hypothesized to be due to the thermal expansion mismatch between the gold film and the silicon wafer substrate. At some elevated temperature the gold film would be placed in compression since gold expands more rapidly than silicon. The compressive force on the gold provides the driving force for crystal growth as gold atoms migrated to regions of lower potential energy. This movement is aided by the increased mobility of gold atoms at elevated temperatures.

Fig. 8 Hillock and void formation caused failures in the initial unpassivated metallization. The sample shown above failed after 320 hours at 320°C.

The failure rate due to gold hillock growth may be reduced by suppressing hillock formation. This has been attempted in two ways. First, the driving force can be eliminated by depositing the gold at high temperatures [2]. Second, a passivation layer can be deposited to constrain the metallization surface and prevent hillock growth.

If a thermal expansion mismatch is the cause of the crystal growth in the gold metal layer when they are annealed at high temperatures then an obvious solution is to deposit the metallization onto wafers that are heated to this temperature range. Then there would be no induced stains in films at the elevated temperature while at all lower temperatures the strain on the gold would be tensile and not conducive to crystal formation.

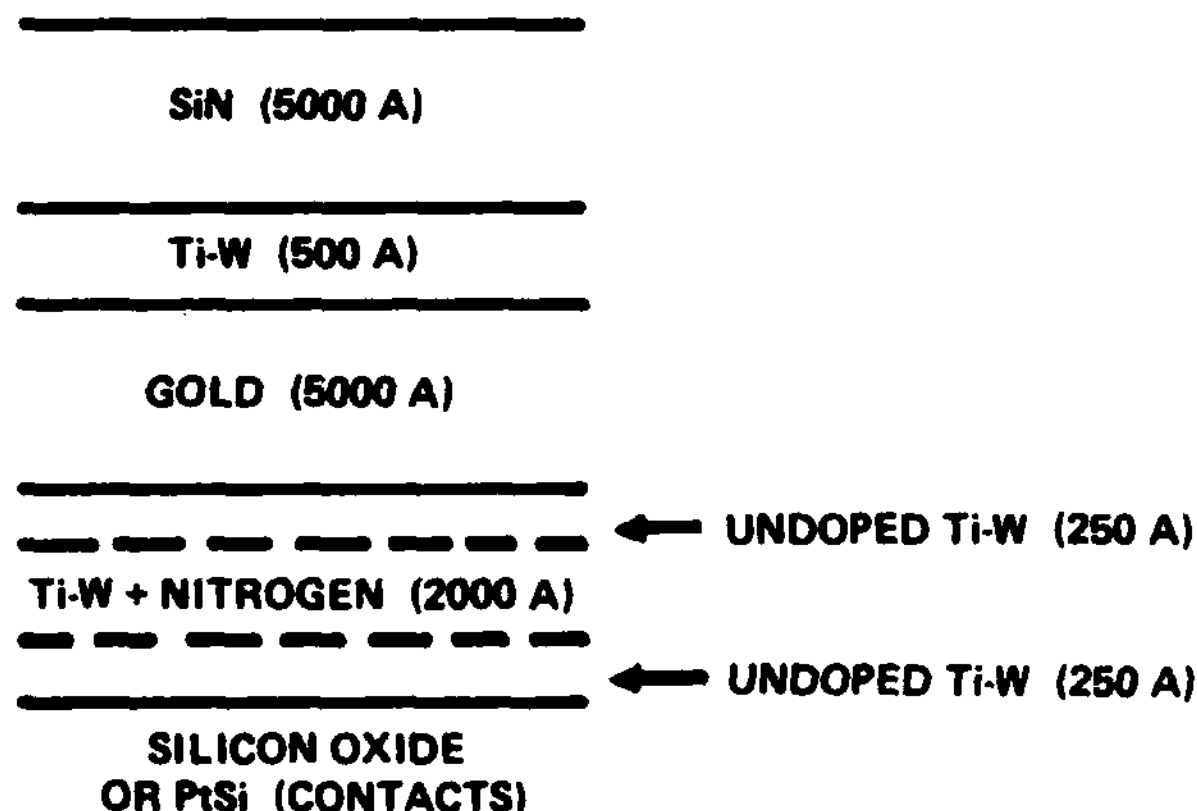
Fig. 12 The high temperature integrated circuit metallization system as shown above is deposited without breaking vacuum. The interconnect lines were defined followed by the deposition of the silicon nitride passivation layer.
