INSTALLATION RESTORATION PROGRAM

PHASE I - RECORDS SEARCH

AAC - NORTHERN REGION

SEPTEMBER 1985

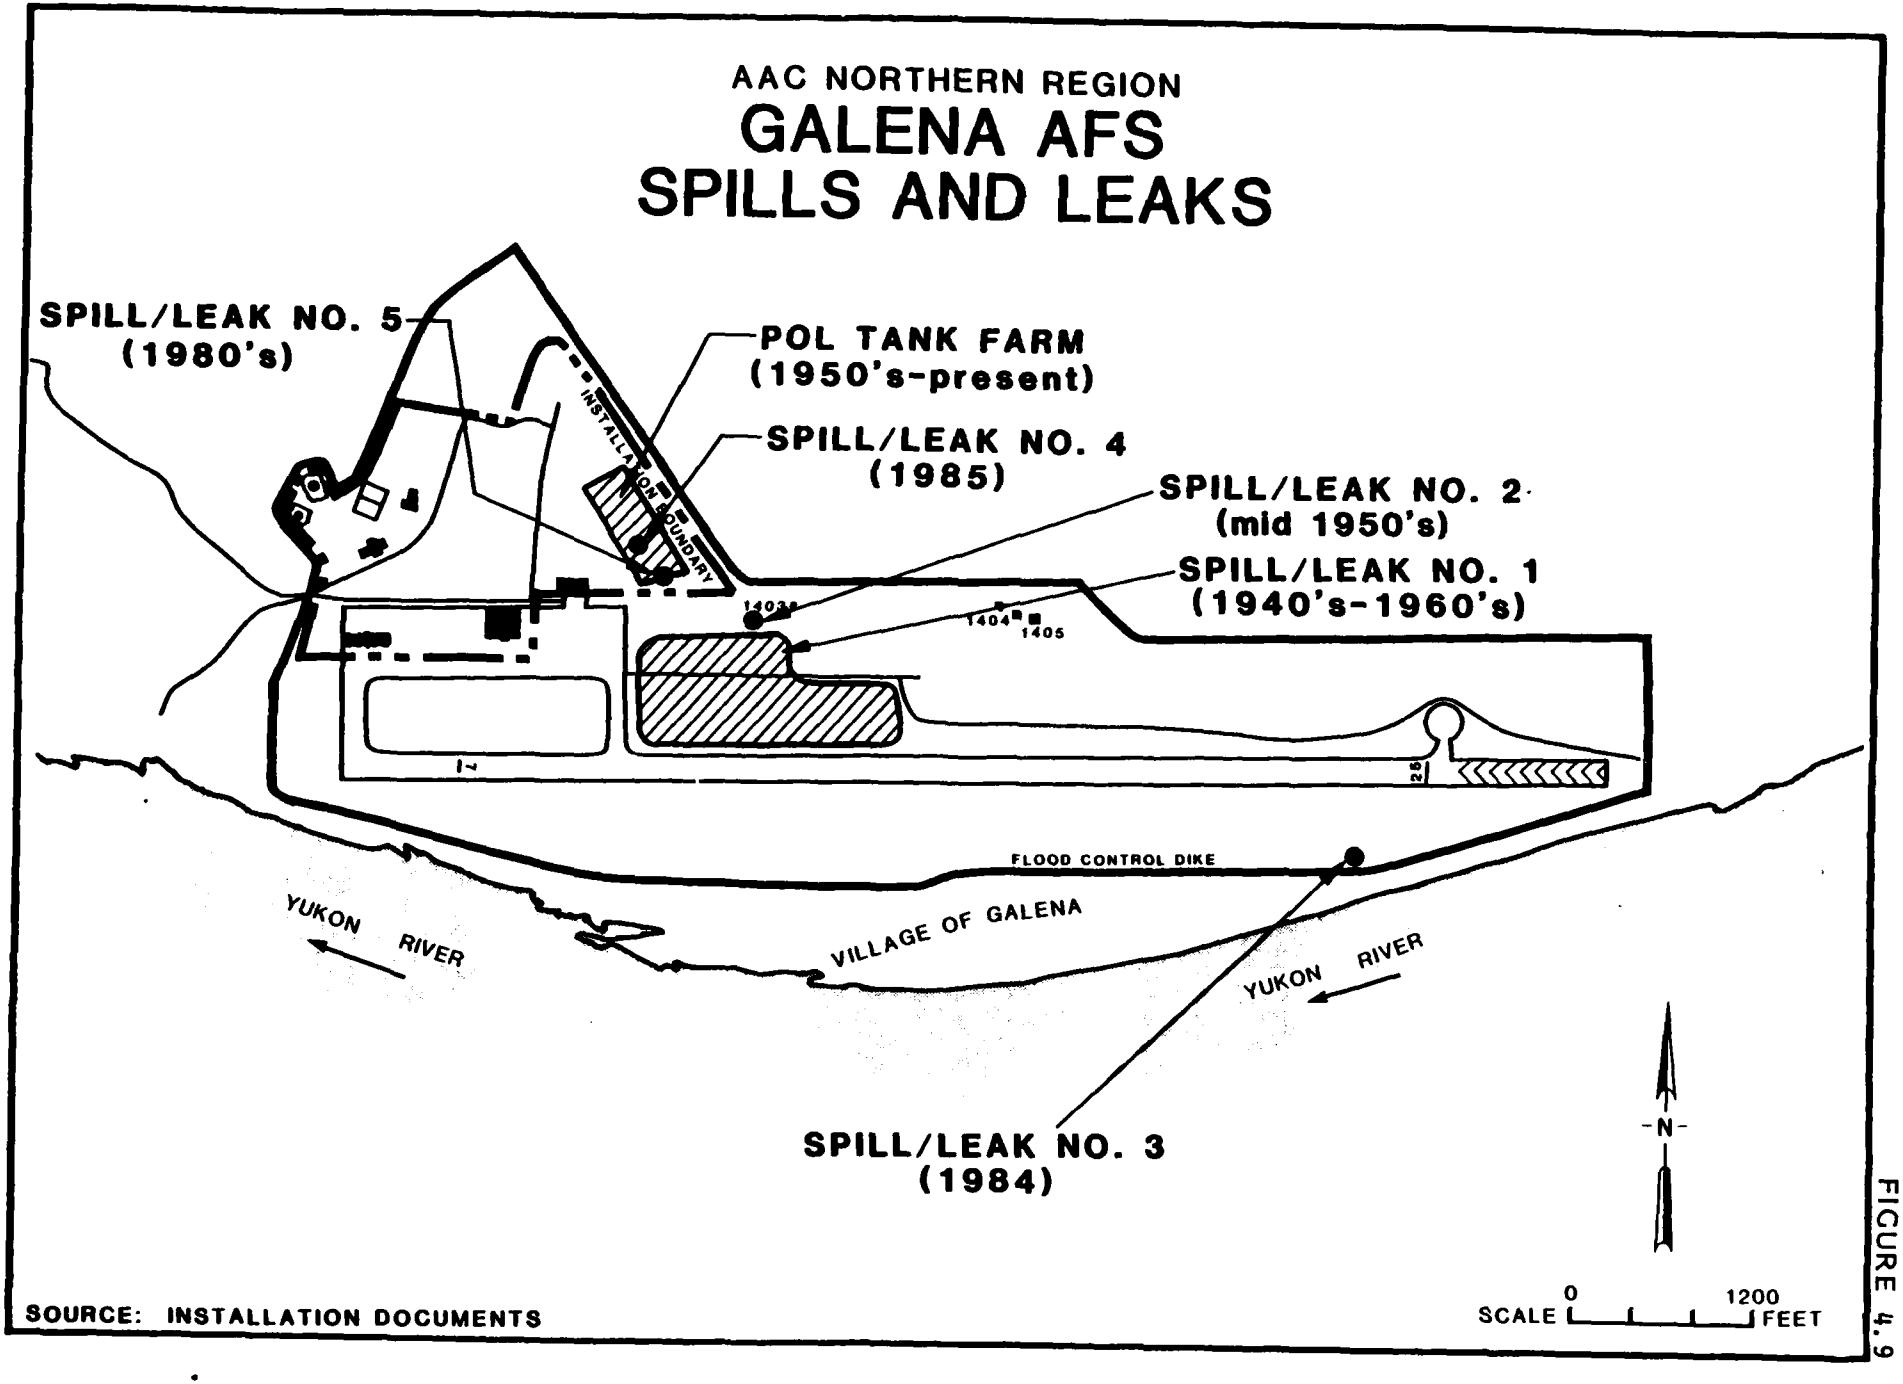
Valve Pit No. 2, located near the MOGAS fill stand (Spill/Leak No. 4) is also reported to be an area with periodic small equipment leaks. This pit (Spill/Leak No. 5) is located where a number of POL pipelines join (Figure 4.9).

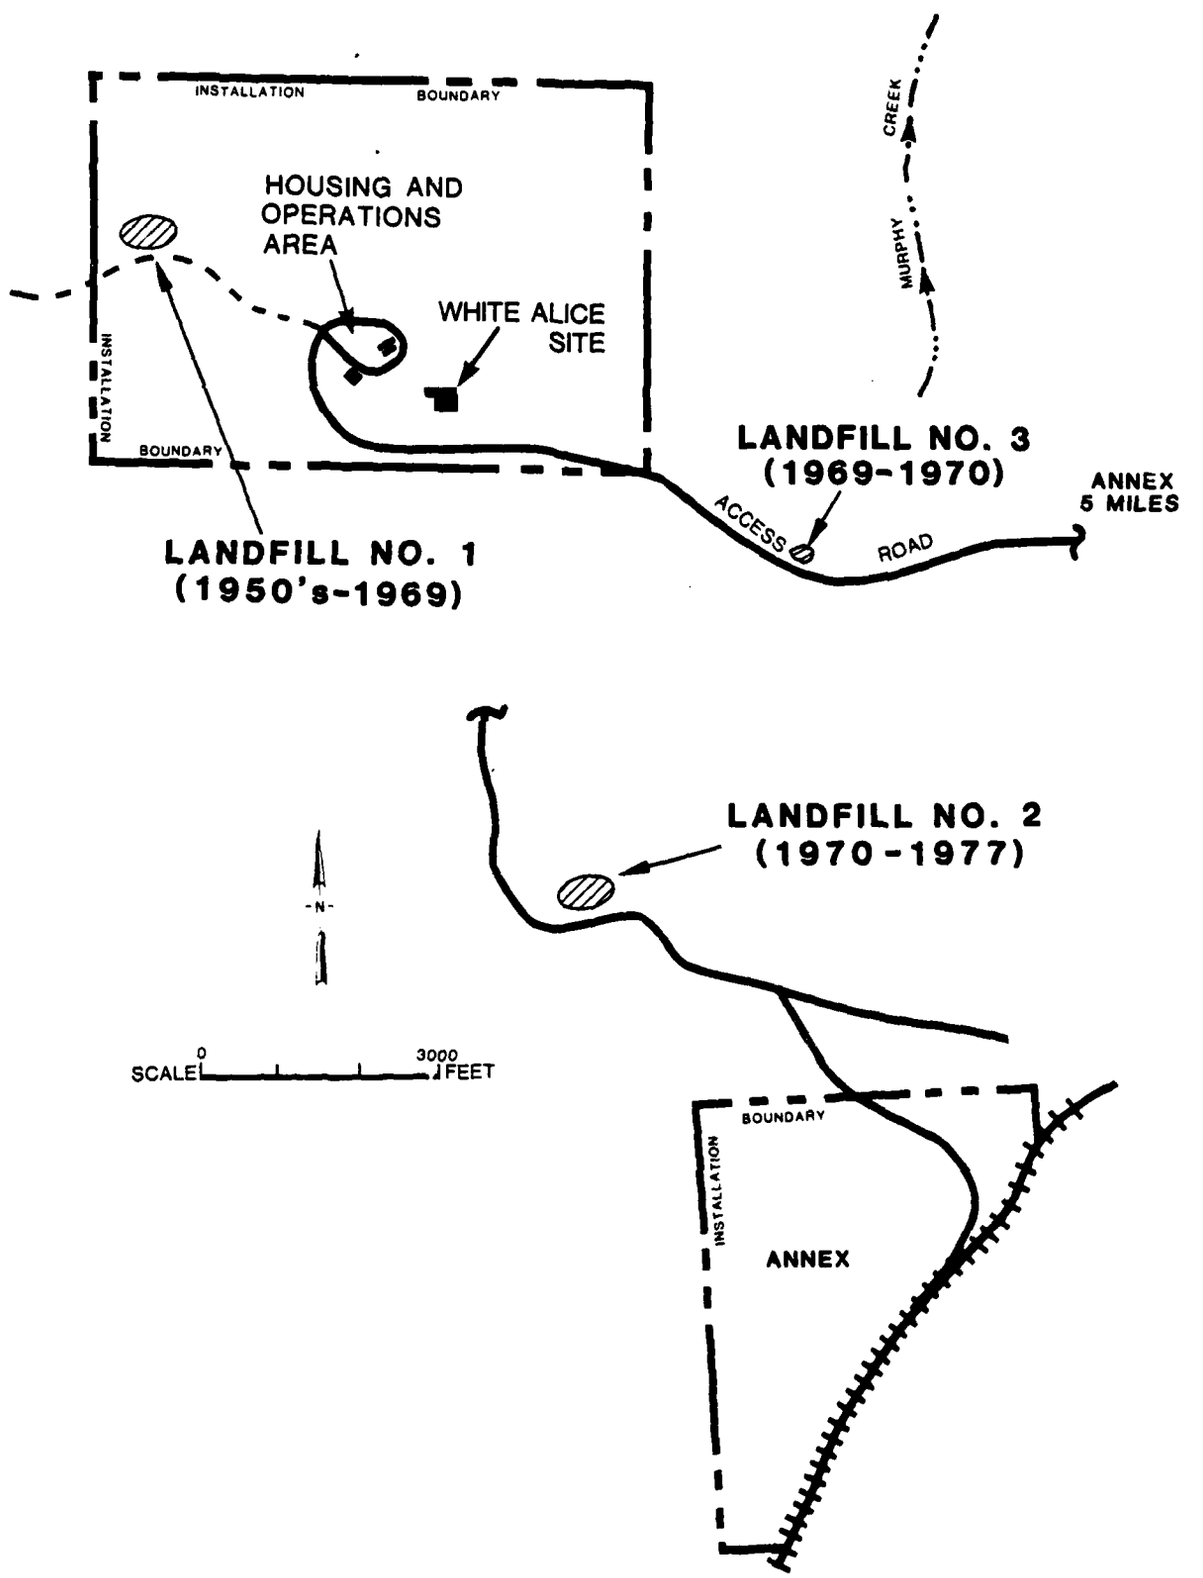
FIGURE 4.24

Three landfills were identified as being used by the Murphy Dome AFS installation (Figure 4.24). The initial operation (Landfill No. 1) was located about 0.5 mile northwest of the helicoptor landing area. Access to the site is along an unimproved road; the landfill is situated where the road divides and goes two different directions. This site is approximately an acre in size with fill depths of 10 to 15 feet. Garbage, rubbish, wood, metal, plastic, drums and other debris have been

buried at the site. Burning of wastes was practiced. This site operated until 1969.

Landfill No. 2 is located about 6 miles southeast of the installation adjacent to the main access road. This site is off installation property but was solely used by the Air Force from 1970 to 1977. The site is approximately one acre and fill depths were approximately 8 to 10 feet. Garbage, rubbish, incinerator ash, wood, plastic, metal and other wastes similar to those disposed at Landfill No. 1 were taken to this site. Wastes were burned at the landfill.

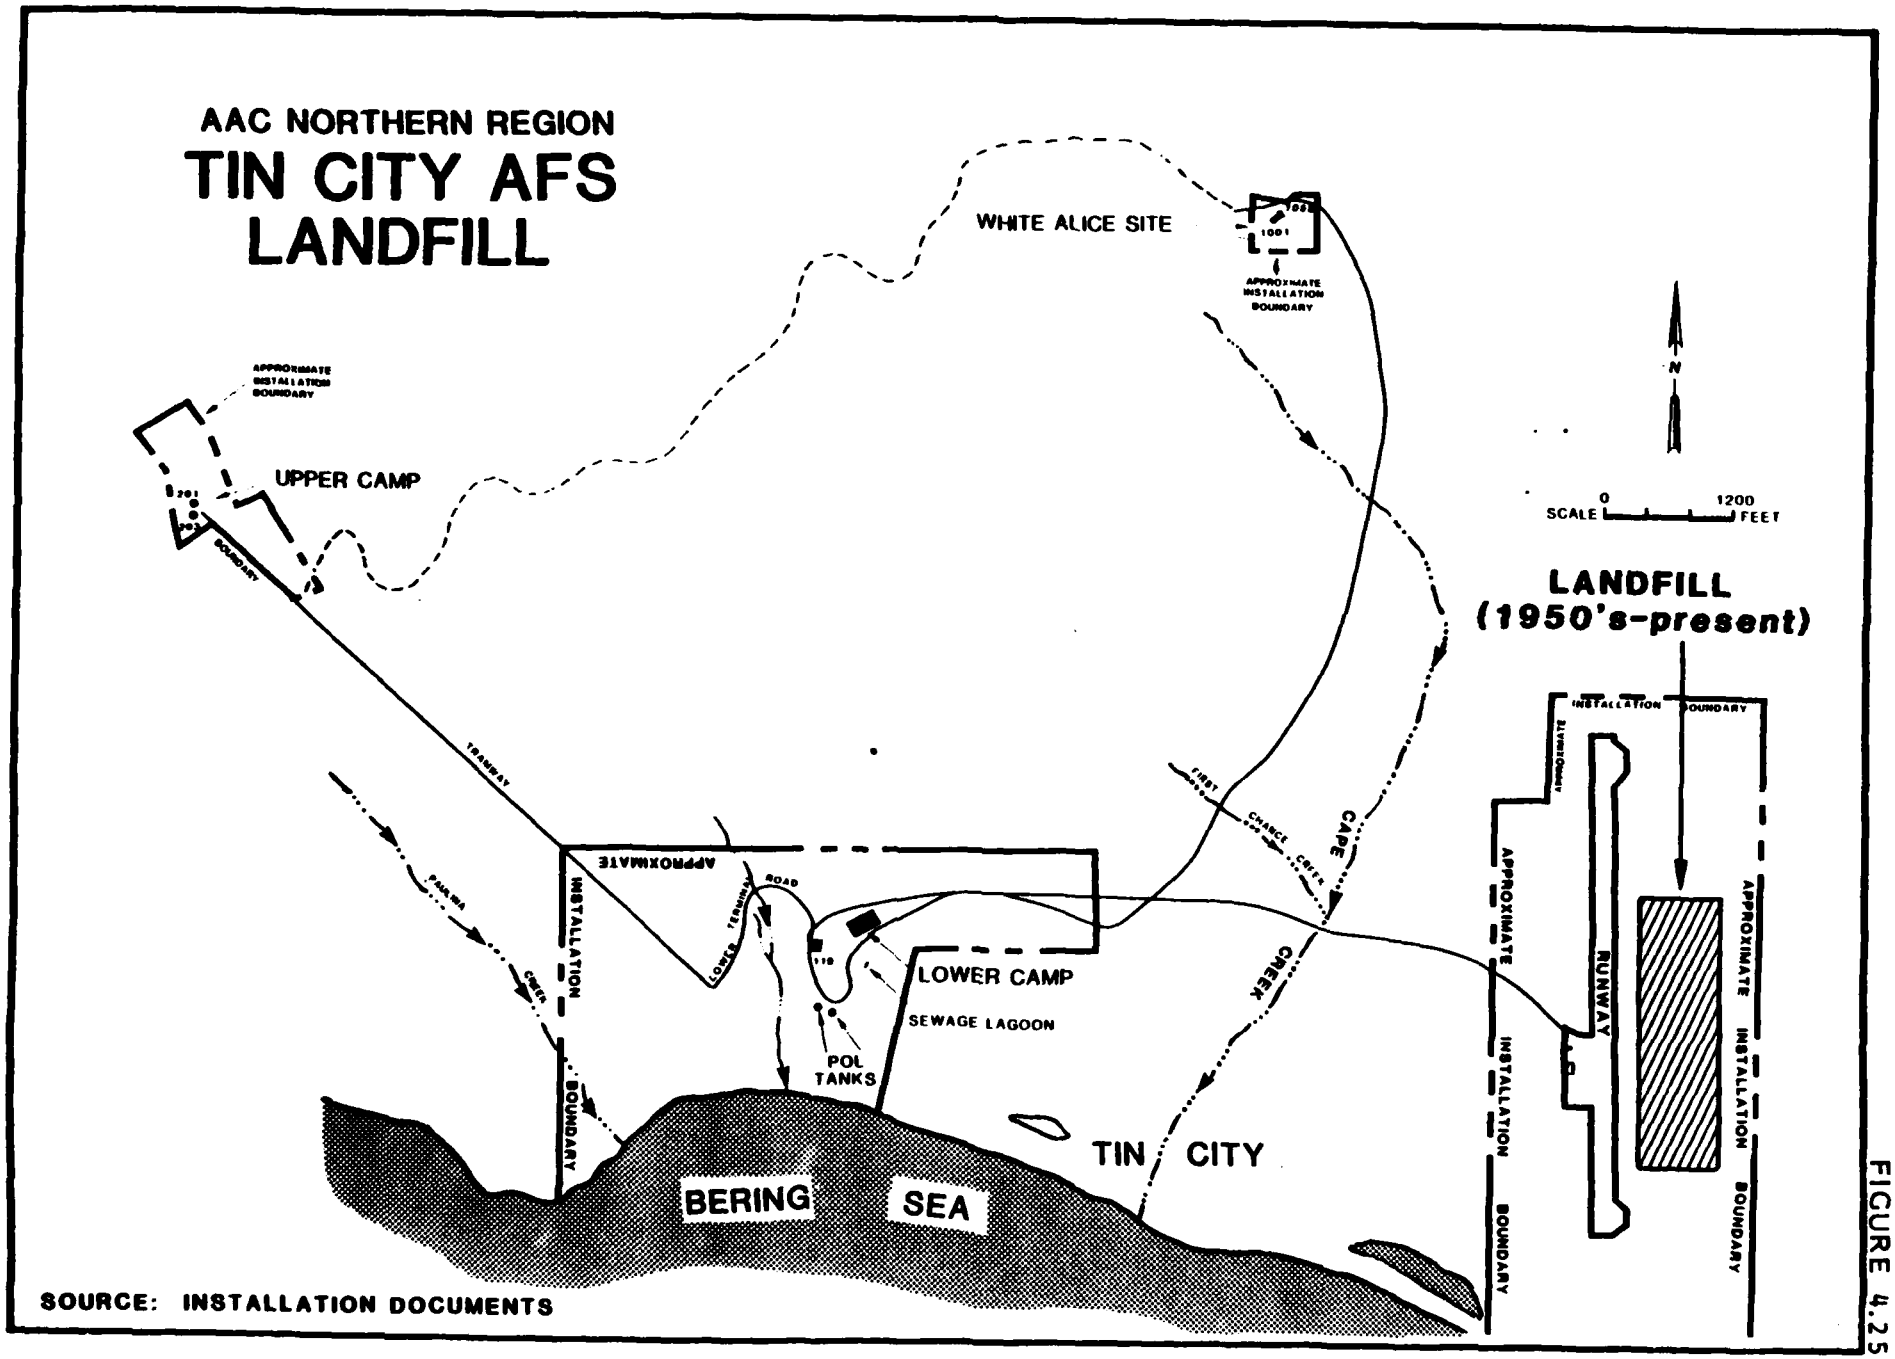
FIGURE 4.25

There has been only one landfill site at Tin City AFS as shown in Figure 4.25. It is located east of the runway. The landfill is a trench and fill operation. During the winter months trash, garbage, scrap metal, packing materials, empty paint cans, oily rags, etc. are hauled to the landfill and stockpiled. During the summer months when the soil can be excavated, the wastes are put into landfill trenches and covered. A large percentage of the hazardous wastes generated at the installation consist of petroleum-based wastes. These wastes are combustible and have been given to the nearby tin mine, where they were burned in furnaces. However, small quantities of these wastes are suspected of being disposed of in the landfill. Also in the late 1970's, 35,000 gallons of diesel fuel is suspected of having been burned in a pit in the vicinity of the landfill.

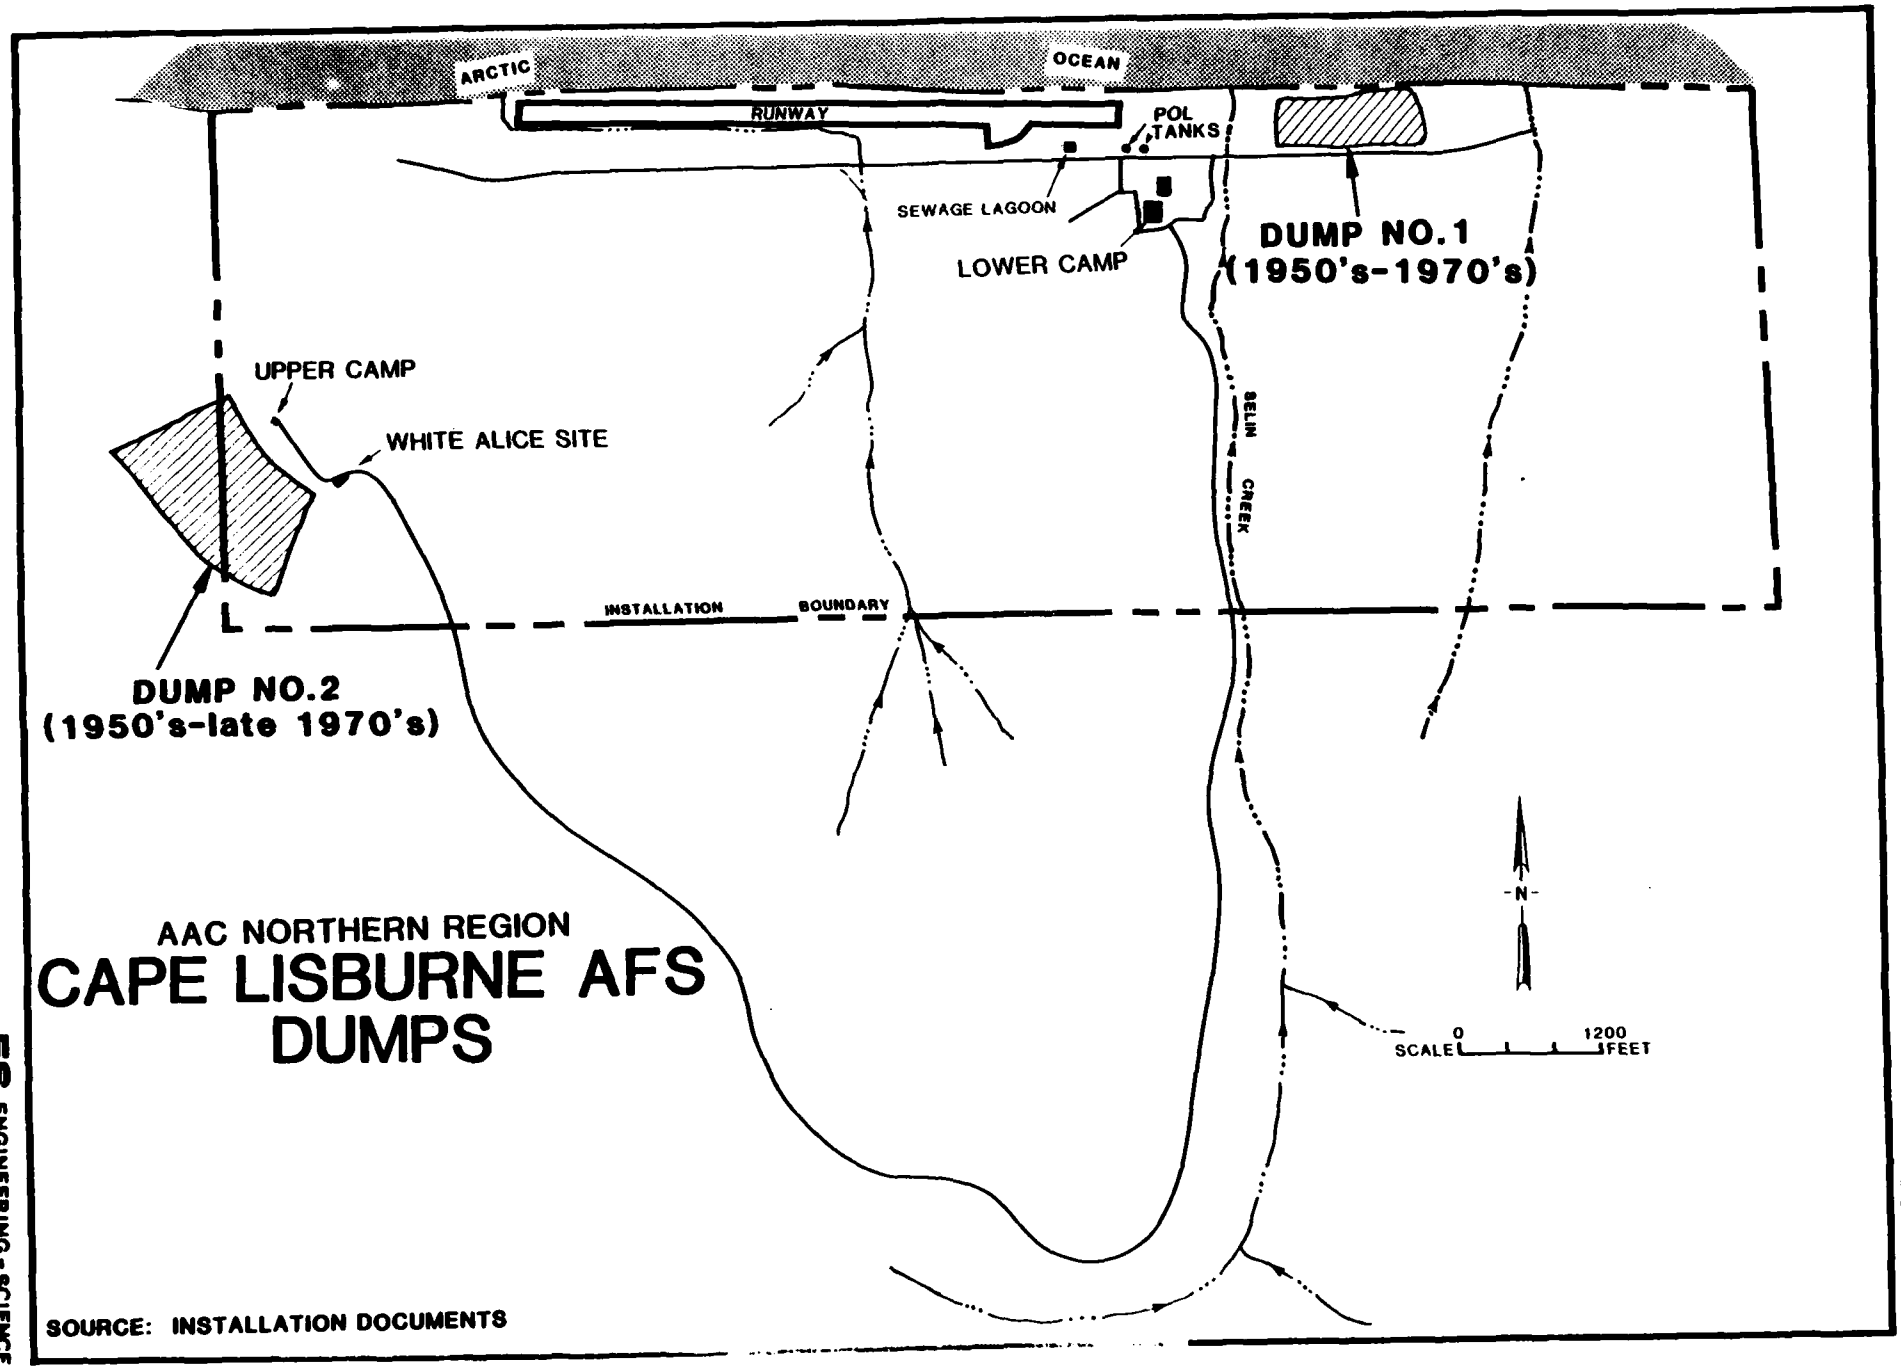
FIGURE 4.26

There have been two dumps at Cape Lisburne AFS. The locations of the dumps are shown in Figure 4.26. Dump No. 1 has been previously discussed as a waste accumulation area adjacent to the base landfill. This dump was used up to 1977-1978 when a cleanup of the installation was conducted. At this time accumulated waste oils were removed from the dump and shipped off base for disposal to DPDO at Elmendorf AFB. Most of the damaged drums were placed in overpacks for shipment, however, some of the drums were buried in the landfill and the dump. Old vehicles, tanks and large metal objects were used as rip rap between the beach and the runway. The metal objects were covered with large rocks blasted off the mountain.

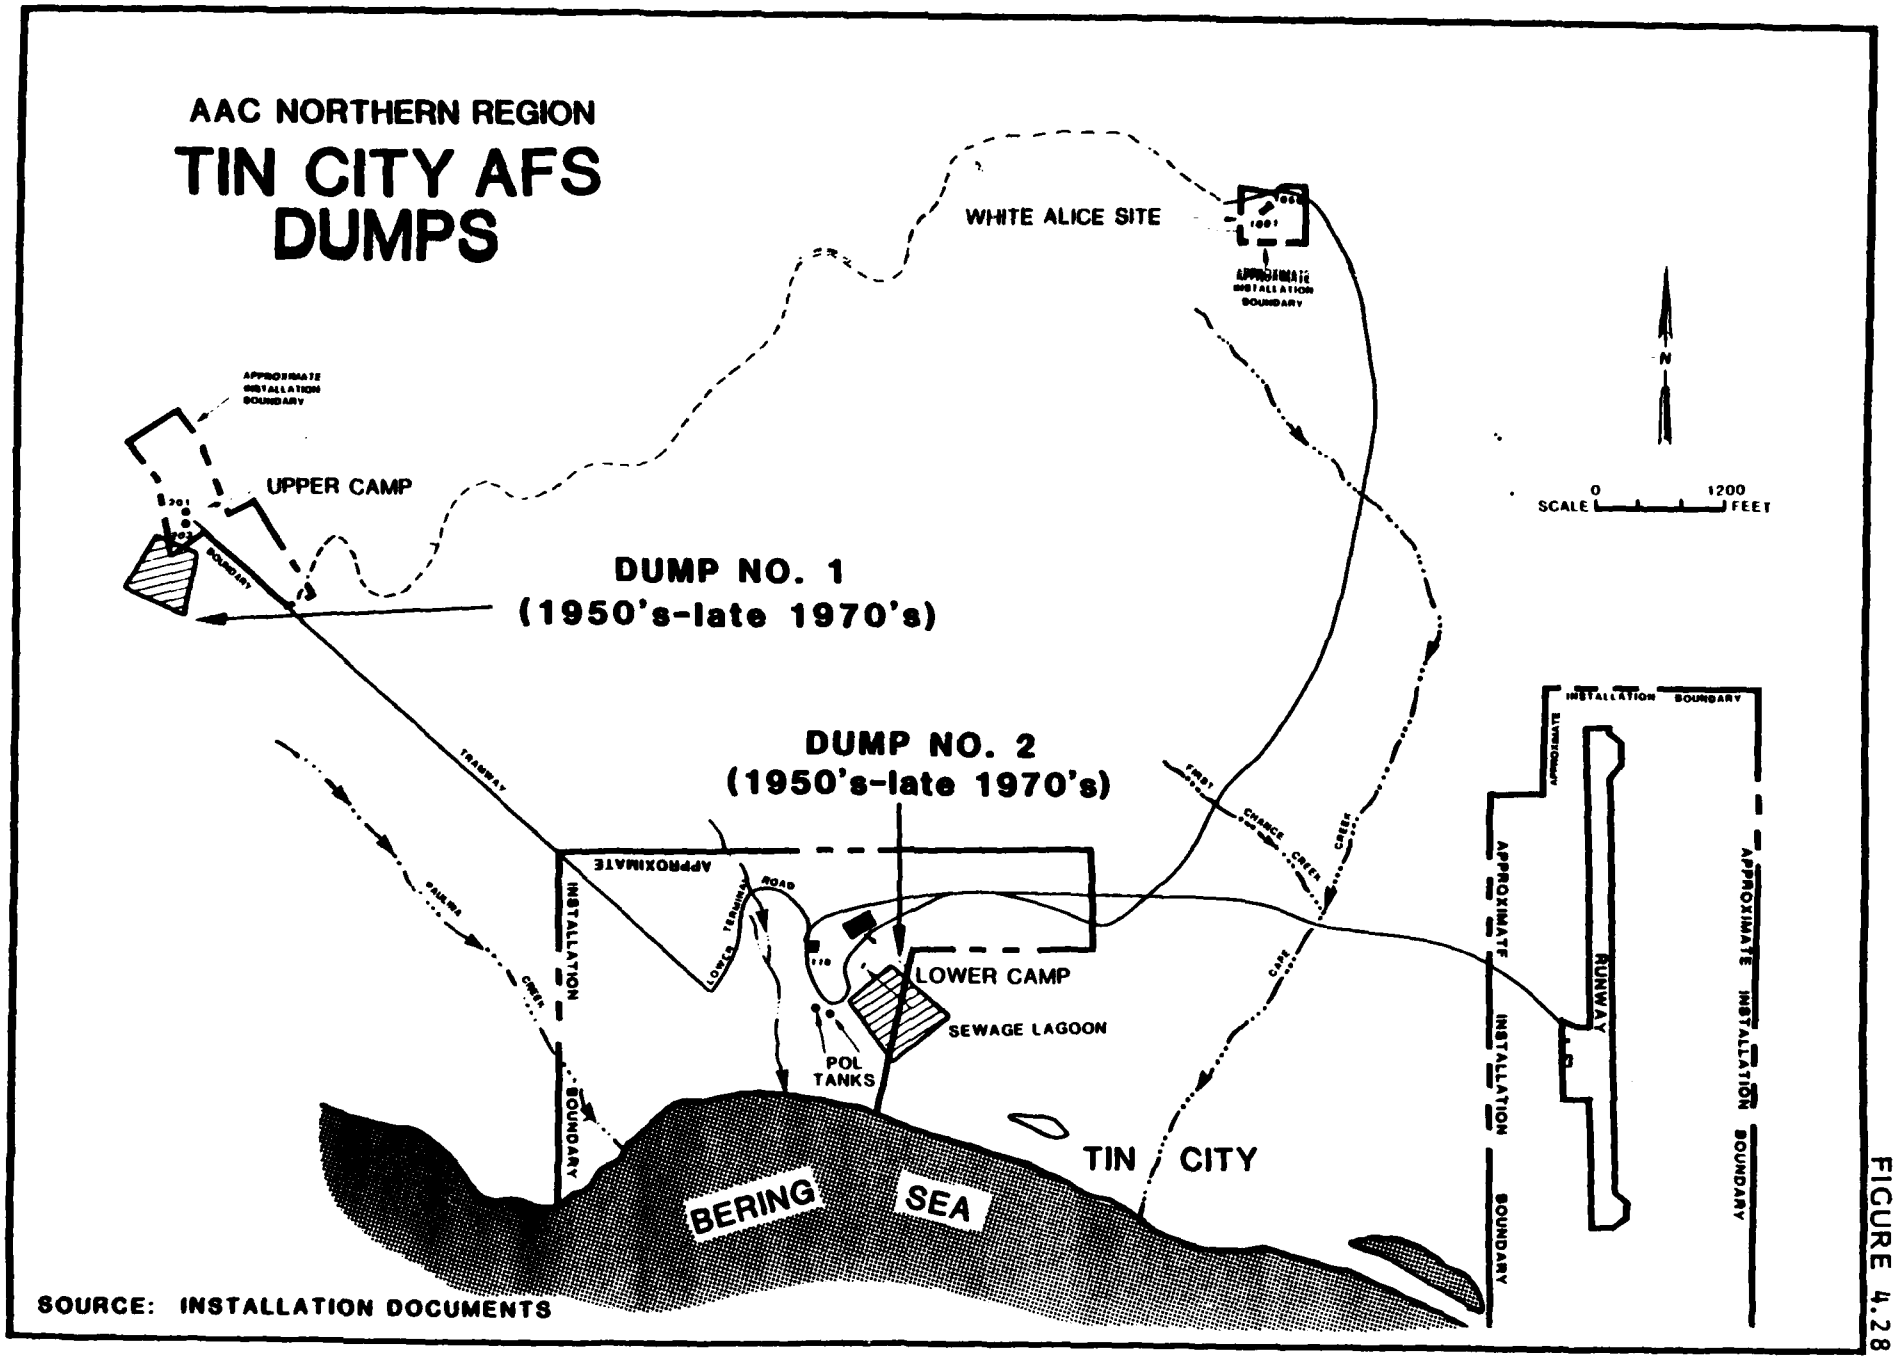
FIGURE 4.28

Two general dump areas have been identified at Tin City AFS as shown in Figure 4.28. One of these dump areas (Dump No. 1) was located in the valleys beneath the Upper Camp. The other dump area (Dump No. 2) was located beneath the Lower Camp, between the Lower Camp and the tin

mine site. Empty drums, drums of used and unused oil, scrap metal and lumber, garbage and refuse were thrown and/or blown into these areas. Wastes from these dumps were collected during site cleanups conducted in 1978 and 1984. Waste oils and other wastes were shipped off base for disposal. Scrap metal, wood, broken equipment, etc., was buried in the installation landfill.

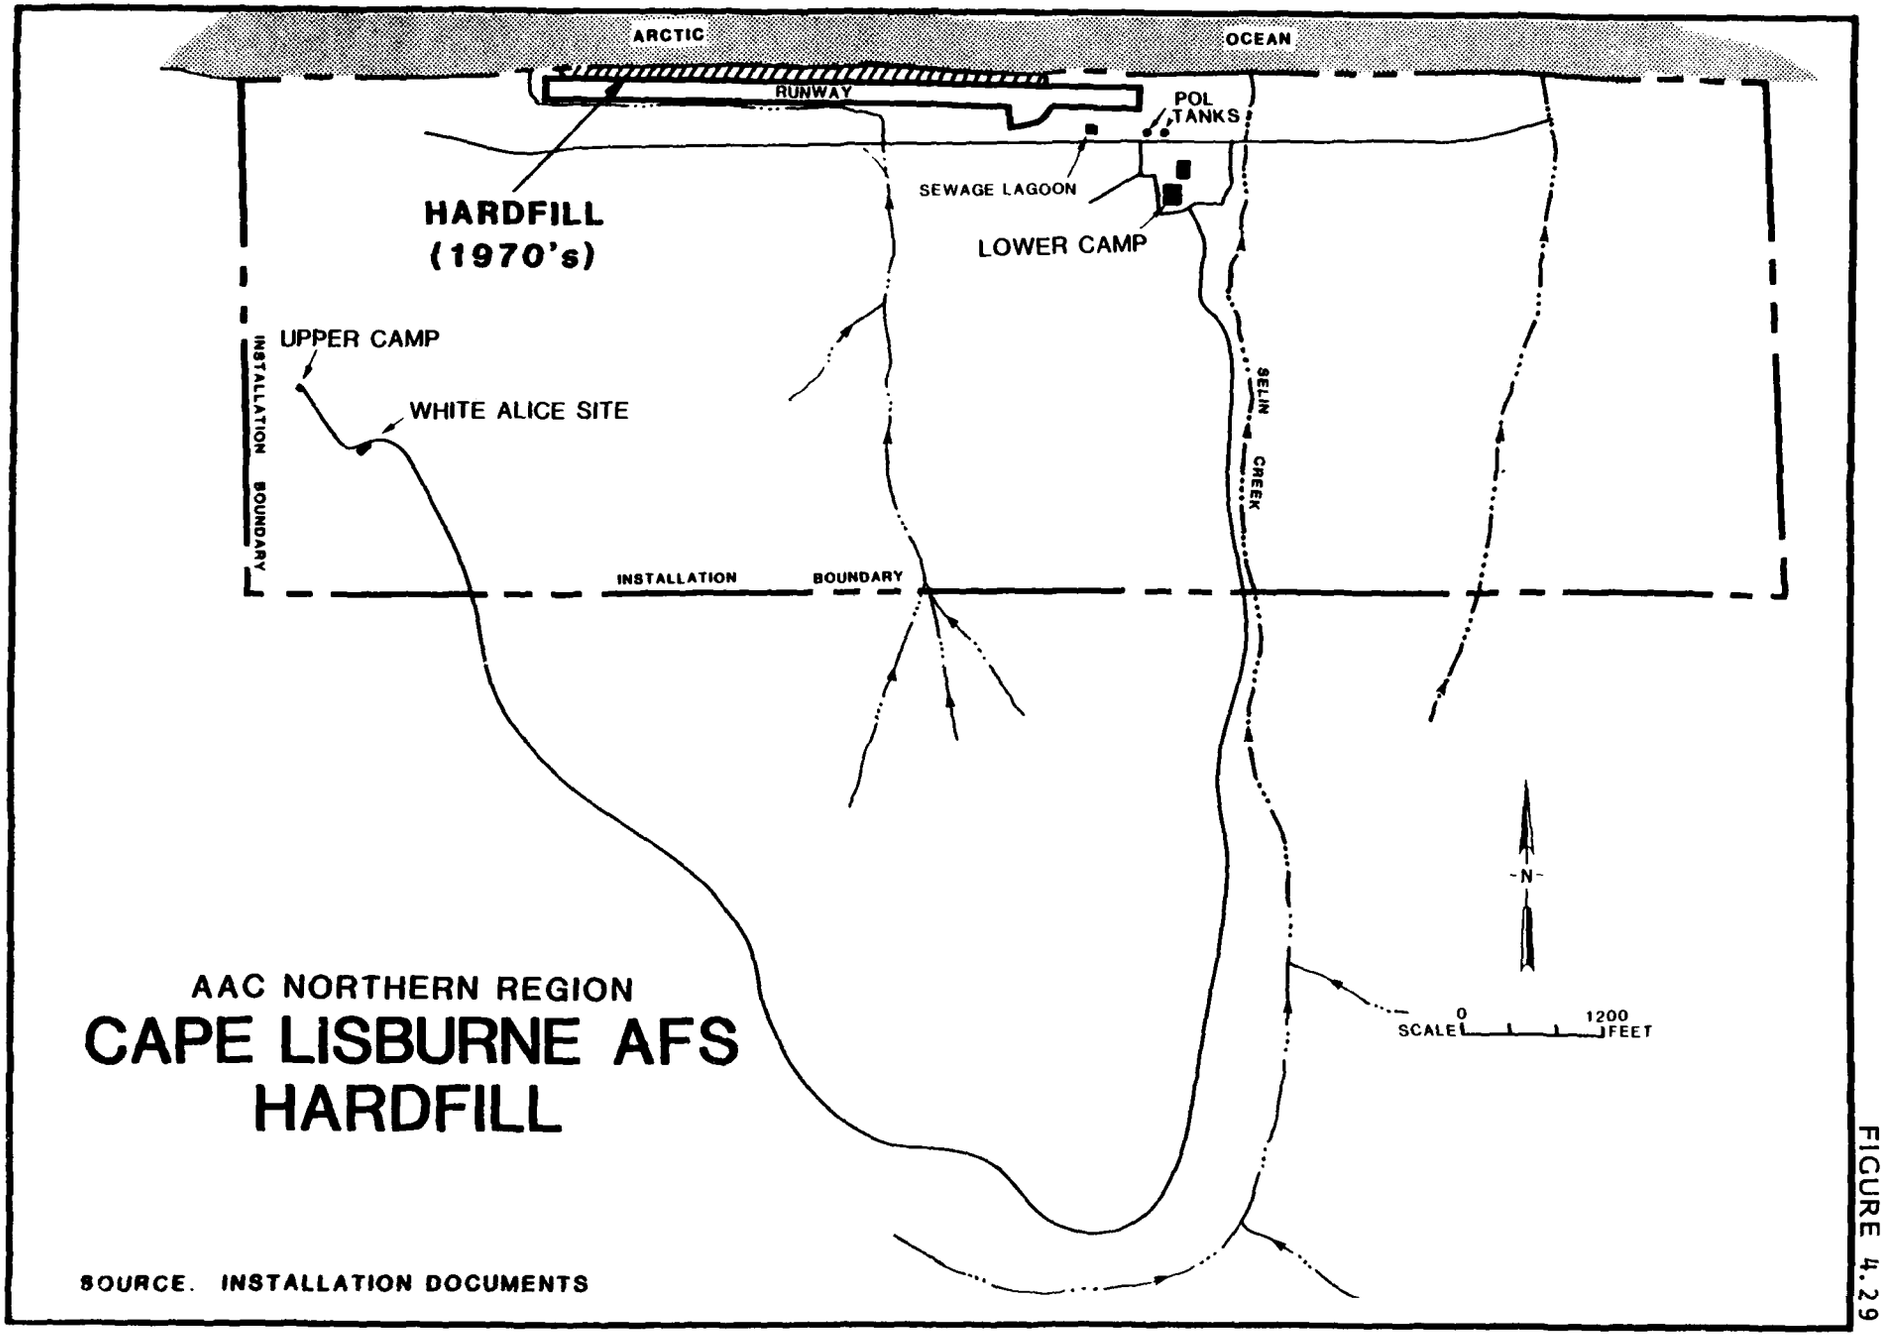
FIGURE 4.29

One hardfill area has been identified at Cape Lisburne AFS (Figure 4.29). This hardfill was used to prevent erosion of the runway. Old tanks, vehicles, etc., were placed into the Chukchi Sea and covered with rock. There is no indication that hazardous wastes were disposed of in this area.

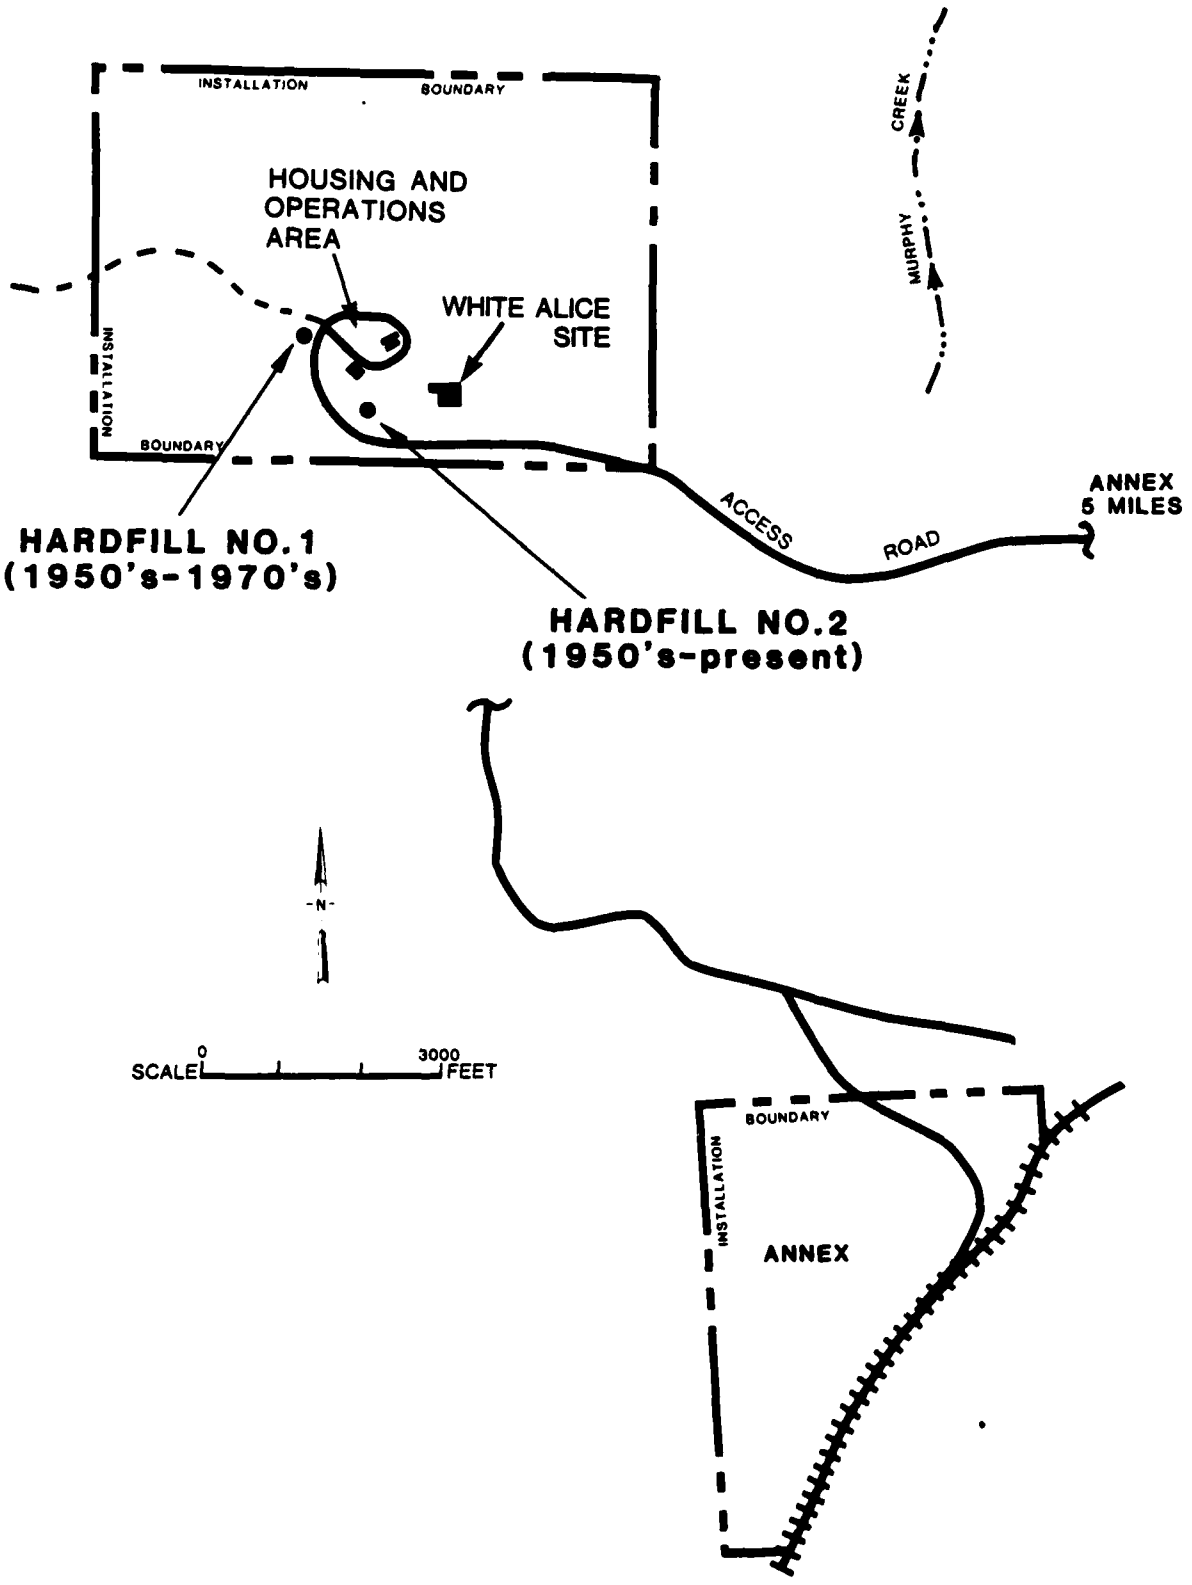
FIGURE 4.31

Two hardfills were operated at Murphy Dome (Figure 4.31). One site (Hardfill No. 1) was located near the helicopter landing area just south of the unimproved road which leads to Landfill No. 1. Another site (Hardfill No. 2) is located south of the bulk fuel storage area. Both sites have some evidence of concrete, wood, pipe and scrap metal from construction and demolition operations at the surface. Hardfill No. 2 currently has equipment and other debris stored on the ground and not buried yet.

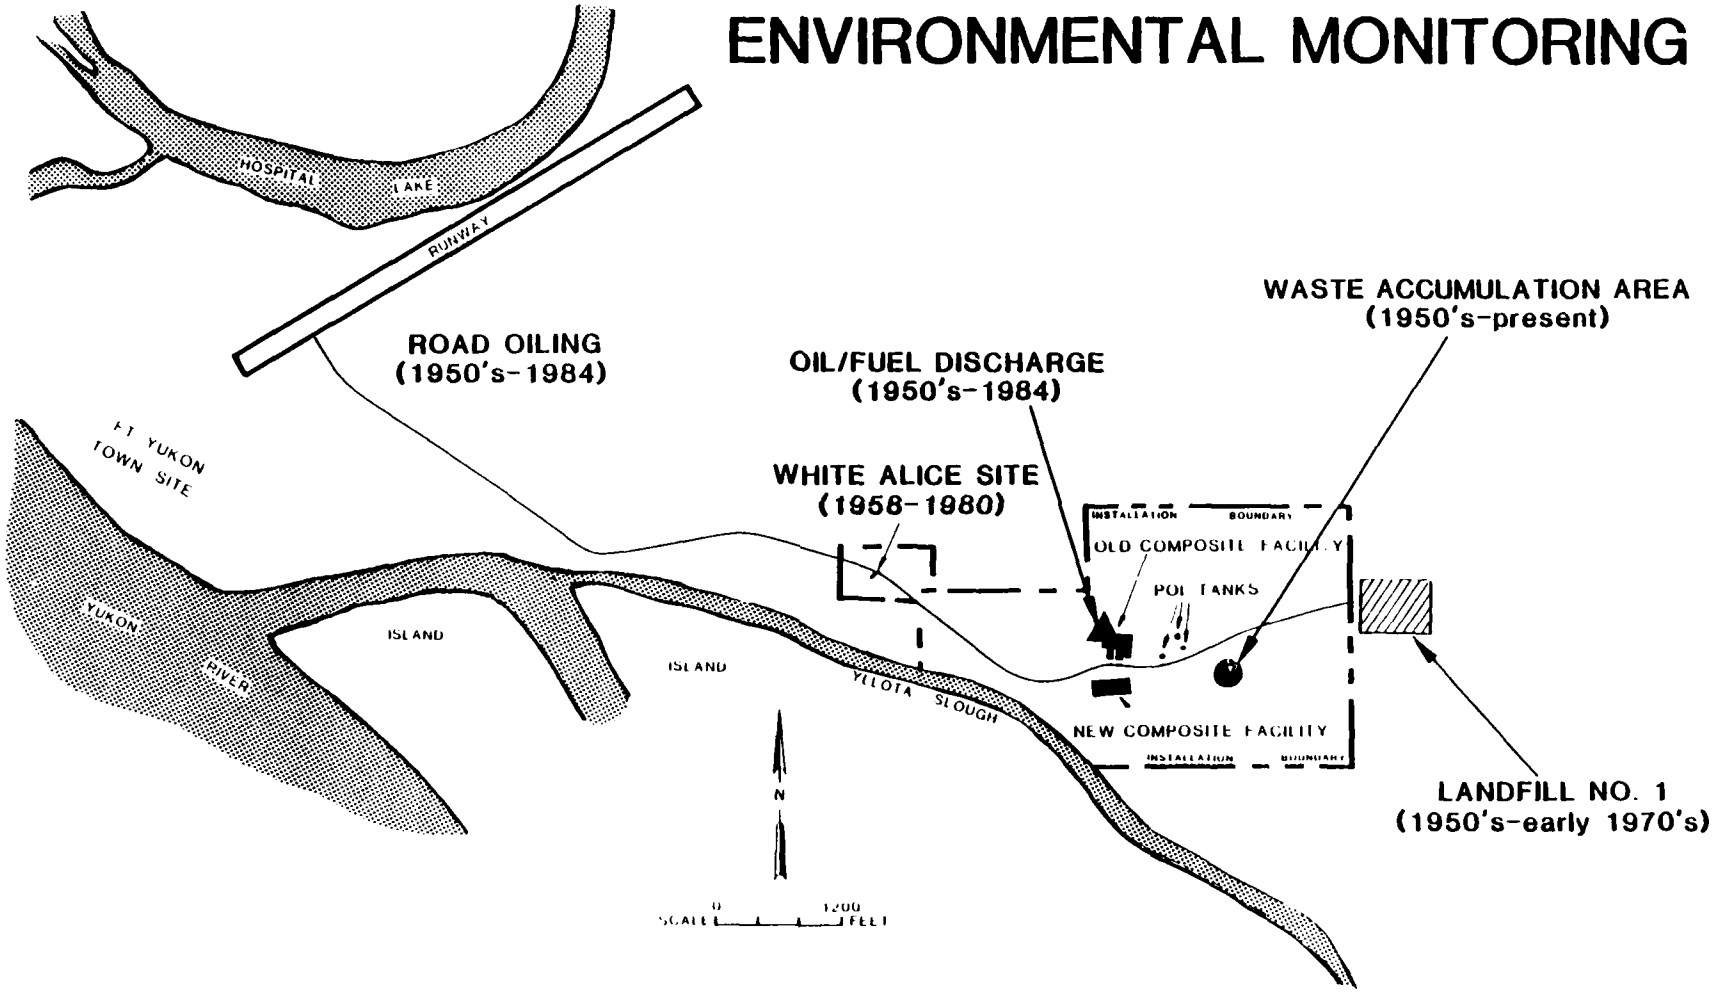
FIGURE 6.7

Five disposal sites have been identified at Fort Yukon AFS for further study in the Phase II IRP (Figure 6.7). These sites were evaluated utilizing the Phase II Investigation Decision Path, Figure 6.1. The following key items were noted relative to the subject sites:

- Four of the identified sites are located within a relatively small section of the installation.
- Fort Yukon AFS is underlain by an aquifer of regional significance (Yukon River alluvium).
- Fort Yukon AFS is located in a sensitive environment, the Yukon Flats National Wildlife Refuge.

For these reasons, it has been determined that an intensive environmental study should be performed at Fort Yukon AFS for all the sites located there: Road Oiling, Waste Accumulation Area, Landfill No. 1 and the Power Plant Oil Discharge. A flow chart illustrating the essential tasks of an intensive environmental assessment is presented as Figure 6.3. A summary of typical intensive assessment tasks, goals and performance standards is listed in Table 6.1.

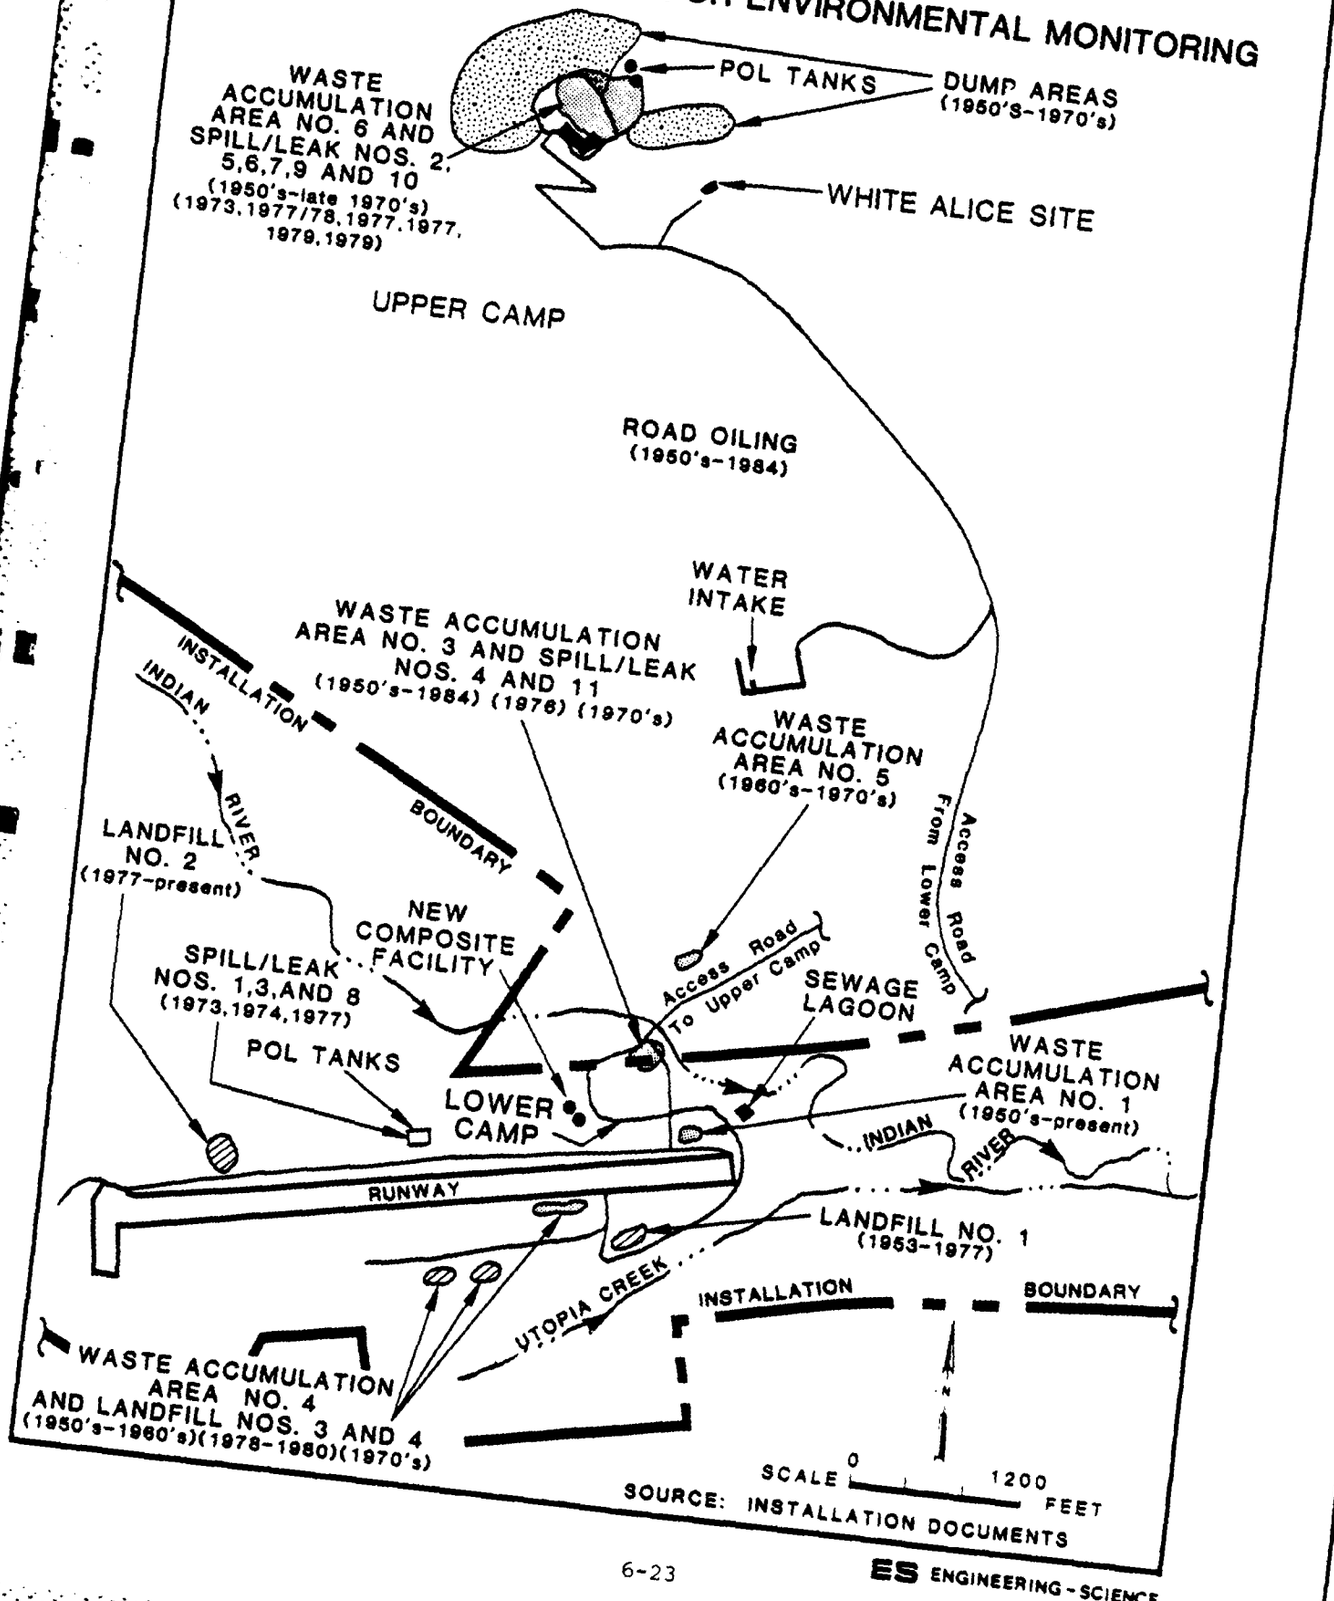
FIGURE 6.8

Indian Mountain AFS is a relatively large installation. Eleven potential contamination sites have been identified for Phase II IRP follow-on studies (Figure 6.8). Eight sites are situated at the Lower Camp and three sites are located at the Upper Camp. These sites were evaluated, utilizing the Phase II Investigation Decision Path, Figure 6.1. The following key items were noted relative to the subject sites:

For these above reasons, it has been determined that two intensive environmental studies should be performed. An intensive study at the Upper Camp would be for two sites located there and a similar study at the Lower Camp would be for seven sites. A flow chart illustrating the intensive environmental study is shown as Figure 6.3. A summary of typical intensive study tasks, goals and performance standards is listed in Table 6.1.
