INSTALLATION RESTORATION PROGRAM

PHASE I - RECORDS SEARCH

AAC - NORTHERN REGION

SEPTEMBER 1985

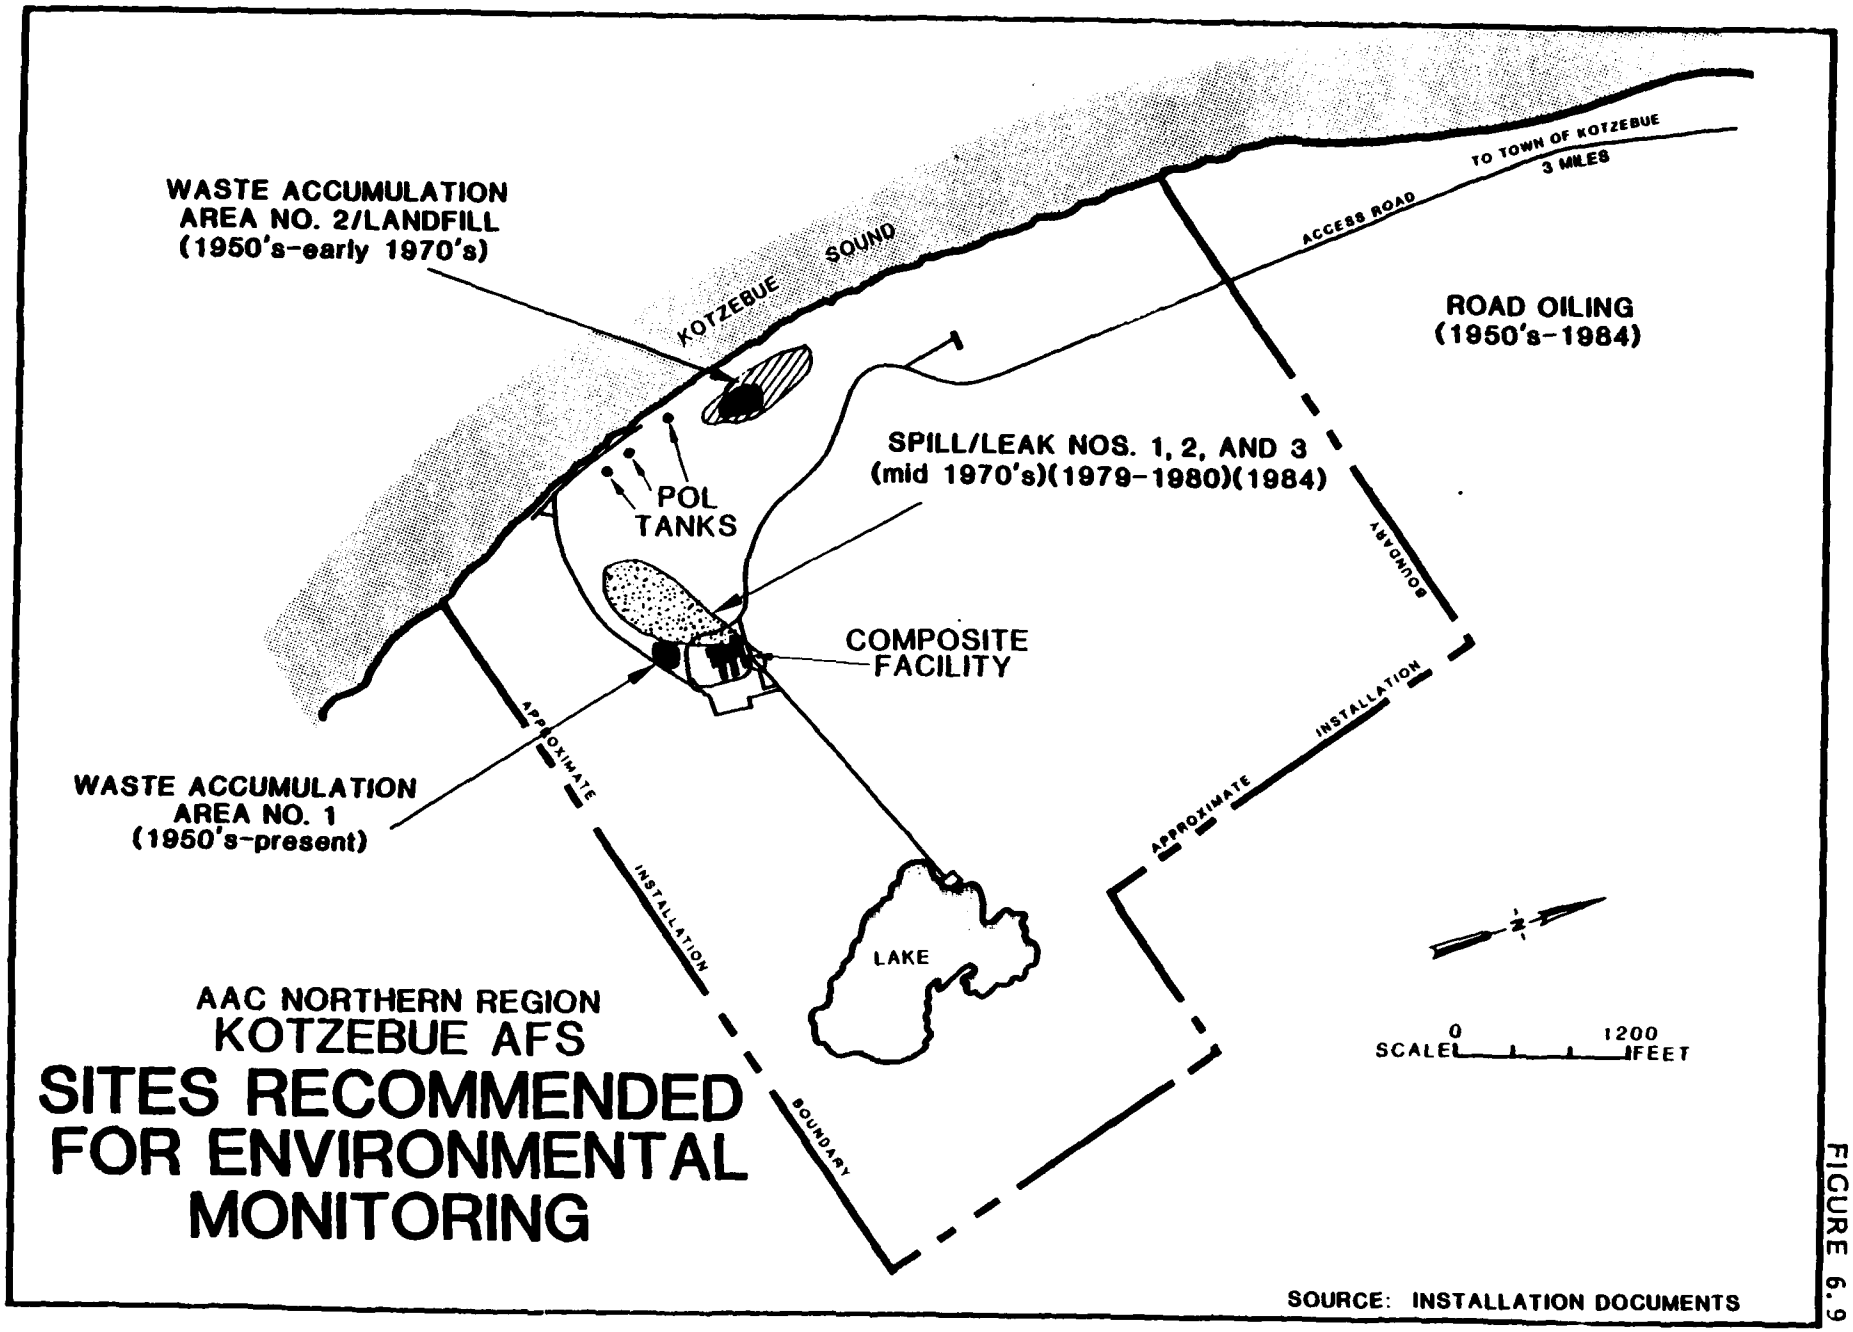
FIGURE 6.9

Phase II investigations are warranted at three sites at Kotzebue LRR (Figure 6.9). These three sites are: Spill/Leak Nos. 1, 2, and 3, Waste Accumulation Area No. 1 and Road Oiling. These sites were evaluated using the Phase II Investigation Decision Path, Figure 6.1. A basic Phase II investigation (Figure 6.2) is recommended for the sites at Kotzebue AFS.

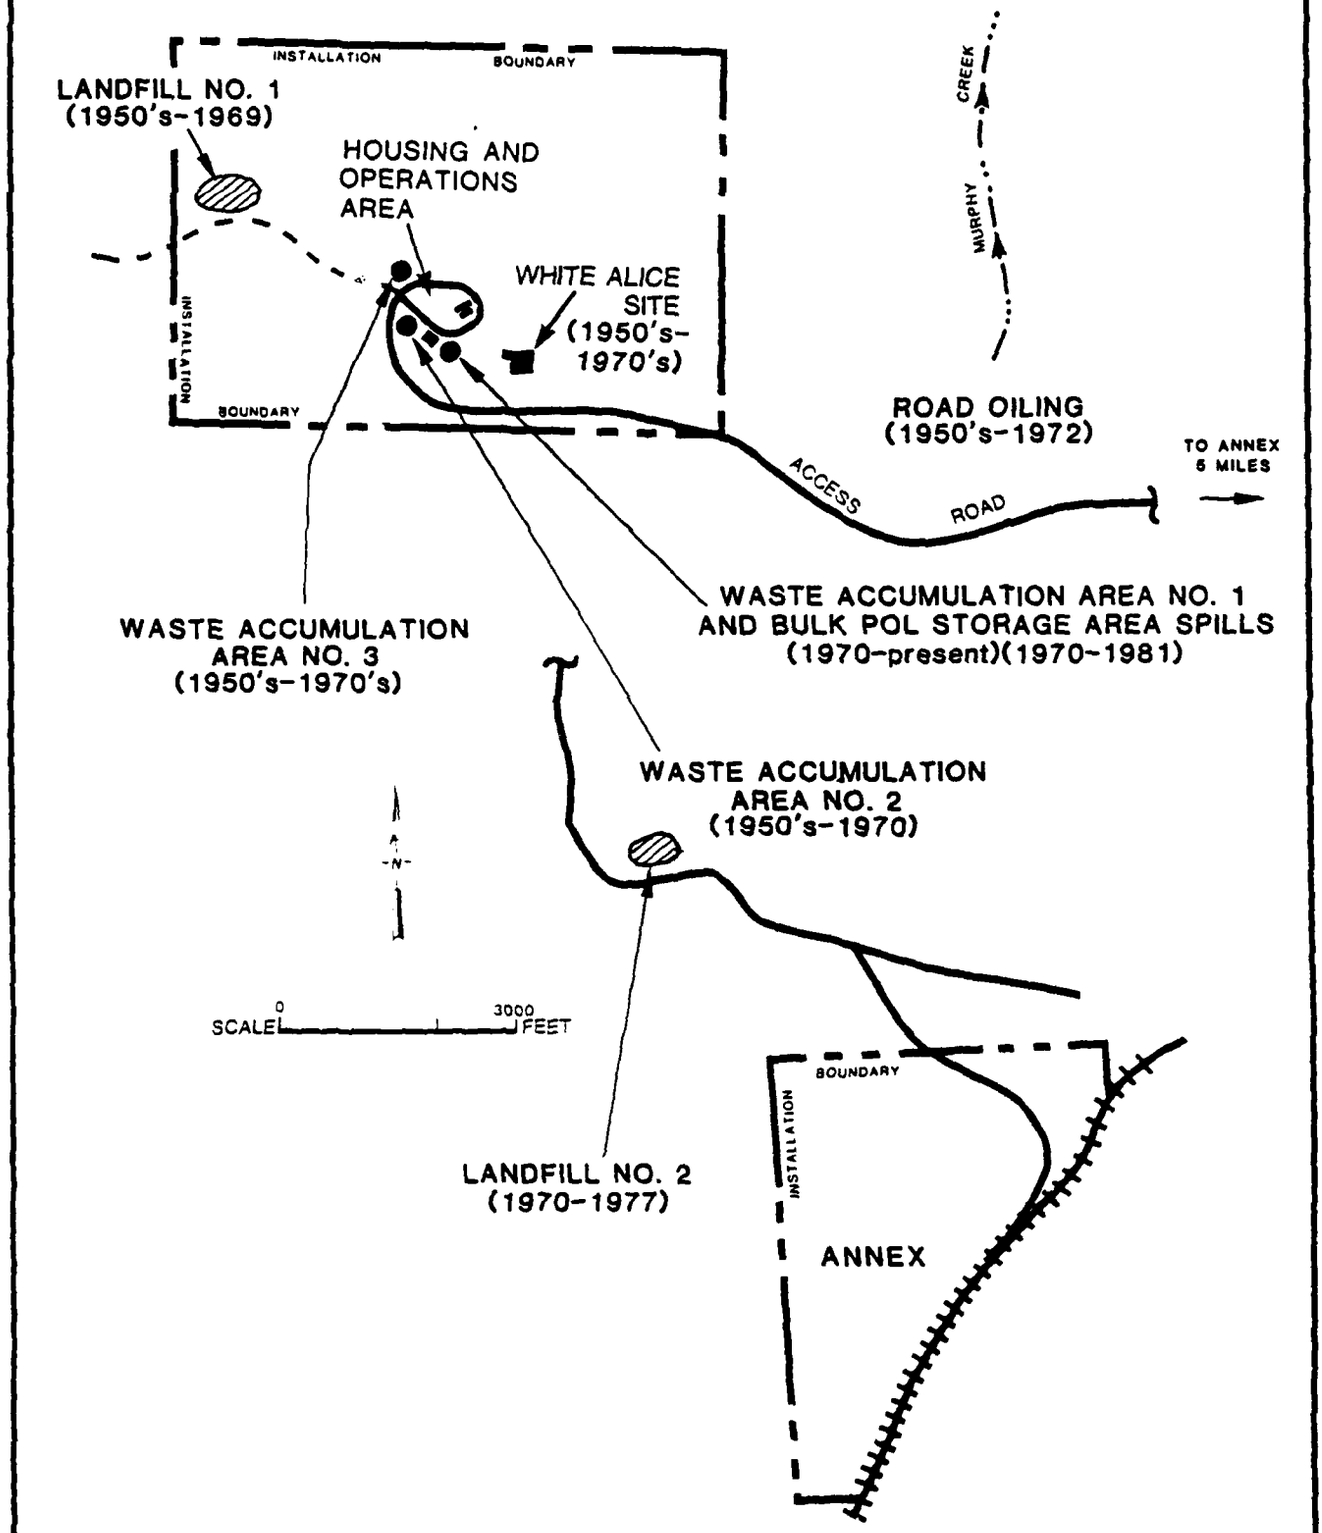
Murphy Dome AFS has seven sites recommended for follow-on Phase II investigations (Figure 6.10). Most of the sites are located near the housing and operations area. Landfill No. 2, however, is located off the installation approximately six miles away adjacent to the access road. An evaluation of sites and their environmental setting was undertaken using the approach outlined in Figure 6.1. It is concluded that the Murphy Dome sites can be accomodated by a basic Phase II program (Figure 6.2). Emphasis should be placed upon characterizing subsurface soils to assess the presence of contamination and the potential extent of migration. The recommendations for Phase II IRP at Murphy Dome are presented in Table 6.9.

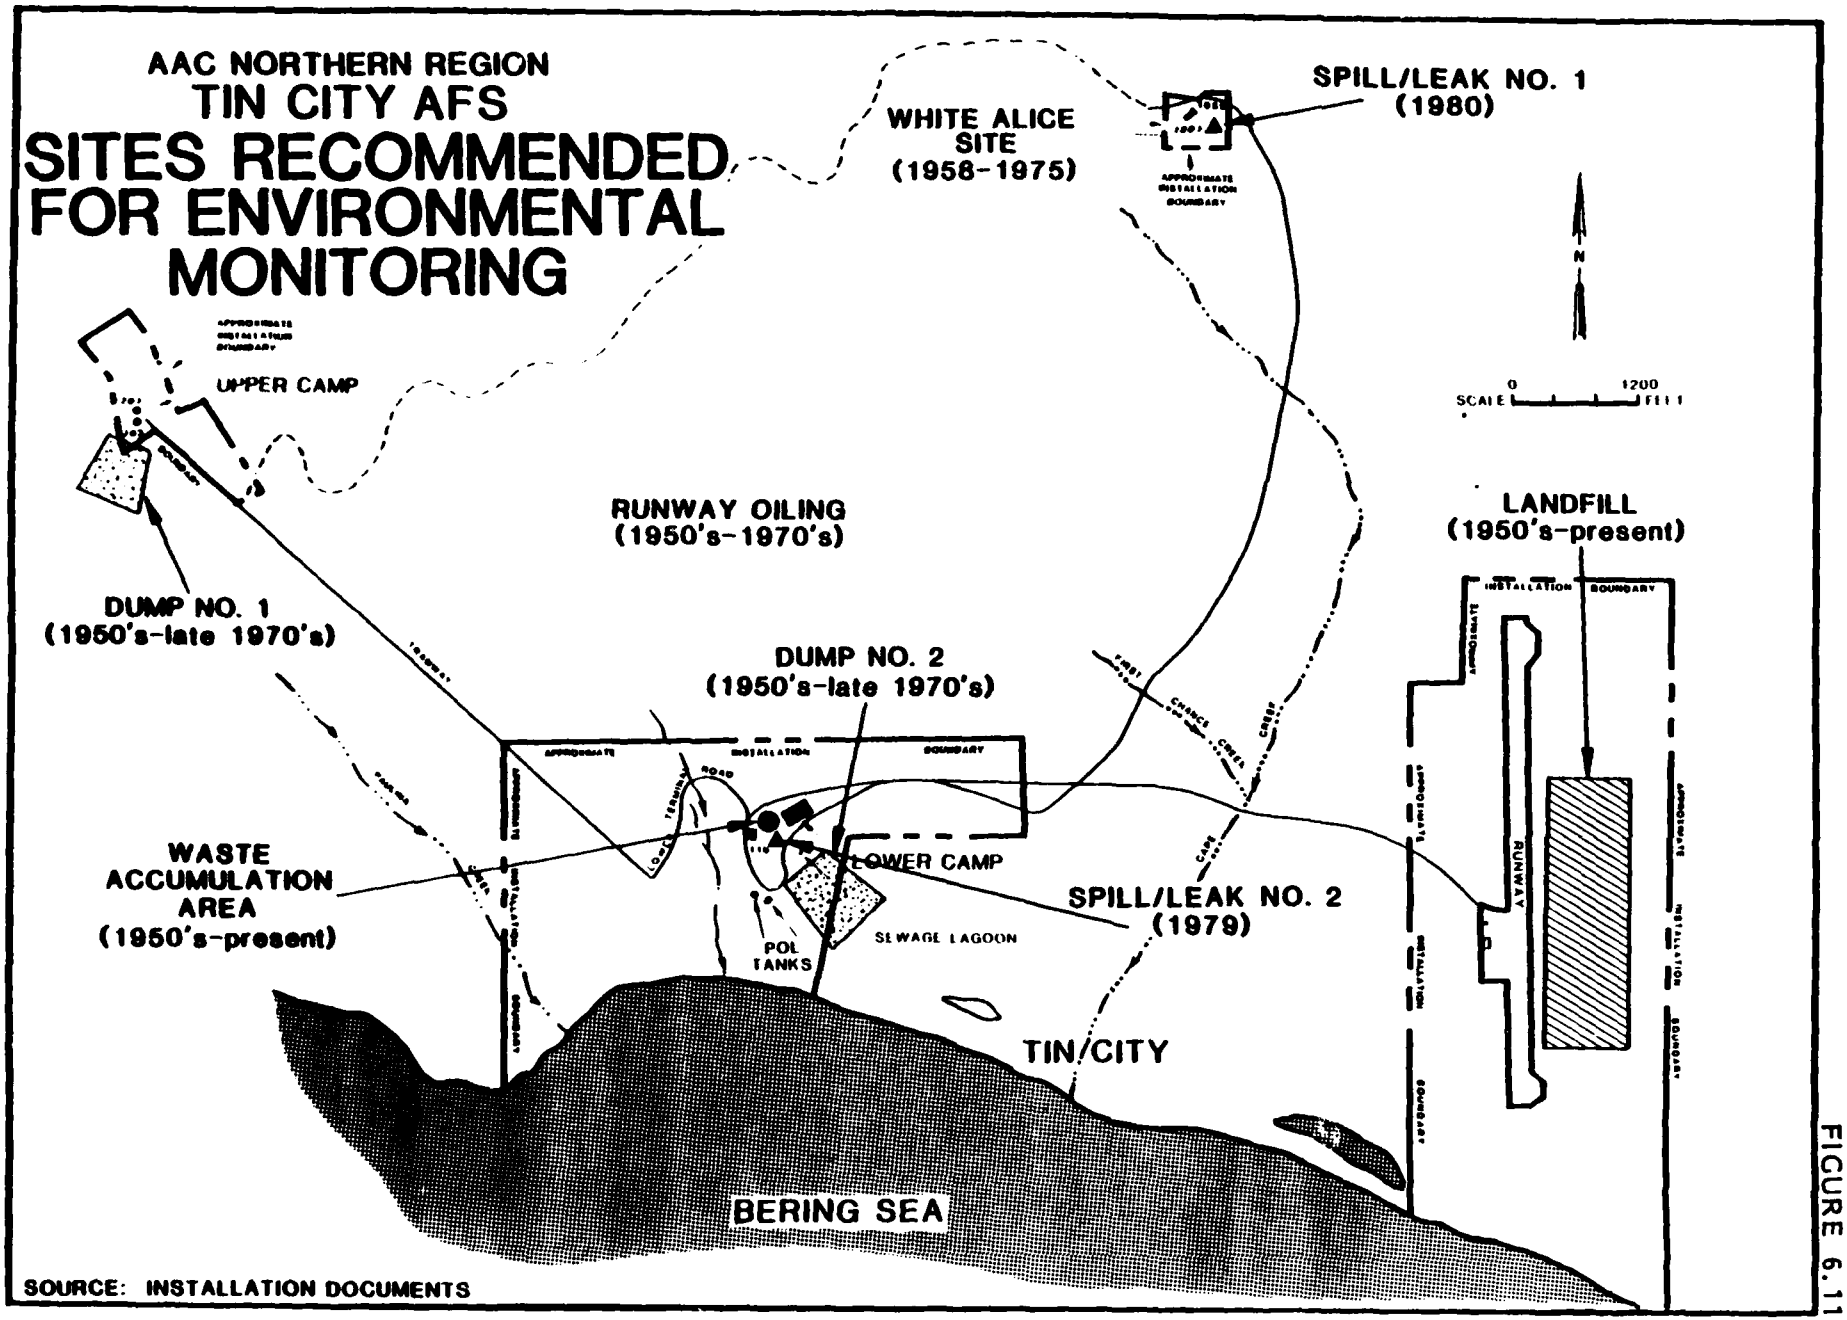
FIGURE 6.11

Tin City AFS is a relatively small installation, divided into an Upper Camp and a Lower Camp. An inactive White Alice Communications System site is set apart from the two operational camps. The environmental setting of the installation is not complex. The six disposal sites identified at Tin City AFS (Figure 6.11) were evaluated, utilizing the Phase II Investigation Decision Path, Figure 6.1. It has been determined that the receiving environment proximate to these sites can be efficiently studied by performing a basic study (Figure 6.2) at the identified locations. The basic study performed at the sites should focus on soil, surface water and ground-water quality to detect contaminant migration.

The generalized recommendations for Phase II IRP investigations at Tin City AFS are summarized in Table 6.10. Also included in Table 6.10 are specific analyses for drinking quality protection. The installation drinking water collection system is at risk to potential contaminant migration.
