USAAEFA PROJECT NO. 83-26

# PRELIMINARY AIRWORTHINESS EVALUATION (PAE) OF THE OH - 58D HELICOPTER (AHIP)

DECEMBER 1984

FINAL REPORT

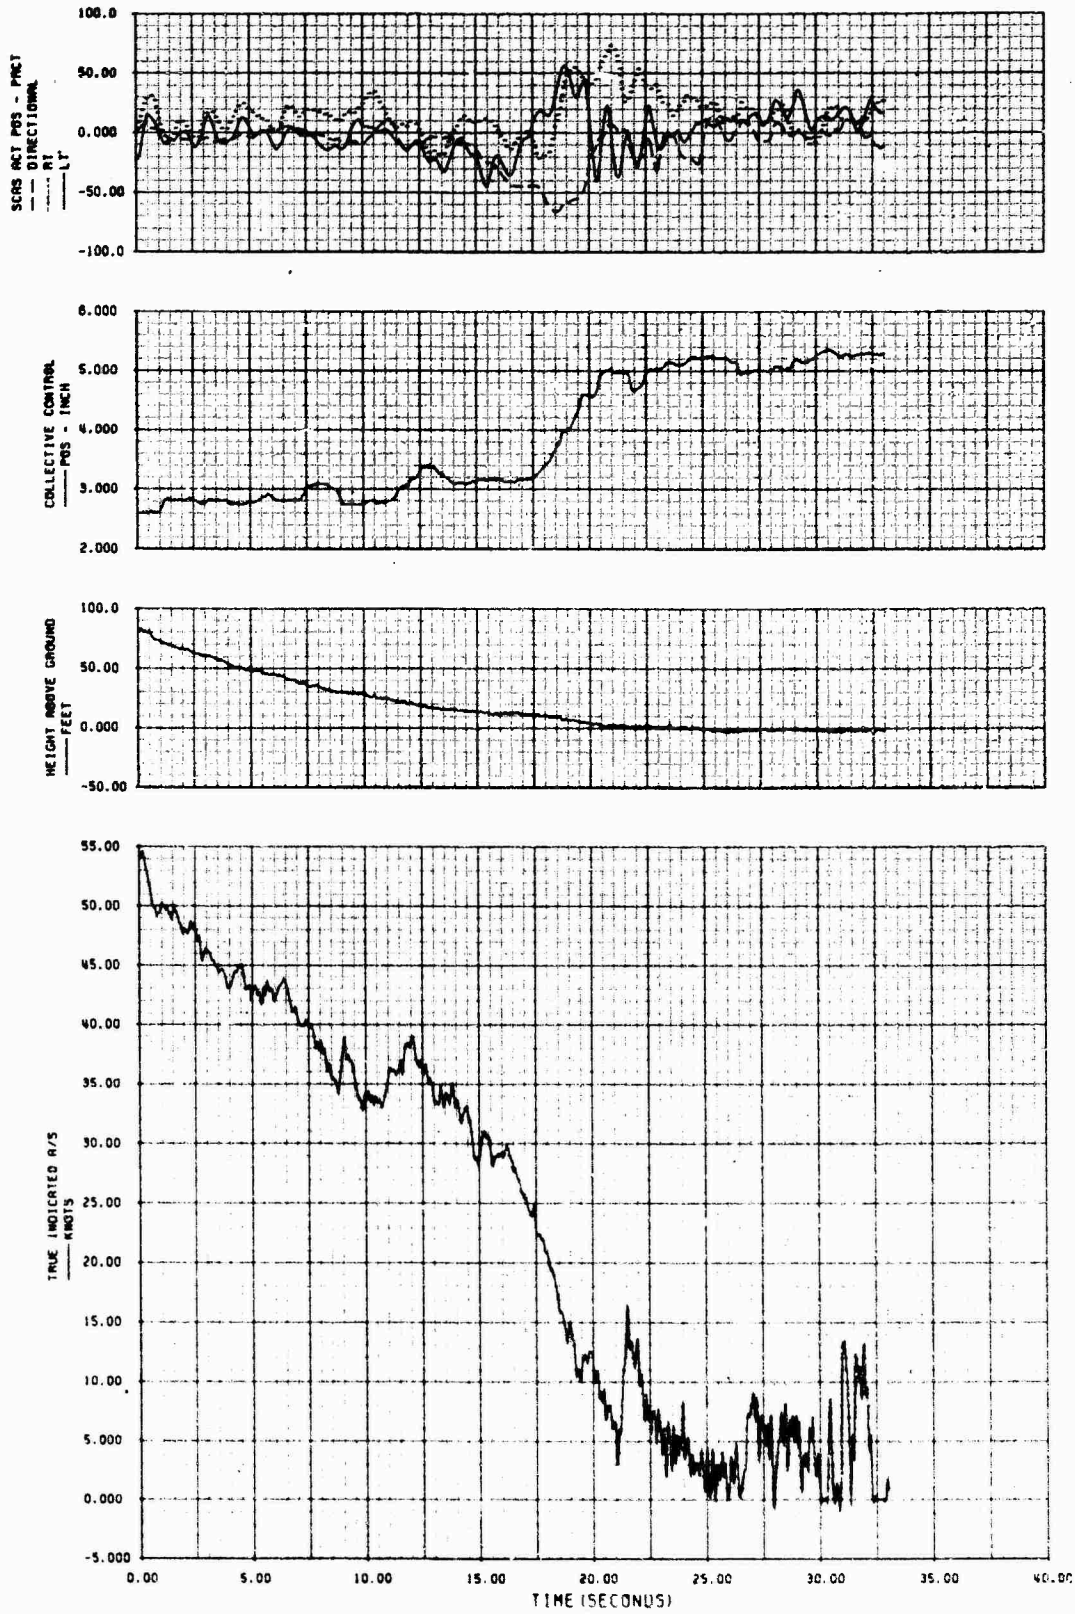
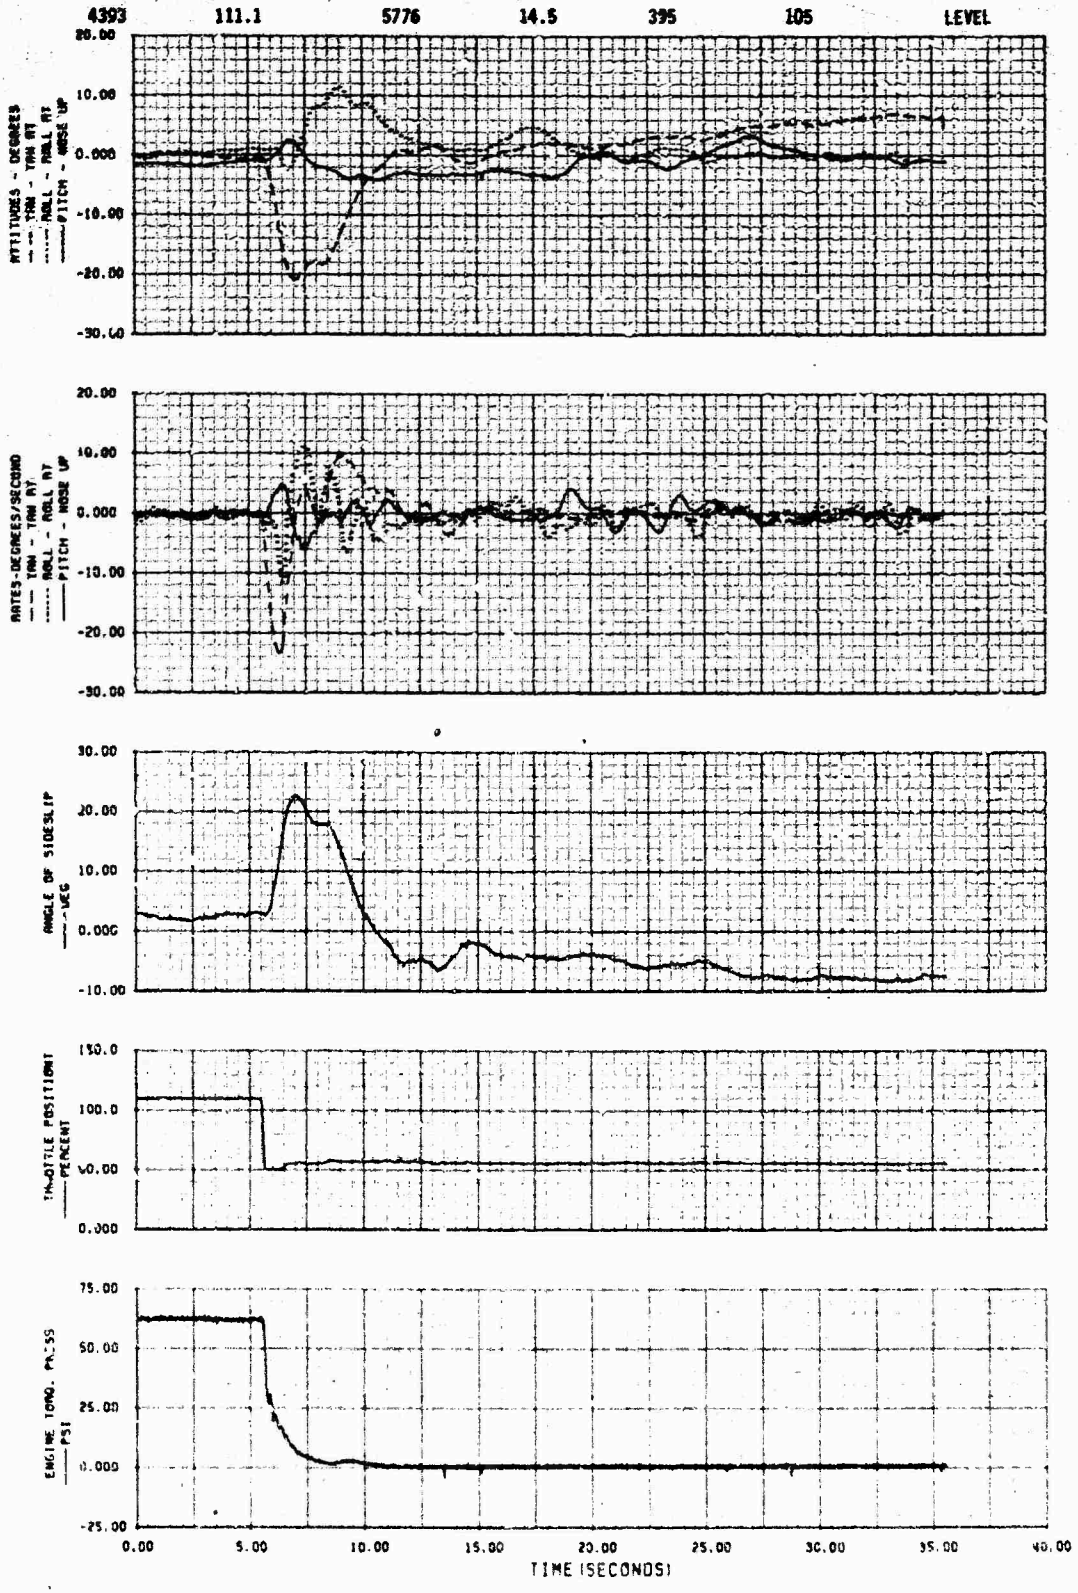
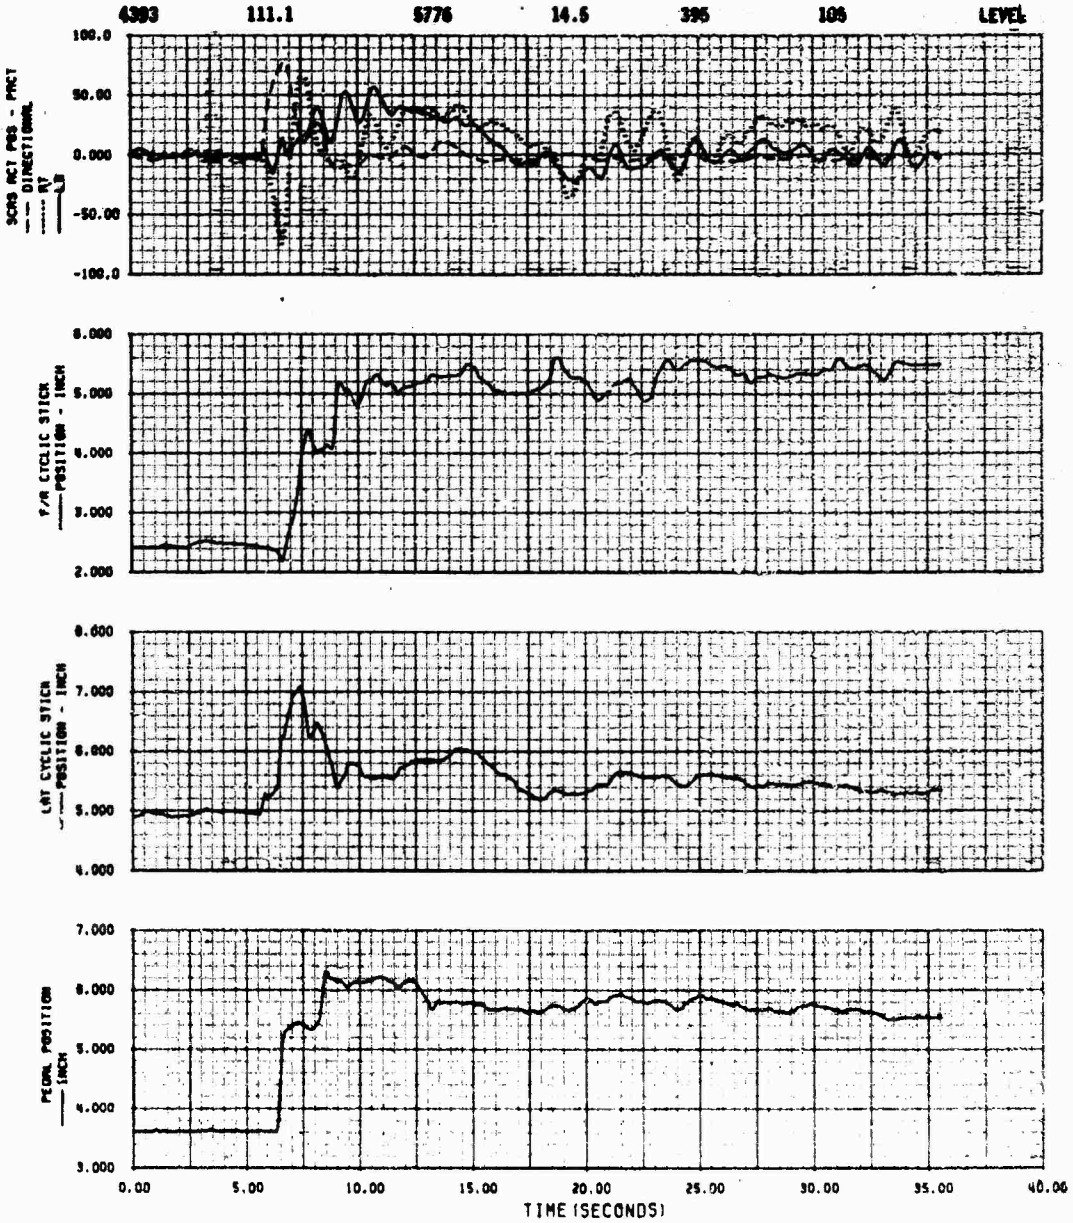
FIGURE 51A
SIMULATED ENGINE FAILURE
OH-58D USA S/N 69-16285

32. Simulated sudden engine failures were evaluated with the standard (unweighted) main rotor blades at the conditions shown in table 1. Sudden engine failures were evaluated at 50, 75, and 100 KCAS at incremental engine powers varying from that required for a 500 fpm descent to intermediate rated power (IRP). Sudden engine failures were simulated by a rapid reduction in the throttle to flight idle with controls fixed until recovery was necessary. A time history of the most critical conditions (100 KCAS and IRP) is presented in figure 51, appendix E. The predominant characteristics of all simulated engine failures tested was minimal pitch and roll attitude changes coupled with a large yaw acceleration and consequent yaw attitude change prior to collective reduction. The large yaw acceleration caused immediate inertially induced lateral cyclic input even though the pilot was trying to maintain controls fixed. However, the cyclic movement was in a direction to minimize roll attitude changes. At 100 KCAS, IRP, rotor speed decayed at a rate of 55 rpm per second. Minimum rotor speed attained was 317 rpm with a collective reaction delay time of 0.9 seconds. Stabilizing in a steady state autorotation was easy and required 3 inches of aft longitudinal cyclic, 2 inches of right lateral cyclic and 2.5 inches of right pedal (HQRS 3). Rotor speed increase after collective reduction was slower than the decay with no apparent tendency to overspeed. The large yaw acceleration upon throttle reduction was the first indication of engine failure and was followed by low rotor speed visual and audio warning. The short collective delay time allowable, following a sudden engine failure, in order to remain above the minimum rotor speed of 310 rpm is a shortcoming. Collective delay time allowable following a sudden engine failure did not meet the requirements of the System Specification, paragraph 3.2.1.4.b in that collective delay time

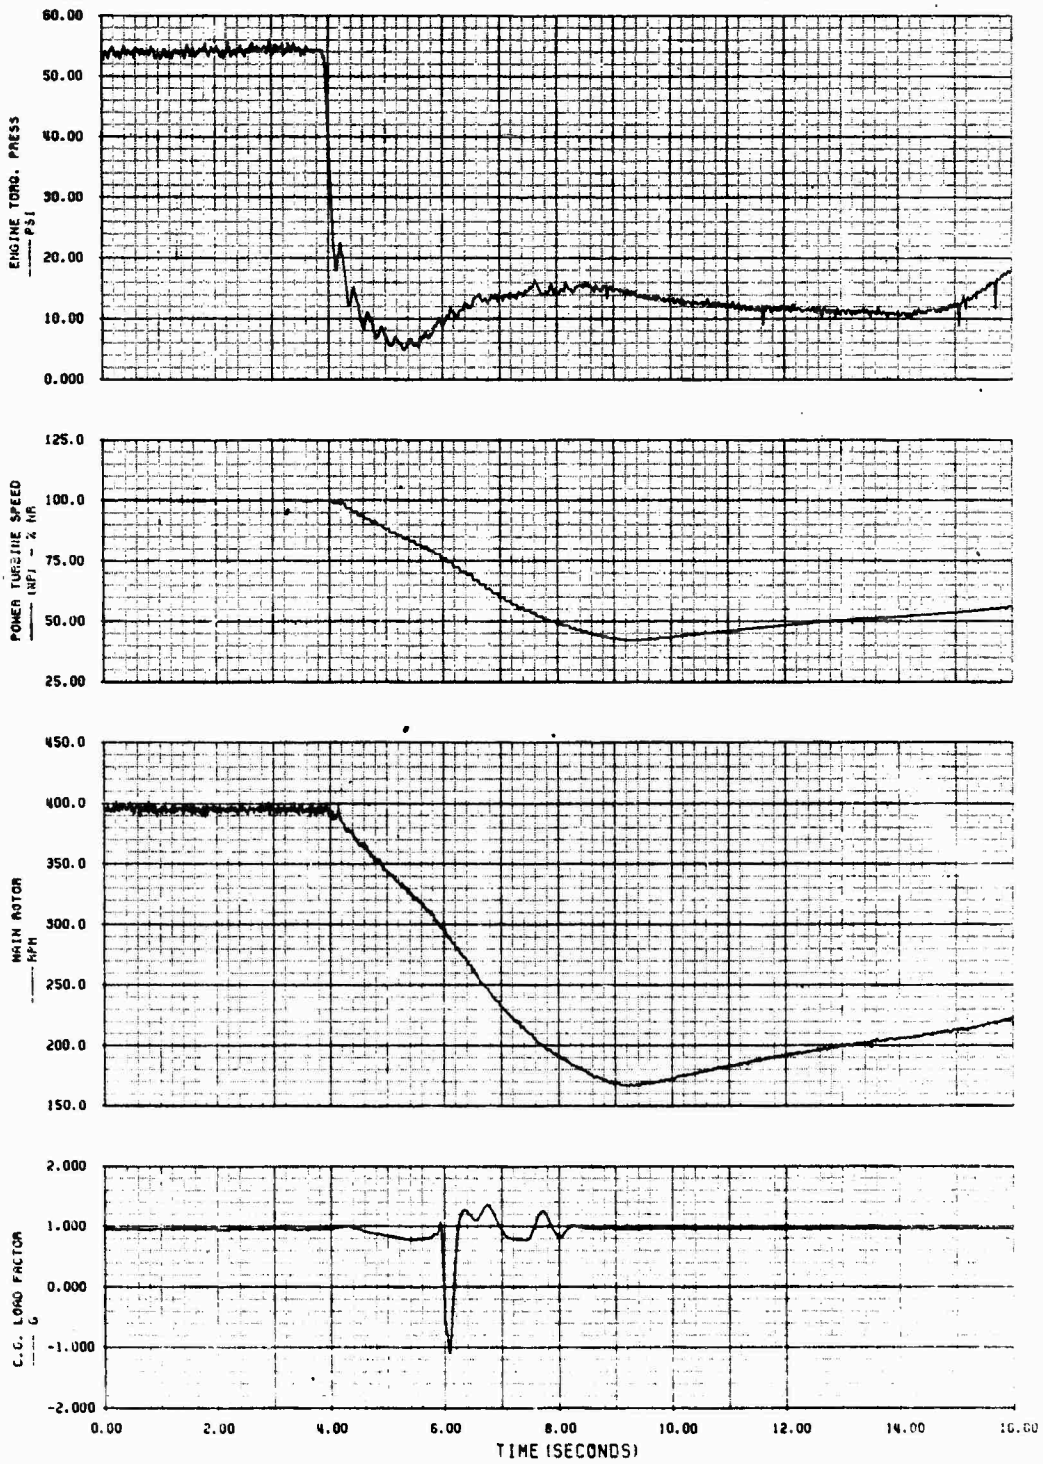
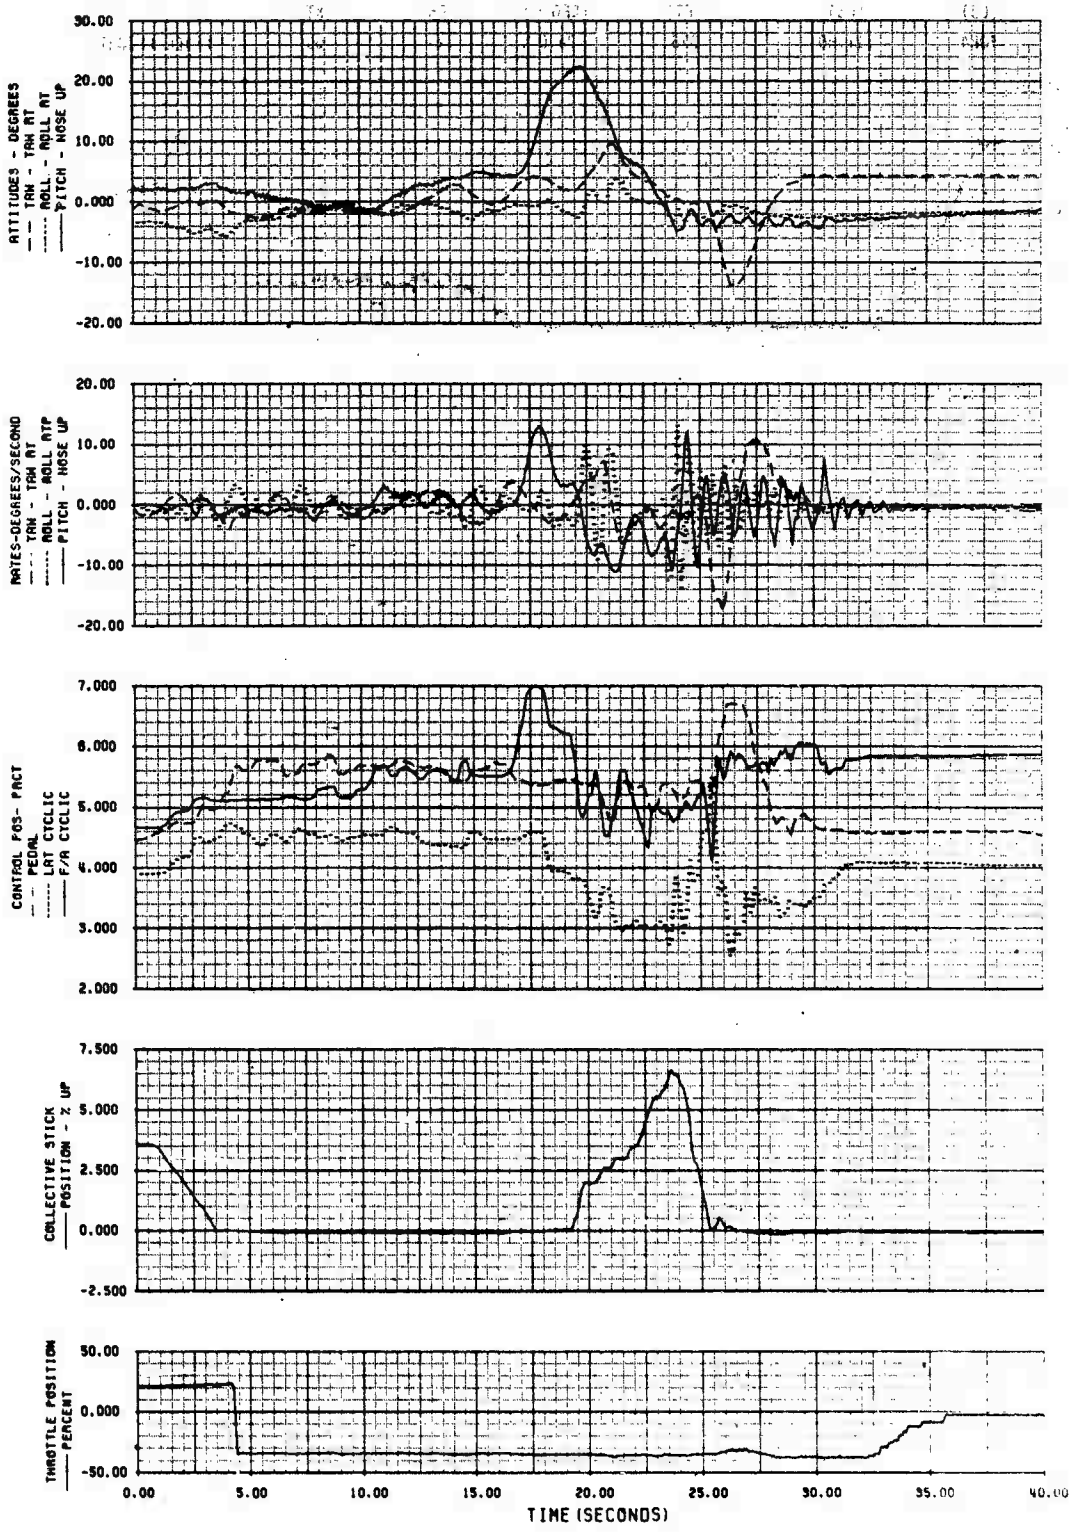
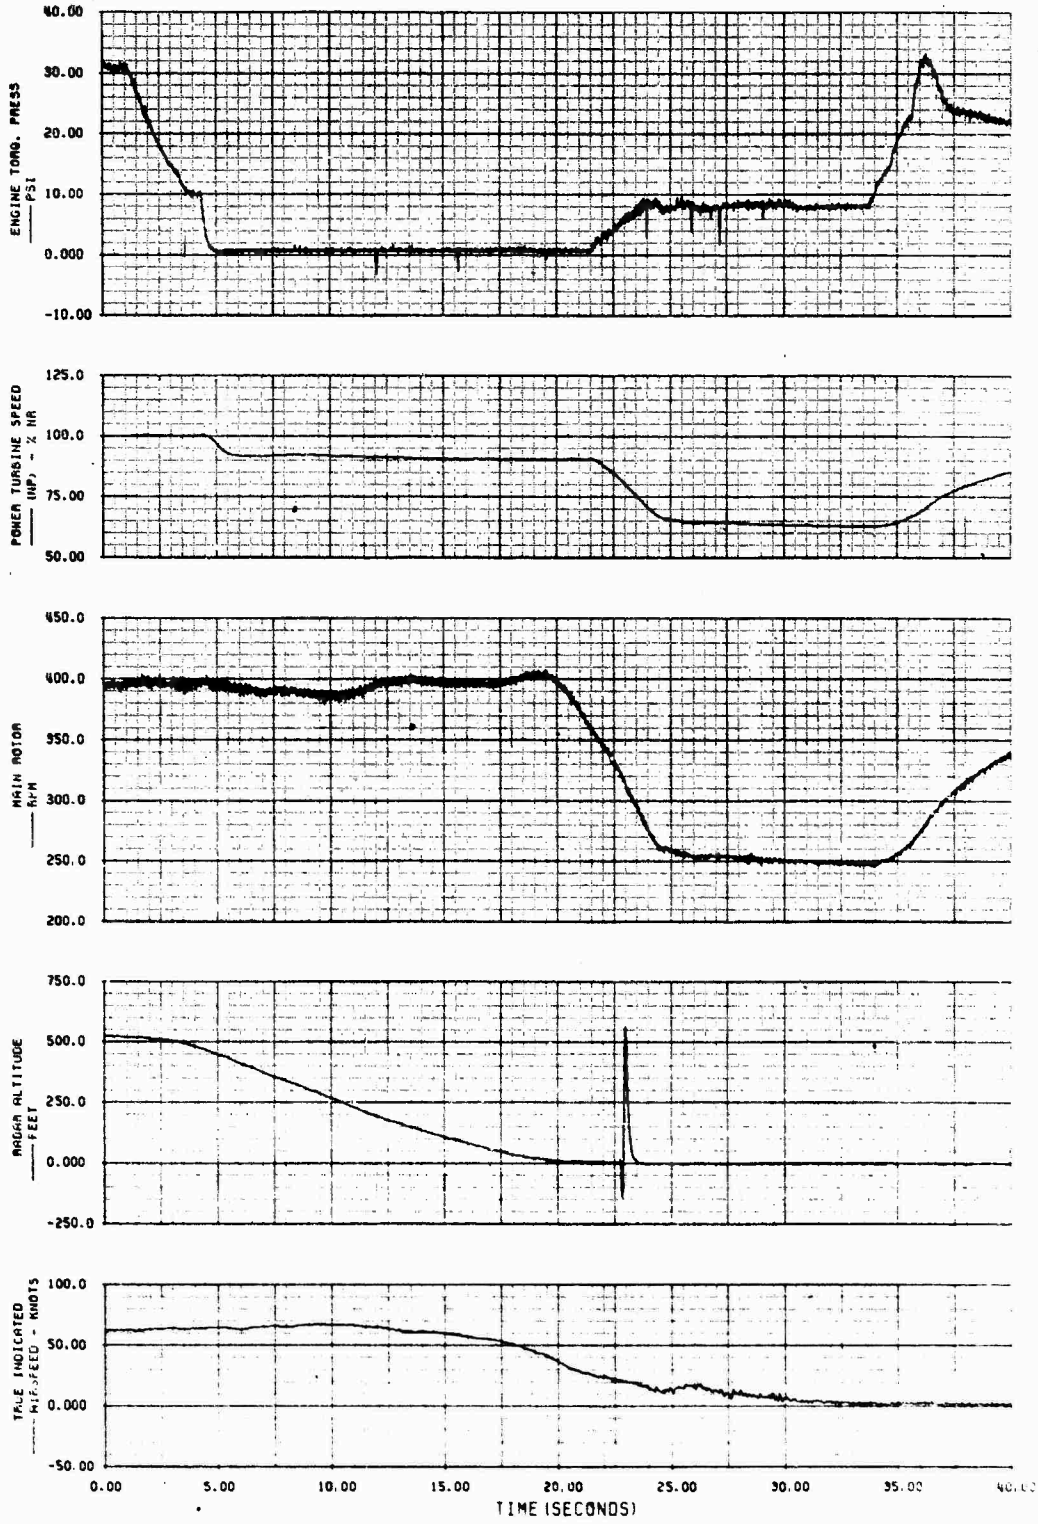
FIGURE 57A
AUTOROTATIONAL APPROACH AND LANDING
OH-58D USA S/N 69-16285

39. Straight-in autorotations with the unweighted main rotor blades installed were initiated from an altitude of 700 feet above ground level (AGL) at approximately 65 to 70 KIAS. Autorotational entry was accomplished by lowering collective to full down, rolling the throttle to flight idle position, and reducing airspeed to 60 to 65 KIAS. A representative time history is presented in figure 57, appendix E. Initial descent rate was high (2100 fpm) and rotor rpm decayed slightly (382 rpm) during the descent. Flare altitude was critical in that too high an altitude would result in loss of flare affectiveness at an altitude too high to effectively cushion the landing and too low of a flare altitude would result in either very long ground runs (greater than 100 ft) or tail stinger contact. Initiation of the flare occurred at approximately 50 to 60 feet AGL with maximum pitch attitude occurring at approximately 35 feet AGL. Flare effectiveness was minimal and resulted in little perceived decrease in forward velocity and descent rate with the apparent approach angle remaining the same. Forward cyclic and initial collective application were nearly simultaneous. Collective application was a two step movement. Initial collective application of approximately 2 inches was held 0.5 seconds and was immediately followed by sufficient collective application (approximately 5 inches) to cushion the touchdown. Autorotational landings with descent rate below 200 fpm at touchdown and ground run below 50 feet could not be accomplished. Precise judgement of flare initiation ($\pm$10 ft of optimum), flare attitude (23 degrees nose up $\pm$3 degrees), and application of cyclic and collective to cushion the touchdown was required. Even properly executed autorotational landings resulted in high touchdown speeds and long ground runs (HQRS 7).

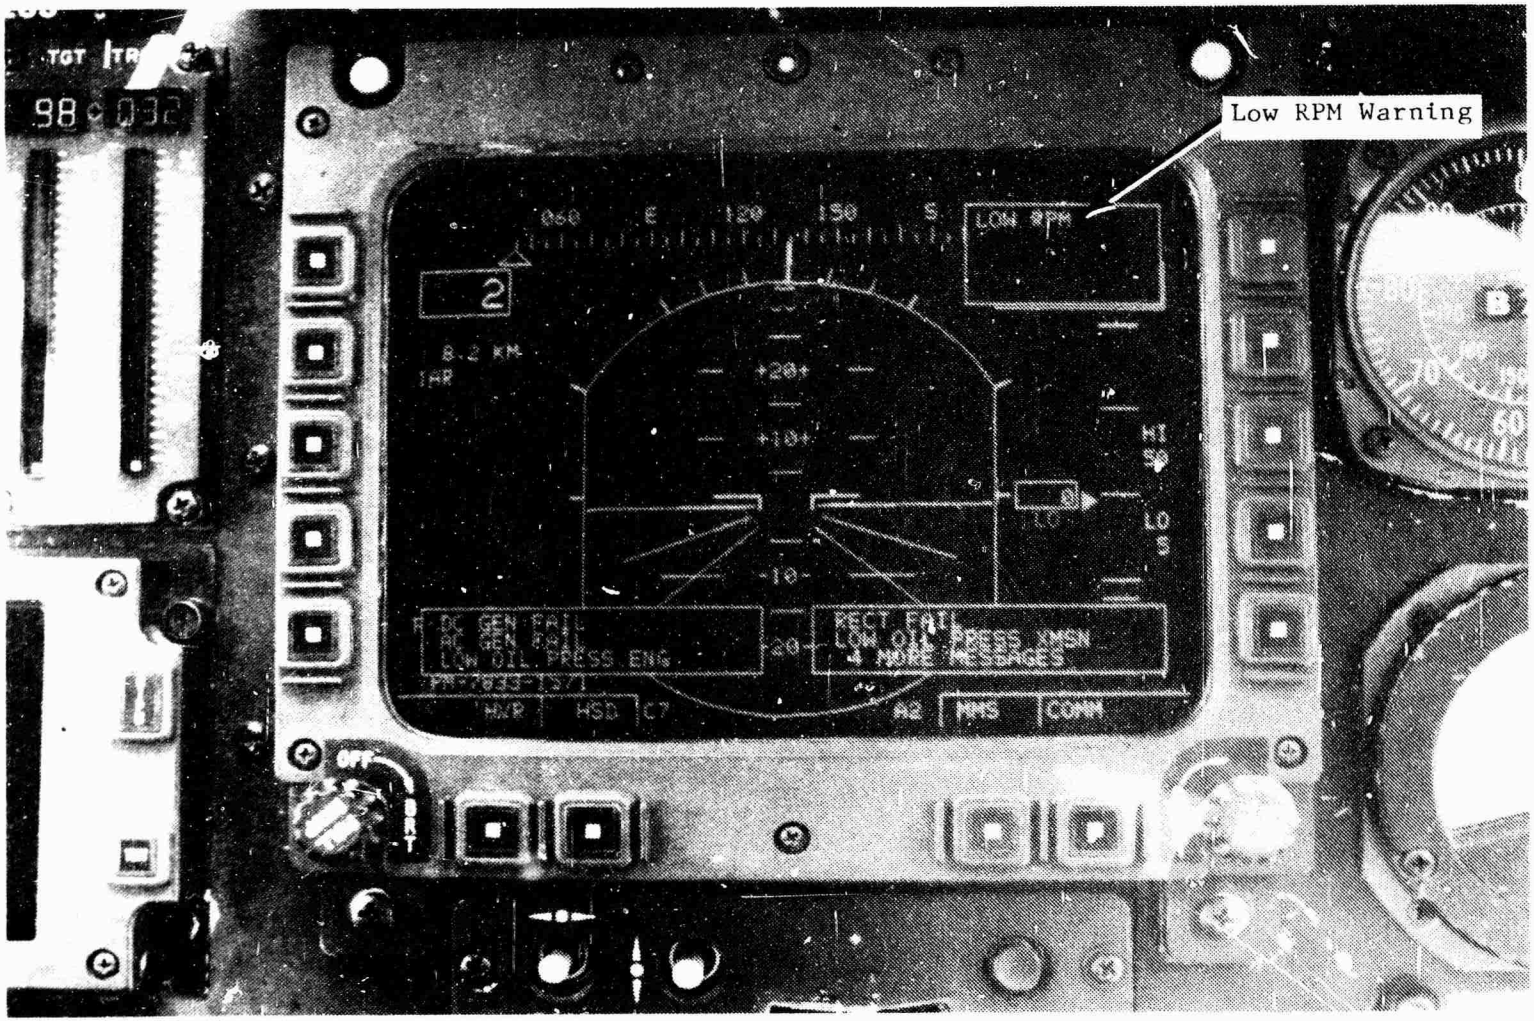
Photo 2. Multifunction Display with Warning Indication

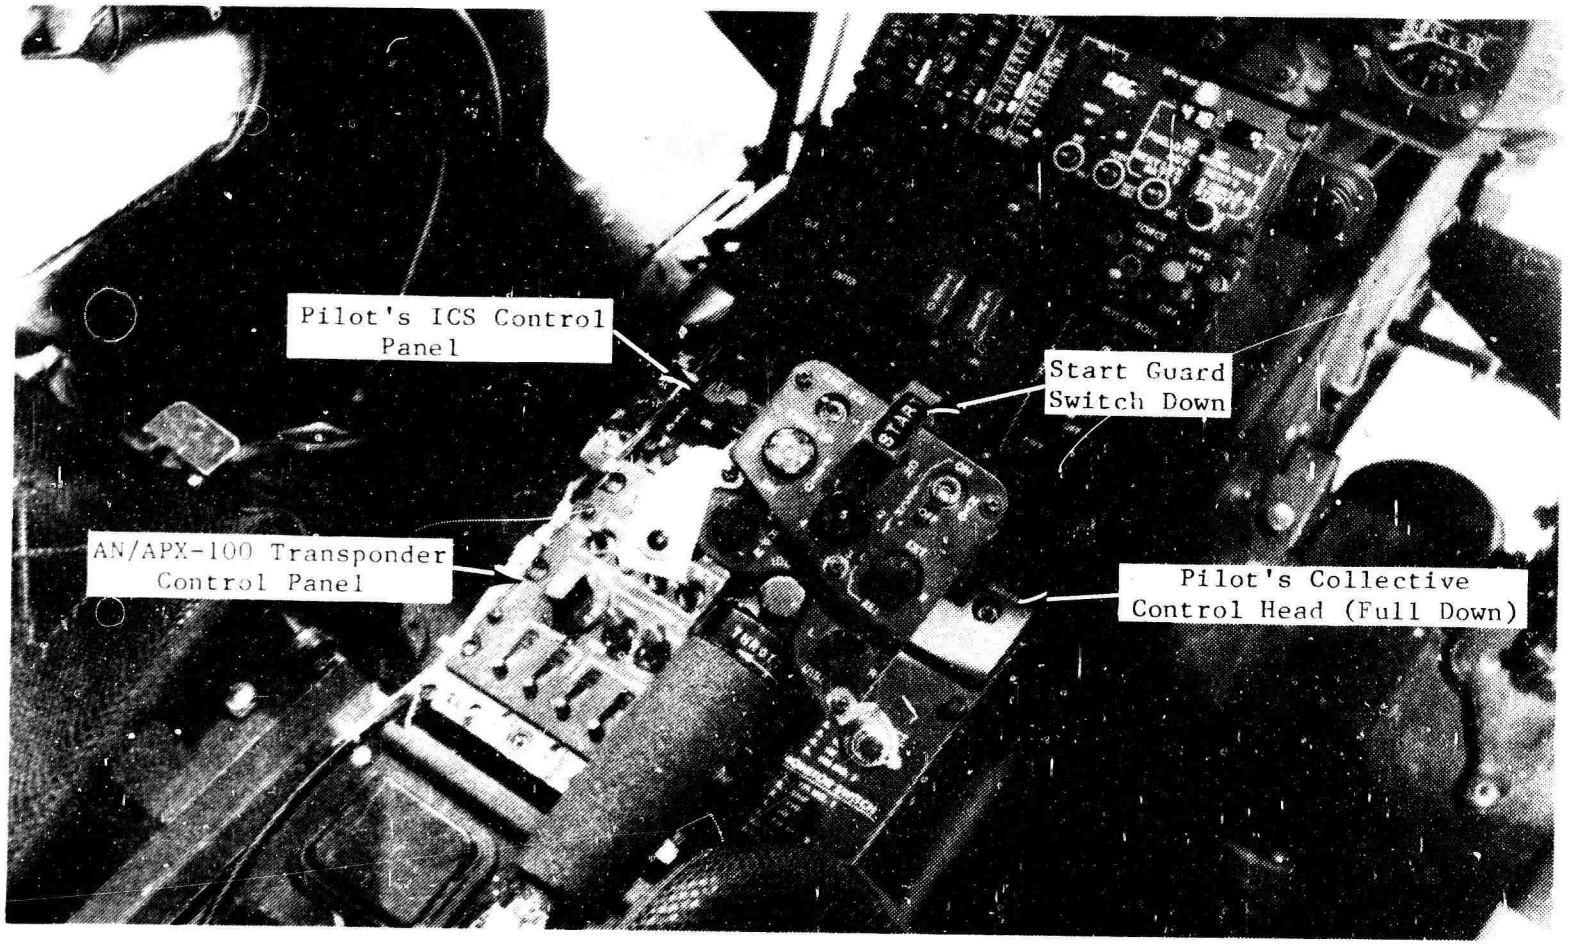
Photo 4. Blocked View of Transponder and Pilot's ICS Control Panel with Collective Full Down

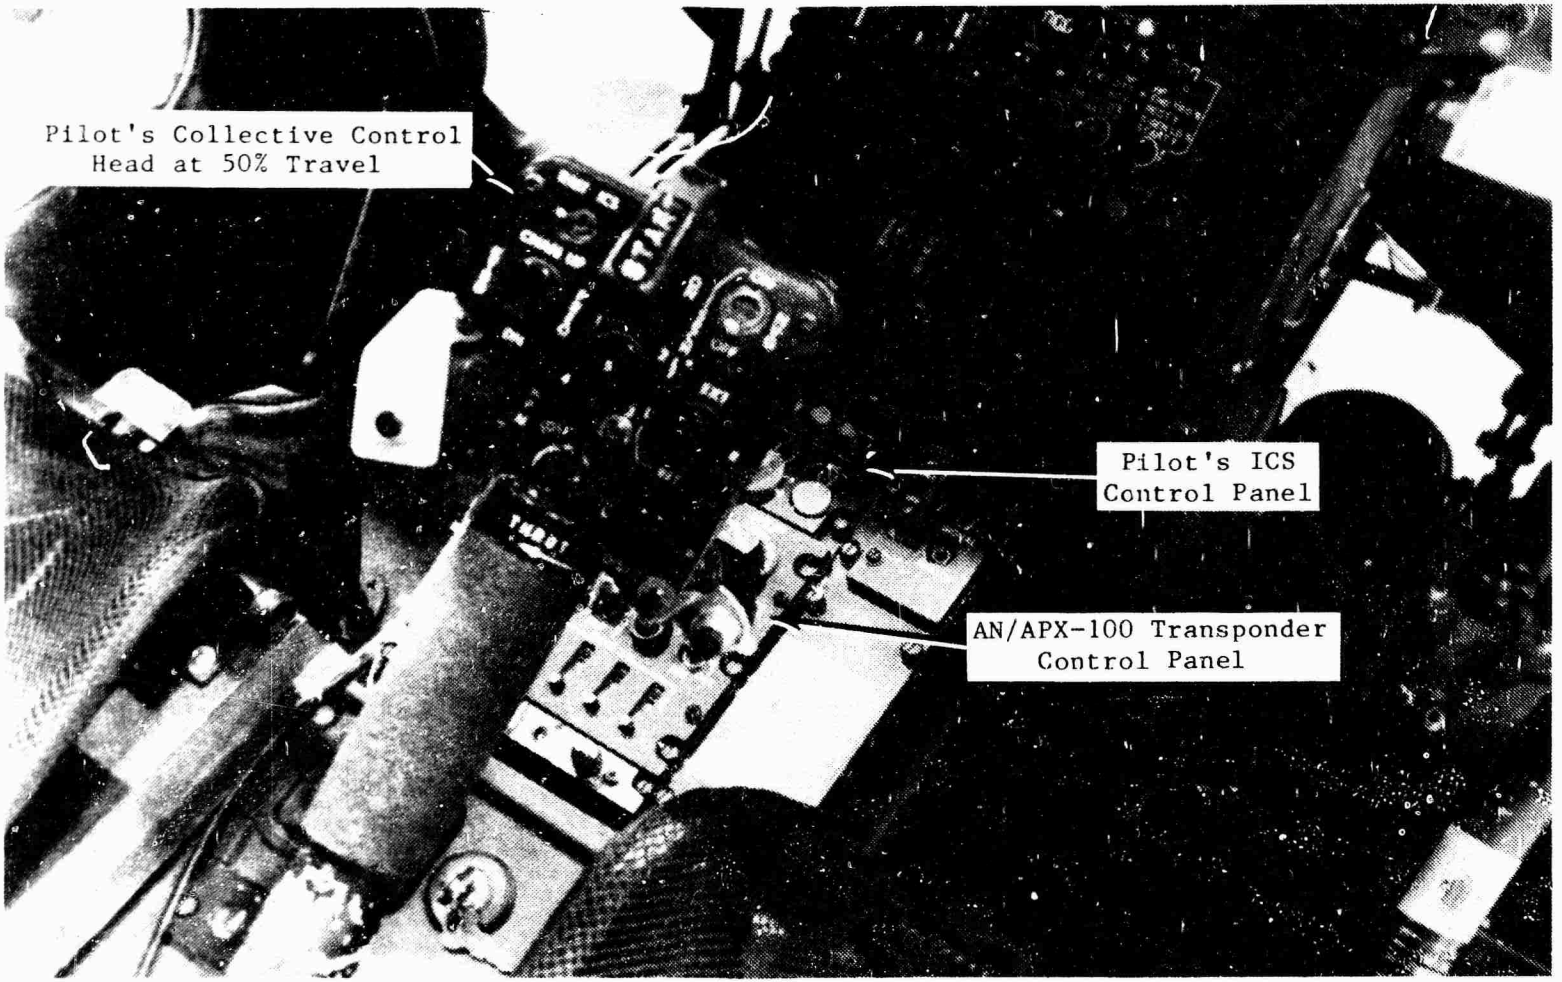
Photo 5. Blocked View of Transponder and Pilot's ICS Control Panels with Collective at 50% Travel

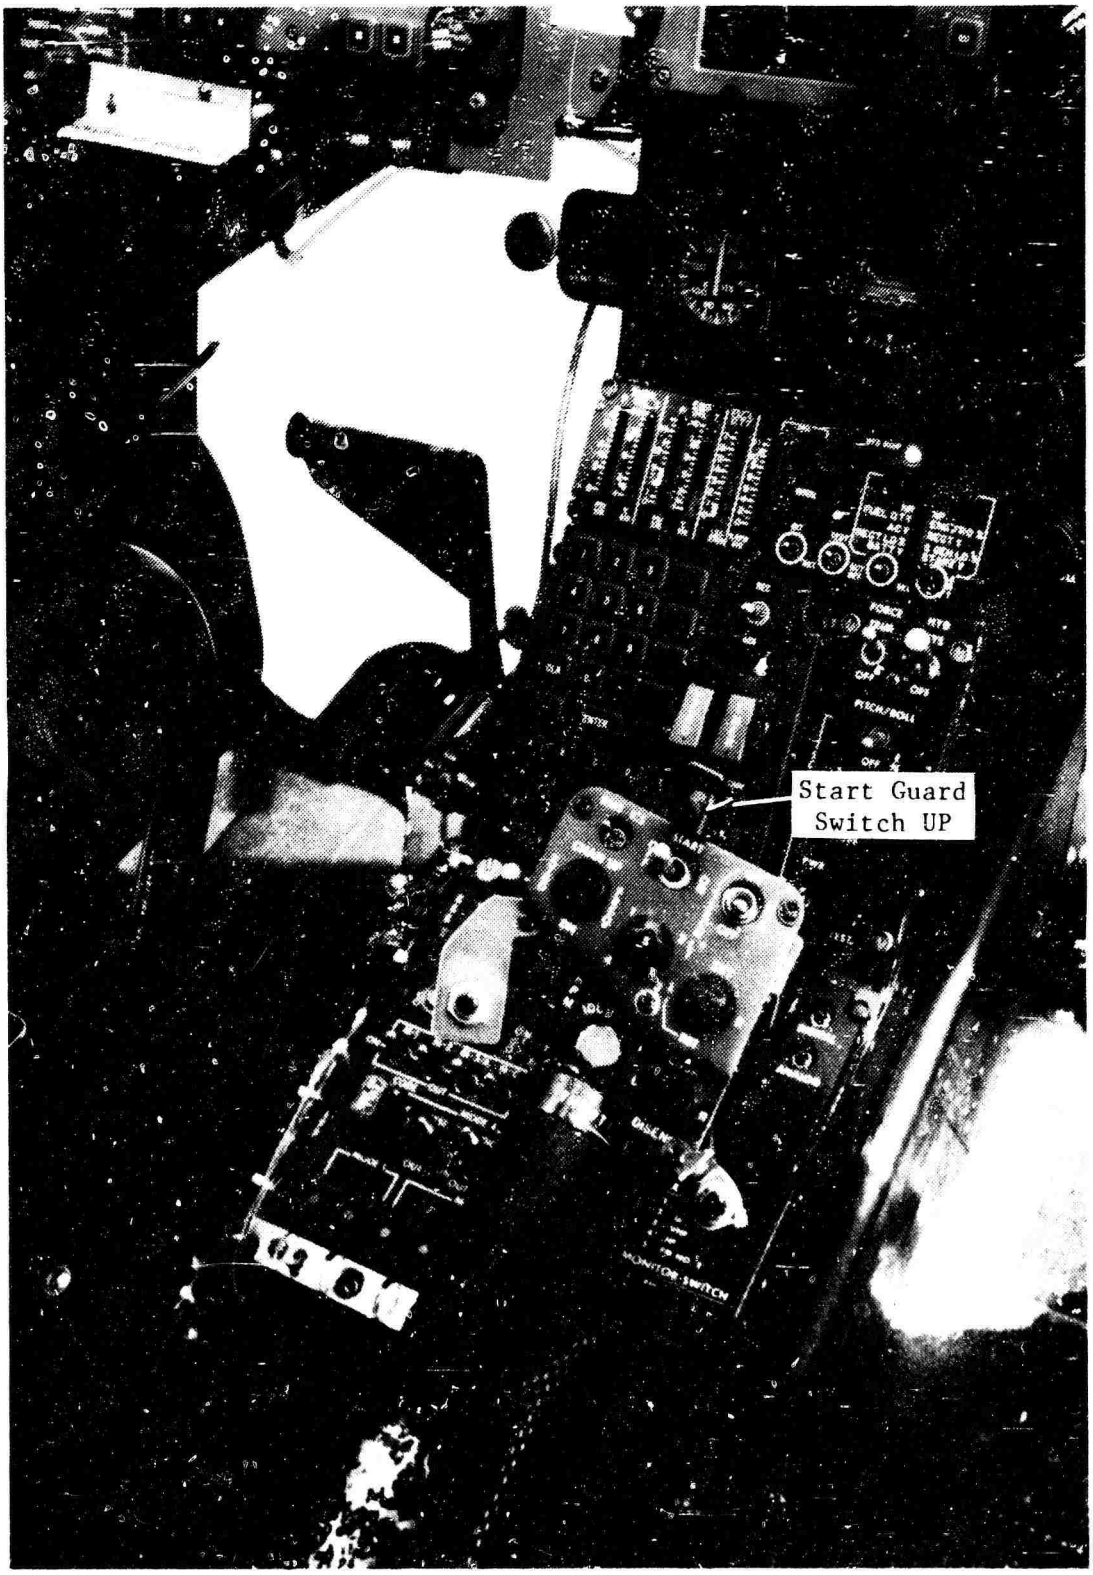
Photo 6. Pilot's Collective Control Head with the Start Guard Switch UP

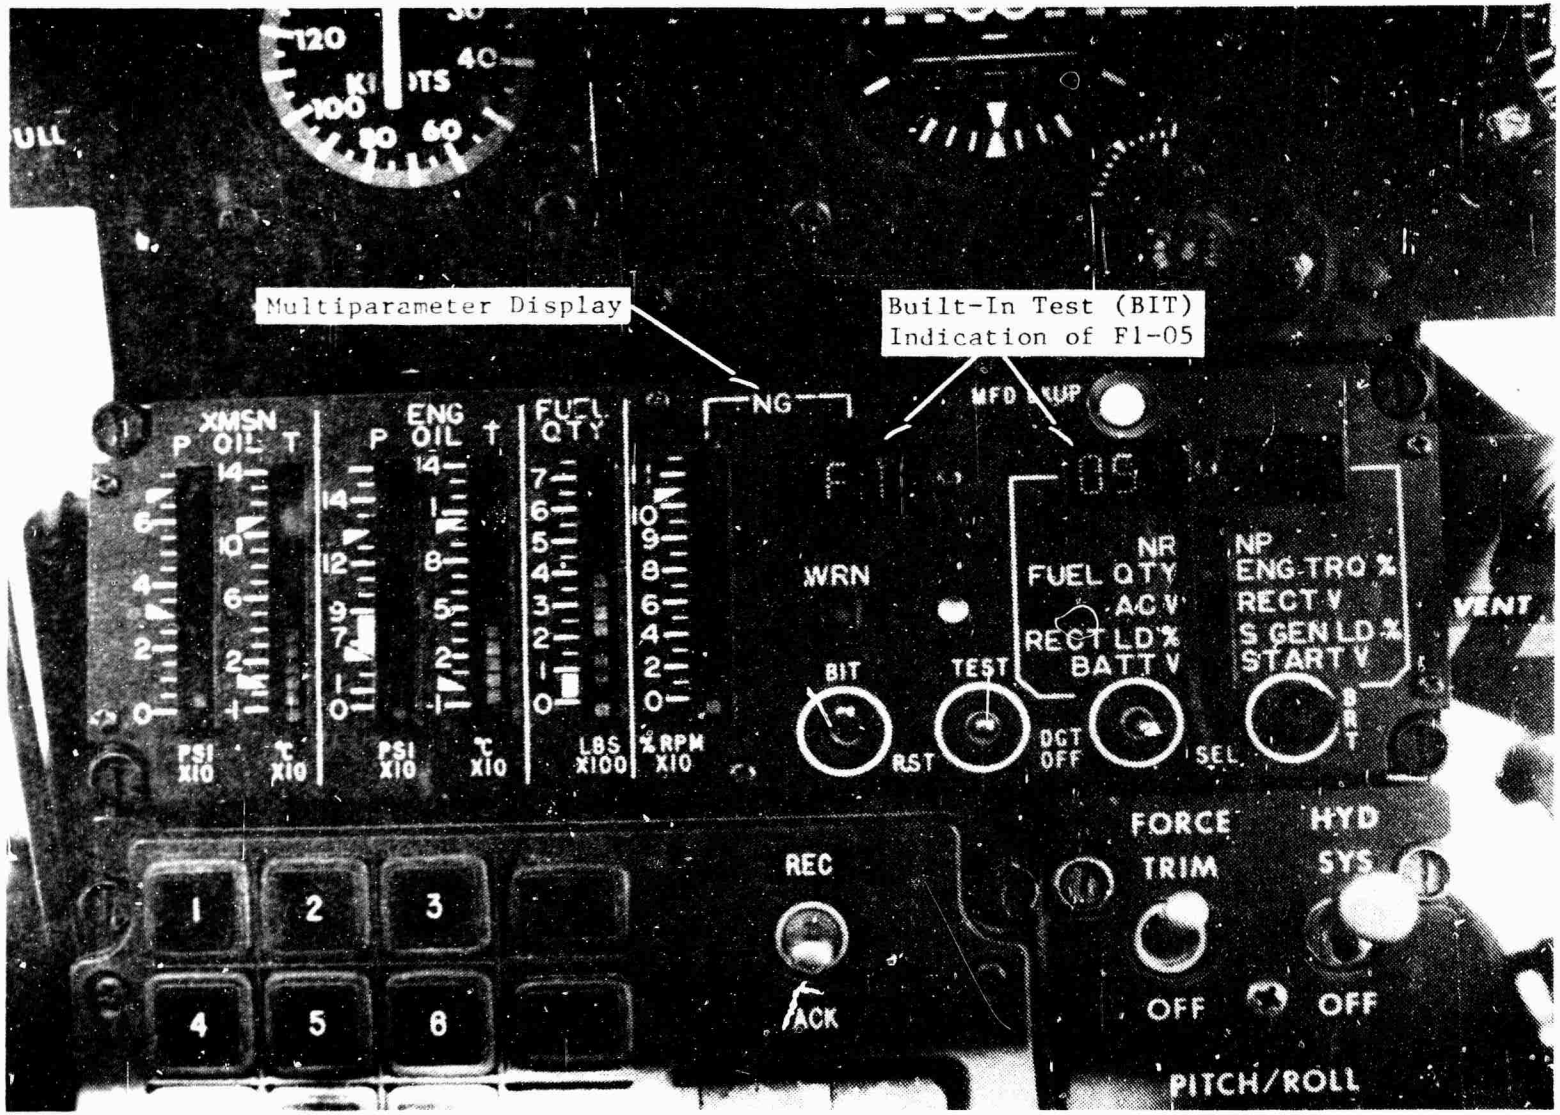
Photo 9. Multiparameter Display with Built-In Test Error Indication
