AD-A191 144 FOUNDATION REPORT ON STONEWALL JACKSON DAM WEST FORK RIVER BASIN HESTON W..(U) CORPS OF ENGINEERS HUNTINGTON WV HUNTINGTON DISTRICT D NUGEN 21 DEC 87 1/6

FOUNDATION REPORT
STONEWALL JACKSON DAM
WESTON, WEST VIRGINIA

CONTRACT NO. DACW59-83-C-0053

VOLUME 1 OF 2

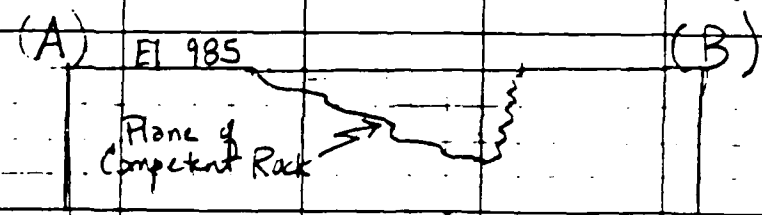
SECTION A-B SCALE: 1" = 10'

(Indicating fault materials being removed in gray)

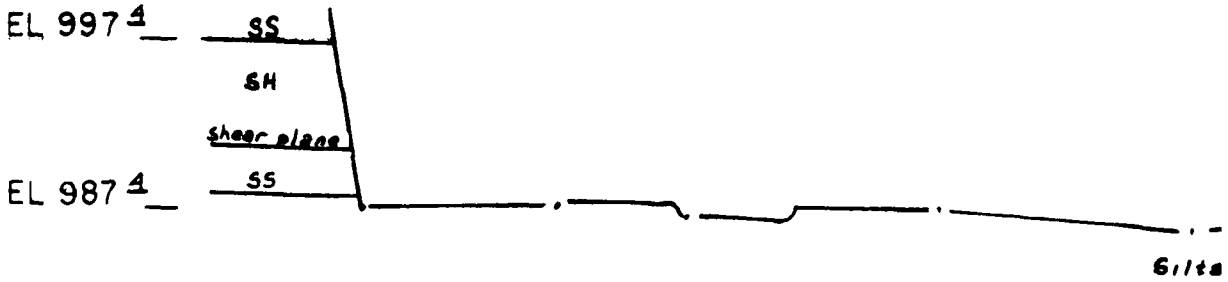
PLAN

(4) Special or Unusual Conditions: Installed 6 uplift cells: Sheared bedding plane at approximate elevation 990 exposed in upstream, downstream, and right side excavated faces; few high angle to vertical fractures and joints running lengthwise of floor

EL 997 4
SS
SH
shear plane
EL 987 4
SS

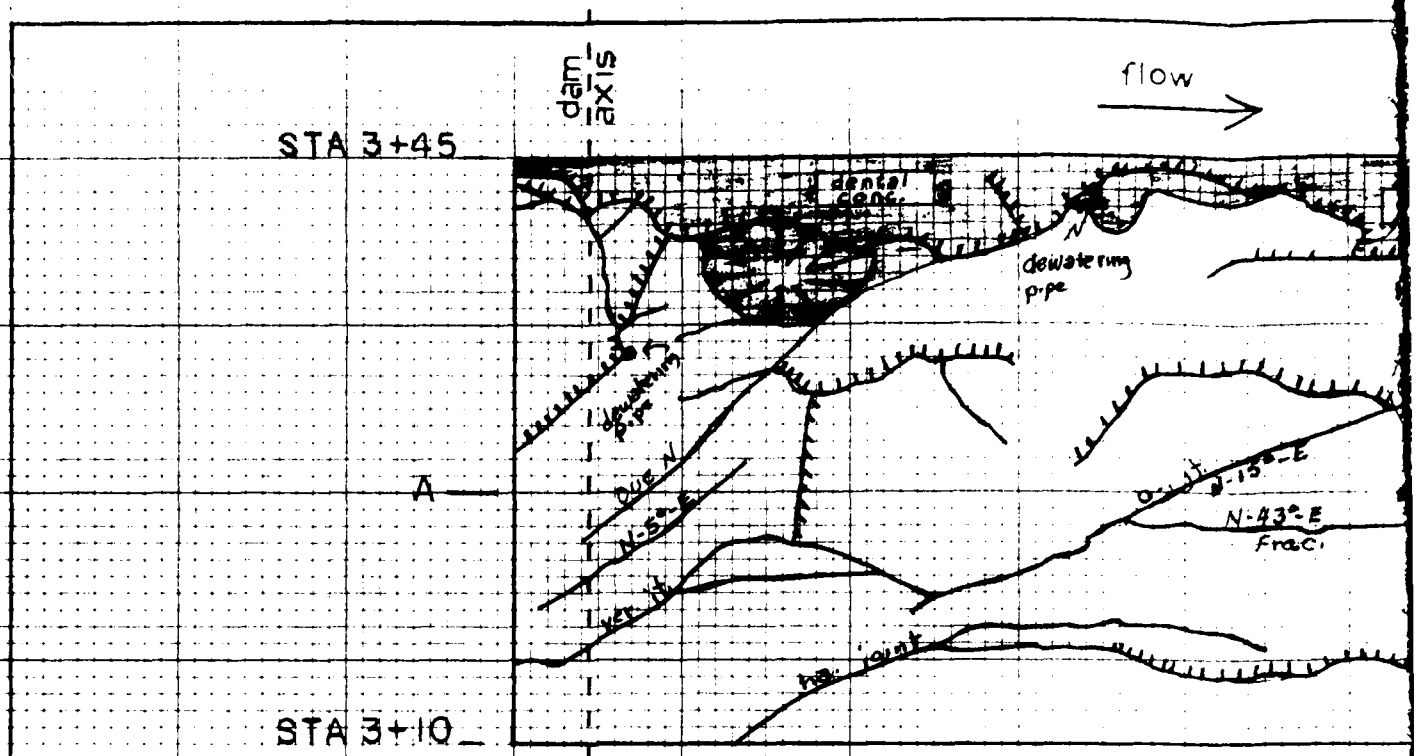
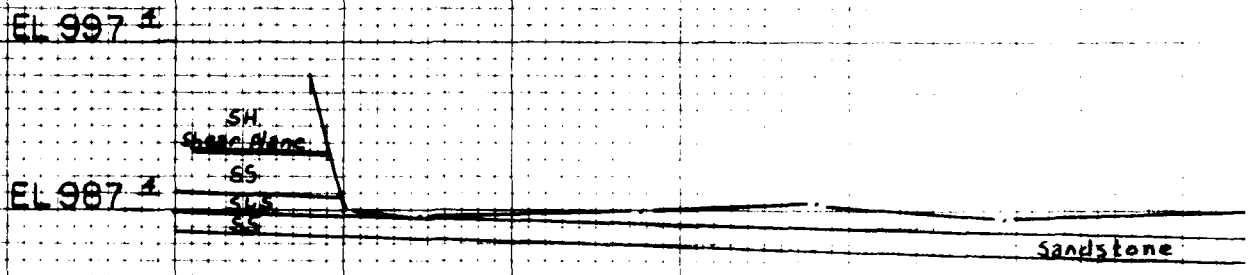
EXHIBIT NO. 9-68

(4) Special or Unusual Conditions: Several high angle to vertical fractures in foundation floor

(6) Dewatering: 2-4 in. diameter PVC pipes were installed vertically along water producing joint in foundation floor: After being used for dewatering during concrete placement, these pipes were backfilled with neat grout at elevation 995.5

dam axis
flow
STA 3+45
dental conc.
dewatering pipe
dewatering pipe
A
Qtz N
N-5°-E
Vert. joint
Qtz. joint
N-15°-E
N-43°-E
Frac.
Vert. joint
STA 3+10

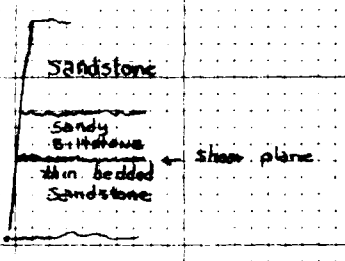
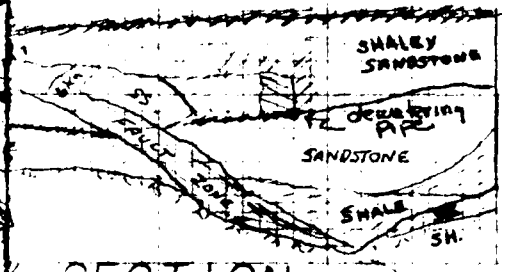
EXHIBIT NO. 9-11B

STA.
flow
B'
dam axis
5+40
5+30
5+20
5+10
5+00
A
FAULT LINE
Dental Conc.
B
P
ELEV.
985
SS
SLS
SS
X
ELEV.
990
bd. shear plane
Siltstone
SANDSTONE
980
X-SECT
B

(3) Description: Fractured, fine grained, silty sandstone and sandy siltstone

(4) Special or Unusual Conditions: Fault zone crossing monolith with associated open joint systems
