Cumberland River Basin
Remedial Construction
Wolf Creek Dam, Kentucky

Wolf Creek Dam Concrete Diaphragm Walls Final Completion Reports Phases I and II

December 1988

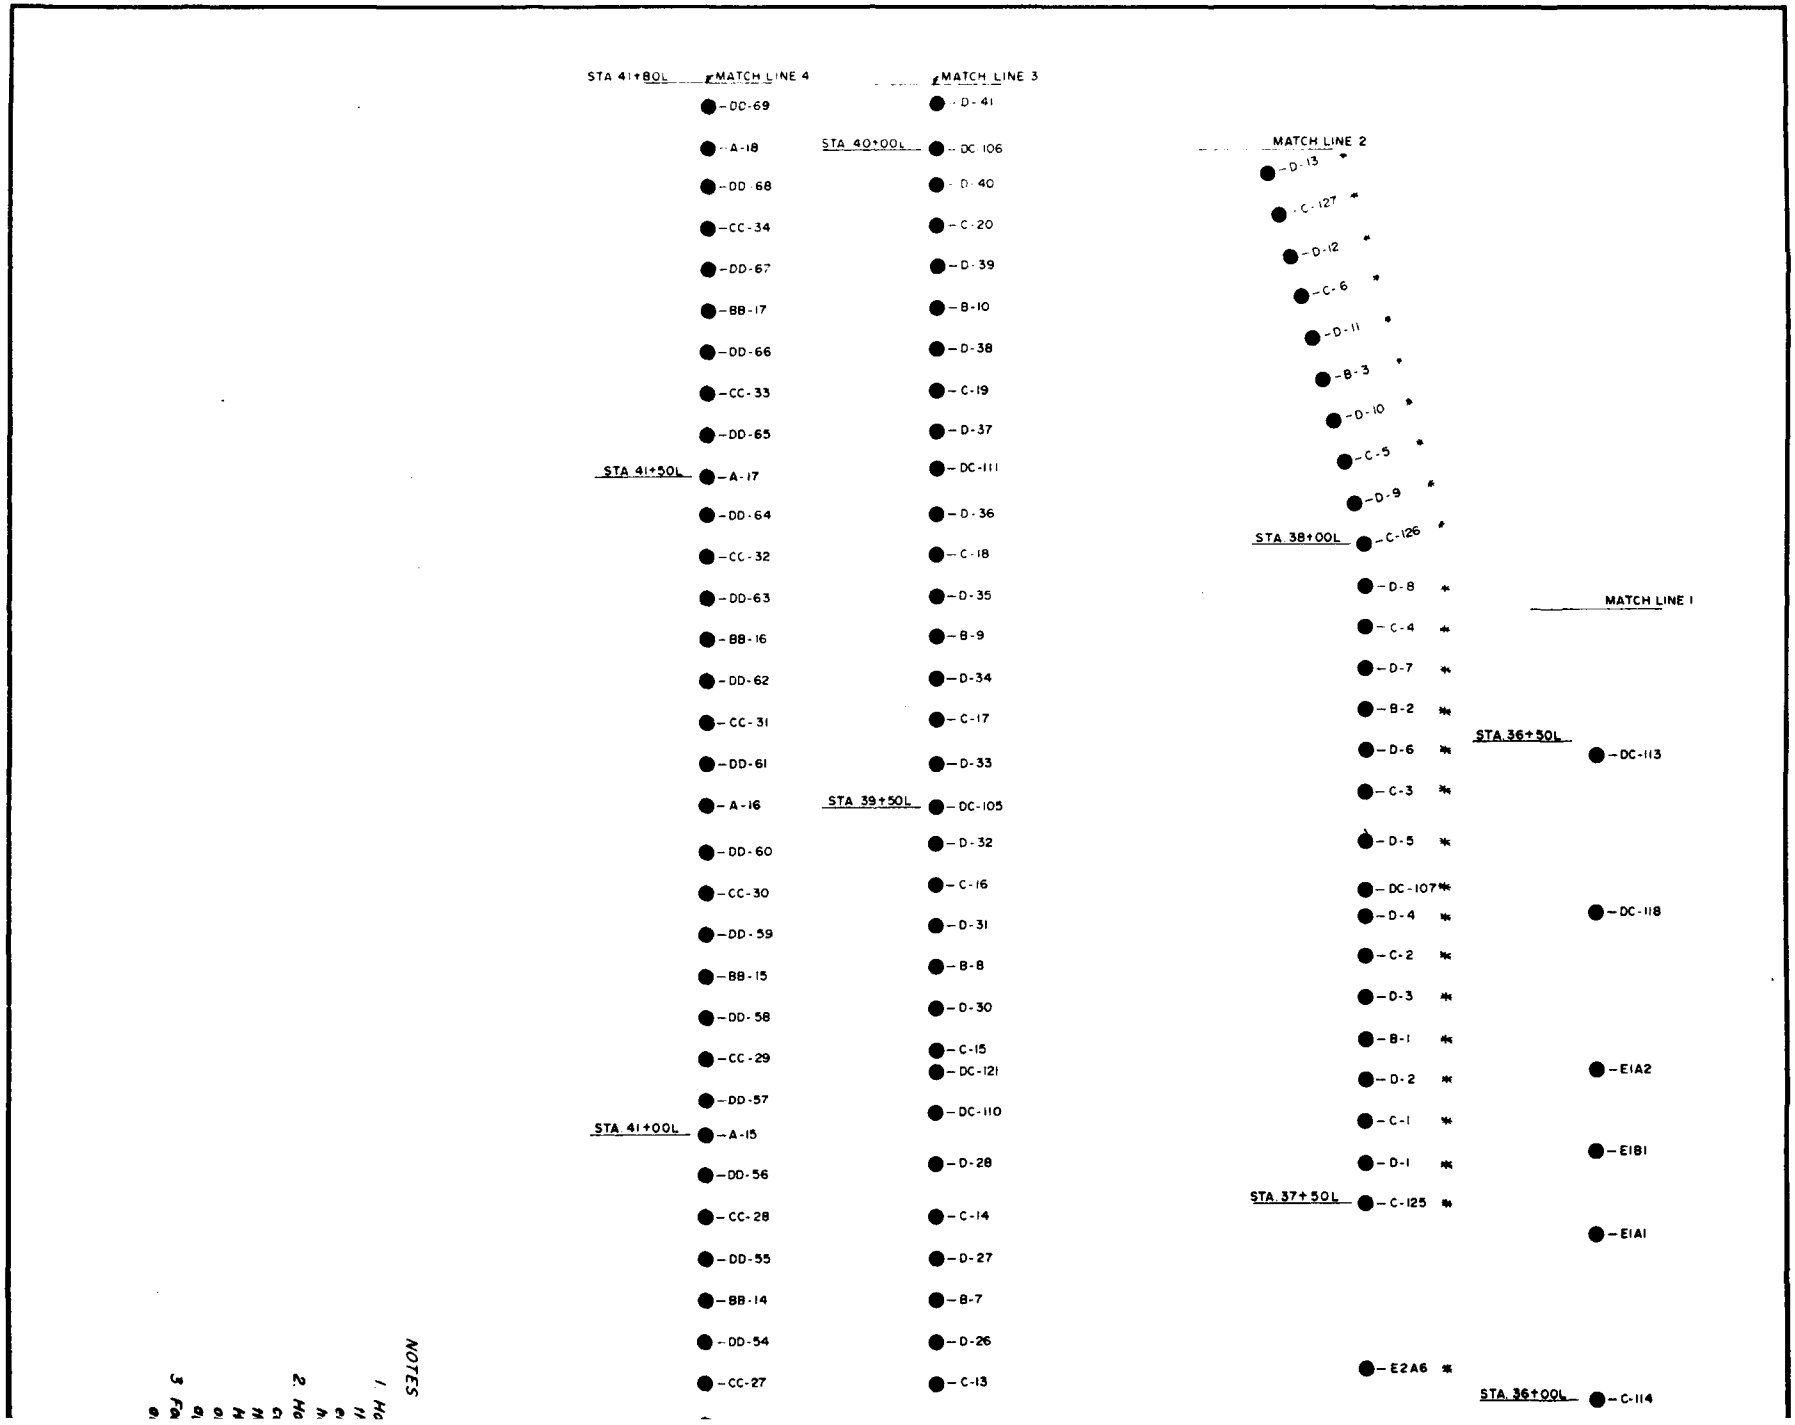
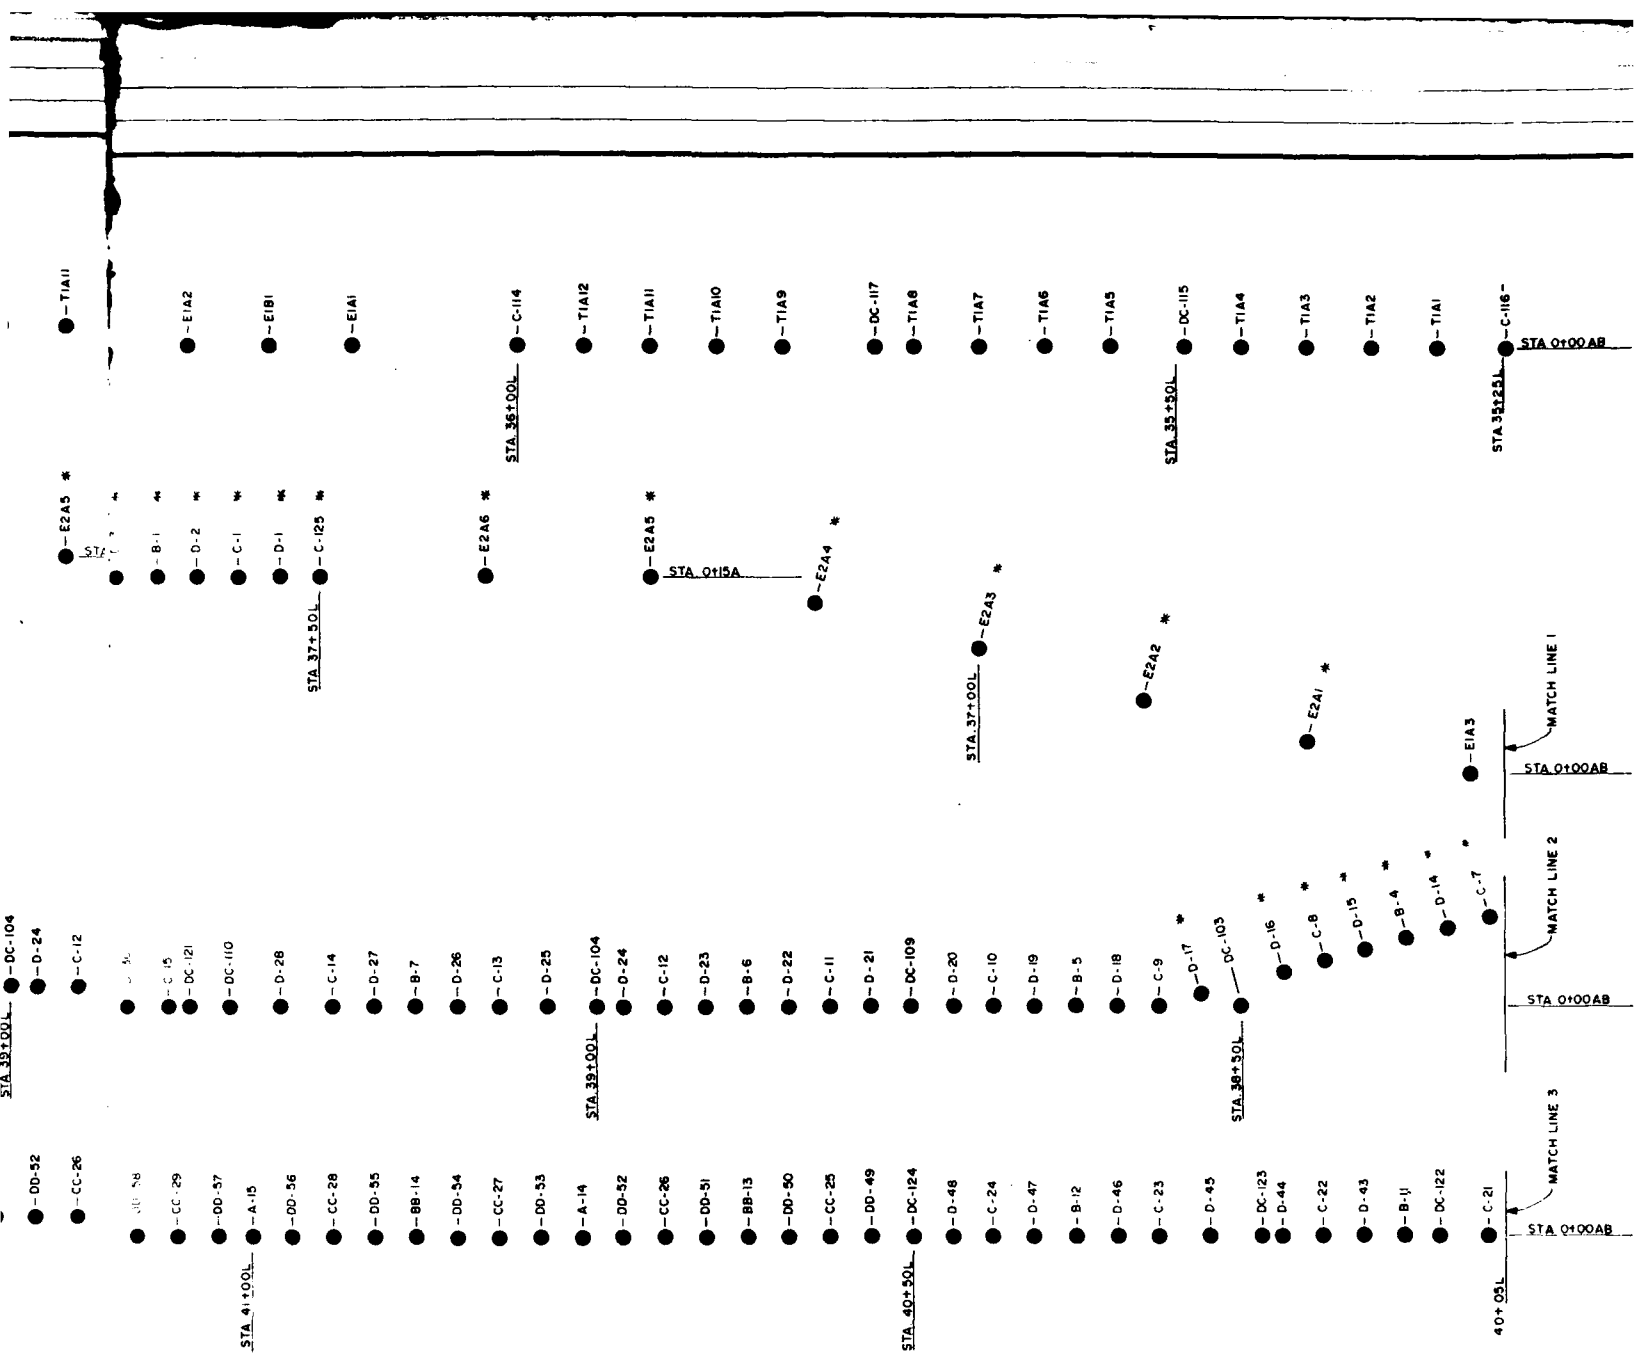
PLATE A-13

1. *Holes marked with asterisk were offset to avoid the construction tailtower buried in the embankment in this area. All remaining holes were drilled along Sta. 0+00 AB.*
2. *Holes C-126 and DC-122 have grouted in casing from top of ground to top of rock that will require removal prior to excavation Hole DC-110 has 93' feet of casing broken off in the embankment and grouted in approximately 90' below the surface.*
3. *For geologic sections along the wall alignment see Dwg. Nos. 02-52/190, 191, and 192*

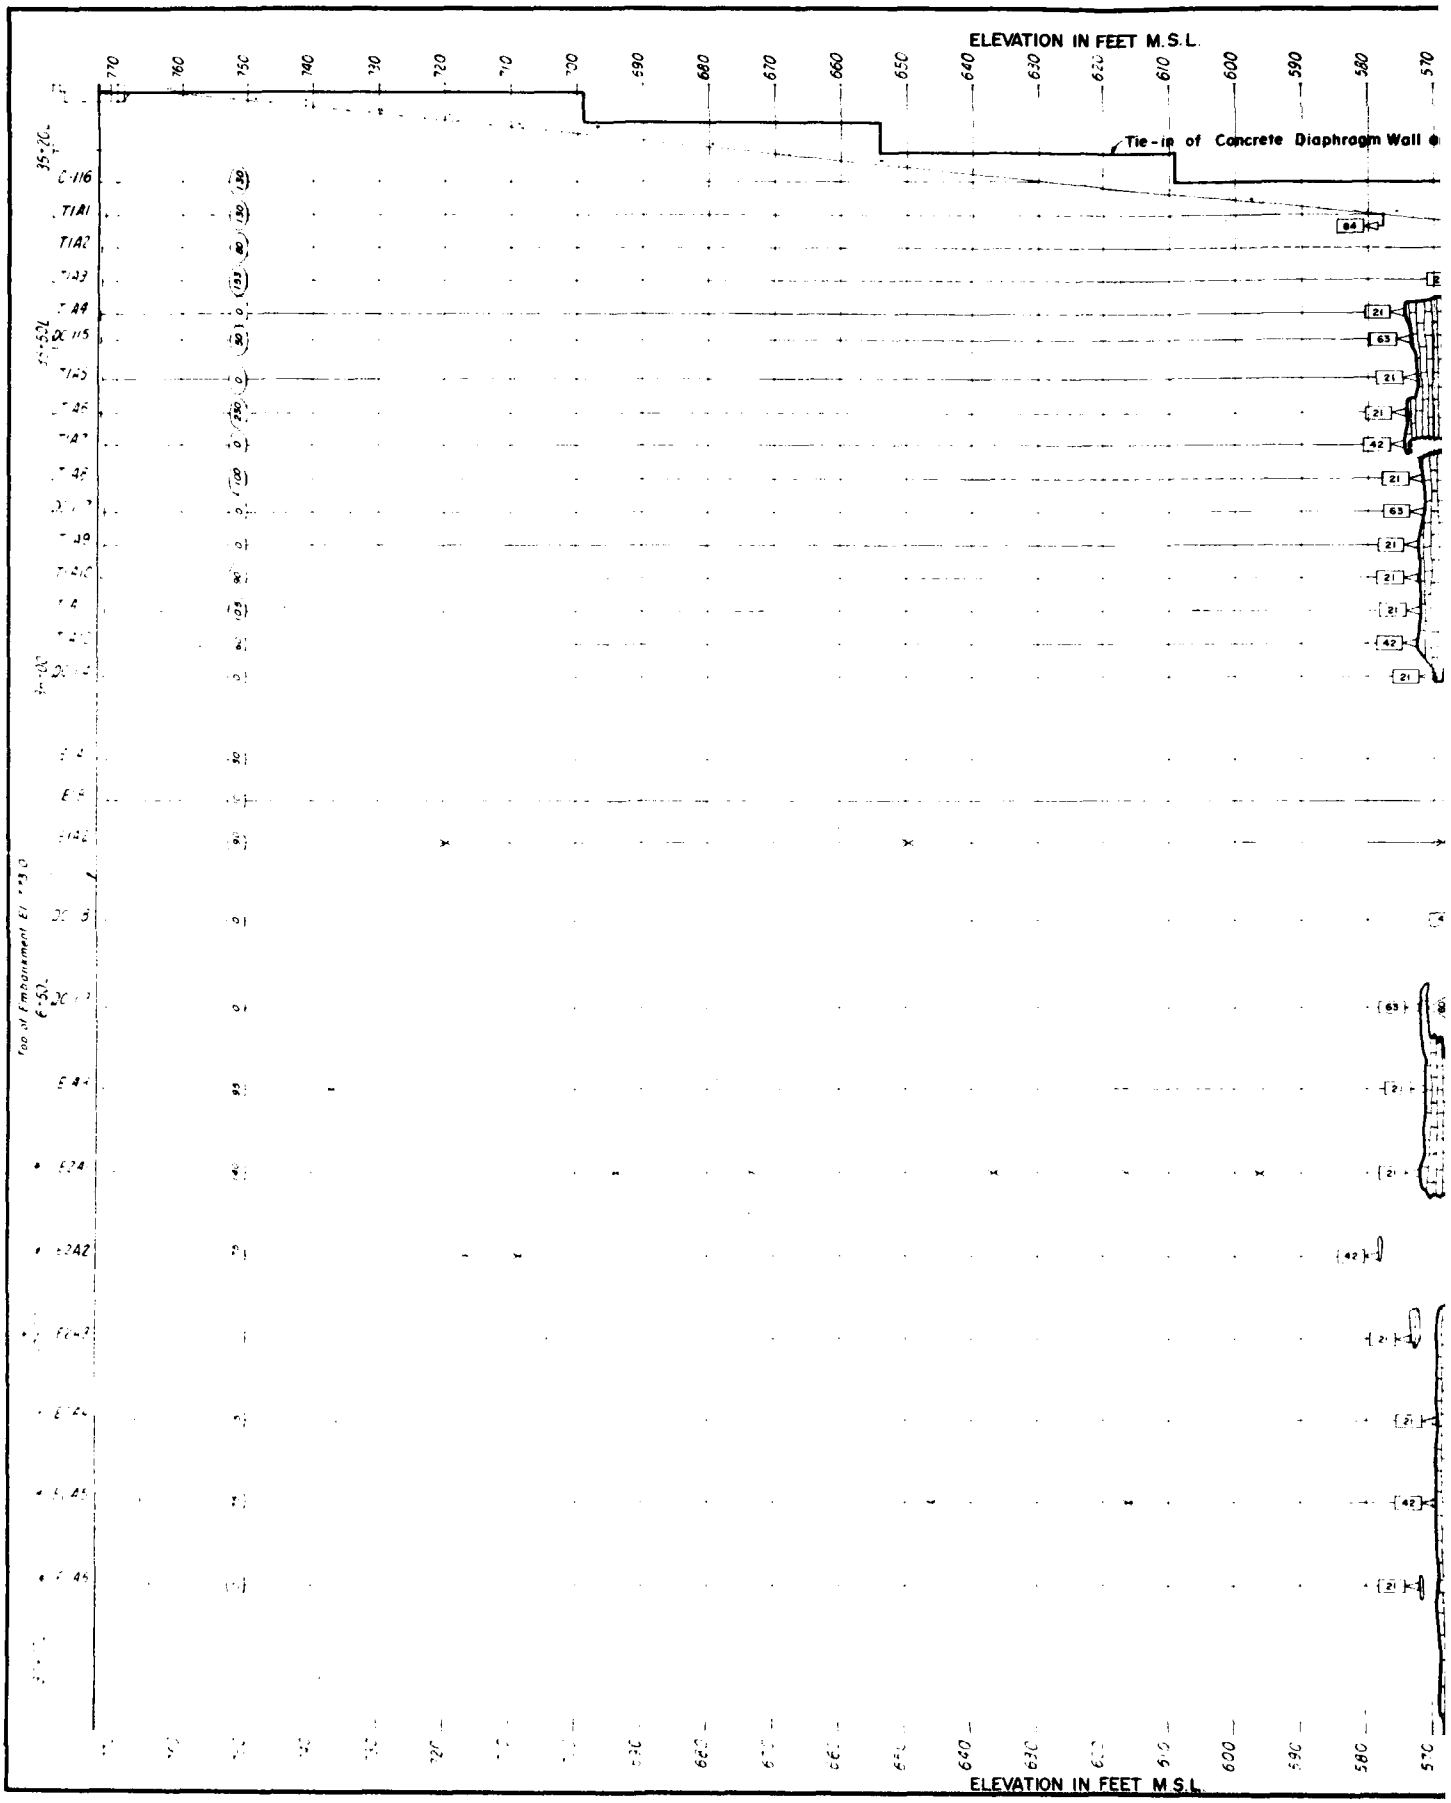
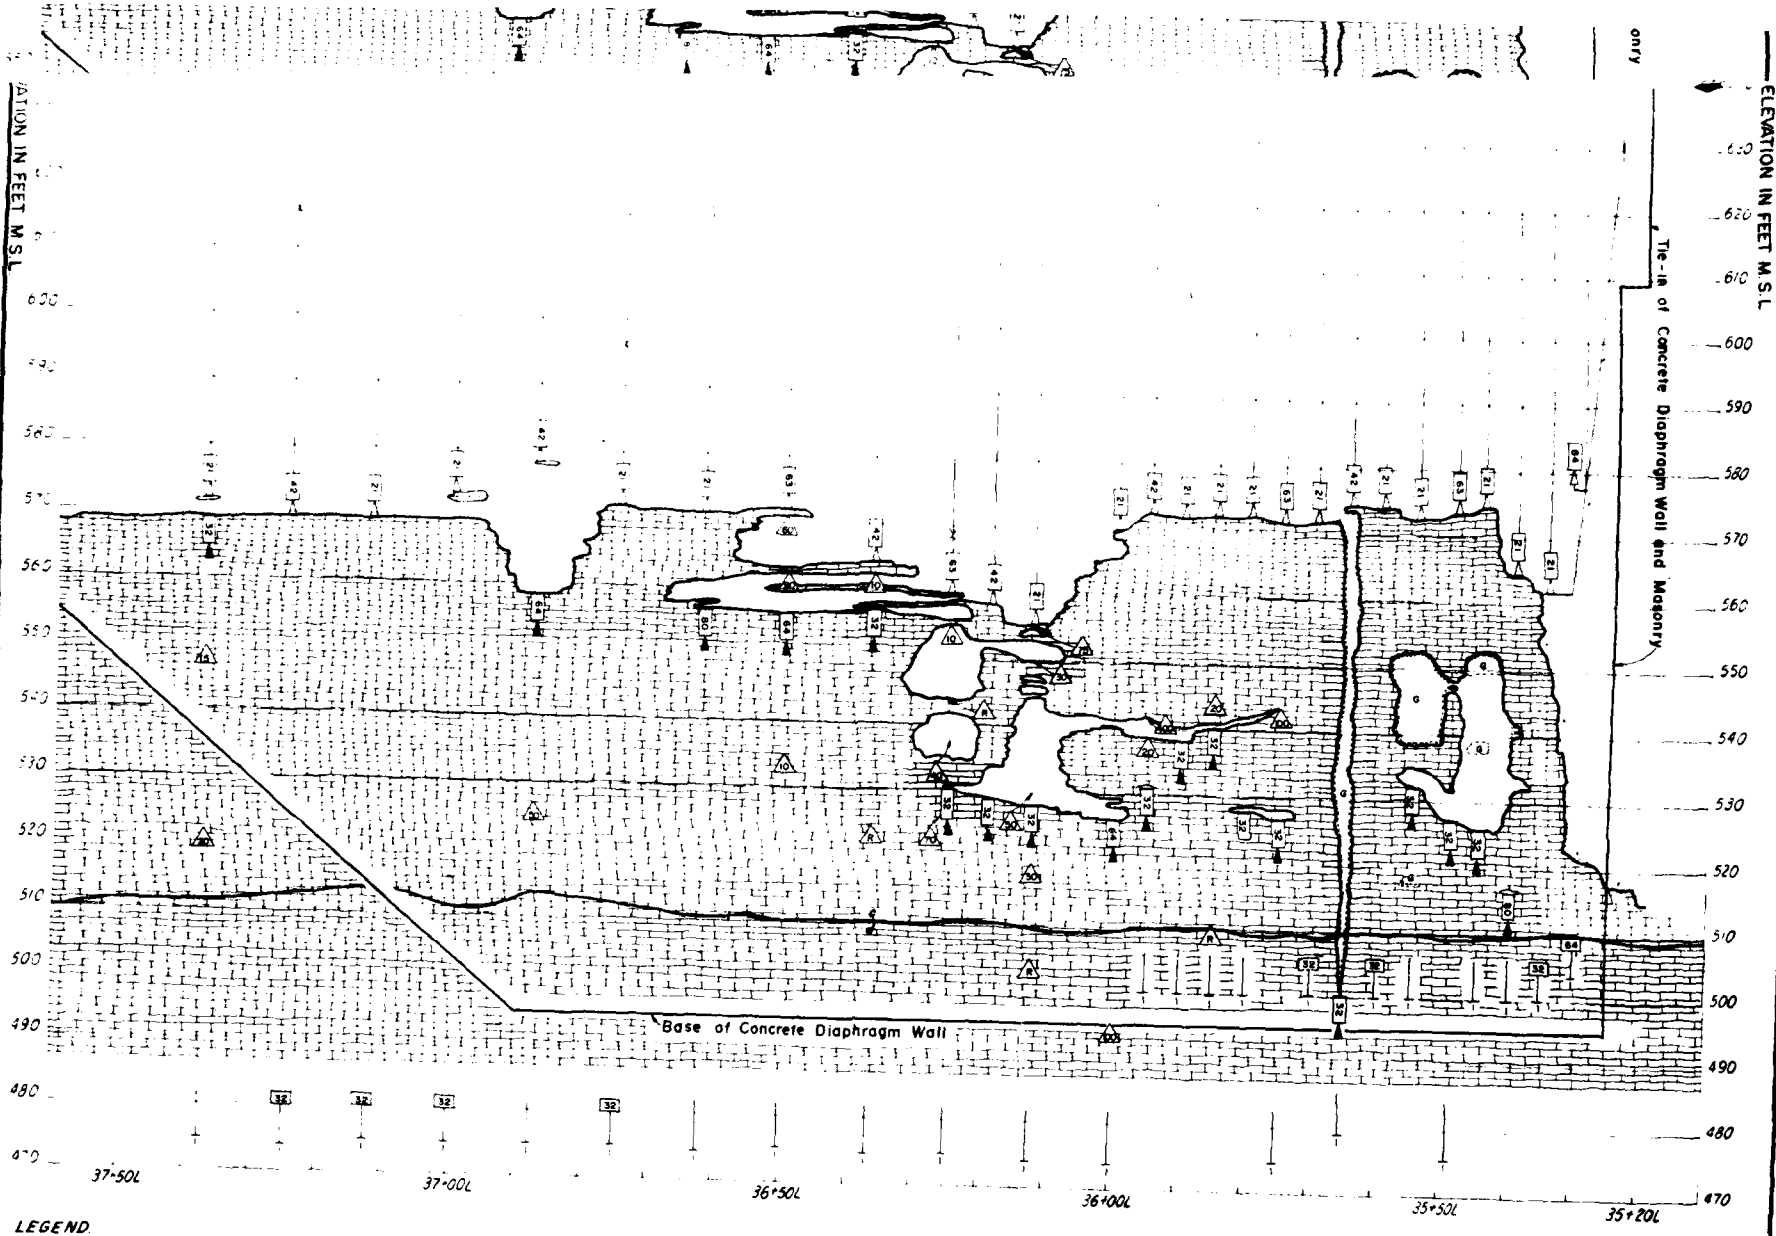
PLATE A-17

1. All holes are drilled along STA 0+00AB except those noted by an asterisk For approximate hole and section locations See Dwg No 02-52/186
2. Hole C-116 and T1A1 encountered the sloping face of monolith 37 and traveled down the surface before entering the concrete and are not considered vertical
3. All elevations refer to Mean Sea Level Sandy Hook Datum

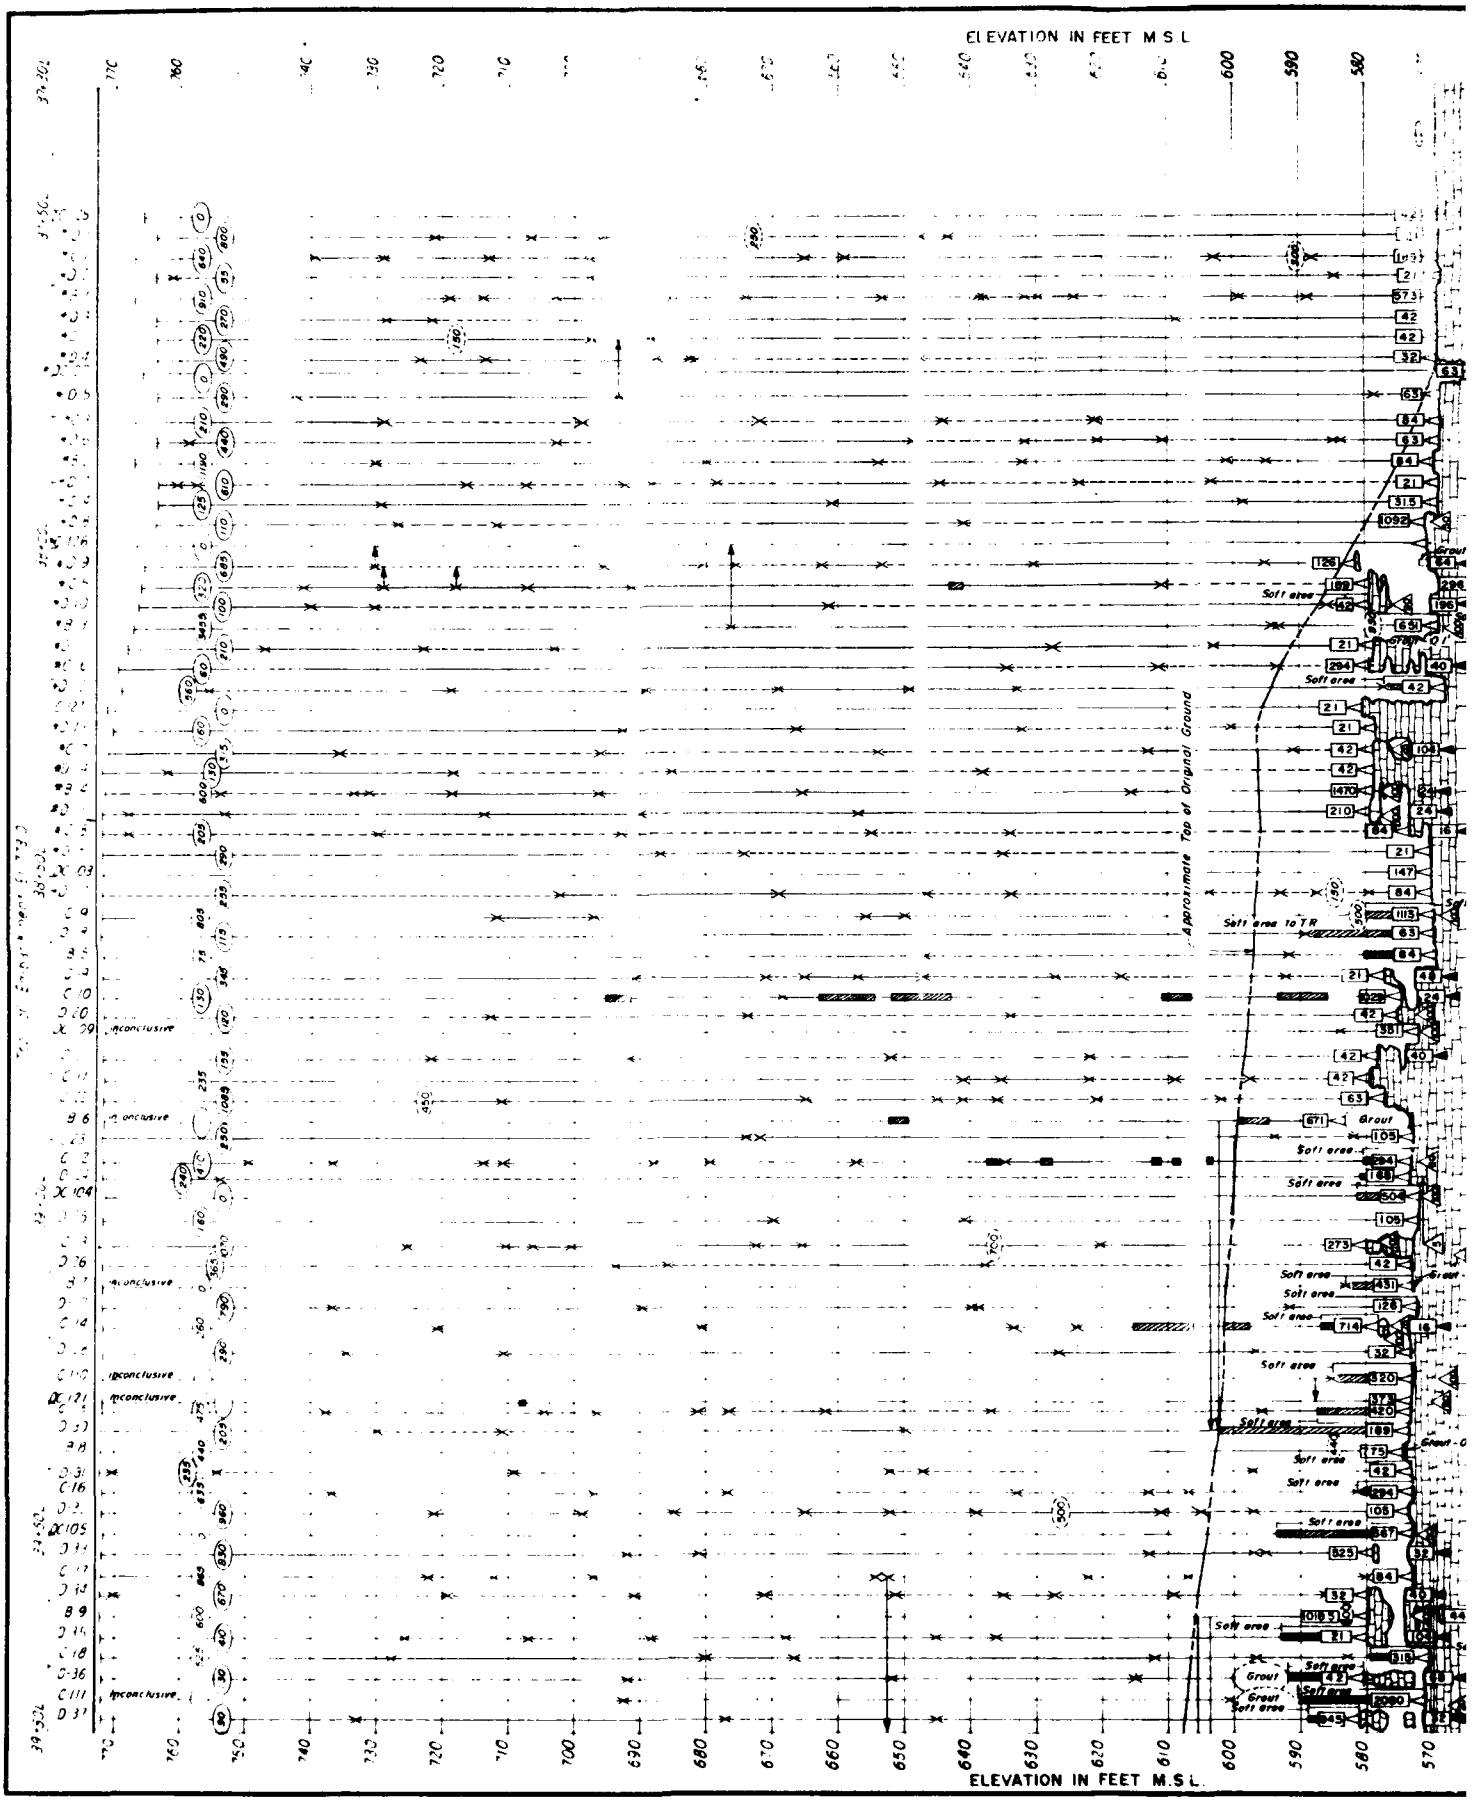
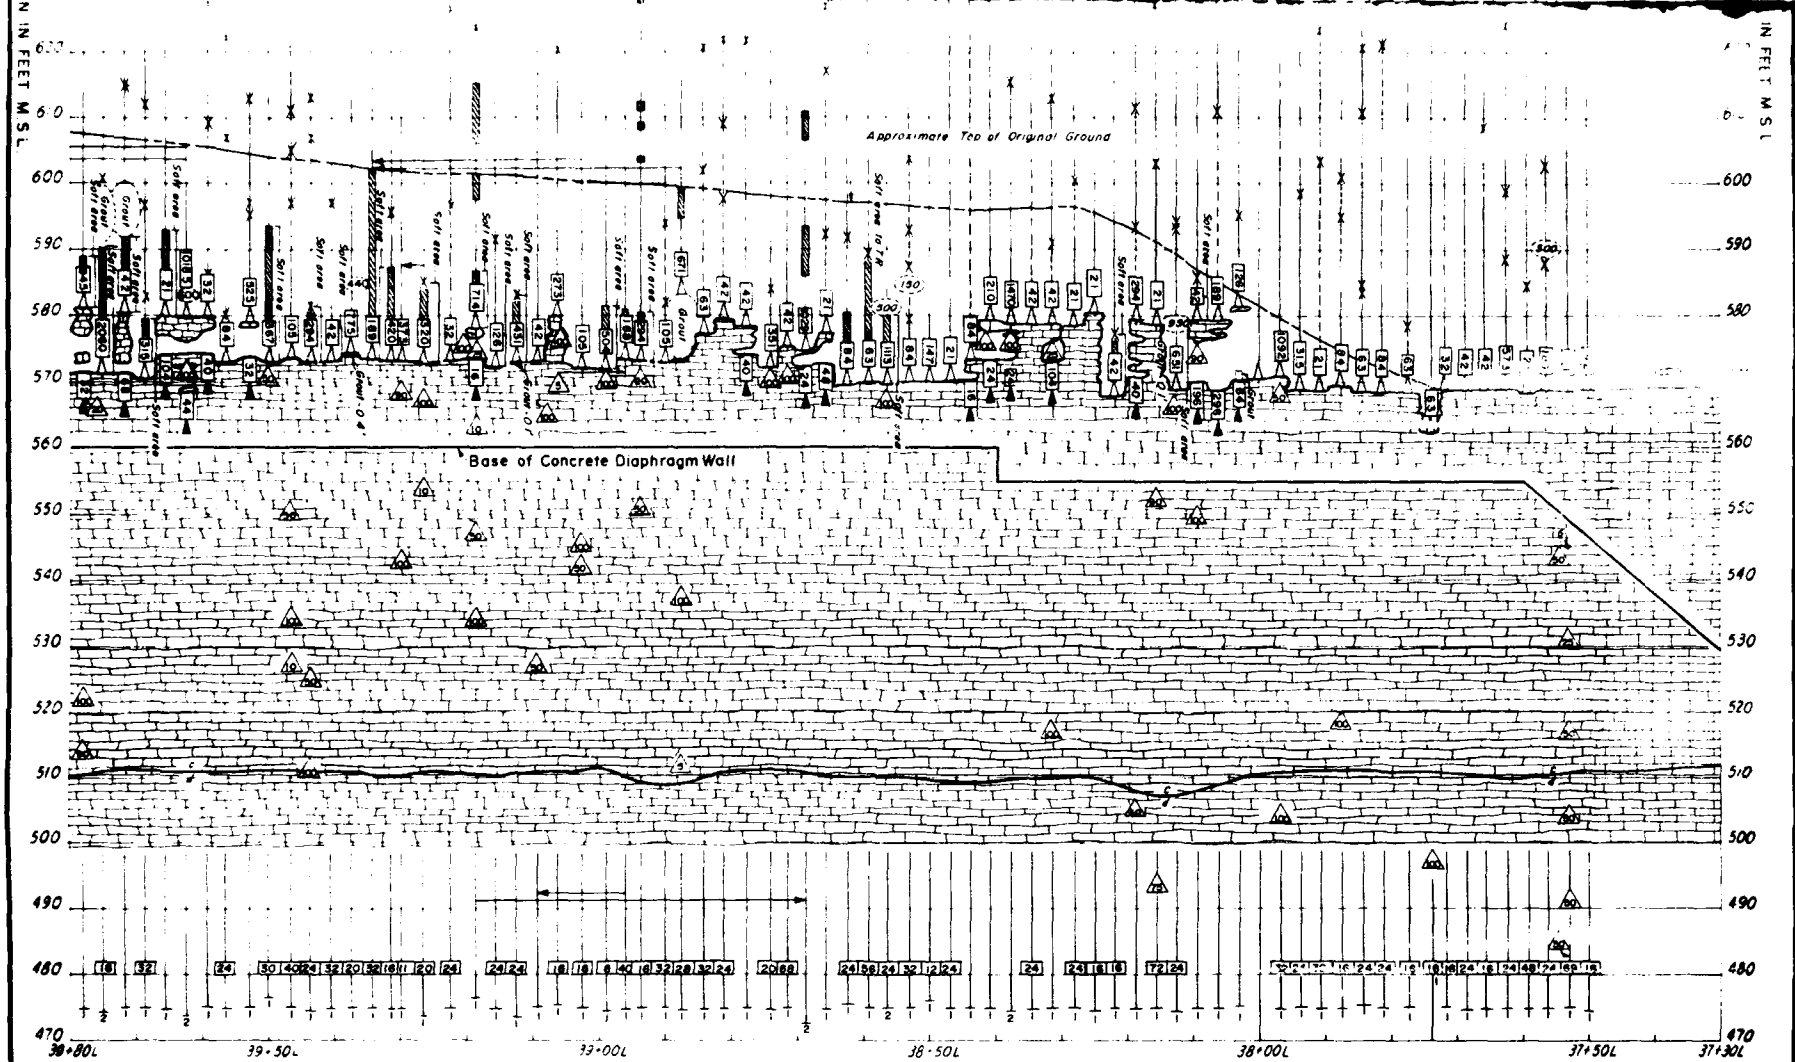
PLATE A-18
02-52/190

1. All holes indicated on section are drilled along Sta. 0+00 AB except those noted by an asterisk. For approximate locations of all holes see Dwg. No. 02-52/186
2. Hole C-126 has not been backfilled and is cased to top of rock, casing is grouted in
3. Approximately 92' of NX casing was broken off in hole C-110 and was not recovered. Casing is grouted in place.
4. The rock portion of hole D-26 was backfilled during backfilling of hole D-24
5. All elevations refer to Mean Sea Level Sandy Hook Datum

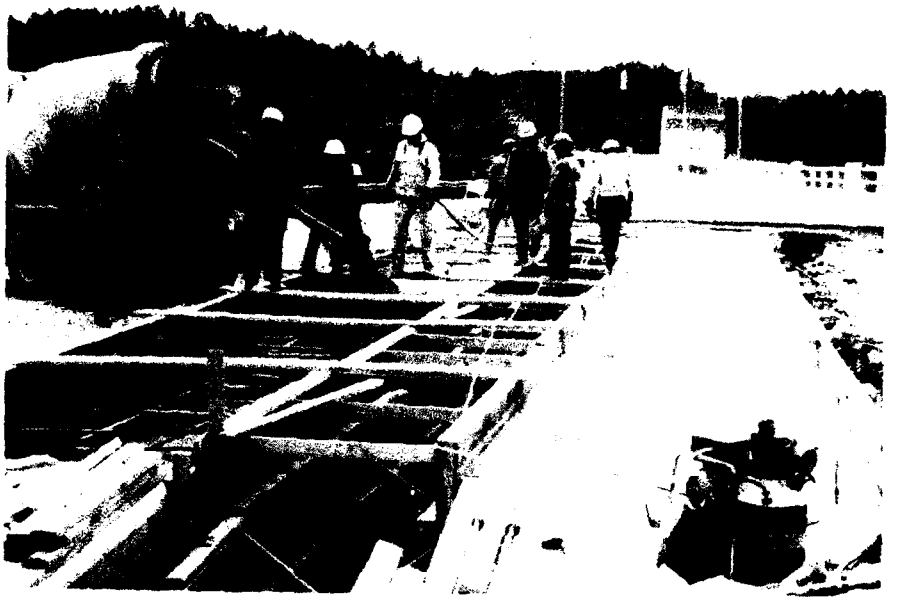
4. Downstream piling and anchor rods.
