Report of Sampling and Analysis Results

Westport Army Housing Units
Westport, Connecticut

June 1990

SAMPLING AND ANALYSIS AT THE U.S. ARMY
FAMILY HOUSING UNIT (FHU) PROPERTY
WESTPORT, CONNECTICUT

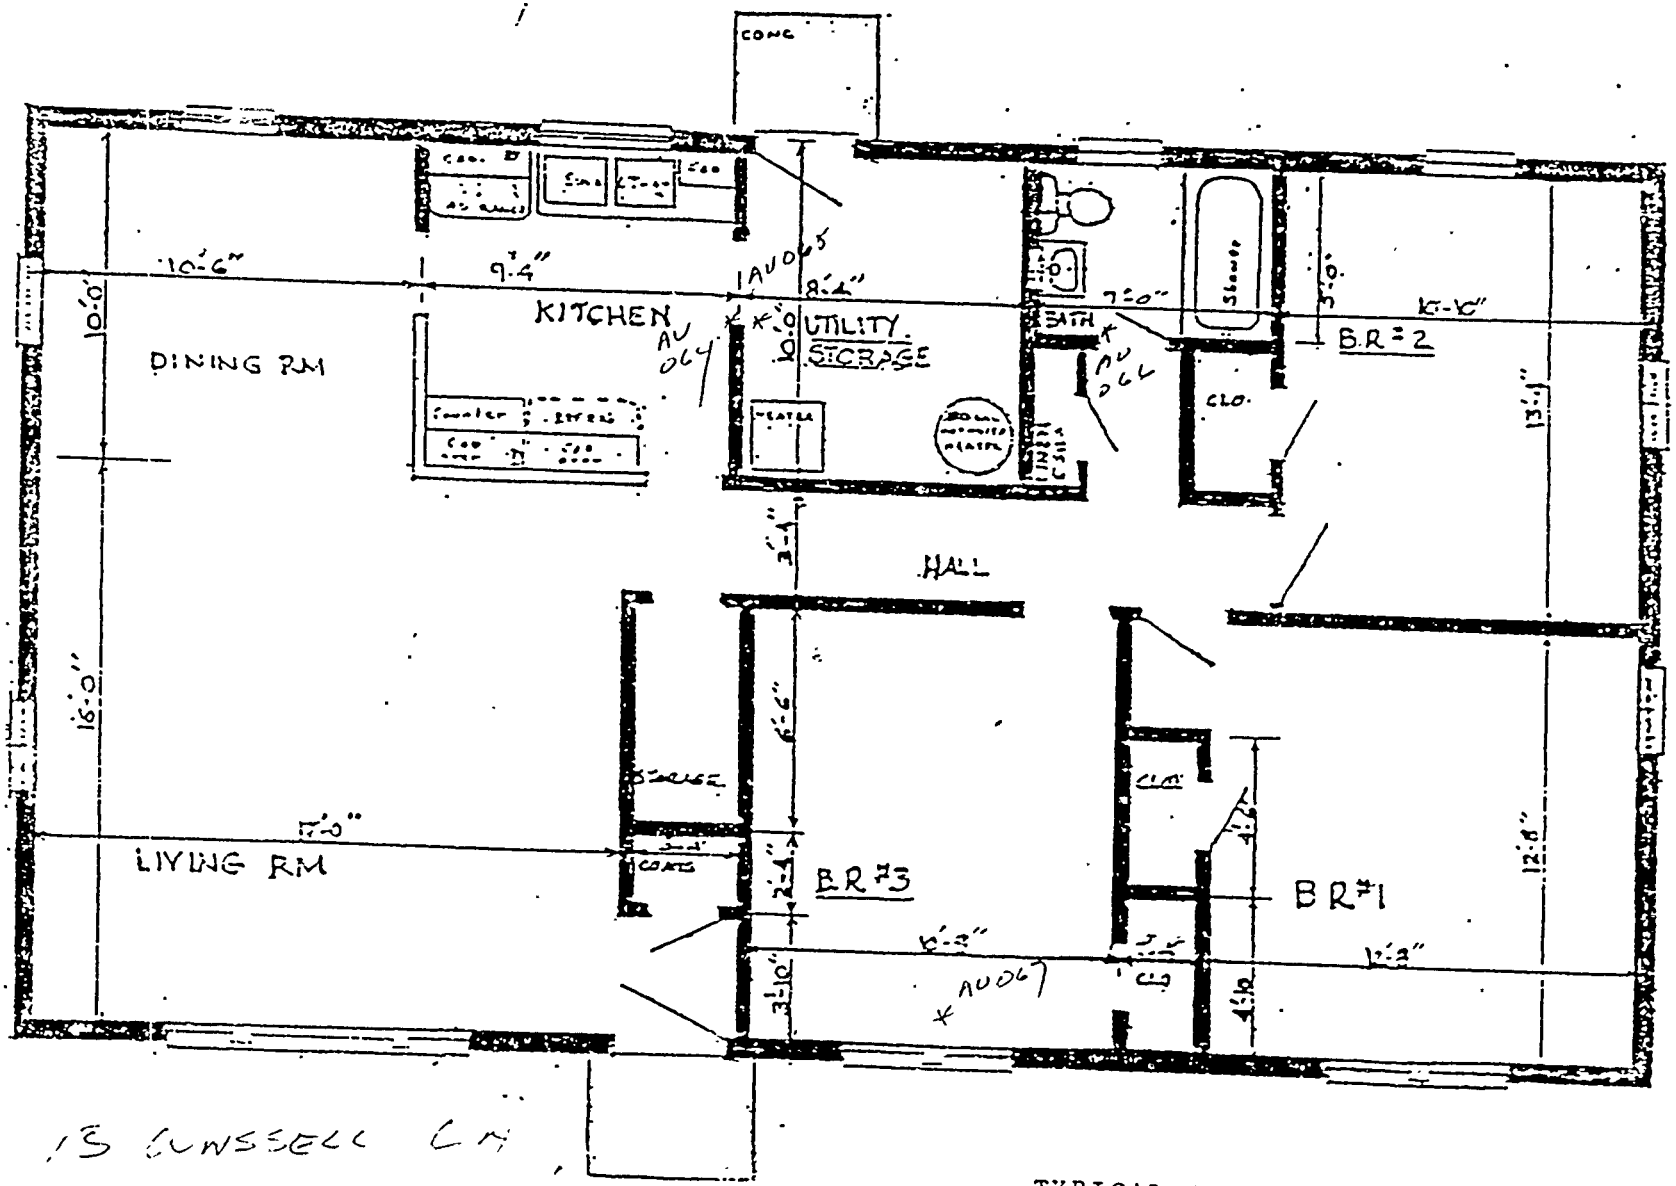
15 CUNSELL CT

NOTE NO.	NOTES/REMARKS/COMMENTS/DETAILS/OTHER MATERIALS, QUANTITY, ETC.
01	12x12 brown and white sparkled floor tile in kitchen only.
02	9x9 brown floor tile in all rooms except kitchen and bath.
03	brown sheet vinyl in bath only.
04	9x9 white floor tile over old floor vents

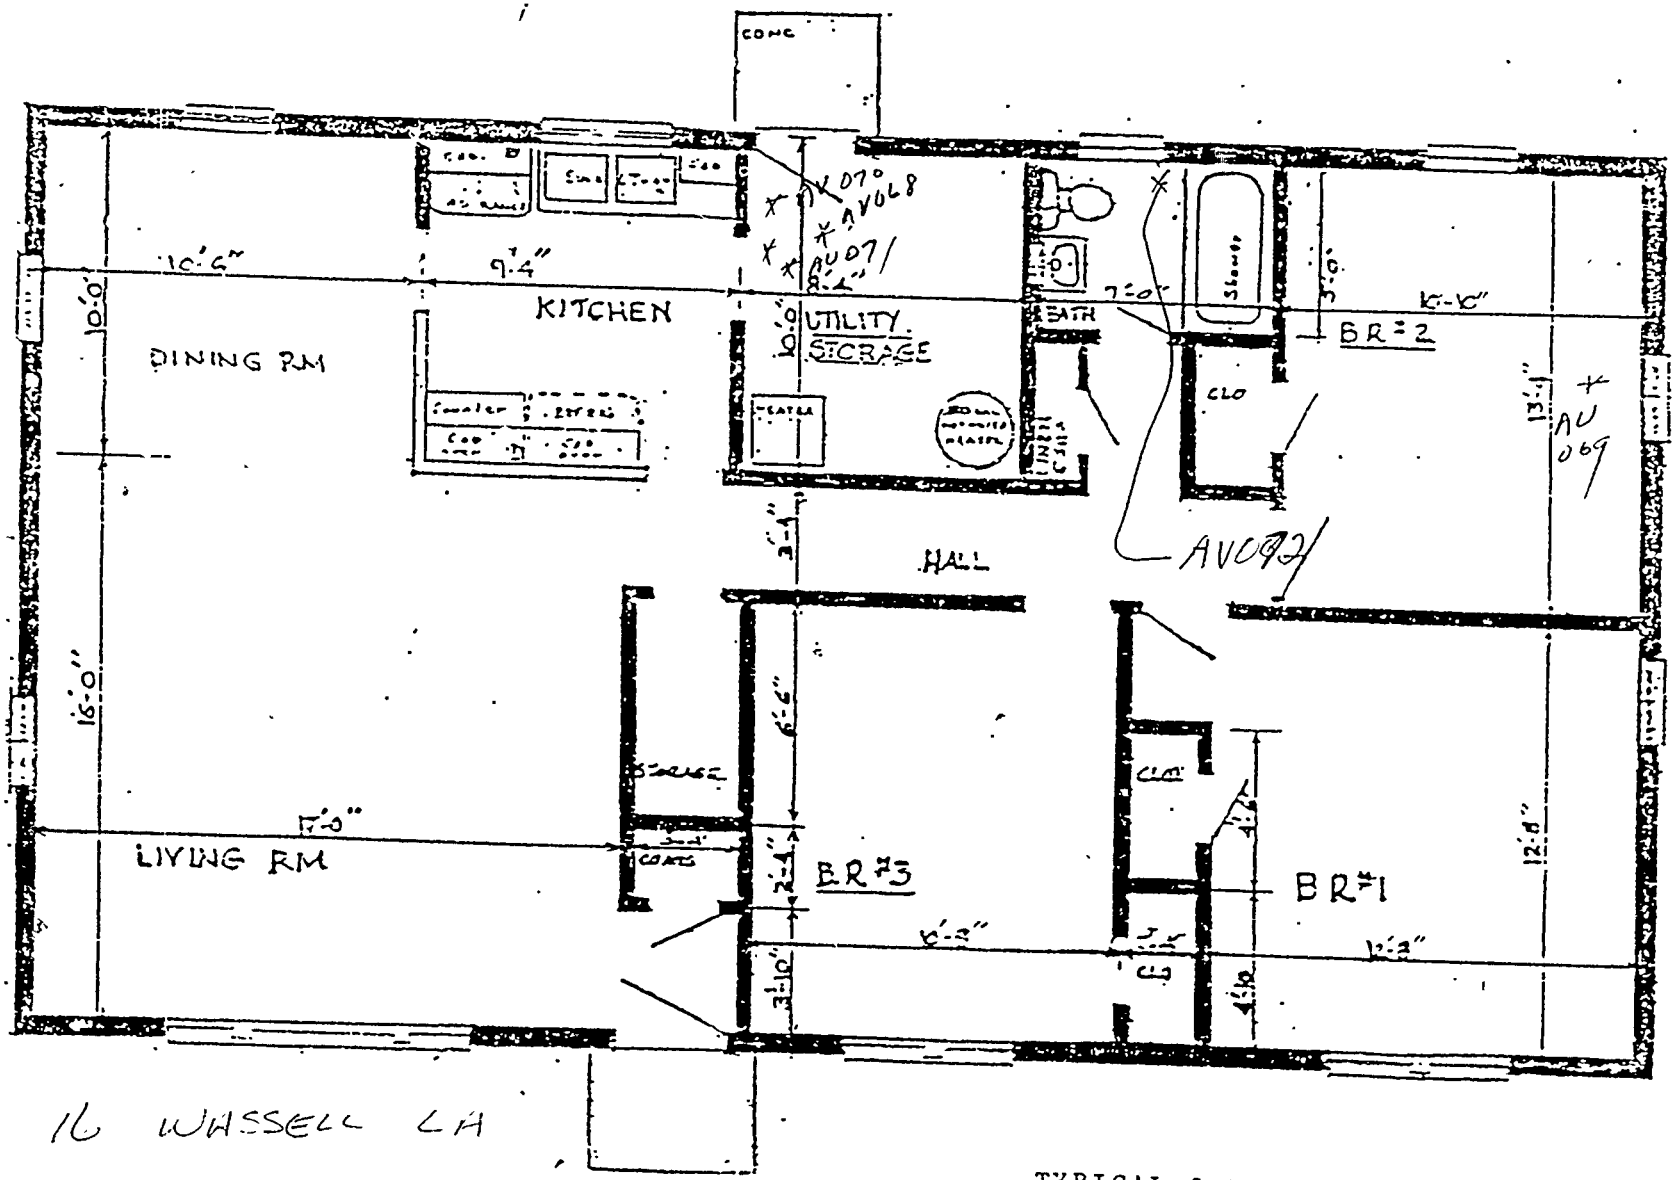
CAPEHART TYPE "A"

NOTE NO.	NOTES/REMARKS/COMMENTS/DETAILS/OTHER MATERIALS, QUANTITY, ETC.
01	9x9 ~~brown~~ tan floor tile in all rooms except kitchen and bath
02	9x9 white floor tile over old floor vents.
03	12x12 brown and white speckled floor tile in kitchen only
04	12x12 brown floor tile patch in utility room.
05	brown sheet vinyl in bath only.
