IRP PHASE I - RS AF PLANT 83

DEC 1983

USAF PLANT NO. 83
GENERAL ELECTRIC ALBUQUERQUE PLANT

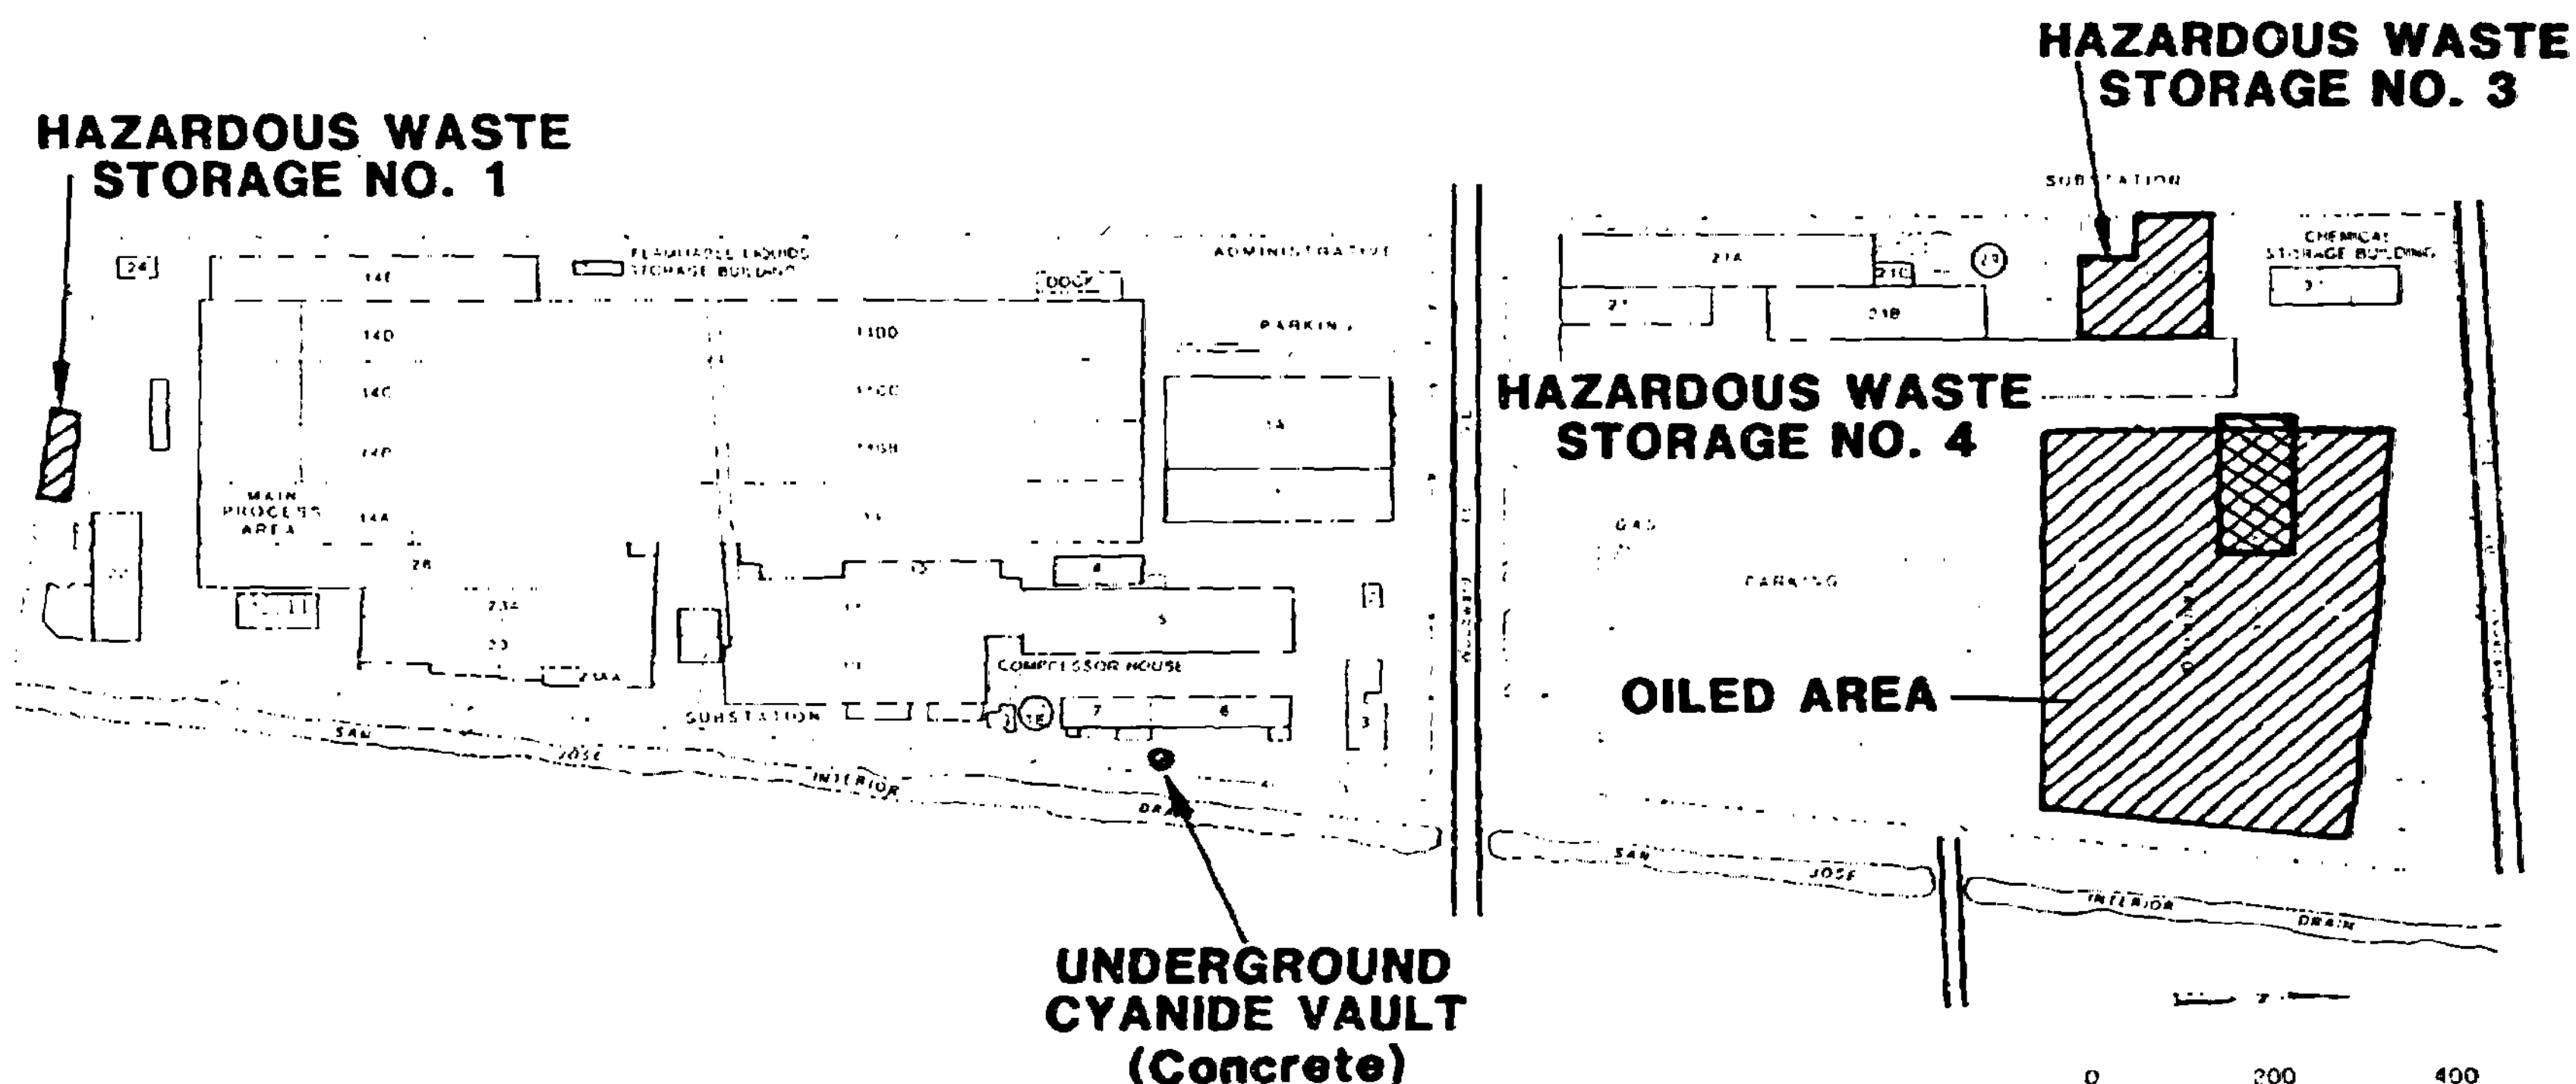
SITES OF POTENTIAL ENVIRONMENTAL CONTAMINATION

Rank	Site	Operating Period	Final HARM Score
1	North Parking Lot	1979-1980	64
1	Hazardous Waste Storage No. 1	1954-Present	62
2	Hazardous Waste Storage No. 3	Late 1950's to Present	60
4	Hazardous Waste Storage No. 4	Mid 1970's-1981	54
5	Underground Cyanide Vault	Mid 1950's to Late 1970's	51

North Parking Lot	- Soil Sampling, Install and Sample Monitoring Wells.
Hazardous Waste Storage No. 1	- Soil Sampling, Install and Sample Monitoring Wells.
Hazardous Waste Storage No. 3	- Soil Sampling, Install and Sample Monitoring Wells.
Hazardous Waste Storage No. 4	- Soil Sampling, Install and Sample Monitoring Wells.

Underground Cyanide Vault	- Locate, investigate and analyze contents. If leakage has occurred, install and sample monitoring wells.

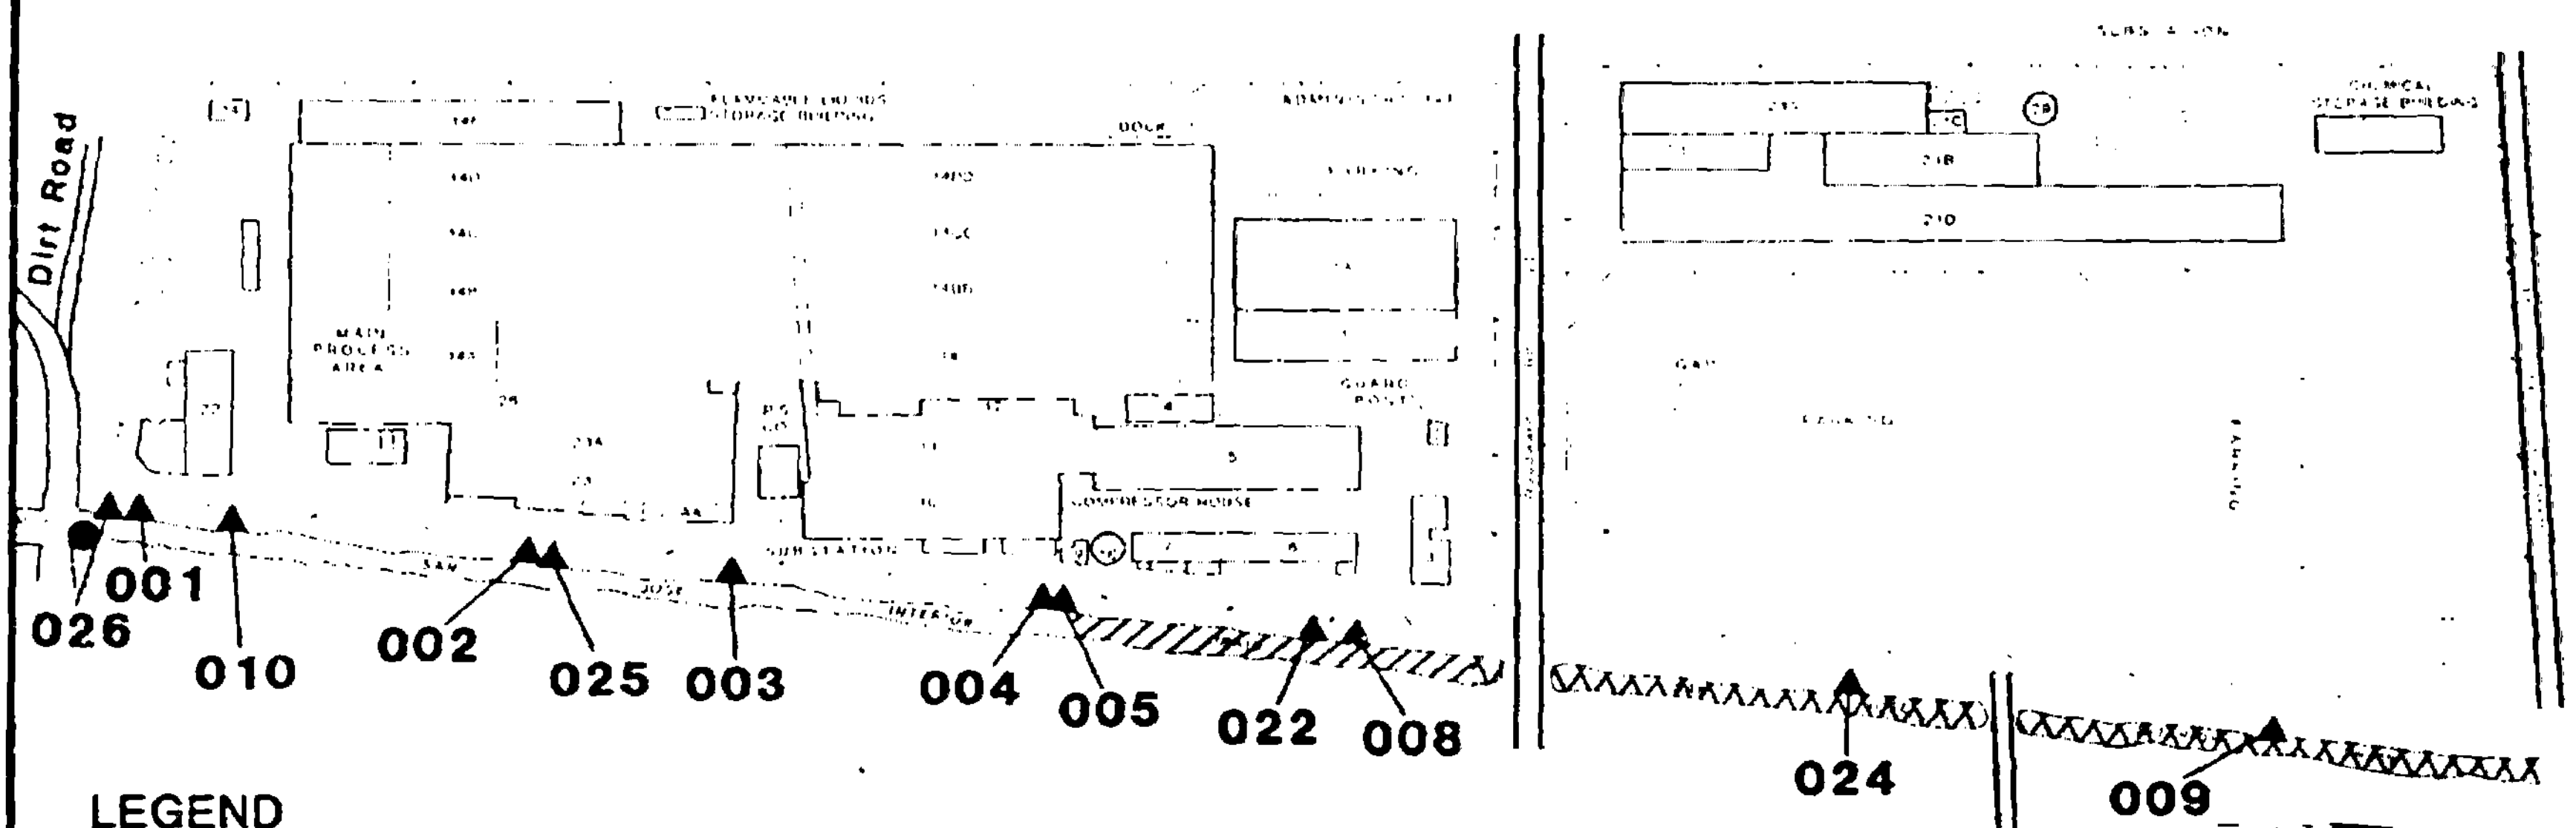
FIGURE 3.6

In the immediate vicinity of the plant the New Mexico Environmental Improvement Division (NMEID) obtained two grab water samples from the San Jose Drain downstream from the plant (McQuillian, et al., 1982). The location is shown on Figure 3.6. Trace amounts of three organic contaminants were found. These contaminants were trichloromethane, 1,2-dichloroethane and 1,1,1-trichloroethane (Table 3.3). The highest concentration of 1,2-dichloroethane was 0.002 mg/l which is well below

Water quality sampling of the twelve water discharge outfall points into the San Jose Drain are conducted by the plant (Figure 3.6). These twelve discharge points are sampled according to the National Pollutant Discharge Elimination System (NPDES). The results of recent sampling are shown in Table 3.3. The allowable discharge limits for oil and grease has been exceeded on six occasions while the allowable discharge for chemical oxygen demand has been exceeded on five occasions. The stations at which these excesses were detected were station numbers 001, 002, 003, 008 and 010. The station at which the most excess occurred was station number 003 on August 1, 1983.

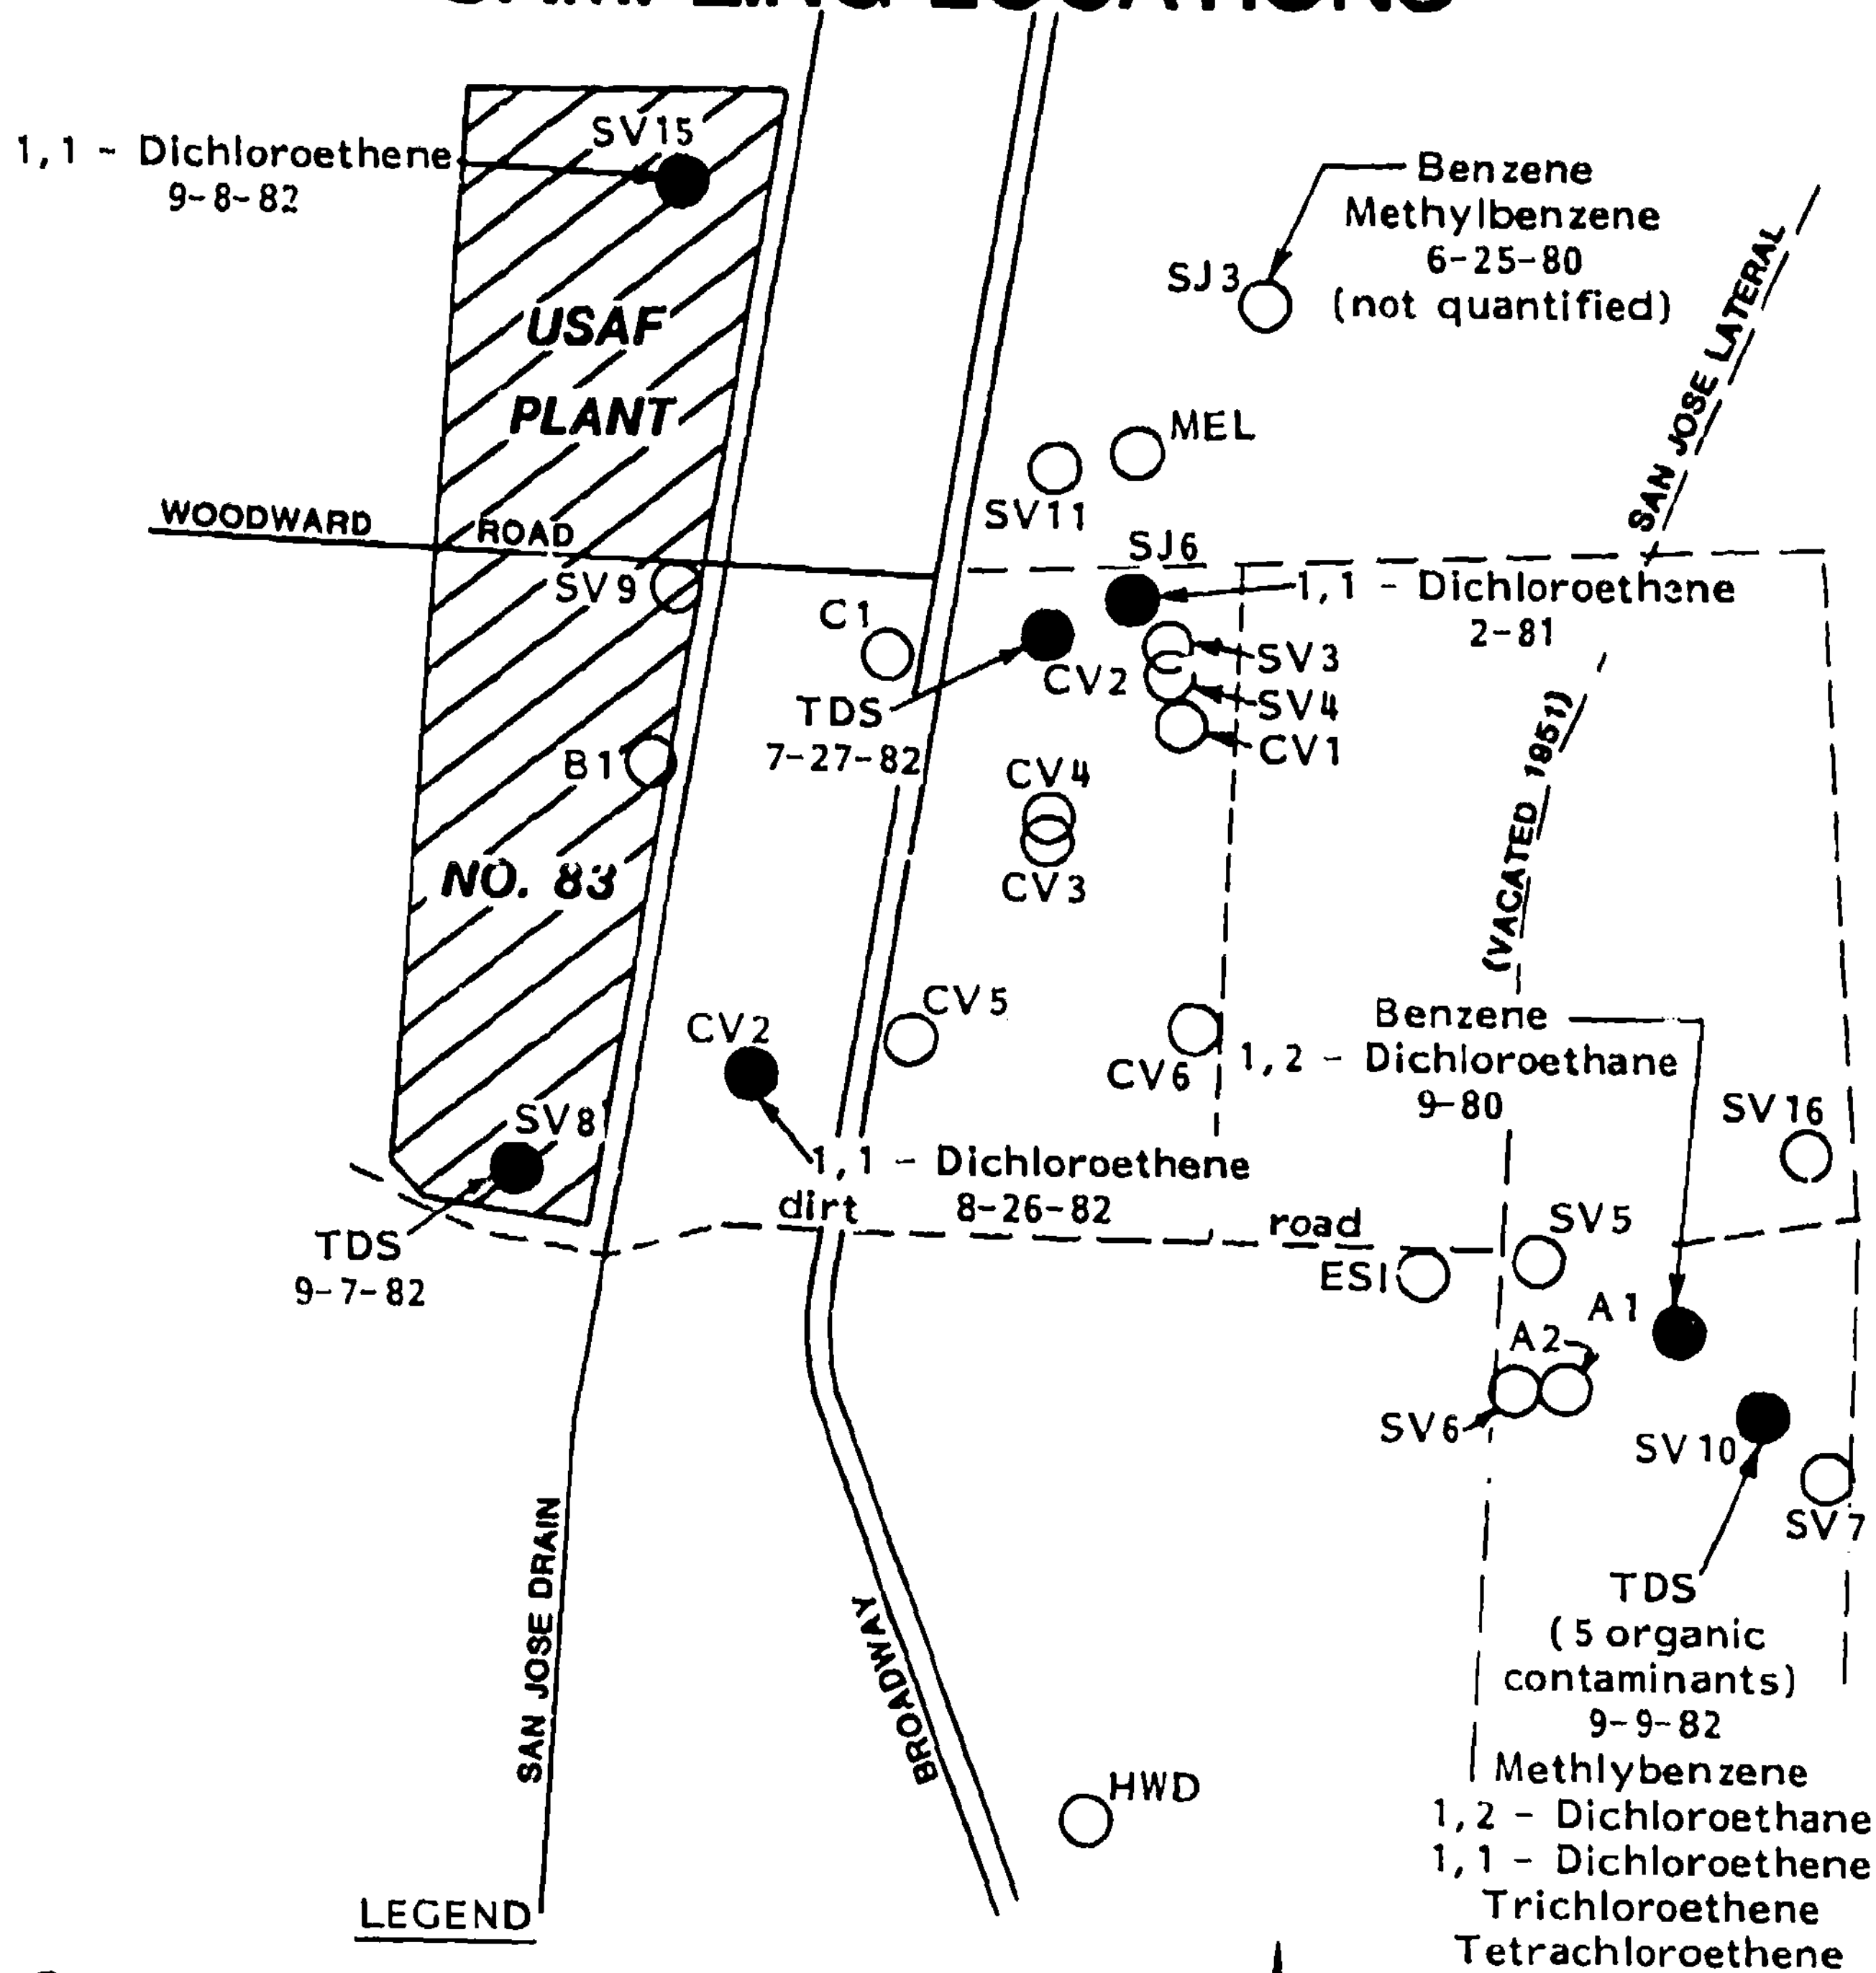
FIGURE 3.18

Plant No. 83 is located in the South Valley where wells SJ3 and SJ6 continue to be shut down due to organic contamination. Other wells which have been shut down due to past contamination problems are A1, C1 and ESI. Figure 3.18 illustrates the ground-water contamination problem in the vicinity of the plant. Seven wells in the area have ground water in which organic contaminants have exceeded the NMWQCC Human Health

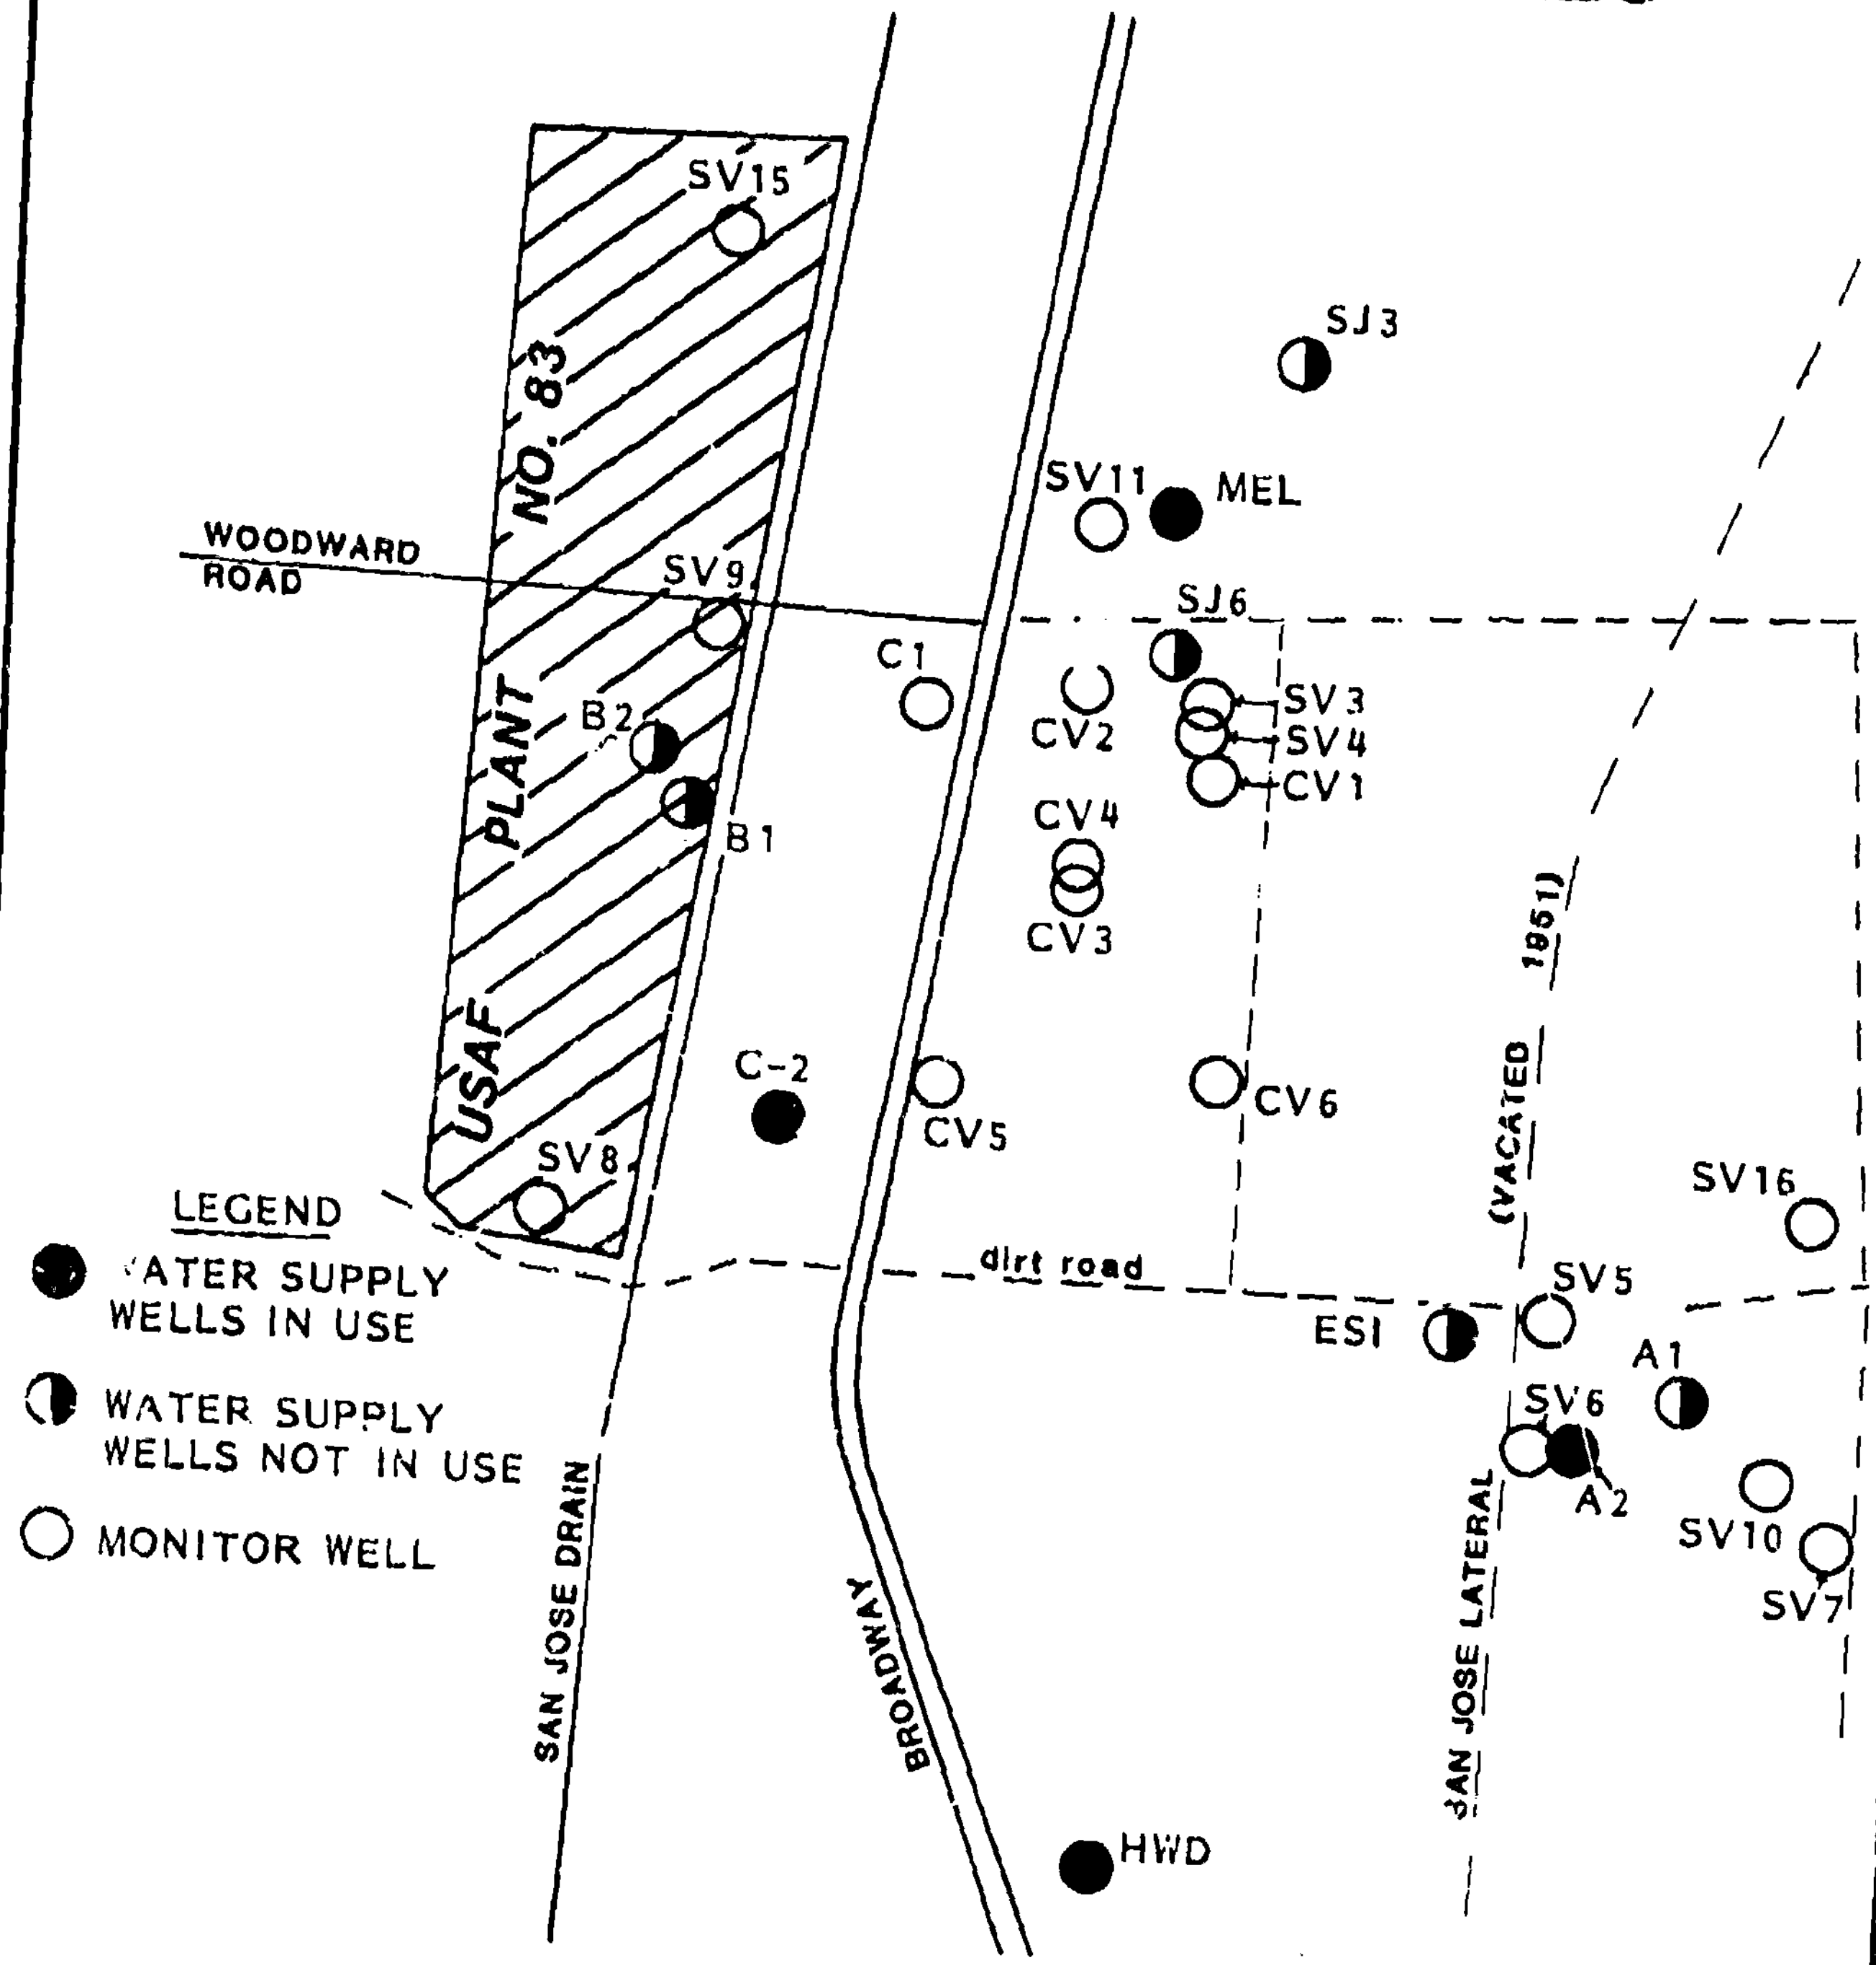
USAF PLANT NO. 83
GENERAL ELECTRIC ALBUQUERQUE PLANT
LOCATION OF WATER WELLS

WELLS SJ3, SJ6, ESI AND A1 ARE TEMPORARILY NOT IN USE DUE TO CONTAMINATION.

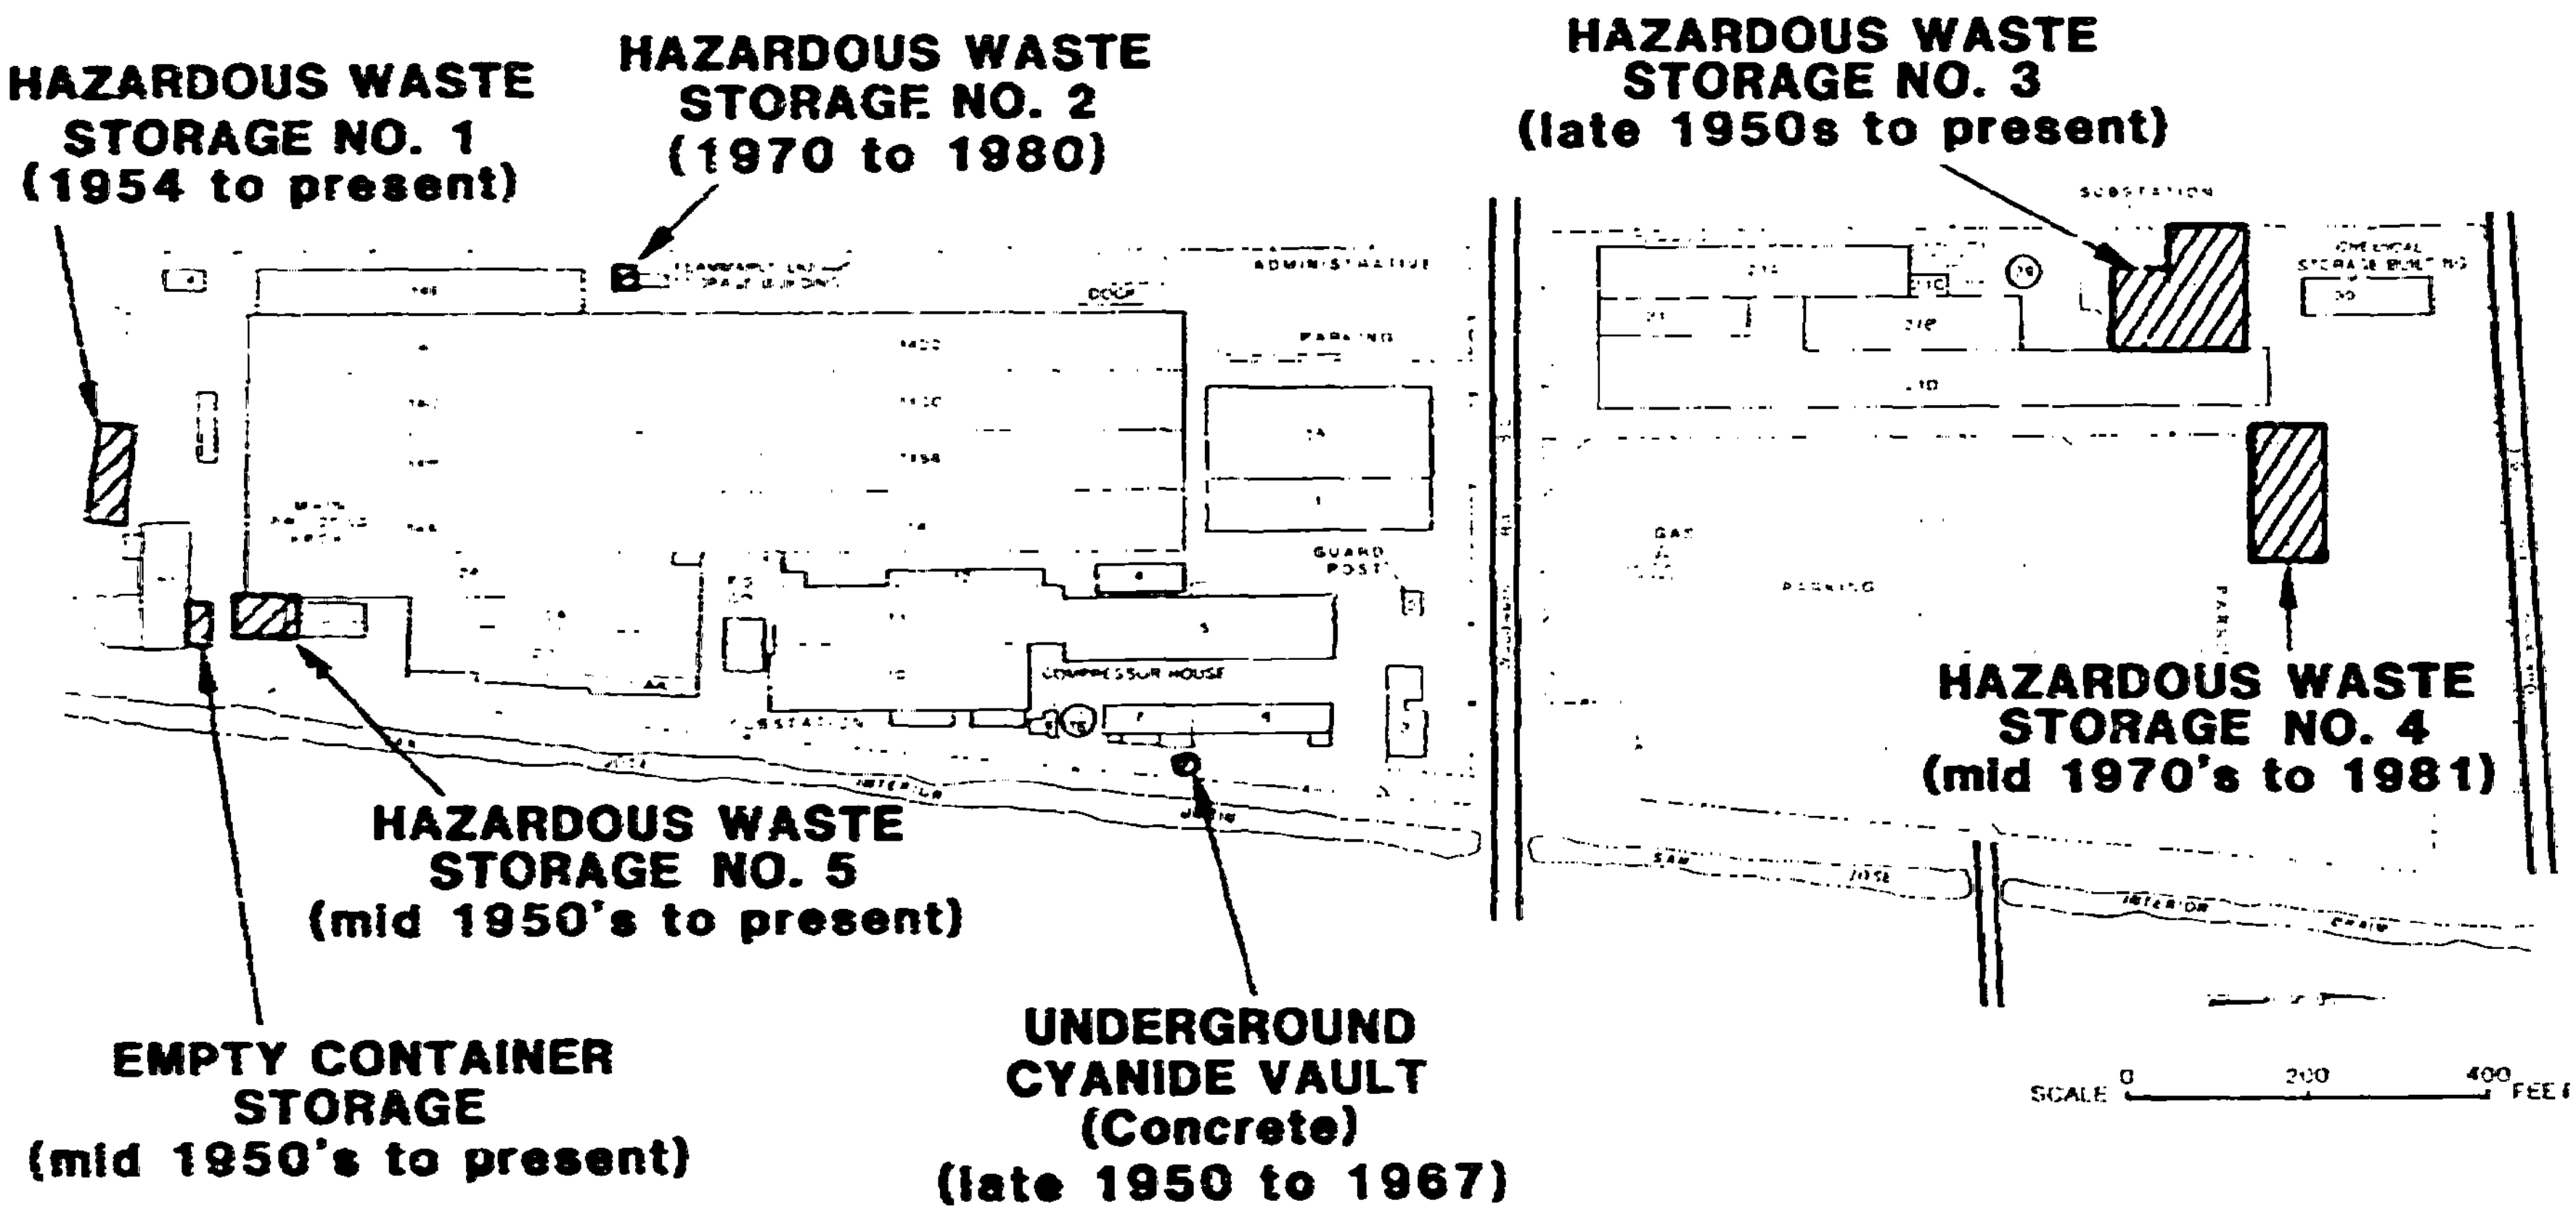
USAF PLANT NO. 83
GENERAL ELECTRIC ALBUQUERQUE PLANT
HAZARDOUS WASTE STORAGE AREAS

The area designated Hazardous Waste Storage No. 1 has been used as a chemical waste storage area since approximately 1954. The site was used primarily as a storage point for waste oils, coolants and some solvents used in the process areas. The area houses several tanks situated on a concrete slab. These include two 1300-gallon fiberglass open topped tanks (referred to as "swimming pool tanks"), and a

3400-gallon rectangular steel box (referred to as the "green tank"). Waste oils and coolants have been the principal products stored in the area. The coolant, known as Trimsol, is a water based lubricant used in cutting and grinding machines. A recent analysis of the waste Trimsol detected 37 mg/l of carbon tetrachloride and 2 mg/l of 1,1-dichloroethylene (refer to listing of data in Appendix C-3). Other contaminants previously reported to have been detected in the waste Trimsol include methylene chloride and 1,1,1 trichloroethane.
