INSTALLATION RESTORATION PROGRAM

PRELIMINARY ASSESSMENT
182nd TACTICAL AIR SUPPORT GROUP
ILLINOIS AIR NATIONAL GUARD
PEORIA, ILLINOIS

4. TITLE AND SUBTITLE Preliminary Assessment
182nd Tactical Air Support Group
Illinois Air National Guard
Peoria, Illinois

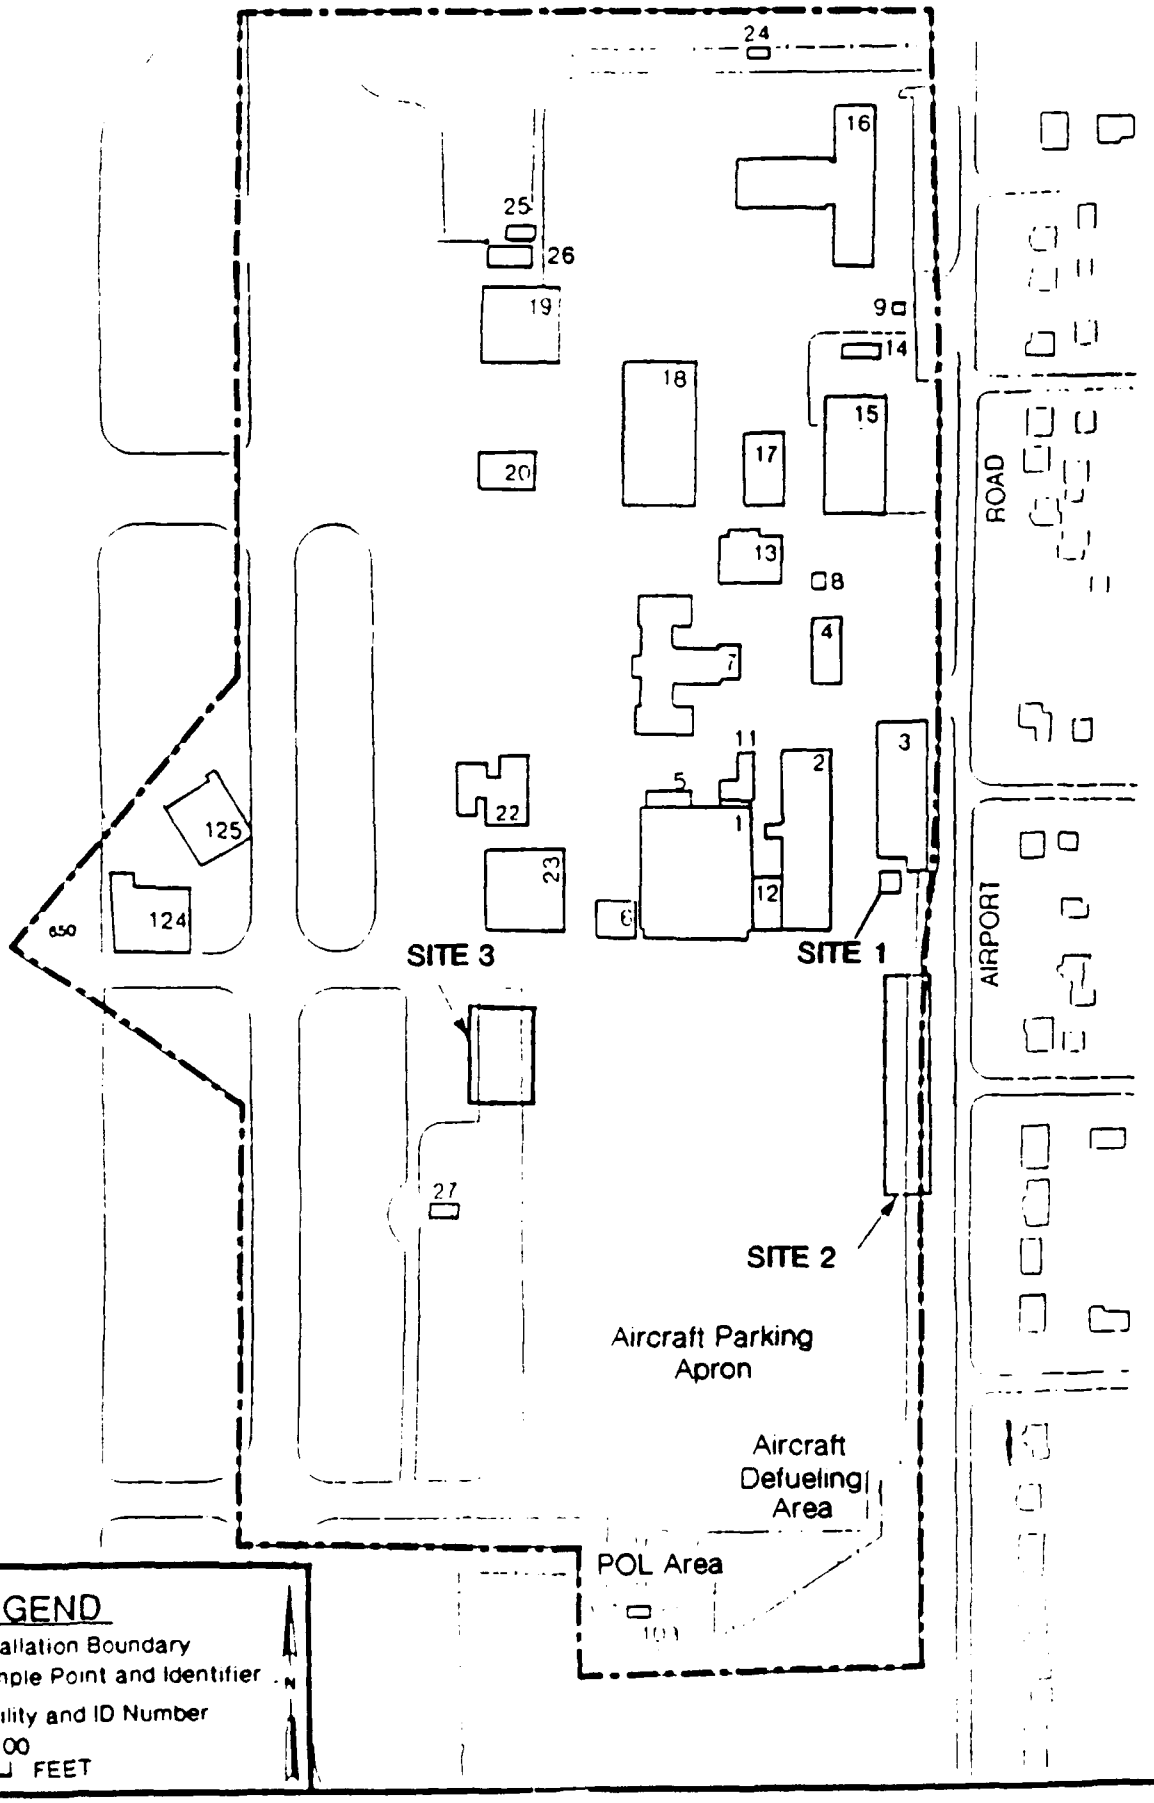
SITES OF POTENTIAL CONTAMINATION

The PA identified three sites of potential contamination (Figure 4.1). These sites were evaluated using the Decision Tree Methodology shown in Figure 1.1 and have been scored using the Hazard Assessment Rating Methodology (HARM). The HARM ranking procedure is discussed in Appendix D and the detailed rating form for each site is presented in Appendix E. The HARM system is designed to indicate the relative need for follow-on action.

In accordance with applicable regulations, further IRP investigations are recommended for Sites 1, 2 and 3.

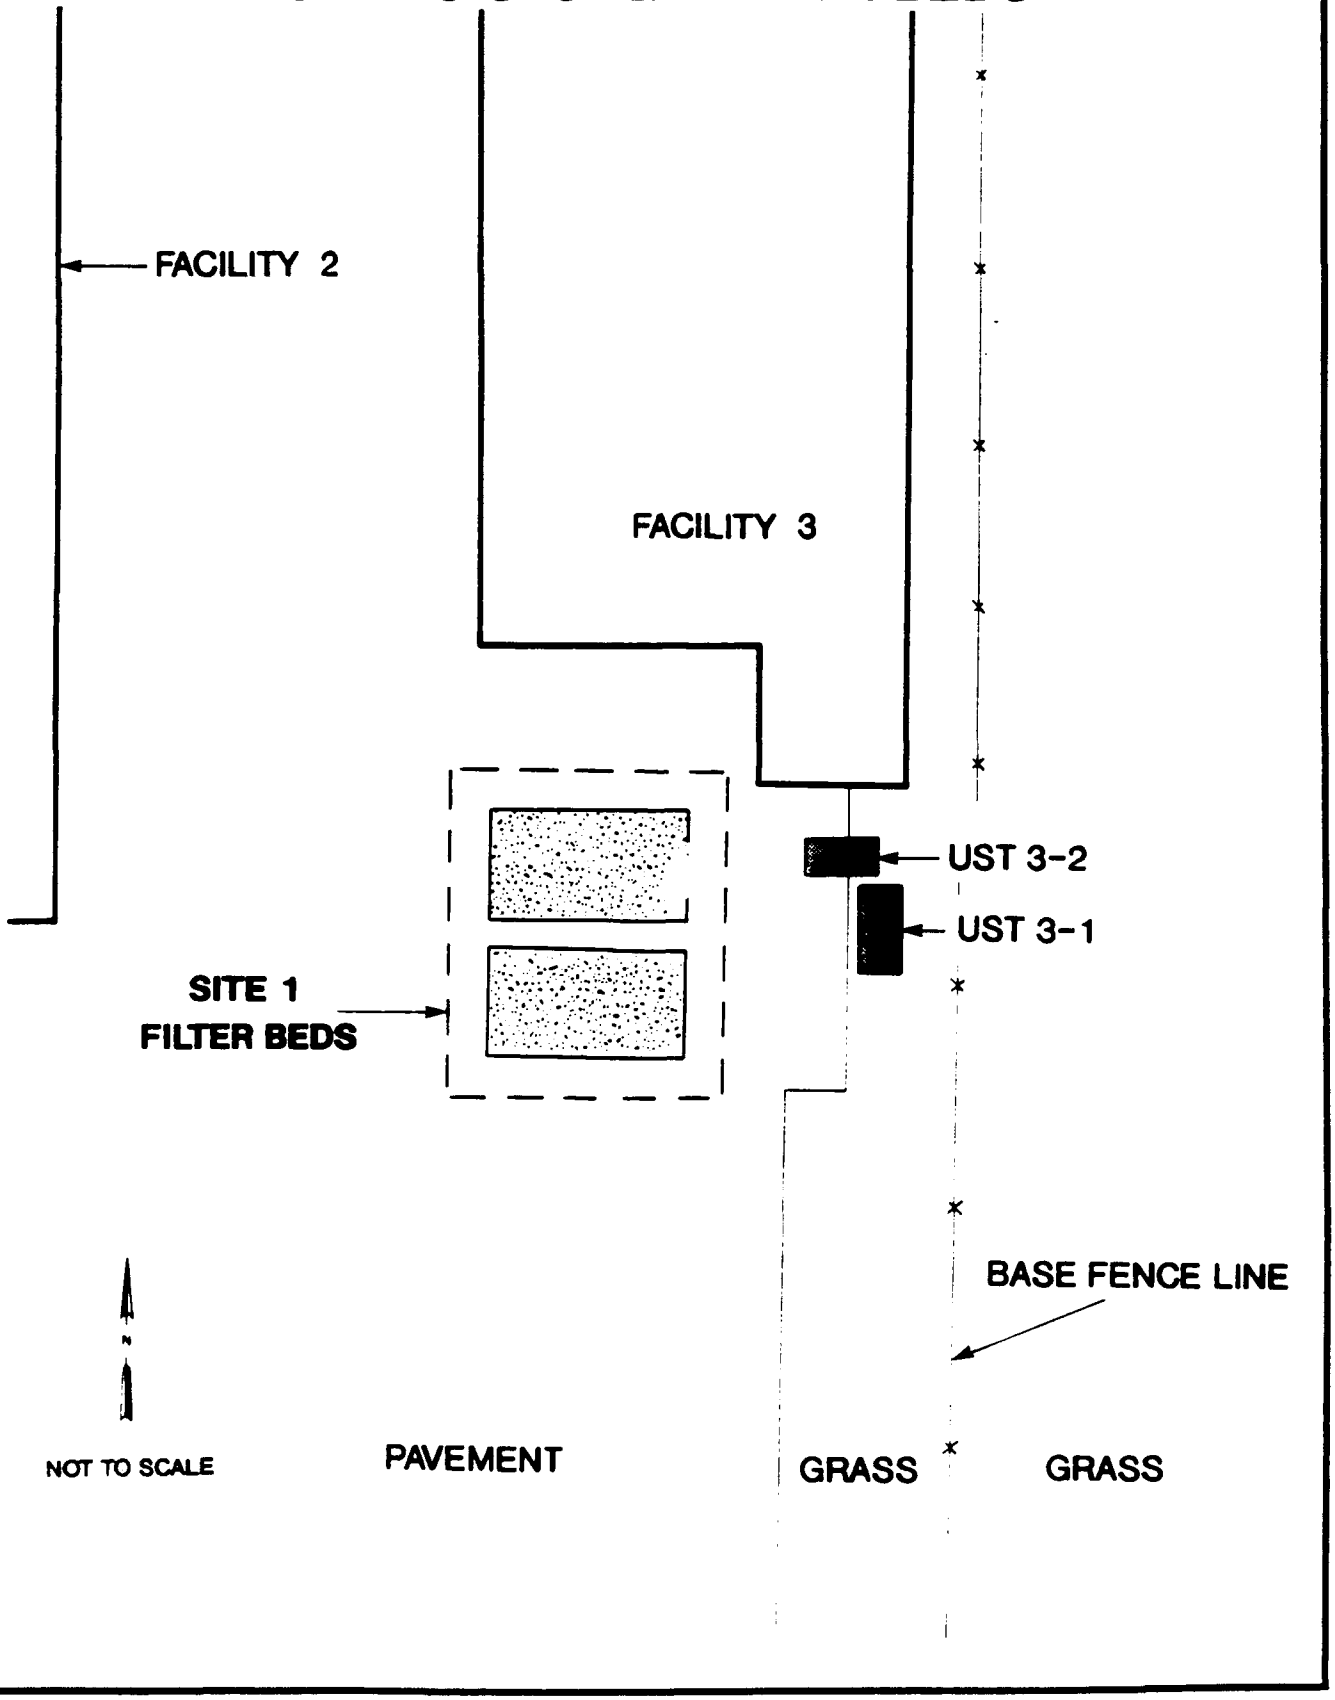
APPROXIMATE LOCATION OF SITE 1 SEPTIC SYSTEM FILTER BEDS

Site 1 has been HARM-scored because of the possibility that hazardous wastes were disposed into the septic system filter beds. Such activities may have

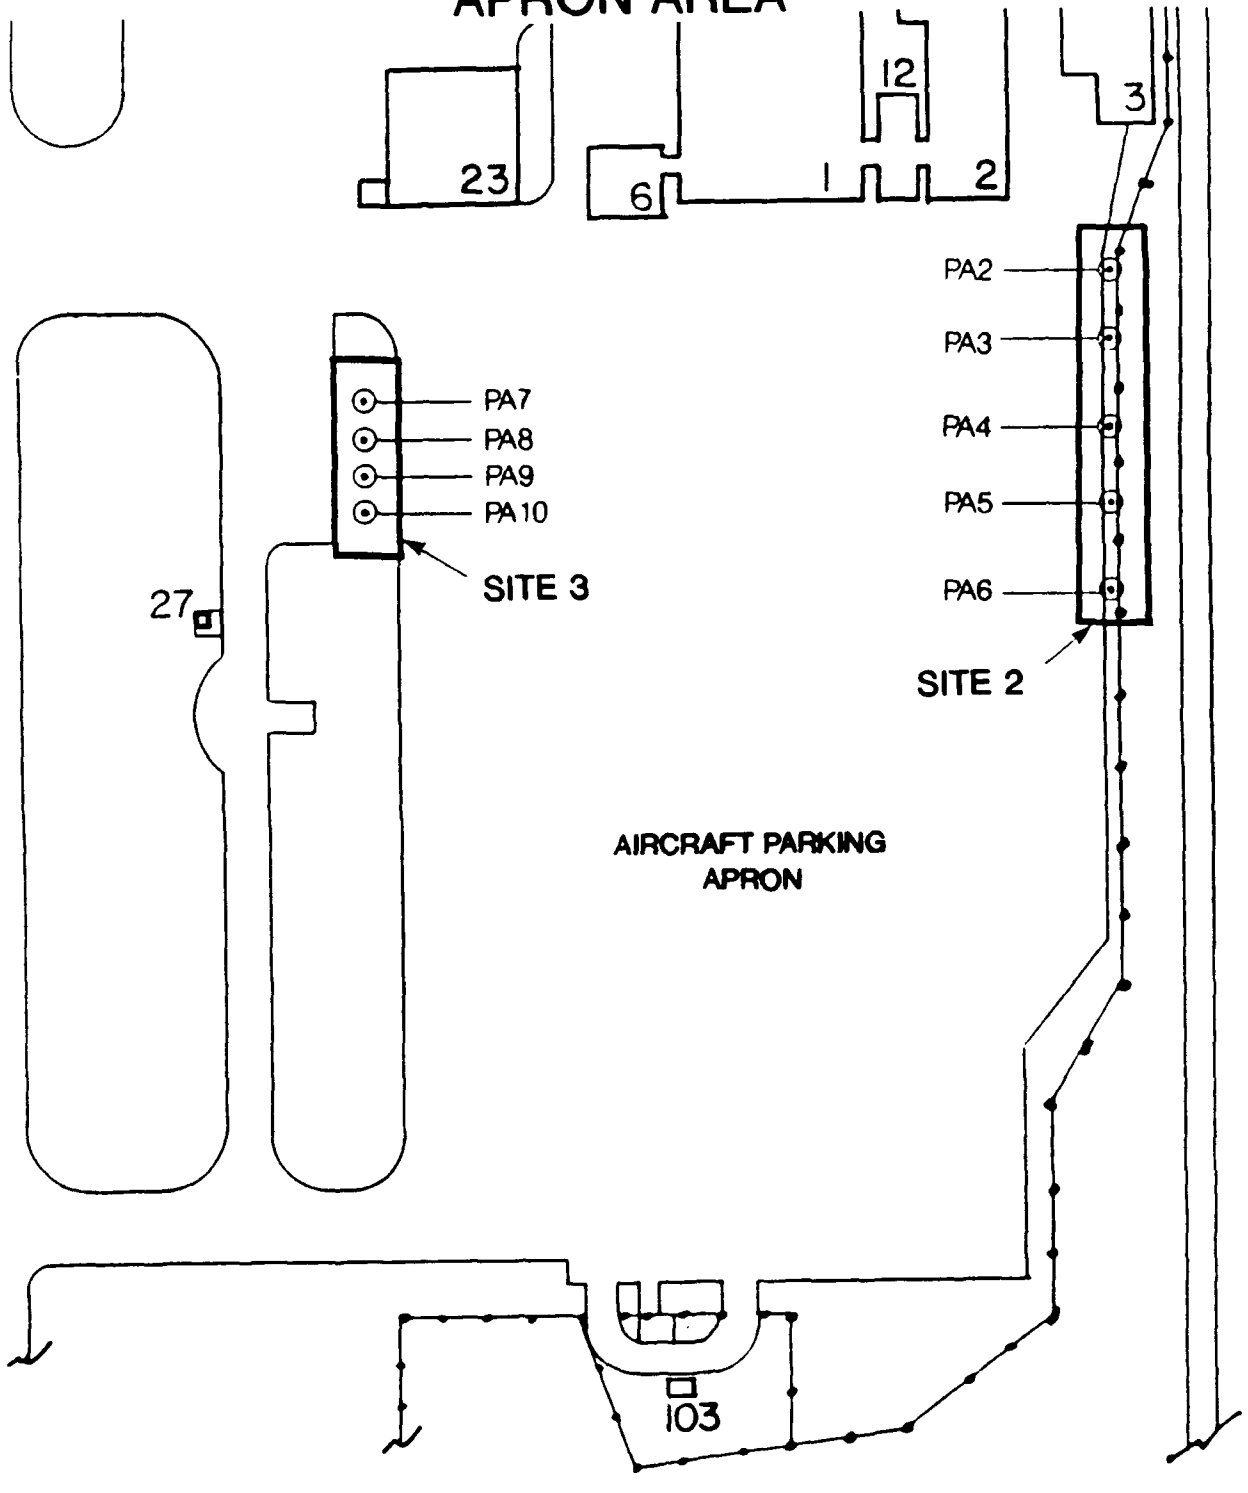
APPROXIMATE LOCATION OF SITE 2 AND SITE 3 APRON AREA

points with concentrations in both samples of 68 micrograms per kilogram (µg/kg). The analytical results for soil samples (ILANG-PA2 through PA6) are presented in Appendix F. In summary, no surficial site-related contamination was observed at Site 2.
