**US Army Corps
of Engineers**
Construction Engineering
Research Laboratory

Causes and Control of Corrosion in Buried-Conduit Heat Distribution Systems

TR M-91/08

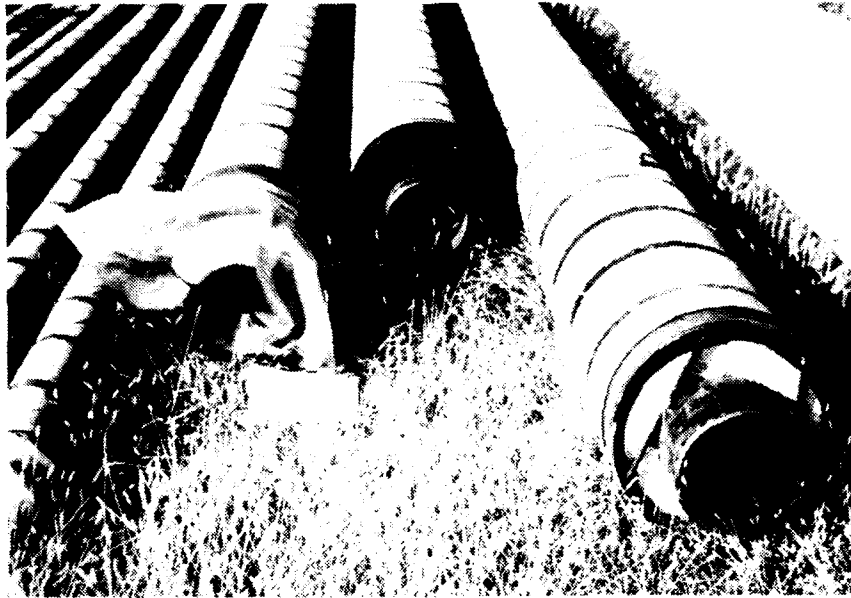
Although moisture/water should not normally exist in the annuli between the carrier pipes and the conduits, wet insulation is a relatively common occurrence in Army heat distribution systems. A number of sources can contribute to wet insulation, including: (1) rain/condensation absorbed by the insulation during unprotected storage before installation (Figures 1 and 2), (2) leaks in conduit joints that allow groundwater to collect inside the annuli, (3) leaks in the carrier pipes that allow the conveyed product to collect in the annuli, and (4) leaks in the conduits (caused by the aggressive soils) that allow groundwater to collect in the annuli. Although soil-side coatings over a weld defect/leak can initially support a 15 psi pressure test,* subsequent coating deterioration at the site can allow groundwater to ingress into the annuli containing the insulation.

Moisture/water in the annuli between the carrier pipes and the conduits can cause leaching of aggressive species from certain insulations.[6] Further, moisture in the insulation can significantly reduce the effectiveness of the insulation; moisture at the insulation-carrier pipe interfaces can be converted to steam that will, in turn, destroy the desired intimate contact between the two.

Figure 1. Conduit without protective covers.

Corrosion of the outside surfaces of carrier pipes and the inside surfaces of the conduits that are associated with the insulation can be minimized by a number of techniques, including: (1) regular inspection and maintenance to ensure that the insulation is dry, (2) consultations between the system designers, insulation contractors, and system operators during the design stage to ensure that a suitable specification is developed for the total system, and (3) cooperation between all contractors during installation to ensure that the system design requirements are satisfied. Most important, specifications that limit deleterious amounts of leachable aggressive species in insulation should be developed. West Germany has developed a standard thermal insulation used in conjunction with copper-tube carriers. German Draft Standard DIN 1988, *Part 8 - Technical Rules for Drinking Water Installations; Avoidance of Corrosion Damage and Incrustation* states: "Heat insulation materials for copper pipes must be free of nitrite and must not contain more than 0.2% by weight ammonia."[9] Similar limits could be established for chlorides and sulfates. Limiting chlorides would not reduce the availability of insulation because manufactured insulation free of chlorides (e.g., cellular glasses) is currently available.

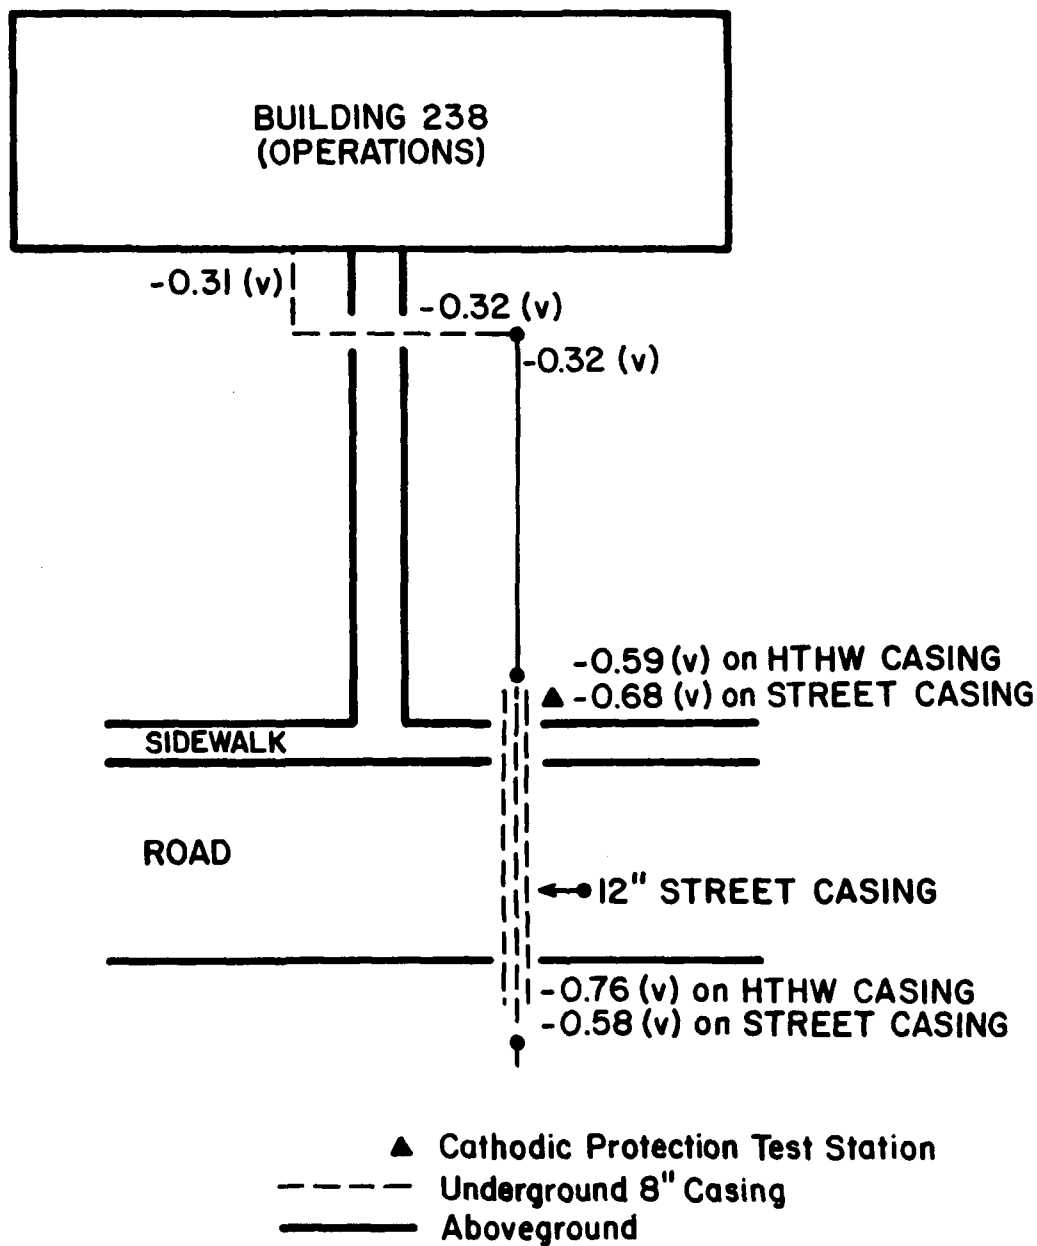
-0.76 (v) on HTHW CASING
-0.58 (v) on STREET CASING

Figure 4. Schematic diagram of conduit for Building 238, Pease AFB, NH.

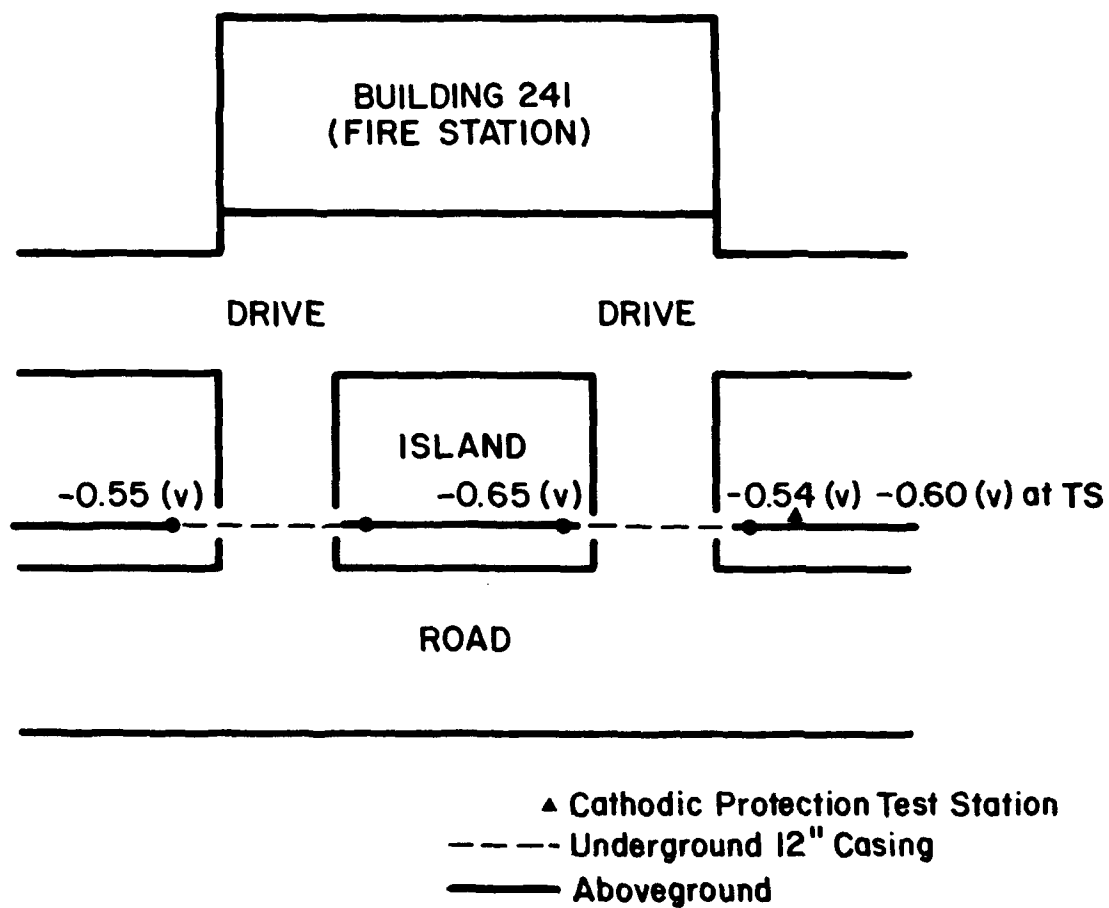
Figure 5. Schematic diagram of conduit for Building 241, Pease AFB, NH.

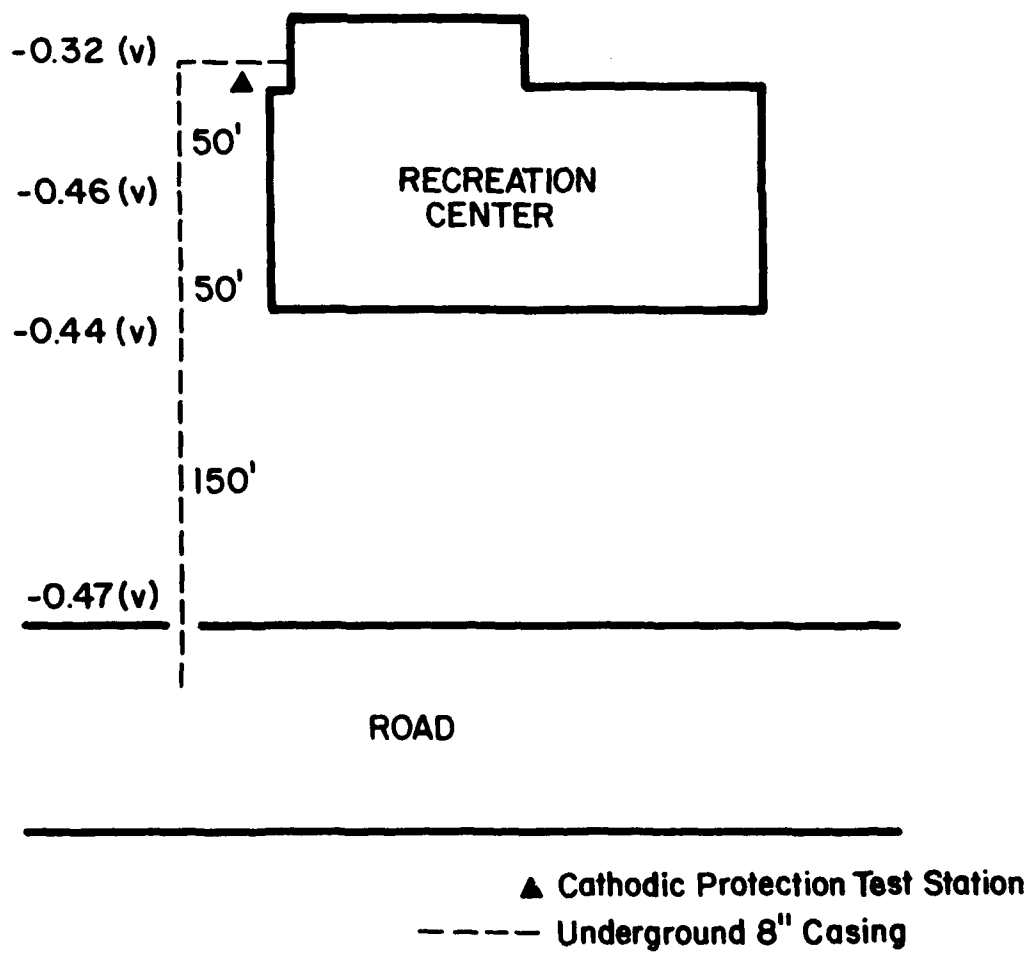
Figure 6. Schematic diagram of conduit for the Recreation Center, Pease AFB, NH.

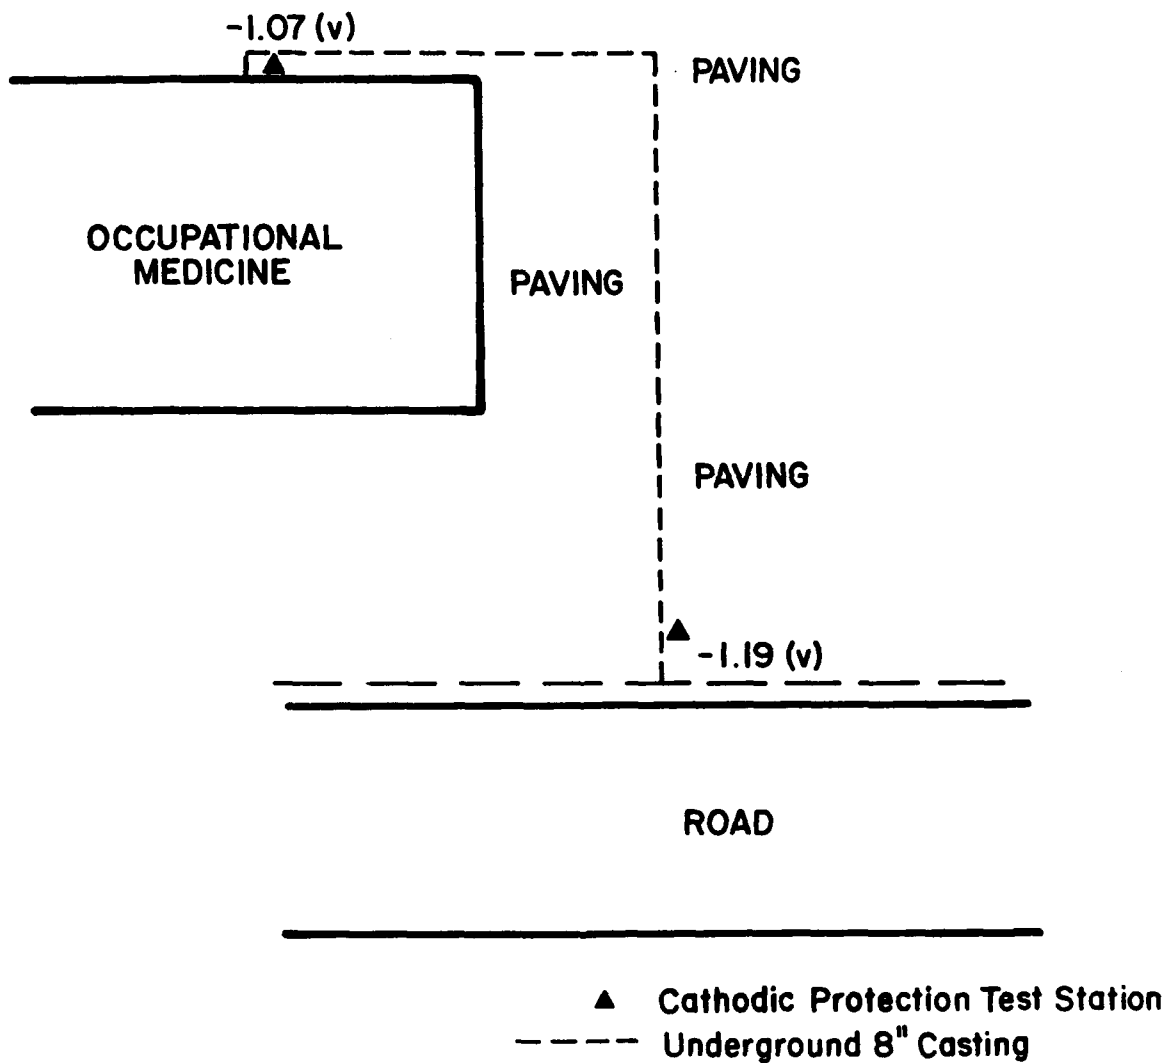
Figure 9. Schematic diagram of conduit for the Occupational Medicine Building at Hill AFB, UT.

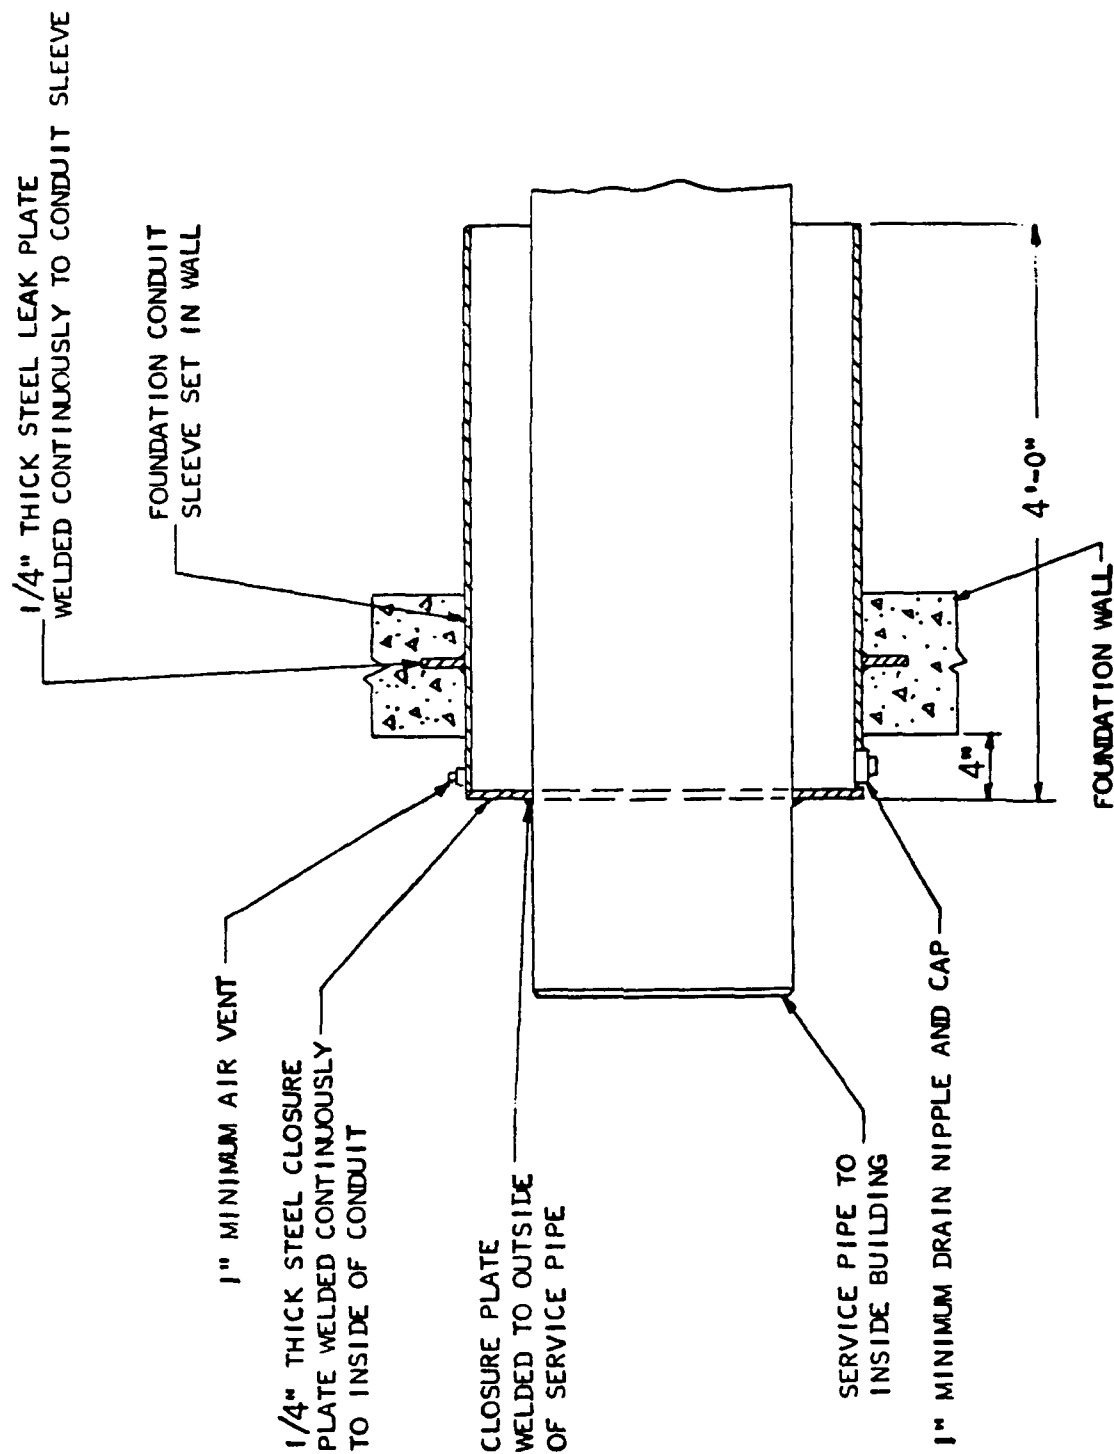
Electrical isolation of the heat distribution system conduits can be a major concern because they are in metallic contact with the carrier pipes at conduit terminations (Figure 10).[13] Further, supports for the carrier pipes typically make electrical contact with the conduits. This creates the need to electrically isolate the carrier pipes (e.g., by placing an isolating flange in each line) immediately after they enter the buildings and before they can contact any other metallic structure within the buildings. Examination of Figure 10 also suggests that the steel leak plates that are electrically continuous with the conduits could very well contact steel reinforcements in concrete foundations/walls, creating a short that could be of monumental magnitude. Although it is theoretically possible to avoid shorts between the conduits and the steel reinforcements in the concrete by placing insulation between the steel wall sleeves and the conduits (Figure 11),[14] attempts to achieve electrical isolation by this method are not always successful (e.g., when the insulation is not properly installed or when the conduit is "cocked" in the steel wall sleeve). Rigid, nonmetallic sleeves and flexible, nonmetallic (e.g., neoprene) seals should be used where pipes penetrate concrete walls and foundation.[15]

Figure 10. Schematic diagram of conduit penetrating a concrete wall foundation.
Used by permission, Midwesco Enterprises, Inc.

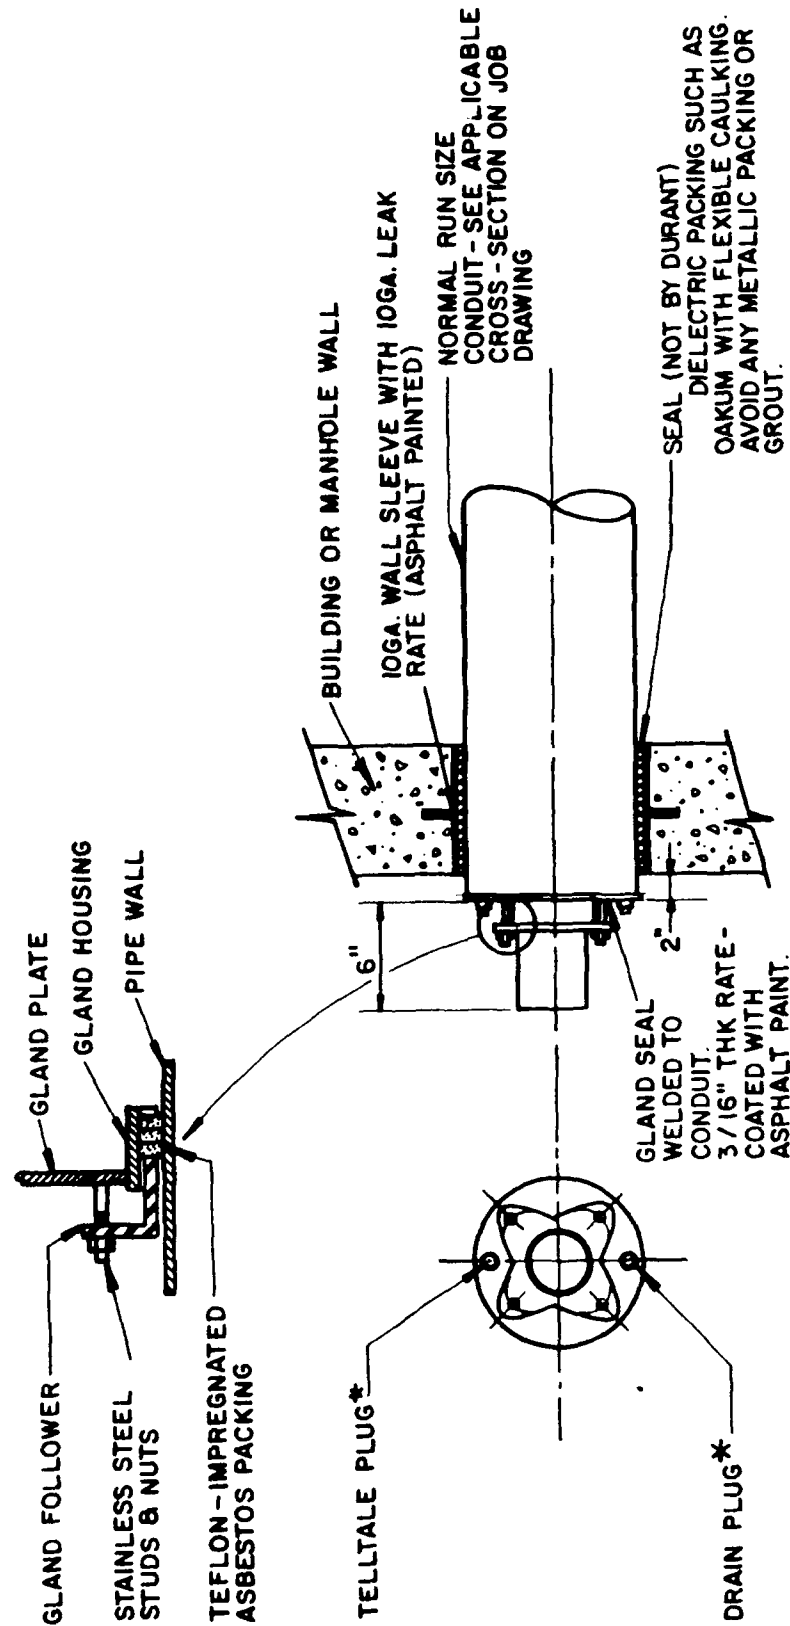
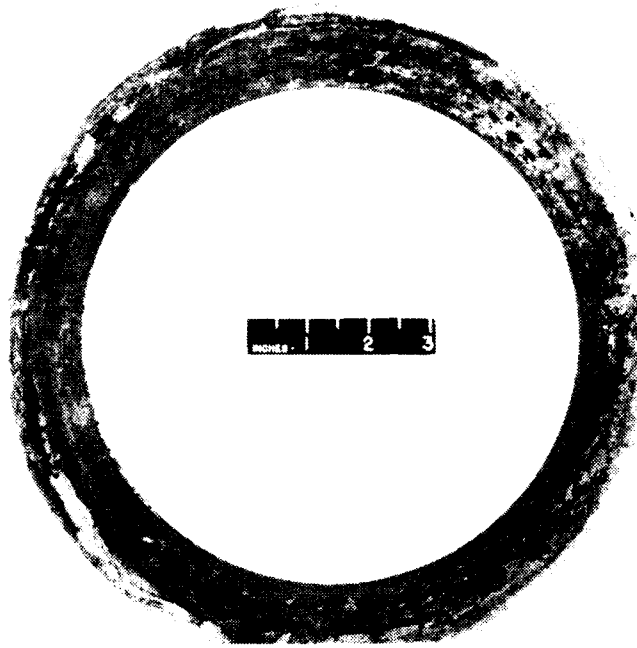
Figure 12. A gasket that failed due to unevenly loaded bolts.

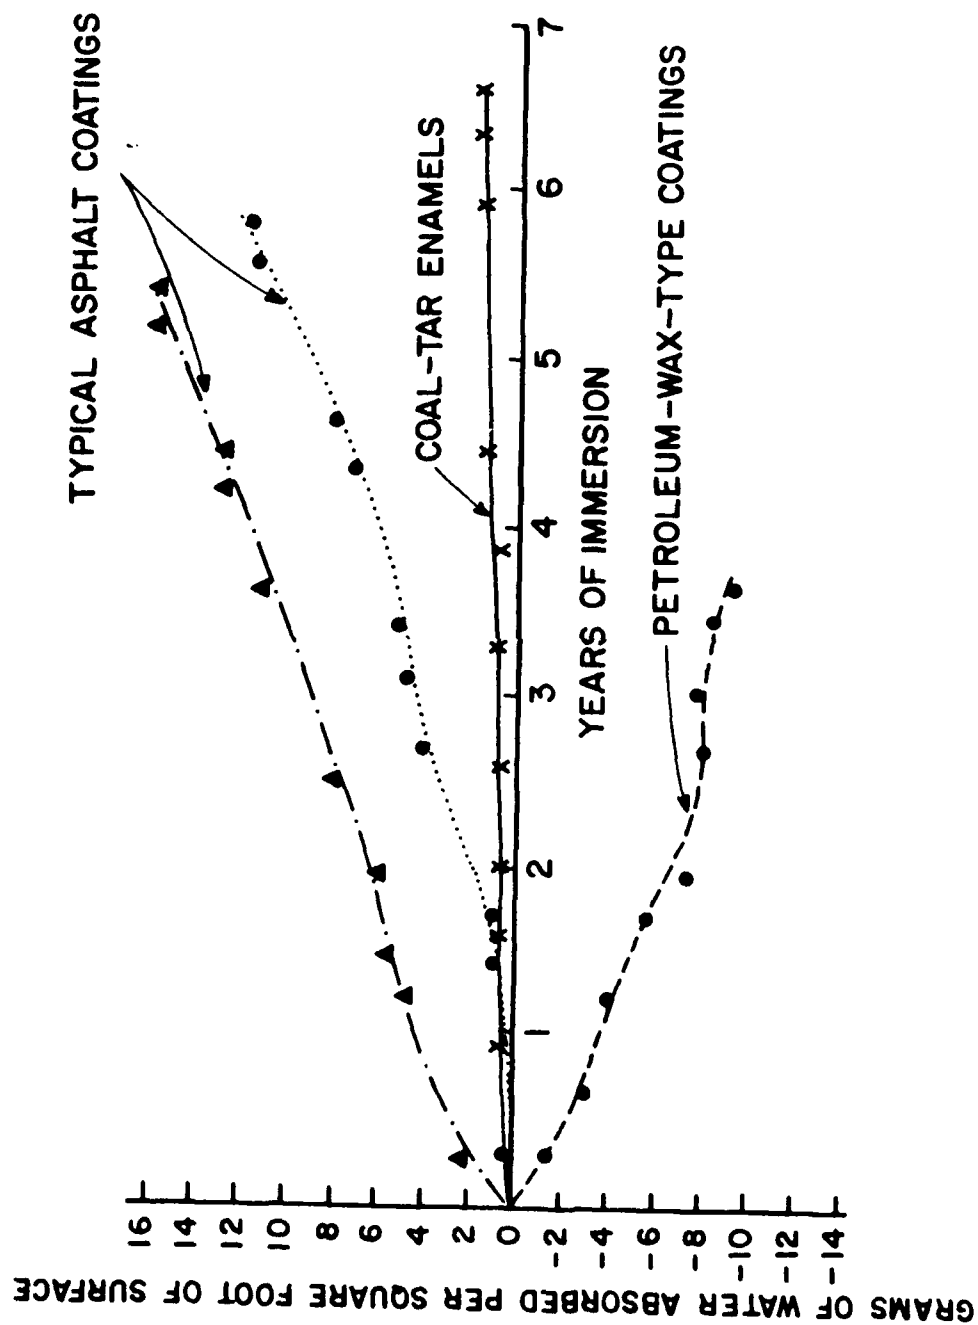
tar matrices. Asphalt based coatings in general can be expected to absorb unacceptable amounts of moisture when exposed to continuously wet environments (Figure 14) and lose a significant amount of their dielectric strength (Figure 15).[23]

Figure 14. Effect of immersion time on the amount of water absorbed by selected coatings for steel in underground environments.

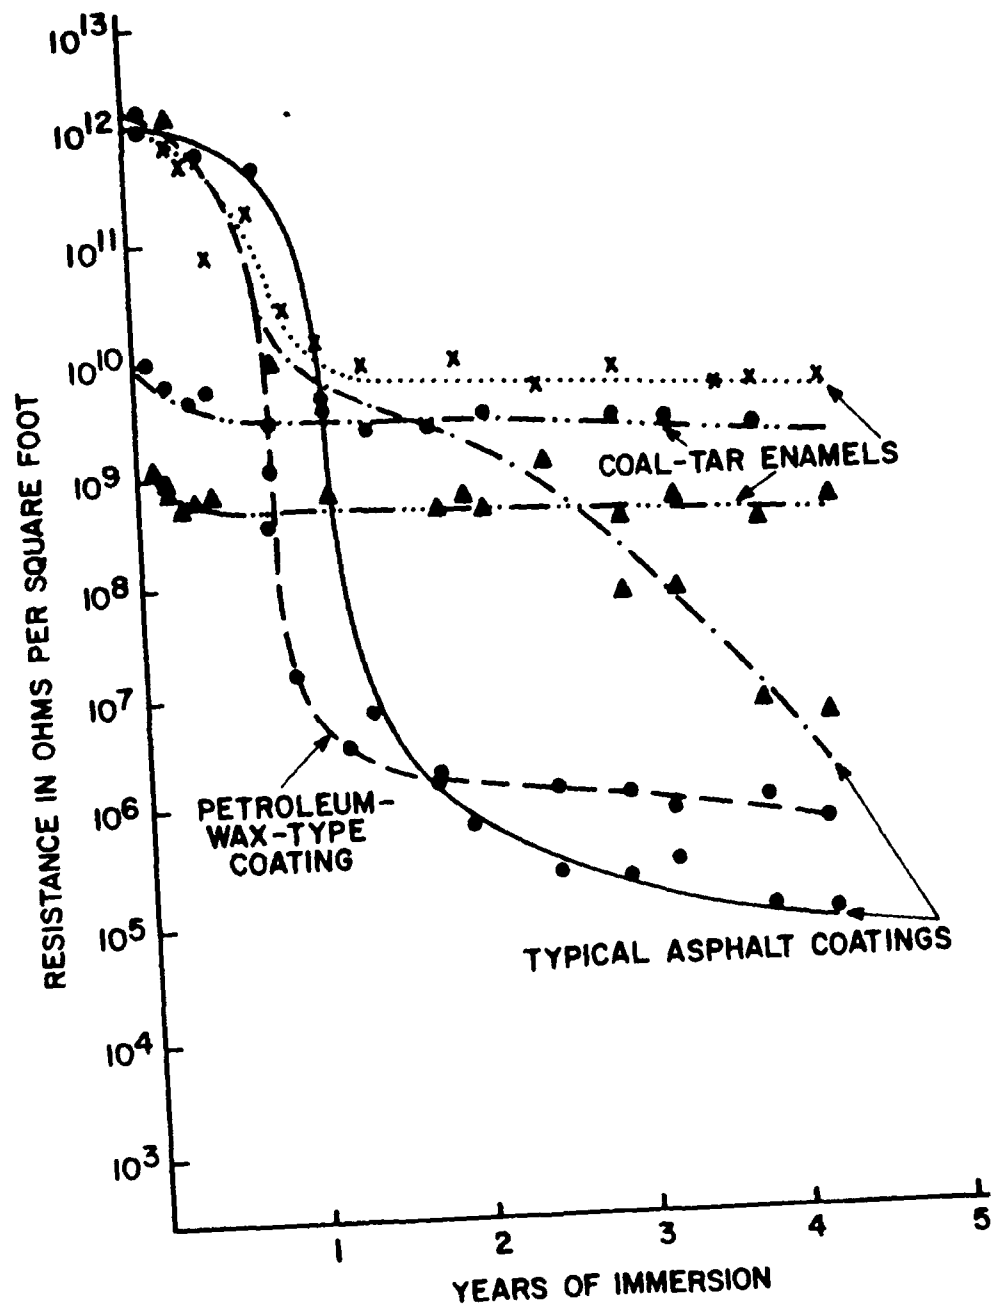
Figure 15. Effect of immersion time on the electrical resistance of selected coatings for steel in underground environments.
