MONITORING OF JETTY REHABILITATION AT MANASQUAN INLET, NEW JERSEY

September 1991

Final Report

7. PERFORMING ORGANIZATION NAME(S) AND ADDRESS(ES) See reverse	8. PERFORMING ORGANIZATION REPORT NUMBER Miscellaneous Paper CERC-91-8

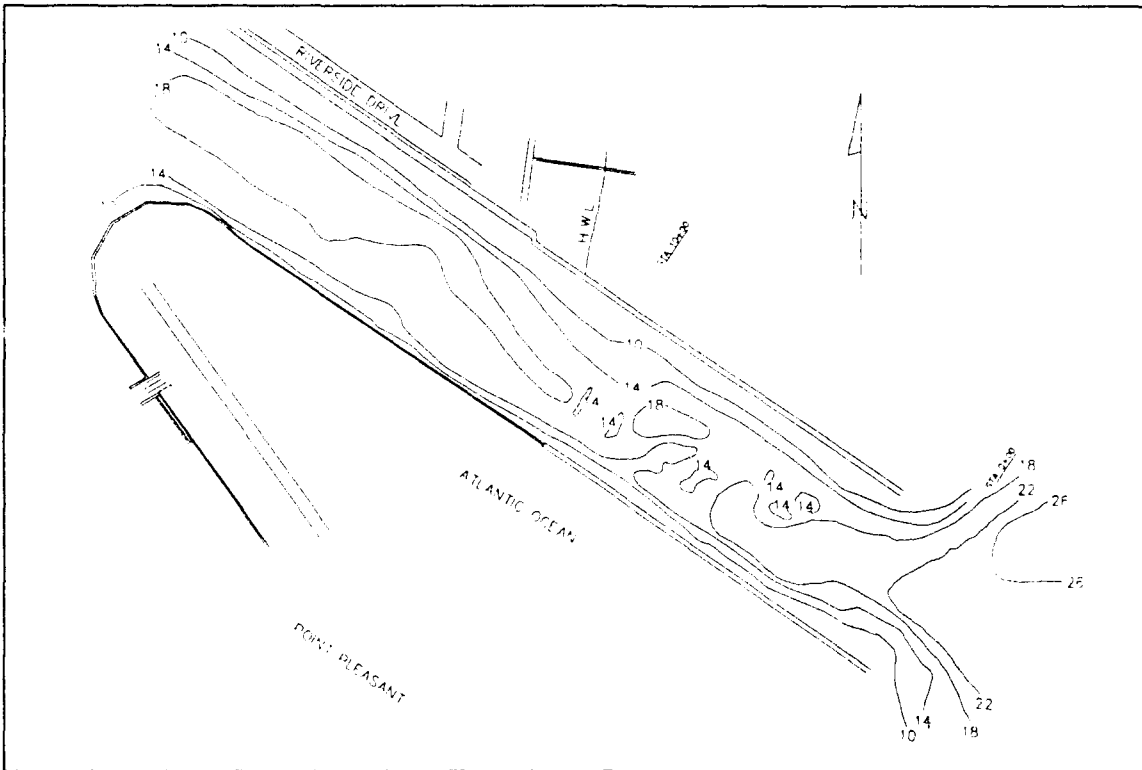
The structure appeared in good shape in the SSS record, even though it had experienced nearly the design storm only 4 months earlier. Several "holes," or areas where dolosse appeared to be missing, could be seen in the record. Rock displaced from the structure slope and, possibly, its core could be seen in the record. There was also some debris, possibly from a fishing boat that had been sunk in the inlet in a storm, noted on the record.

Figure 35   Sample side-scan sonar

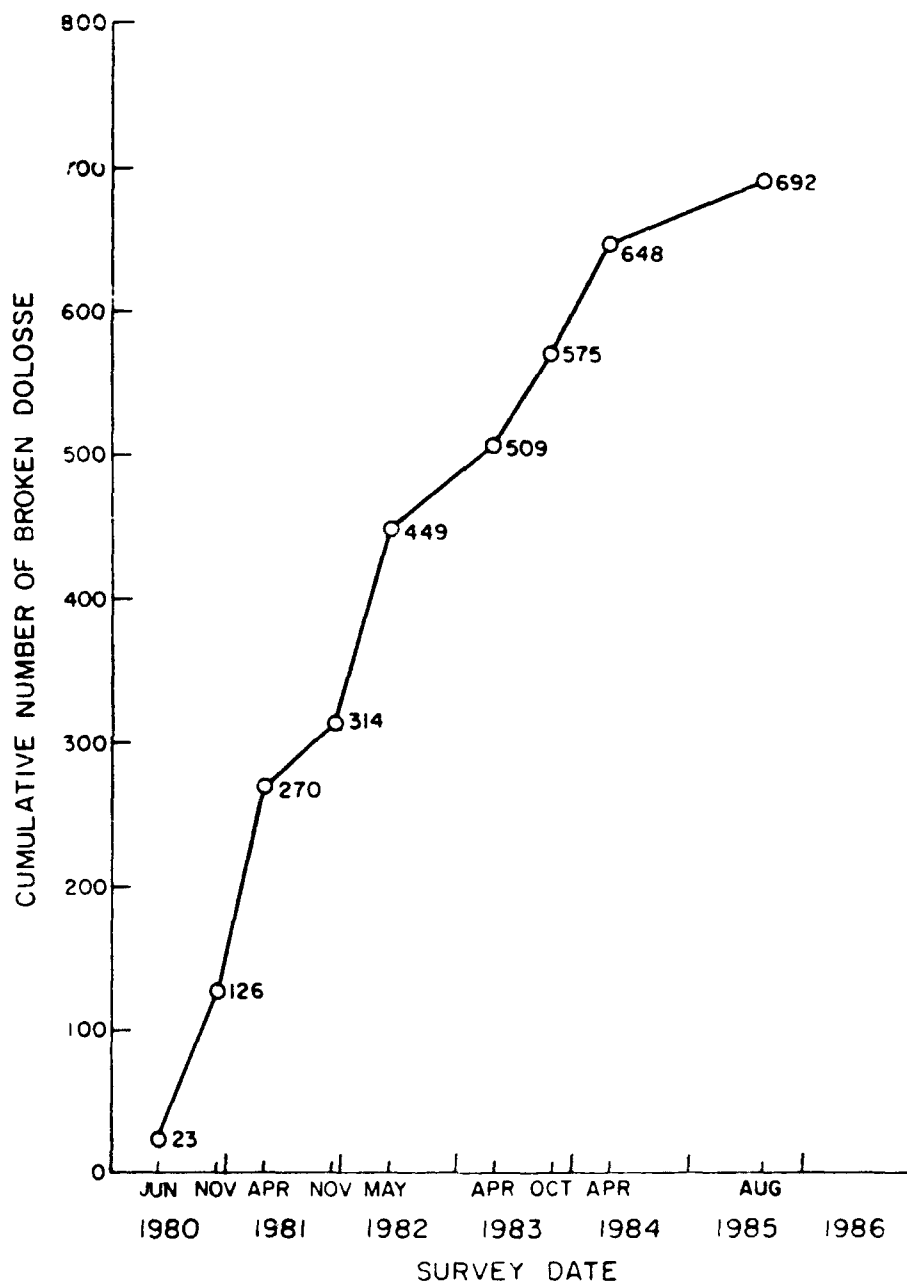
Figure 65. Cumulative number of broken dolosse, Cleveland Harbor East Breakwater

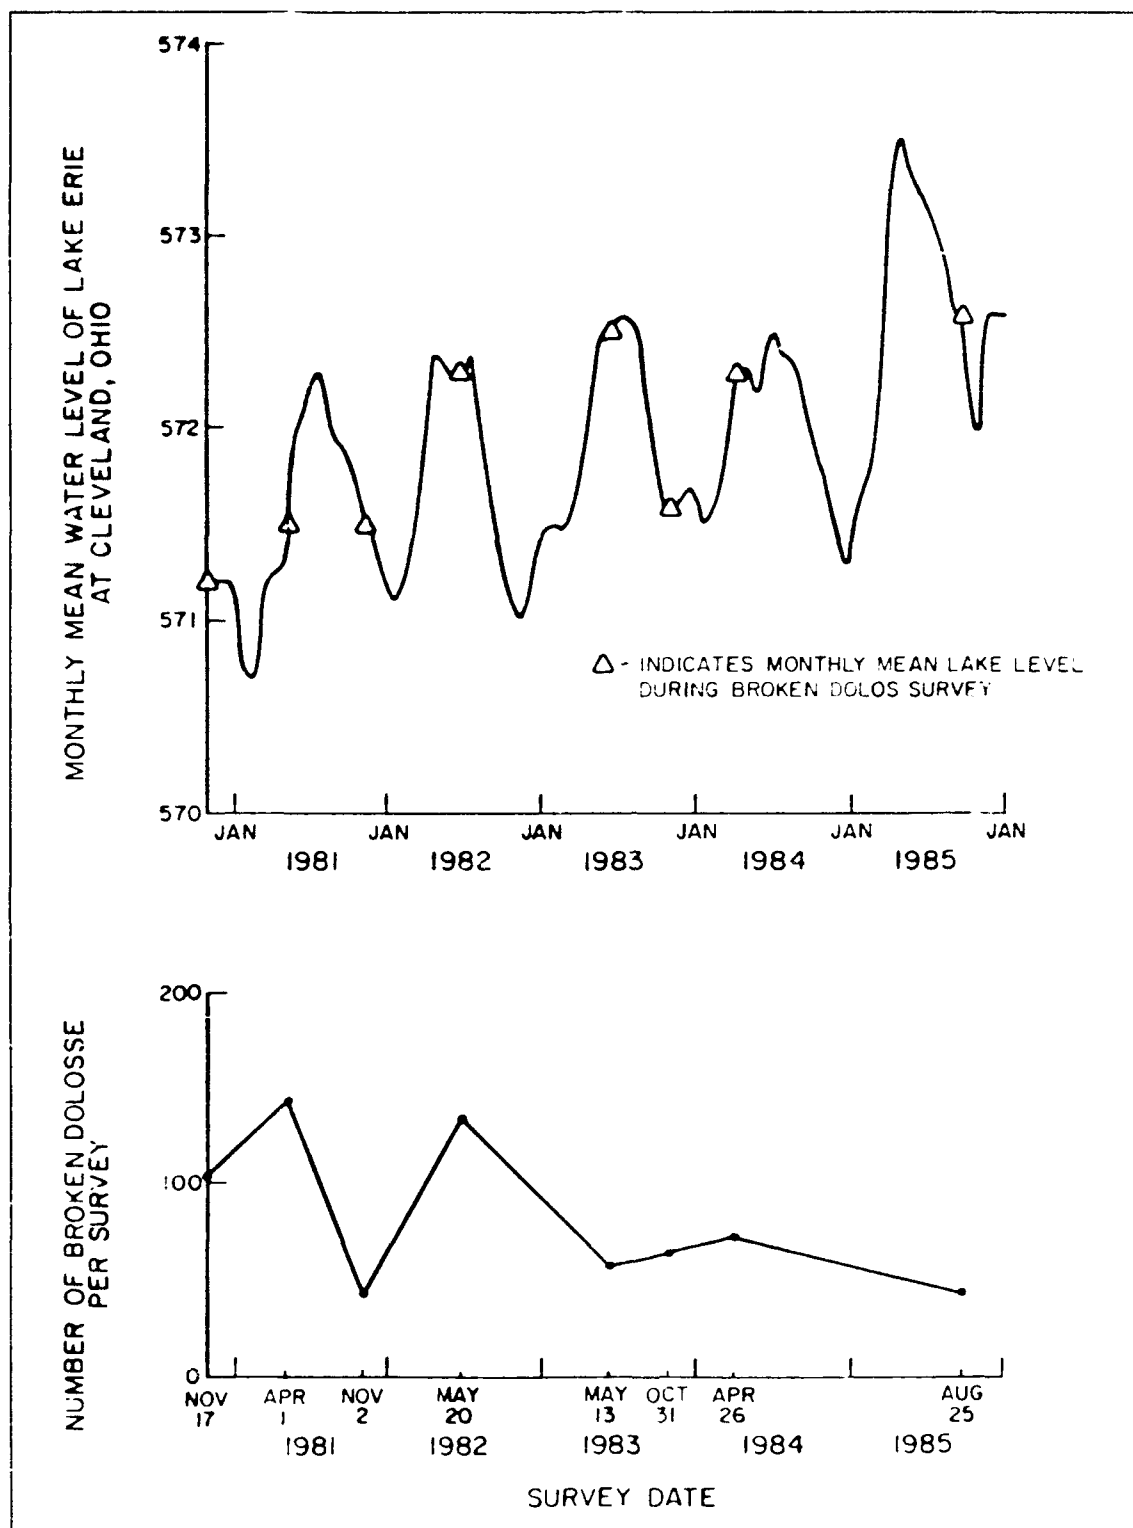
Figure 66. Comparison of lake level and number of broken dolosse per survey, Cleveland Harbor, Ohio

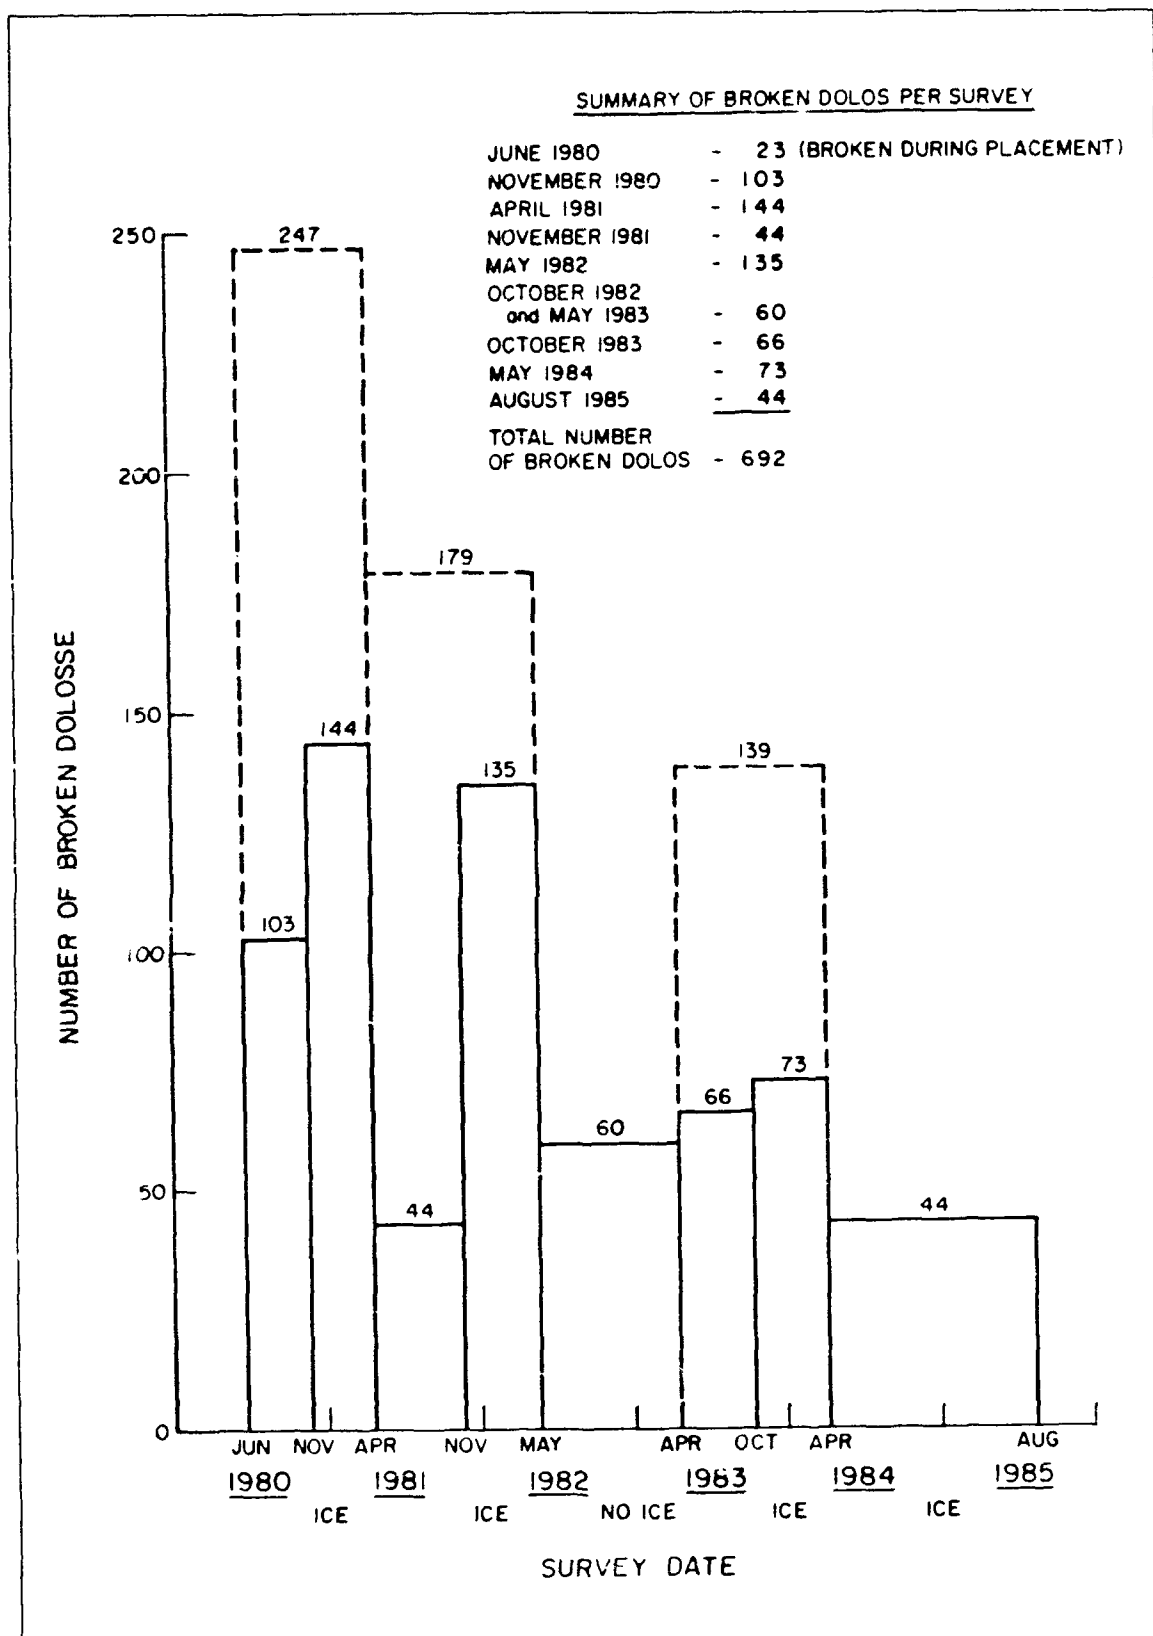
JUNE 1980	-	23 (BROKEN DURING PLACEMENT)
NOVEMBER 1980	-	103
APRIL 1981	-	144
NOVEMBER 1981	-	44
MAY 1982	-	135
OCTOBER 1982 and MAY 1983	-	60
OCTOBER 1983	-	66
MAY 1984	-	73
AUGUST 1985	-	44
TOTAL NUMBER OF BROKEN DOLOS	-	692

Figure 67. Summary of broken dolosse per survey at Cleveland Harbor
