INSTALLATION RESTORATION PROGRAM

Site Investigation Report

GEORGIA AIR NATIONAL GUARD
SAVANNAH, GEORGIA

January 1992

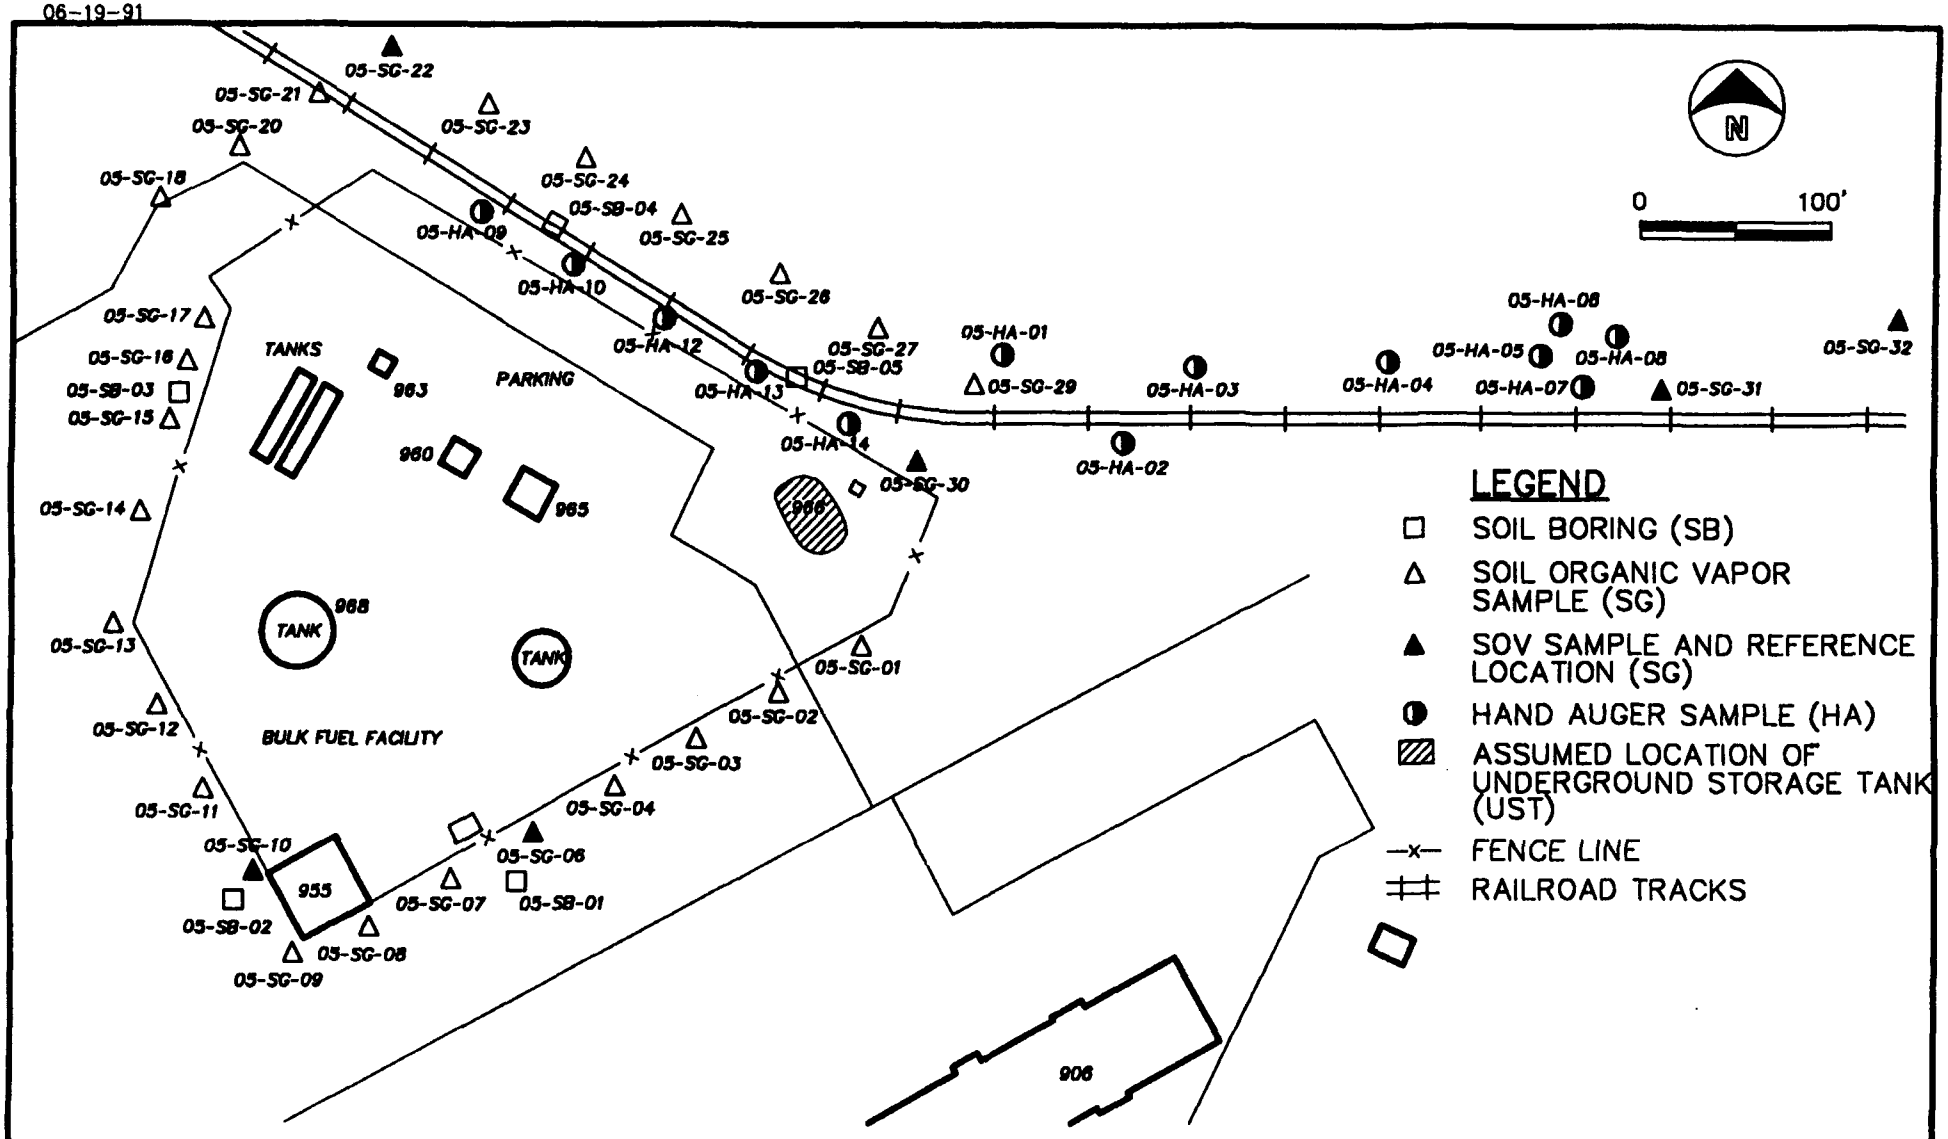
FIGURE 2-3

Field activities consisted of performing an SOV survey at 30 sampling points, collecting soil samples for head-space analyses from 13 hand-auger borings, and performing head-space analysis on soil samples collected from 5 soil borings. The locations of these sampling points are shown in Figure 2-3. In the SOV survey, toluene and total xylenes were detected at low concentrations in most samples. Although some of the samples may have contained these target compounds, vapors emanating from the Bulk Fuel Facility may have influenced the samples. No air quality sampling was performed to confirm this; however, fuel odors were evident, and these could impact field screening results.

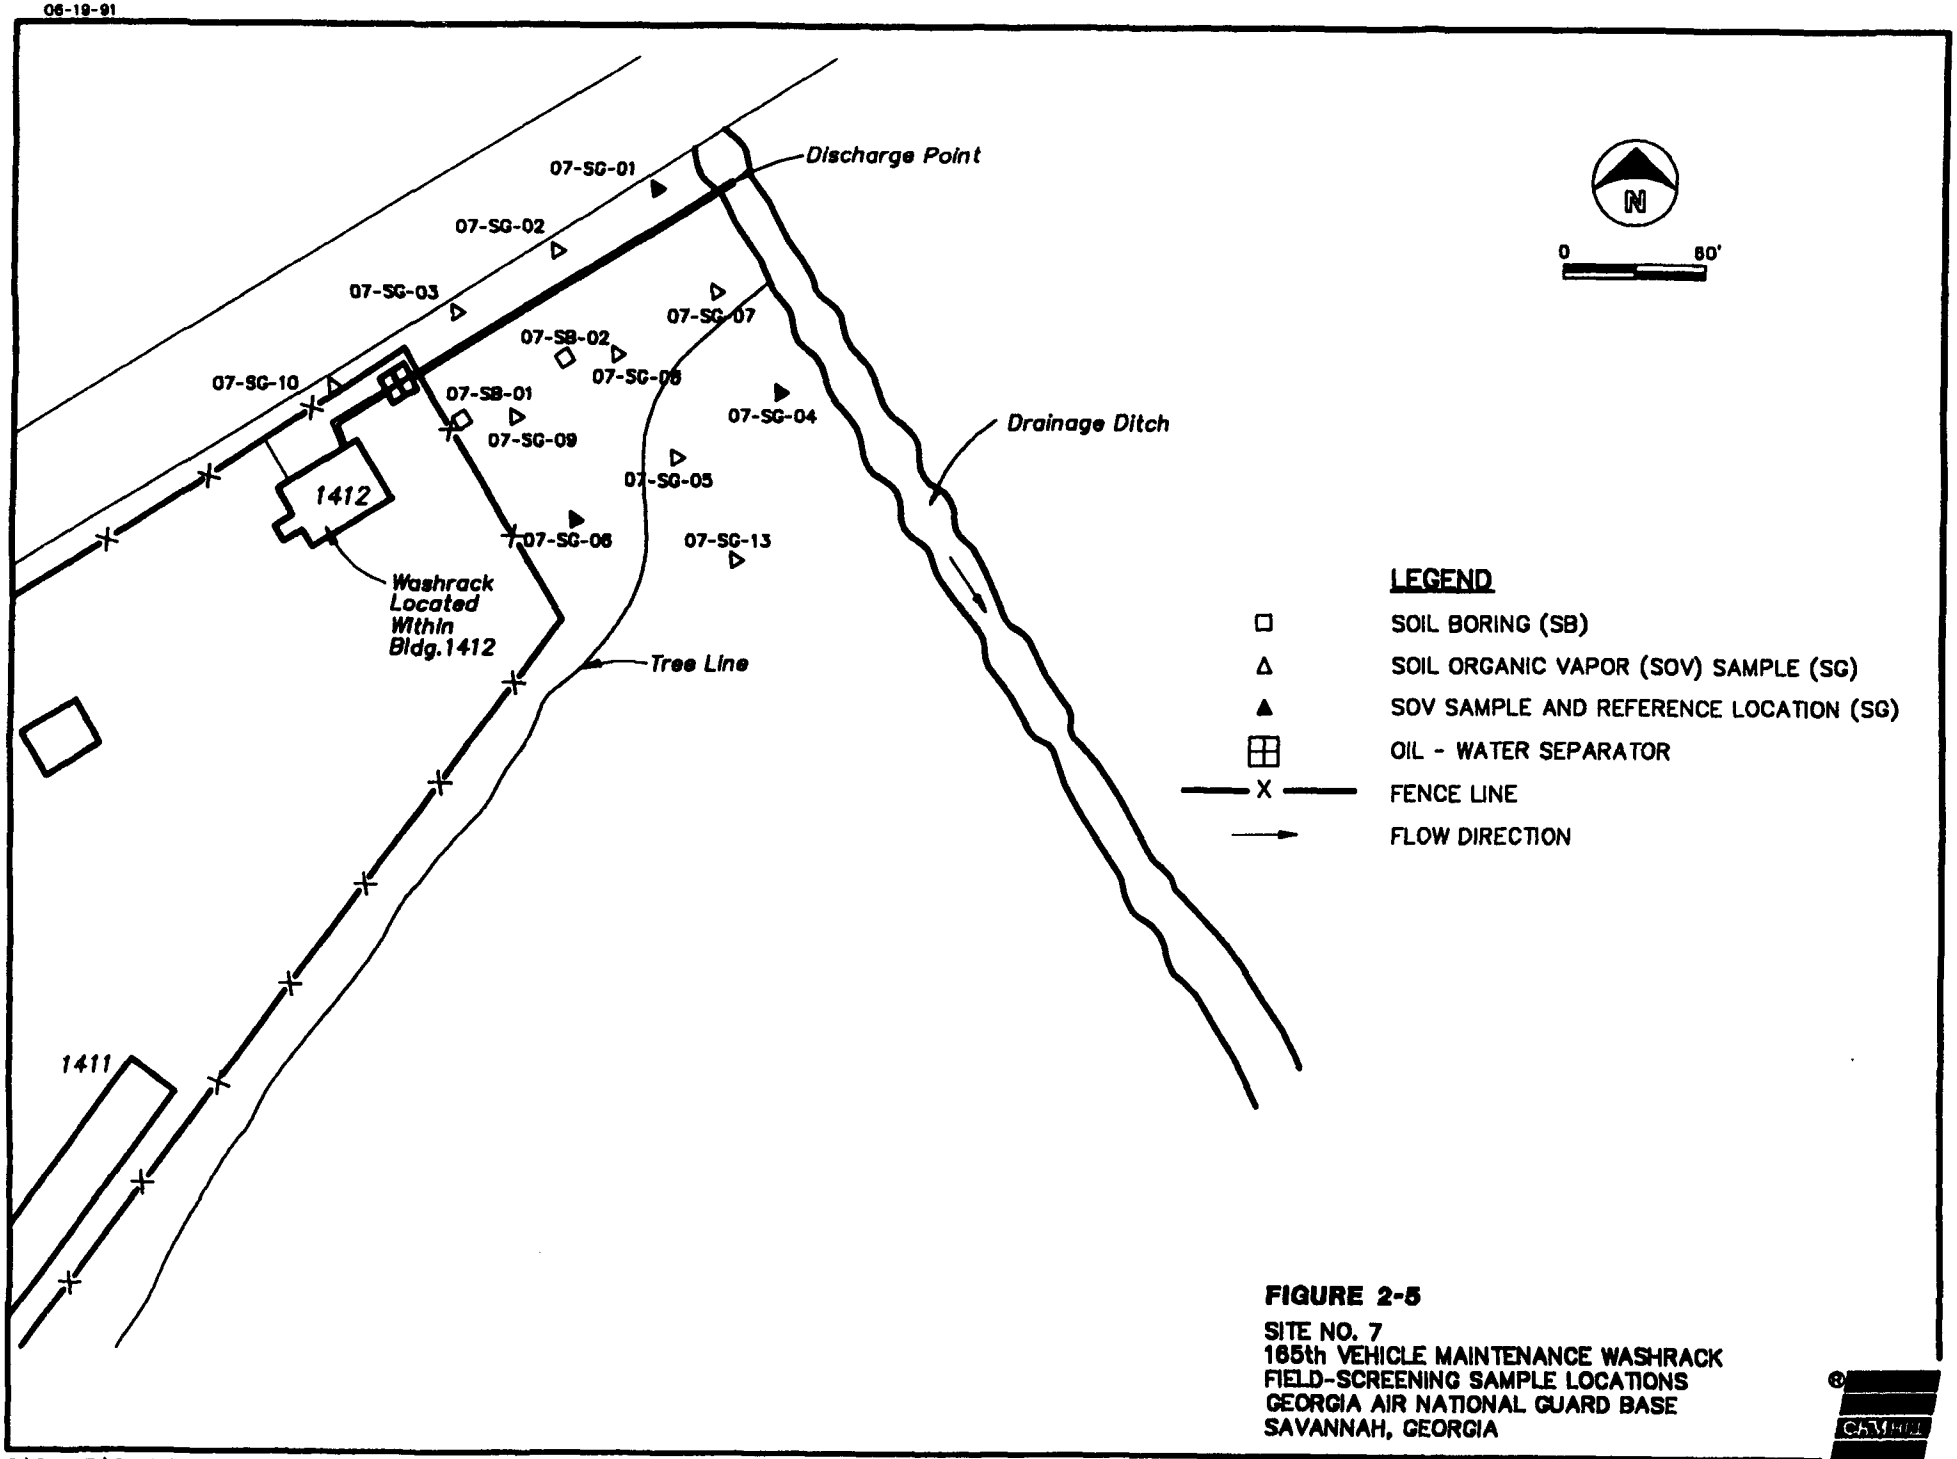
FIGURE 2-5

Field screening was performed with an SOV survey and during installation of the soil borings. An SOV survey consisting of 12 sampling points was performed in the grassy area north of the washrack. Figure 2-5 shows the location of the field-screening sampling points. This area was selected for to identify contamination remaining from runoff from the washrack area or to detect remnants of the reported spill.

The SOV screening indicated three points with elevated concentrations of the target compounds. Two of these points (07-SG-05 and 07-SG-13) were in the wooded area northeast of the site, and one point (07-SG-10) was adjacent to the oil-water separator. In several other samples, trace quantities of toluene or total xylenes were detected at concentrations between 4 and 16 ppb.

The target compounds detected in the samples from an area by the oil-water separator appeared to be attributable to onsite discharges, but the compounds detected in the samples from the two points northeast of the site may not be attributable to Site No. 7 because of the distance of the sampling points from Site No. 7.

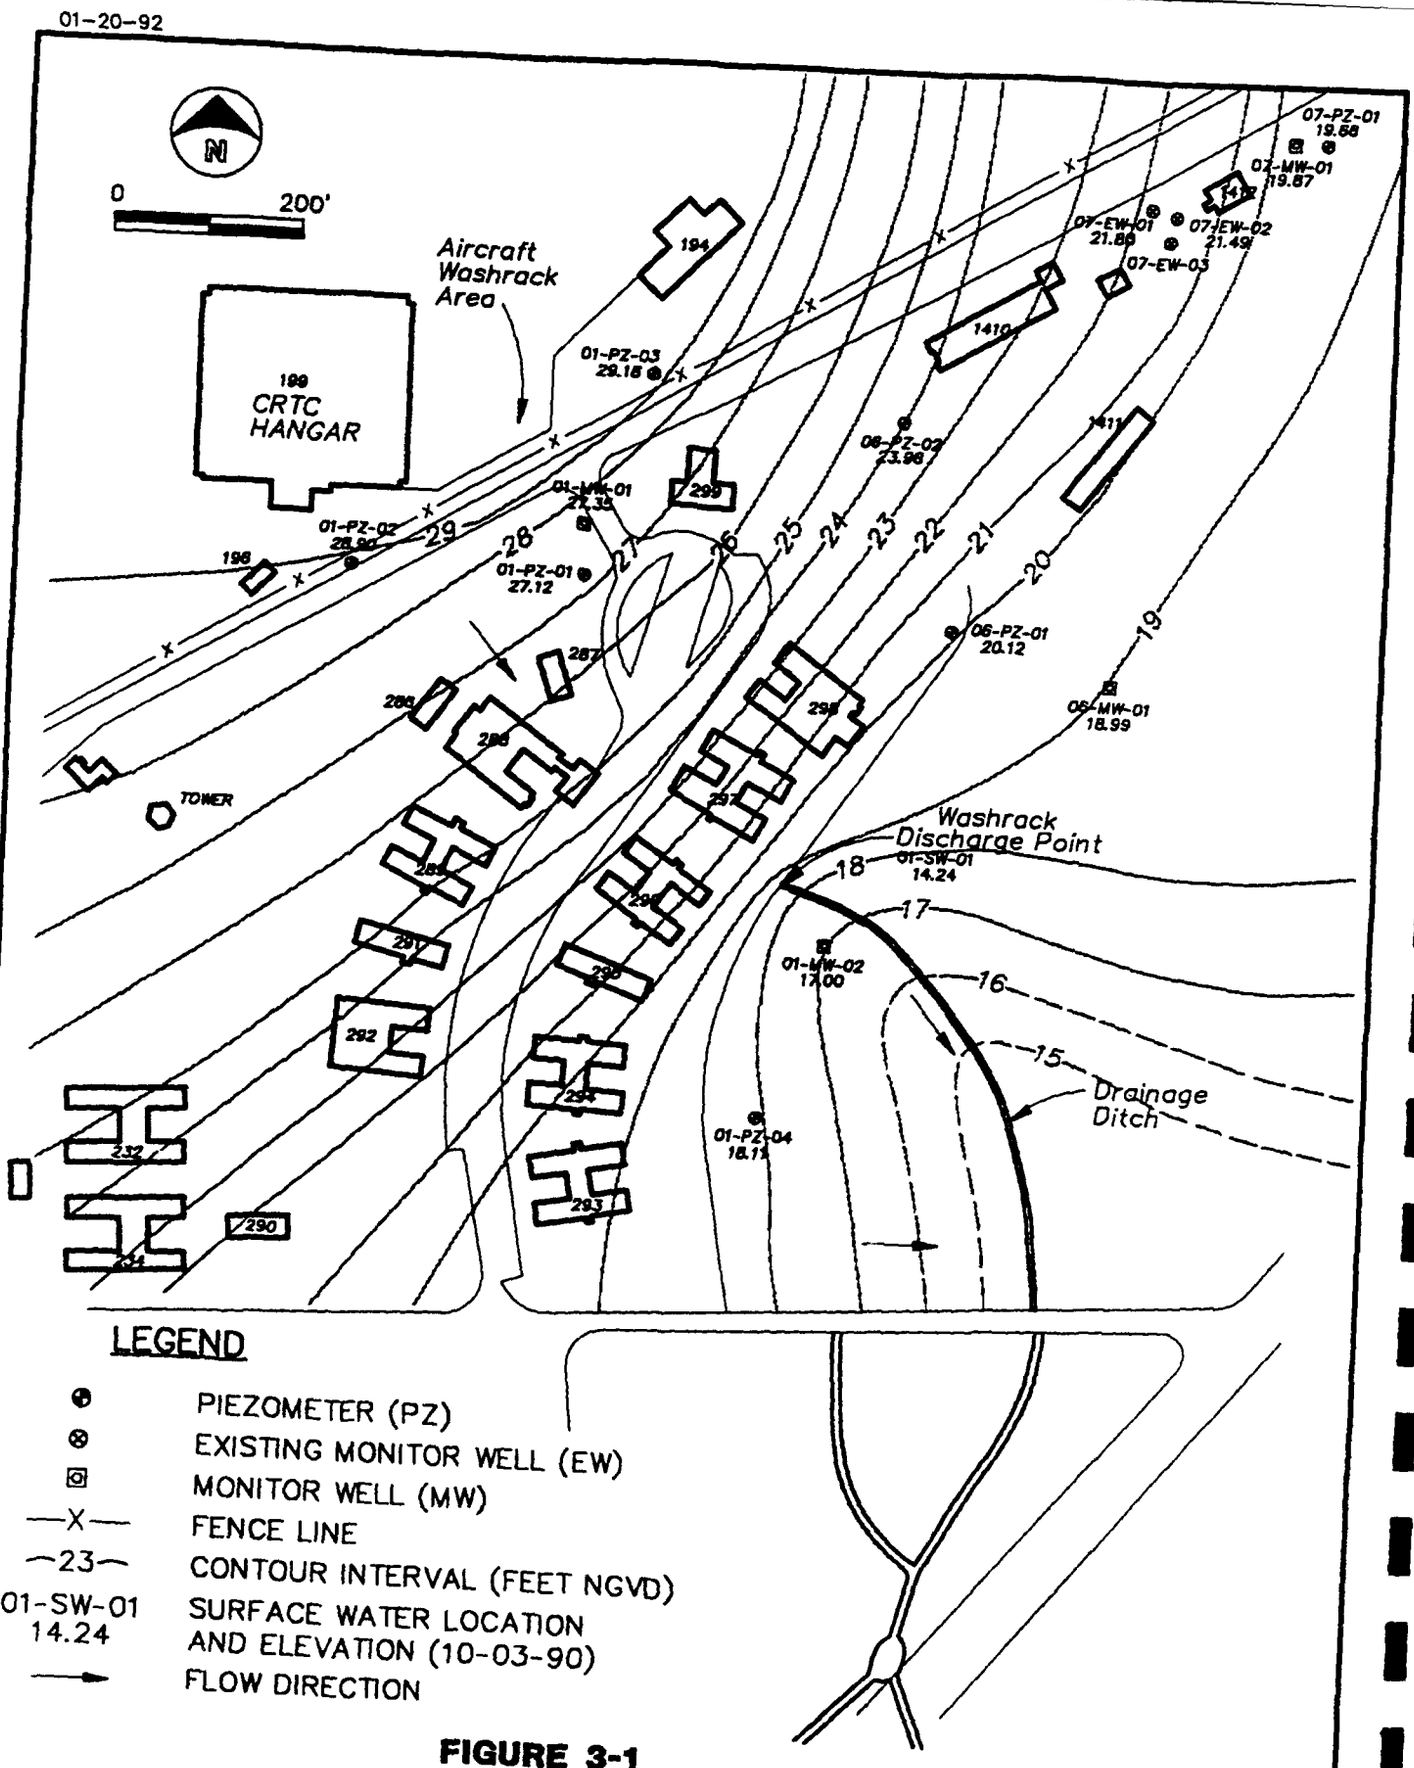
FIGURE 3-1
SITE NO. 1
CRTC HANGAR AND WASHRACK DISCHARGE POINT
GROUNDWATER CONTOURS (10-3-90)
GEORGIA AIR NATIONAL GUARD BASE
SAVANNAH, GEORGIA

Following the installation of two monitor wells (01-MW-01 and 01-MW-02), a second round of water level measurements was performed on October 3, 1990. Figure 3-1 shows the contours produced from the second set of measurements. This figure also includes measurements from piezometers and monitor wells at Site No. 6 and Site No. 7. The contours confirm the earlier projections, with slightly more definition shown around the drainage ditch and washrack area. The average groundwater flow gradient remained approximately 0.02 feet per foot to the southeast.

On October 1, 1990, a slug test was performed in Monitor Well 01-MW-01. The test yielded a value of 11.85 feet per day (fpd) (4.18×10^{-3} centimeters per second [cm/s]) for hydraulic conductivity. This value appears consistent with the clean fine sands observed at the site and represents relatively good or moderate permeability. Using the observed hydraulic gradient of 0.02, the estimated hydraulic conductivity of

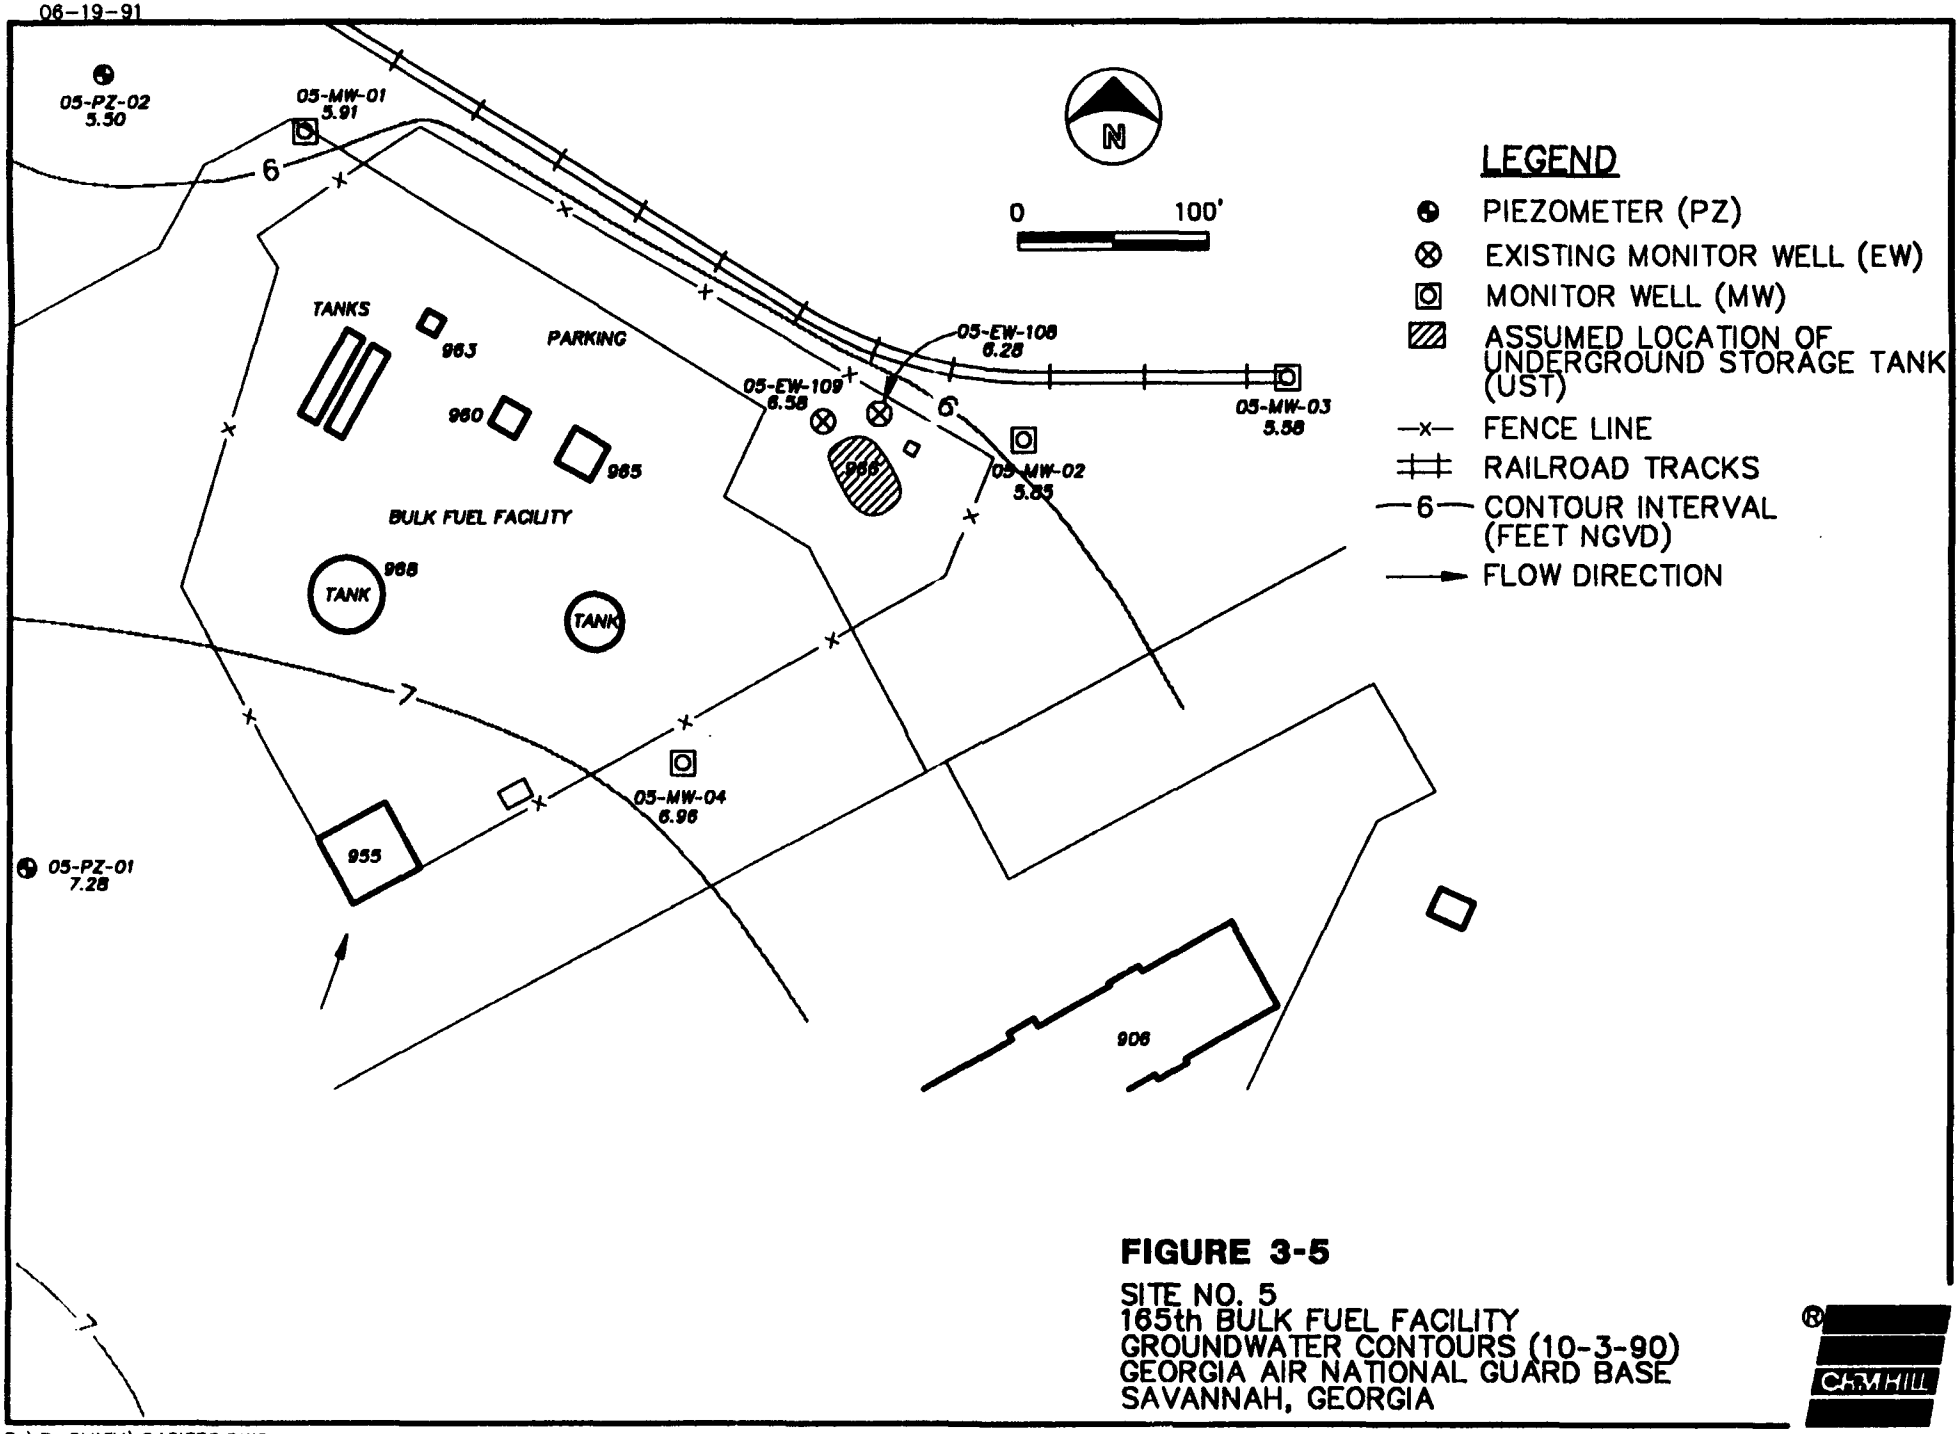
FIGURE 3-5

Following the installation of monitor wells at the site, a second set of ground water measurements was collected. On October 3, 1990, measurements were collected from the points used in the July 13 data set and from one new well installed at Site No. 2 and four new wells installed at Site No. 5. Figure 3-5 shows the contours developed using these measurements. From these contours, it appears that groundwater flows across Site No. 5 to the north-northeast. There is a groundwater divide in the grassy area to the south of the Bulk Fuel Facility. From this divide, groundwater may flow either north across the facility or south, eventually intersecting a distant drainage ditch. Using these data, a groundwater gradient of approximately 0.0041 was estimated.

On October 1, 1990, a slug test was performed at Monitor Well 05-MW-02. The slug test was performed as a "slug-out" or recovery test to examine the surrounding formation. The aquifer test yielded a hydraulic conductivity value of about 14.54 fpd (5.13×10^{-3} cm/s). This value is consistent with soil classifications and with other values obtained around GANGB.

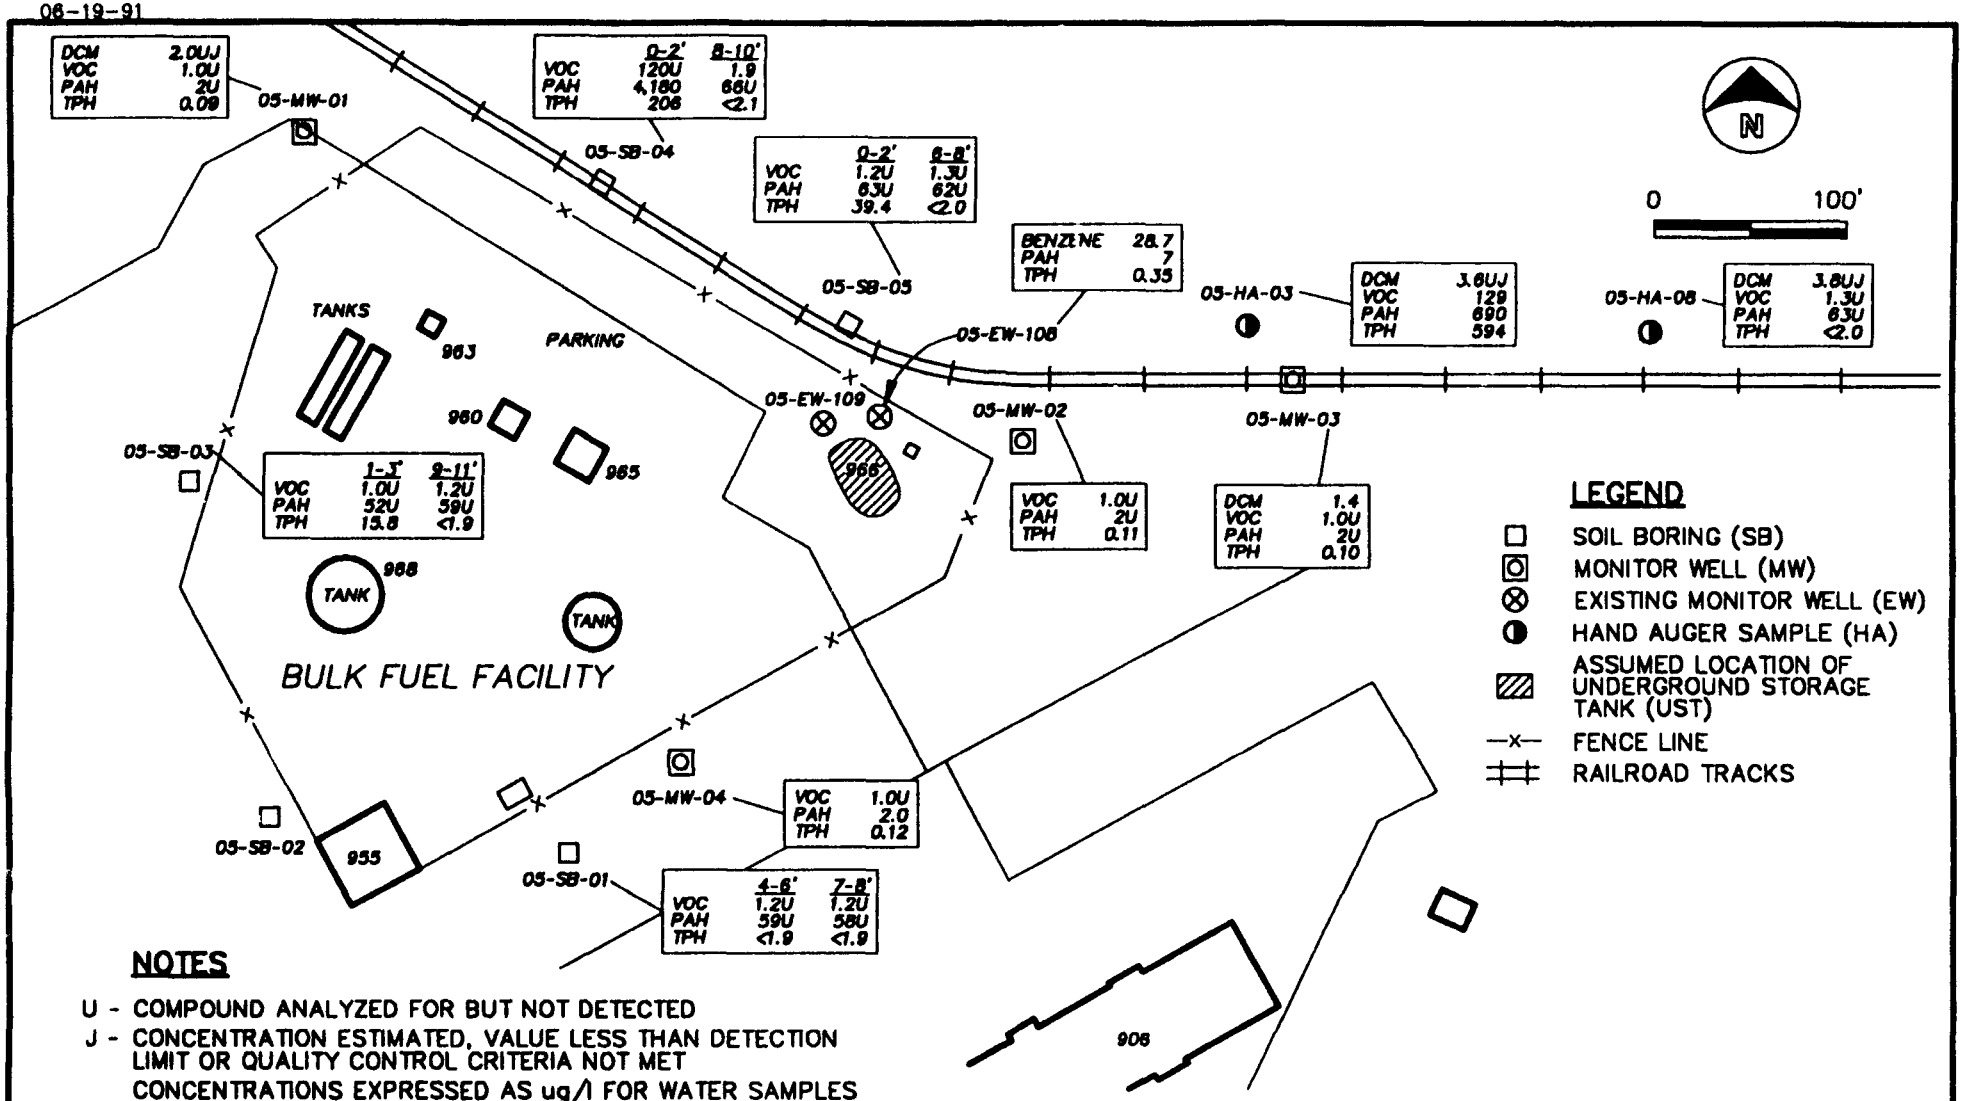
FIGURE 3-6

Laboratory analyses were performed on samples from two hand-auger borings, four soil borings, four new groundwater monitor wells, and one existing monitor well. The locations of these sampling points are shown in Figure 3-6. Samples were analyzed for VOCs, PAH compounds, TPH, and priority pollutant metals. The results of the laboratory analyses are shown in Tables 3-4A, 3-4B, 3-5A and 3-5B and also summarized on Figure 3-6.

Groundwater samples were collected from each of the four new monitor wells and from one existing well (05-EW-108) at the northeast corner of the Bulk Fuel Facility. Figure 3-6 shows the locations of the monitor wells. In the sample from the existing well, benzene was detected at 25 µg/l and ethyl benzene was detected at 3.7 µg/l. Dichloromethane was detected in Monitor Wells 05-EW-108 and 05-MW-03 in concentrations of 2.0 and 1.4 µg/l, respectively; however, this detection is believed to be a laboratory artifact. Naphthalene, 2-methyl naphthalene, and 1-methyl naphthalene were detected in Monitor Well 05-EW-108 located next to the existing underground storage tank. TPH was detected in all five groundwater samples. Arsenic, beryllium, cadmium, chromium, copper, lead, nickel, silver, and zinc were also detected in the groundwater samples. Lead was measured at 47 and 23 µg/l in the unfiltered samples from Monitor Wells 05-MW-01 and 05-MW-03, respectively, but lead concentrations were less than 2 µg/l in the filtered samples.

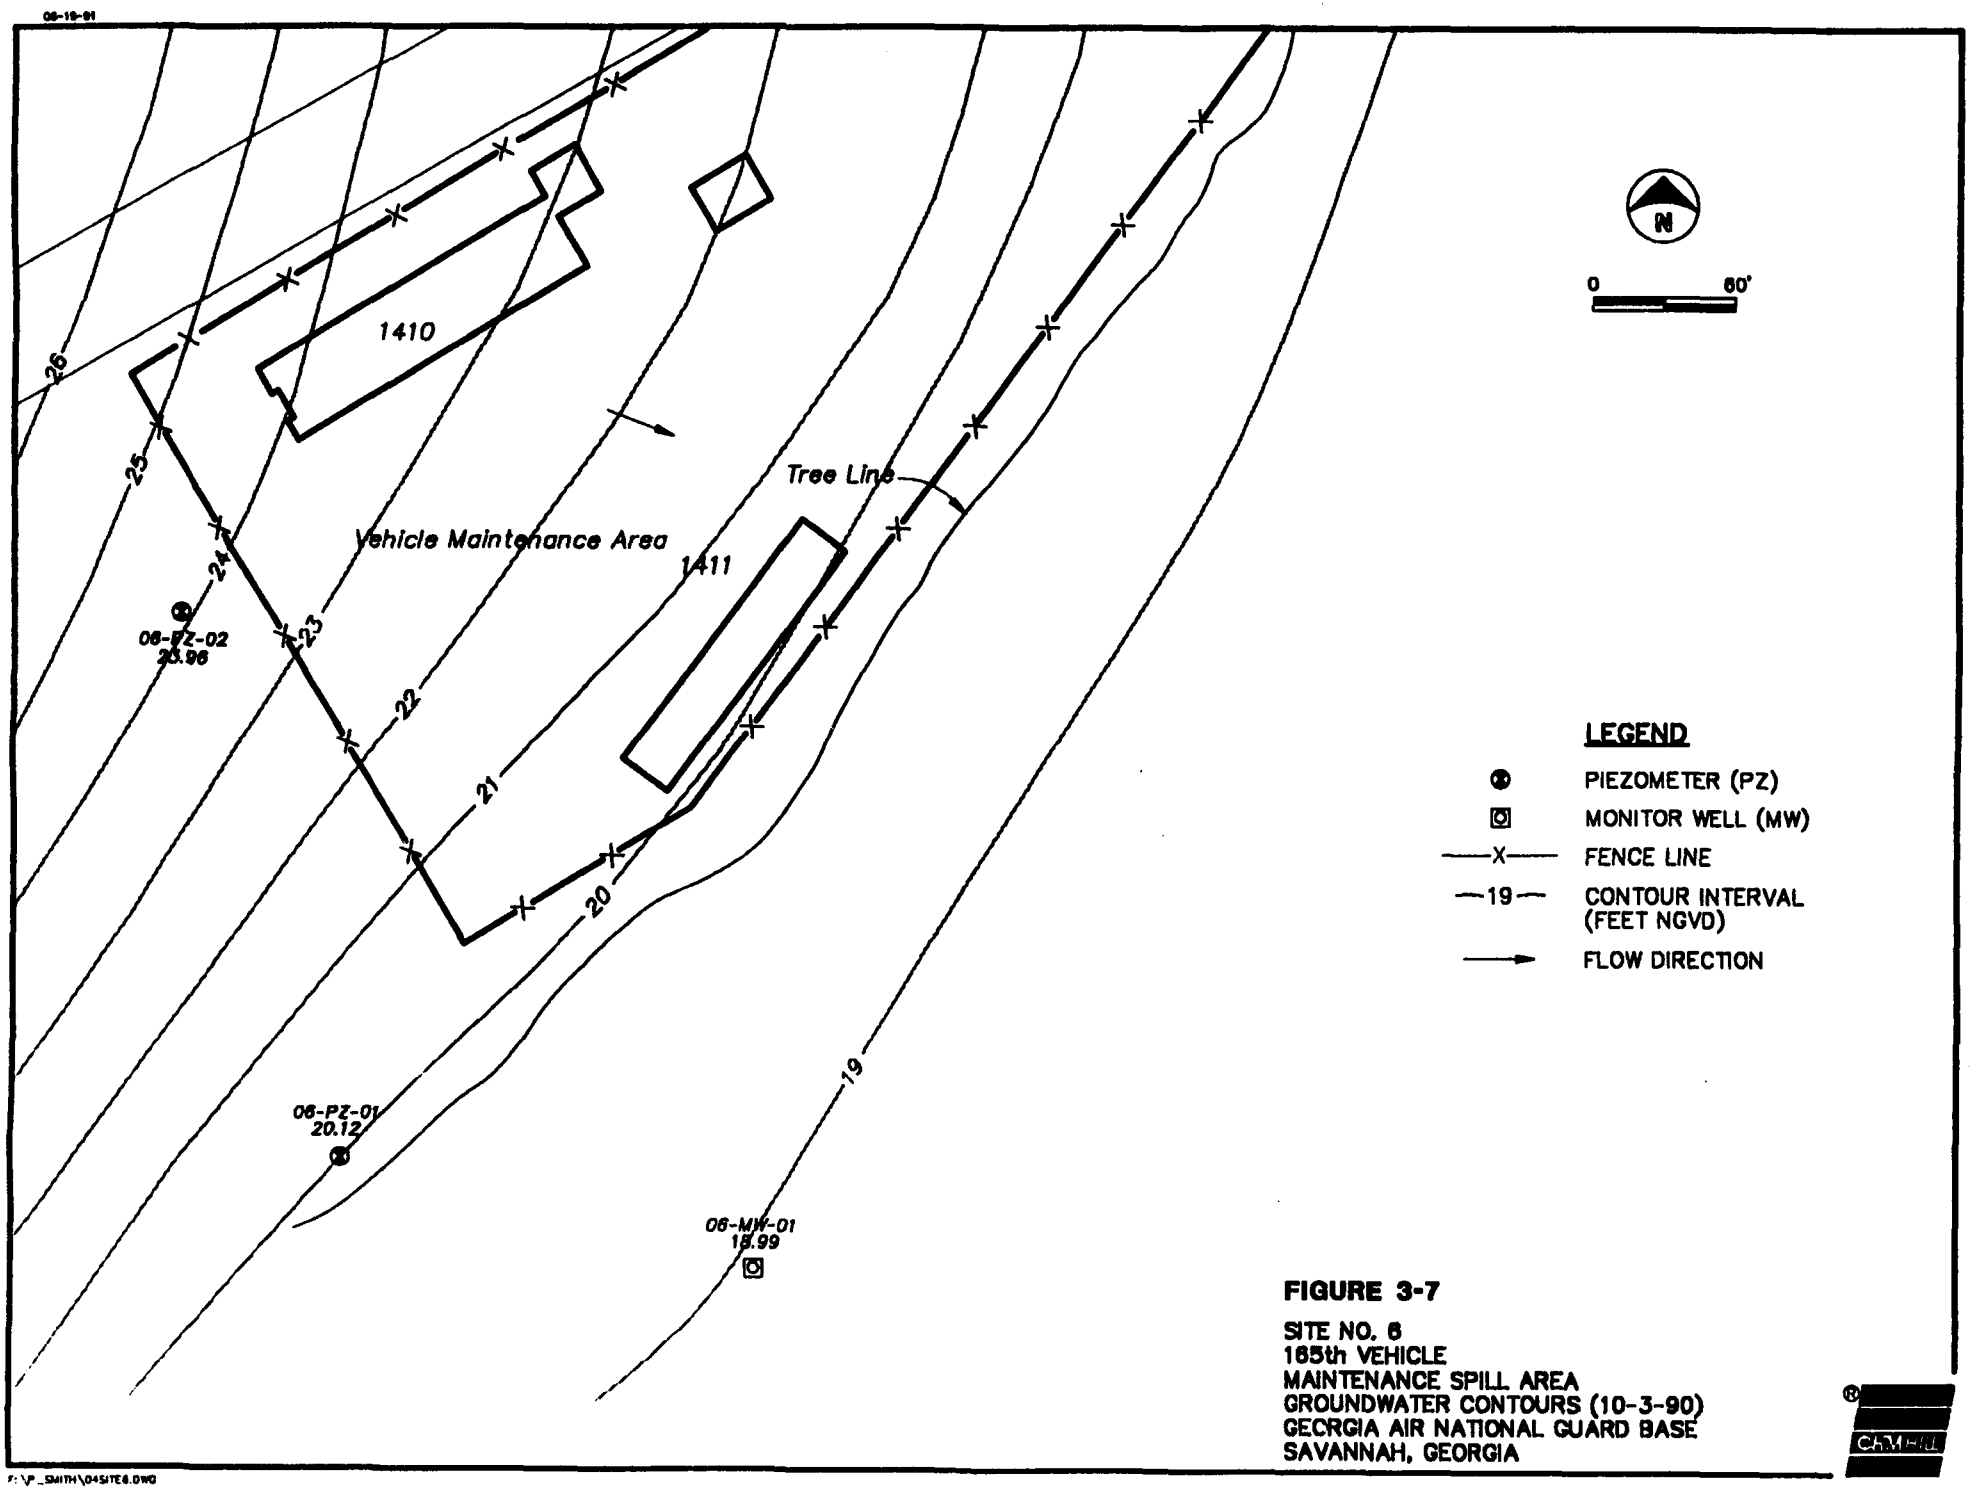
FIGURE 3-7

A slug test was performed in Monitor Well 06-MW-01. This well was installed using a hand auger and penetrated the groundwater surface by approximately 18 inches. The slug test yielded a hydraulic conductivity value of approximately 331.65 fpd (1.17×10^{-1} cm/s). Although the soil appeared moderately permeable, this value appears above the acceptable range for a poorly graded sand.

Monitor Well 06-MW-01 was installed using a hand auger, which produced a large borehole surrounding the well. Therefore, the high hydraulic conductivity value produced from the slug test may be more indicative of the gravel pack surrounding

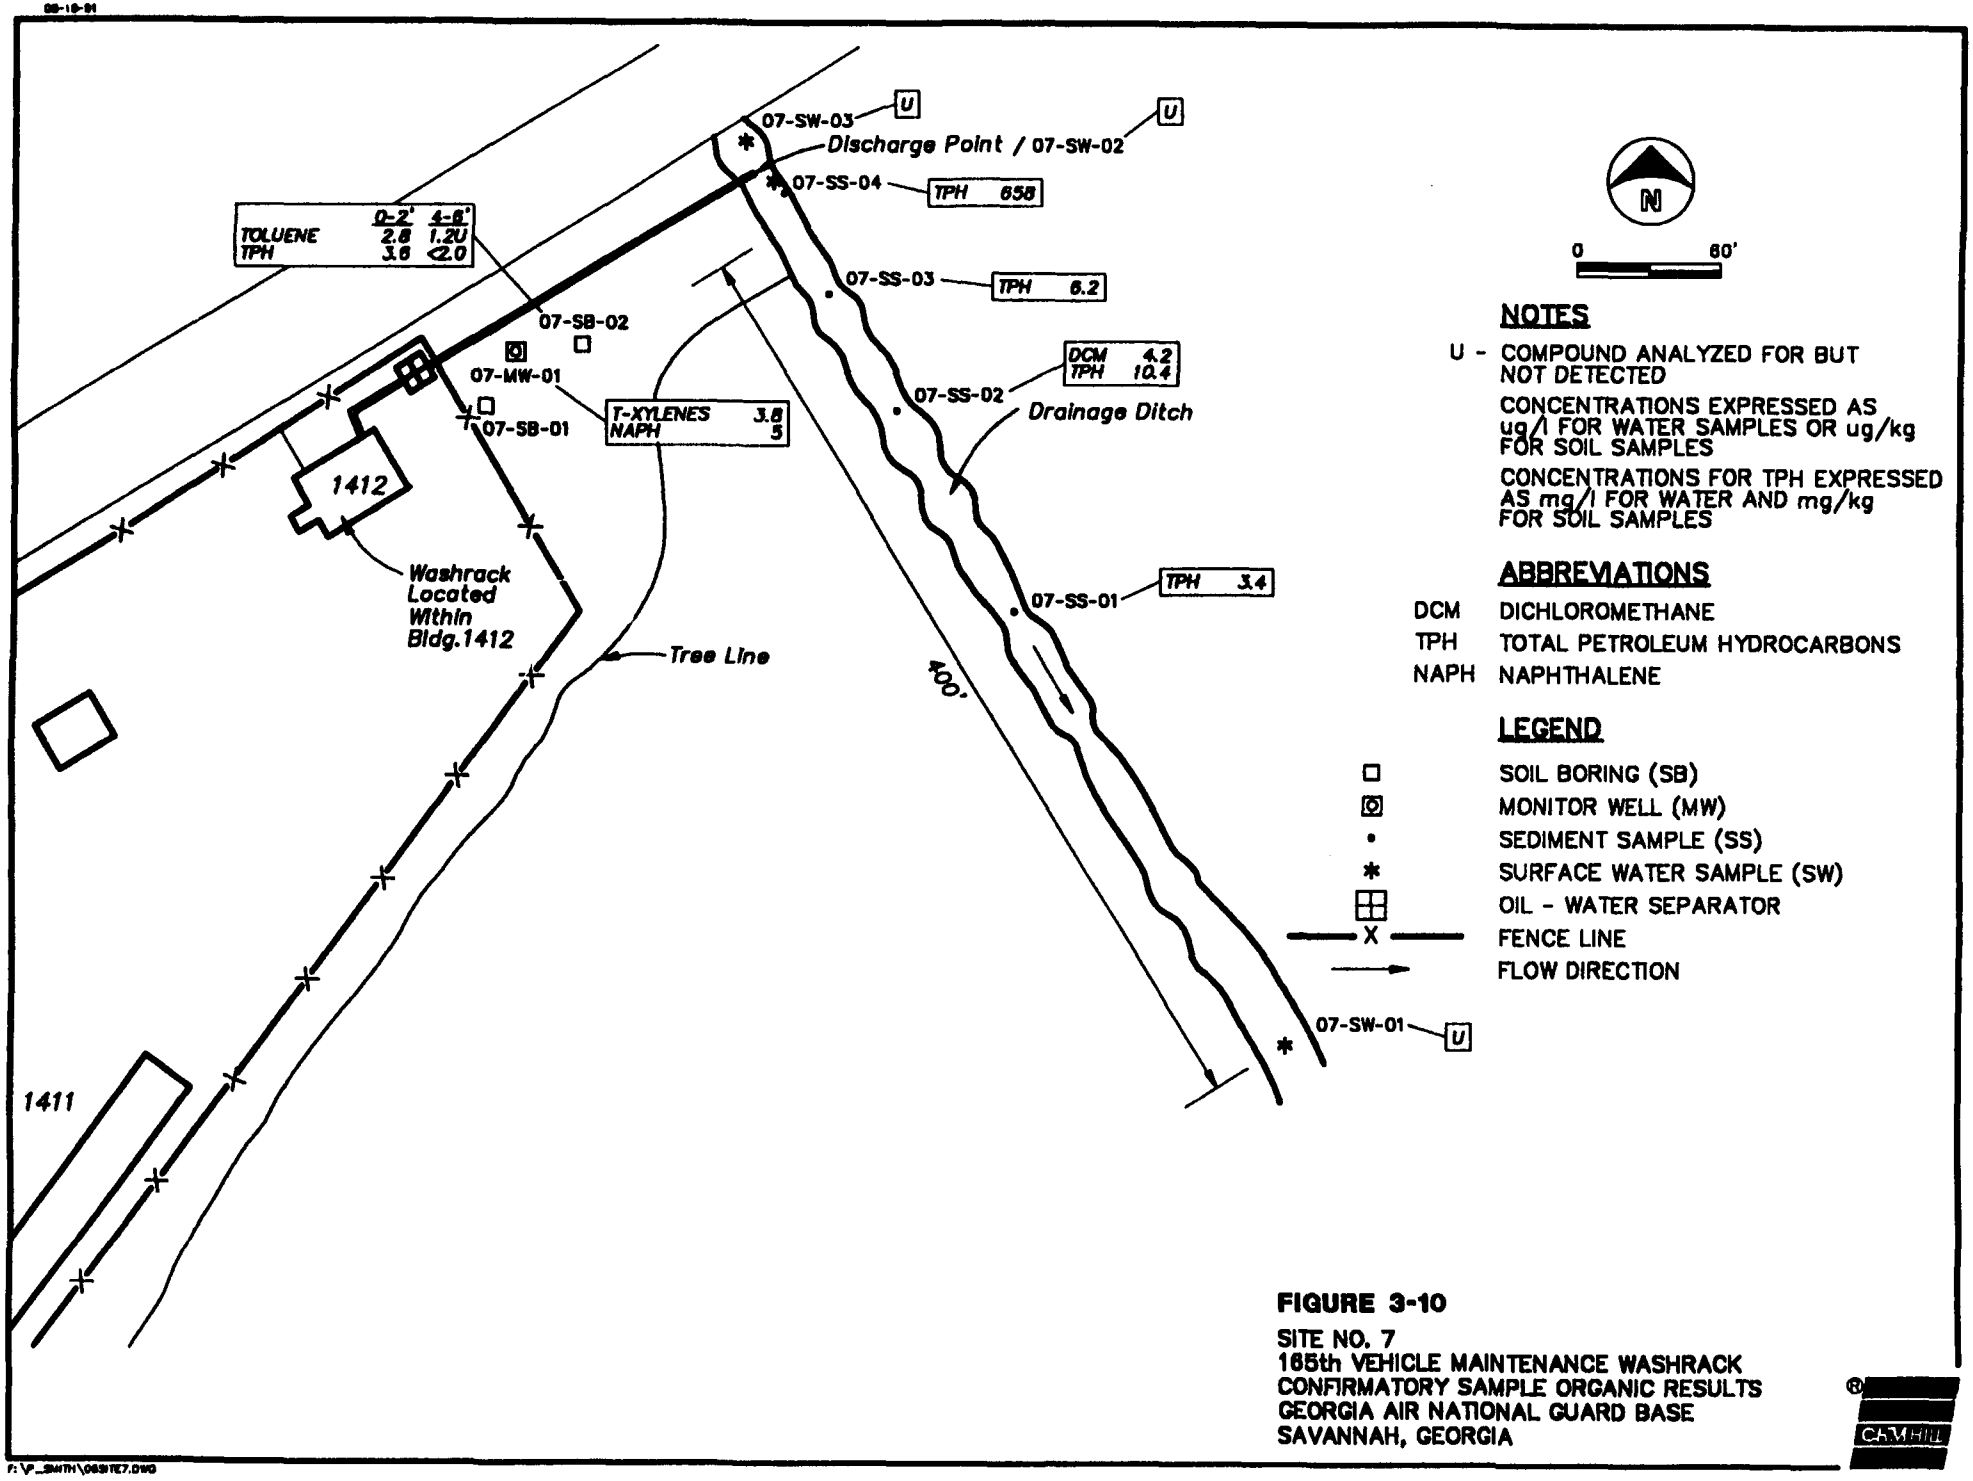
FIGURE 3-10

The drainage ditch that receives the washrack discharge was also sampled. The analyses of three surface water samples collected at various locations along the ditch indicated values below detection limits in each sample for each analyte. The analyses of the four sediment samples, however, detected TPH in each of the samples. Concentrations of TPH ranged from 3.4 to 658 mg/kg, and in general, decreased with distance from the discharge point.
