INSTALLATION RESTORATION PROGRAM

Site Investigation Report

GEORGIA AIR NATIONAL GUARD
SAVANNAH, GEORGIA

January 1992

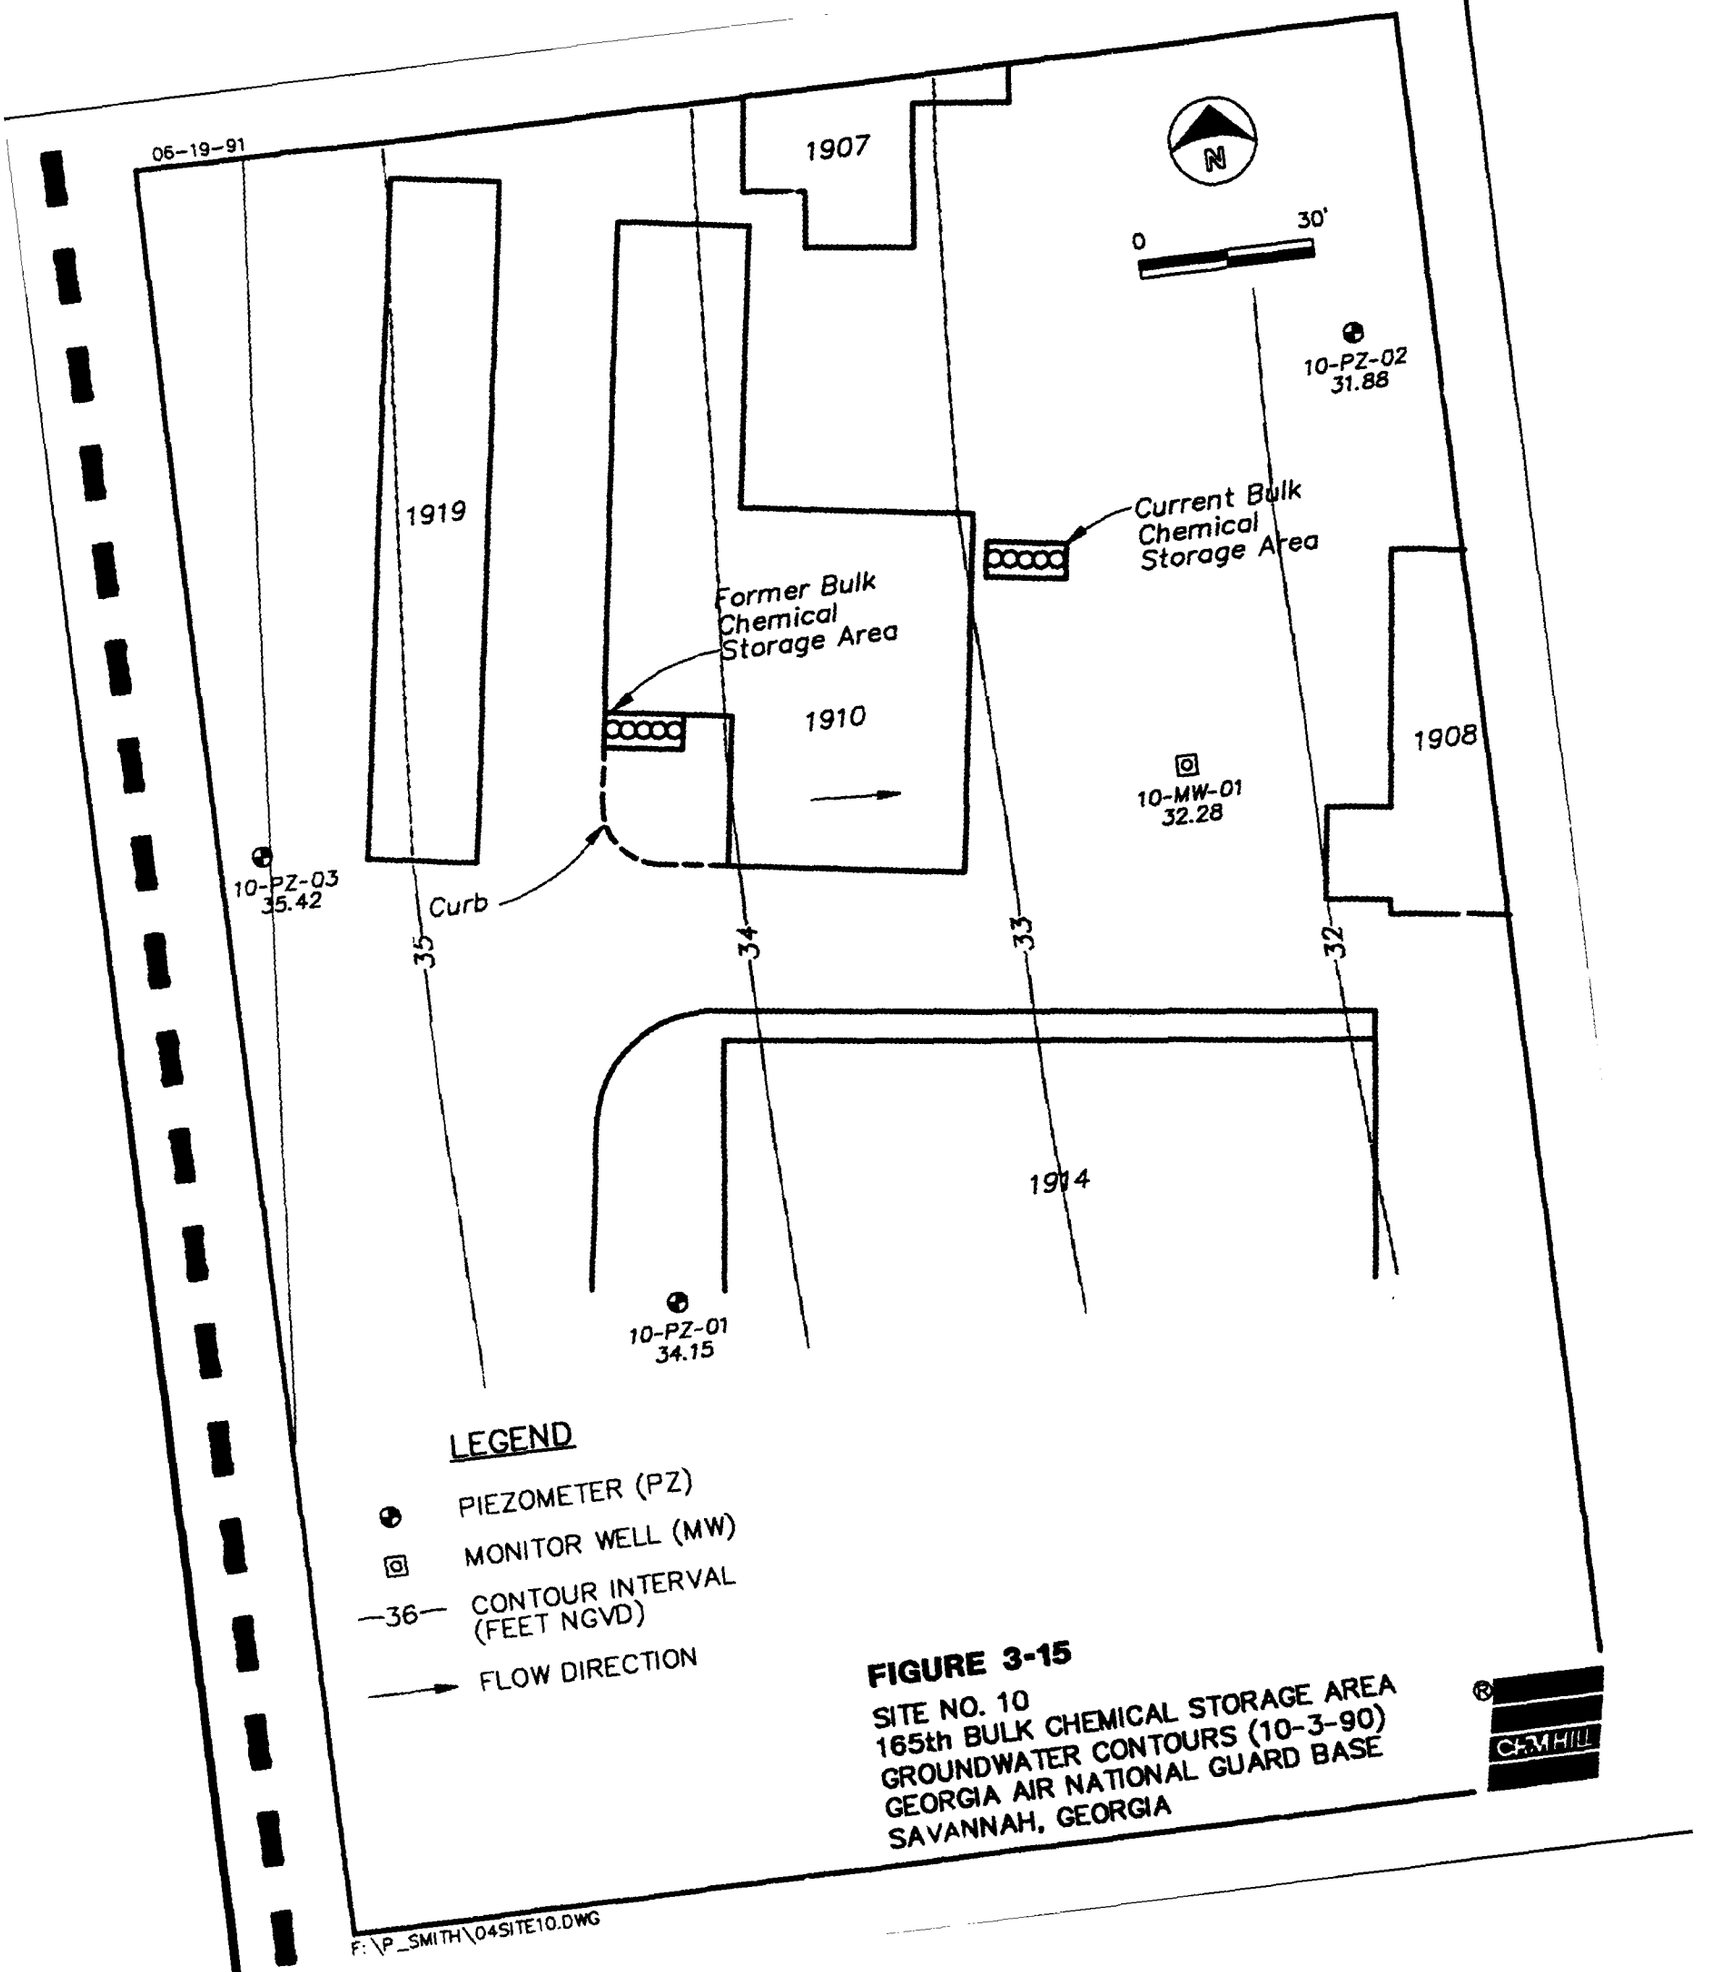
FIGURE 3-15

The field screening at Site No. 10 provided very limited information. Although VOC contamination was detected (and later confirmed in the actual storage area), this information could have been provided from observation and screening using a FID or PID. In the areas surrounding the storage area, low concentrations of VOCs were

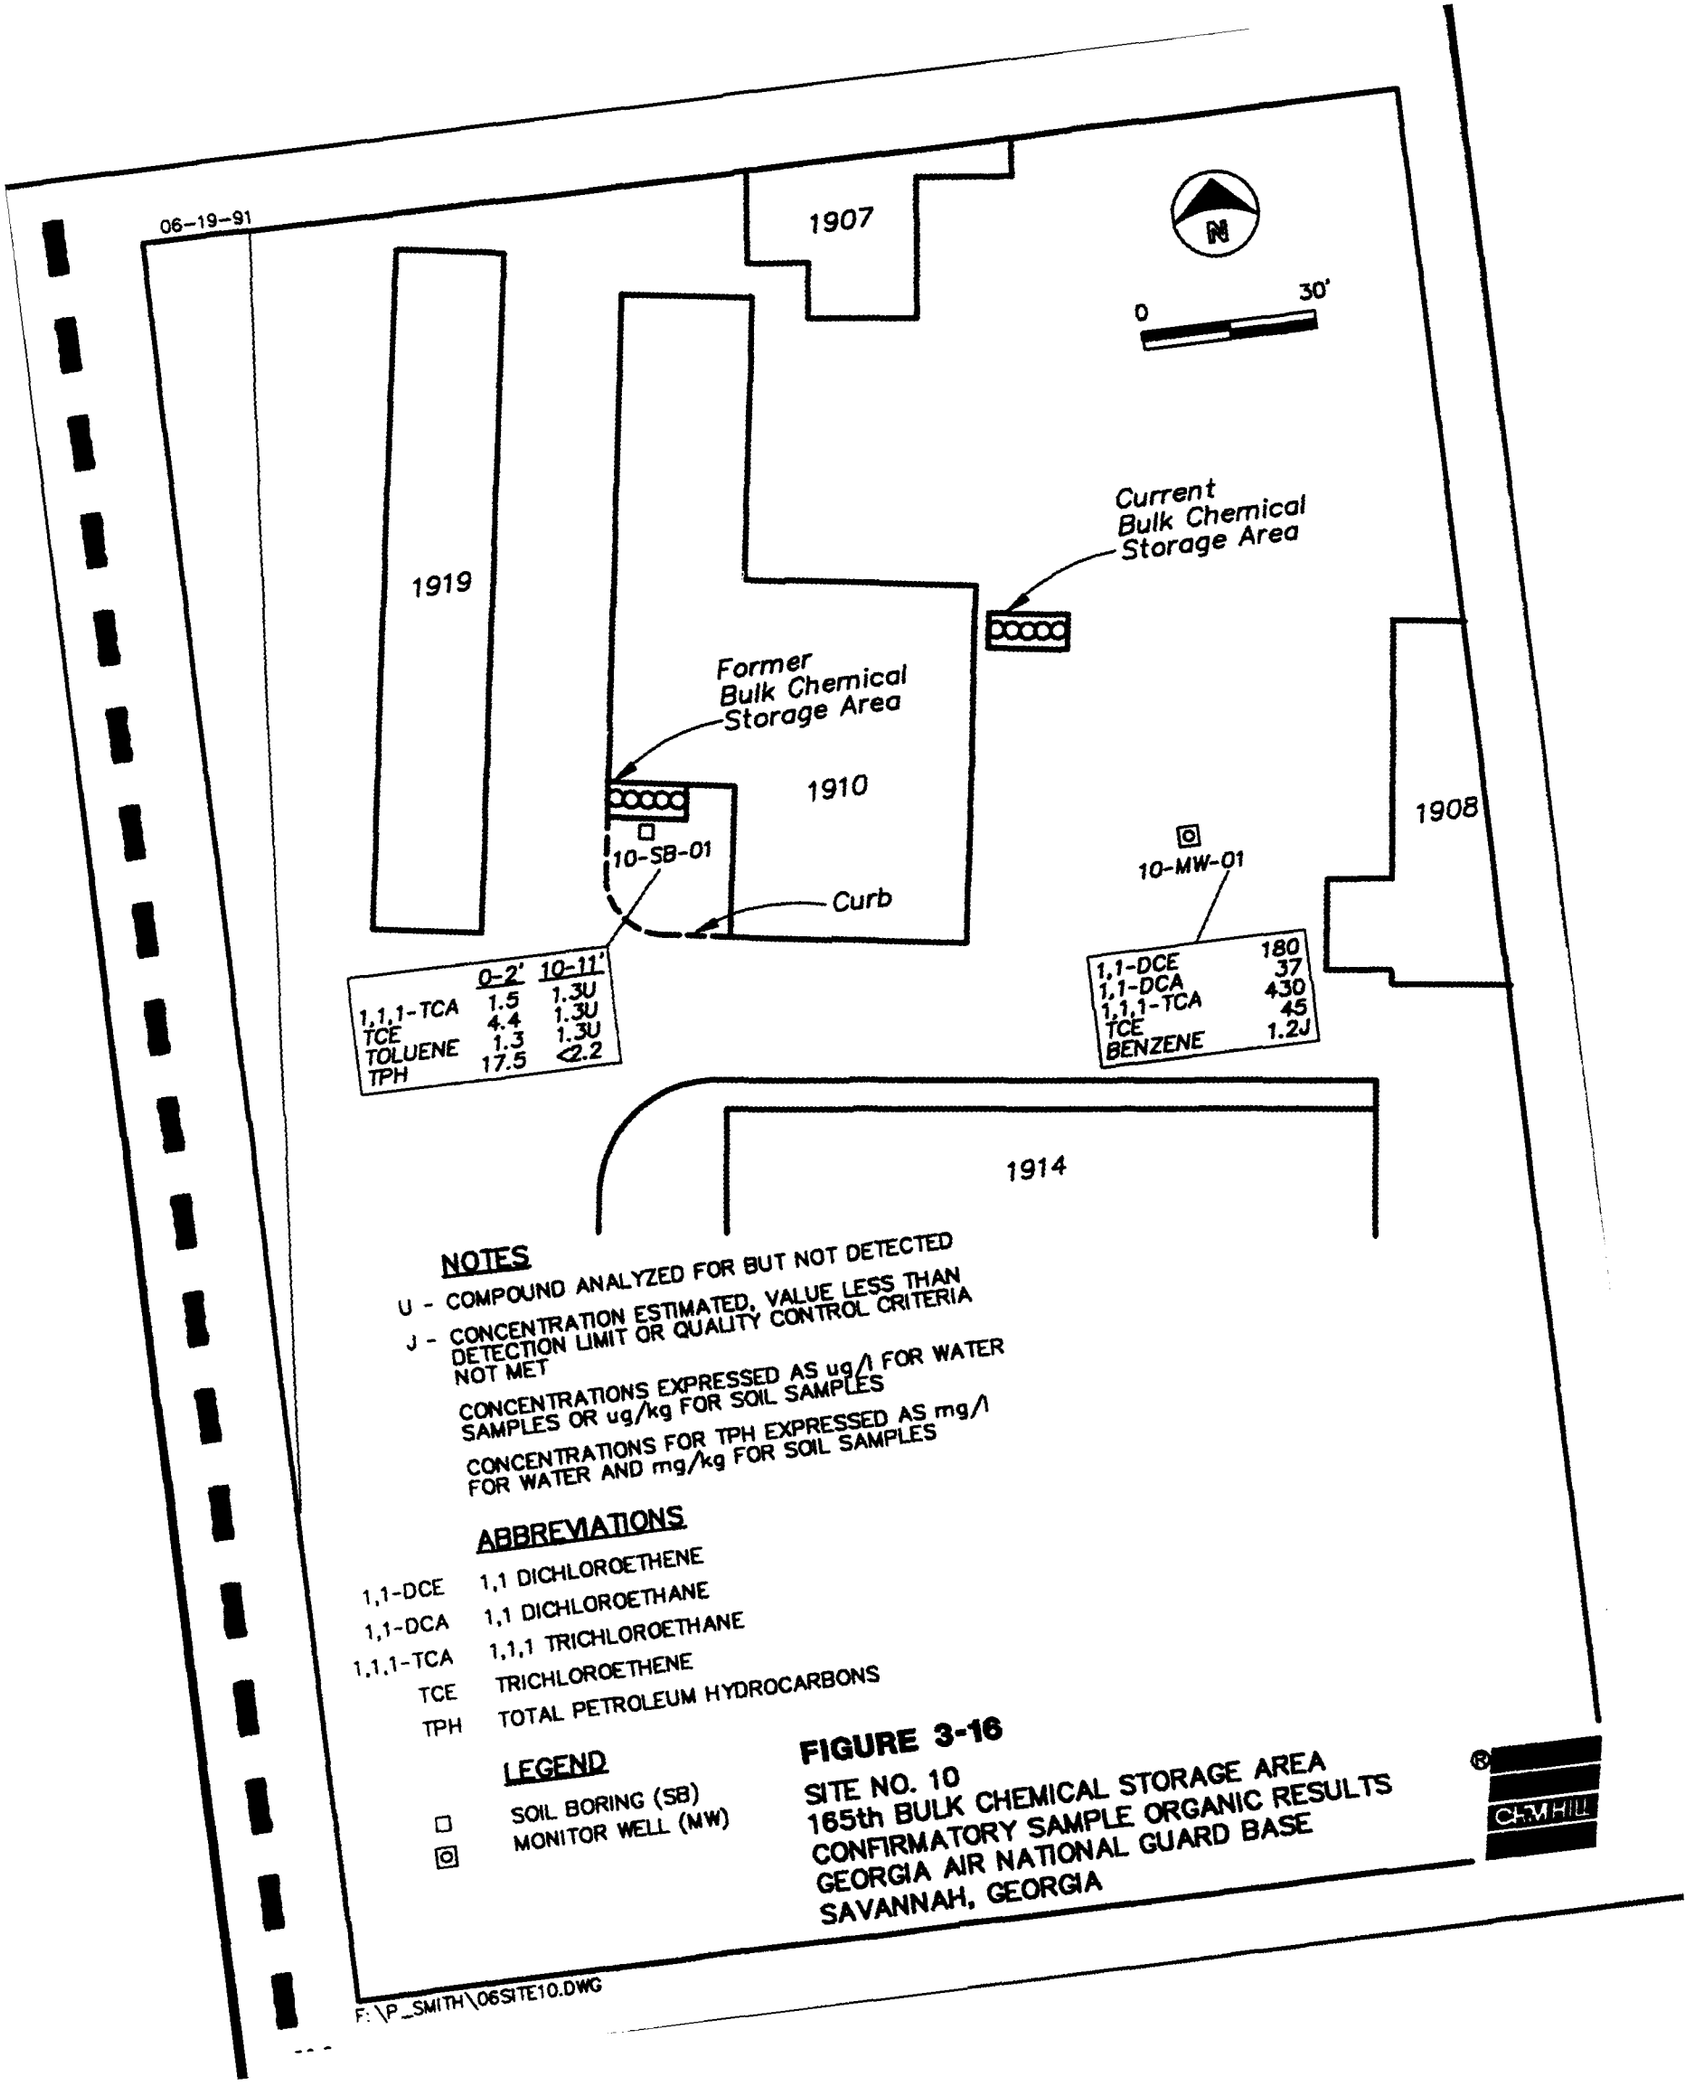
FIGURE 3-16

Contamination was detected in the soils and groundwater at Site No. 10. Soil contamination appears to be isolated to the areas that lie directly under the drum storage area. Little vertical migration in the soils was apparent based on laboratory analyses of the deep soil sample. A groundwater sample collected from a monitor well located downgradient from the site contained several volatile compounds.

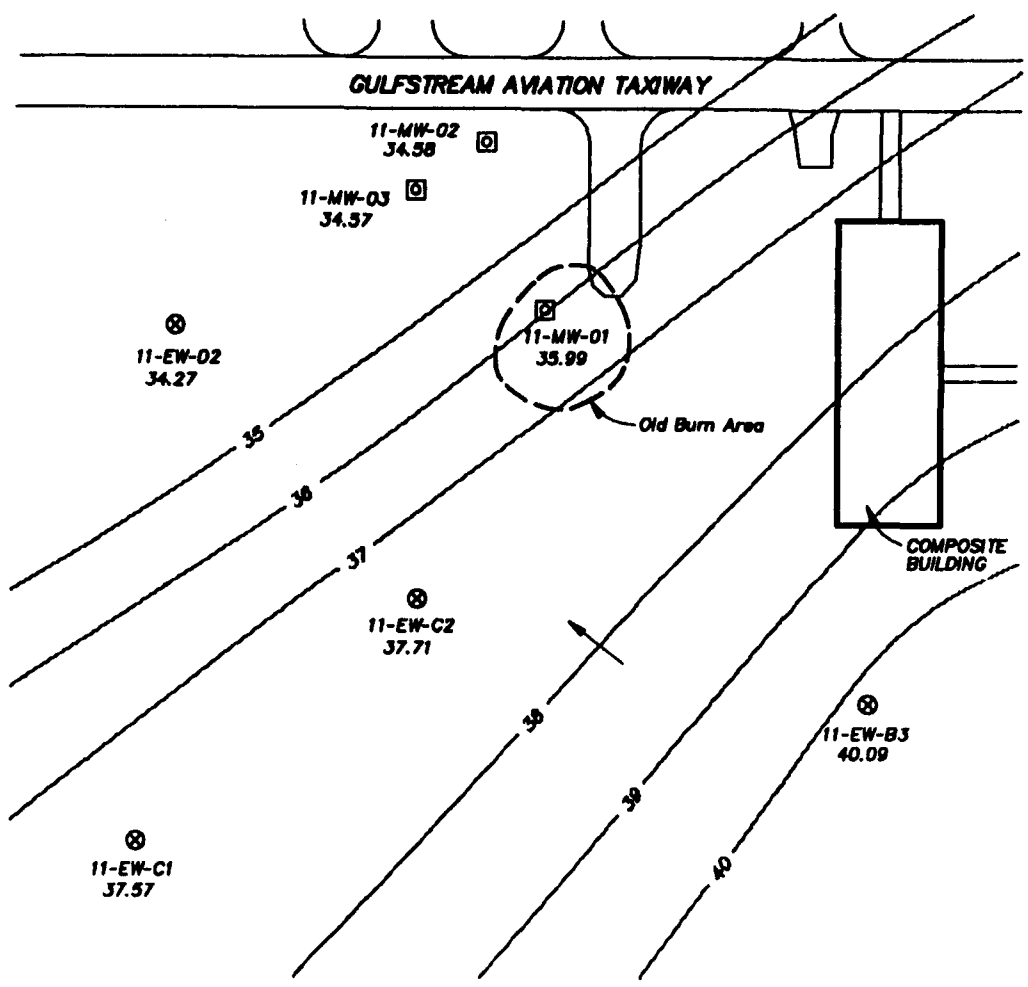
SITE NO. 11
165th OLD BURN AREA
GROUNDWATER CONTOURS (10-3-90)
GEORGIA AIR NATIONAL GUARD BASE
SAVANNAH, GEORGIA

The groundwater surface at Site No. 11 was relatively deep compared to the rest of the Savannah International Airport and was observed at between 7 and 10 feet bls. Water level measurements were collected from some of the existing wells at Site No. 11 on July 13, 1990. A gradient of 0.0055 feet per foot to the north-northwest was estimated.

One slug test was performed at Site No. 11 in Monitor Well 11-MW-01. The test yielded a value of 2.41×10^{-3} cm/s for hydraulic conductivity. This value appears consistent with the soil types observed and with other regionally produced values. Using the groundwater gradient of 0.0065, the estimated hydraulic conductivity value of 2.41×10^{-3} cm/s, and an assumed porosity value of 0.40, an average groundwater flow velocity of 0.11 fpd to the northwest was estimated for the site.

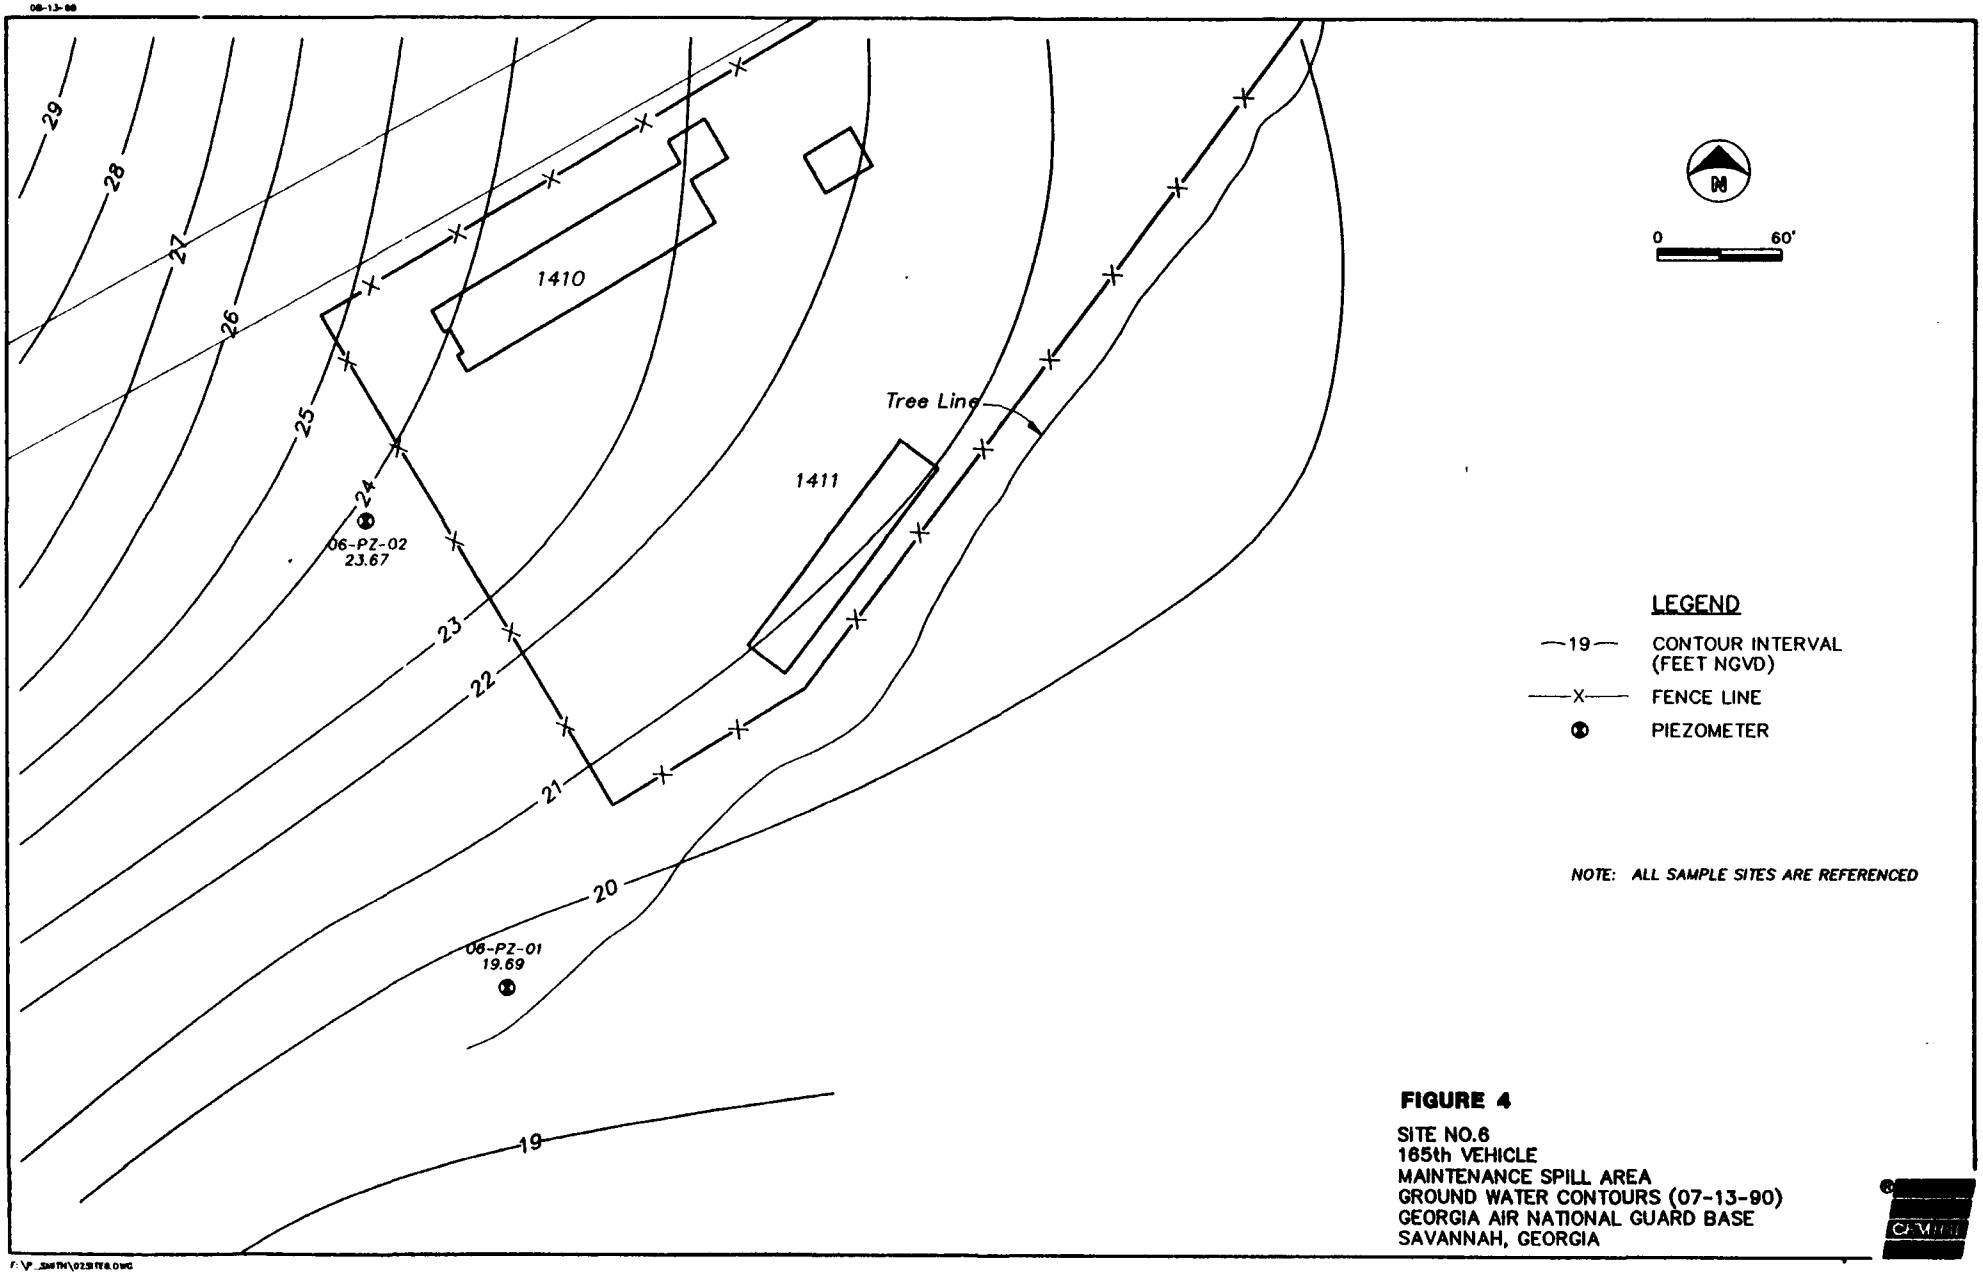
FIGURE 4

Site No. 6: Groundwater flow direction at Site No. 6 was projected by interpreting data from Sites No. 1, 6, and 7. From this data, it appears that groundwater flows to the southeast at a moderately steep gradient (2.1 feet/100 feet). This evaluation is consistent with local topography and drainage features. Figure 4 of Exhibit I illustrates groundwater flow direction for Site No. 6.

SITE NO.6
165th VEHICLE
MAINTENANCE SPILL AREA
GROUND WATER CONTOURS (07-13-90)
GEORGIA AIR NATIONAL GUARD BASE
SAVANNAH, GEORGIA

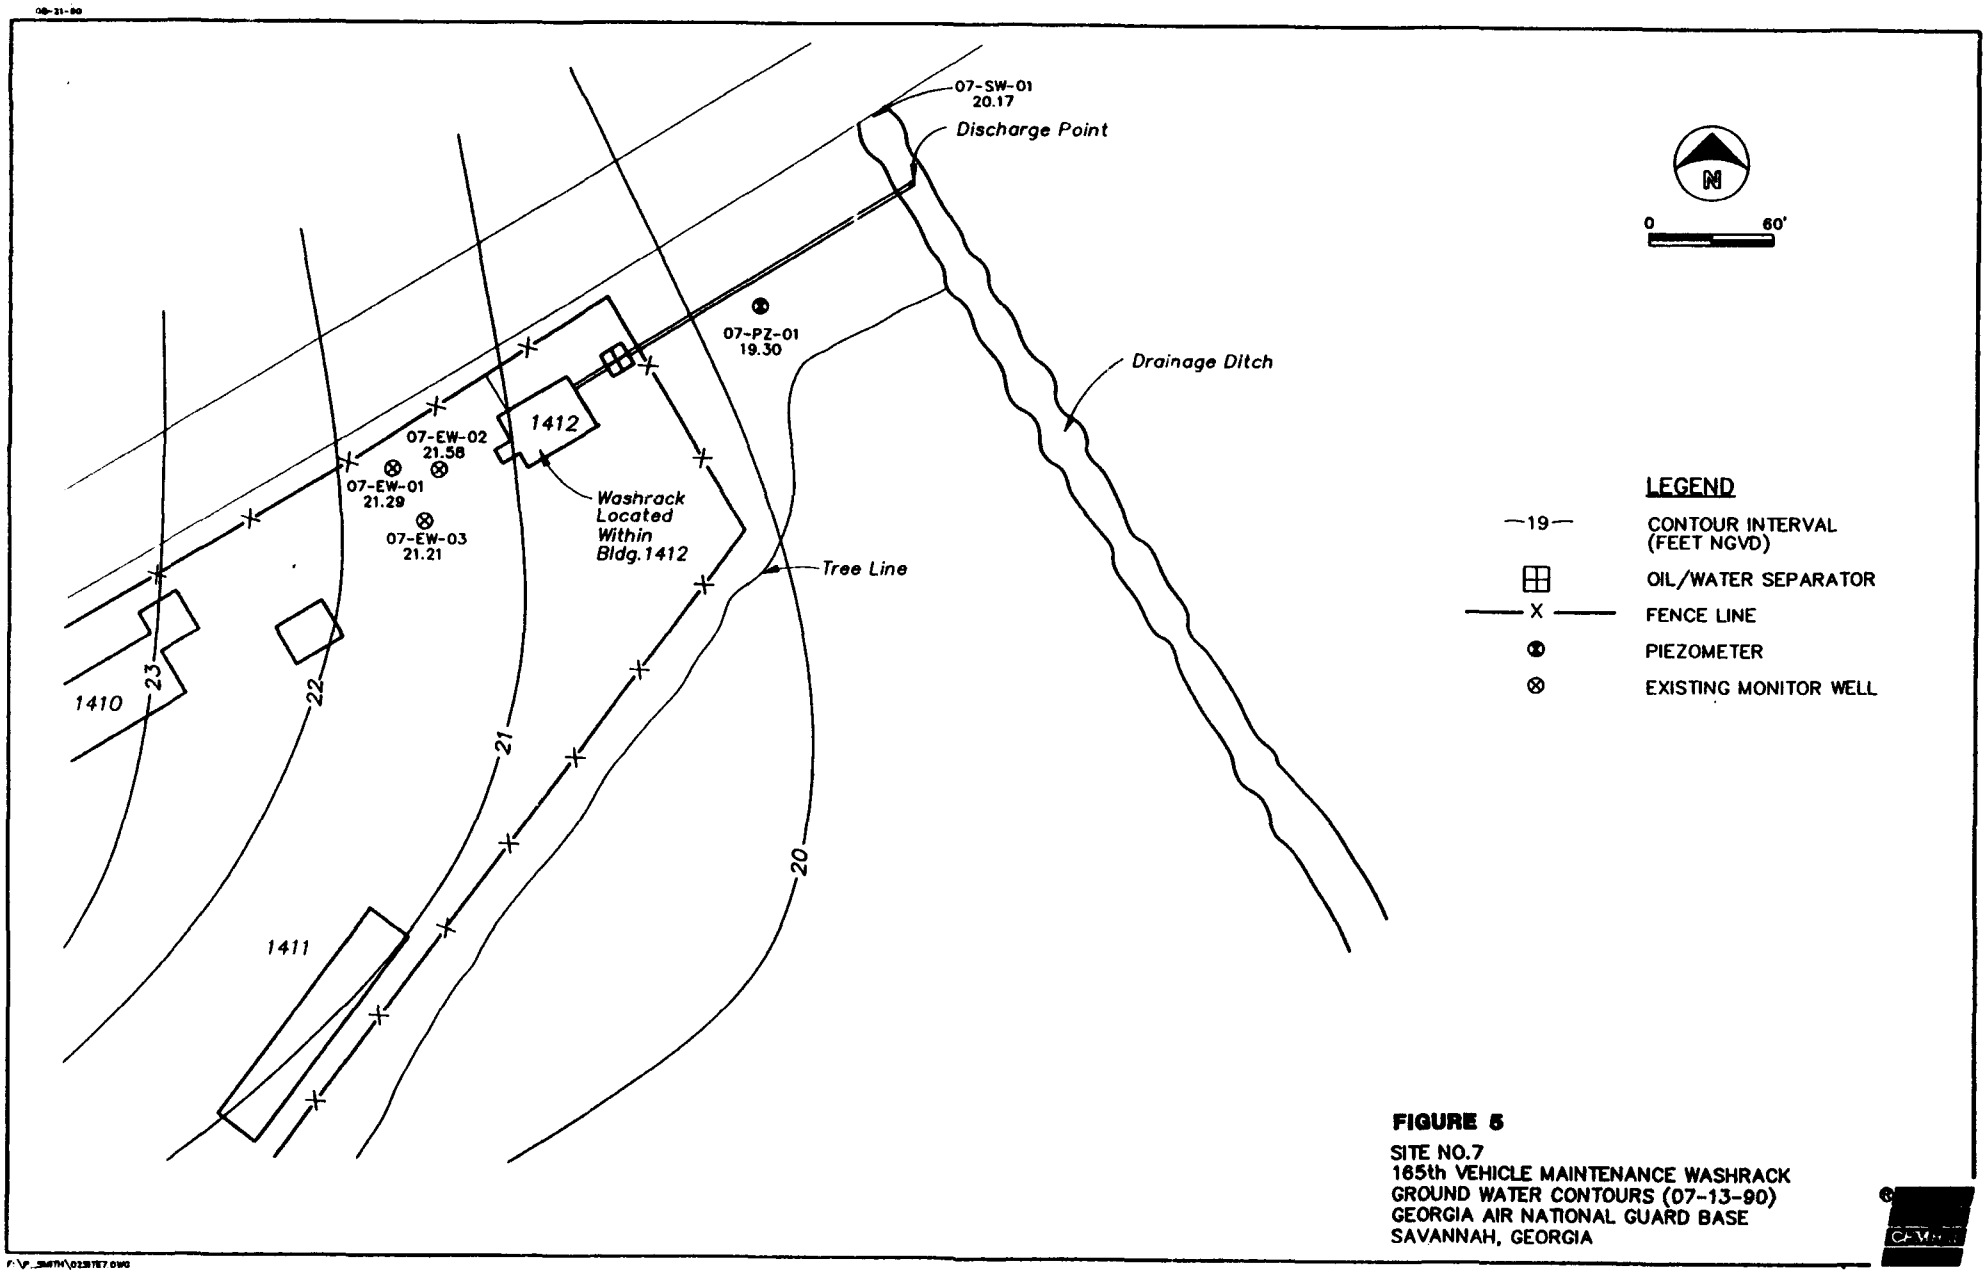
FIGURE 5

Site No. 7: Groundwater flow direction at Site No. 7 was projected by evaluating data from Sites No. 1, 6, and 7. From this data, groundwater appears to flow southeasterly across the site. In the vicinity of the drainage ditch, however, groundwater may move into or out of the ditch depending upon recent stormwater runoff. On July 13, 1990, it appears that water from the ditch was recharging groundwater levels. This observation will be confirmed during future field activities. Figure 5 of Exhibit I illustrates groundwater flow direction for Site No. 7.

SITE NO.7
165th VEHICLE MAINTENANCE WASHRACK
GROUND WATER CONTOURS (07-13-90)
GEORGIA AIR NATIONAL GUARD BASE
SAVANNAH, GEORGIA

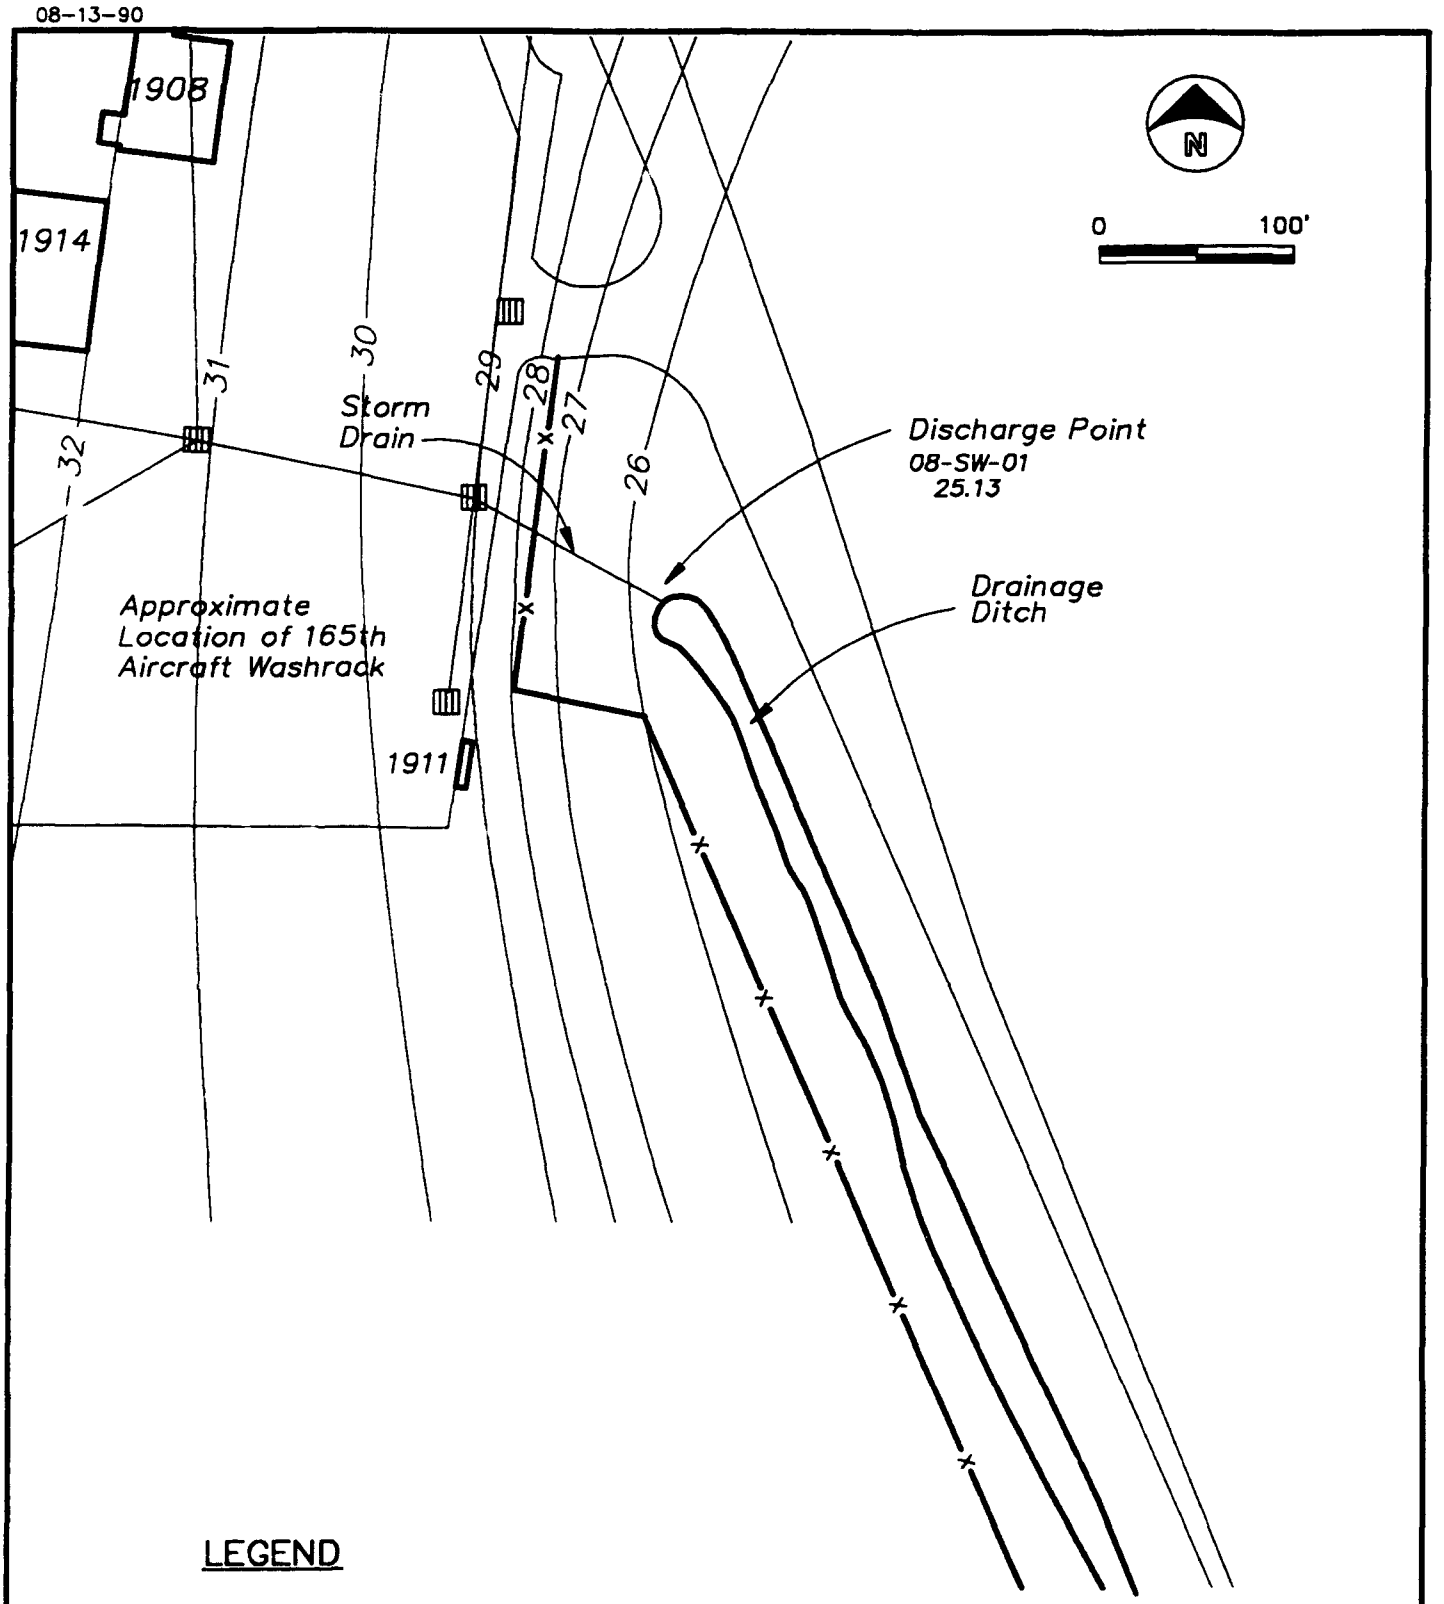
FIGURE 6

Site No. 8: No piezometers were installed at Site No. 8, however, by evaluating surface water elevations and potentiometric data from Site No. 10, it appears groundwater flows to the east-southeast. This projection is consistent with the basic assumption that groundwater flows radially away from the center of the airport and with observations of groundwater entering the ditch. Groundwater at this site appears to be captured by the drainage ditch. Figure 6 of Exhibit I illustrates groundwater flow patterns projected for Site No. 8. It should be noted that the groundwater contours prepared for Site No. 8 are only projections using data from a distant site (No. 10) and a surface water body. Actual conditions may vary significantly and will be depicted more precisely when permanent monitor wells are installed.

SITE NO.8
OLD 165th AIRCRAFT WASHRACK
GROUND WATER CONTOURS (07-13-90)
GEORGIA AIR NATIONAL GUARD BASE
SAVANNAH, GEORGIA

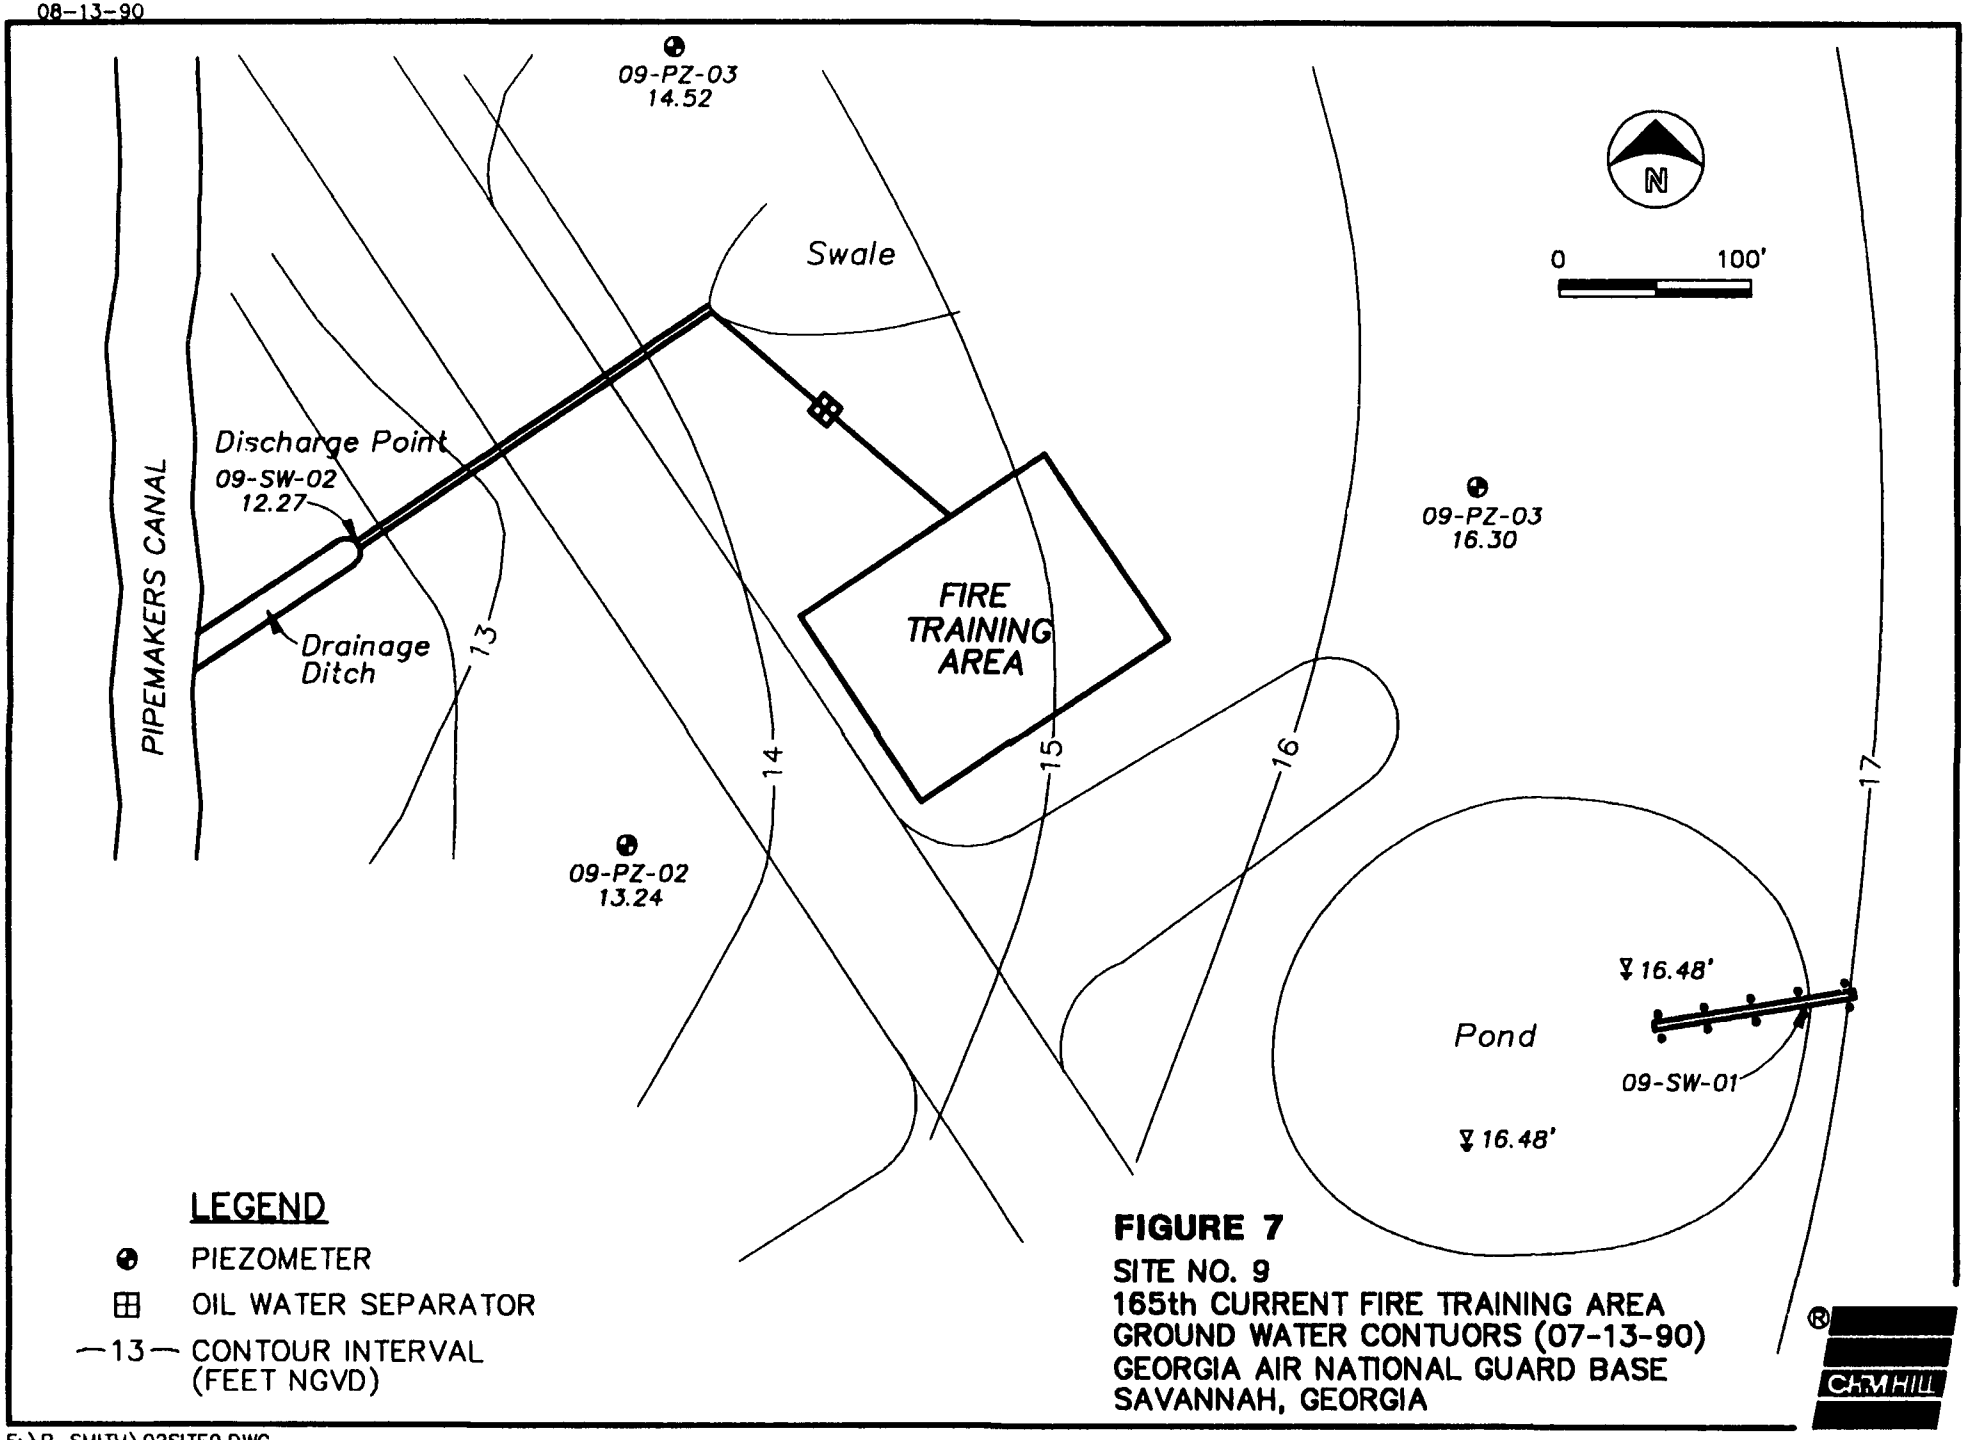
FIGURE 7
SITE NO. 9
165th CURRENT FIRE TRAINING AREA
GROUND WATER CONTUORS (07-13-90)
GEORGIA AIR NATIONAL GUARD BASE
SAVANNAH, GEORGIA

Site No. 9: Groundwater flow direction at this site was determined from data collected from three piezometers and two surface water bodies. From these measuring points it appears that groundwater flows to the west-southwest. Figure No. 7 of Exhibit I illustrates groundwater flow patterns for Site No. 9.

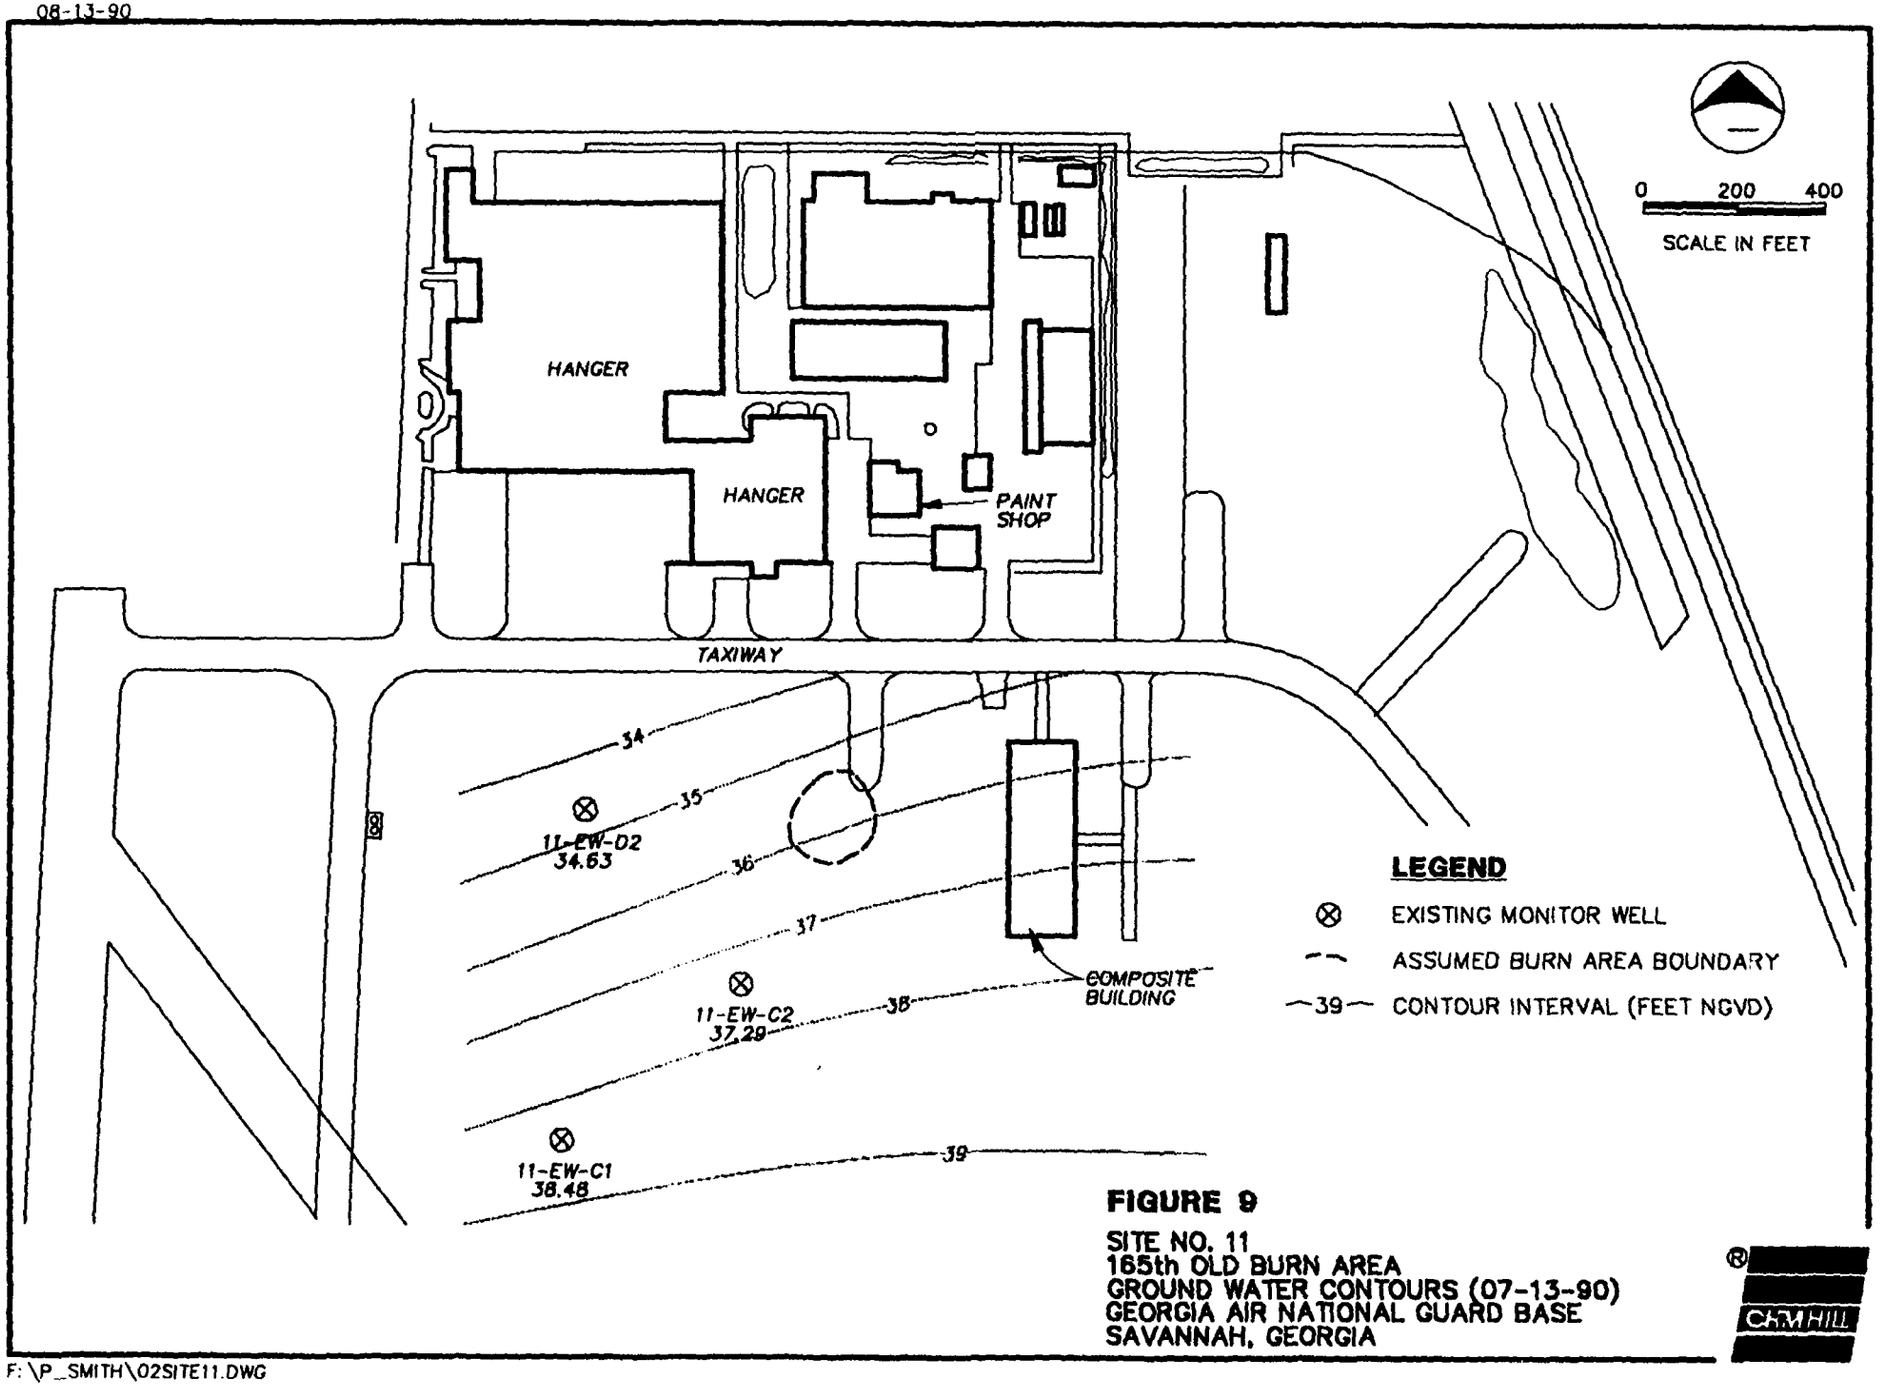
FIGURE 9

evaluation performed in 1984 by another consultant. Figure 9 of Exhibit I illustrates groundwater flow patterns projected for Site No. 11.

SITE NO. 11
165th OLD BURN AREA
GROUND WATER CONTOURS (07-13-90)
GEORGIA AIR NATIONAL GUARD BASE
SAVANNAH, GEORGIA

Site No. 11: The monitor wells at Site No. 11 must be repositioned to replace wells which no longer exist. Of the wells originally installed (during a previous investigation performed by Talbut, Cox, and Associates) only wells B3, C1, C2, C3X and D2 still exist and are in locations which will be useful. Well B3 will now serve as an upgradient (background) well, while Well C3X will serve as a well within of the source. Should Well C3X not be suitable for sampling, the well deleted from Site No. 1 (01-MW-01) will be installed near this location. Additionally, the burn area represents a smaller area than originally depicted. To accurately reflect the smaller area and to compensate for the missing wells, the two new wells will now be installed downgradient of the burn area to the north and west.
