Exploratory Evaluation of Alumina-Ceramic Housings for Deep Submergence Service

Third Generation Housings
Volume 2: Appendices

J. D. Stachiw

Technical Report 1314
September 1989
Revised June 1993
Approved for public release; distribution is unlimited.

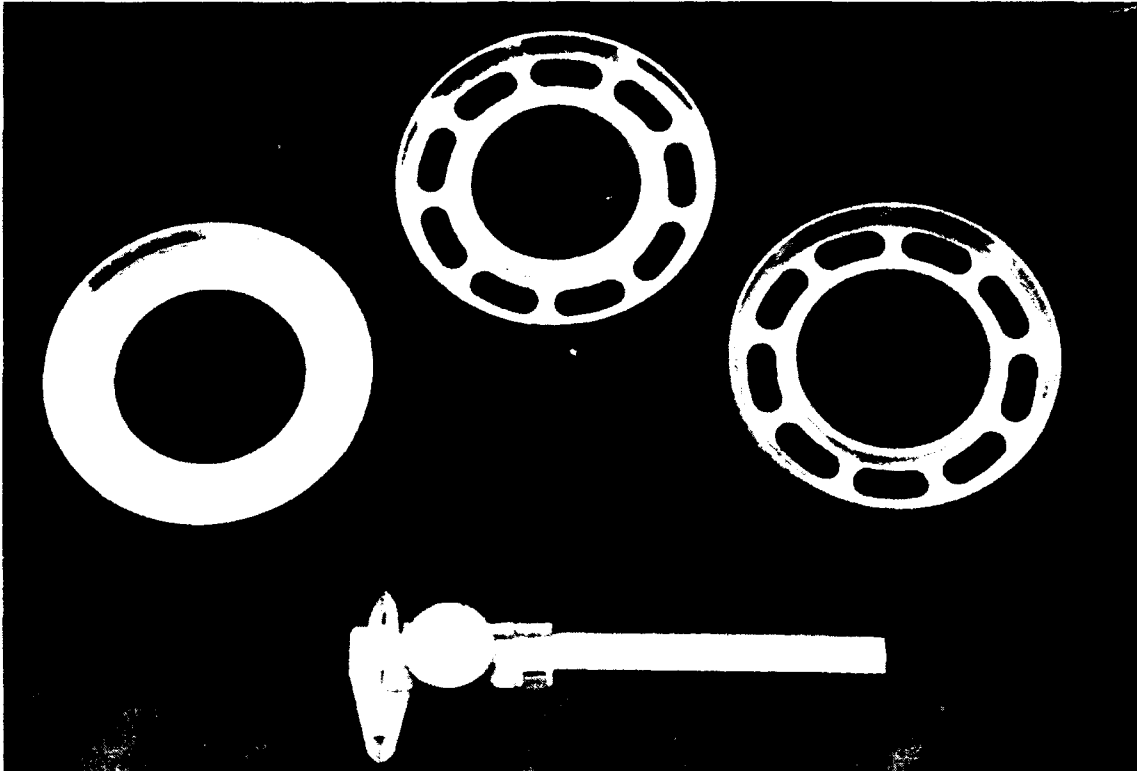
Figure A-35. Internal midbay stiffeners for Type 3 ceramic cylinders. Critical pressure of Type 3 cylinders is 18,000 psi with Mod 0, 9,800 psi with Mod 1, and 15,000 psi with Mod 2 internal stiffeners.

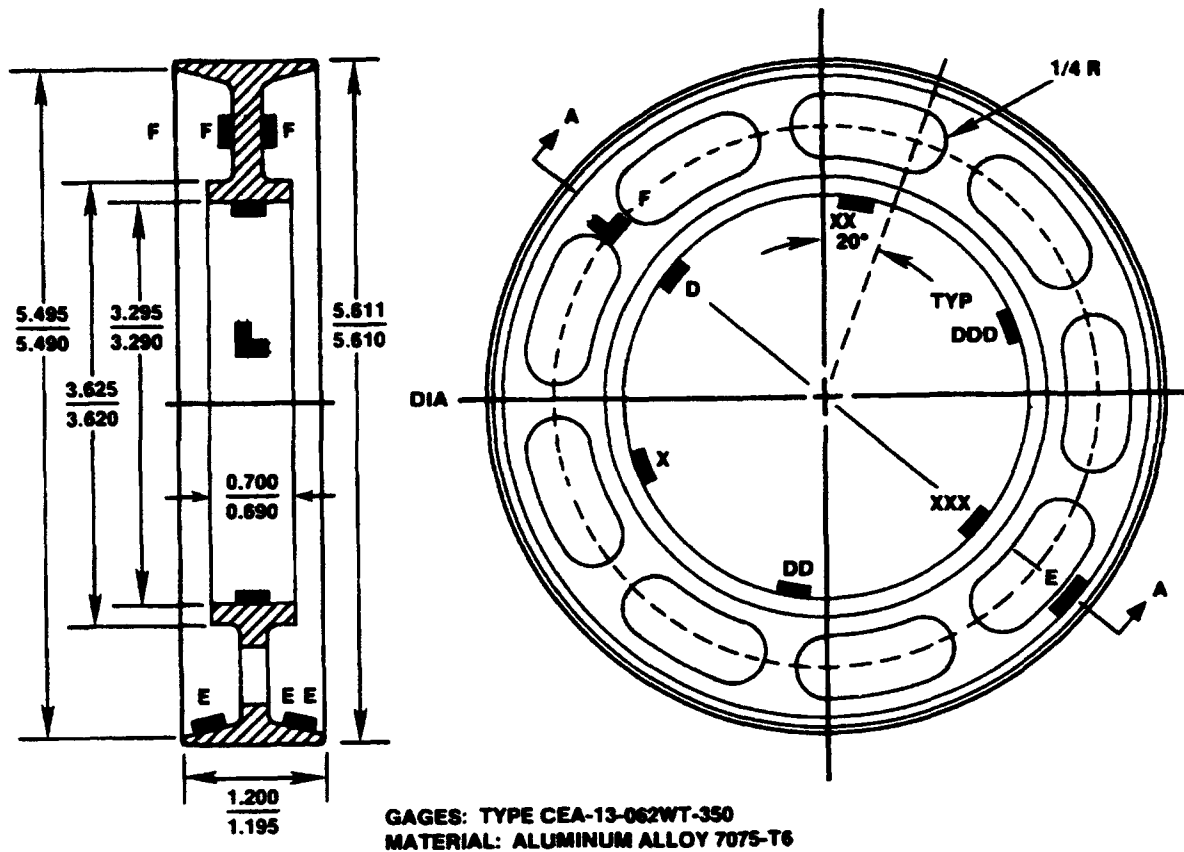
stiffeners (figures A-38 through A-55). The Mod 1 stiffener failed during the proof test by buckling at 9,900 psi (figure A-44), while the Mod 2 stiffener, like Mod 0, passed all the tests successfully.

Figure A-43. Location of strain gages on midbay stiffener Mod 1.

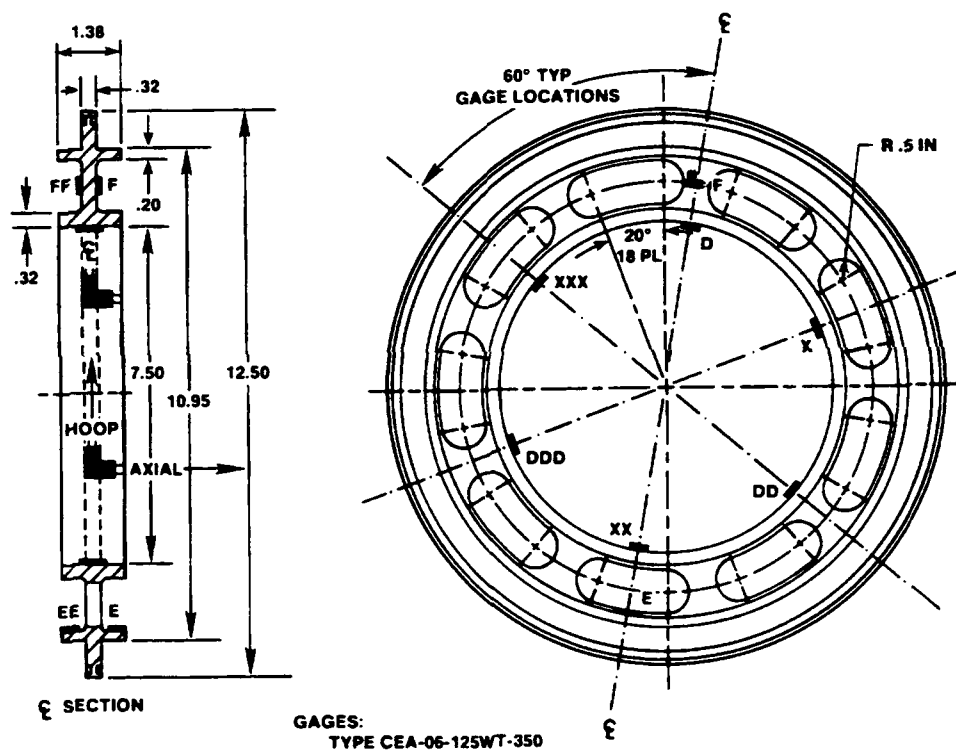
9,910 psi (figure B-44). The strains departed linearity at 7,500 psi external pressure loading. The cause of failure was local elastic buckling of the inner flange under excessively large lightening holes in the web of the stiffener. Because of the excessive long spans between web supports, the inner flange formed a series of lobes between these supports with maximum tensile hoop stresses *under* each web support, and maximum compressive hoop stresses midway between supports. At the moment of failure, the compressive stresses midway between web supports exceeded –85,000 psi.

Figure B-44. Failed ring stiffener DWG 0121604 after implosion of housing test assembly 1C at 9,910 psi.

3. If there is a requirement for holes in the webs of stiffeners to act as feedthroughs for electric cables or hydraulic lines, it should be met preferentially by 18 circular holes of 0.75-inch diameter located uniformly at 20-degree intervals on the web's mean diameter. Only as the last resort should one replace the circular holes with elliptical slots of the same width.

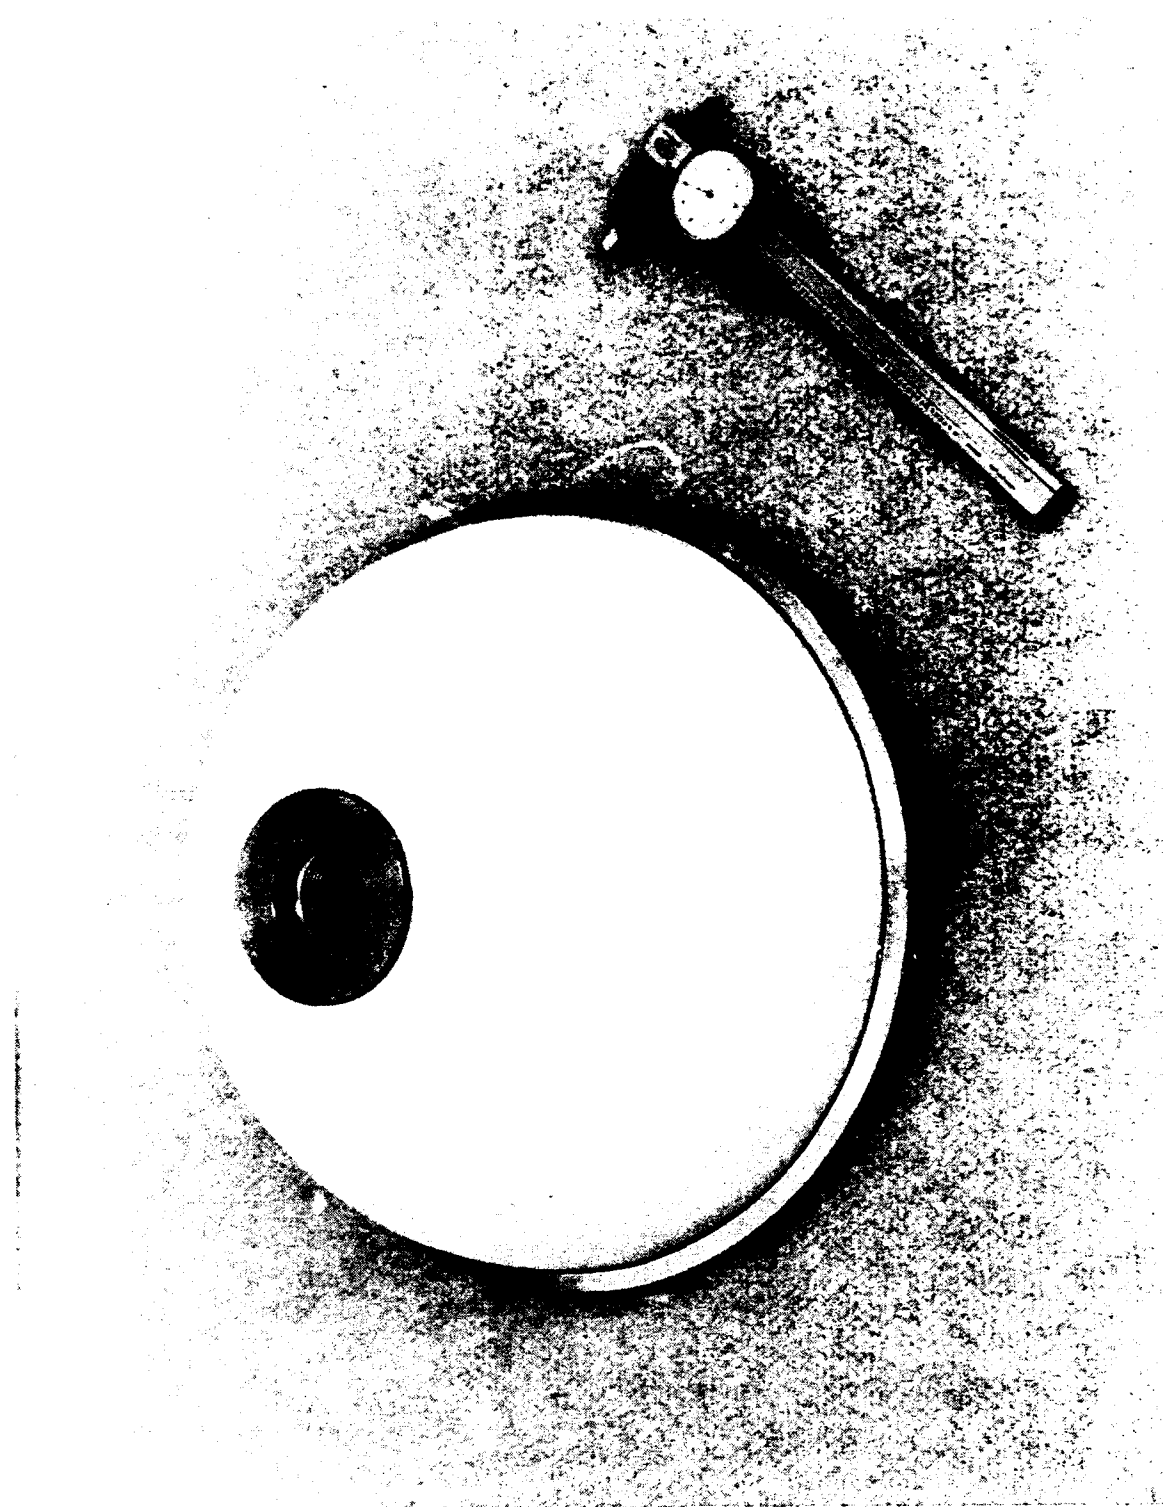
Figure C-31. Ceramic bulkhead assembly Mod 2; exterior view.

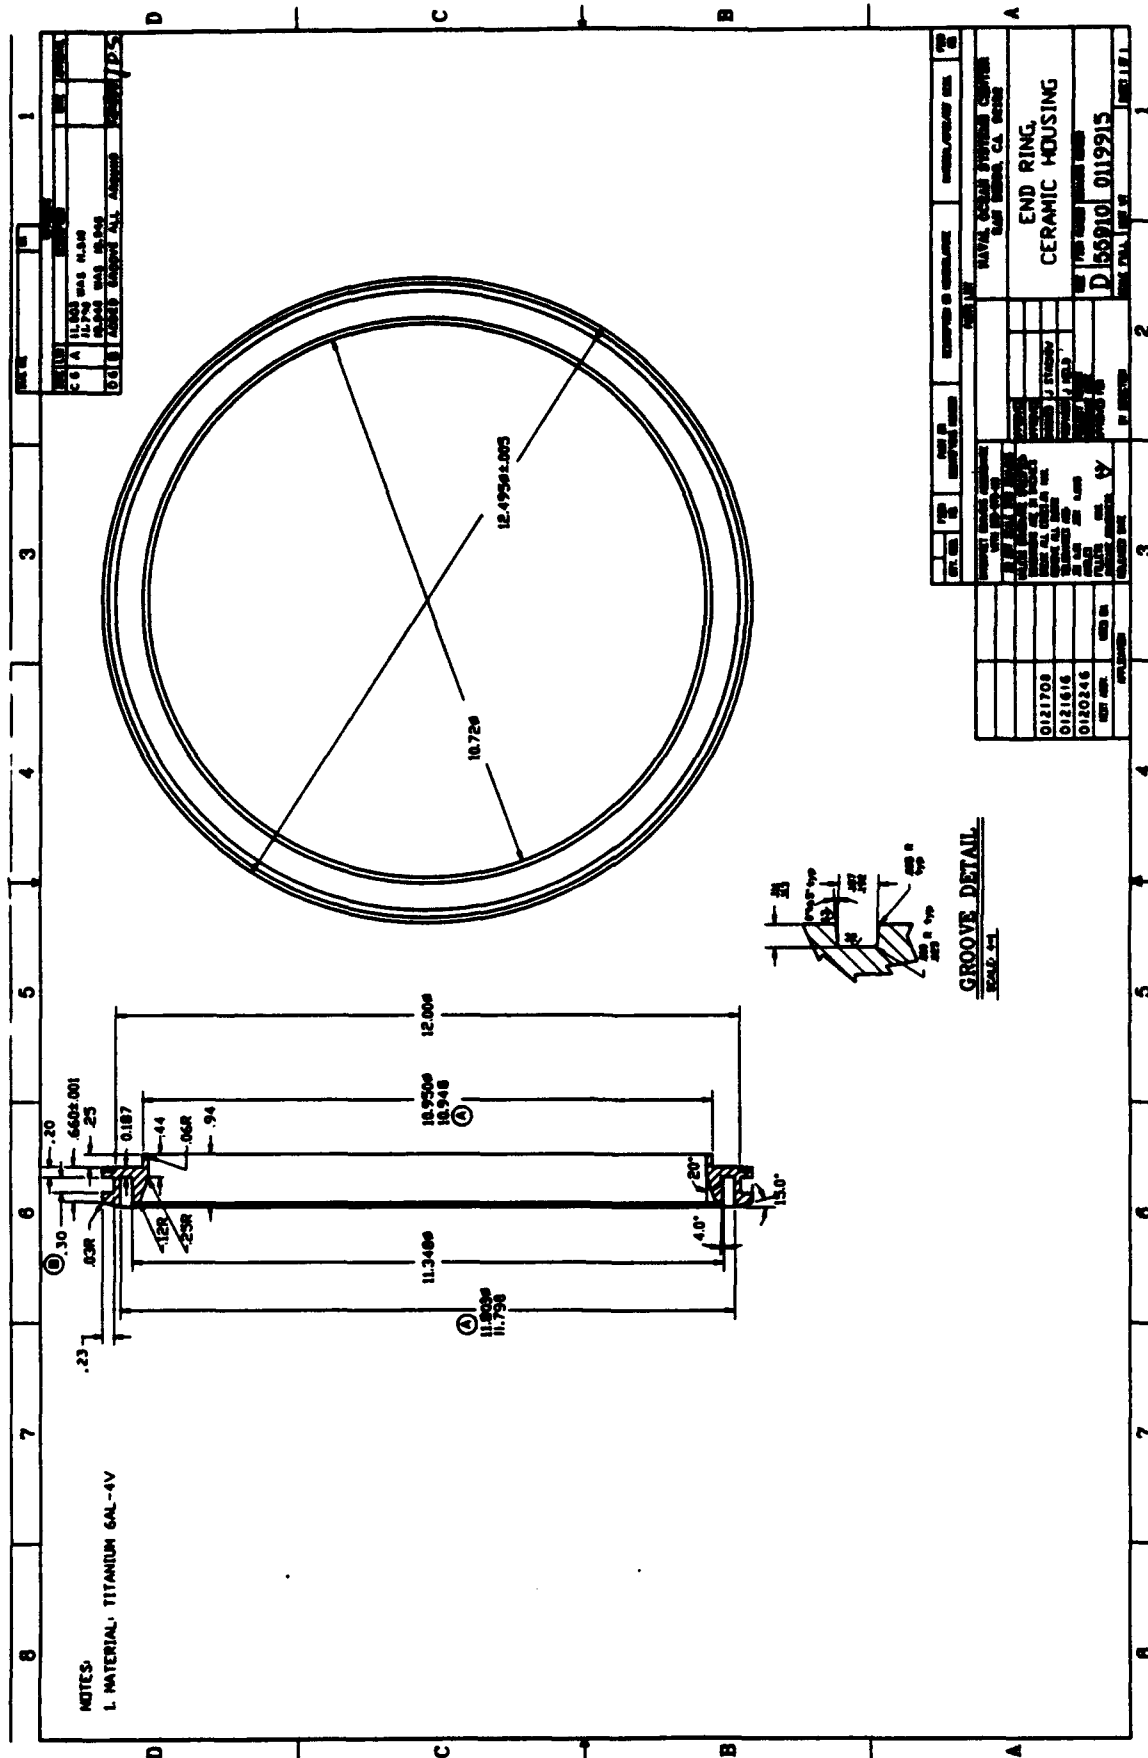
3. *Mod 0 end caps for hemispheres* with flange height $h=2.37t_s$ (where t_s = thickness of spherical shell) do not provide adequate radial support to the ends of the ceramic hemisphere under external pressure loading, generating 134,000-psi axial bearing stress. As a result, spalling of the external spherical surface initiates after about 30 cycles to design pressure.

Figure D-3. End ring Mod 0 for 11.79-inch-OD x 11.37-inch-ID ceramic hemisphere.

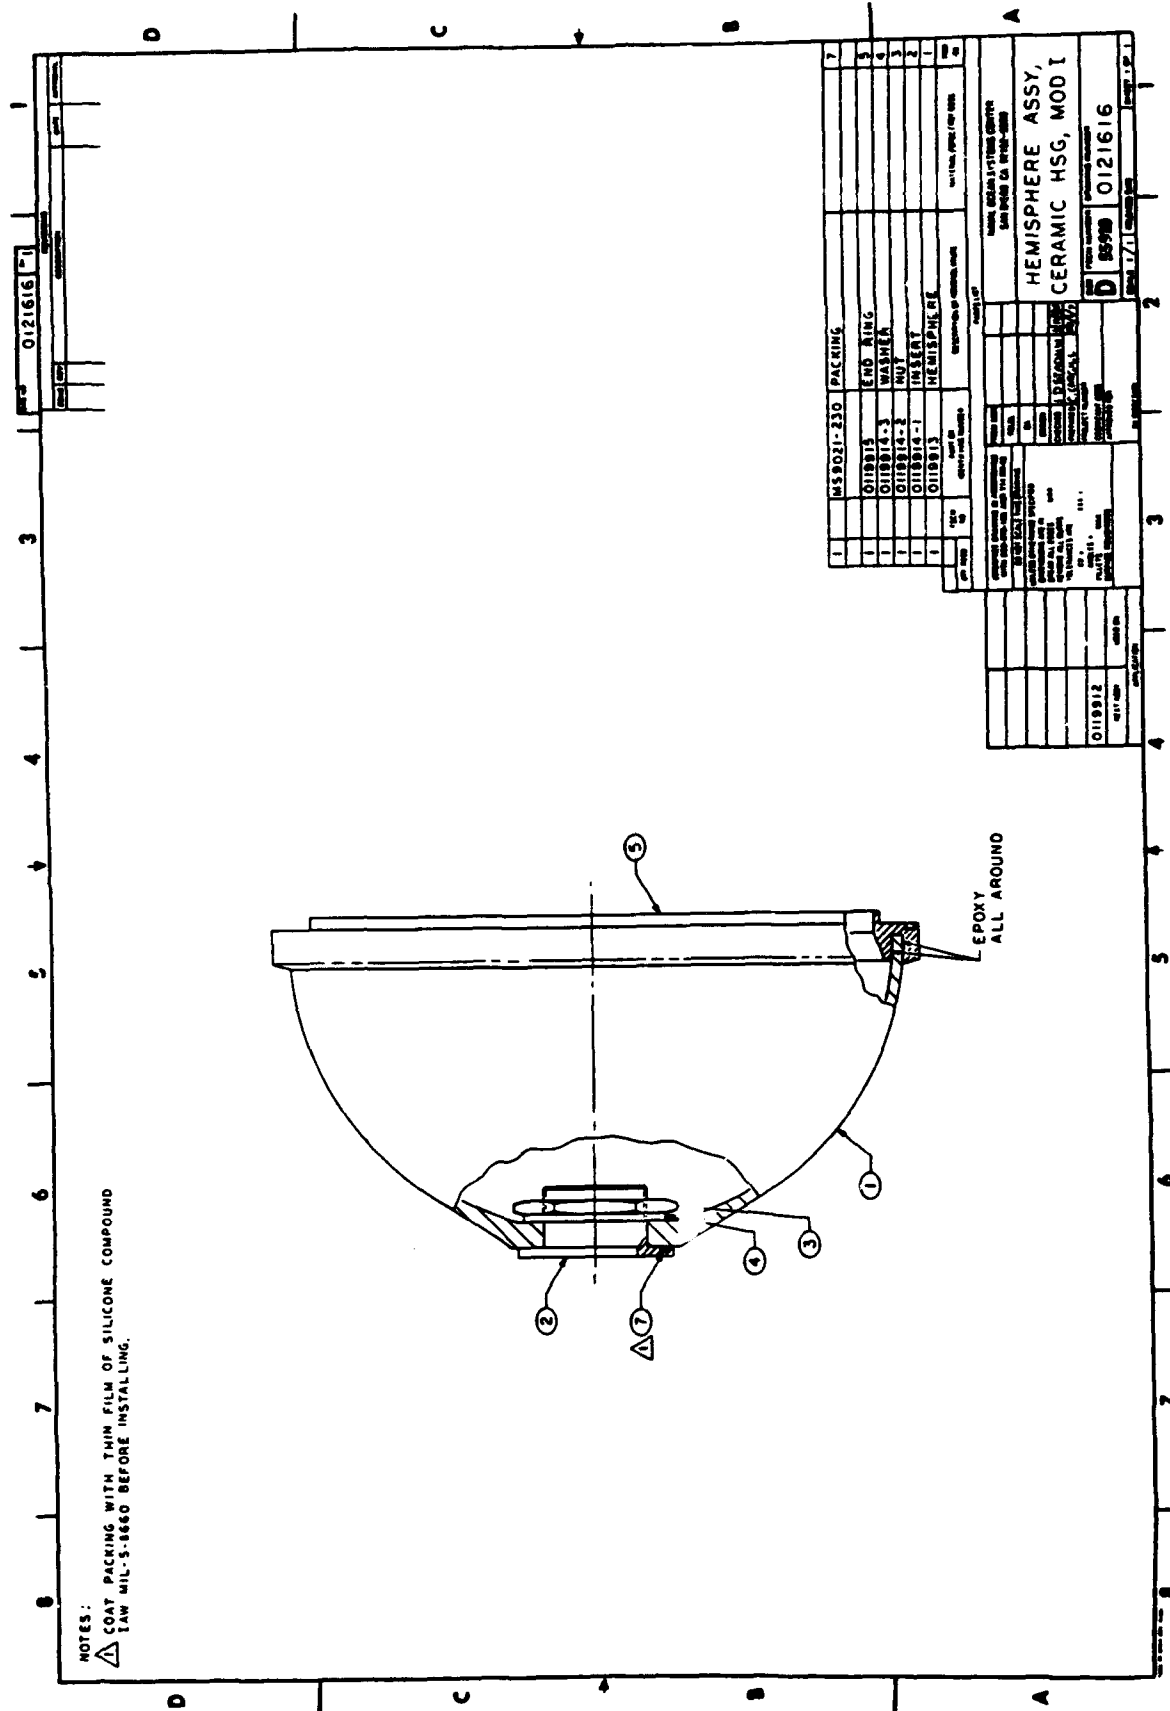
Figure D-5. 12-inch-diameter hemispherical ceramic housing section equipped with Mod 1 end ring.

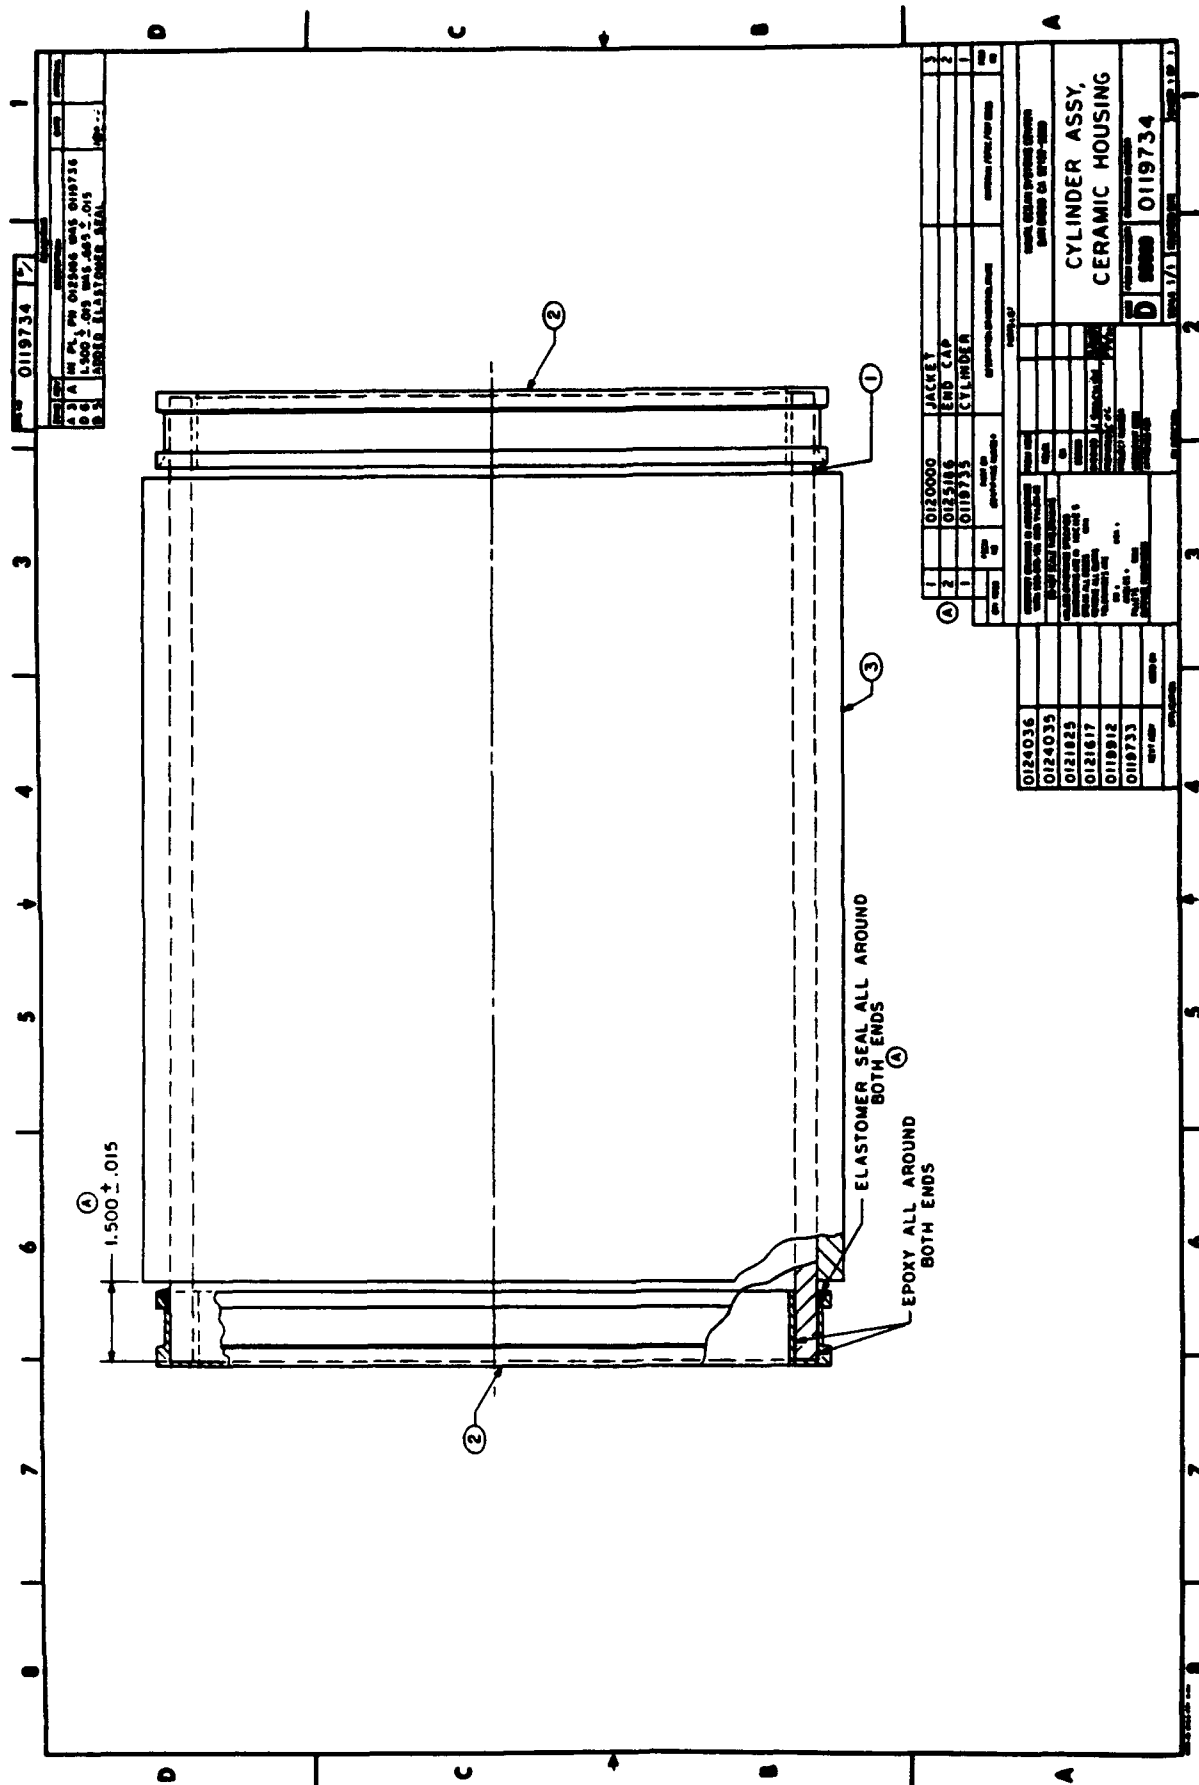
To experimentally validate the beneficial effect of extending the height of the flanges on Mod 1 end caps, a single 12-inch-diameter cylinder (cylinder #1) was equipped with Mod 1 end caps (figure D-8), mated with titanium hemispherical bulkheads, and cycled to 9,000-psi design pressure. The cycling was terminated after 500 cycles without any visual evidence of external spalling. Ultrasonic NDT performed by through-transmission techniques did not detect any internal delaminations extending above the flanges (appendix E).

Figure D-8. 12-inch-diameter cylindrical ceramic housing section equipped with improved Mod 1 end caps.

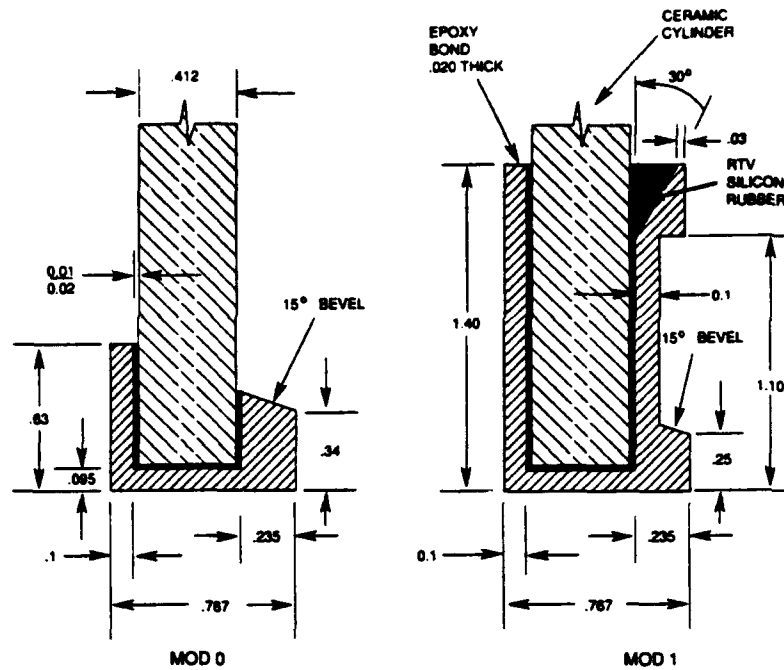
Figure D-9. Comparison of dimensions on Mod 0 and Mod 1 end caps for 12-inch-diameter ceramic cylinders.

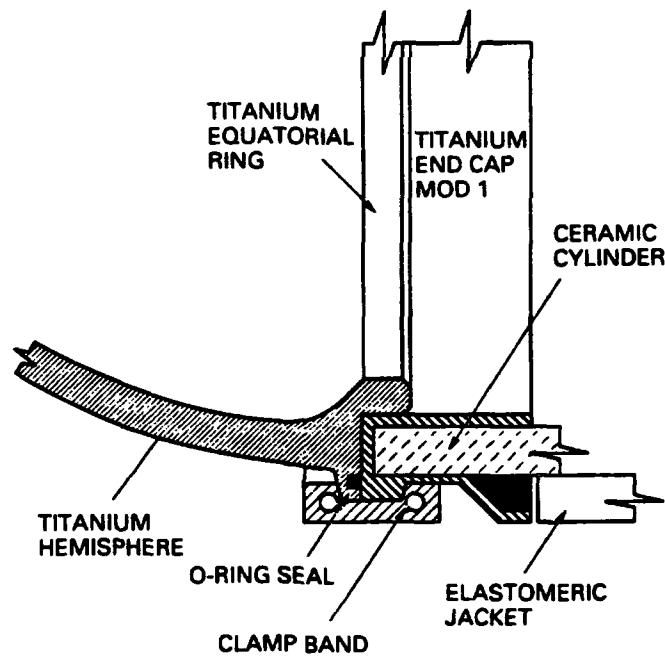
Figure D-10. Configuration of joint between titanium hemisphere and 12-inch-diameter ceramic cylinder equipped with Mod 1 end cap.

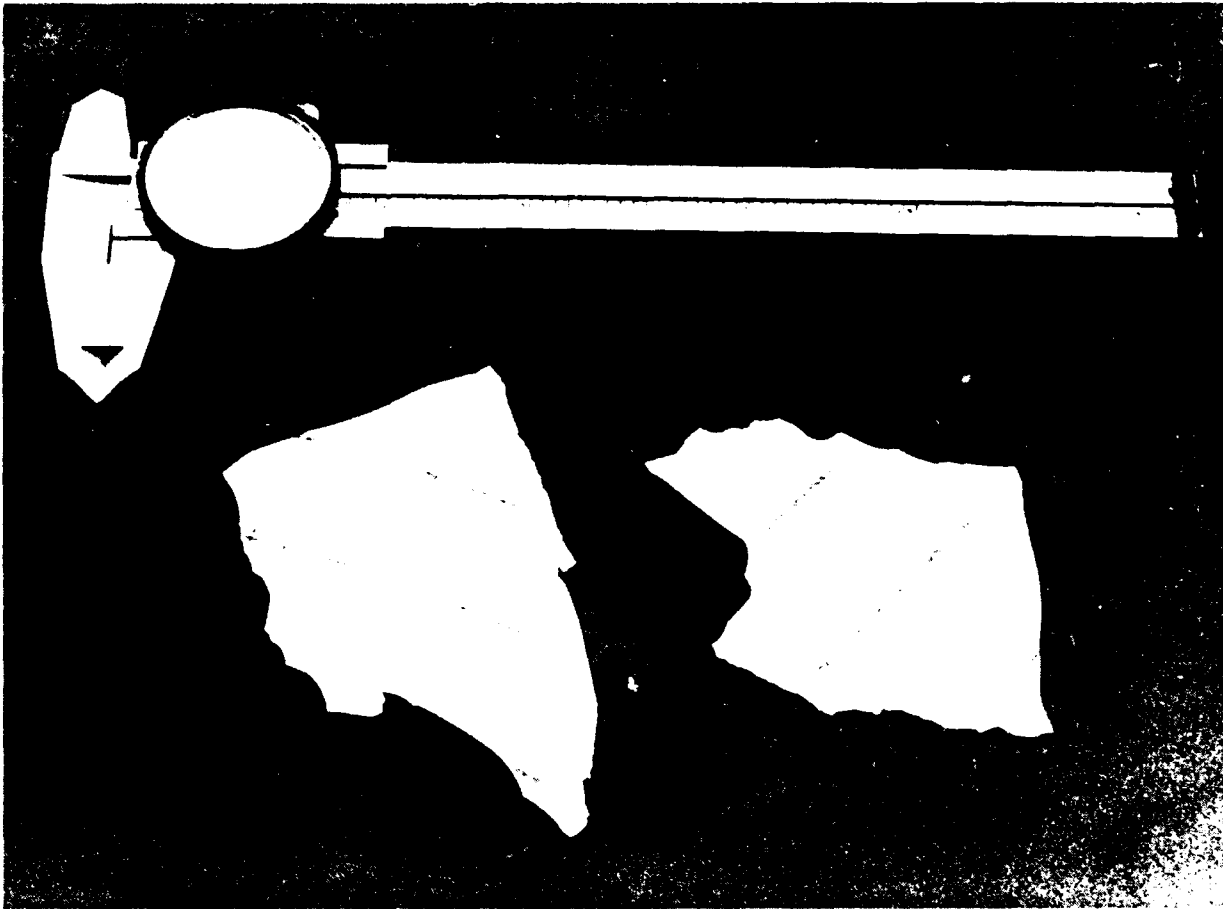
Figure E-4. Typical spall fragments from 12-inch-diameter ceramic cylinders. The fragments are approximately 0.06 inch thick.

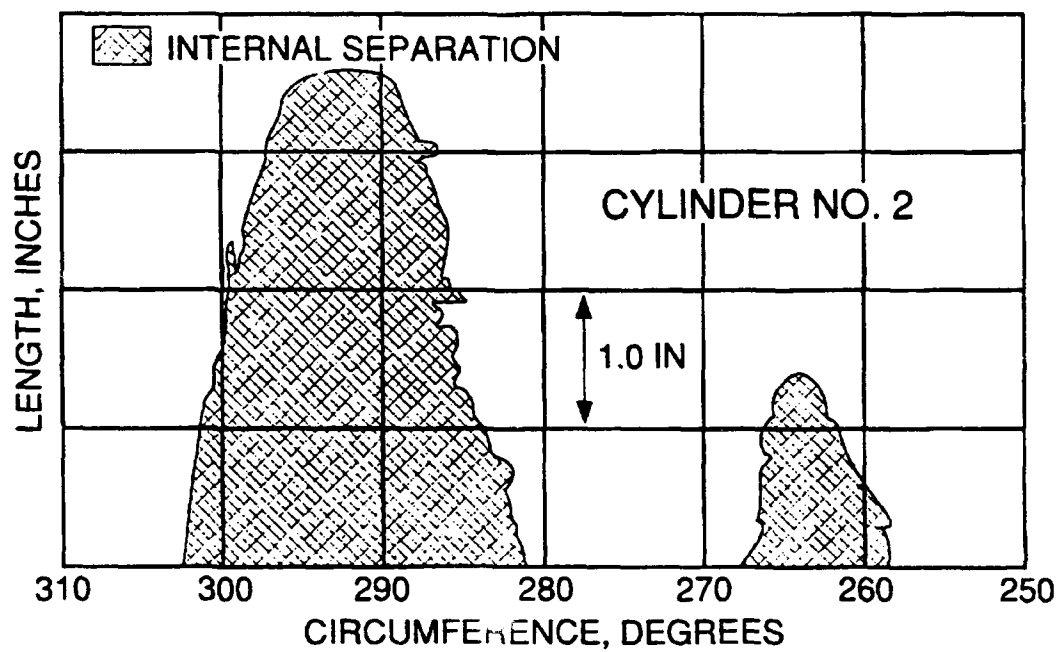
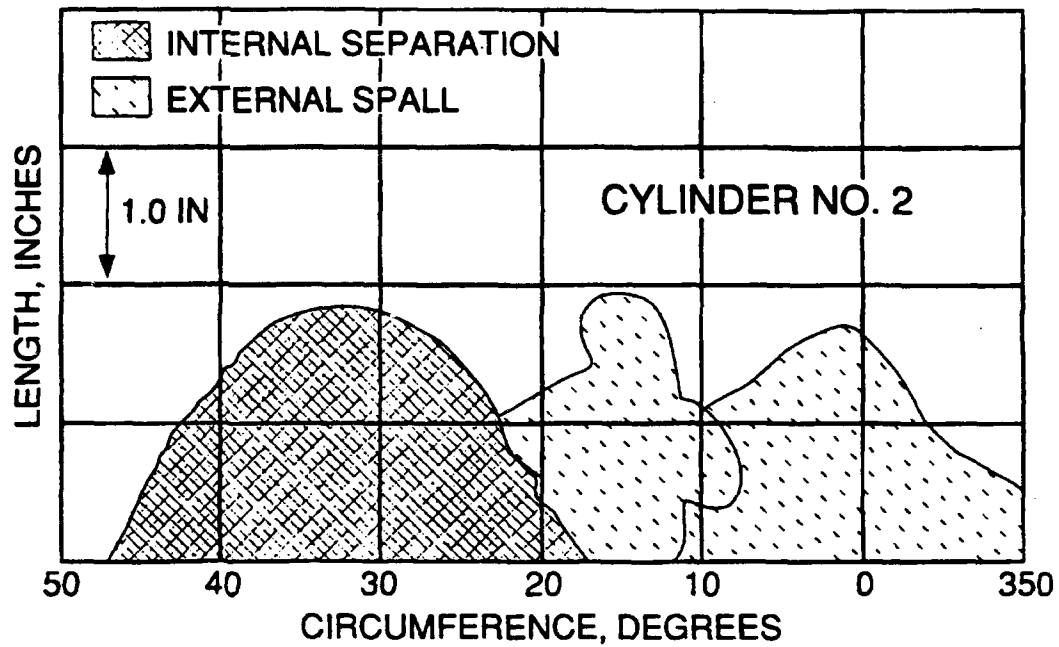
Figure E-5. Ultrasonic C-scan of spalled and delaminated areas above the end cap on cylinder #2.

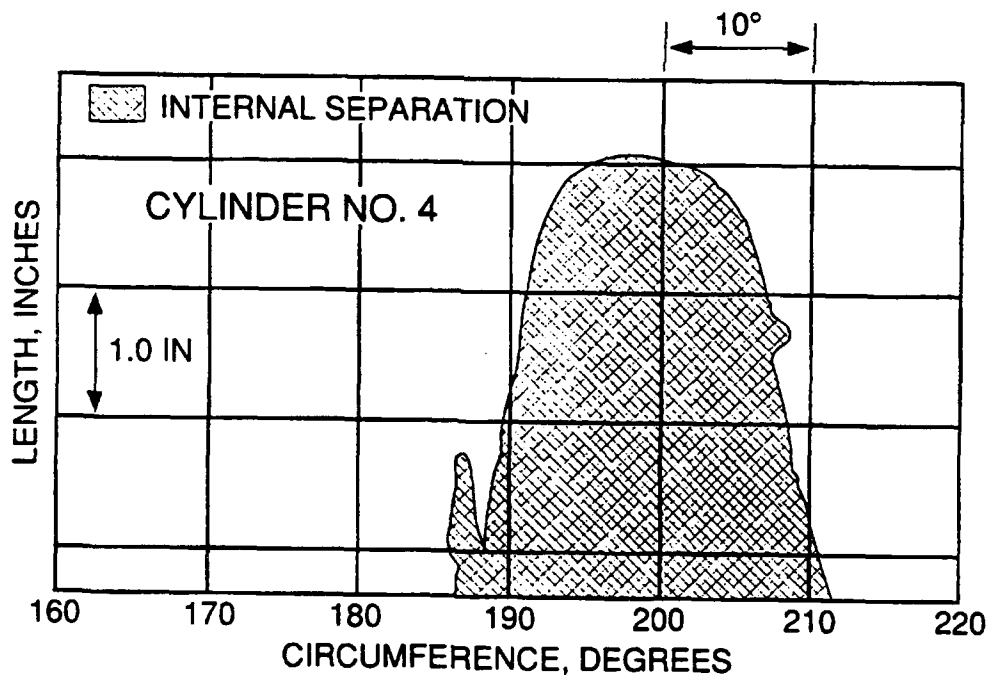
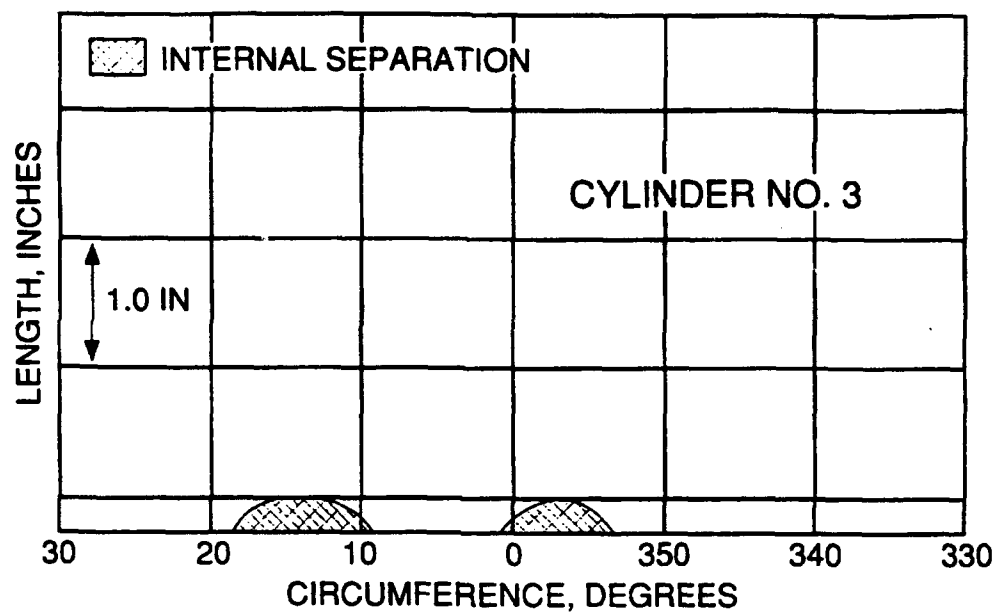
Figure E-6. Ultrasonic C-scan of spalled and delaminated areas above the end cap on cylinders #2, #3, and #4.

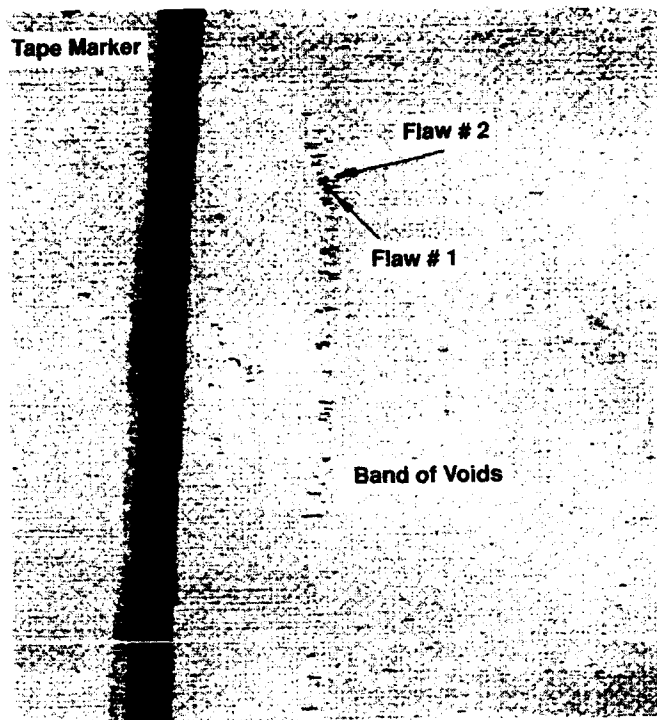
Figure E-7. Ultrasonic C-scan of cylinder #1. Note the narrow band of indications detected with 10 MHz through-transmission.

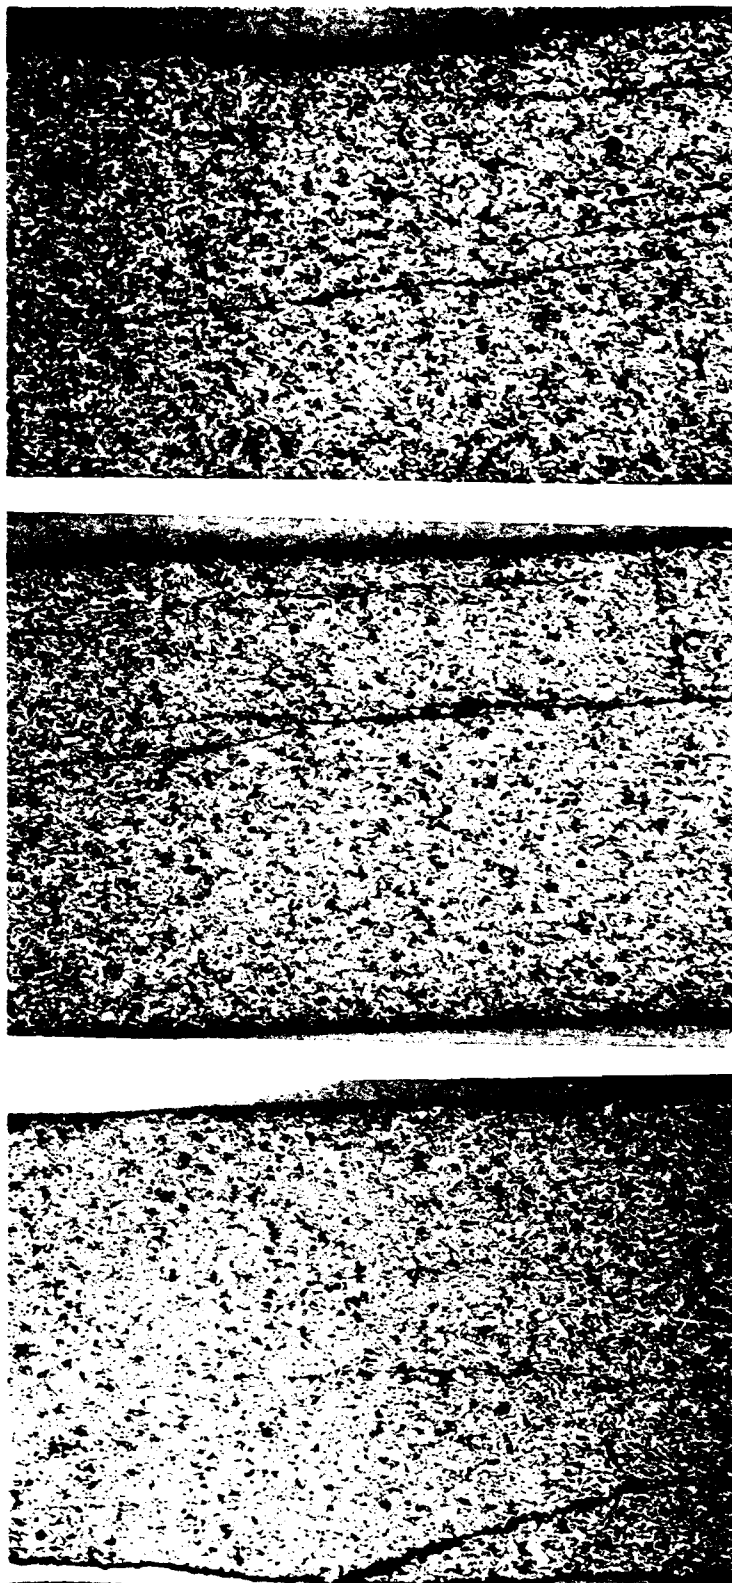
Figure E-13. Photomicrographs of plane bearing surfaces on ceramic spalls from cylinder #4. Note that the predominant orientation of cracks is circumferential.

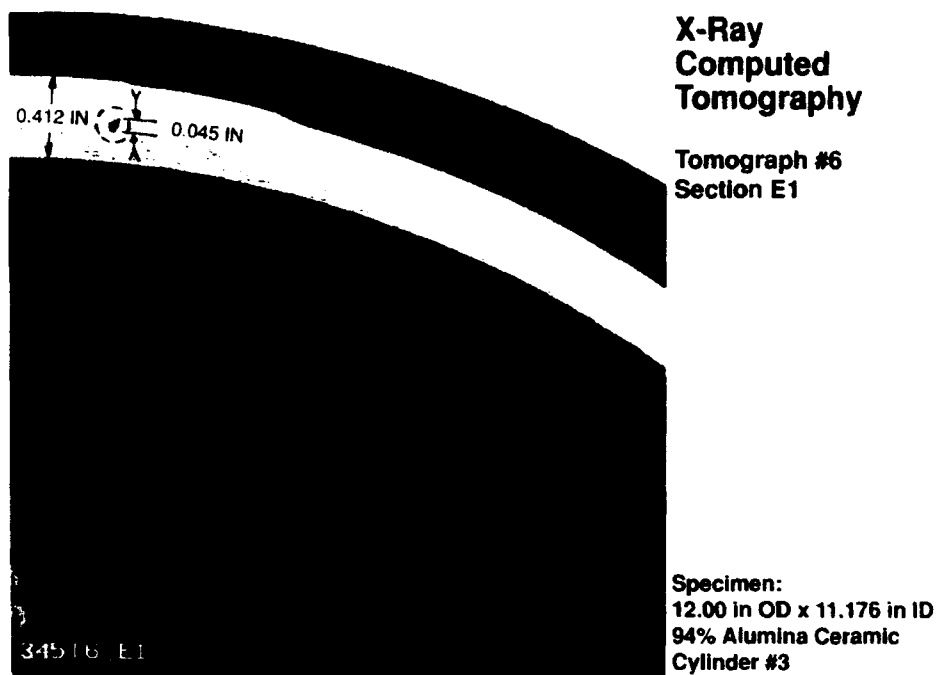
Figure E-16. RCT slice through a large flaw in cylinder #3. The measured size of indication cross section is 0.045 inch. The SAM indication of this flaw is shown in figures E-11 and E-12.

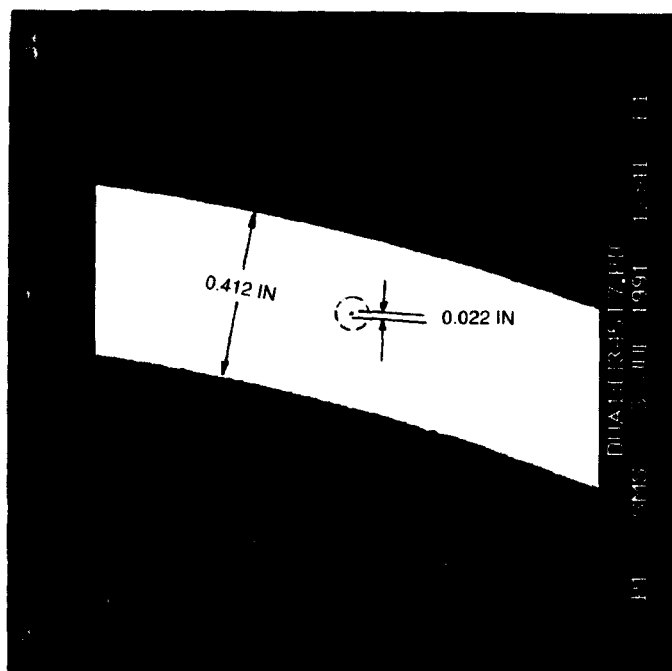
Figure E-17. Enlarged image of RCT slice shown on figure E-16.

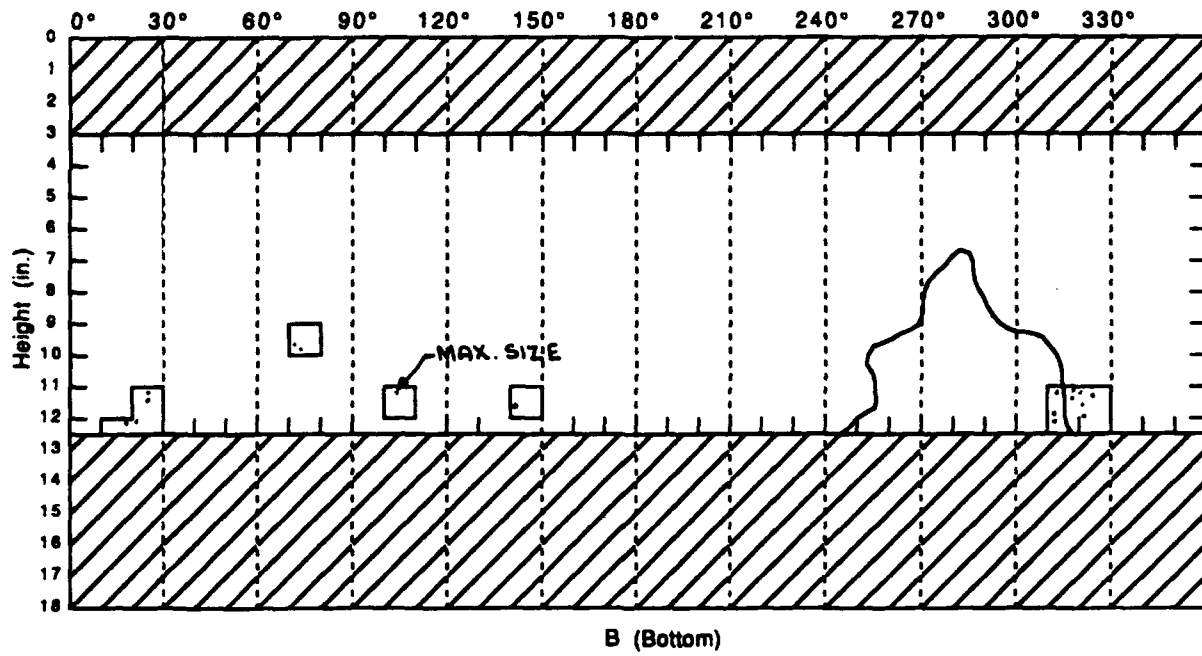
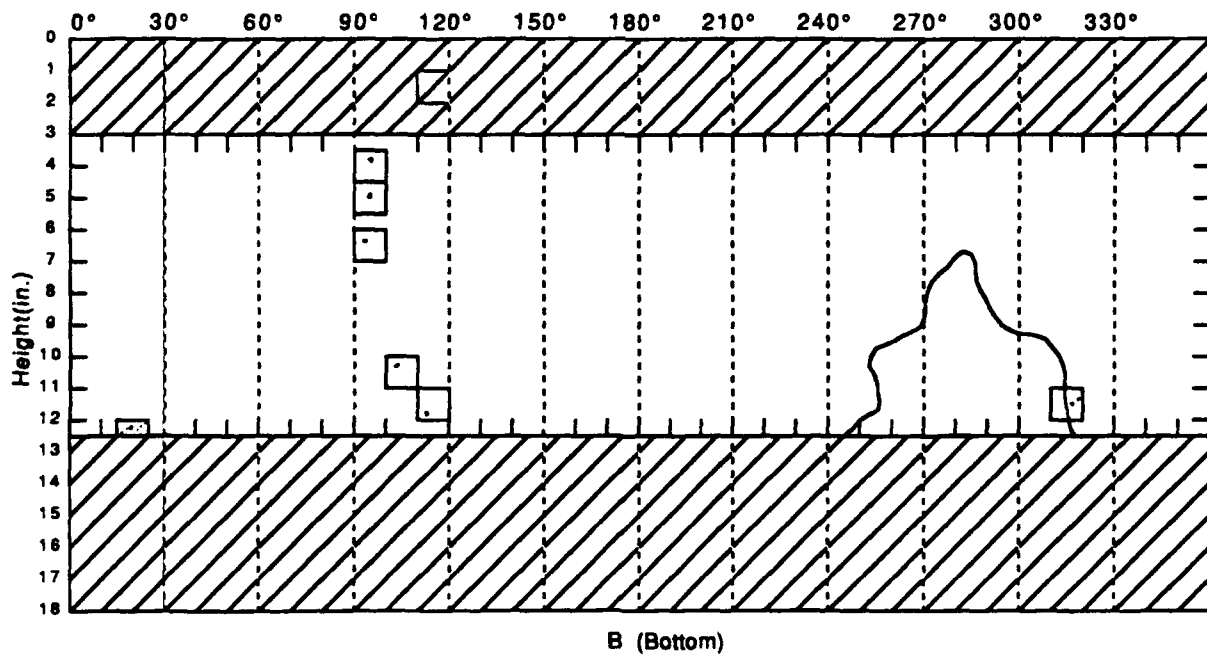
Figure E-22. Indications of flaws detected by film radiography of cylinder #3.

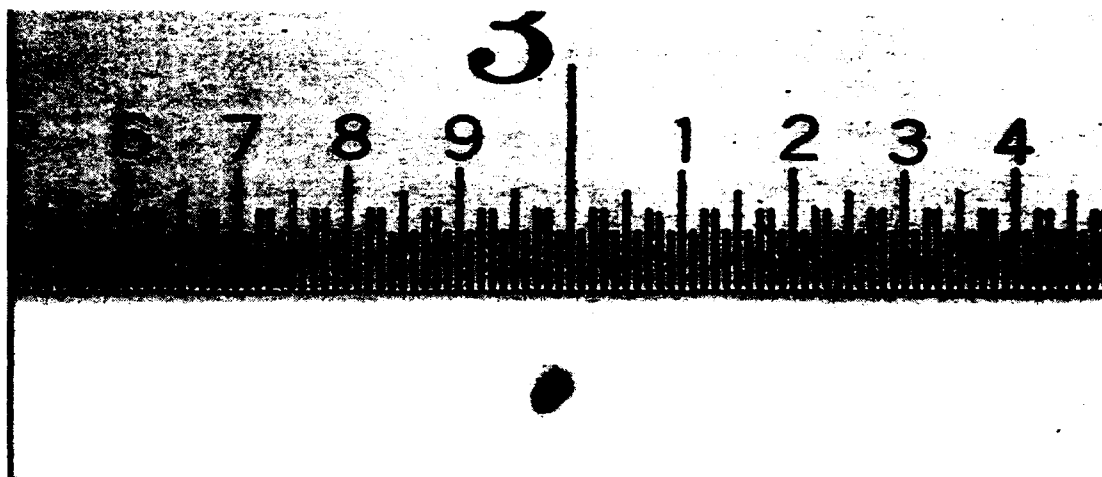
C.
11", 140°, 0.046"

Figure E-25. Subsurface flaws C and D uncovered by grinding away external surface of cylinder #3.

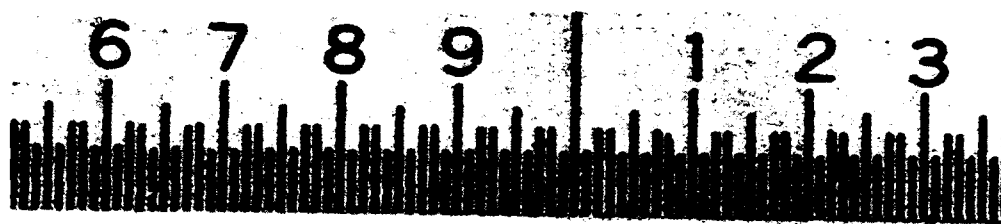
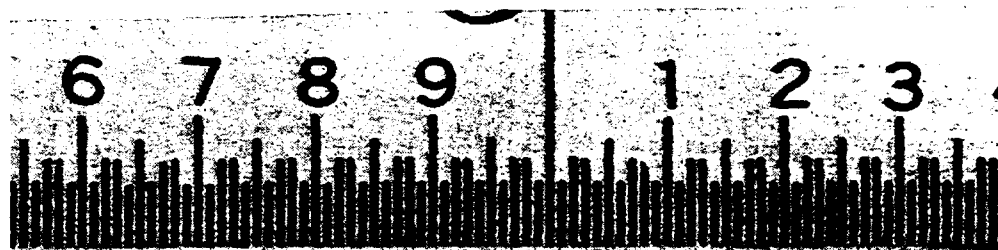
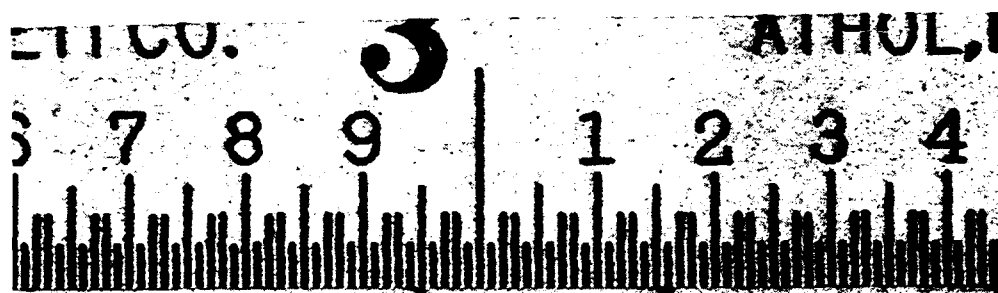
G.
12.25", 20°, 0.140"

G.
12.25", 20°, 0.148"

G.
12.25", 20°, 0.150"

Figure E-26. Flaw G cross section uncovered during incremental removal of material from exterior surface of cylinder #3. Note the irregularity of the flaw shape.
