Exploratory Evaluation of Alumina-Ceramic Housings for Deep Submergence Service

Third Generation Housings
Volume 2: Appendices

J. D. Stachiw

Technical Report 1314
September 1989
Revised June 1993
Approved for public release; distribution is unlimited.

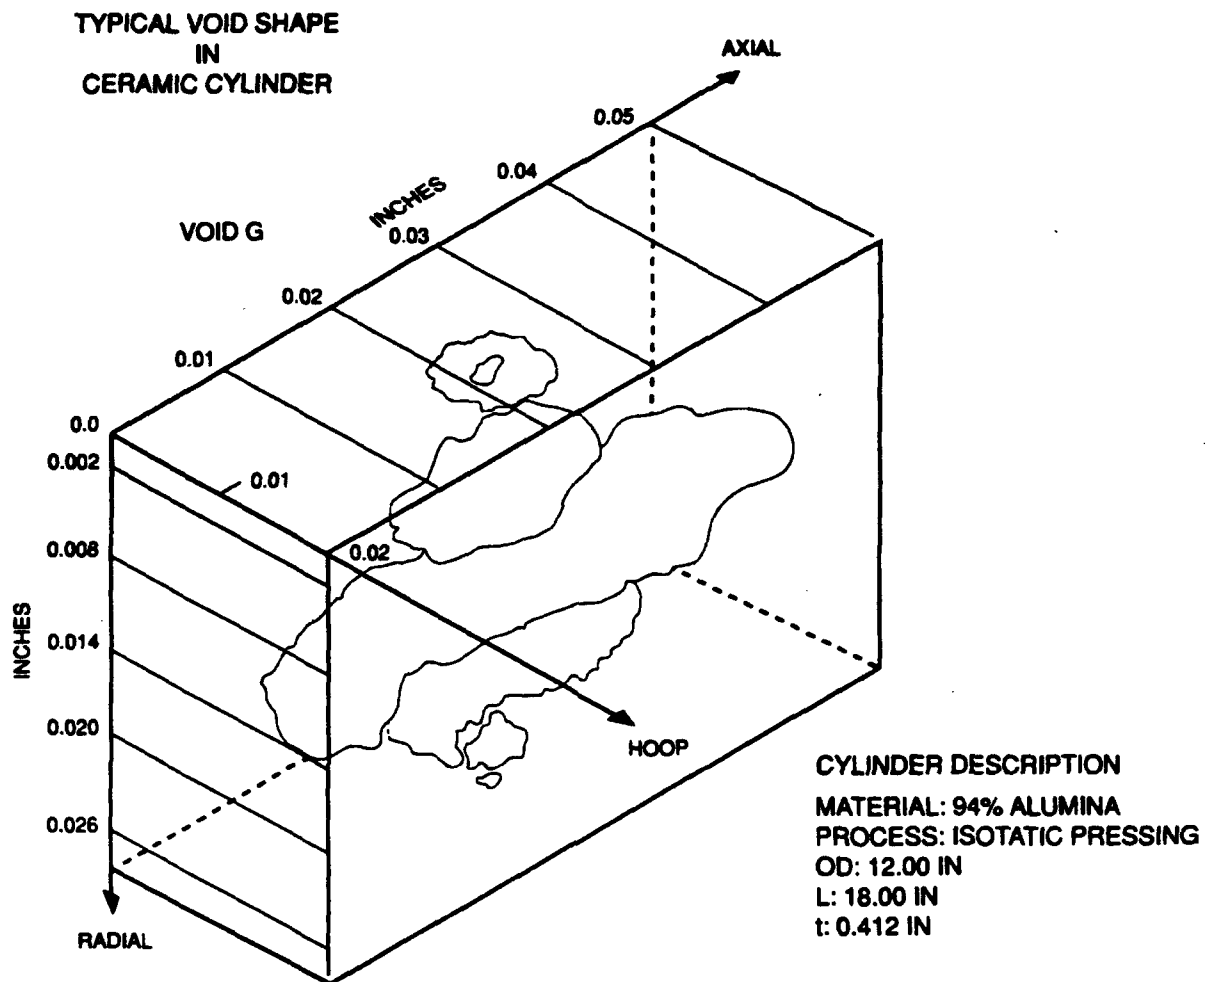
Figure E-28. Three-dimensional reconstruction of a typical flaw on the basis of cross section images uncovered during successive passes of the grinding wheel. Note that the irregularity of the flaw shape makes it impossible to analyze its crack initiation potential by analytical approaches of fracture mechanics.
