DEVELOPMENT OF REPAIR PROCESSES AND SOURCES FOR C/KC-135 AIRCRAFT WINDOWS/WINDSHIELDS

RICHARD J. OLSON

SEPTEMBER 1994

TECHNICAL REPORT FOR 09/91 - 01/94
C/KC-135 FINAL REPORT
CONTRACT NUMBER FO9603-90-D-2217-SD02

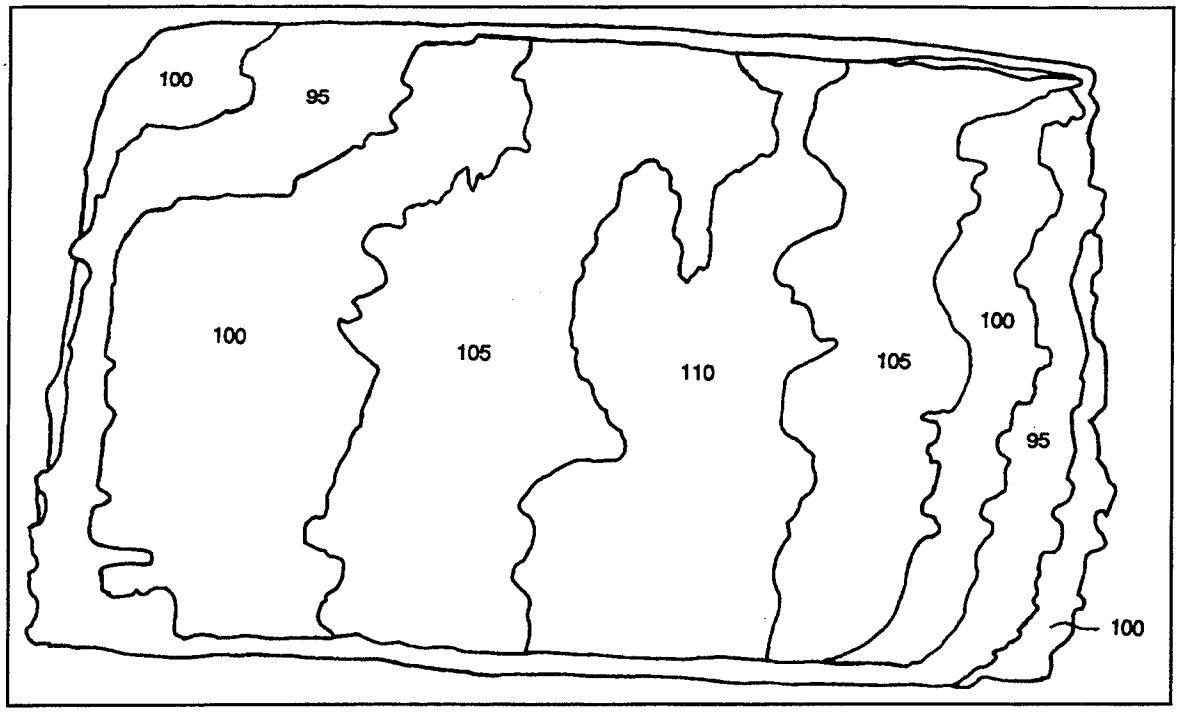
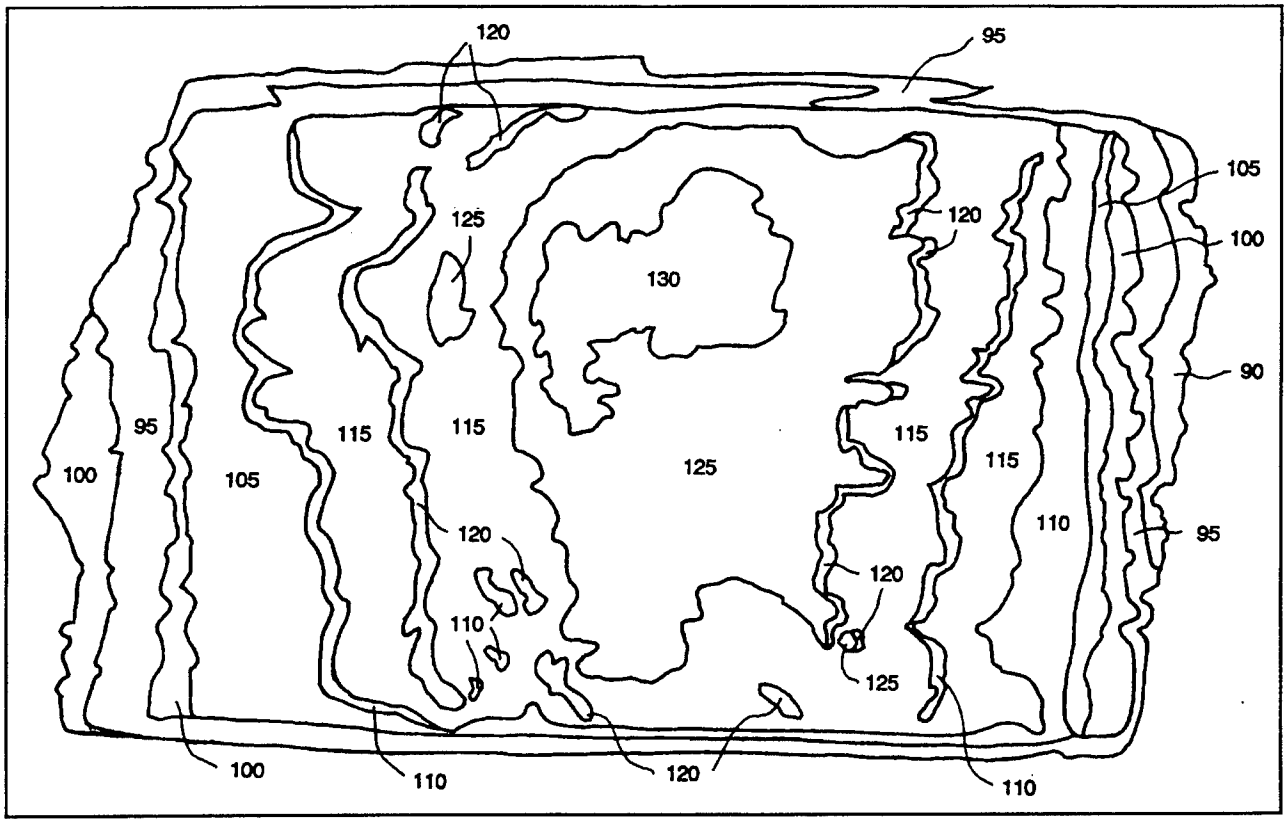
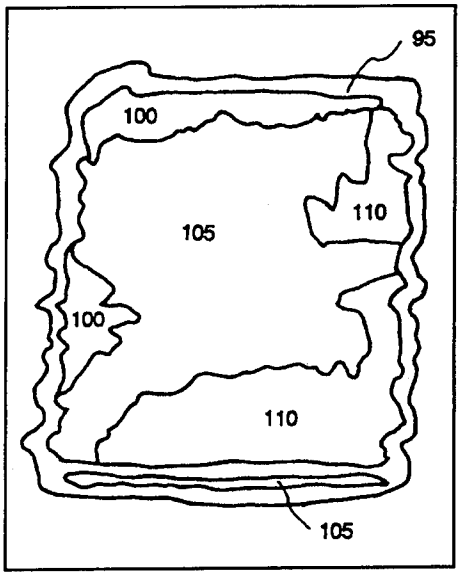
a) Typical (S/N 86-H-10-06-062)

b) Most Out-of-the-Ordinary (S/N 82-H-9-6-537)

Figure 4.1 C/KC-135 #1 Thermal Images From the Heater Test

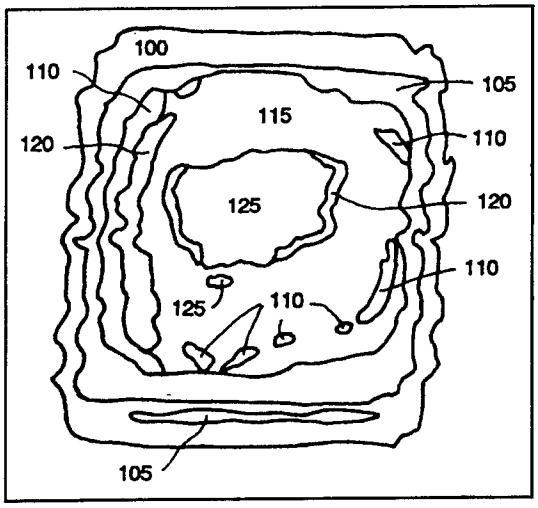
a) Typical (S/N 92-064-HO-471)

b) Most Out-of-the-Ordinary (S/N 92-093-HO-392)

Figure 4.2 C/KC-135 #4 W/WS Thermal Images From the Heater Test

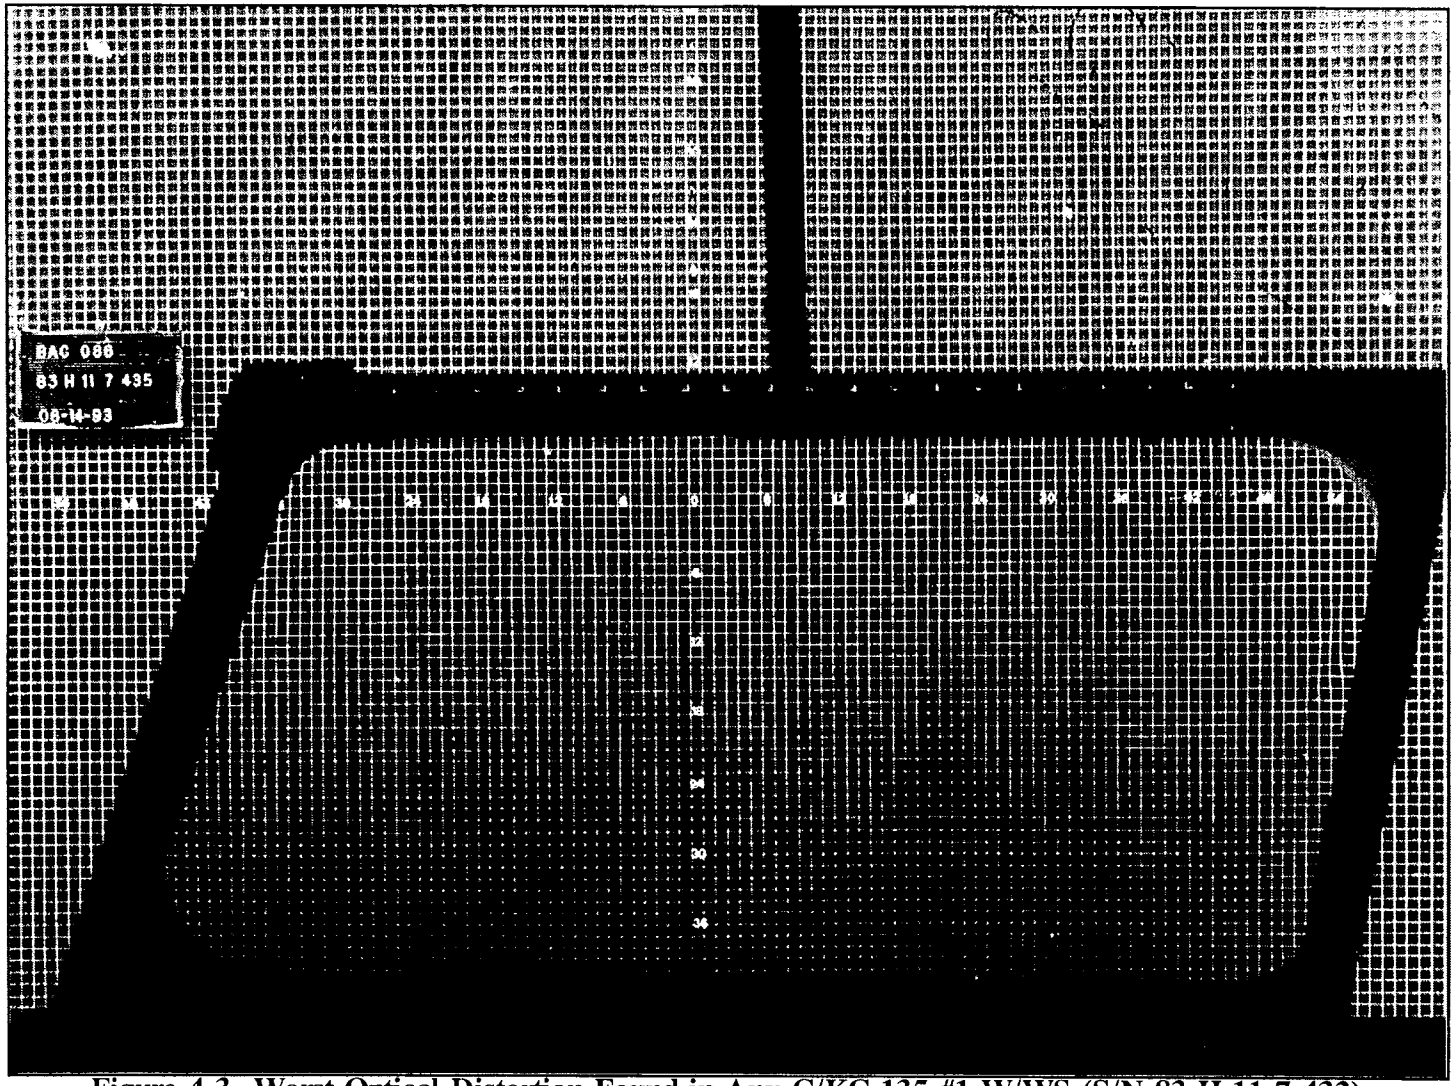
Figure 4.3 Worst Optical Distortion Found in Any C/KC-135 #1 W/WS (S/N 83-H-11-7-432)

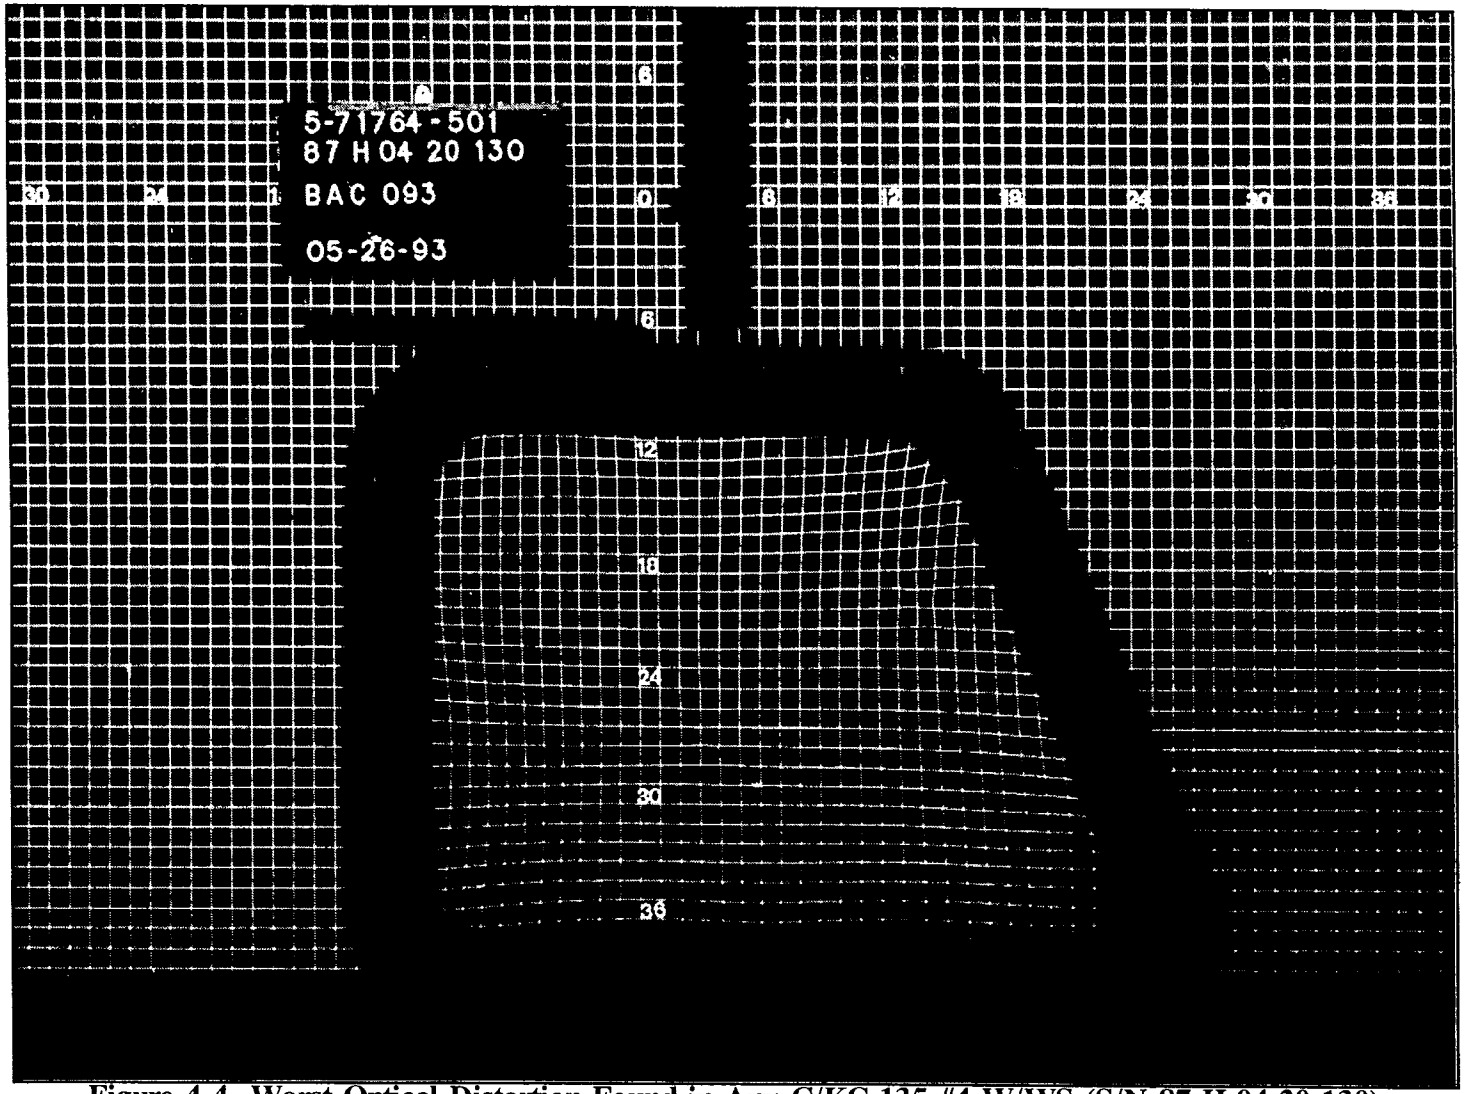
Figure 4.4 Worst Optical Distortion Found in Any C/KC-135 #4 W/WS (S/N 87-H-04-20-130)

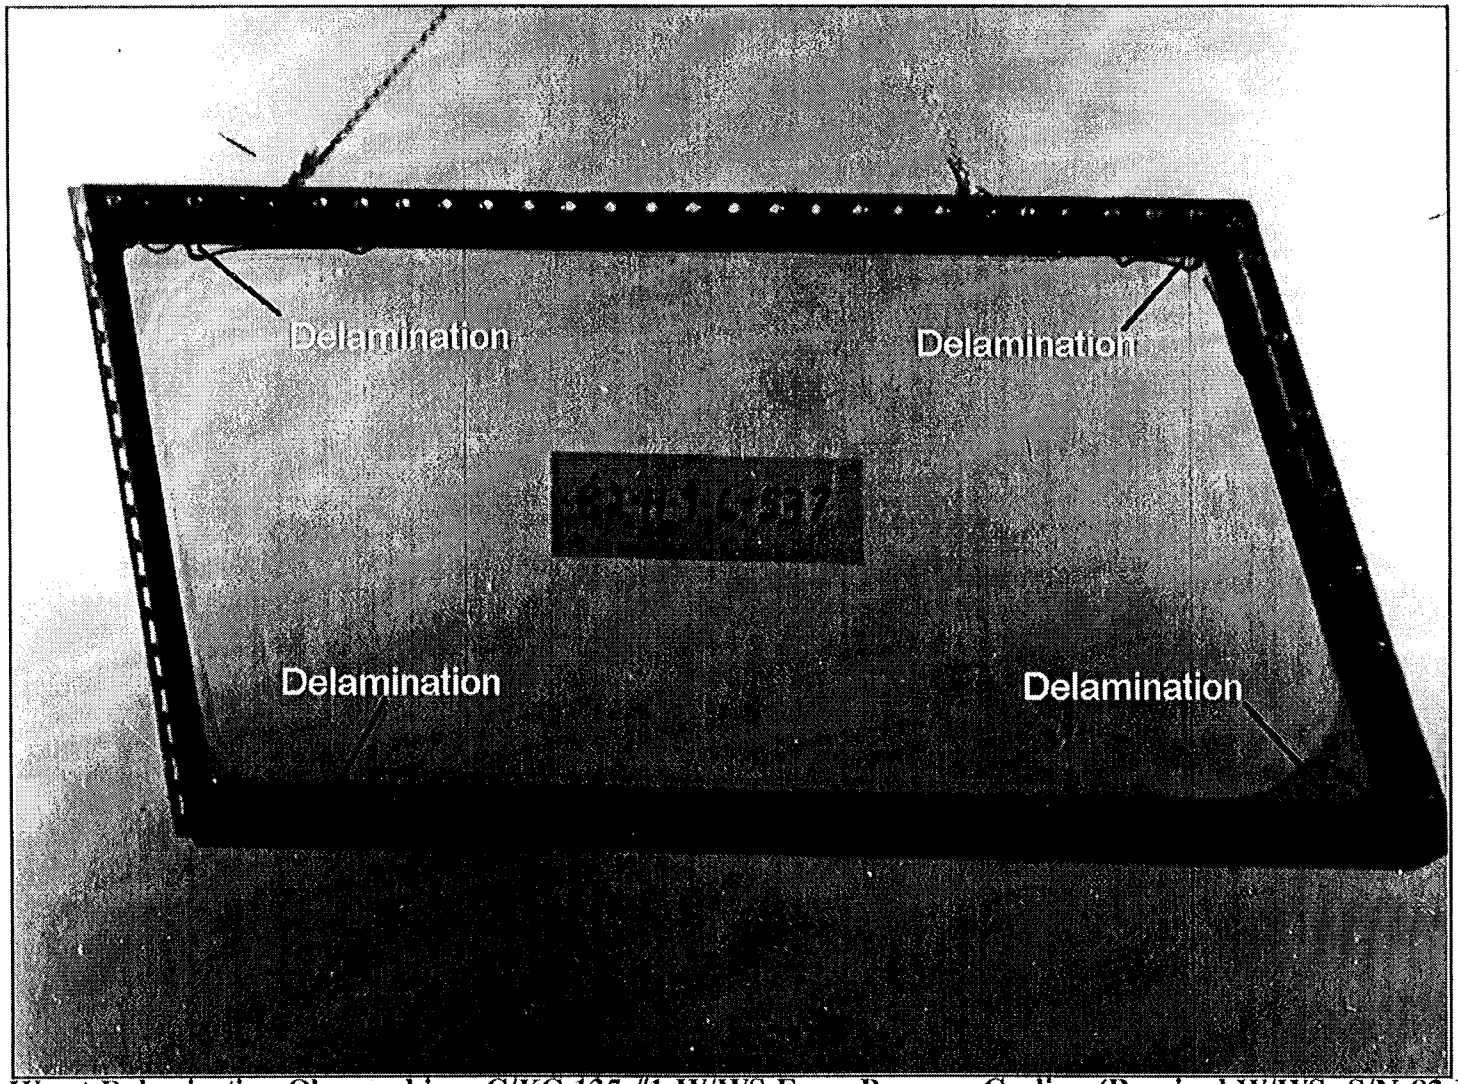
Figure 4.11 Worst Delamination Observed in a C/KC-135 #1 W/WS From Pressure Cycling (Repaired W/WS, S/N 82-H-09-06-537)

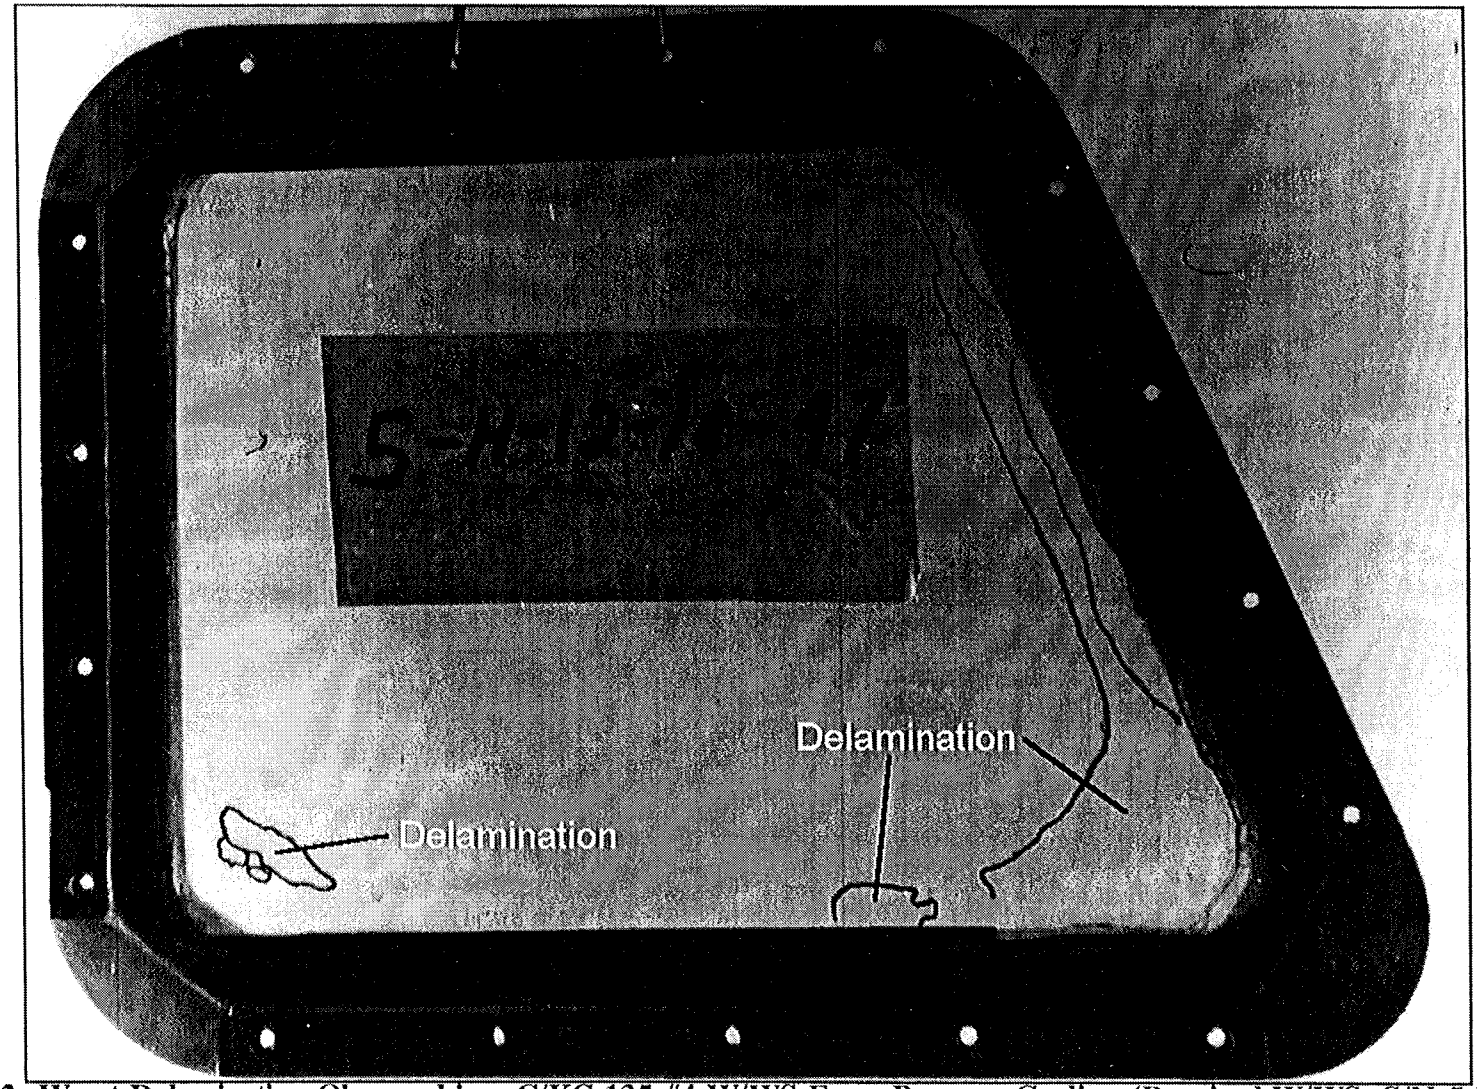
Figure 4.12 Worst Delamination Observed in a C/KC-135 #4 W/WS From Pressure Cycling (Repaired W/WS, S/N 5-H-12-16-47)

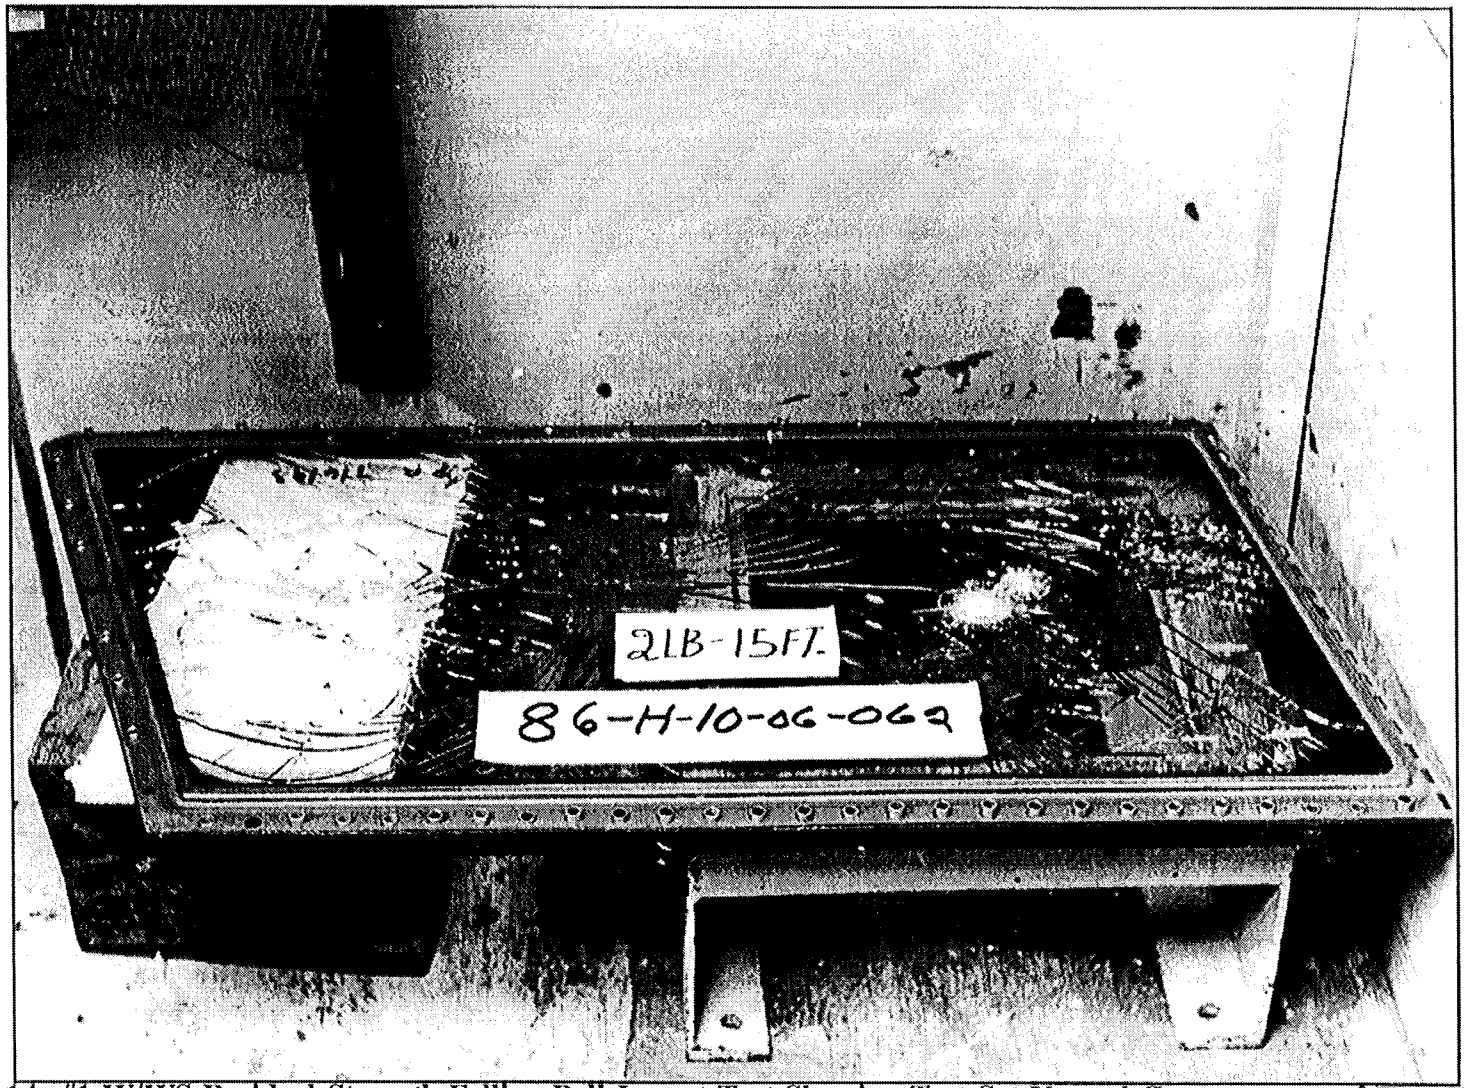
Figure 4.14 #1 W/WS Residual Strength Falling Ball Impact Test Showing Test Set Up and Consequences of Two Ball Drops (New W/WS, S/N 86-H-10-06-062)

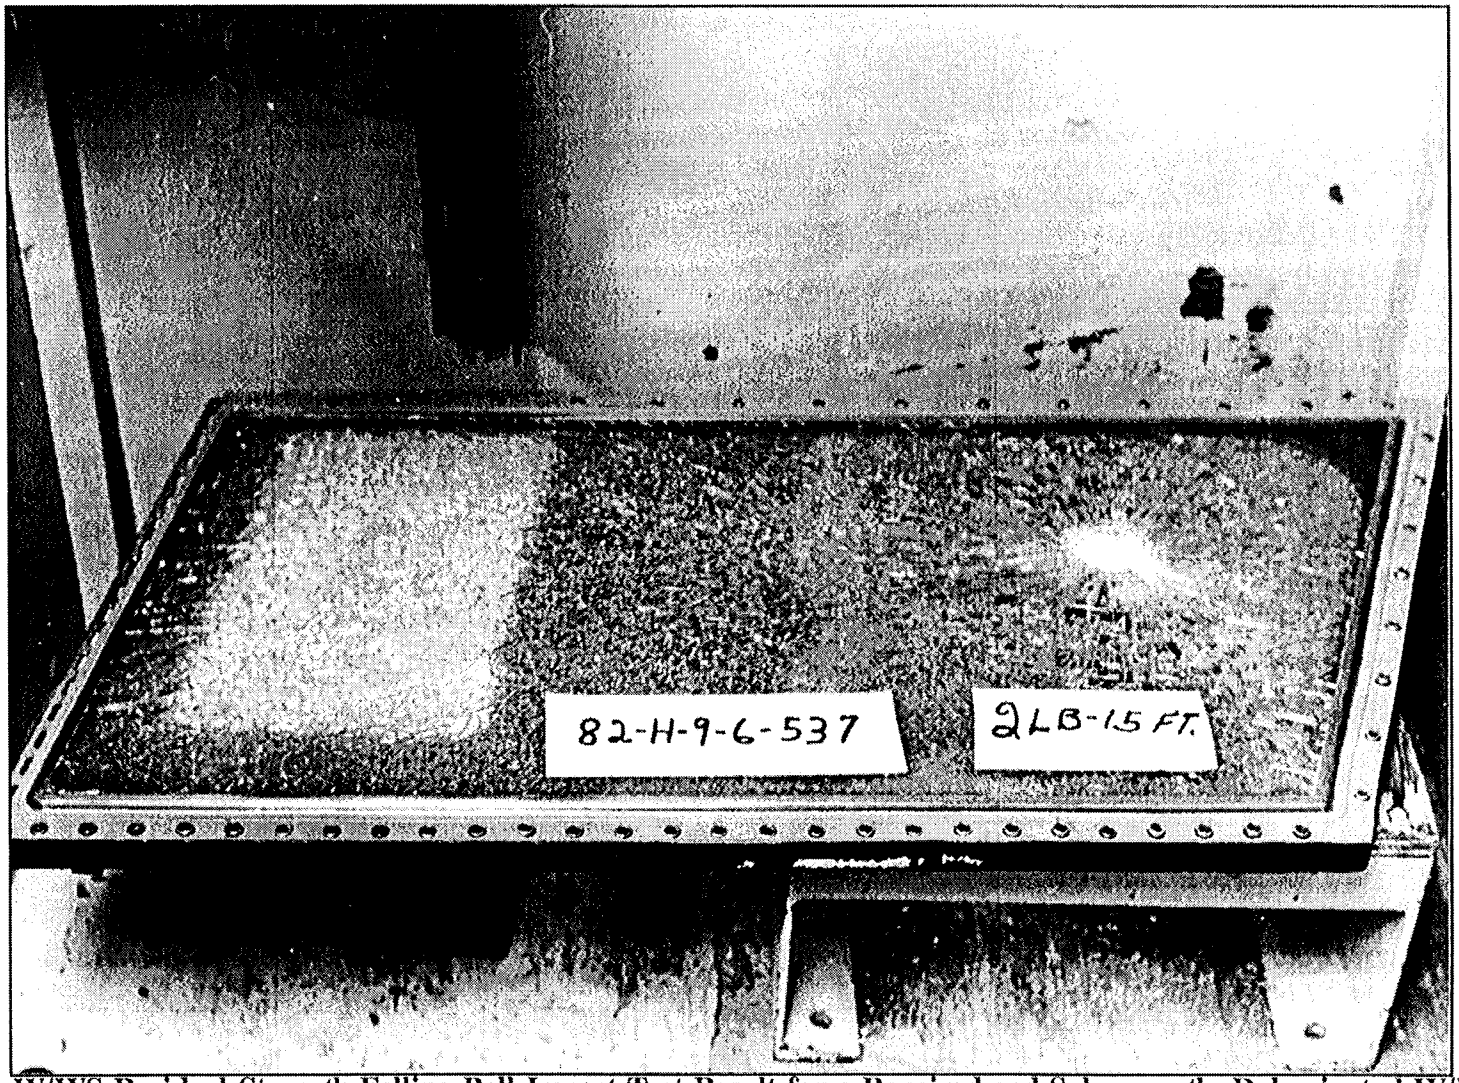
Figure 4.15 #1 W/WS Residual Strength Falling Ball Impact Test Result for a Repaired and Subsequently Delaminated W/WS, Single Ball Drop, Outboard View (S/N 82-H-9-6-537)

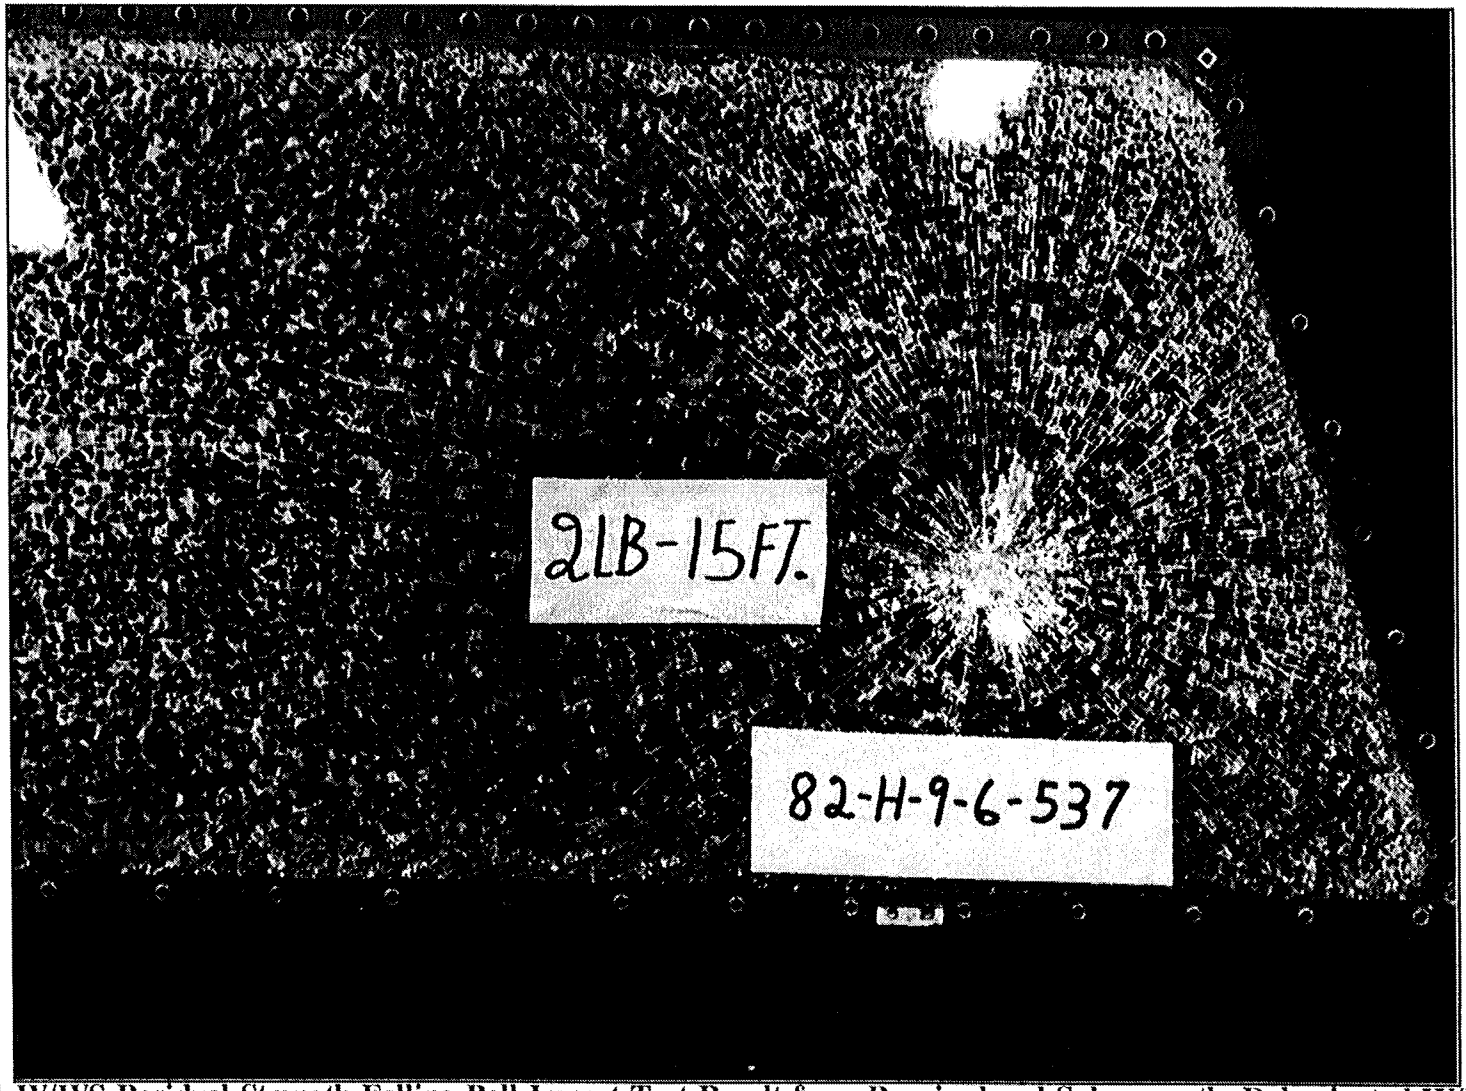
Figure 4.16 #1 W/WS Residual Strength Falling Ball Impact Test Result for a Repaired and Subsequently Delaminated W/WS, Single Ball Drop, Inboard View (S/N 82-H-9-6-537)

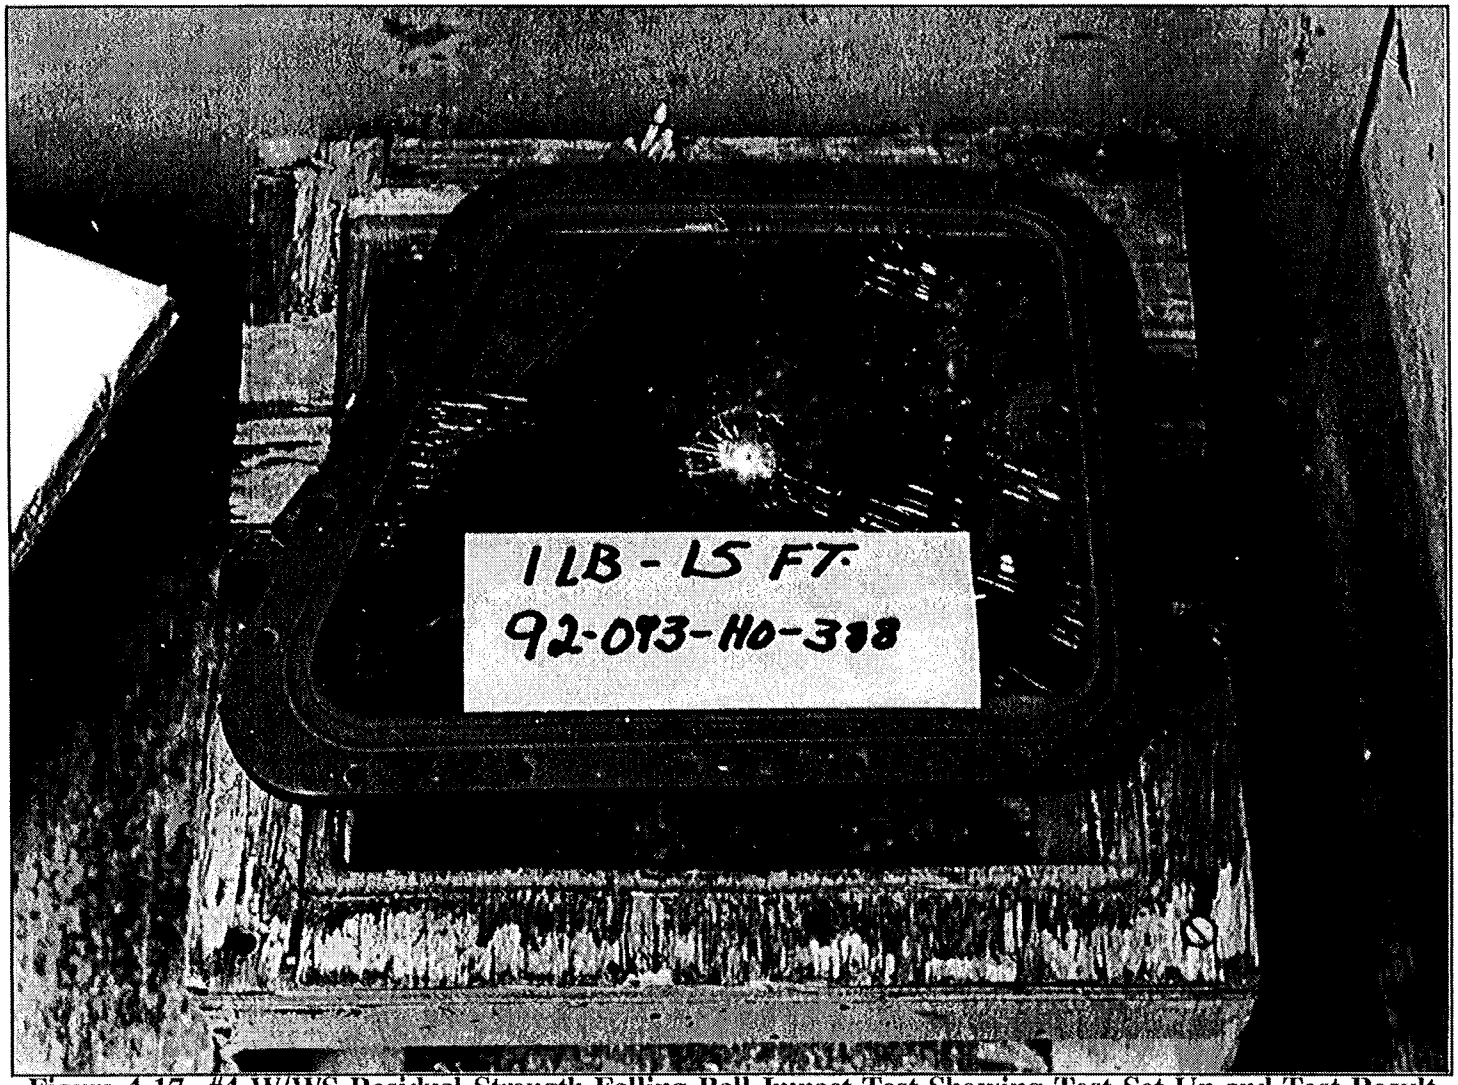
Figure 4.17 #4 W/WS Residual Strength Falling Ball Impact Test Showing Test Set Up and Test Result (New W/WS, S/N 92-093-HO-388)

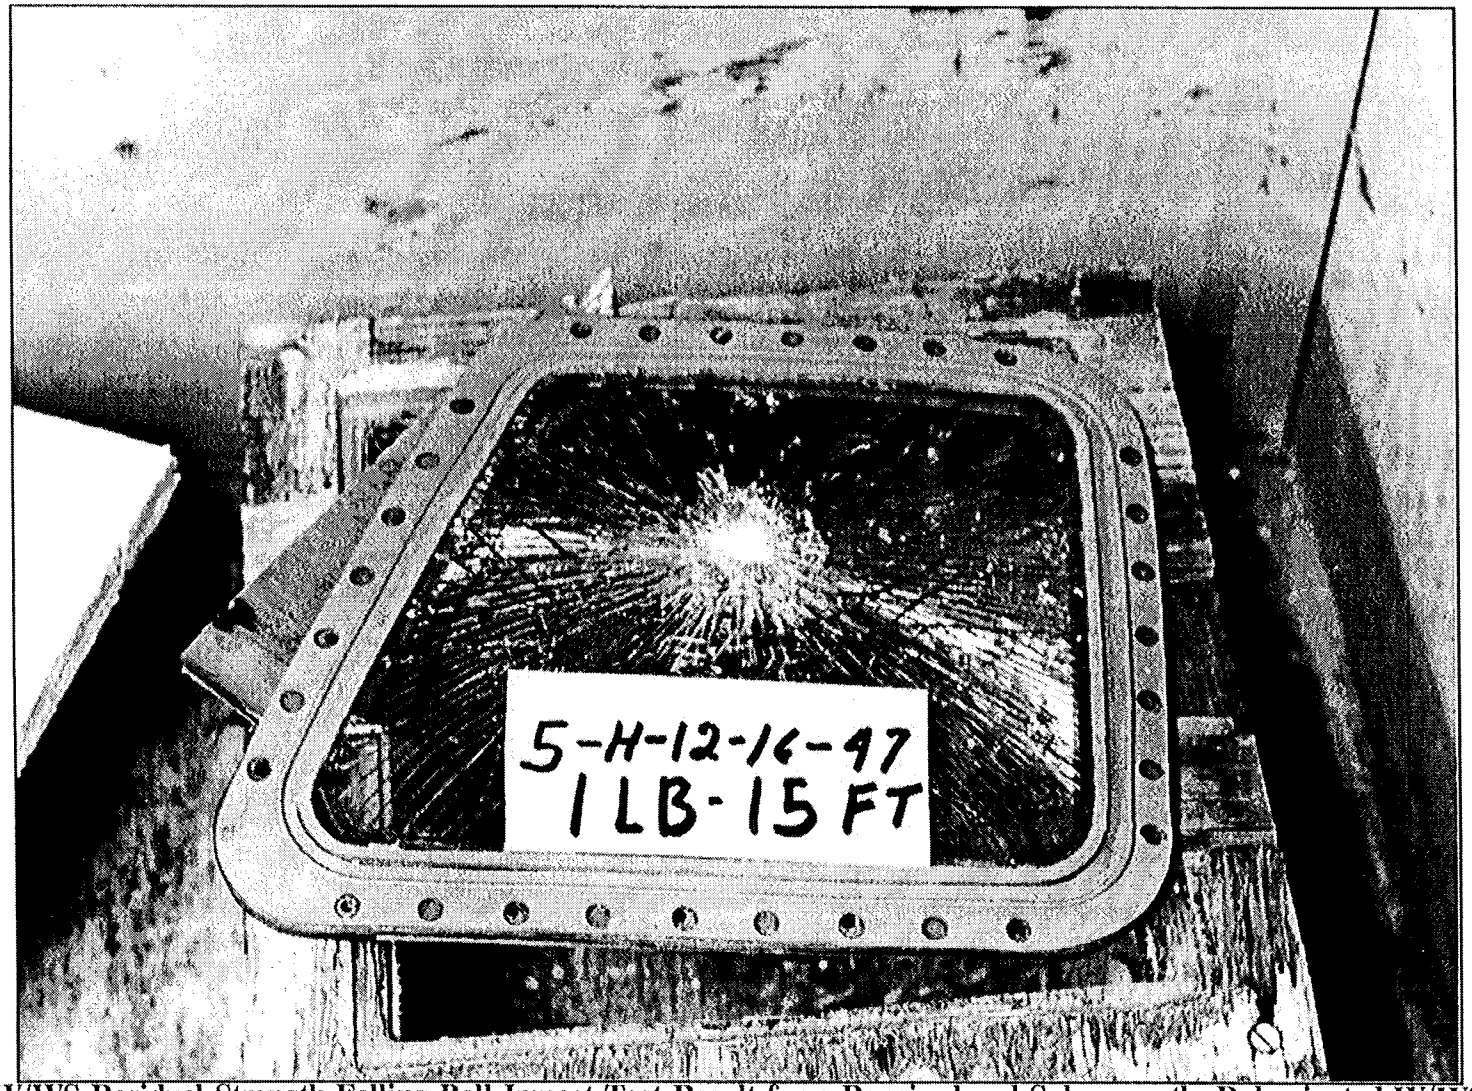
Figure 4.18 #4 W/WS Residual Strength Falling Ball Impact Test Result for a Repaired and Subsequently Delaminated W/WS, Outboard View (S/N 5-H-12-16-47)

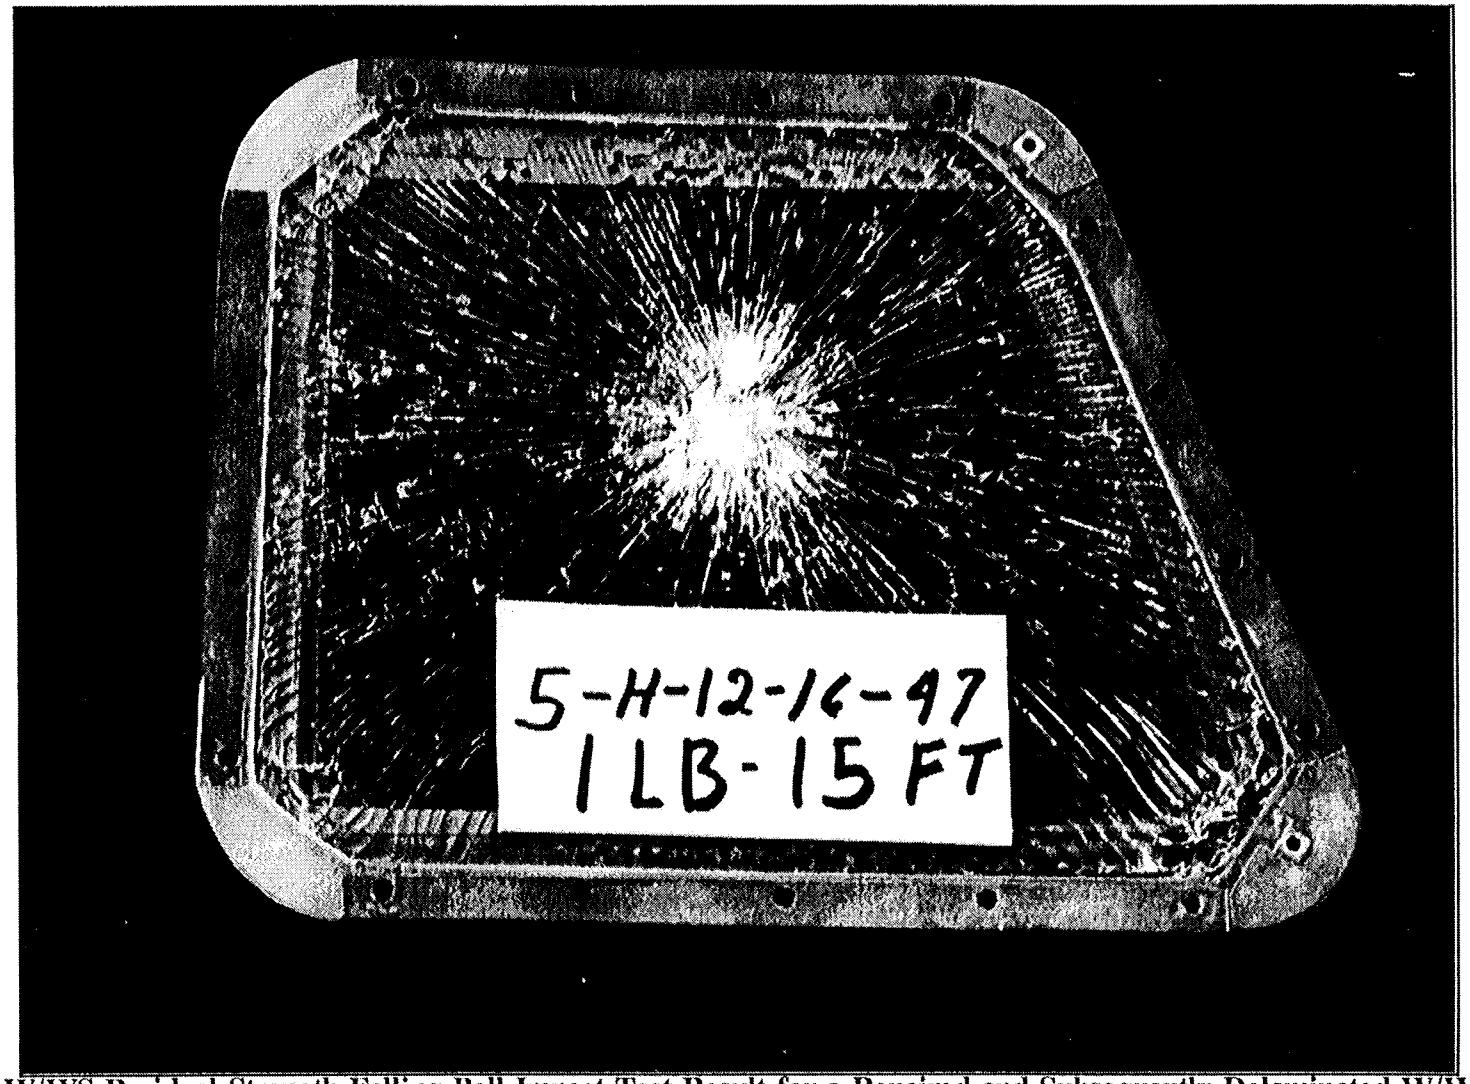
Figure 4.19 #4 W/WS Residual Strength Falling Ball Impact Test Result for a Repaired and Subsequently Delaminated W/WS, Inboard View (S/N 5-H-12-16-47)

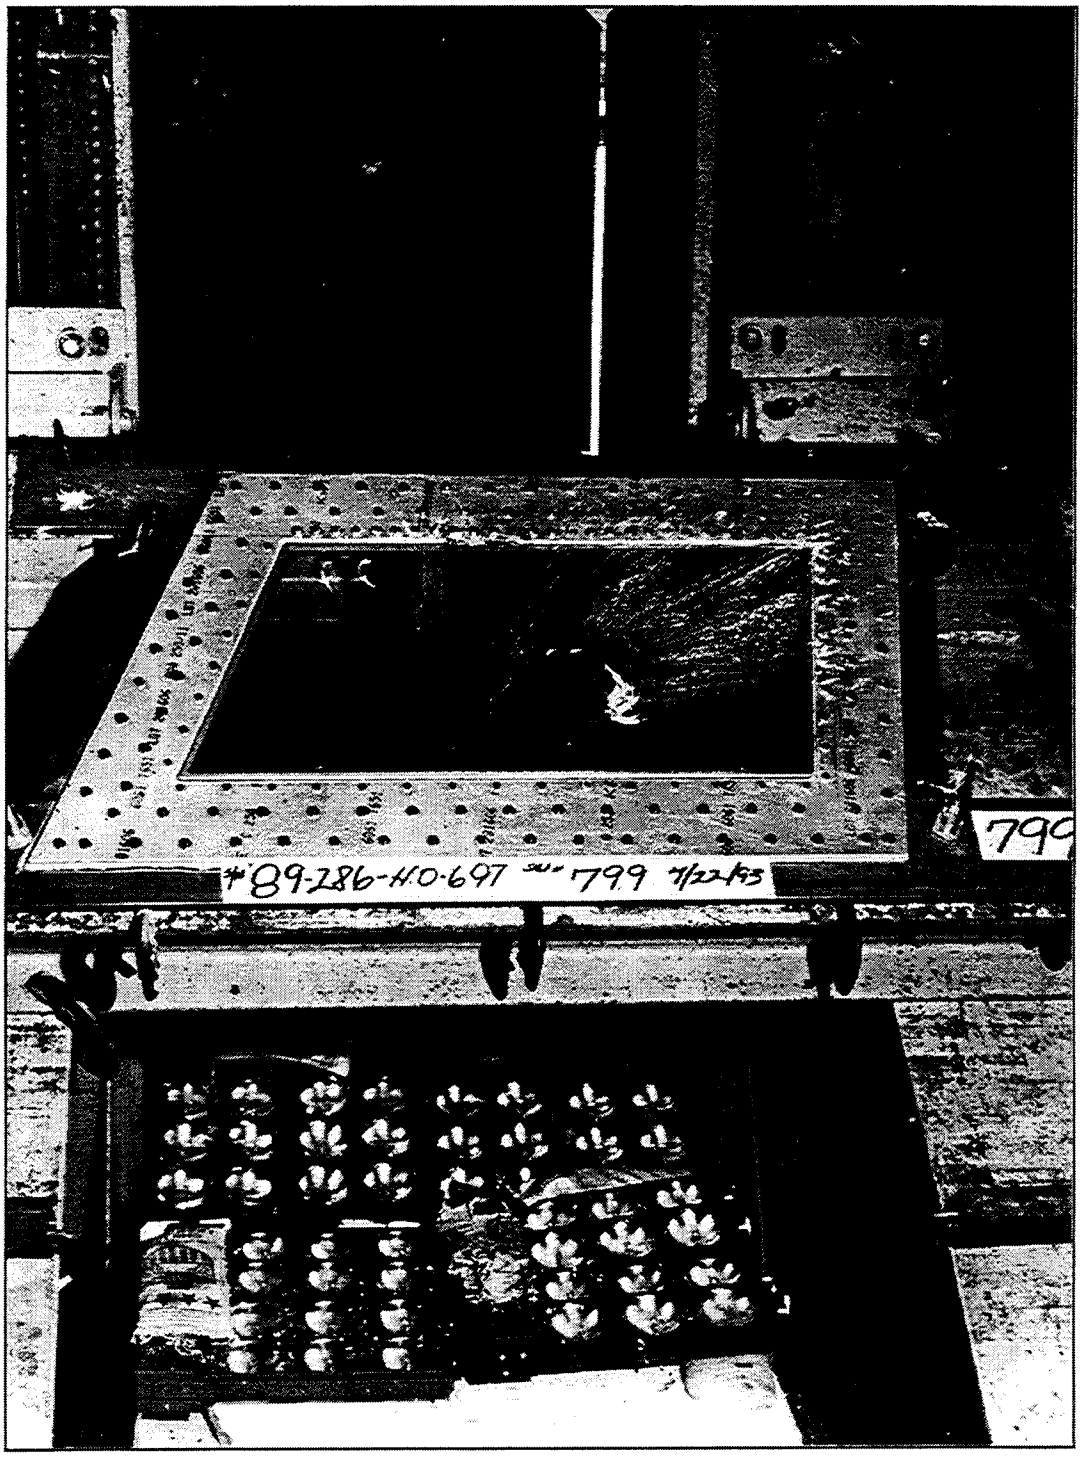
Figure 4.29 C/KC-135 #1 W/WS Showing No Damage From a 4-Pound Bird Impact at 250.8 Knots (Repaired W/WS, S/N 89-286-HO-697)

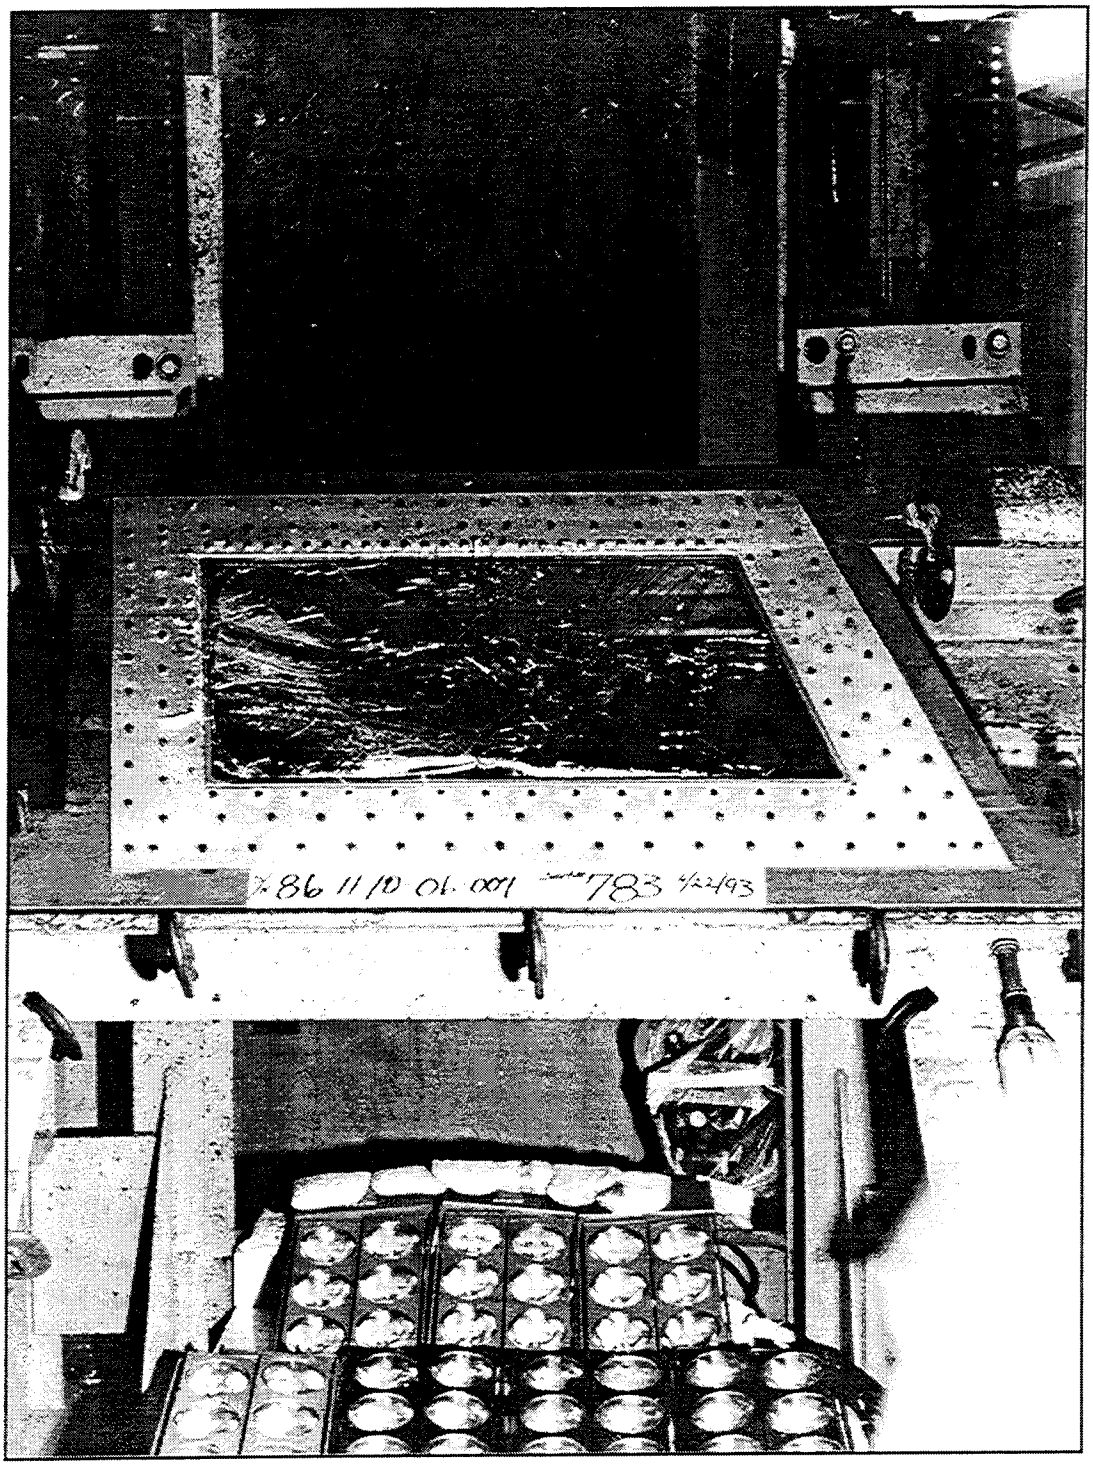
Figure 4.30 C/KC-135 #1 W/WS Showing Outboard Ply Failure From a 4-Pound Bird Impact at 251.7 Knots, Front View (New W/WS, S/N 86-H-10-06-007)
