DEVELOPMENT OF REPAIR PROCESSES AND SOURCES FOR C/KC-135 AIRCRAFT WINDOWS/WINDSHIELDS

RICHARD J. OLSON

SEPTEMBER 1994

TECHNICAL REPORT FOR 09/91 - 01/94
C/KC-135 FINAL REPORT
CONTRACT NUMBER FO9603-90-D-2217-SD02

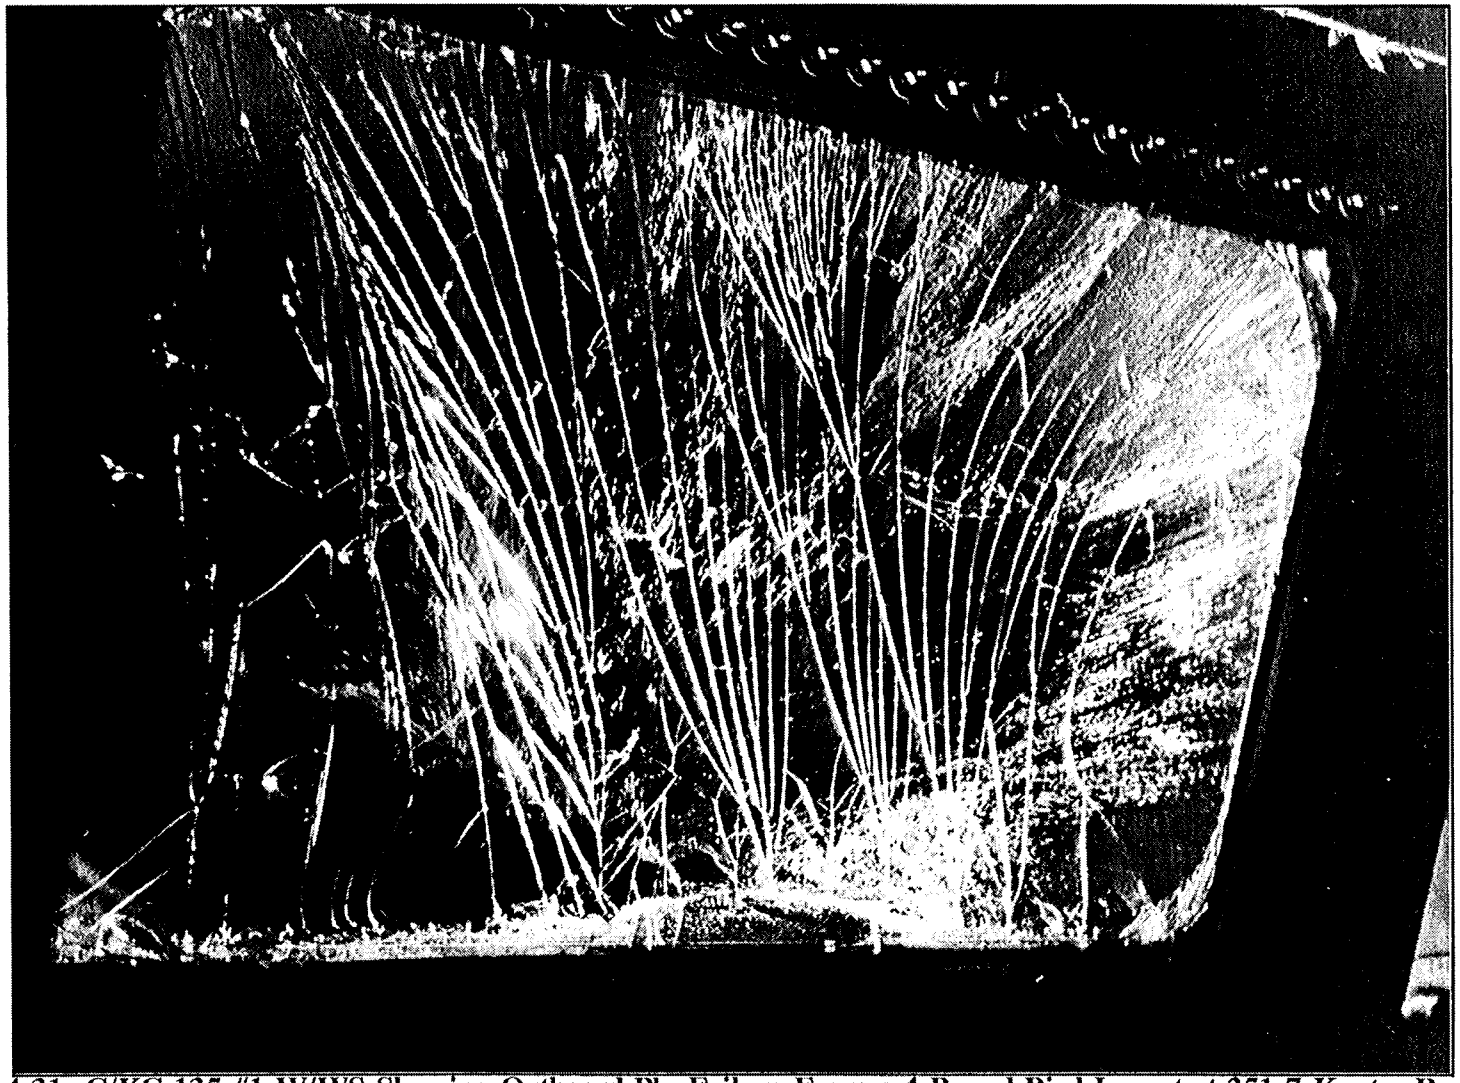
Figure 4.31 C/KC-135 #1 W/WS Showing Outboard Ply Failure From a 4-Pound Bird Impact at 251.7 Knots, Rear View (New W/WS, S/N 86-H-10-06-007)

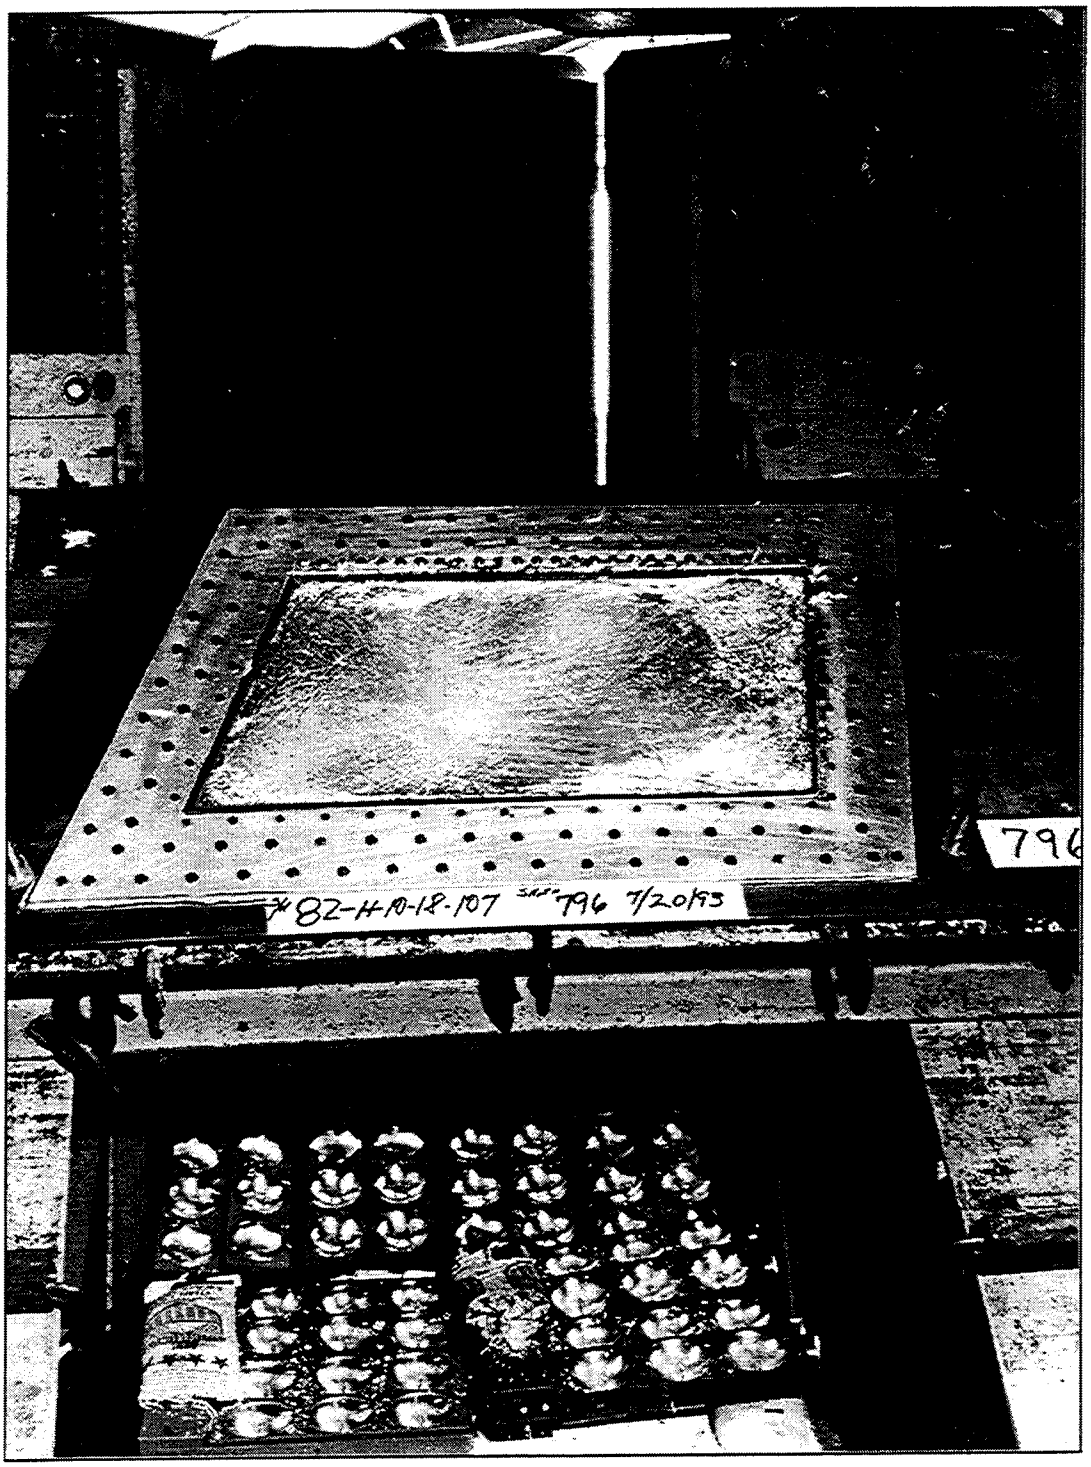
Figure 4.32 C/KC-135 #1 W/WS Showing All Glass Plies Failed From a 4-Pound Bird Impact at 249.4 Knots, Front View (Repaired W/WS, S/N 82-H-10-18-107)

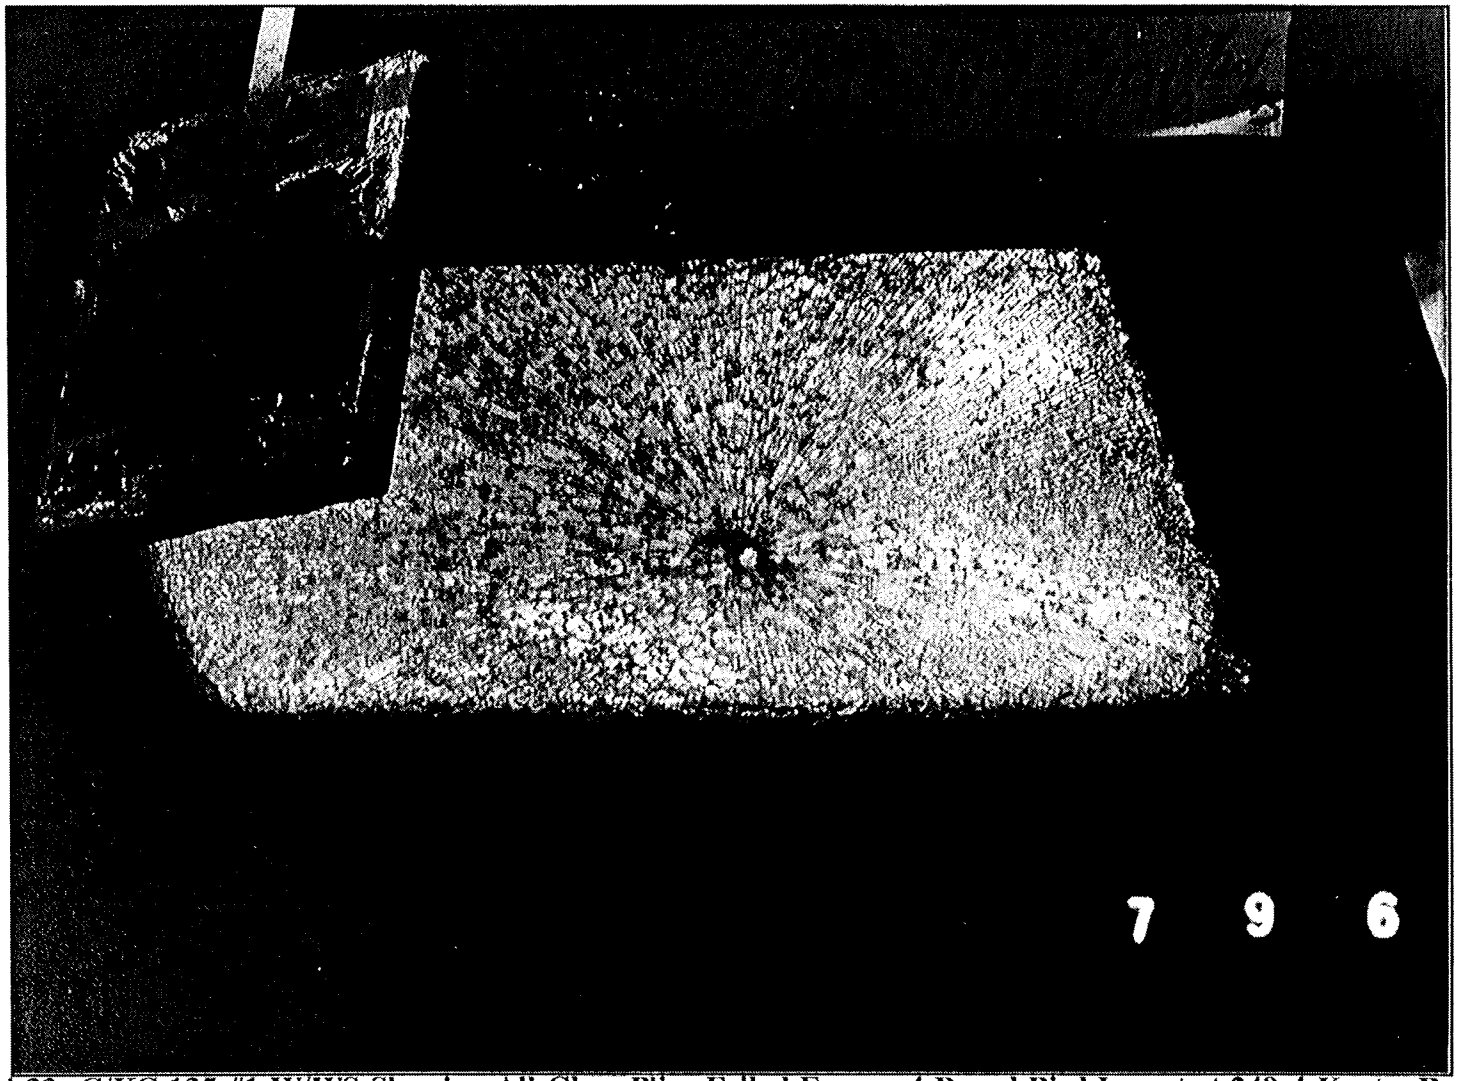
Figure 4.33 C/KC-135 #1 W/WS Showing All Glass Plies Failed From a 4-Pound Bird Impact at 249.4 Knots, Rear View (Repaired W/WS, S/N 82-H-10-18-107)

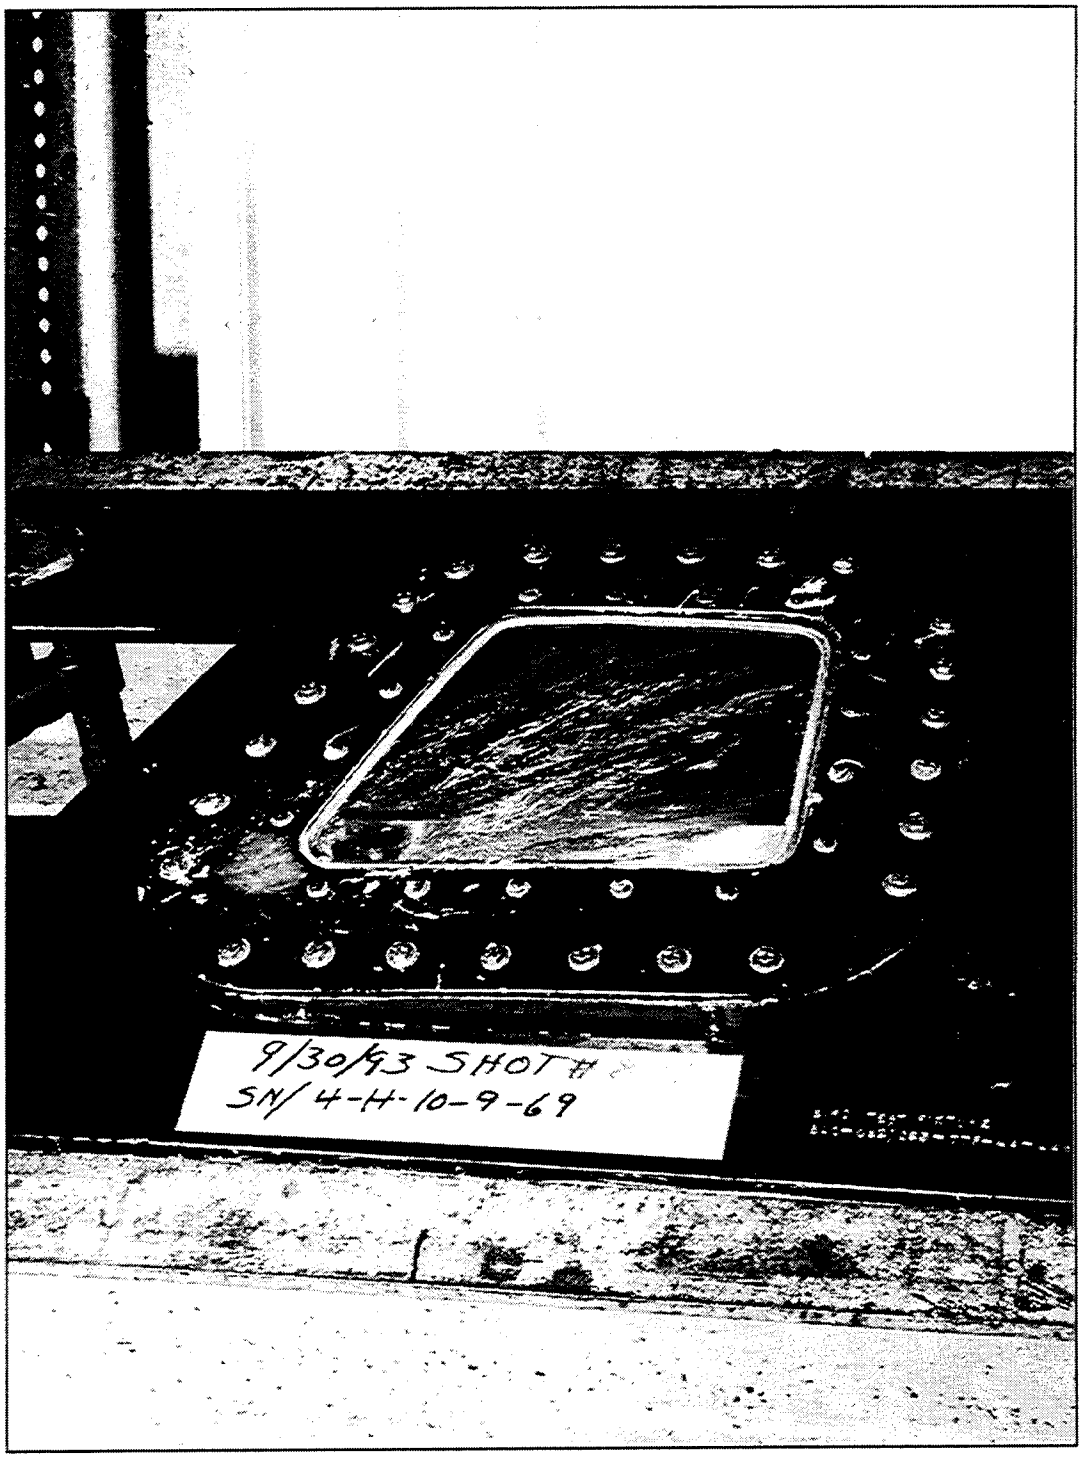
Figure 4.35 C/KC-135 #4 W/WS Showing No Damage From a 4-Pound Bird Impact at 248.7 Knots (Not Repaired W/WS, S/N 4-H-10-9-69)

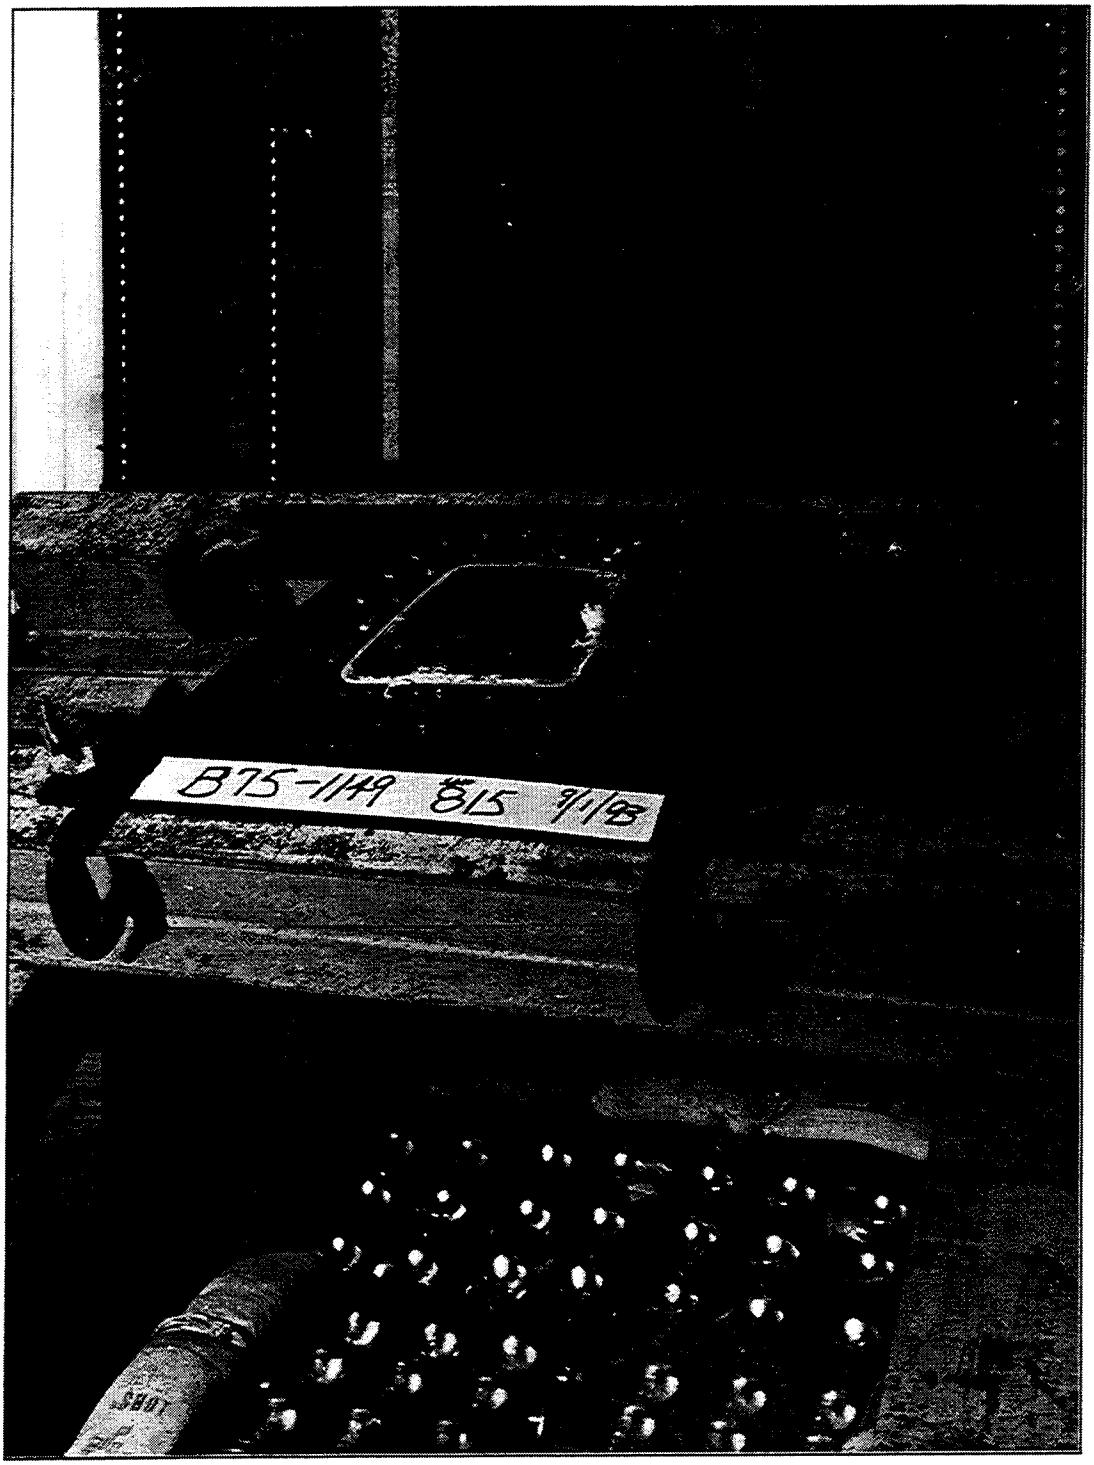
Figure 4.36 C/KC-135 #4 W/WS Showing Outboard Ply Failure From a 4-Pound Bird Impact at 247.5 Knots, Front View (Repaired W/WS, S/N B75-1149)

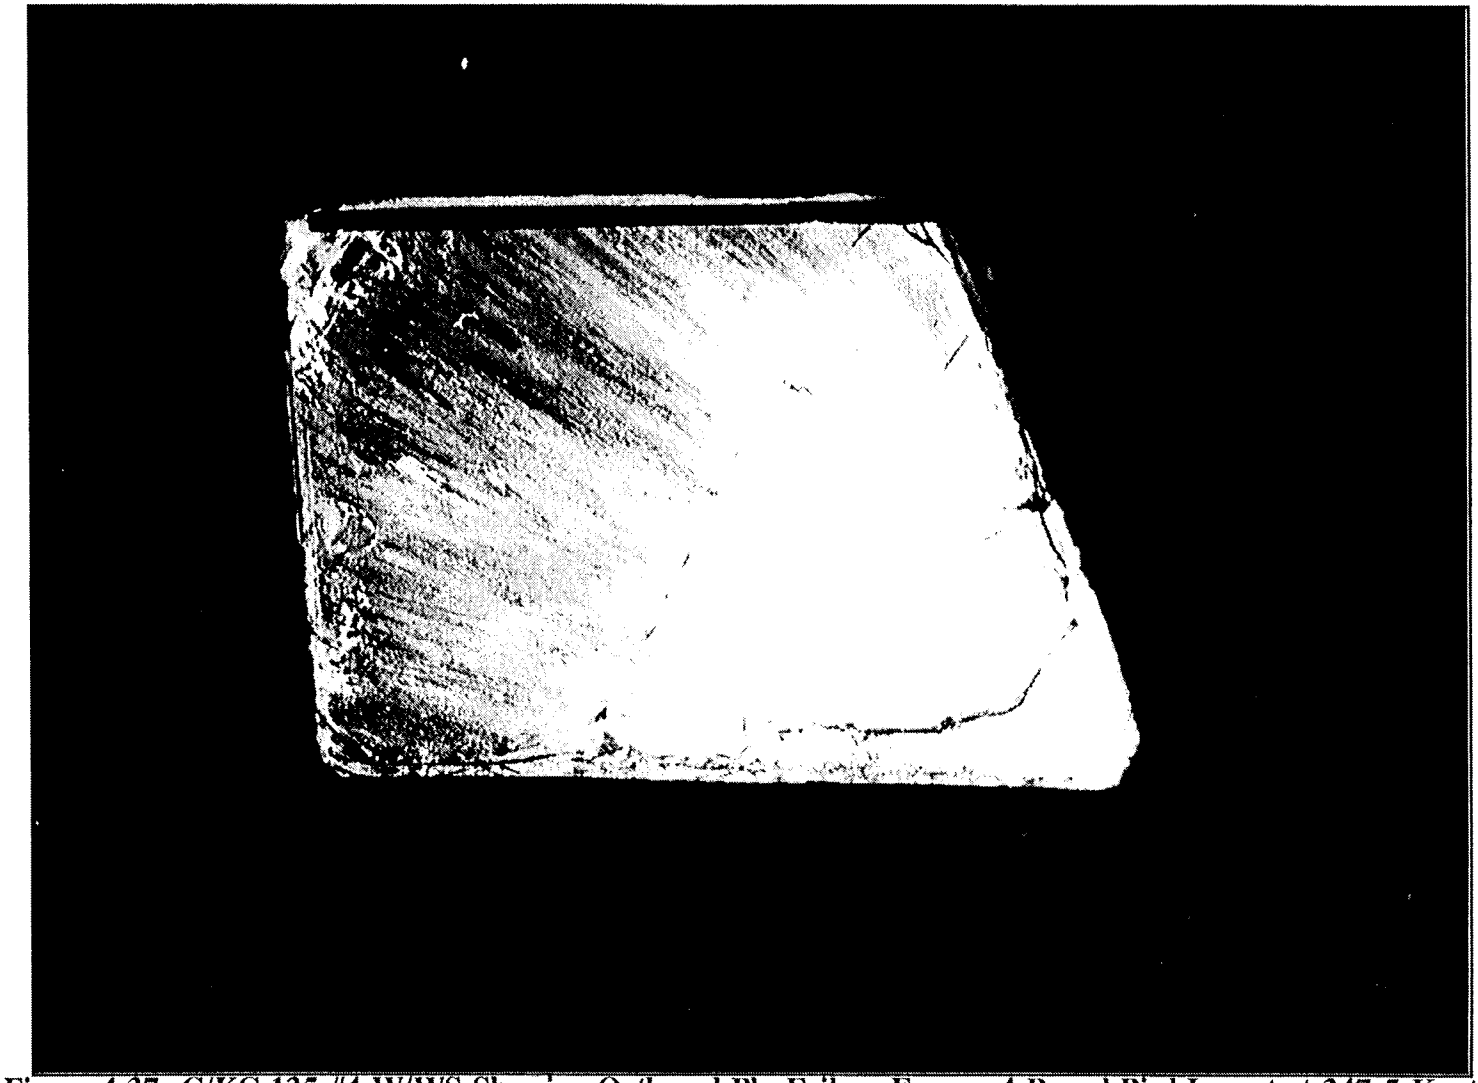
Figure 4.37 C/KC-135 #4 W/WS Showing Outboard Ply Failure From a 4-Pound Bird Impact at 247.5 Knots, Rear View (Repaired W/WS, S/N B75-1149)

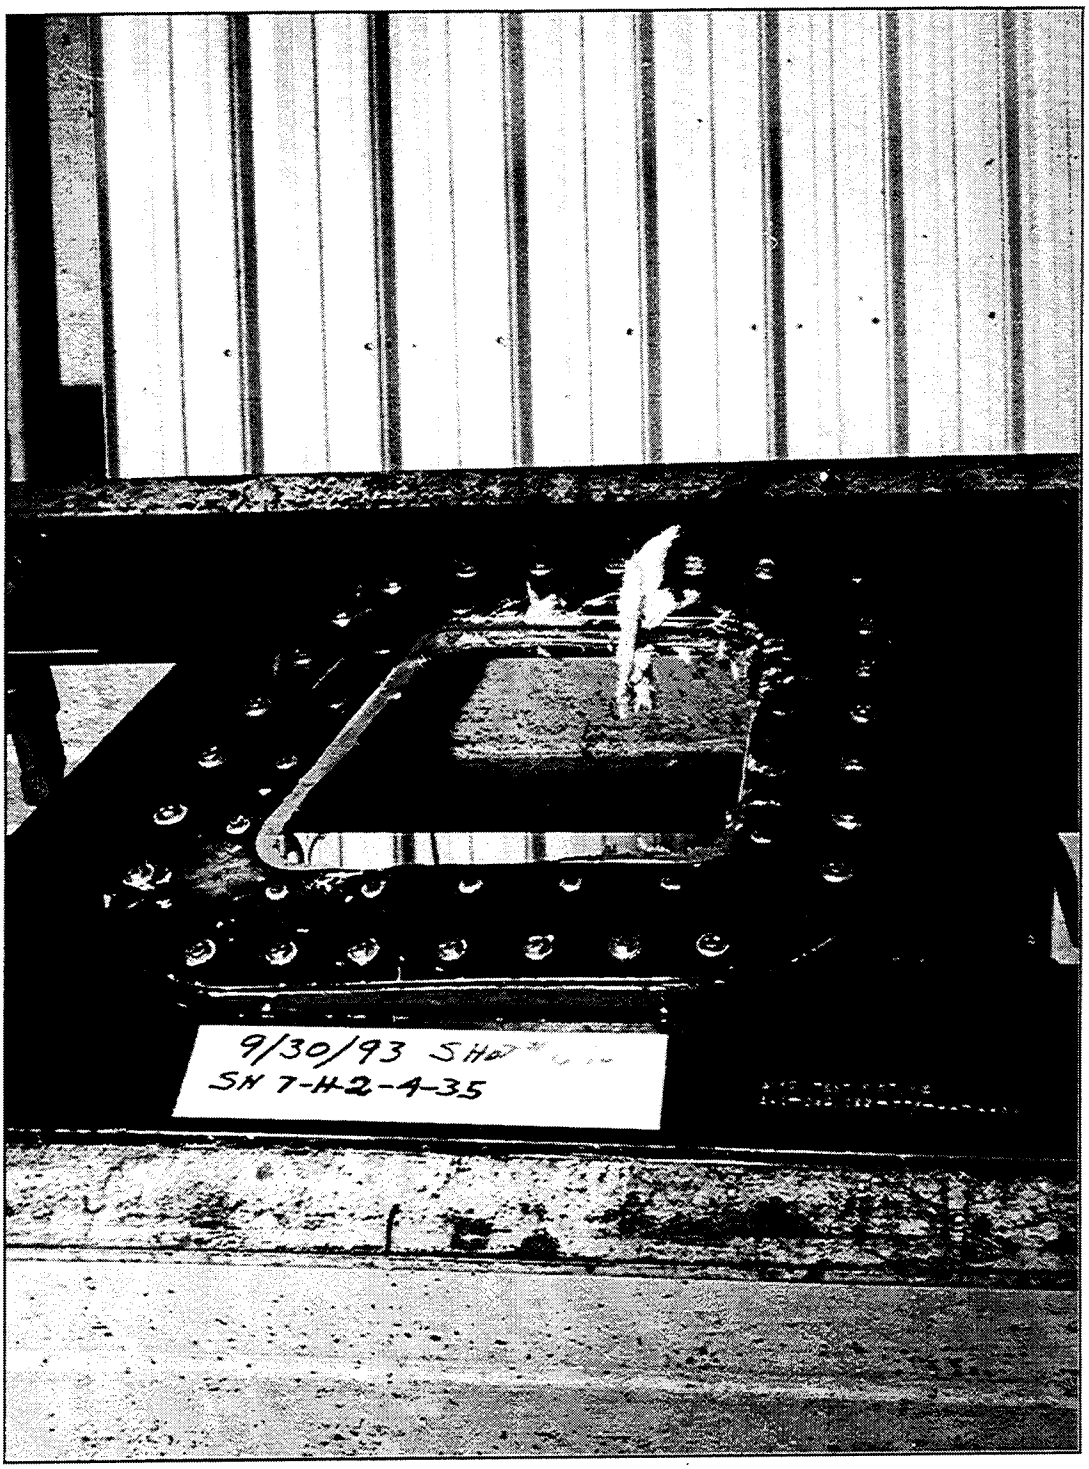
Figure 4.38 C/KC-135 #4 W/WS Showing a Catastrophic All Glass Plies Failure From a 4-Pound Bird Impact at 250.8 Knots, Front View (Not Repaired W/WS, S/N 7-H-2-4-35)

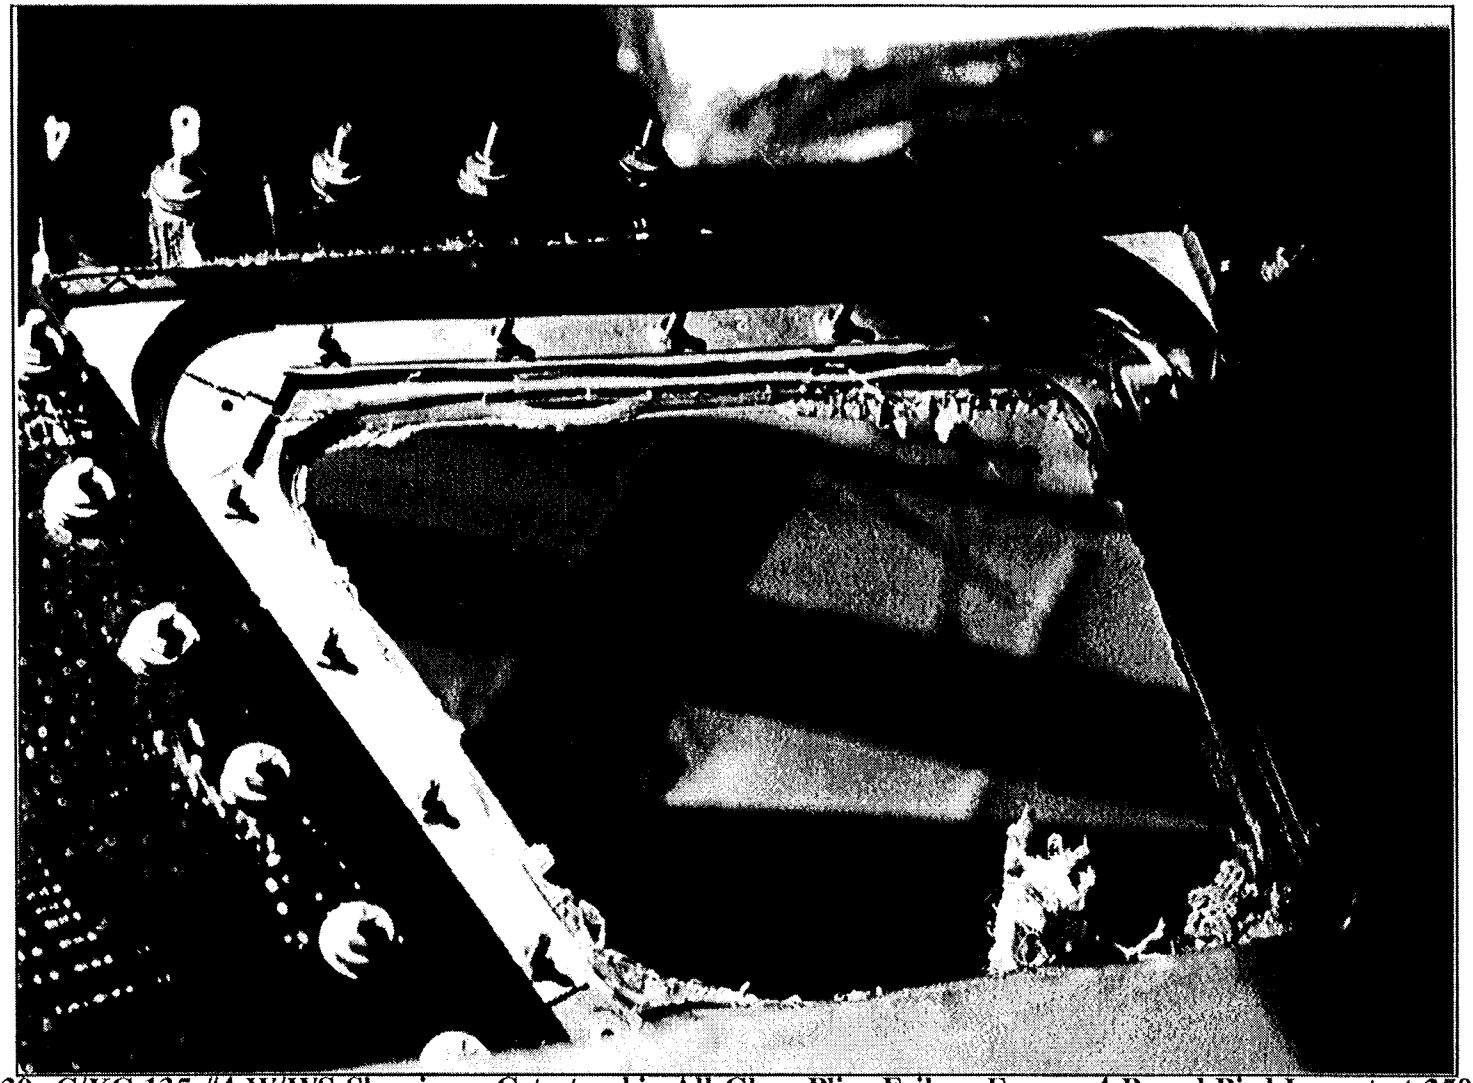
Figure 4.39 C/KC-135 #4 W/WS Showing a Catastrophic All Glass Plies Failure From a 4-Pound Bird Impact at 250.8 Knots, Rear View (Not Repaired W/WS, S/N 7-H-2-4-35)

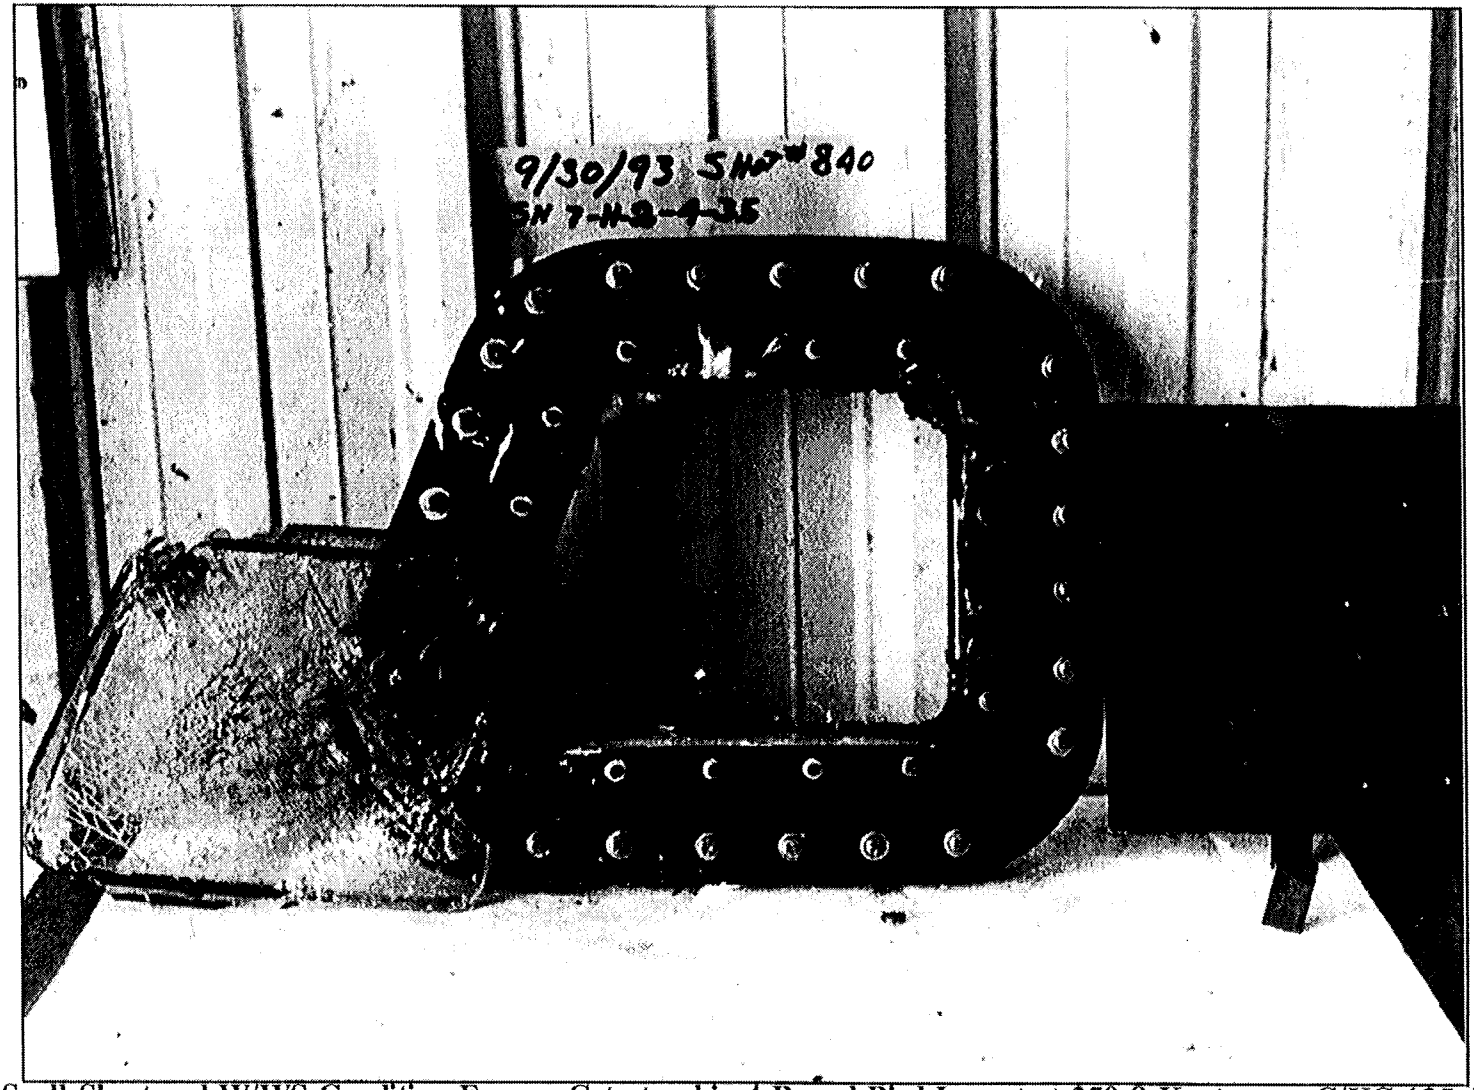
Figure 4.40 Spall Sheet and W/WS Condition From a Catastrophic 4-Pound Bird Impact at 250.8 Knots on a C/KC-135 #4 W/WS (Not Repaired W/WS, S/N 7-H-2-4-35)

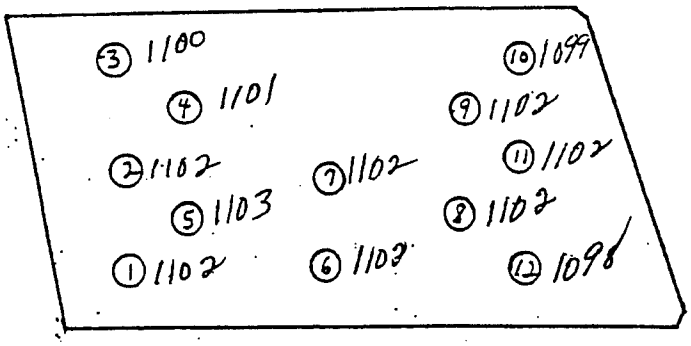
Visual Inspection Map & Comments

AIR, DELAM And WATER JUST About All the WAY Around UNIT

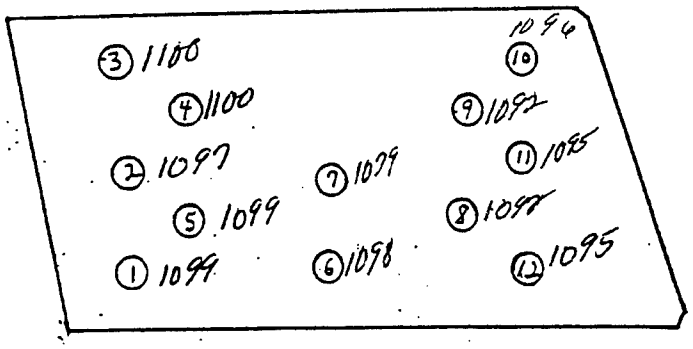
Visual Inspection Map & Comments

Seal Evaluation:	Rej	JUN 04 1993	22 PPG 77
(Comments) Seal needs to be cut too size			
Visual Inspection: (Place comments on attached sheet)	Rej	JUN 04 1993	22 PPG 77

AIR & Delam Located All Around Unit

Surface SCR Located Bottom Aft Edge of Unit

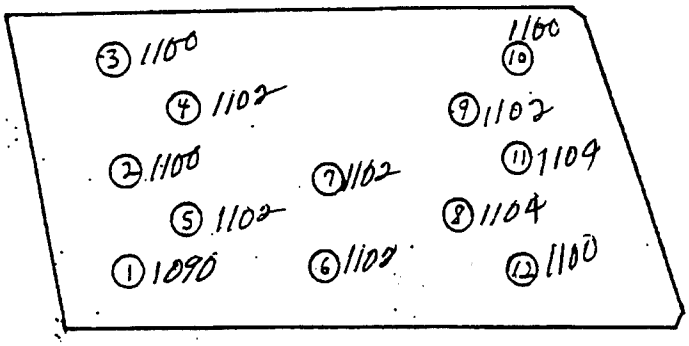
Visual Inspection Map & Comments

Seal Evaluation (Comments): Seal Needs cutting Break on outbd Side

Air and Delam Located All Around the Unit

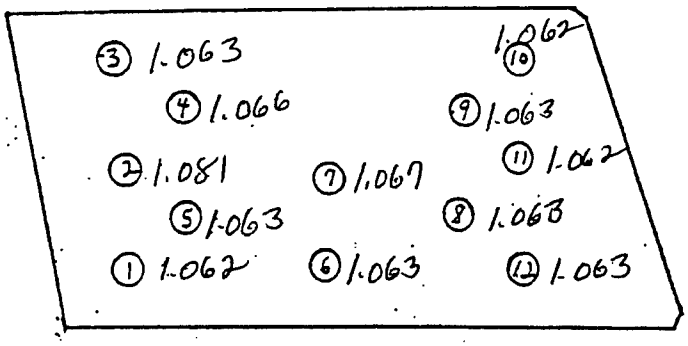
Visual Inspection Map & Comments

DeLAm Alone TOP And Field. Edge of UNIT

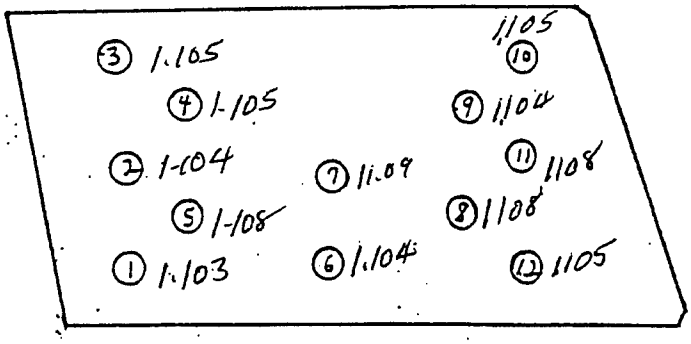
Visual Inspection Map & Comments

5: 1.108 6: 1.104 7: 1.109 8: 1.104				
9: 1.104 10: 1.105 11: 1.108 12: 1.105				
Seal Evaluation: (Comments)		Rej	JUN 02 1993	22 PPG 77
Wrong seal on outbd side.				
Visual Inspection: (Place comments on attached sheet)		Rej	JUN 02 1993	22 PPG 77

Air All Alone The ~~2~~ of unit.

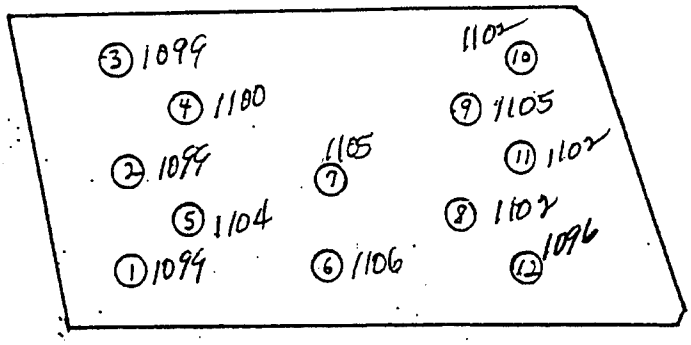
Visual Inspection Map & Comments

Air and Delam around the unit.
Surface air all over the outer side of unit

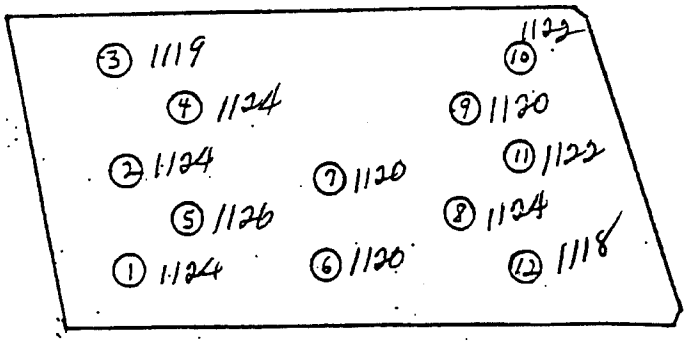
Visual Inspection Map & Comments

Seal Evaluation:	Rej	JUN 04 1993	22 PPG 77
(Comments)	wrong seal on outboard side		
Visual Inspection: (Place comments on attached sheet)	Rej	JUN 04 1993	22 PPG 77

Air & Delam Located ALL Around Unit.

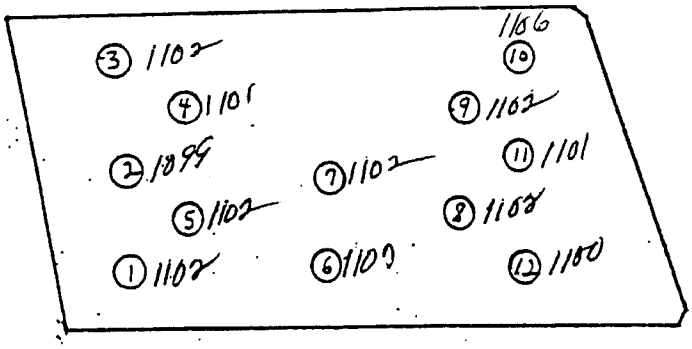
Visual Inspection Map & Comments

Seal Evaluation:	Rej	JUN 04 1993	22 PPG 77
(Comments) SEAL Needs CUTTing TOO SIZE			
Visual Inspection: (Place comments on attached sheet)	Rej	JUN 04 1993	22 PPG 77

AIR & DeLam LOCATED AROUND THE UNIT.
VERY BAD SURFACE SCR LOCATED BOTTOM FWD. EDGE

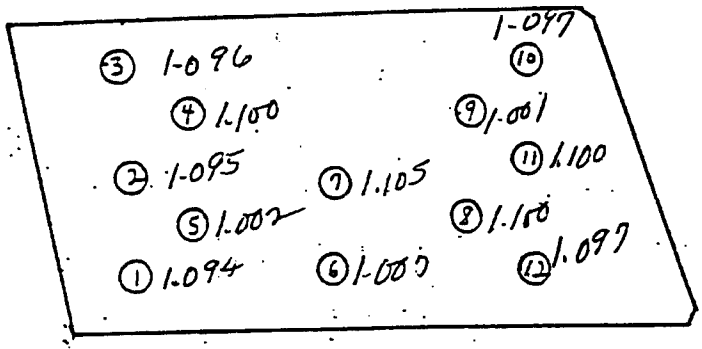
DeLam Located All Around the Unit

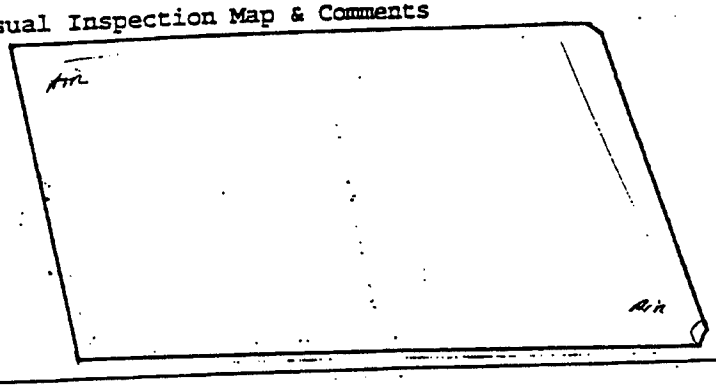
Visual Inspection Map & Comments

Air Starting Alone Edge of Unit

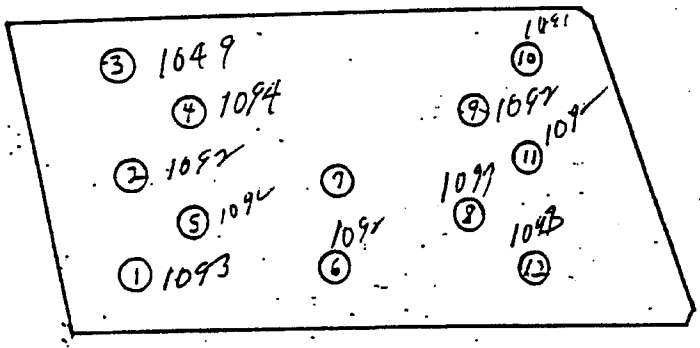
UNIT HAS AIR/DeLam LOCATED THROUGHOUT.

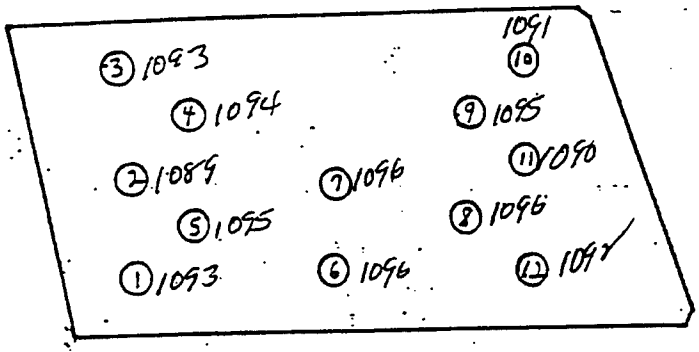
Delam Located in all Four Corners

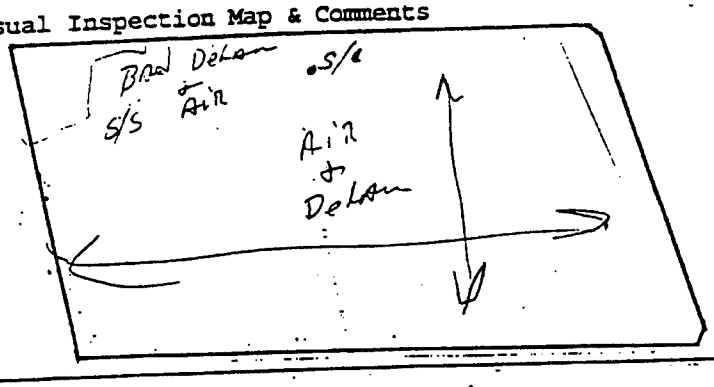
Visual Inspection Map & Comments

Air and DeLam LOCATED ALL AROUND UNIT

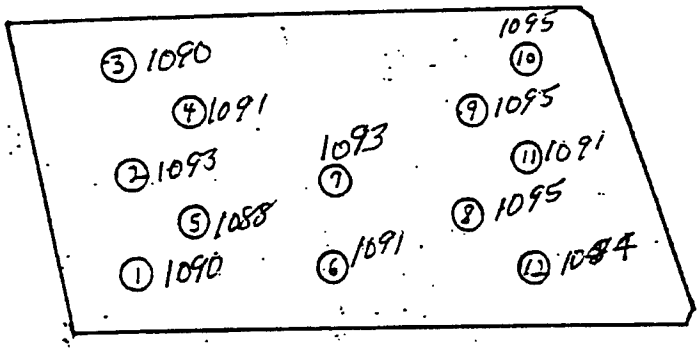
SURFACE SCR LOCATED AS MARKED

SURFACE chip LOCATED AS MARKED

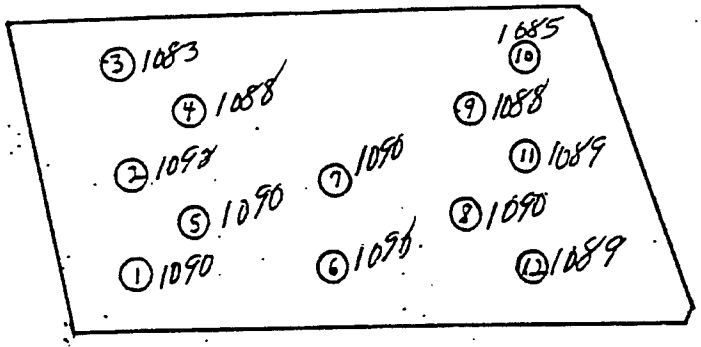
Air And DeLam Located Around the Limit

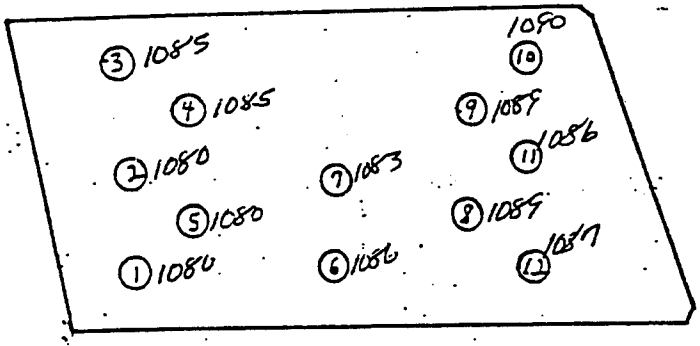
SURFACE SCR LOCATED AS MARKED

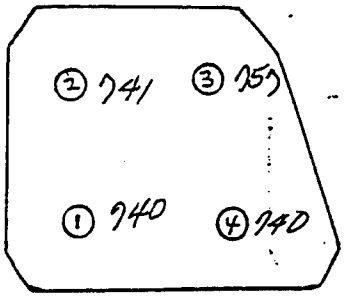
Vinly SEPARATION FROM GLASS Edge ALL AROUND UNIT inBd side.

DeLam AROUND UNIT in OORMER UNIT HAS SURFACE SCR. REMOVER Between PLy.

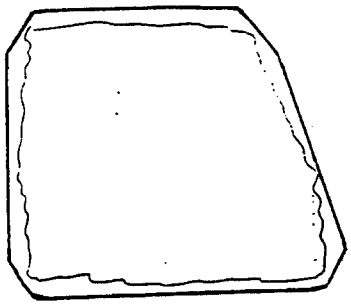
Acc/Rej	Date	Inspector
Bus to Bus Resistance: _____ Ohms	* Rej	MAY 26 1993	22 PPG 77
Thermal Image:			
Insulation Test: Power to Metal: (2500 VAC)			
Nesa Scratch Test (81 VAC):	* Rej	MAY 26 1993	22 PPG 77
Light Transmittance:	82.9	MAY 26 1993	22 PPG 77
Haze:	1.0	MAY 26 1993	22 PPG 77
Photo (Single Exposure):		26 MAY 1993	22 PPG 47
Deviation Inspection: (German Light per Template) 1: 4 2: 10 3: 7 4: 4	Acc	MAY 26 1993	22 PPG 77
Dimensional Inspection:			
Unit Thickness: (Per Template) 1: .693 E.L. 2: .700 3: .695 4: .692			
Check for Vinyl Cracks:	Acc	JUN 02 1993	22 PPG 77
Seal Evaluation:	Rej	JUN 02 1993	22 PPG 77
(Comments)	* OPEN CIRCUIT WRONG SEAL ON OUTBD SIDE INSIDE SEALANT		
Visual Inspection: (Place comments on attached sheet)	Rej	JUN 02 1993	22 PPG 77

open Power Circuit
UNIT HAS AIR ALL ROOND THE UNIT

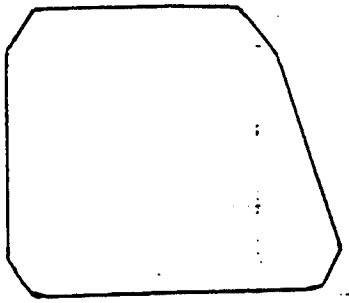
(Comments) WRONG TYPE OF SEAL ON OUTBD SIDE
~~BAD JOINT~~ OPEN CIRCUITS SOMETIME A READING, AND OTHER TIMES NO READING

Open Power Circuit.
Wrong Type of Seal on outbd side

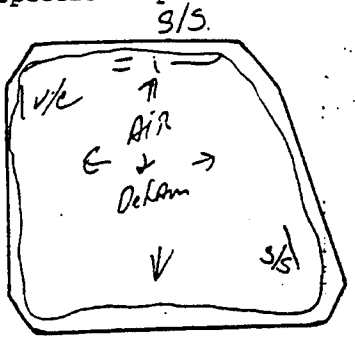
Acc/Rej	Date	Inspector
Bus to Bus Resistance: 118.0 ohms		5-21-93	22 PPG 28
Thermal Image:		5-21-93	22 PPG 28
Insulation Test: Power to Metal: (2500 VAC)	Acc	MAY 2 6 1993	22PPG43
Nesa Scratch Test (81 VAC):	OK	MAY 2 6 1993	22PPG43
Light Transmittance:	80.7	MAY 2 6 1993	22PPG43
Haze:	.4	MAY 2 6 1993	22PPG43
Photo (Single Exposure):	22 PPG 47	JUN 1 4 1993	22 PPG 8
Deviation Inspection: (German Light per Template)	Acc	6-8-93	22 PPG 10
1: < 3 2: < 3 3: < 3 4: < 3			
Dimensional Inspection:			
Unit Thickness: (Per Template)	Acc.	5-24-93	22 PPG 28
1: .642 2: .643 3: .684 4: .686			
Check for Vinyl Cracks:	RoJ	JUN 0 3 1993	22 PPG 77
Seal Evaluation:	RoJ	JUN 0 3 1993	22 PPG 77
(Comments) BAD Seal + Bumper on outbd sides			
Visual Inspection: (Place comments on attached sheet)	RoJ	JUN 0 8 1993	22 PPG 77

AIR & DELAM = LOCATED ALL AROUND UNIT
VINLY CRACK LOCATED AS MARKED
SURFACE SCR LOCATED AS MARKED

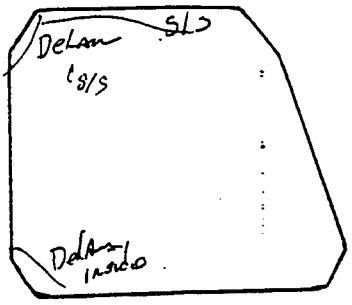
Acc/Rej	Date	Inspector
Bus to Bus Resistance:	119.8 Ohms		5-21-93	22 PPG 28
Thermal Image:			5-21-93	22 PPG 28
Insulation Test: Power to Metal: (2500 VAC)		Acc.	MAY 2 6 1993	22PPG43
Nesa Scratch Test (81 VAC):		OK	MAY 2 6 1993	22PPG43
Light Transmittance:		81.6	MAY 2 6 1993	22PPG43
Haze:		.9	MAY 2 6 1993	22PPG43
Photo (Single Exposure):		22 PPG 47	JUN 1 4 1993	22 PPG 8
Deviation Inspection: (German Light per Template) 1: L 3 2: L 3 3: L 3 4: L 3		ok	6-8-93	22 PPG 10
Dimensional Inspection:				
Unit Thickness: (Per Template) 1: .696 2: .694 3: .692 4: .692		Acc.	5-26-93	22 PPG 28
Check for Vinyl Cracks:			JUN 0 3 1993	22 PPG 77
Seal Evaluation:		Rej	JUN 0 3 1993	22 PPG 77
(Comments) BAD Bumper				
Visual Inspection: (Place comments on attached sheet)		Rej	JUN 0 3 1993	22 PPG 77

Air And Delam Located Around the end Surface Scr. Location As marked

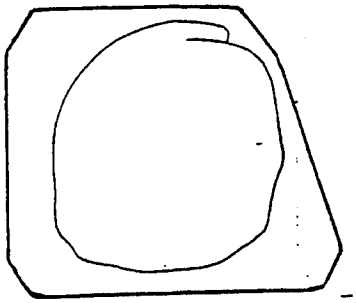
(Comments) No seal on Bumper

Air / DeLam / Vinly CRACKS LOCATED AT AROUND UNIT

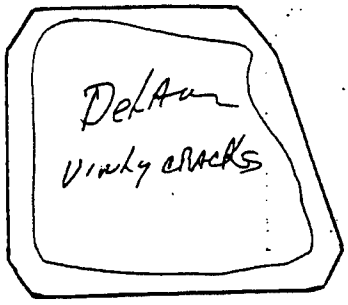
Acc/Rej	Date	Inspector
Bus to Bus Resistance: 79.7 Ohms		5-27-93	[illegible]
Thermal Image:		5-21-93	[illegible]
Insulation Test: Power to Metal: (2500 VAC)	Acc.	MAY 2 6 1993	22PPG43
Nesa Scratch Test (81 VAC):	OK	MAY 2 6 1993	22PPG43
Light Transmittance:	82.3	MAY 2 6 1993	22PPG43
Haze:	1.0	MAY 2 6 1993	22PPG43
Photo (Single Exposure):	22 PPG 47	JUN 1 4 1993	22 PPG 8
Deviation Inspection: (German Light per Template) 1: 2.3 2: 2.45 3: 4.5 4: 7	Acc	6-8-93	22 PPG 10
Dimensional Inspection:			
Unit Thickness: (Per Template) 1: .666 2: .666 3: .668 4: .665	Acc	5-26-93	22 PPG 28
Check for Vinyl Cracks:	PaS	JUN 0 3 1993	22 PPG 77
Seal Evaluation:	PaS	JUN 0 3 1993	22 PPG 77
(Comments) No seal on Bumper			
Visual Inspection: (Place comments on attached sheet)	PaS	JUN 0 8 1993	22 PPG 77

AIR, DeLam And Vinly cracks Located All AR ~~Ocat~~ Unit

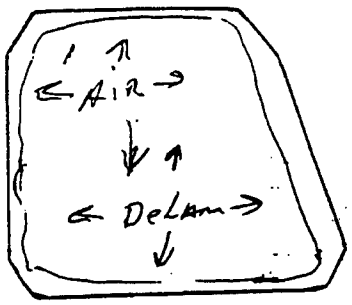
Acc/Rej	Date	Inspector
Bus to Bus Resistance: 123.2 / 96.8 Ohms		5-21-93	22 PPG 28
Thermal Image:		5-21-93	22 PPG 28
Insulation Test: Power to Metal: (2500 VAC)	ACC	MAY 2 6 1993	22PPG43
Nesa Scratch Test (81 VAC):	OK	MAY 2 6 1993	22PPG43
Light Transmittance:	82.2	MAY 2 6 1993	22PPG43
Haze:	.8	MAY 2 6 1993	22PPG43
Photo (Single Exposure):	22 PPG 47	JUN 1 4 1993	22 PPG 28
Deviation Inspection: (German Light per Template) 1: <3 2: <3 3: <3 4: <3	A	JUN 0 9 1993	22 PPG 39
Dimensional Inspection:			
Unit Thickness: (Per Template) 1: .687 2: .646 3: .684 4: .685	Acc.	5-26-93	22 PPG 28
Check for Vinyl Cracks:	Acc	JUN 0 3 1993	22 PPG 77
Seal Evaluation:	Rej	JUN 0 3 1993	22 PPG 77
(Comments) NO BUMPER ON OUTBD SIDE			
Visual Inspection: (Place comments on attached sheet)	Rej	JUN 0 8 1993	22 PPG 77

B/B Rus. 123,2 Lifts before T.I 96.8 after T.I
AiR ALL ARound of unit And ALso DeLam

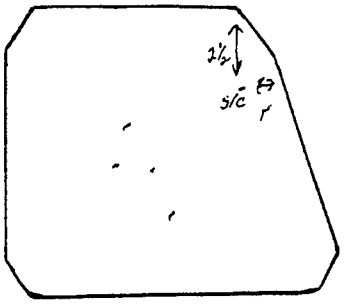
(Comments) Worse seal on outbd side of unit

SURFACE CHIP LOCATED 2½" in down And 1" FROM Fwd. Edge
And OTHER SURFACE Defects LOCATED center of UNIT

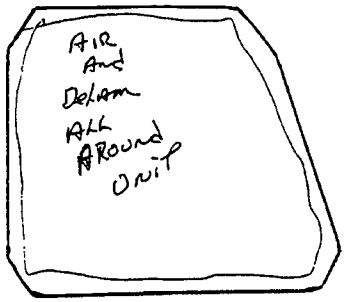
(Comments) Wrong seal on outbd surface
Bumper is not on outbd surface

AIR And Delam located All Around UNIT

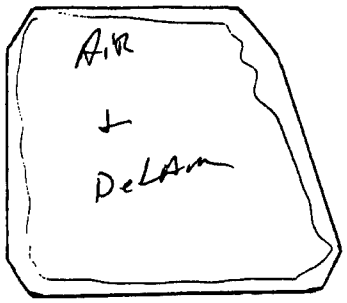
Acc/Rej	Date	Inspector
Bus to Bus Resistance: 83.7 Ohms		5-21-93	22 PPG 28
Thermal Image:		5-21-93	22 PPG 28
Insulation Test: Power to Metal: (2500 VAC)	Acc	MAY 2 6 1993	22PPG43
Nesa Scratch Test (81 VAC):	OK	MAY 2 6 1993	22PPG43
Light Transmittance:	82.8	MAY 2 6 1993	22PPG43
Haze:	.8	MAY 2 6 1993	22PPG43
Photo (Single Exposure):	22 PPG 47	JUN 1 4 1993	22 PPG 28
Deviation Inspection: (German Light per Template) 1: < 3 2: < 4.5 3: < 7 4: 4.5	Acc	6-8-93	22 PPG 28
Dimensional Inspection:			
Unit Thickness: (Per Template) 1: .699 2: .701 3: .697 4: .687	Acc	5-26-93	22 PPG 28
Check for Vinyl Cracks:	Acc	JUN 0 3 1993	22 PPG 77
Seal Evaluation:	Rej	JUN 0 3 1993	22 PPG 77
(Comments) Bad Bubbles and wrong Seal on out bd side			
Visual Inspection: (Place comments on attached sheet)	Rej	JUN 0 3 1993	22 PPG 77

AIR And DeLAm is LOCATED ALL AROUND Unit.

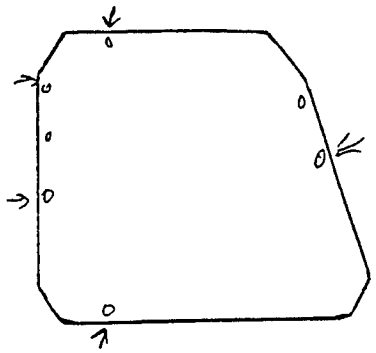
(Comments) Seal Loose But Acceptable

Seal Loose As Marked

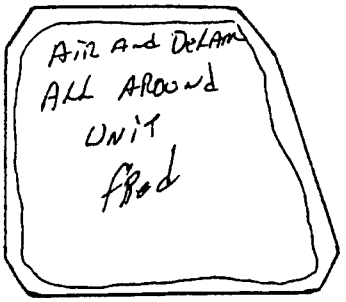
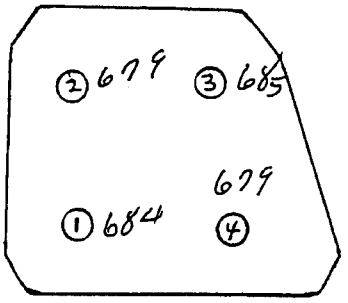
Visual Inspection Map & Comments

Acc/Rej	Date	Inspector
Bus to Bus Resistance: 101.0 Ohms		5-21-93	22 PPG 28
Thermal Image:		5-21-93	22 PPG 28
Insulation Test: Power to Metal: (2500 VAC)	Acc	MAY 2 6 1993	22PPG43
Nesa Scratch Test (81 VAC):	OK	MAY 2 6 1993	22PPG43
Light Transmittance:	81.2	MAY 2 6 1993	22PPG43
Haze:	1.5	MAY 2 6 1993	22PPG43
Photo (Single Exposure):	22 PPG 47	JUN 14 1993	22 PPG 8
Deviation Inspection: (German Light per Template) 1: ~~.644~~ E.L. <3 2: <3 3: <3 4: <3	A	JUN 09 1993	22 PPG 39
Dimensional Inspection:			
Unit Thickness: (Per Template) 1: .684 2: .679 3: .685 4: .679	Acc.	5-26-93	22 PPG 28
Check for Vinyl Cracks:	Acc	JUN 03 1993	22 PPG 77
Seal Evaluation:	Rej	JUN 03 1993	22 PPG 77
(Comments) Wrong Seal on outer Side			
Visual Inspection: (Place comments on attached sheet)	Rej	JUN 03 1993	22 PPG 77

Air And Delam ALL AROUND Edge of Unit

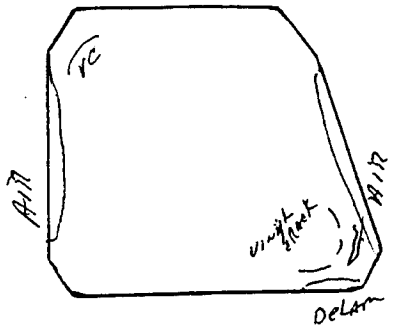
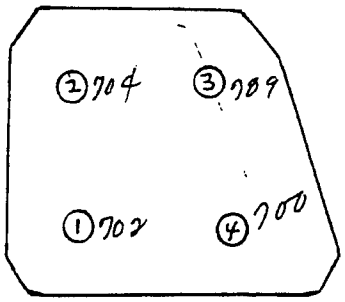
Visual Inspection Map & Comments

(Comments) WRONG SEAL ON OUTBD side And INSIDE SEALANT VERY BAD shape

AIR Located ALL ROUND UNIT. PLUS A LARGE Amount Located LOWER/FWD. Along with DeLam ALSO VINYL CRACKS believe TO BE STARTING
