DEVELOPMENT OF REPAIR PROCESSES AND SOURCES FOR C/KC-135 AIRCRAFT WINDOWS/WINDSHIELDS

RICHARD J. OLSON

SEPTEMBER 1994

TECHNICAL REPORT FOR 09/91 - 01/94
C/KC-135 FINAL REPORT
CONTRACT NUMBER FO9603-90-D-2217-SD02

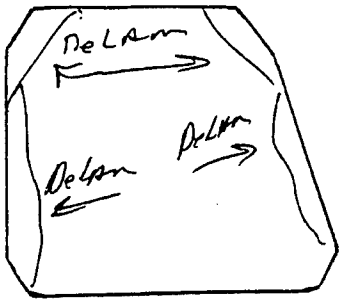
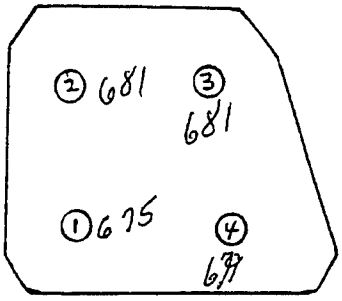
Visual Inspection Map & Comments

DeLam And Air All Around Unit

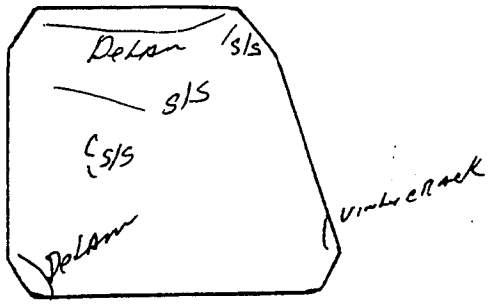
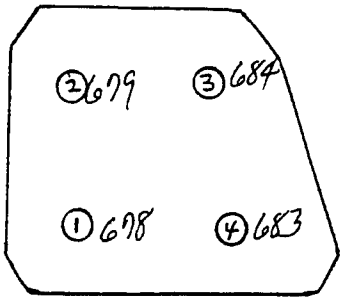
Visual Inspection Map & Comments

Acc/Rej	Date	Inspector
Bus to Bus Resistance:	87.0 ohms		5-21-93	22 PPG 28
Thermal Image:			5-21-93	22 PPG 28
Insulation Test: Power to Metal: (2500 VAC)		Acc.	MAY 2 6 1993	22PPG43
Nesa Scratch Test (81 VAC):		OK	MAY 2 6 1993	22PPG43
Light Transmittance:		81.1	MAY 2 6 1993	22PPG43
Haze:		1.1	MAY 2 6 1993	22PPG43
Photo (Single Exposure):		22 PPG 47.	JUN 14 1993	22 PPG 28
Deviation Inspection: (German Light per Template)		~~Acc~~	6-8-93	22 PPG 28
1: ∠3 2: ∠3 3: ∠3 4: ∠3				
Dimensional Inspection:				
Unit Thickness: (Per Template)		Acc.	5-26-93	22 PPG 28
1: .678 2: .679 3: .684 4: .683				
Check for Vinyl Cracks:		~~Rej~~	JUN 03 1993	22 PPG 28
Seal Evaluation:		Rej	JUN 03 1993	22 PPG 28
(Comments)	No seal And Bad Bumper on OUTBd Side			
Visual Inspection: (Place comments on attached sheet)		Rej	JUN 03 1993	22 PPG 28

DeLam as marked
Surface scr. as marked
Vinyl crack as marked

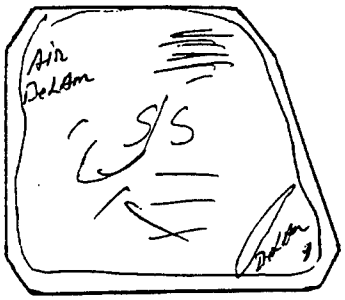
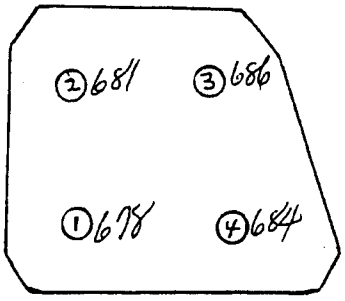
Visual Inspection Map & Comments

Acc/Rej	Date	Inspector
Bus to Bus Resistance: 127.7 Ohms		5-21-93	22 PPG 28
Thermal Image:		5-21-93	22 PPG 28
Insulation Test: Power to Metal: (2500 VAC)	Acc.	MAY 2 6 1993	22PPG43
Nesa Scratch Test (81 VAC):	OK	MAY 2 6 1993	22PPG43
Light Transmittance:	81.6	MAY 2 6 1993	22PPG43
Haze:	1.4	MAY 2 6 1993	22PPG43
Photo (Single Exposure):	22 PPG 47	JUN 1 4 1993	22 PPG 8
Deviation Inspection: (German Light per Template) 1: ∠3 2: ∠3 3: ∠3 4: ∠3	Acc	6-8-93	22 PPG 10
Dimensional Inspection:		JUN 1 4 1993	
Unit Thickness: (Per Template) 1: .678 2: .681 3: .686 4: .684	Acc	5-26-93	22 PPG 28
Check for Vinyl Cracks:	Rej	JUN 0 3 1993	22 PPG 77
Seal Evaluation:	Rej	JUN 0 3 1993	22 PPG 77
(Comments) BAD Seal And Bumper			
Visual Inspection: (Place comments on attached sheet)	Rej	JUN 0 3 1993	PPG 77

BAD SURFACE SCR LOCATED THROUGHOUT THE UNIT BOTH SIDE

AIR And DeLAm LOCATED ALL AROUND UNIT

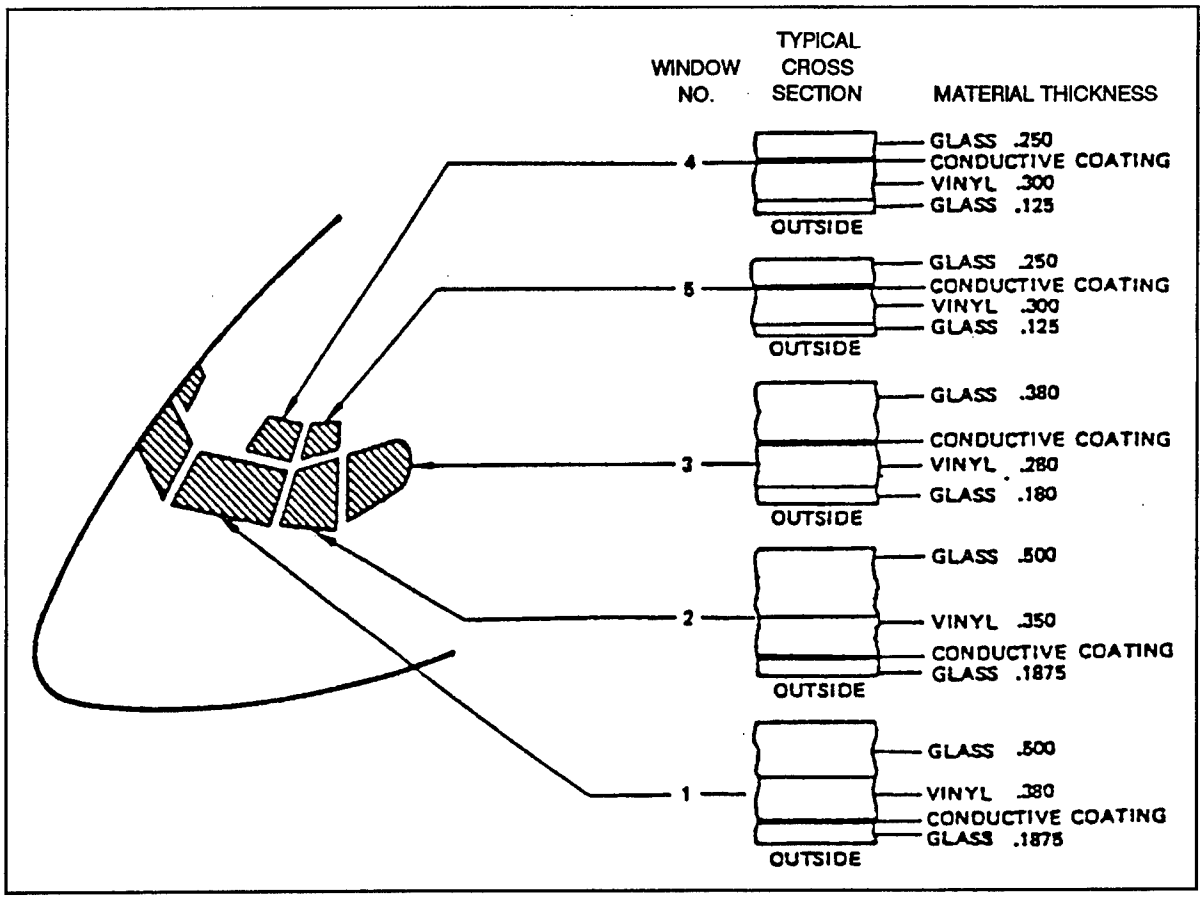
Figure 2.2 C/KC-135 W/WS Construction

Figure 2.2 shows the general construction of the C/KC-135 W/WS. The C/KC-135 W/WS have a three-part glass and vinyl laminate construction. The inner layer is thick, heat-strengthened plate glass designed to withstand cabin pressure forces. A transparent, plasticized, polyvinyl butyral core layer acts as the "fail-safe" load carrying member and prevents shattering in the event of inner ply failure. The outer ply is a relatively thin layer of heat-strengthened glass with no structural significance, but it provides rigidity and a scratch-resistant surface. A phenolic or masonite filler strip, located around the edge of the W/WS, and a metal filler strip embedded in the vinyl provide the means to attach the W/WS to the airframe. Vinyl or vinyl and rubber bumpers protect the sides of the outer ply.

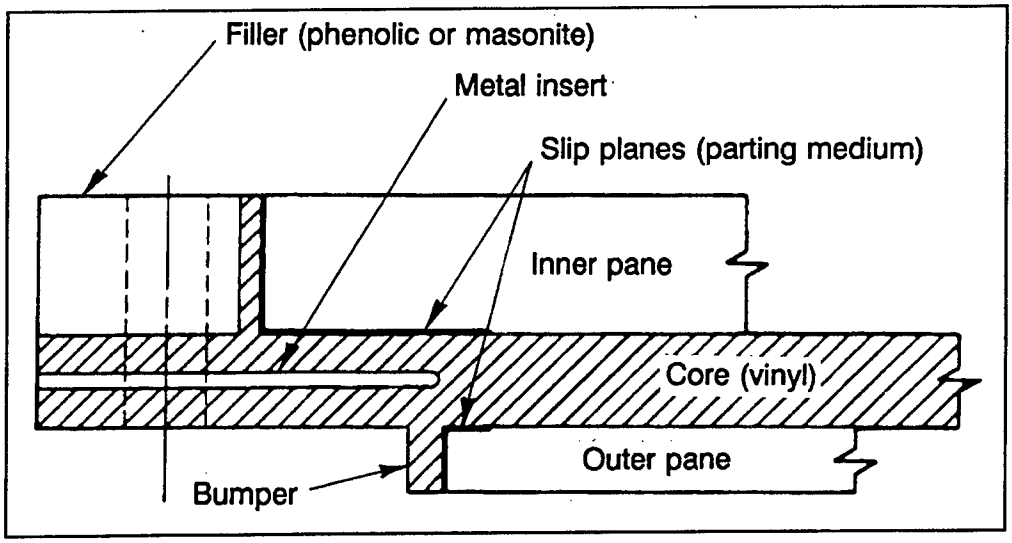
Figure 2.3 W/WS Construction Showing Location of Slip Planes

An integral part of the C/KC-135 W/WS construction is slip planes or a parting medium at the edges of the glass. A slip plane is located between both the inner glass ply and the vinyl and the outer glass ply and the vinyl as shown in Figure 2.3. The slip planes are thin strips of material at the glass-vinyl interface that keep the glass from bonding to the vinyl. This allows the various plys to move independently at these locations in response to pressure loads and differential thermal expansion. Without the slip planes, the glass at the edges of the W/WS would be prone to fracture because it would exceed its strain limit as it tried to move with the underlying vinyl. The slip planes form a "softer" connection that promotes a more gradual build up of strains in the glass so that it does not exceed its strain capacity. Although the slip planes look similar to delamination, they are not defects but an intentional part of the W/WS design.

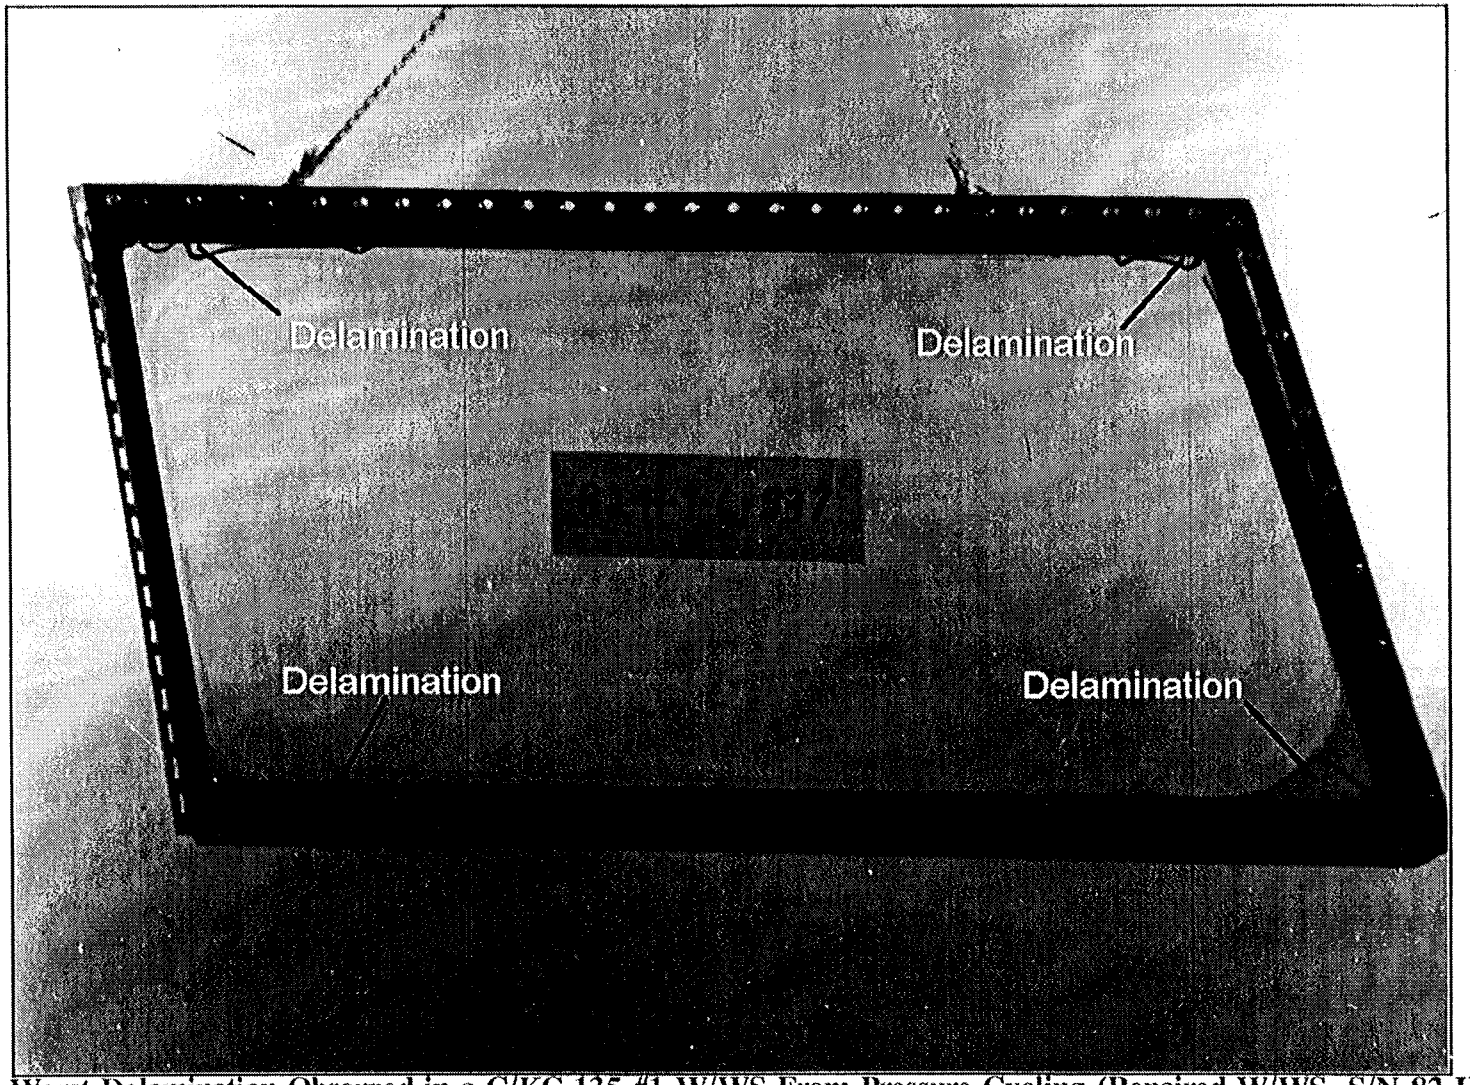
Figure 4.11 Worst Delamination Observed in a C/KC-135 #1 W/WS From Pressure Cycling (Repaired W/WS, S/N 82-H-09-06-537)

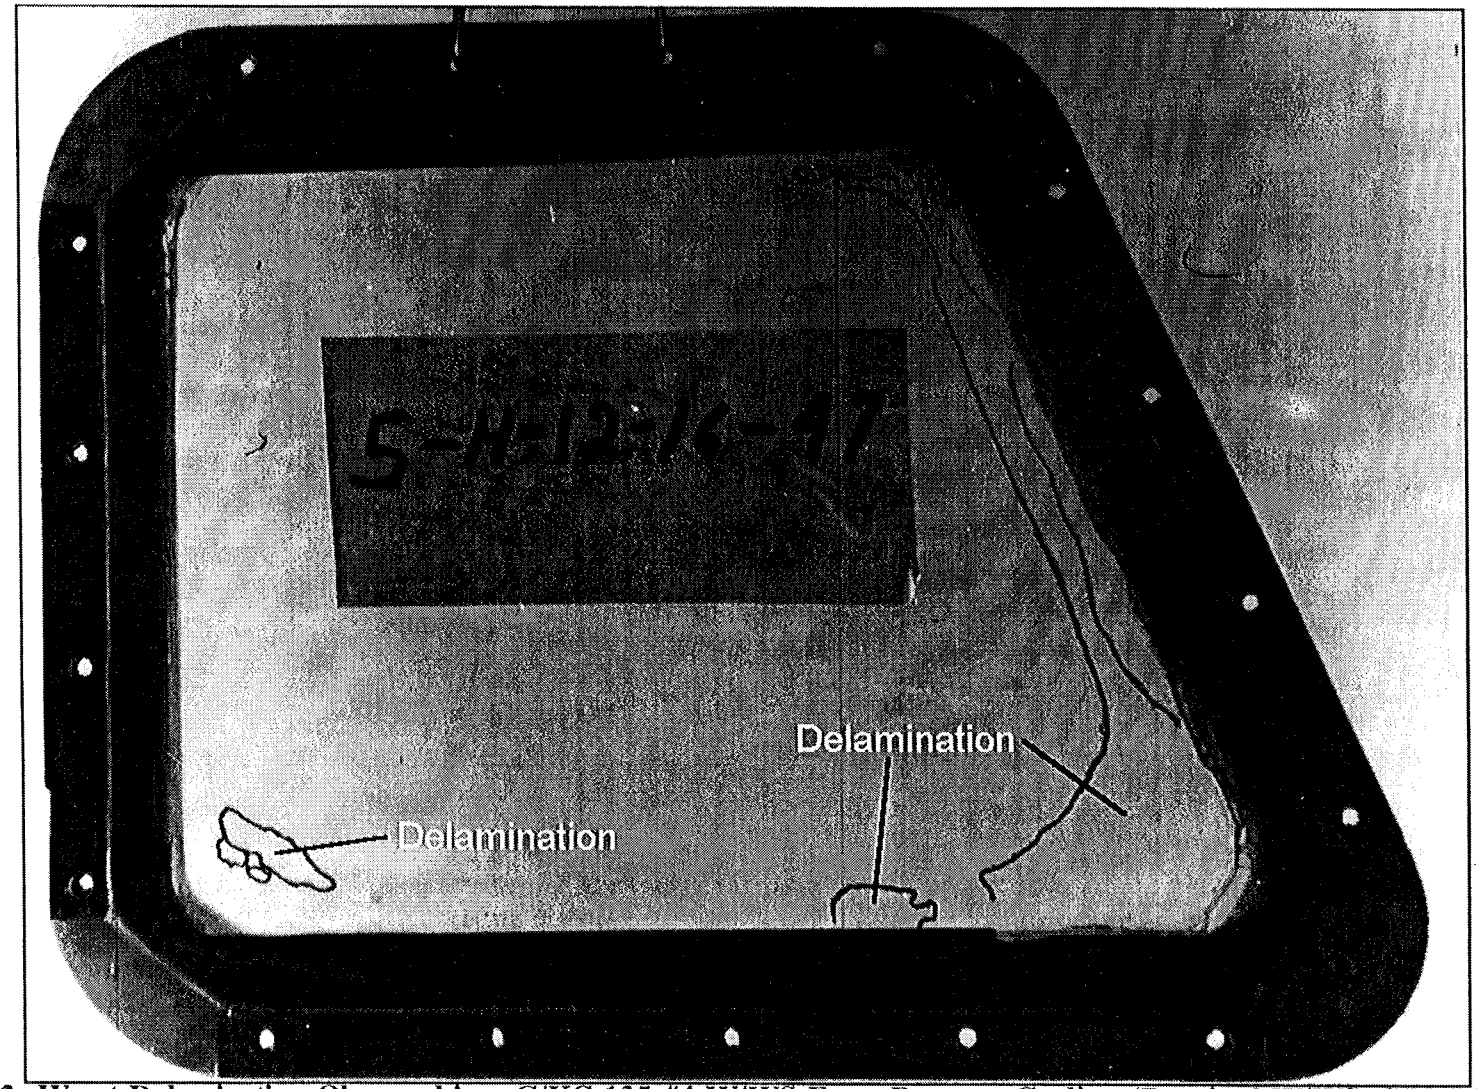
Figure 4.12 Worst Delamination Observed in a C/KC-135 #4 W/WS From Pressure Cycling (Repaired W/WS, S/N 5-H-12-16-47)

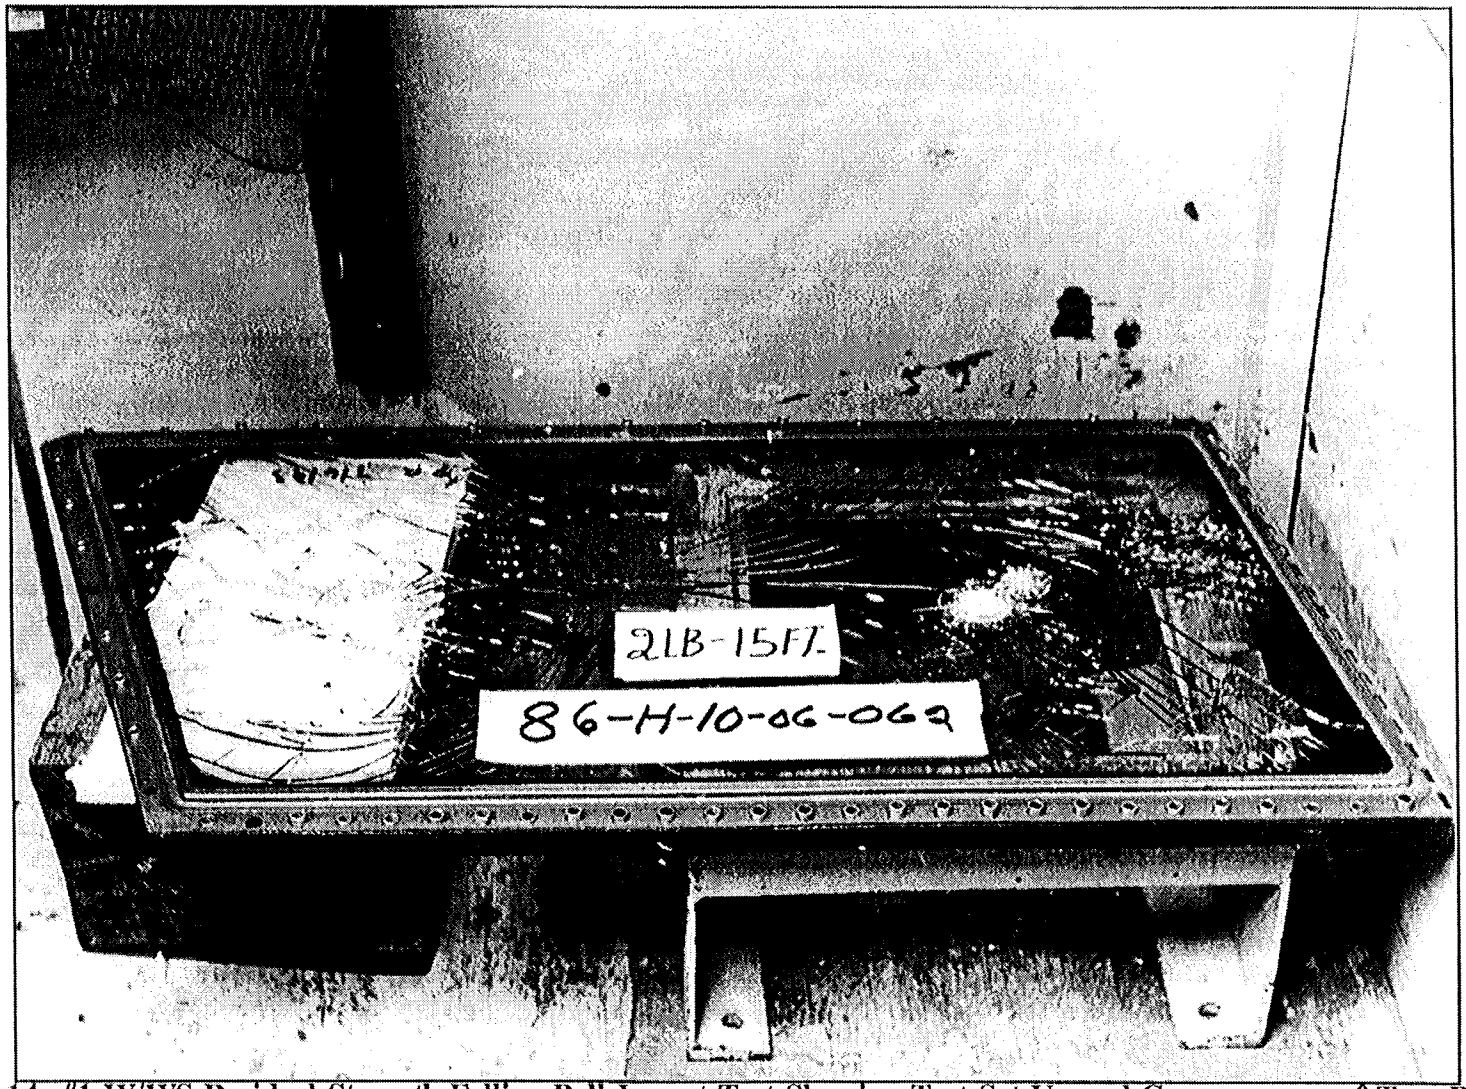
Tables 4.11 and 4.12 detail the results of the falling ball residual strength impact testing, while Figures 4.14 through 4.19 show the test set-ups and selected consequences of the impacts. The results of the ball drop are not conclusive because only a single new W/WS was tested of each type. The worst damage occurred in repaired W/WS with delamination, so there appears to be a suggestion that the ball drops do more damage to the repaired W/WS than the new W/WS.

Figure 4.14 #1 W/WS Residual Strength Falling Ball Impact Test Showing Test Set Up and Consequences of Two Ball Drops (New W/WS, S/N 86-H-10-06-062)

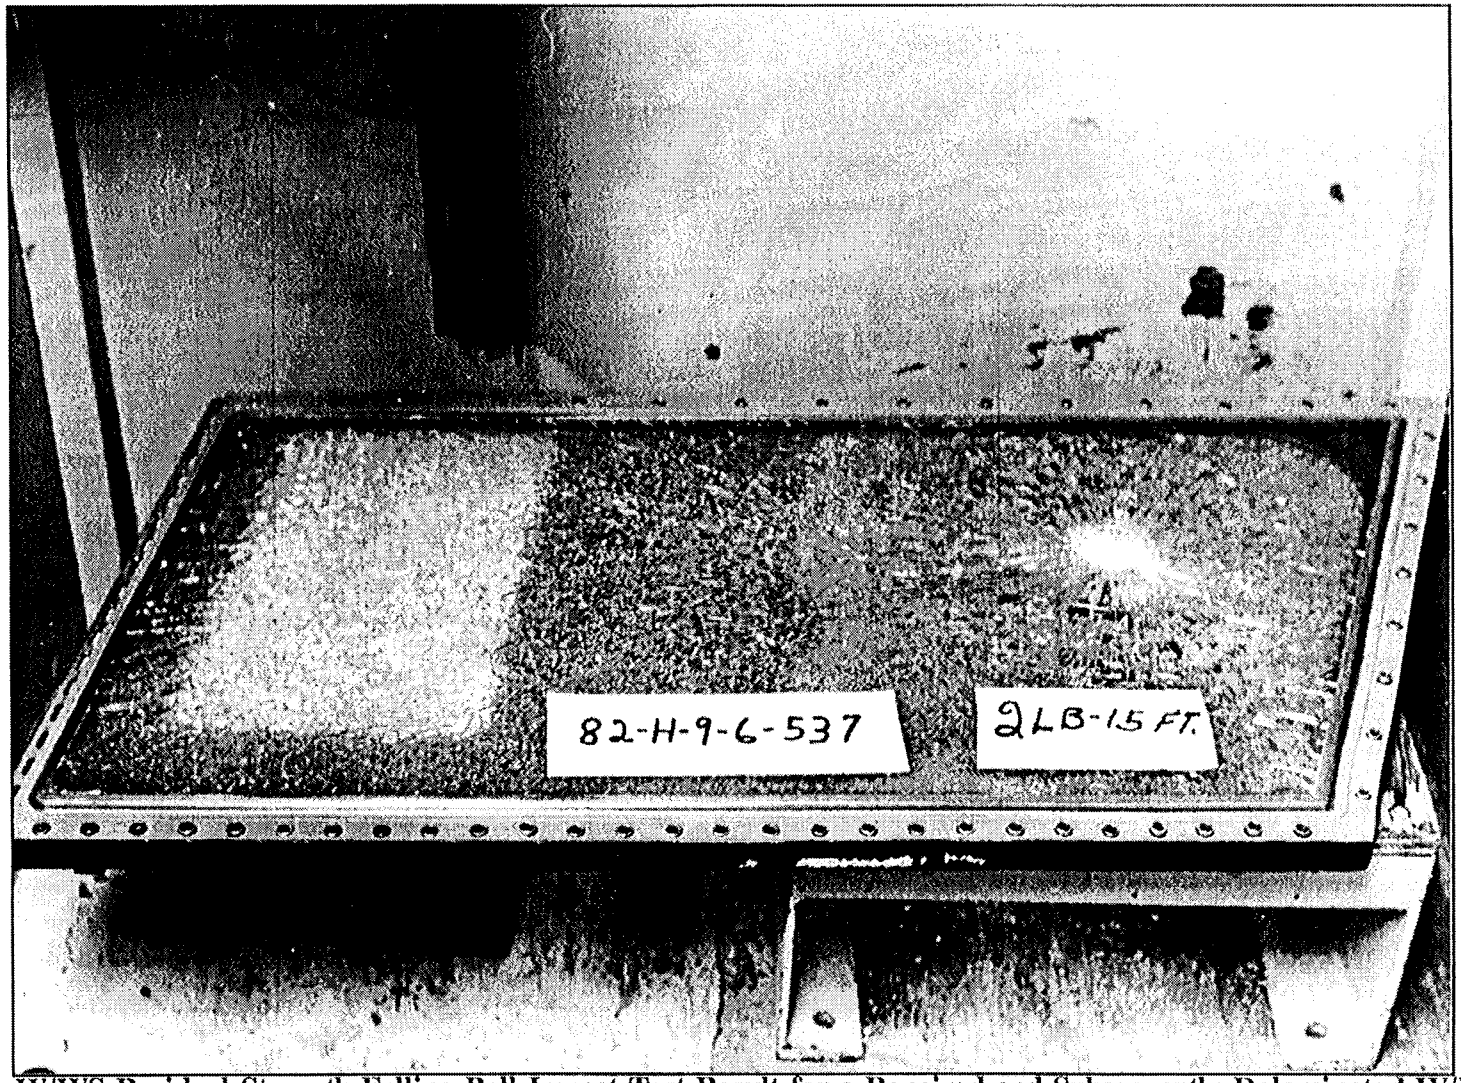
Figure 4.15 #1 W/WS Residual Strength Falling Ball Impact Test Result for a Repaired and Subsequently Delaminated W/WS, Single Ball Drop, Outboard View (S/N 82-H-9-6-537)

Figure 4.16 #1 W/WS Residual Strength Falling Ball Impact Test Result for a Repaired and Subsequently Delaminated W/WS, Single Ball Drop, Inboard View (S/N 82-H-9-6-537)

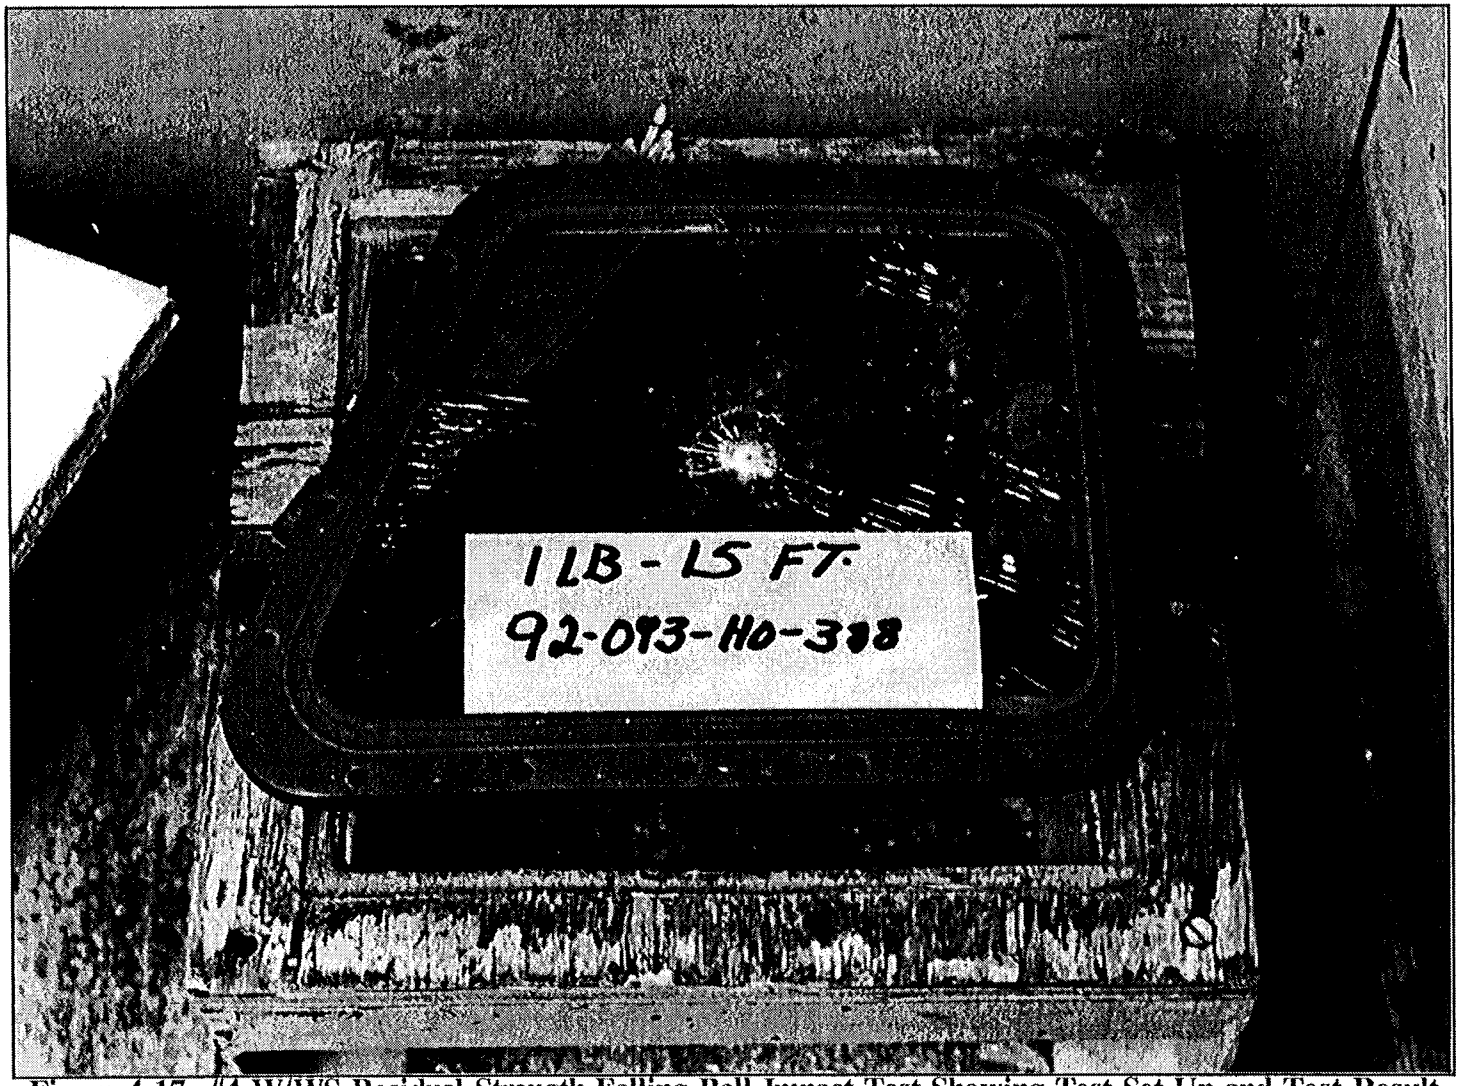
Figure 4.17 #4 W/WS Residual Strength Falling Ball Impact Test Showing Test Set Up and Test Result (New W/WS, S/N 92-093-HO-388)

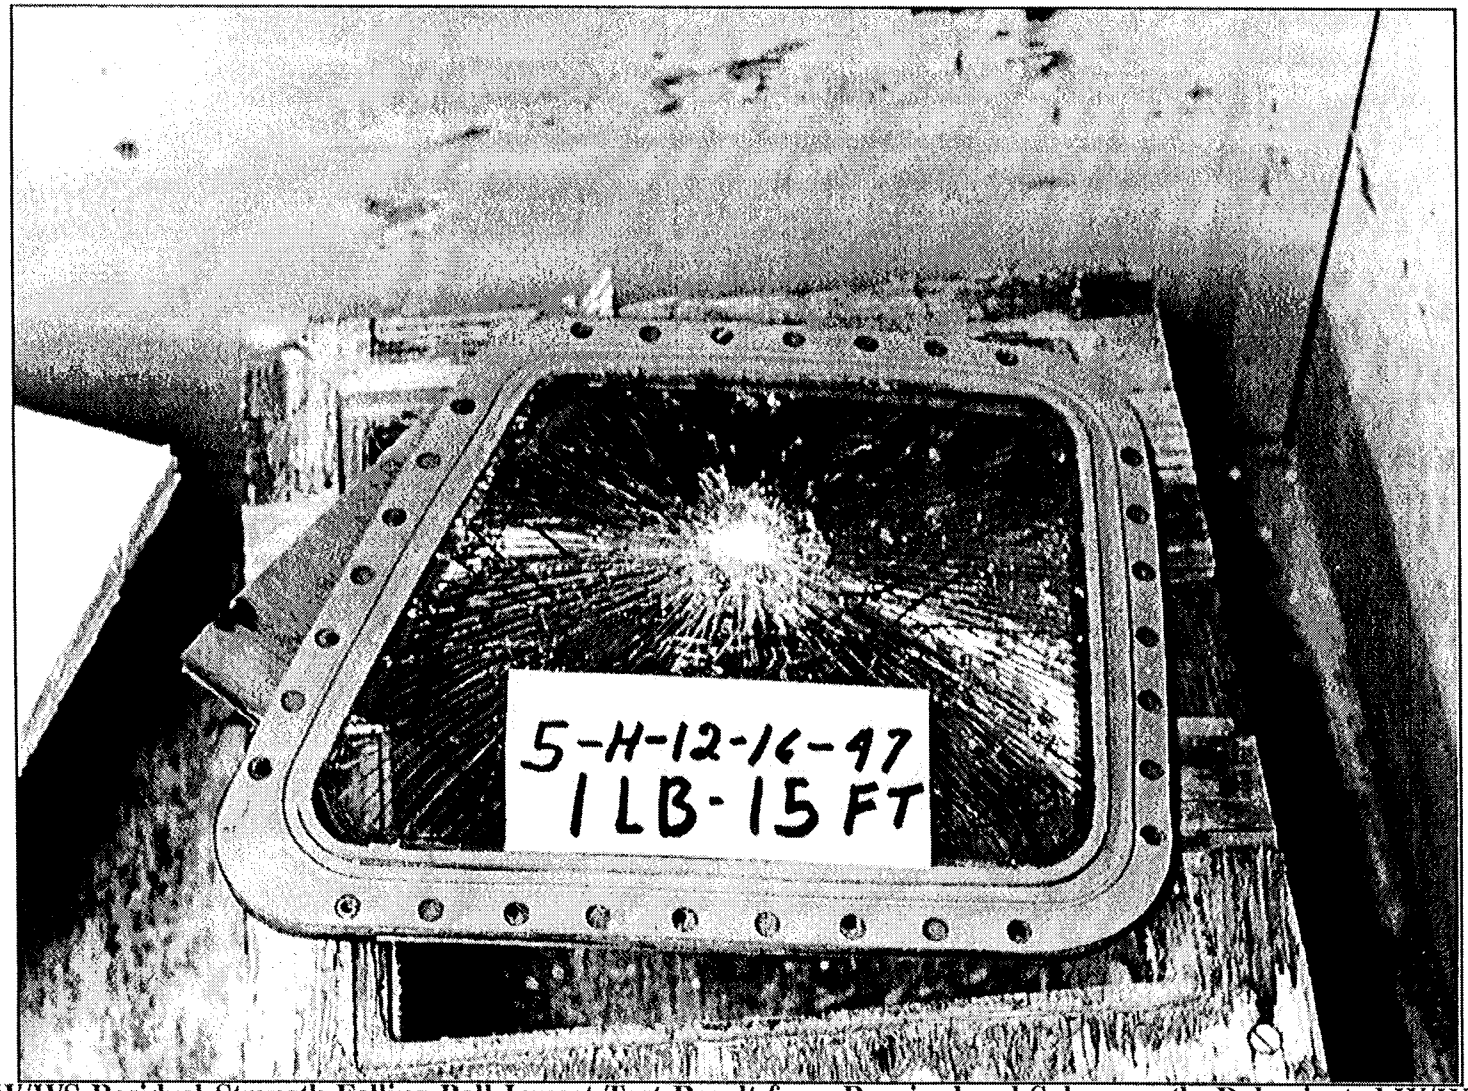
Figure 4.18 #4 W/WS Residual Strength Falling Ball Impact Test Result for a Repaired and Subsequently Delaminated W/WS, Outboard View (S/N 5-H-12-16-47)

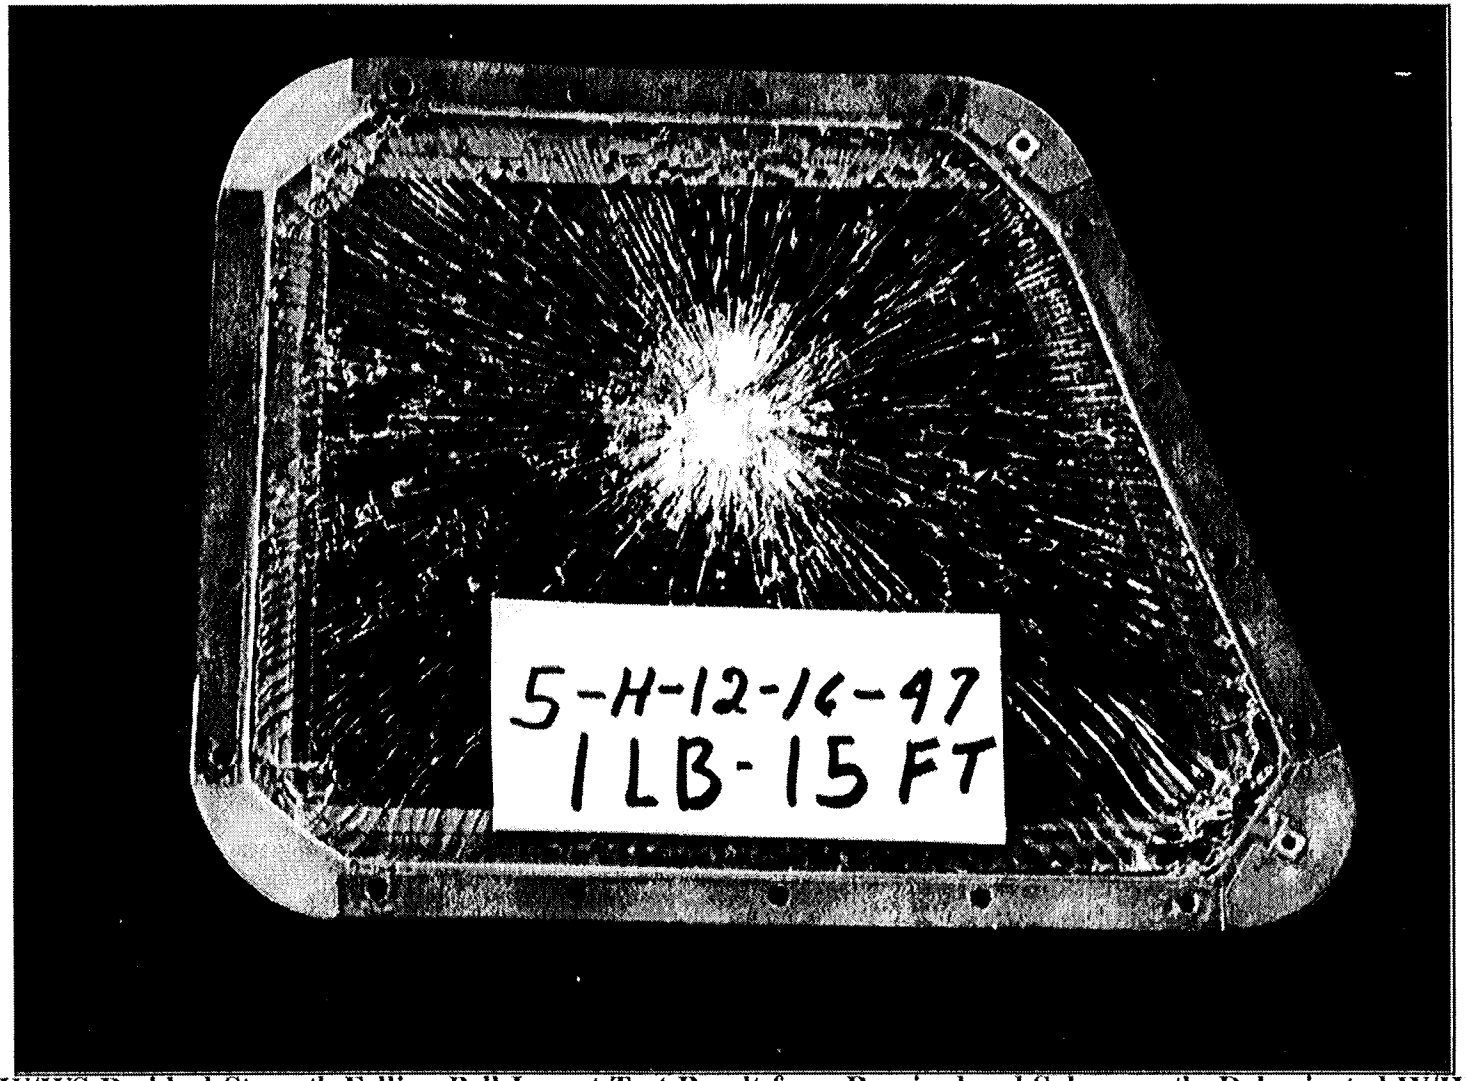
Figure 4.19 #4 W/WS Residual Strength Falling Ball Impact Test Result for a Repaired and Subsequently Delaminated W/WS, Inboard View (S/N 5-H-12-16-47)

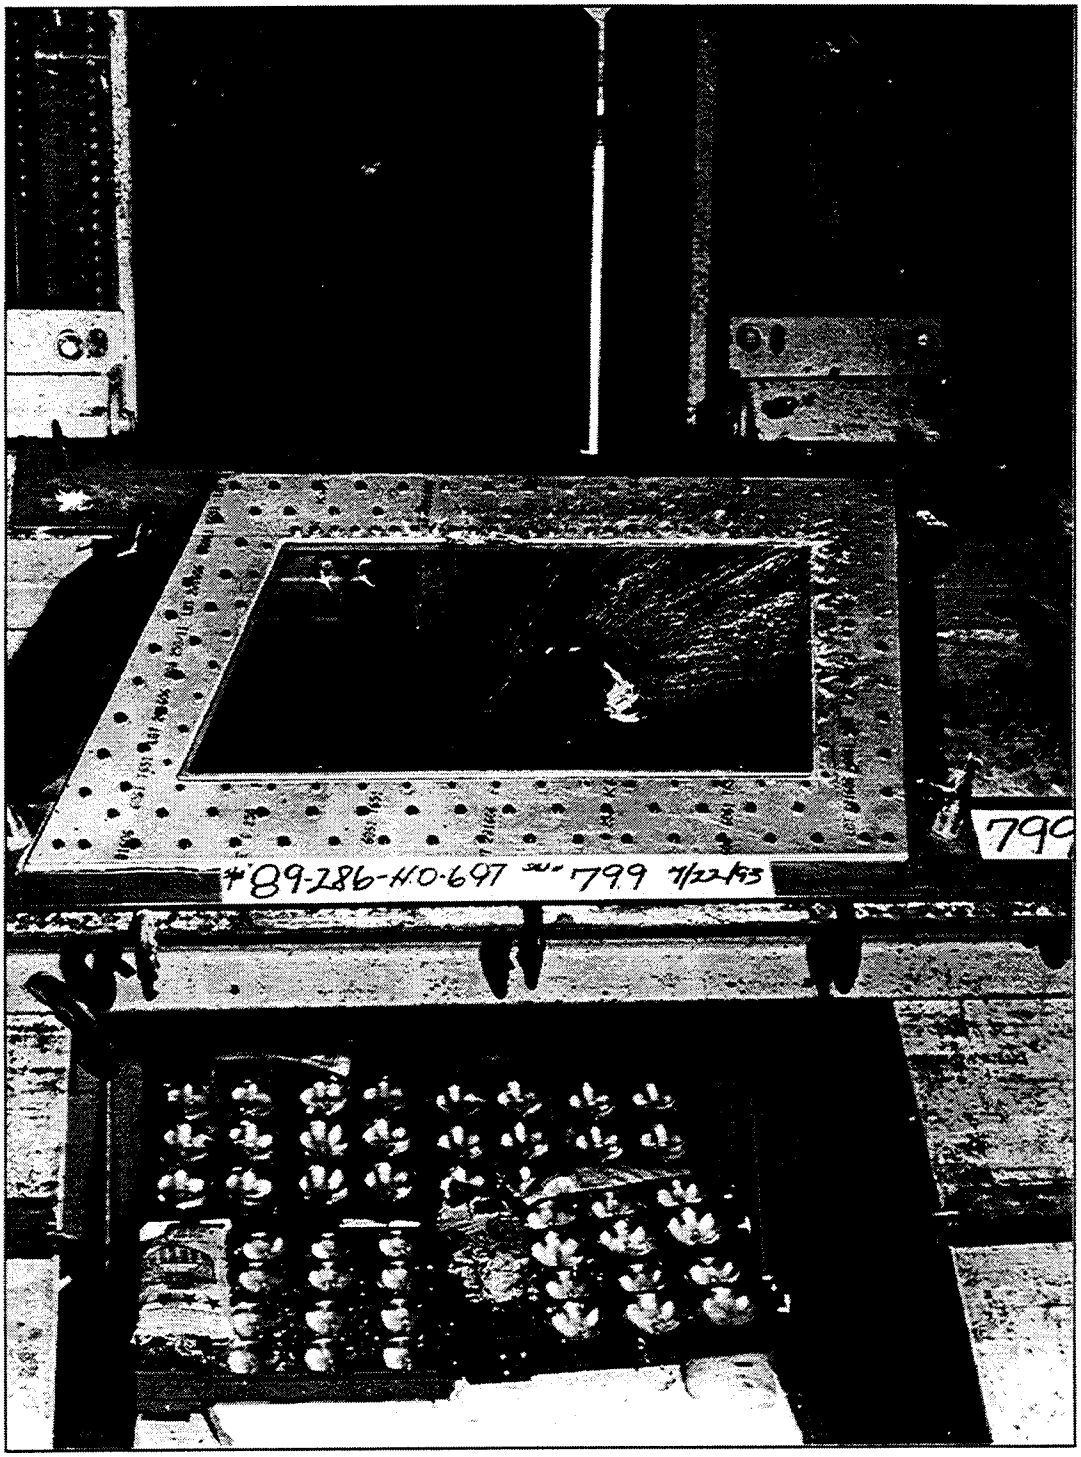
Figure 4.29 C/KC-135 #1 W/WS Showing No Damage From a 4-Pound Bird Impact at 250.8 Knots (Repaired W/WS, S/N 89-286-HO-697)

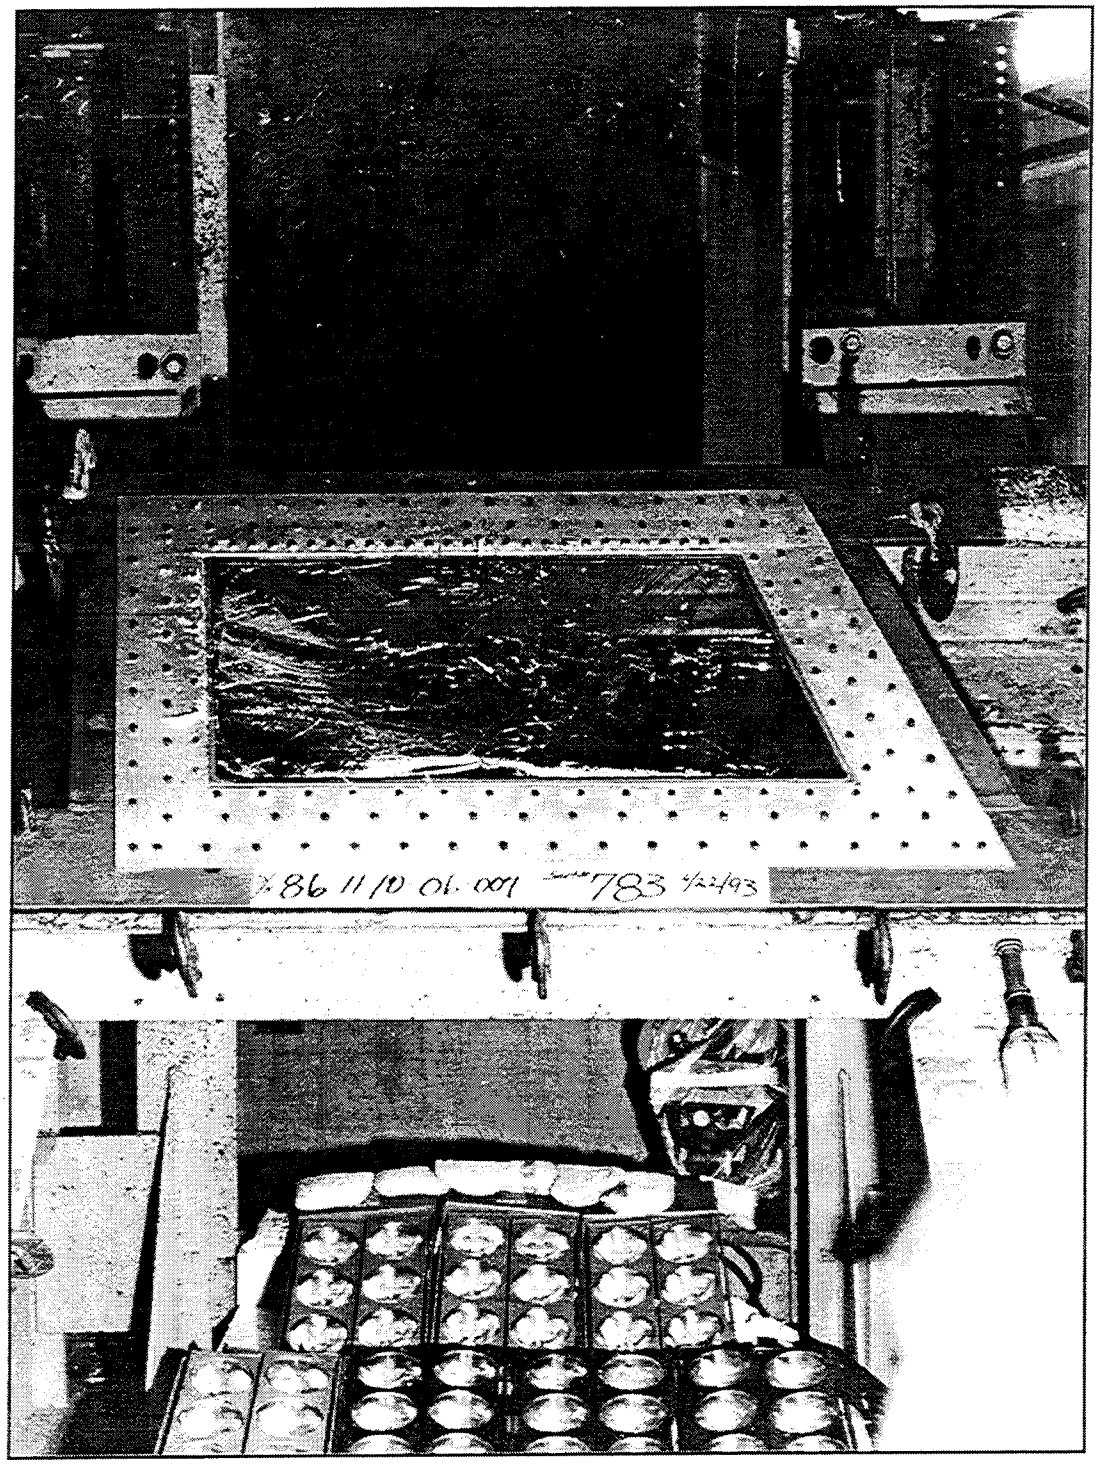
Figure 4.30 C/KC-135 #1 W/WS Showing Outboard Ply Failure From a 4-Pound Bird Impact at 251.7 Knots, Front View (New W/WS, S/N 86-H-10-06-007)

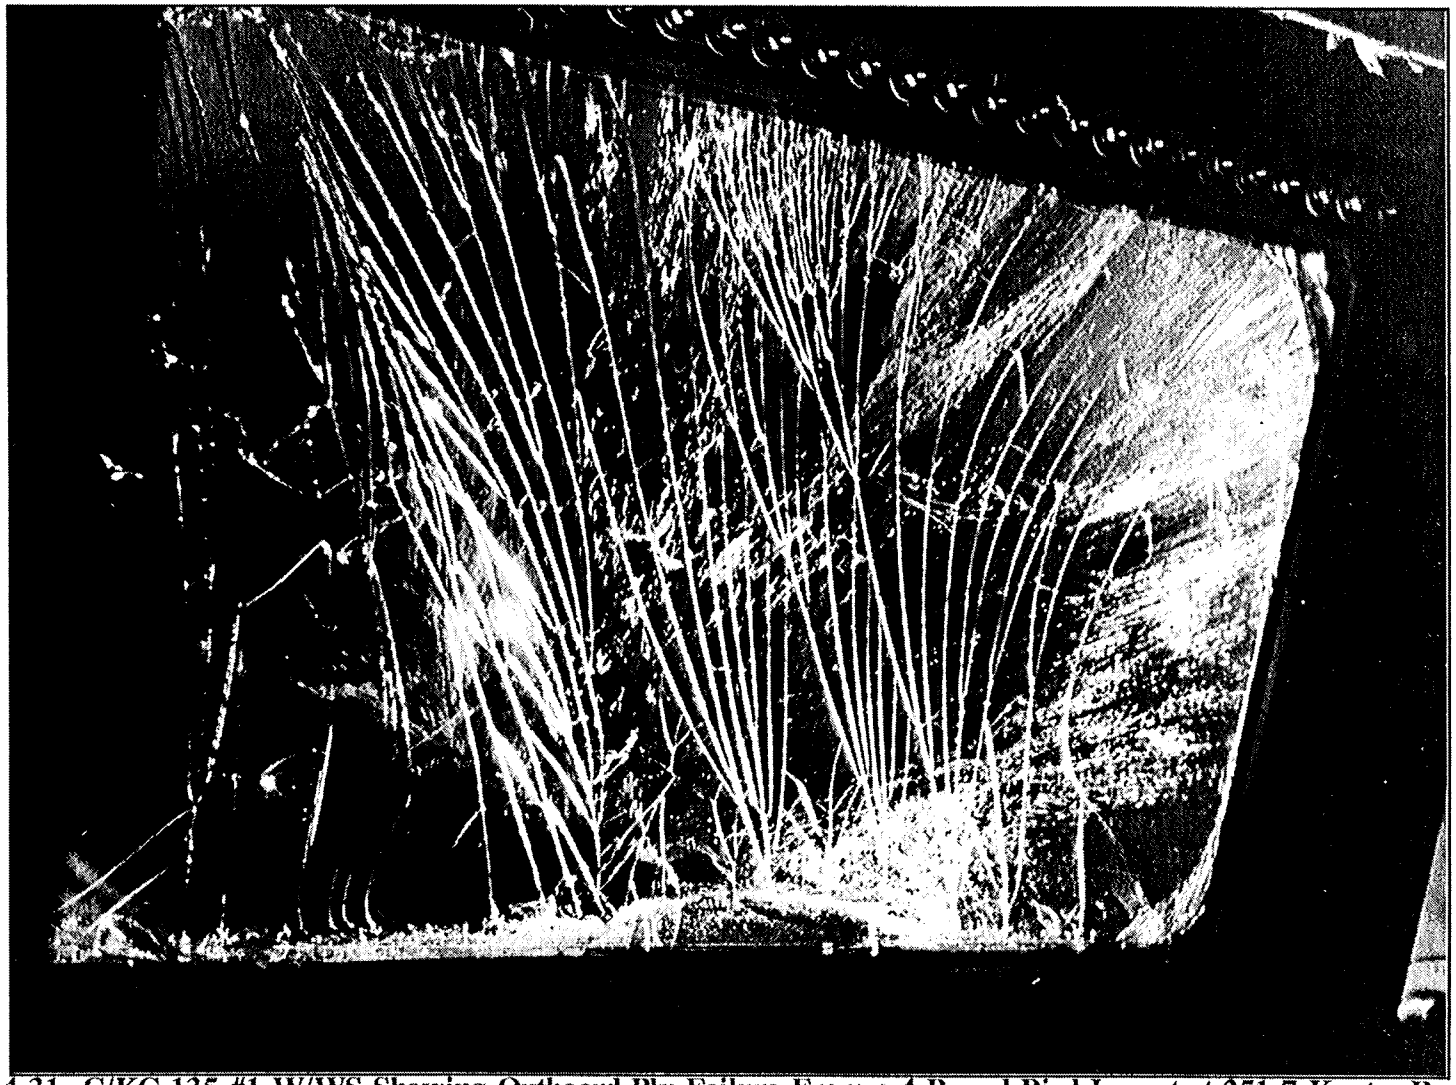
Figure 4.31 C/KC-135 #1 W/WS Showing Outboard Ply Failure From a 4-Pound Bird Impact at 251.7 Knots, Rear View (New W/WS, S/N 86-H-10-06-007)

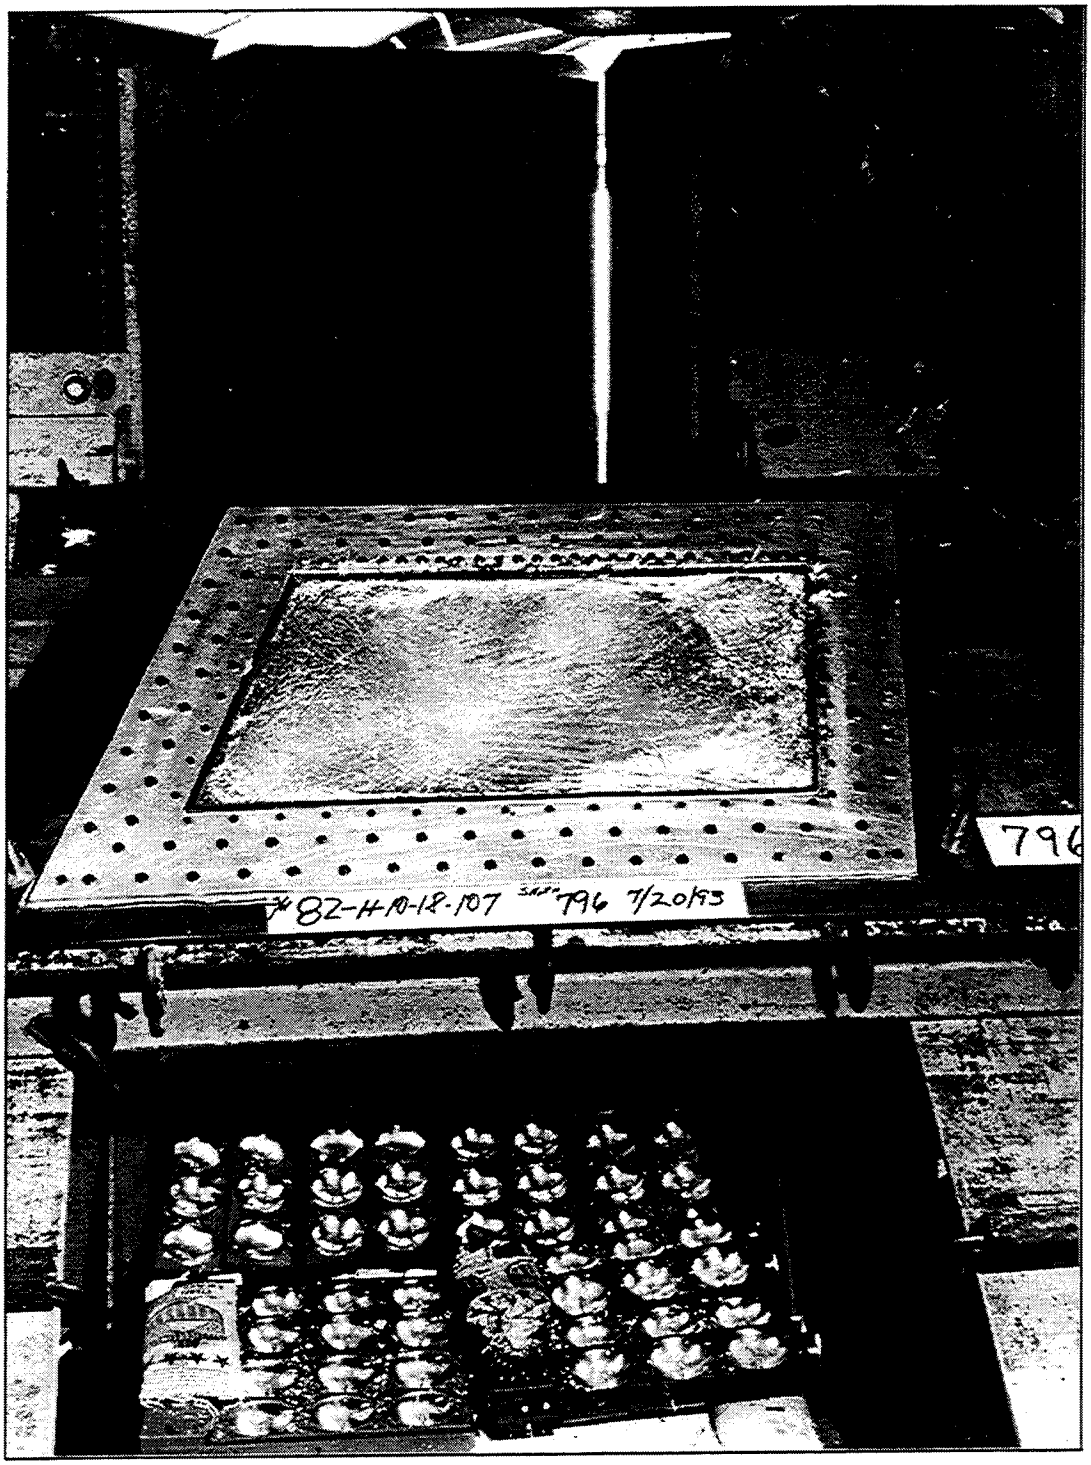
Figure 4.32 C/KC-135 #1 W/WS Showing All Glass Plies Failed From a 4-Pound Bird Impact at 249.4 Knots, Front View (Repaired W/WS, S/N 82-H-10-18-107)

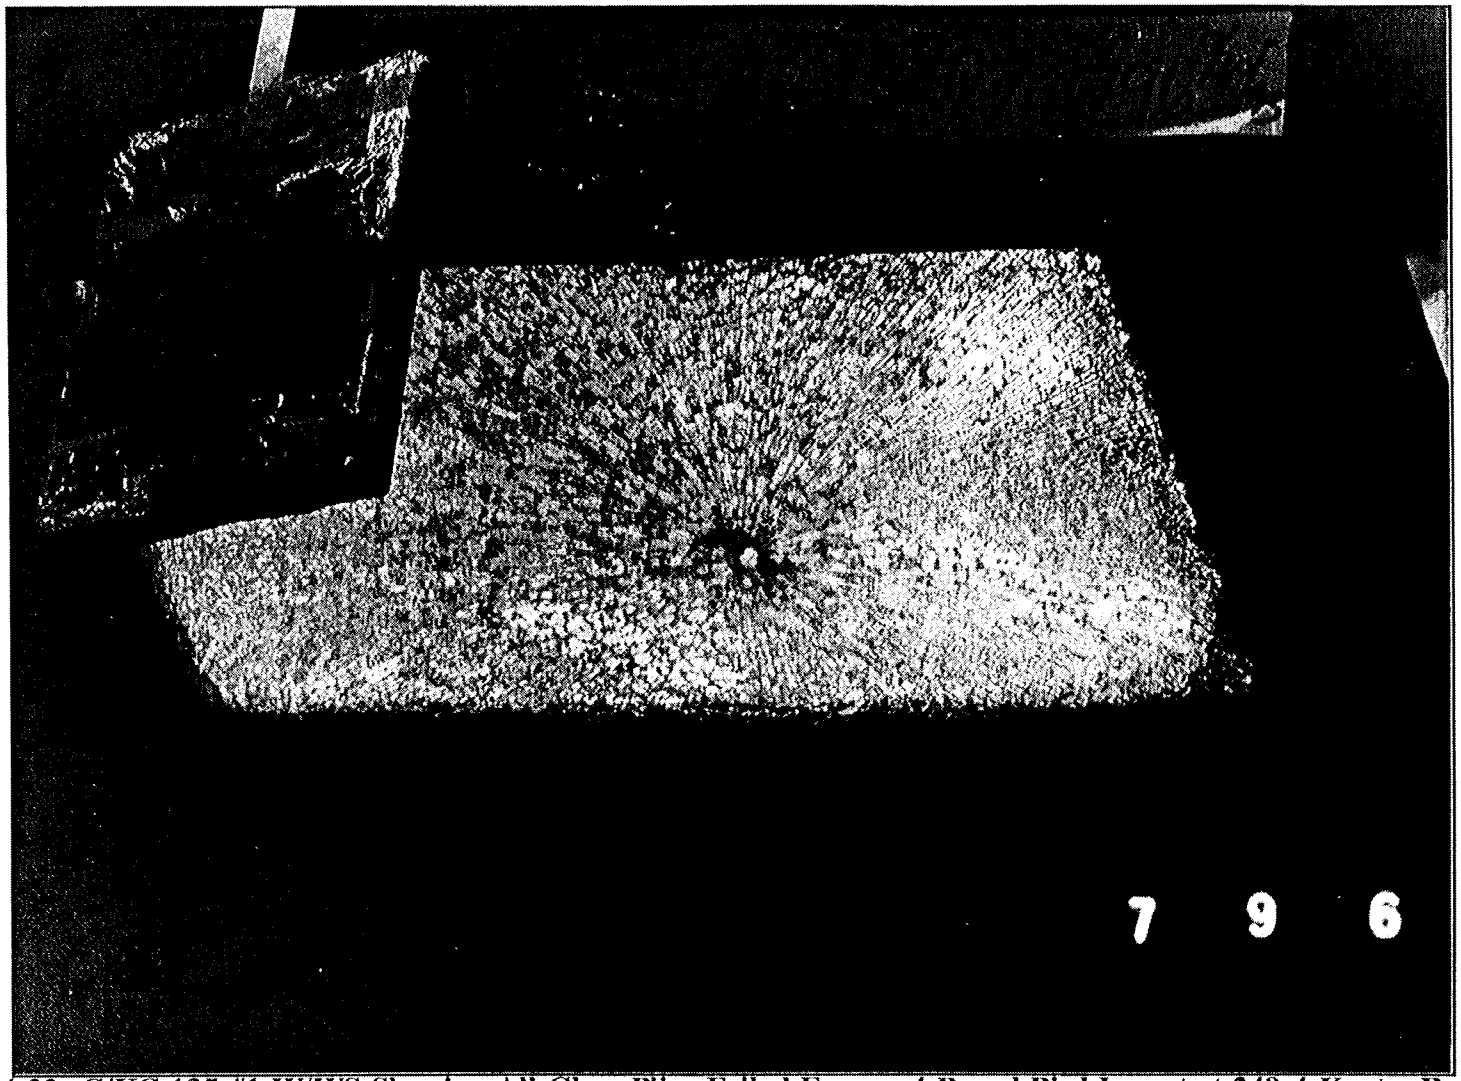
Figure 4.33 C/KC-135 #1 W/WS Showing All Glass Plies Failed From a 4-Pound Bird Impact at 249.4 Knots, Rear View (Repaired W/WS, S/N 82-H-10-18-107)
