DEVELOPMENT OF REPAIR PROCESSES AND SOURCES FOR C/KC-135 AIRCRAFT WINDOWS/WINDSHIELDS

RICHARD J. OLSON

SEPTEMBER 1994

TECHNICAL REPORT FOR 09/91 - 01/94
C/KC-135 FINAL REPORT
CONTRACT NUMBER FO9603-90-D-2217-SD02

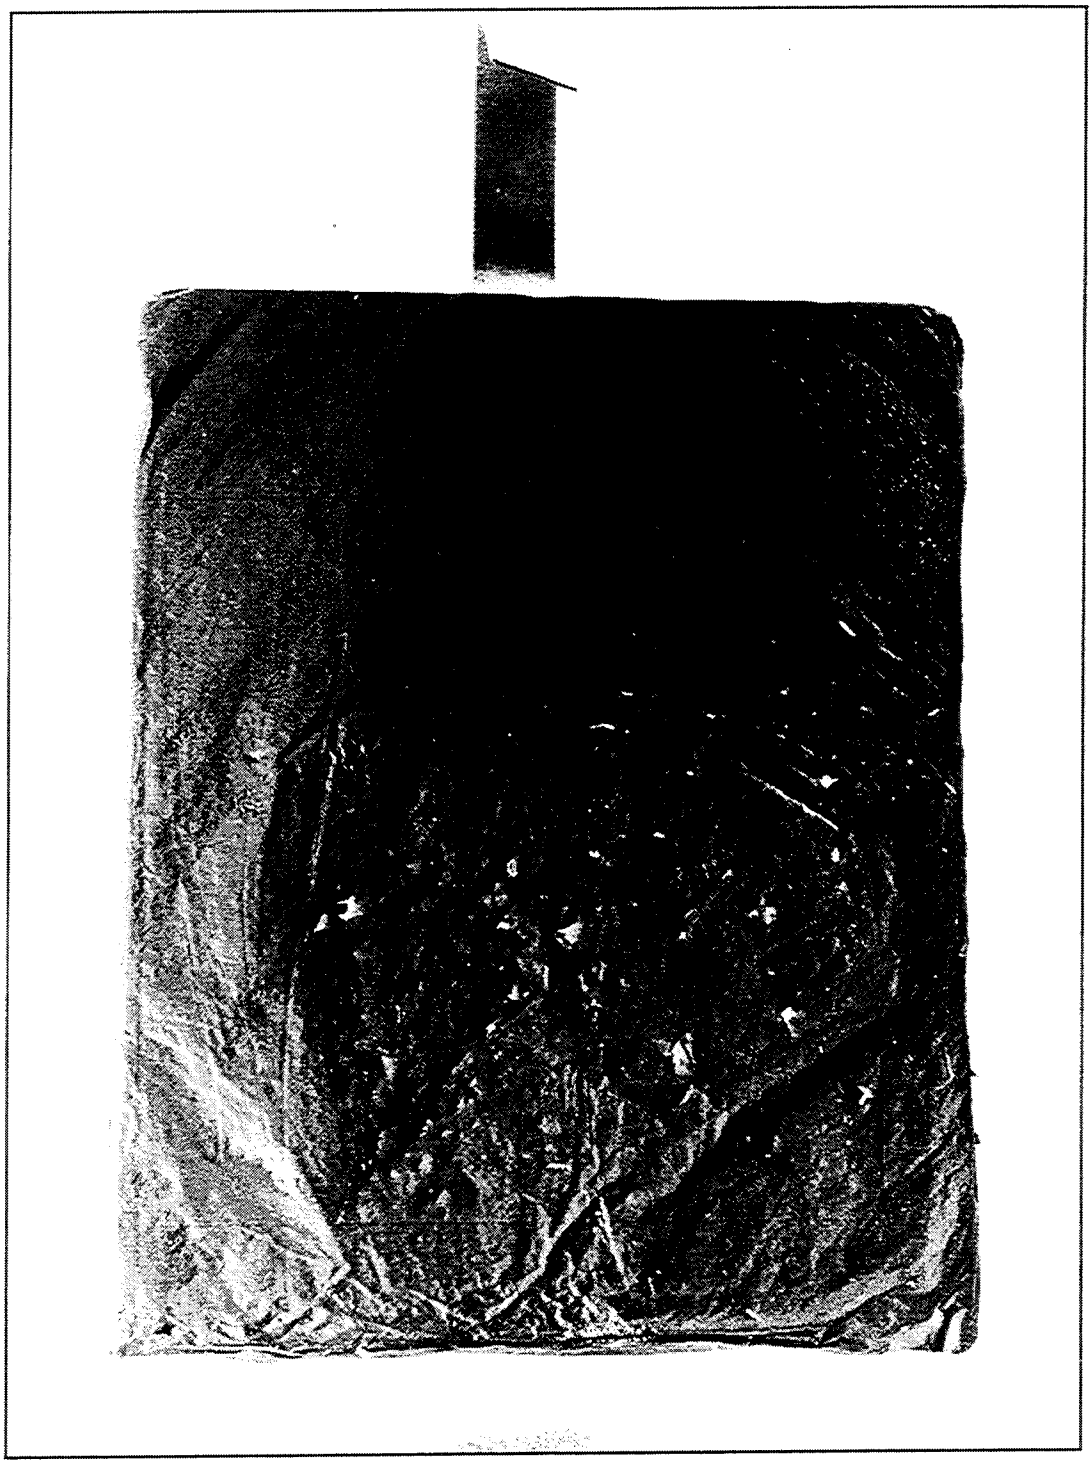
Figure 4.34 Spall Sheet Condition From a 4-Pound Bird Impact at 249.4 Knots on a C/KC-135 #1 W/WS With All Glass Plies Failed (Repaired W/WS, S/N 82-H-10-18-107)

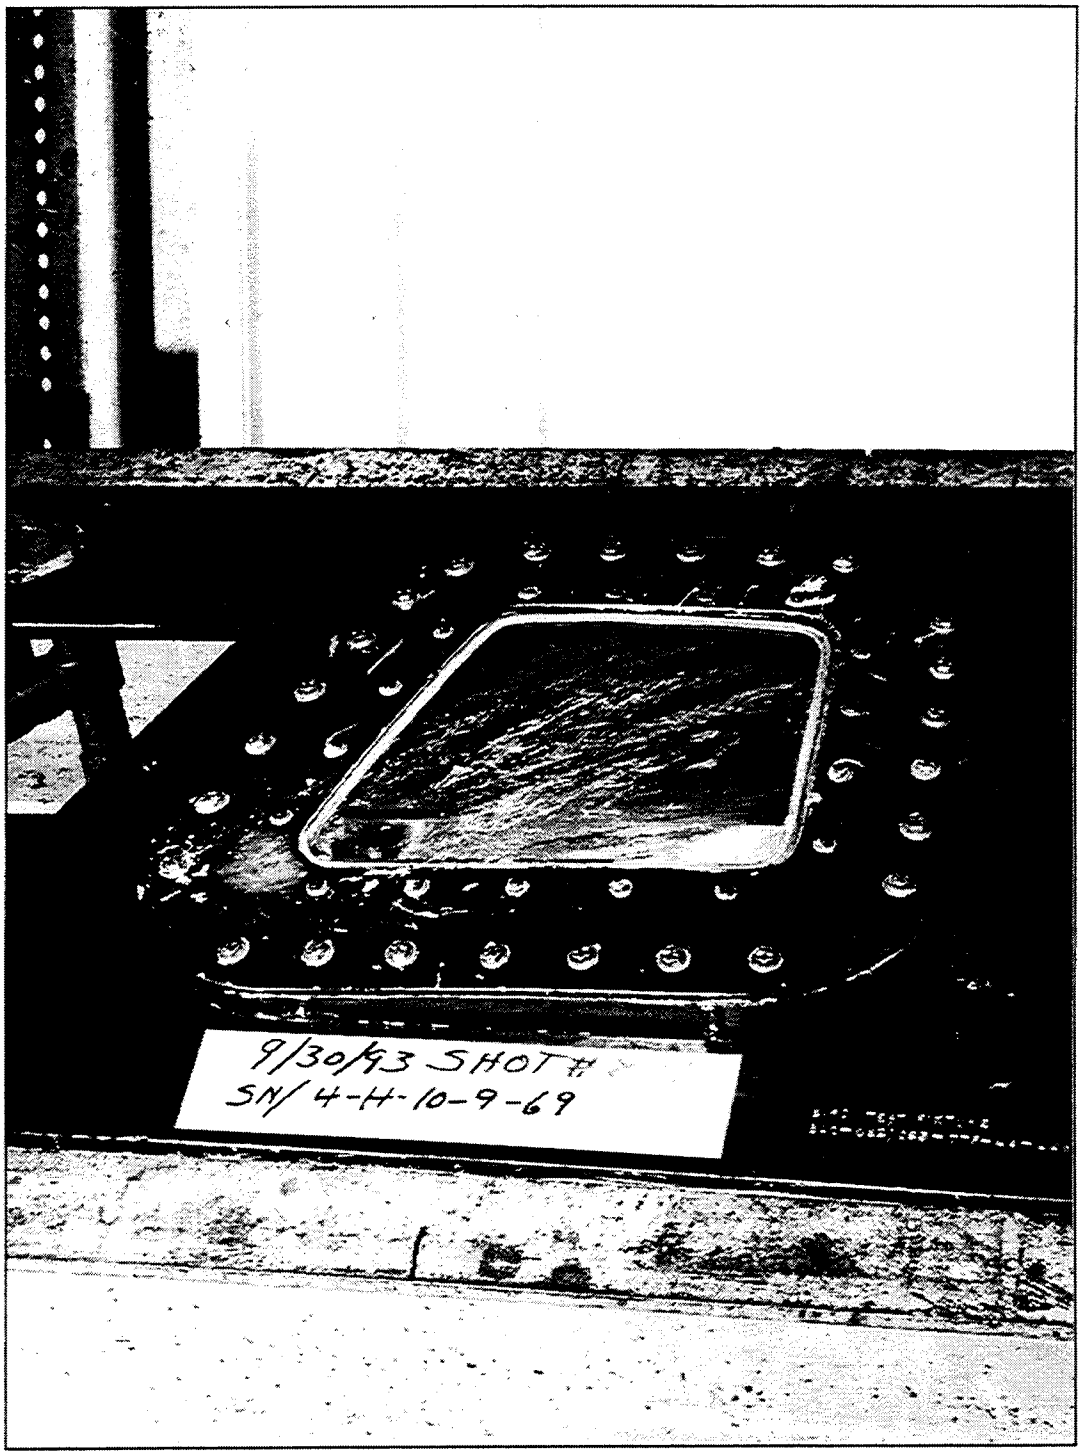
Figure 4.35 C/KC-135 #4 W/WS Showing No Damage From a 4-Pound Bird Impact at 248.7 Knots (Not Repaired W/WS, S/N 4-H-10-9-69)

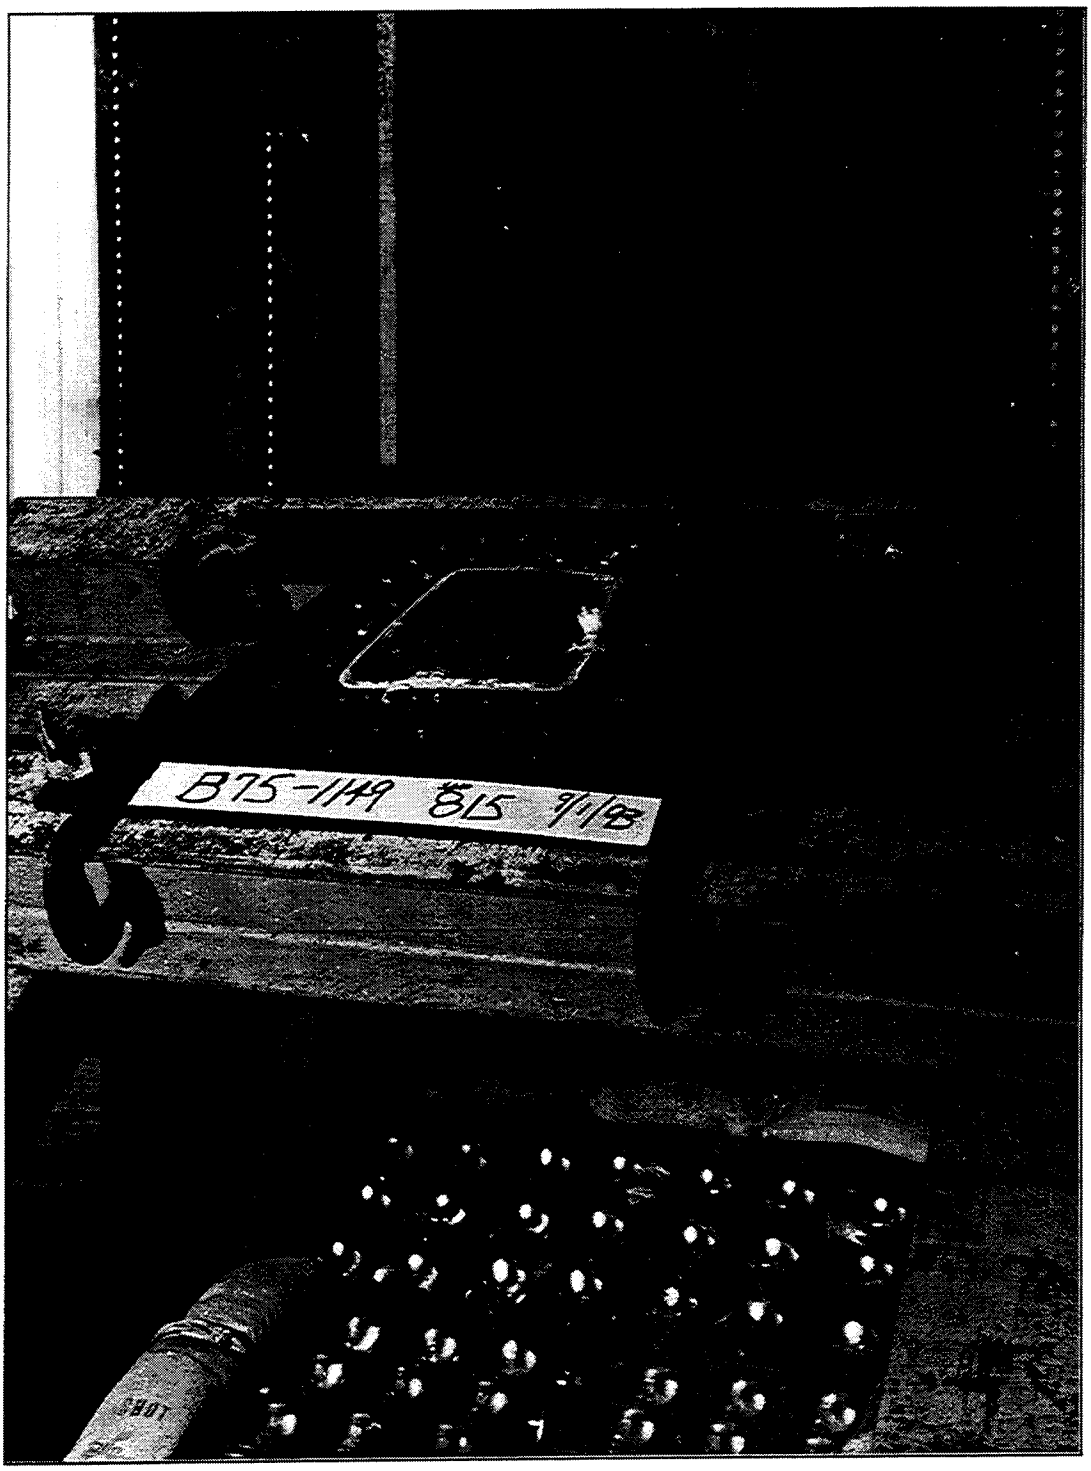
Figure 4.36 C/KC-135 #4 W/WS Showing Outboard Ply Failure From a 4-Pound Bird Impact at 247.5 Knots, Front View (Repaired W/WS, S/N B75-1149)

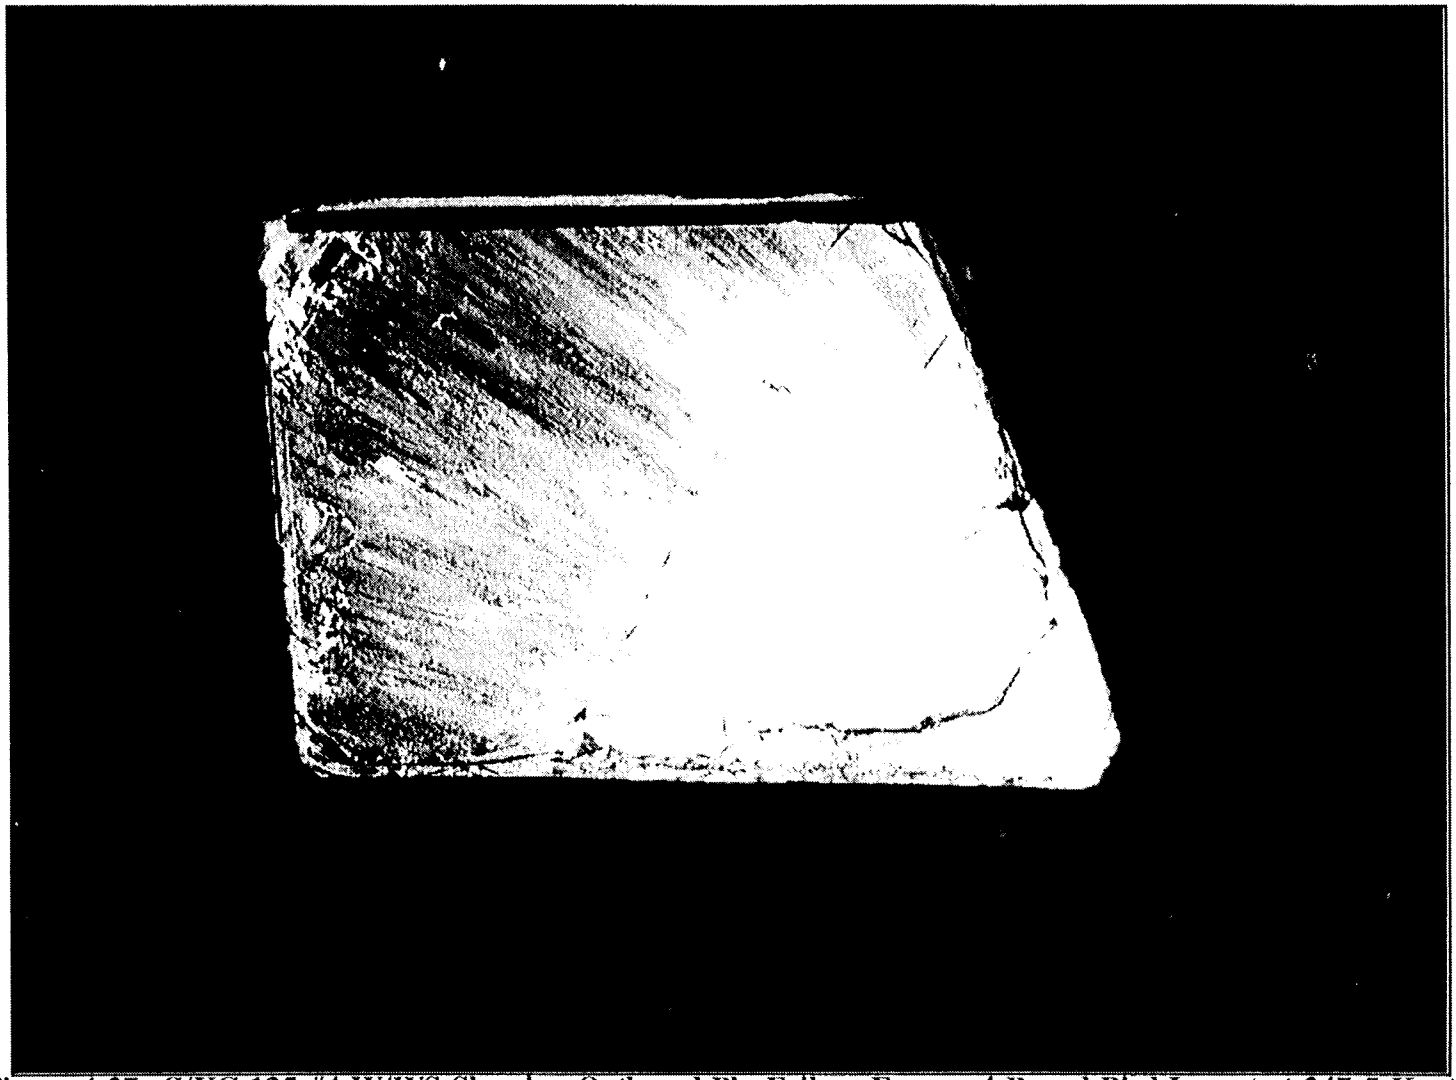
Figure 4.37 C/KC-135 #4 W/WS Showing Outboard Ply Failure From a 4-Pound Bird Impact at 247.5 Knots, Rear View (Repaired W/WS, S/N B75-1149)

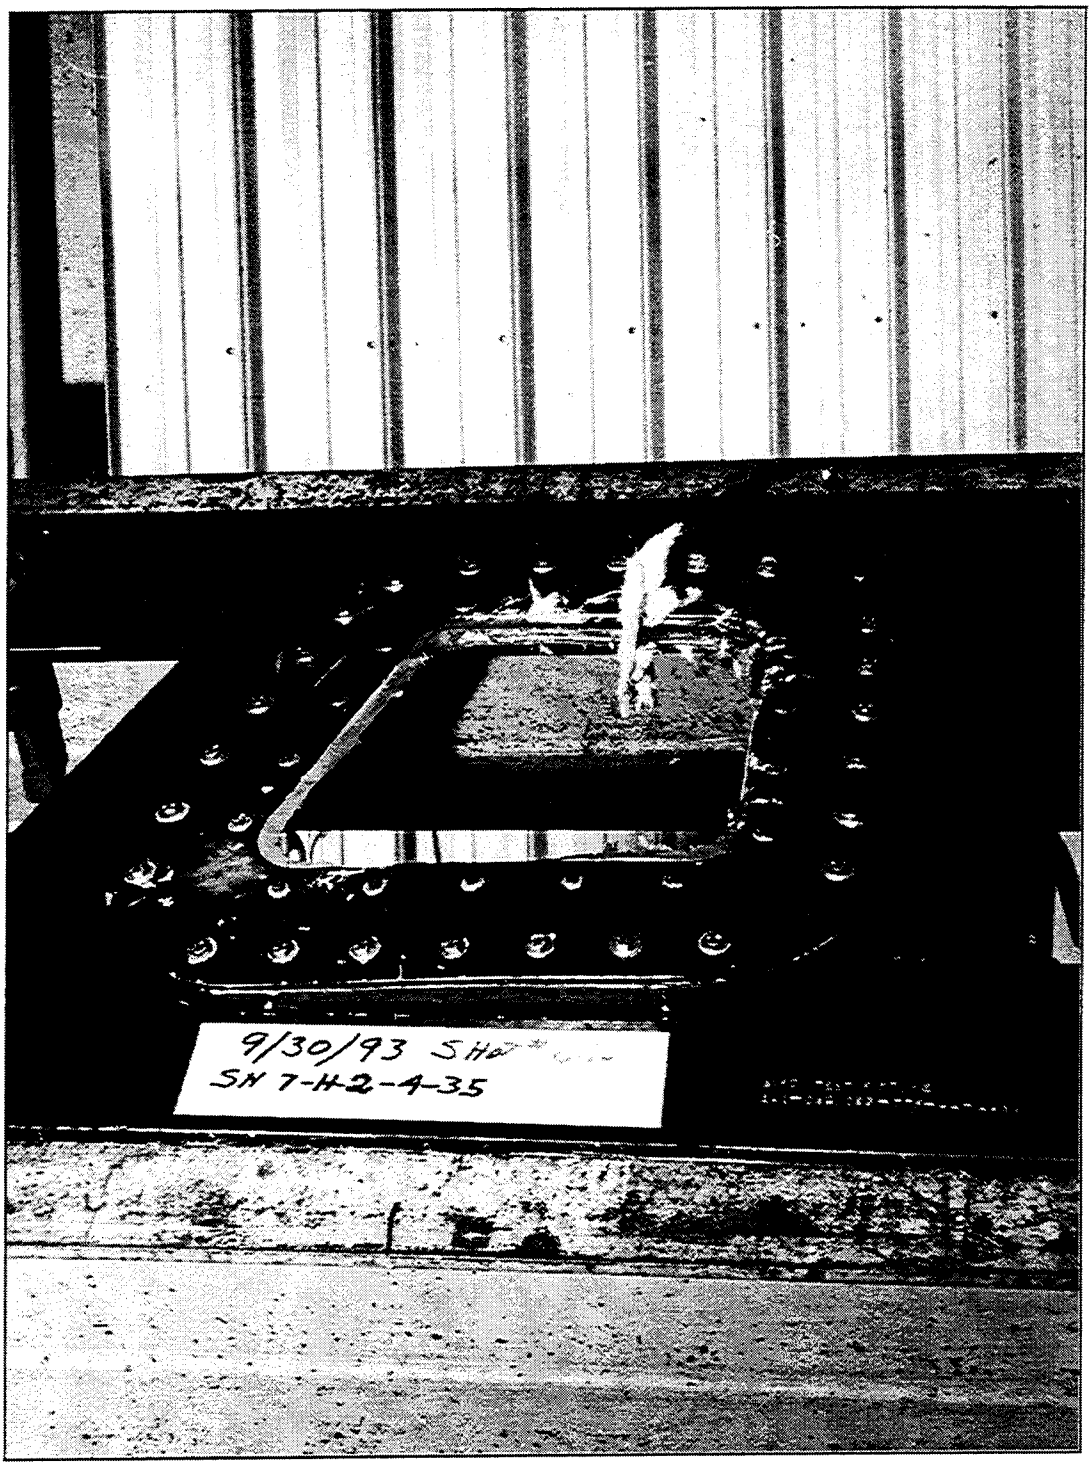
Figure 4.38 C/KC-135 #4 W/WS Showing a Catastrophic All Glass Plies Failure From a 4-Pound Bird Impact at 250.8 Knots, Front View (Not Repaired W/WS, S/N 7-H-2-4-35)

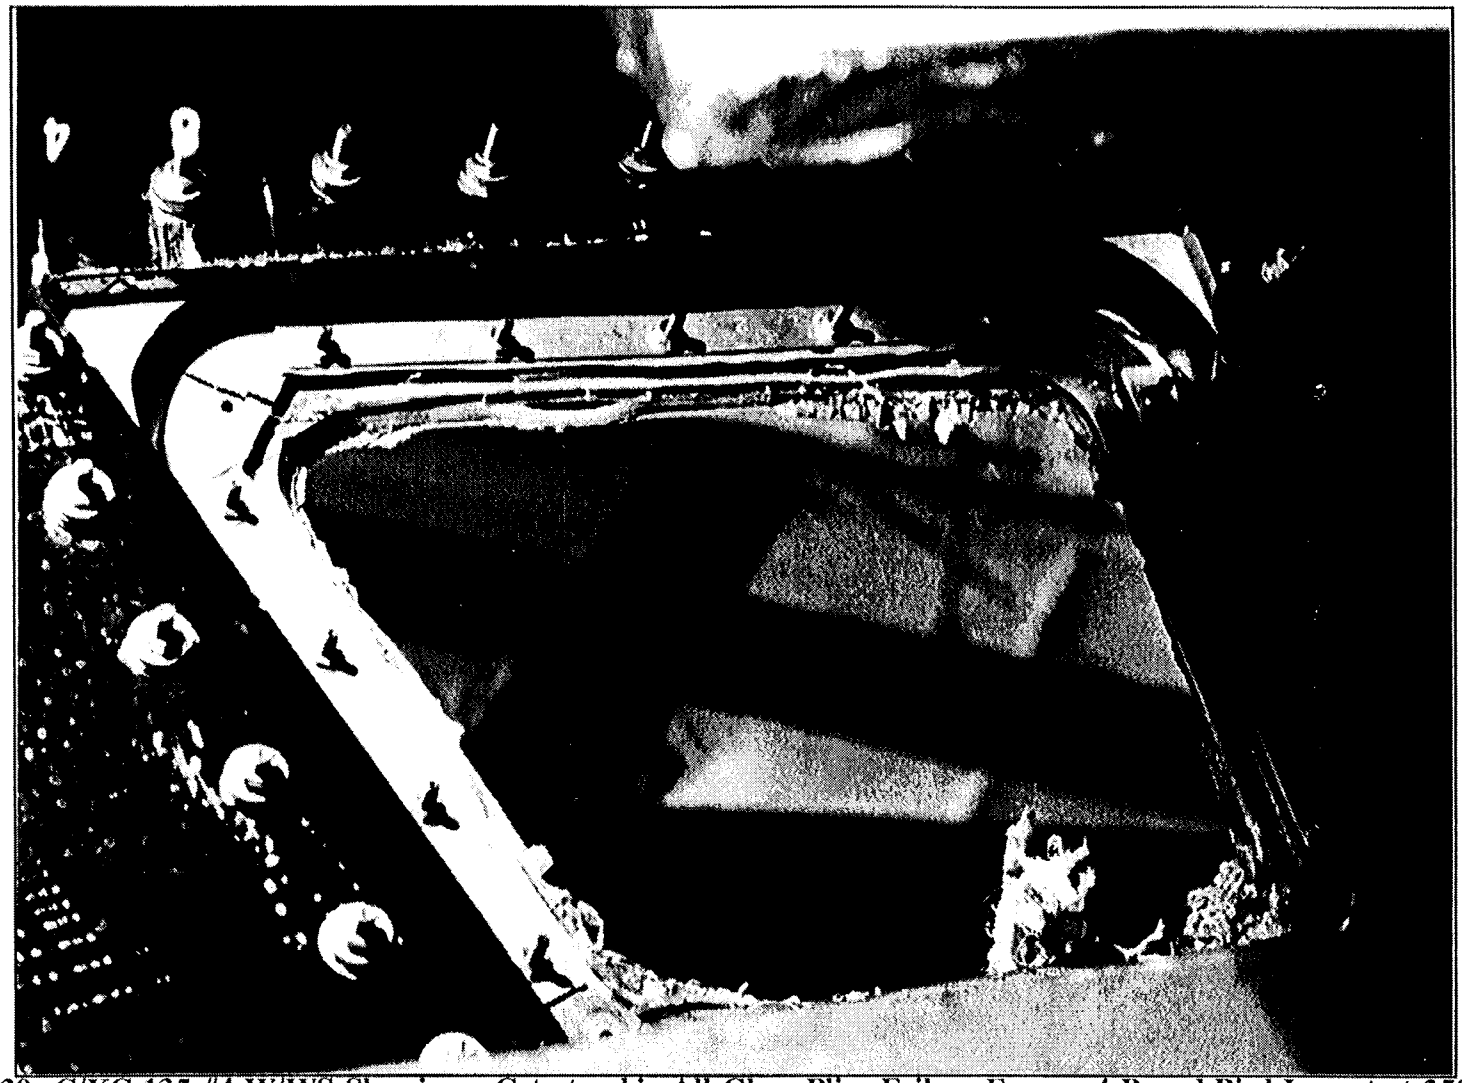
Figure 4.39 C/KC-135 #4 W/WS Showing a Catastrophic All Glass Plies Failure From a 4-Pound Bird Impact at 250.8 Knots, Rear View (Not Repaired W/WS, S/N 7-H-2-4-35)

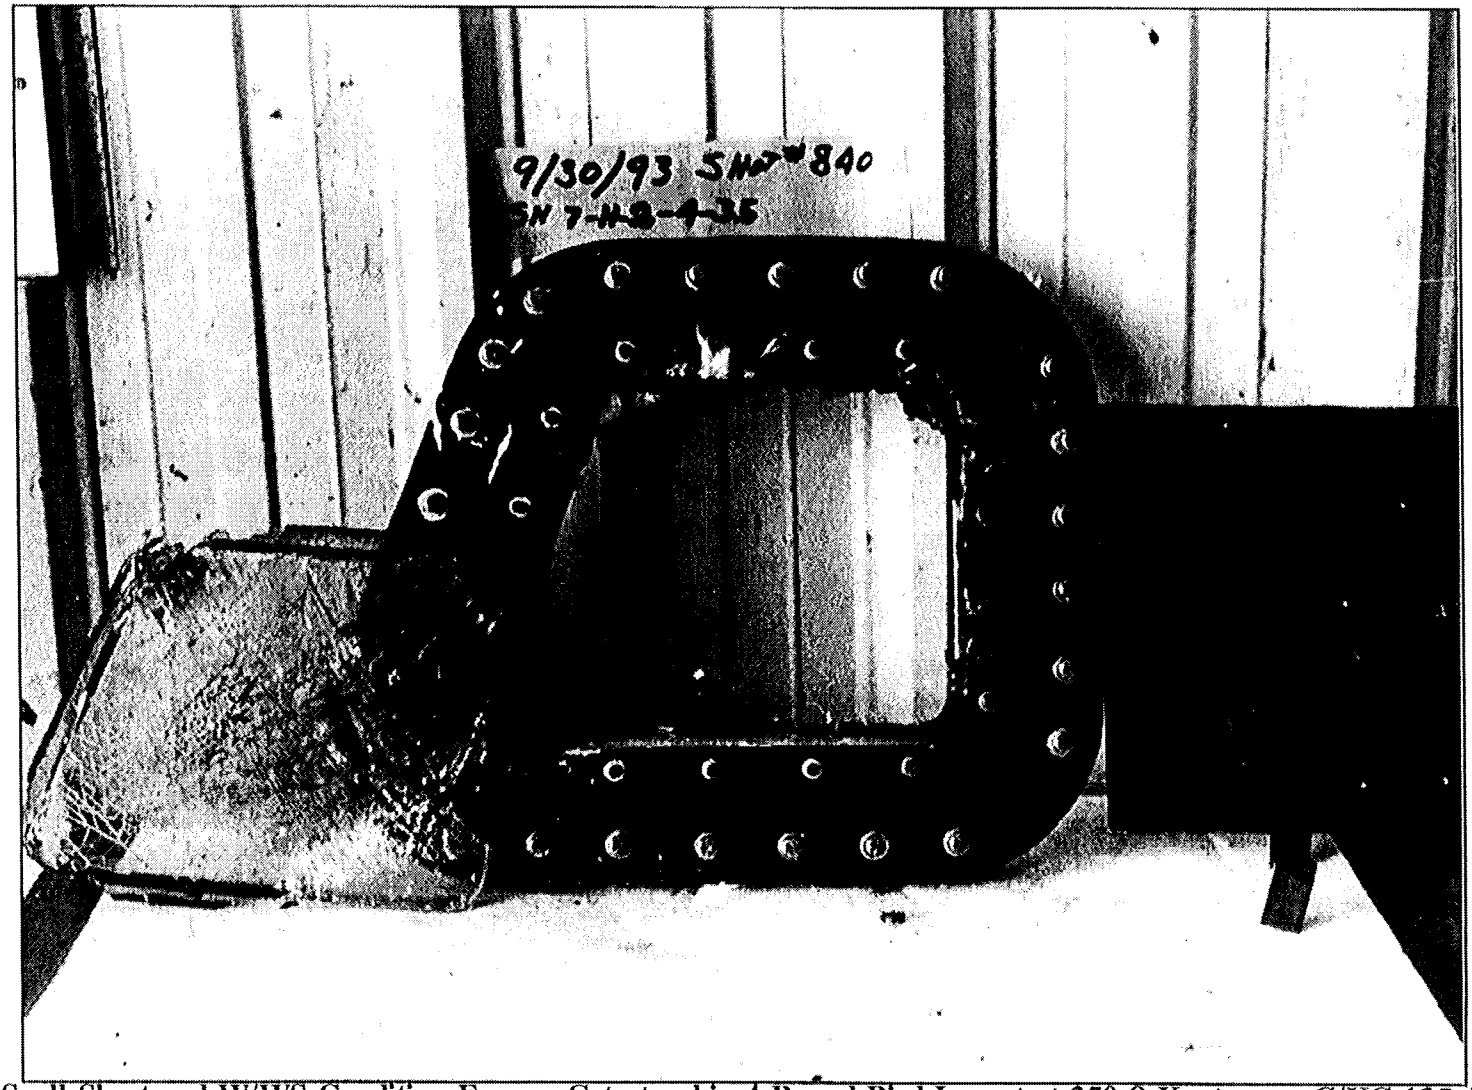
Figure 4.40 Spall Sheet and W/WS Condition From a Catastrophic 4-Pound Bird Impact at 250.8 Knots on a C/KC-135 #4 W/WS (Not Repaired W/WS, S/N 7-H-2-4-35)

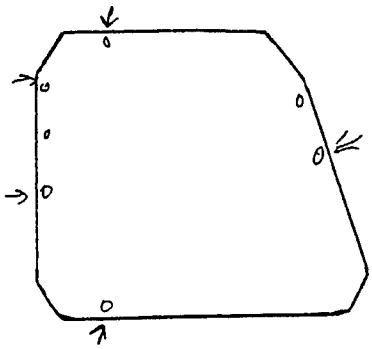
(Comments) Seal Loose But Acceptable

Seal Loose AS MARKed

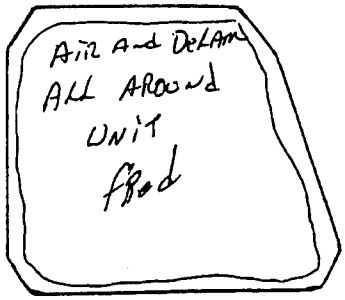
Visual Inspection Map & Comments

Acc/Rej	Date	Inspector
Bus to Bus Resistance: 101.0 Ohms		5-21-93	22 PPG 28
Thermal Image:		5-21-93	22 PPG 28
Insulation Test: Power to Metal: (2500 VAC)	Acc	MAY 2 6 1993	22PPG43
Nesa Scratch Test (81 VAC):	OK	MAY 2 6 1993	22PPG43
Light Transmittance:	81.2	MAY 2 6 1993	22PPG43
Haze:	1.5	MAY 2 6 1993	22PPG43
Photo (Single Exposure):	22 PPG 47	JUN 14 1993	22 PPG 8
Deviation Inspection: (German Light per Template) 1: ~~444~~ <3 2: <3 3: <3 4: <3	A	JUN 09 1993	22 PPG 39
Dimensional Inspection:			
Unit Thickness: (Per Template) 1: .684 2: .679 3: .685 4: .679	Acc.	5-26-93	22 PPG 28
Check for Vinyl Cracks:	Acc	JUN 03 1993	22 PPG 77
Seal Evaluation:	Rej	JUN 03 1993	22 PPG 77
(Comments) Wrong Seal on outer Sid.			
Visual Inspection: (Place comments on attached sheet)	Rej	JUN 03 1993	22 PPG 77

Air And Delam ALL AROUND Edge of Unit

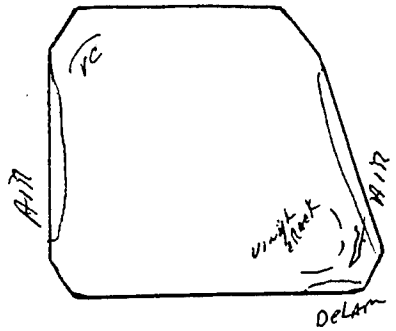
Visual Inspection Map & Comments

(Comments) Wrong seal on outbd side and inside sealant very bad shape

AIR Located ALL ROUND UNIT. PLUS A LARGE Amount LOCATED LOWER/FWD. ALONG WITH DeLam ALSO VINLY CRACKS BeLeive TO BE STARTING

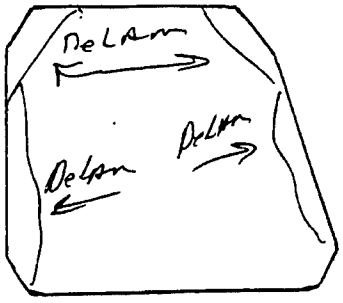
Visual Inspection Map & Comments

DeLam And Air All Around Unit

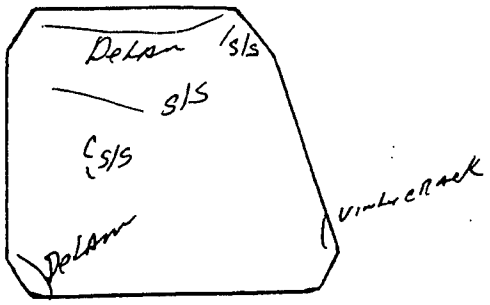
Visual Inspection Map & Comments

(Comments) No seal And Bad Bumper on outBd side

DeLam As marked
Surface scr. As marked
Vinly crack As marked

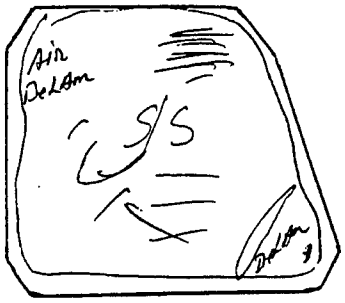
Visual Inspection Map & Comments

Acc/Rej	Date	Inspector
Bus to Bus Resistance:	127.7 Ohms		5-21-93	22 PPG 28
Thermal Image:			5-21-93	22 PPG 28
Insulation Test: Power to Metal: (2500 VAC)		Acc.	MAY 2 6 1993	22PPG43
Nesa Scratch Test (81 VAC):		OK	MAY 2 6 1993	22PPG43
Light Transmittance:		81.8	MAY 2 6 1993	22PPG43
Haze:		1.4	MAY 2 6 1993	22PPG43
Photo (Single Exposure):		22 PPG 47	JUN 1 4 1993	22 PPG 8
Deviation Inspection:		Acc	6-8-93	22 PPG 10
(German Light per Template) 1: ∠3 2: ∠3 3: ∠3 4: ∠3				
Dimensional Inspection:			JUN 1 4 1993	
Unit Thickness:		Acc	5-26-93	22 PPG 28
(Per Template) 1: .678 2: .681 3: .686 4: .684				
Check for Vinyl Cracks:		Rej	JUN 0 3 1993	22 PPG 77
Seal Evaluation:		Rej	JUN 0 3 1993	22 PPG 77
(Comments)	BAD Seal And Bumper			
Visual Inspection: (Place comments on attached sheet)		Rej	JUN 0 3 1993	22 PPG 77

BAD SURFACE SCR LOCATED THROUGHOUT THE UNIT BOTH SIDE

AIR And DeLAm LOCATED ALL AROUND UNIT

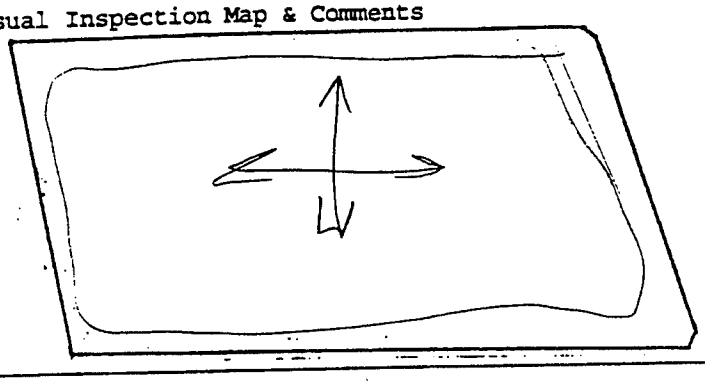
Visual Inspection Map & Comments

5: 1.103	6: 1.102	7: 1.102	8: 1.102	
9: 1.102	10: 1.099	11: 1.102	12: 1.098	
Seal Evaluation:		Rej	JUN 04 1993	22 PPG 77
(Comments)	The Seal itself looks Good and Bumper did flow but Air & Dolam. and WATER enter UNIT			
Visual Inspection:		Rej	JUN 04 1993	22 PPG 77
(Place comments on attached sheet)

AIR, DELAM And WATER JUST About All The WAY AROUND UNIT

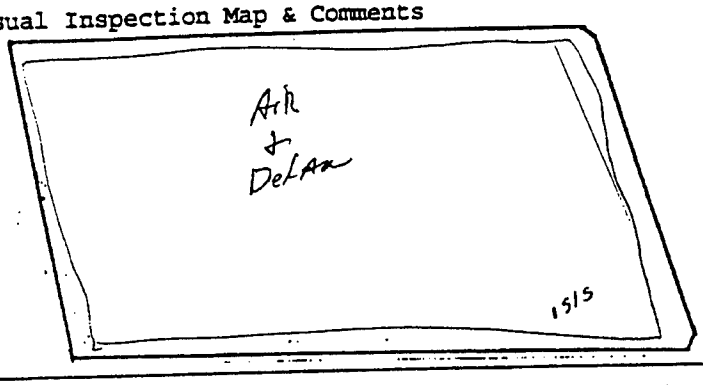
Visual Inspection Map & Comments

Seal Evaluation:	Rej	JUN 04 1993	22 PPG 77
(Comments)	Seal needs to be cut too size		
Visual Inspection: (Place comments on attached sheet)	Rej	JUN 04 1993	22 PPG 77

AIR & Delam Located All Around Unit

Surface SCR Located Bottom Aft Edge of Unit

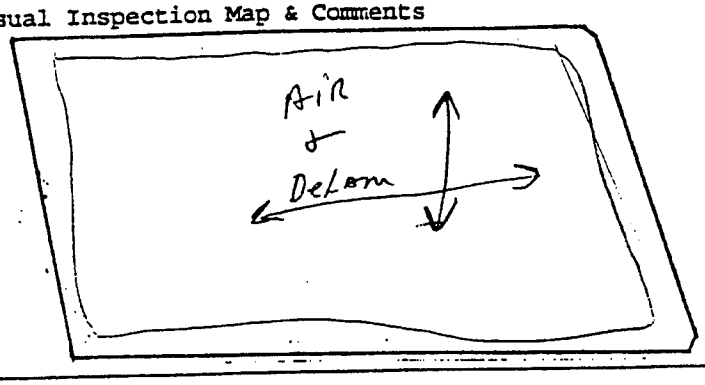
Visual Inspection Map & Comments

Air and Delam located all around the unit

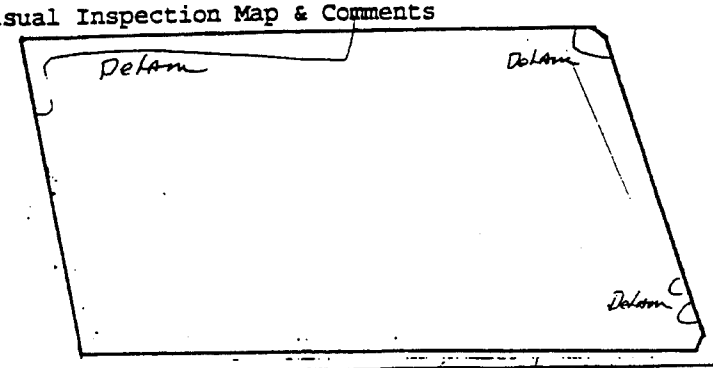
Visual Inspection Map & Comments

DeLAm Alone TOP And Field. Edge of UNIT

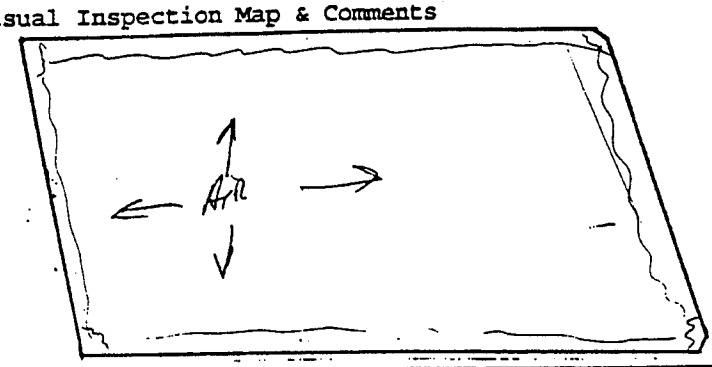
Visual Inspection Map & Comments

5: 1.108 6: 1.104 7: 1.109 8: 1.104				
9: 1.104 10: 1.105 11: 1.108 12: 1.105				
Seal Evaluation: (Comments)		Rej	JUN 02 1993	22 PPG 77
Wrong seal on outbd side				
Visual Inspection: (Place comments on attached sheet)		Rej	JUN 02 1993	22 PPG 77

Air All Alone The ~~Edge~~ of unit.

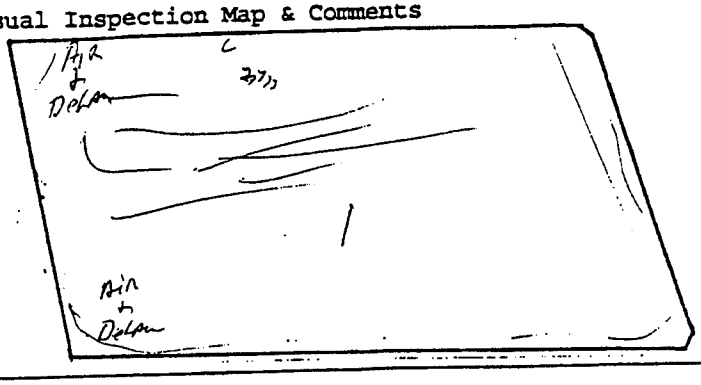
Visual Inspection Map & Comments

Air and Delam around the unit.
Surface over all over the outer side of unit

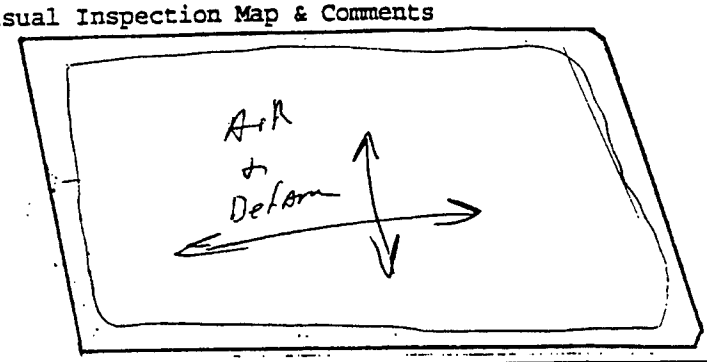
Visual Inspection Map & Comments

Air & Delam Located All Around Unit.

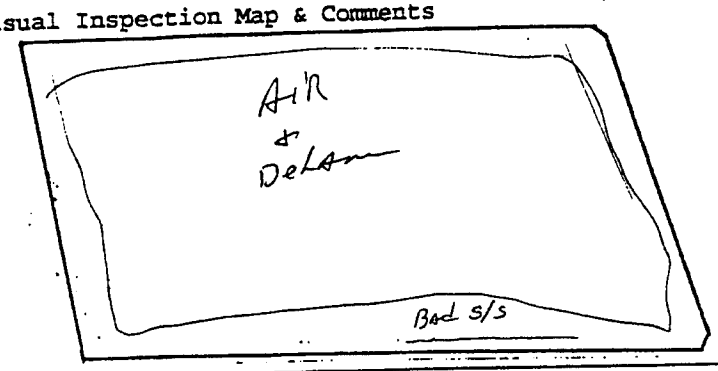
Visual Inspection Map & Comments

AIR & DeLam LOCATED AROUND THE UNIT.
VERY BAD SURFACE SCR LOCATED BOTTOM FWD. EDGE

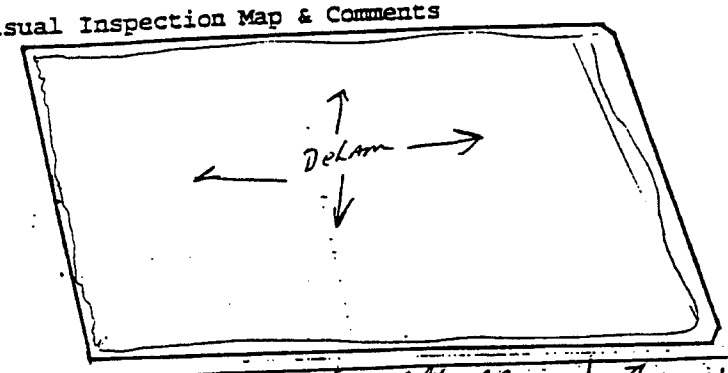
Visual Inspection Map & Comments

Seal Evaluation: Rej JUN 02 1993 PPG 77
(Comments) WRONG SEAL ON OUTBD SIDE

DeLam LOCATED ALL AROUND the UNIT

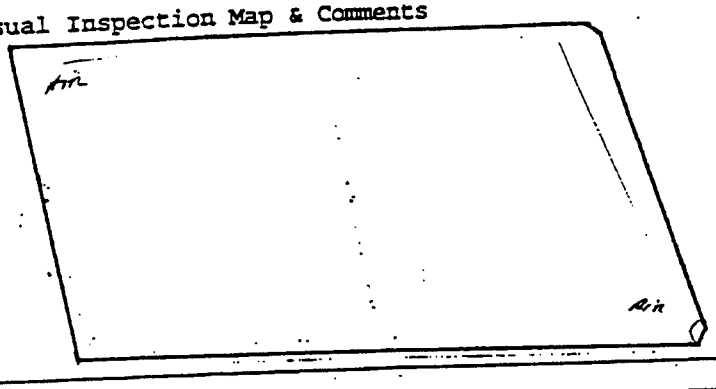
Visual Inspection Map & Comments

Seal Evaluation: Rej JUN 02 1993 22 PPG 77
(Comments) WRONG SEAL ON OUTBd. Side

Air Starting Alone 2/3 of Unit

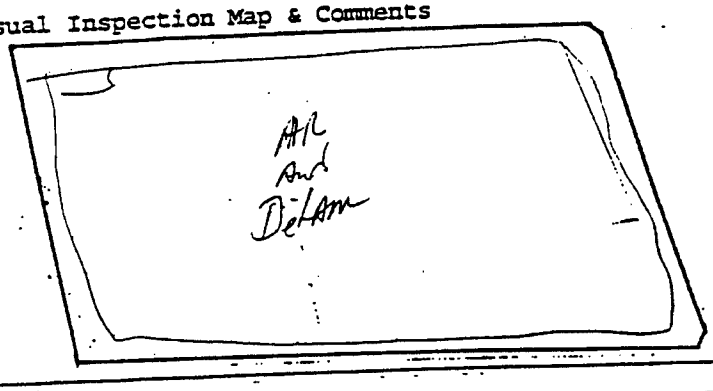
Visual Inspection Map & Comments

UNIT HAS AIR / Delam LOCATED THROUGHOUT.

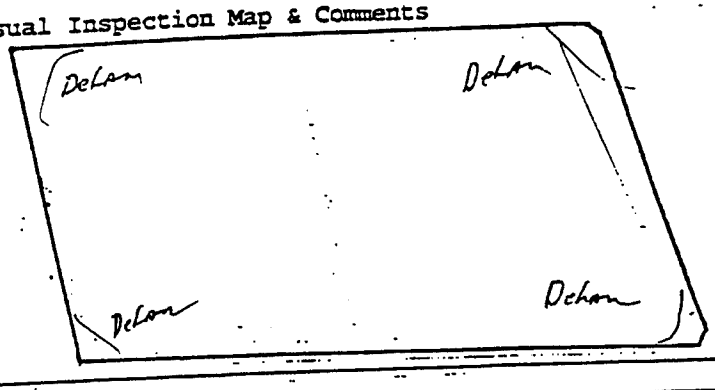
Visual Inspection Map & Comments

(Comments) Seal needs cutting to size

Delam Located in All Floor Coverer

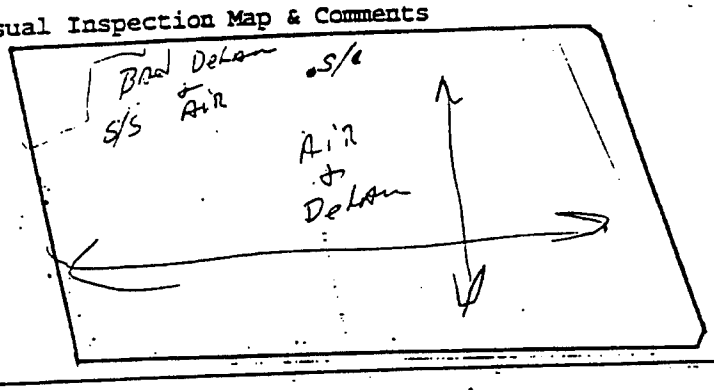
Visual Inspection Map & Comments

Air and DeLam LOCATED ALL AROUND UNIT

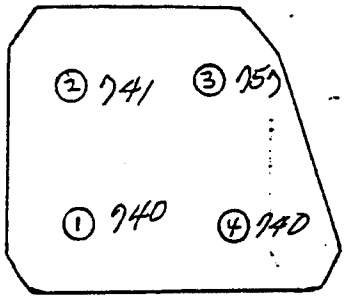
Visual Inspection Map & Comments

Vinly SEPARATION FROM GLASS Edge ALL AROUND UNIT inBd side.

DeLam AROUND UNIT in corner UNIT has SURFACE SEB. Remover Between Ply.

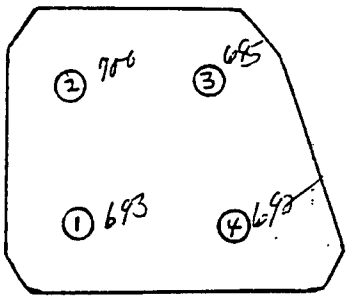
Visual Inspection Map & Comments

open Power Circuit
UNIT HAS AIR ALL ROOND TO UNIT

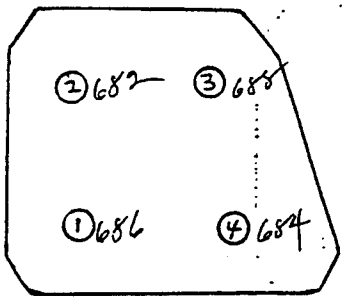
Visual Inspection Map & Comments

(Comments) WRONG Type of SEAL on OUTBd side ~~Bad Joint~~ OPEN CIRCUITS SOMETIME A Reading And OTHER TIMES NO Reading

Open Power Circuit.

Wrong Type of Seal on outbd side

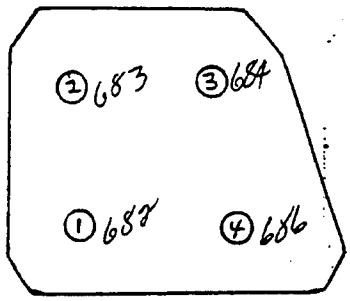
Visual Inspection Map & Comments

AIR & DELAM = LOCATED ALL AROUND UNIT
VINLY CRACK LOCATED AS MARKED
SURFACE SCR LOCATED AS MARKED

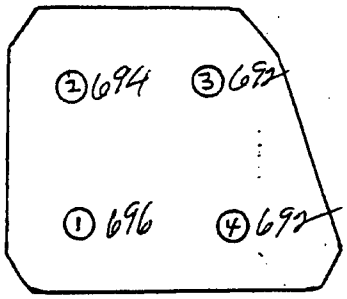
Visual Inspection Map & Comments

AIR And DeLAm Located Around the end
Surface Scr. Location As marked

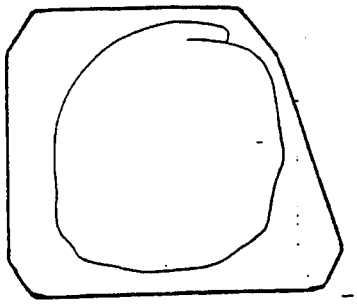
Visual Inspection Map & Comments

Air / DeLam / Vinyl CRACKS LOCATED AT AROUND UNIT

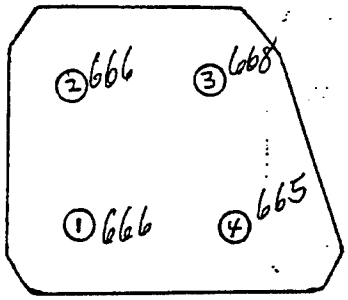
Air, Delam And Vinly cracks Located All
~~AR~~ Out Unit

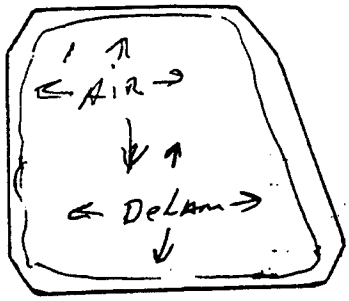
Deep S/S

B/B Res. 123.2 ~~Lifter~~ before T.I 96.8 after T.I

AIR ALL AROUND of Unit And ALSO DeLam

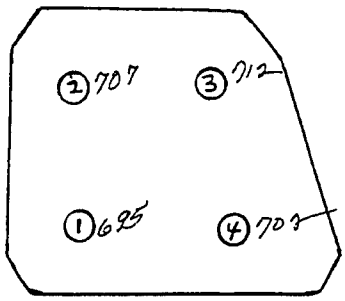
Surface chip located 2½" in down and 1" from fwd. edge
And other surface defects located center of unit

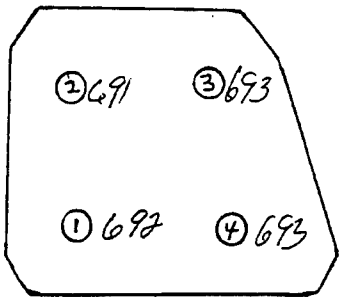
AIR And DeLAm located All AROund UNIT
