# Recreational Boat Collision Accident Research

## Volume 1

Miles A. Beam III, P.E.
Senior Project Engineer
Marine Department

October 1992

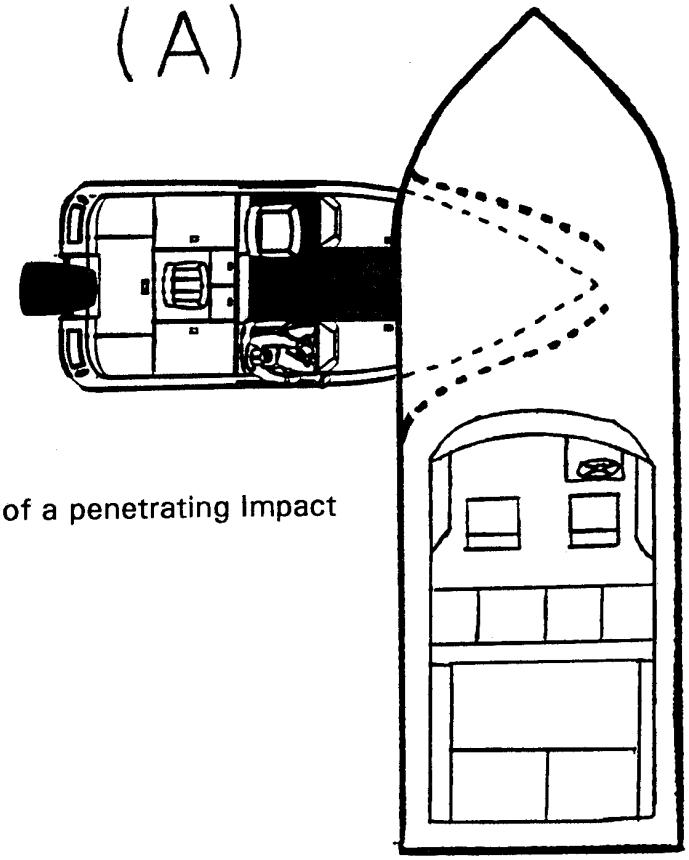
Damage to Boat After an Override Collision

Result of a penetrating Impact

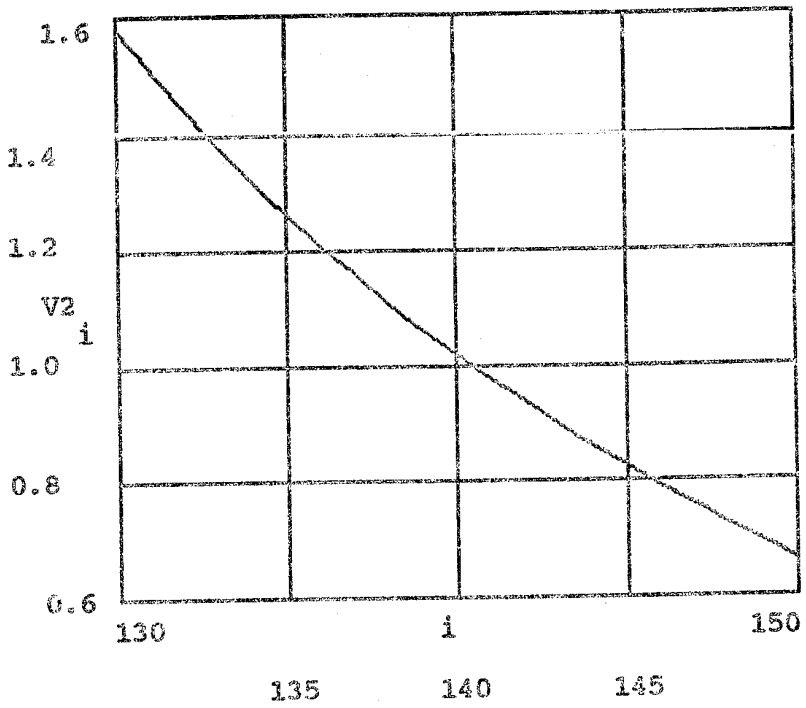
Figure 13-8

What do the charts tell us? Look at Figure 13-8. If the value of θ3 is 139 degrees, then VR = V2/V1 = 1.066. This means that the magnitude of V2 was 1.066 times that of V1. Or stated another way, if the speed of boat 1 was 50 mph, then the speed of boat 2 was 50*1.066 or 53.3 mph. Remember that while the actual calculations may be quite precise, the numbers that go into them are only approximations at best. This technique should not be presumed to produce velocity ratios with great precision. These methods produce only approximations.

Accident No:1, Striation Analysis for θ2 := 112 degrees.

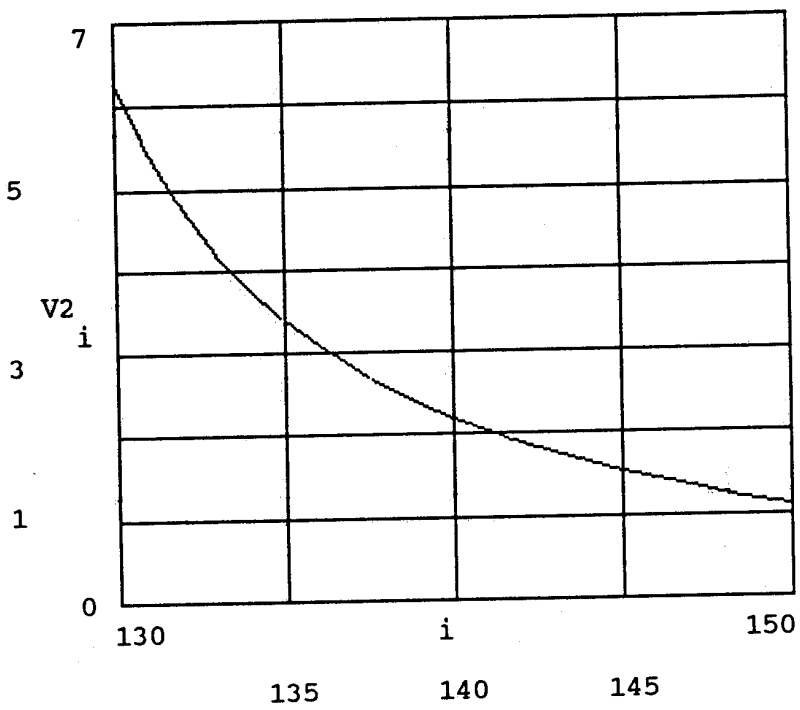
**Figure 13-10**

Witness statements initially estimated the speed of the bullet boat at approximately 25 mph and the target boat at 60 mph. This is a velocity ratio of V2/V1 of 2.4. From the VR charts, using the measured striation angle ($\theta 3$ = 139 degrees), we need a value for $\theta 2$ of 123 degrees (see Figure 13-10) to achieve a velocity ratio close to that. We see that these speeds are possible. If these speed estimates are accurate, it is also likely that the target boat would have been in a hard turn to starboard, which would have helped to create the consistency needed between the damage to the top of the outboard motor and the striations on the bottom of the bullet boat. This analysis also assumes an initial impact point on the target boat at the leading edge of the damage, approximately seven feet aft from the bow.

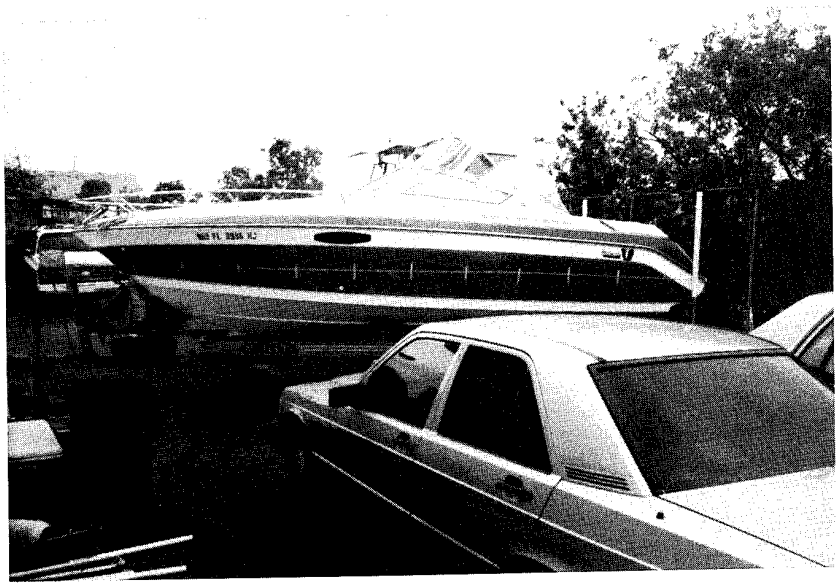
Figure 13-12

The accident happened near shore, and both boats rested in shallow water among a group of mangroves. The mangroves caused additional damage to the boats, especially to the cruiser. Figures 13-12 and 13-13 show overall views of the cruiser and ski boat respectively.

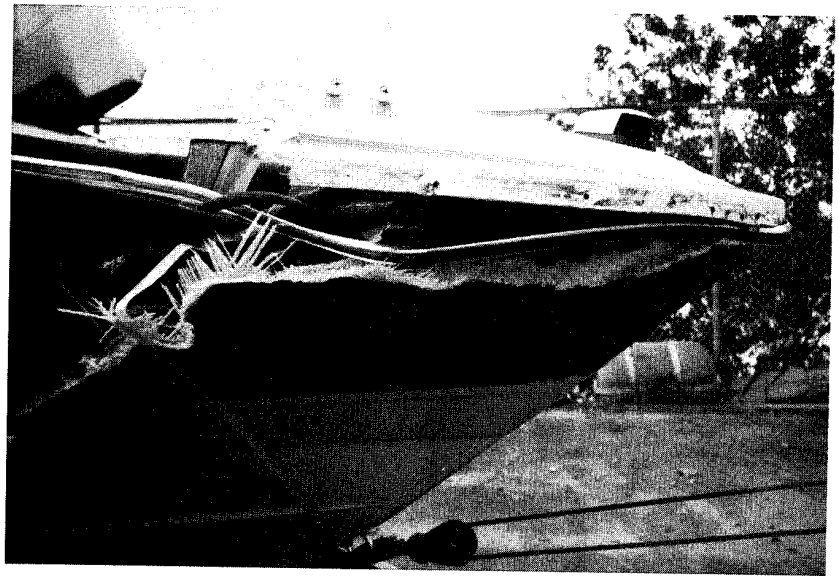
Figure 13-14

The starboard bow was badly damaged. A large vee shaped cut was carved into the hull. The forward edge of the vee shaped cut-out was a notch shaped cut as shown in Figure 13-14. This notch was believed to have been from penetration of the bow hook on the bullet boat.

The damaged area on the starboard bow of the target boat shown in Figure 13-13 is believed to be the initial impact area. The notch in the forward most part of the "V" shaped section is likely where the bow hook of the bullet boat passed through. Dimensions

of the hole, and the bow eye on the bullet boat were documented and analyzed. The notch is nearly identical in size to the bow eye on the bullet boat. Note that this notch is not vertical, but angled down and toward the bow. The bow eye on the bullet boat was bent to starboard, indicating that it had likely made contact with the hull. Striations on the bow of the bullet boat as shown in Figure 13-16, appeared to be nearly vertical when viewed with the boat on the trailer after the accident. These striations extended for 12 to 18 inches on the bow, still in the vertical direction. This indicates the entire area was in contact with the target boat at the same time. Figure 13-17, shows how the initial contact might have been possible to account for this damage. This theory is further supported by the shape of the notch. The shape of the notch's cut from the bow eye closely matches the profile, not the straight on view of the bow eye.

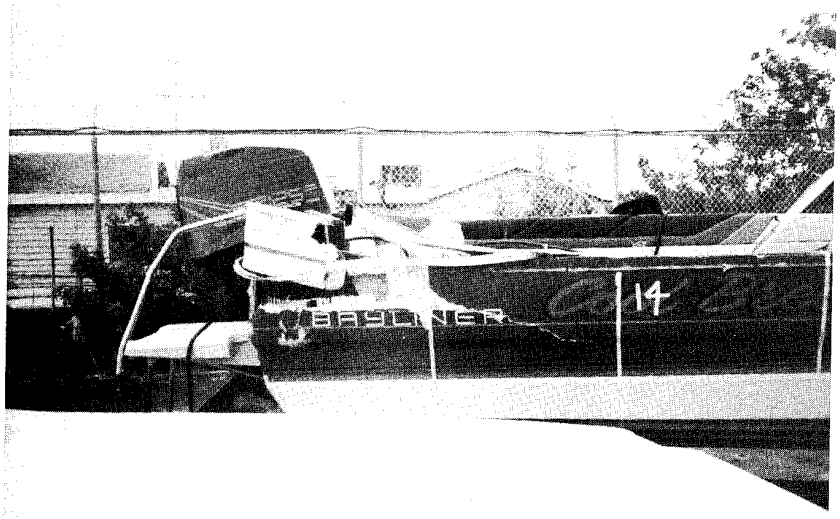
Damage to the starboard rear quarter near the stern as shown in Figure 13-15 may have been the area where the outdrive impacted; however, investigators informed UL that rescuers on the scene had to literally cut part of the ski boat out of the way in order to get to occupants trapped in the wreckage. Without knowing any more details of what was cut away, it was difficult to distinguish between impact damage and damage caused by the rescuers. The most forward edge of the area of the corner appears as though it may have been impact damage. The horizontal cuts adjacent to it are much cleaner as though a saw had been used.

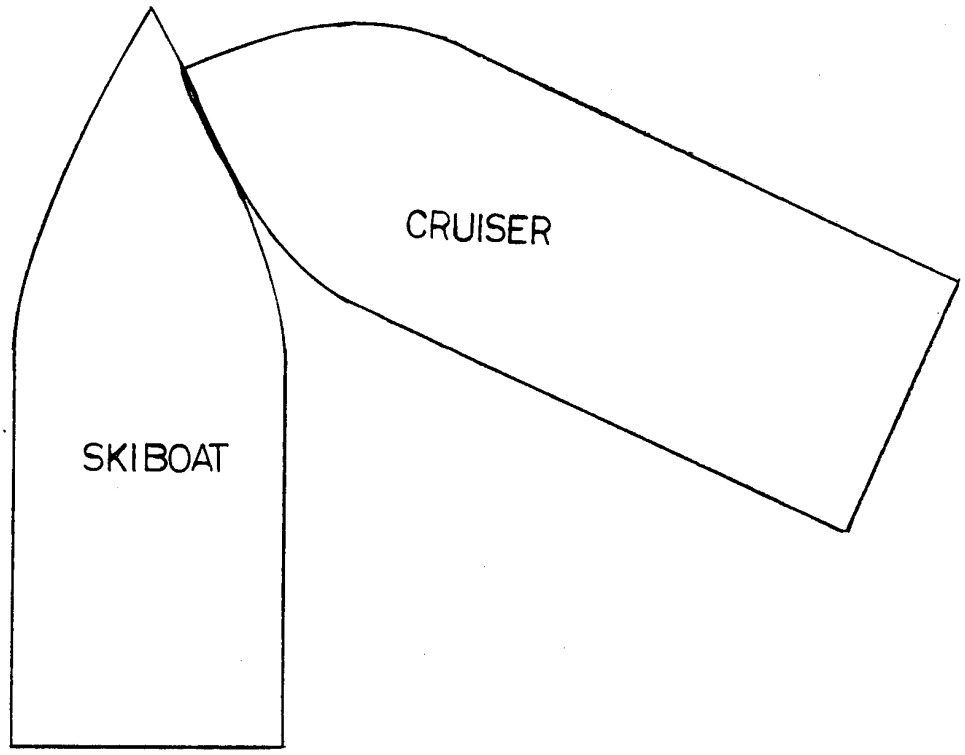
**Figure 13-17**

This Diagram Shows How the Striation Marks on the Bow of the Cruiser Might Have Been Made. Note That a Large Area of the Two Boats is in Contact.

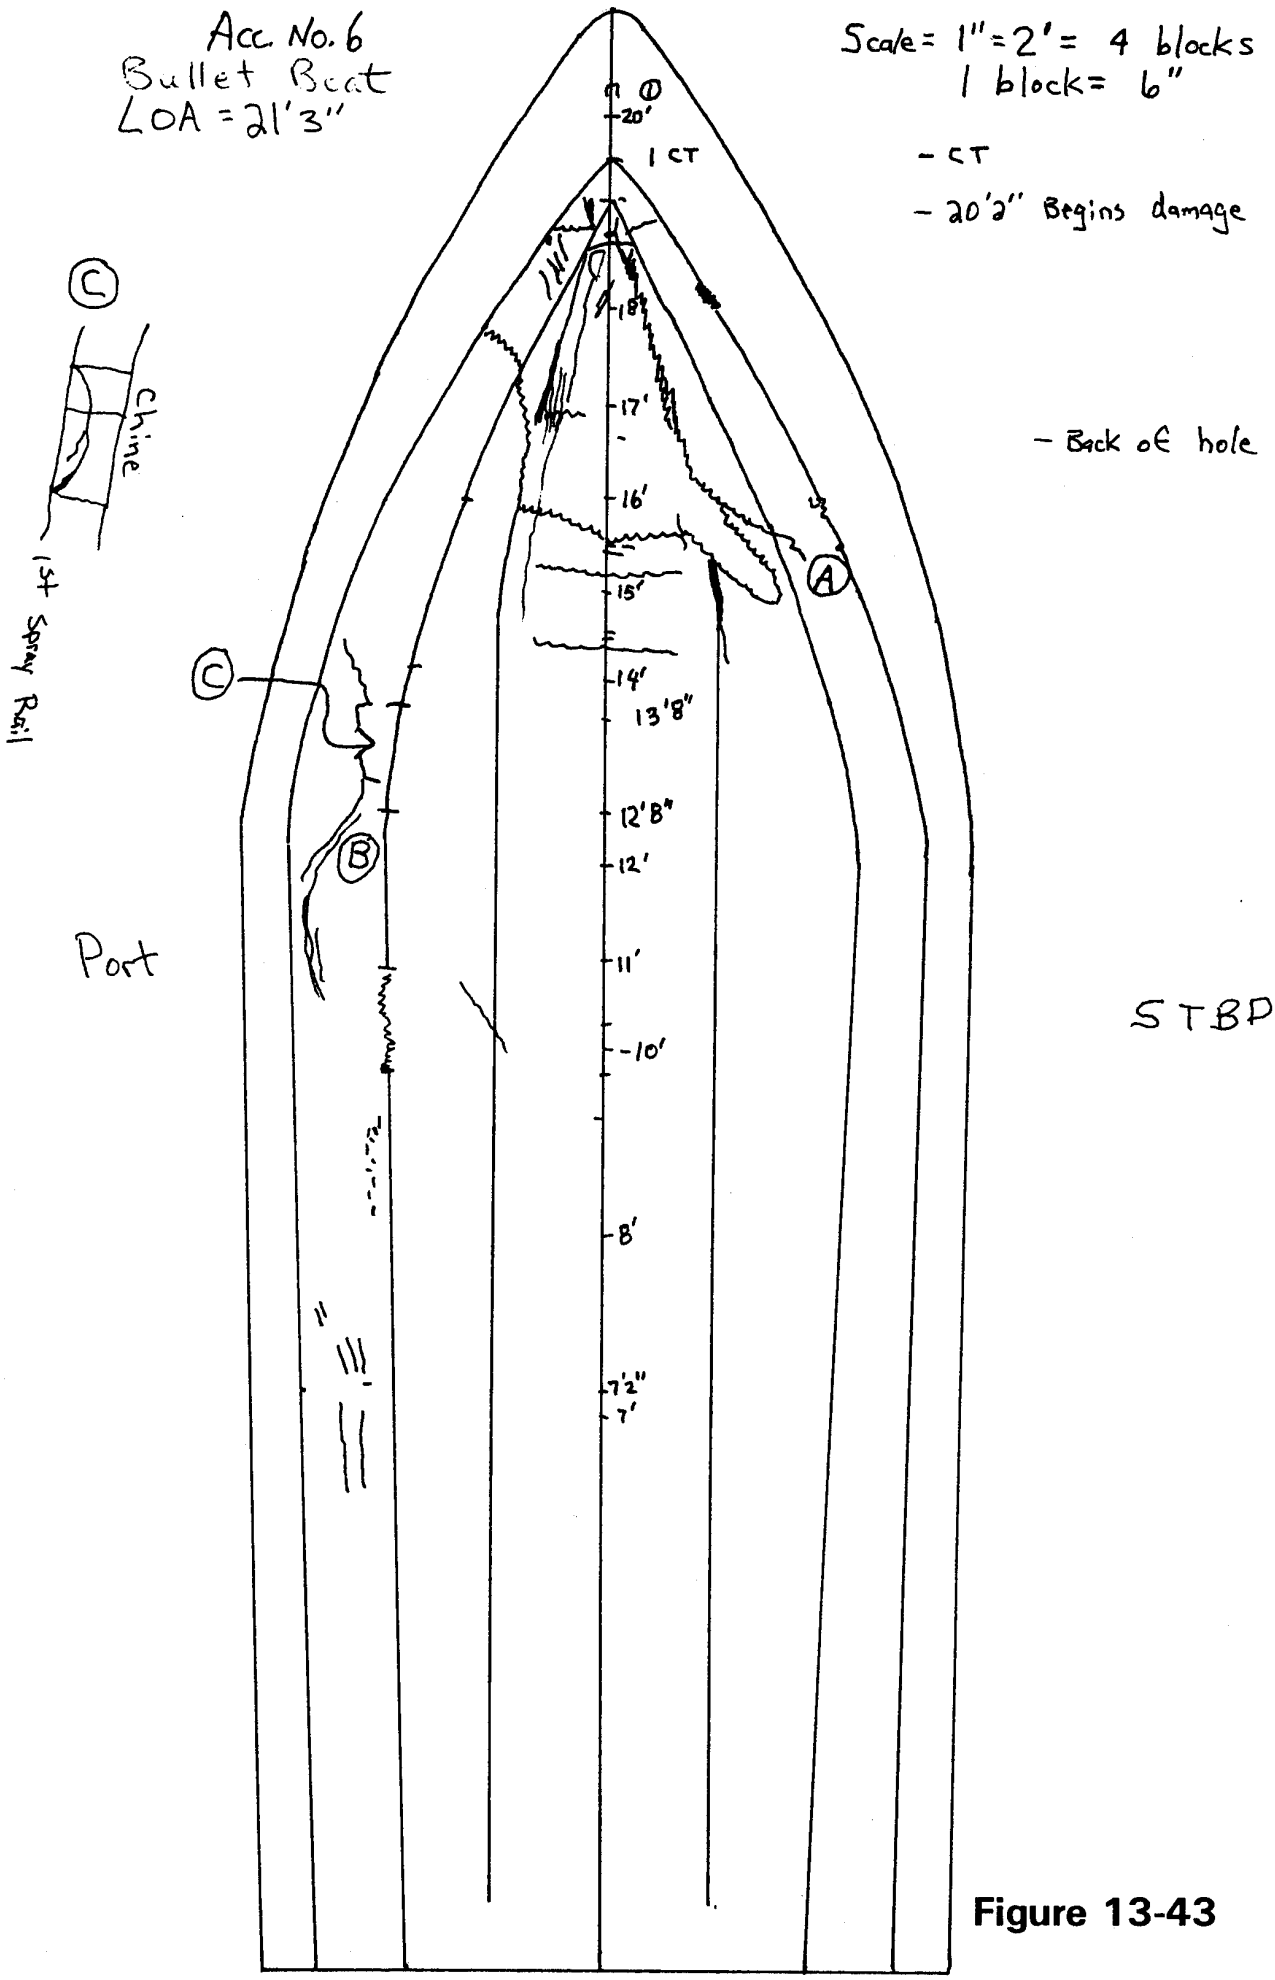
**Figure 13-42**

Acc. No. 6
Bullet Boat
LOA = 21'3"
Scale = 1" = 2' = 4 blocks
1 block = 6"
- CT
- 20'2" Begins damage
- Back of hole
C
Chine
1st Spray Rail
Port
STBD
A
B
C
20'
1 CT
18'
17'
16'
15'
14'
13'8"
12'8"
12'
11'
10'
8'
7'2"
7'

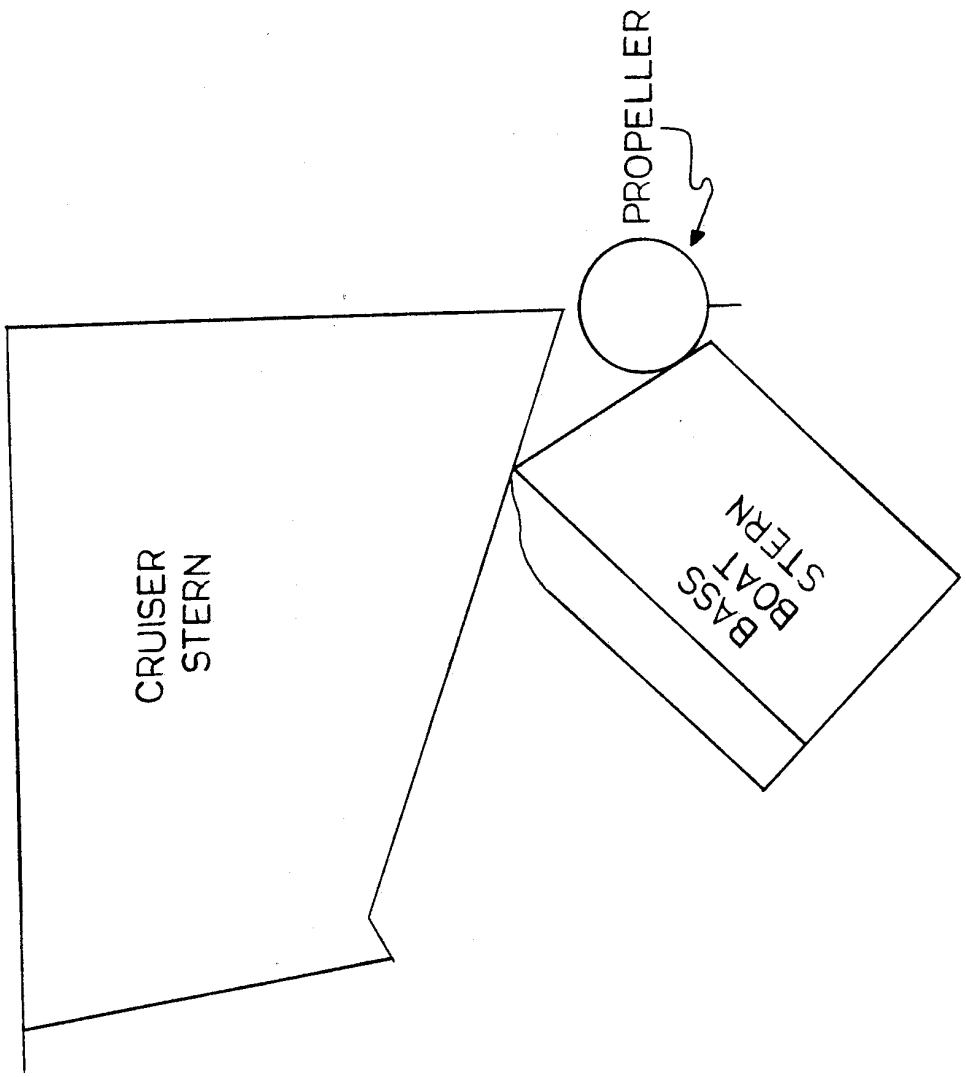
**Figure 13-45**

Accident No. 6

This Diagram Shows the Relative Orientation Required for the Two Boats to Come in Contact with the Propeller of the Cruiser Striking the Bass Boat.

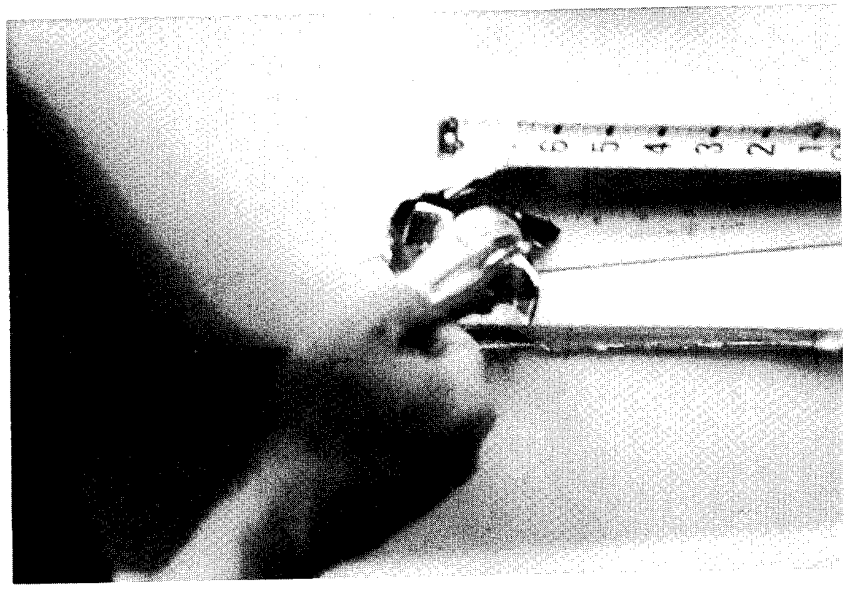
**Figure 13-69**

The general shape of the damaged area is significant. The forward most area of the cut out area is believed to be the initial impact point. The navigation light from the bullet boat appears to have penetrated through the forward area of the cut as shown in Figure 13-69. The navigation light from the bullet boat was found in the target boat in front of the operator's seat. The bow of the bullet boat actually cut through the hull, but the side of the navigation light housing may have cut the notch shown in this Figure. If this is true, it may also show the approximate angle of the two boats at impact. The navigation light impact point is fairly low on the hull of the target boat. If the other boat was on plane, then the initial impact area of the target boat must have been raised higher than normal. Either the target boat was plowing, or engaged in a hard turn to starboard. Witness statements indicated that both boats were on plane at impact. Figure 13-69 indicates that the bullet boat may have been in a turn to starboard at impact.

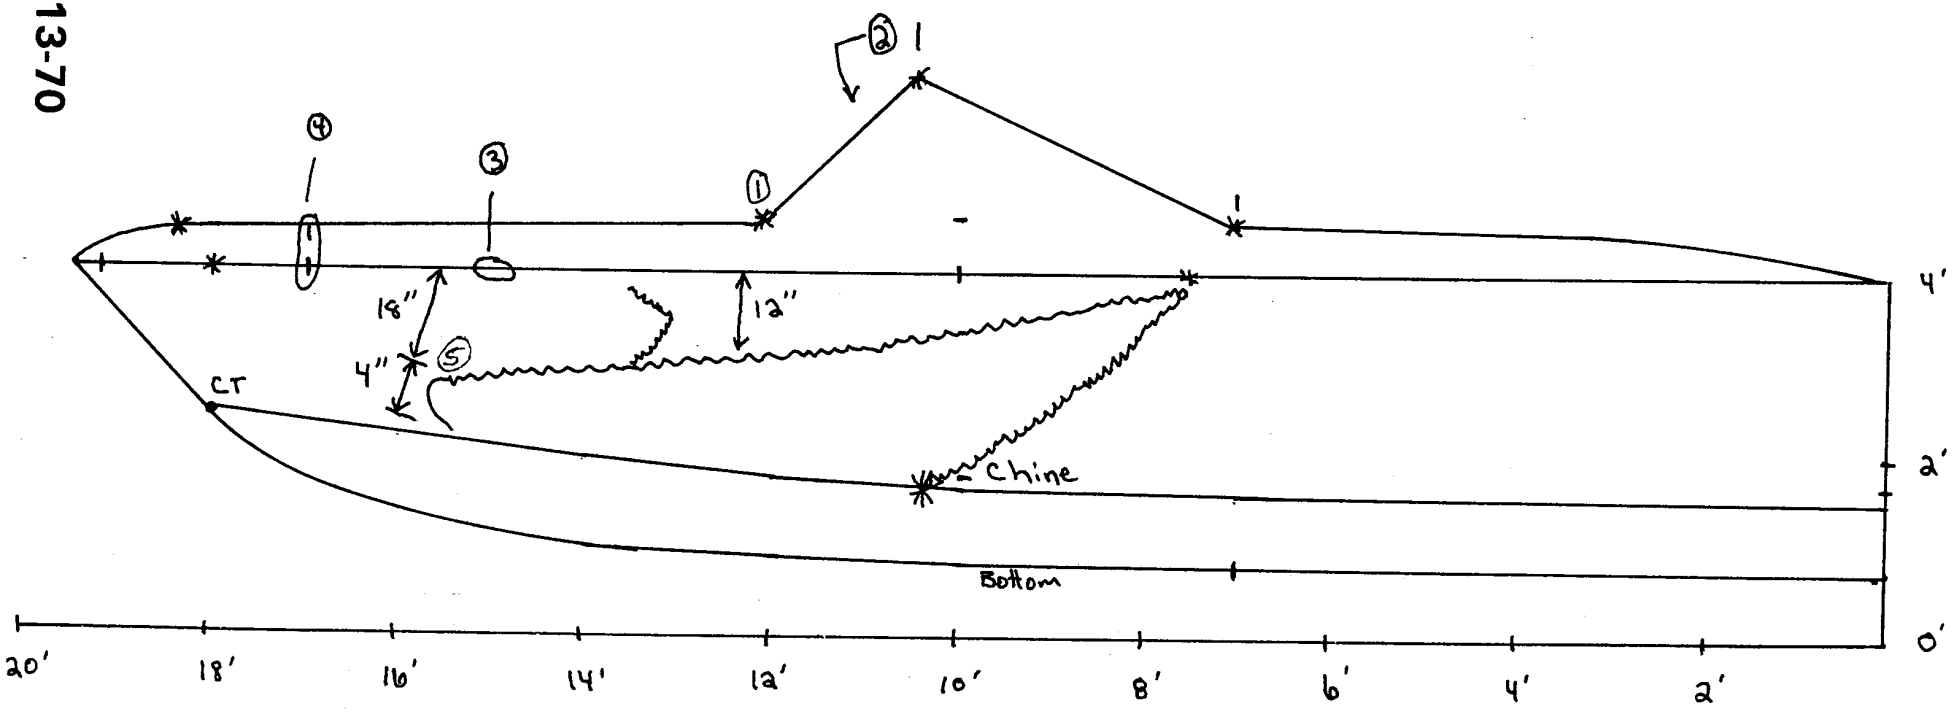
Figure 13-70

① WS Front
② WS Angle = 48°
③ 1" red smear on rub rail
④ 16' 11" = # on tape
⑤ Possible nav light impact point

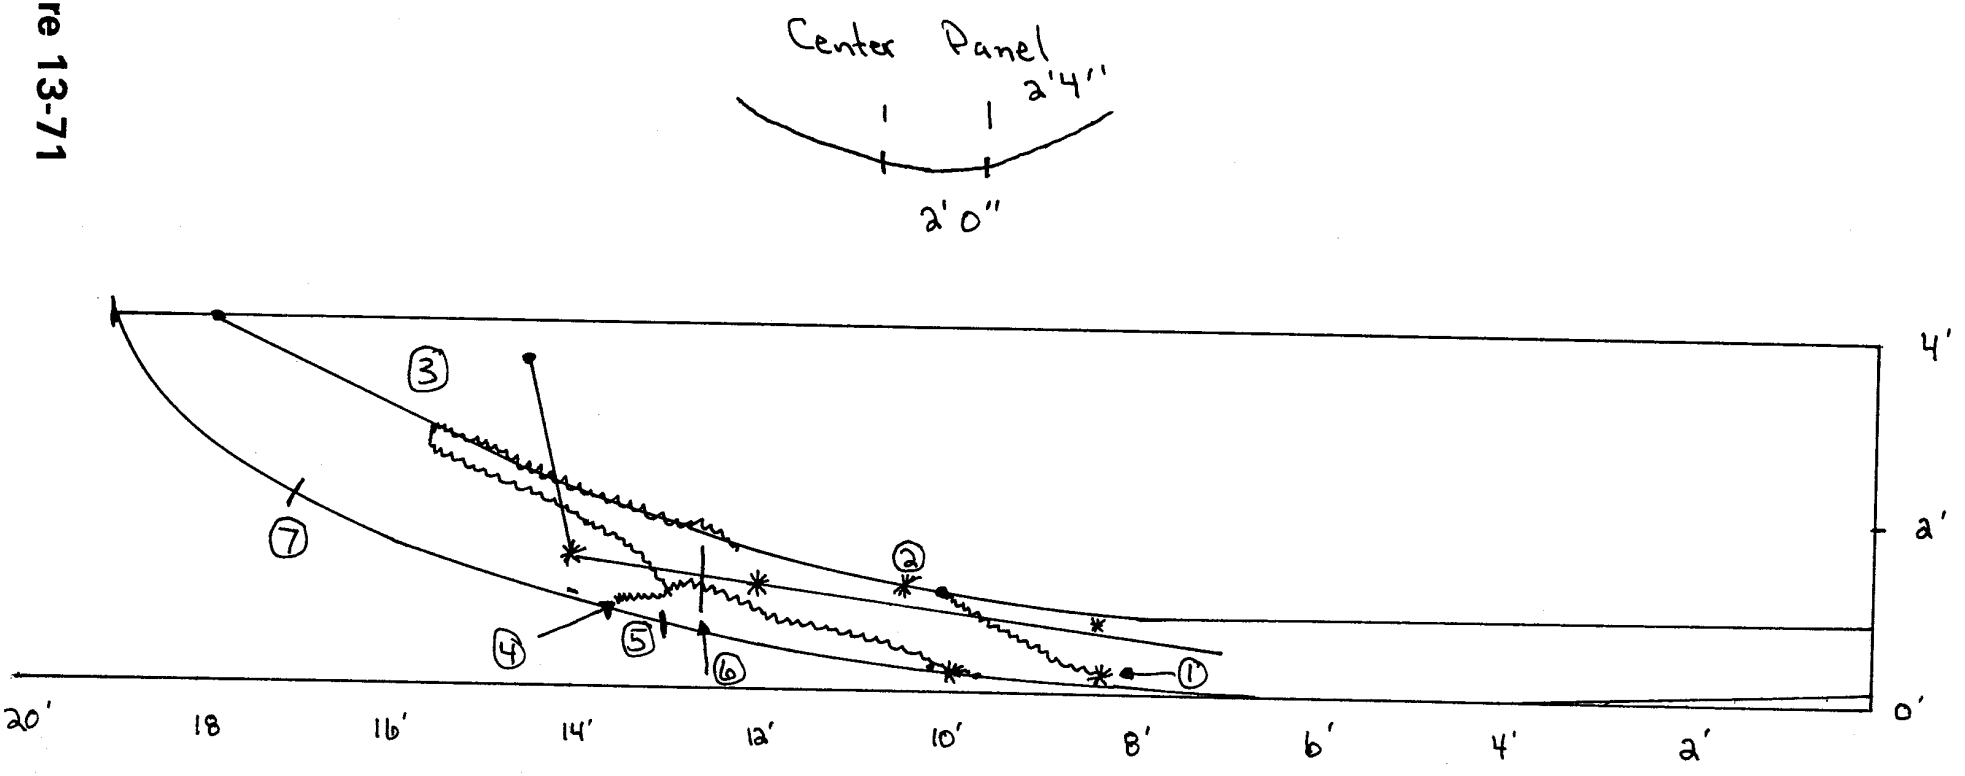
Figure 13-71

① end of "hole"
② hole at chine - aft
③ beginning of hole at chine - fwd
④ Crack
⑤ main crackline
⑥ vertical cut
⑦ red paint transfer on rub rail

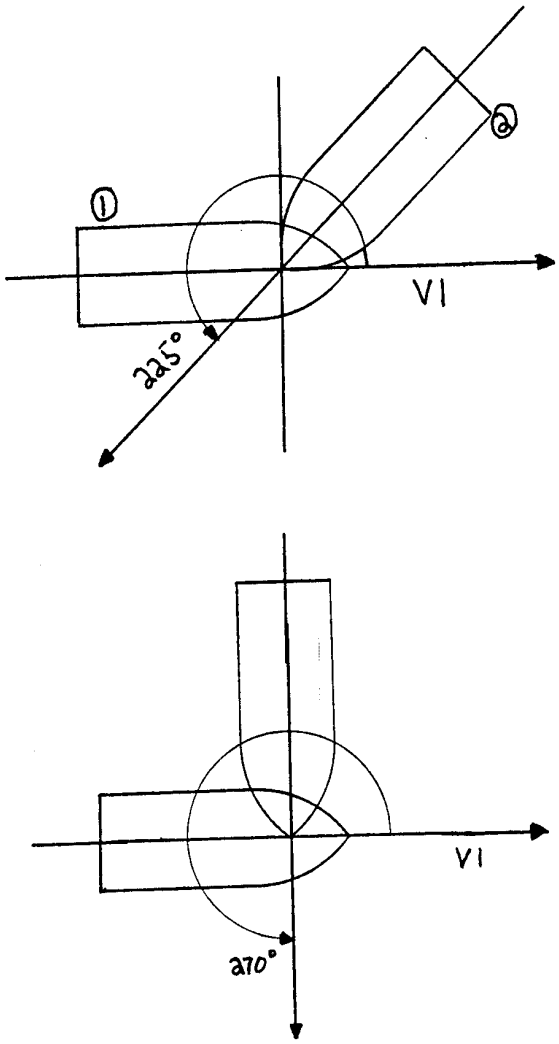
Accident No. 10

Possible Impact Angle for Accident No. 10. The Vector Impact Angles Range From Approximately 225° to 270°.

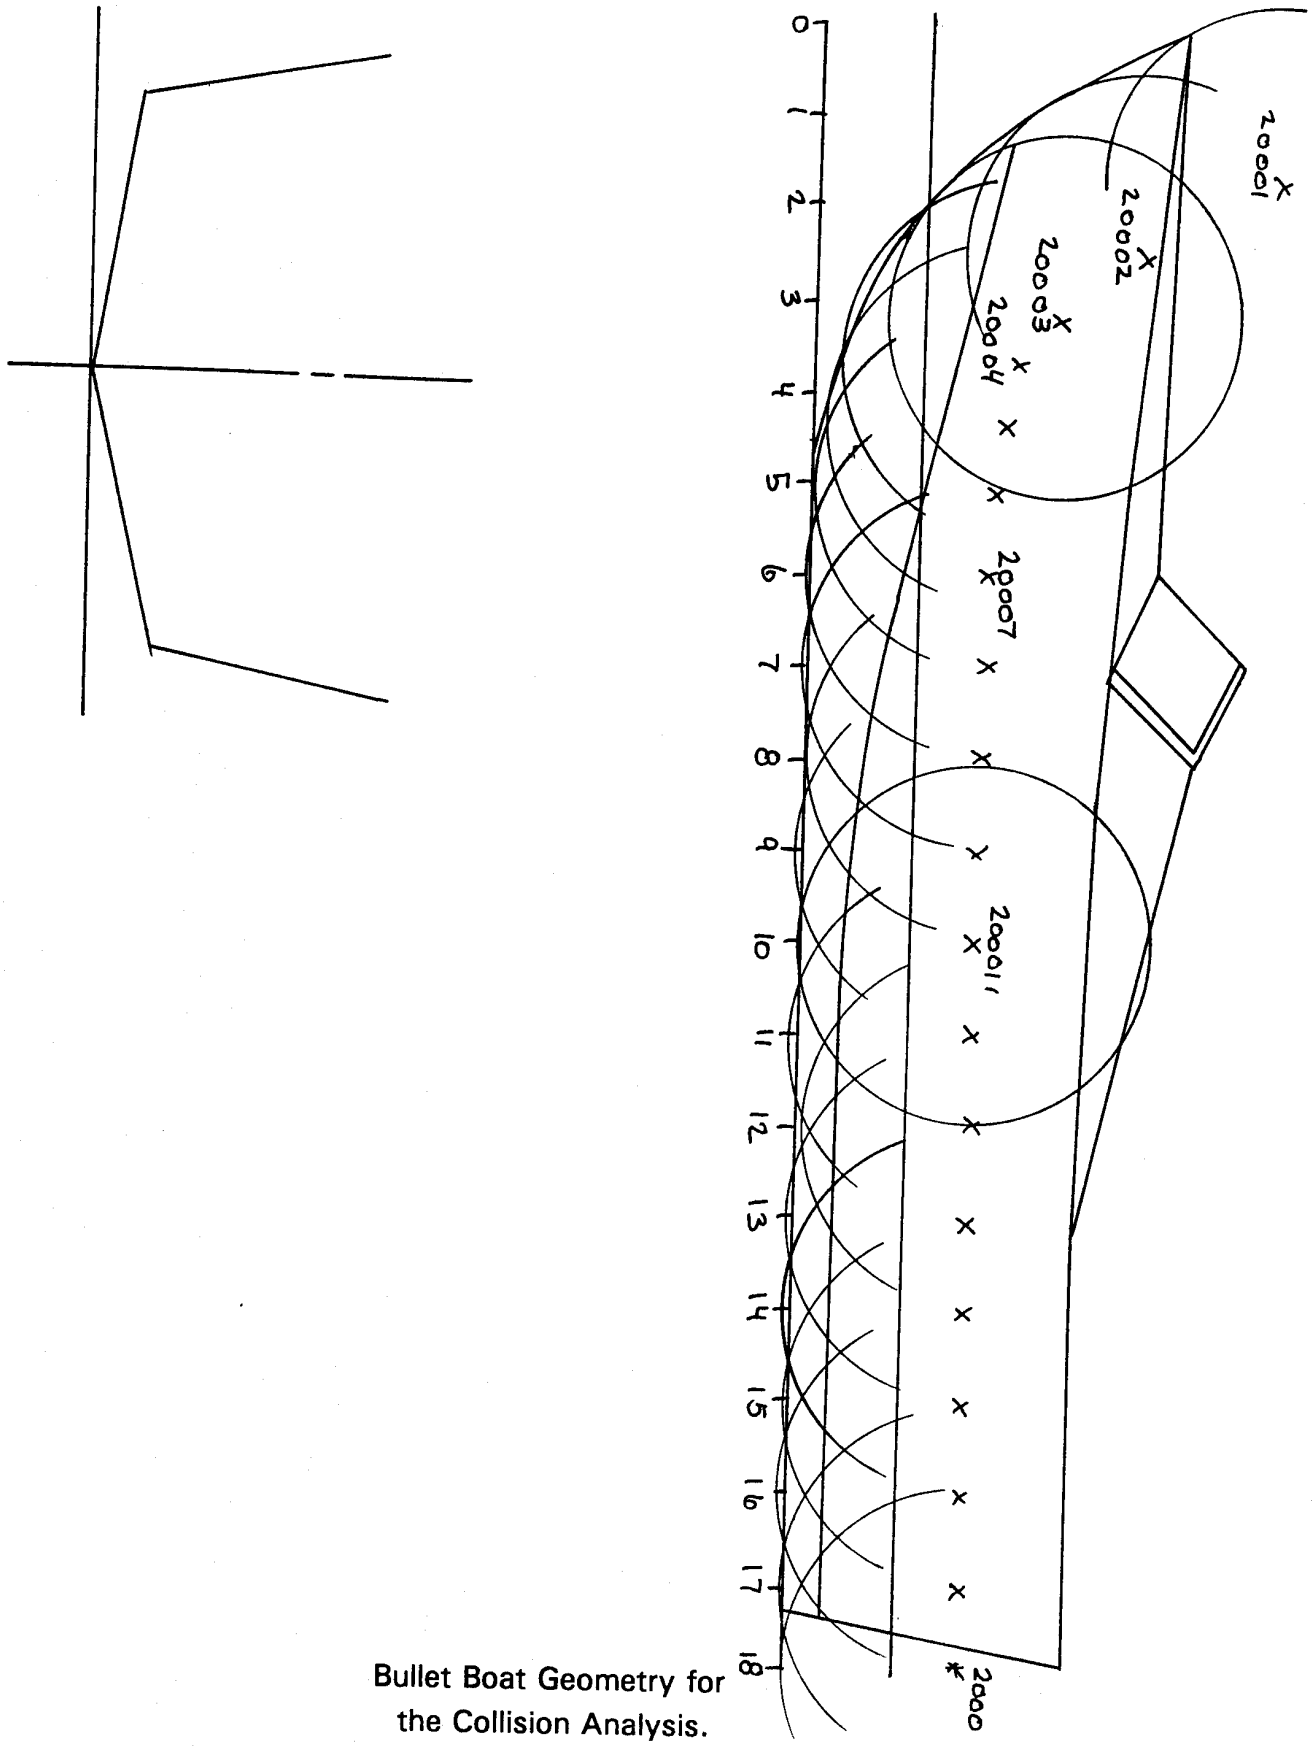
**Figure 14-6**

Figure 14-6 shows the overall geometry of the collision scene at the beginning of the simulation run. Five important markers are included in this figure. Marker number 100 is a fixed reference point, located on the surface of the water in line with the path of the bullet boat. This point serves as the global origin for the simulation. Markers 200 and 201 are fixed relative to part number 2 (the bullet boat). Markers 300 and 301 are fixed relative to part number 3 (the target boat). Markers 200 and 300 are identified in the respective part 2 and part 3 statements as center of mass markers. Markers 201 and 301 are positioned directly under the bow points of the boats, on the extension of the keel lines, as shown in Figure 14-5.

Basic Geometry of the 30 mph Collision.

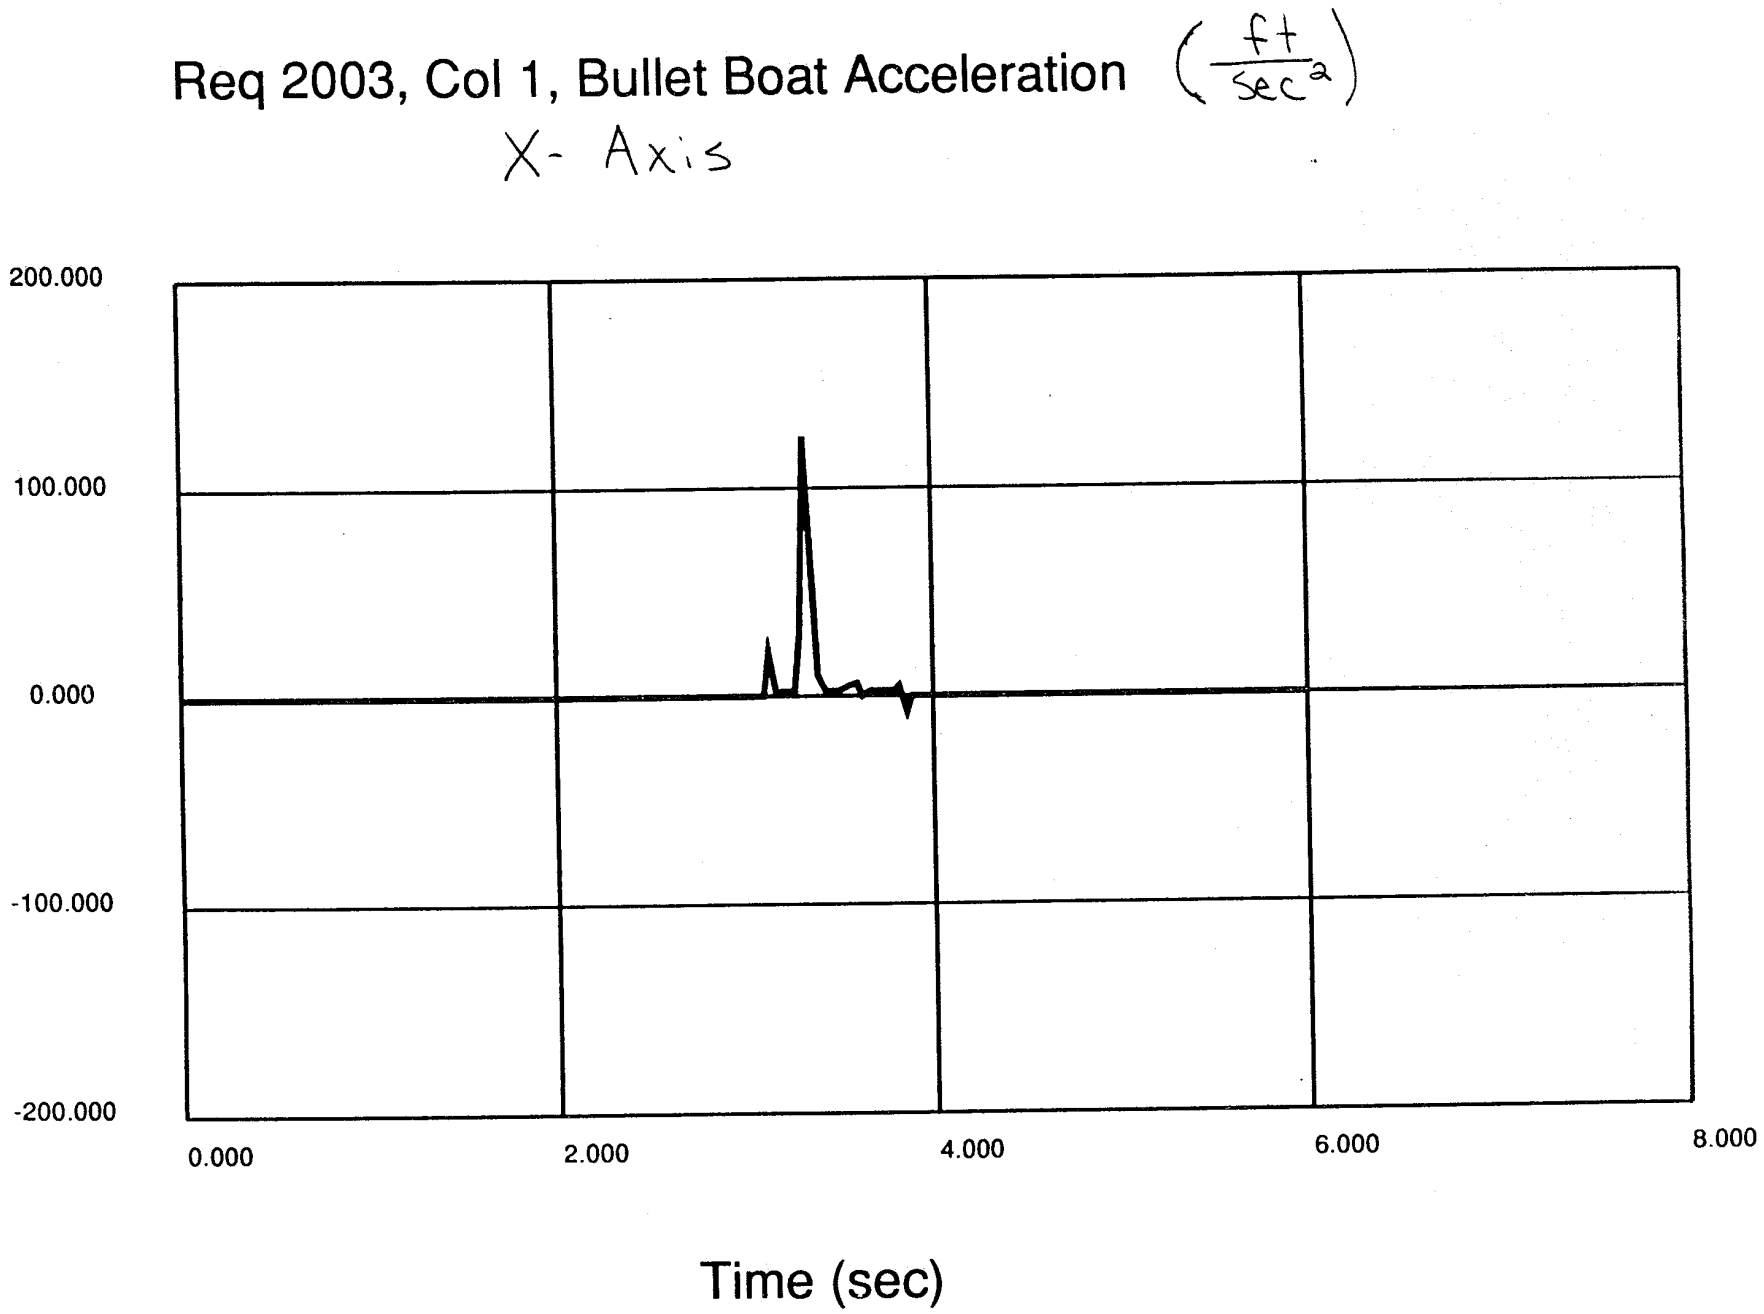
Figure 14-12 and 14-13 show the accelerations for the bullet boat in the x and z axis respectively. The units are given in $ft/sec^2$. Note that the plot for the z axis shows the pre-impact accelerations at approximately zero. Thus the values obtained from the graph for the z axis must have the component of acceleration due to gravity added for our analysis. This must be done since we are really interested in the forces on the occupants, as calculated from F = ma. Thus, components of acceleration for the z axis expressed in feet/per $second^2$ will have the value of 32.2 added to them. When acceleration is expressed in g's, the force on an object can be calculated by multiplying this number times the weight of the object. If this sounds confusing, think of the force between the person and the boat if the boat were suddenly allowed to accelerate downward at 32.2 ft/sec/sec. The contact force would be zero! However, if the same boat were suddenly accelerated upward at 32.2 ft/sec/sec, the contact force between the occupant the boat would be two times the occupant weight. Thus, a person weighing 150 lbs would exert a force of 300 lbs on the boat.

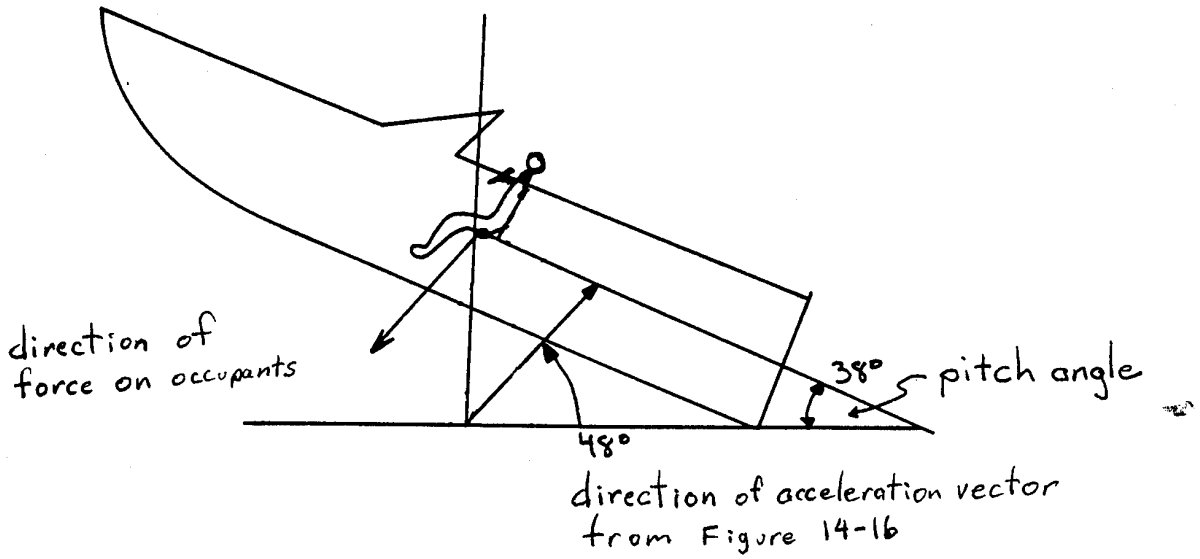
**Figure 14-16**

What affect does this have on the occupants? The occupants will experience a force that acts on them opposite to the direction of the acceleration vector and equal in magnitude to their mass times their weight (F= ma). Figure 14-16 shows the direction relative to a fixed axis of the maximum experienced acceleration at the CG of the target boat.

Occupants of the Bullet Boat at the CG Experience a Force Opposite in Direction to the Total Acceleration Vector of the CG.
