Technical Report ARFSD-TR-94021

M864 CARGO EXPULSION FAILURE INVESTIGATION

Paul N. Rasmussen

March 1995

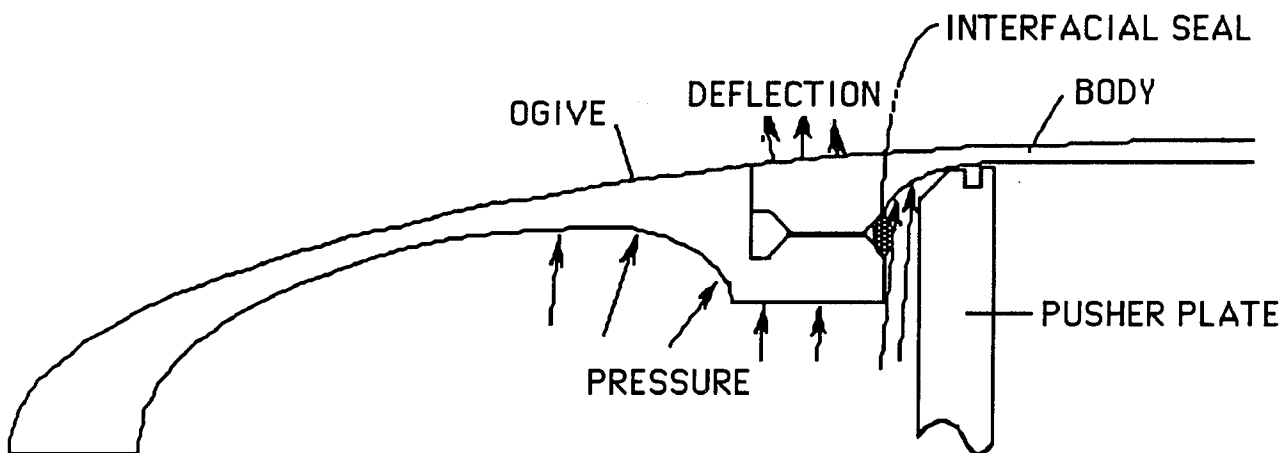
Figure 1. Interfacial seal

An interfacial seal (fig.1) was formed by applying Loctite's Ultrablue 587 to the interior surface of the body-ogive joint. This sealant adds no radial strength to the joint, but does seal the joint from the expulsion gasses. The ultrablue was selected because it is used on the weatherseal assembly in the base burner assembly. The sealant must be allowed to cure for 24 hrs before final assembly is initiated. The cost of the interfacial seal was estimated to be between $4 (FY92) and $5 (FY92) per unit.

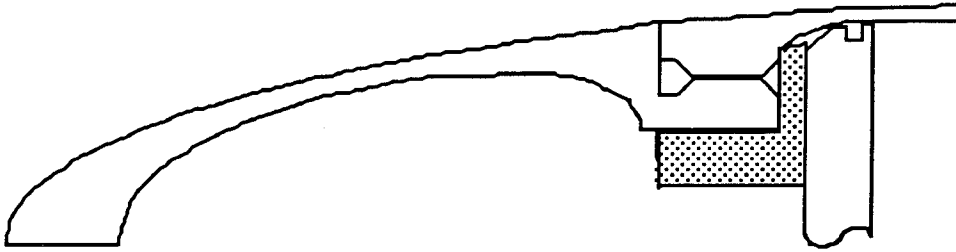
Figure 2. Molded seal

The interfacial seal did not lend itself easily to a rework procedure for the previously loaded projectiles. Other methods of sealing the joint were researched with two processes being pursued. The molded seal (fig.2) is a modification of the EPDM boot. Grease/mold release is applied to the pusher plate's front surface. A circular mold is placed into the ogive and held and positioned with a press tool. A force of 3

tons is applied to crush the rubber pad behind the pusher plate. When the fast-cure urethane rubber is poured into the area, it flows into the area between the joint and the pusher plate thus forming a rubber seal. By allowing the seal to bond to the ogive surfaces and not the pusher plate, the expulsion gasses hold the seal in place.

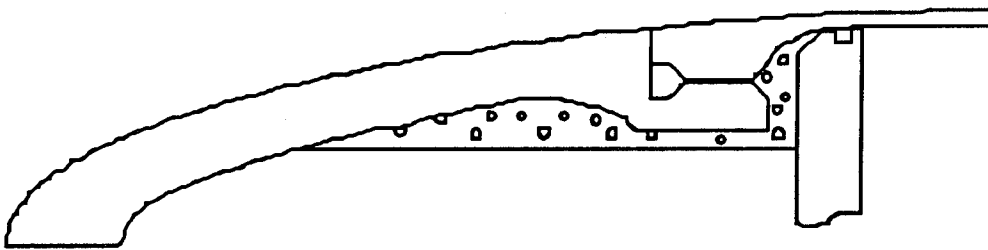
Figure 3. Fluidic seal

The fluidic seal (fig.3) is a mixture of Dow Corning (DC) 111 valve lubricant with glass beads. The DC 111 is a very high viscosity lubricant used primarily in the refrigeration industry; it has a working temperature range of -50°F to 400°F. The glass beads are added to guarantee that a gap exists between the pusher plate and the rear surface of the ogive. The components can be added to the ogive separately (glass beads first is recommended) without any mixing required. During setback in the gun tube, the fluidic seal will form a buffer region between the joint and the interior of the ogive. During the expulsion event the joint is protected from the gasses.

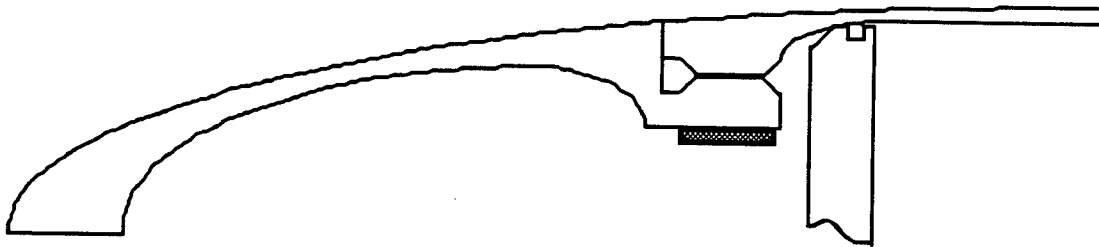
Figure 4. Expansion ring

Another solution which was proposed was called the expansion ring (fig.4). The expansion ring was a steel ring which was pressed into a body-ogive causing an interference fit inside the ogive at the joint. Stress analysis showed that this would decrease the radial displacement within the joint by up to 0.006 ins. thus strengthening the joint. Samples of each of the three solutions were prepared and ballistically tested at YPG. The results are tabulated in tables 11 through 13. One failure to expel was observed during a low expulsion charge test of the fluidic seal, but there were no blown ogives during any of the tests.
