SALT LAKE CITY STREAMS, UTAH

LITTLE DELL LAKE

FOUNDATION REPORT

APRIL 1995

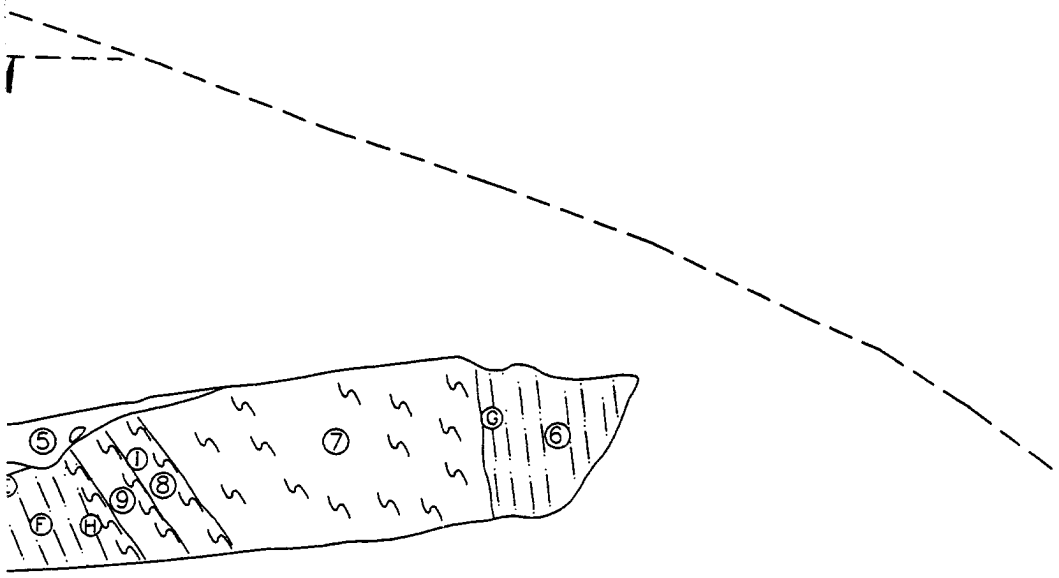
FT – 3

2.2 **Description of the Bedrock Step in Trench FT-3**. At trench FT-3 (see trench log, Figure 5), during routine mapping of the stratigraphic units, slickensides were observed in the channel deposits of Fluvial Cycle 4 age. It was therefore decided to excavate the trench into bedrock under the alluvium. Observed at this location was a bedrock step that apparently resulted from compressional stresses. Excavation to the limits of the backhoe indicated that the step was greater than 30 feet (9 meters). The step occurs along a sheared and altered bed in the Frontier Formation, and the adjacent and overlying Fluvial Cycle 4 deposits are deformed (Fluvial Cycle 3 deposits had been removed prior to trenching). The bedrock step dips about 65 degrees southeast and bedding in the channel deposits nearly parallels the step, thus suggesting that movement occurred along the bedding plane fault after the fluvial

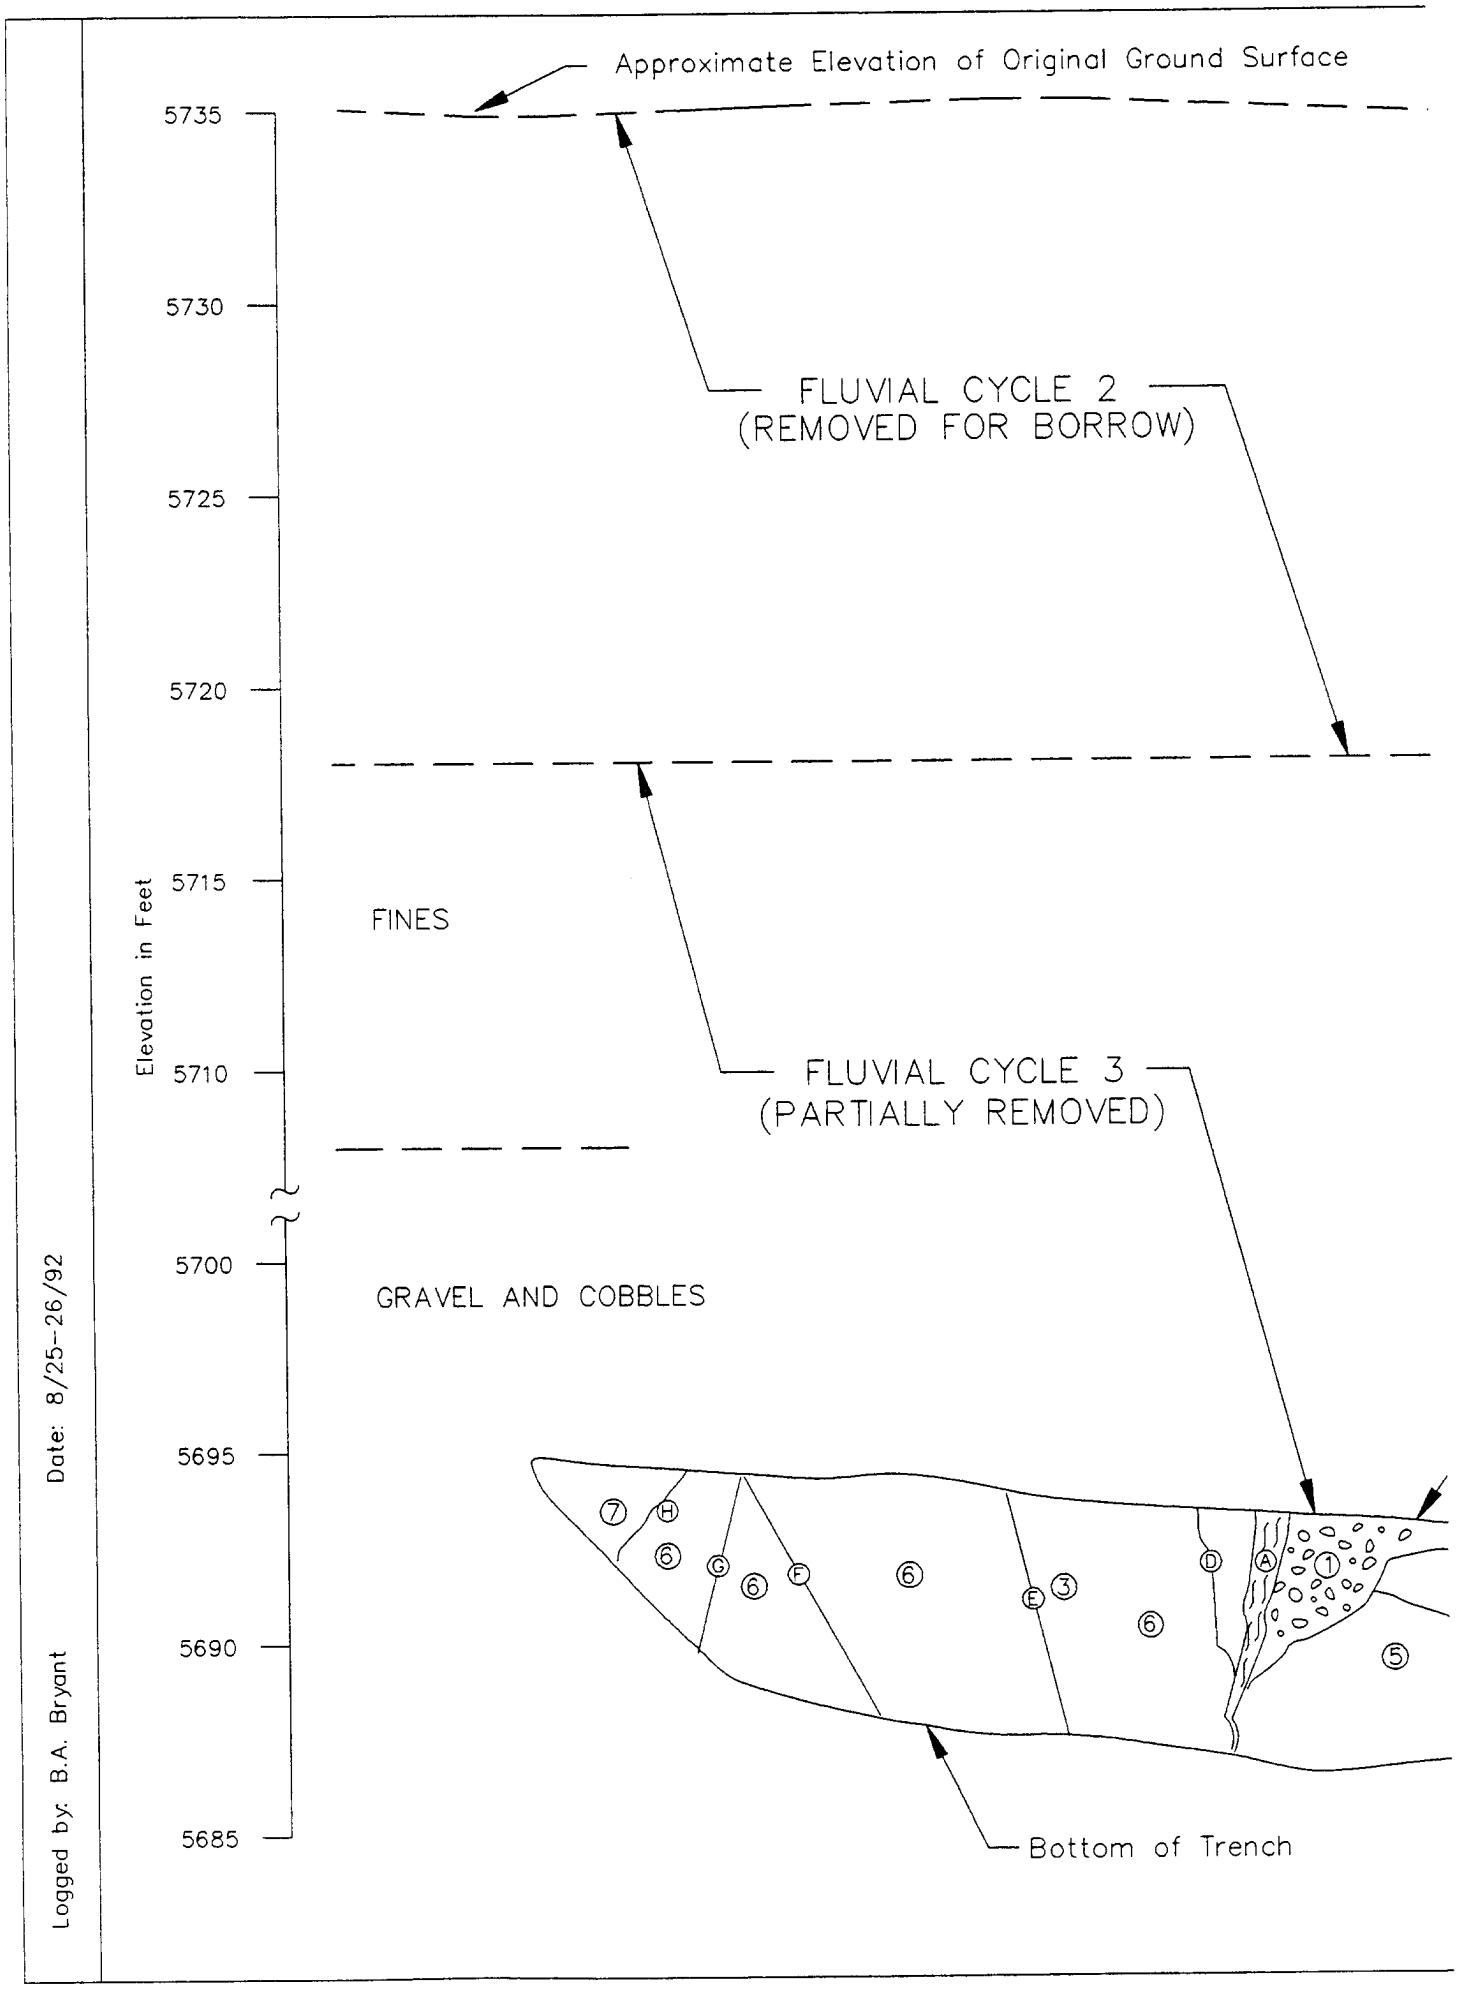
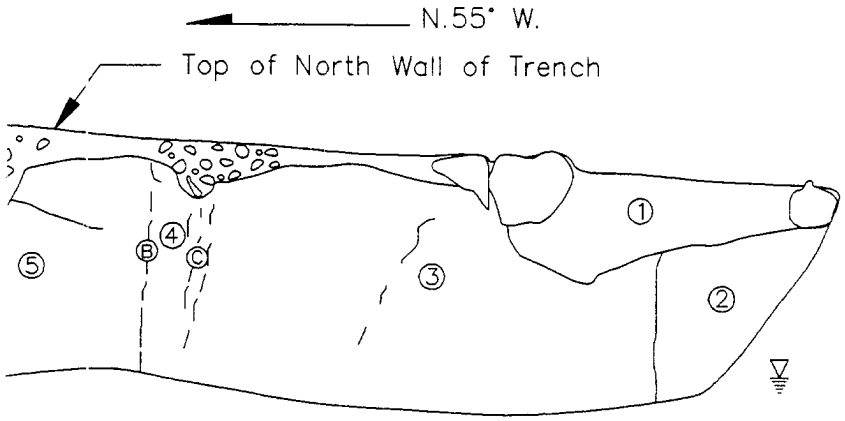
Figure 8

FT-6 (Figure 8): Fluvial Cycle 4 overbank deposits are sheared, apparently caused by movement of an underlying bedrock step (fault). Deformation of Fluvial Cycle 3 gravel deposits may have occurred. Total offset along the contact of the Fluvial Cycle 3 basal gravel with the Fluvial Cycle 4 overbank deposits is approximately 5 to 6 feet (1.5 to 1.8 meters).

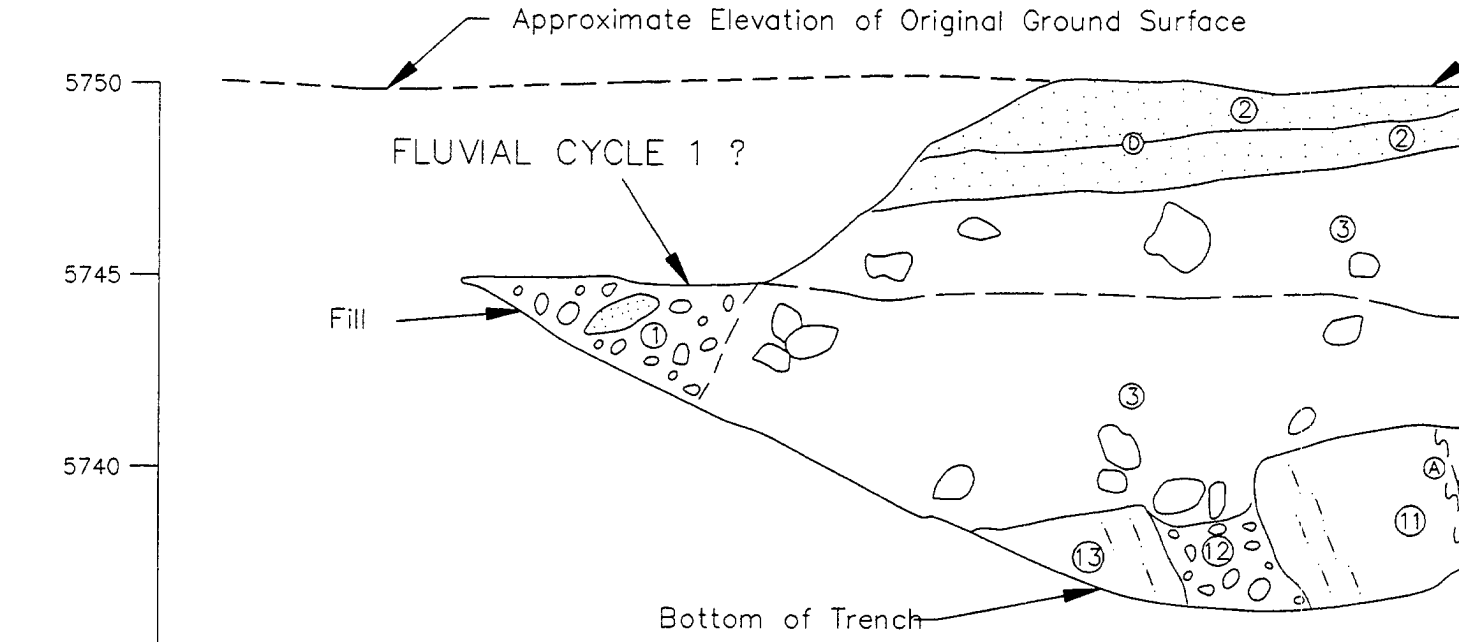
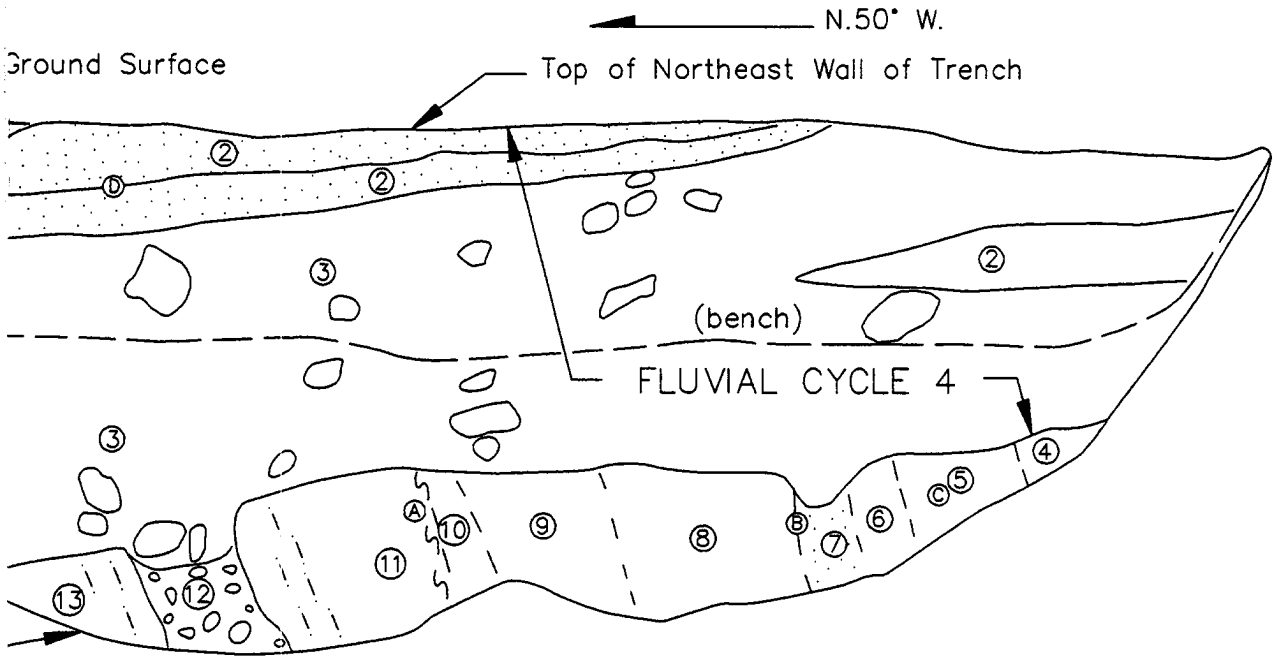
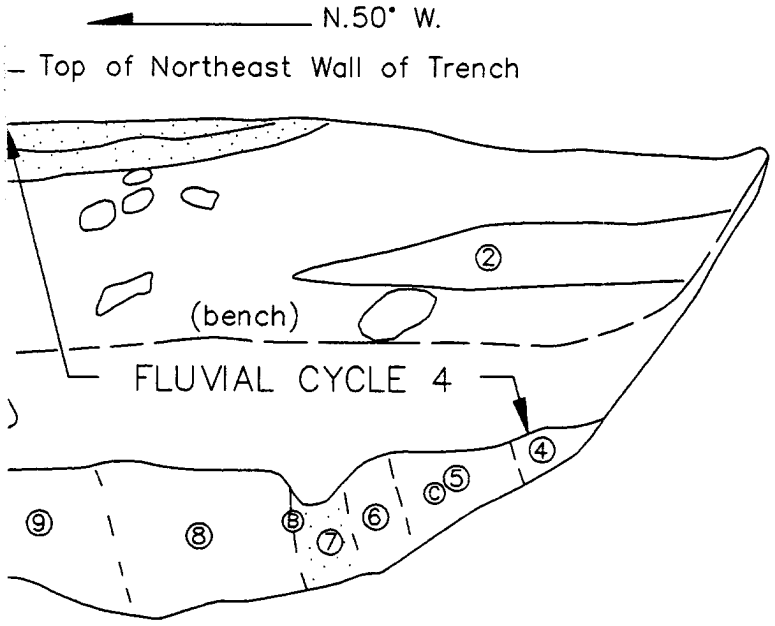
Figure 9

FT-7 (Figure 9): The trench contains a bedrock fault in contact with a gravel bed of Fluvial Cycle 3. There is no conclusive evidence indicating if the contact of the fluvial deposits with the fault is depositional or tectonic.

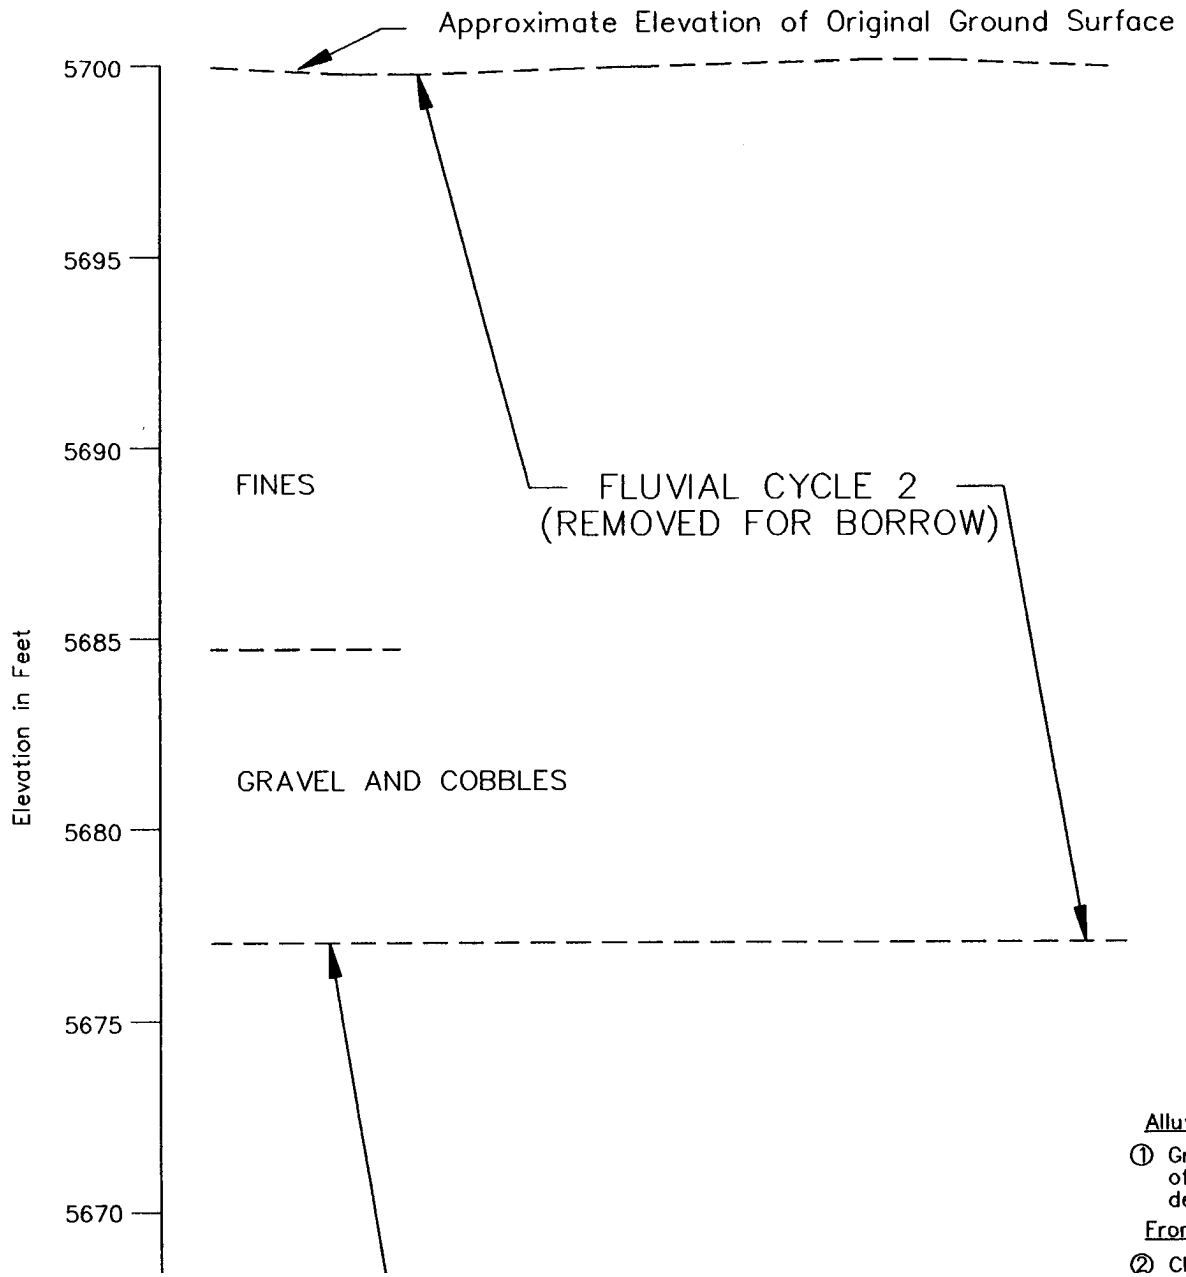
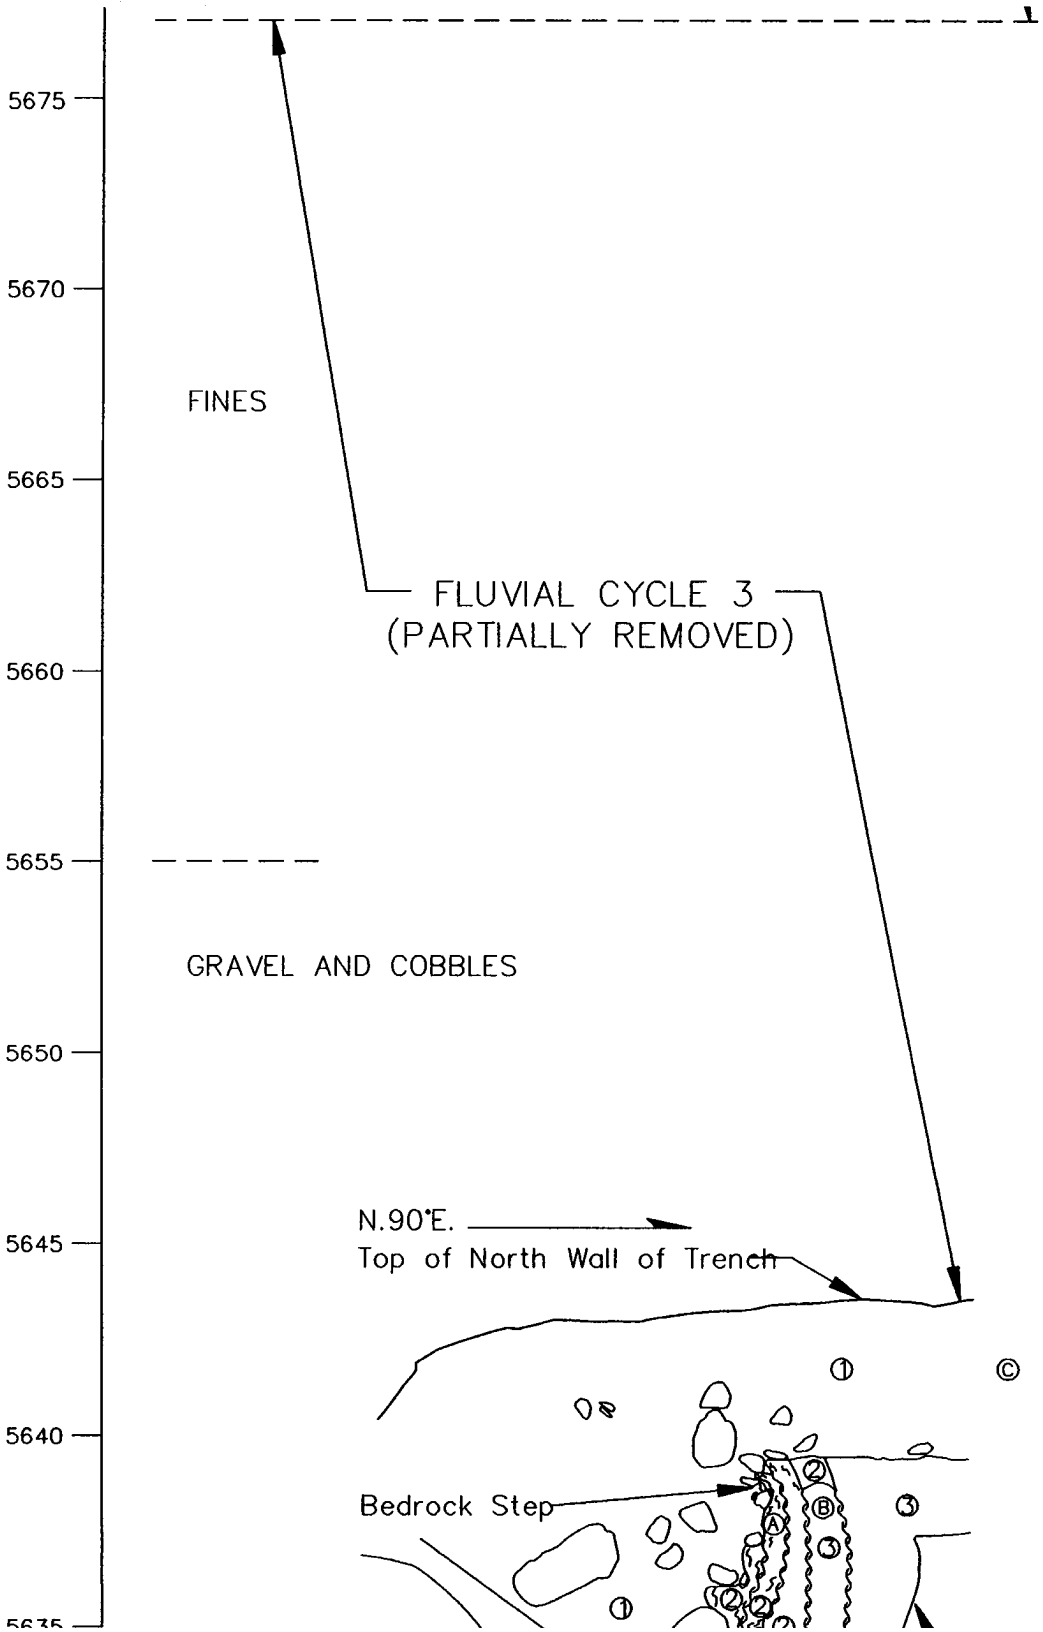
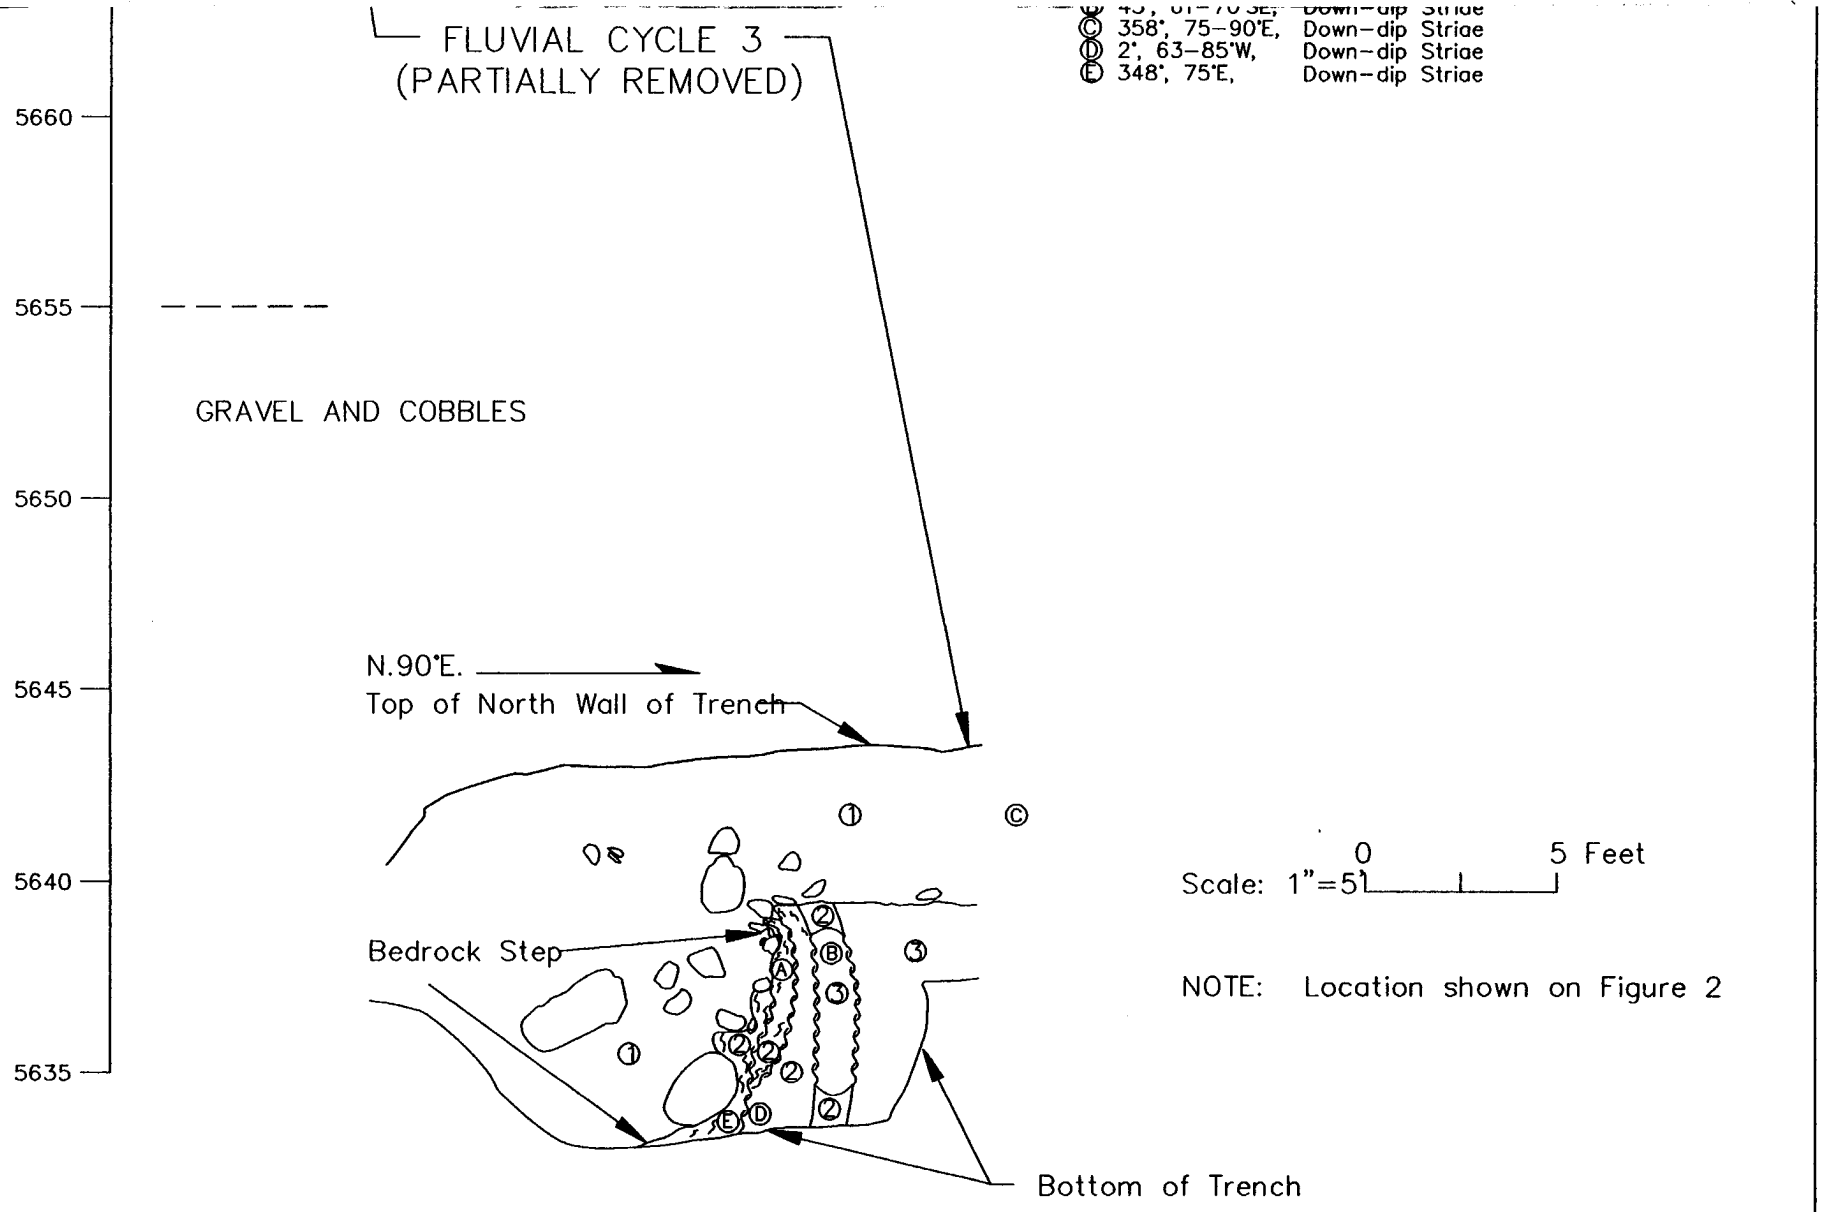
Figure 10

FT-9 (Figure 10): The trench log shows a depositional contact between basal gravel of Fluvial Cycle 4 and bedrock of the Frontier Formation.

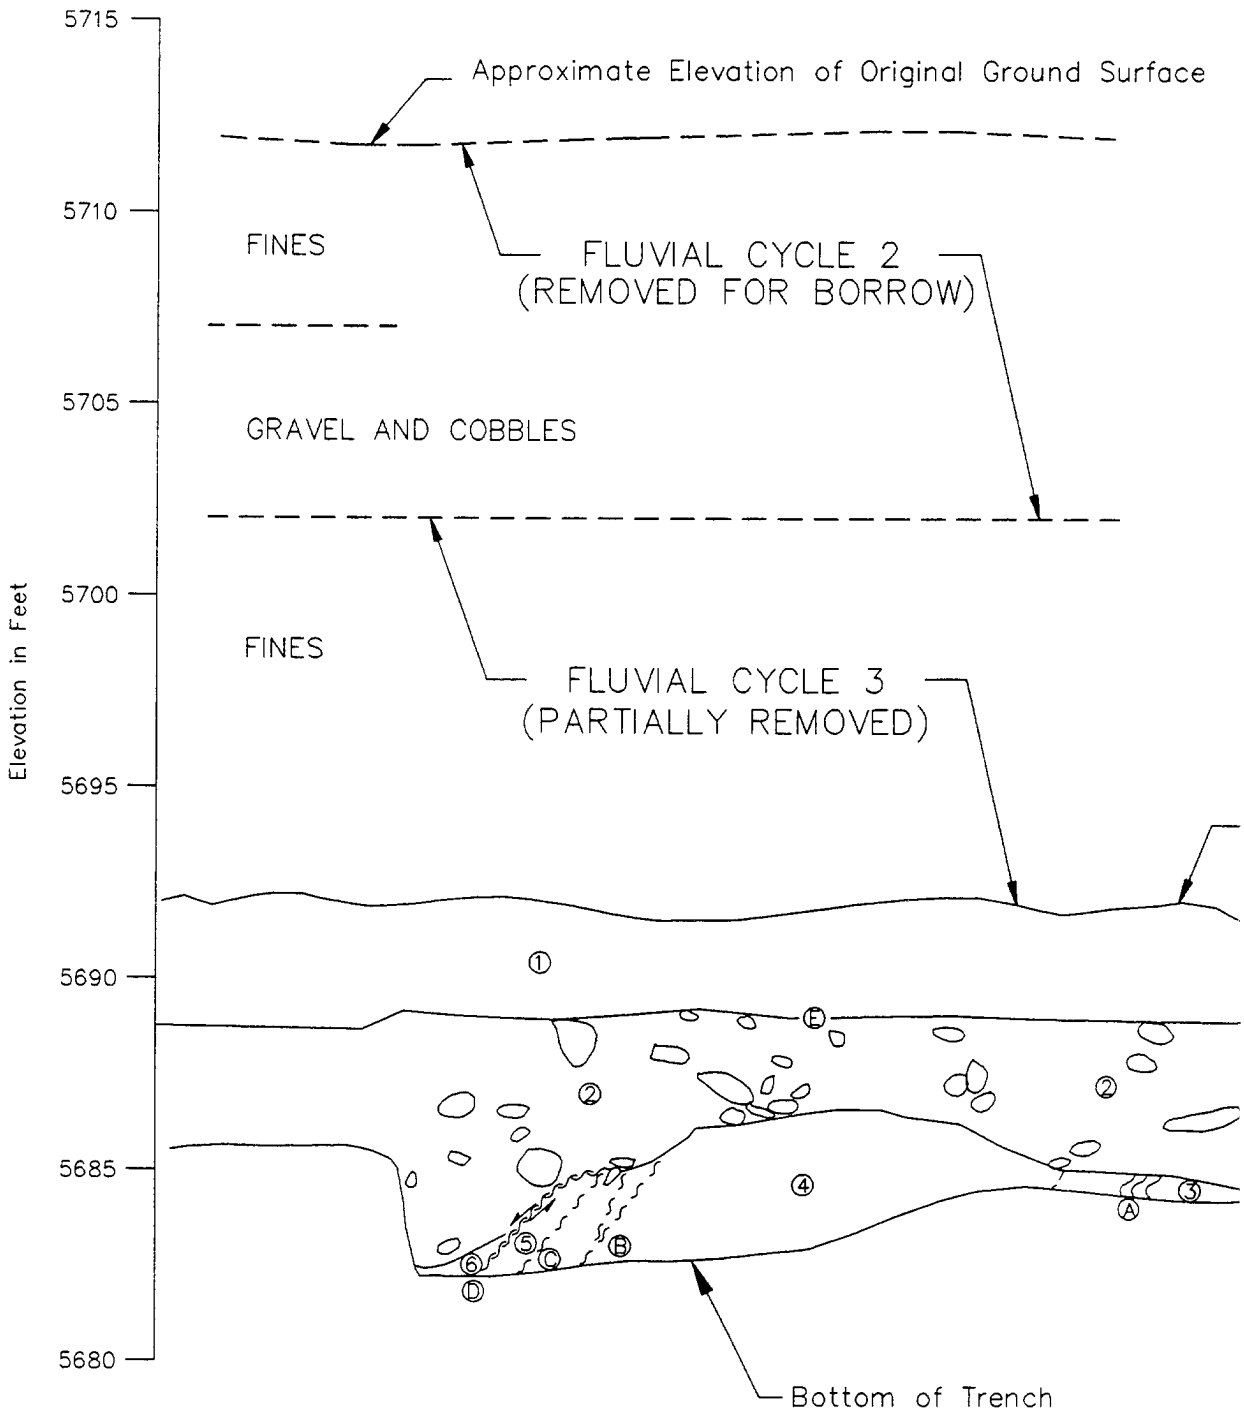
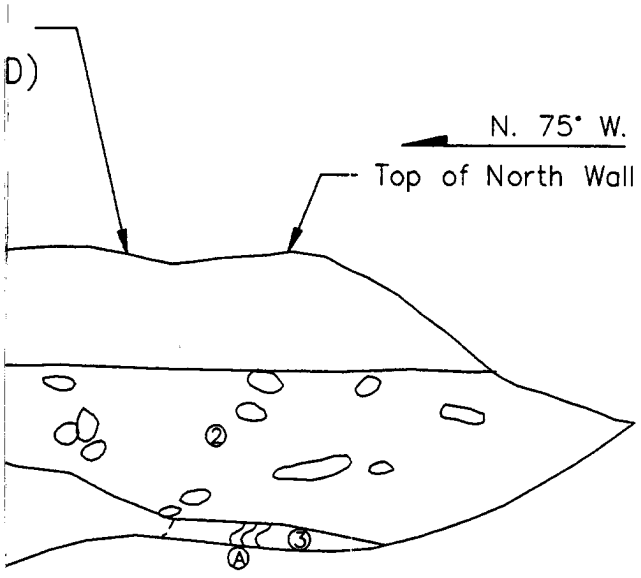
Figure 14

FT-13 (Figure 14): The entire trench was in basal gravel of Fluvial Cycle 4 to an approximate depth of 20 feet (6.1 meters). No distinctive feature was noted.

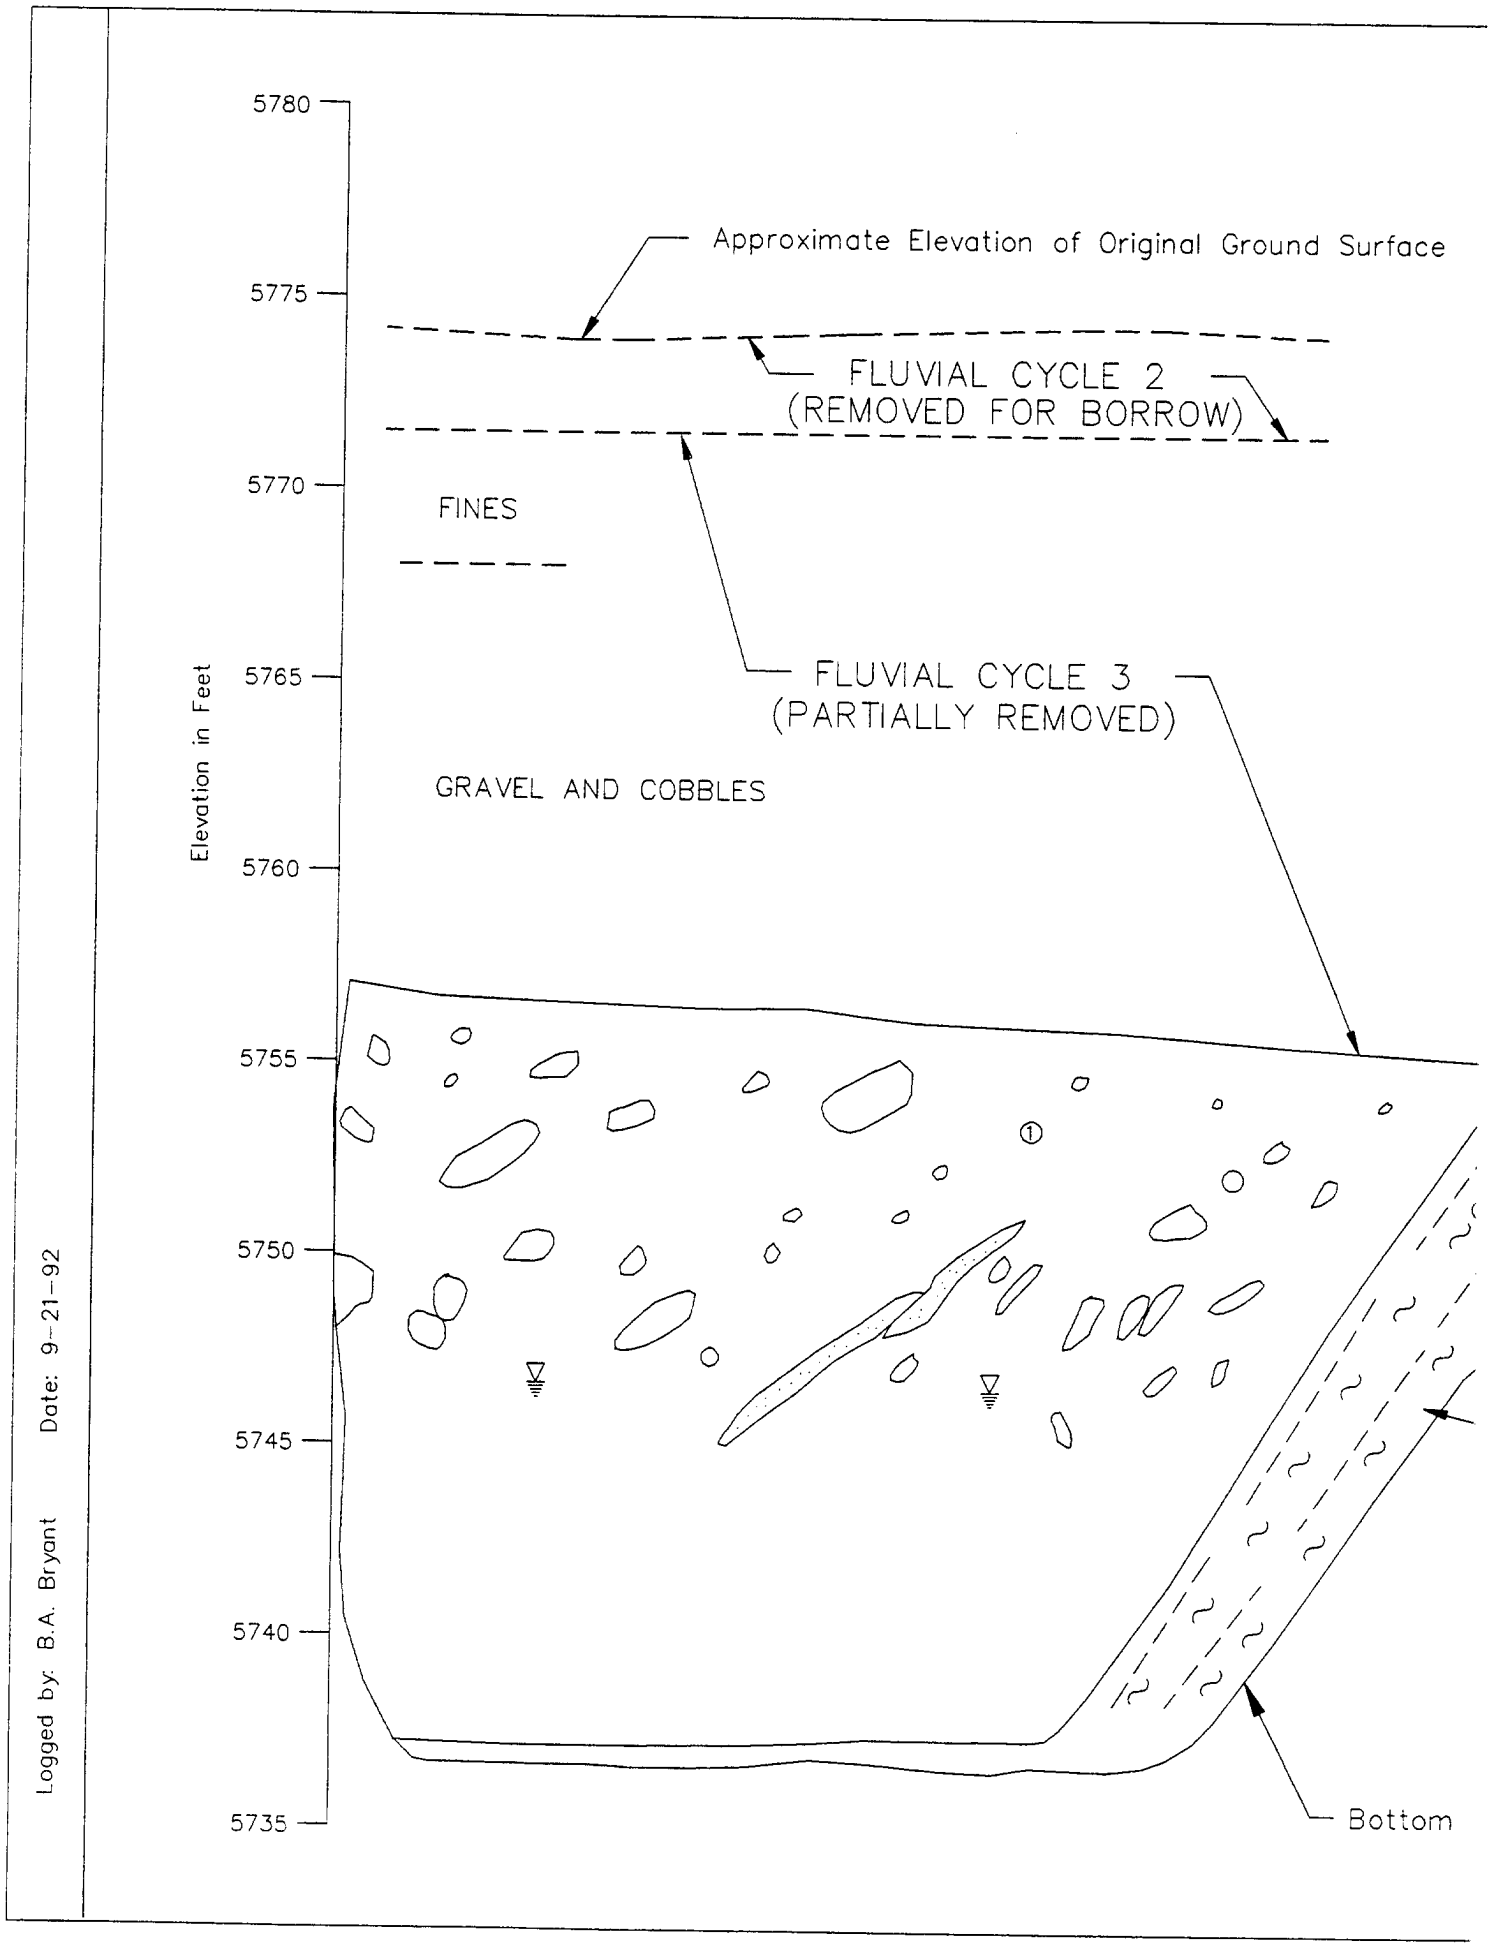
Figure 18

FT-17 (Figure 18): Several shears were observed in the bedrock with three (3) of them creating a 1 to 2-foot (0.3 to 0.6-meter) bedrock step overlain by basal gravel of Fluvial Cycle 3. The gravel was not displaced. Shearing is generally along bedding within an altered claystone or other fine-grained rock, with the dip of the shears varying slightly.

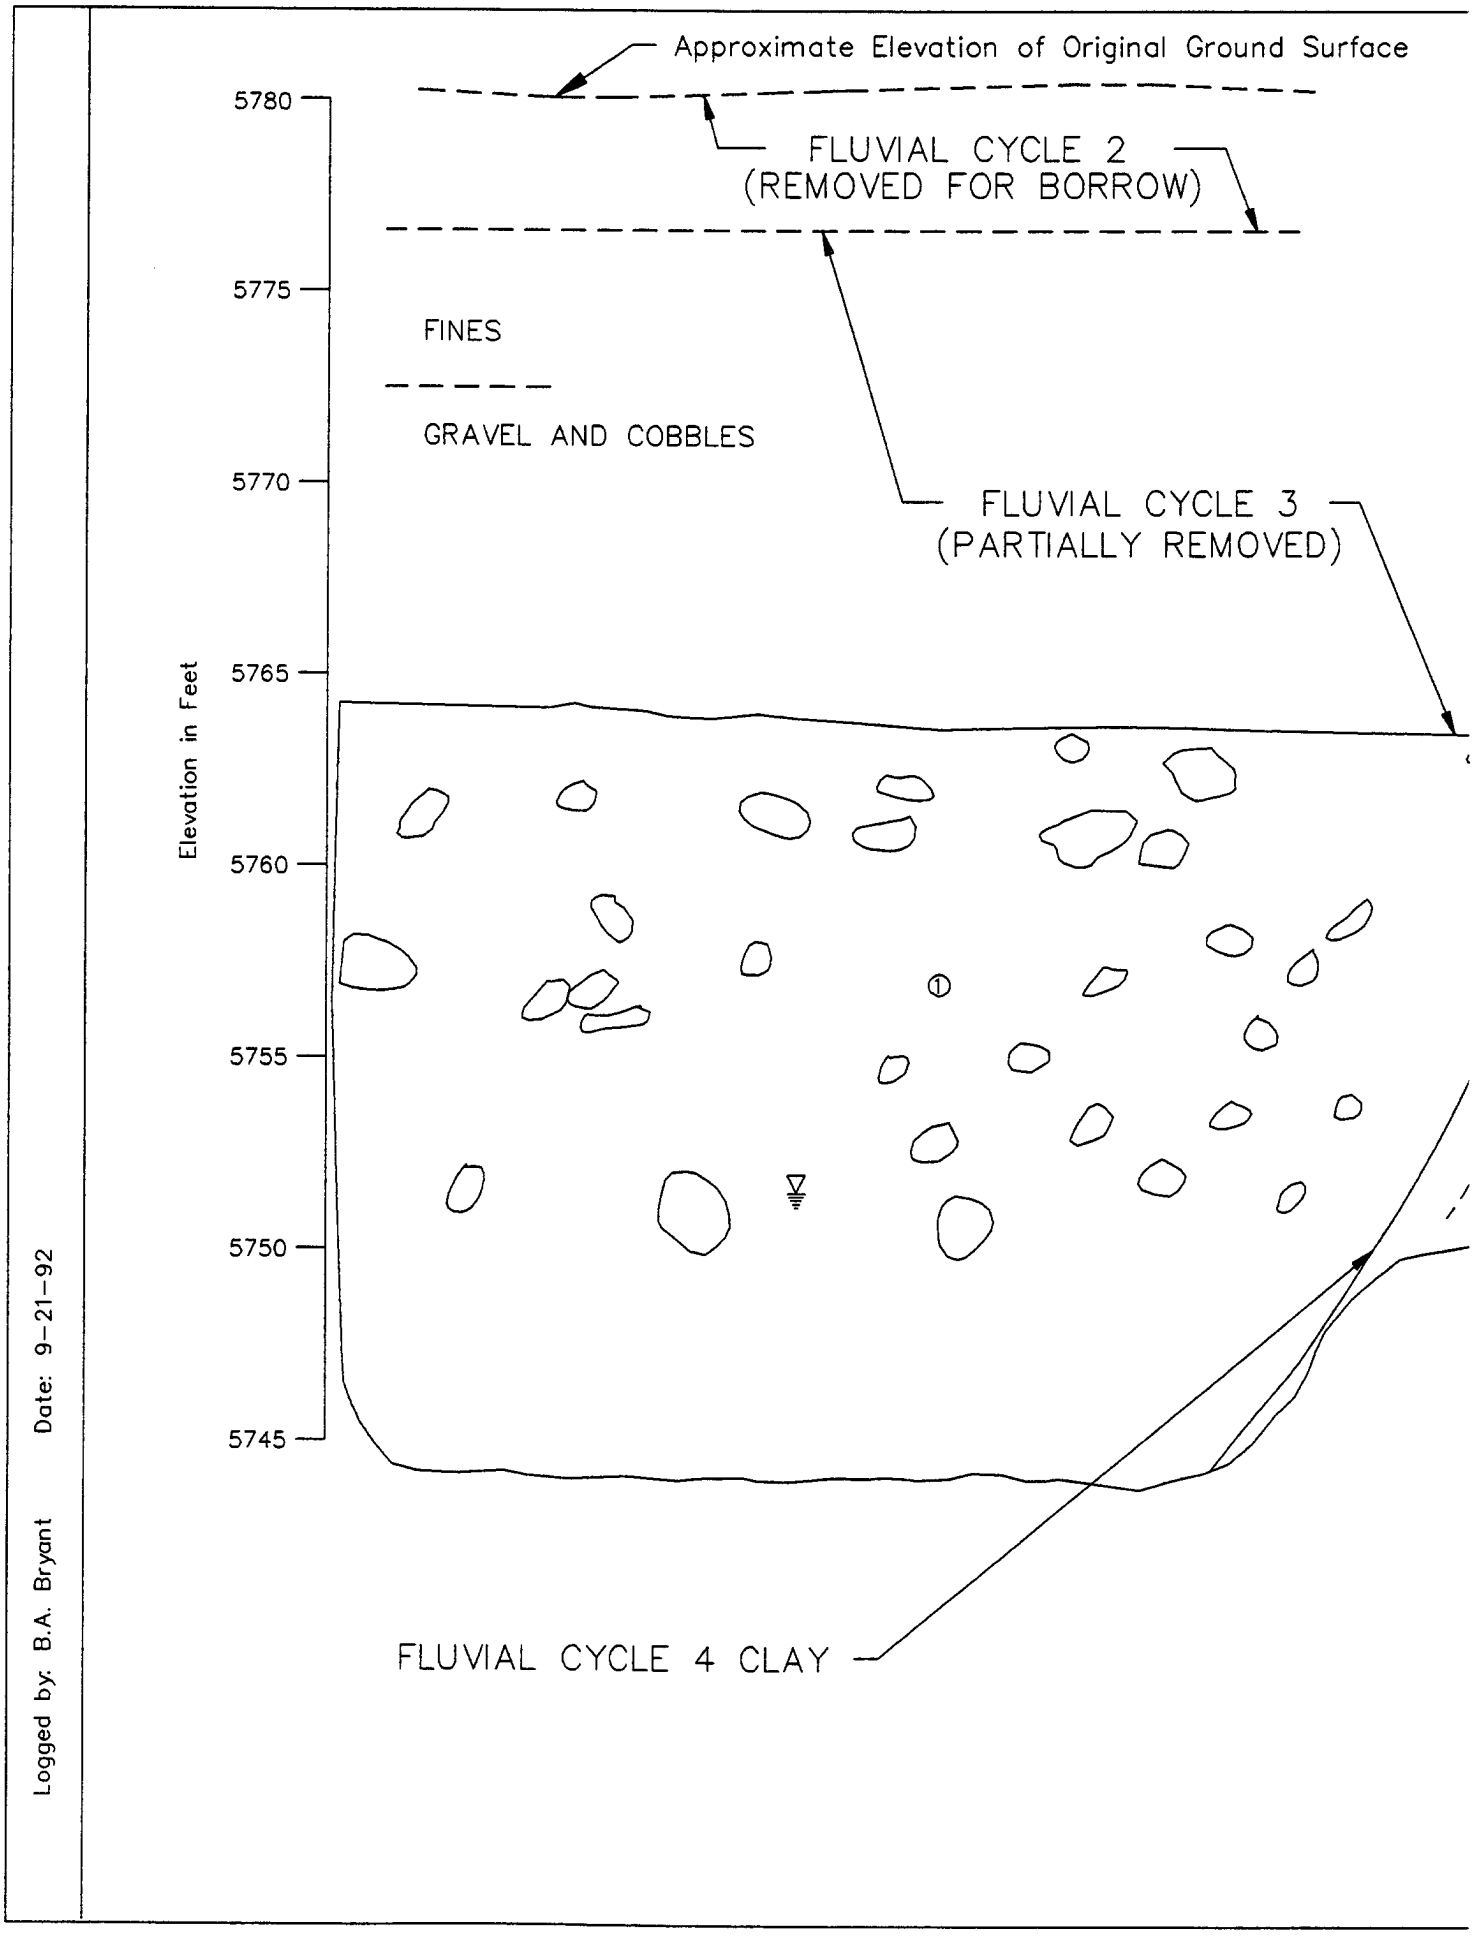
Figure 19

FT-18 (Figure 19): Fine-grained overbank deposits of Fluvial Cycle 4 are overlain by what appears to be thick channel deposits of Fluvial Cycle 3 basal gravel. No shearing was observed within the basal gravel; however, the fine-grained beds within Fluvial Cycle 3 appear to have been pushed up and deformed similar to that of the underlying Fluvial Cycle 4 clays. Total deformation appears to be approximately 20 feet (6.1 meters). Shears with polished surfaces and down-dip striae were observed in the fine-grained Fluvial Cycle 4 deposits.

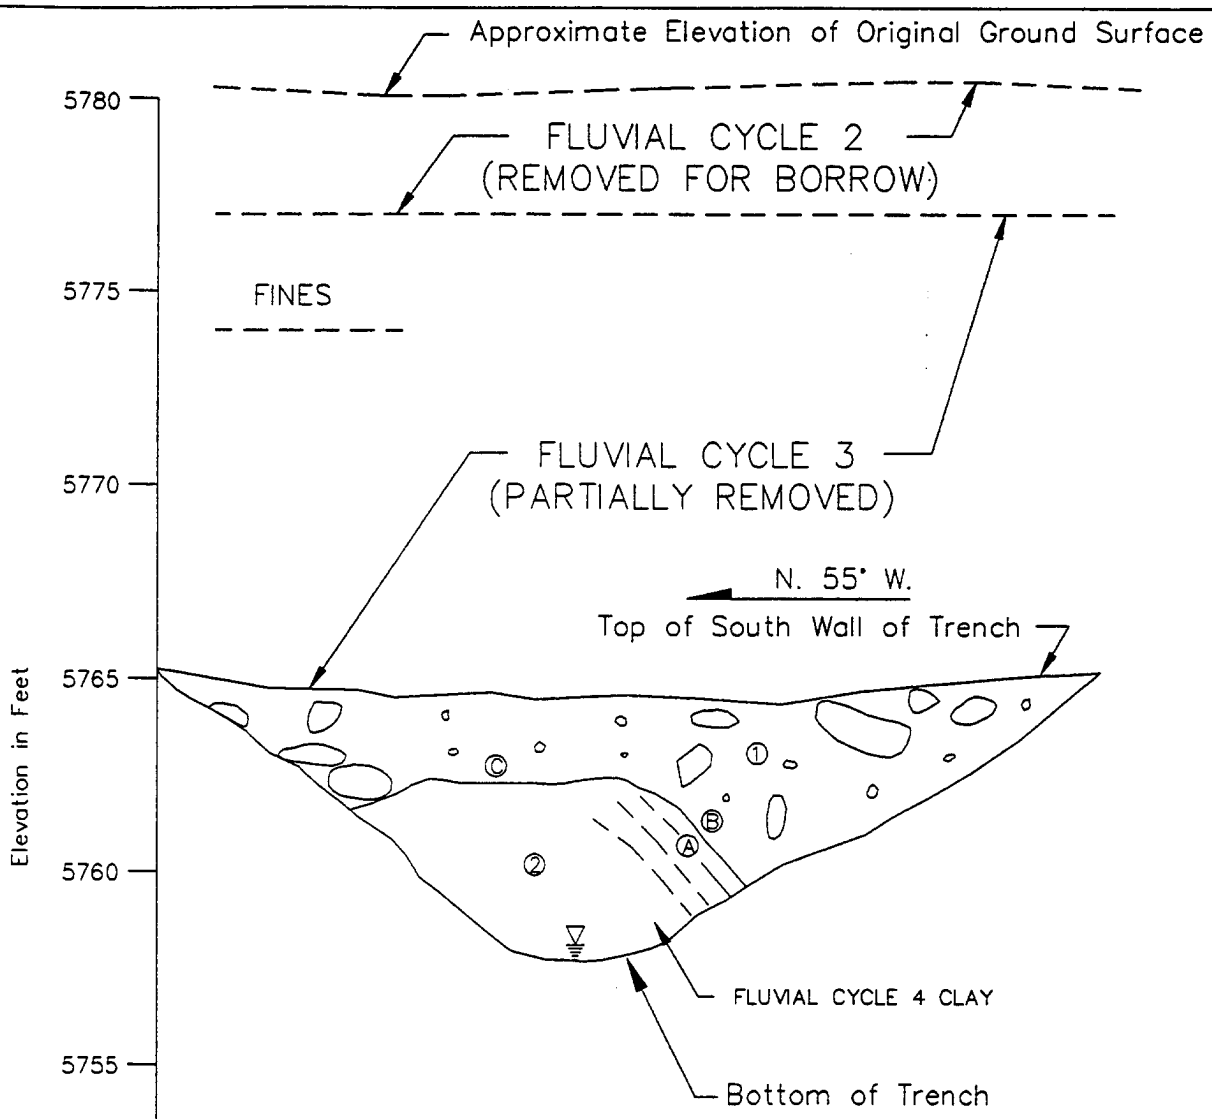
Figure 20

FT-19, 20, 21 and 22 (Figures 20, 21, 22, and 23): Generally, the same relationships as were observed in trench FT-18 were seen in FT-19, 20, 21 and 22.
