SALT LAKE CITY STREAMS, UTAH

LITTLE DELL LAKE

FOUNDATION REPORT

APRIL 1995

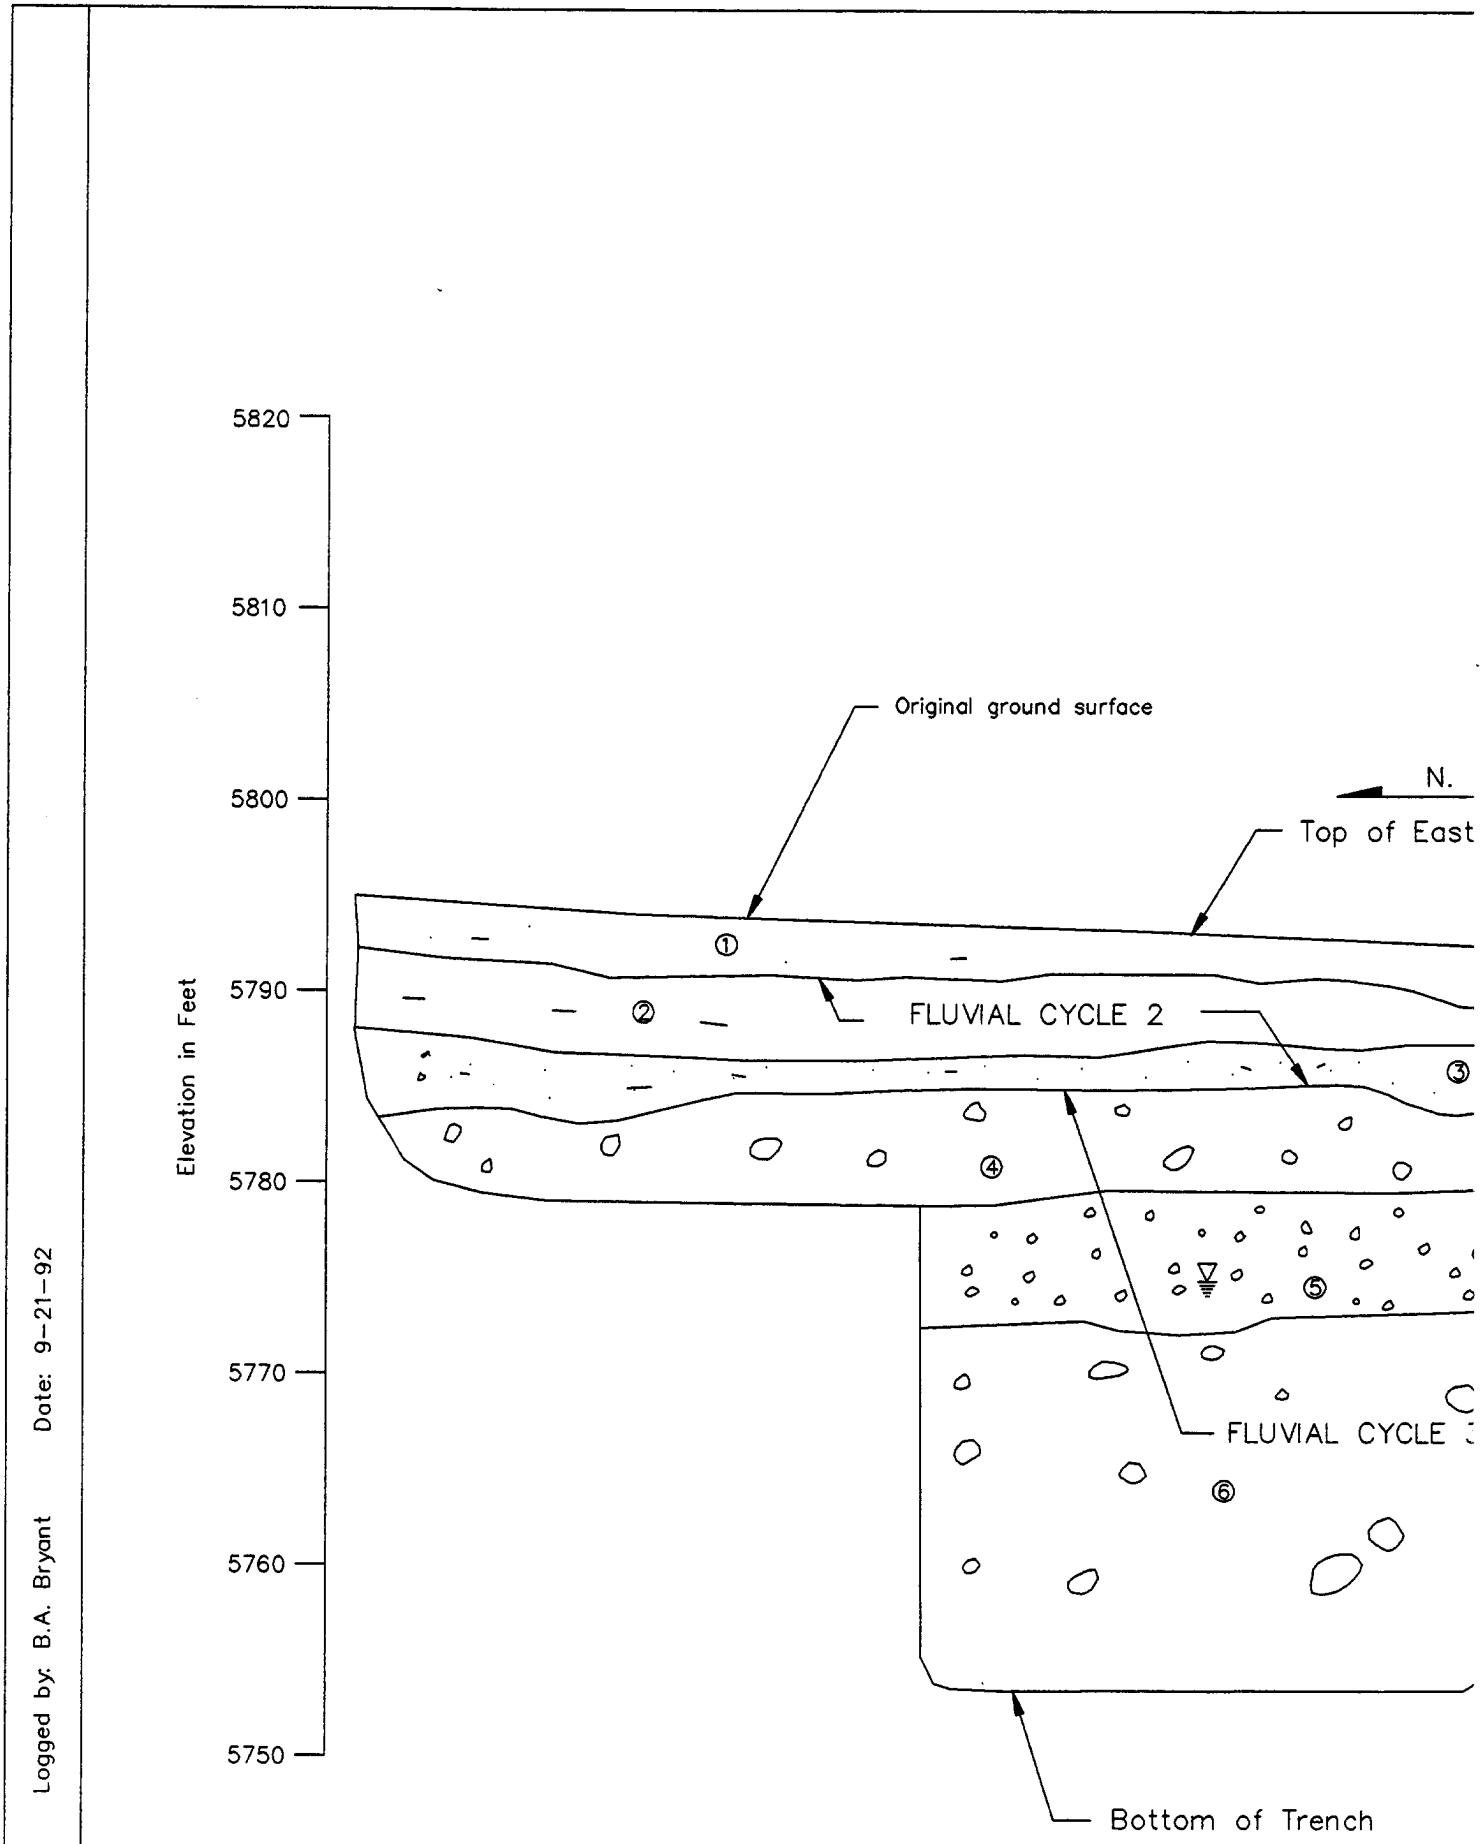
Figure 23

FT-19, 20, 21 and 22 (Figures 20, 21, 22, and 23): Generally, the same relationships as were observed in trench FT-18 were seen in FT-19, 20, 21 and 22.

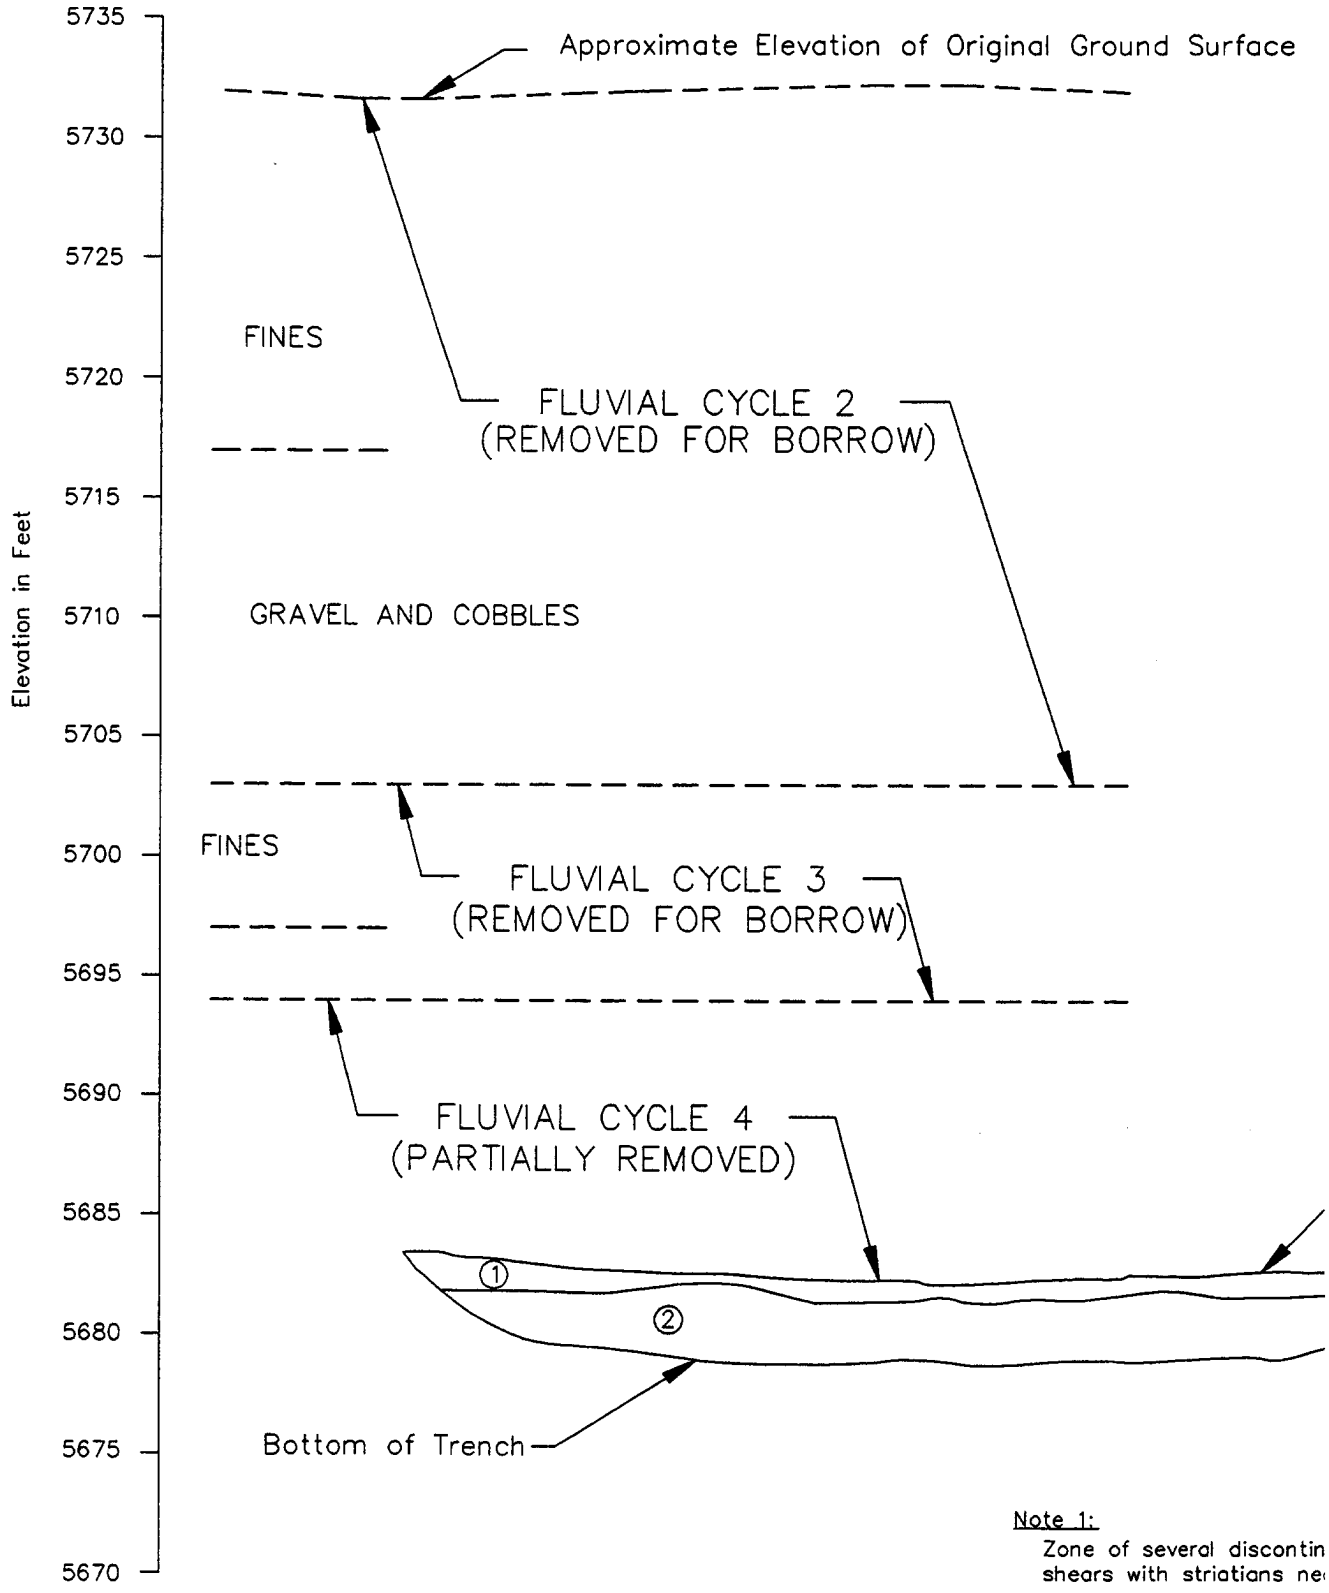
Figure 24

FT-23 (Figure 24): This trench is in alignment with folded fluvial deposits and the observed bedrock steps. Fine-grained deposits of Fluvial Cycle 4, observed in nearby trenches, are exposed on the bottom of this trench with the same sheared characteristics. This lowermost fine grained deposit is probably Fluvial Cycle 4 overbank deposits in contact with the overlying basal gravel of Fluvial Cycle 3. Several gravel beds and an overlying fine-grained deposit of limited areal extent comprise Fluvial Cycle 3 and are in contact with an upper gravel judged to be of Fluvial Cycle 2. Deposits of Fluvial Cycle 3 and Fluvial Cycle 2, including its near-surface soil horizon, show no offset or shearing.

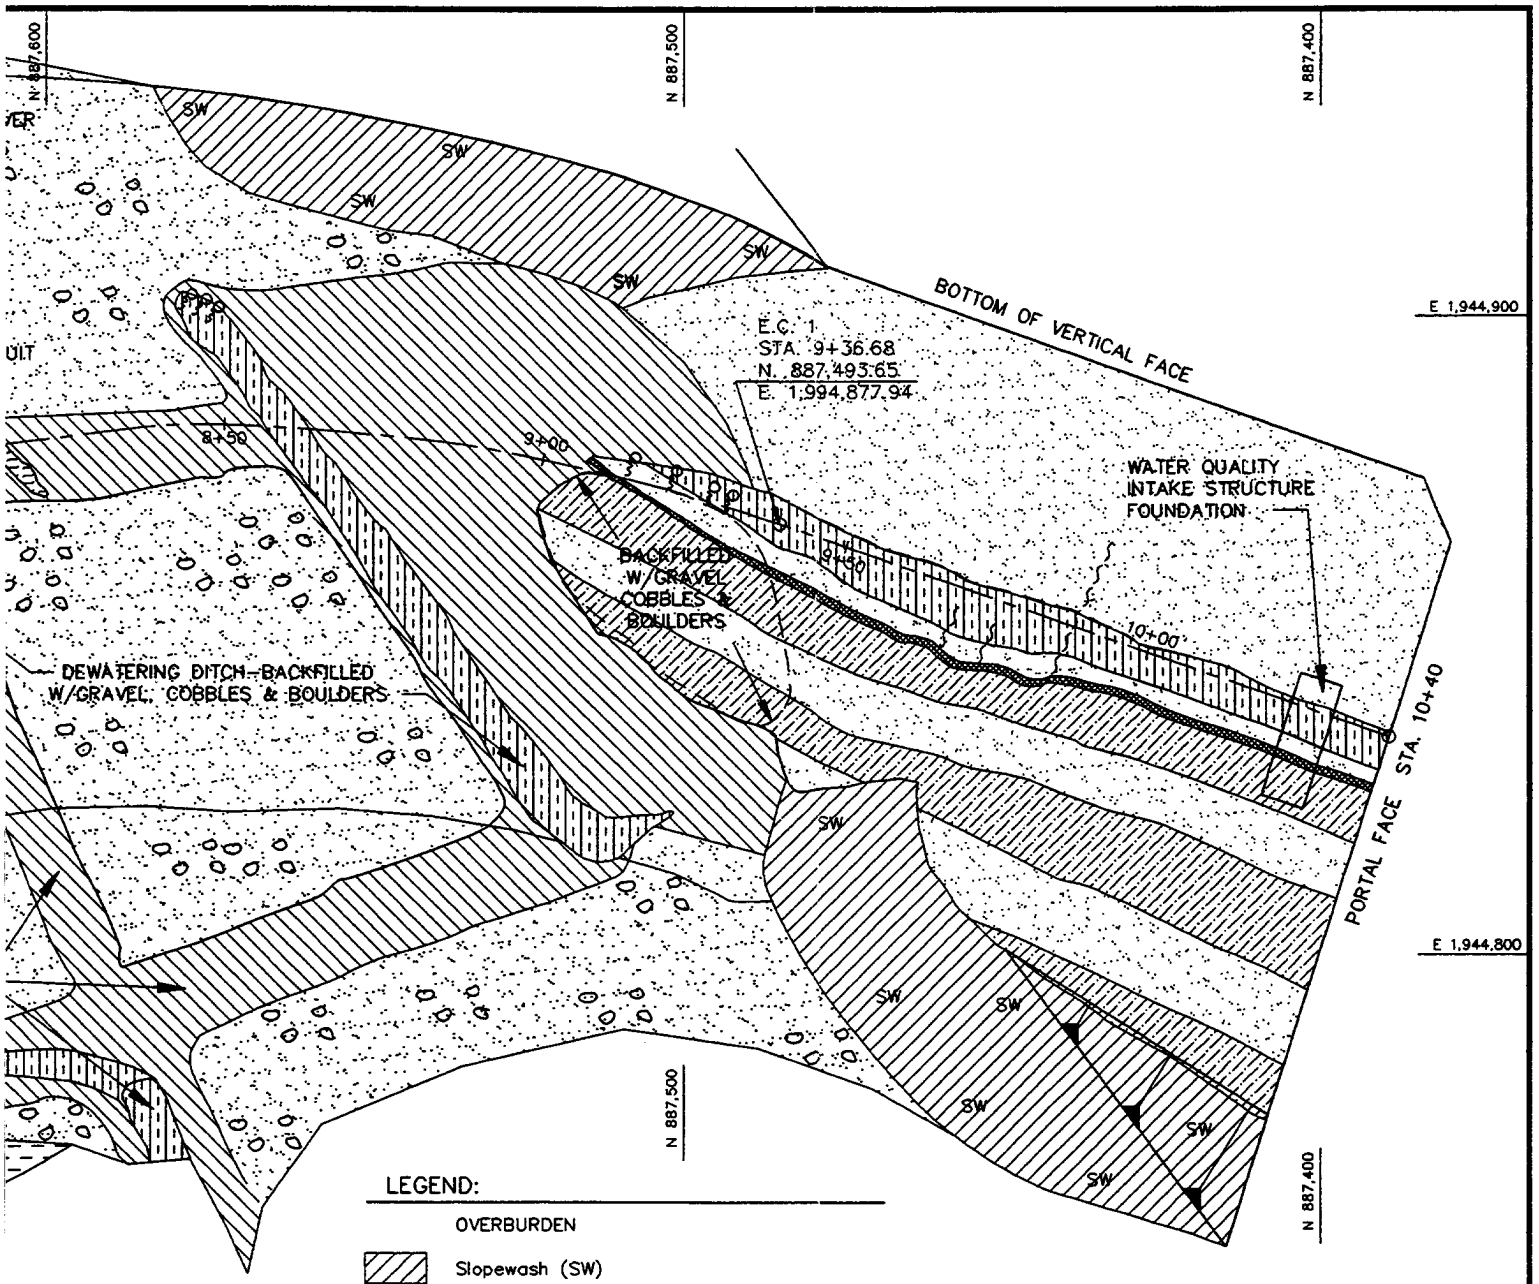
SUBMITTED:	APPROVED:		
Robert L. Israel for CARL E. COLE, RESIDENT GEOLOGIST	PAUL M. PARSONEAULT, RESIDENT ENGINEER		
DR. BY: ERE	CH. BY:	CHKD. BY: CEC	FILE NO: PLATE 28

3.6.2 Outlet Works. Plates 28 through 45 present the geology of the outlet works. Alluvium covered bedrock at the Outlet Works Intake Structure and along most of the Cut-and-Cover Conduit. Before excavation at the Outlet Works Intake Structure, several feet of wet organic overbank deposits covered most of the surface except along several smaller active channels. Bedrock was exposed at the downstream portion of the Cut-and-Cover Conduit where alluvium, slopewash and residual soil were removed. Portal excavations encountered slopewash and residual soil at the higher elevations. Bedrock was exposed in the middle elevations of the portal and bedrock with lenses of Older Alluvium and Younger Alluvium existed at the lower elevations. The tunnel and Emergency Control Chamber (ECC) were excavated through the Kelvin and Frontier Formations. The Downstream Operational Control Structure (DOCS) was founded entirely on the Kelvin Formation, and the plunge pool wing walls were founded on Younger Alluvium and the Kelvin Formation, as discussed in the foundation conditions section of this report. The plunge pool was excavated through Younger Alluvium and into the Kelvin Formation.

5.3.2.1 Upstream Portal. Plate 28, Geologic Map of Intake Structure and Cut-and-Cover Conduit foundations shows the geologic materials encountered in the excavation for these structures. Plate 29 shows the rock anchor and shotcrete system employed for the portal excavation. The portal excavation was begun in slopewash at the upper elevations and encountered residual soil and weathered rock in the middle part of the excavation. At the lower elevations of the cut-slope and at the vertical portion of the excavation, bedrock of the Frontier Formation was encountered. The upstream and downstream parts of the vertical cut were in slopewash and the middle part was in bedrock of the Frontier Formation. Thin lenses of Older Alluvium were encountered at the upstream and downstream ends of the vertical cut, occurring between the bedrock and slopewash.

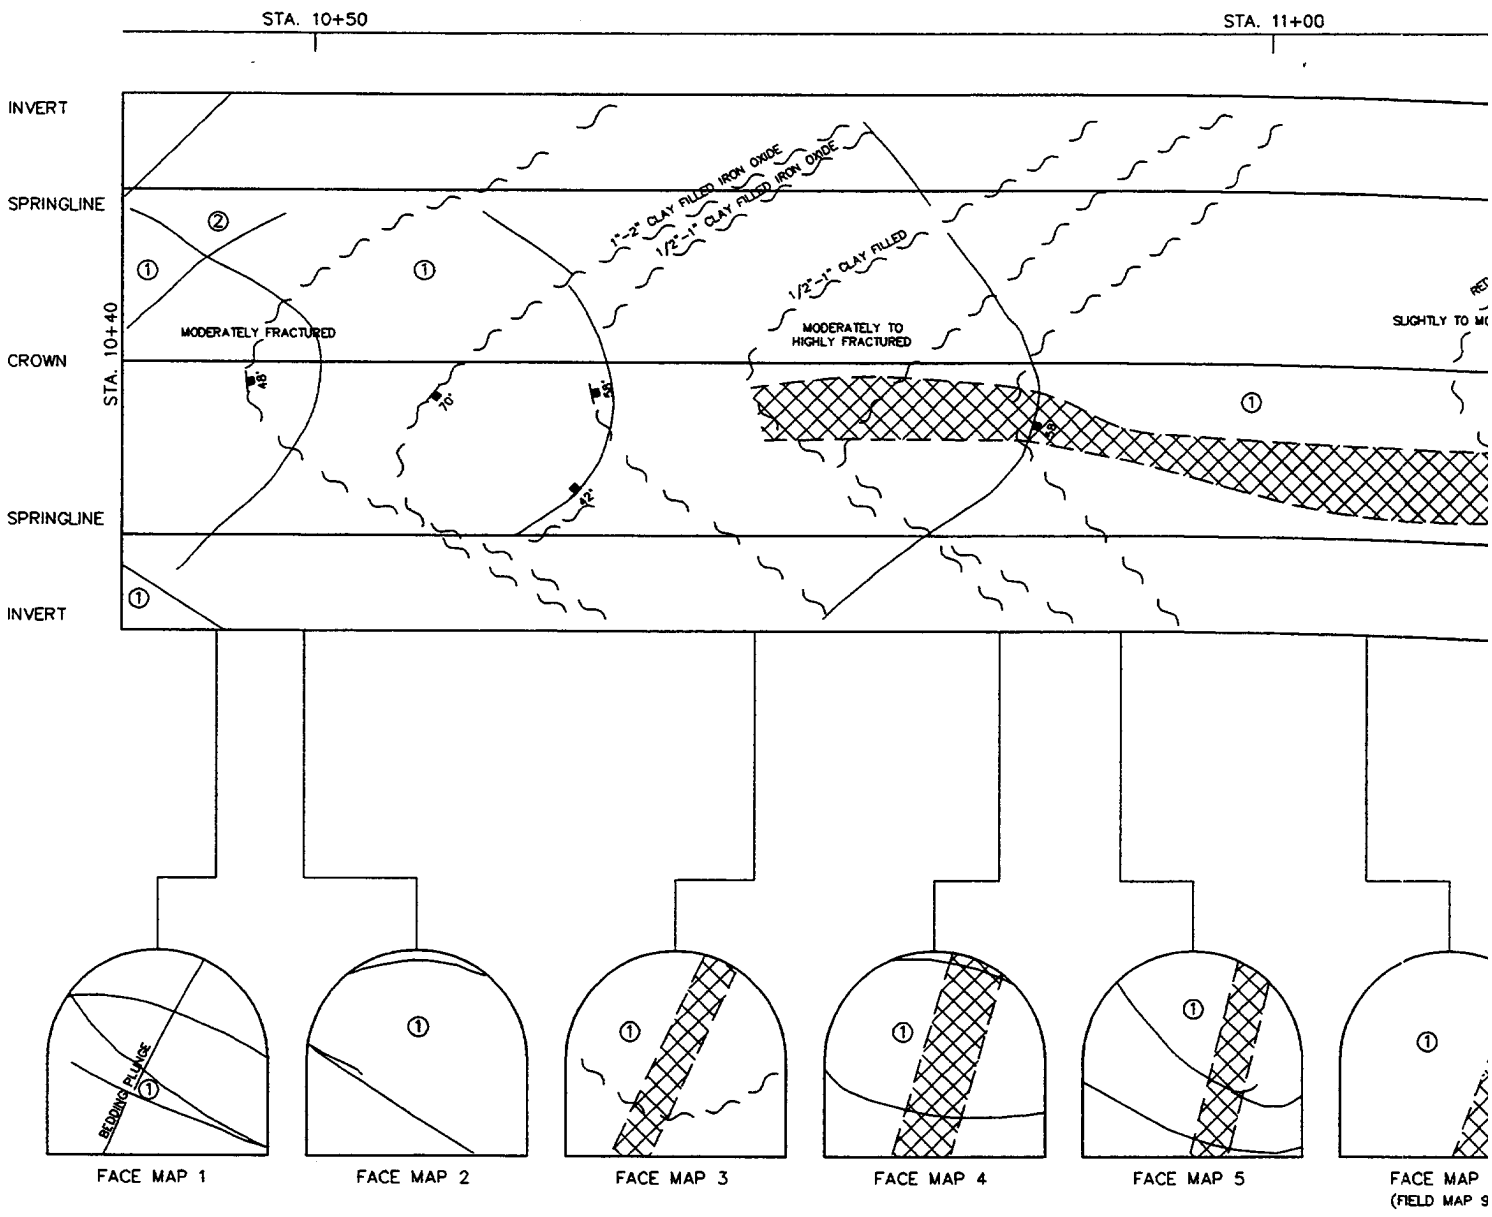
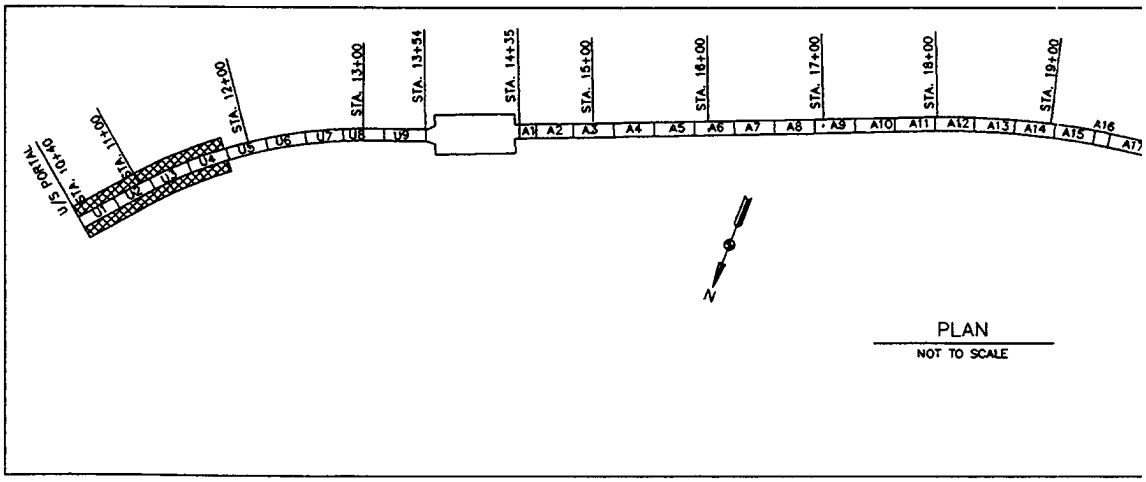
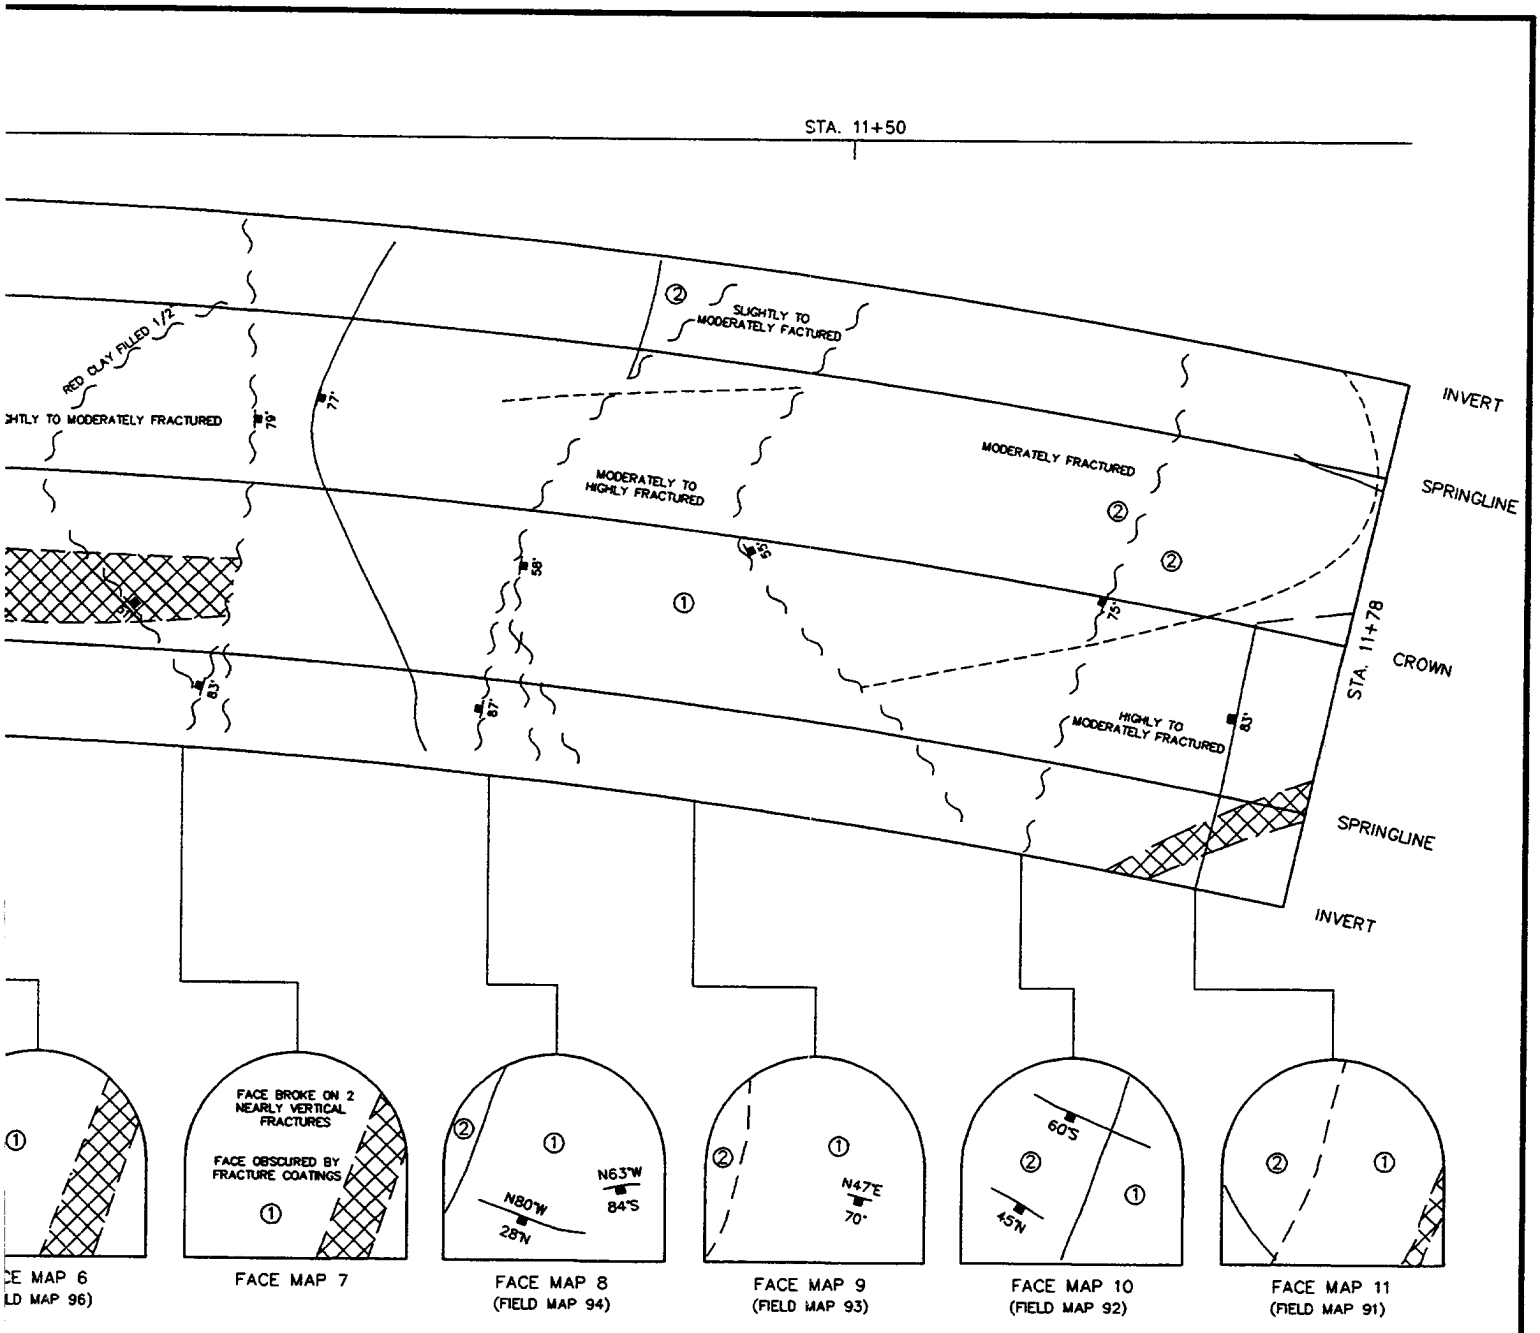
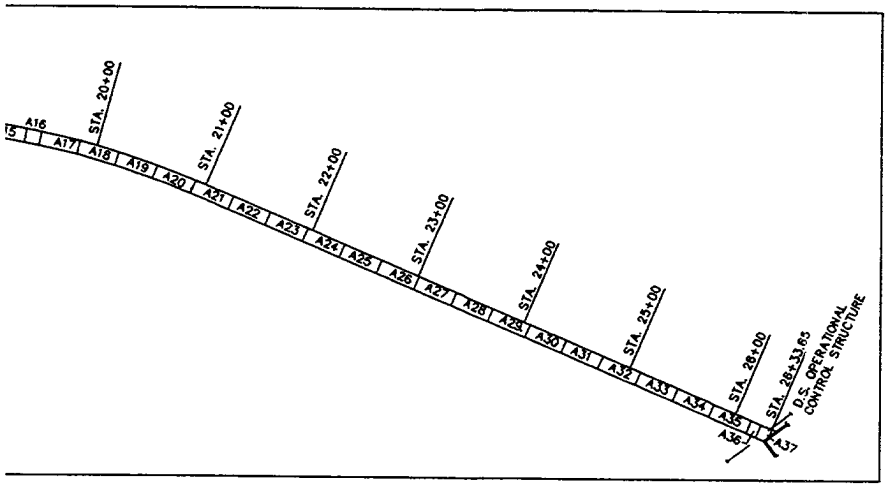
DR. BY:	TR. BY:	CHK. BY:	FILE NO:
ERE		CEC	PLATE 30

3) A tunnel and Emergency Control Chamber (ECC) excavated through the left abutment. Plates 5 and 6 provide details on the upstream and downstream portals and Plate 30 (location detail) shows the details on the tunnel configuration. The upstream 330 feet of the tunnel was excavated as a horseshoe-shaped opening approximately 11 feet wide by 11 feet high. A circular 6-foot-ID reinforced concrete lining was placed in the excavation. The ECC was excavated to approximately 36 feet wide by 28 feet high. The reinforced concrete lining was placed as a 28-foot-wide by 17.5-foot-high horseshoe. The downstream adit tunnel was excavated as a 13-foot-wide by 12-foot-high horseshoe and was lined with a 9.5-foot-wide by 7.3-foot-high horseshoe-shaped reinforced concrete lining.

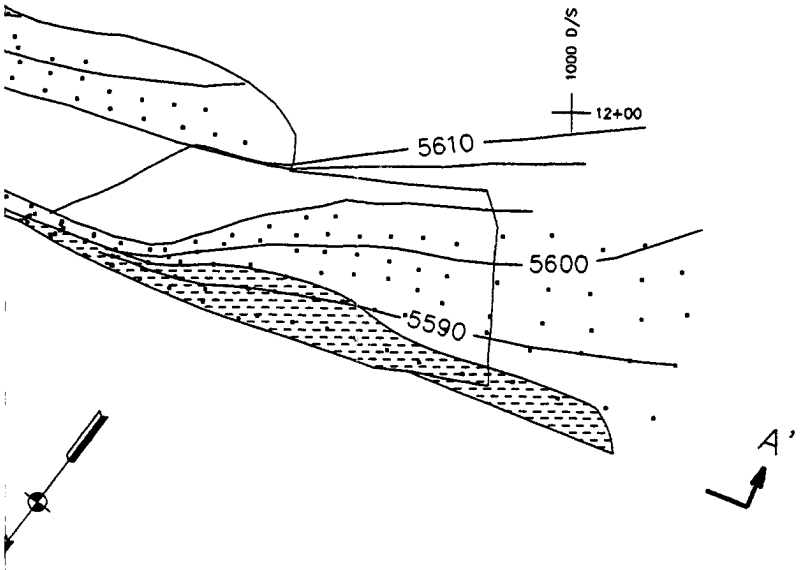
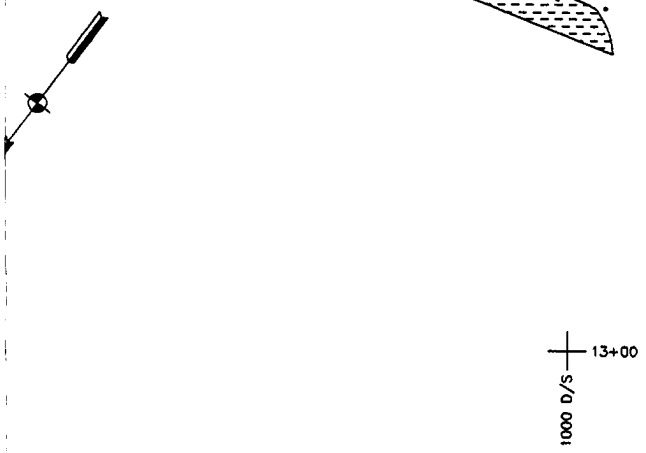
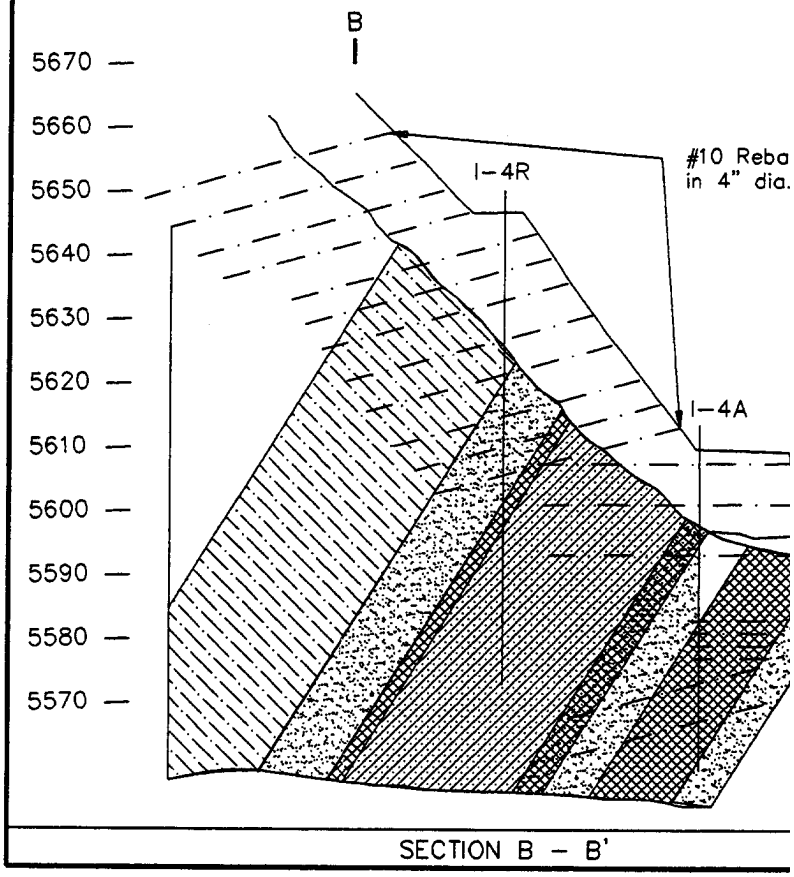
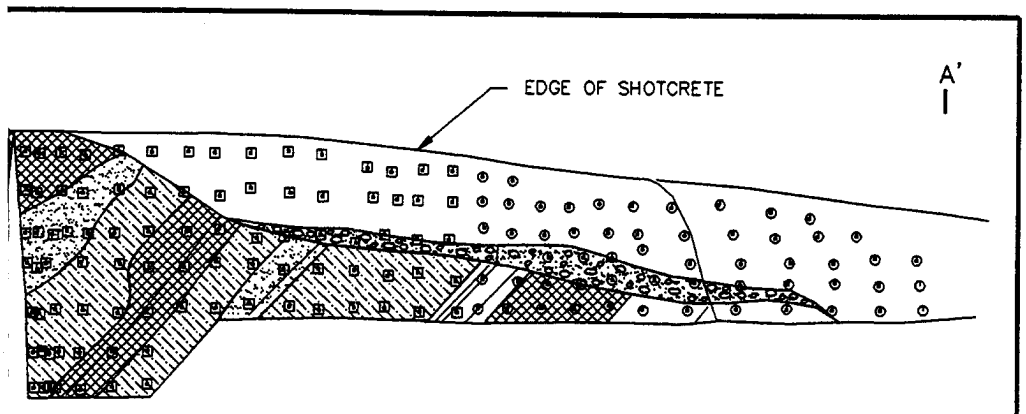
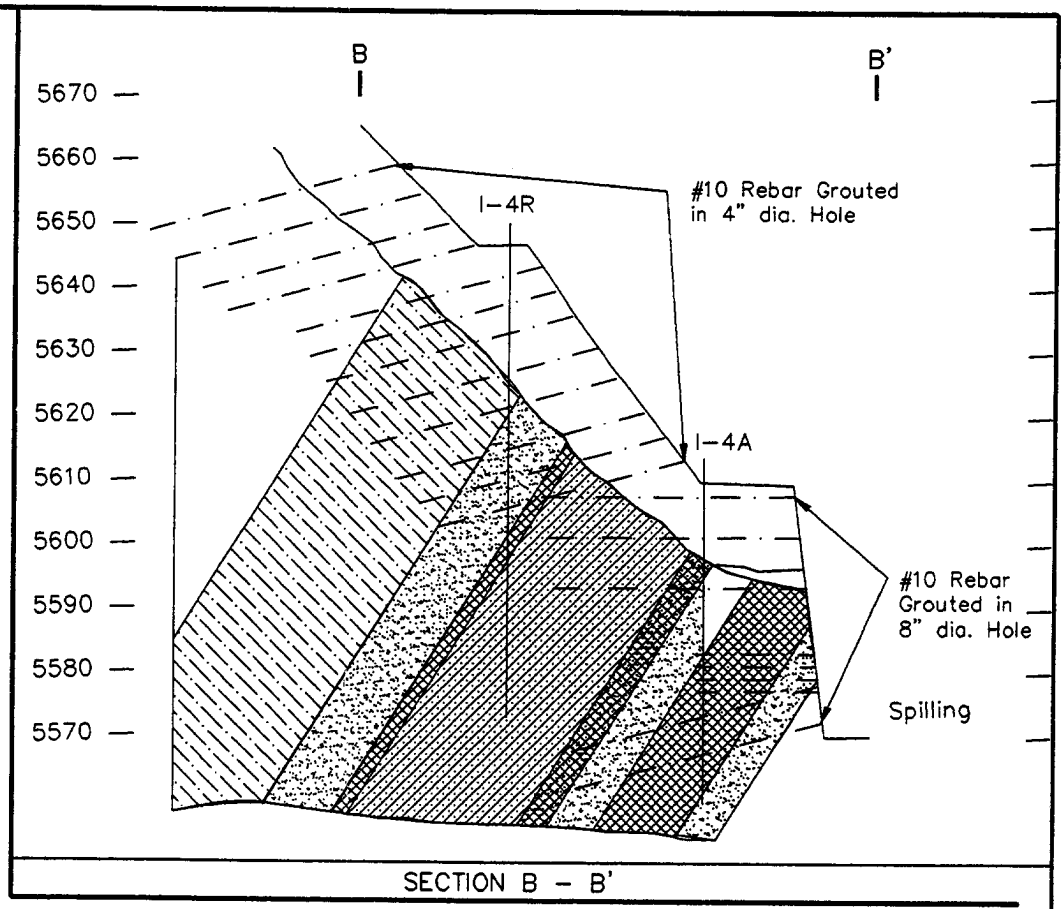
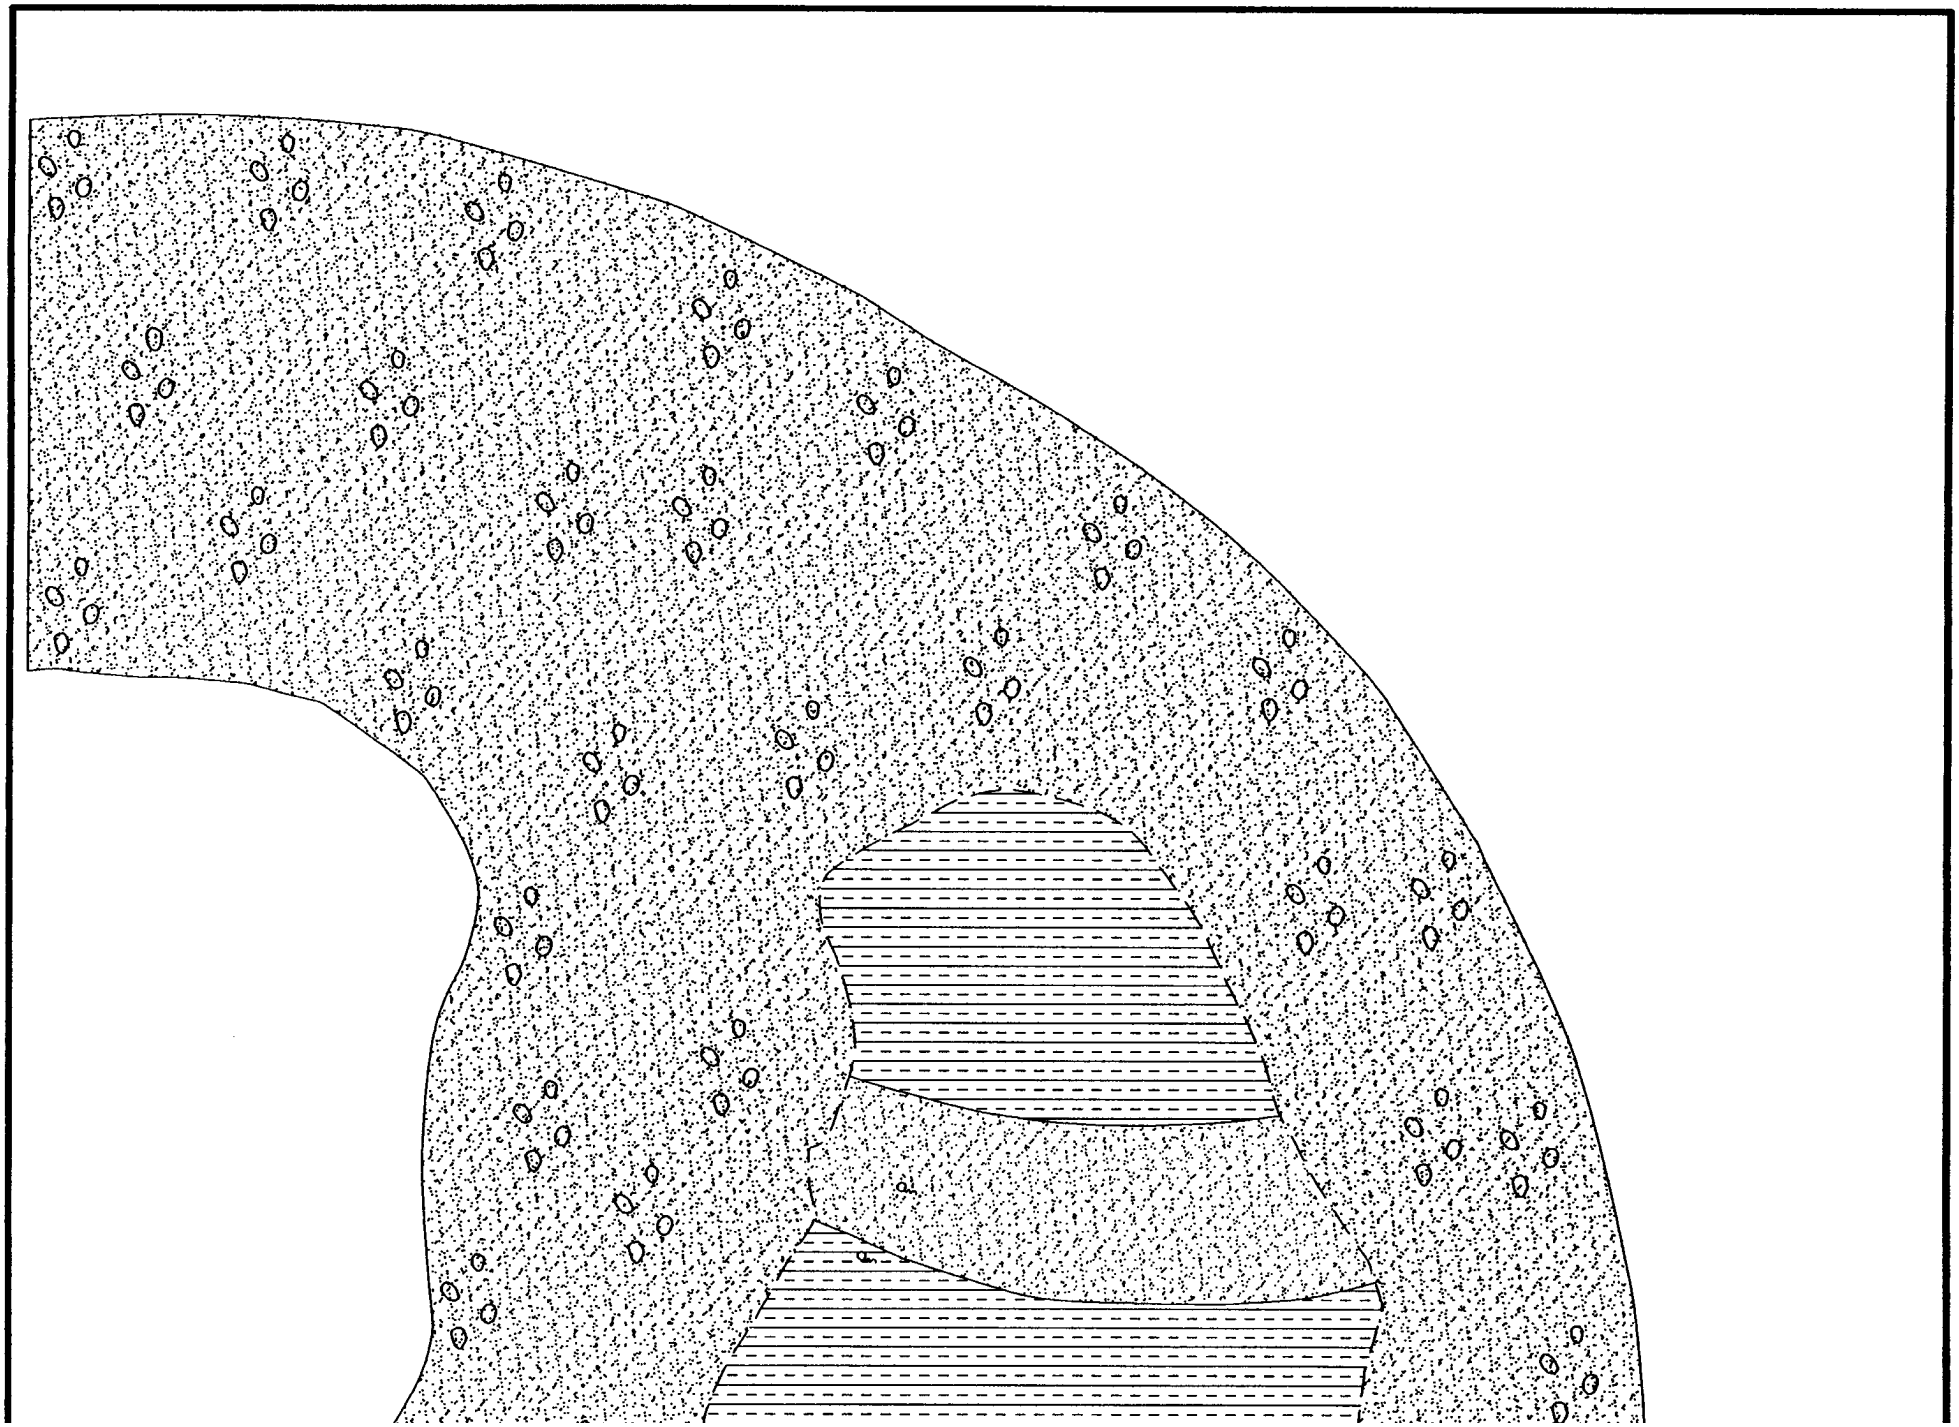
DR. BY:	CHECKED BY:	CHECKED BY:	FILE No.:
JWR	JWR	MDR	PLATE 44

Plate 44 shows the Downstream Portal Geologic Map. The upper part of the portal excavation was in slopewash and residual soil (Photo P6). Bedrock of the Kelvin Formation was encountered several feet above the bench at Elevation 5610 feet. The middle portions of the excavation were in rock below that elevation. The upstream and downstream portions encountered slopewash, residual soil and a cobbley lens of the Older Alluvium.

7.2 Portal Instrumentation. Inclinometers were installed at both portals as excavation progressed. Inclinometers I-4 and I-5 were installed soon after the initial excavation at the downstream portal (Plate 44). I-4 was accidentally destroyed during construction. I-4A was installed to monitor the excavation of the vertical cut and I-4 was later replaced by I-4R. I-1 and I-2 were installed shortly after the initial excavation at the upstream slope (Plate 29). Two short inclinometers, I-3A and I-3B, were substituted for a longer inclinometer which was originally planned for the vertical cut at the upstream portal.
