SALT LAKE CITY STREAMS, UTAH

LITTLE DELL LAKE

FOUNDATION REPORT

APRIL 1995

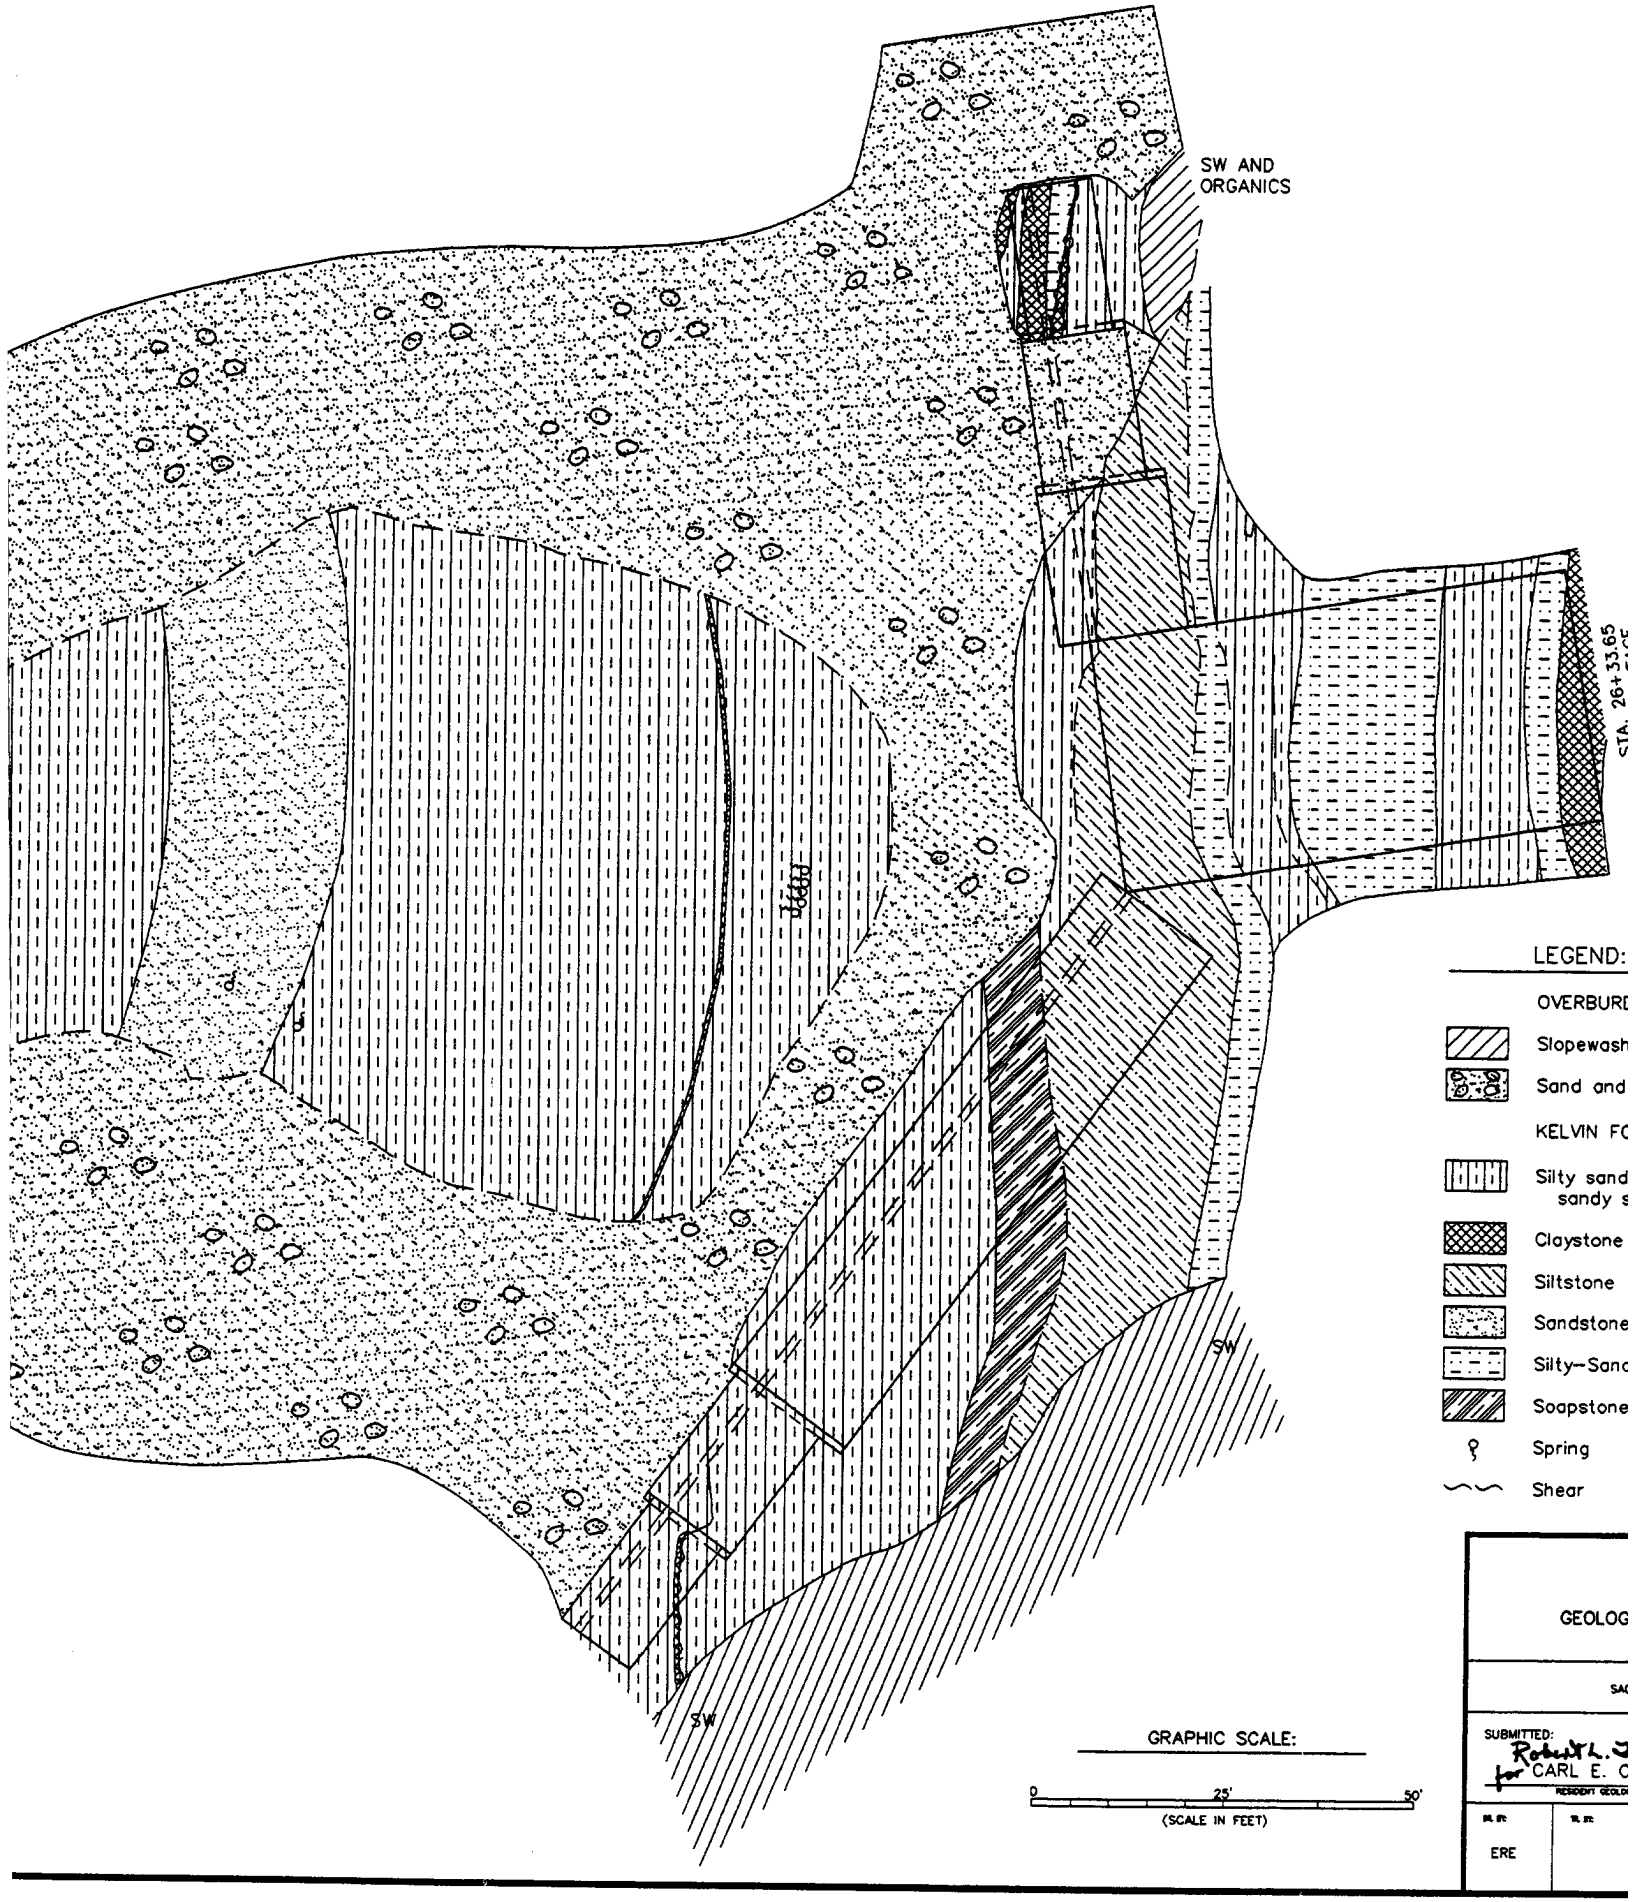
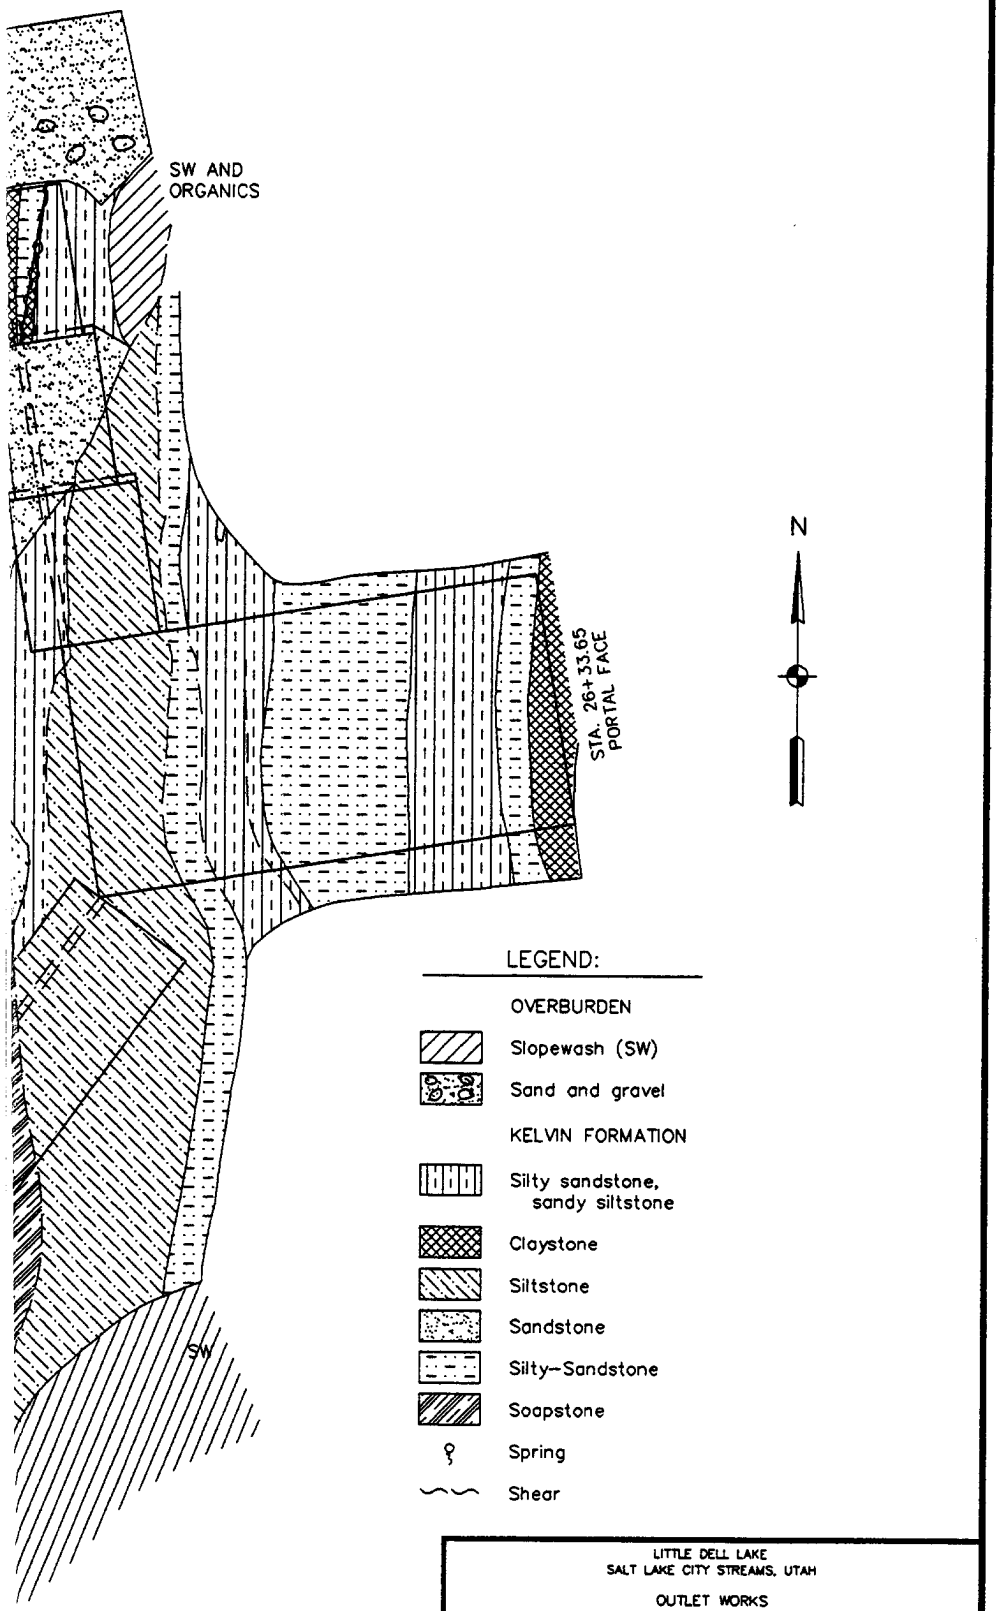
DR. BY:	TR. BY:	GEOL. BY:	FILE No.:
ERE		CEC	PLATE 45

5.3.4.2 Downstream Operational Control Structure (DOCS). Foundation materials encountered at the downstream outlet works structures are shown on Plate 45. The DOCS was founded on firm siltstone, sandstone and claystone of the Kelvin Formation and should experience no problems. At the upstream half of the building, the foundation was thoroughly cleaned of all loose or unsuitable material and a concrete "mud" slab was placed to prevent deterioration of the soft rock. No further foundation treatment was required. At the downstream part of the foundation, bedrock was several feet below the floor elevation but the footing walls were founded on bedrock. Soil backfill was originally planned between the foundation and the floor of the DOCS at this location. The Contractor requested a variance to use concrete because of the difficulties of placing and adequately compacting soil in the confined space. The variance was granted and the concrete was placed on firm Kelvin Formation material.

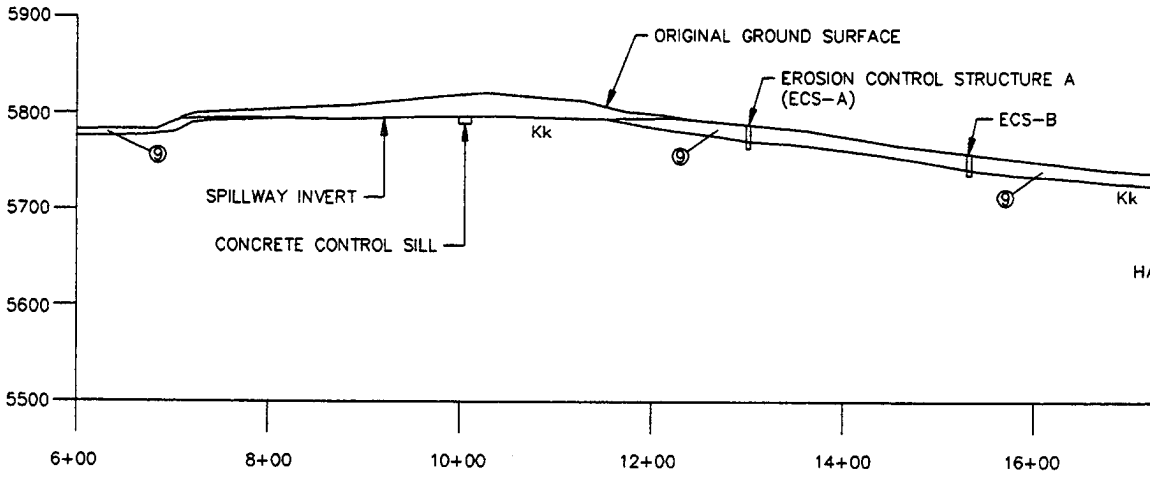
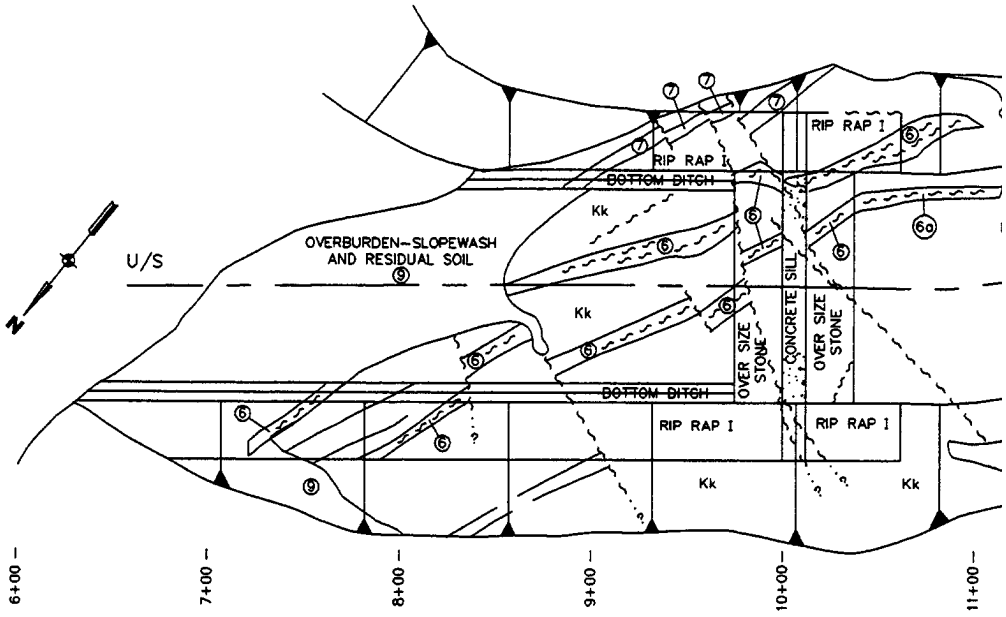
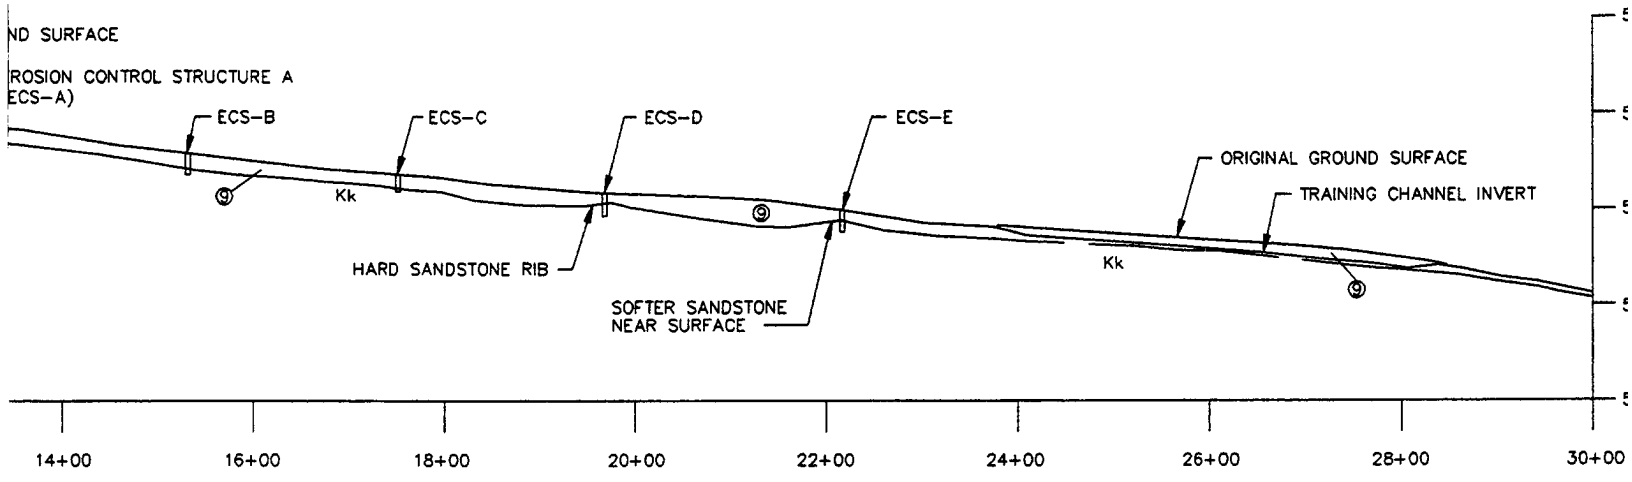
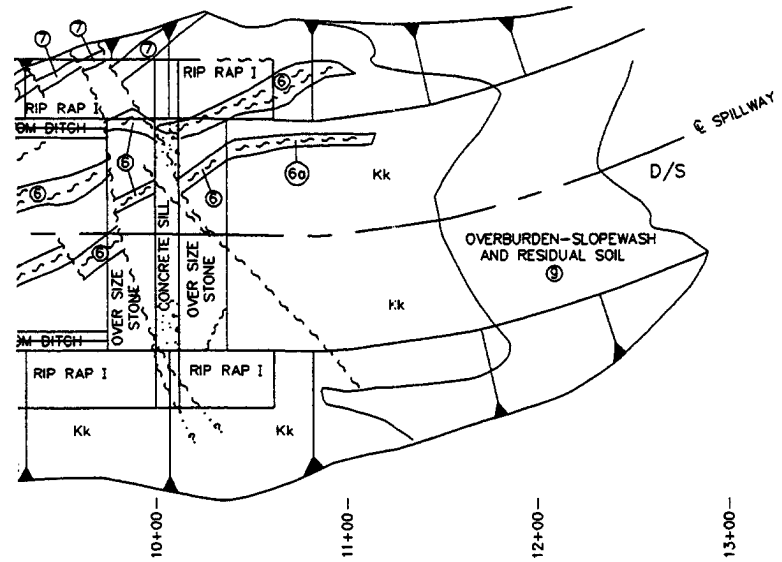
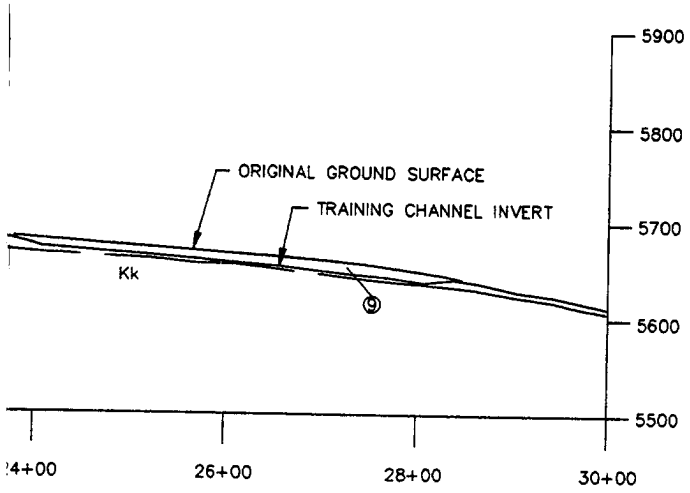
ERE		BAB	PLATE 46

5.4 Spillway. The spillway cut follows a small saddle about 300 feet northwest of the right end of the dam. As seen on the Spillway Geologic Map, Plate 46, the middle part of the cut exposed bedrock of the Kelvin Formation at invert level. Thin overburden covers bedrock at the upstream and downstream ends of the cut. The concrete sill was founded on firm bedrock. Numerous shears were mapped in the spillway cut. Bedding plane shearing was extensive along two weak, altered claystone beds trending subparallel to the spillway centerline and several small displacement shears were also seen to cross bedding. There was no evidence of recent activity along any of the shears and they pose no threat to the structure. Minor problems resulted from groundwater seeping out of the foundation along shears at the lower right cut-slope. The water contributed to rapid deterioration of the bedrock foundation. The Contractor requested that he be allowed to place a concrete "mud" mat over most of the right side of the sill foundation to protect the foundation while the sill was formed. This was allowed and the technique resulted in good foundation conditions for the sill.

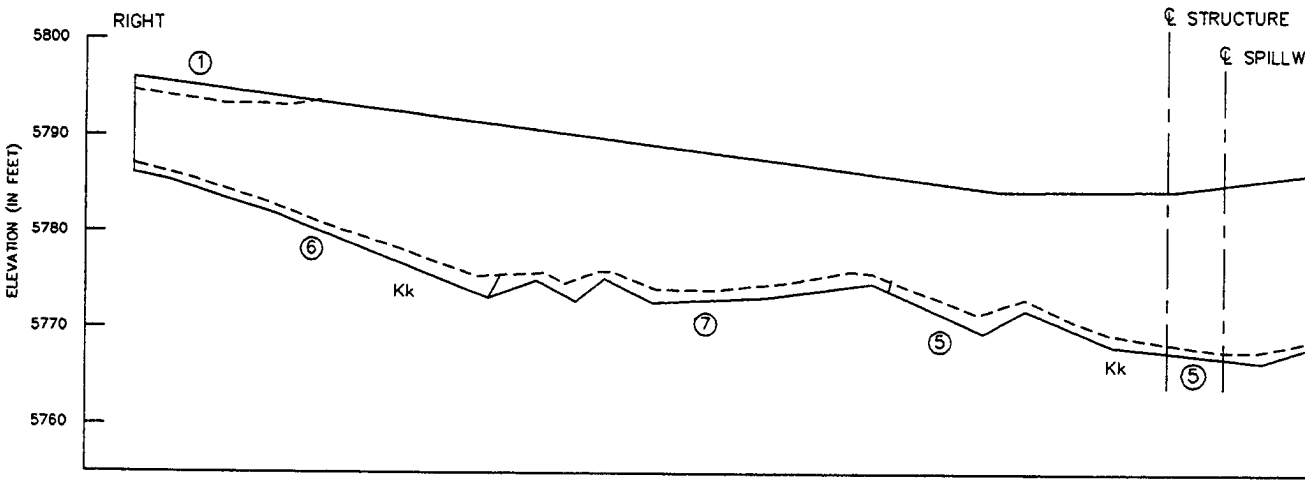
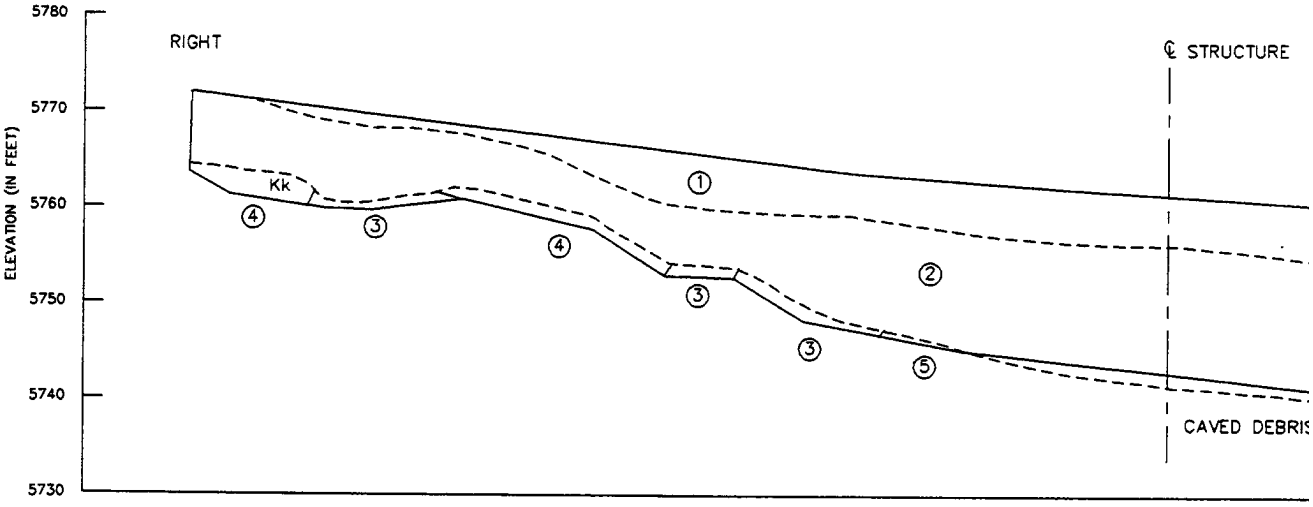
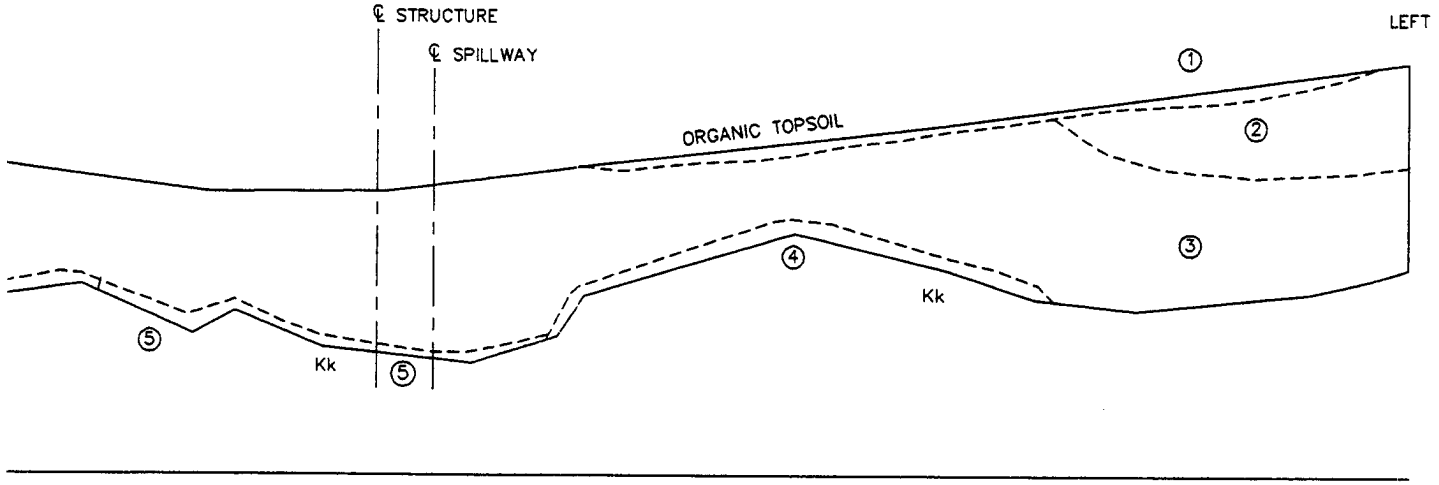
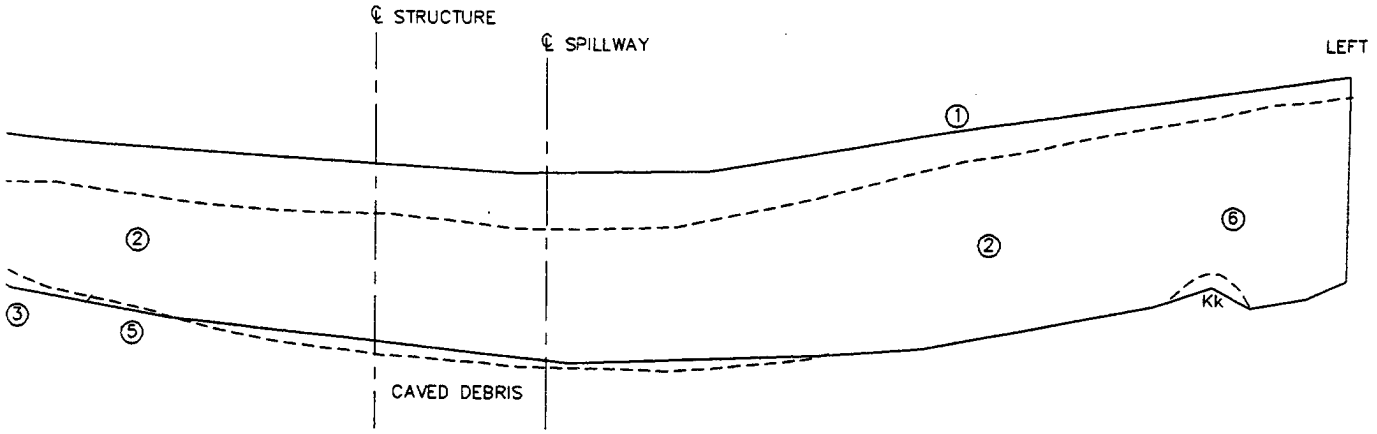
DR. BY:	TR. BY:	CHK. BY:	FILE No.:
GEB		BAB	PLATE 48

All of the erosion control structures (ECS) were founded on bedrock after excavating through slopewash, residual soil and Older Alluvium. For the most part, the excavation for these concrete-filled trenches extended to about 20 feet deep. However, as seen on the trench logs, Plates 48 and 49, bedrock was encountered higher in some locations and the bottoms of those structures were shallower than designed. A problem occurred at ECS-E when groundwater was encountered in the excavation. The middle portions of the trench caved in before concrete could be placed. This resulted in the placement being made in two phases and caused the middle section of the structure to be thicker than designed. This should not cause any reduction in the performance of the structure.

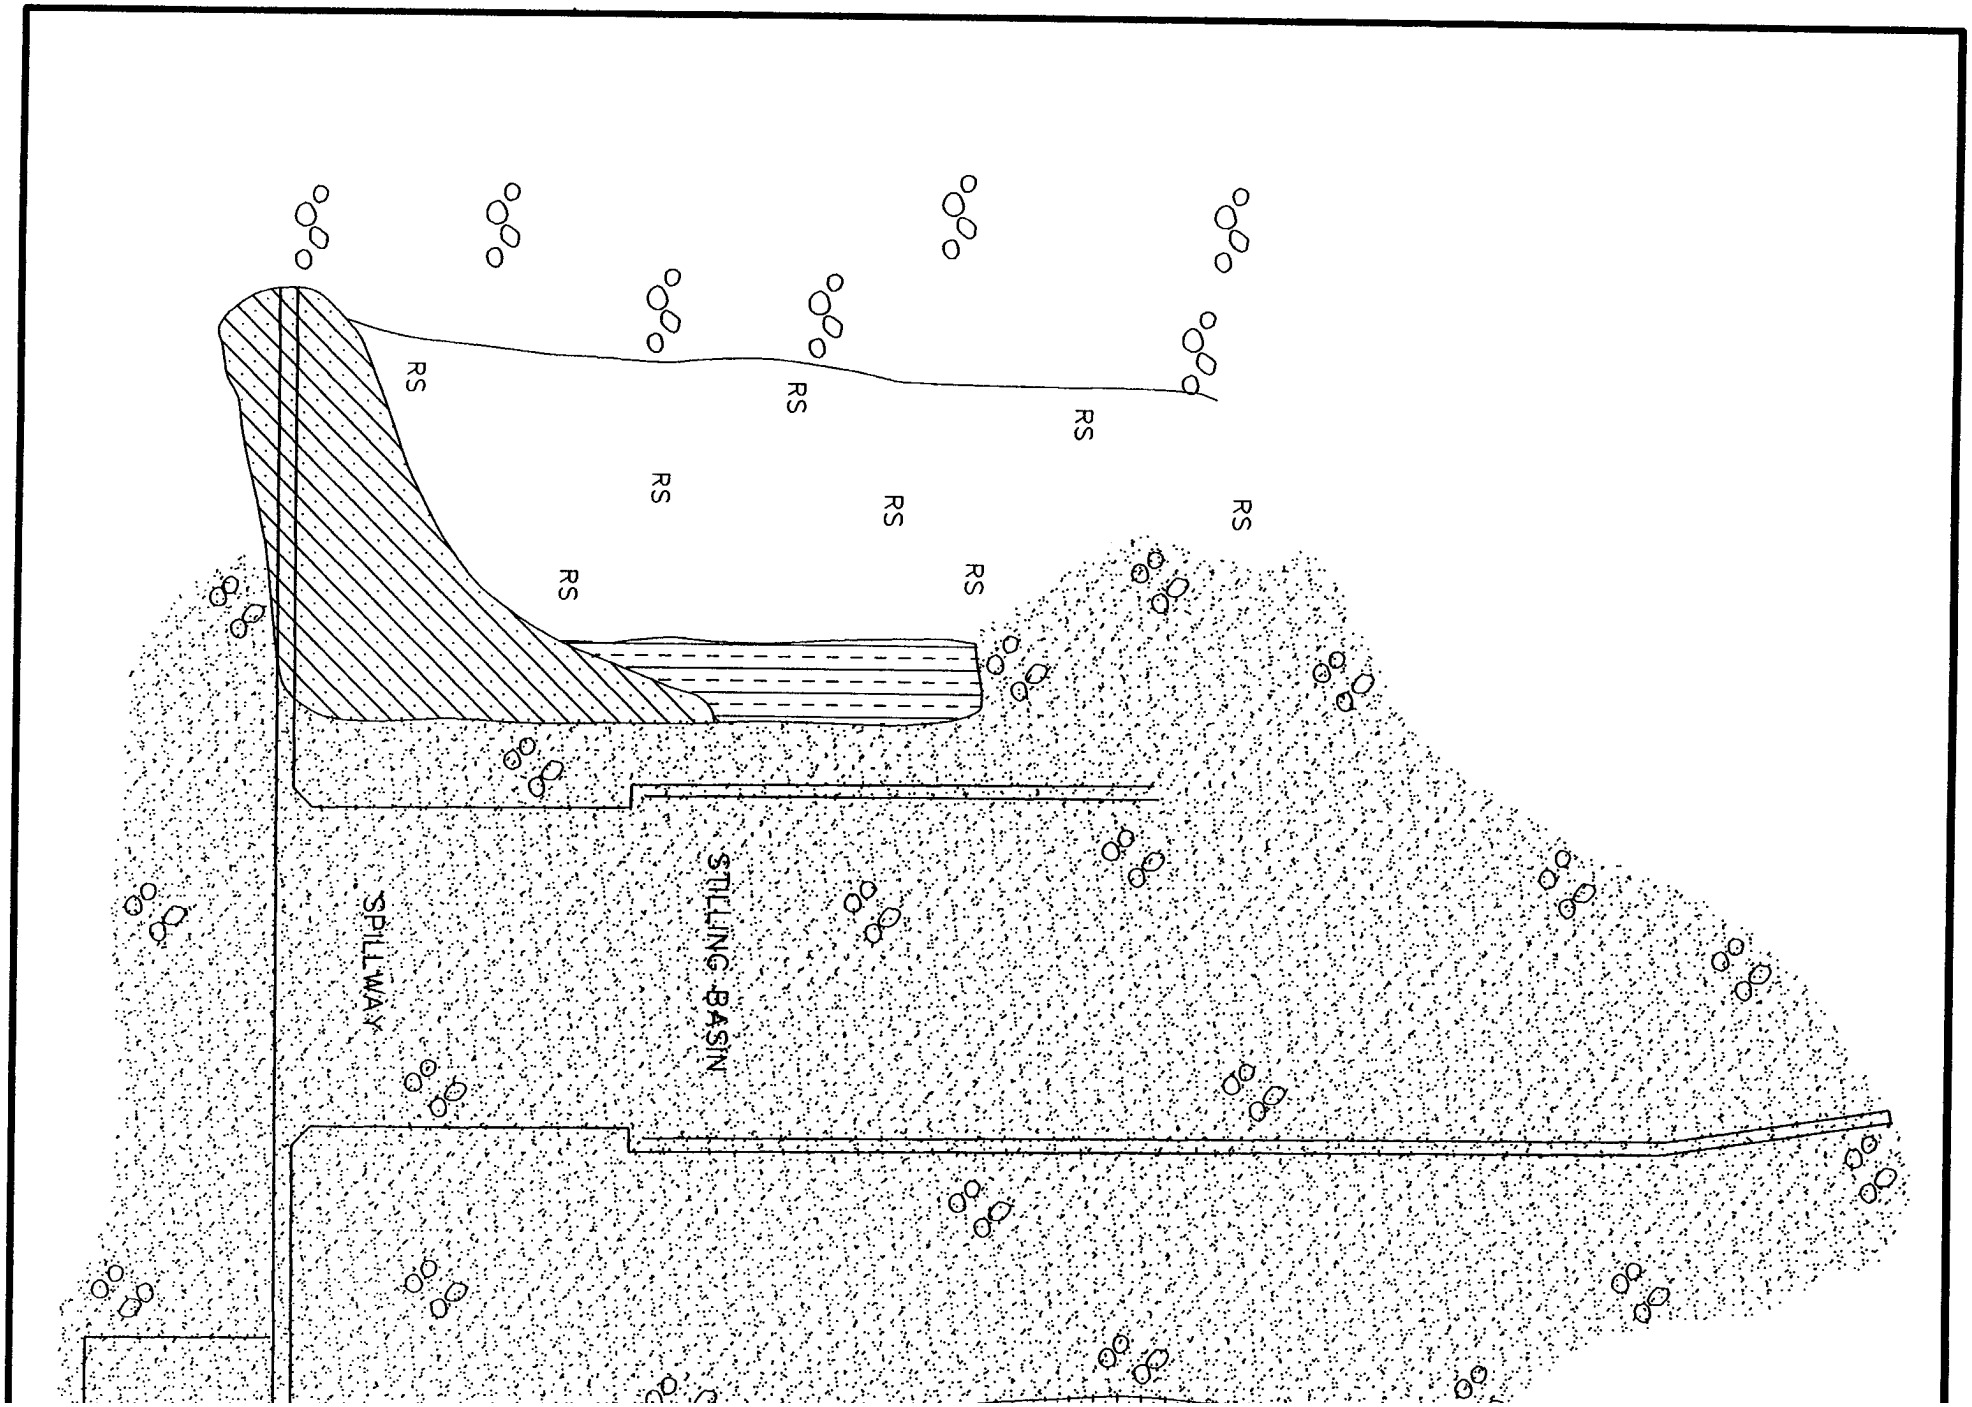
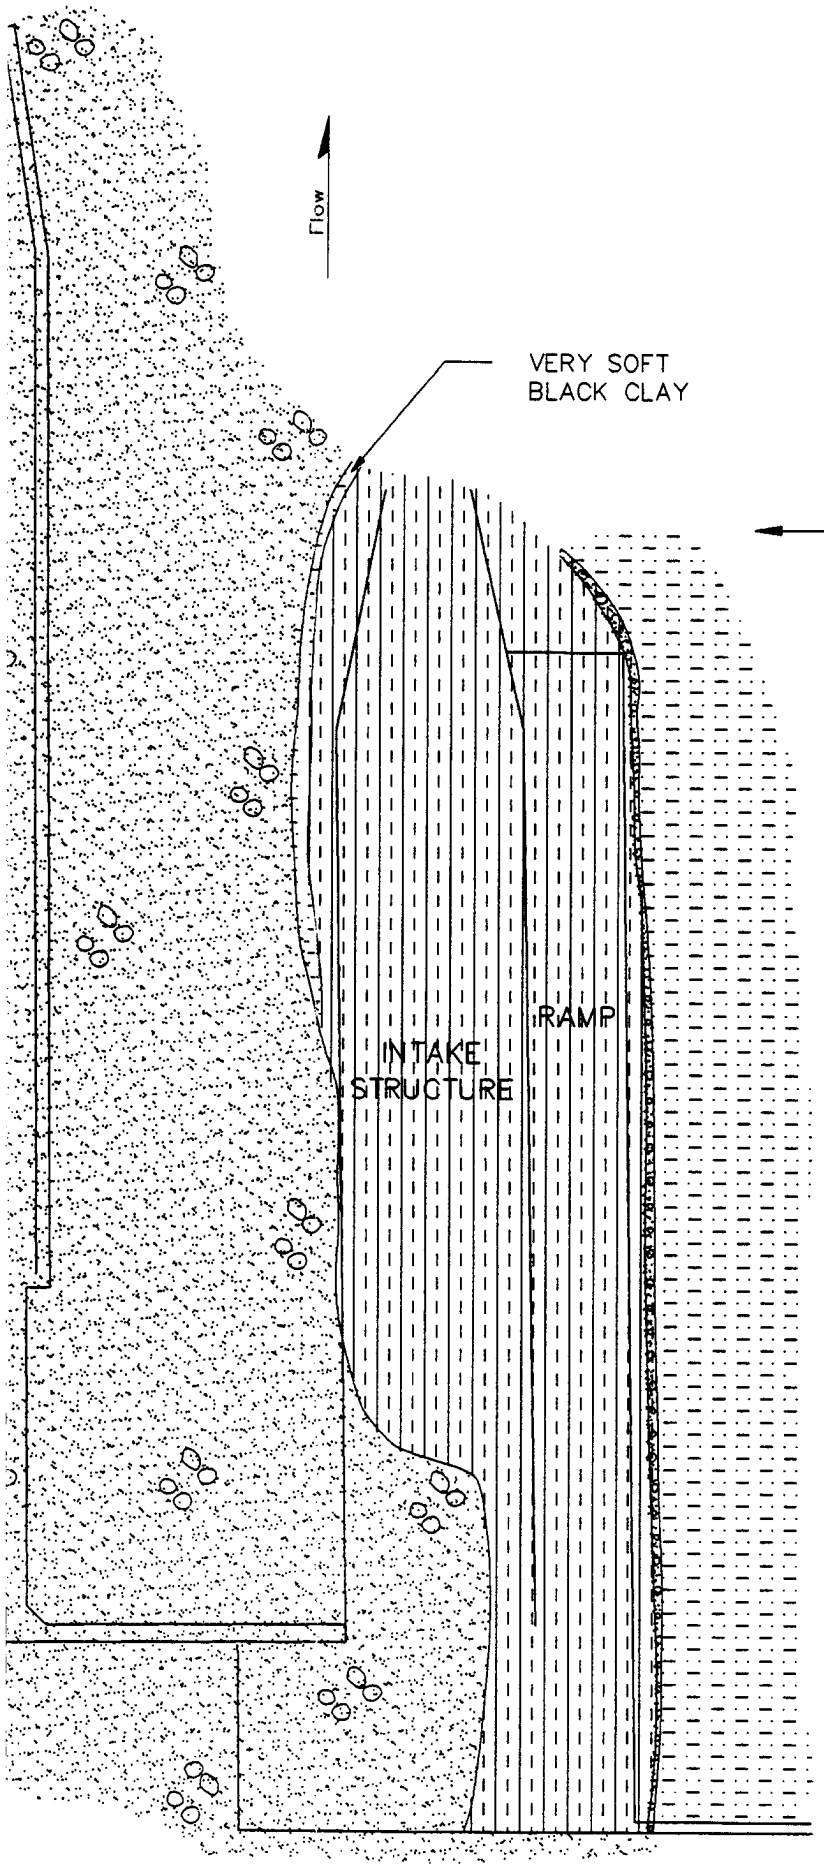
DR. BY:	TR. BY:	CORR. BY:	FILE No:
ERE		CEC	PLATE 50

5.5 Parley's Creek Diversion Structure. Plate 50, Geologic Map of Parley's Creek Diversion Structure, shows the foundation geology at the Parley's Creek Diversion Structure and Spillway. Originally, excavation was planned to remove weak clayey materials and expose dense, cobbley alluvium. Engineered backfill was planned to bring the foundation back to grade for the concrete structures. At the left side of the excavation, where the Spillway was to be placed, this was substantially the case, although some soft spots were revealed by proof-rolling and were removed. The upstream right side of the excavation encountered dense alluvium as expected, and some bedrock. Groundwater caused serious problems at the downstream right part of the foundation (Photo PC2). This area was the foundation for the downstream part of the diversion

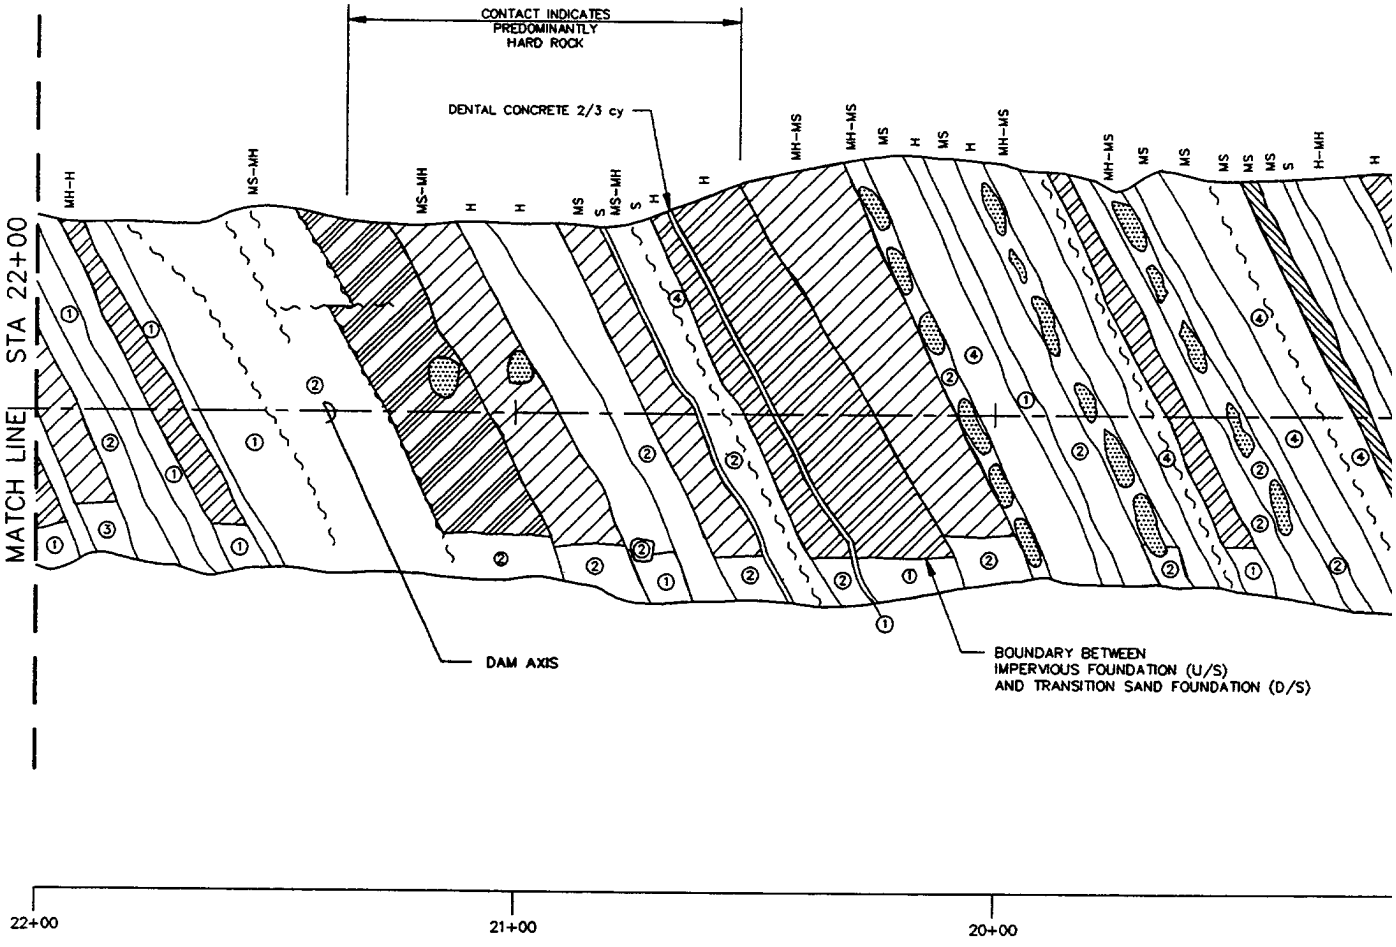
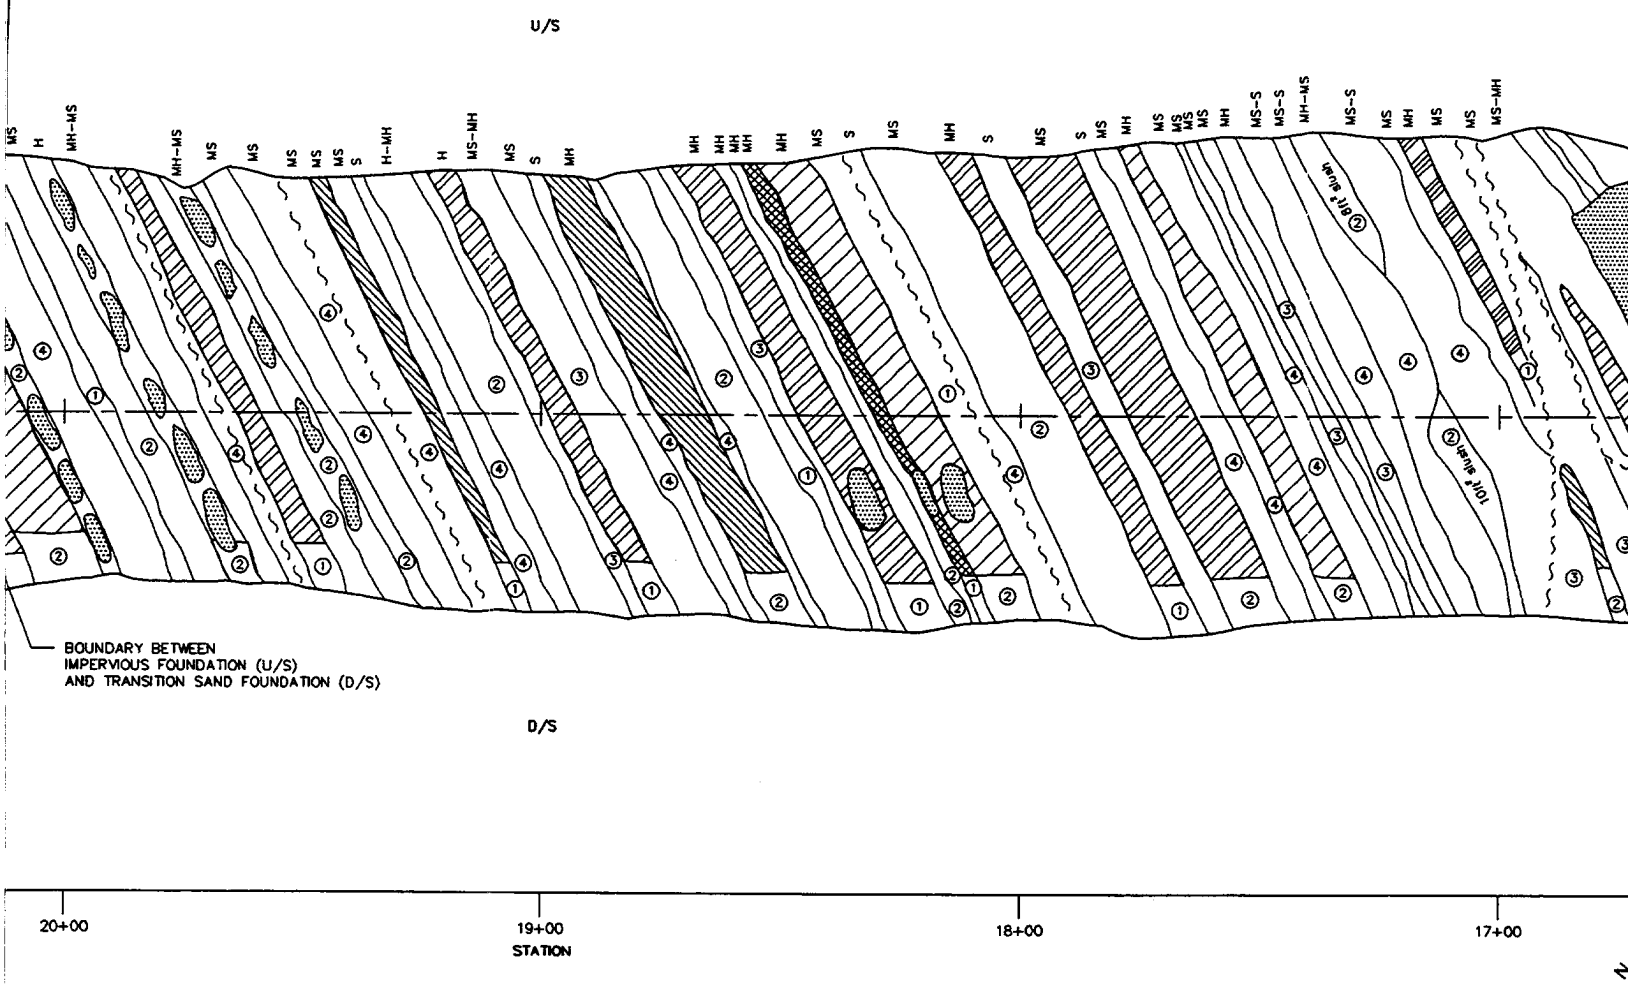
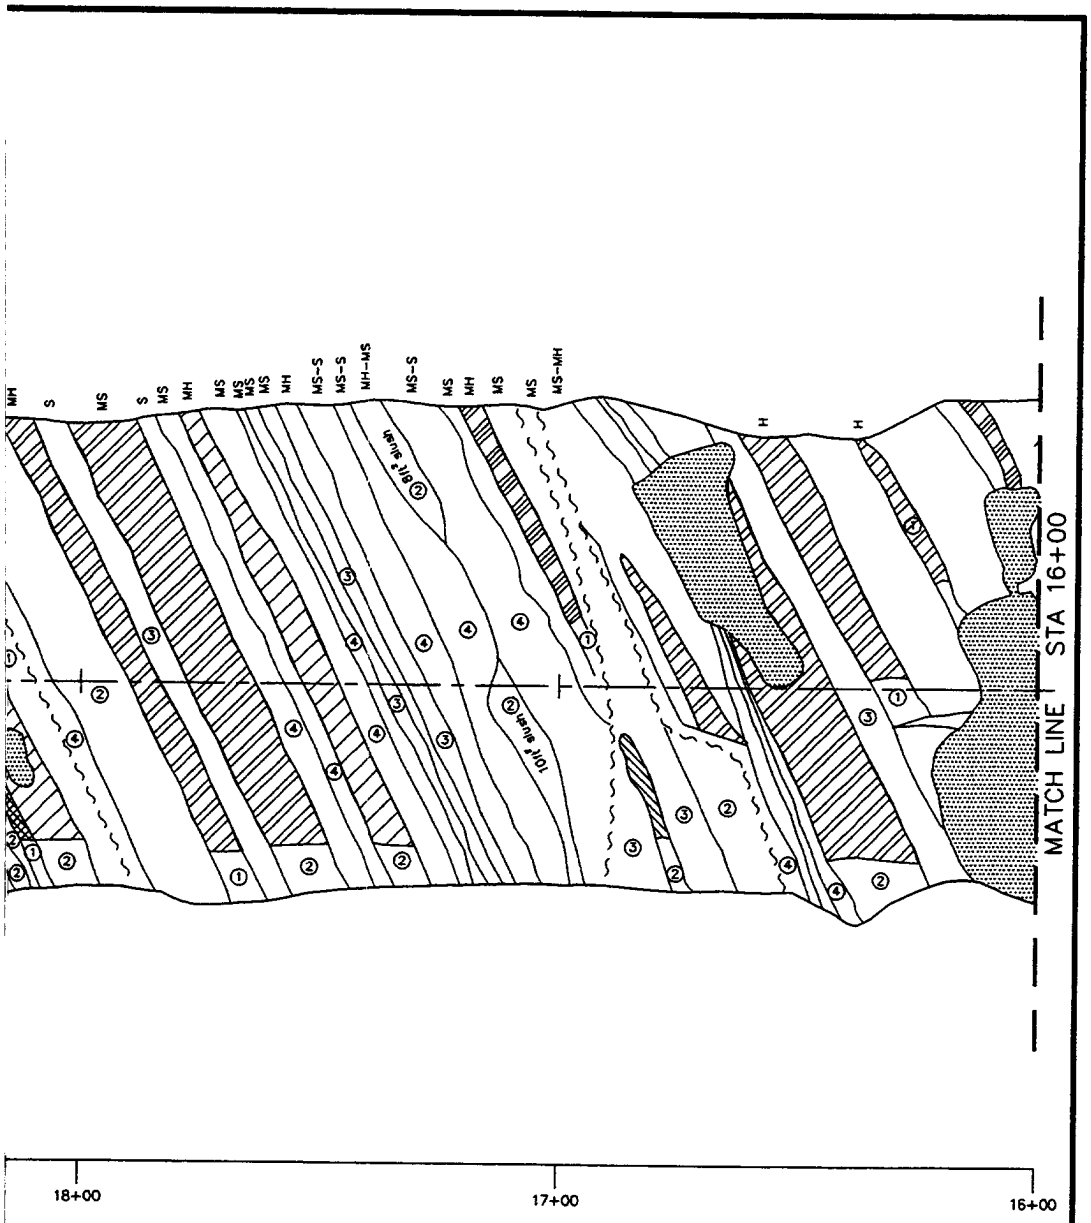
LITTLE DELL LAKE
SALT LAKE CITY STREAMS, UTAH
MAIN DAM
CORE TRENCH FOUNDATION
TREATMENT MAP
STA. 22+00 TO STA. 16+00

Numerous concrete fillets were used to correct overhangs in the harder rock beds on the left abutment. These are shown on the Core Trench Foundation Treatment Map, Plates 92 and 93. In several cases, large open fractures were observed in the rock to be covered by the fillet and these were filled with a 1:1 (W:C) grout mix. The concrete fillets were formed so that the resulting sloped surfaces were generally no steeper than

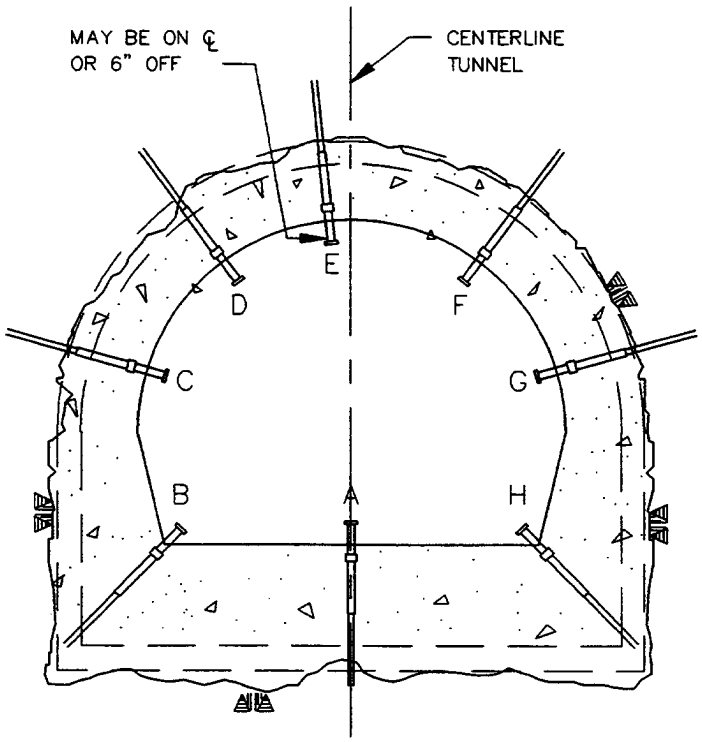
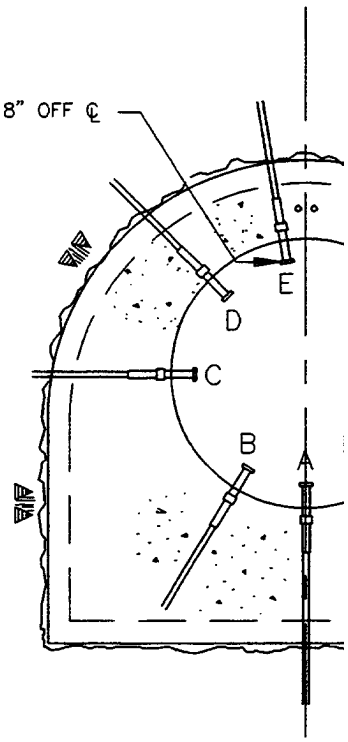
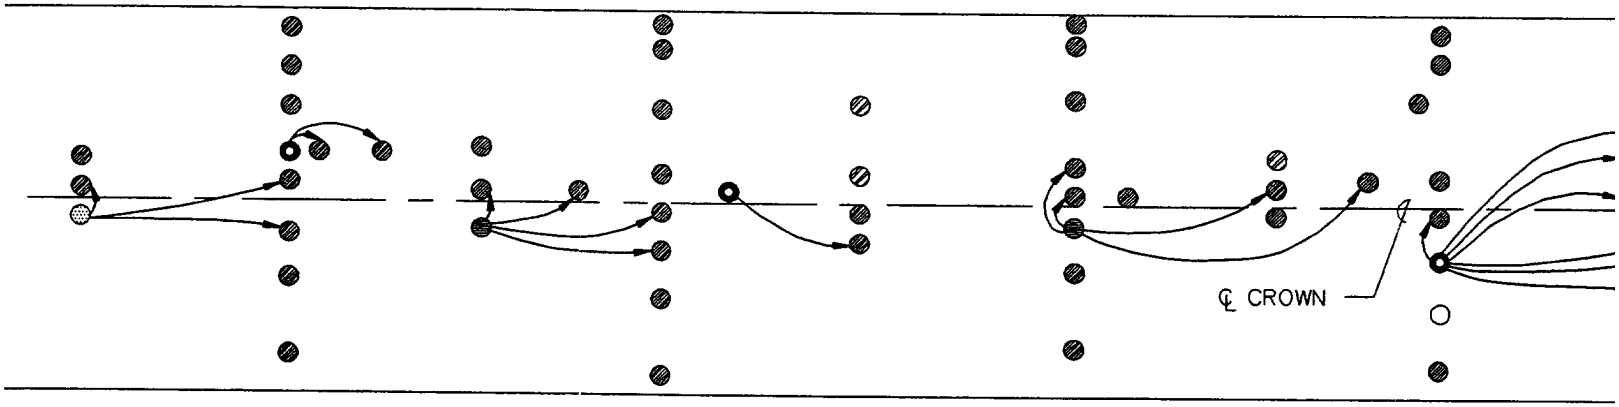
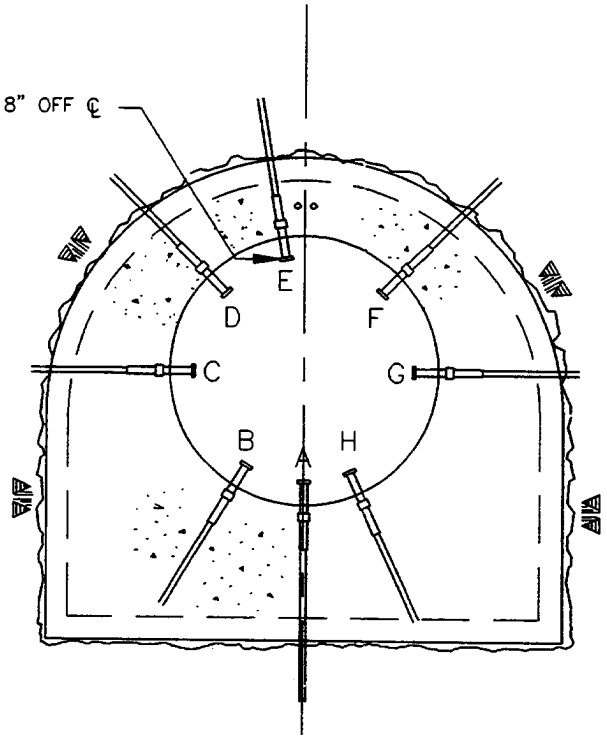
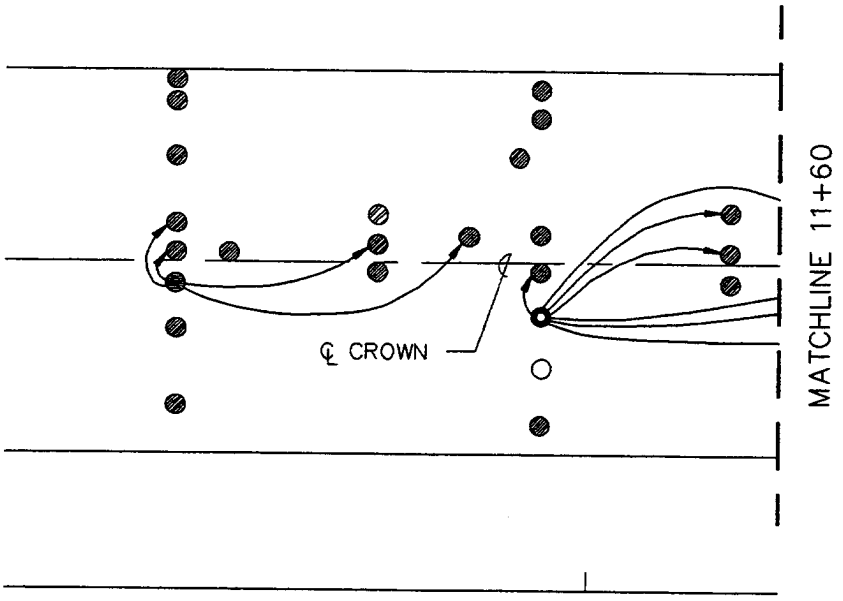
ERE		BAB	PLATE 94

6.2.1 General. After installing the concrete tunnel lining, contact grouting was done in the crown throughout the entire length of the tunnel and ECC, and consolidation grouting was done from the upstream end of the tunnel down to Station 19+49 (Photo T26). The specifications originally called for the consolidation grouting to be discontinued at about Station 17+36. However, because of problems encountered at the Set 263 fault zone, consolidation grouting was continued down to Station 19+49. Grout hole arrays, grout travel and ranges of grout takes are shown on the tunnel grouting maps, Plates 94 through 107. Quantities are shown in Table 7, Detailed Summary of Drilling and Grouting in Tunnel.

6.2.2 Grouting Results. The results of the grouting is detailed on the Plates 94 through 99, and in Table 7. A generalized summary is presented in Table 4, above. However, several locations warrant further discussion here.

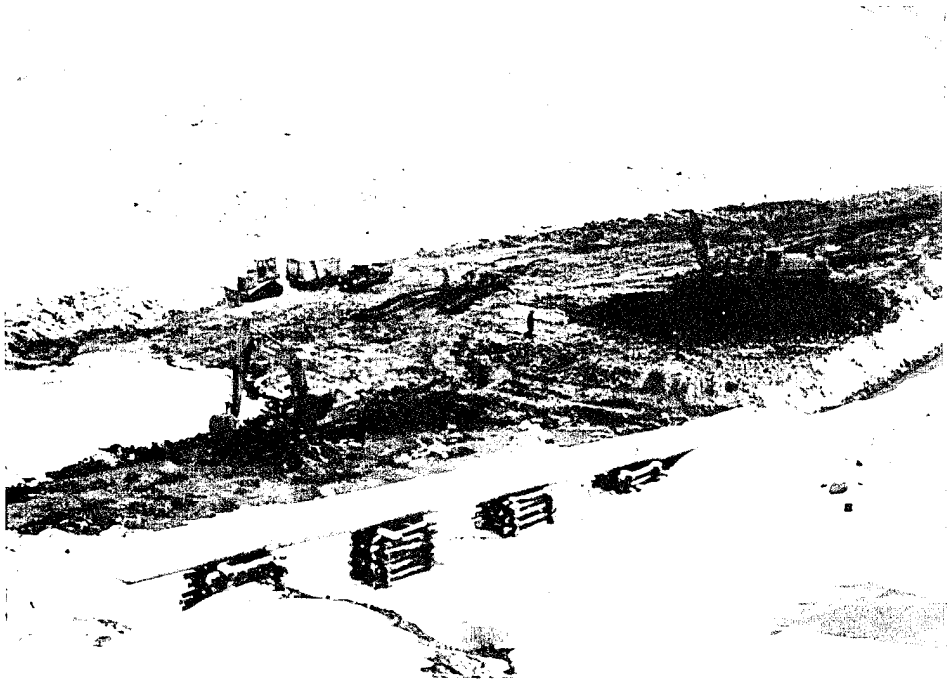
PHOTO CT1 (Core Trench 1). Contractor attempted to perform preliminary cleanup of core trench on this date, 2/14/90, but abandoned the effort. Photo looks south at the orange backhoe near dam axis, Sta. 15+00.
