SALT LAKE CITY STREAMS, UTAH

LITTLE DELL LAKE

FOUNDATION REPORT

APRIL 1995

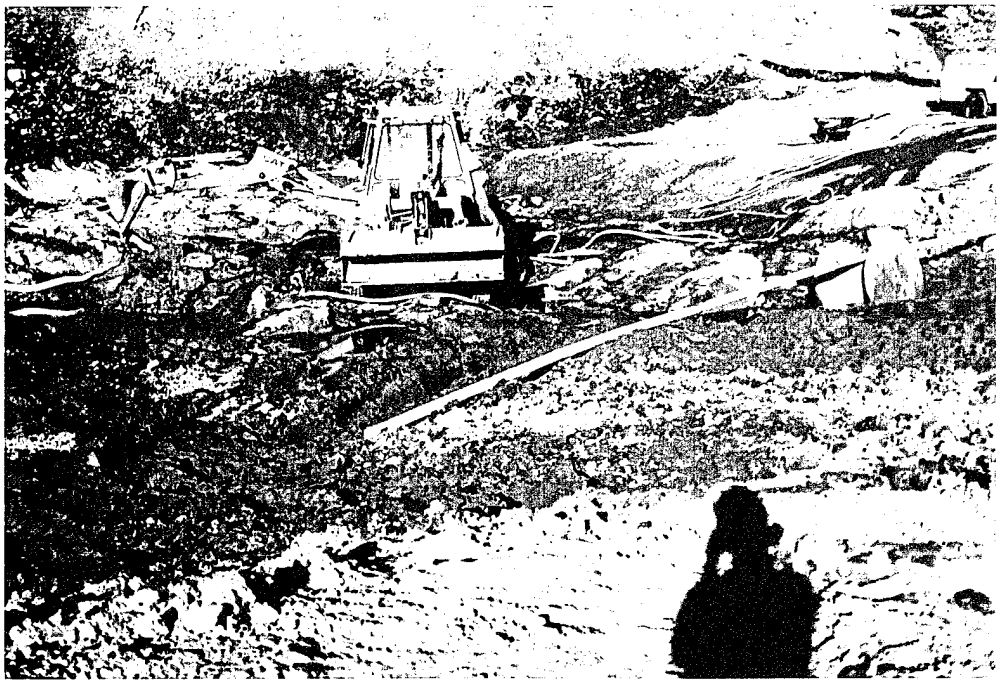
PHOTO CT2. Looking upstream as Contractor works on preliminary cleanup near Sta. 14+20. 3/22/90.

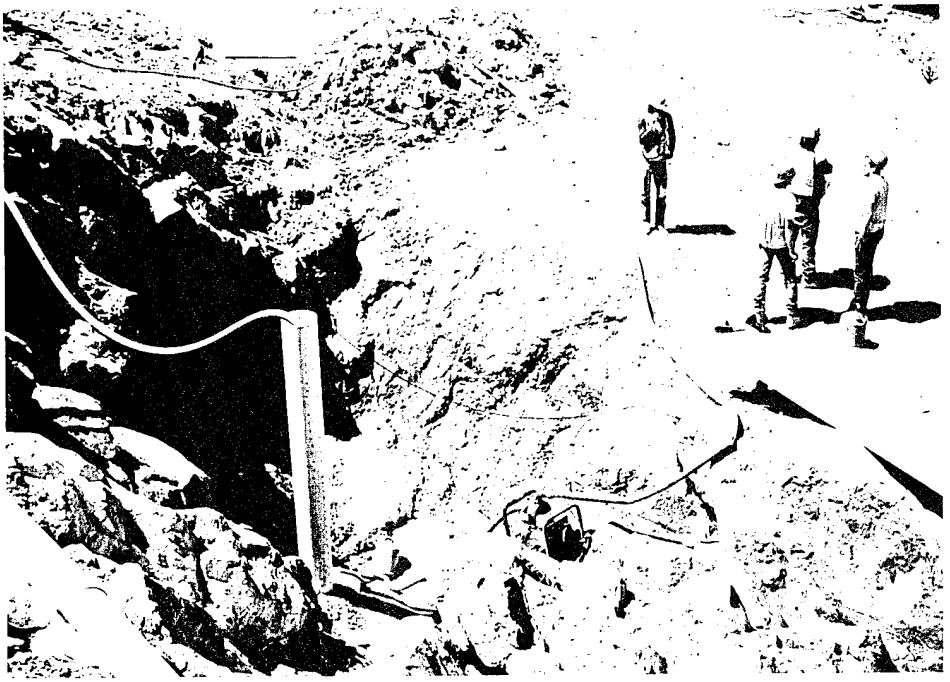
PHOTO CT7. Looking down and downstream at dental excavation used as dewatering sump at the base of the left abutment (near Station 14+00) near the downstream edge of the impervious fill foundation.

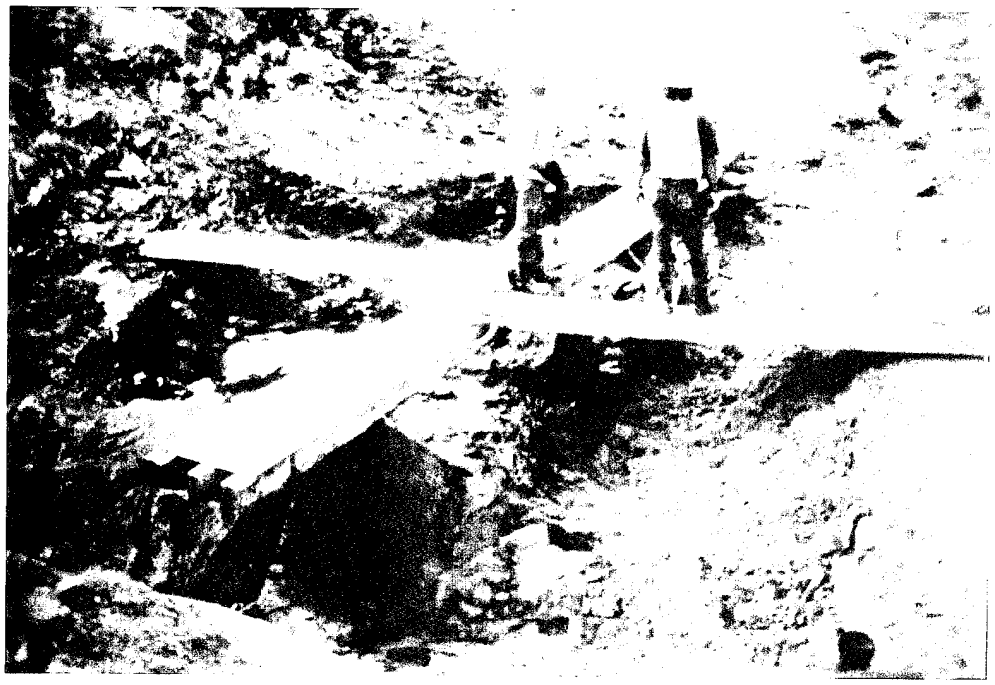
PHOTO CT9. Looking downstream at the base of the left abutment at area upstream of grout curtain prepared for dental/leveling concrete.

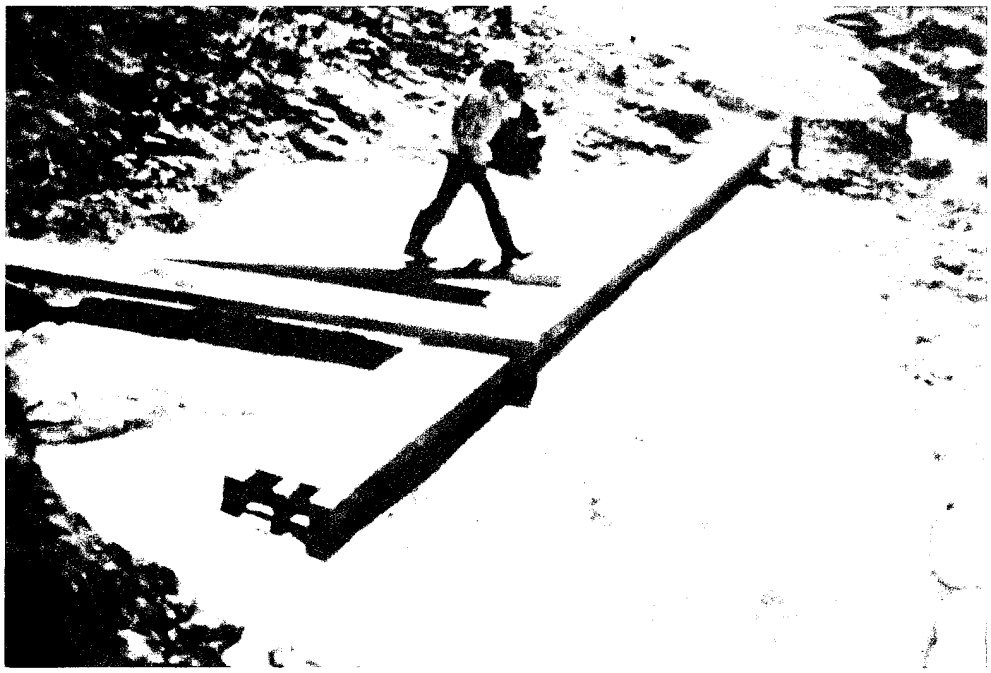
PHOTO CT10. Same area as previous photo. Note sand bags used to form edges to prevent "feathered" edges.

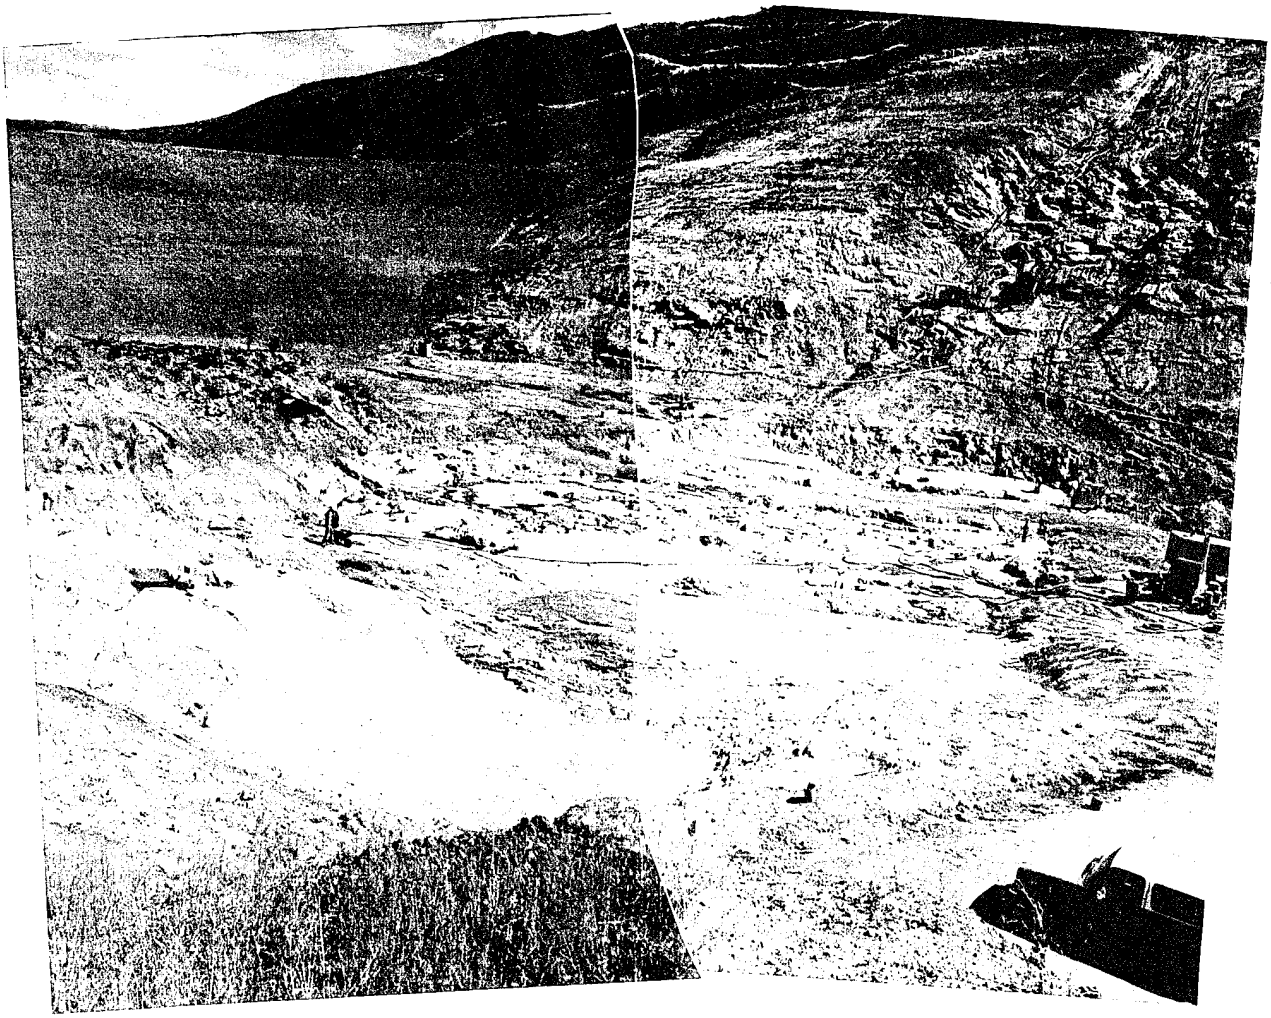
PHOTO CT17. Looking East at the core trench from the top of the downstream cut-slope near Station 17+00.

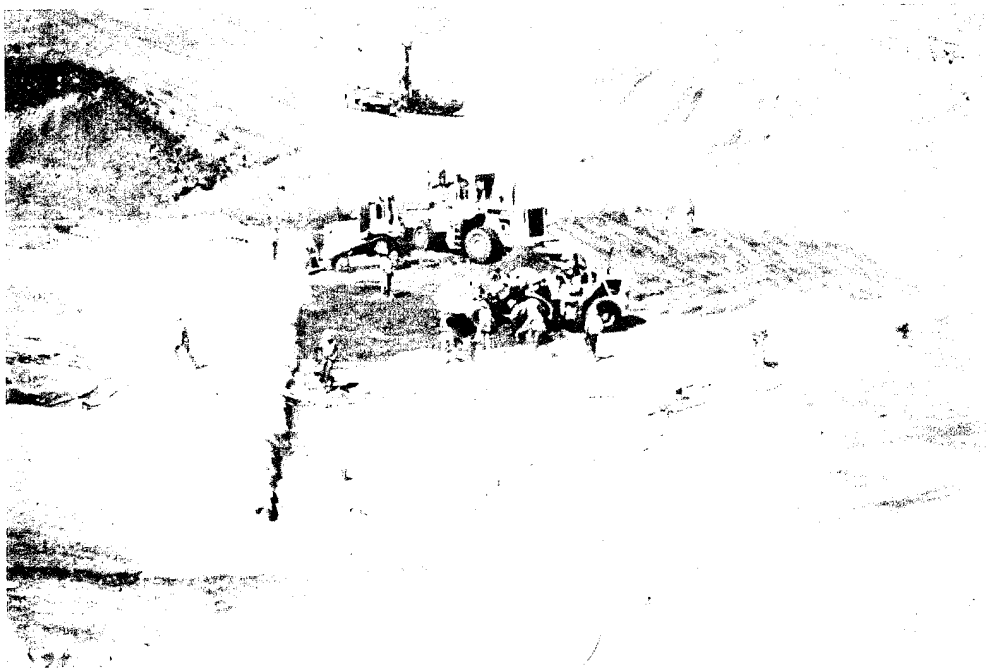
PHOTO CT19. The first impervious fill placement at about Sta. 15+50 to 16+00.

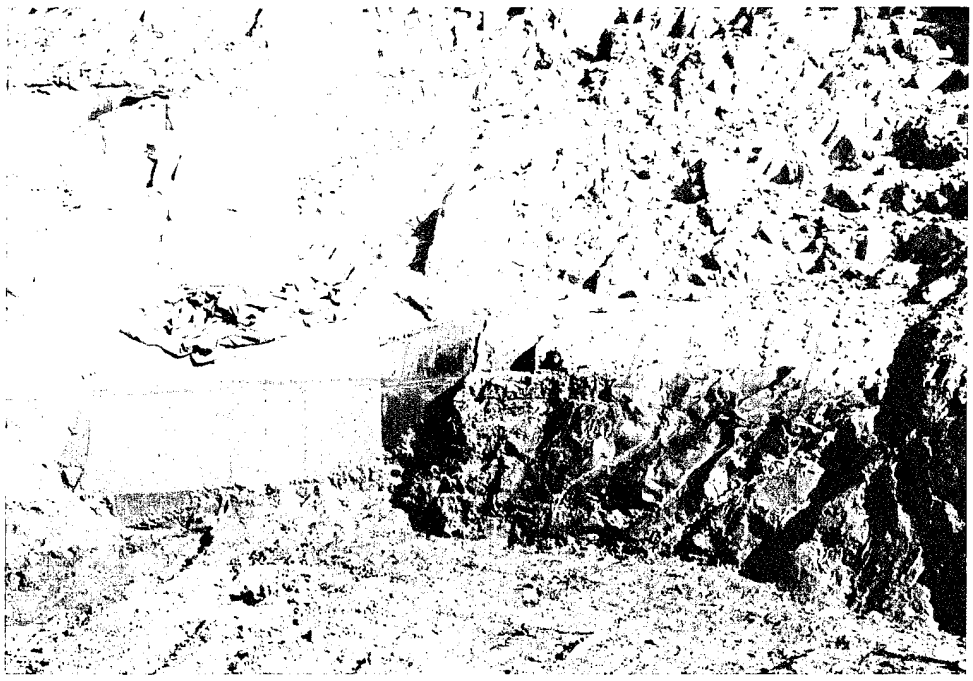
PHOTO CT22. Same area as the previous photo, after placing the fillet.

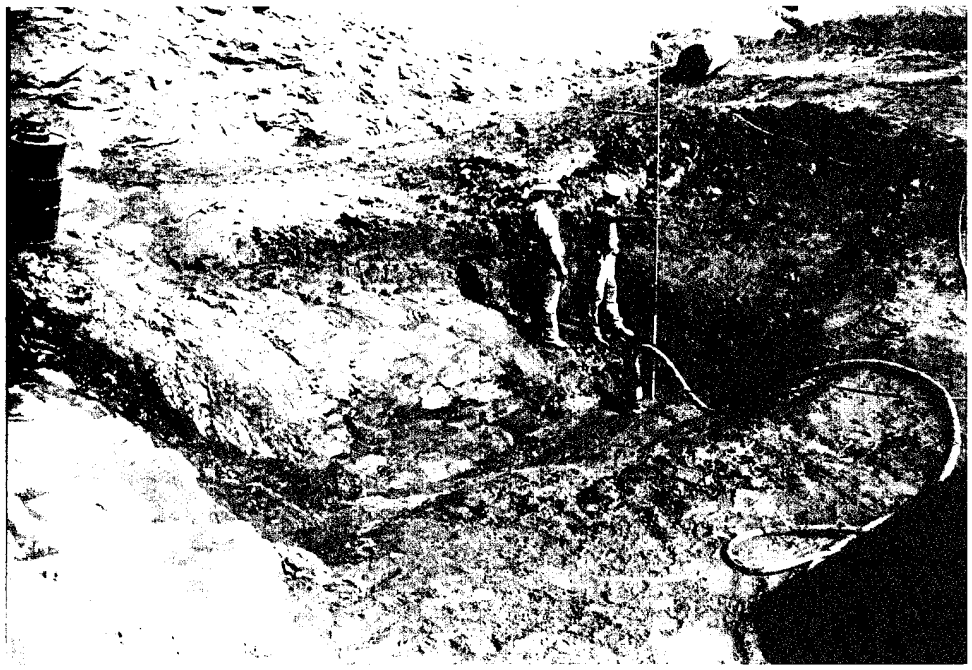
PHOTO CT33. Excavation for sump 38 feet upstream of the dam axis at Sta. 23+40. Looking upstream and left from Sta. 23+50 on the dam axis.

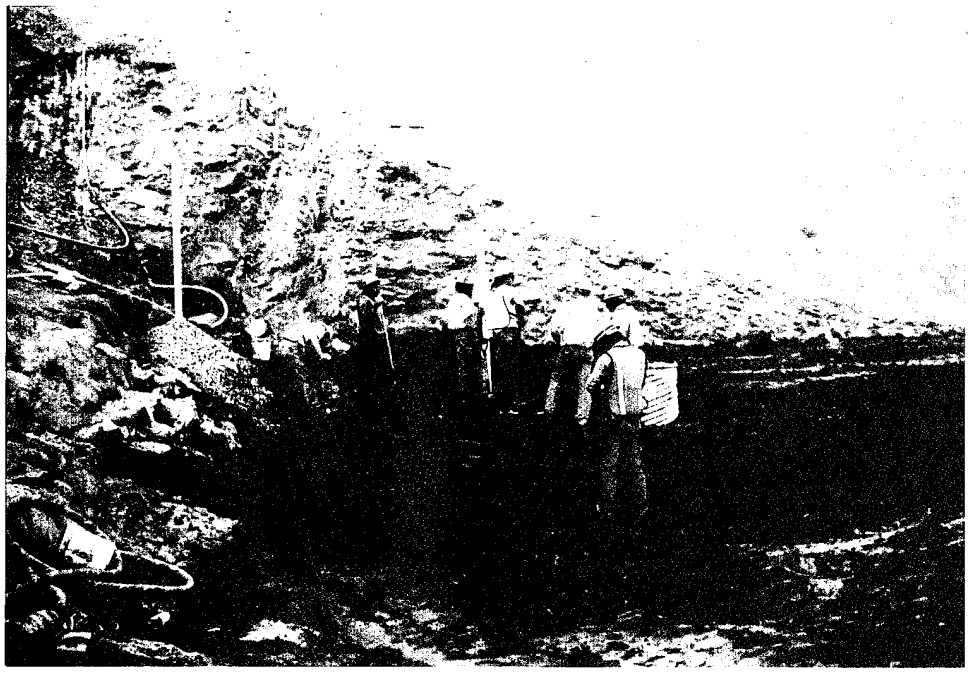
PHOTO CT35. Looking upstream along Sta. 23+50 at sump. Note the 24-inch-diameter CMP and two 4-inch diameter PVC pipes installed to facilitate grouting the sump later. Also note the gravel collector extending up to the spring shown in the previous photo.

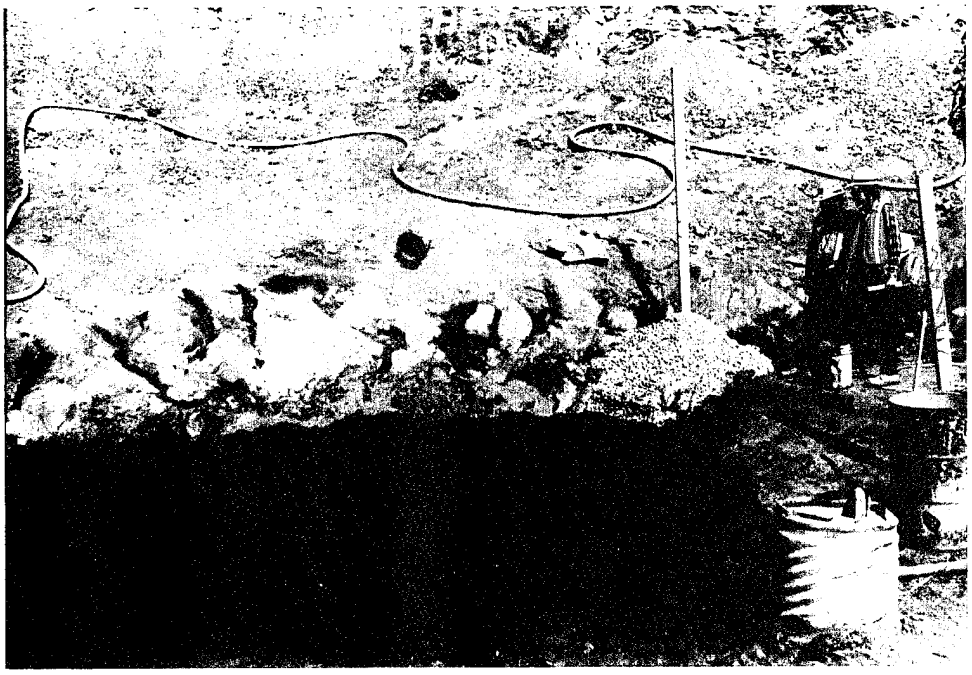
PHOTO CT37. Area in previous photo after placing slush grout over an area of about 4-feet by 10-feet.

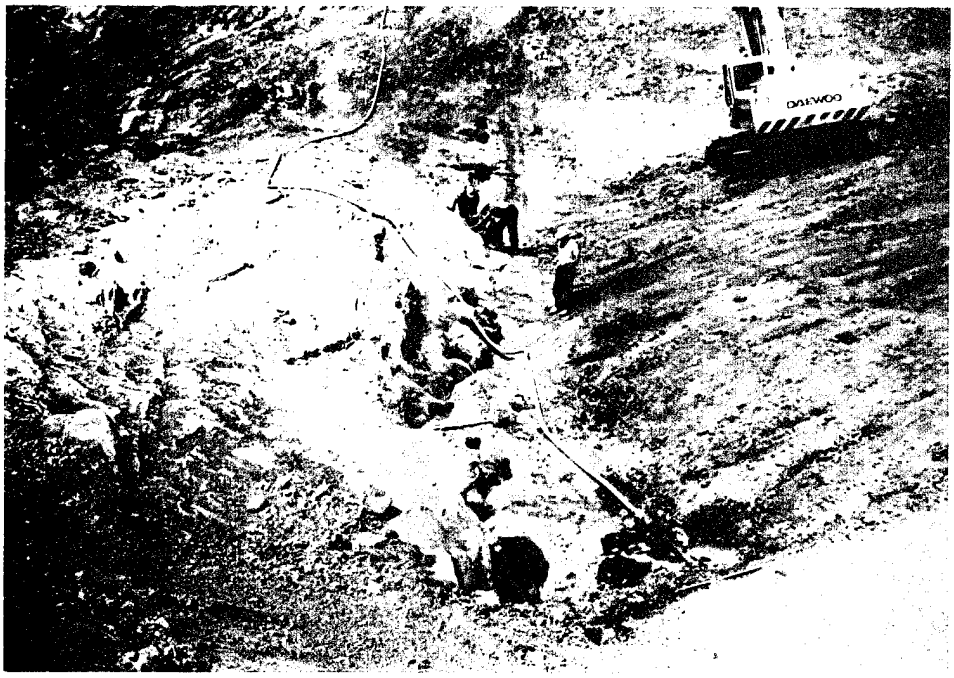
PHOTO CT38. Looking upstream at excavation of anomalous soft zones within hard sandstone bed crossing the dam axis between Sta. 20+05 and 20+15.

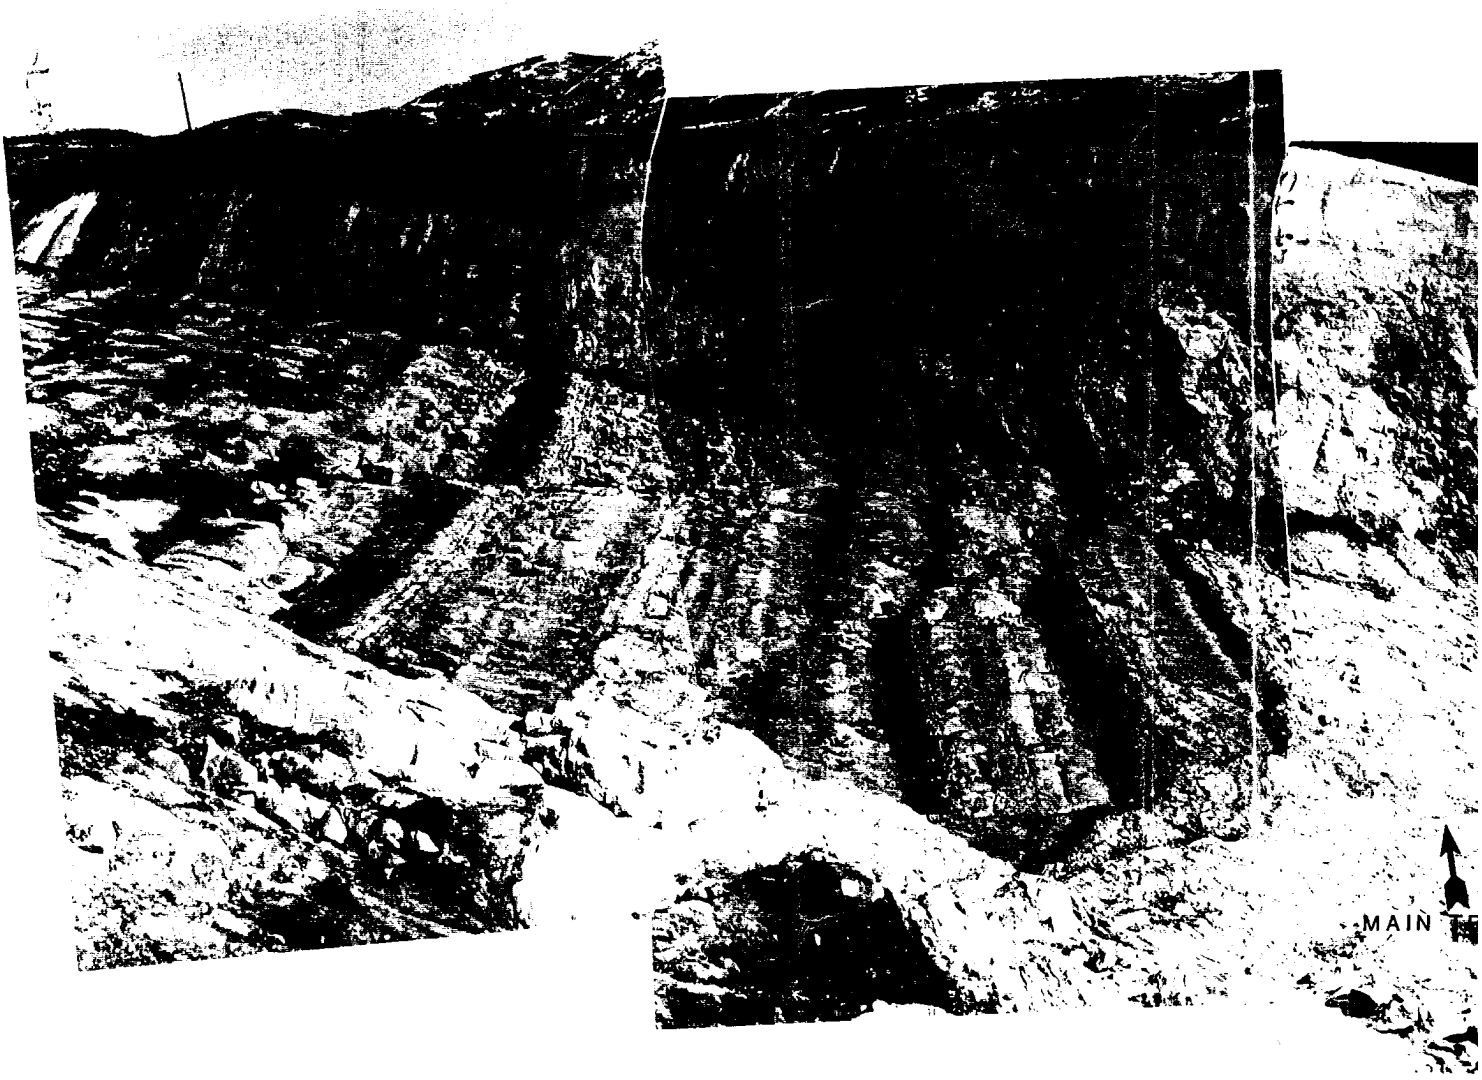
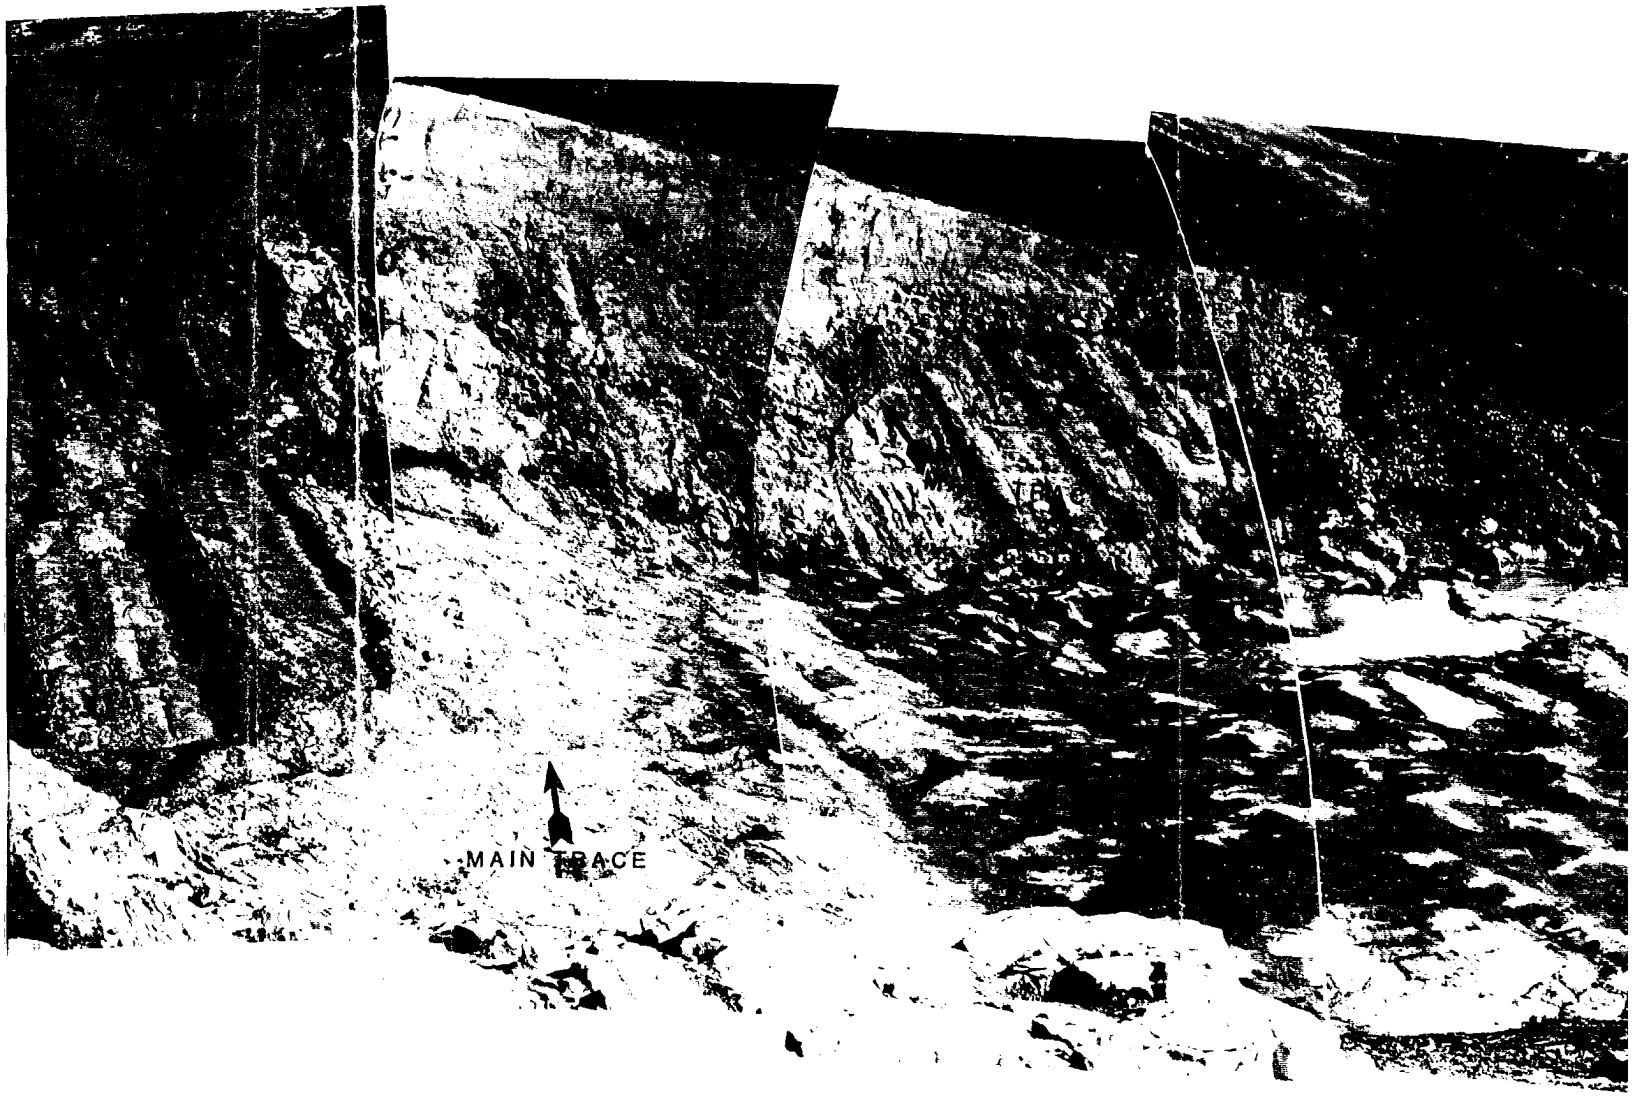
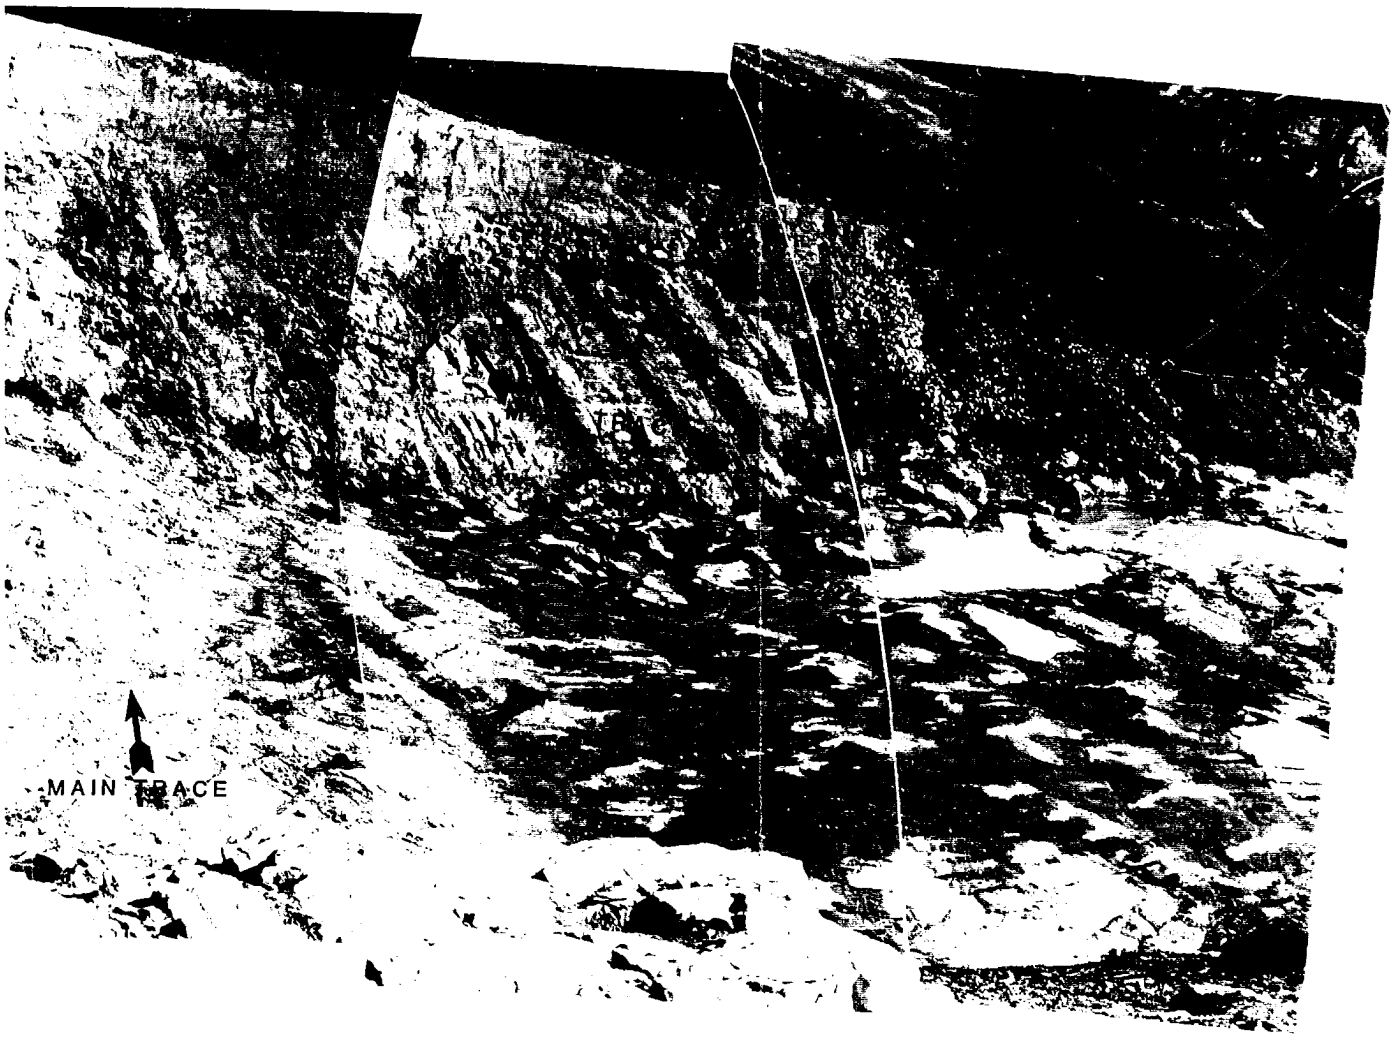
PHOTO CT45. Looking upstream from the top of the downstream cutslope at the Station 22 Fault Zone.

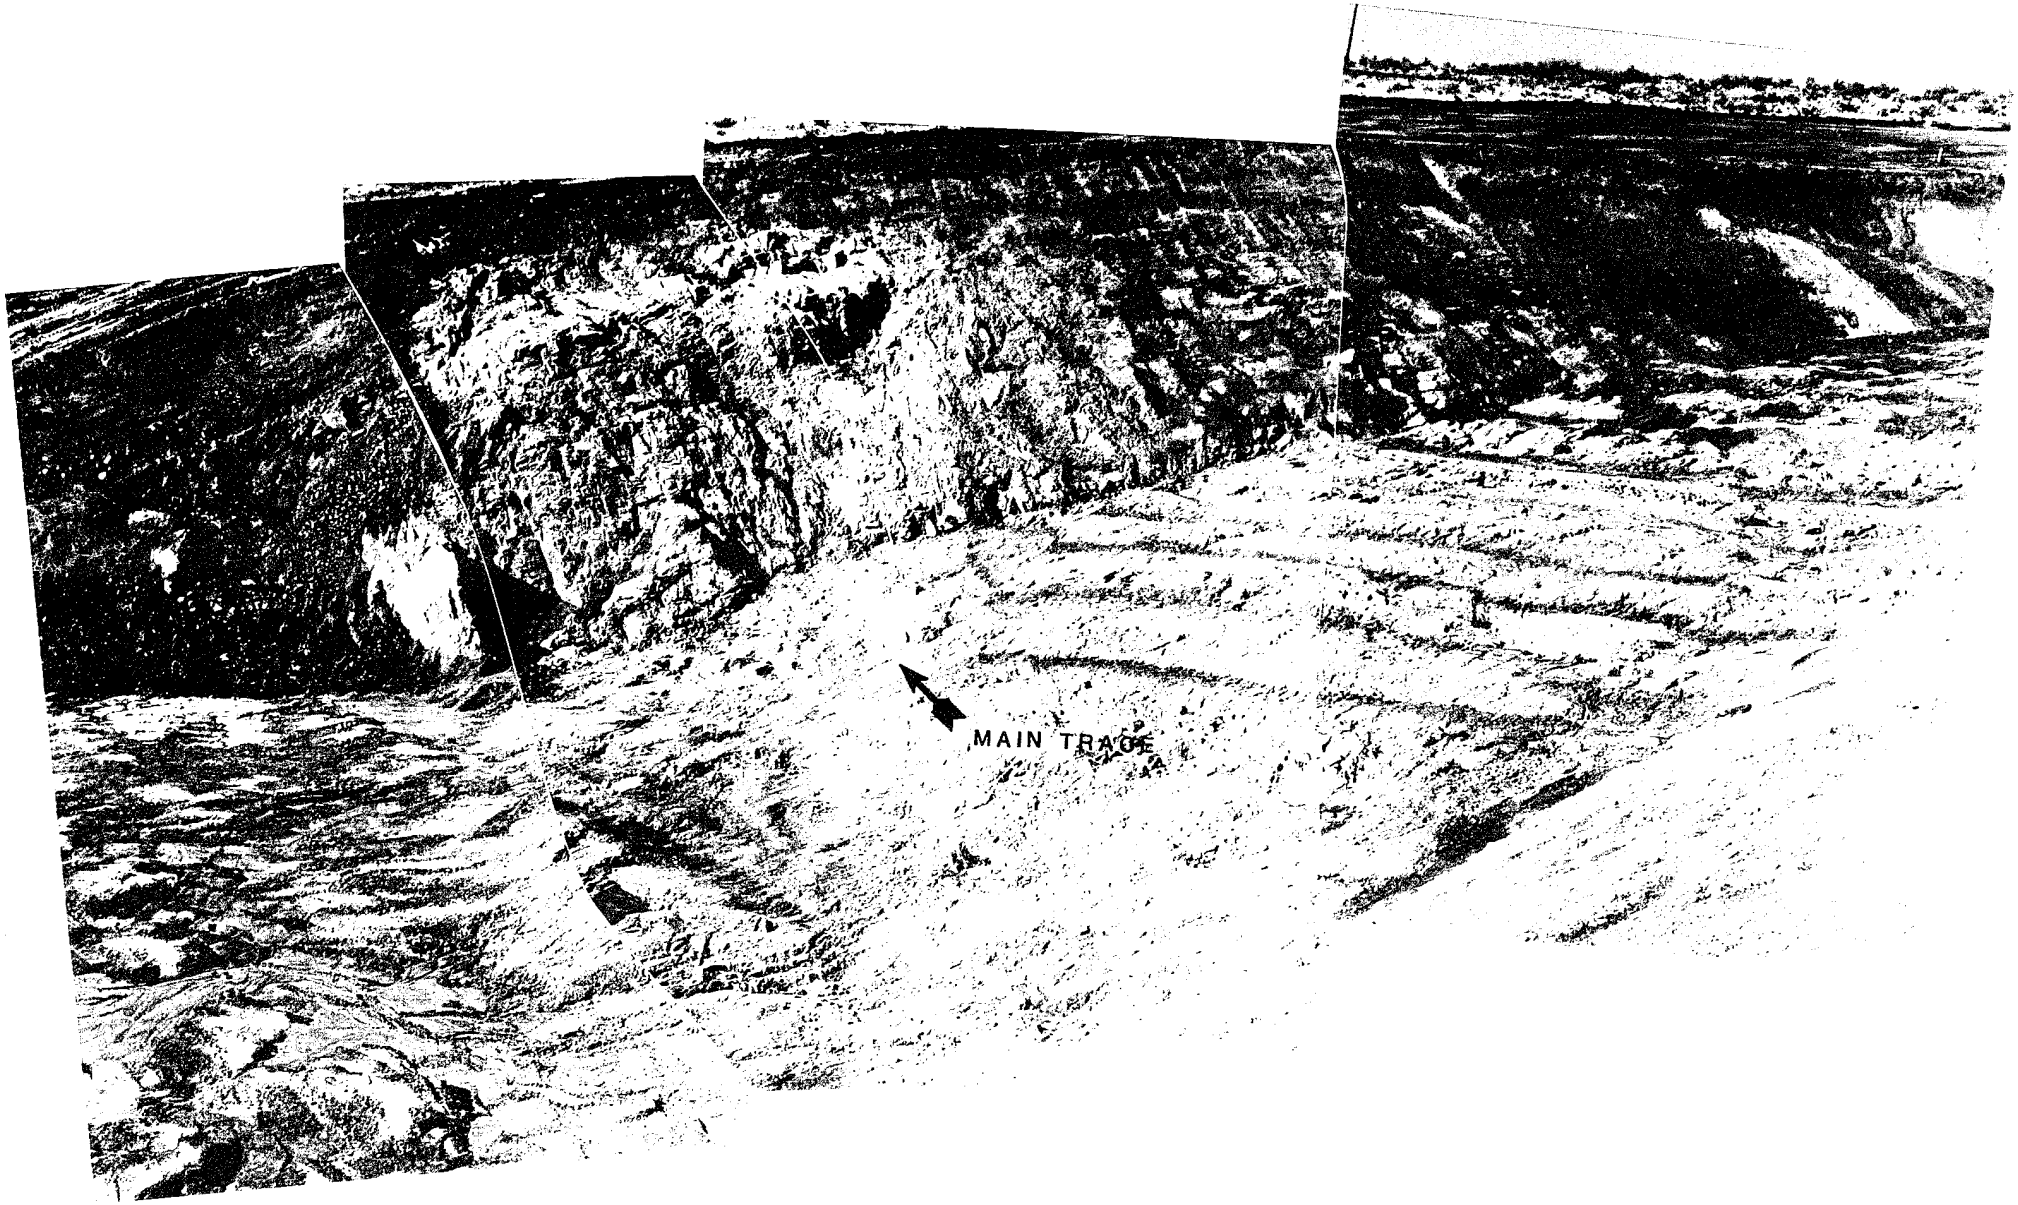
PHOTO CT46. Looking downstream from the top of the downstream cutslope at the Station 22 Fault Zone.

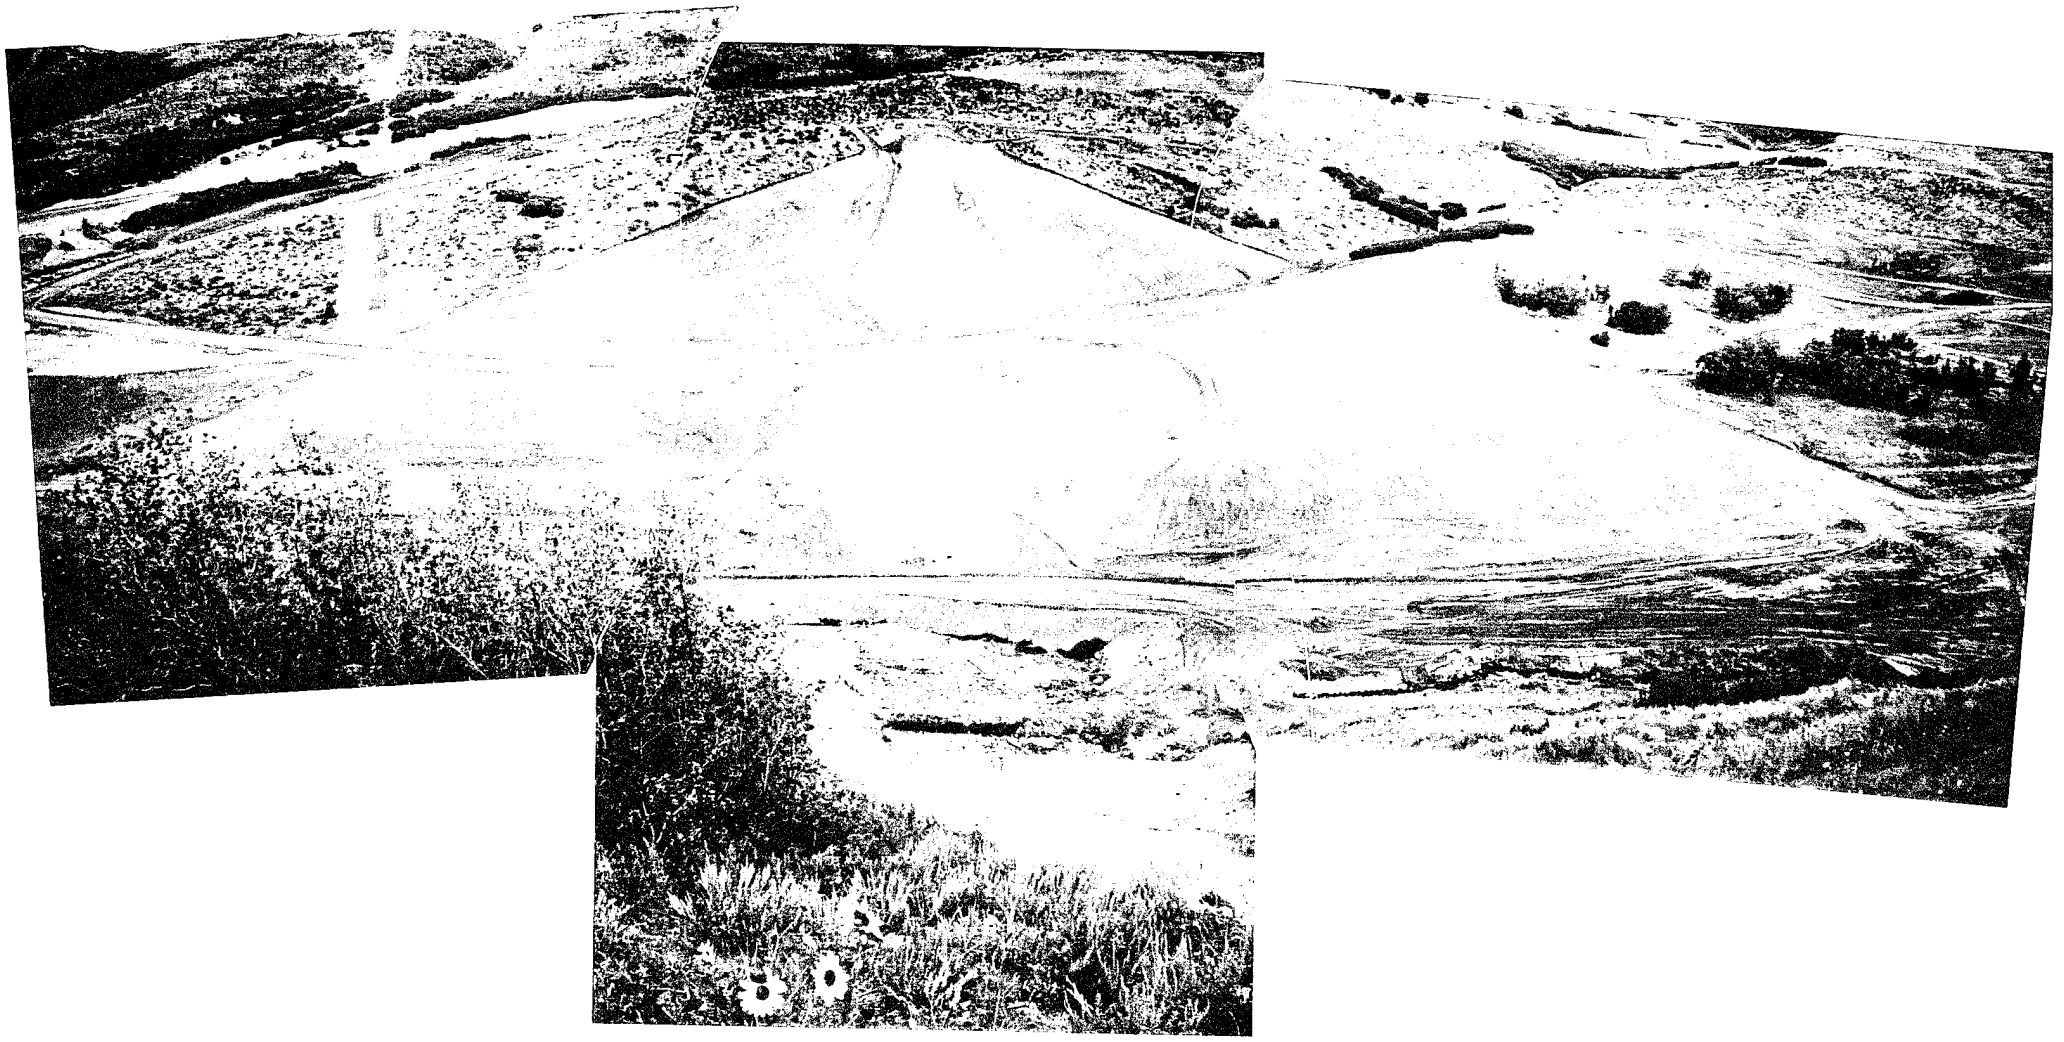
PHOTO EMB3. The right abutment after striping was completed in 1989.

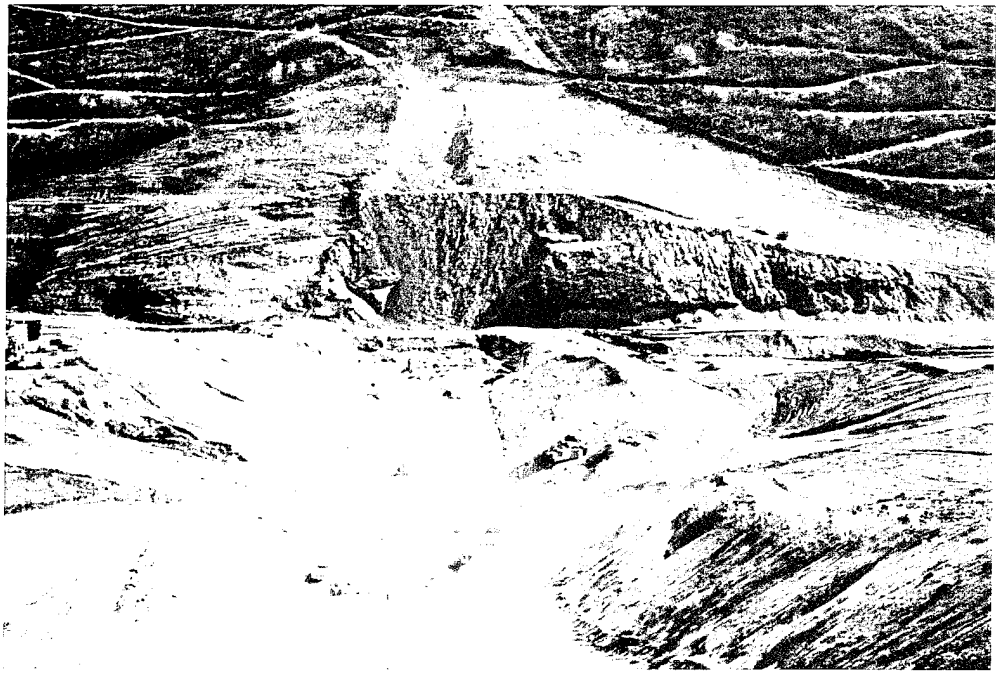
EMB5 The left abutment on 10/23/89. The abutment has been stripped and excavation of the overburden at the downstream shell foundation is in progress.

PHOTO EMB5. The left abutment on 10/23/89. The abutment has been stripped and excavation of the overburden at the downstream shell foundation is in progress.

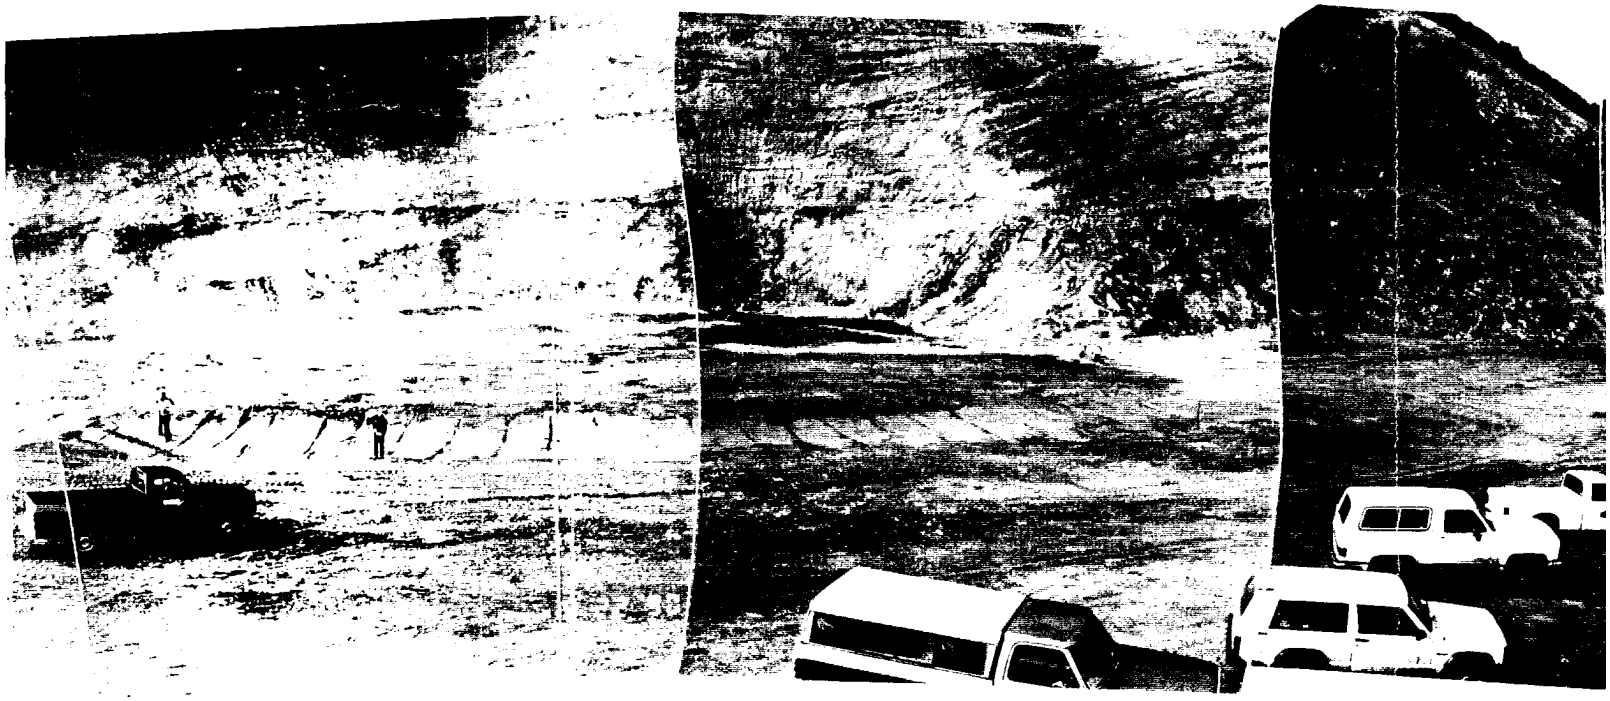
EMB6 Looking left (northeast to southeast) at the portion of the upstream shell foundation approved as "Area G" (5-30-90). Excavation and proof-rolling has been completed in this area on which the maximum section of the dam will be founded.

PHOTO EMB6. Looking left (northeast to southeast) at t
the upstream shell foundation approved as "Area G" (5-3
Excavation and proof-rolling has been completed in this
the maximum section of the dam will be founded.

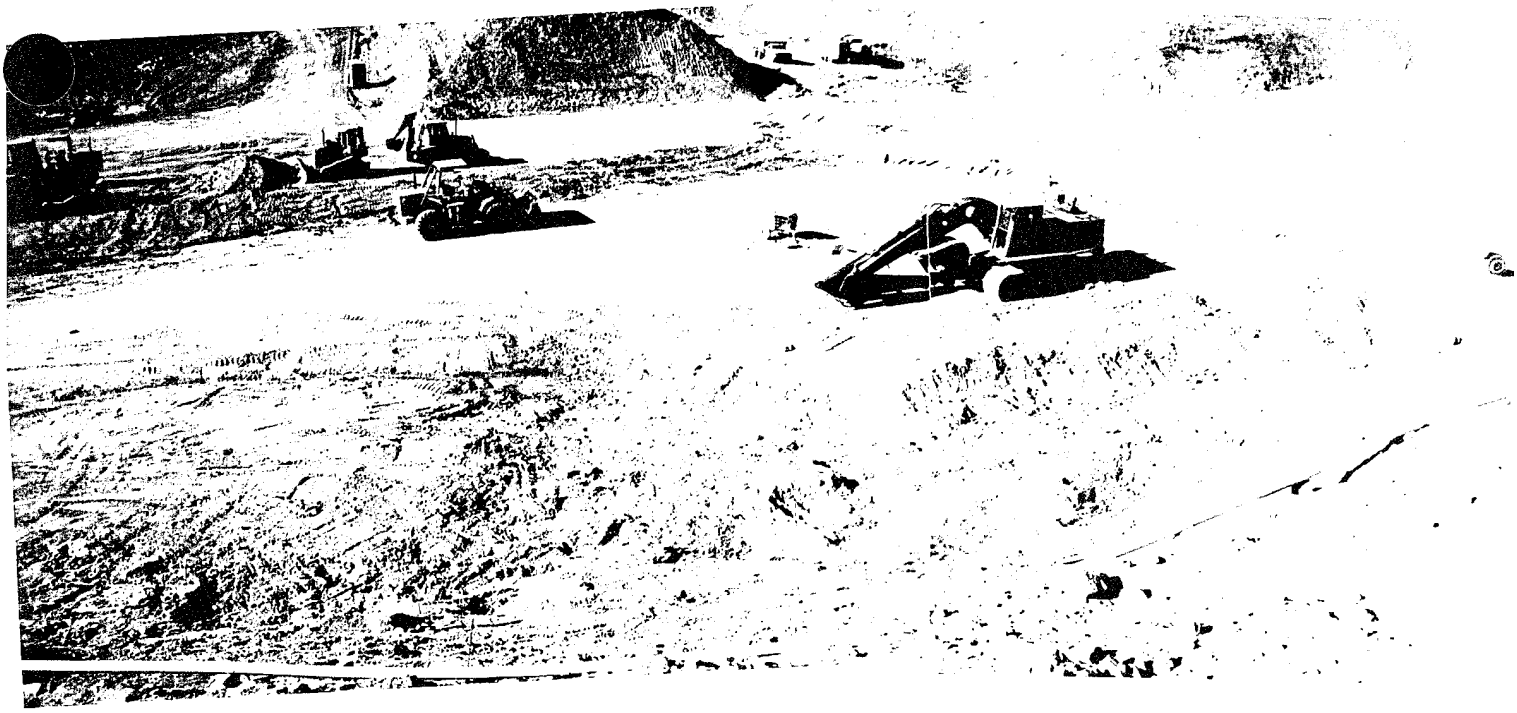
EMB8 Looking right at the upstream portion of the downstream shell foundation approved as "Area AB" (5-4-90).

PHOTO EMB8. Looking right at the upstream portion of the downstream shell foundation approved as "Area AB" (5-4-90).

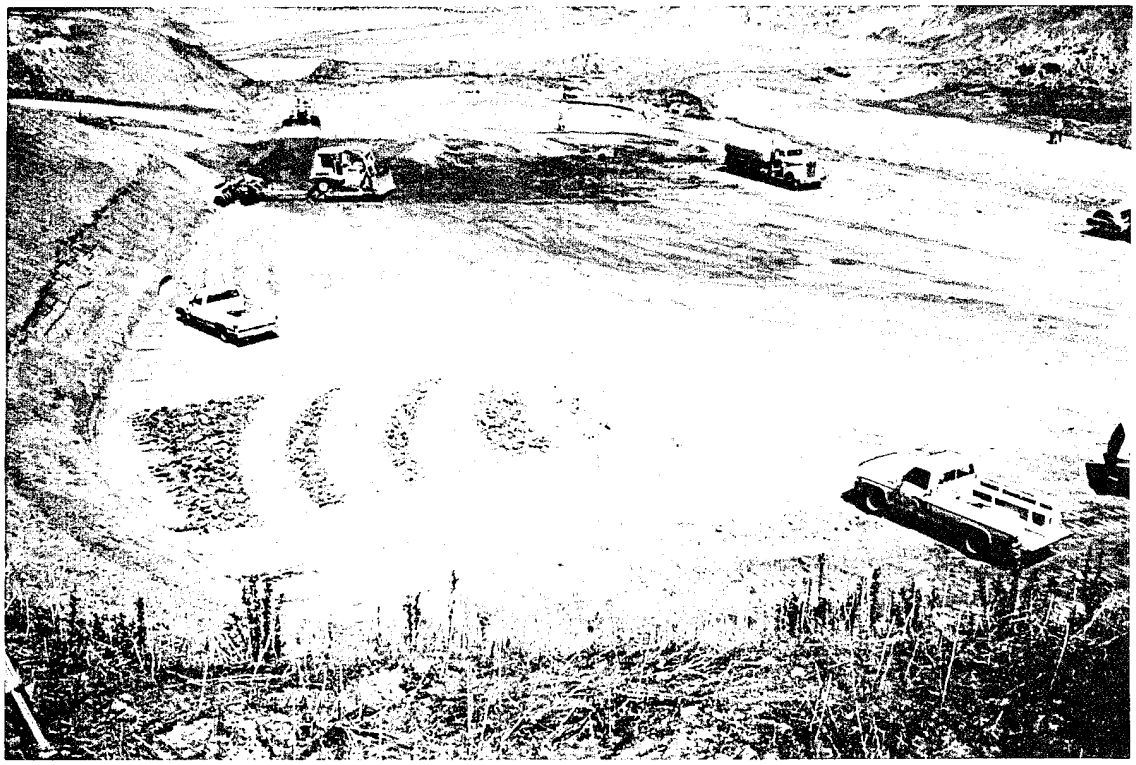
EMB9 Looking upstream at the portion of the downstream shell foundation approved as "Area 051691A".

PHOTO EMB9. Looking upstream at the portion of the downstream shell foundation approved as "Area 051691A"

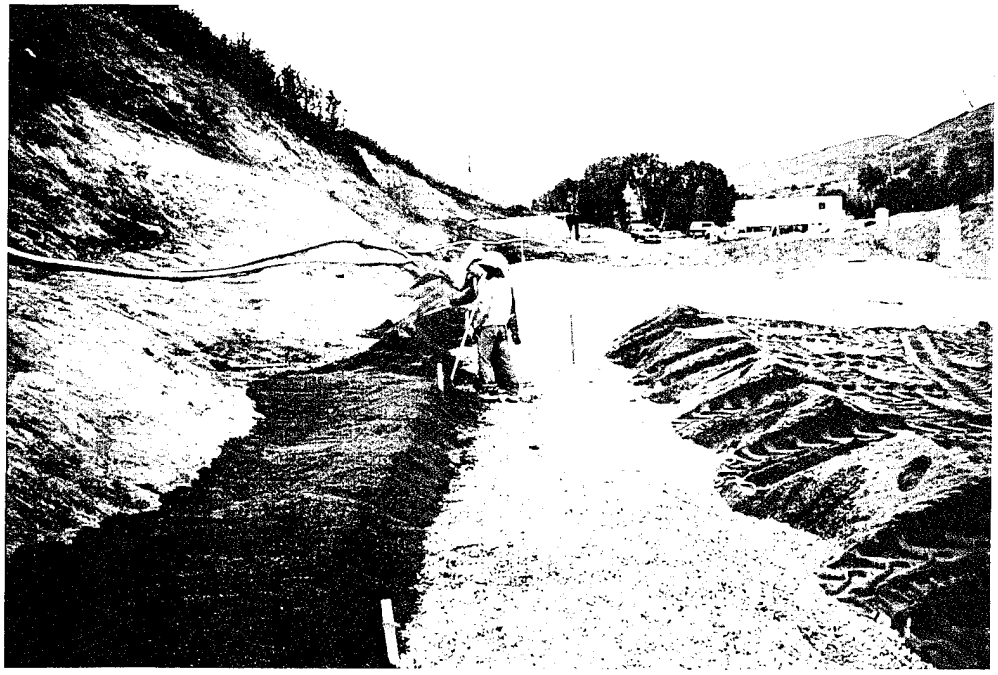
EMB11 Looking downstream along the downstream left abutment as Transition 1 is placed on approved foundation.

PHOTO EMB11. Looking downstream along the downstream left abutment as Transition 1 is placed on approved foundation.

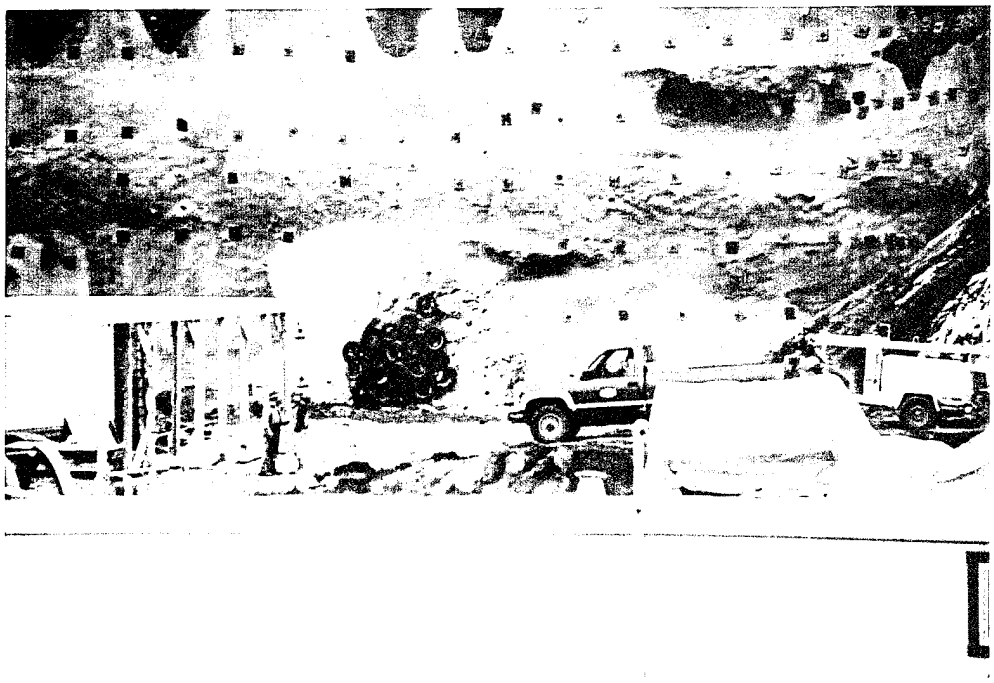
PHOTO T1 (Tunnel 1). Downstream portal of outlet works tunnel before blasting the first round. Blasting mat made of old tires was used to reduce "fly rock".
