SALT LAKE CITY STREAMS, UTAH

LITTLE DELL LAKE

FOUNDATION REPORT

APRIL 1995

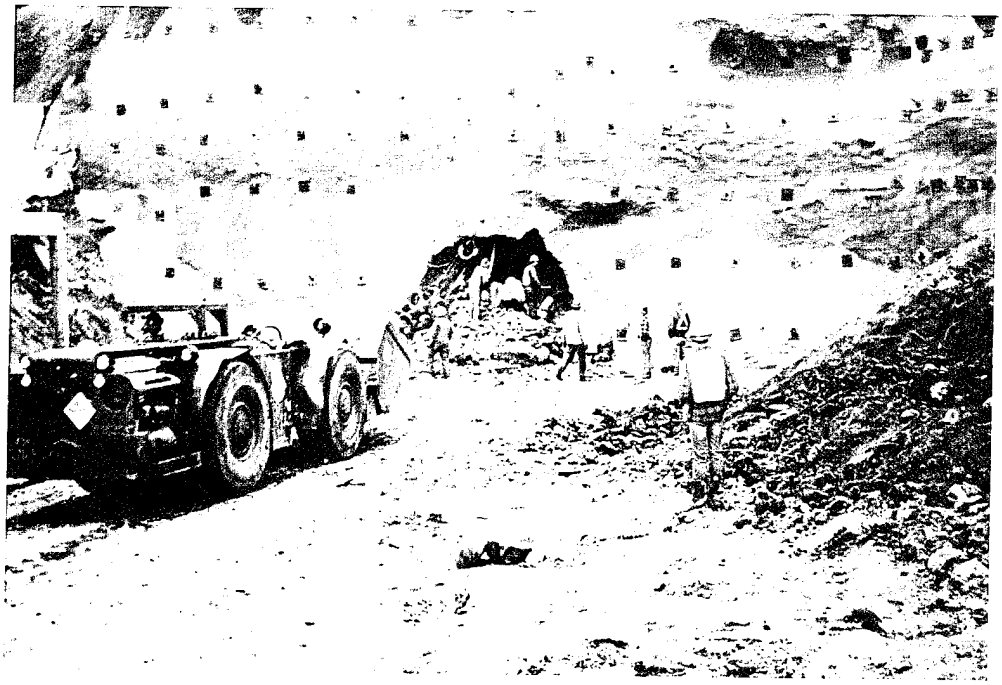
PHOTO T2. Same area as previous photo, after blasting first round.

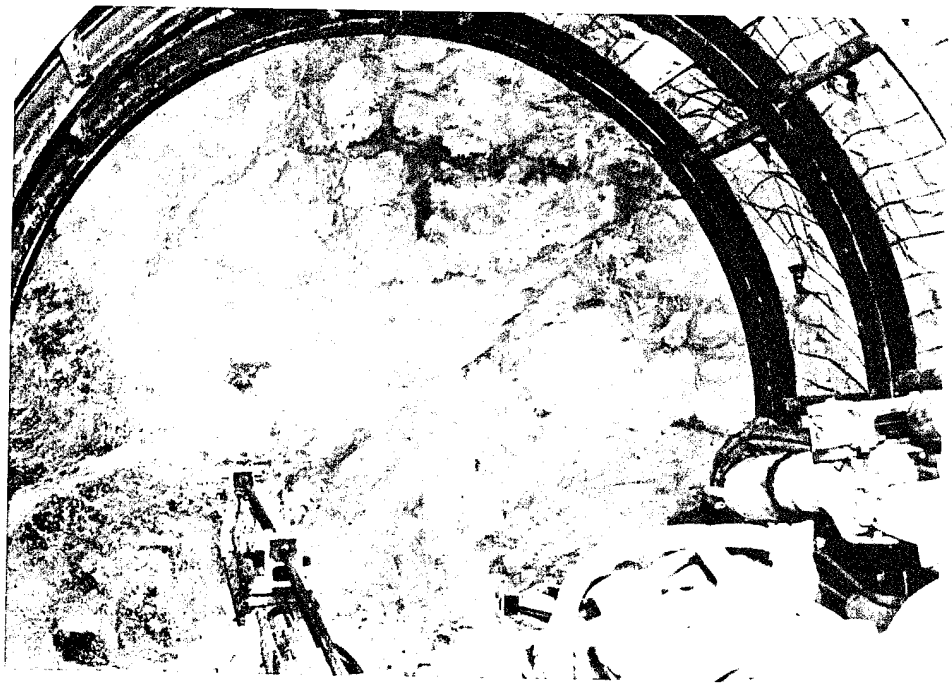
PHOTO T3. Looking upstream at area mapped as face No. 97 at Sta. 25+98. Two-boom jumbo is drilling blast holes in at heading.

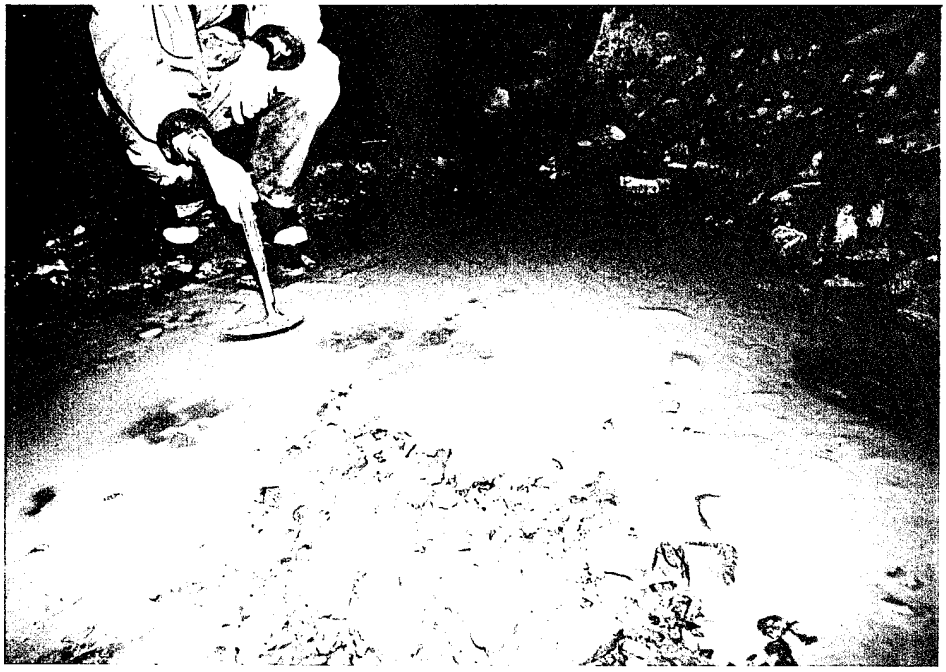
PHOTO T4. Dark areas are water seeping up from the invert near Sta. 22+98.

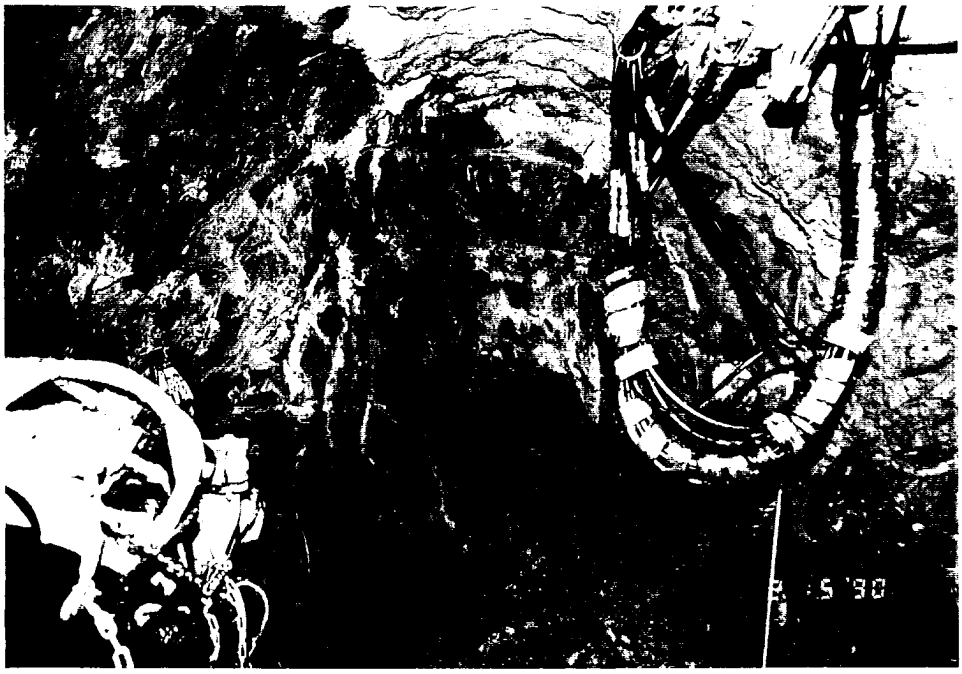
PHOTO T5. Looking upstream at area mapped as face No. 70 at Sta. 21+96. Montmorillonitic clay layer did not fragment properly when blasted, causing damage to several sets already in place.

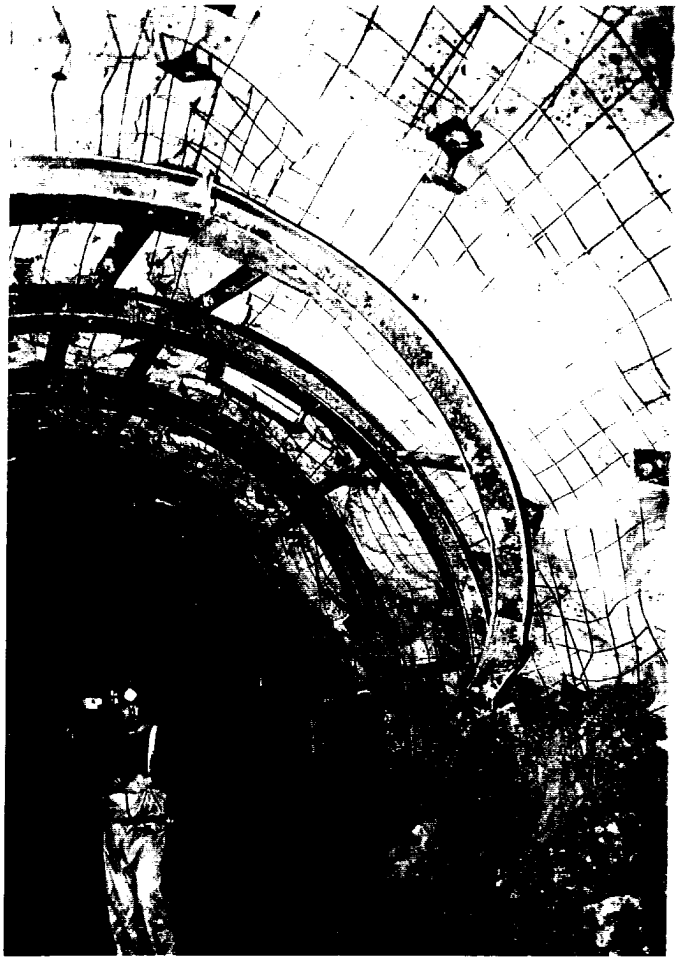
PHOTO T6. Damaged sets at area described in previous photo.

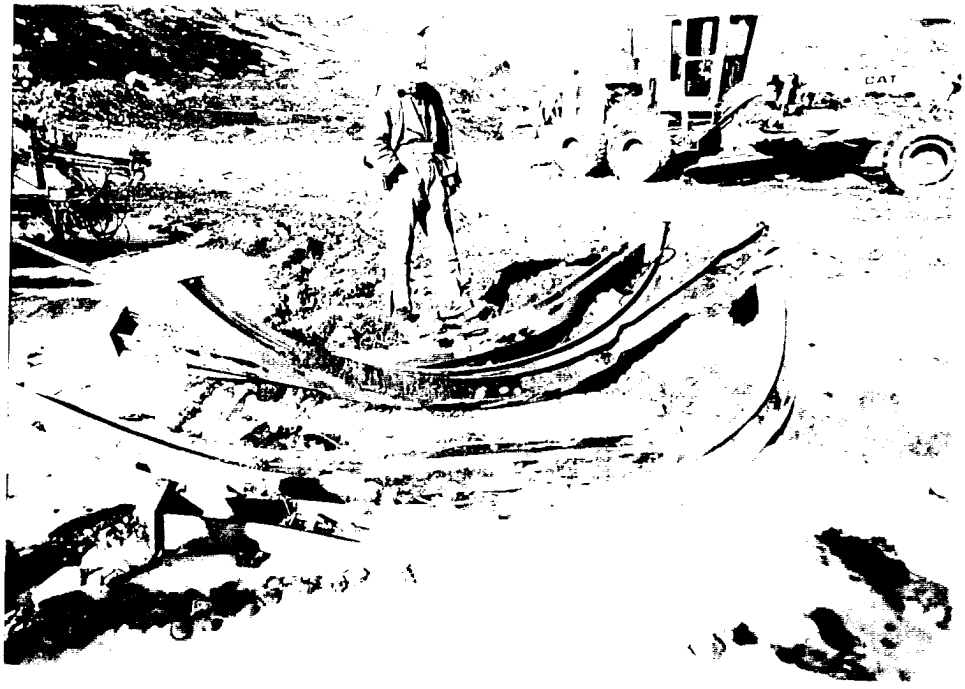
T5 Looking upstream at area mapped as face no. 70 at Sta. 21+96. Montmorillonitic clay layer did not fragment properly when blasted causing damage to several sets already in place.

T7 Damaged sets after being removed from tunnel.

PHOTO T7. Damaged sets after being removed from tunnel.

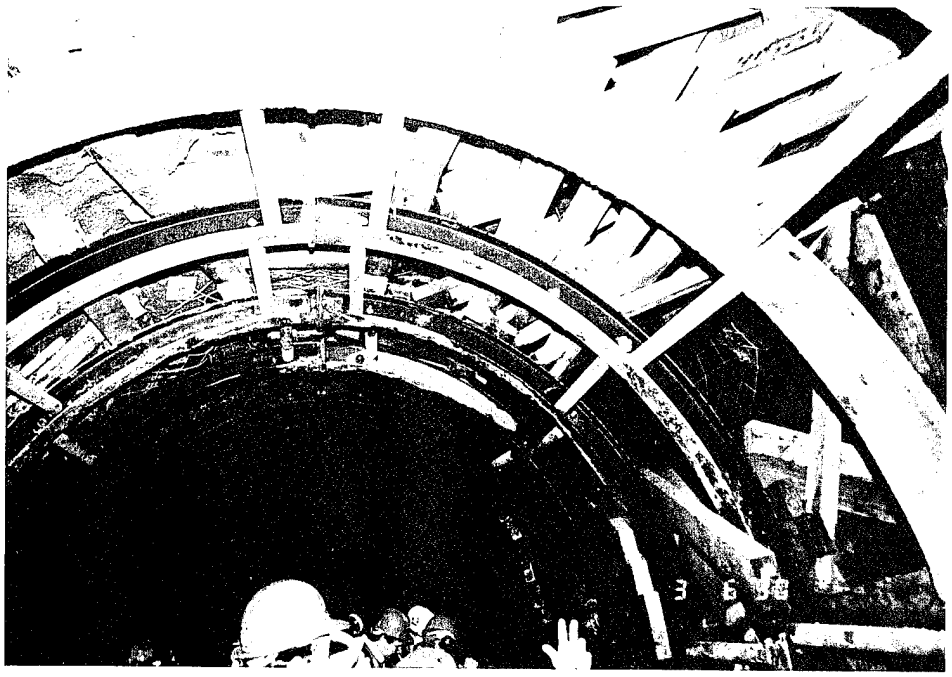
PHOTO T12. Looking upstream and to the left (southeast) side of the tunnel at the Set 263 Fault. Farthest set is set 262 at about Sta. 18+58. Note extensive wood blocking.

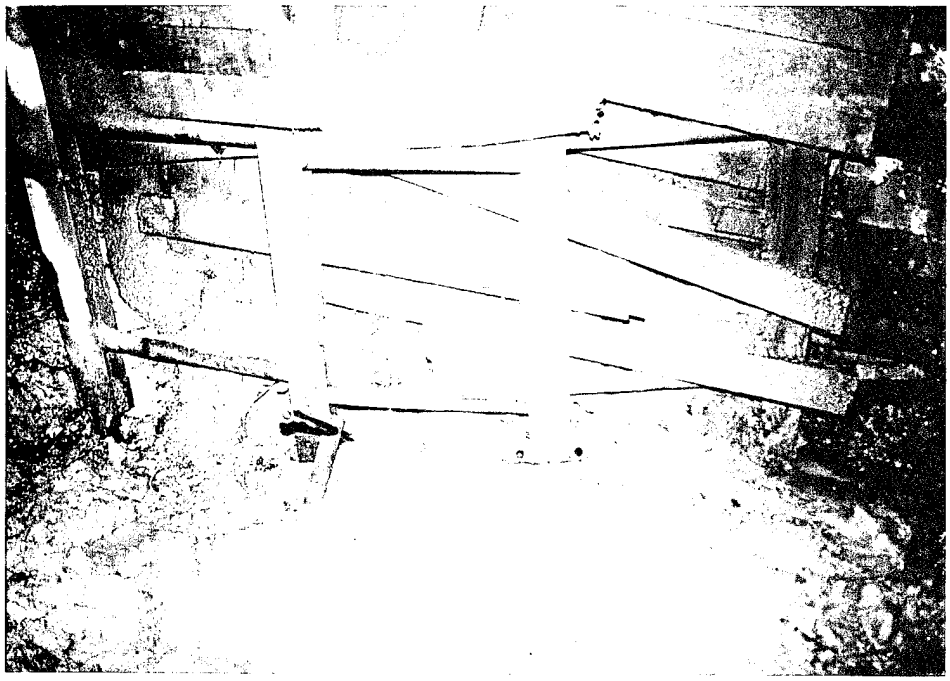
PHOTO T15. Same area as previous photos. Looking more directly at lower part of left side of tunnel. Yellow material at bottom of sets is fault gouge. Water flowing from fault was visually estimated at greater than 20 gpm.

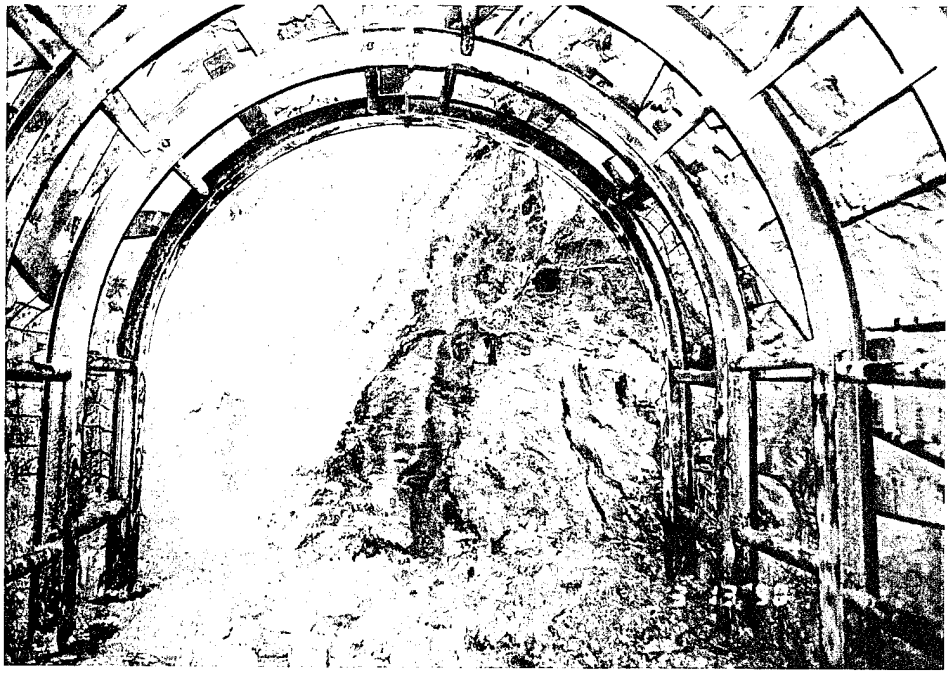
PHOTO T16. Looking upstream at the Set 263 Fault in heading at about Sta. 18+32. Yellow-brown clay gouge and breccia slope across the left side of the photo.

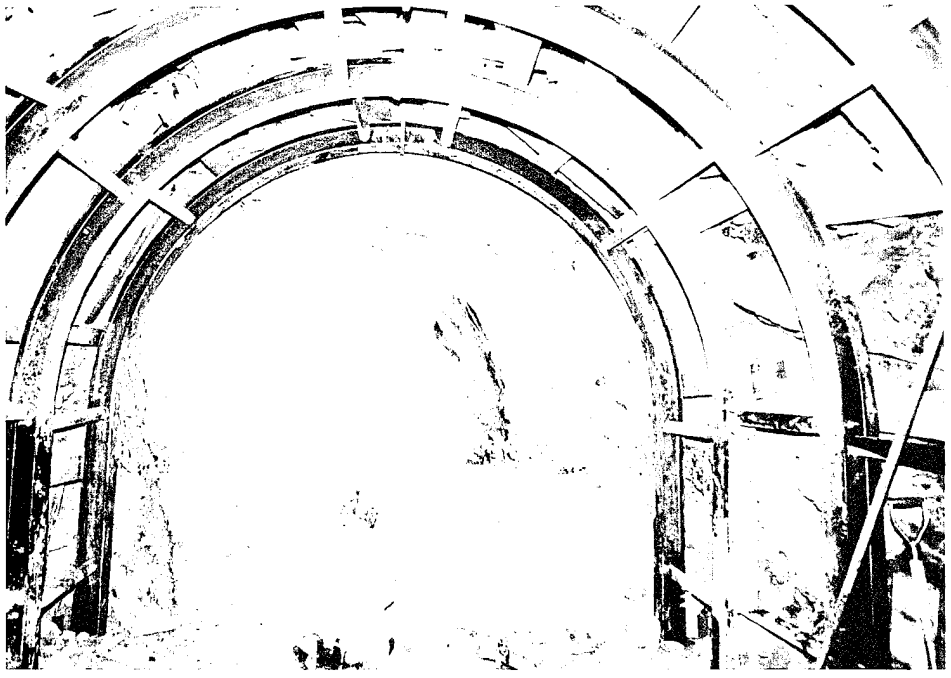
PHOTO T18. Looking upstream at the heading mapped at Sta. 17+89.

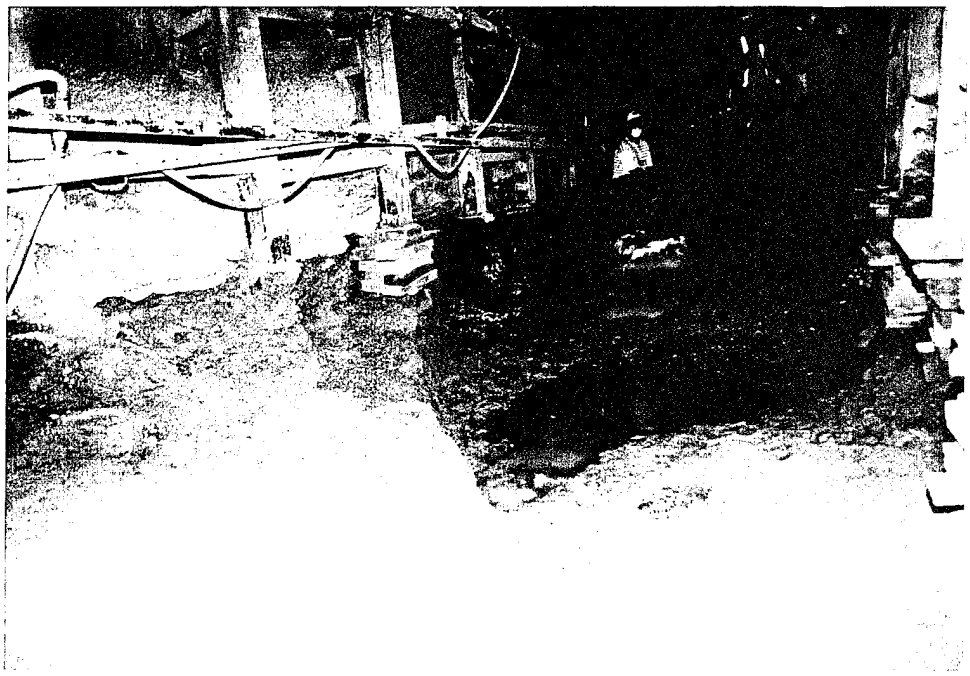
PHOTO T24. Example of where invert was seriously degraded. Note extensive wood blocking under the base of some sets. This resulted when muck was removed in preparation for placing the invert slab.

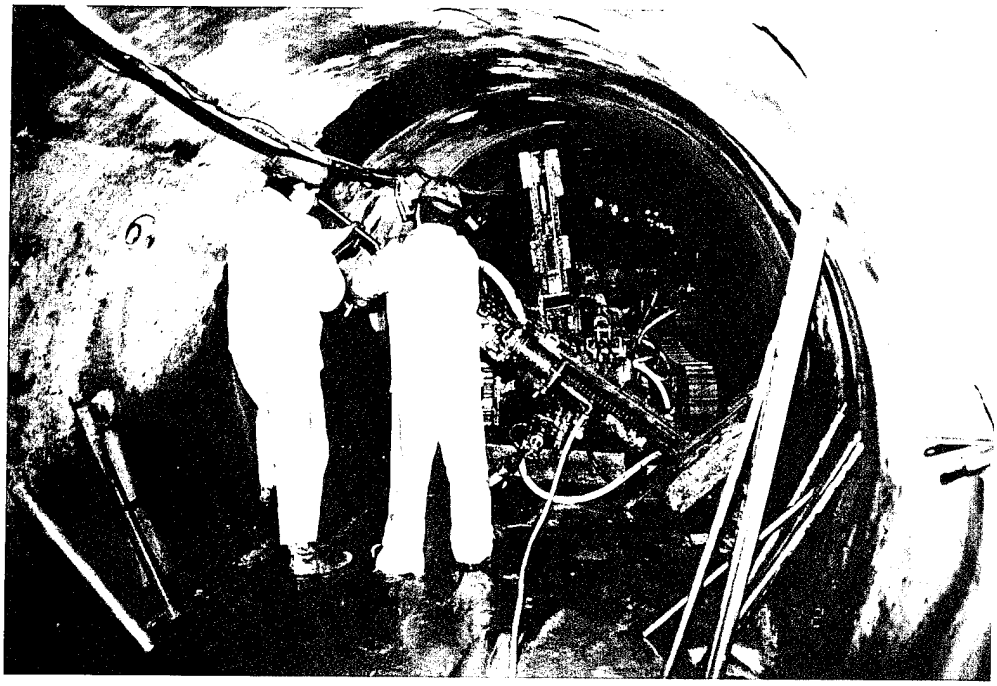
PHOTO T25. Crew drilling grout holes in adit.

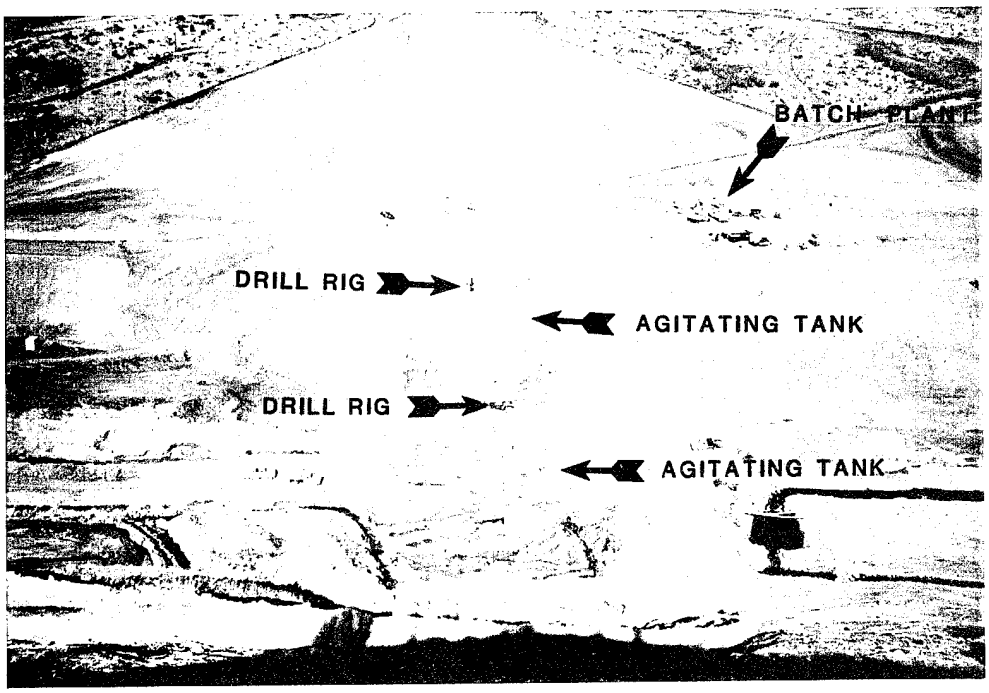
PHOTO GC1 (Grout Curtain 1). Overall curtain grouting operation viewed from the top of the left abutment

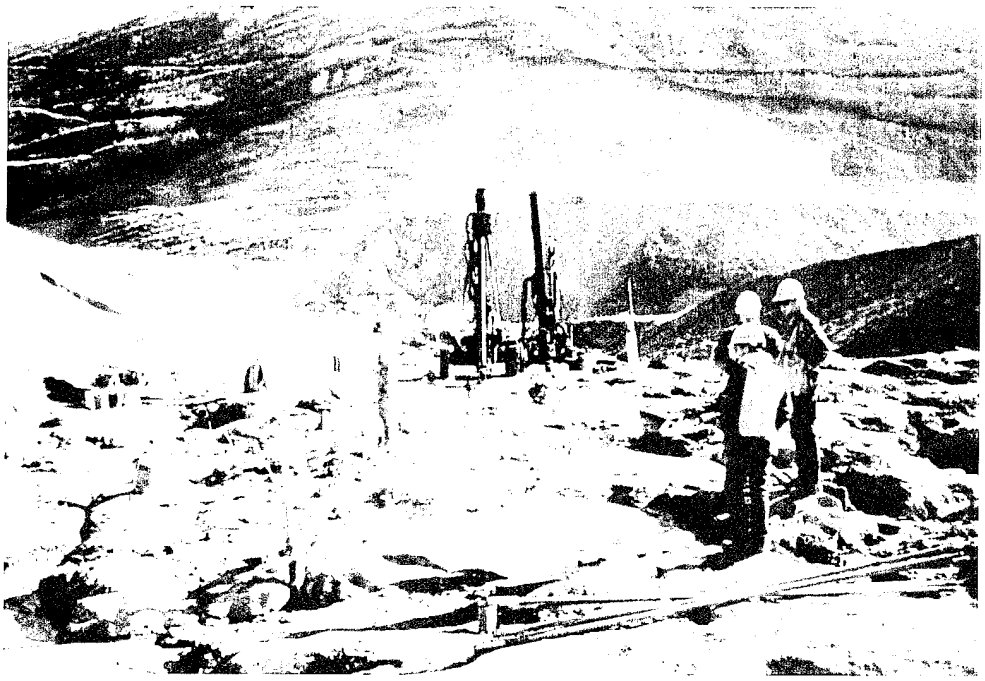
GC5 Inspecting the foundation grouting. Looking left at about Sta. 21+00.

PHOTO GC5. Inspecting the foundation grouting. Looking left at about Sta. 21+00.

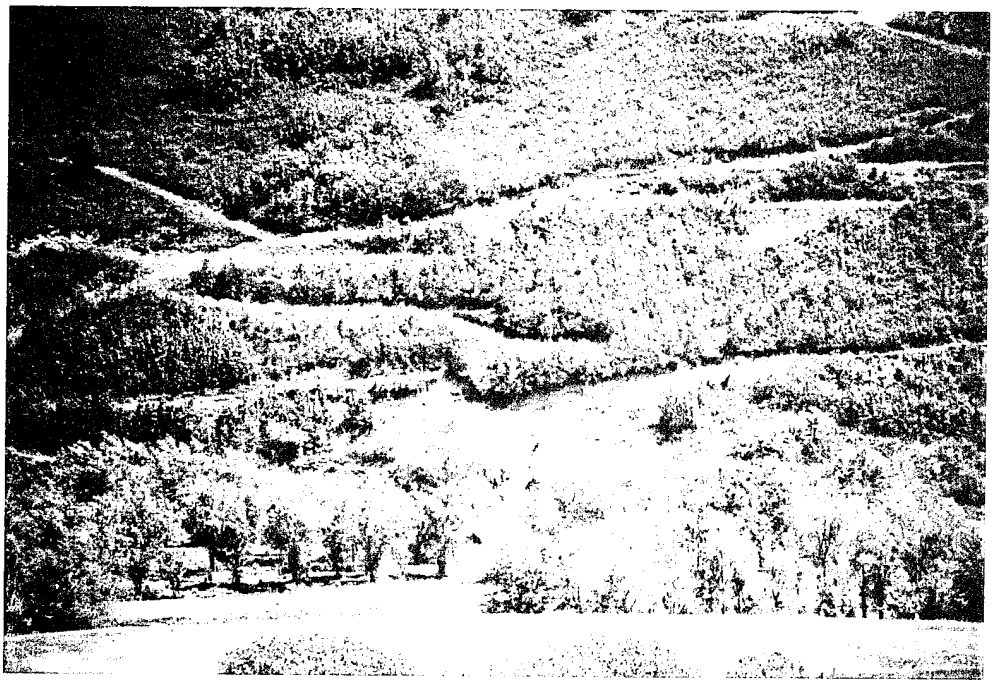
PHOTO P1 (Portals). View of the upstream portal area before beginning the excavation. Photo taken from Highway 65 with telephoto lens.

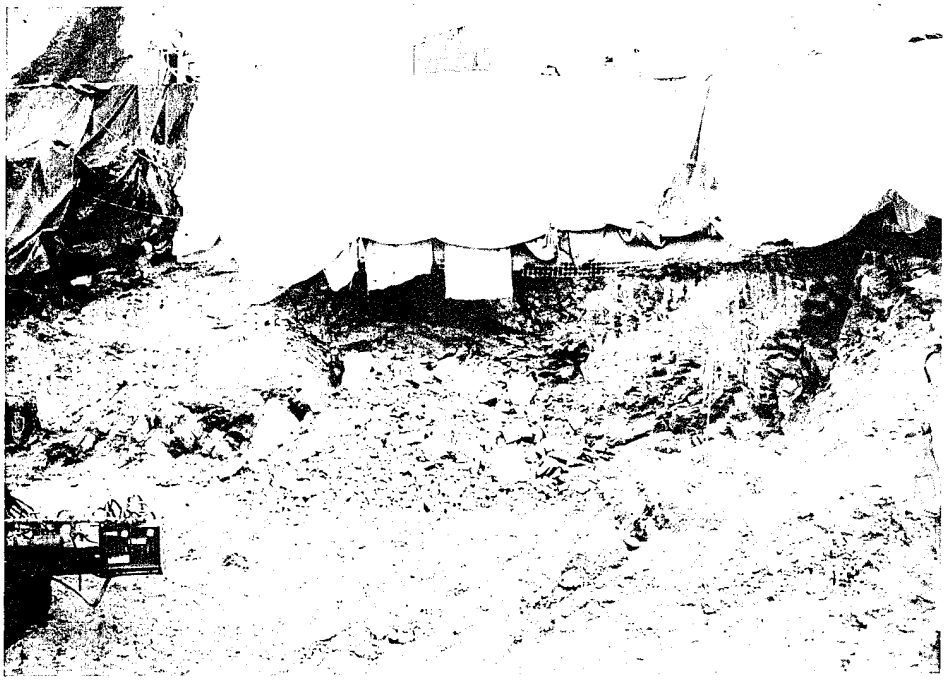
PHOTO P17. Failure of vertical face at downstream portal excavation. Cut failed in a weak, altered bed when a 14+ feet high increment was excavated without support.

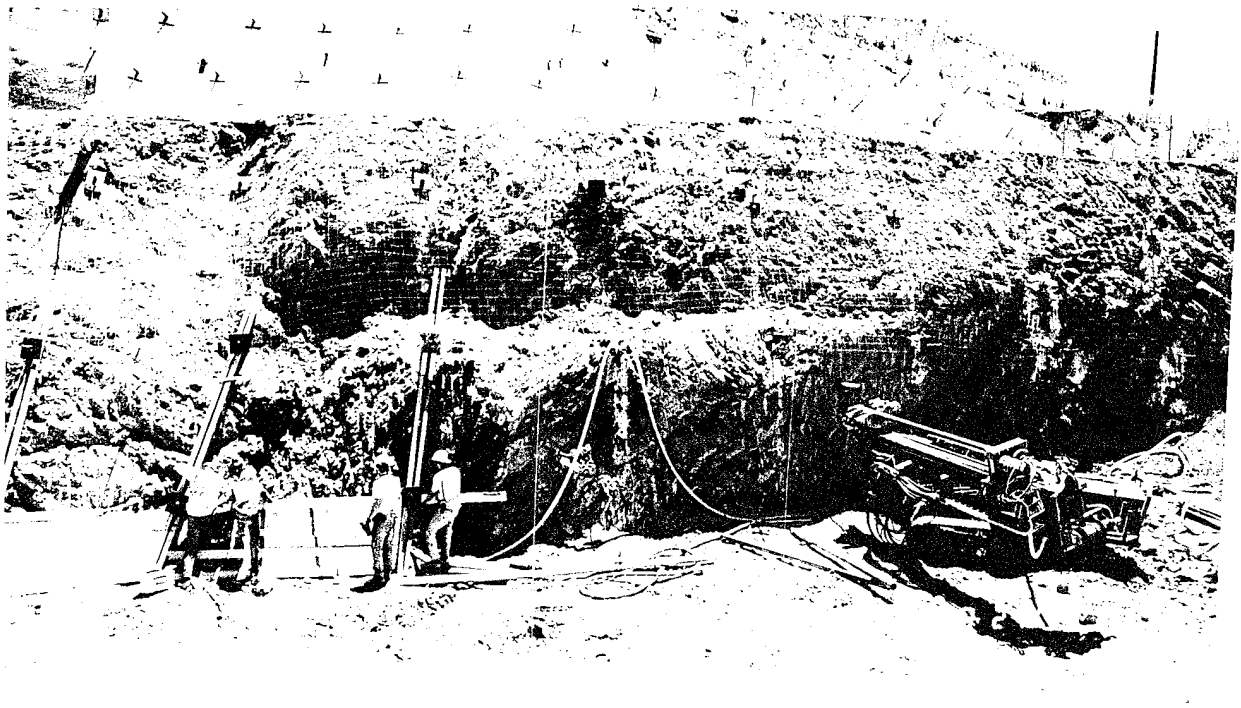
PHOTO D3. Looking south at rock anchors and wood cribbing being installed to support the unstable slope adjacent to the downstream wingwall foundations.

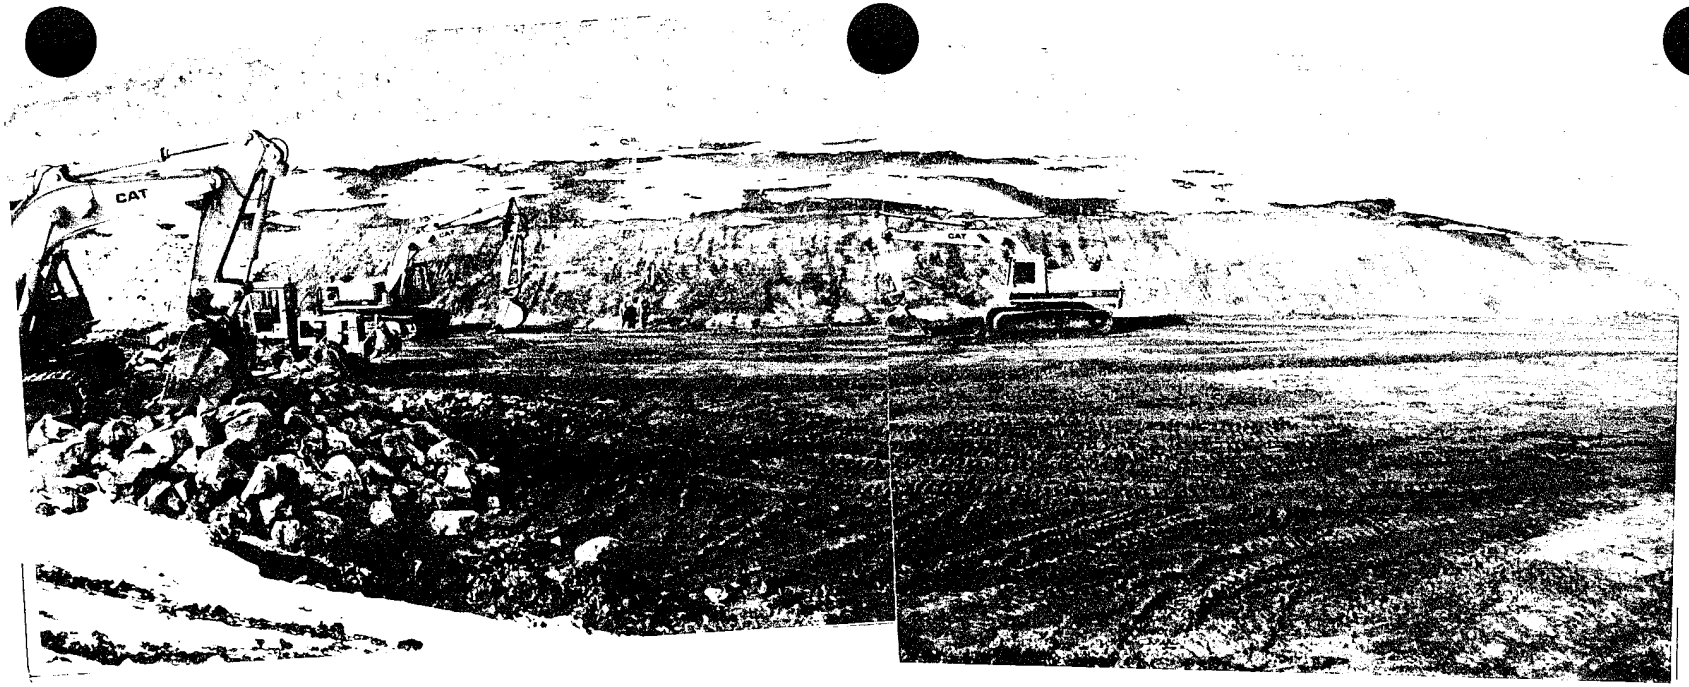
PHOTO S5. Looking right at the foundation for the rip rap on the upstream right cutslope of the spillway.

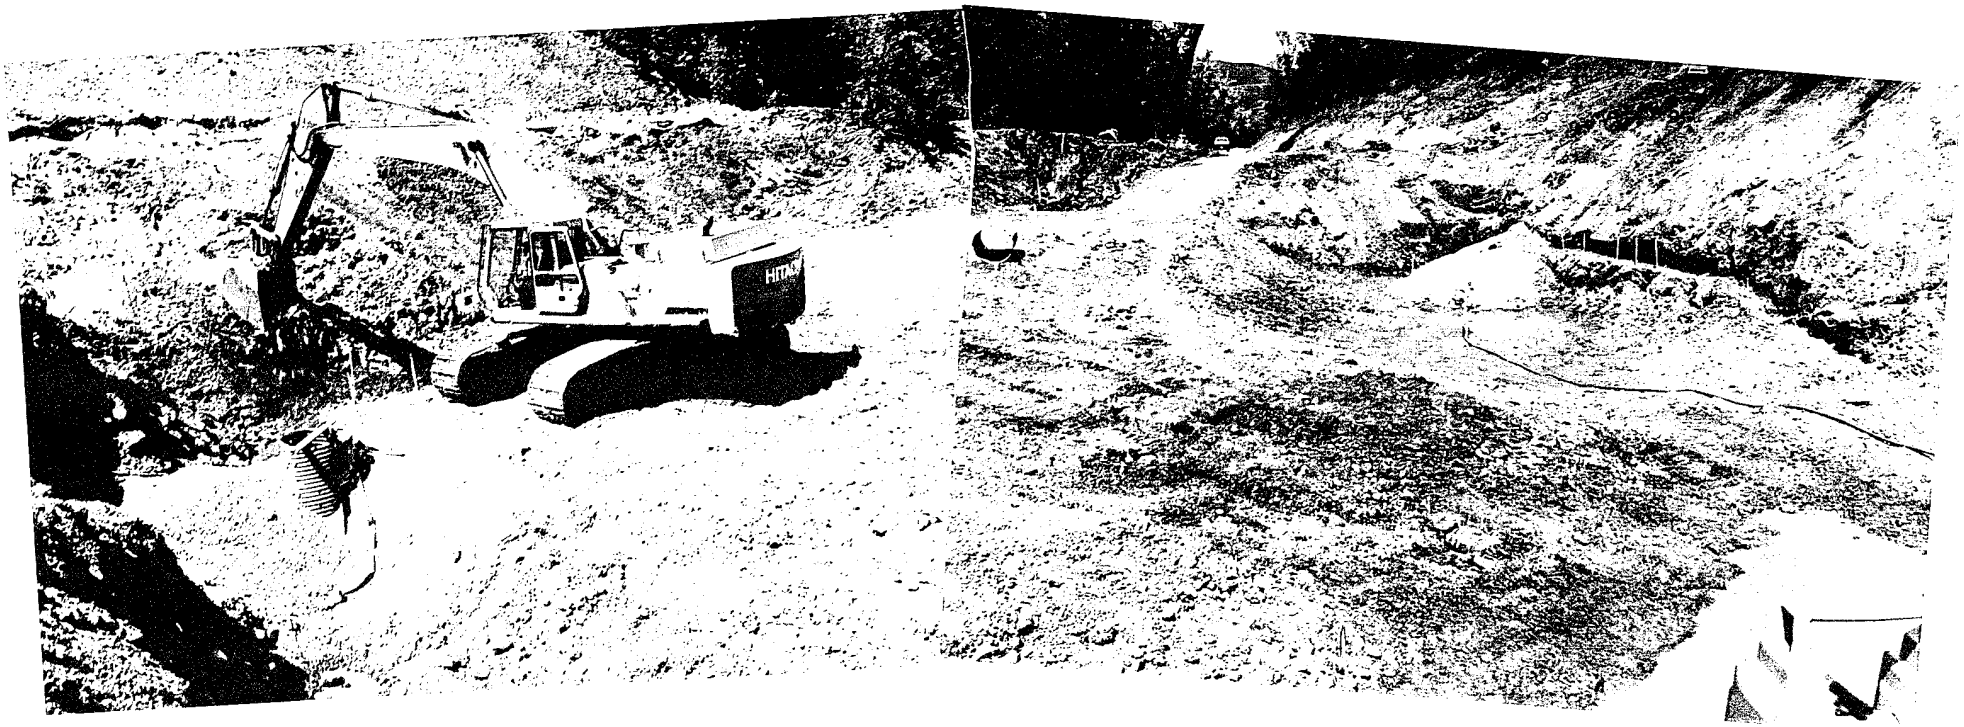
PHOTO PC1 (Parley's Creek Diversion Structure). Looking downstream from the upstream end of the Diversion Structure foundation. The Hitachi trackhoe is doing final excavation before placing fill at the spillway. The right half of the foundation requires additional excavation.

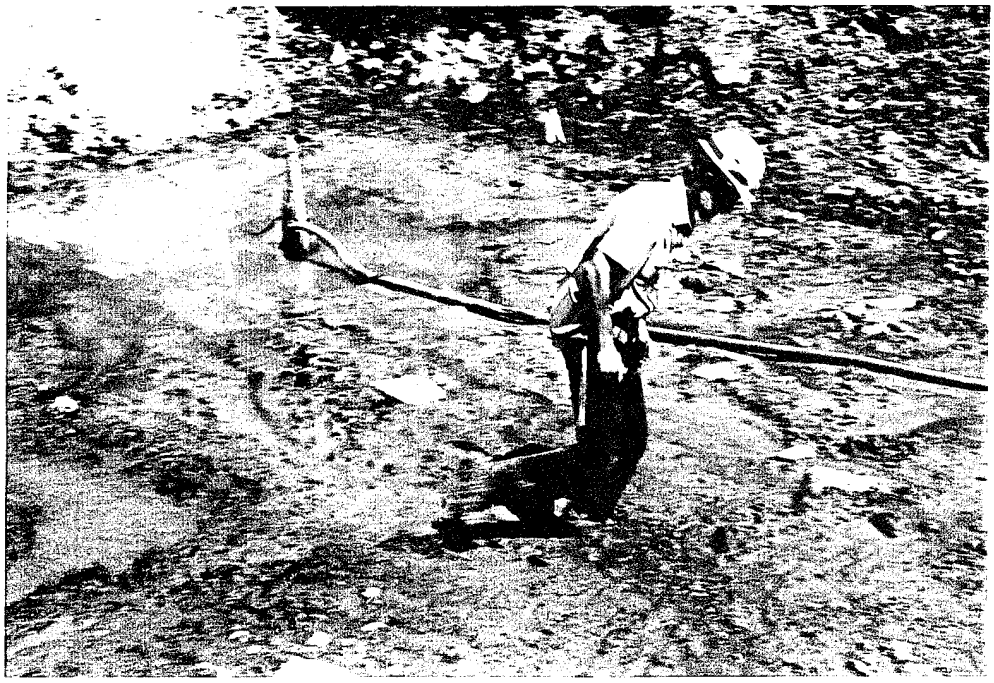
PHOTO PC2. Foundation of the downstream right half of the structure continued to deteriorate until all the alluvium was removed, in part because the Contractor could not control ground water.

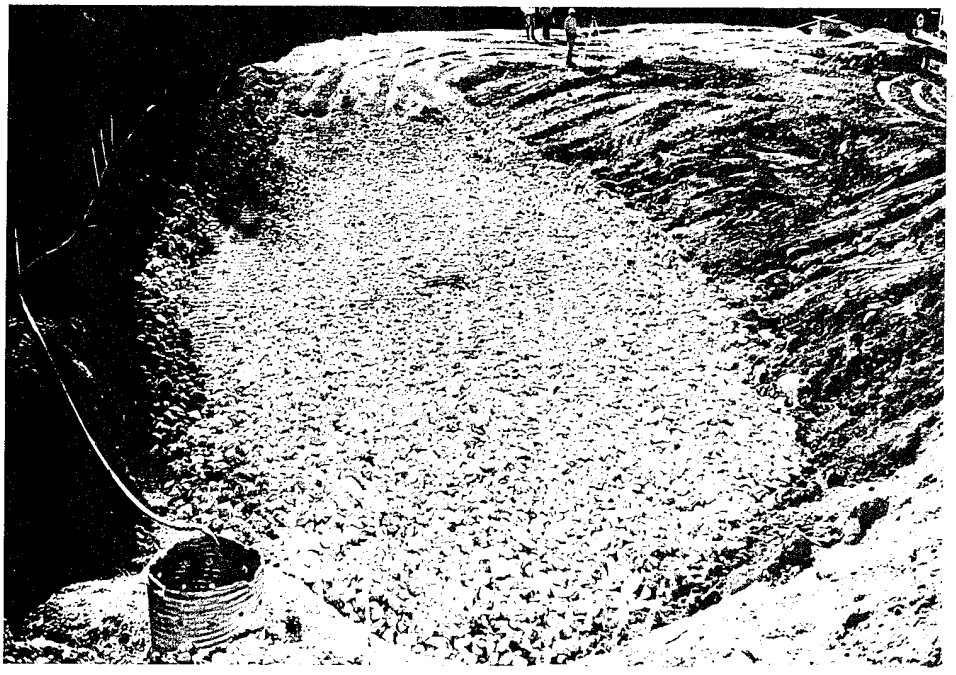
PHOTO PC5. The foundation at the downstream right corner of the diversion structure as approved.

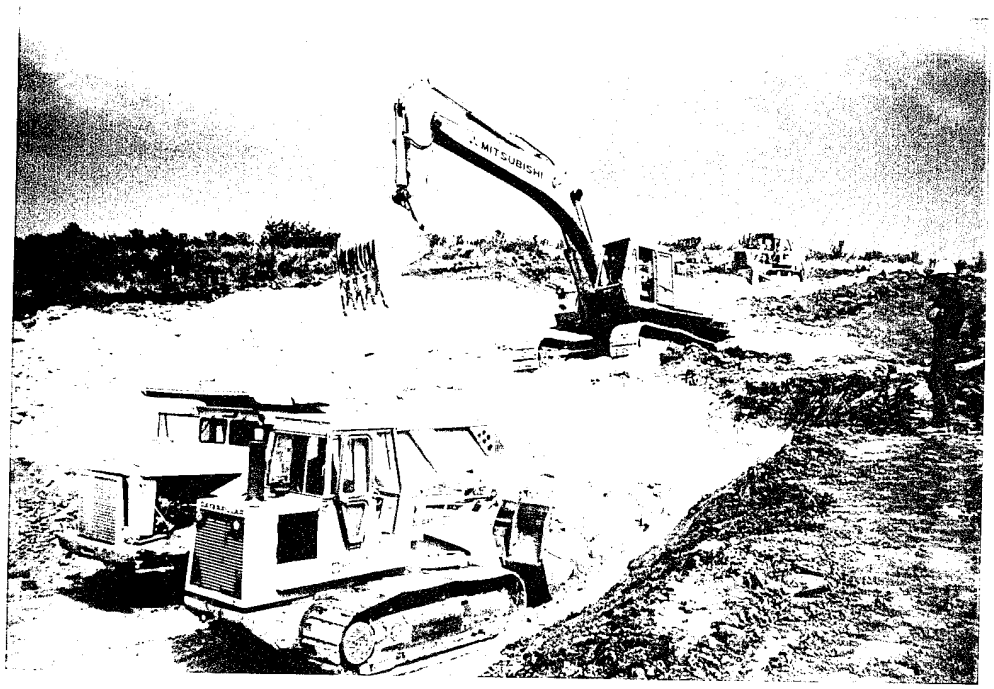
PHOTO E1 (Equipment 1). Dozer, track hoe, front end loader and dump truck excavating at the upper right abutment during the core trench contract.

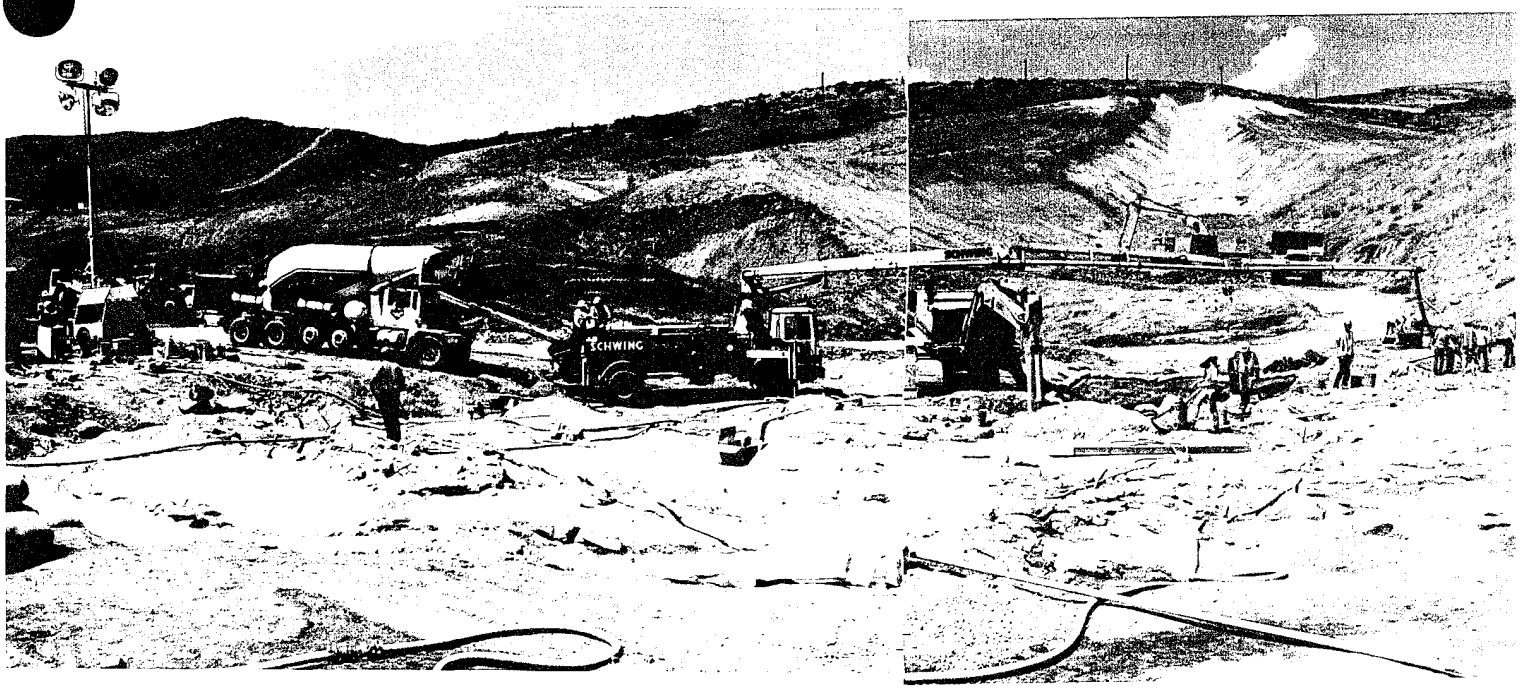
PHOTO E14. Concrete truck and concrete pump truck placing leveling concrete near Sta. 15+00, toe of upstream cutslope.

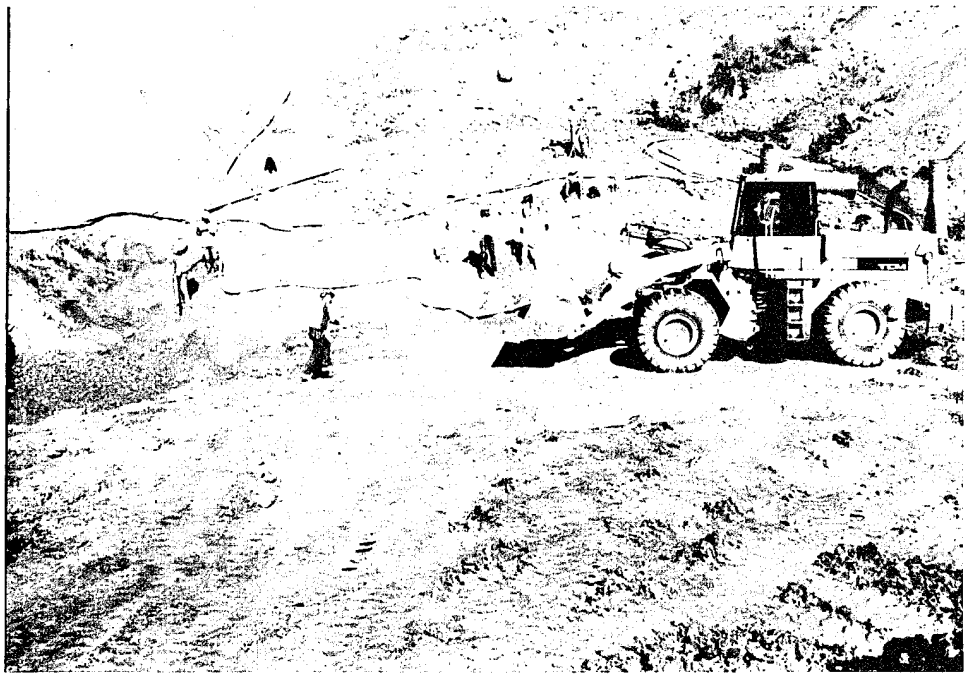
PHOTO E16. Mesco 870 front end loader wheel rolling impervious core against core trench abutment. Photo looks at right abutment approximate Sta. 22+50. Front edge of bucket is near centerline.

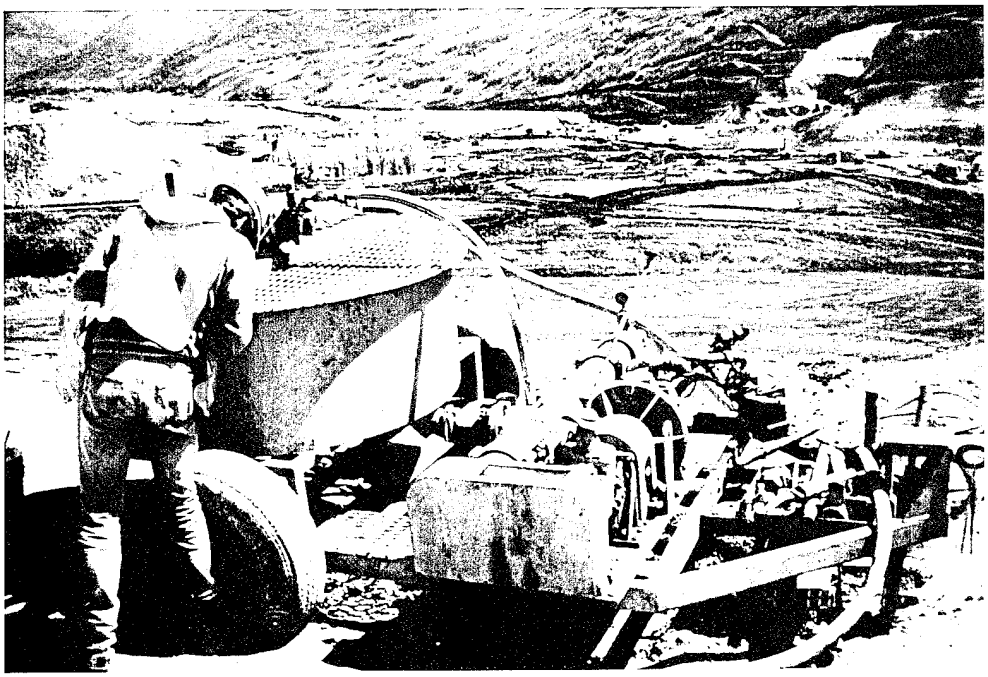
PHOTO E17. Boyles Bros. shop frabricated agitating tank/transfer tub.

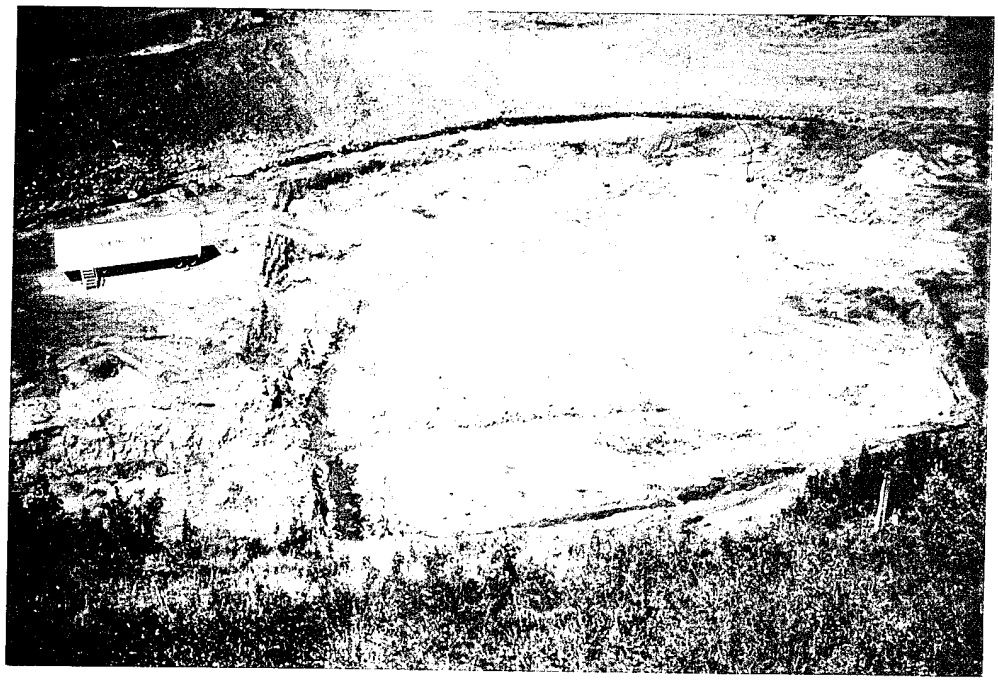
PHOTO CC2. Outlet Works intake area, looking upstream from the portal area at the foundation for the engineered fill under the intake structure and the cut-and-cover conduit.
