Report No. SFIM-AEC-BC-CR-95047

UNDERGROUND STORAGE TANK INVESTIGATION REPORT UMATILLA DEPOT ACTIVITY HERMISTON, OREGON

DAMES & MOORE
849 International Drive, Suite 320
Linthicum, Maryland 21090

JUNE 1995

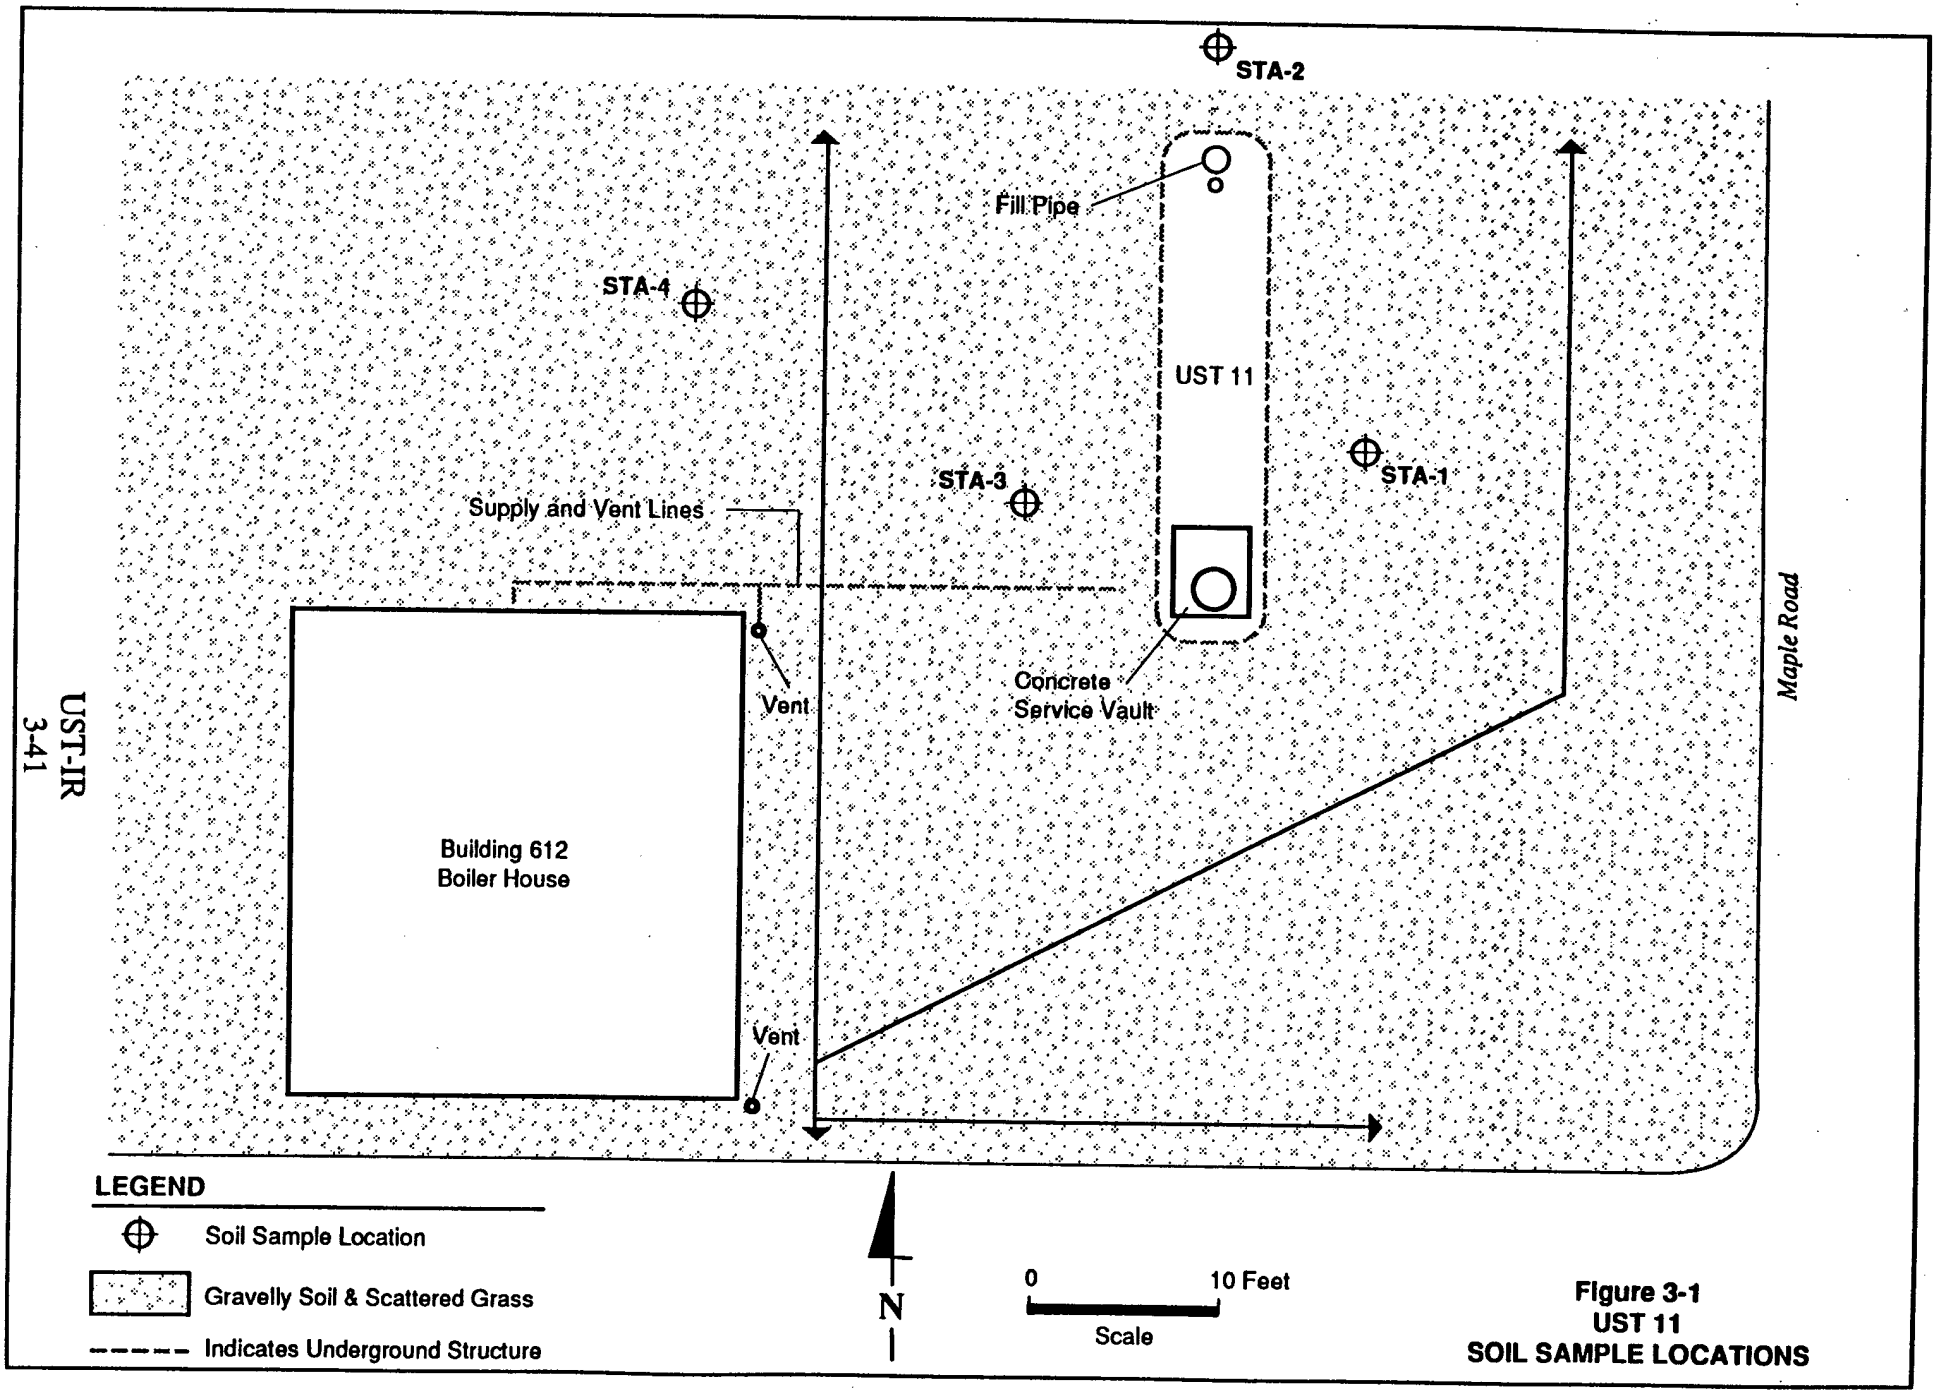
Figure 3-1
UST 11
SOIL SAMPLE LOCATIONS

highest PID reading. Samples were analyzed for TCL VOAs, TCL BNAs, and TPHCs. Soil sample locations are shown on Figure 3-1.

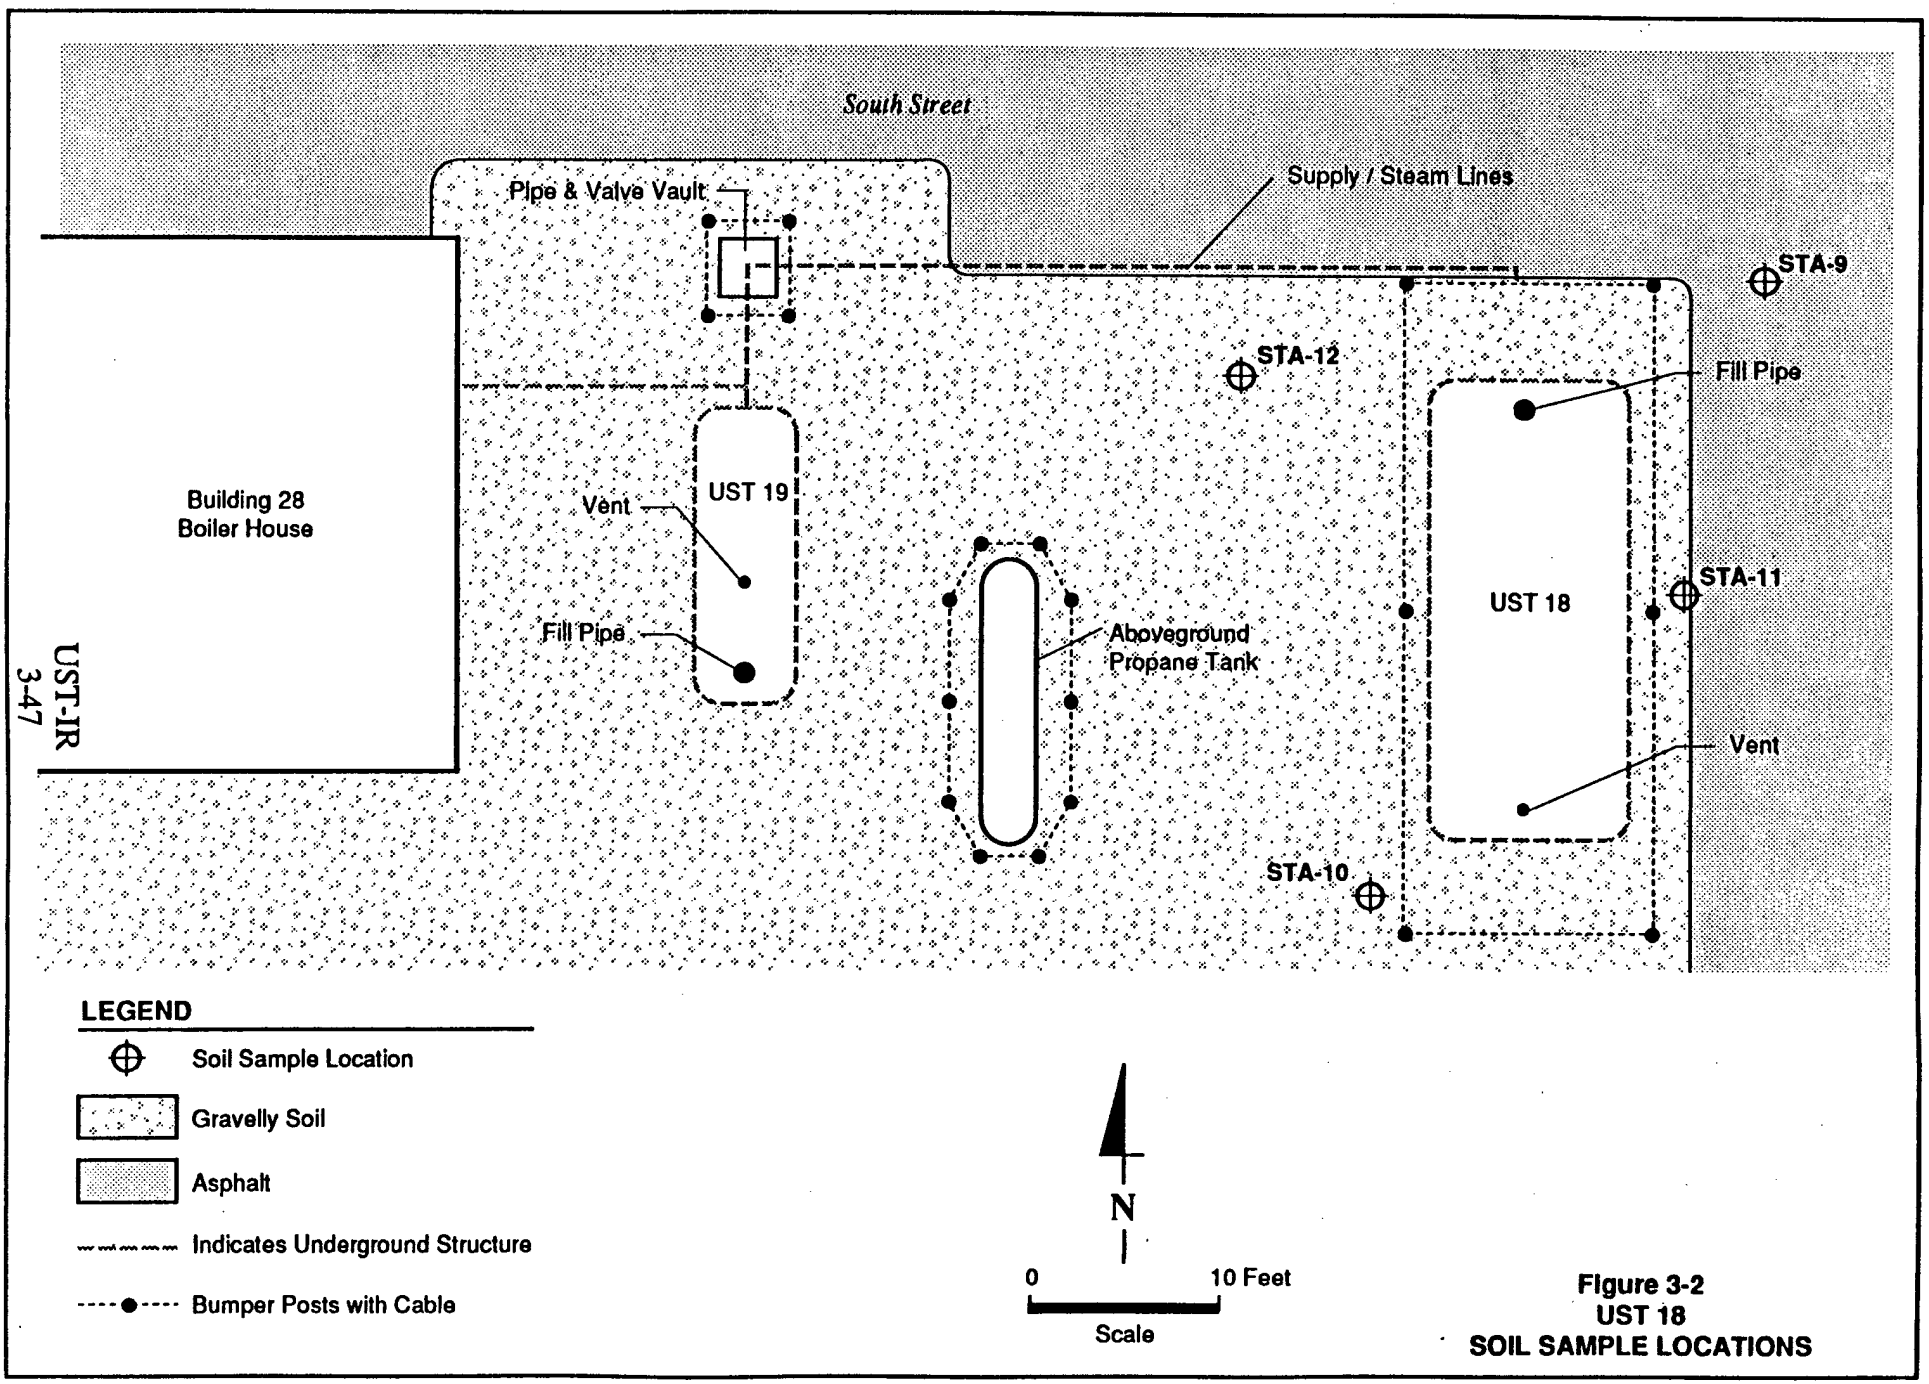
Figure 3-2
UST 18
SOIL SAMPLE LOCATIONS

Although tank leak test results were inconclusive, no TCL VOAs were detected in soil at UST 18, and TPHCs and one TCL BNA were detected in only one sample--each at low concentrations. Because the potential for contamination at this tank is low, no immediate action is recommended for UST 18. However, because U.S. Army regulations require all USTs to be treated as regulated tanks, UMDA may consider

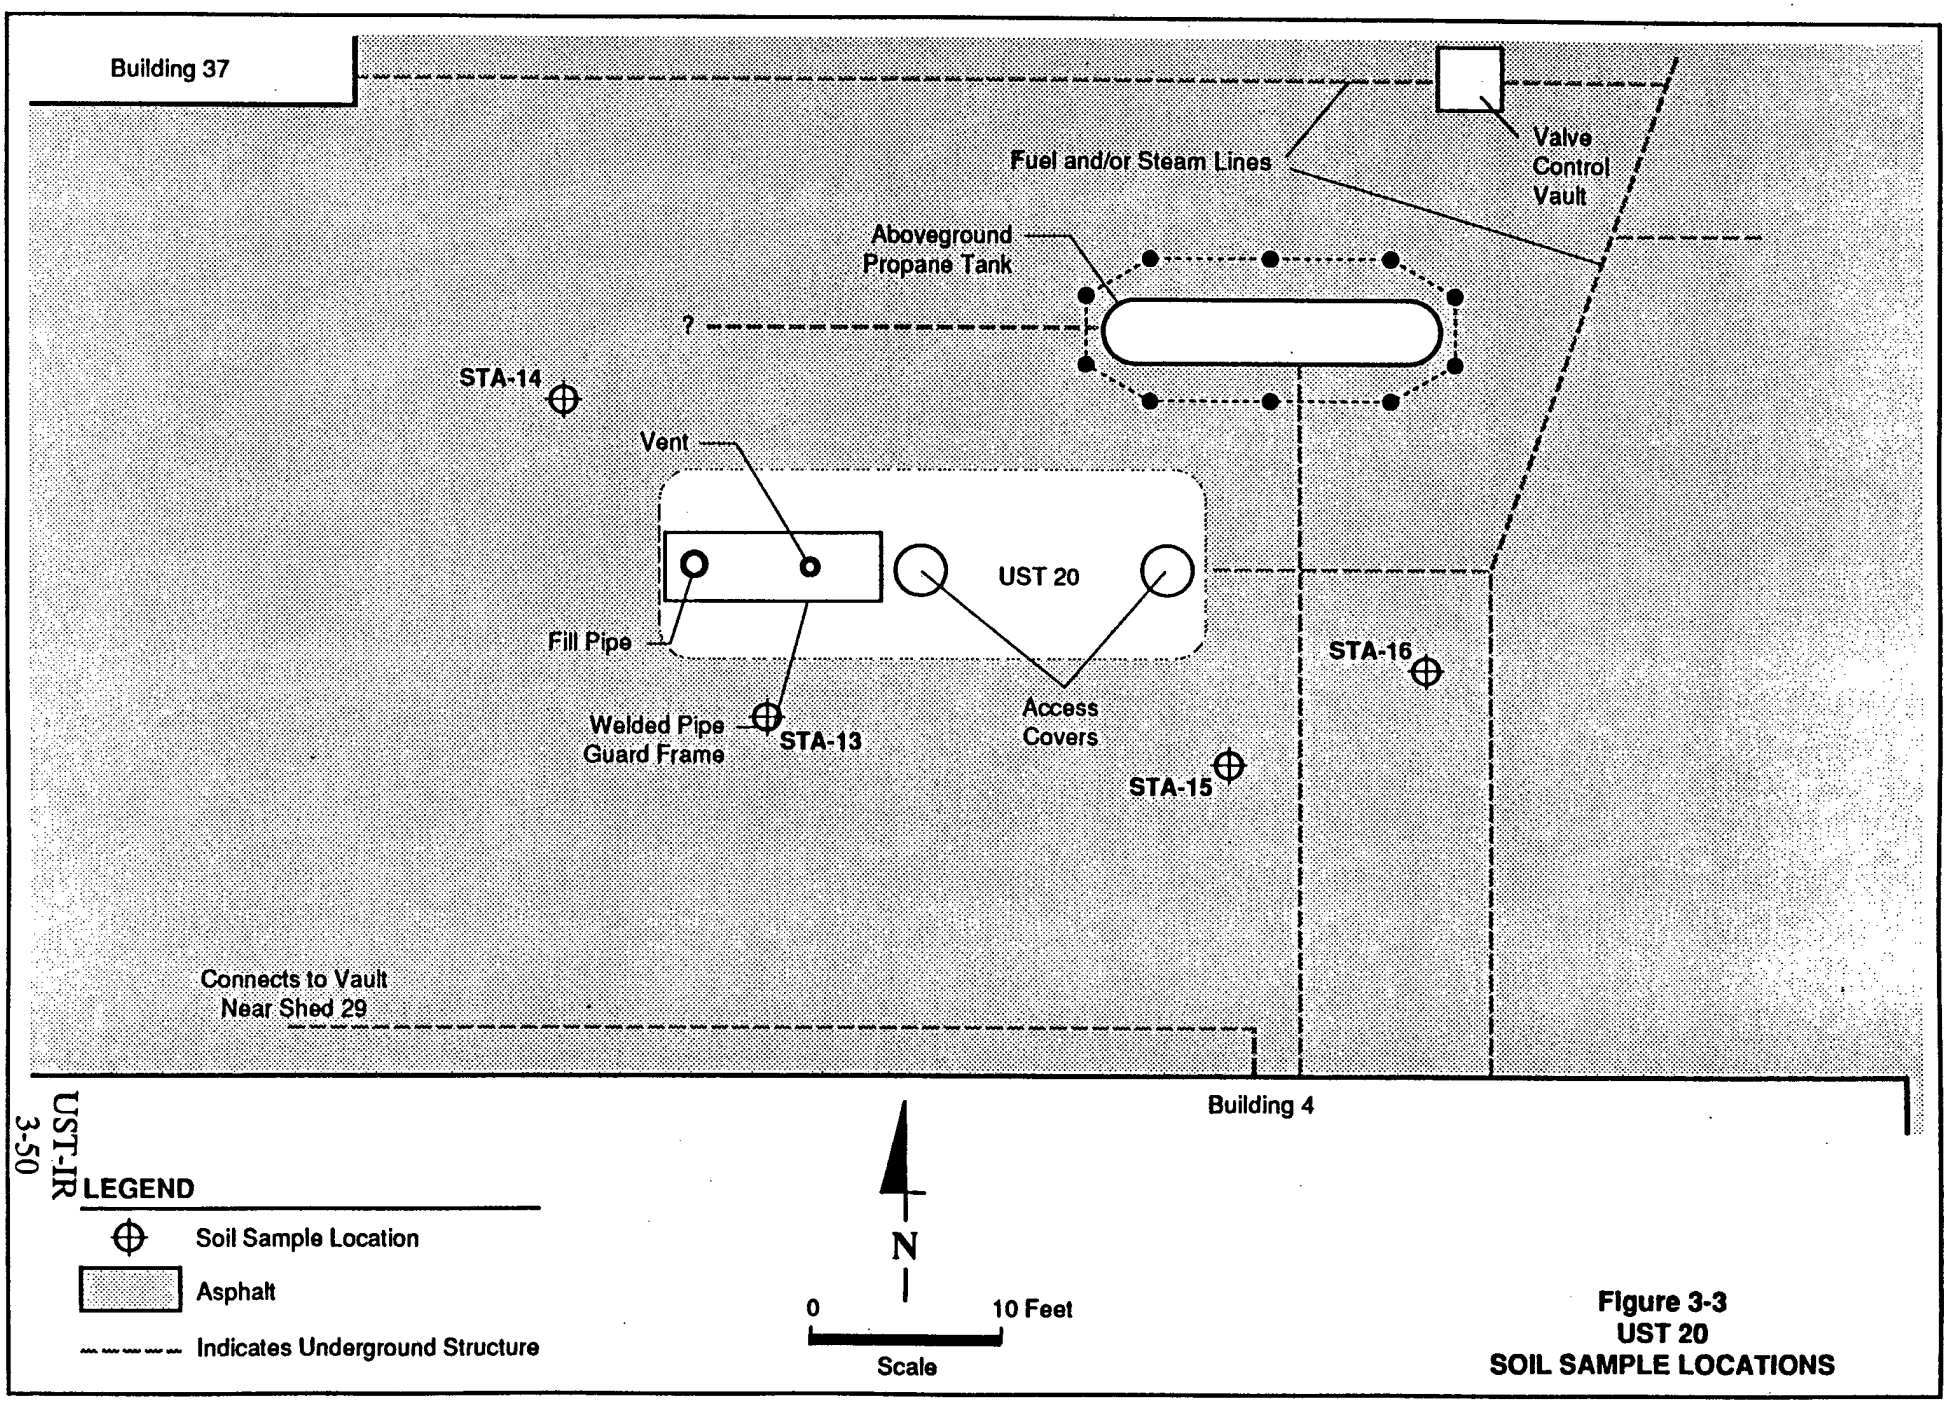
Figure 3-3
UST 20
SOIL SAMPLE LOCATIONS

Although tank leak test results were inconclusive, TPHCs were detected at low-to-high concentrations in soil at UST 20, indicating that fuel stored in this tank has leaked to the surrounding soil. Therefore, it is recommended that UST 20 be excavated and removed, and that the contaminated soil surrounding the tank be excavated and properly disposed of.

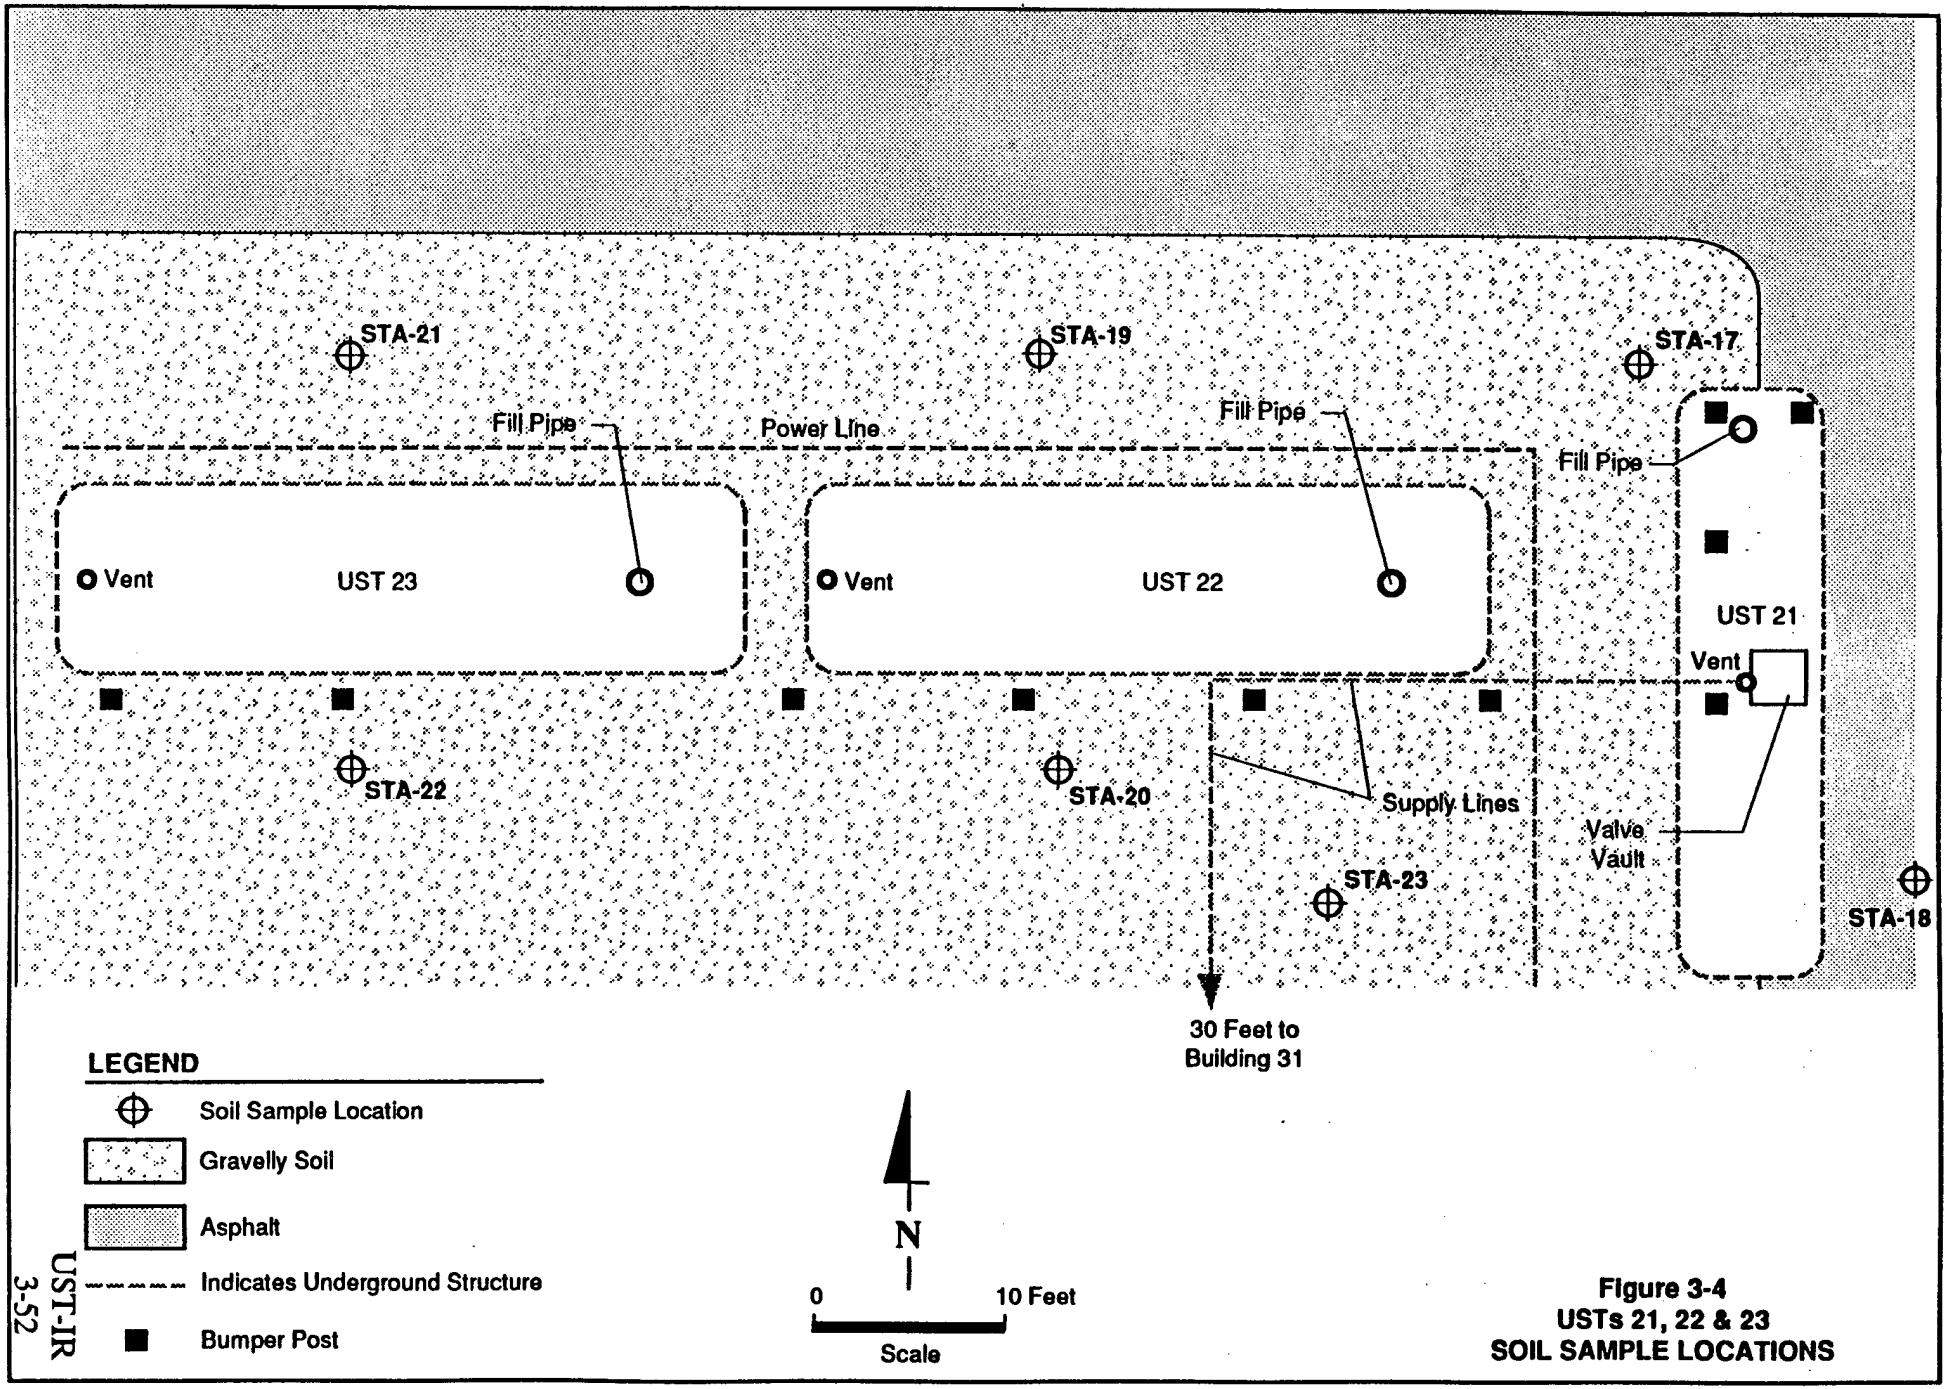
Figure 3-4
USTs 21, 22 & 23
SOIL SAMPLE LOCATIONS

Although tank leak test results for USTs 21 to 23 were inconclusive, no TCL VOAs, TCL BNAs, or TPHCs were detected in soil at the tanks. No immediate action is recommended for USTs 21 to 23, because the potential for contamination is low. However, because U.S. Army regulations require all USTs to be treated as

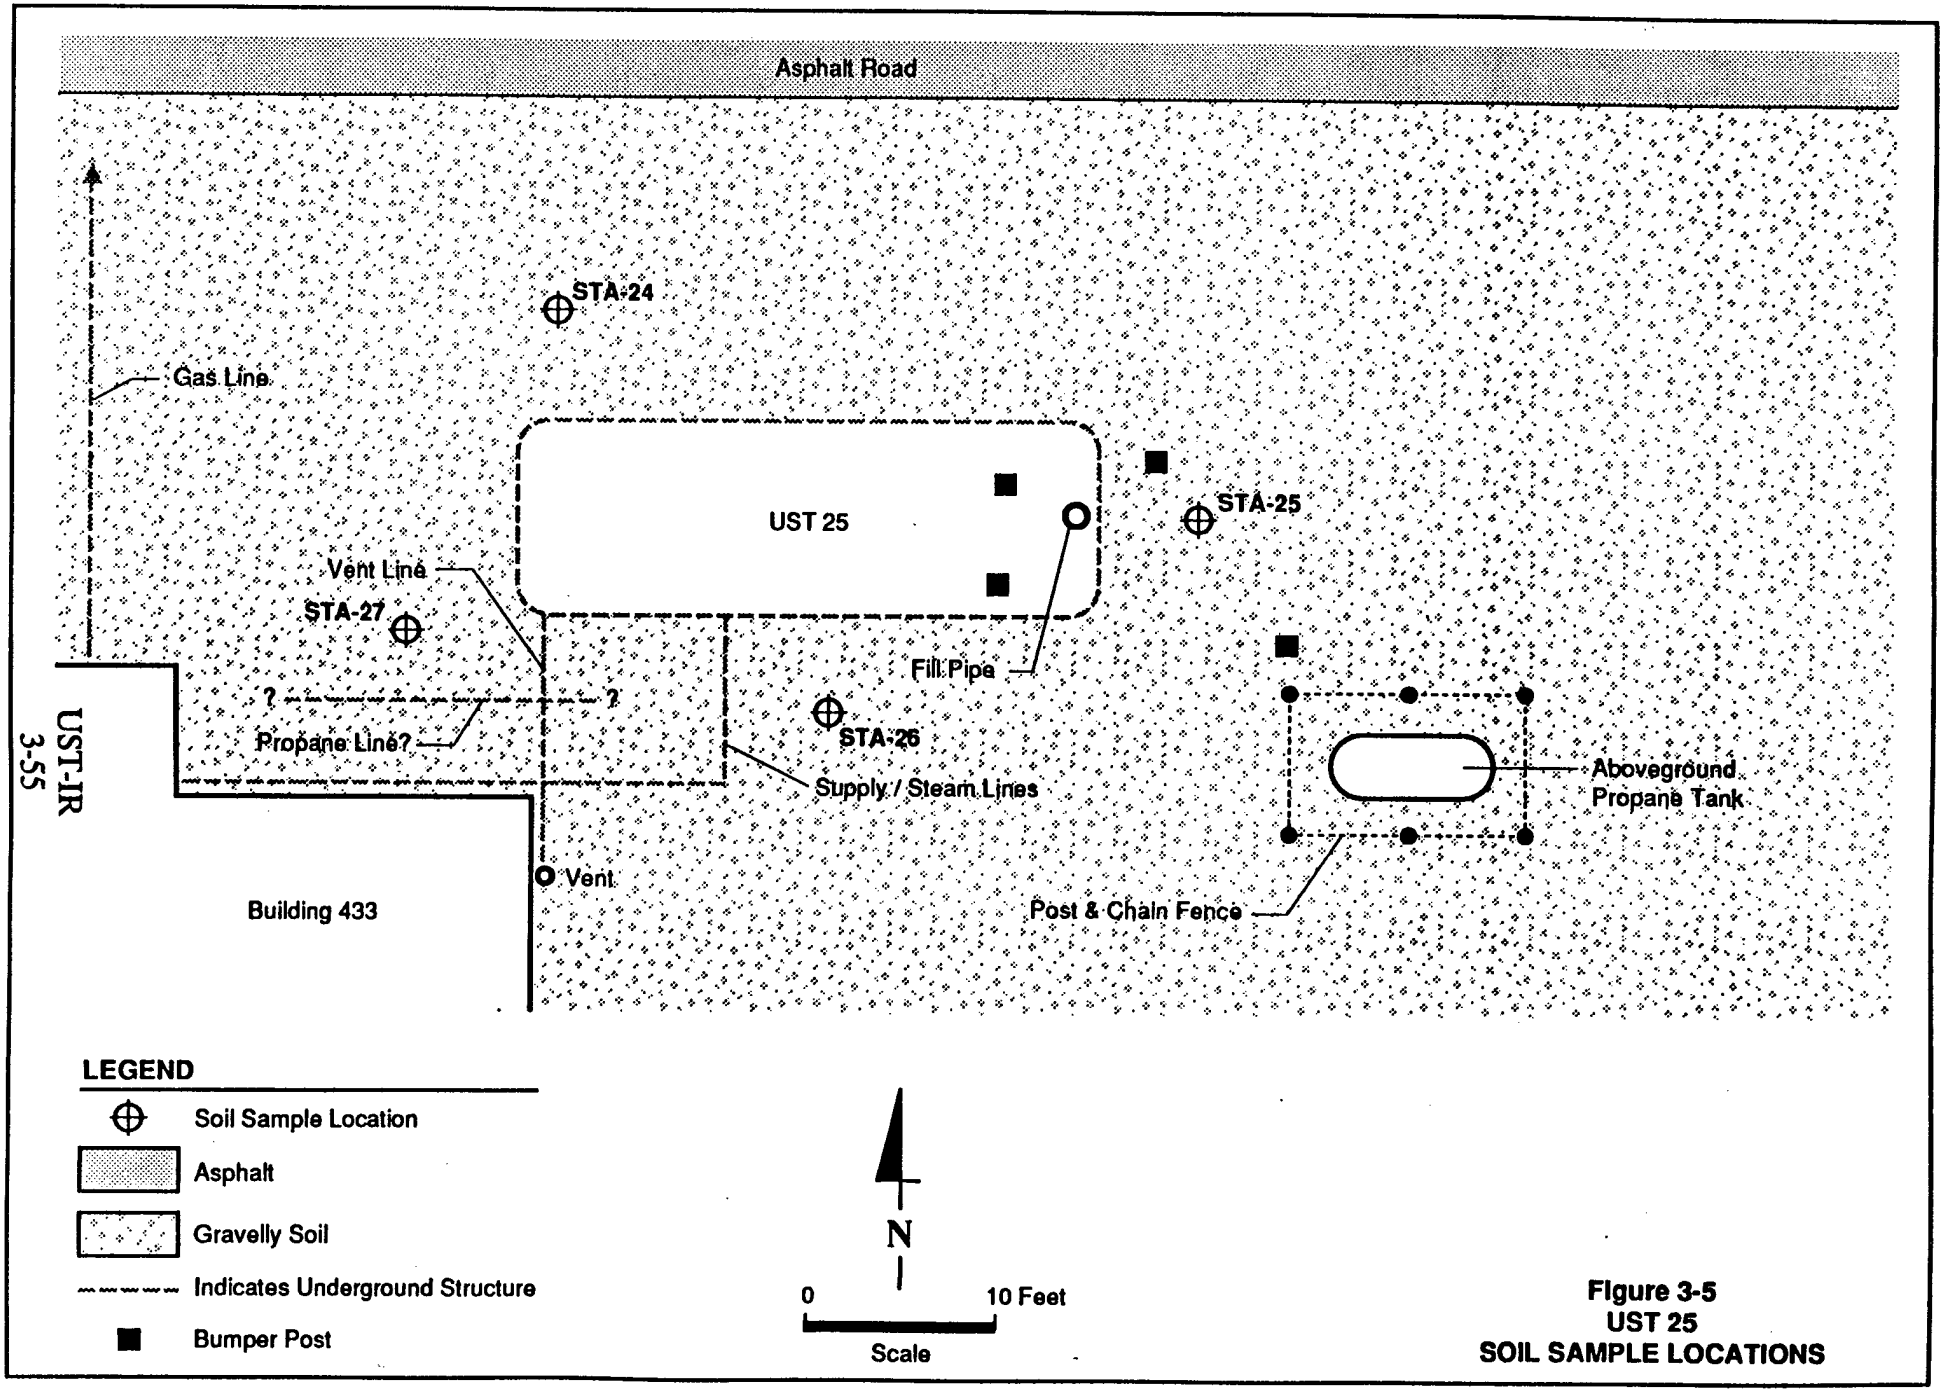
Figure 3-5
UST 25
SOIL SAMPLE LOCATIONS

2.7, soil samples were collected from the maximum depth of 10 feet in STA-24, STA-25, and STA-26 and from a depth of 6.5 feet in STA-27. All soil samples were analyzed for TLC VOAs, TCL BNAs, and TPHCs. Soil sample locations are shown in Figure 3-5.

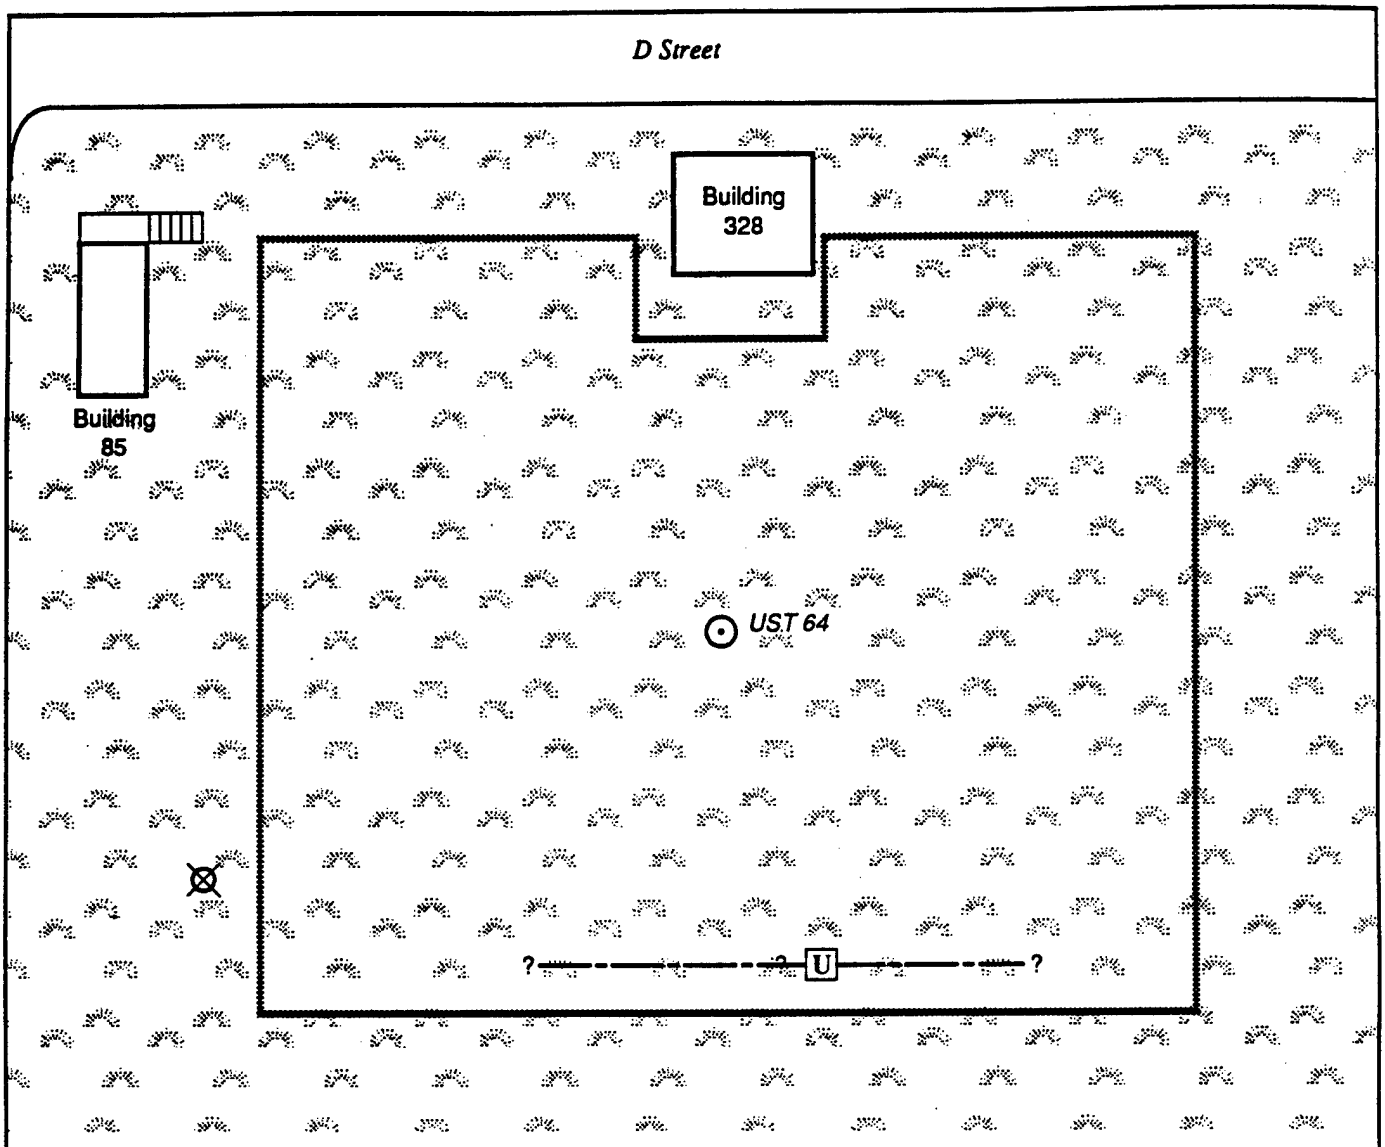
Figure 3-7 presents the active soil gas results for the BTEX and TVHC components of the survey conducted at UST 64. Results of the carbon dioxide and methane components of the survey are presented in Appendix D. The soil gas survey results indicate trace levels of benzene, toluene, and TVHCs at some of the 20 sampled locations. Ethylbenzene and xylene were not detected at this site. Benzene was detected in nine samples, with concentrations ranging from 0.06 (which is slightly greater than the detection limit of 0.04 microgram per liter (μg/L)) to a maximum of 0.5 μg/L. Toluene was detected at five locations coincident with benzene detections; it was reported at concentrations ranging from 0.1 (which is slightly greater than the detection limit of 0.05 μg/L) to a maximum of 0.5 μg/L. TVHCs were reported at six of the locations, with concentrations ranging from 0.4 (which is slightly greater than the detection limit of 0.3 μg/L) to a maximum of 3 μg/L.

Although detectable concentrations of volatiles were noted in the immediate vicinity of the reported location of UST 64, they are very low and are not considered to indicate significant, if any, contamination. Concentrations of all analytes were slightly greater to the south of the reported UST location, but these and other volatiles concentrations do not exhibit a consistent or contiguous pattern typical of

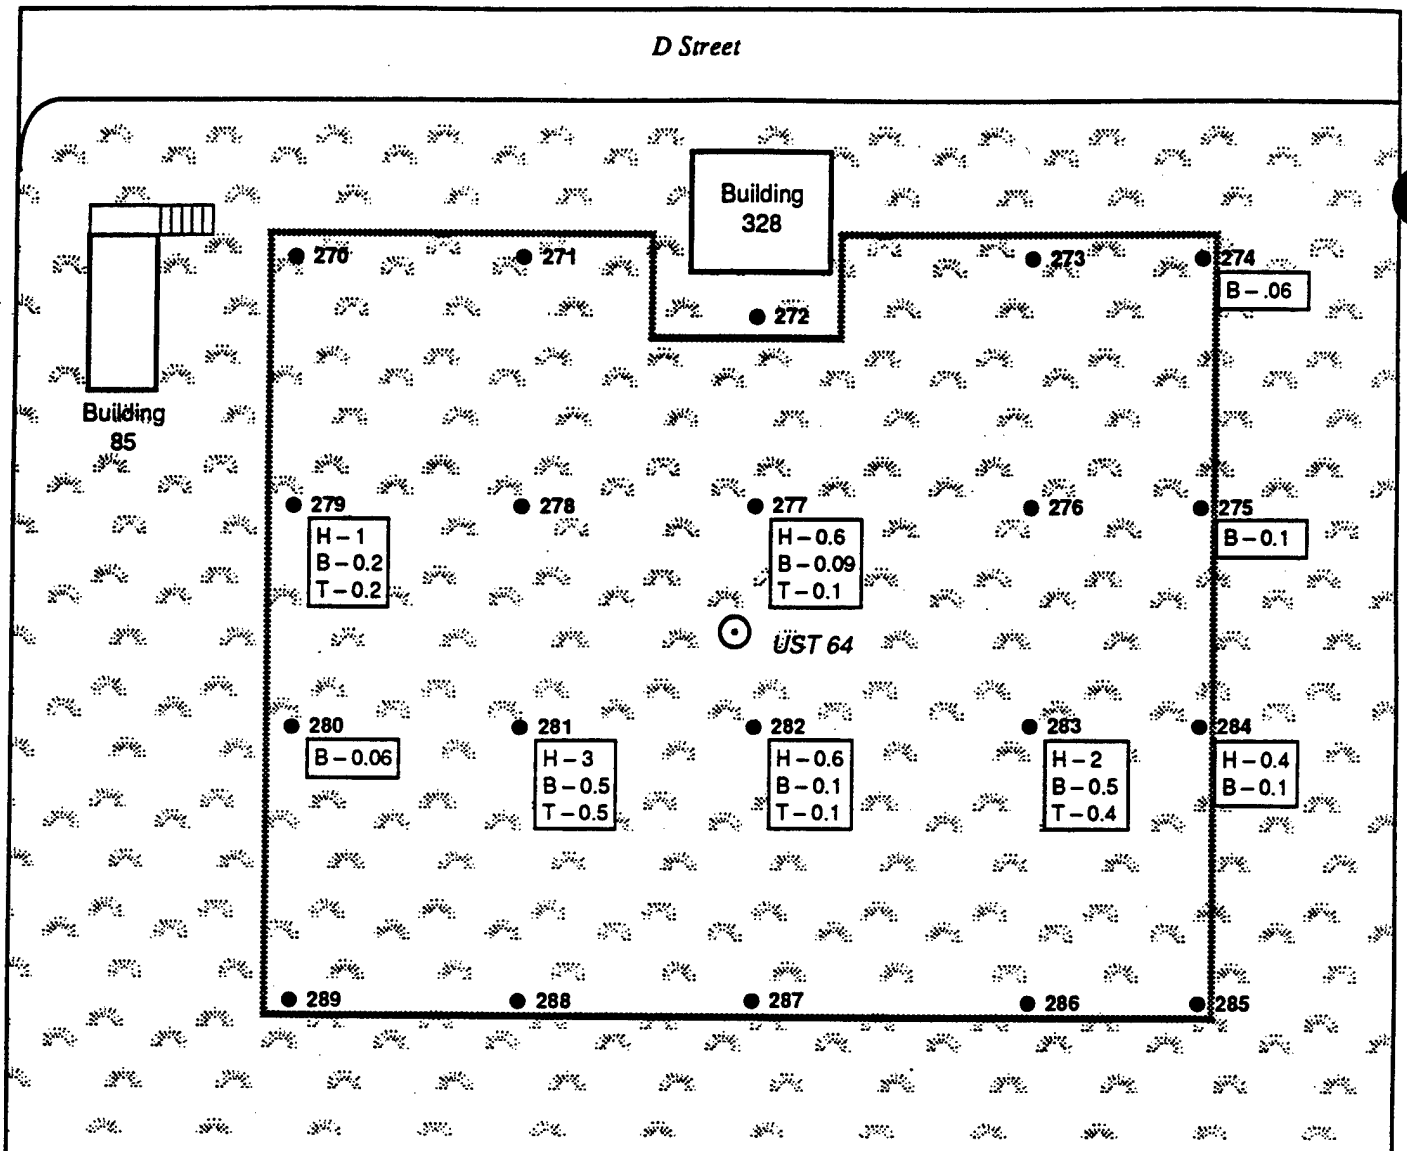
Figure 3-6
UST 64
RESULTS OF GEOPHYSICAL SURVEY

Figure 3-6 shows the reported location of UST 64 and summarizes the results of the geophysical survey. Detailed survey summaries and contour maps of the geophysical data are presented in Appendix C. The results of the survey indicate that it is unlikely that an UST is present within the surveyed area. Several magnetic and conductivity anomalies observed at the site were not characteristic of an UST and appear to be associated with underground utilities (i.e., possible abandoned water lines and a utility vault) or interference from Building 328, a small abandoned building placed on skids and stored near the former location of Building 84, which was moved behind the Services Branch Building. Magnetic interference prohibited the collection of data near the building. It is unknown whether the UST is or may have been located directly below Building 328, though this is considered to be unlikely.

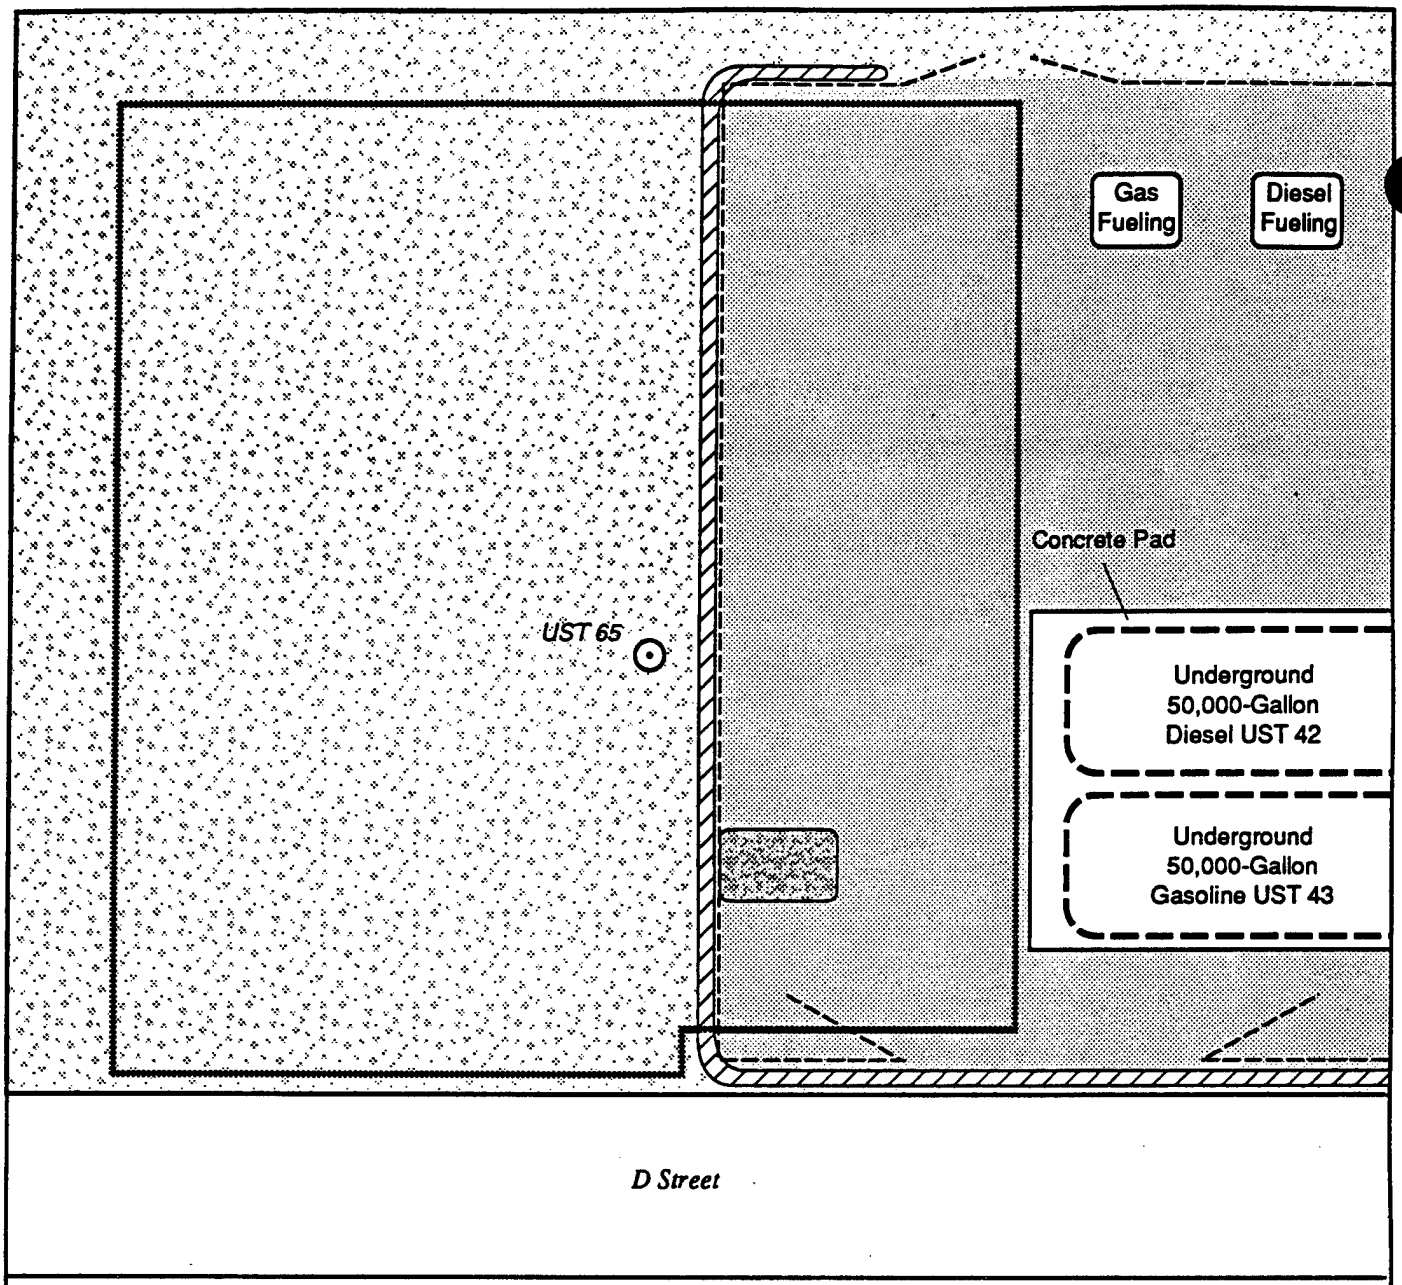
The results of the geophysical survey, which covered approximately 9,500 square feet, indicate that an UST is unlikely to be present in the area reported to contain UST 65. Although a small asphalt patch located in the southeast corner of the survey area may be the former location of an UST, data from the geophysical survey--though affected by the fence near the patch--do not indicate whether UST 65 had been here previously and was removed.

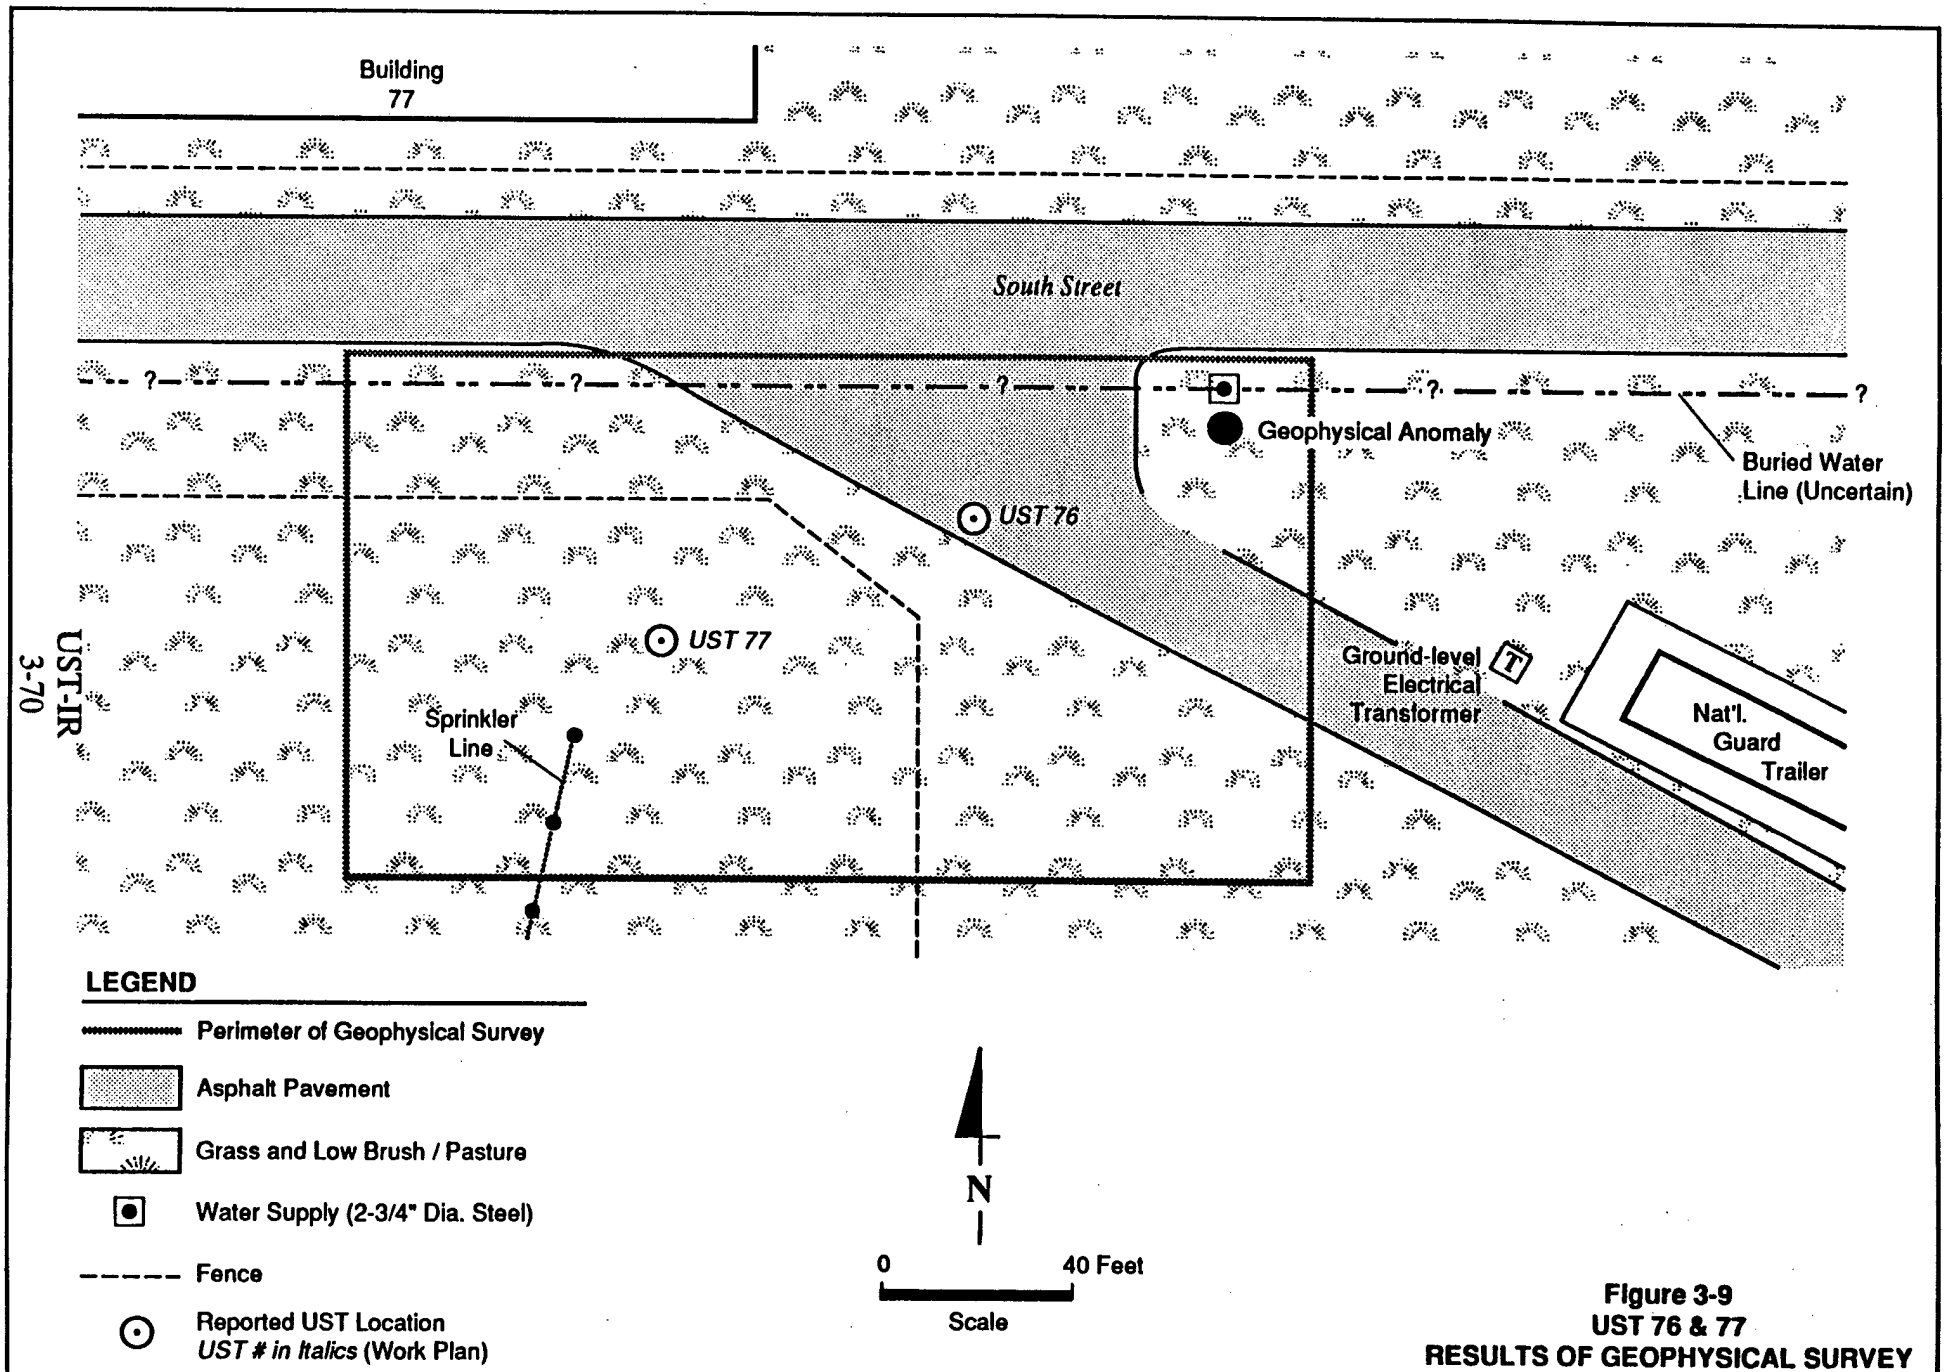
Figure 3-9
UST 76 & 77
RESULTS OF GEOPHYSICAL SURVEY

Figure 3-9 shows the reported locations of USTs 76 and 77 and summarizes the results of the geophysical survey. Detailed survey summaries and contour maps of the geophysical data are presented in Appendix C. The results of the geophysical survey indicate that it is unlikely that USTs are present within the surveyed area. Several magnetic and conductivity anomalies observed at the site were not characteristic of USTs and appear to be associated with underground utilities, such as a water line with
