Report No. SFIM-AEC-BC-CR-95047

UNDERGROUND STORAGE TANK INVESTIGATION REPORT UMATILLA DEPOT ACTIVITY HERMISTON, OREGON

DAMES & MOORE
849 International Drive, Suite 320
Linthicum, Maryland 21090

JUNE 1995

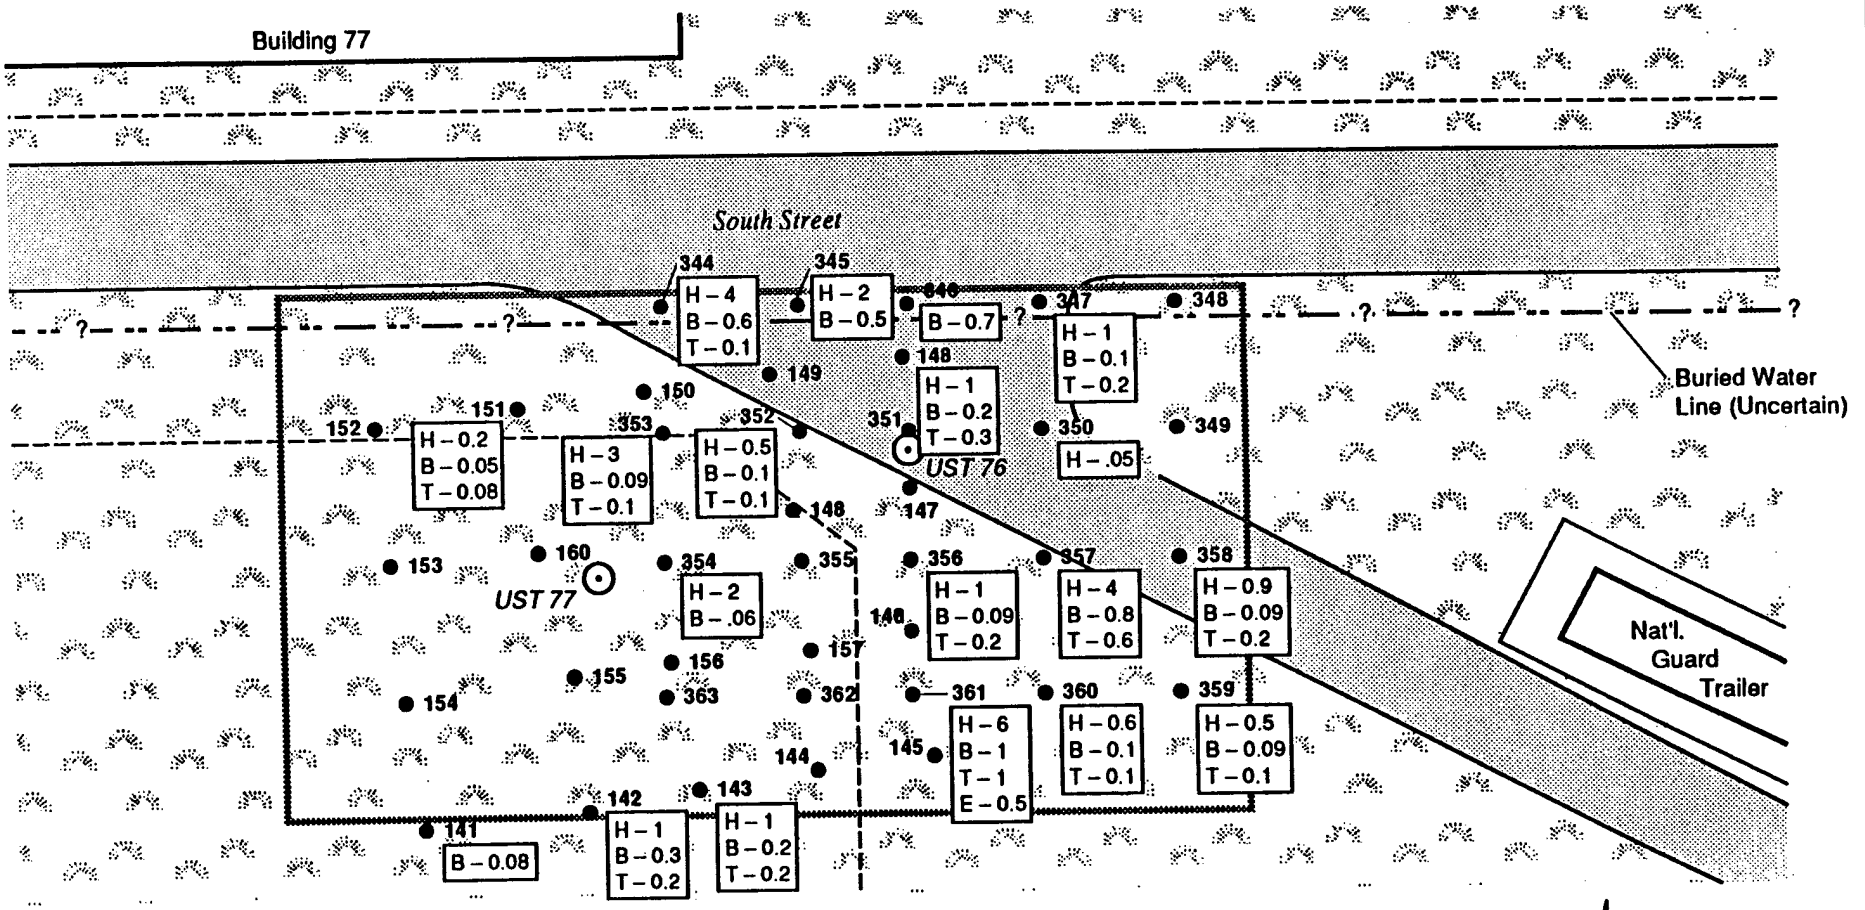
Figure 3-10 presents results for the BTEX and TVHC components of the active soil gas survey conducted at USTs 76 and 77. Results of the carbon dioxide and methane components of the survey are presented in Appendix D. The soil gas survey results indicate trace levels of benzene, toluene, ethylbenzene, and TVHCs at some of the 40 sampled locations. Xylene was not detected at this site. Benzene was detected in 19 samples, with concentrations ranging from 0.05 (which is slightly greater than the detection limit of 0.02 μg/L) to a maximum of 1 μg/L. Toluene was detected at 14 locations coincident with benzene detections; it was reported at concentrations ranging from 0.08 (which is slightly greater than the detection limit of 0.04 μg/L) to a maximum of 1 μg/L. Ethylbenzene was reported at one location, with a concentration of 0.5 μg/L, which is slightly greater than the detection limit of 0.1 μg/L. TVHCs were reported at 16 of the locations, with concentrations ranging from 0.2 (which is slightly greater than the detection limit of 0.1 μg/L) to a maximum of 6 μg/L.

Although detectable concentrations of volatiles were noted in the immediate vicinity of the reported location of UST 76, the concentrations are very low and are not considered to indicate significant, if any, contamination. Concentrations of all analytes were slightly greater at and near the asphalt road, but these and other volatiles concentrations do not exhibit a consistent or contiguous pattern typical of point sources of contamination such as tanks. The trace levels of volatiles are not considered to be of concern and may indicate minor tank leakage, if the UST existed. The results also may reflect the inadvertent introduction of volatile asphalt constituents into the soil gas samples collected below the roadway, or localized surface

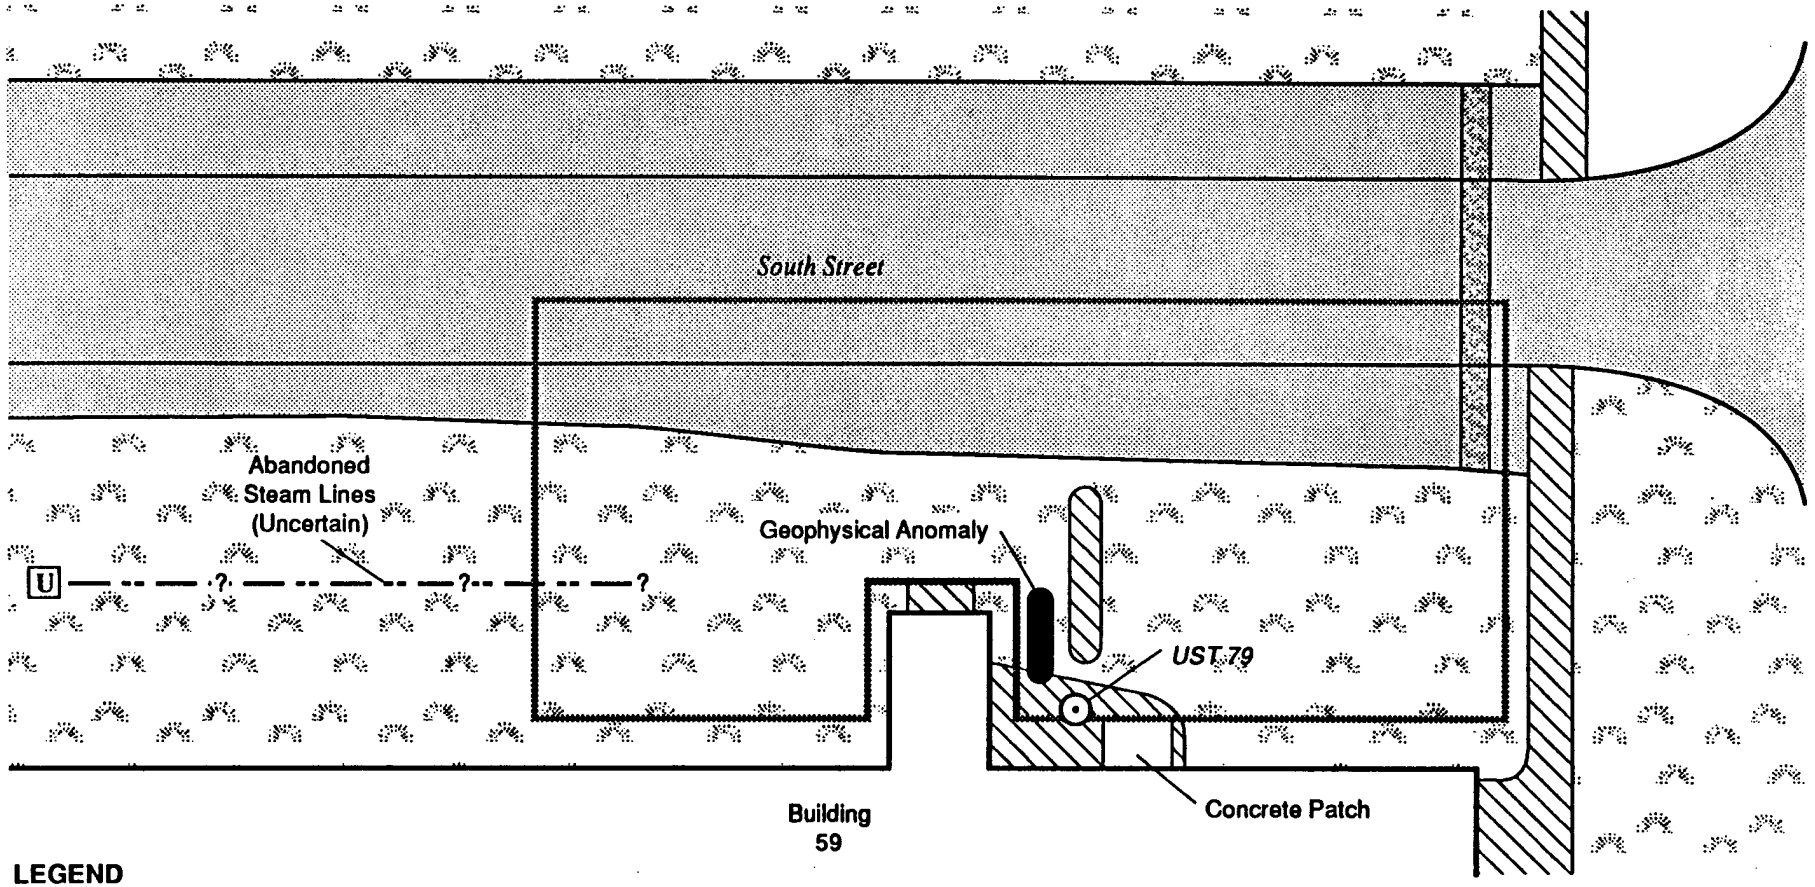
Figure 3-11
UST 79
RESULTS OF GEOPHYSICAL SURVEY

Figure 3-11 shows the reported location of UST 79 and summarizes the results of the geophysical survey. Detailed survey summaries and contour maps of the geophysical data are presented in Appendix C. The results of the survey indicate that several small anomalies were detected in the surveyed area--all but one of which appear to be associated with utilities or interferences from Building 54. One strong geophysical anomaly, observed in both the vertical magnetic gradient and EM data, was detected near the reported UST location adjacent to the building. Although the

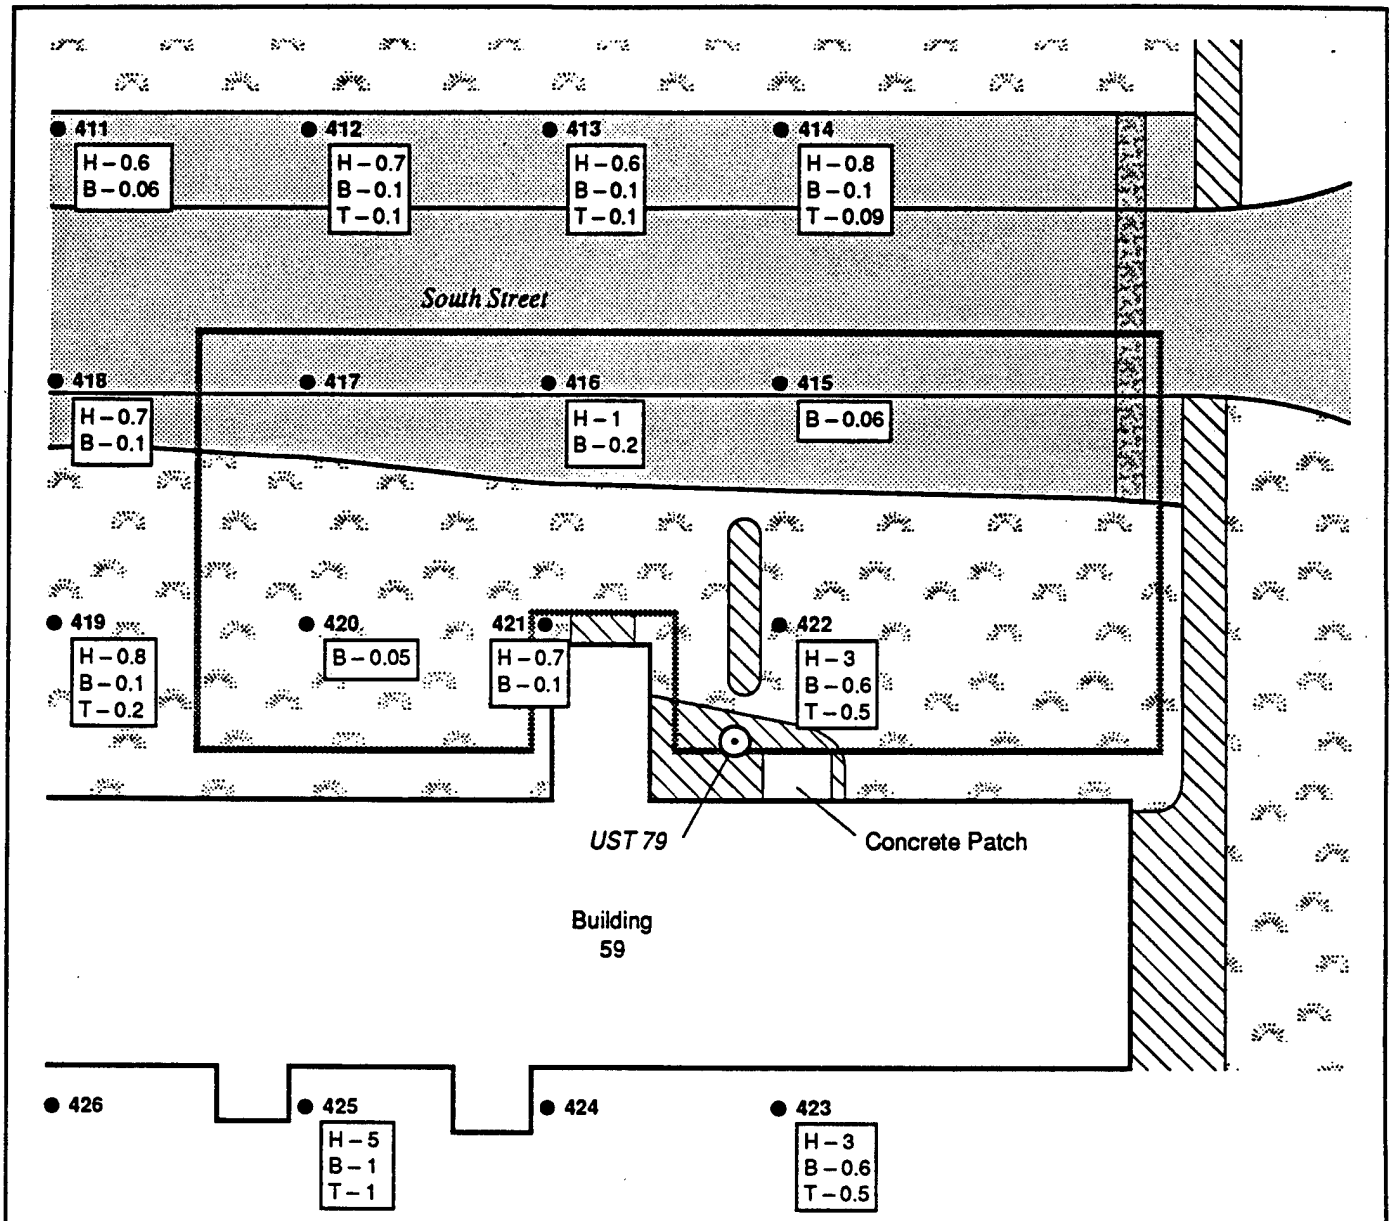
Figure 3-12
UST 79
RESULTS OF SOIL GAS SURVEY

Figure 3-12 presents the results for the BTEX and TVHC components of the active soil gas survey conducted at UST 79. Results of the carbon dioxide and methane components of the survey are presented in Appendix D. The soil gas survey results indicate trace levels of benzene, toluene, and TVHCs at some of the 16 sampled locations. Ethylbenzene and xylene were not detected at this site. Benzene was detected in 13 samples, with concentrations ranging from 0.05 (which is slightly greater than the detection limit of 0.04 μg/L) to a maximum of 1 μg/L. Toluene was detected at seven locations coincident with benzene detections; it was reported at concentrations ranging from 0.09 (which is at the detection limit of 0.09 μg/L) to a maximum of 1 μg/L. TVHCs were reported at 11 of the 16 locations, with concentrations ranging from 0.6 (which is slightly greater than the detection limit of 0.4 μg/L) to a maximum of 5 μg/L.

Although detectable concentrations of volatiles were noted in the immediate vicinity of the reported location of UST 79, the concentrations are very low and are not considered to indicate significant, if any, contamination. Concentrations of all analytes were slightly greater near Building 54 and the reported UST location, with more consistent concentrations at the roadway, but these and other volatiles concentrations do not exhibit a consistent or contiguous pattern typical of point sources of contamination such as tanks. The trace levels of volatiles are not considered to be of concern and may indicate minor tank leakage if the UST existed (or exists). The results may also reflect the inadvertent introduction of asphalt constituents into the soil gas samples collected below the roadway or localized surface spillage near the building.

Carbon dioxide was reported at all locations, with concentrations ranging from 670 (which is slightly greater than the detection limit of 310 μg/L) to a maximum of 2,700 μg/L (Appendix D). Although slightly elevated levels of carbon dioxide

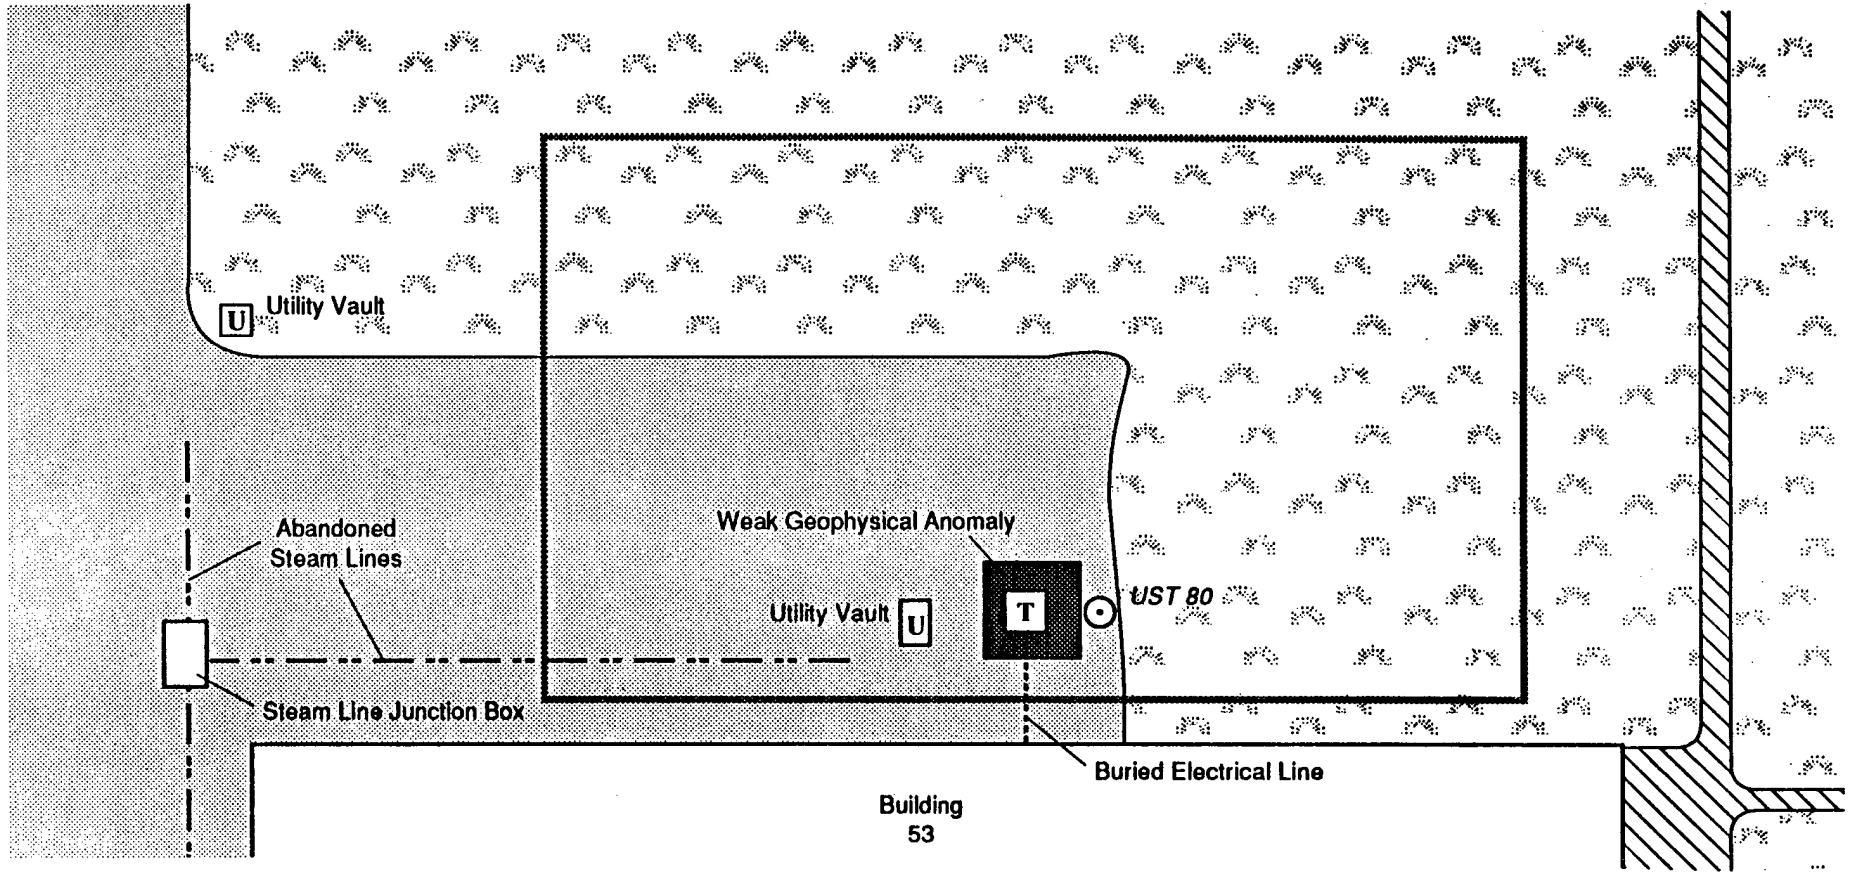
Figure 3-13
UST 80
RESULTS OF GEOPHYSICAL SURVEY

Figure 3-13 shows the reported location of UST 80 and summarizes the results of the geophysical survey. Detailed survey summaries and contour maps of the geophysical data are presented in Appendix C. The results of the survey indicate that

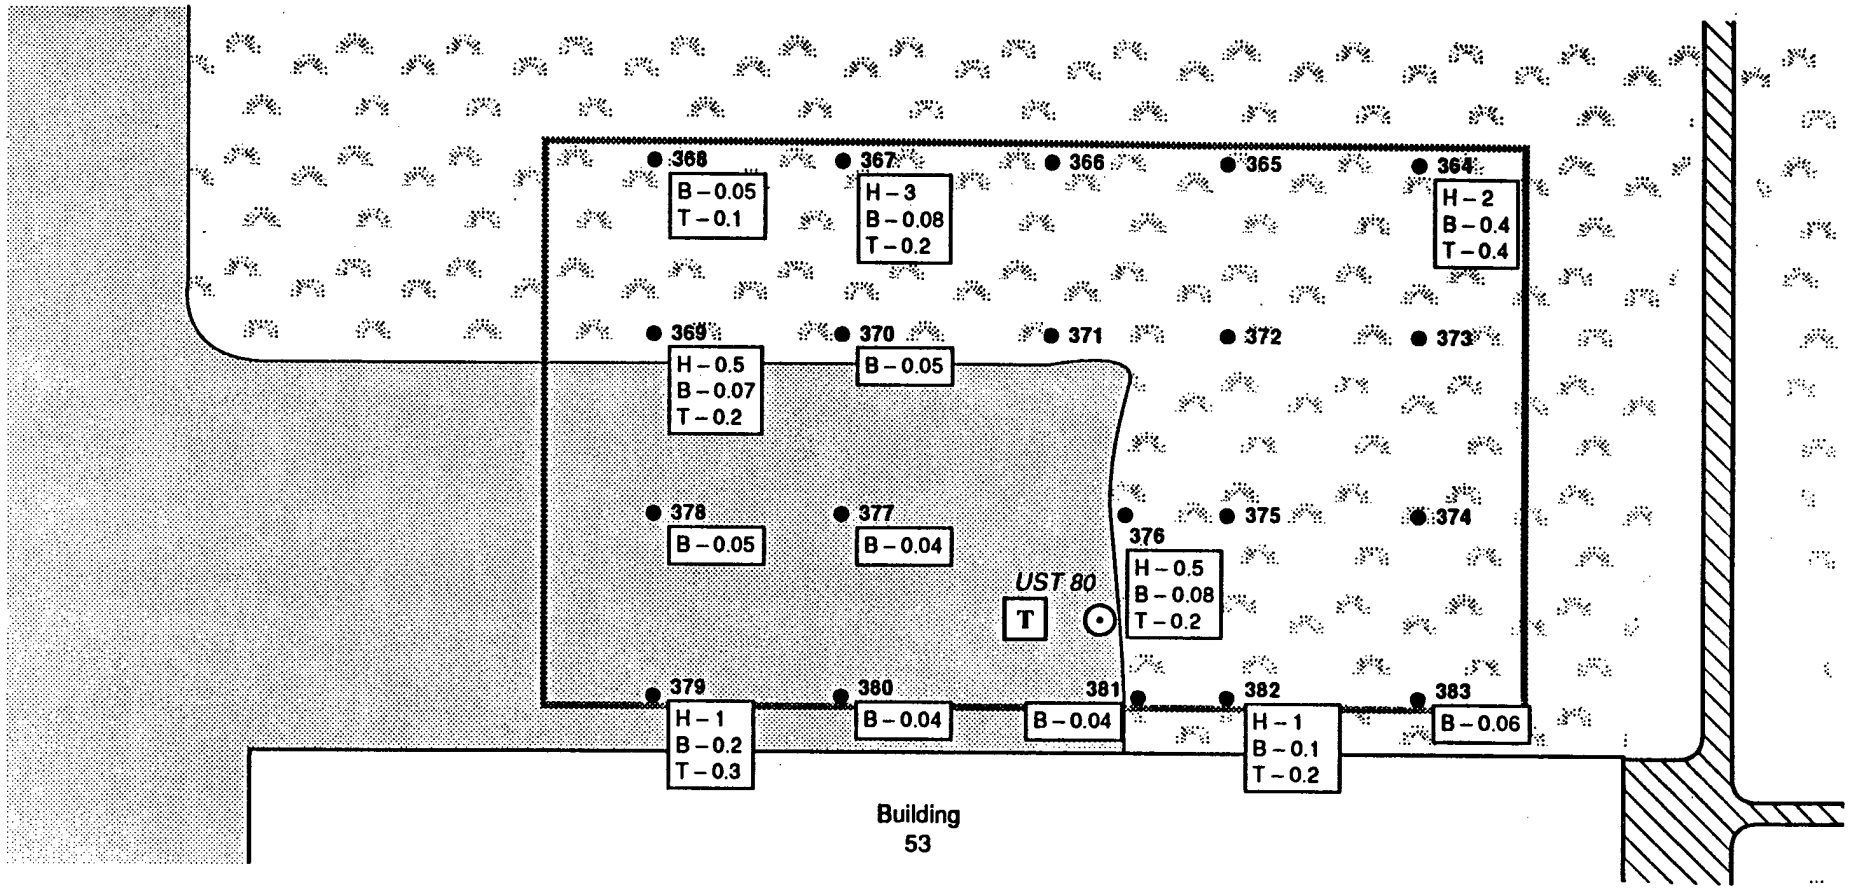
Figure 3-14 presents results for the BTEX and TVHC components of the active soil gas survey conducted at UST 80. Results of the carbon dioxide and methane components of the survey are presented in Appendix D. The soil gas survey results indicate trace levels of benzene, toluene, and TVHCs at some of the 20 sampled locations. Ethylbenzene and xylene were not detected at the site. Benzene was detected in 13 samples, with concentrations ranging from 0.04 (which is at the detection limit of 0.04 μg/L) to a maximum of 0.4 μg/L. Toluene was detected at seven locations coincident with benzene detections; it was reported at concentrations ranging from 0.1 (which is at the detection limit of 0.1 μg/L) to a maximum of 0.4 μg/L. TVHCs were reported at six of the locations, with concentrations ranging from 0.3 (which is at the detection limit of 0.3 μg/L) to a maximum of 2 μg/L.

Although detectable concentrations of volatiles were noted in the vicinity of the reported location of UST 80, the concentrations are very low and are not considered to indicate significant, if any, contamination. The concentrations of all analytes were greatest in one sample collected near Building 53, northeast of the reported UST. Samples with more consistent concentrations were located in the vicinity of the reported UST, but concentrations were also reported at similar levels in samples collected below the asphalt lot west of the reported UST and in soil north of this lot. The volatiles do not exhibit a consistent or contiguous pattern typical of point sources

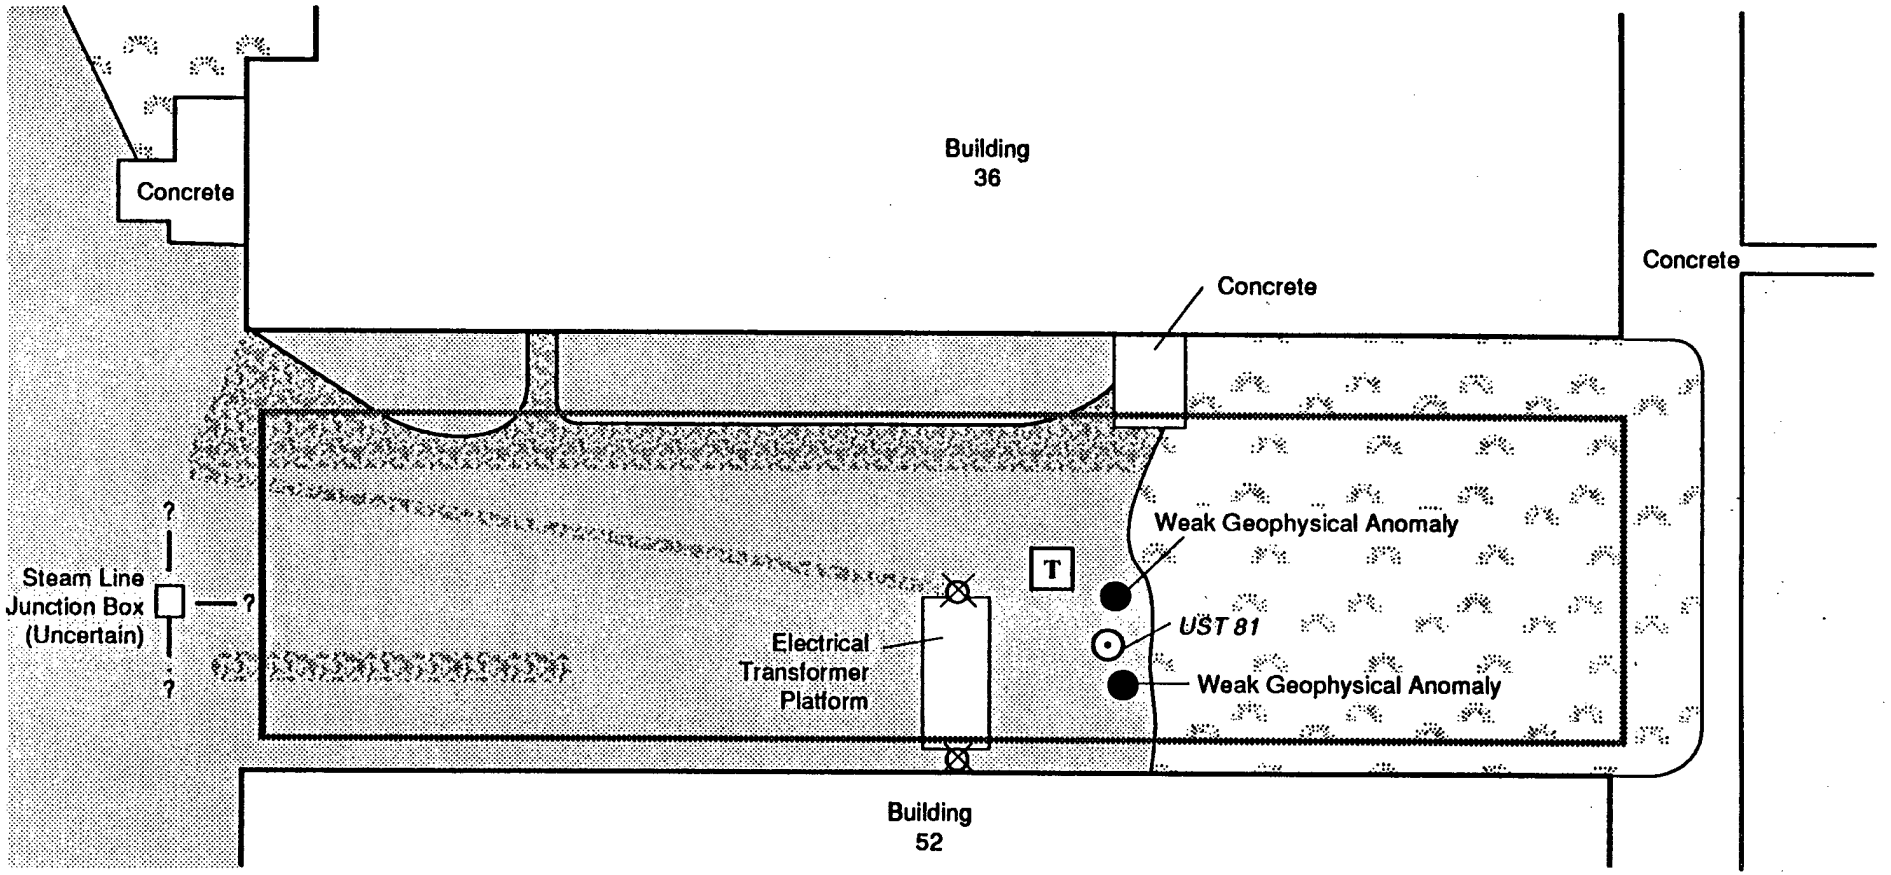
Figure 3-15
UST 81
RESULTS OF GEOPHYSICAL SURVEY

Figure 3-15 shows the reported location of UST 81 and summarizes the results of the geophysical survey. Detailed survey summaries and contour maps of the geophysical data are presented in Appendix C. The results of the survey indicate that several small EM anomalies were detected in the surveyed area. However, large amounts of cultural interference hindered clear interpretation of the data. Anomalies in the eastern third and northwestern quarter of the site appear to be associated with utilities or interferences from Building 52. Two EM anomalies--located east of the transformer and near the reported location of UST 81--should be considered possible targets. However, because of the cultural interference encountered at the site, it is uncertain whether the anomalies are due to underground structures or to interferences from the building, transformer, or guy/anchor lines.

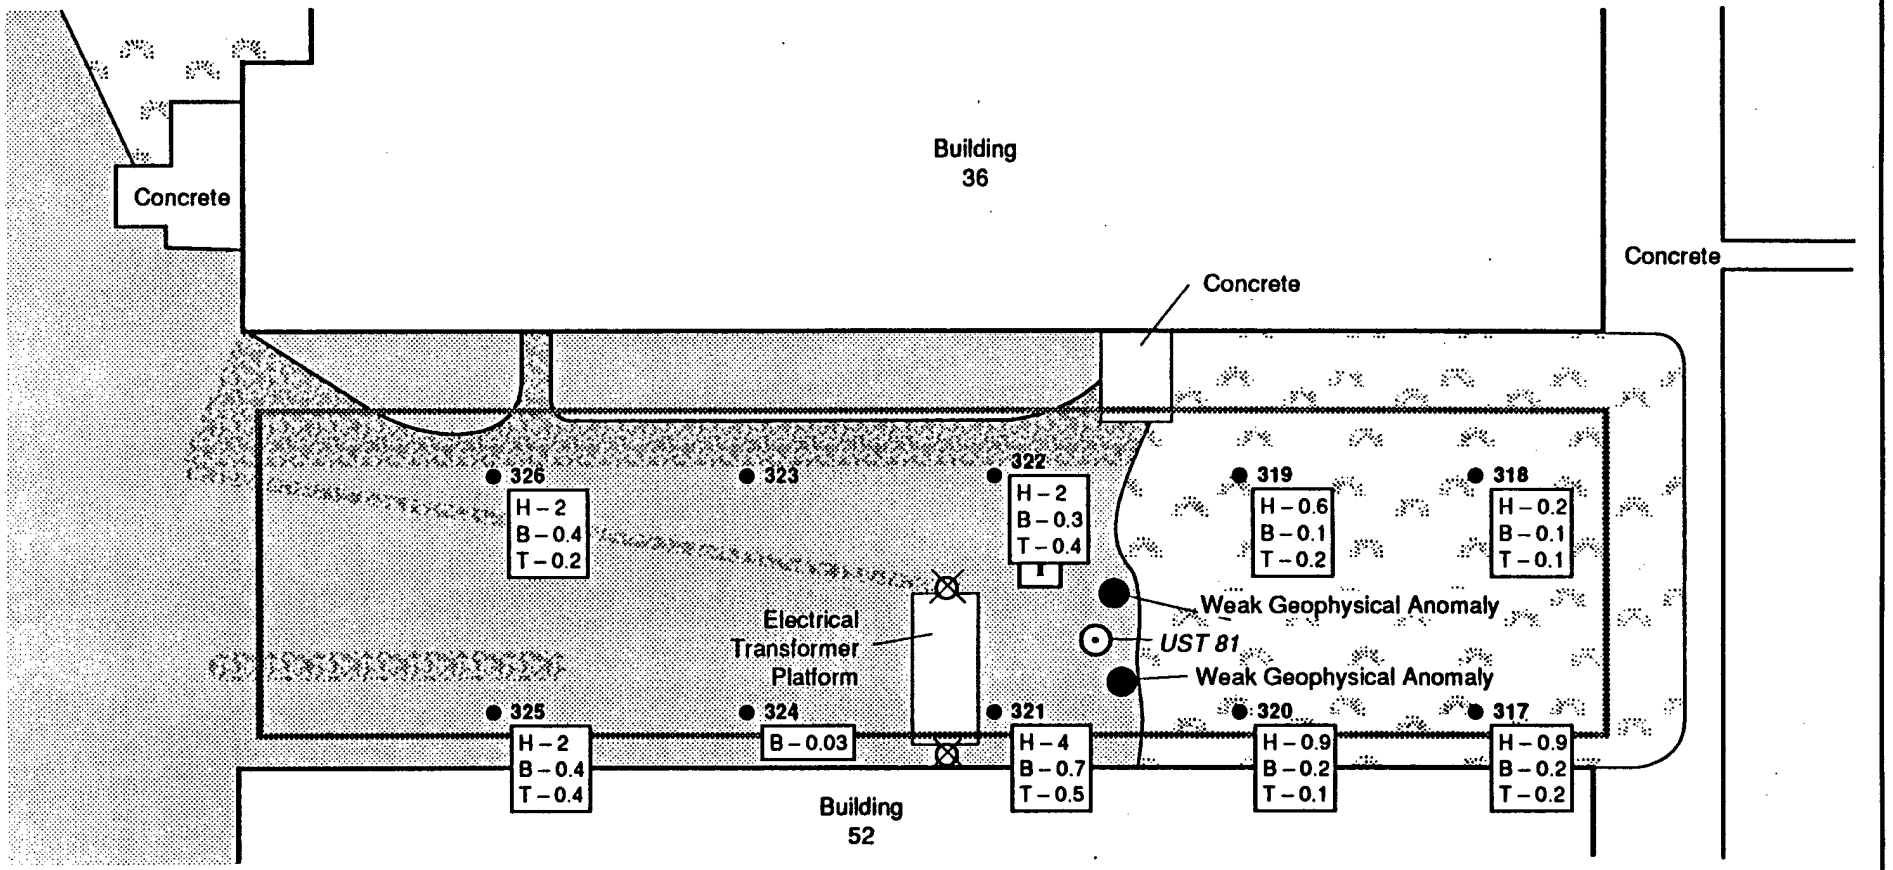
Figure 3-16
UST 81
RESULTS OF SOIL GAS SURVEY

Figure 3-16 presents results for the BTEX and TVHC components of the active soil gas survey conducted at UST 81. Results of the carbon dioxide and methane components of the survey are presented in Appendix D. The soil gas survey results indicate trace levels of benzene, toluene, and TVHCs at most of the 10 sampled locations. Ethylbenzene and xylene were not detected at this site. Benzene was detected in nine samples, with concentrations ranging from 0.03 (which is slightly greater than the detection limit of 0.02 μg/L) to a maximum of 0.7 μg/L. Toluene was detected at eight locations coincident with benzene detections; it was reported at concentrations ranging from 0.1 (which is slightly greater than the detection limit of 0.04 μg/L) to a maximum of 0.5 μg/L. TVHCs were reported at eight of the locations, with concentrations ranging from 0.2 (which is slightly greater than the detection limit of 0.1 μg/L) to a maximum of 4 μg/L.

Although detectable concentrations of volatiles were noted in the vicinity of the reported location of UST 81, the concentrations are very low and are not considered

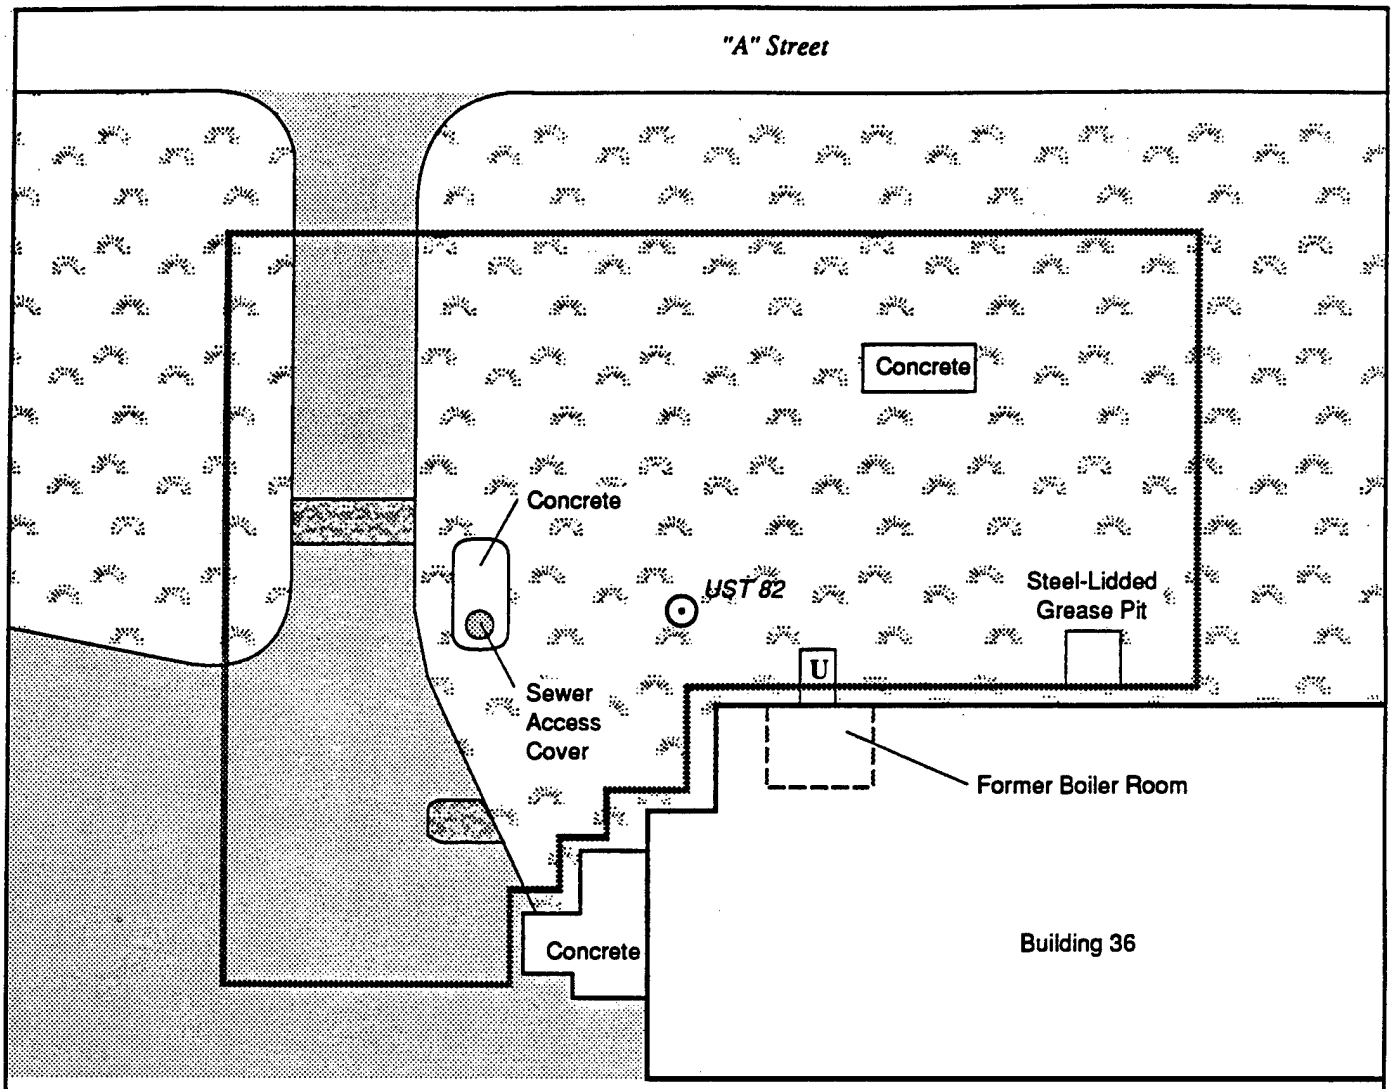
Figure 3-17
UST 82
RESULTS OF GEOPHYSICAL SURVEY

Figure 3-17 shows the reported location of UST 82 and summarizes the results of the geophysical survey. Detailed survey summaries and contour maps of the geophysical data are presented in Appendix C. The results of the survey indicate that several small magnetic anomalies were detected in the surveyed area. Although large amounts of cultural interference hindered clear interpretation of the data, the anomalies at the site appear to be associated with utilities or interferences from Building 36. One magnetic anomaly was observed midway between the building and a concrete pad. Because this anomaly was not observed in the EM data, it is not considered to be a target. In spite of the cultural interference and resultant effects on data interpretation, it does not appear that a target UST is present in the northern half of the survey area. Because of considerable interference, it is unknown whether a target is present in the southern half of the survey area or adjacent to Building 36.

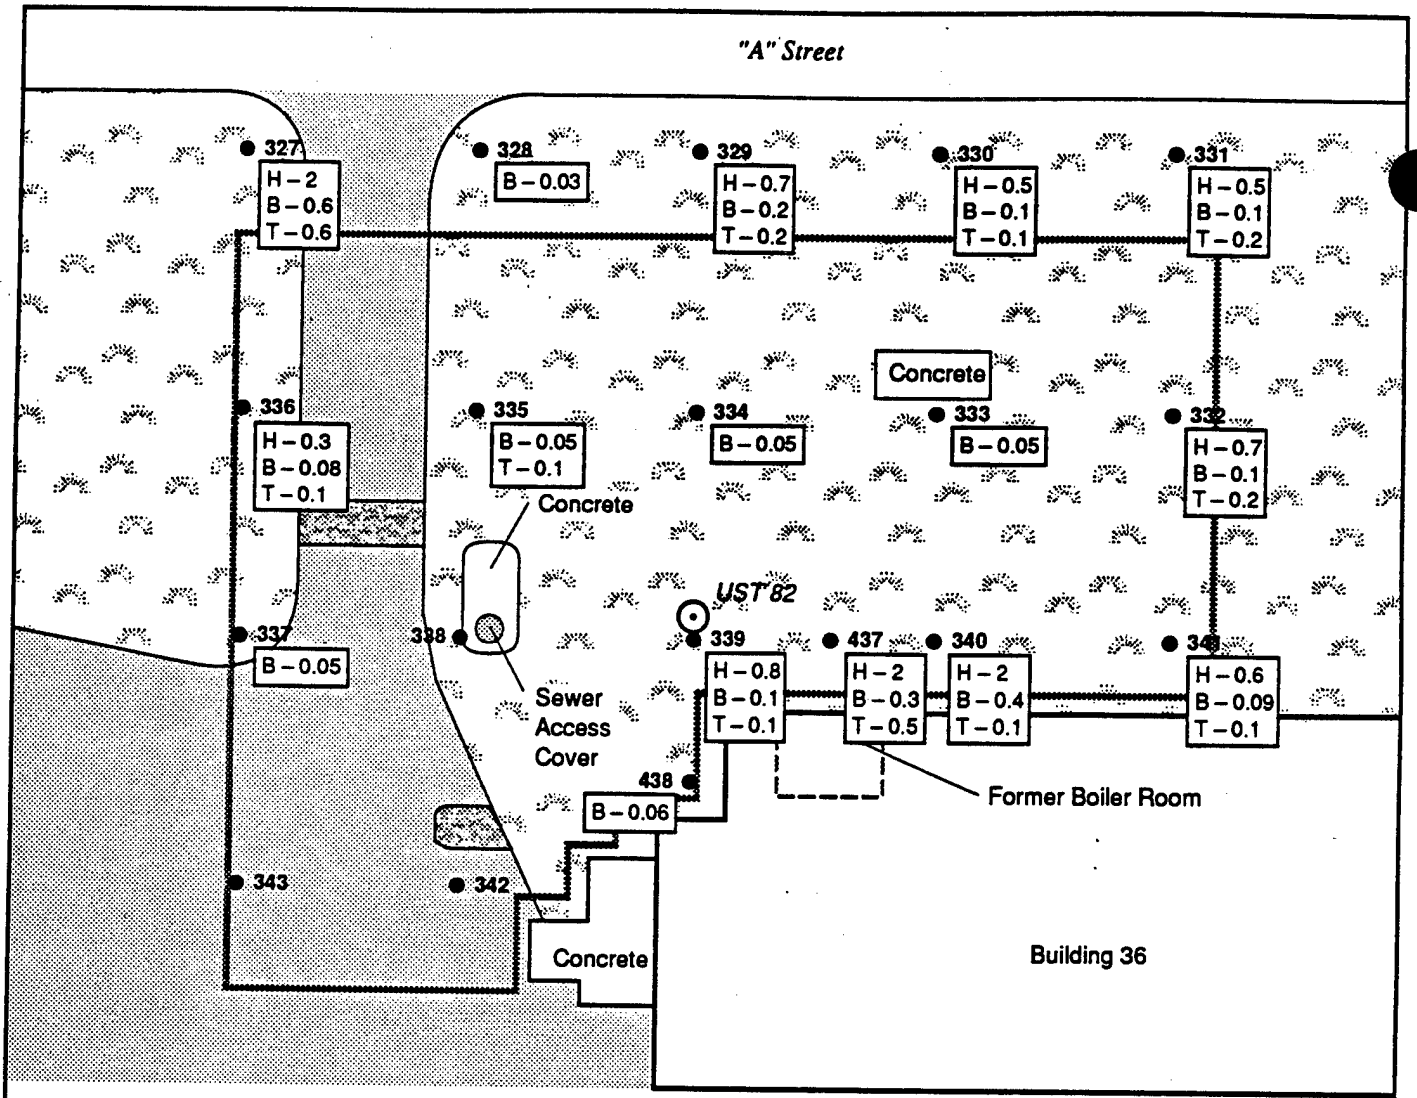
Figure 3-18
UST 82
RESULTS OF SOIL GAS SURVEY

Figure 3-18 presents results for the BTEX and TVHC components of the active soil gas survey conducted at UST 82. Results of the carbon dioxide and methane components of the survey are presented in Appendix D. The soil gas survey results indicate trace levels of benzene, toluene, and TVHCs at some of the 19 sampled locations. Ethylbenzene and xylene were not detected at this site. Benzene was detected in 16 samples, with concentrations ranging from 0.03 (which is at the detection limit of 0.03 μg/L) to a maximum of 0.6 μg/L. Toluene was detected at 11 locations coincident with benzene detections; it was reported at concentrations ranging from 0.1 (which is slightly greater than the detection limit of 0.08 μg/L) to a maximum

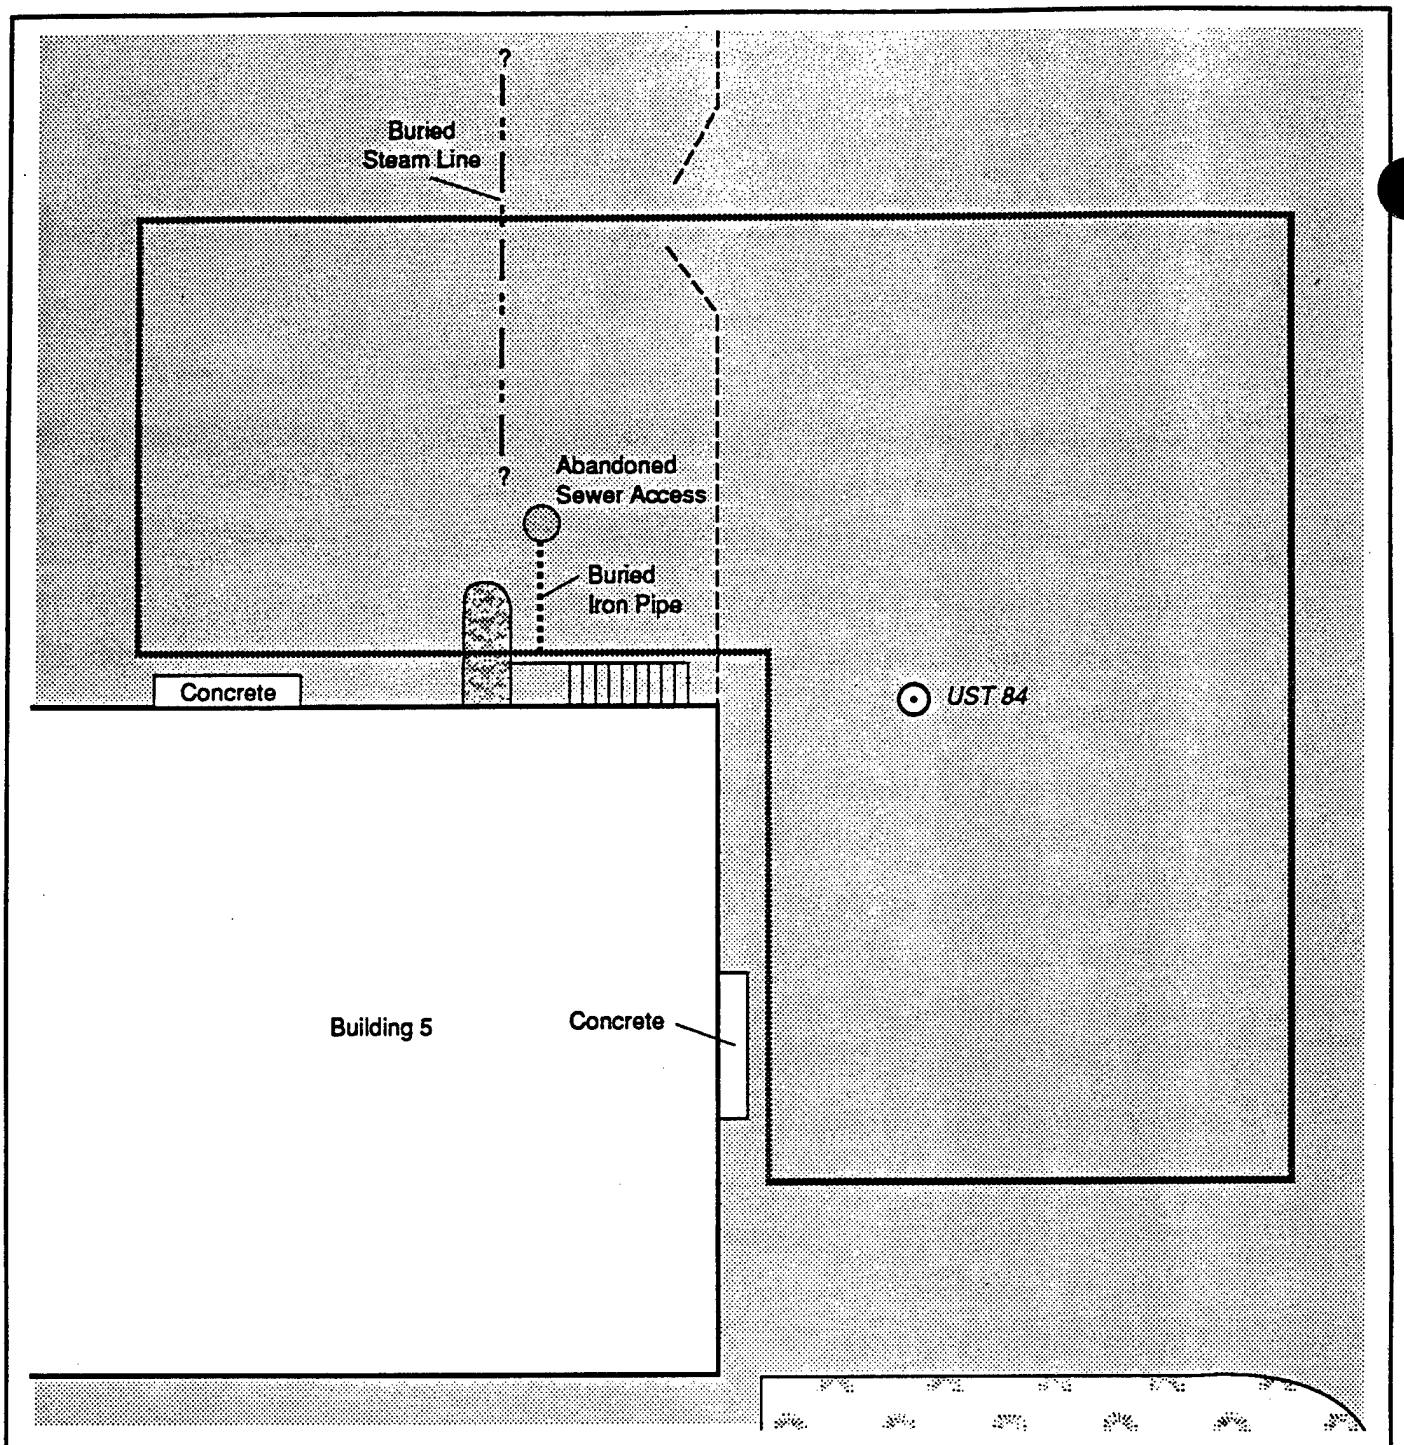
Figure 3-19
UST 84
RESULTS OF GEOPHYSICAL SURVEY

Figure 3-19 shows the reported location of UST 84 and summarizes the results of the geophysical survey. Detailed survey summaries and contour maps of the geophysical data are presented in Appendix C. The results of the survey indicate that several small magnetic anomalies were detected in the surveyed area, though large amounts of cultural interference hindered clear interpretation of the data. However, it appears that the anomalies are associated with utilities or interferences from the building and not an UST.

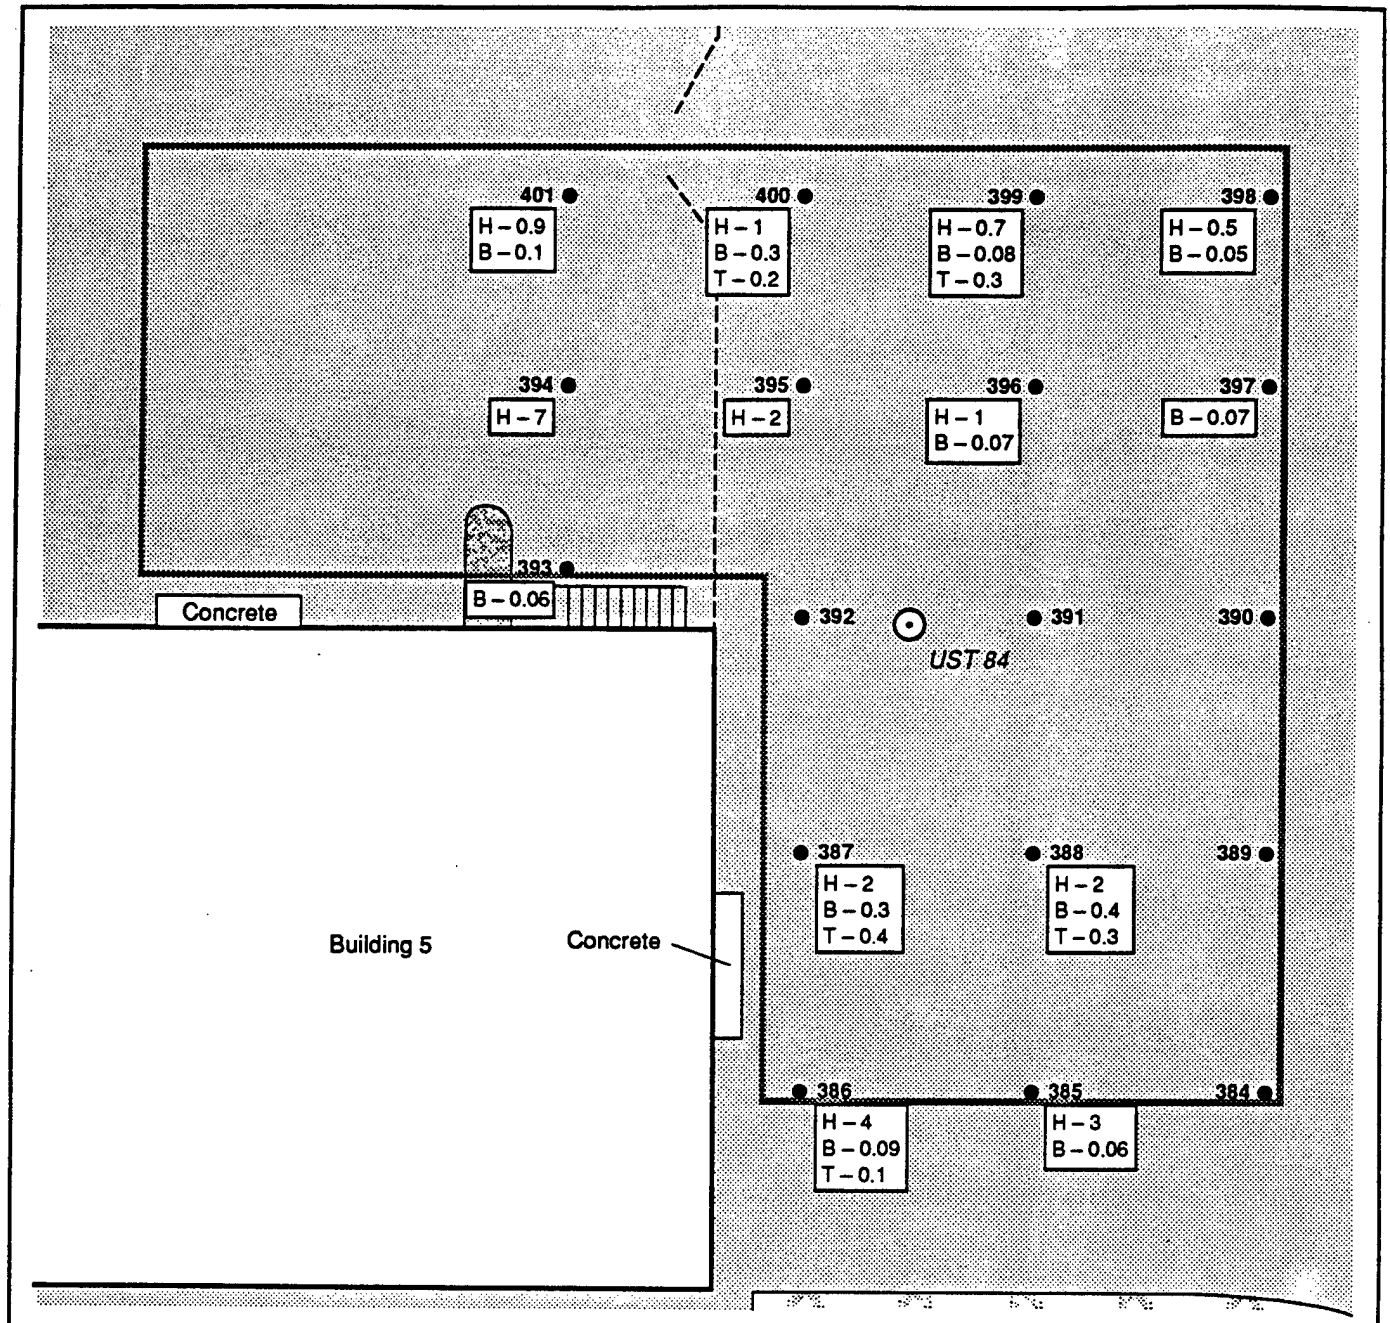
Figure 3-20
UST 84
RESULTS OF SOIL GAS SURVEY

Figure 3-20 presents results for the BTEX and TVHC components of the active soil gas survey conducted at UST 84. Results of the carbon dioxide and methane components of the survey are presented in Appendix D. The soil gas survey results indicate trace levels of benzene, toluene, and TVHCs at some of the 18 sampled locations. Ethylbenzene and xylene were not detected at this site. Benzene was detected in 11 samples, with concentrations ranging from 0.05 (which is slightly greater than the detection limit of 0.04 μg/L) to a maximum of 0.4 μg/L. Toluene was detected at five locations coincident with benzene detections; it was reported at concentrations ranging from 0.1 (which is slightly greater than the detection limit of 0.08 μg/L) to a maximum of 0.4 μg/L. TVHCs were reported at 11 of the locations, with concentrations ranging from 0.3 (which is at the detection limit of 0.3 μg/L) to a maximum of 7 μg/L.

Concentrations of volatiles were detected north and south of the reported location of UST 84, but not in the samples collected at the reported UST location. The reported concentrations are very low and are not considered to indicate significant, if any, contamination. Concentrations were greatest in two samples collected directly south of the reported UST location and in two samples northwest of the reported UST location. However, trace concentrations of benzene and toluene
