Report No. SFIM-AEC-BC-CR-95047

UNDERGROUND STORAGE TANK INVESTIGATION REPORT UMATILLA DEPOT ACTIVITY HERMISTON, OREGON

DAMES & MOORE
849 International Drive, Suite 320
Linthicum, Maryland 21090

JUNE 1995

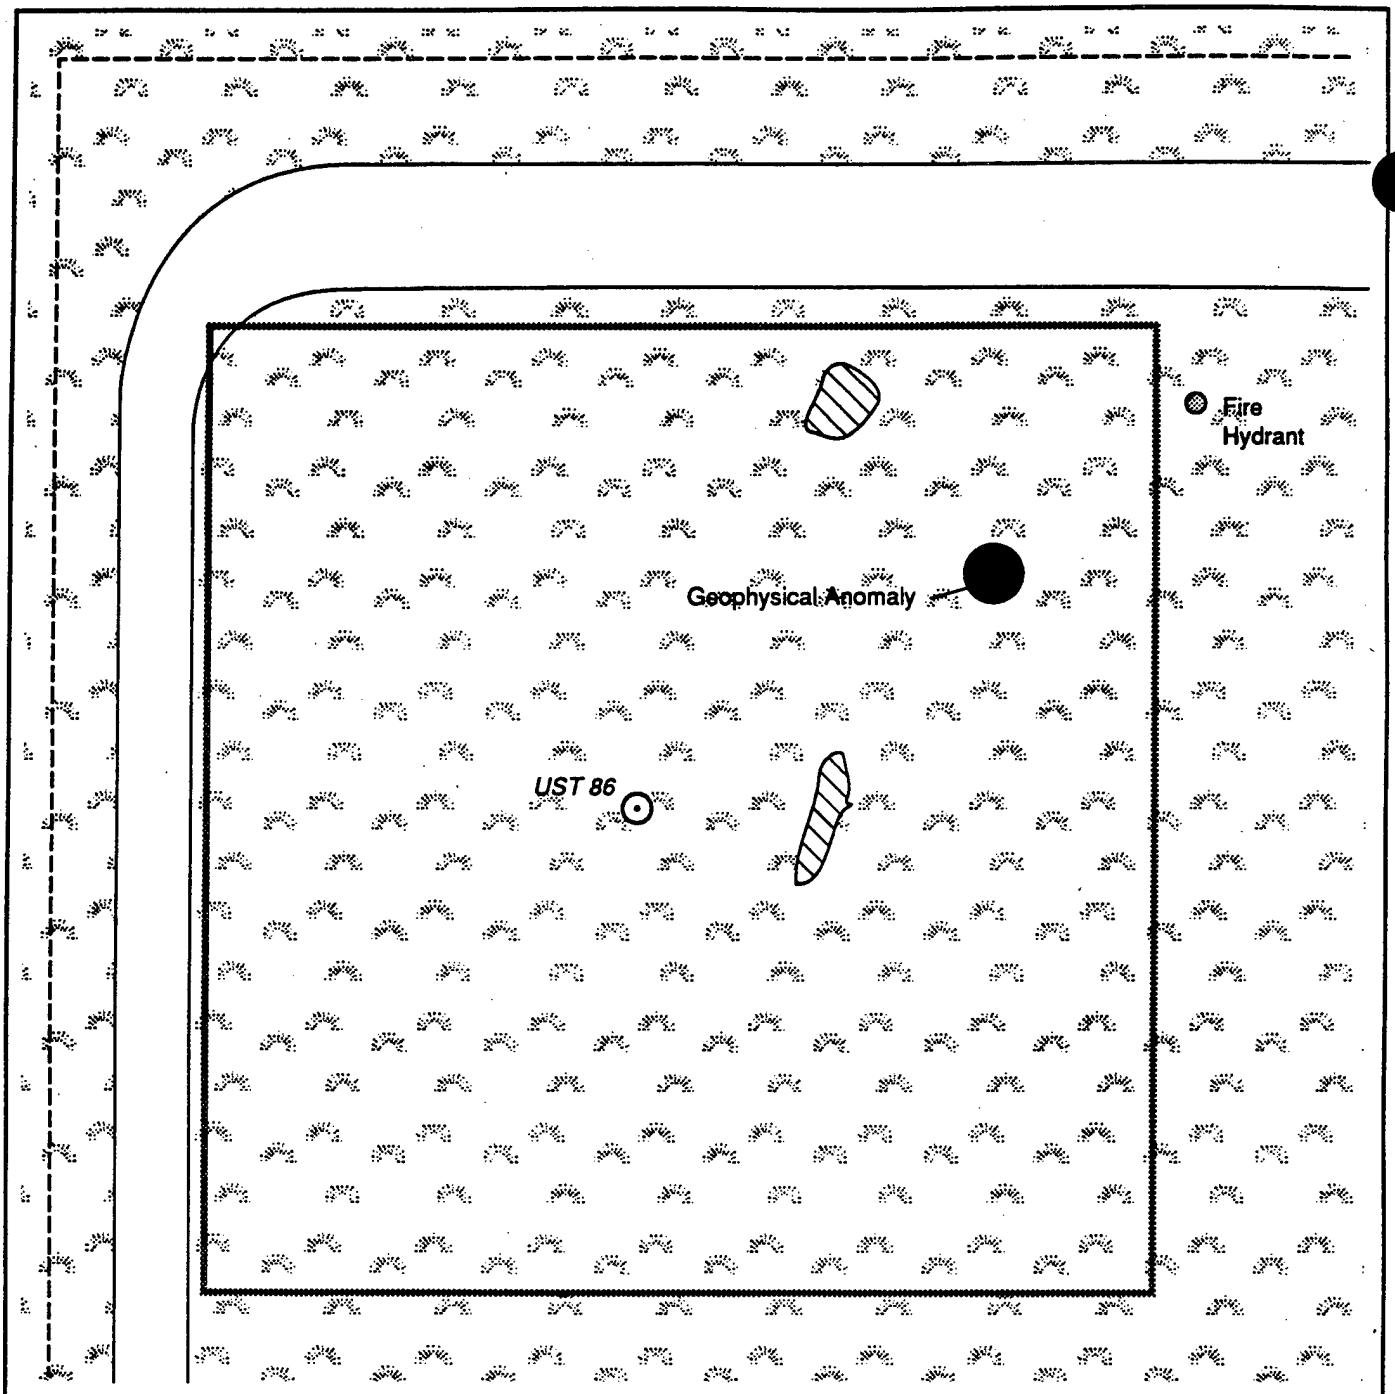
Figure 3-21
UST 86
RESULTS OF GEOPHYSICAL SURVEY

Figure 3-21 shows the reported location of UST 86 and summarizes the results of the geophysical survey. Detailed survey summaries and contour maps of the geophysical data are presented in Appendix C. The results of the survey indicate that it is unlikely that an UST is present within the surveyed area. Several magnetic and EM conductivity anomalies observed at the site were not characteristic of an UST and appear to be associated with underground utilities. One strong anomaly was observed in both the magnetic and EM data coincident with a small surface depression located in the northeast corner of the survey site. However, upon staking the anomaly, a 4-

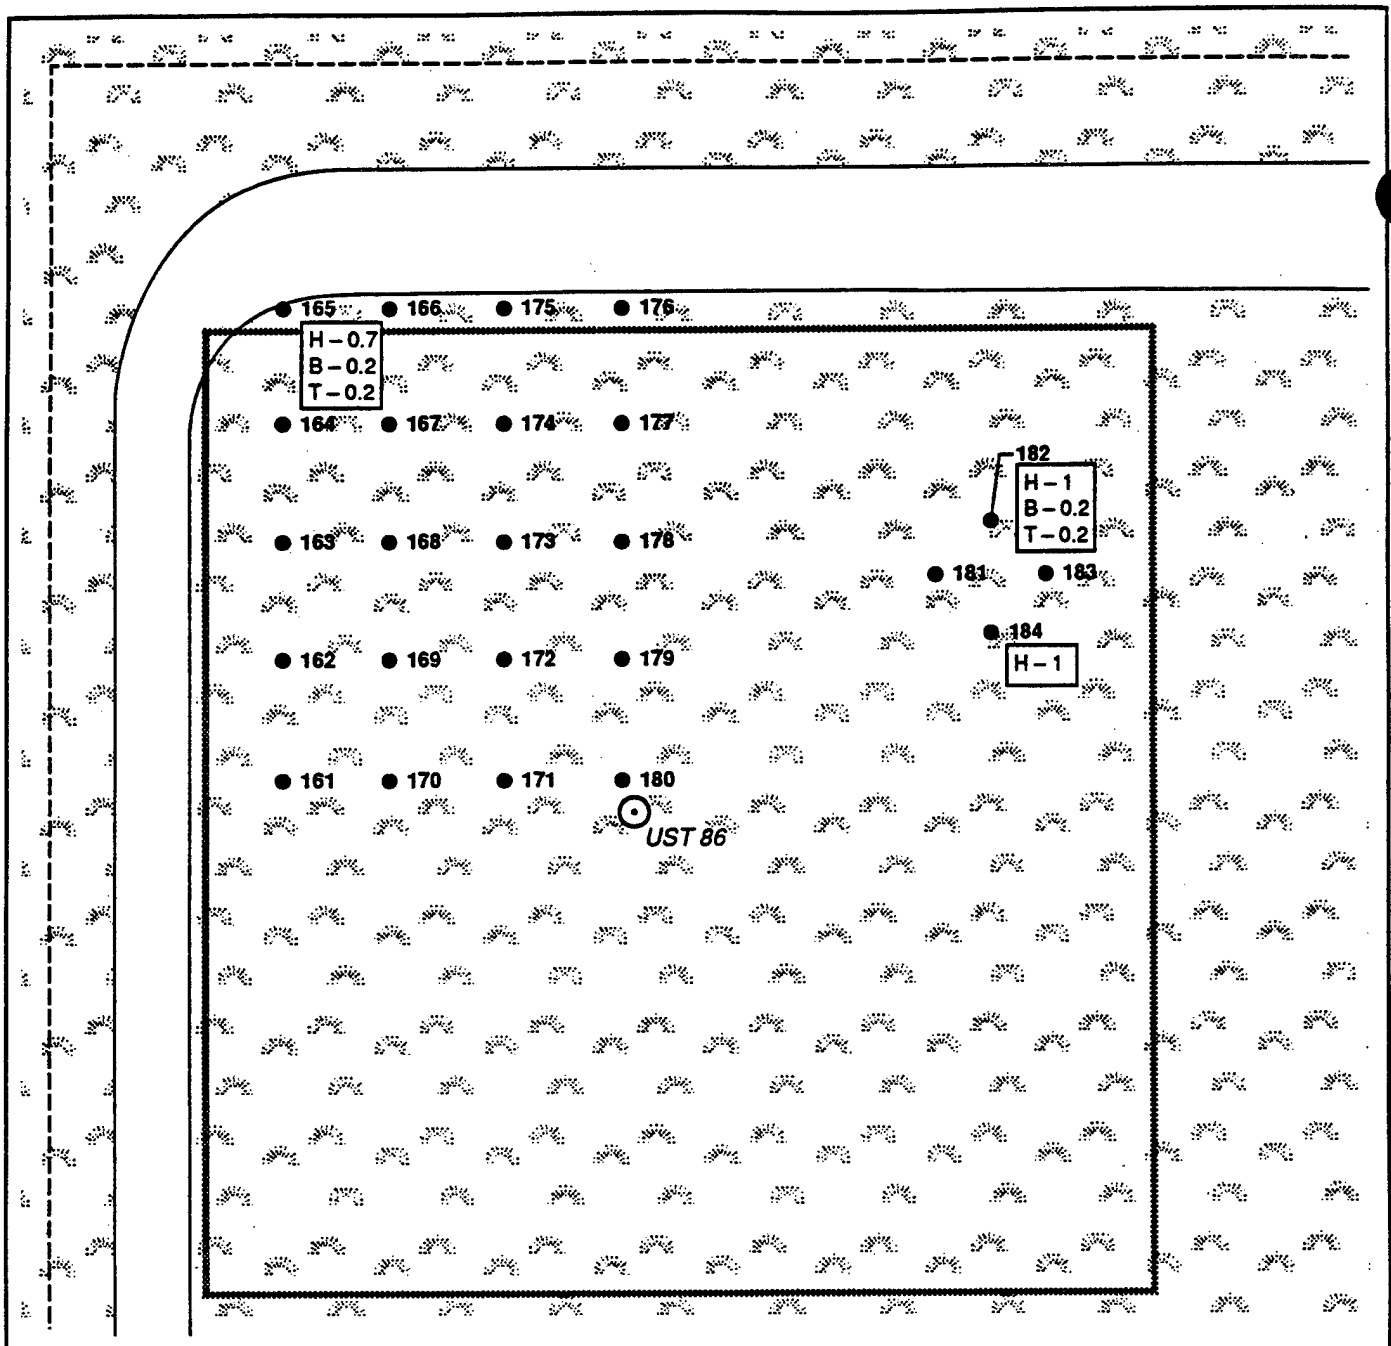
Figure 3-22
UST 86
RESULTS OF SOIL GAS SURVEY

Figure 3-22 presents the results for the BTEX and TVHC components of the active soil gas survey conducted at UST 86. Results of the carbon dioxide and methane components of the survey are shown in Appendix D. The soil gas survey results indicate trace levels of benzene, toluene, and TVHCs at only a few of the 24 sampled locations. Ethylbenzene and xylene were not detected at this site. Benzene was detected in two samples, at a concentration of 0.2 μg/L (which is slightly greater than the detection limit of 0.02 μg/L). Toluene was detected at two locations coincident with benzene detections; it was reported at a concentration of 0.2 μg/L (which is slightly greater than the detection limit of 0.04 μg/L). TVHCs were reported at three locations, with concentrations ranging from 0.7 (which is slightly greater than the detection limit of 0.1 μg/L) to a maximum of 1 μg/L.

Although detectable concentrations of volatiles were reported in the immediate vicinity of the underground vault, the concentrations are very low and are not considered to indicate significant, if any, contamination. These and other volatiles concentrations do not exhibit a consistent or contiguous pattern typical of point sources of contamination such as a tank. The trace levels of volatiles are not considered to be of concern and may indicate minor contamination from localized surface spillage around the vault.

Carbon dioxide was reported at all locations, with concentrations ranging from 740 (which is slightly greater than the detection limit of 310 μg/L) to a maximum of 7,200 μg/L (Appendix D). Although the highest concentration of carbon dioxide is near two of the samples with detected volatiles, the levels do not correlate with volatile responses; nor do they indicate levels in excess of background concentrations commonly reported for soil gas samples with no detectable volatiles. Methane, with a detection limit of 890 μg/L, was not detected at the site.

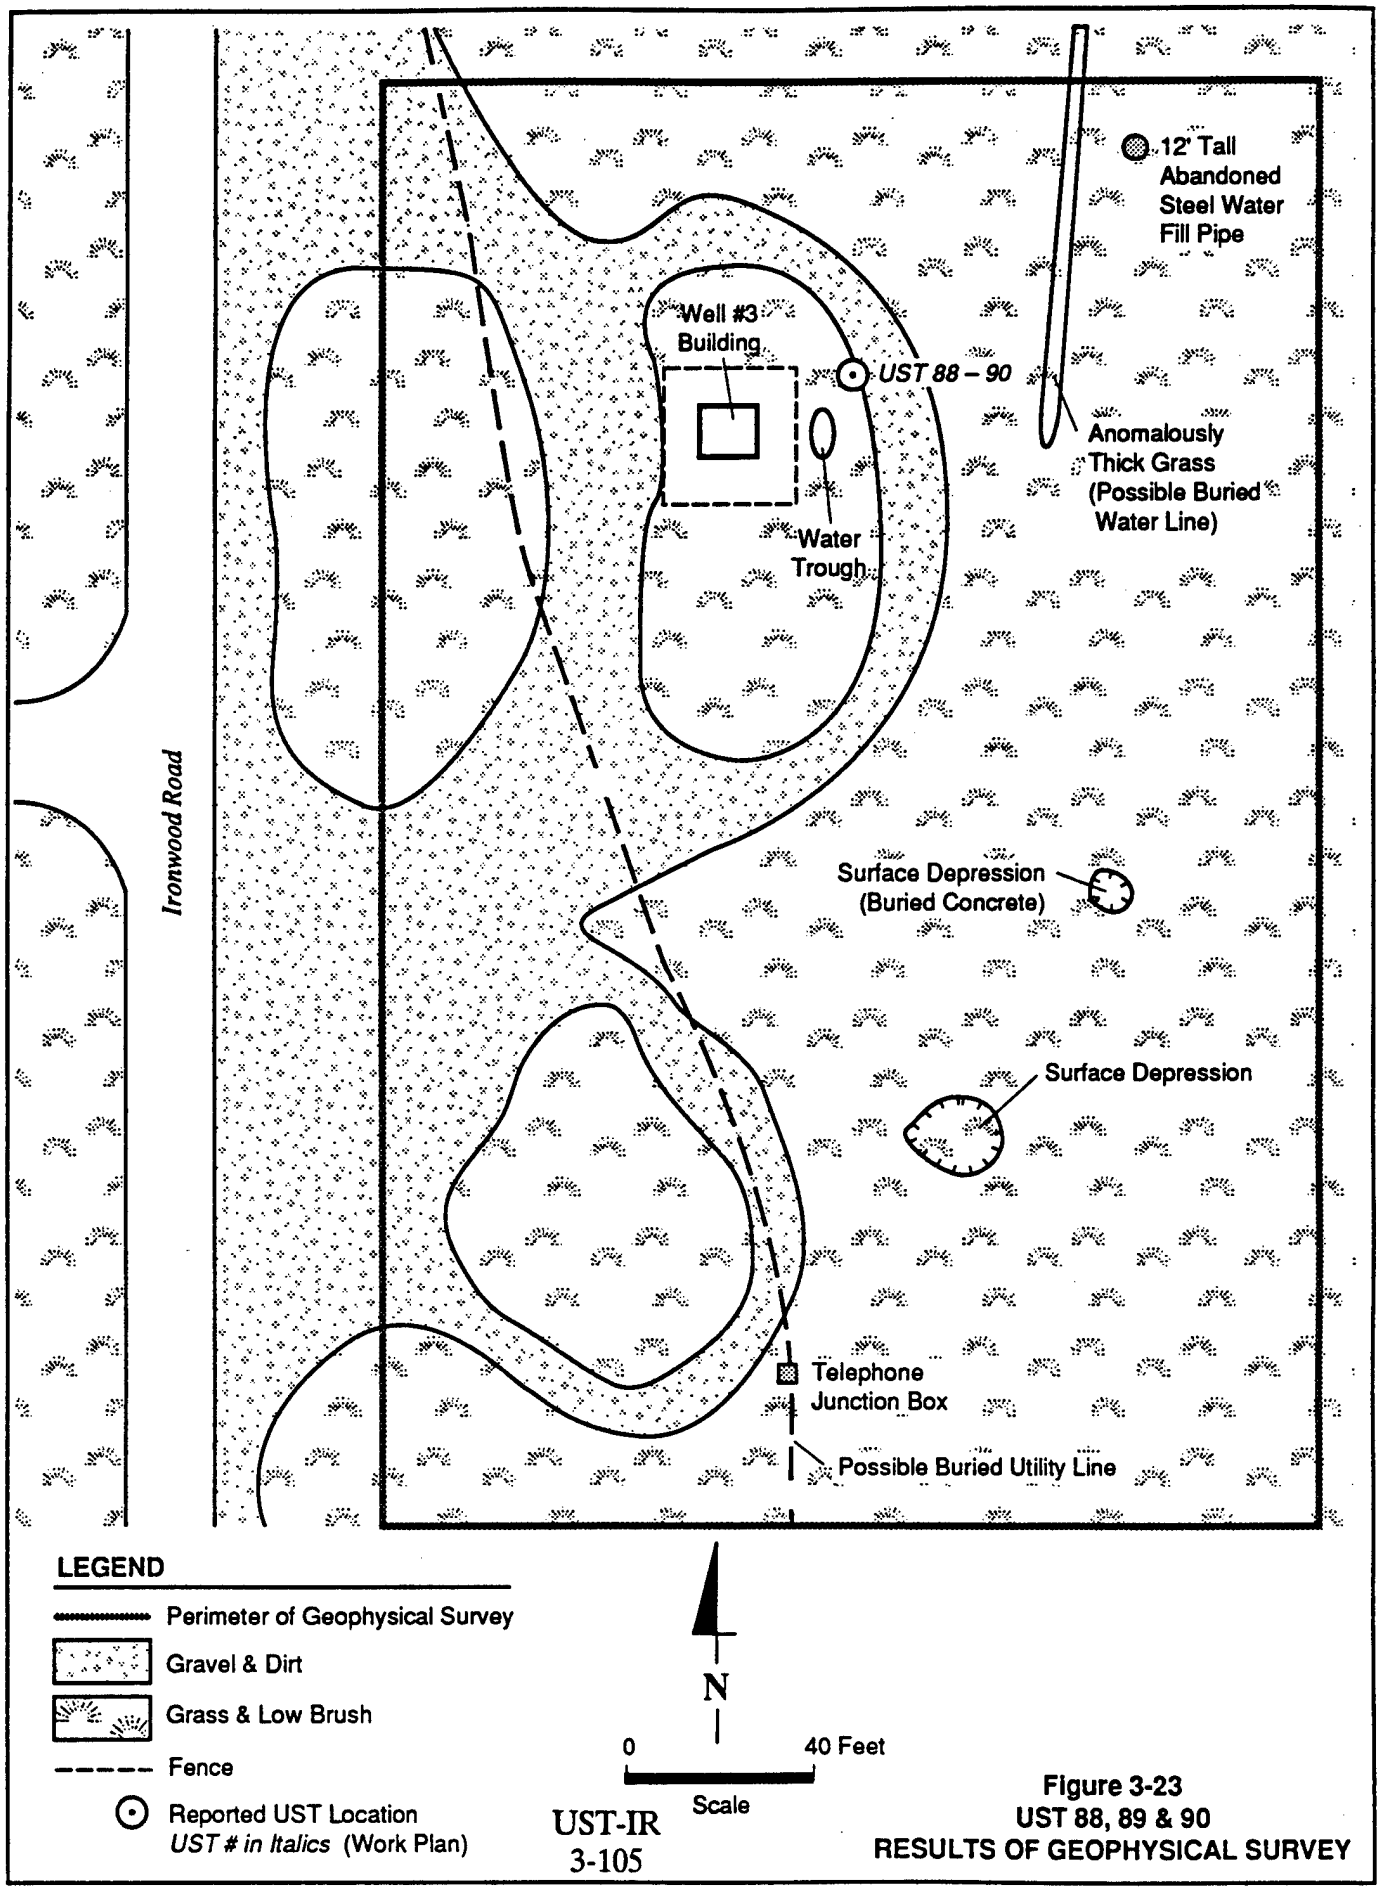
Figure 3-23
UST 88, 89 & 90
RESULTS OF GEOPHYSICAL SURVEY

Figure 3-23 shows the reported location of USTs 88 to 90 and summarizes the results of the geophysical survey. Detailed survey summaries and contour maps of the geophysical data are presented in Appendix C. The results of the survey indicate that it is unlikely that USTs are present within the surveyed area. Several magnetic anomalies were observed at the site, but they are not considered to be targets because they either were associated with underground utilities or were not confirmed by the EM data. Because of interference from aboveground structures near Supply House No. 3, it is unknown whether USTs are present within the fenced areas adjacent to the building.

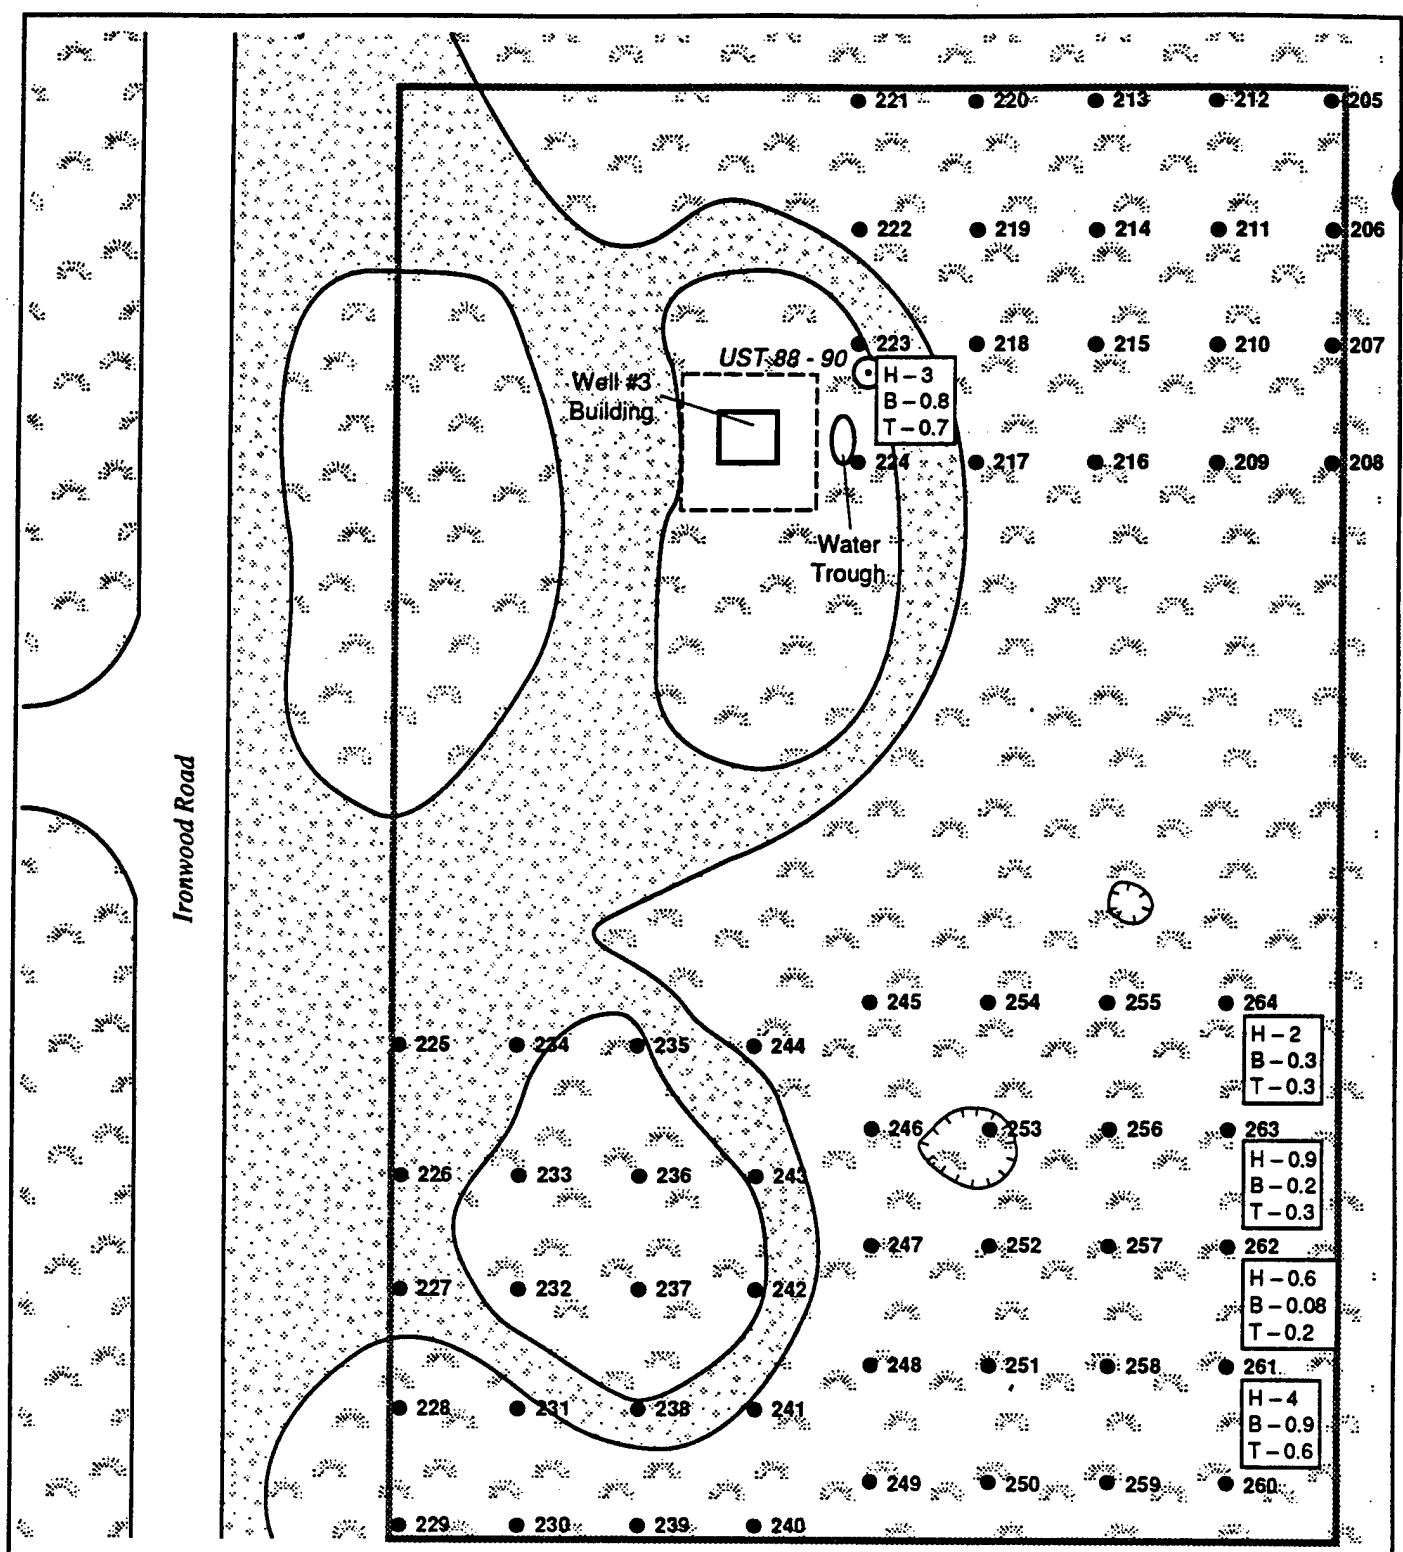
Figure 3-24
UST 88, 89 & 90
RESULTS OF SOIL GAS SURVEY

Figure 3-24 presents the results for the BTEX and TVHC components of the active soil gas survey conducted at USTs 88 to 90. Two soil gas survey grids were established to concentrate on two areas at this site. The northern grid was set up at the reported location of the USTs. Because the geophysical survey did not locate the tanks, a southern grid was established in an area where surface depressions and buried concrete were observed. Also, the road pattern indicated that there may have been activity in this area. Results of the carbon dioxide and methane components of the

survey are shown in Appendix D. The soil gas survey results indicate trace levels of benzene, toluene, and TVHCs at five locations. Ethylbenzene and xylene were not detected at this site. Benzene was detected in five samples, at a concentration of 0.08 μg/L (which is slightly greater than the detection limit of 0.03 μg/L). Toluene was detected at five locations coincident with benzene detections; it was reported at concentrations ranging from 0.2 (which is slightly greater than the detection limit of 0.09 μg/L) to a maximum of 0.7 μg/L. TVHCs were reported at five of the locations, with concentrations ranging from 0.6 (which is slightly greater than the detection limit of 0.3 μg/L) to a maximum of 4 μg/L.

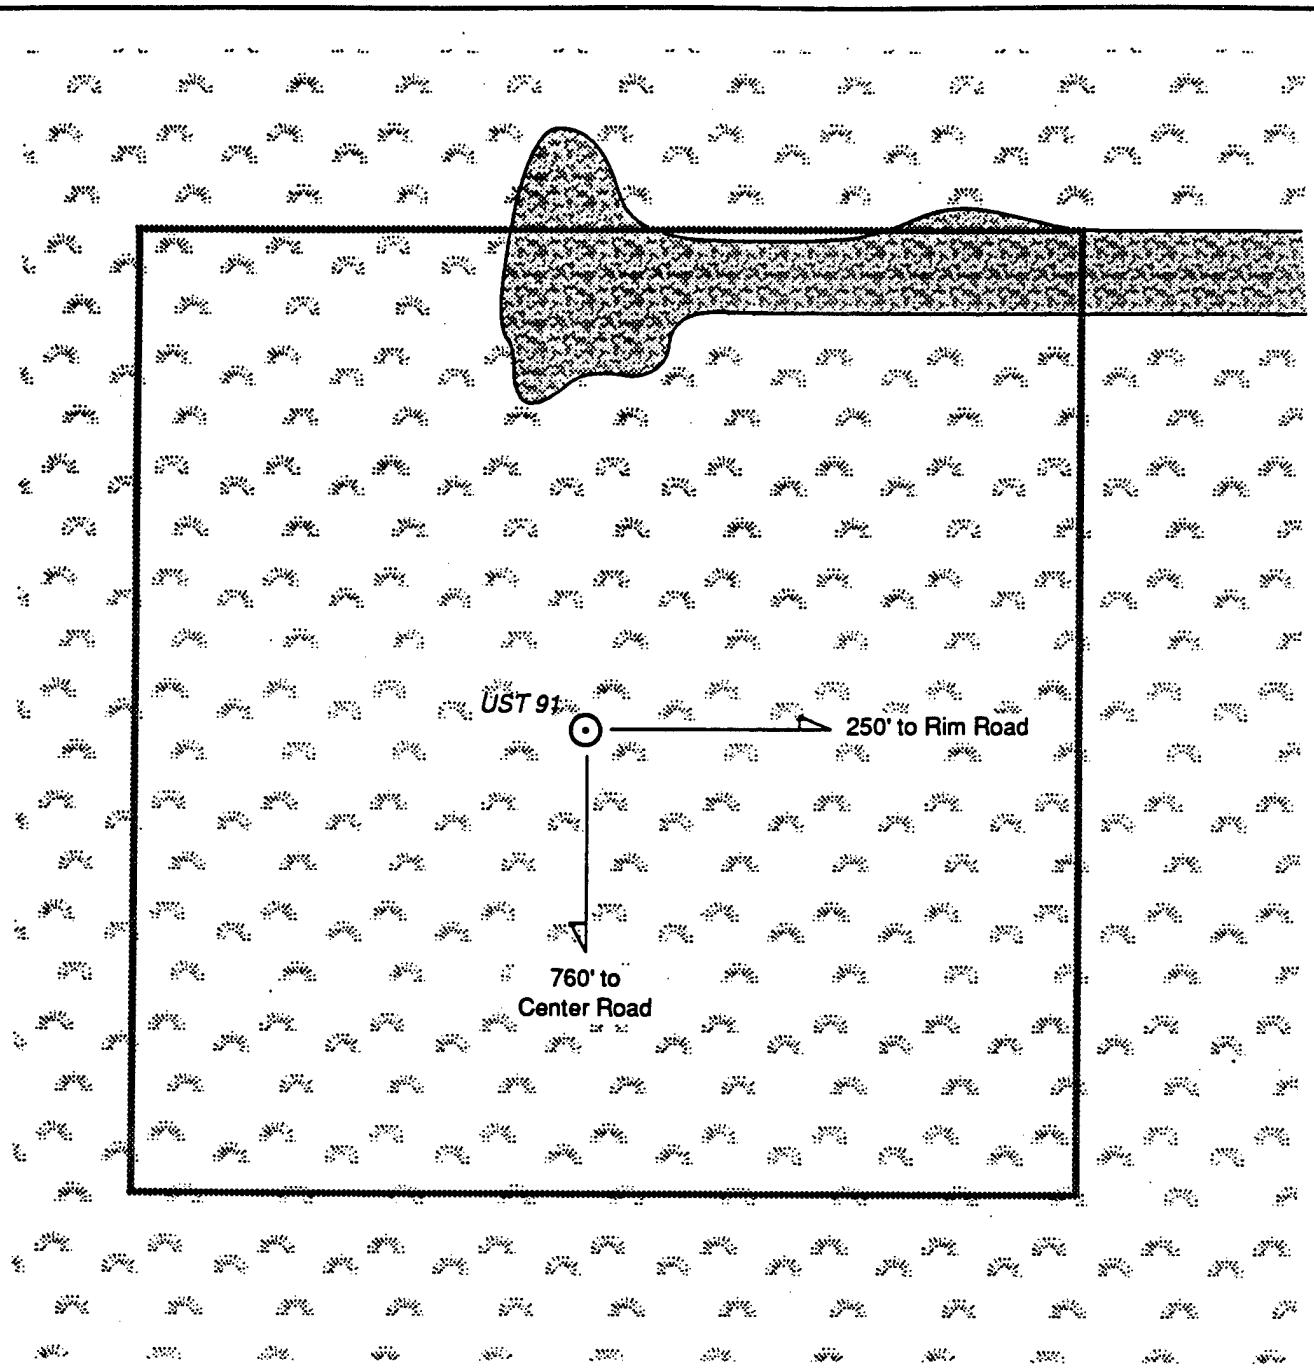
Figure 3-25
UST 91
RESULTS OF GEOPHYSICAL SURVEY

Figure 3-25 shows the reported location of UST 91 and summarizes the results of the geophysical survey. Detailed survey summaries and contour maps of the geophysical data are presented in Appendix C. The results of the survey indicate that it is unlikely that an UST is present within the surveyed area. Several small and weak magnetic anomalies were observed, but they are not considered geophysical targets because they could not be confirmed by the EM data.

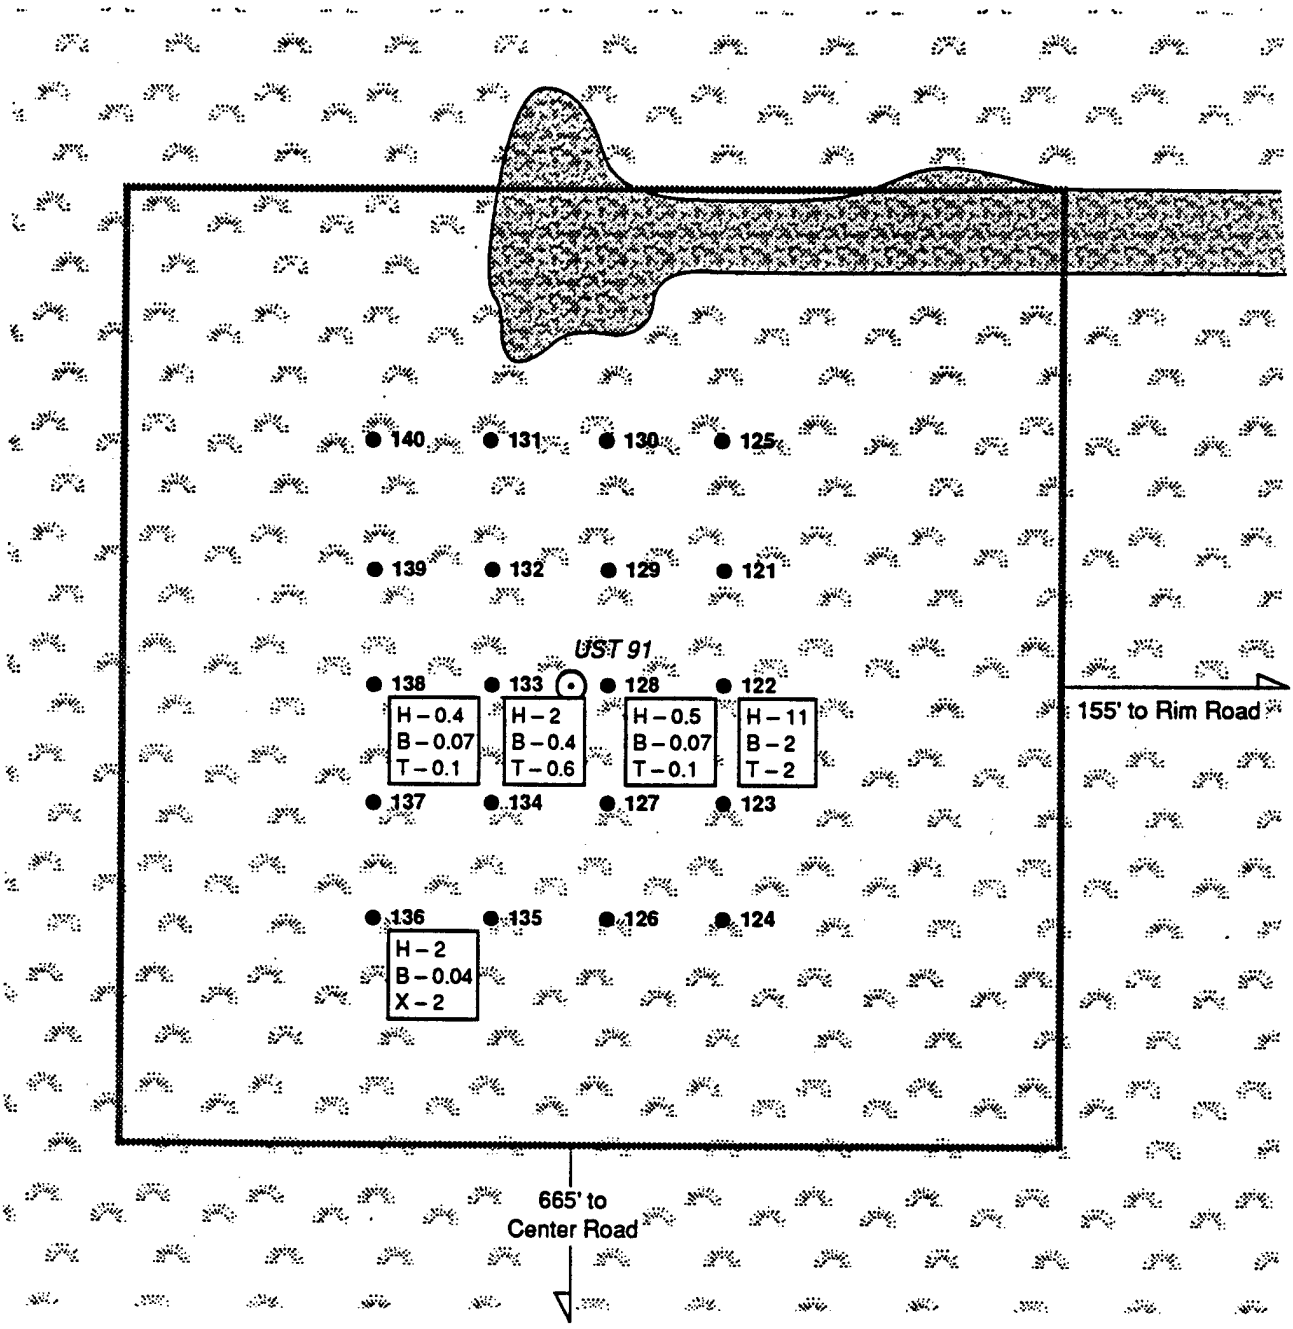
Figure 3-26
UST 91
RESULTS OF SOIL GAS SURVEY

Figure 3-26 presents soil gas results for the BTEX and TVHC components of the active soil gas survey conducted at UST 91. Results of the carbon dioxide and methane components of the survey are presented in Appendix D. The soil gas survey results indicate trace levels of benzene, toluene, xylene, and TVHCs at only a few of the 20 sampled locations. Ethylbenzene was not detected at this site. Benzene was detected in five samples, with concentrations ranging from 0.07 (which is slightly greater than the detection limit of 0.02 μg/L) to a maximum of 2 μg/L. Toluene was detected at four locations coincident with benzene detections; it was reported at concentrations ranging from 0.1 (which is slightly greater than the detection limit of 0.05 μg/L) to a maximum of 2 μg/L. Xylene was reported at one location at a concentration of 2 μg/L (which is one order of magnitude greater than the detection limit of 0.2 μg/L). TVHCs were reported at five locations, with concentrations ranging from 0.4 (which is slightly greater than the detection limit of 0.2 μg/L) to a maximum of 11 μg/L.

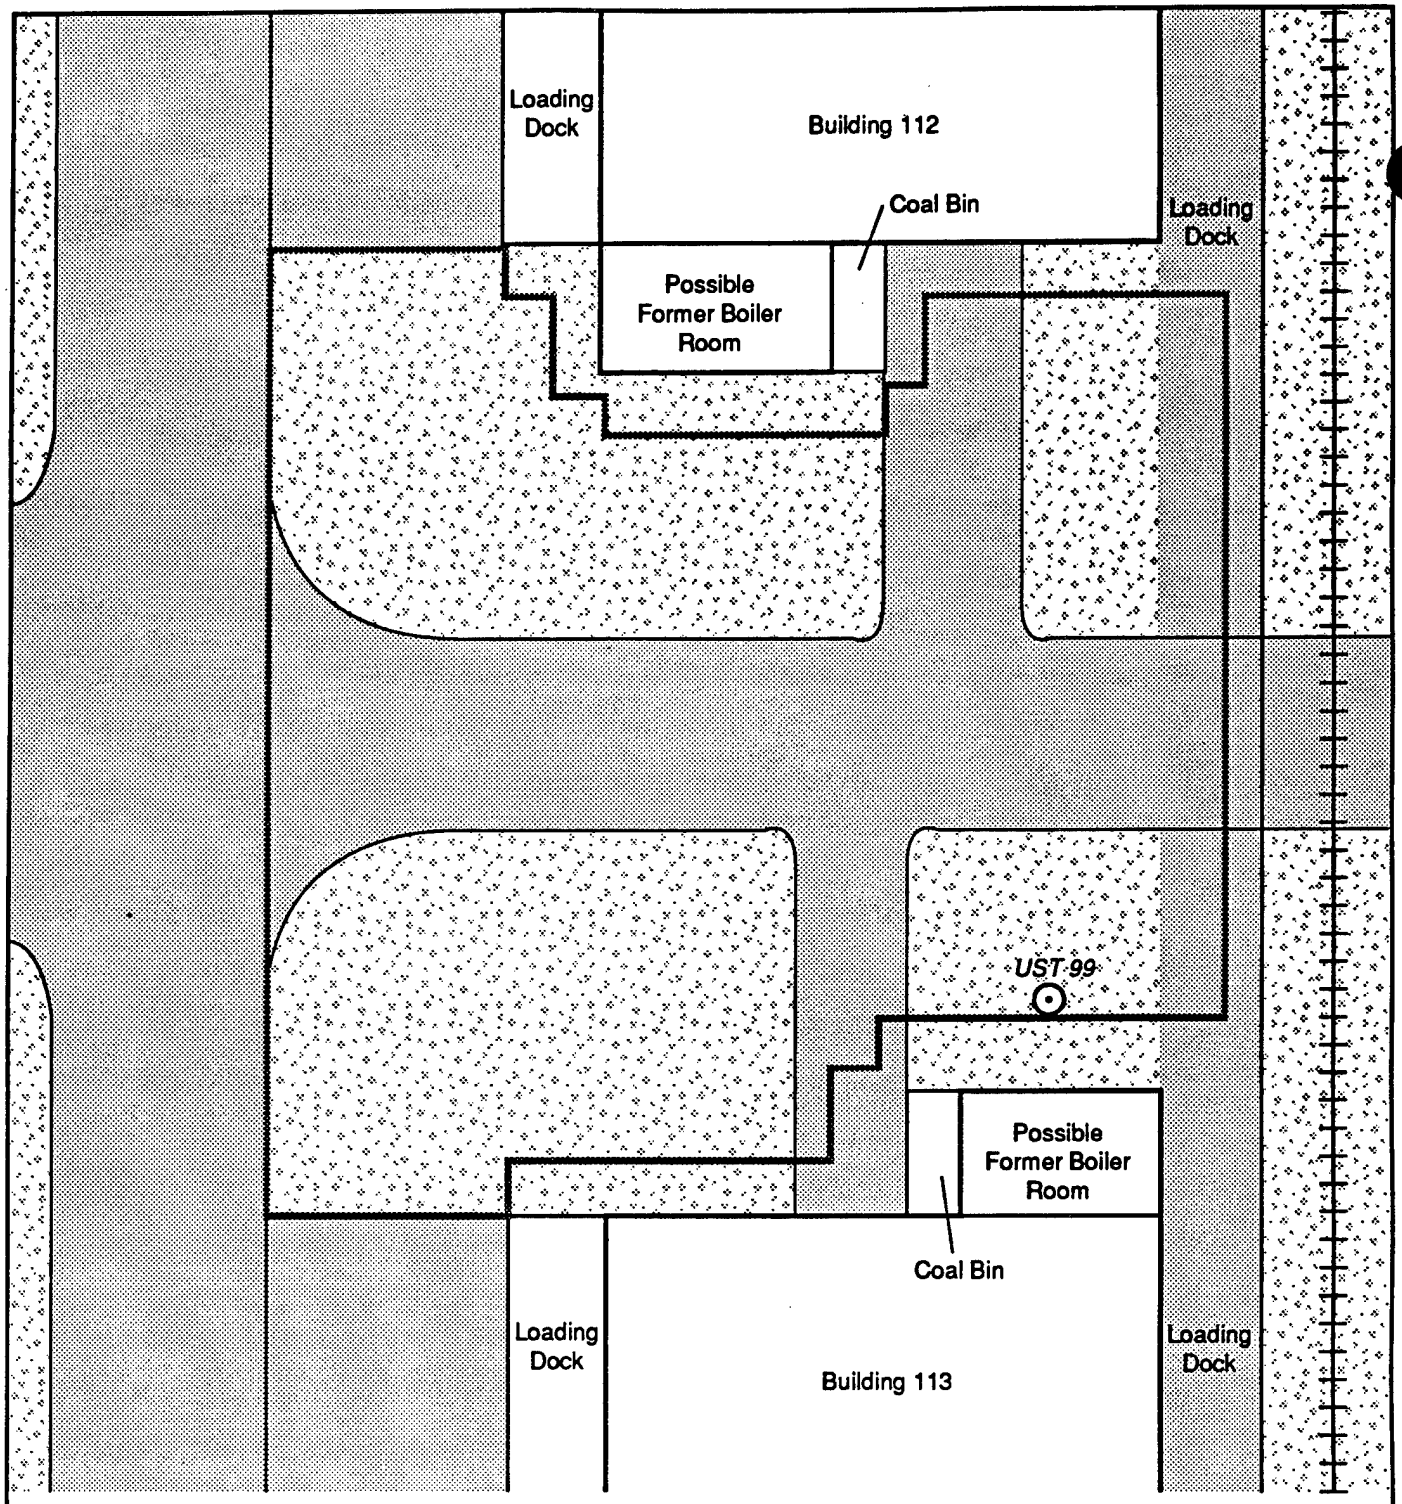
Figure 3-27
UST 99
RESULTS OF GEOPHYSICAL SURVEY

Figure 3-27 shows the reported location of UST 99 and summarizes the results of the geophysical survey. Detailed survey summaries and contour maps of the geophysical data are presented in Appendix C. The results of the survey indicate that it is unlikely that an UST is present within the surveyed area. Several small and weak anomalies were observed, but they are associated with cultural interference from structures such as buildings and utilities. Although such interference hindered the interpretation of magnetic data, no UST targets were indicated by the EM results.

The results of the geophysical survey, which covered approximately 9,500 square feet, indicate that an UST is unlikely to be present in the area reported to contain UST 99. However, data from the geophysical survey do not indicate whether UST 99 had been located here and was removed.

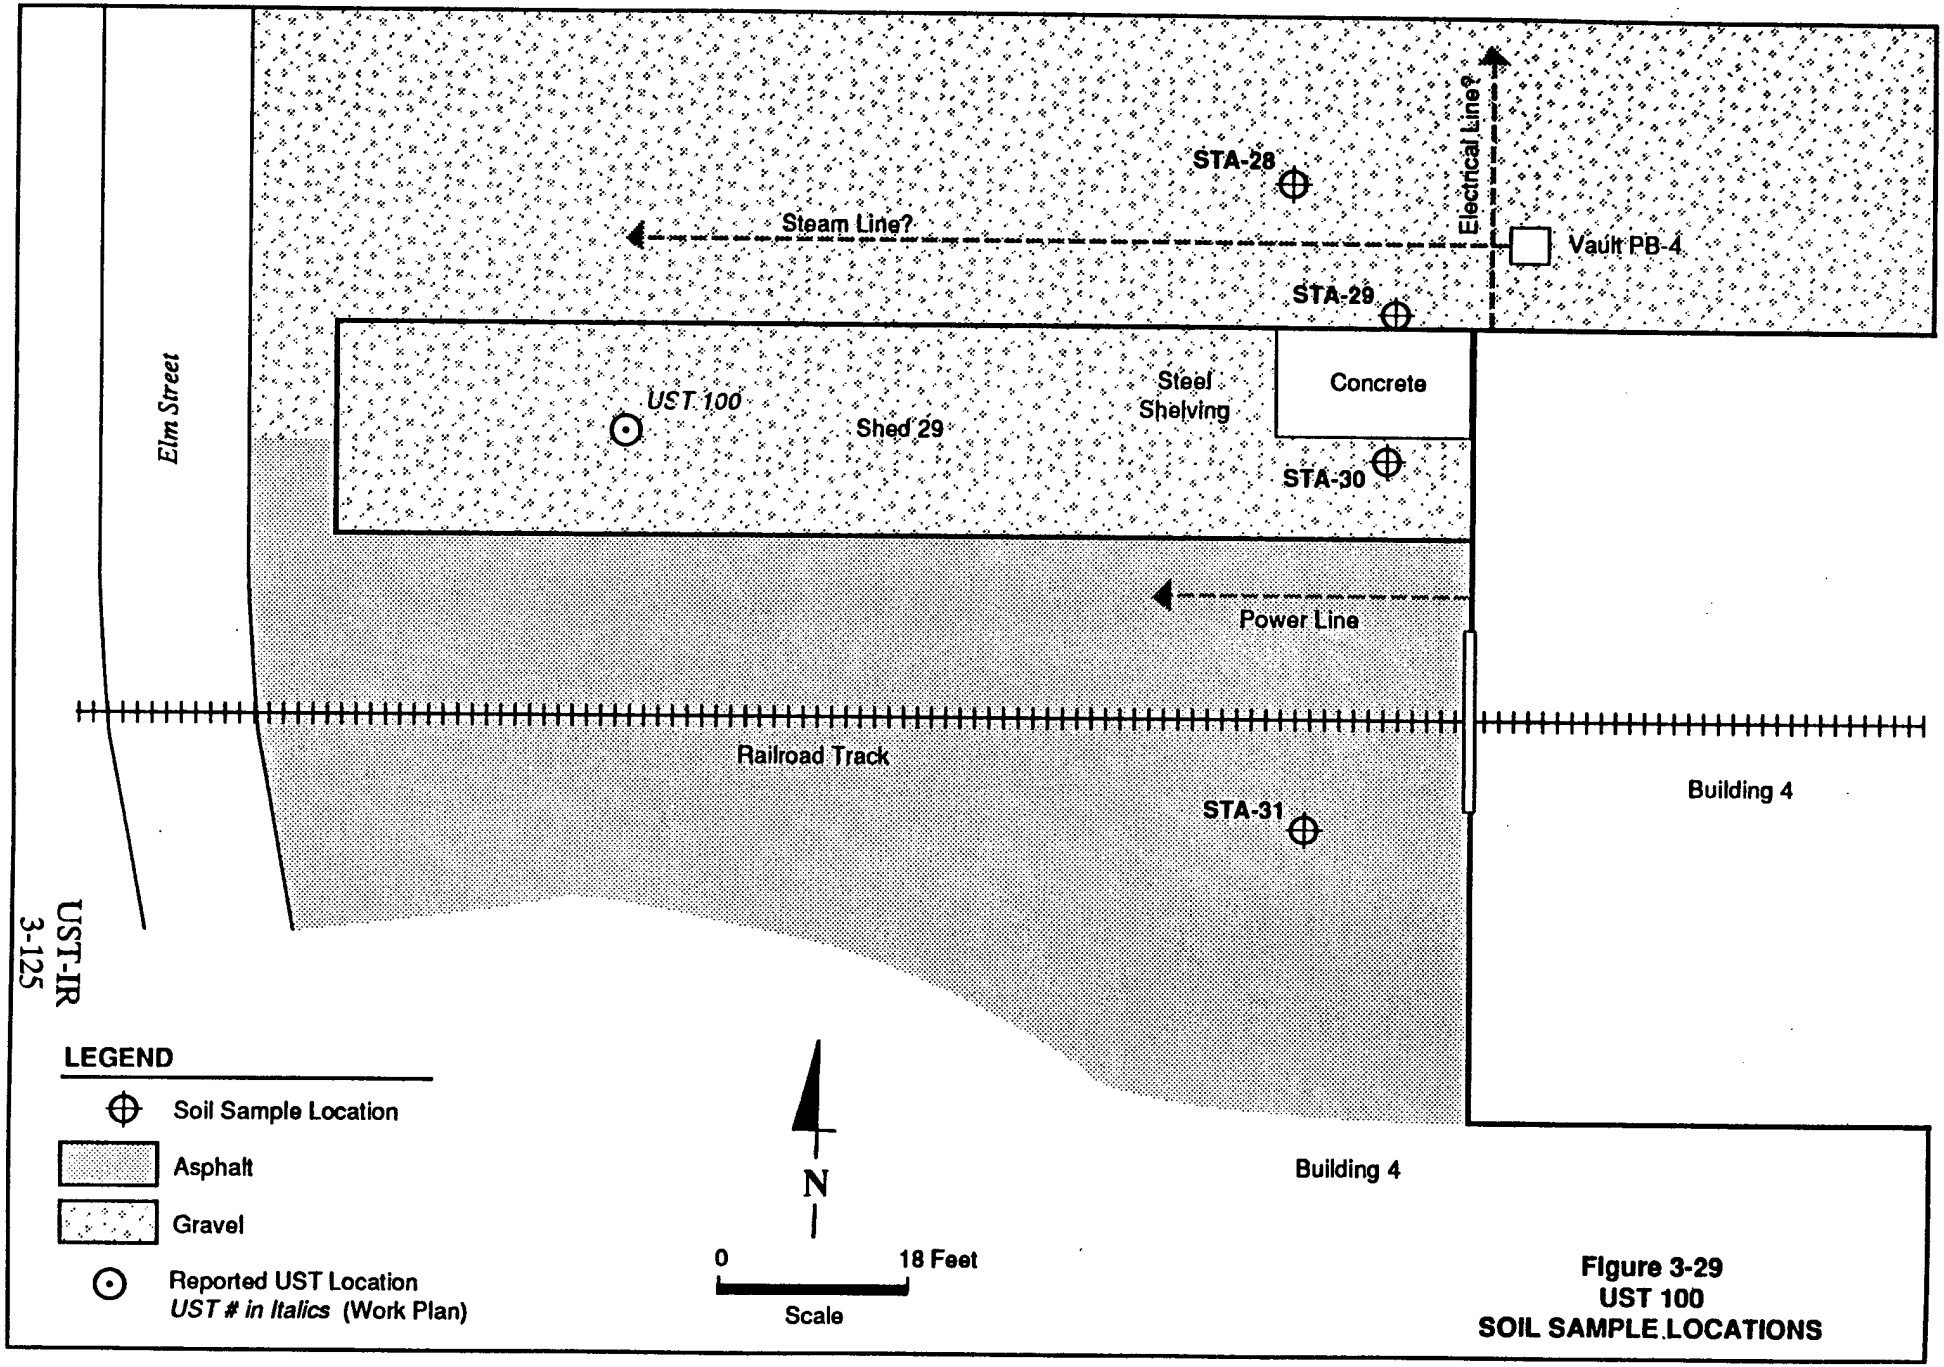
Figure 3-29
UST 100
SOIL SAMPLE LOCATIONS

Based on the soil gas results, soil samples were collected from four borings (STA-28 through STA-31) in the areas reported to have the greatest TVHC concentrations to confirm the presence of volatiles and petroleum hydrocarbons in the soil. Boring locations are shown in Figure 3-29. Soil borings STA-28 and STA-31 were advanced to a depth of 10 feet, and soil samples were collected at the surface and at depths of 2.5, 5, 7.5, and 10 feet. Borings STA-29 and STA-30 were located adjacent to and beneath the shelter, respectively, so drilling was not possible. At these locations a hand auger was used for the boring, and soil samples were collected at the surface and at 1.5 feet. The samples collected from all four borings were chemically analyzed for TCL VOAs, TCL BNAs, and TPHCs.

PID readings of 0.2 ppm were detected at 1.5 feet in both STA-29 and STA-30. An oily odor was noted in STA-29, and an oily asphalt-like odor was noted in STA-30--but no asphalt was present at the surface. A PID reading of 3.5 ppm, accompanied by a slight petroleum odor, was detected in STA-28 at 2.5 feet.

Although no TCL VOAs were detected in site soil samples and TCL BNA concentrations were low, TPHC concentrations detected in all four soil borings were high. No TPHCs were detected below a depth of 2.5 feet, indicating that contamination may be due to surface spills rather than a leaking tank. Although the levels of contamination present at and near the surface are high, the potential for vertical migration of contaminants to greater depths and to groundwater is not considered to be a concern, because samples collected at greater depths (to 10 feet) contained no detectable levels of contaminants. Therefore, only surficial migration via windblown dust may be a concern.

Based on results of the soil gas survey and soil sampling, it is recommended that the soil at the eastern quarter of Building 29 and slightly south of the shed be excavated and disposed of. Because the soil contaminants present in this area appear to be the result of surface spills and not directly related to UST 100, no immediate action is recommended.

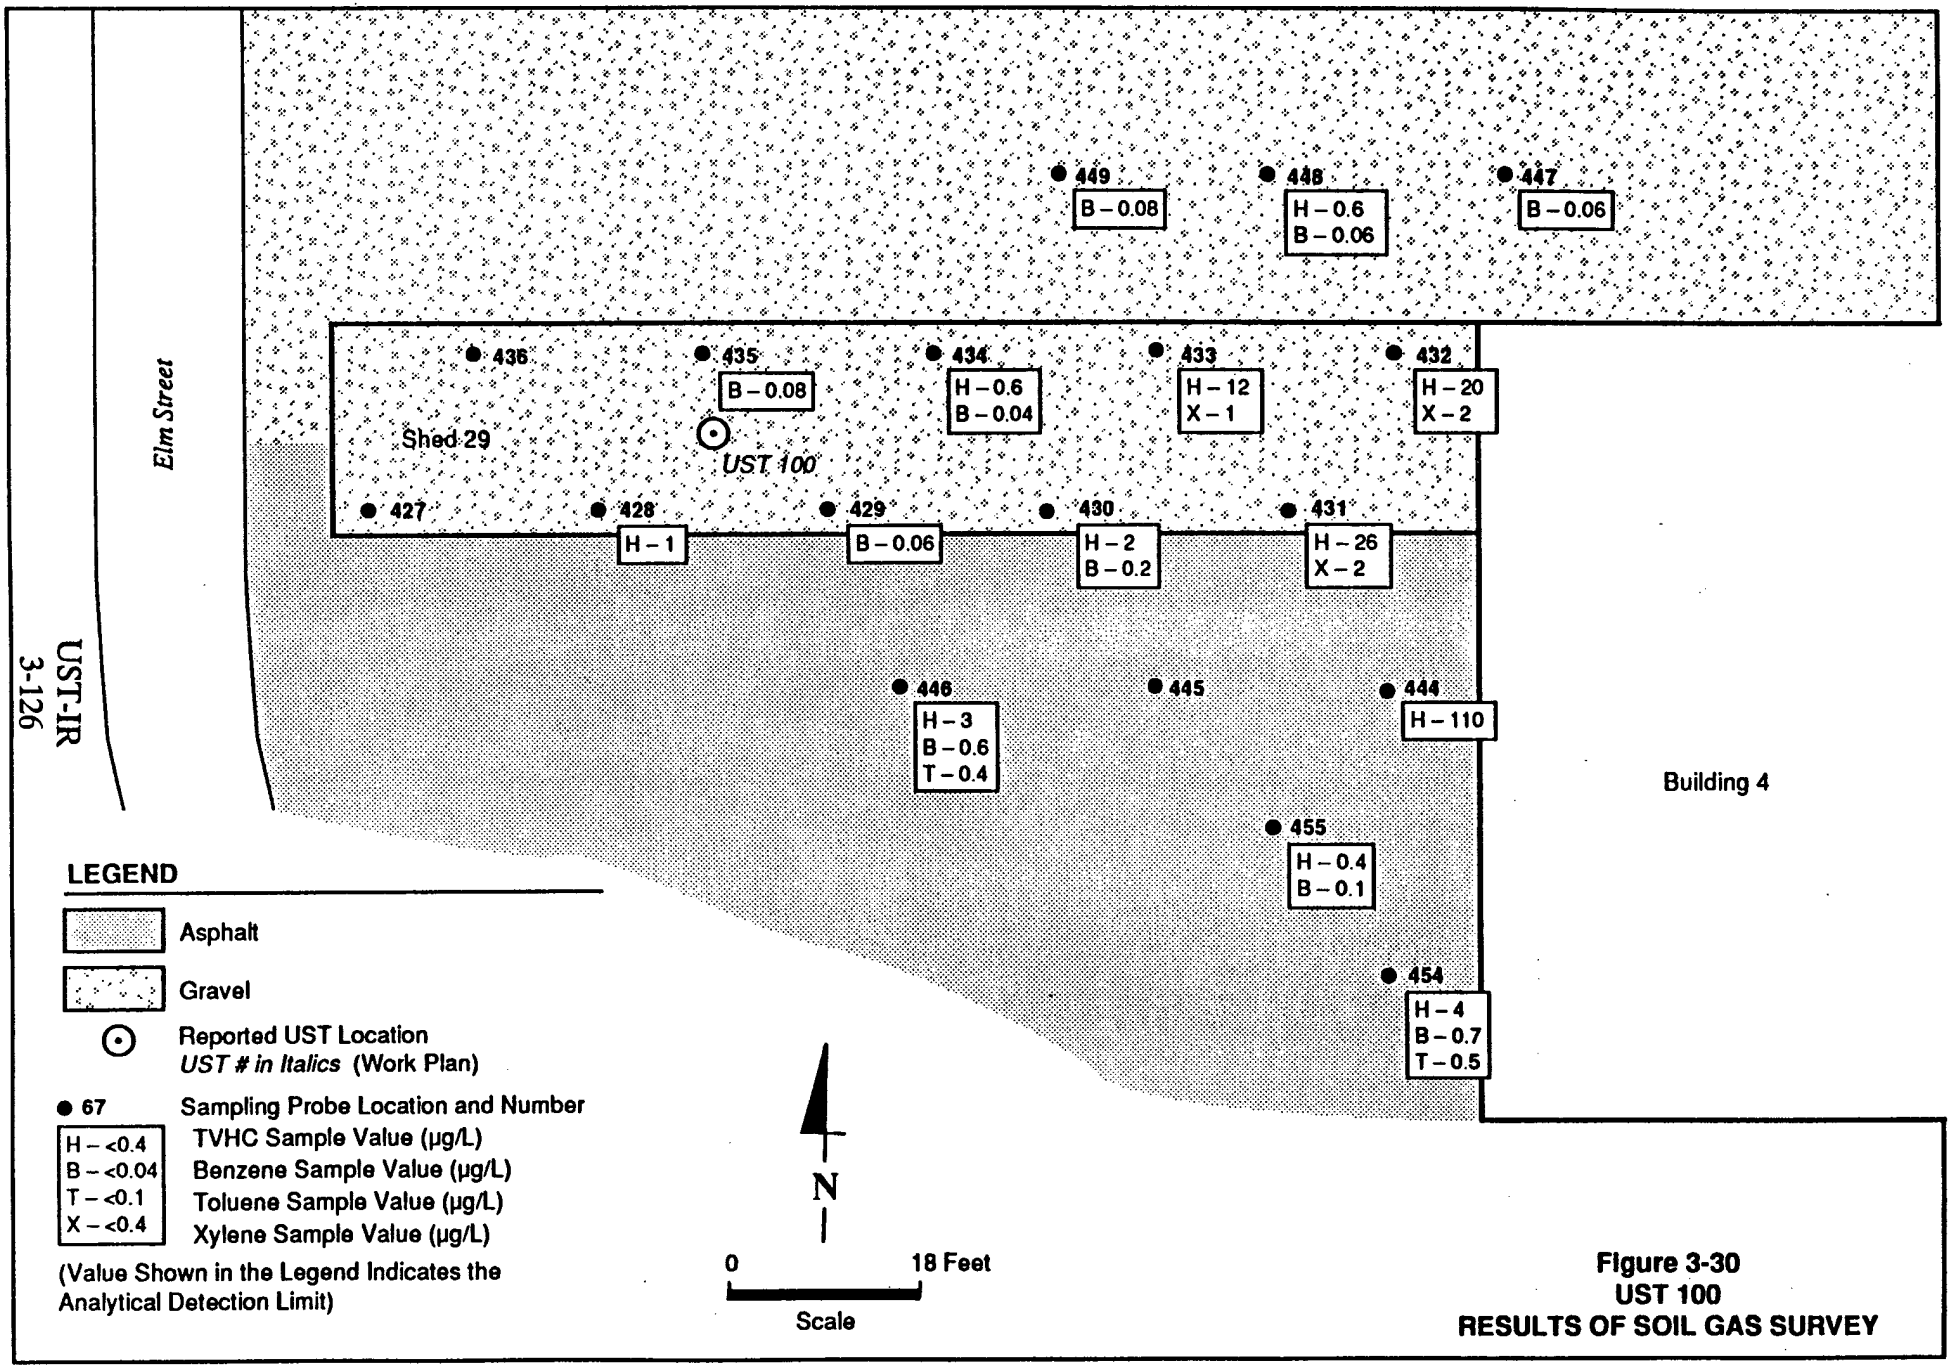
Figure 3-30
UST 100
RESULTS OF SOIL GAS SURVEY

Figure 3-30 presents results for the BTEX and TVHC components of the active soil gas survey conducted at UST 100. Results of the carbon dioxide and methane components of the survey are presented in Appendix D. The soil gas survey results indicate low-to-high levels of benzene, toluene, xylene, and TVHCs at some of the 18 sampled locations. However, ethylbenzene was not detected at this site. Benzene was detected at low levels in 10 samples, with concentrations ranging from 0.04 (which is at the detection limit of 0.04 μg/L) to a maximum of 0.7 μg/L. Toluene was detected at two locations coincident with benzene detections; it was reported at concentrations ranging from 0.4 (which is slightly greater than the detection limit of 0.1 μg/L) to a maximum of 0.5 μg/L. TVHCs were reported at 11 of the locations, with concentrations ranging from 0.4 (which is at the detection limit of 0.4 μg/L) to a maximum of 110 μg/L.
