Report No. SFIM-AEC-BC-CR-95047

UNDERGROUND STORAGE TANK INVESTIGATION REPORT UMATILLA DEPOT ACTIVITY HERMISTON, OREGON

DAMES & MOORE
849 International Drive, Suite 320
Linthicum, Maryland 21090

JUNE 1995

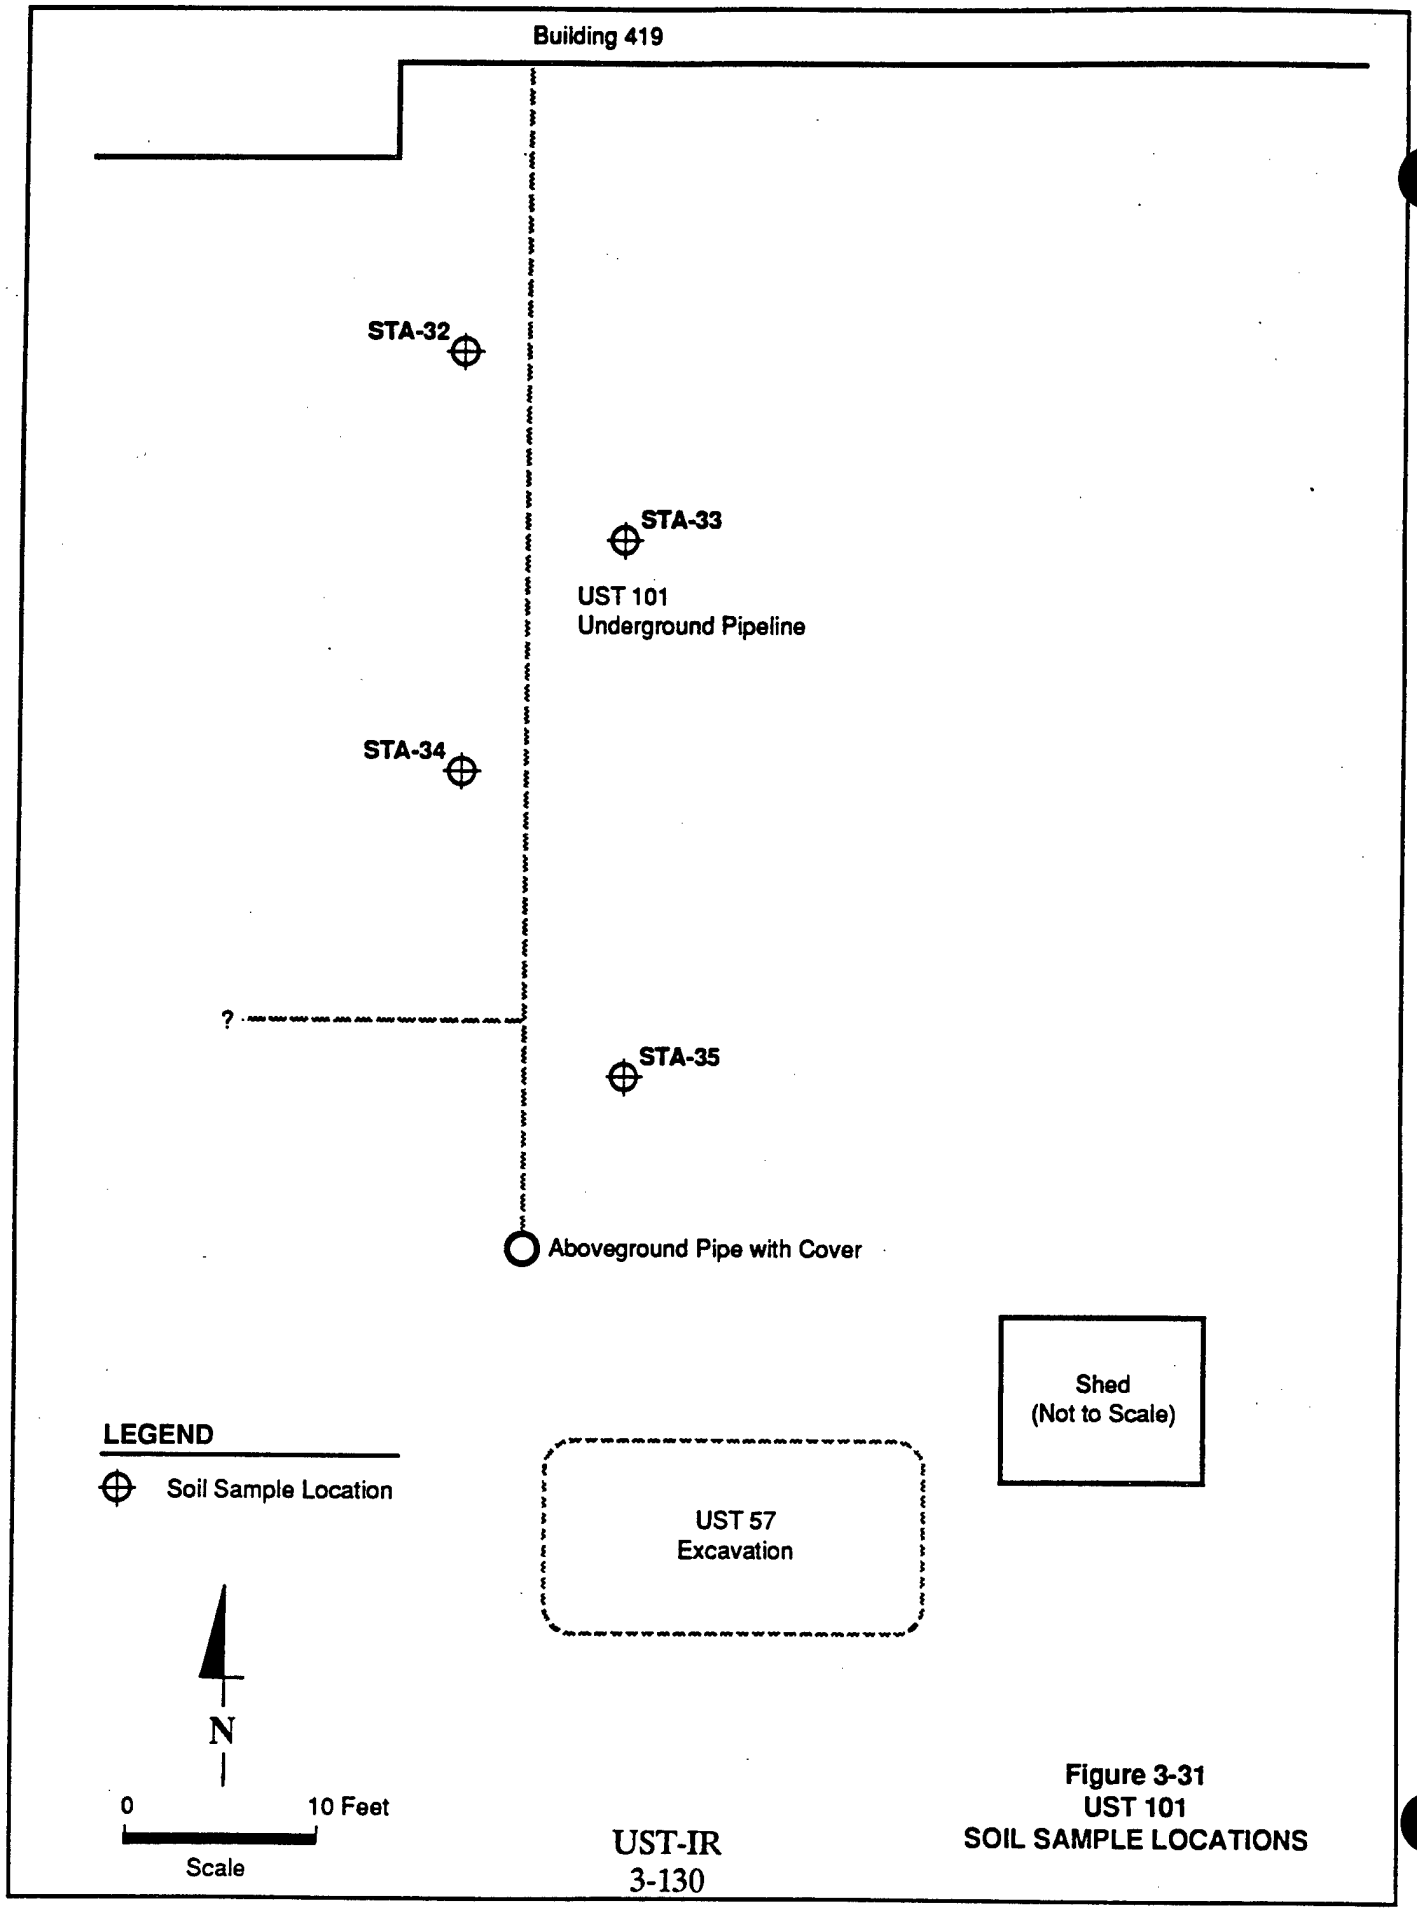
Figure 3-31
UST 101
SOIL SAMPLE LOCATIONS

As indicated in Table 3-1, tank contents sampling results indicate that no constituents analyzed for were present in UST 101. As indicated in Table 3-4, no TCL VOAs, TCL BNAs, or TPHCs were detected. Very low levels of one known and one unknown VOA TIC were detected in only one sample. Based on these results, potential contamination due to a leaking pipeline is not considered to be a concern.

Because no contamination of concern was detected at UST 101, no further action is recommended.

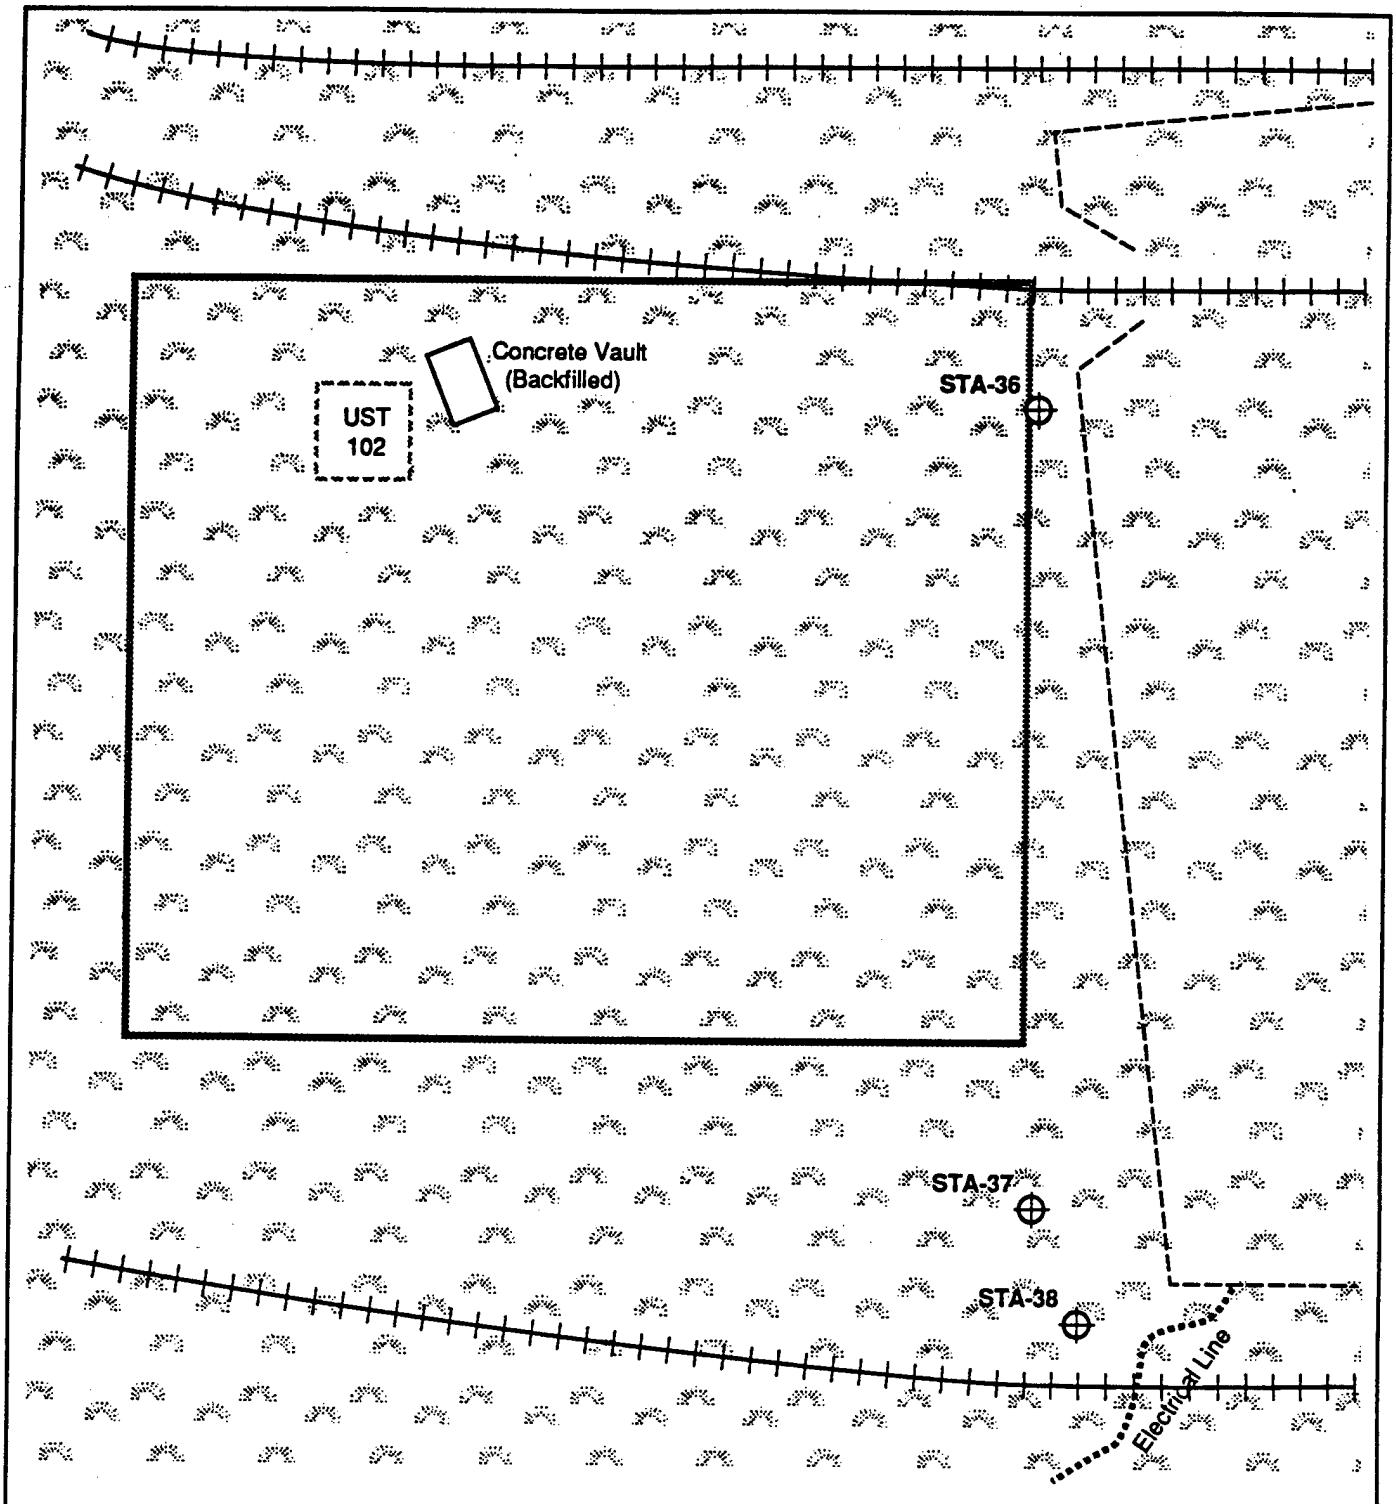
Figure 3-32
UST 102
SOIL SAMPLE LOCATIONS

Based on soil gas results, soil samples were collected from three 10-foot borings (STA-36 through STA-38) in the areas east of UST 102 reported to have the greatest TVHC concentrations. Soil sampling locations are shown in Figure 3-32. In borings STA-36 and STA-37, samples were collected at the surface and at depths of 2.5, 7.5, and 10 feet. In STA-38, samples were collected at the surface and at depths of 2.5, 5, 7.5, and 10 feet. All samples were chemically analyzed for TCL VOAs, TCL BNAs, and TPHCs.

As indicated in Table 3-4, low concentrations of four TCL BNAs were detected in soil samples collected near UST 102 (see Figure 3-32). Bis(2-ethylhexyl)phthalate was detected at 10 feet in STA-36 and at 2.5 feet in STA-37 and STA-38.

Concentrations detected were 14 μg/g, 0.77 μg/g, and 0.83 μg/g, respectively. Fluoranthene, phenanthrene, and pyrene were detected only in the surface sample at STA-38, at concentrations of 0.09 μg/g, 0.04 μg/g, and 0.11 μg/g, respectively.

TPHCs were detected at concentrations of 35.5 μg/g in the surface and 2.5-foot deep samples at STA-37, and at a concentration of 35.7 μg/g in the sample collected from a depth of 7.5 feet at STA-38. No TCL VOAs were detected in any of the samples. One TCL VOA TIC and one unknown VOA TIC were detected in each of two soil samples. Based on these results, it does not appear that potential contamination due to a leaking tank is of concern.

Soil samples collected in the vicinity of elevated soil gas TVHC and toluene levels exhibited only low concentrations of several TCL BNAs and TPHCs in limited locations. Based on these results, and because the low detected levels of organics do not appear to be associated with the buried USTs, no immediate action is recommended.

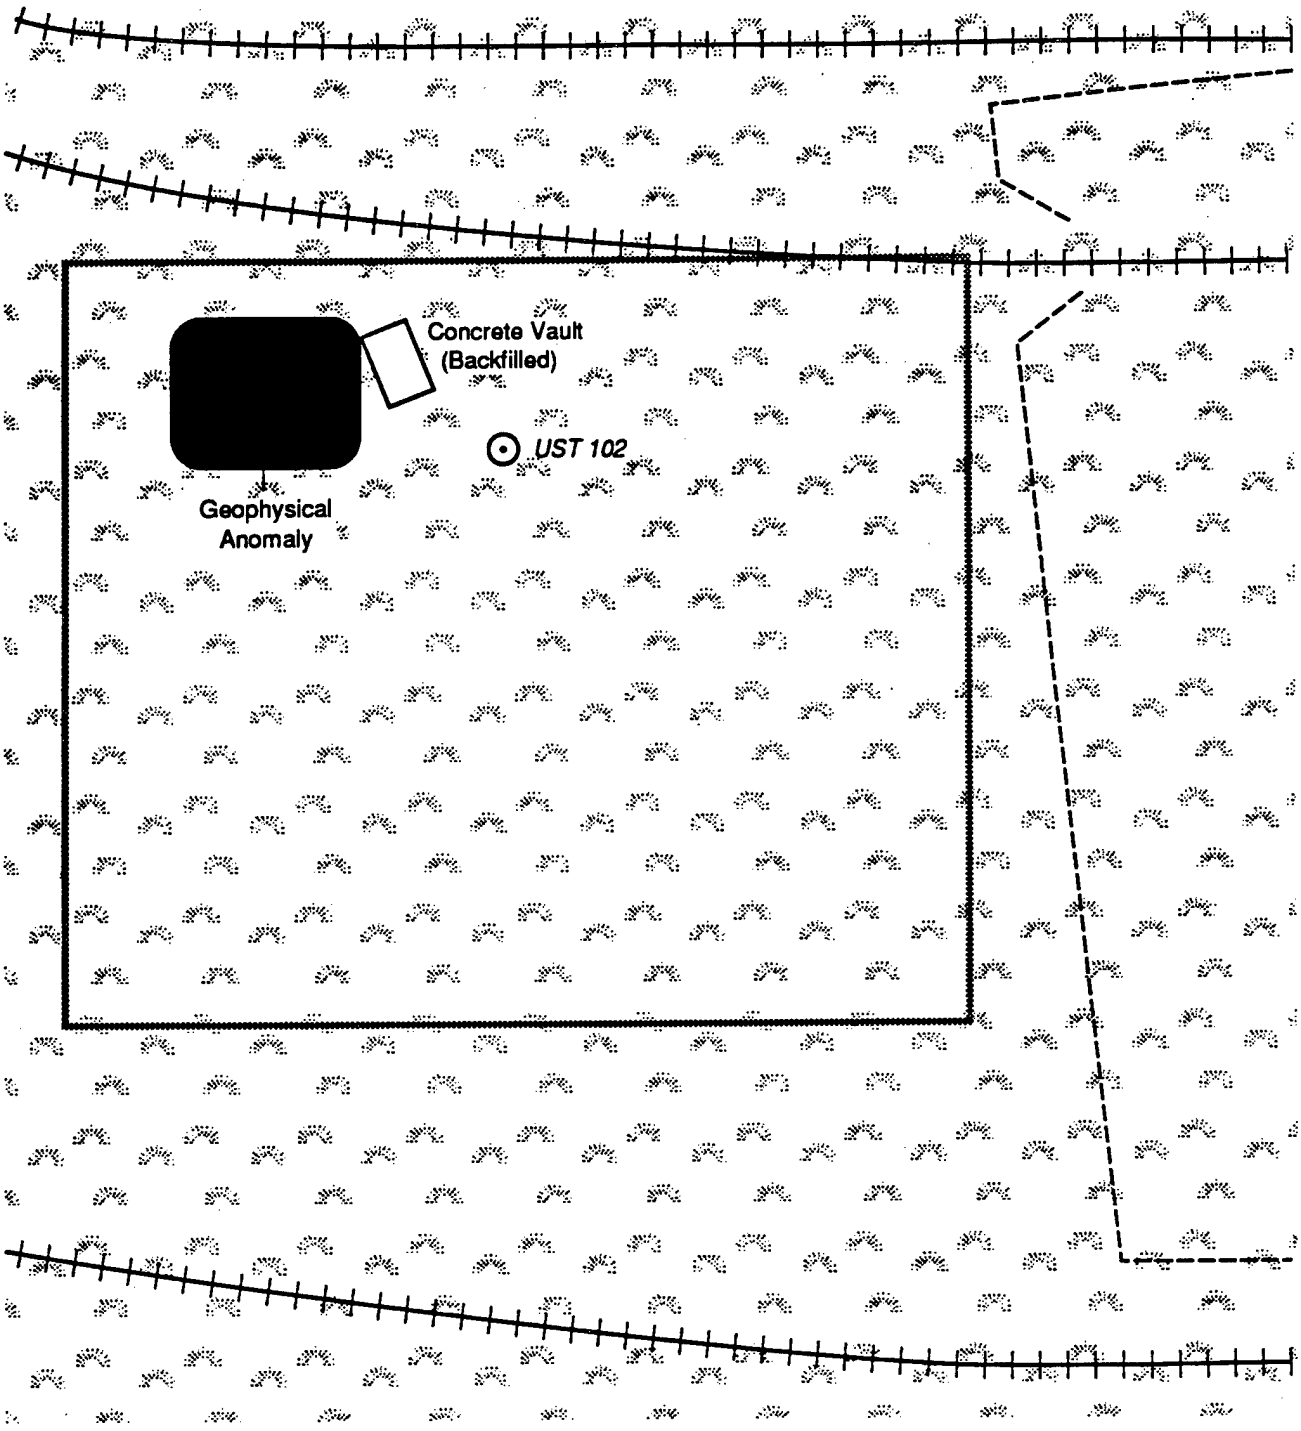
Figure 3-33
UST 102
RESULTS OF GEOPHYSICAL SURVEY

Figure 3-33 shows the reported location of UST 102 and summarizes the results of the geophysical survey. Detailed survey summaries and contour maps of the geophysical data are presented in Appendix C. The results of the survey indicate that a strong underground geophysical target is located immediately west of the concrete vault. These results suggest that two targets may be underground at the anomaly location. Based on typical dimensions of tanks with this capacity, the size of the anomaly--which is approximately 16 by 20 feet--also suggests the presence of two tanks placed side-by-side.

However, it is recommended that the area of the geophysical anomaly be excavated by UMDA to confirm the presence of the potential target. If abandoned USTs are discovered, the tanks should be placed under the UMDA tank closure program. The tanks should be removed and the surrounding soil tested and remediated, if necessary, according to State tank closure procedures.

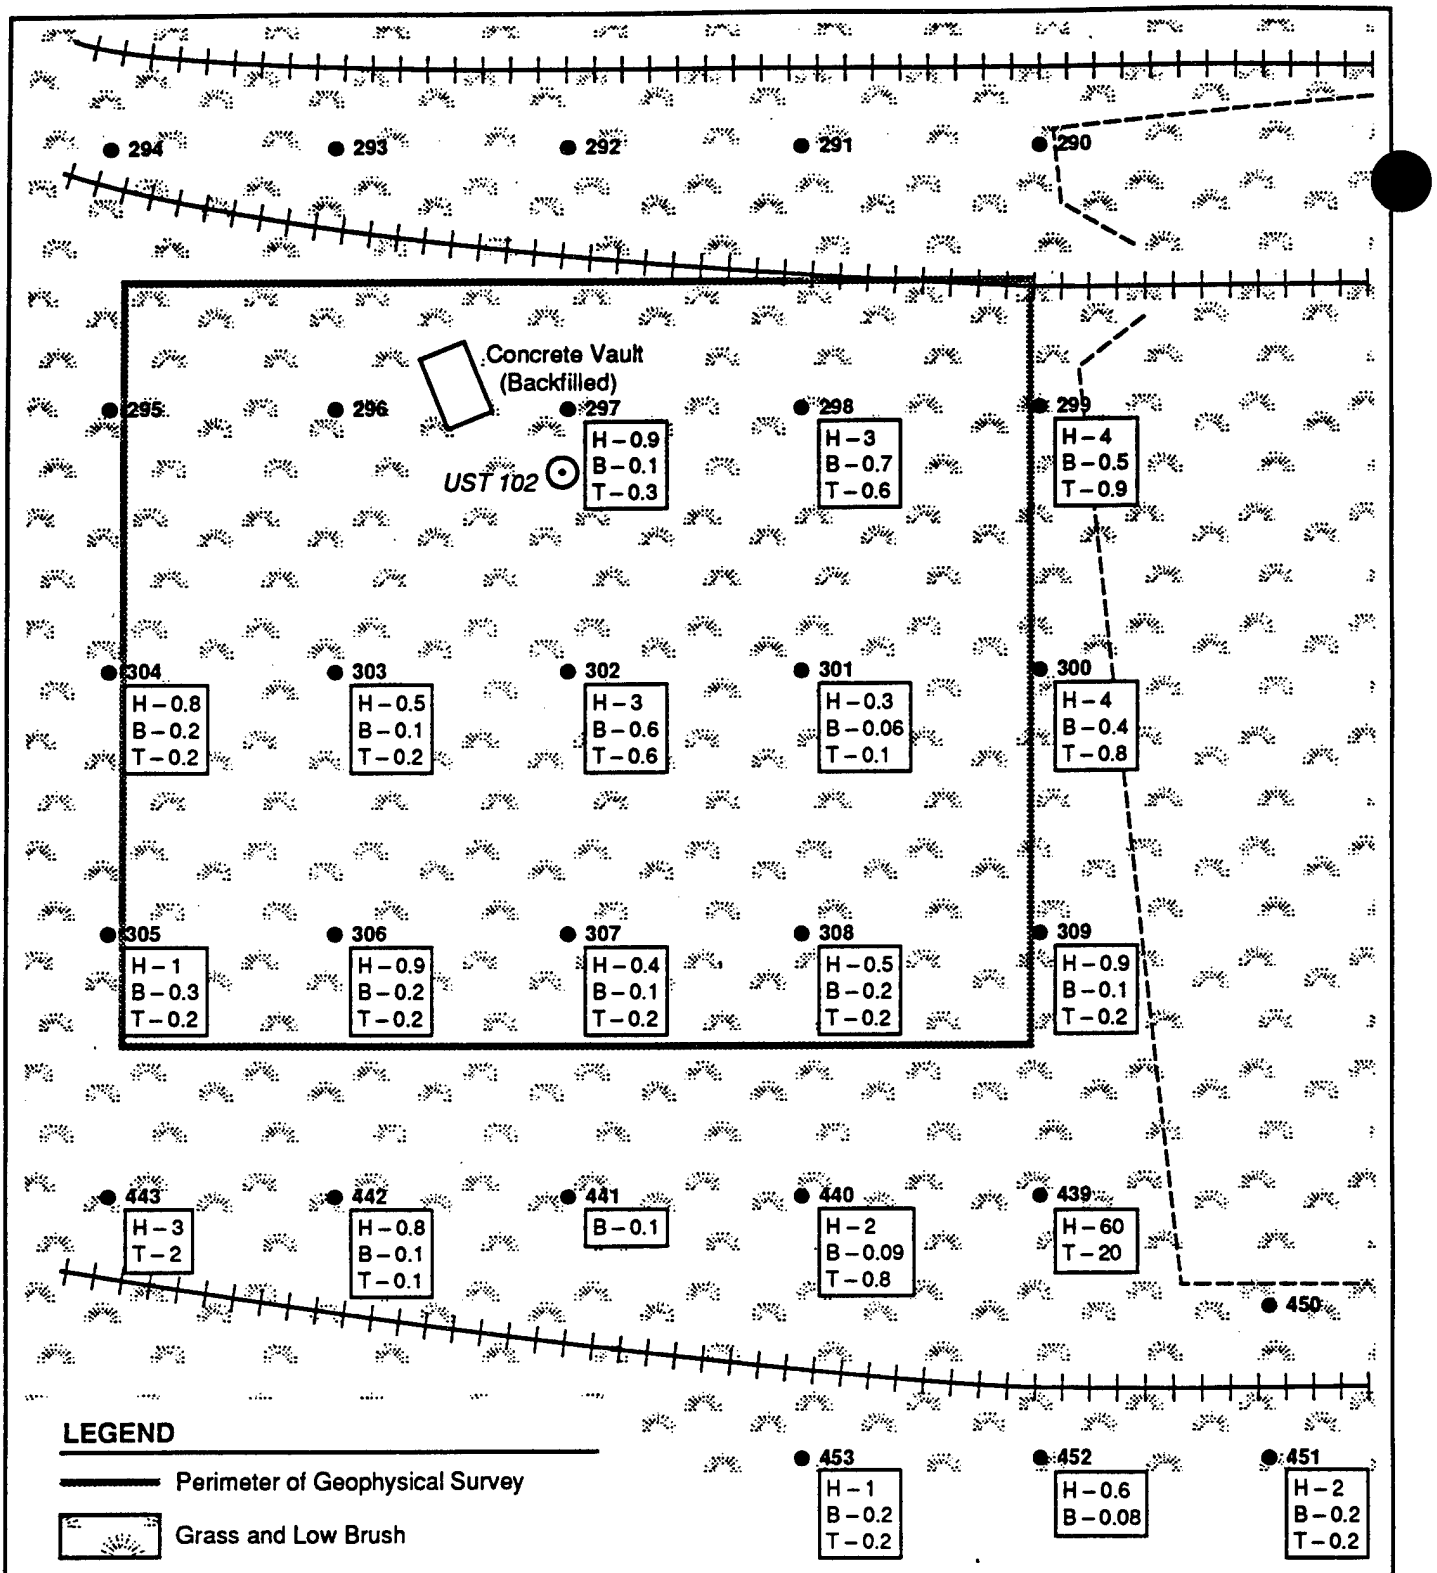
Figure 3-34
UST 102
RESULTS OF SOIL GAS SURVEY

Figure 3-34 presents results for the BTEX and TVHC components of the active soil gas survey conducted at UST 102. Results of the carbon dioxide and methane components of the survey are presented in Appendix D. The soil gas survey results indicate trace levels of benzene, toluene, and TVHCs at some of the 29 sampled locations in the vicinity of UST 102. Ethylbenzene and xylene were not detected at this site. Benzene was detected in 19 samples, with concentrations ranging from 0.06 (which is slightly greater than the detection limit of 0.04 μg/L) to a maximum of 0.7 μg/L. Toluene was detected at 19 locations coincident with benzene detections; it was reported at concentrations ranging from 0.1 (which is at the detection limit of 0.1 μg/L) to a maximum of 20 μg/L. TVHCs were reported at 20 locations, with concentrations ranging from 0.3 (which is at the detection limit of 0.3 μg/L) to a maximum of 60 μg/L.

Carbon dioxide was reported at 27 locations, with concentrations ranging from 660 (which is slightly greater than the detection limit of 310 μg/L) to a maximum of 1,900 μg/L (Appendix D). Methane, with a detection limit of 680 μg/L, was not detected at the site.

The chemical results of 29 active soil gas samples collected at the reported site indicate low concentrations of benzene, toluene, and TVHCs in all but one of the 20 samples containing detectable volatiles. Volatiles were not detected in soil gas samples collected closest to the potential tanks, which indicates that they likely did not leak sufficiently (if at all) to affect the environment. However, significant toluene and TVHC soil gas concentrations were reported for one sample location in the southeast corner of the survey area. The surrounding soil gas sample results indicate that this relatively high level of potential contamination is localized, but that lower levels of contamination may extend north along the fence in the eastern part of the survey area.

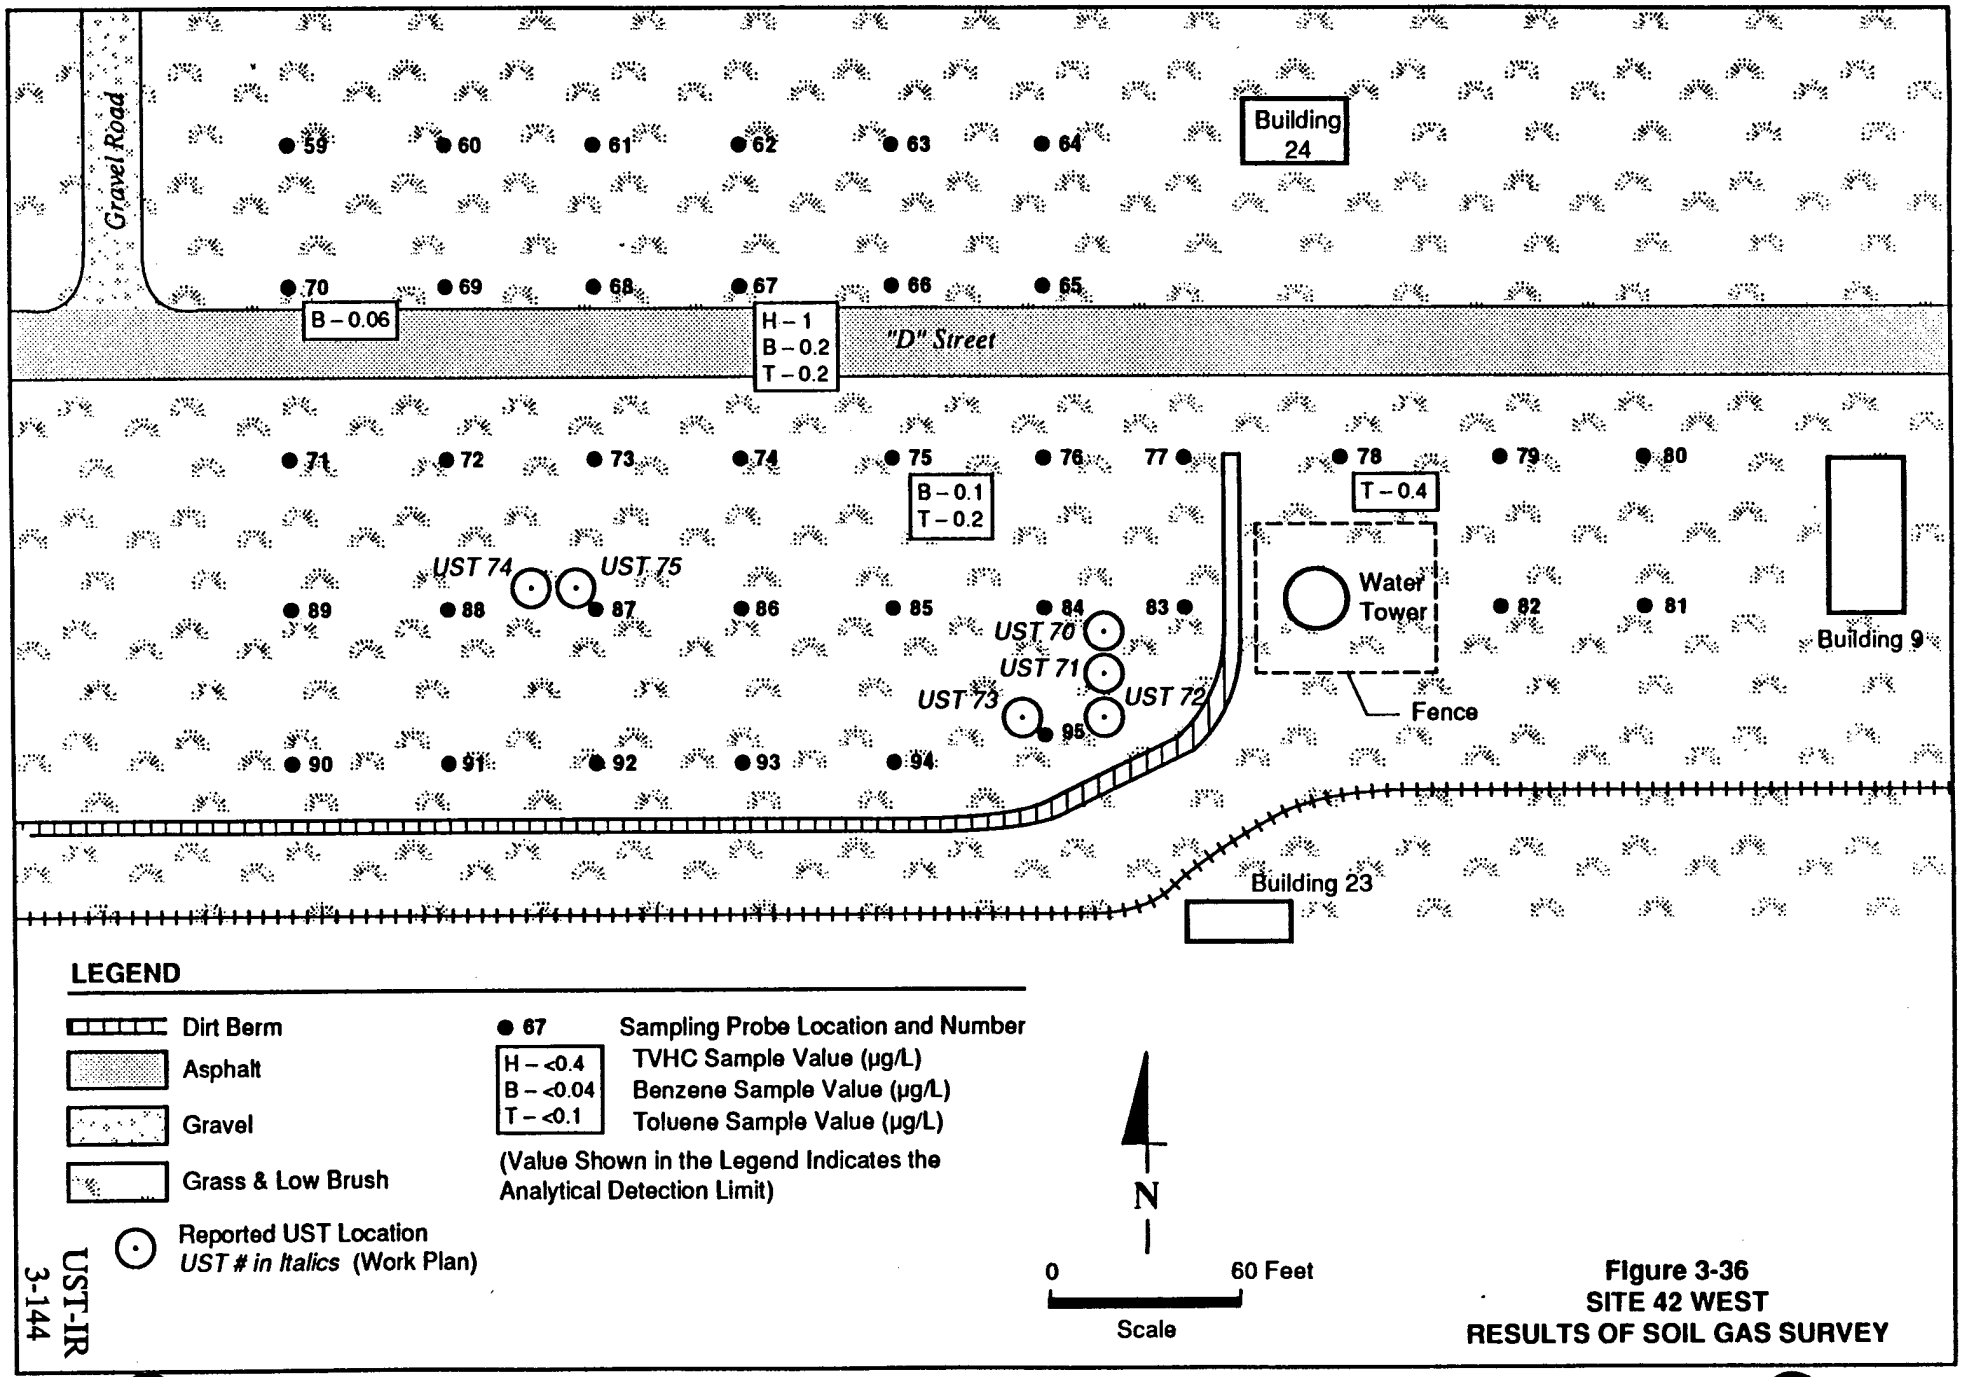
Figure 3-36
SITE 42 WEST
RESULTS OF SOIL GAS SURVEY

- Site 42 West--Figure 3-36 presents results for the BTEX and TVHC components of the active soil gas survey conducted in the western portion of Site 42. Results of the carbon dioxide and methane components of the survey are presented in Appendix D. The soil gas survey results indicate trace levels of benzene, toluene, and TVHCs at

only a few of the 37 sampled locations. Ethylbenzene and xylene were not detected at this site. Benzene was detected in three samples, with concentrations ranging from 0.06 (which is at the detection limit of 0.06 μg/L) to a maximum of 0.2 μg/L. Toluene was detected at three locations mostly coincident with benzene detections; it was reported at concentrations ranging from 0.2 (which is slightly greater than the detection limit of 0.1 μg/L) to a maximum of 0.4 μg/L. TVHCs were reported at one location at a concentration of 1 μg/L (which is slightly greater than the detection limit of 0.5 μg/L).

Because the soil gas survey results indicate limited and trace levels of soil contamination, no further action is recommended at Site 42.

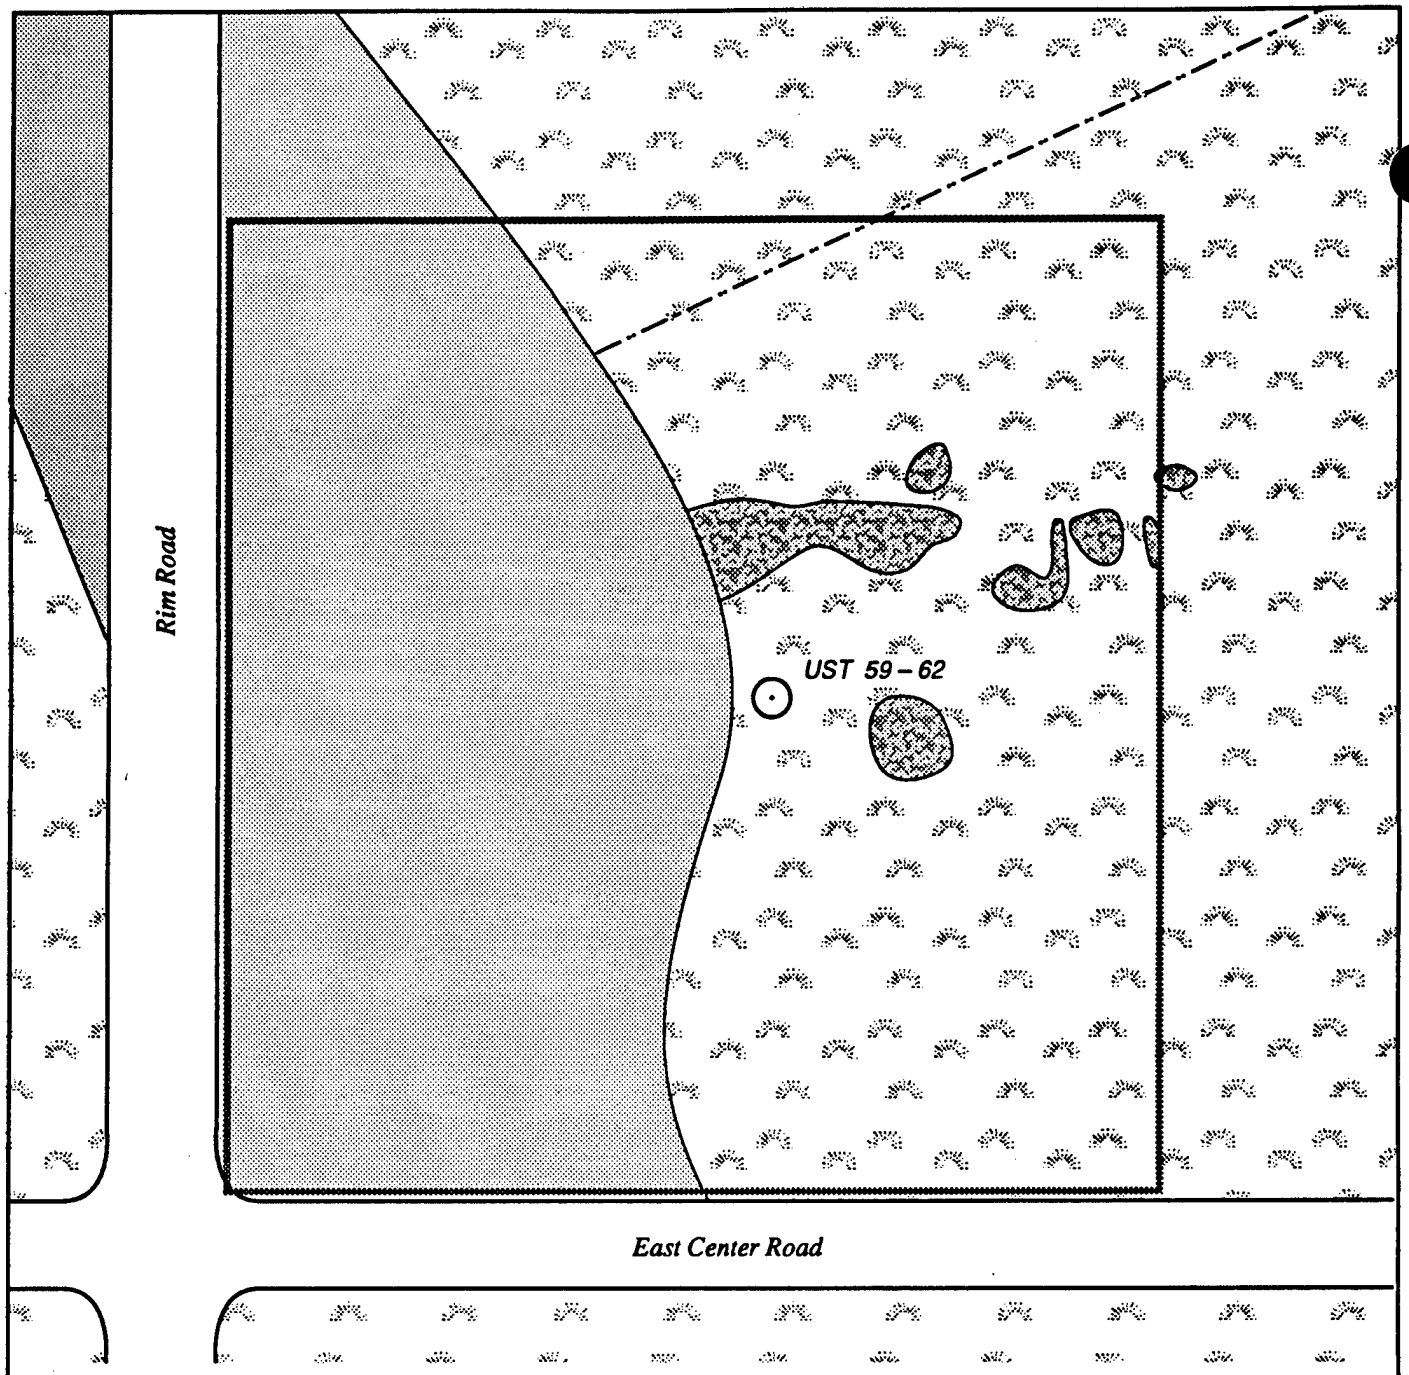
Figure 3-37
SITE 43, FORMER GAS STATION
RESULTS OF GEOPHYSICAL SURVEY

Figure 3-37 shows the reported locations of USTs 59 to 62 and summarizes the results of the geophysical survey. Detailed survey summaries and contour maps of the geophysical data are presented in Appendix C. The results of the survey indicate that it is unlikely that USTs are present within the surveyed area. Several small and weak magnetic anomalies were observed, but they are not considered to be USTs because of their size and strength and because they could not be confirmed by the EM data. The anomalies were attributed to local utilities. Several areas of stressed vegetation were observed during the survey--in particular, one large area east of the asphalt lot. Although the areas may represent the remains of past excavation and grading activities conducted as part of the gas station demolition, the causes of the stressed vegetation are presently unknown.

Because the geophysical survey indicates that USTs are unlikely to be present and the soil gas survey results indicate limited and trace levels of soil contamination, no further action is recommended at this site.

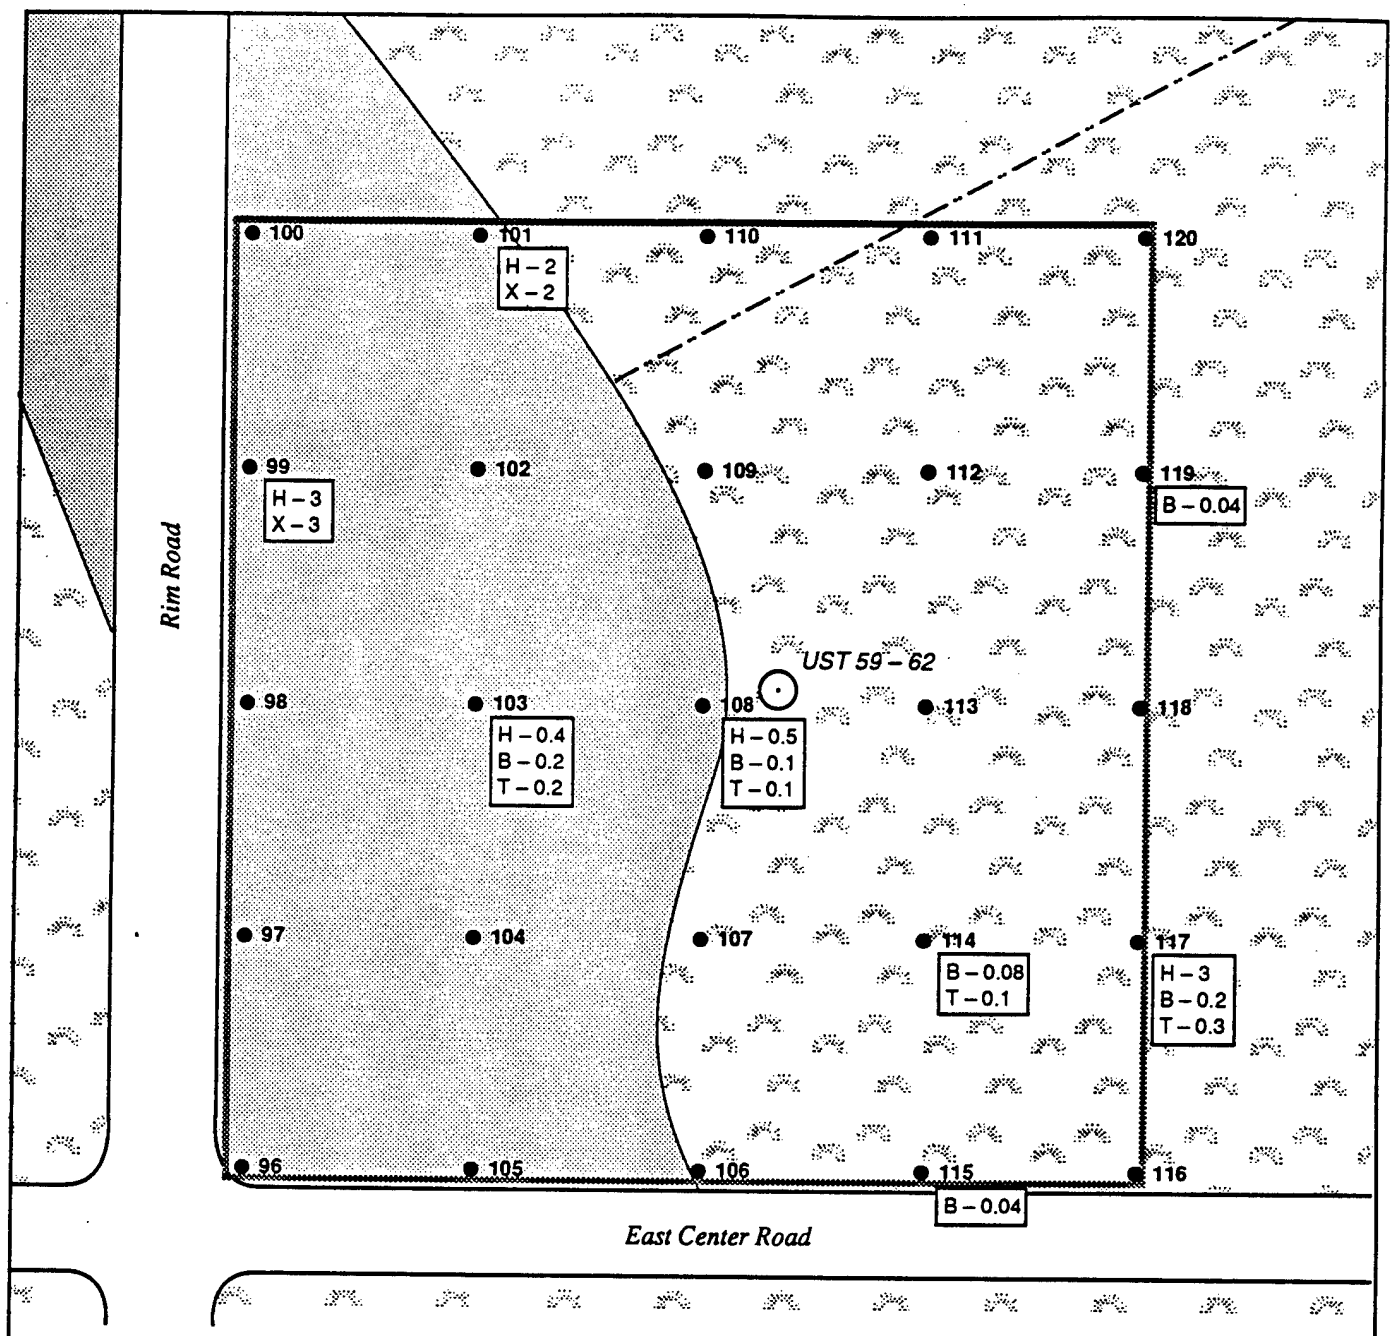
Figure 3-38
SITE 43, FORMER GAS STATION
RESULTS OF SOIL GAS SURVEY

Figure 3-38 presents results for the BTEX and TVHC components of the active soil gas survey conducted at Site 43. Results of the carbon dioxide and methane components of the survey are presented in Appendix D. The soil gas survey results indicate trace levels of benzene, toluene, xylene, and TVHCs at some of the 25 sampled locations. Ethylbenzene was not detected at this site. Benzene was detected in six samples, with concentrations ranging from 0.04 (which is slightly greater than the detection limit of 0.009 μg/L) to a maximum of 0.2 μg/L. Toluene was detected at four locations coincident with benzene detections; it was reported at concentrations ranging from 0.1 (which is at the detection limit of 0.1 μg/L) to a maximum of 0.3 μg/L. Xylene was detected at two locations coincident with TVHC detections, at concentrations of 2 μg/L and 3 μg/L. TVHCs were reported at five locations, with concentrations ranging from 0.4 (which is slightly greater than the detection limit of 0.4 μg/L) to a maximum of 3 μg/L.

The chemical results of 25 active soil gas samples collected at the reported site indicate only trace concentrations of benzene, toluene, xylene, and TVHCs at limited locations within the area surveyed. The trace levels and limited occurrence of these analytes are not considered to be of concern, and indicate that--if the tanks were present--they did not leak sufficient quantities (if at all) to affect the environment.

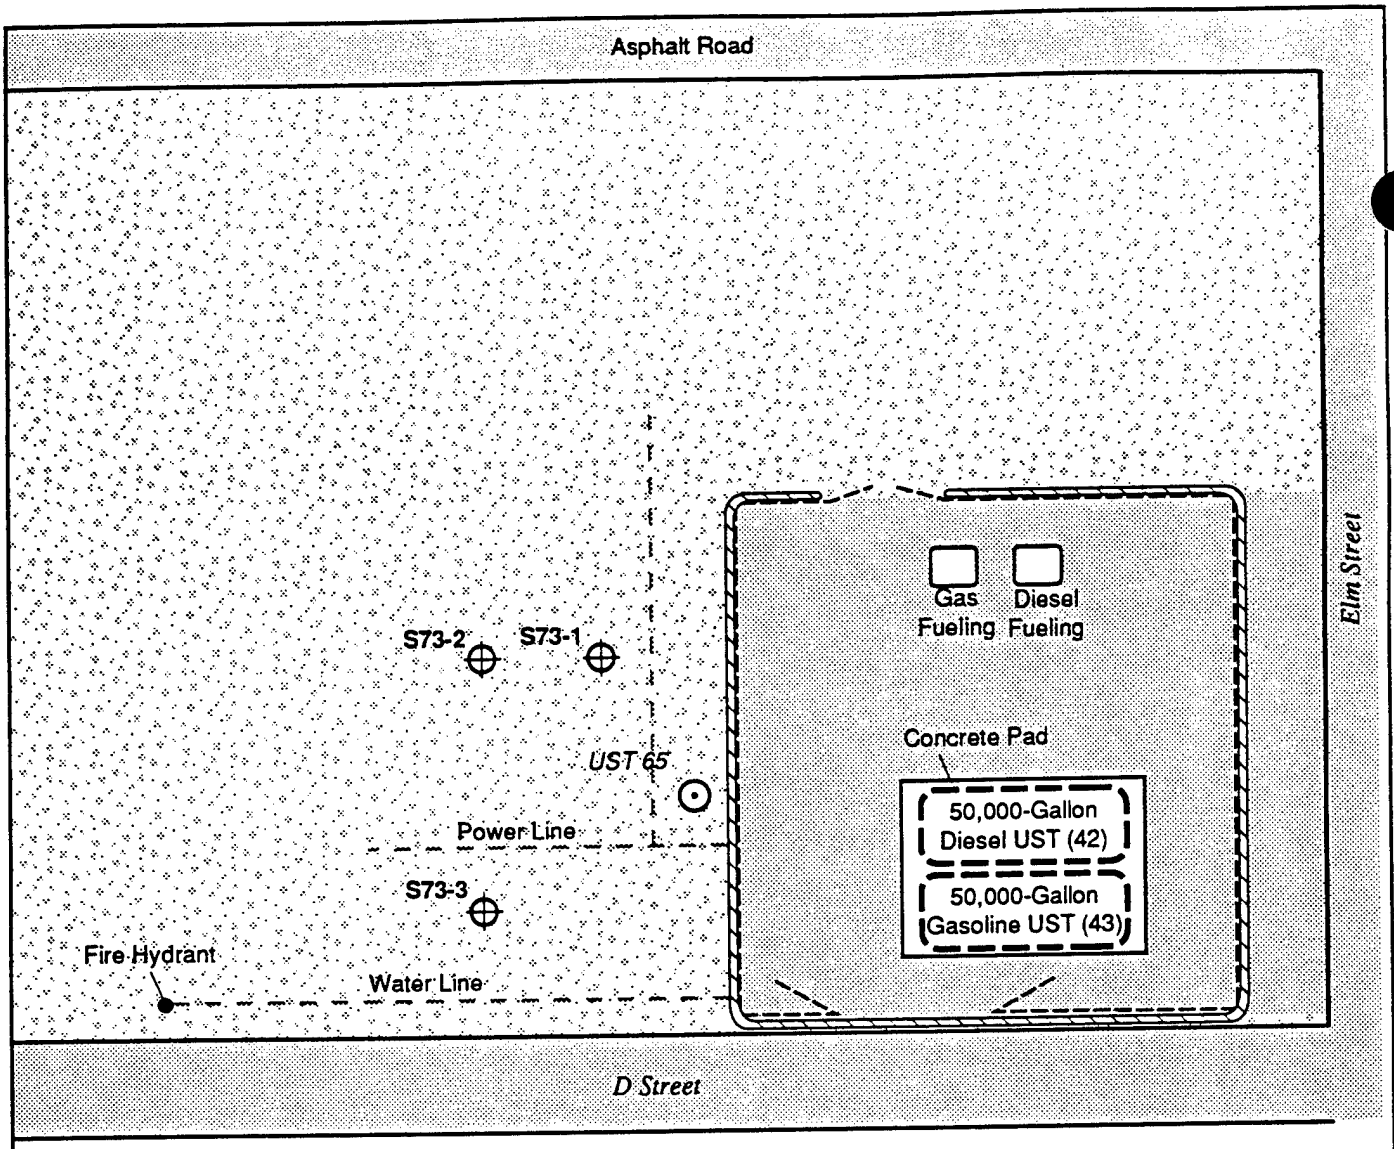
Figure 3-39
SITE 73
DIESEL FUEL SPILL LOCATION
SOIL SAMPLE LOCATIONS

A total of 57 active soil gas samples were collected at Site 73. Initially, 36 samples were collected around USTs 42 and 43, the area that included UST 65 and was reported to have been affected by the spill. After detecting a significant concentration of TVHCs at SG-24, 21 additional samples were collected to define the western boundaries of potential soil contamination. The samples were collected in a 25-foot rectangular grid in the vicinity of the spill area. Soil gas was extracted from a depth of 3 feet and analyzed for BTEX, TVHCs, carbon dioxide, and methane. Based on the soil gas results, soil samples were collected from three 10-foot borings (S73-1 through S73-3) in the areas reported to have elevated TVHC concentrations. In borings S73-1 and S73-2, soil samples were collected at the surface and at depths of 2.5, 5, and 10 feet. In boring S73-3, samples were collected at the surface and at depths of 2.5, 5, 7.5, and 10 feet. All samples were chemically analyzed for TCL VOAs, TCL BNAs, and TPHCs. Approximate sample locations are shown in Figure 3-39.

As indicated in Table 3-4, only one TCL VOA--chloroform--was detected in one soil sample (S73-3), at a very low concentration (0.001 μg/g; see Figure 3-39). One VOA TIC was detected in each of three soil samples, also at very low concentrations. No TCL BNAs were detected in any samples. Low-to-moderate levels of TPHCs were detected in some of the samples collected from borings S73-1 and S73-2. In S73-1, a moderate TPHC concentration of 804 μg/g was detected at the surface, with decreasing concentrations of 79.9 μg/g and 39.1 μg/g detected at depths of 2.5 and 5 feet, respectively. No TPHCs were detected at the 10-foot depth. In S73-2, a level

of 38.0 μg/g TPHCs was detected at the surface, and 37.3 μg/g were detected at 5 feet. No TPHCs were detected at the 2.5- and 10-foot depths. These results indicate that TPHC contamination may be due to surficial spills, not a leaking tank, because levels decreased with depth. A PID reading of 22.8 ppm was detected at the surface (but under asphalt) in boring S73-1.

Based on results of the soil gas survey and soil sampling, it is recommended that the soil in the area west of USTs 42 and 43 be remediated. No further action is recommended for the USTs. However, because U.S. Army regulations require all USTs to be treated as regulated tanks, UMDA may consider annual leak testing to evaluate the continued integrity of the tanks and to identify potential leaks.

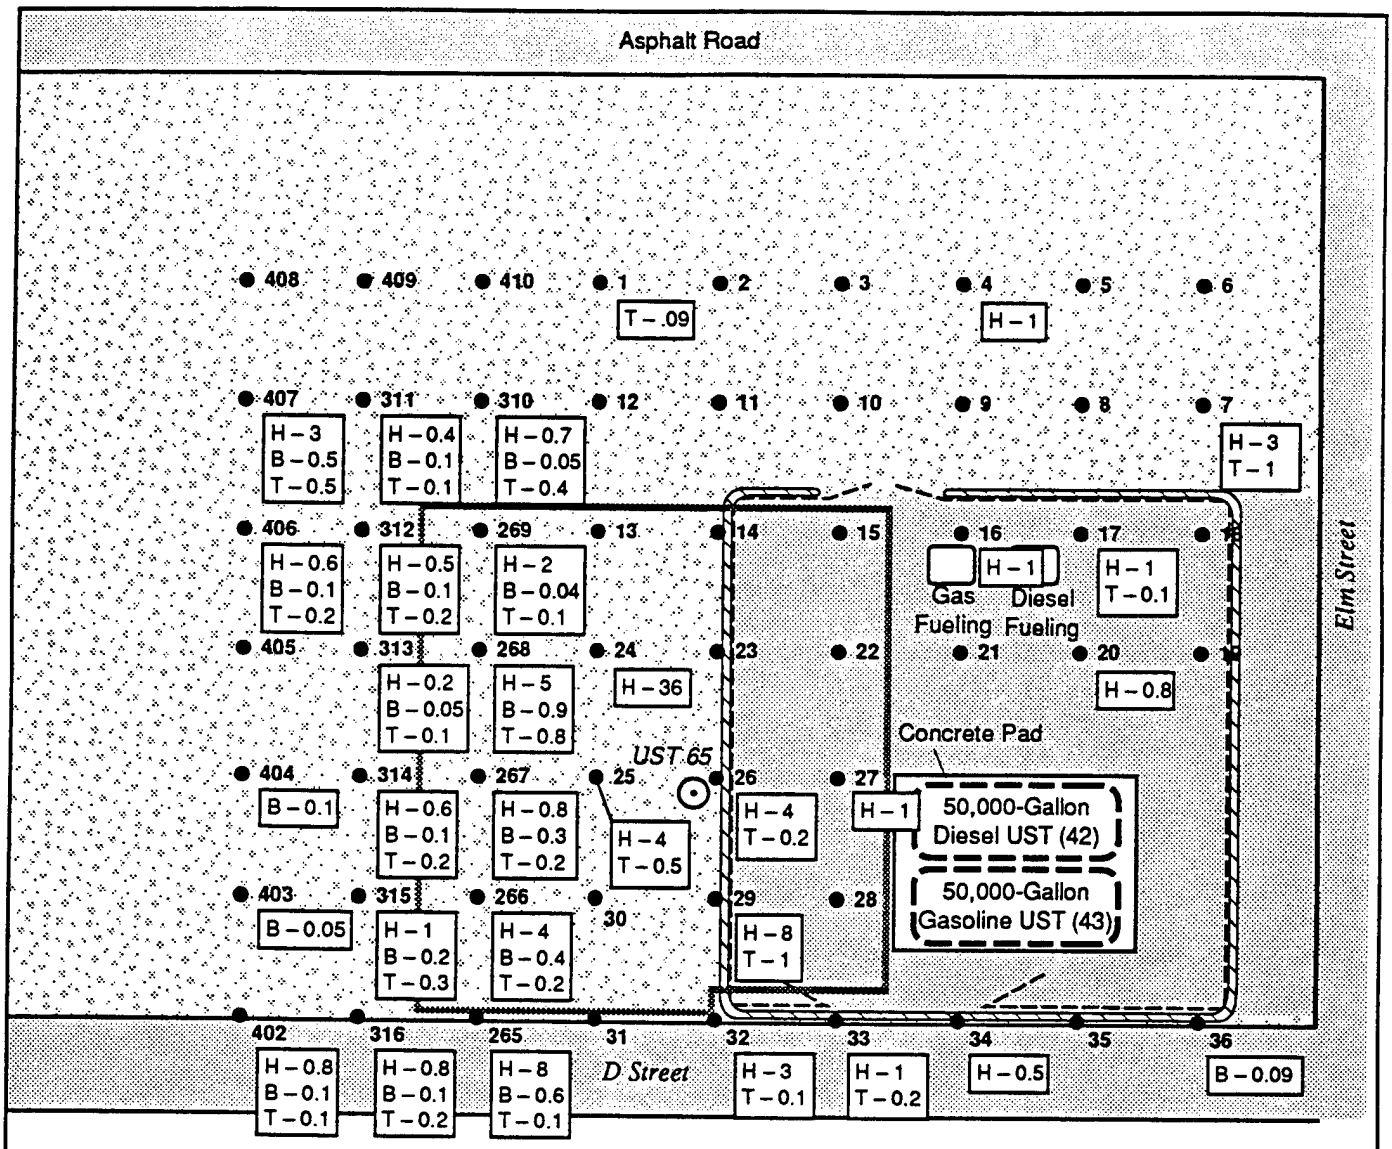
Figure 3-40
SITE 73
DIESEL FUEL SPILL LOCATION
RESULTS OF SOIL GAS SURVEY

Figure 3-40 presents results for the BTEX and TVHC components of the active soil gas survey conducted at Site 73. Results of the carbon dioxide and methane components of the survey are presented in Appendix D. Soil gas survey results indicate trace levels of benzene and toluene at some of the 57 sampled locations. Low-to-moderate concentrations of TVHCs were reported at 28 locations. Ethylbenzene and xylene were not detected at this site. Benzene was detected in 18 samples, with concentrations ranging from 0.04 (which is at the detection limit of 0.04 μg/L) to a maximum of 0.9 μg/L. Toluene was detected at 23 locations mostly coincident with benzene detections; it was reported at concentrations ranging from 0.09 (which is at the detection limit of 0.09 μg/L) to a maximum of 1 μg/L. TVHCs
