Report No. SFIM-AEC-BC-CR-95047

UNDERGROUND STORAGE TANK INVESTIGATION REPORT UMATILLA DEPOT ACTIVITY HERMISTON, OREGON

DAMES & MOORE
849 International Drive, Suite 320
Linthicum, Maryland 21090

JUNE 1995

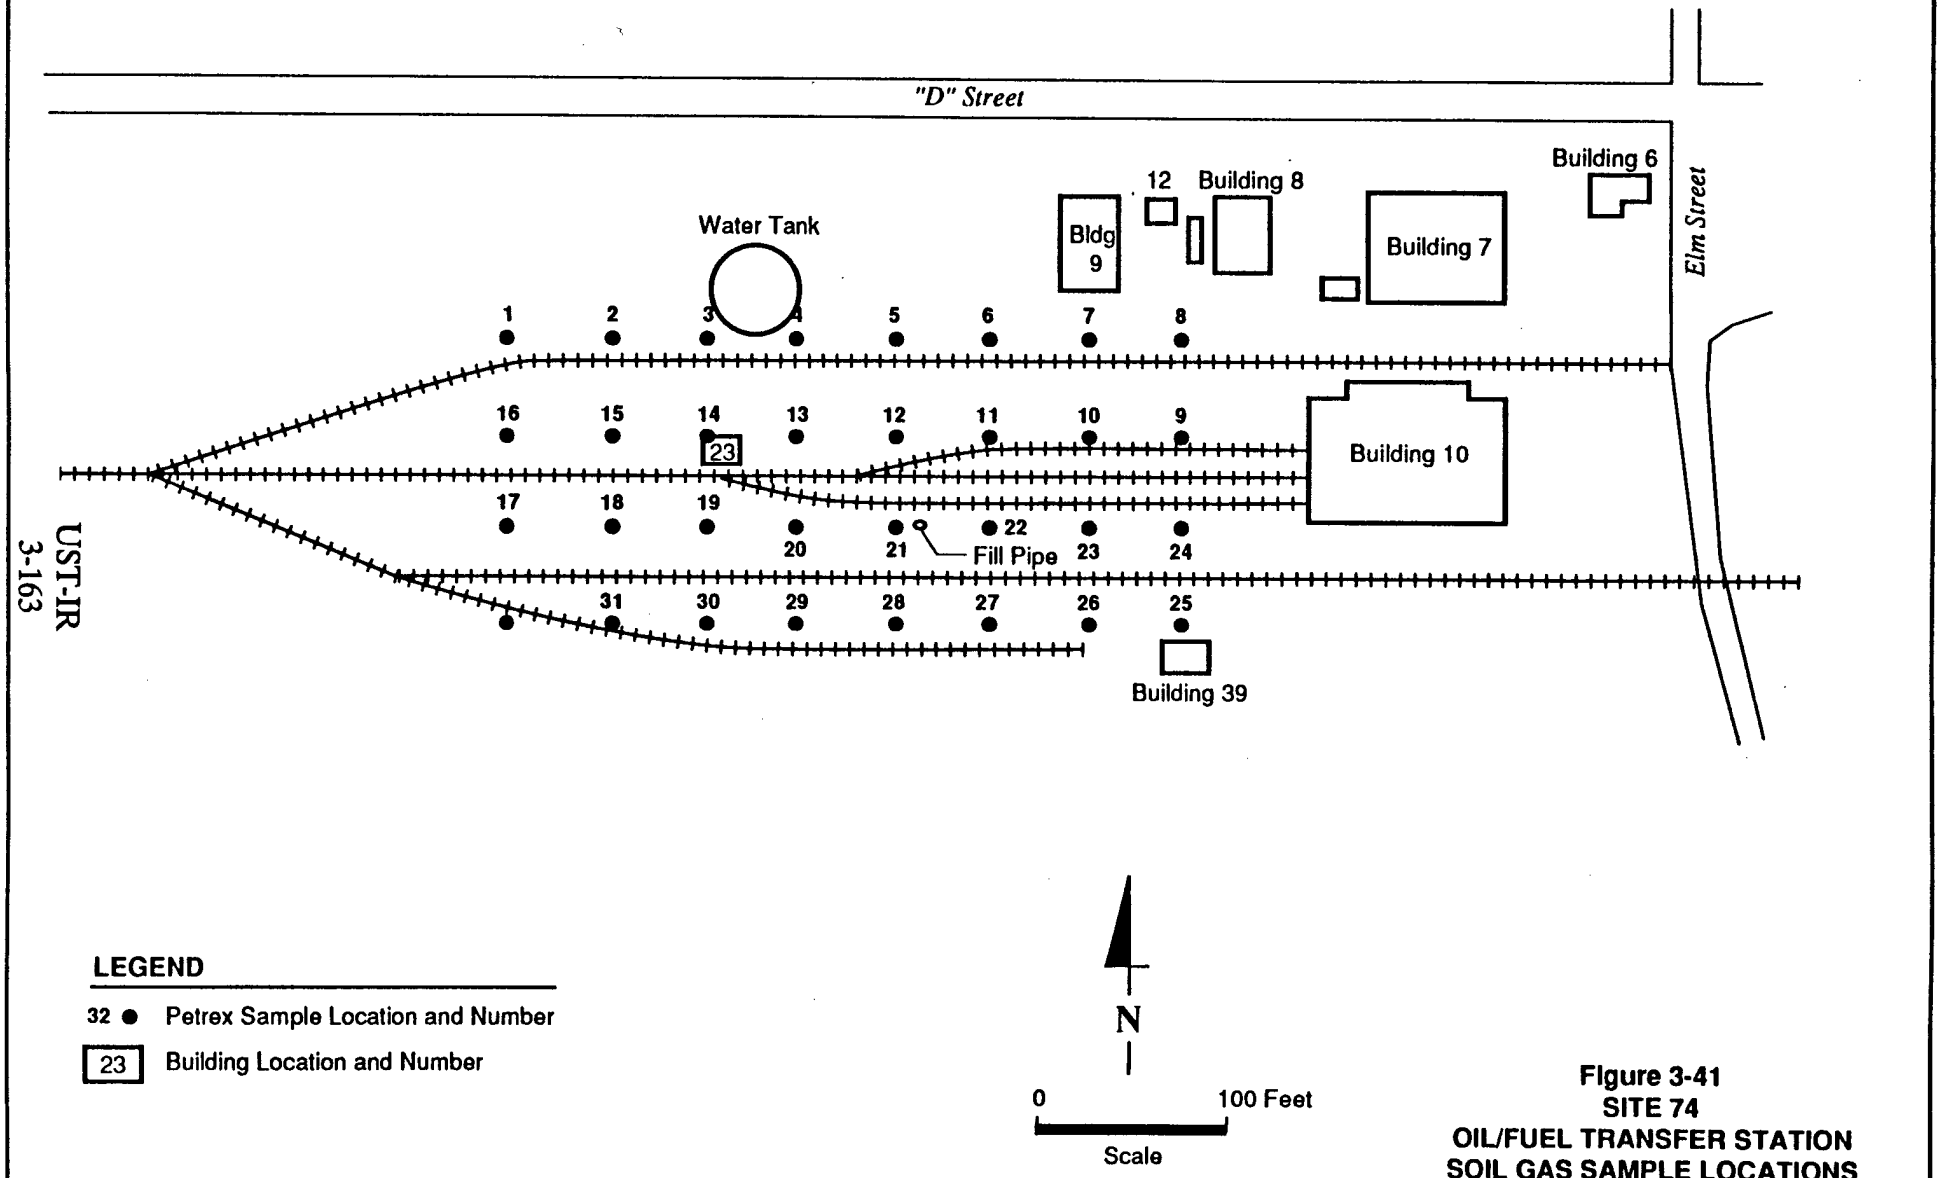
Figure 3-41
SITE 74
OIL/FUEL TRANSFER STATION
SOIL GAS SAMPLE LOCATIONS

As shown in Figure 3-41, a total of 36 passive soil gas samples were collected in the area potentially impacted by the activities near the transfer station. The samples were collected in a 50-foot rectangular grid. Soil gas was collected from a depth of 1 foot and analyzed for relative ion counts of total BTEX, PCE, and TCE. The ion counts represent relative and semiquantitative analyte concentrations of soil vapor collected over a period of 7 days and do not necessarily correspond directly to mass per unit volume measurements (see Section 2.5).

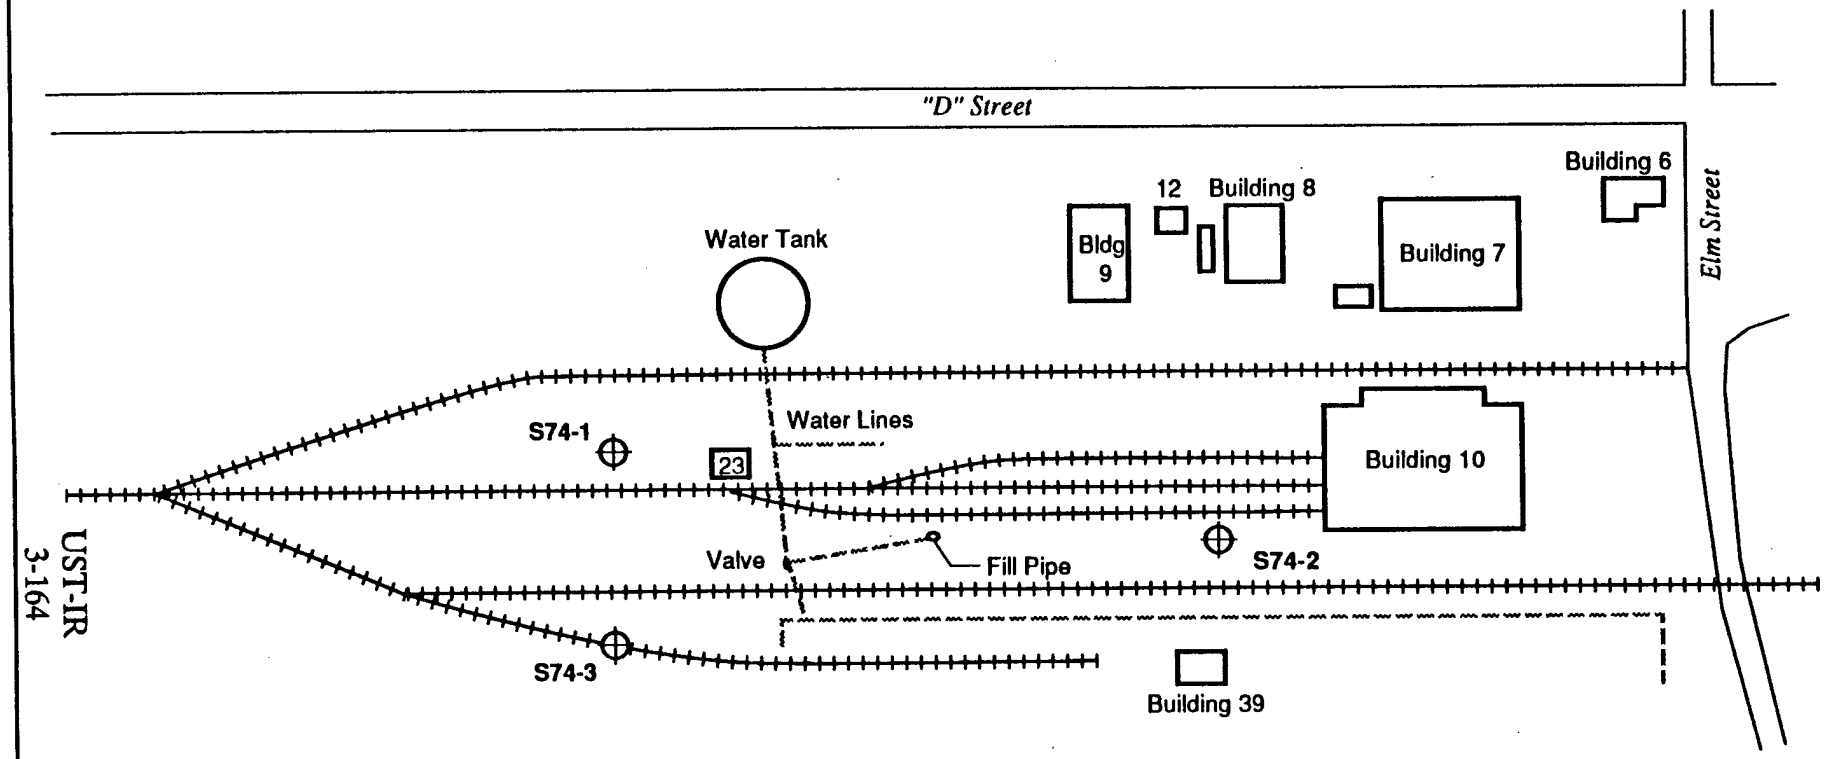
Figure 3-42
SITE 74
OIL/FUEL TRANSFER STATION
SOIL SAMPLE LOCATIONS

Based on the passive soil gas results, soil samples were collected from three 10-foot borings (S74-1 through S74-3) in the areas reported to have elevated VOC concentrations. Boring locations are shown in Figure 3-42. Samples were collected

As indicated in Table 3-4, only two TCL VOAs--ethylbenzene and xylene--were detected at very low concentrations (0.005 and 0.033 μg/g, respectively) in one soil sample from boring S74-1 (see Figure 3-42). Low levels of one VOA TIC were

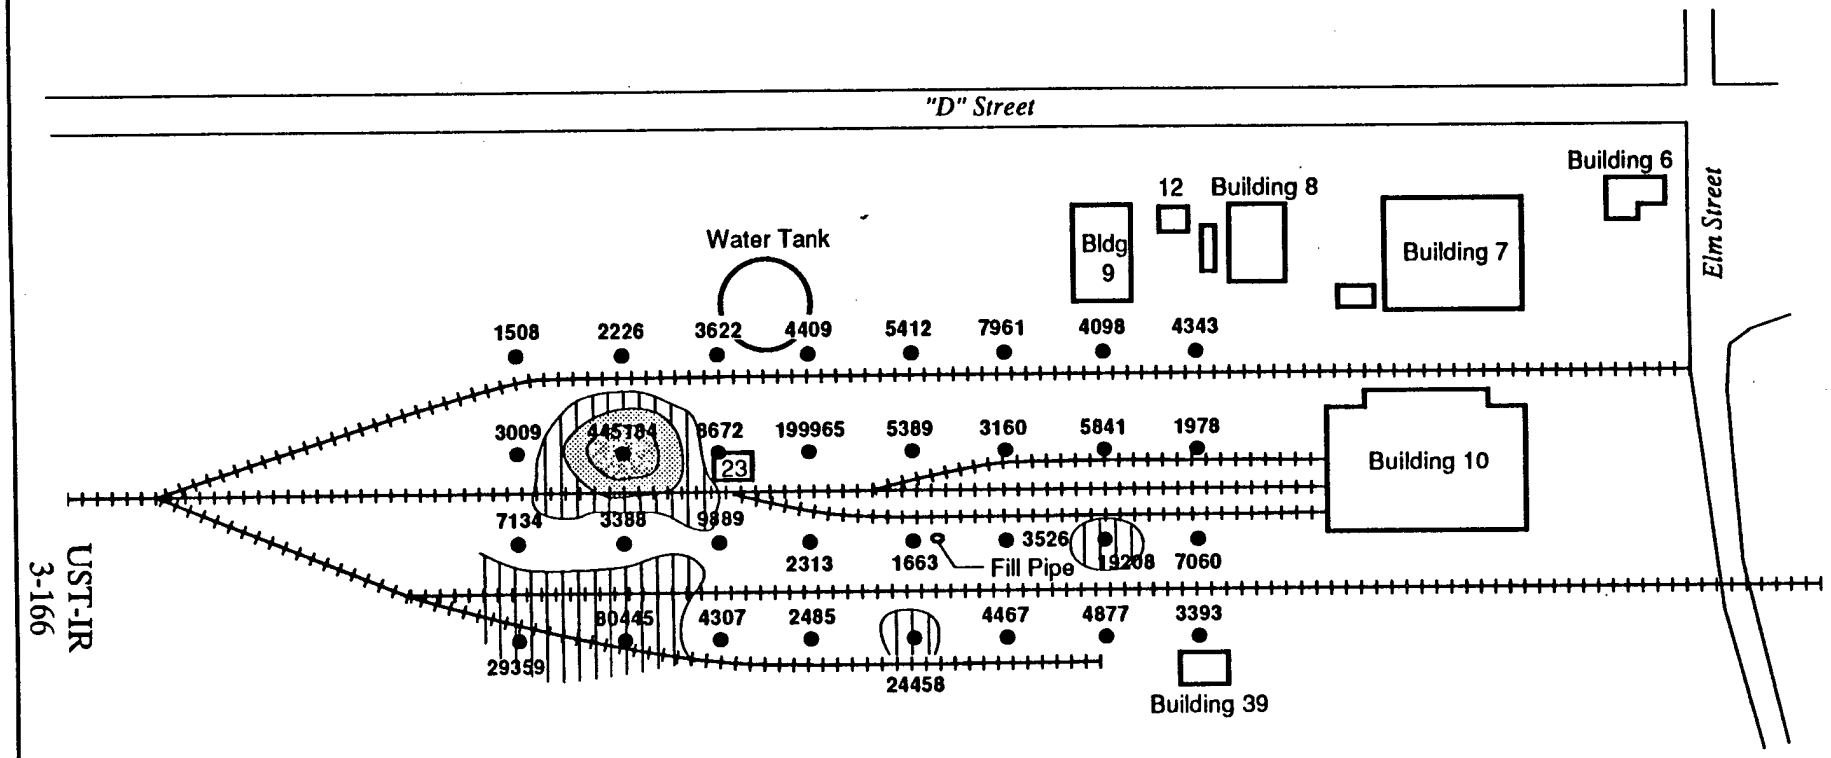
Figure 3-43
SITE 74
OIL/FUEL TRANSFER STATION
RESULTS OF SOIL GAS SURVEY
TOTAL BTEX

Figures 3-43, 3-44, and 3-45 present the results of the total BTEX, PCE, and TCE components of the passive soil gas survey, respectively. As shown in Figure 3-43, the results indicate moderately elevated ion counts for total BTEX in several areas. Elevated ion counts at six locations ranged from one to two orders of magnitude greater than typical or baseline levels reported for the site. These results suggest possible BTEX contamination in the soil east and west of Building 23 and in the southwestern edge of the survey area near the railroad tracks and north of UST 102. However, active soil gas results for samples collected in the vicinity of this sample at UST 102 do not confirm any detectable levels of BTEX (see Section 3.49).

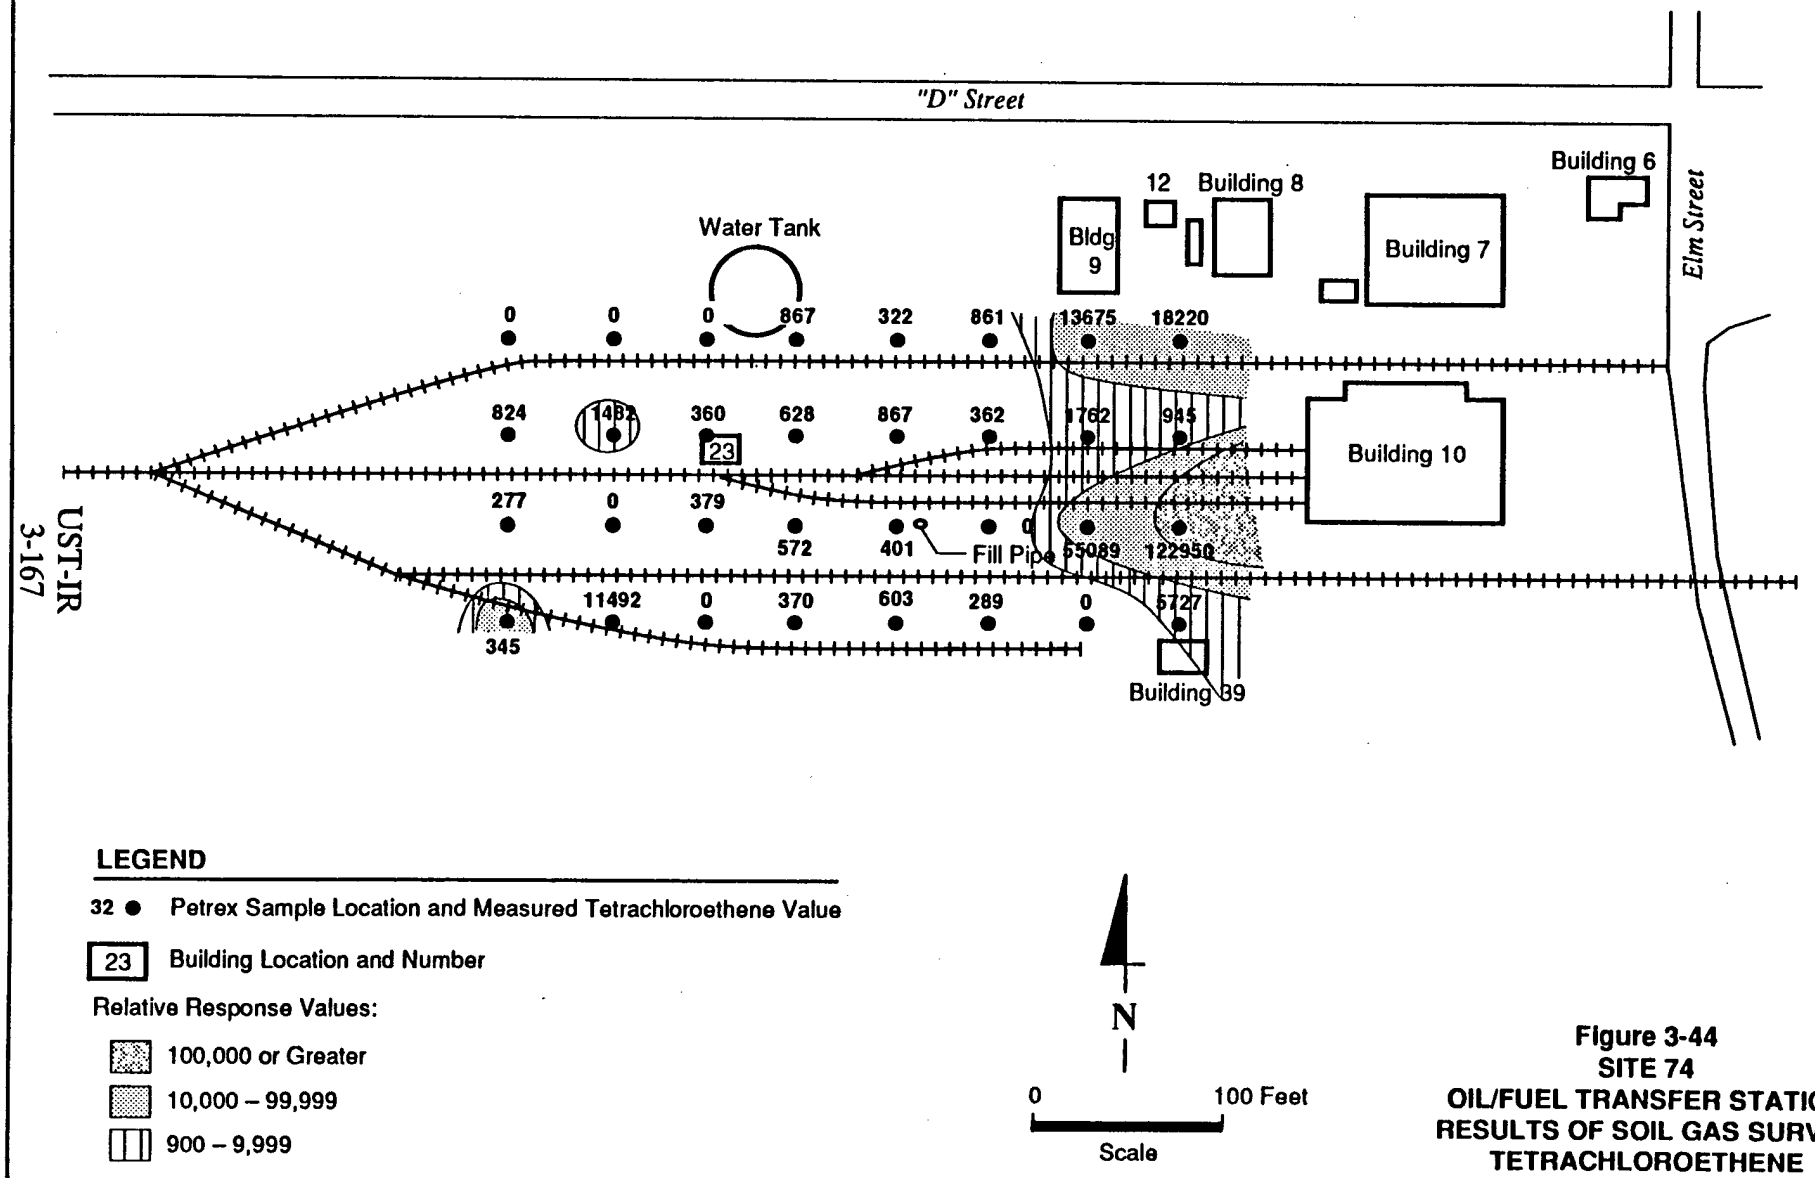
Figure 3-44
SITE 74
OIL/FUEL TRANSFER STATION
RESULTS OF SOIL GAS SURVEY
TETRACHLOROETHENE

Soil gas results indicate low-to-high ion counts for PCE at three locations in the survey area (Figure 3-44). Elevated ion counts of six samples in the eastern/northeastern quarter of the site ranged from slightly less than one to nearly three orders of magnitude greater than typical or baseline levels reported for the site. As shown in Figure 3-45, a similar distribution of TCE was identified in this area, which indicates a potential contaminant source distinct from operations at the fuel transfer station. The source of this potential contamination is likely the result of operations at Building 10, the locomotive house and associated railyard.

The remaining soil gas results suggest potential but limited PCE and TCE contamination in samples east and west of Building 23 and in samples at the southwestern edge of the survey area near the railroad tracks and north of UST 102. The one sample east of the building and both samples in the southwestern edge of the survey area also contained elevated levels of total BTEX.

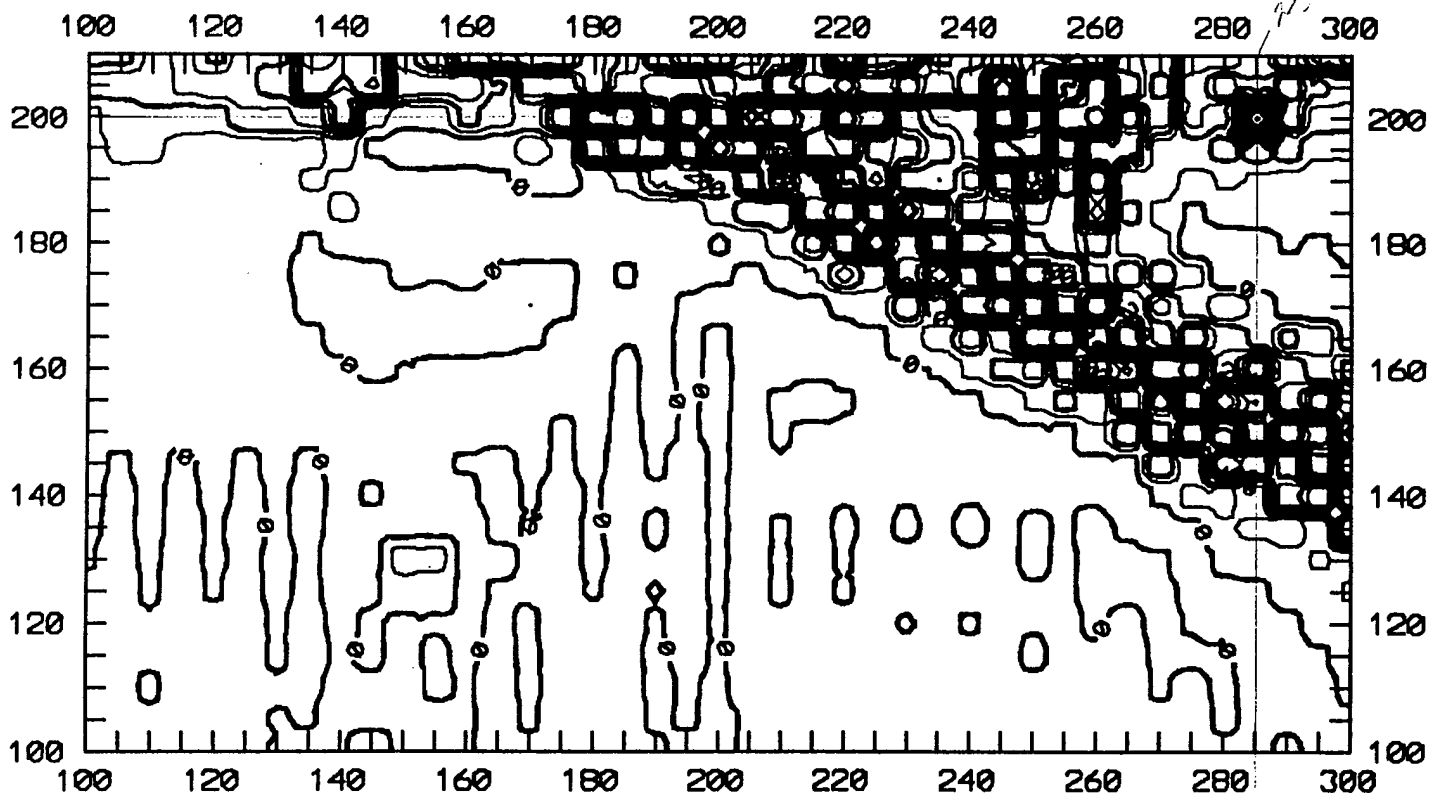
UST 76 & 77 Vertical Magnetic Gradient

- Several anomalies are observed in the magnetometer data sets. All but one of these anomalies appear to result from cultural interference (utilities, building, etc.) The remaining anomaly is observed in the vertical gradient data, and is located N110/E155. Although it is possible that this anomaly results from interference due to nearby Building 54, a geophysical targets appears to be located in the vicinity of N110/E155.

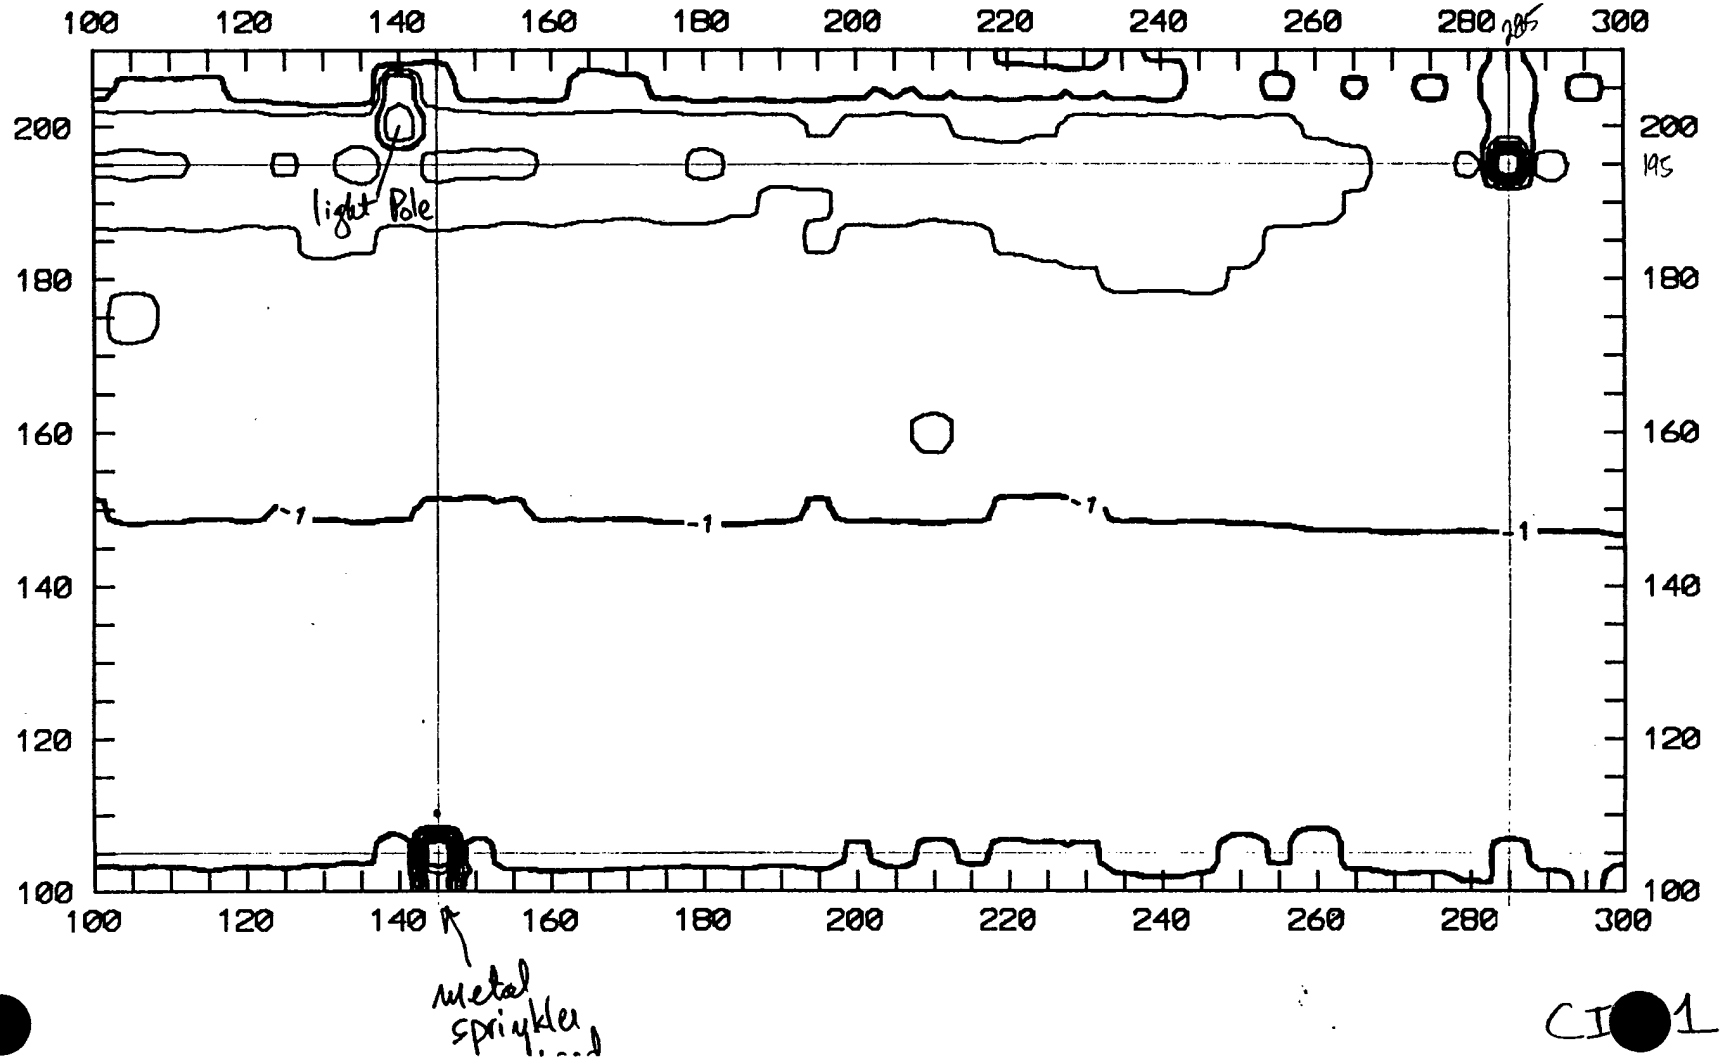
UST 76 & 77 EM In-Phase Readings

- Several small anomalies are observed in the In-Phase EM data sets. All but one of these anomalies appear to be associated with utilities or the building. The remaining anomaly, located N110-115/E155, occurs in the vicinity of the reported UST (Work Plan), and is nearly coincidental to the magnetic vertical gradient anomaly discussed above. The anomaly is better defined by the In-Phase Difference map rather than the N-S In-Phase Readings map.

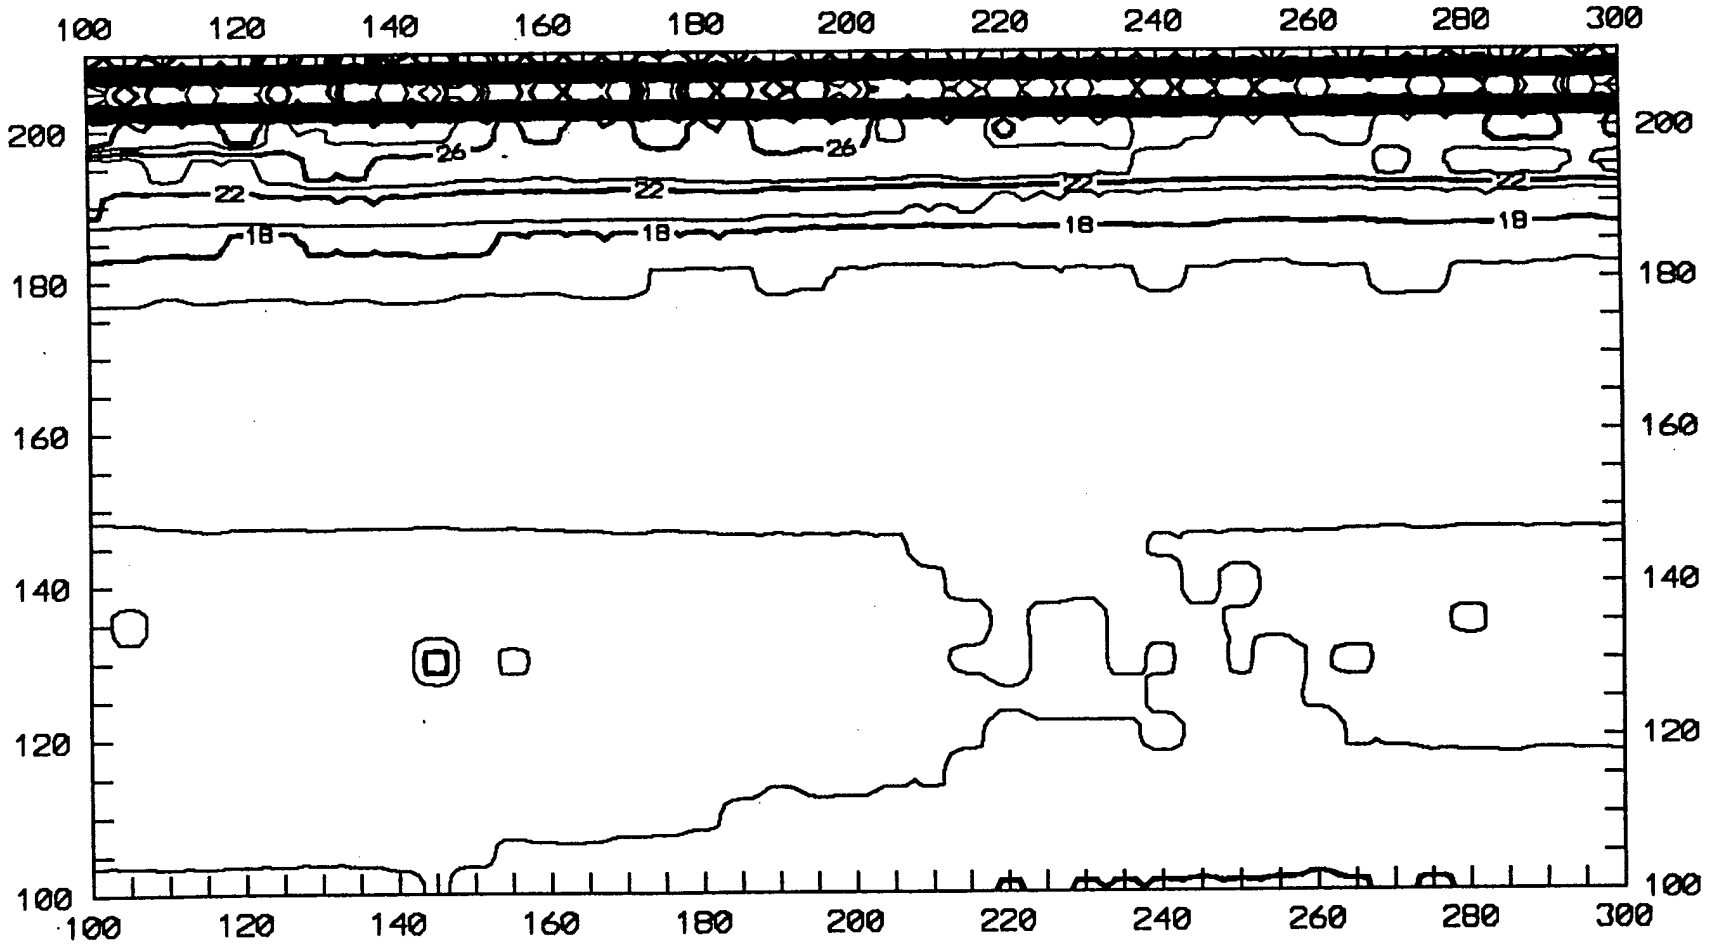
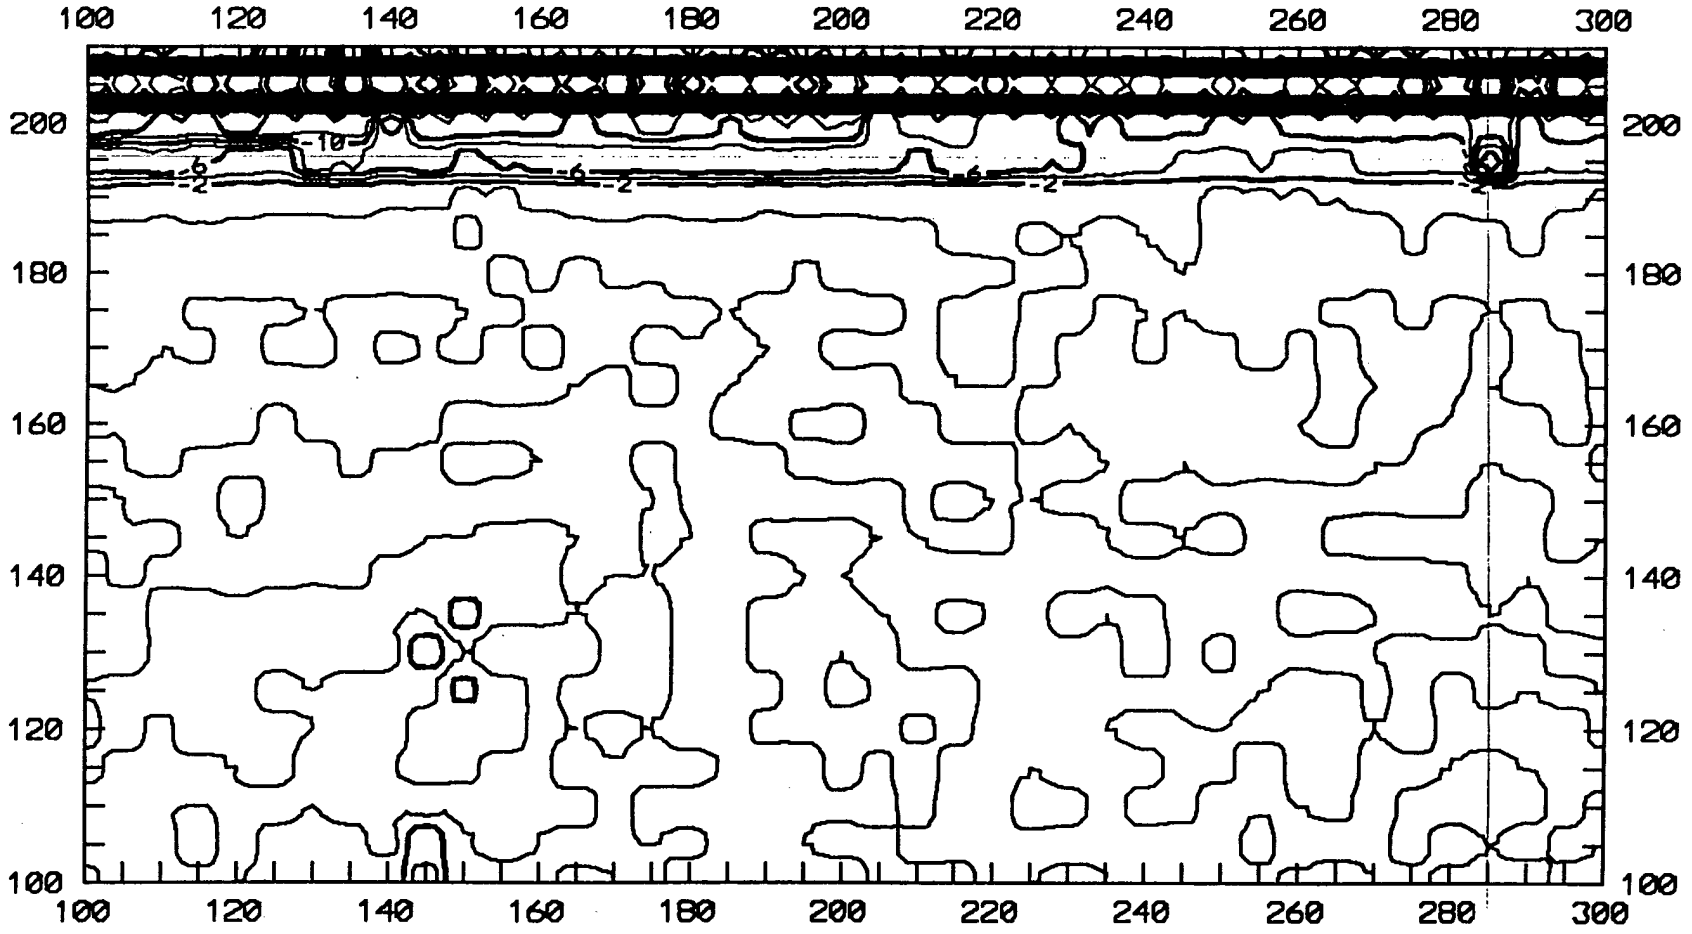
- Several anomalies are observed in the EM Conductivity data sets. All but one of these anomalies appear to be associated with utilities or the building. The remaining anomaly, located N105/E155, occurs in the vicinity of the reported UST (Work Plan), and is nearby both the In-Phase EM anomaly and the magnetic vertical gradient anomaly discussed above.

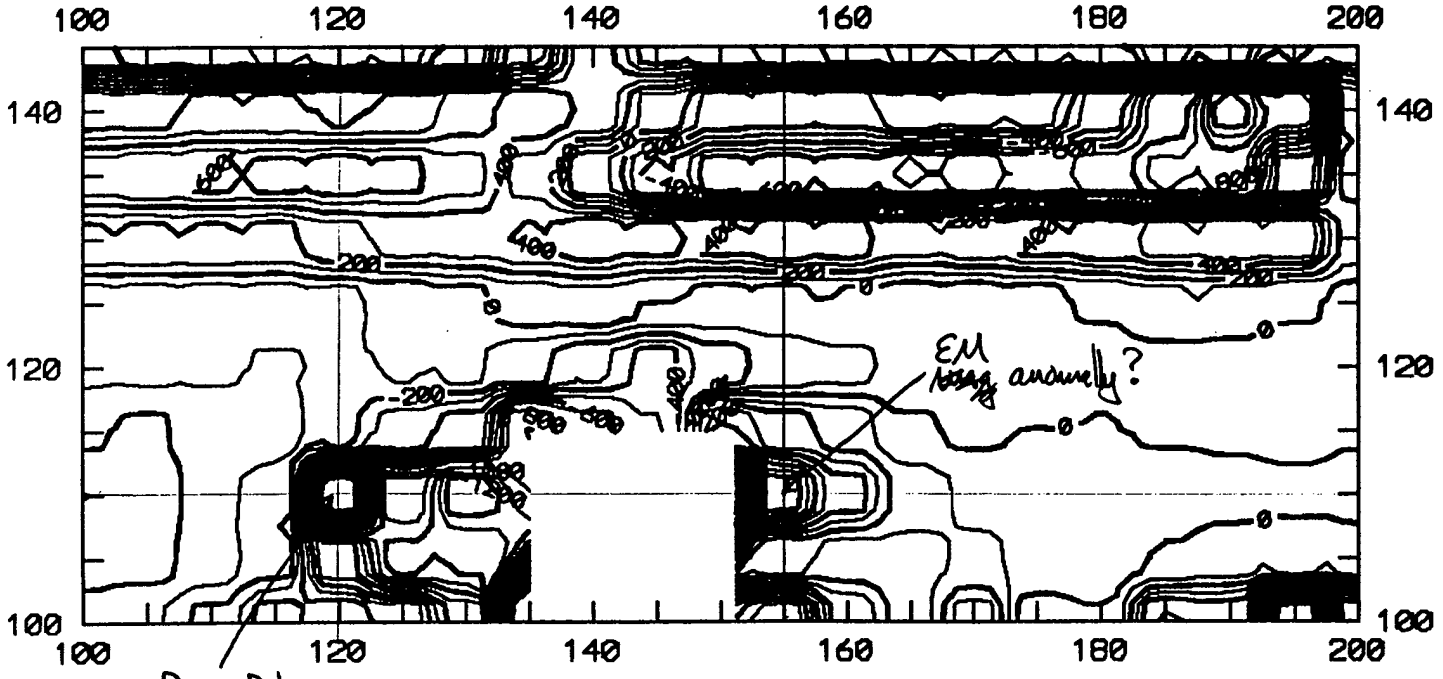
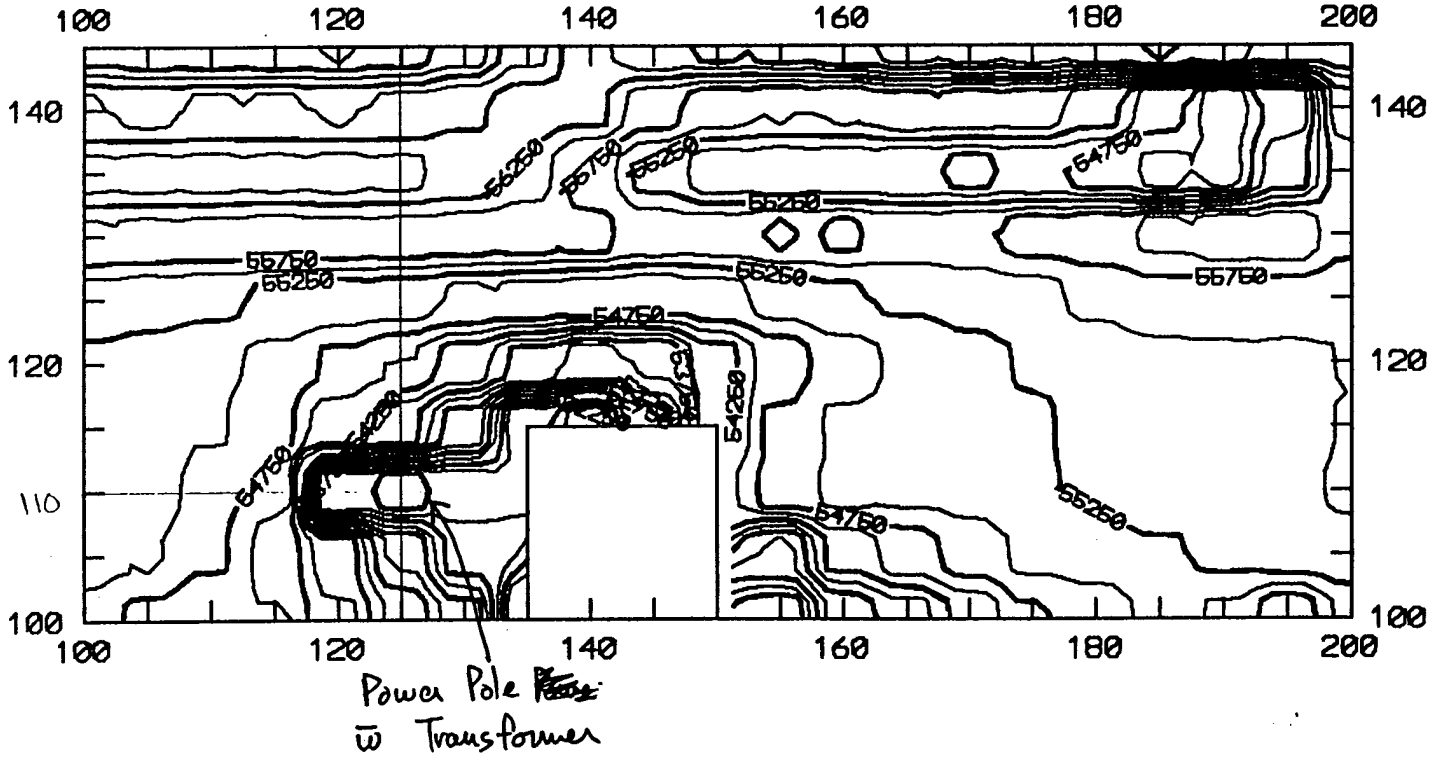
- Several anomalies are observed in the magnetic data sets. All but one of these anomalies appear to result from cultural interference (utilities, building, etc.) The remaining anomaly is observed in both the vertical gradient and total field data, and is located N105/E160. Although it is possible that this anomaly results from interference due to nearby utilities, a geophysical targets appears to be located in the vicinity of N105/E160.

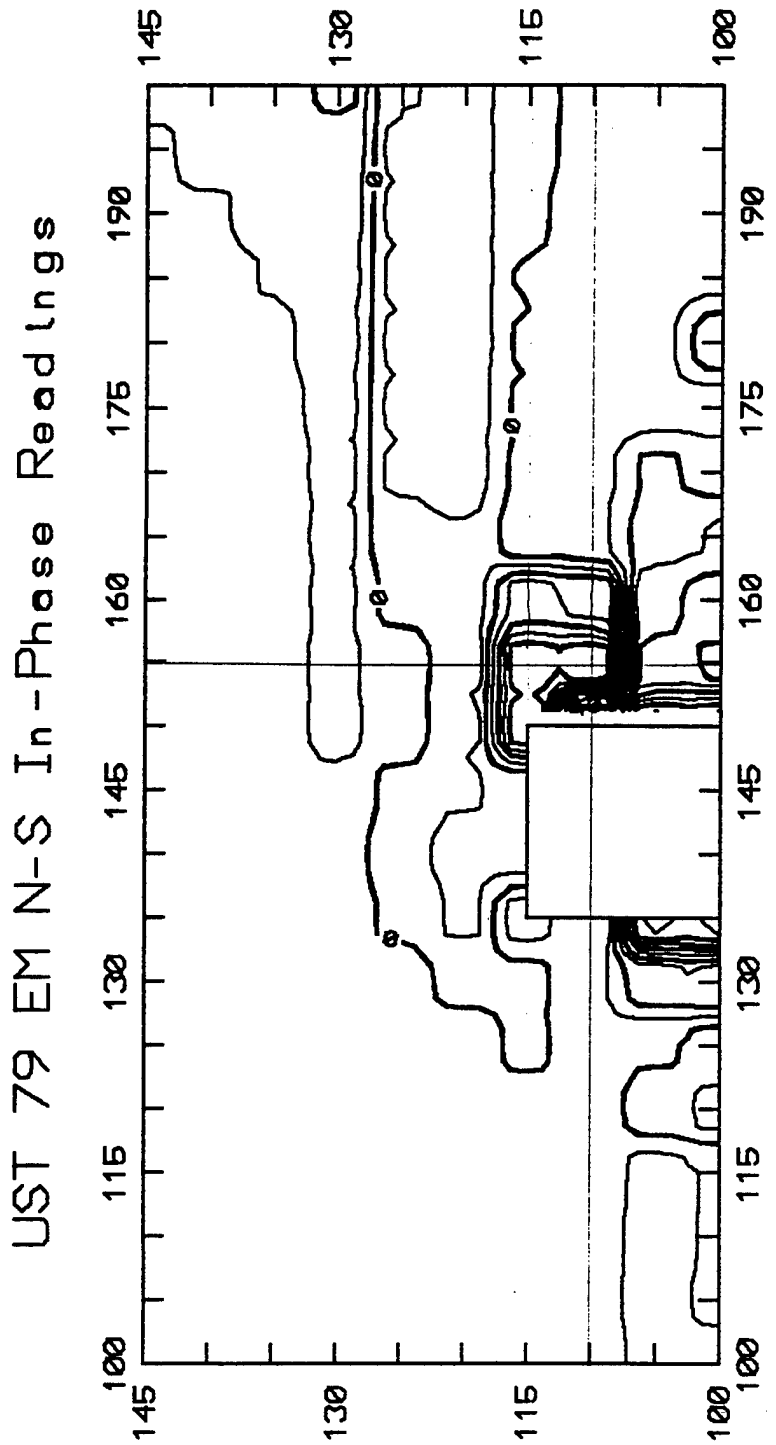
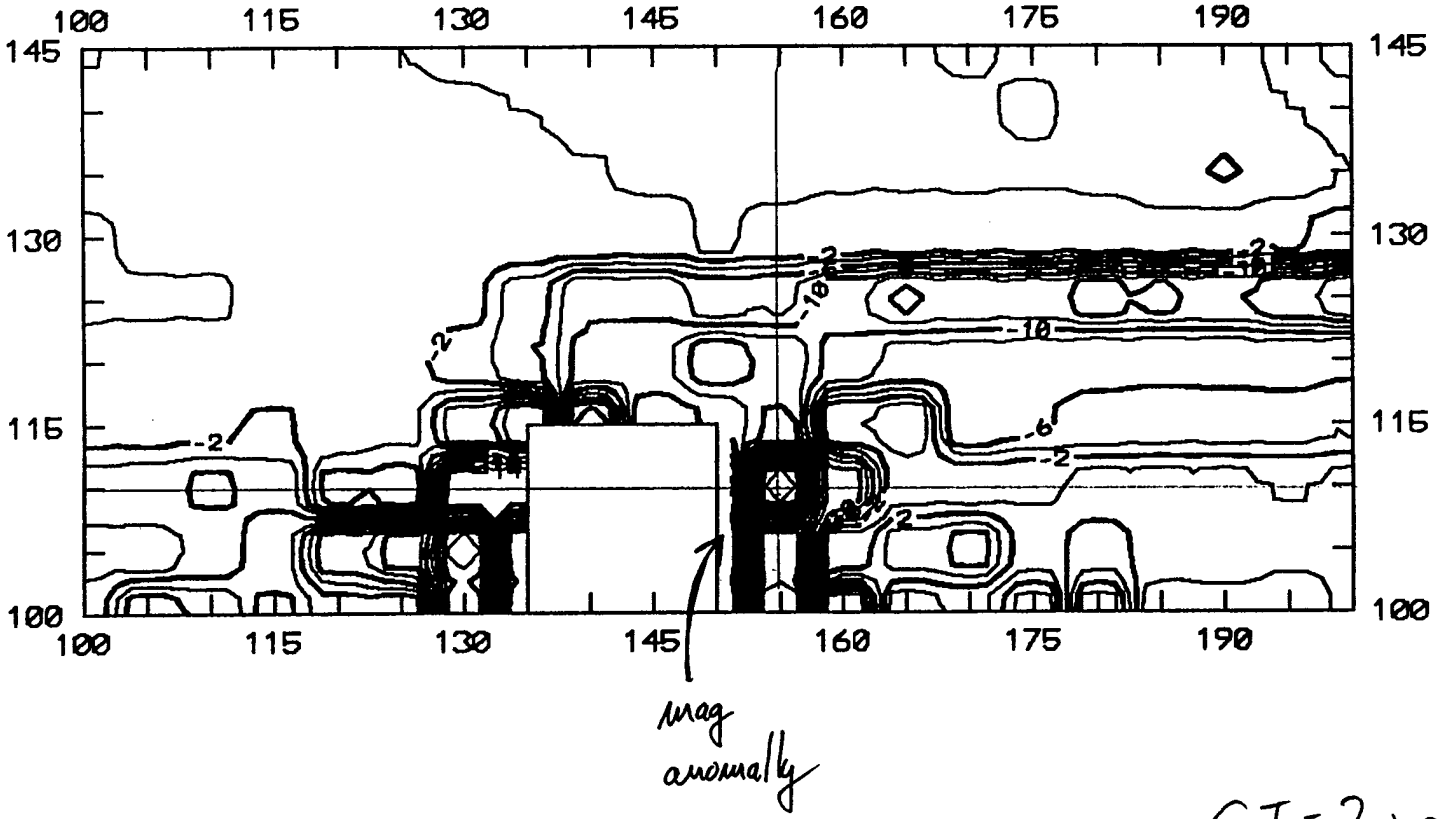
- Several anomalies are observed in the In-Phase EM data sets. Most of these anomalies appear to be associated with either the building, utilities, or varioations in the soils. One anomaly, located N105-110/E160, occurs in the vicinity of the reported UST (Work Plan), and is nearly coincidental to the magnetic anomaly discussed above. The anomaly is better defined by the In-Phase Difference map rather than the N-S In-Phase Readings map.
  Although it is possible that this anomaly results from interference due to nearby Building 53 or utilities, a geophysical targets appears to be located in the vicinity of N105-110/E160.
- Some of the larger patterns of elevated values, such as the area from N120-125/E165-200, may be attributed to incomplete decoupling of the in-phase and conductivity components.

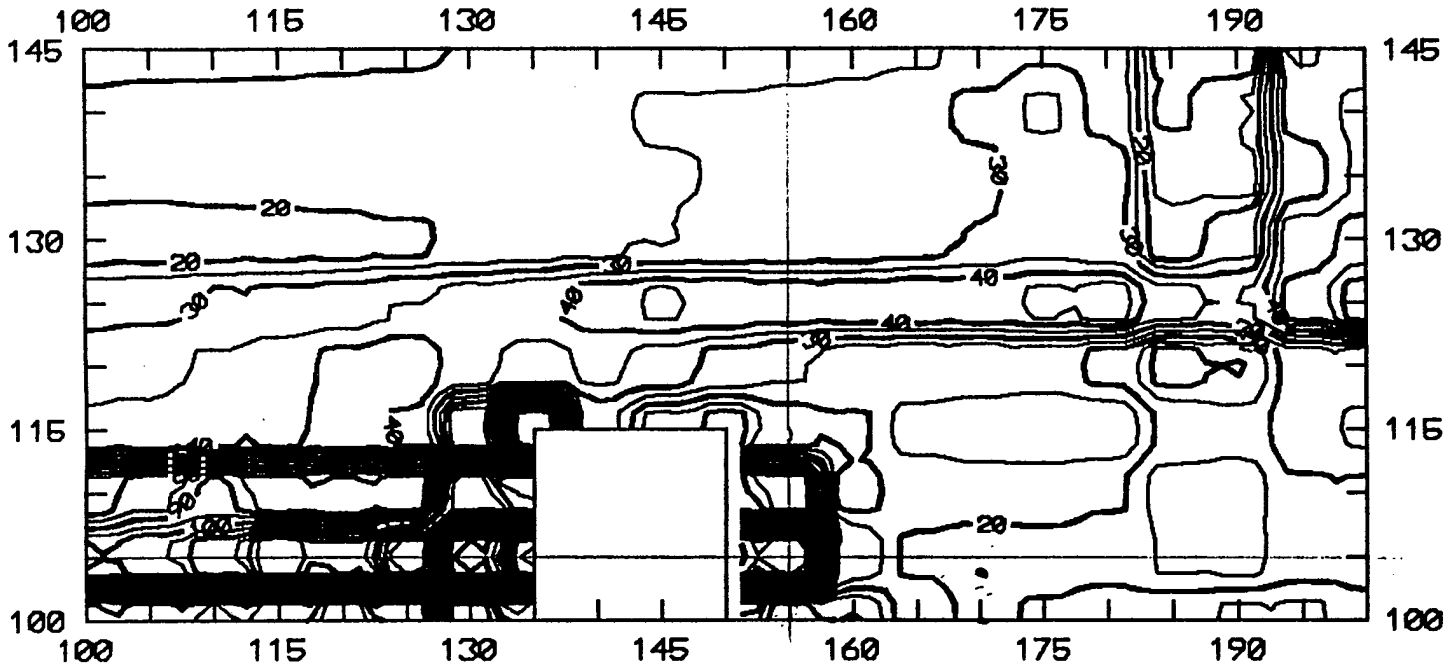
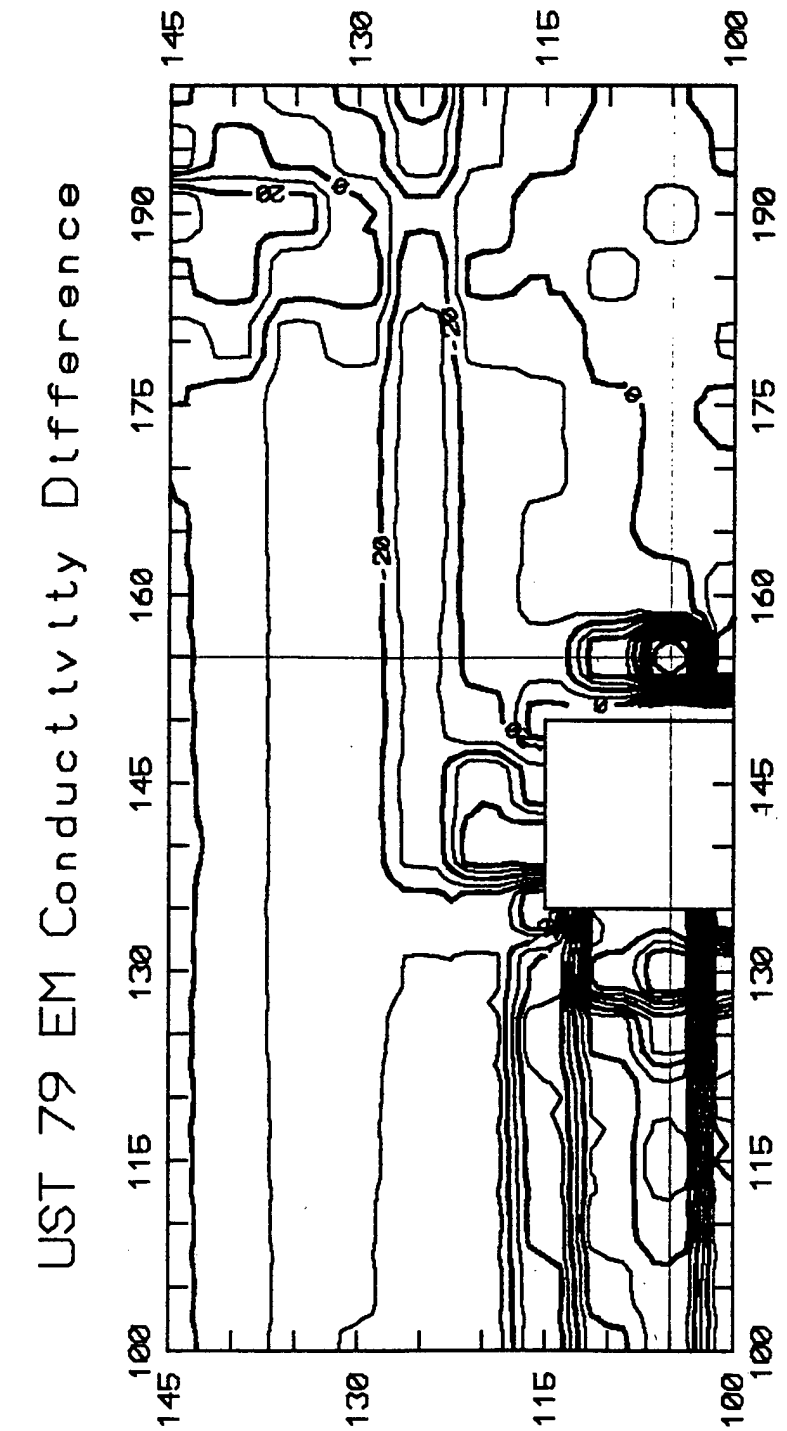
- Several anomalies are also observed in the EM Conductivity data sets. Most of these anomalies appear to be associated with either the building, utilities, or variations in the soils. One anomaly, located N105/E160, occurs in the vicinity of the reported UST (Work Plan), and is nearby both the In-Phase EM anomaly and the vertical magnetic gradient anomaly discussed above. The EM Conductivity anomaly appears to be masked by cultural interference.
  Although it is possible that this anomaly results from interference due to nearby Building 53, a geophysical targets appears to be located in the vicinity of N105/E160.
- Additional processing of the EM Conductivity data may allow an enhanced interpretation.
