Report No. SFIM-AEC-BC-CR-95047

UNDERGROUND STORAGE TANK INVESTIGATION REPORT UMATILLA DEPOT ACTIVITY HERMISTON, OREGON

DAMES & MOORE
849 International Drive, Suite 320
Linthicum, Maryland 21090

JUNE 1995

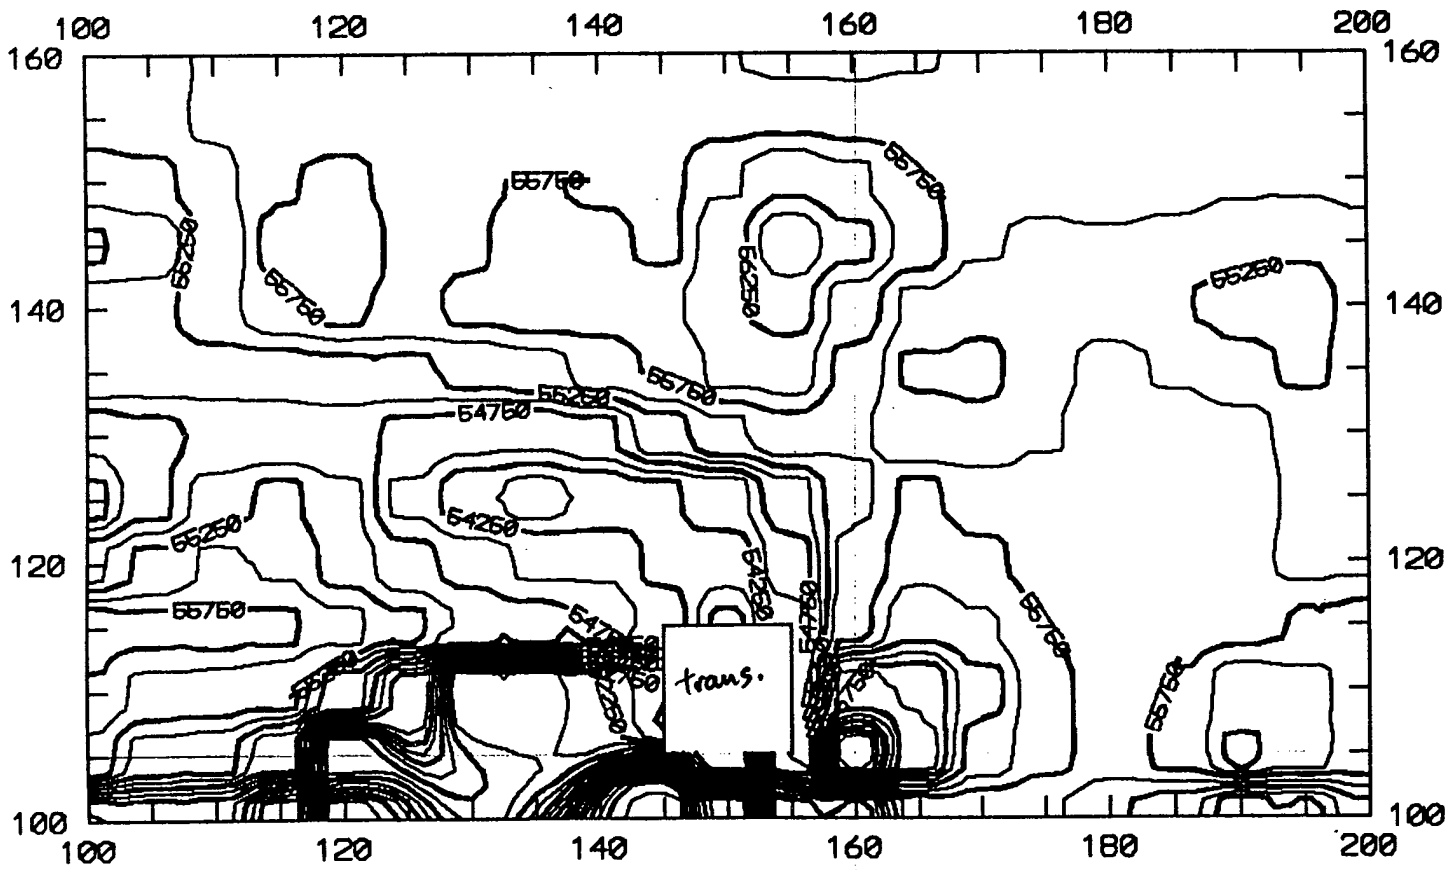
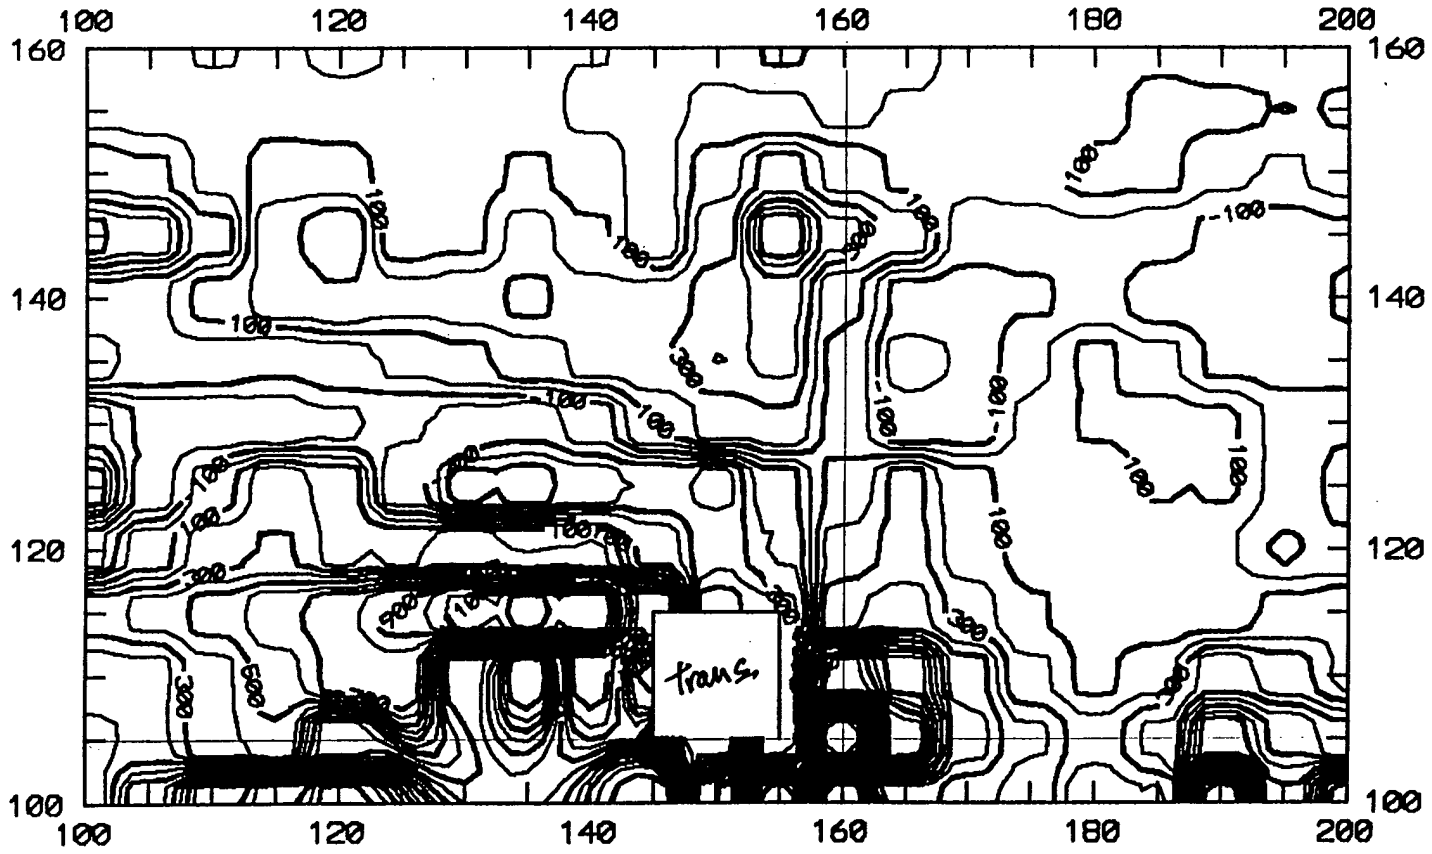
- Interpretation of the magnetometer data is hindered by the large amount of cultural interference encountered at the site. We recommend that further processing be undertaken to enhance the interpretation.
- However, even without additional processing, it appears that no geophysical targets of substantial size or strength appear in either the eastern third or the northwestern quarter of the surveyed area.
- In the eastern third of the survey grid, both the total and vertical magnetic gradient data were less affected by cultural interference than the EM data.

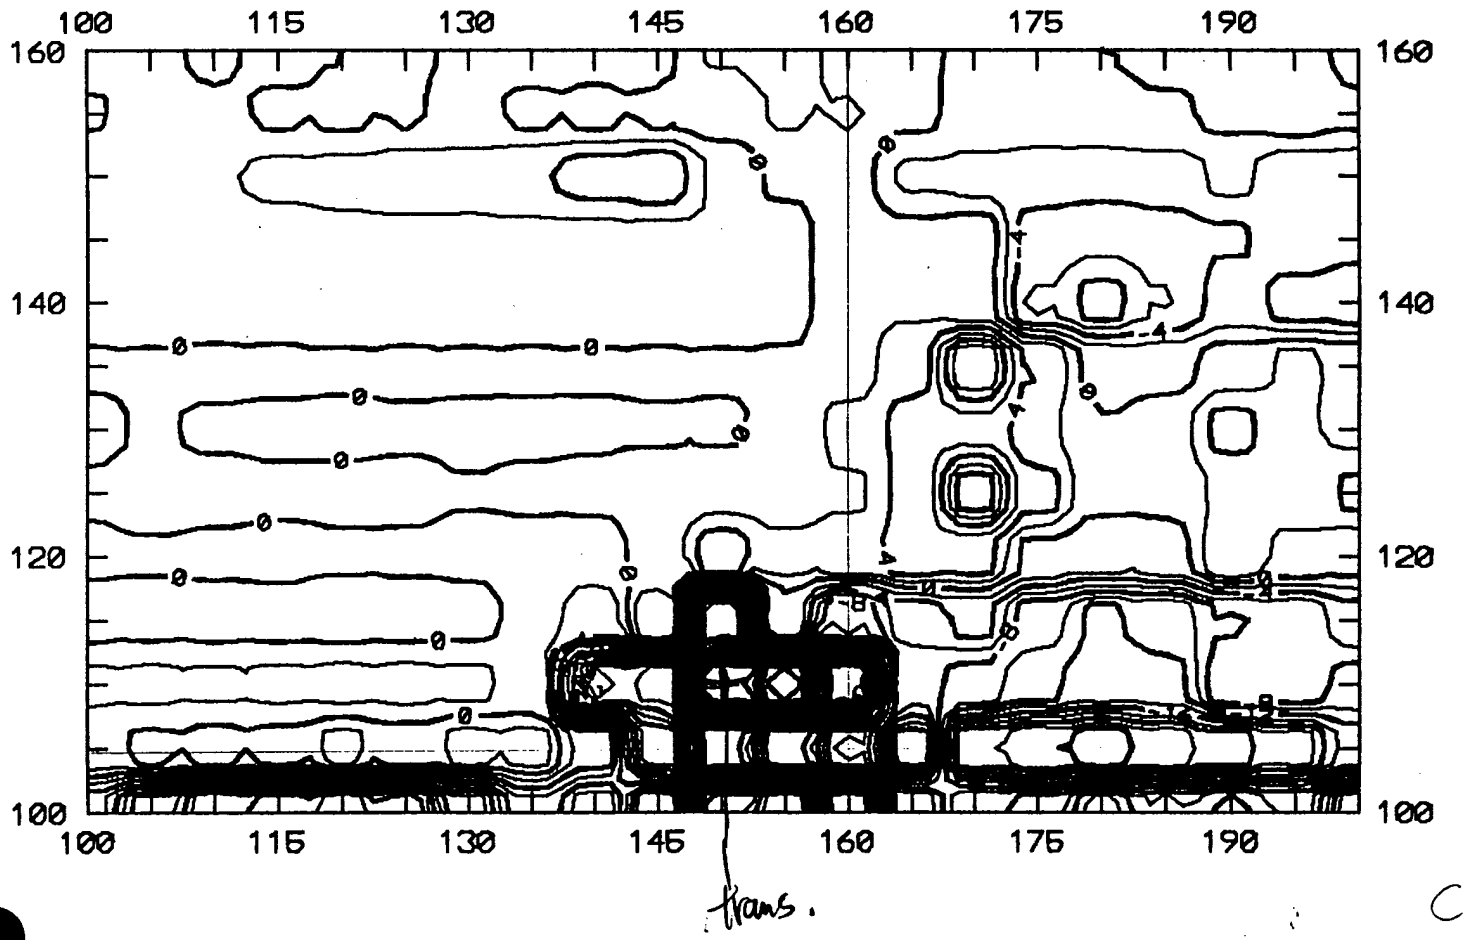
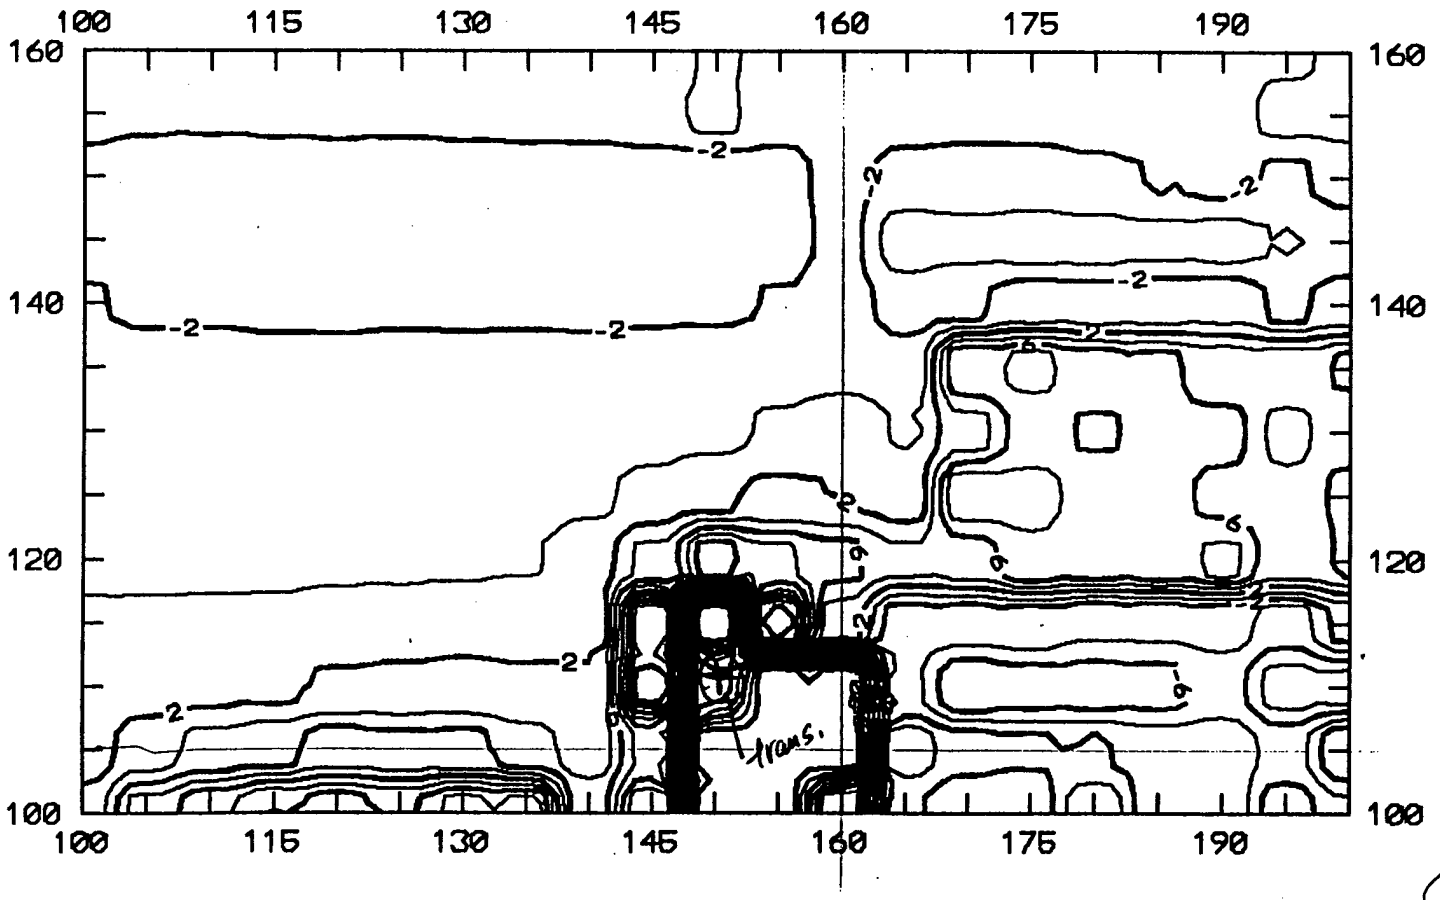
- Interpretation of the In-Phase EM data is hindered by the large amount of cultural interference encountered at the site. We recommend that further processing be undertaken to enhance the interpretation.
- However, even without additional processing, it preliminarily appears that two geophysical targets may occur east of the transformer in the reported location of the UST (Work Plan). These preliminarily defined targets occur N105/E190 and N115/E190. It is noted that the first target (N105/E190) may be due to interference from the building, and that the second target (N115/E190) may be due to interference from the guy line/anchor or transformer.

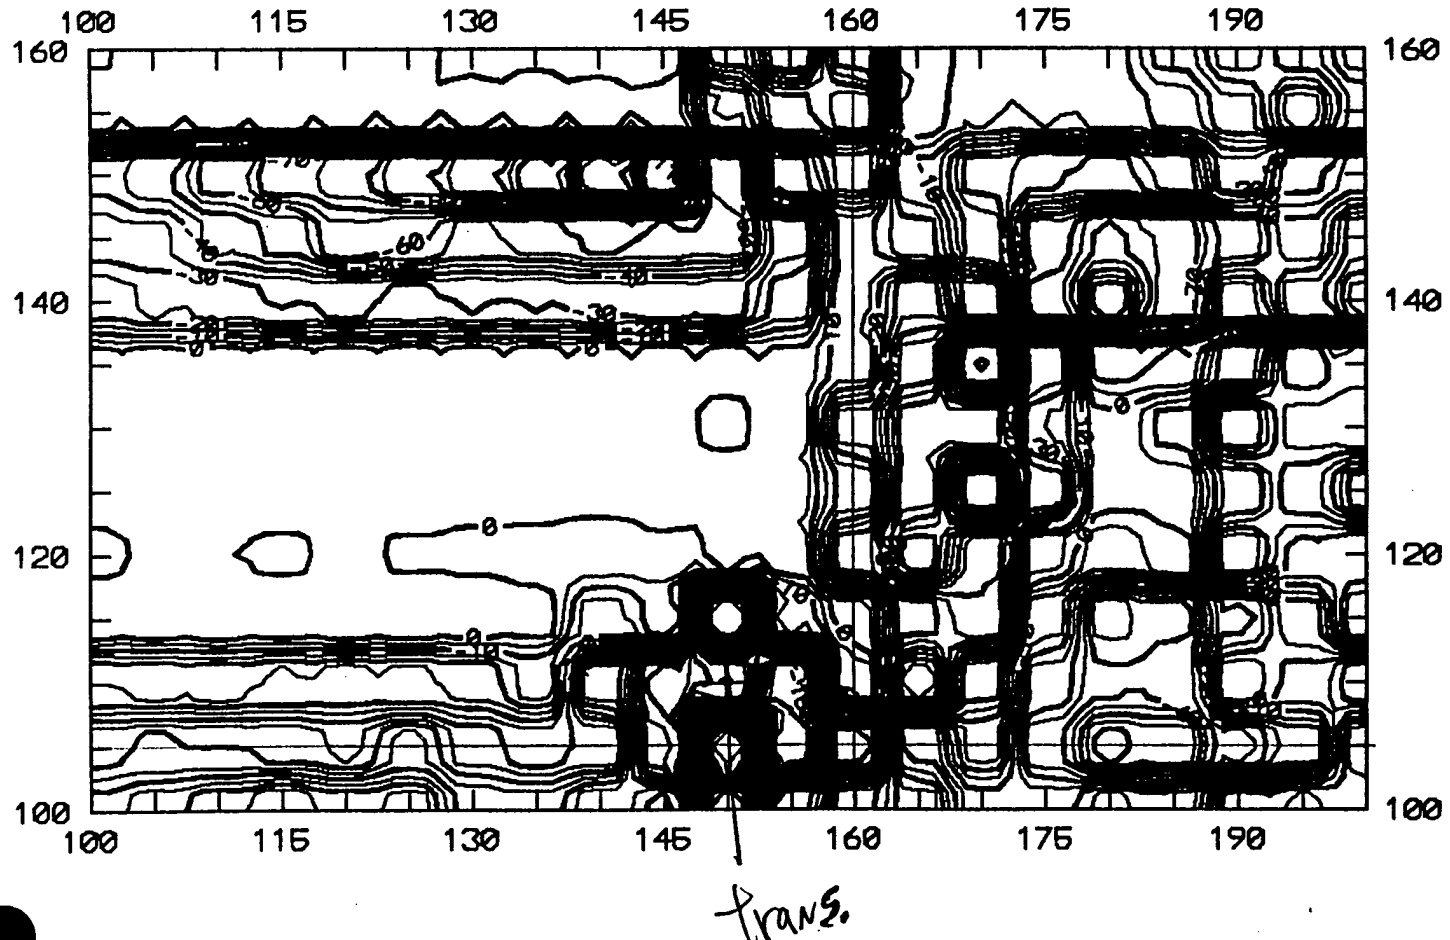
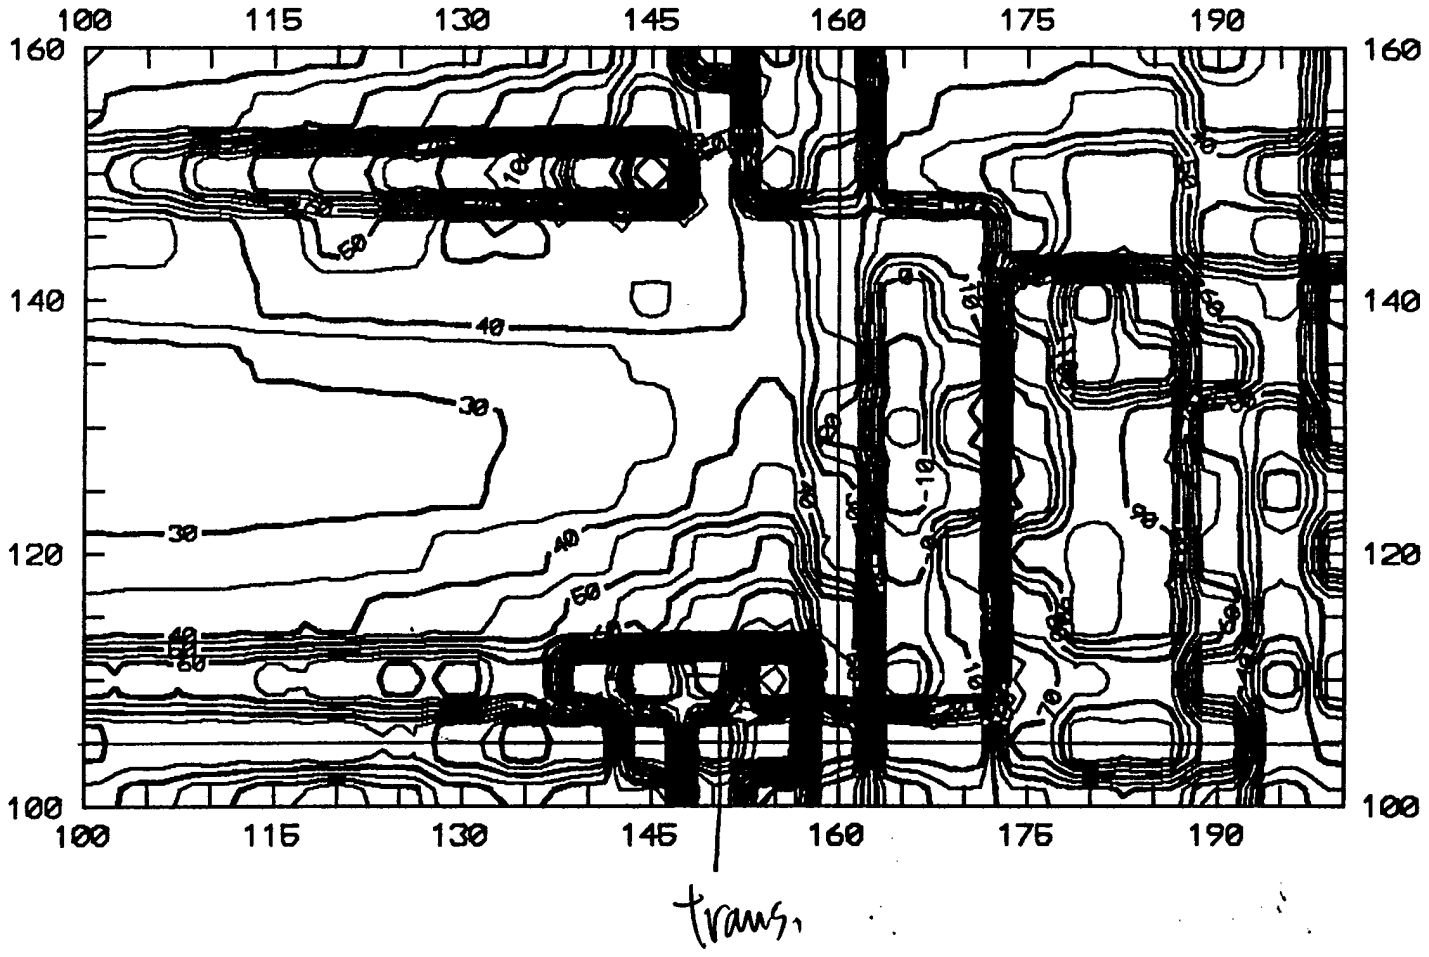
- Interpretation of the EM Conductivity data is hindered by the large amount of cultural interference encountered at the site. We recommend that further processing be undertaken to enhance the interpretation.

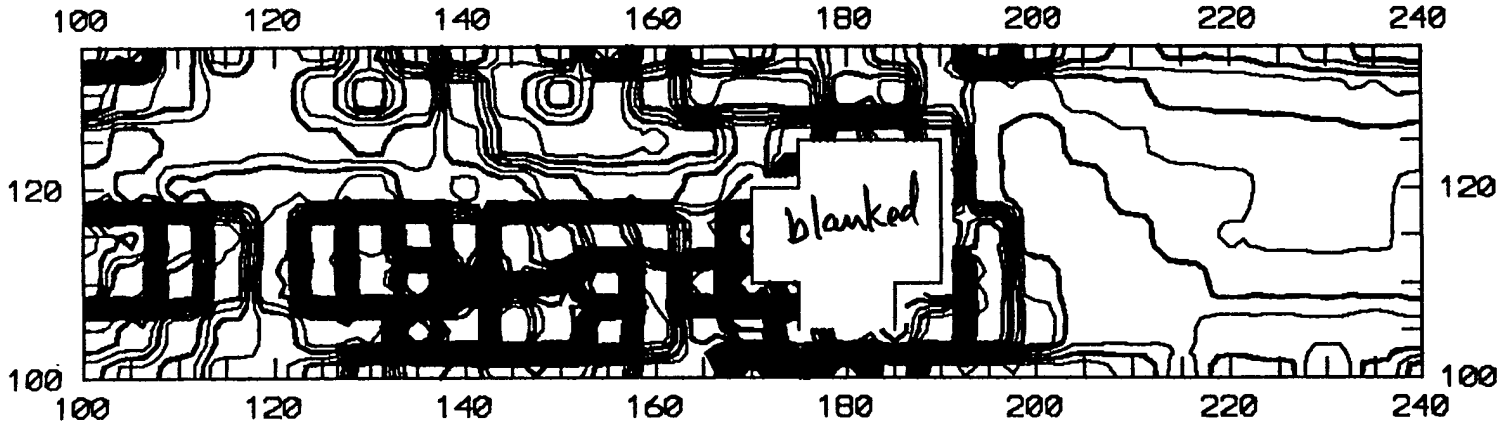
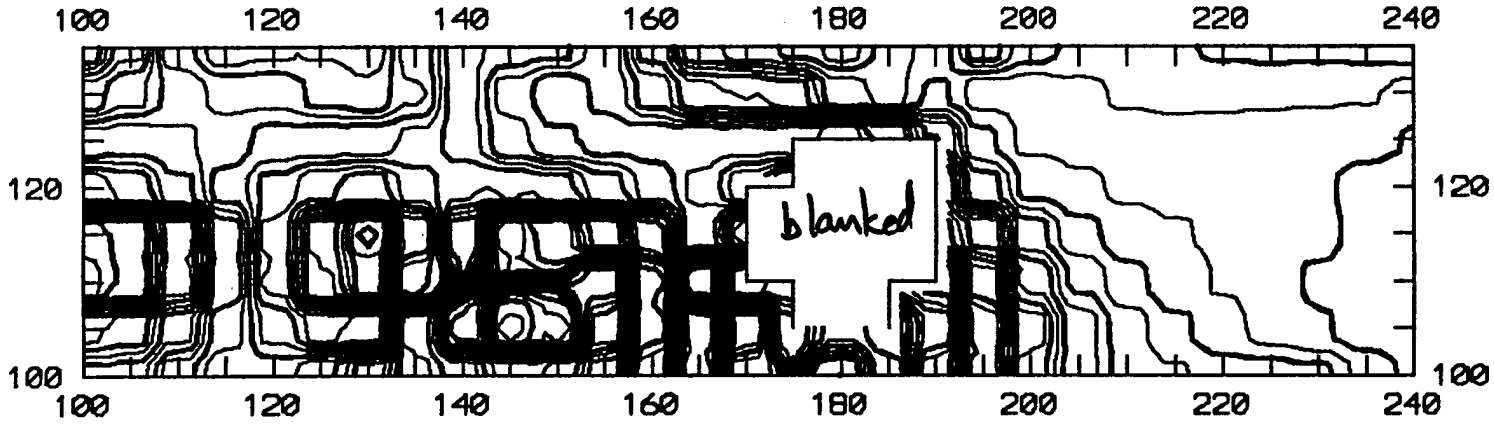
- Several anomalies are observed in the magnetic data. Most of these anomalies appear result from cultural interference (utilities, building,etc.) A remaining anomaly is located N150-155/E160-170. This magnetic anomaly does not appear as an anomaly in the EM data.
  This magnetic anomaly is not interpreted to be a geophysical target because of its response, and because it is not confirmed by EM data.

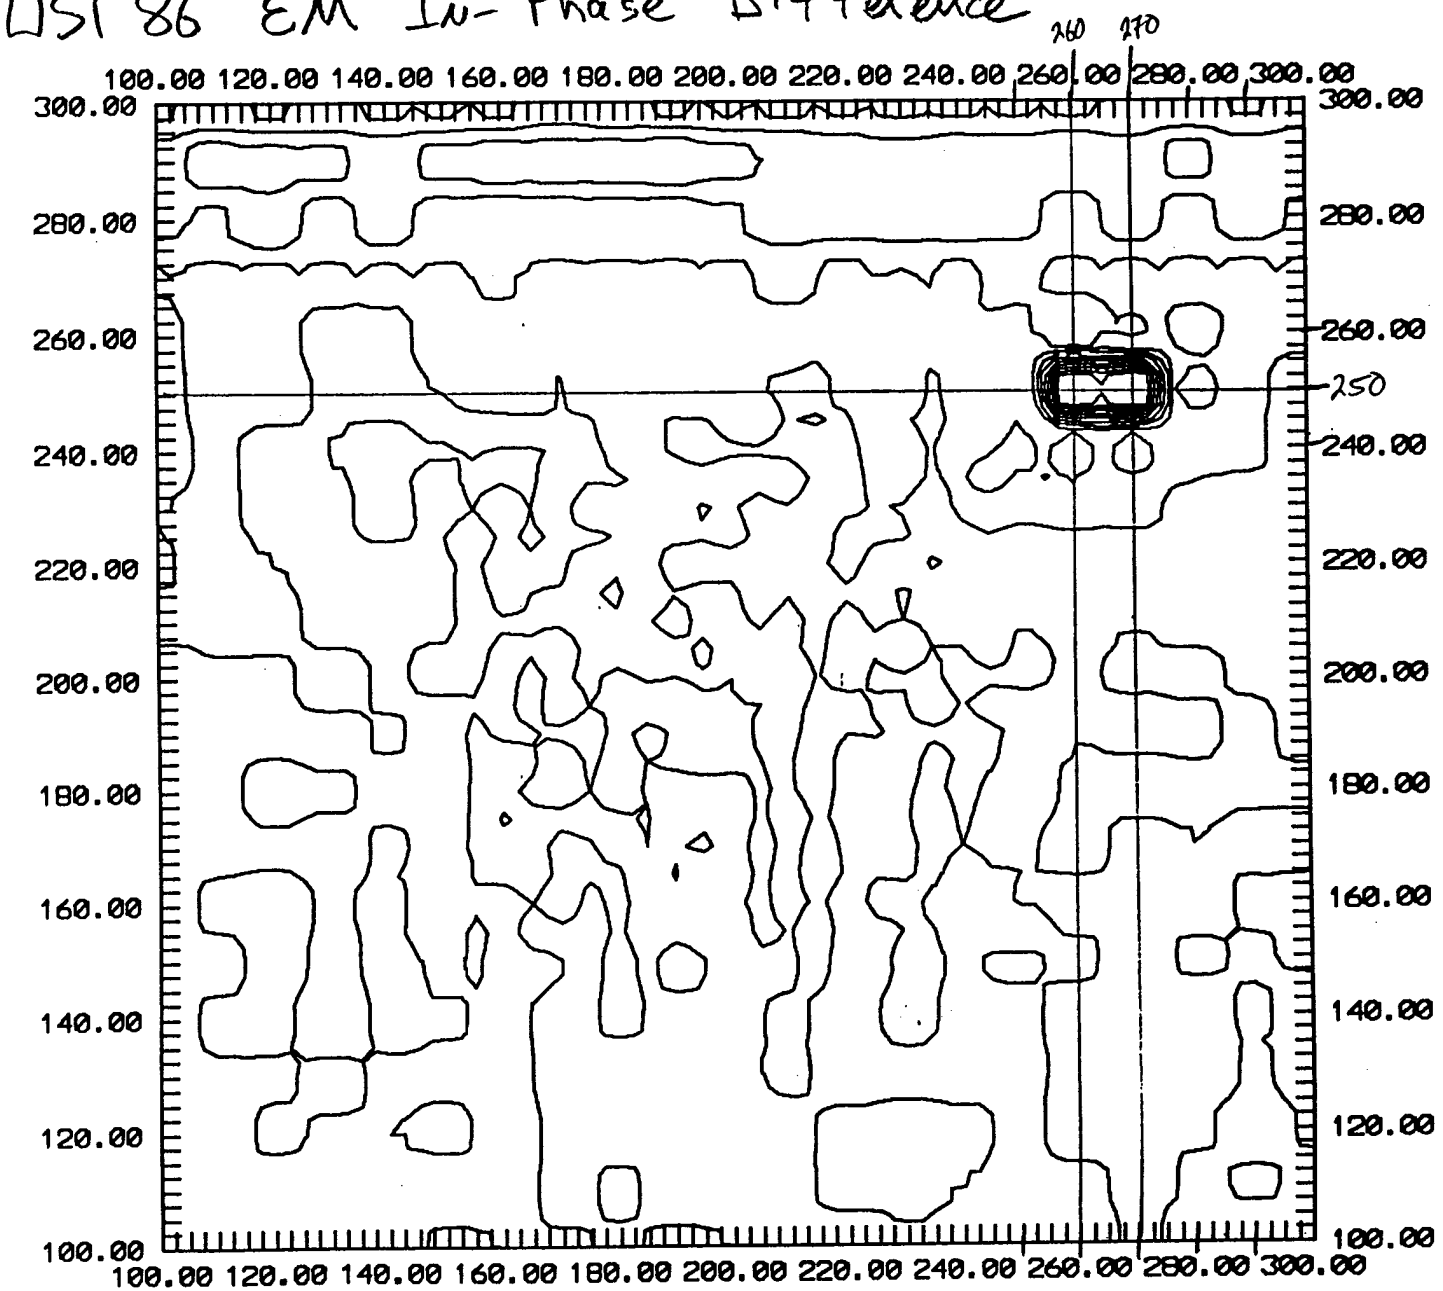
UST 86 EM In-Phase Difference
86EM-I
IN-PHASE DIFFERENCE (PPT)
CI = 1ppt
260
270
250
100.00 120.00 140.00 160.00 180.00 200.00 220.00 240.00 260.00 280.00 300.00
300.00
280.00
260.00
240.00
220.00
200.00
180.00
160.00
140.00
120.00
100.00

- One strong anomaly is observed in the In-Phase Difference map. The anomaly is located N250/E260-270. This location is nearly coincidental to both the magnetic anomaly and surface evidence. Upon staking this anomaly it was discovered to be a 4'x5' steel-lidded vault cover buried less than 1' below ground surface.

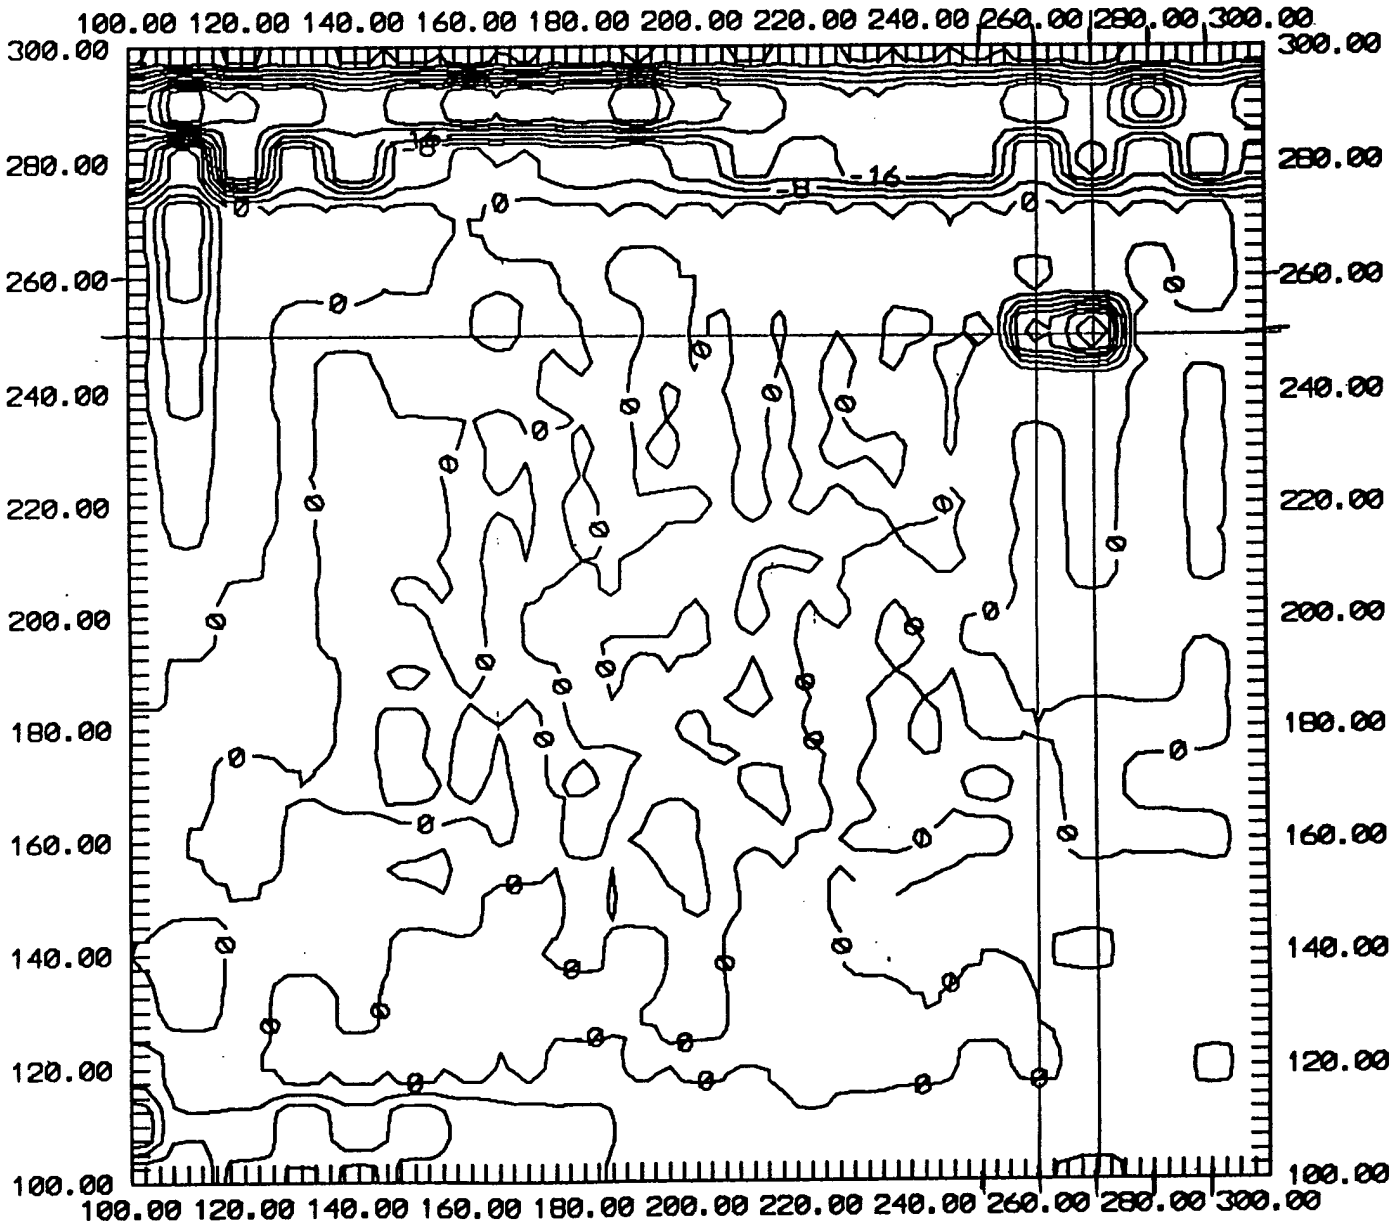
UST 86 EM Conductivity Difference

- One moderately strong anomaly is observed in the Conductivity Difference map. The anomaly is located N250/E260-270. This location is nearly coincidental to both the magnetic anomaly and surface evidence. Upon staking this anomaly it was discovered to be a 4'x5' steel-lidded vault cover buried less than 1' below ground surface.

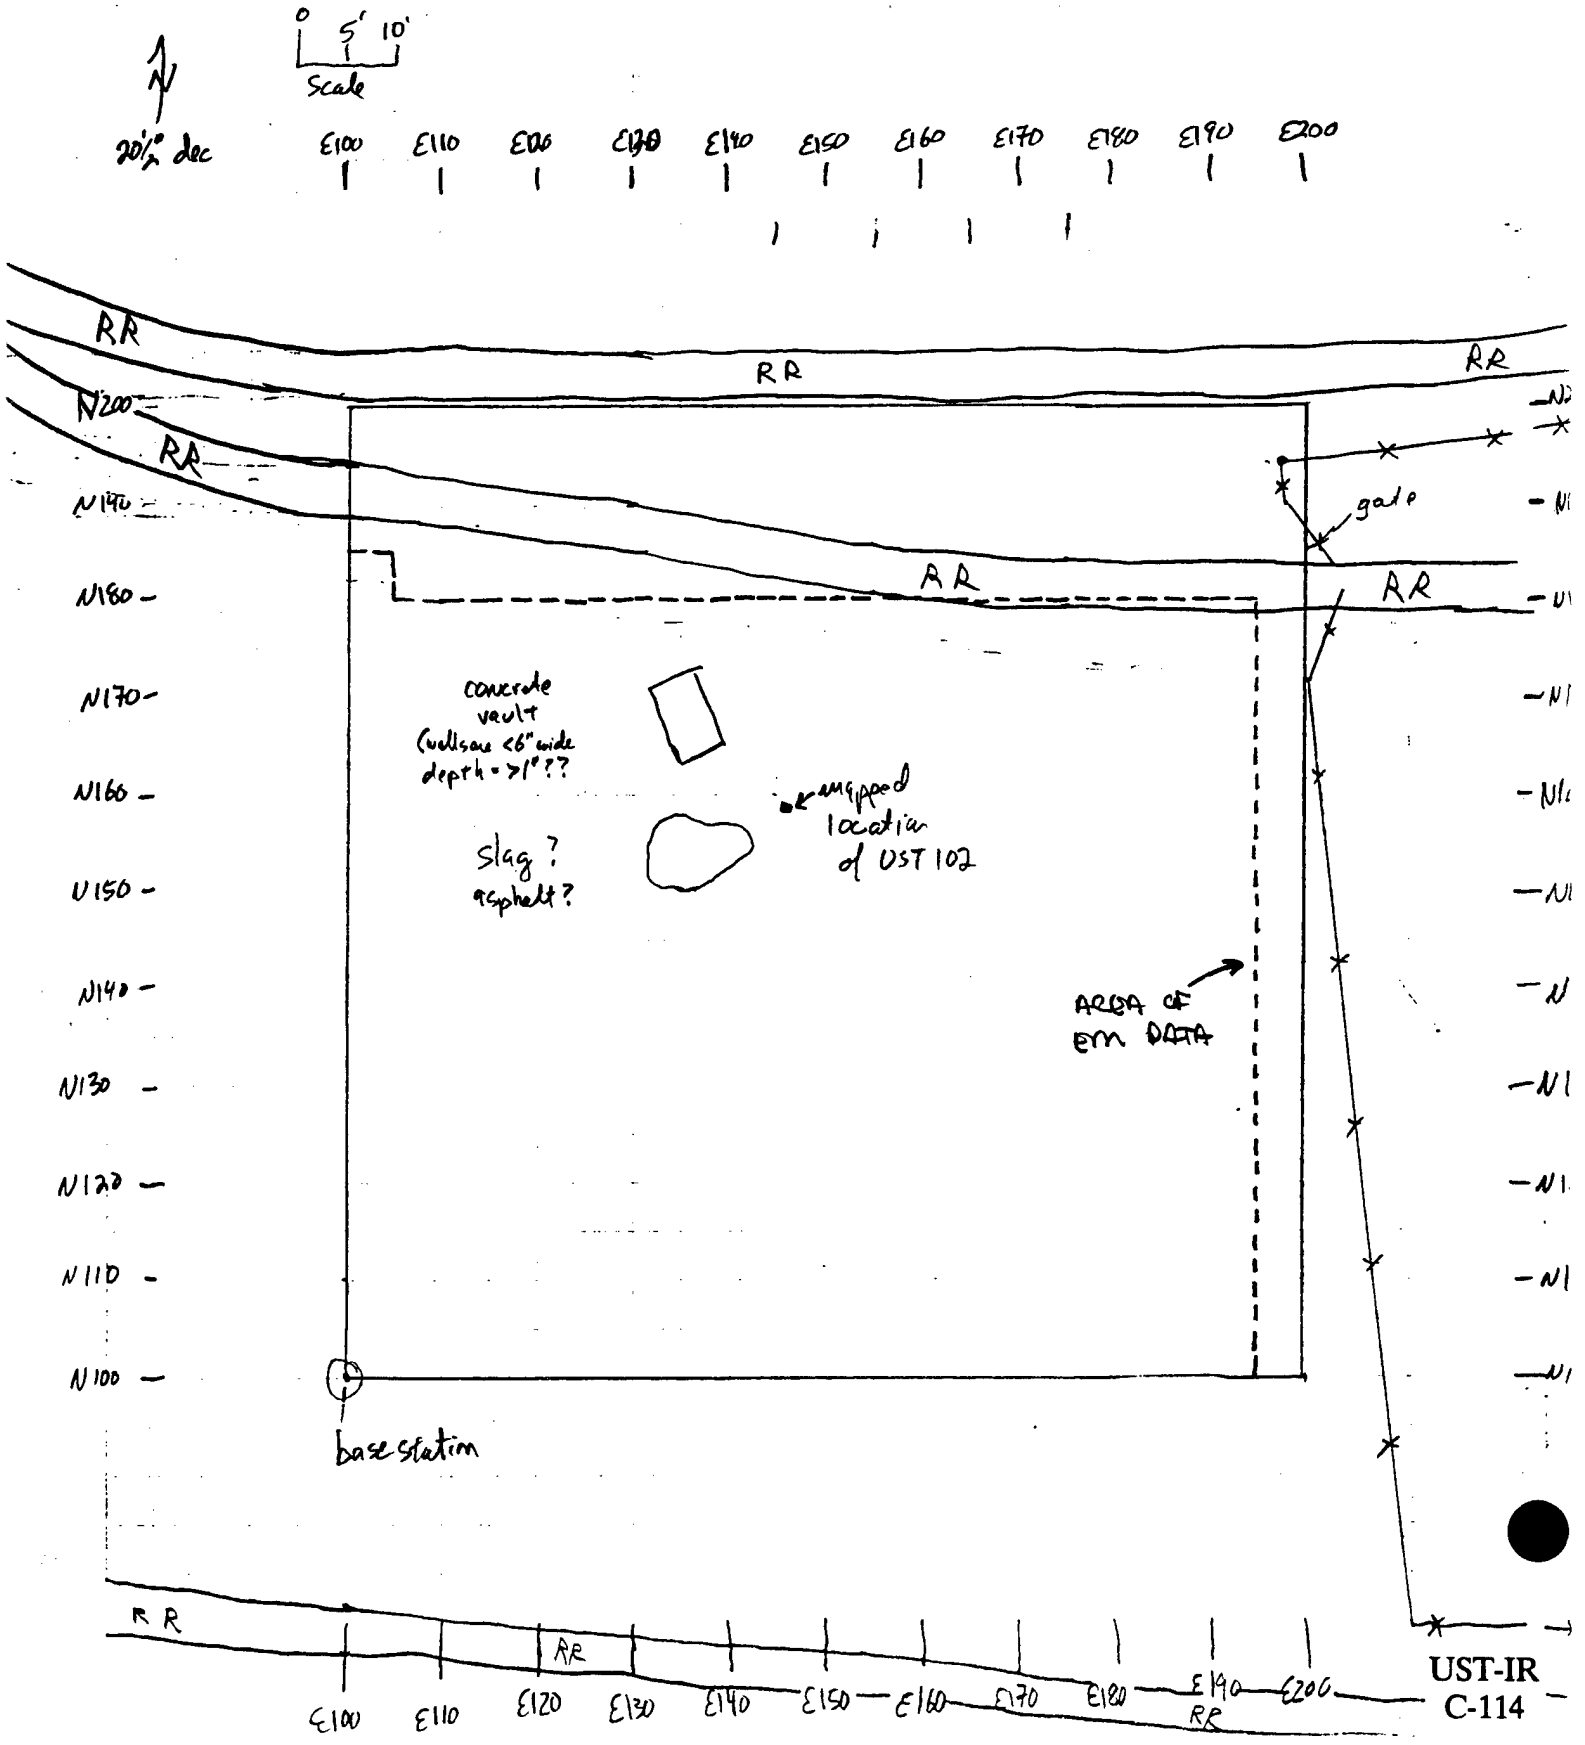
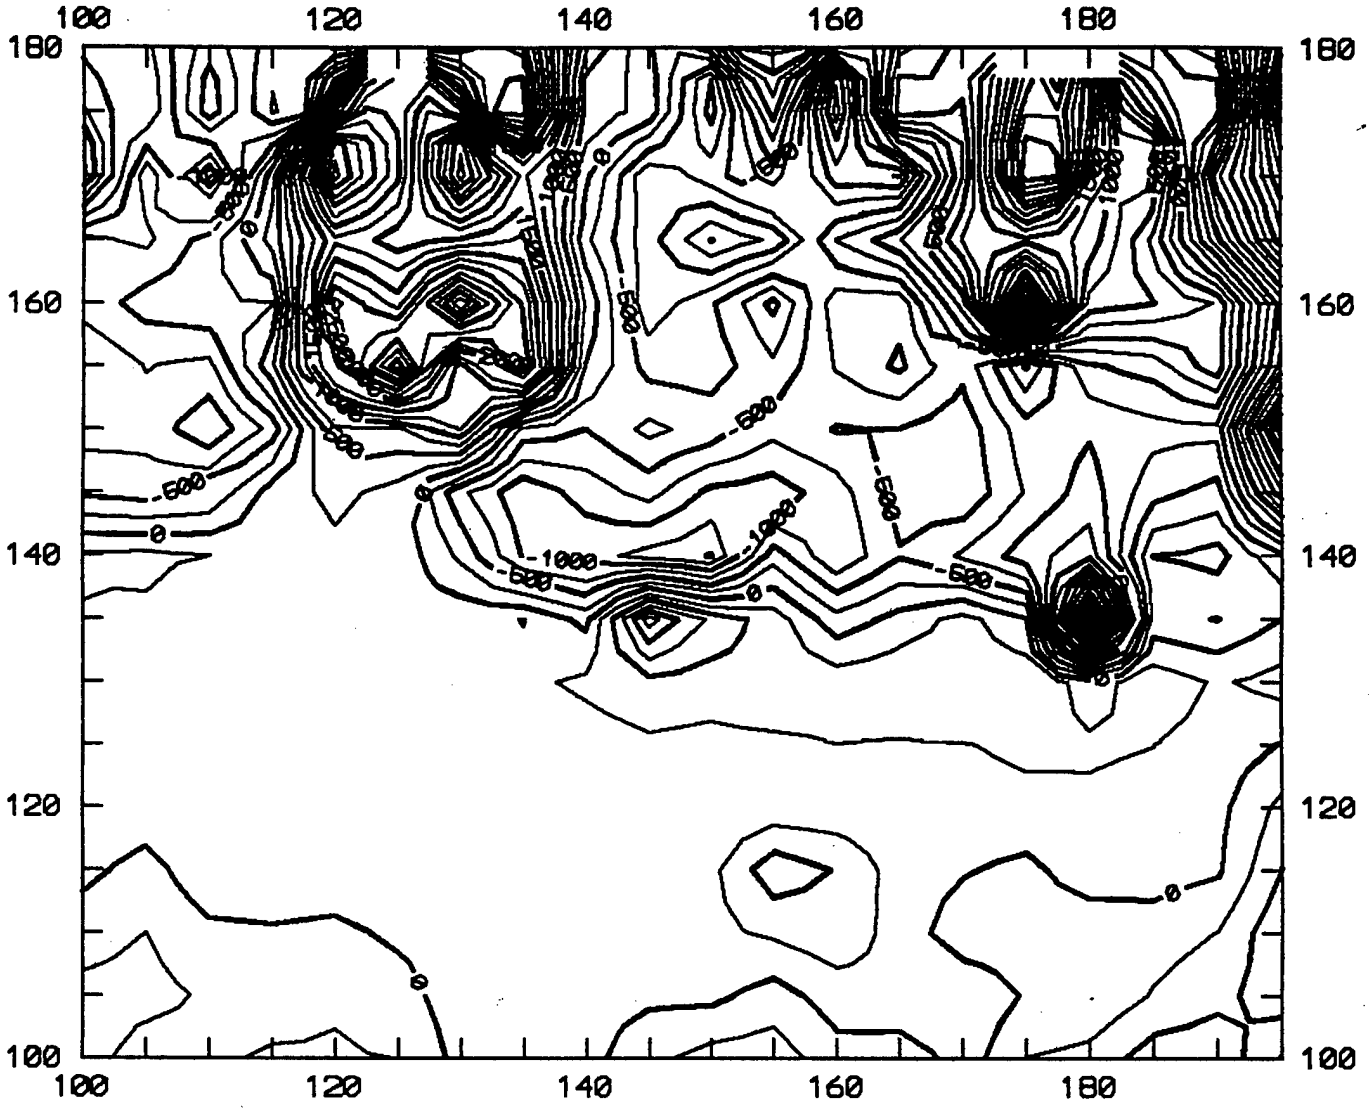
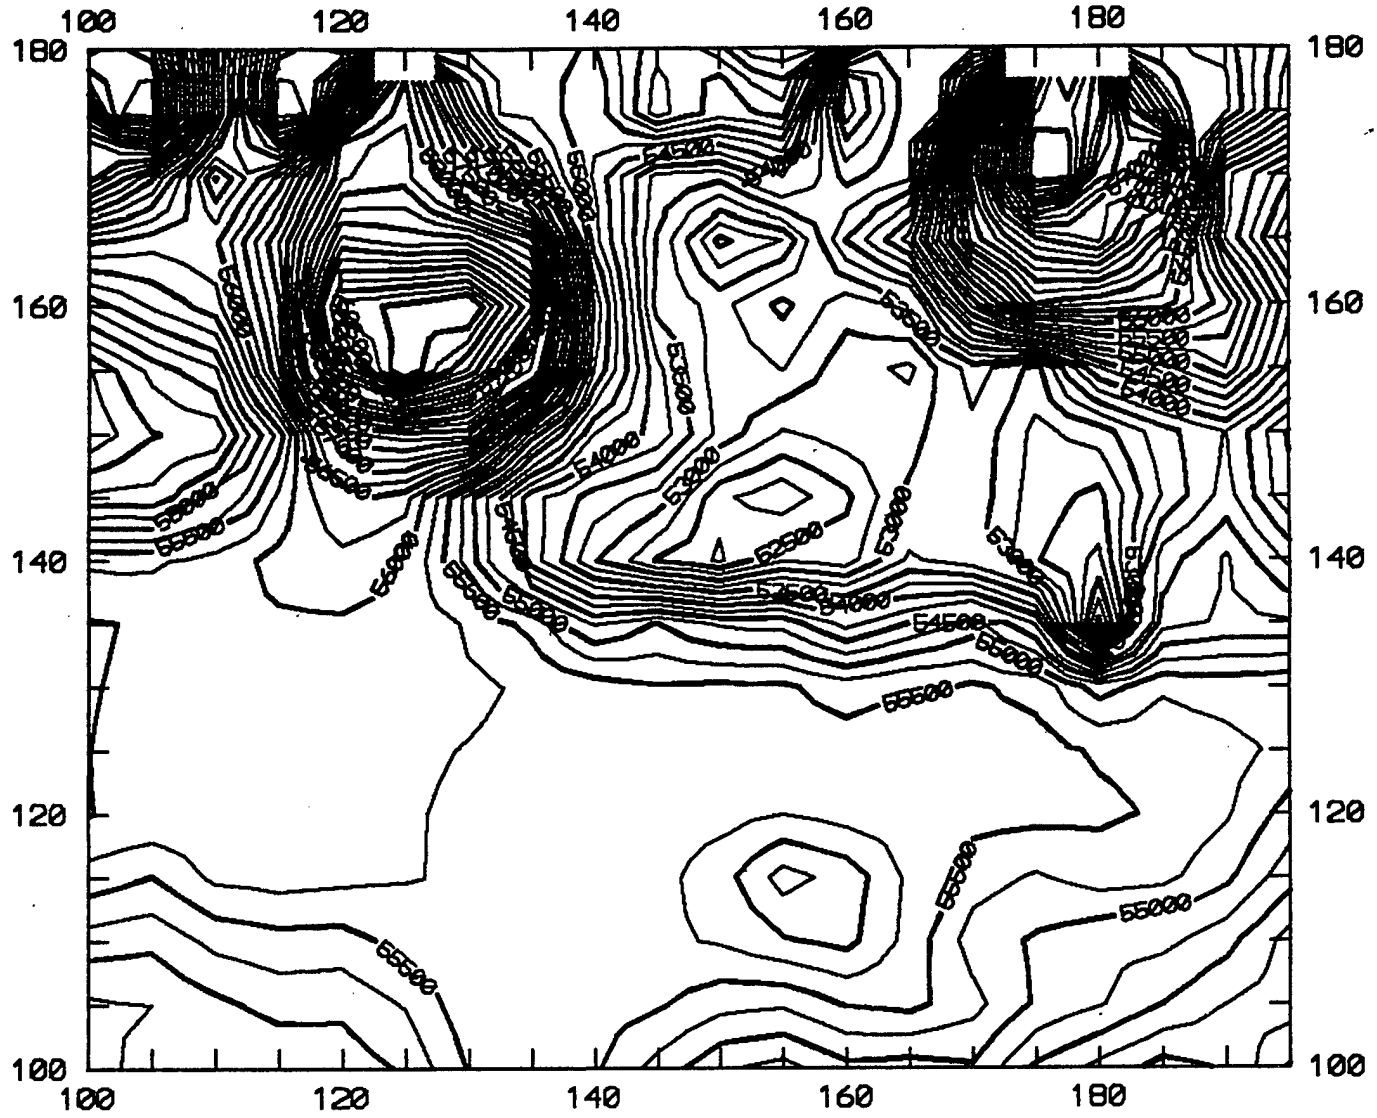
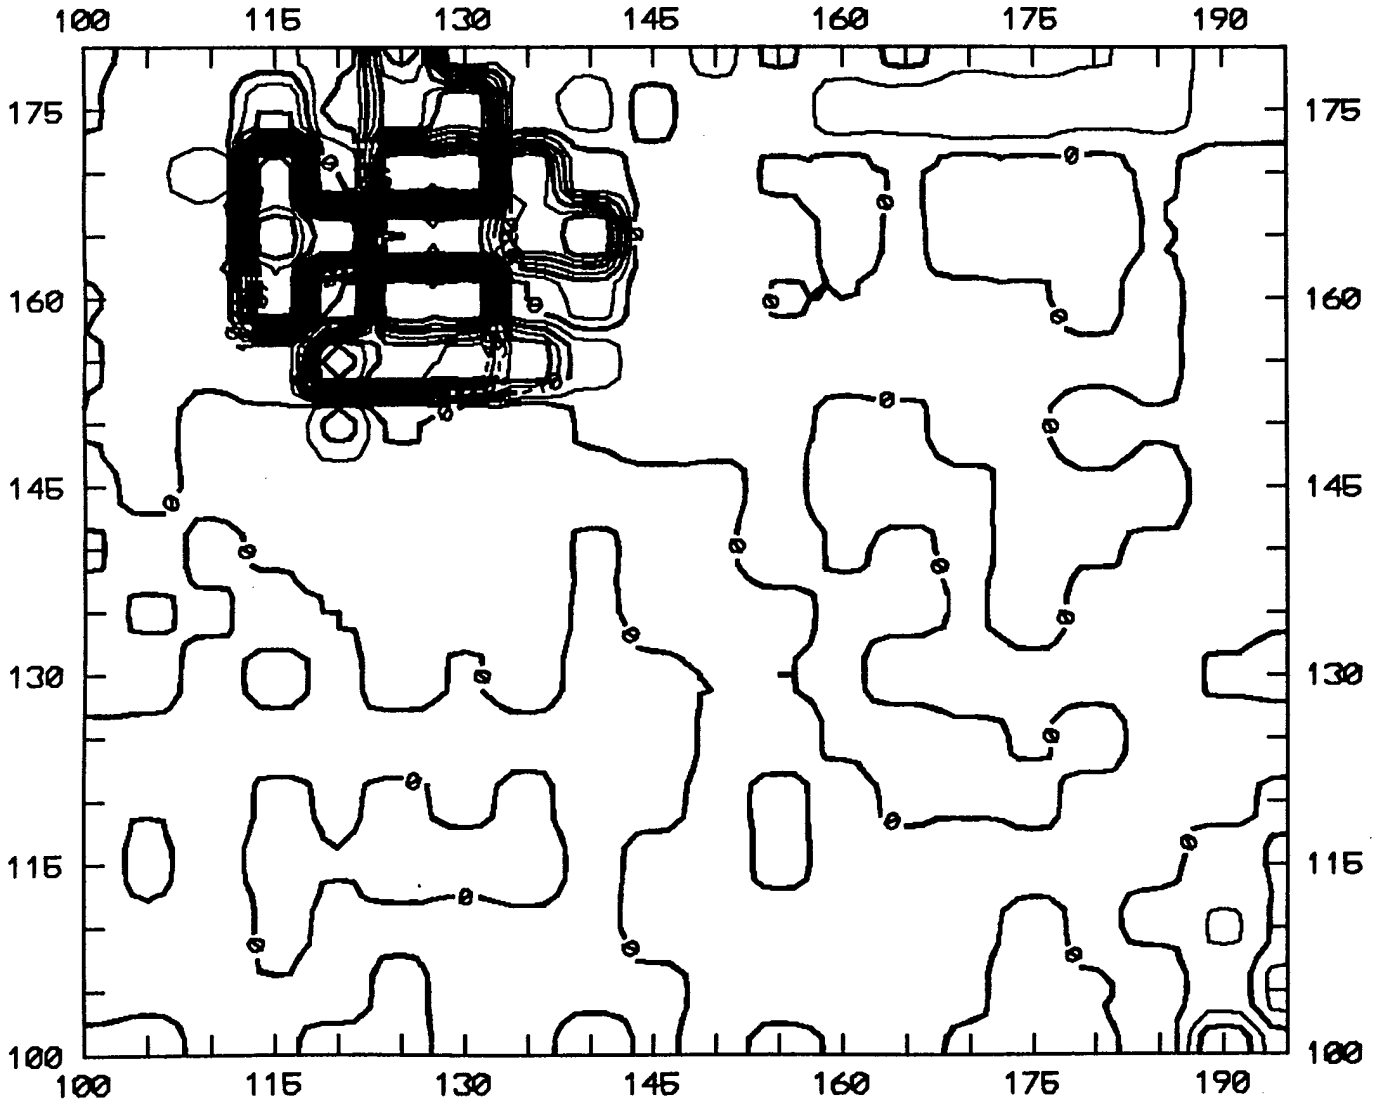
UST 102 Vertical Magnetic Gradient

- One large, strong geophysical target was observed in both the magnetic and EM data. The target is located approximately N155-175/E115-135.
- The target may be composed of 2 side-by-side targets.

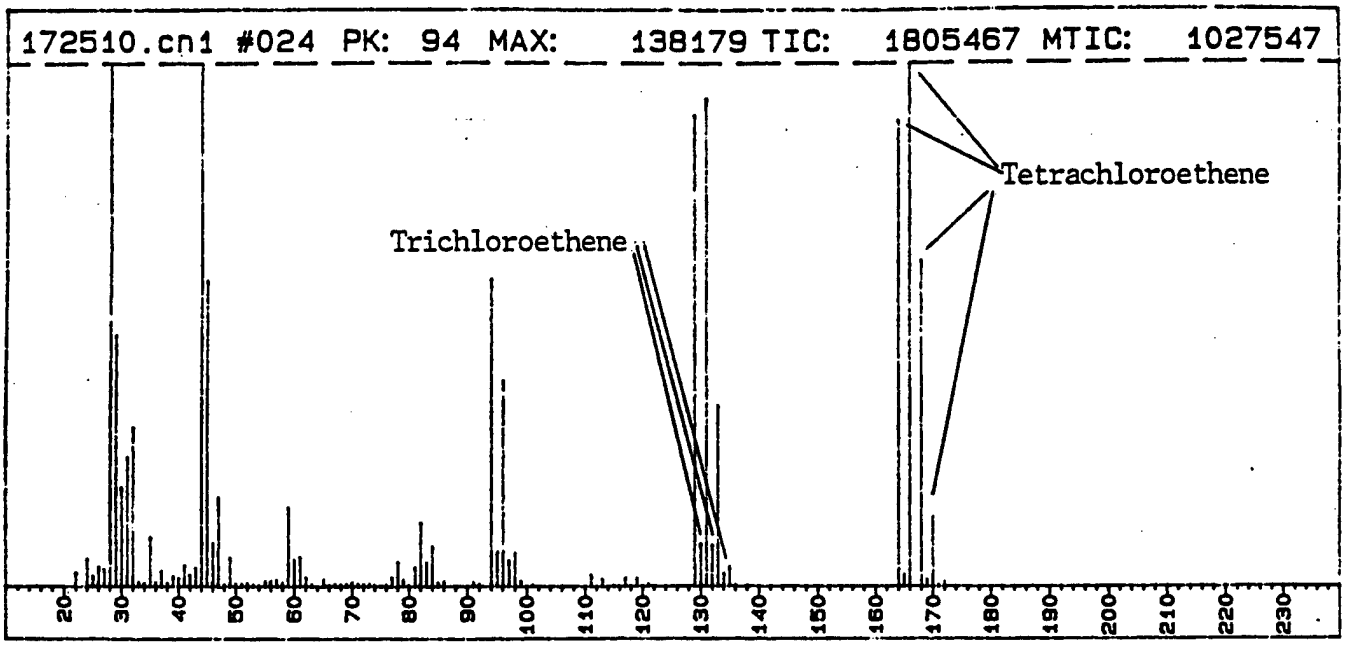
Figure 1.

Mass spectral peaks associated with chlorinated comounds reported in plates 2 and 3. Sampling location 24, Umatilla Army Depot, Hermiston, Oregon.

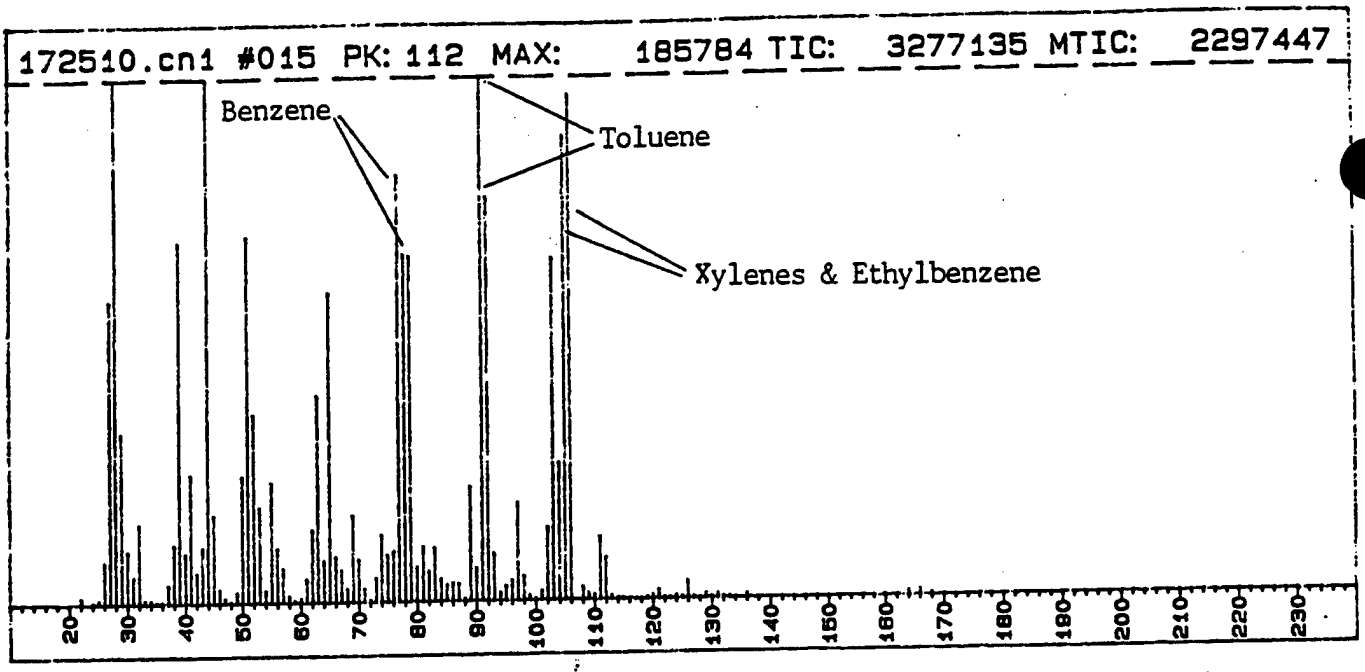
Figure 2.

Mass spectral peaks associated with hydrocarbon compounds reported in plate 4. Sampling location 15, Umatilla Army Depot, Hermiston, Oregon.
