Report No. SFIM-AEC-BC-CR-95047

UNDERGROUND STORAGE TANK INVESTIGATION REPORT UMATILLA DEPOT ACTIVITY HERMISTON, OREGON

DAMES & MOORE
849 International Drive, Suite 320
Linthicum, Maryland 21090

JUNE 1995

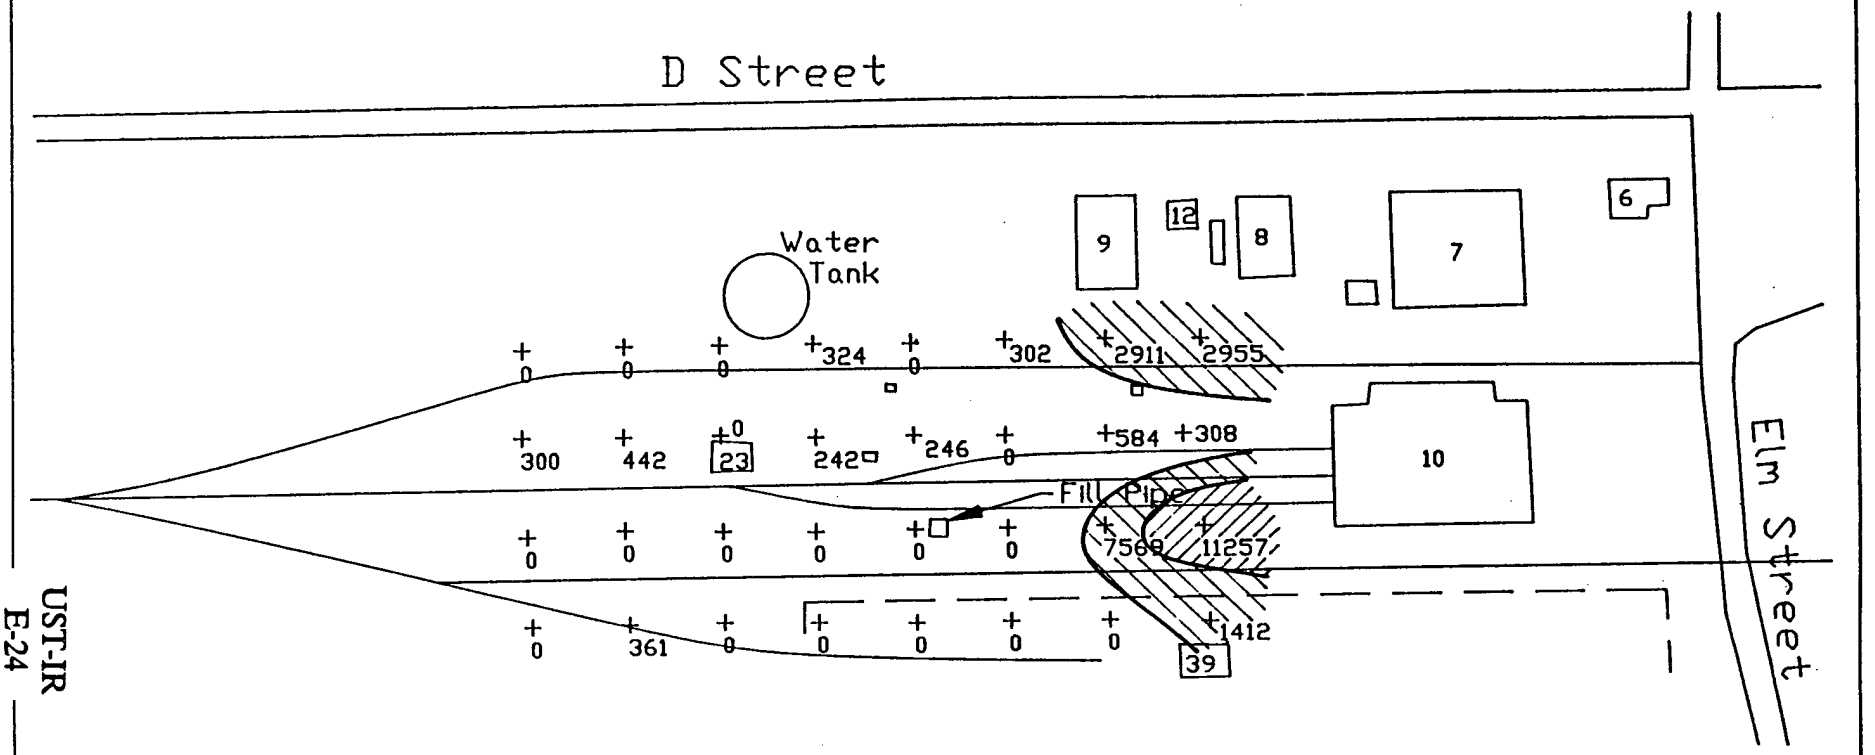
Plate 3

TCE occurrence is shown on Plate 3, Appendix D.

Trichloroethene was also identified in the east portion of the survey with a relative distribution similar to that of PCE. As such, either a coincidental source product or degradation of PCE to TCE is suggested by these results. Note that the PETREX method is much less sensitive to TCE than PCE. Thus, lower ion counts of TCE are typically more significant than equal counts of PCE. The extent of the TCE occurrence has not been determined in an east and northeast directions.

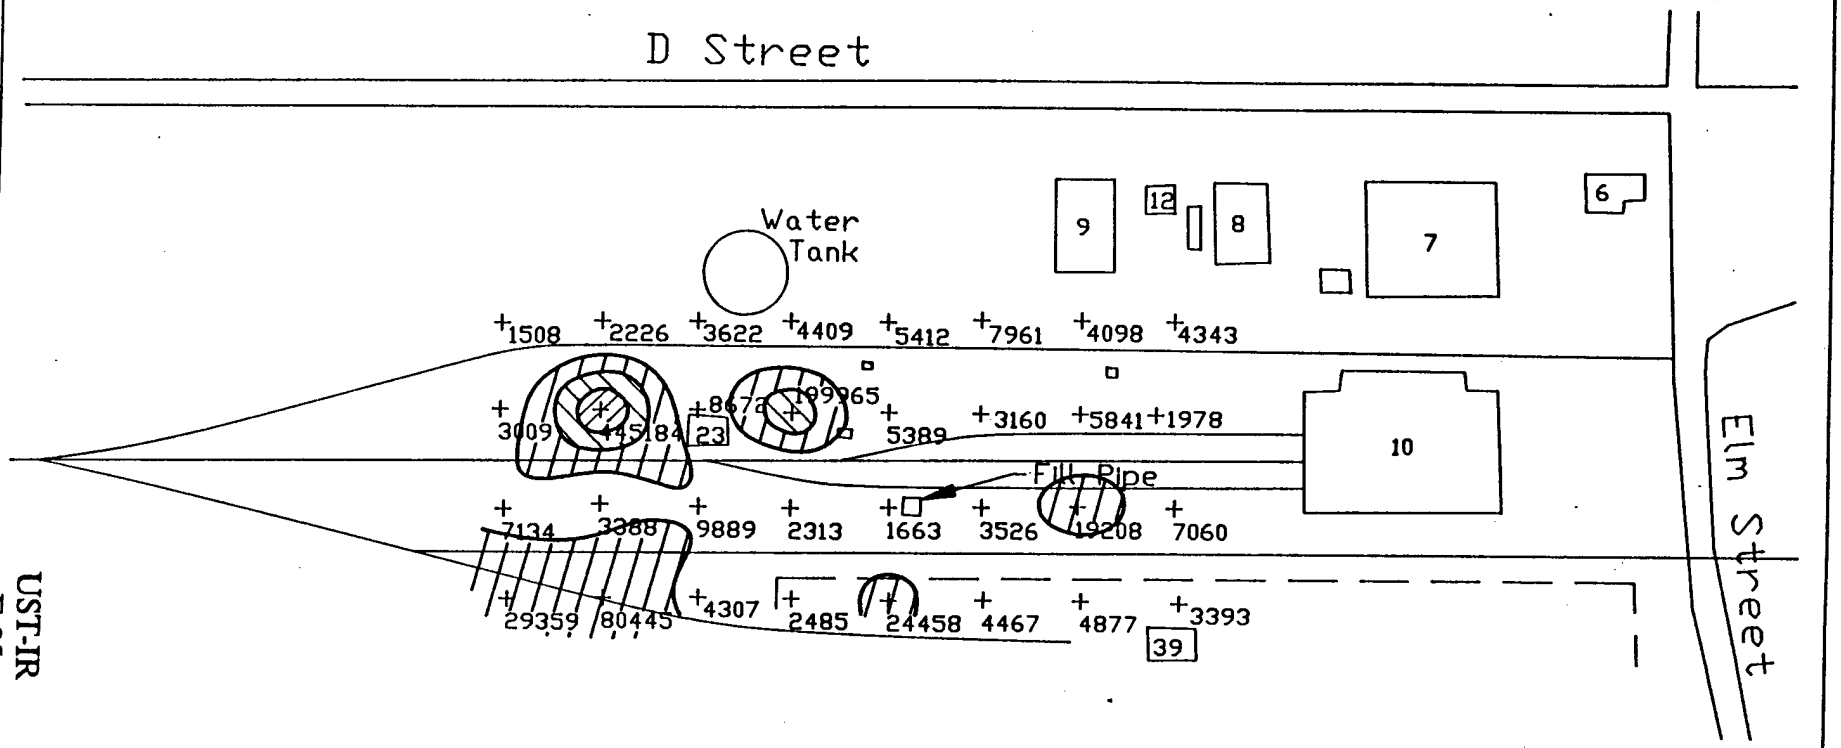
Plate 4

BTXE compounds were detected from high to low levels in limited portions of the site. The occurrences of BTXE are shown on Plate 3, Appendix D. The highest detections occurred at locations 13 and 15 with a background level detection at location 14. Several additional low level detections occurred at locations 23, 28, 31, and 32. With the exception of the southwest corner of the survey, the identifiable areal extent of BTXE was contained within the survey boundaries.
