WL-TR-97-2053

THIN DENSE CHROME BEARING INSERTION PROGRAM

GE AIRCRAFT ENGINES
ADVANCED ENGINEERING PROGRAMS DEPT
ONE NEUMANN WAY
CINCINNATI OH 45215-6301

FINAL REPORT FOR 03/01/92-12/01/96

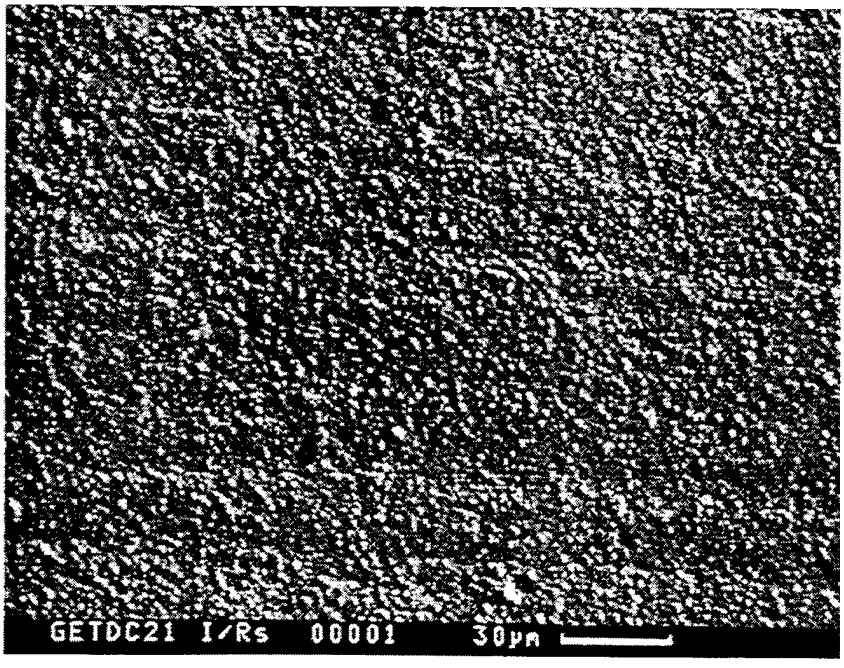
Figures 3 through 10 show the TDC topography of the raceway and shoulder in four different locations around the bearing using the scanning electron microscope (SEM) at 500X. The coating exhibits a nodular TDC without any evidence of cracking. Although this topography passed the GE specification, some variation in nodule size is evident in these micrographs.

Figure 3. SEM Quality/Topography Photo of Position 1 (0°) in Raceway. *Within spec.*

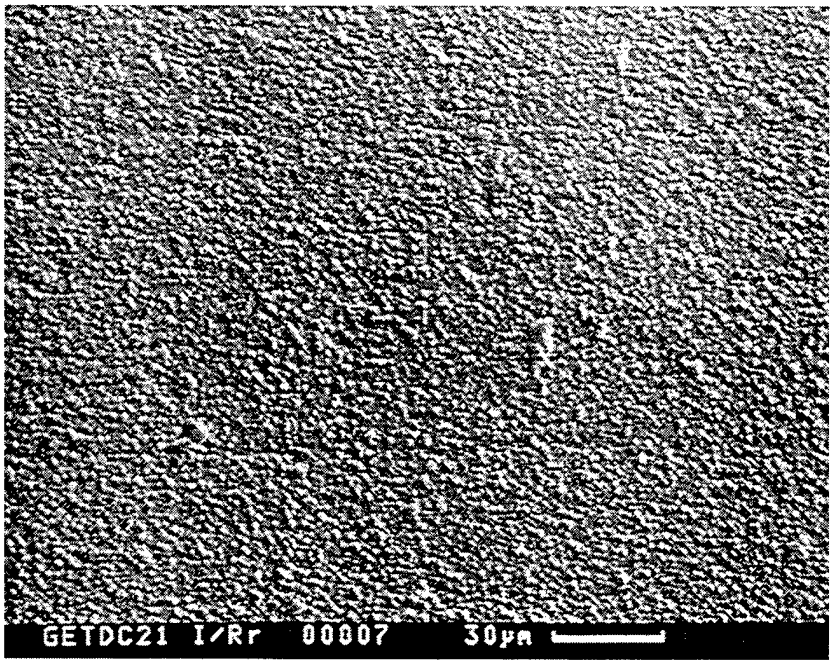
Figure 4. SEM Quality/Topography Photo of Position 1 (0°) in Shoulder. *Within spec.*

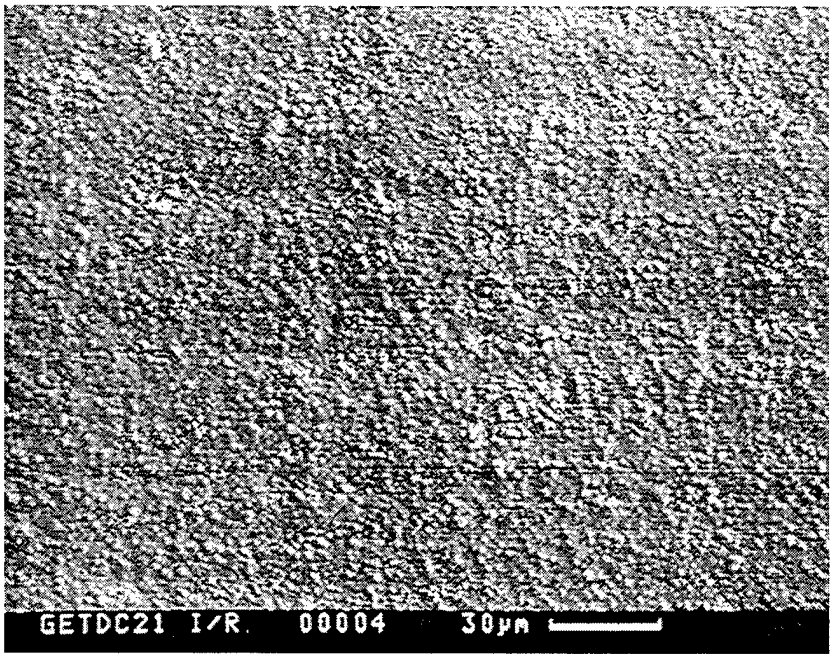
Figure 5. SEM Quality/Topography Photo of Position 2 (90°) in Raceway. *Within spec.*

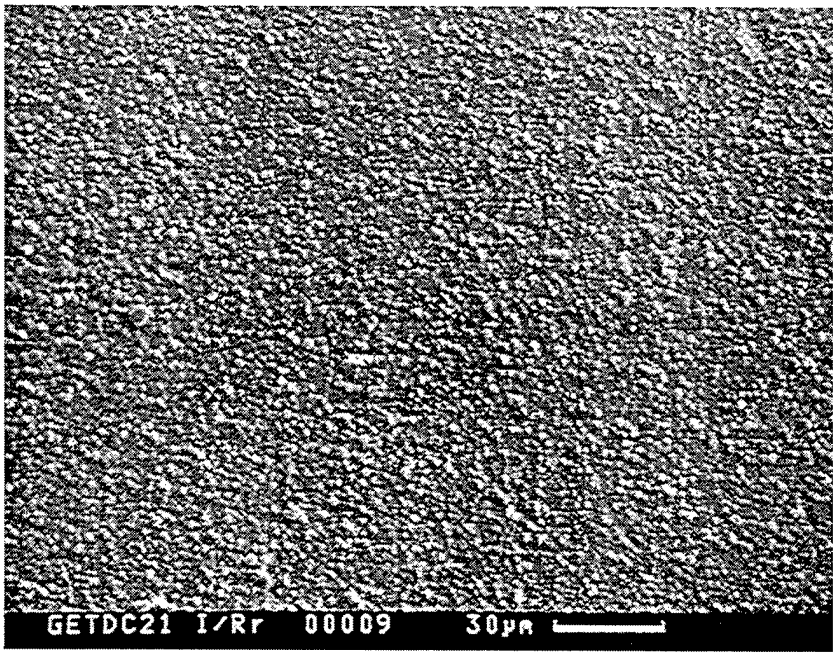
Figure 6. SEM Quality/Topography Photo of Position 2 (90°) in Shoulder. *Within spec.*

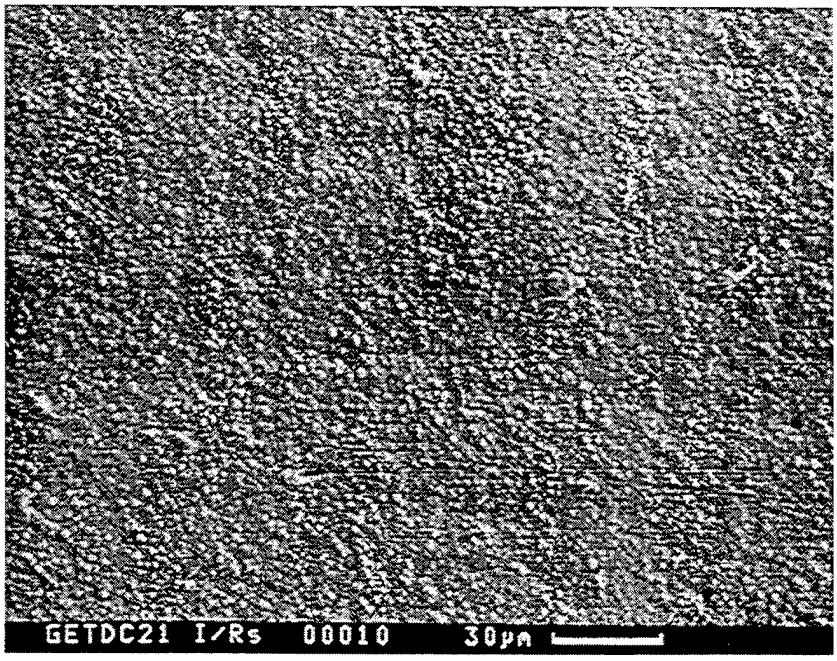
Figure 7. SEM Quality/Topography Photo of Position 3 (180°) in Raceway. *Within spec.*

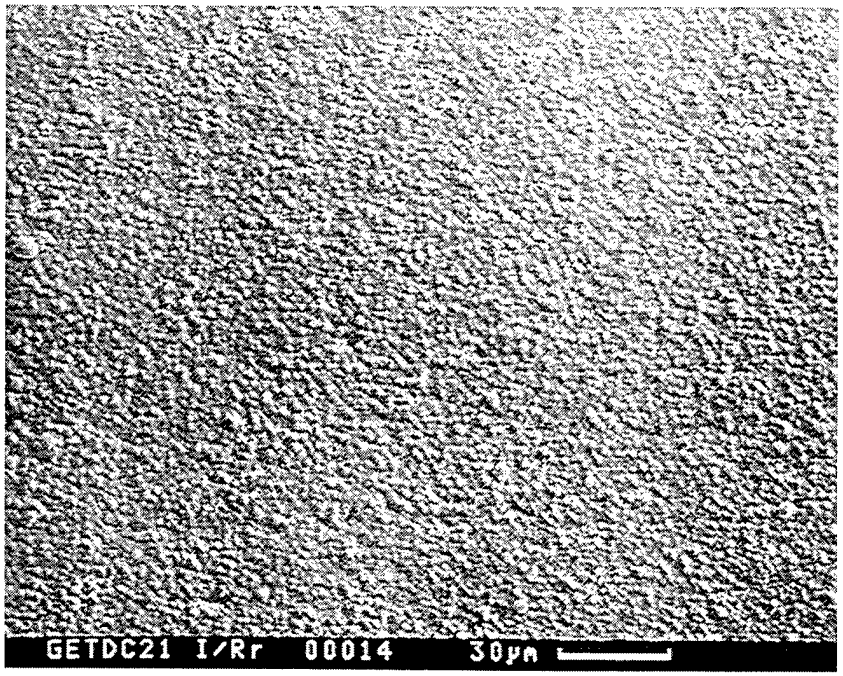
Figure 8. SEM Quality/Topography Photo of Position 3 (180°) in Shoulder. *Within spec.*

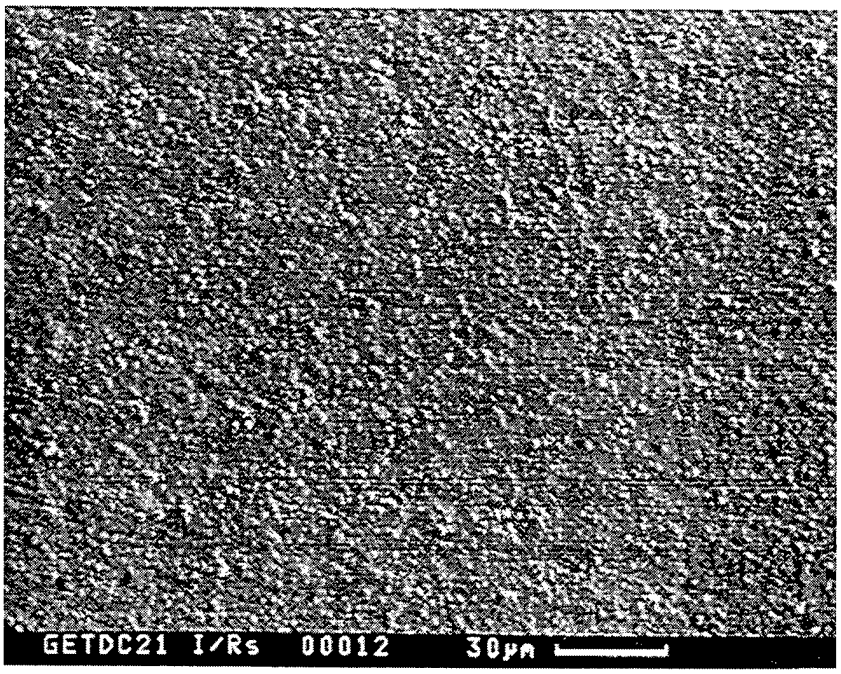
Figure 9. SEM Quality/Topography Photo of Position 4 (270°) in Raceway. *Within spec.*

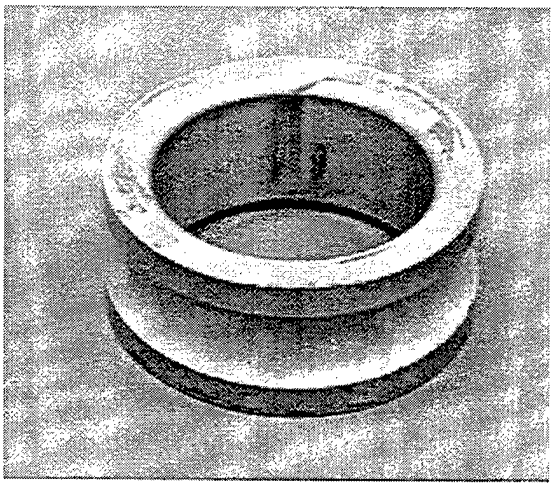
The tested bearing is shown in **Figure** 11. The staining which is evident on the bearing came from stamp marks, vibration peen marks, and corners of the sample, and was not present in the ball track. It was estimated that the total corrosion was less than 1% of the total area and most of the poor appearance was due to runoff from those isolated areas. A certification of the testing results is included in Appendix A. Although the sample was deemed to have passed this 24–hour salt spray test, the evidence of corrosion indicated that making a bearing totally free from localized corrosion may be difficult and achieving an absolute corrosion free part after the 24–hour salt spray exposure is very challenging.

Figure 11. Photo of Inner Ring from 24–Hour Salt Spray Test (MRC Round 1). *Although the ball track was free of corrosion, a few isolated areas did corrode resulting in the staining evident in the photo.*

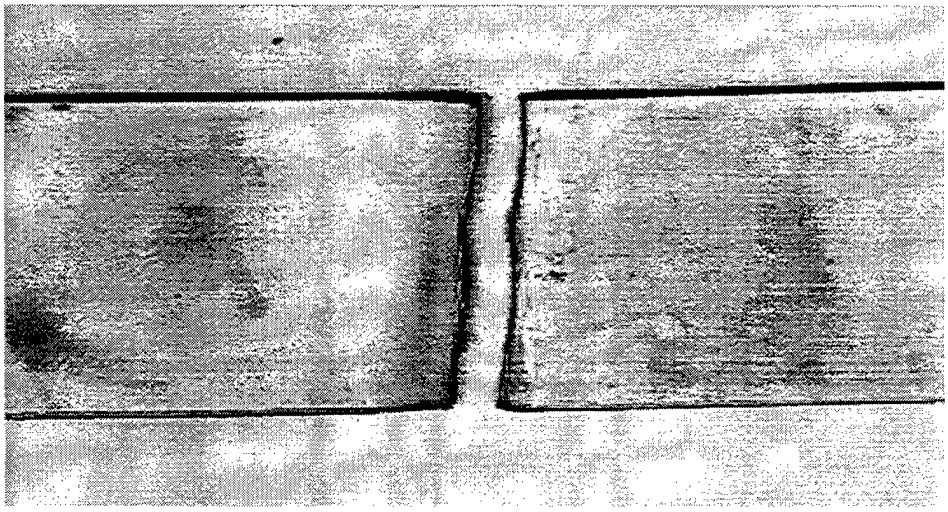
Figure 14 shows the panel used in the bend test performed by Armoloy of Connecticut. Postbend test inspection indicated that the TDC coating adhered to the base metal, and did not flake, peel, or delaminate.

Figure 14. Photos of Bend Test Specimen.
TDC did not flake, peel, or delaminate.

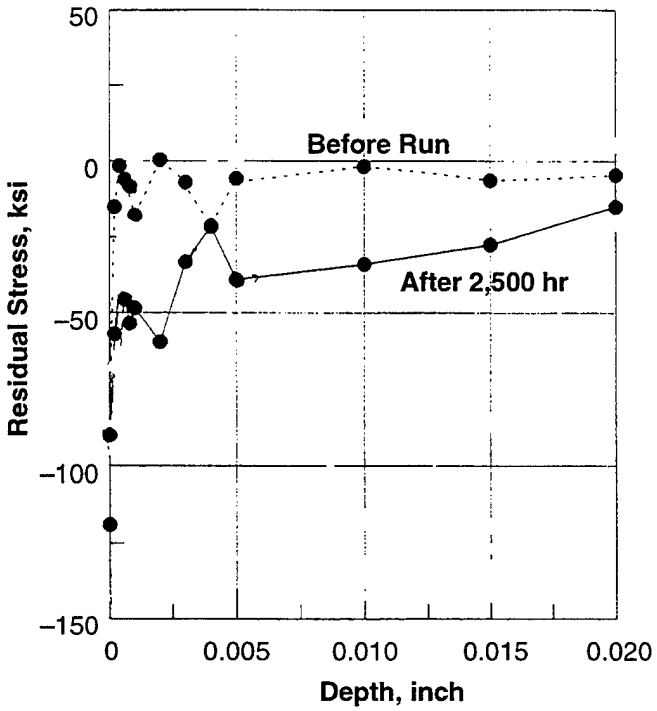
Residual stress profiles of plain and TDC coated bearing inner rings after 2,500 hours of endurance testing, as shown in **Figures** 37 and 38 indicated both a large residual compressive stress in the area of the 0.010in deep for the TDC coated and a smaller and shallower (≈0.005in deep) subsurface compressive stress for the plain bearing. Since the depth of maximum shear stress is proportional to the contact area which in turn is proportional to the applied load and inversely proportional to the modulus of elasticity, it was concluded that the TDC bearing was either operating at a higher load, at a higher contact temperature, or both.

Figure 37. Residual Stress Profiles of MRC Round 1 Bare Baseline Rings. *Note the degree of change between the before and after the 2,500 hours is small when compared to the profile of the TDC coated bearings shown in Figure 38.*

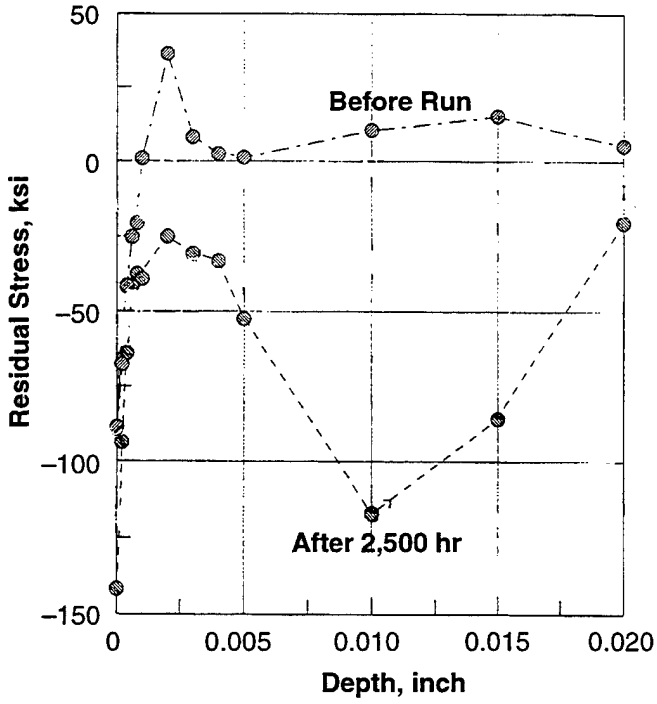
Figure 38. Residual Stress Profiles of MRC Round 1 TDC Coated Rings. *Note the Large compressive stress at 0.010 inch deep as a result of the 2,500 hours of operation.*

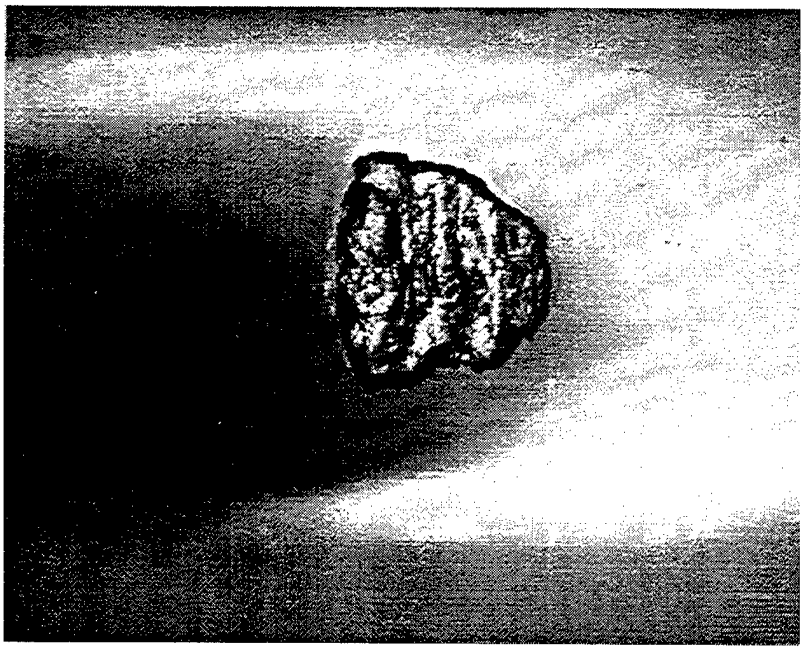
Figure 42. SEM Photo of GE TDC 24 Inner Ring Spall from MRC Round 1.
TDC plated bearing, 876 hours, one of three plated bearing failures.

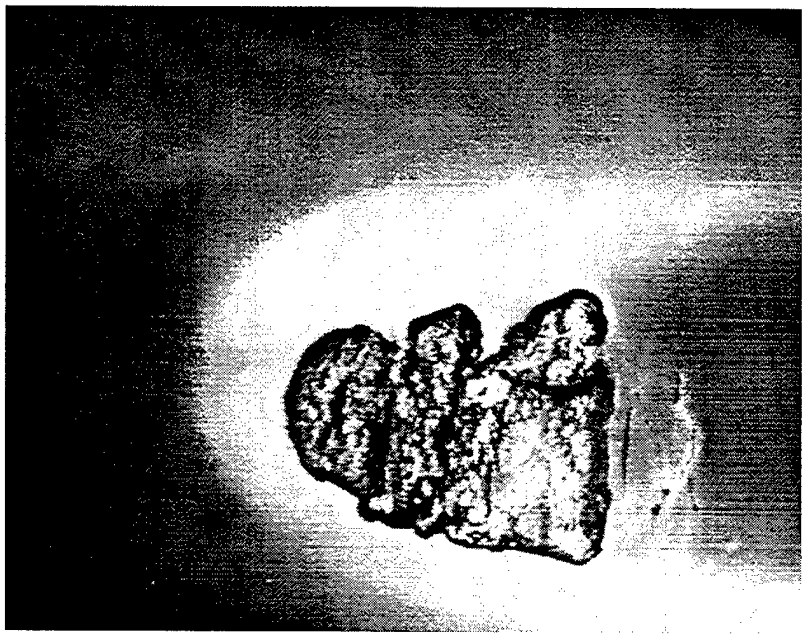
Figure 43. SEM Photo of GE TDC 09 Inner Ring Spall from MRC Round 1.
TDC plated bearing, 2152 hours, one of three plated bearing failures.

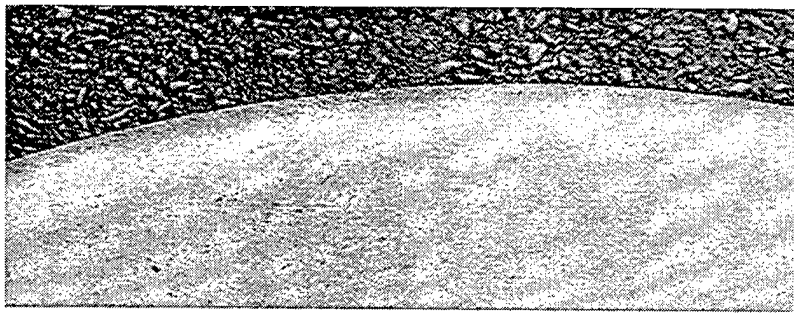
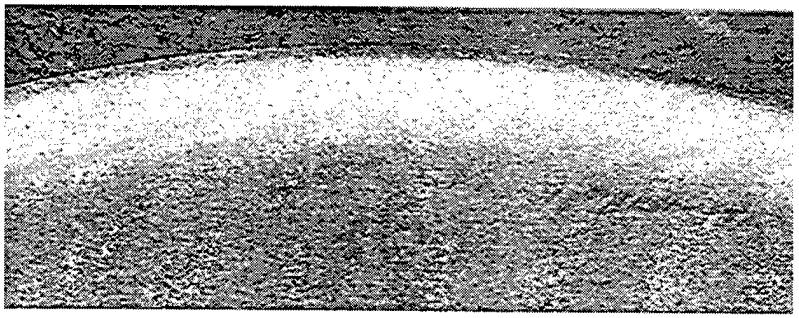
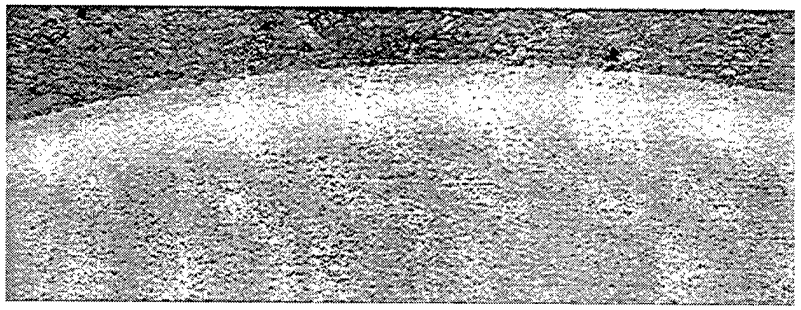
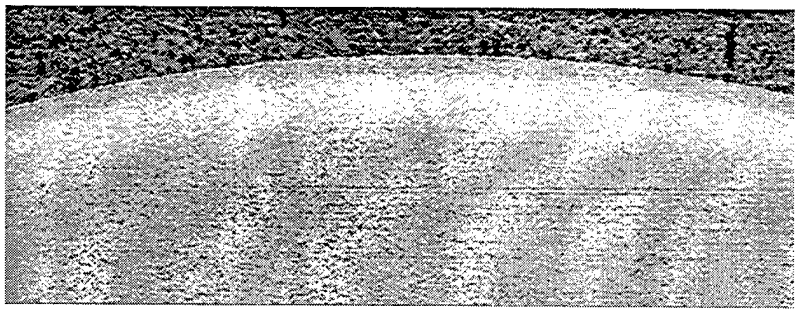
An examination of the M50 balls from both the TDC plated bearings and the plain bearings revealed a larger amount of stress induced microstructural alterations (white etching microstructure) at the maximum shear depth in the TDC plated bearings than in the plain bearings. This is further evidence that the TDC bearings were operating at a higher load, higher temperature, or both. **Figure** 46 shows the white etching regions in the TDC plated bearings and **Figure** 47 in the plain bearings.

Figure 46. Optical Micrograph of MRC Round 1 TDC Test Balls.
Note white etching layer in max. shear zone.

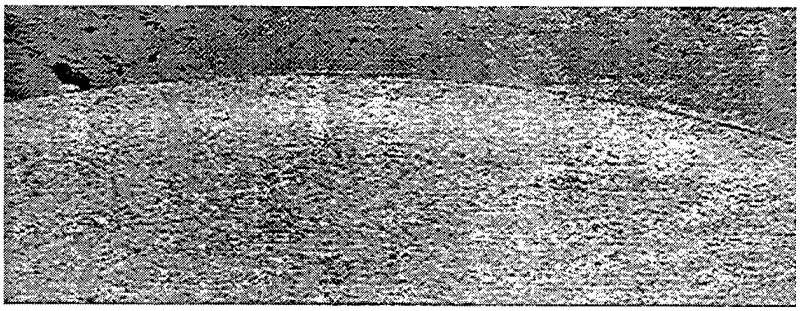
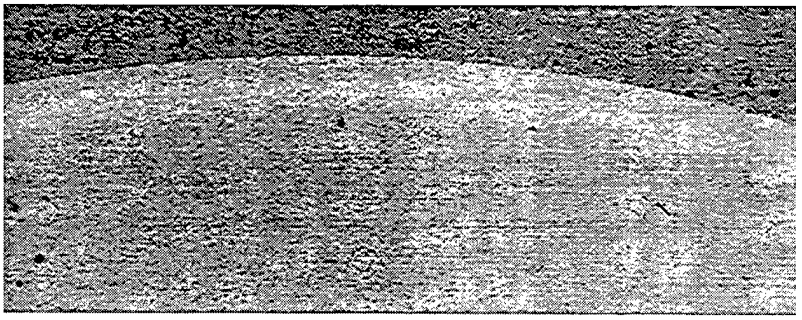
Figure 47. Optical Micrograph of MRC Round 1 Plain Test Balls. *Note lesser amount of white etching layer compared to balls from coated bearing balls, Figure 46.*

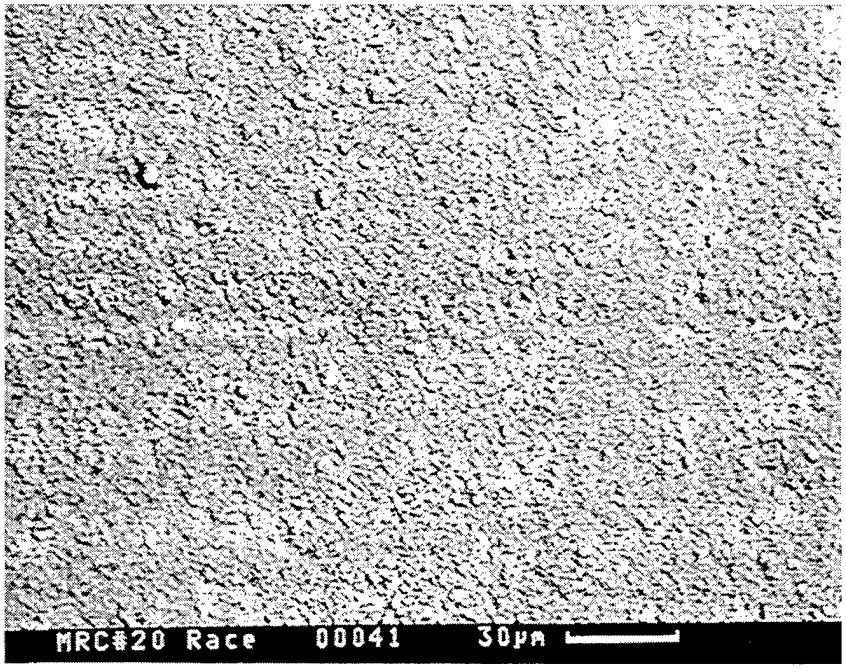
Scanning Electron Microscope inspection of an inner ring GE TDC 20 (**Figures** 48 through 51) indicated that the TDC coating lacked the typical well rounded nodules in the ball track and more importantly contained cracks in the TDC coating on the lands. The cracking is most evident at the 500X magnification and in the Backscatter Electron Imagery (BEI) mode on the SEM. This cracking in the lands led to concerns about how this lot would perform in the corrosion test. The lack of nodularity in the ball track may in fact have contributed to the improved RCF results noted later in this report.

Figure 48. SEM Photo of Bearing Raceway, SEI Mode. *Note lack of nodularity, coating appears somewhat flat.*

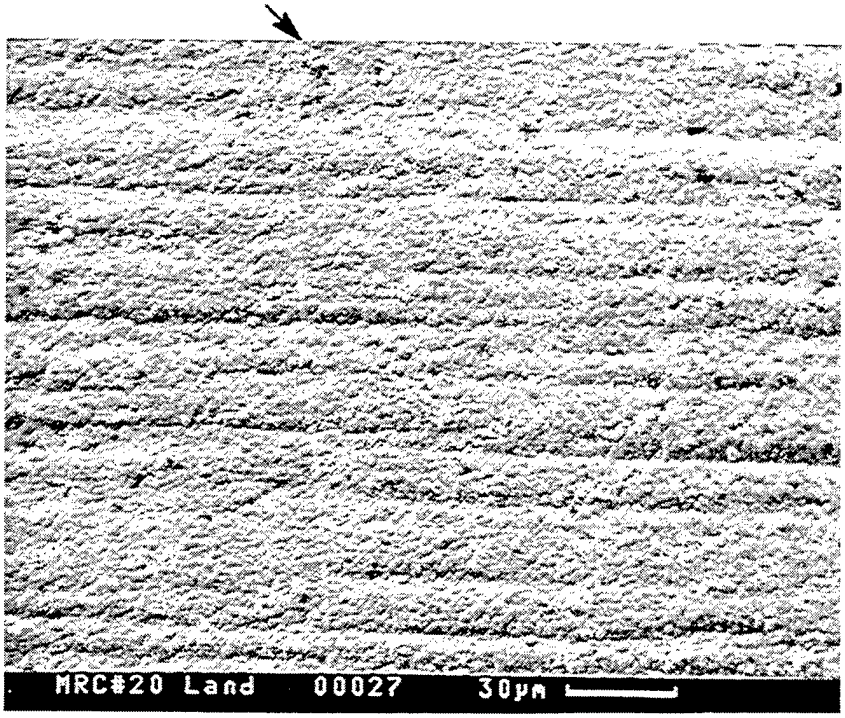
Figure 49. SEM Photo of Bearing Raceway, BEI Mode. *Note lack of typical TDC nodularity.*

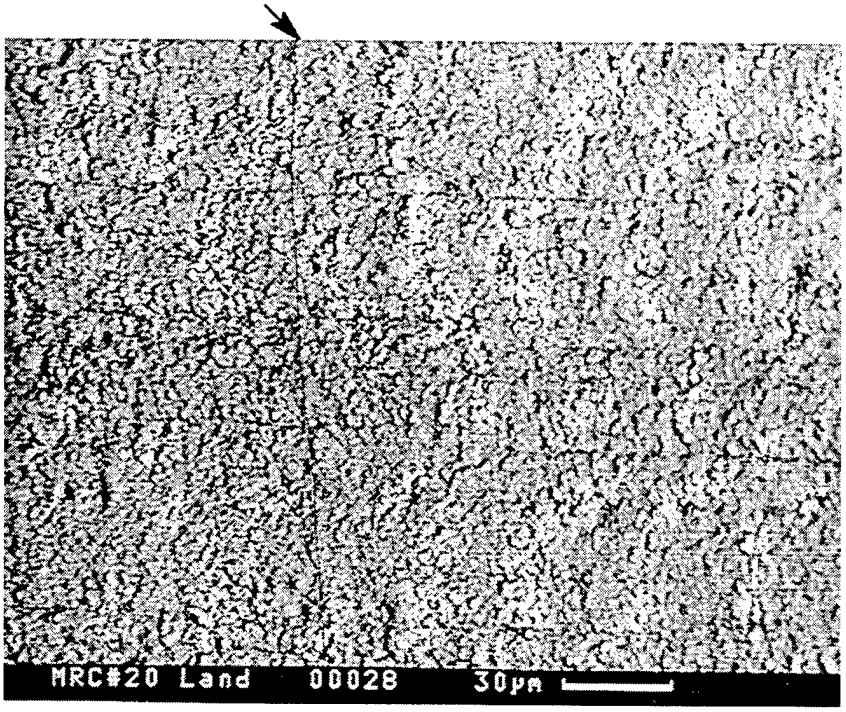
Figure 50. SEM Photo of Bearing Land, SEI Mode.
Note crack in TDC coating.

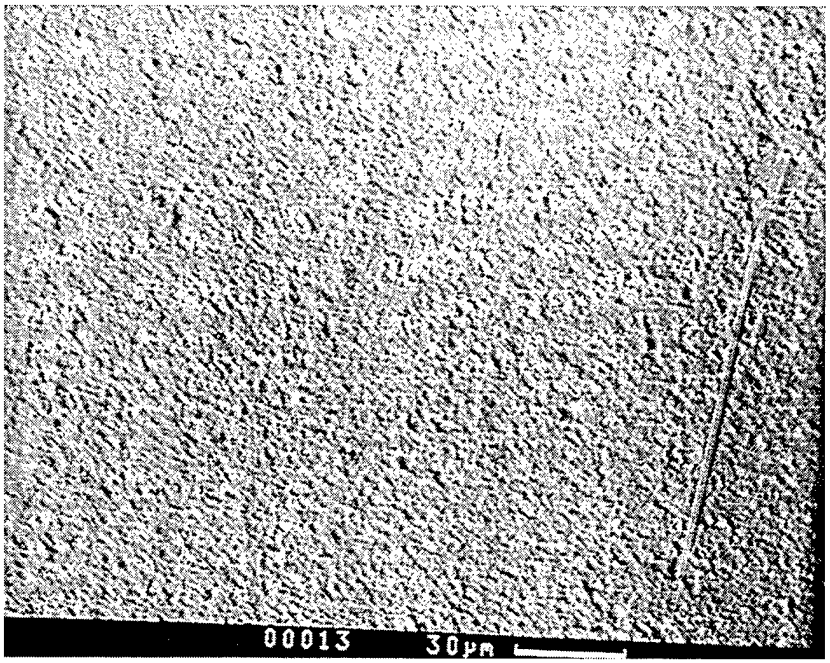
Figure 51. SEM Photo of Bearing Land, BEI Mode.
Note crack in TDC coating.

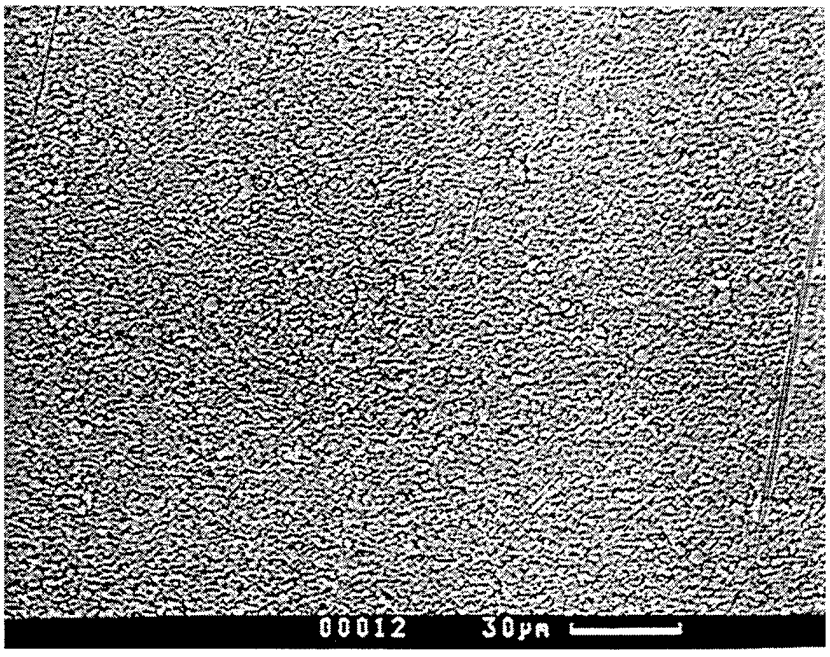
Prior to testing, inner ring GE TDC 31 was evaluated on the SEM to determine if it contained cracks as was seen in S/N 20. **Figures** 52 through 61 show the topography of this bearing. Cracks were evident at the edge of the raceway track and the edge of the land. Upon completion of the 24–hour salt spray testing, numerous rust spots appeared on this specimen (**Figure** 62) and it was deemed to have failed this test. This result was also confirmed with inner race GE TDC 18. It contained a similar amount of corrosion after a salt spray test. The amount of corrosion in Round 2 was considerably greater than that exhibited in Round 1. Test results are in Appendix B.

Figure 52. SEM Photo of Center of Bearing Raceway, SEI Mode.
Note lack of nodularity.

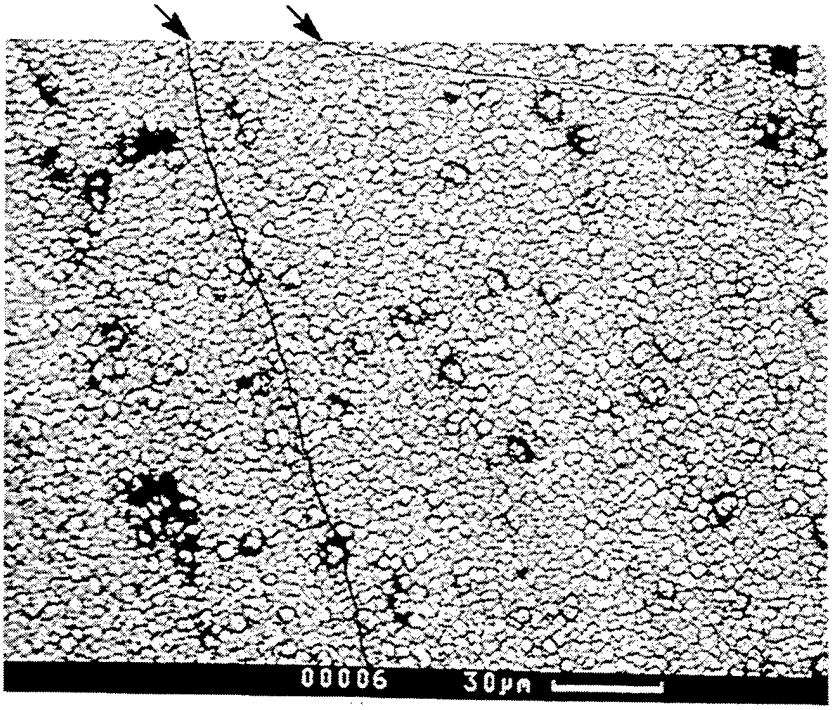
Figure 53. SEM Photo of Center of Bearing Raceway, BEI Mode.
Coating is intact in this area.

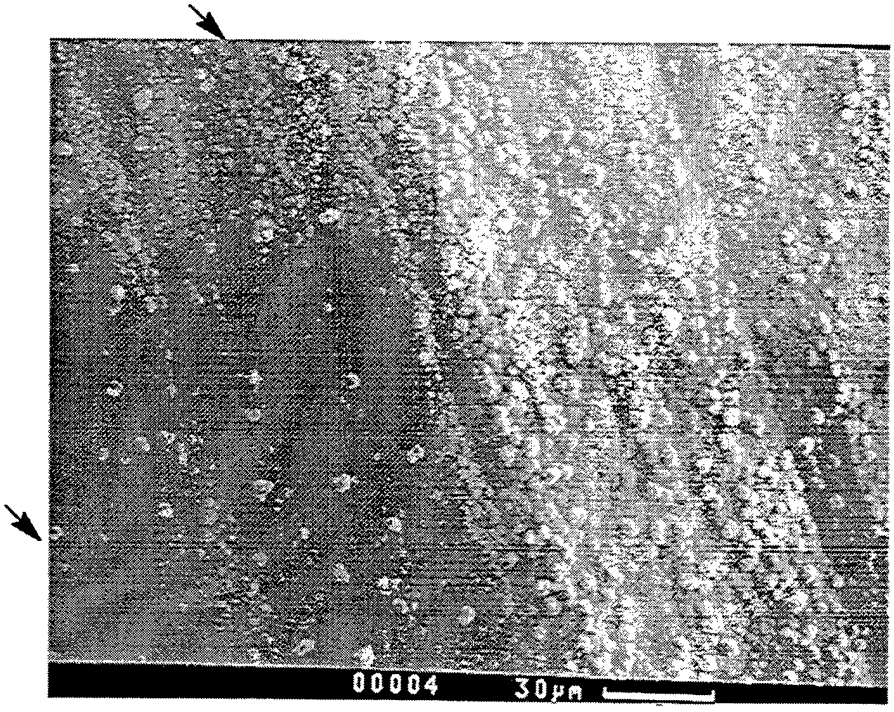
Figure 54. SEM Photo of Edge of Bearing Raceway Track, BEI Mode.
Note cracks.

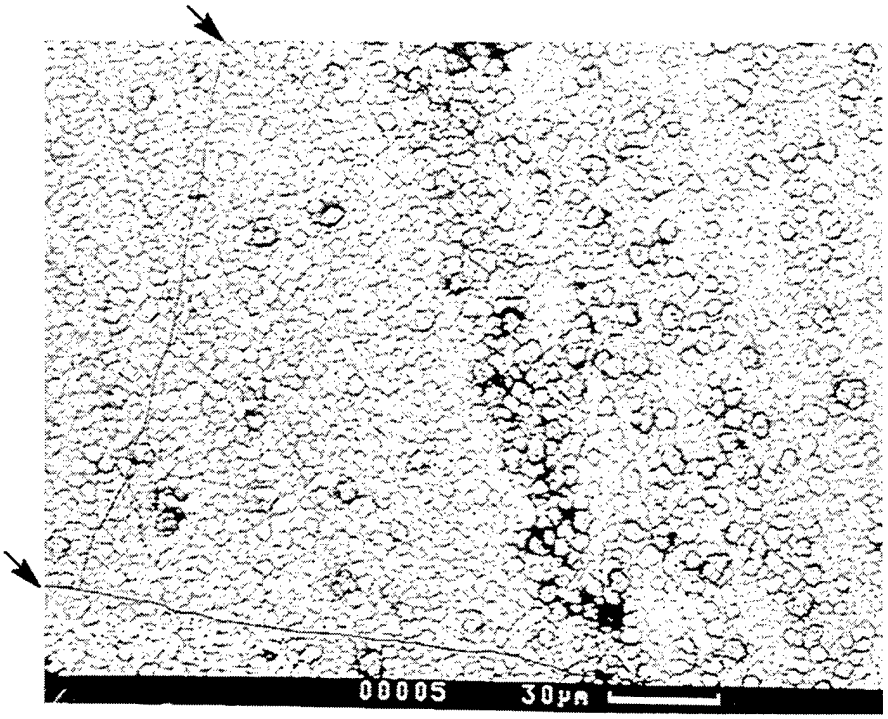
Figure 55. SEM Photo of Edge of Land No. 1, SEI Mode.
Note chrome clusters and cracks.

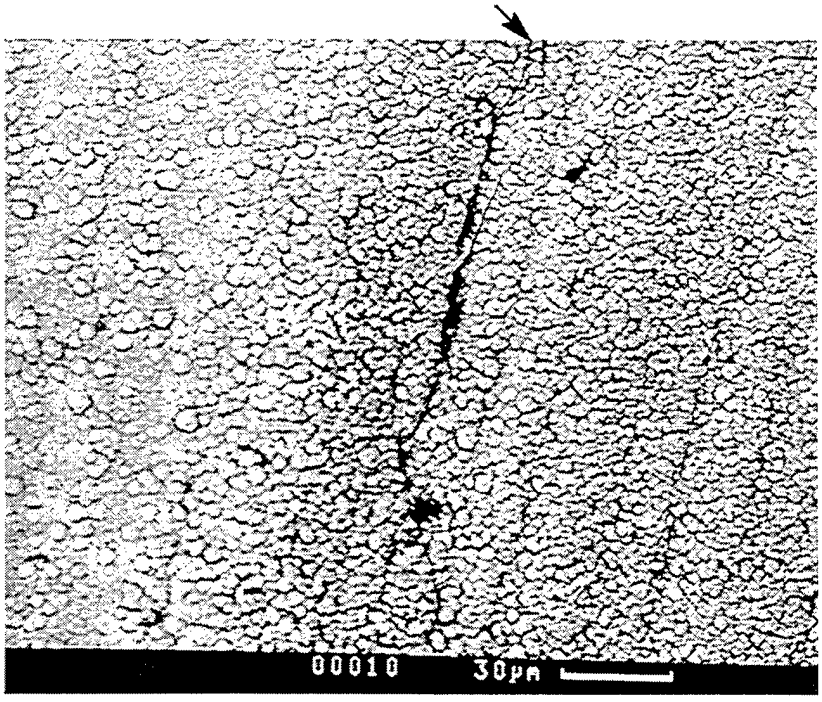
Figure 56. SEM Photo of Edge of Land No. 1, BEI Mode.
Note crack in same area as Figure 55 highlighted in BEI mode.

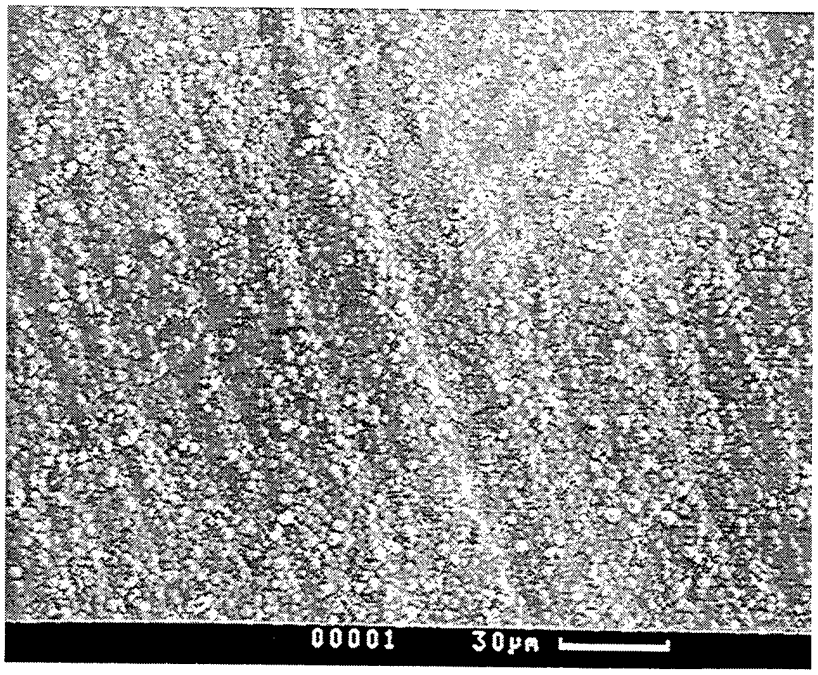
Figure 57. SEM Photo of Edge of Land No. 2, BEI Mode.
Note crack.

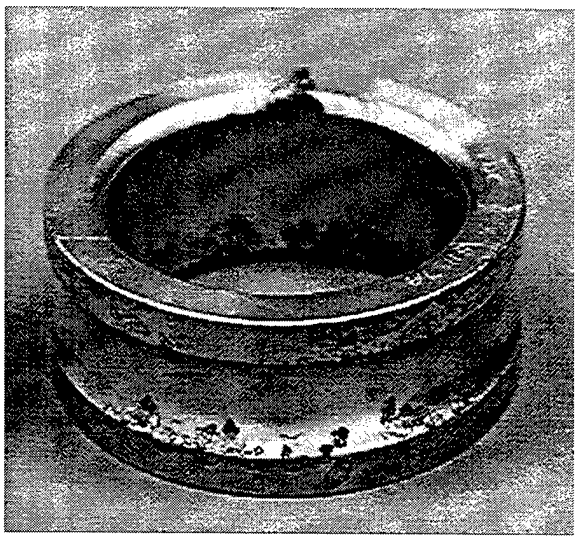
Figure 62. Photo of GE TDC 31 Inner Ring Corrosion after Salt Spray Test. *Note large amount of rust.*

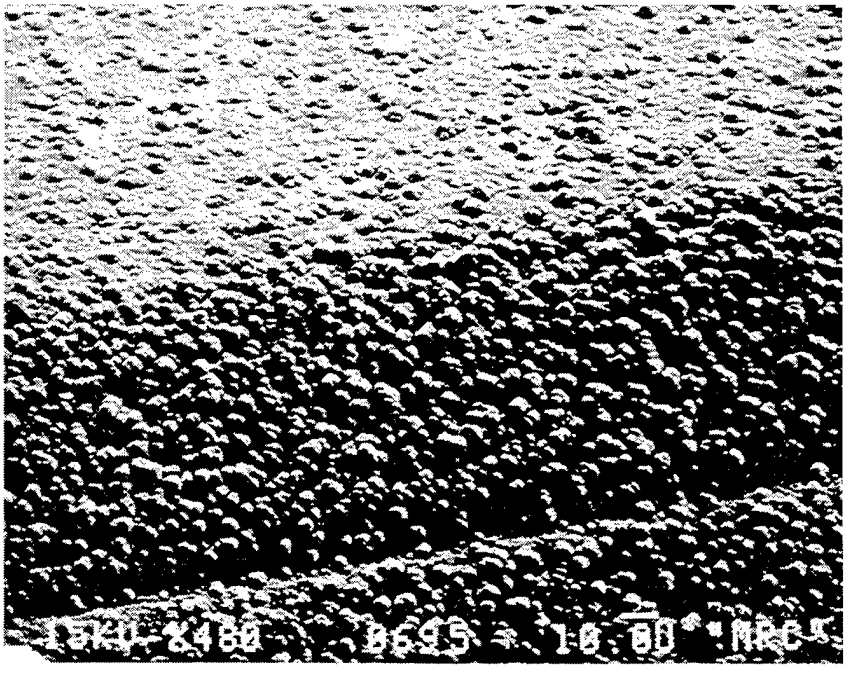
Figure 63. SEM Photo of Raceway, 0°. *Note lack of nodularity.*

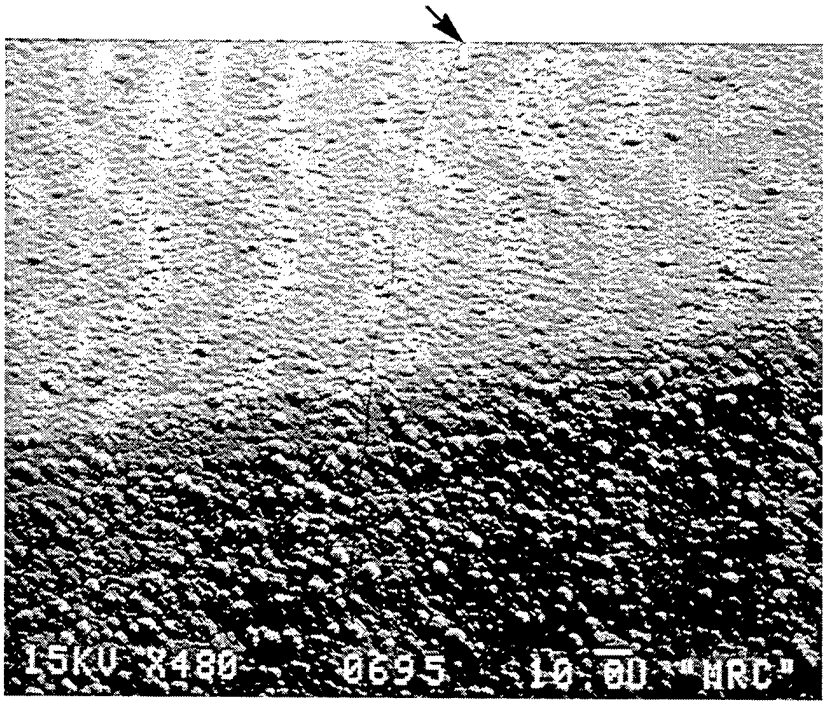
Figure 65. SEM Photo of Raceway, 90°. *Note lack of nodularity.*

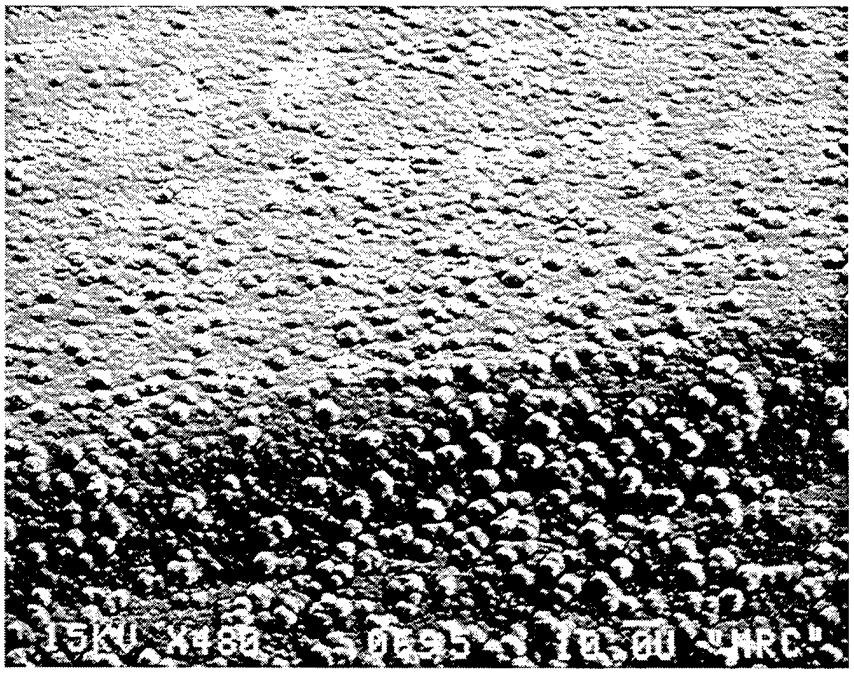
Figure 67. SEM Photo of Raceway, 180°. *Note lack of nodularity.*

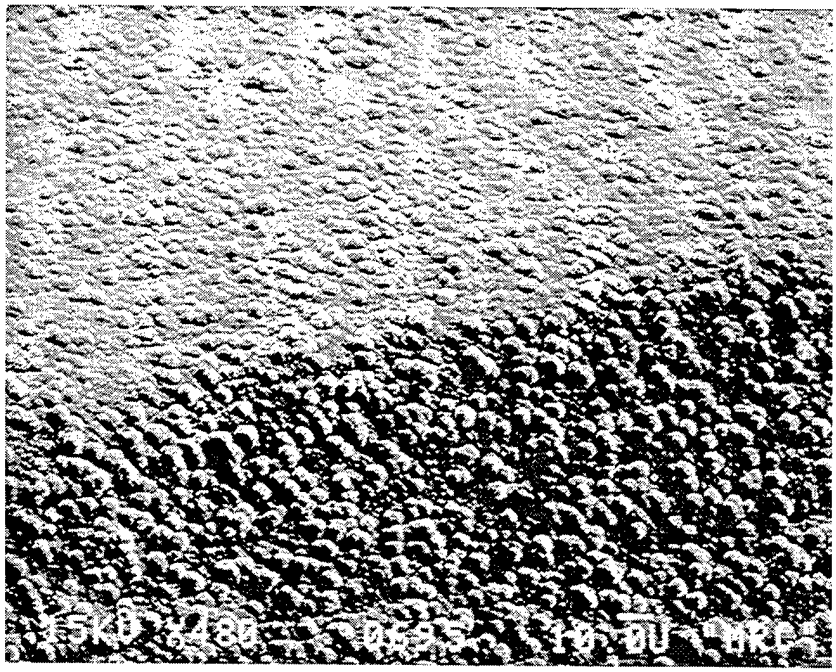
Figure 69. SEM Photo of Raceway, 270°. *Note lack of nodularity.*

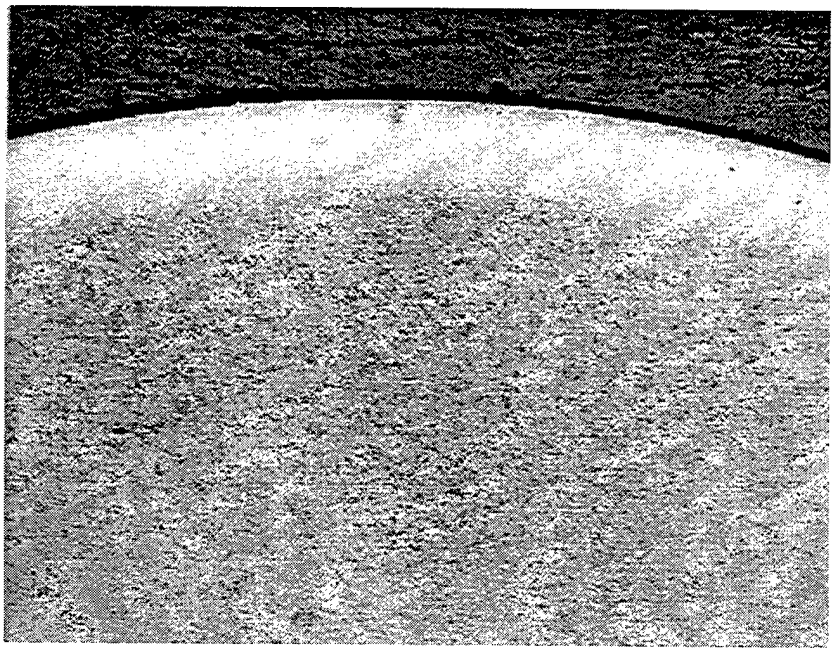
Figure 71. Subsurface Stress Induced Microstructural Alteration (White Layer) in Ball from Round 2/Test 1. *The layer covered the entire ball indicating the ball was spinning.*

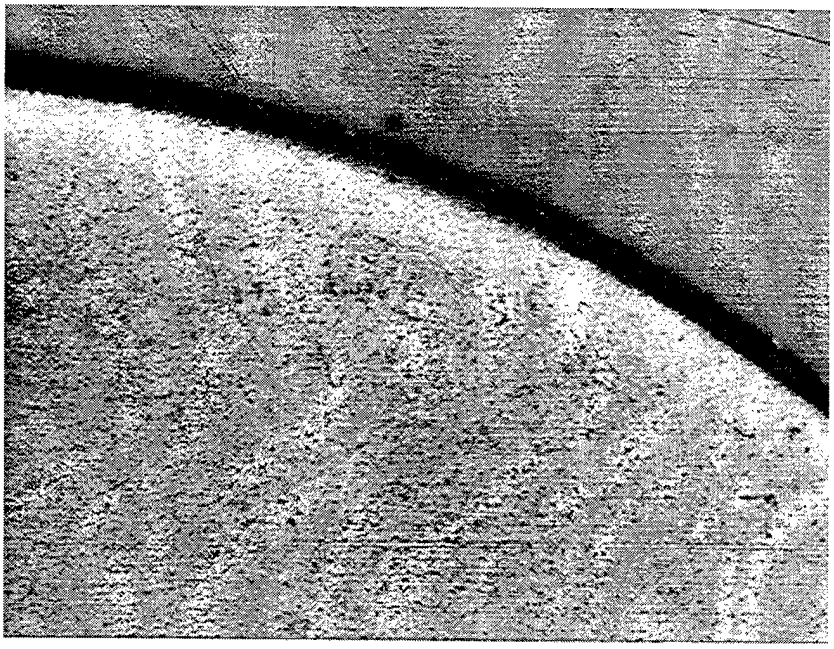
Figure 72. Subsurface Stress Induced Microstructural Alteration (White Layer) in Ball from Round 2/Test 4. *The layer covered the entire ball indicating the ball was spinning.*

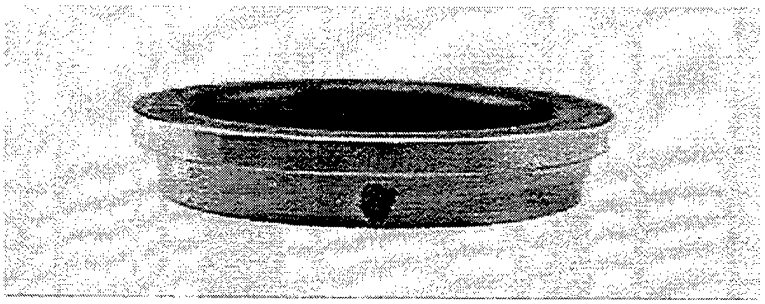
Two baseline (bare M50) failures occurred, one at 620 hours and the other at 4,030 hours. Five TDC coated bearings failed at 41, 225, 1,825, 2,293, and 2,710 hours. All failures were inner ring spalls. The estimated L10 calculation for the population based on this experiment was 2,943 hours for the baseline bearings and 519 hours for the TDC coated bearings. The TDC coated bearings L10 life clearly appeared inferior in RCF to the unplated baseline bearings. **Figures** 89 through 95 show both the failed baseline and TDC coated inner rings from this round of testing.

Figure 89. Photo of Plain Bearing Spall Which Failed at 619 Hours.
Only plain bearing to fail within 2,500 hours.

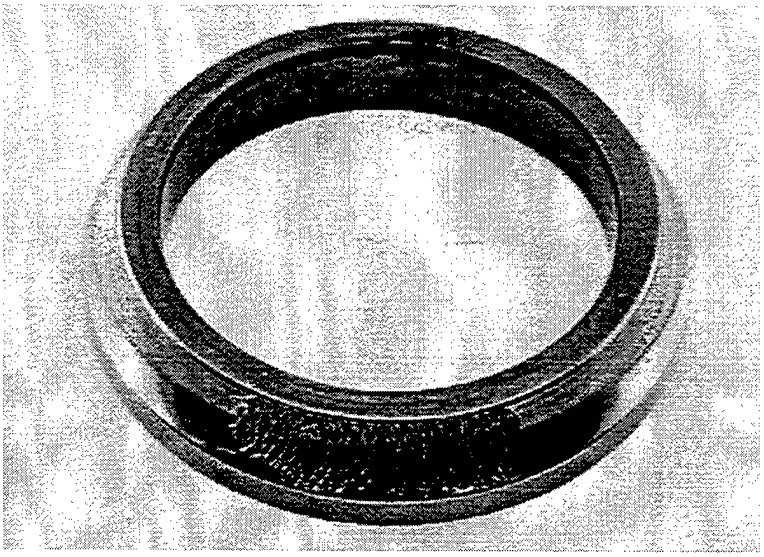
Figure 90. Photo of Plain Bearing Spall Which Failed at 4,030 Hours.

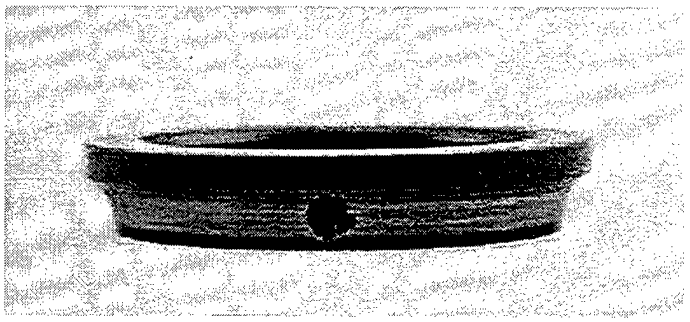
Figure 91. Photo of TDC Coated Bearing Spall Which Failed at 41 Hours.
One of five failures.

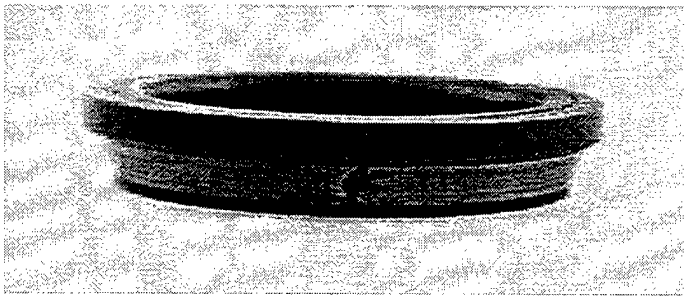
Figure 92. Photo of TDC Coated Bearing Spall Which Failed at 1,825 Hours.
One of five failures.

Surface roughness measurements of the inner race ball track indicated its preplate roughness was approximately 2.0 μin, while its roughness postplating was on the order of 4–5 μin. This corresponded to an initial Lambda around 1.2 to 1.8 for the plain bearings, and around 0.7 for the TDC coated bearing. As in the MRC bearings, this explains why the ball track in the plain bearings was so difficult to see, while they are quite easily found in the TDC coated bearings. Again, it is generally accepted that the fatigue life difference between a bearing with a Lambda of less than 1.0 and one in which it is greater than 1.5 can be very substantial, since the low Lambda ratio bearing is much more prone to surface distress which can lead to early fatigue.

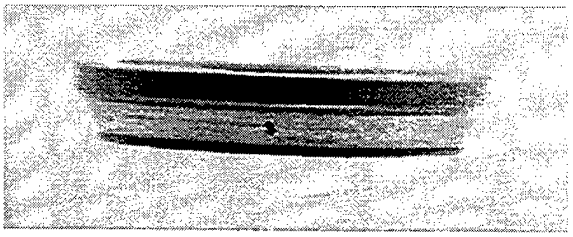
Figure 93. Photo of TDC Coated Bearing Spall Which Failed at 225 Hours.
One of five failures.

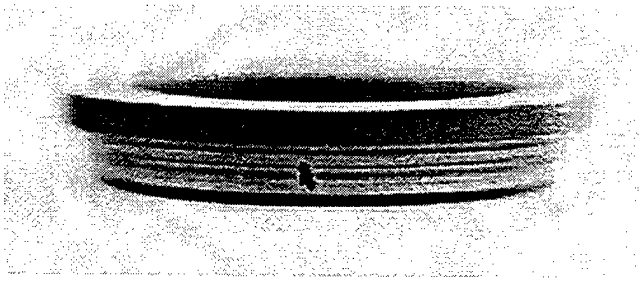
Figure 94. Photo of TDC Coated Bearing Spall Which Failed at 2,710 Hours.
Only TDC failure over 2,500 hours.

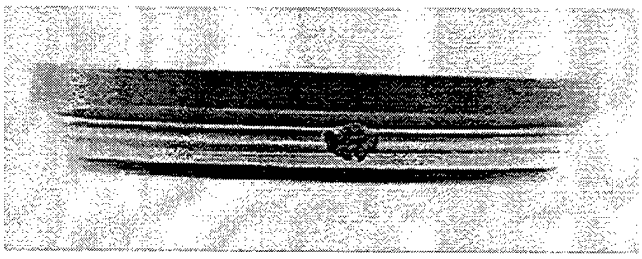
Figure 95. Photo of TDC Coated Bearing Spall Which Failed at 2,293 Hours.
One of five failures. Note easy to see ball track. The L10 of the TDC coated bearing was 1/6th that of the bare bearings.

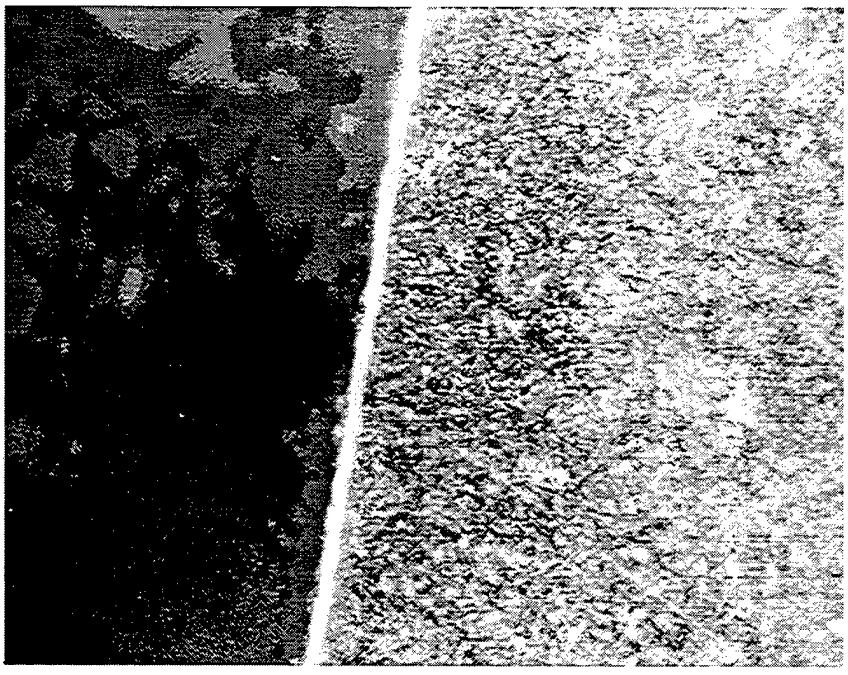
Figure 98. Optical Photomicrograph of Shoulder (Area 2) 125 μin TDC Thickness. *Within specification.*

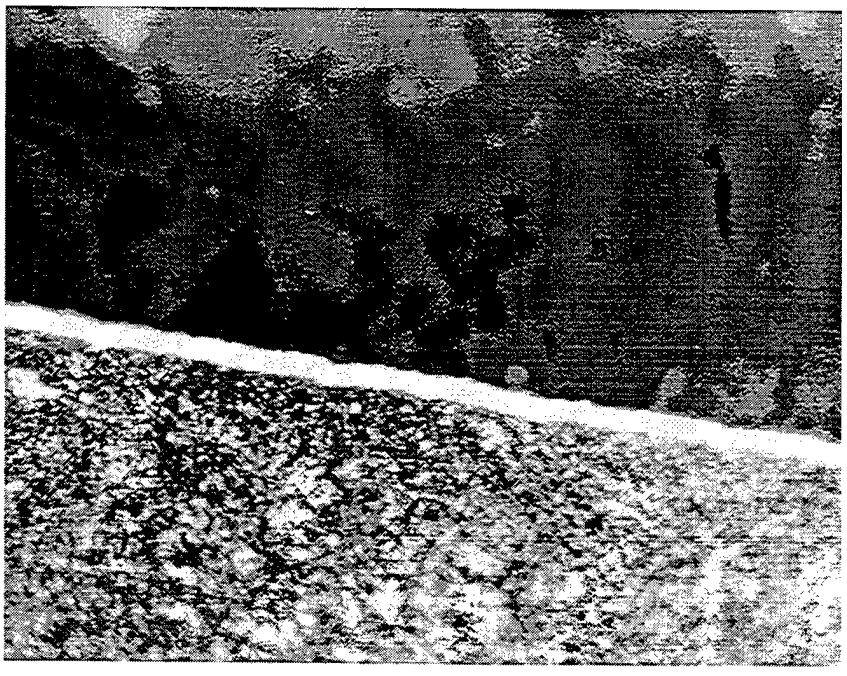
Figure 100. Optical Photomicrograph of Bore Corner (Area 4) 150 μin TDC Thickness.
Within specification.
