WL-TR-97-2053

THIN DENSE CHROME BEARING INSERTION PROGRAM

GE AIRCRAFT ENGINES
ADVANCED ENGINEERING PROGRAMS DEPT
ONE NEUMANN WAY
CINCINNATI OH 45215-6301

FINAL REPORT FOR 03/01/92-12/01/96

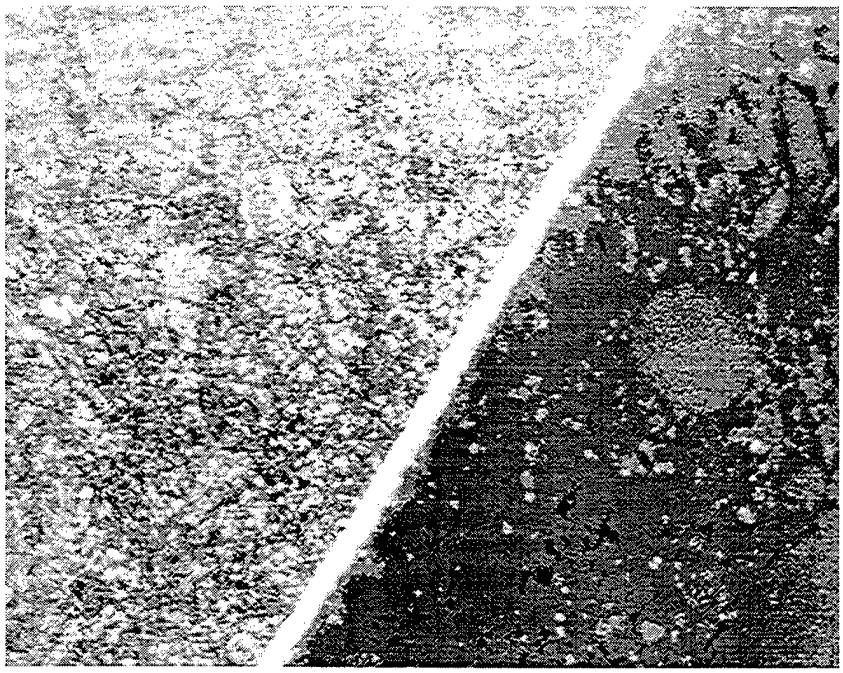
Figure 101. Optical Photomicrograph of Bore (Area 5) 125 μin TDC Thickness.
Within specification.

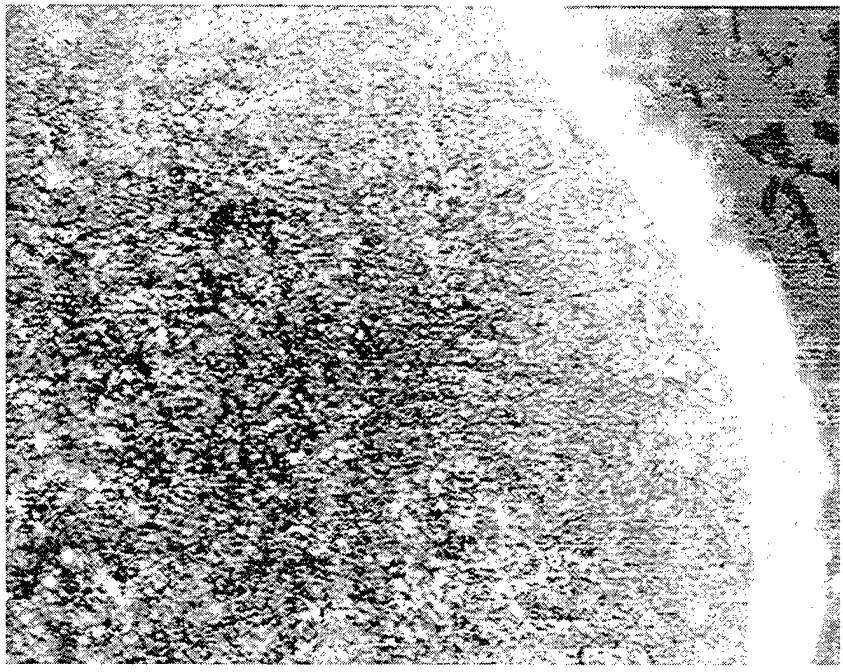
Figure 102. Optical Photomicrograph of Narrow Face (Area 6) 130 μin TDC Thickness. *Within specification.*

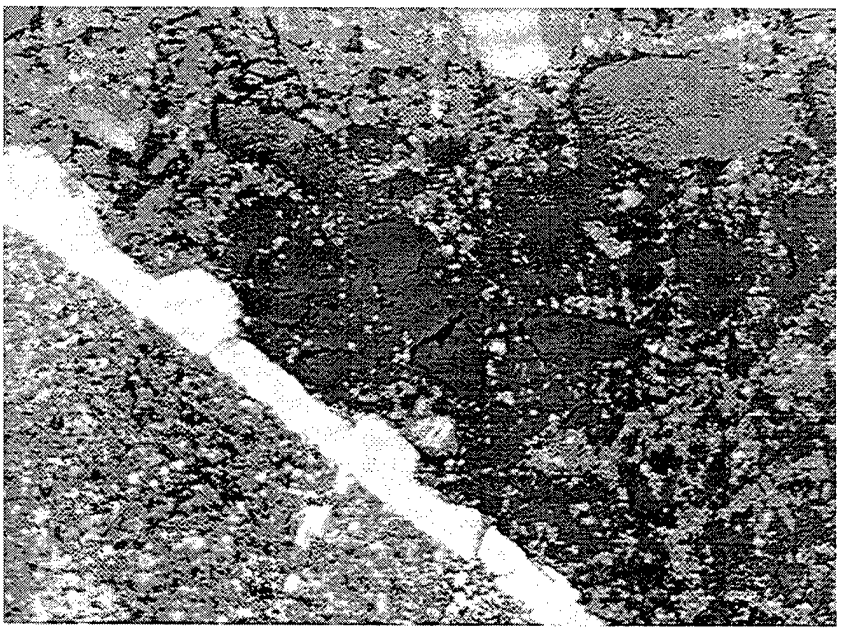
Figures 96 through 104 show the TDC coatings of these seven areas. Note that area number seven, the bore corner, contained TDC with a thickness of 380μin, which is greater than the 250μin maximum allowed in the GE Specification. Examination of **Figure** 104 also shows what appears to be microcracks running through the TDC coating. This condition is not evident in the thinner coating areas.

Figure 103. Optical Photomicrograph of Bore Corner (Area 7) 380 μin TDC Thickness. *Above specification maximum of 250 μin.*

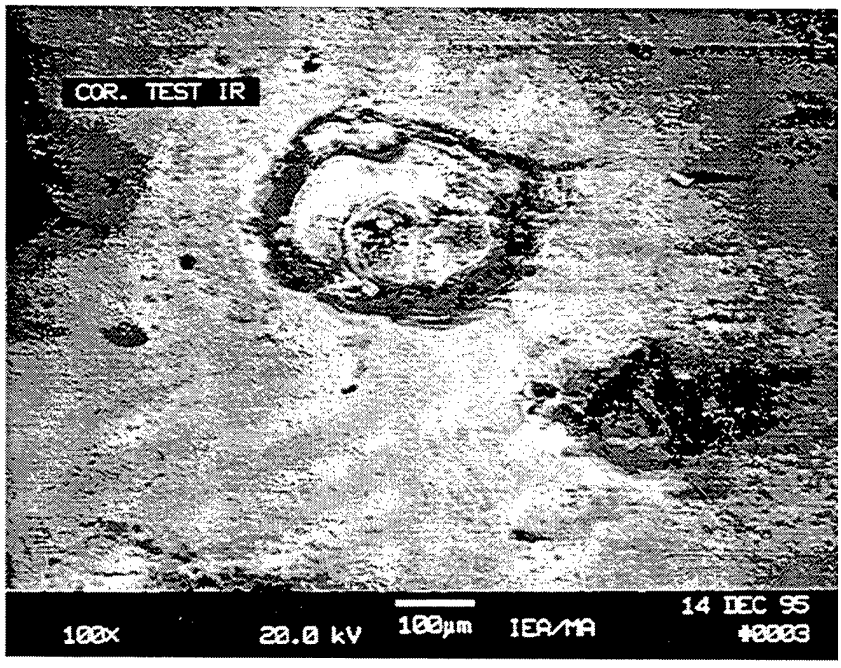
Corrosion testing was performed by Dirats Laboratories. The test ring exhibited isolated areas of rust spots after the 24–hour salt spray test. Additional testing was performed using an acidified copper sulfate to determine the presence of exposed iron. Areas of the bore to abutting face chamfer (Area 7 in Figure 96) and the shoulder exhibited a copper color after six minutes in the solution, indicating exposed iron. One of the corner areas adjacent to the corroded zone appeared to be delaminated. **Figure** 107 shows the corrosion pits as a result of the salt spray test. Appendix D contains a certification report of this test.

Figure 107. SEM Photomicrographs of Corrosion Test Pits on Bearing Shoulder. *Failed test.*

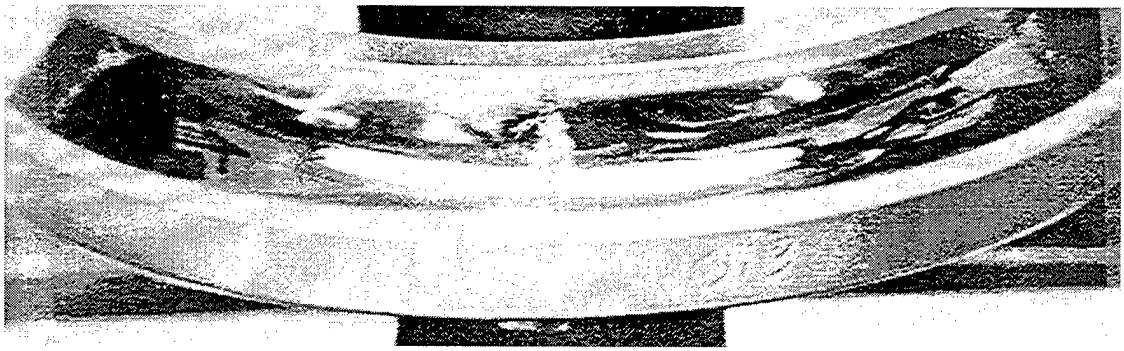
Figures 108 through 112 show the spall failures in the baked TDC plated bearings. SEM examination of the failed bearings revealed that most, if not all, were again surface originated failures. Further examination on the SEM revealed areas just ahead of the spall origination point of distressed TDC, indicated by the white arrows in **Figures** 113 through 115.

Figure 108. Photo of TDC Coated Bearing Spall Failure at 1002.7 Hours. **3.5X**

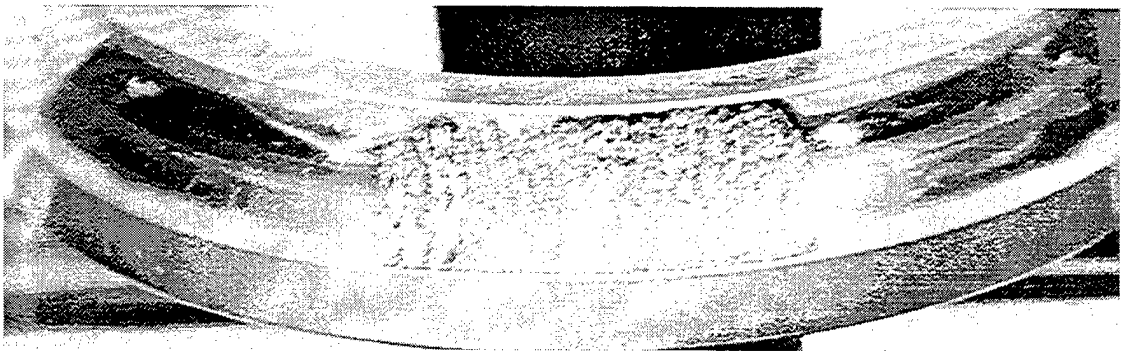
Figure 109. Photo of TDC Coated Bearing Spall Failure at 1193.3 Hours. **3.5X**

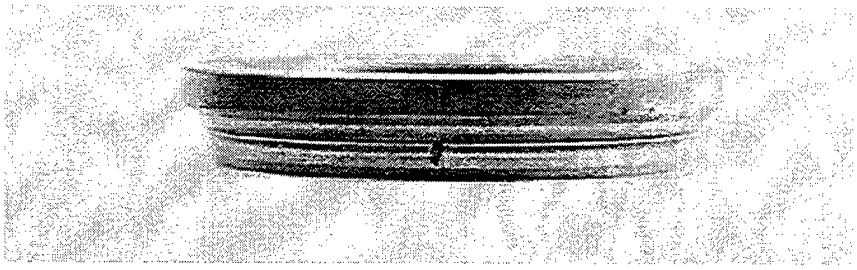
Figure 110. Photo of TDC Coated Bearing Spall Failure at 246.6 Hours.
Bearing had both large and small spalls.

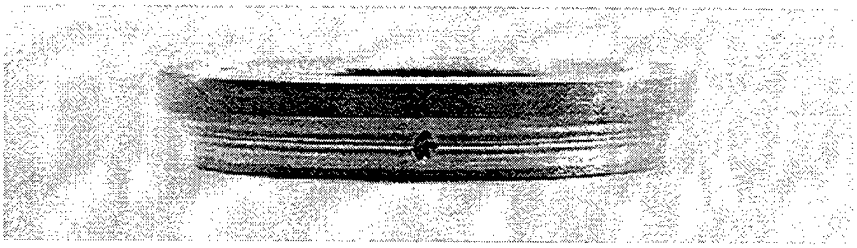
Figure 111. Photo of TDC Coated Bearing Spall Failure at 500.8 Hours.

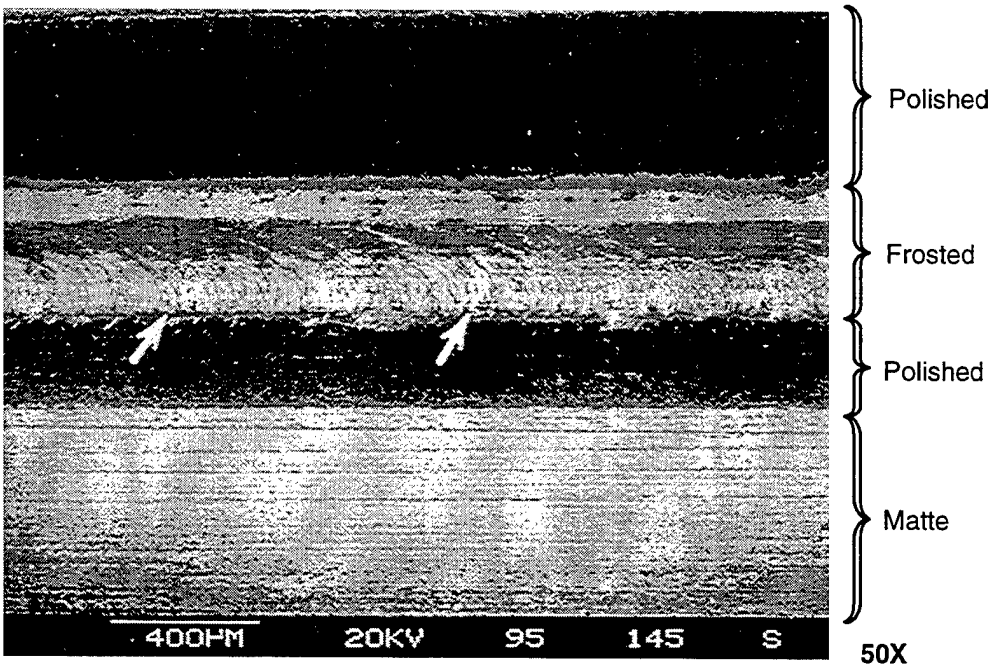
Figure 112. Photo of TDC Coated Bearing Spall Failure at 710 Hours.
The L10 of the TDC coated bearings was approximately 1/6th that of the plain bearings. A major concern exists in the application of TDC in low Lambda regions.

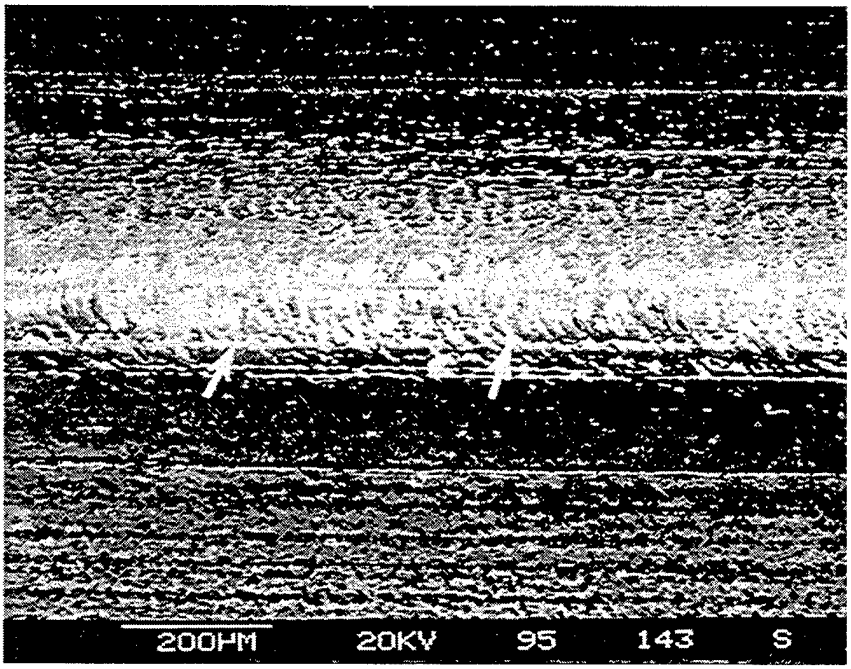
Figure 113. Photomicrograph of Frosted Band in Bearing S/N 0022.
Note distressed TDC from sliding ball in ball track (arrows).

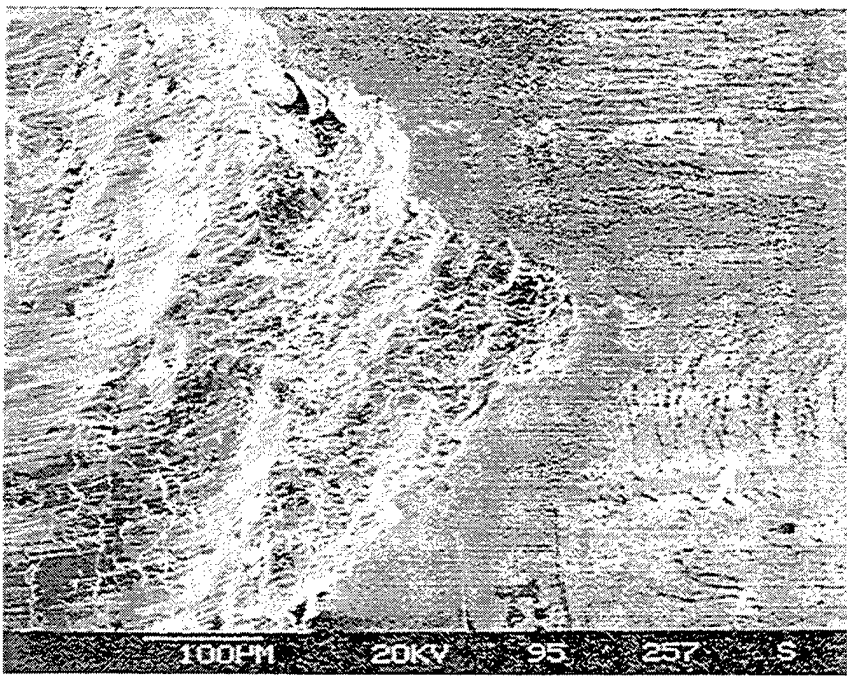
Figure 114. Photomicrograph of Frosted Band in Bearing S/N 0025.
Note sliding type damage in ball track (arrows).

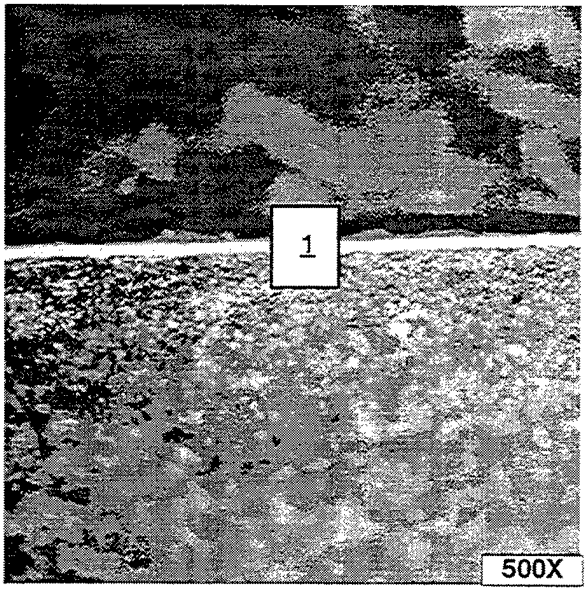
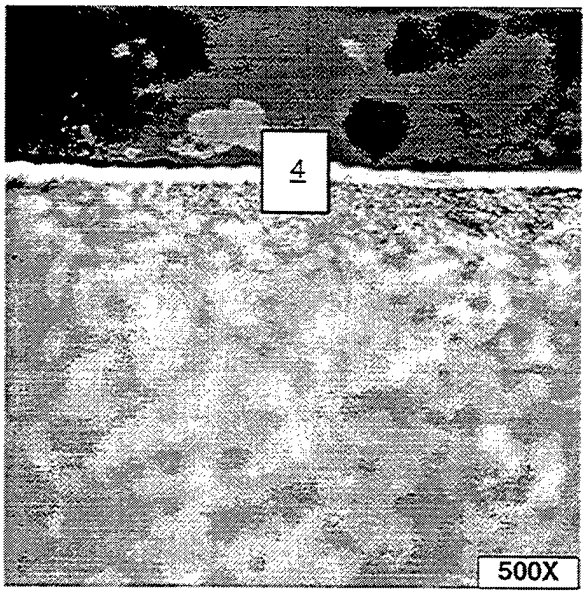
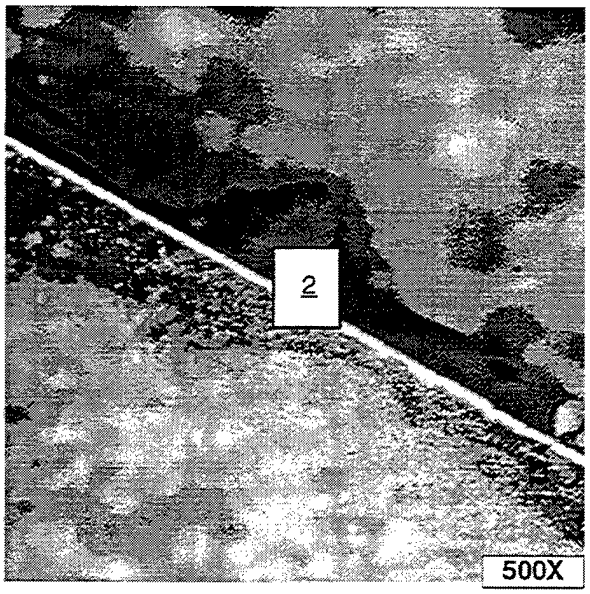
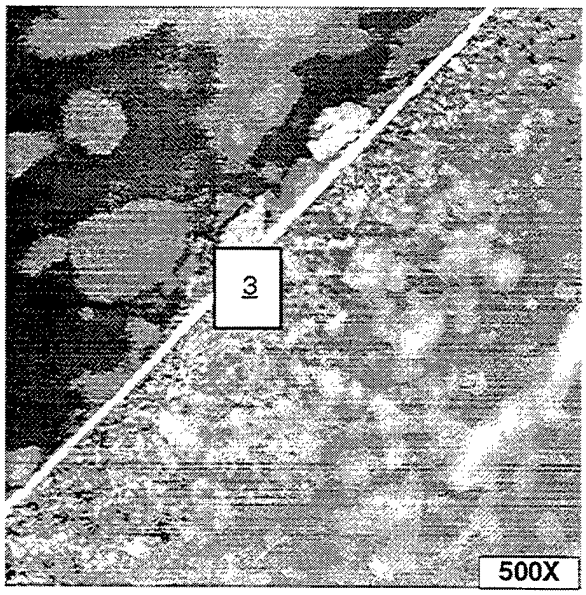
All six bearings successfully completed the required 2,000 hour testing. **Table** 19 summarizes the results of this test. Posttest inspection results indicated that the TDC remained intact in the raceway ball tracks. **Figure** 116 illustrates a typical bearing outer race condition after 2,000 hours of testing. No evidence of TDC coating distress was found on any of the bearings during posttest inspections.

Figure 116. Photos of Bearing S/N MABS9636 After 2,000 Hour Operational Endurance Test.
TDC passed test.

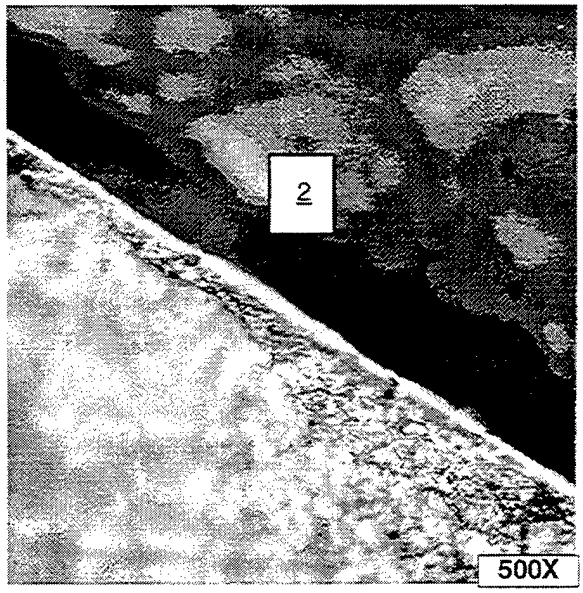
The first test was completed with one TDC coated and one plain M50NiL bearing. Testing was stopped after 96.9 hours due to outer race spalling of the plain bearing. **Figure** 117 is a photograph of the outer race spalling. Condition of the TDC coated bearing was acceptable as illustrated in **Figure** 118.

Figure 118. Photo of Contamination Tested TDC Bearing.
TDC coated bearings demonstrated superior contamination resistance.

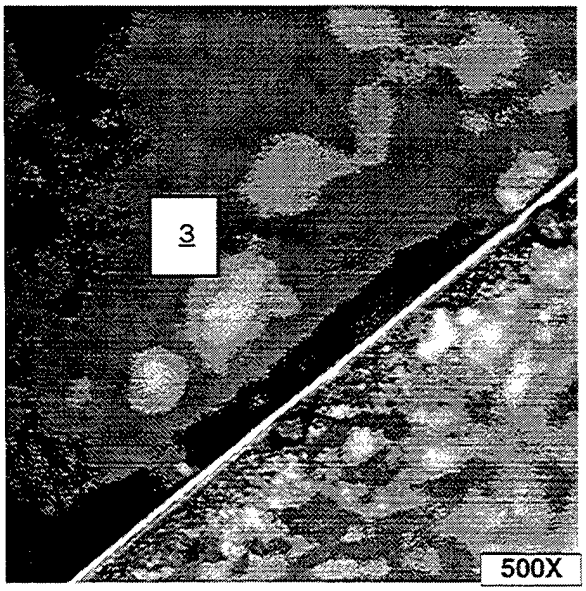
The second test was completed with two TDC coated M50 bearings. Both bearings successfully completed the required 1,000 hours of testing. Posttest inspection indicated that the TDC remained intact on both bearings. **Figure** 119 illustrates the acceptable condition of the TDC coating after test.

Figure 119. Photos of Contamination Tested TDC Bearing S/N MDACE705 After 1,000 Hours.
TDC coating integrity demonstrated in contained environment.

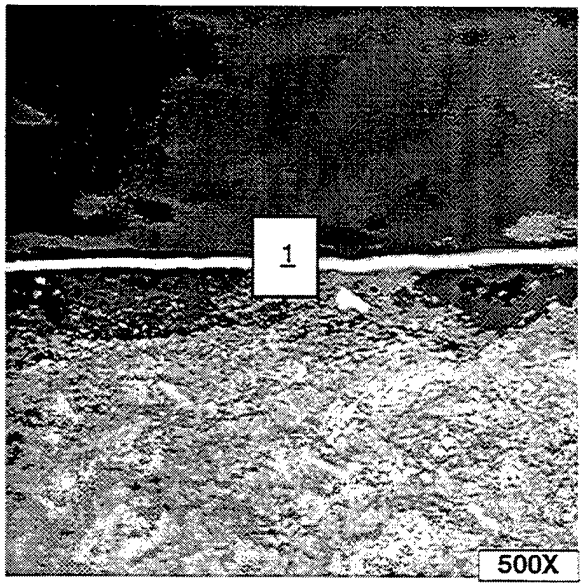
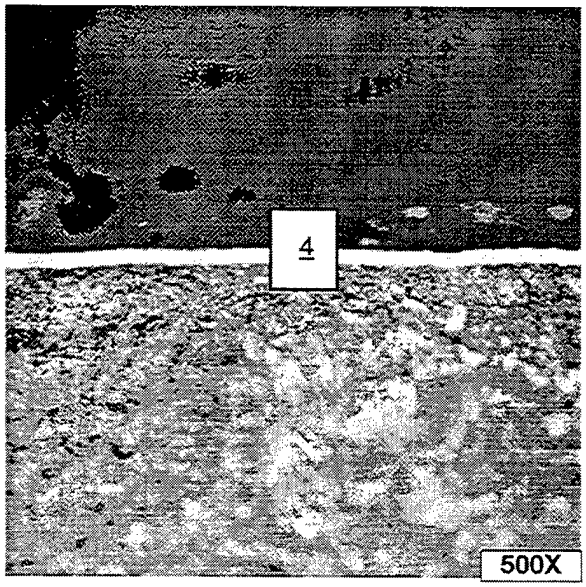
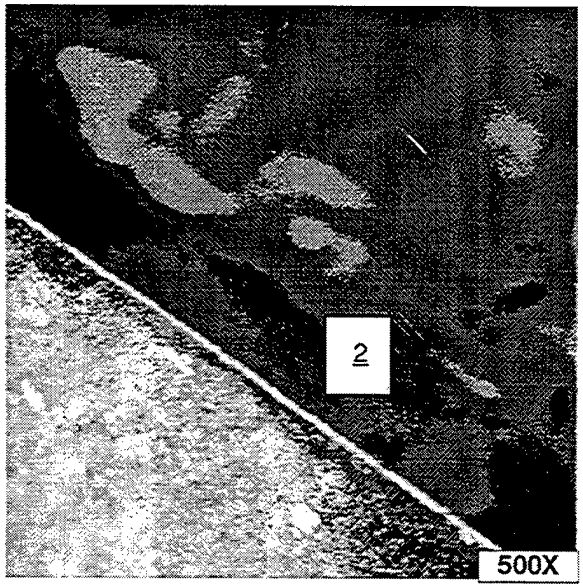
The TDC coating successfully adhered to the base material and did not demonstrate any evidence of distress resulting from oil–off testing. **Figure** 121 is a photograph of a typical TDC coated bearing outer race after testing, illustrating the acceptable condition of the coating.

Figure 121. Photos of Off–Oil Tested TDC Bearing S/N MDACE694.
TDC coating demonstrated acceptable off–oil performance.

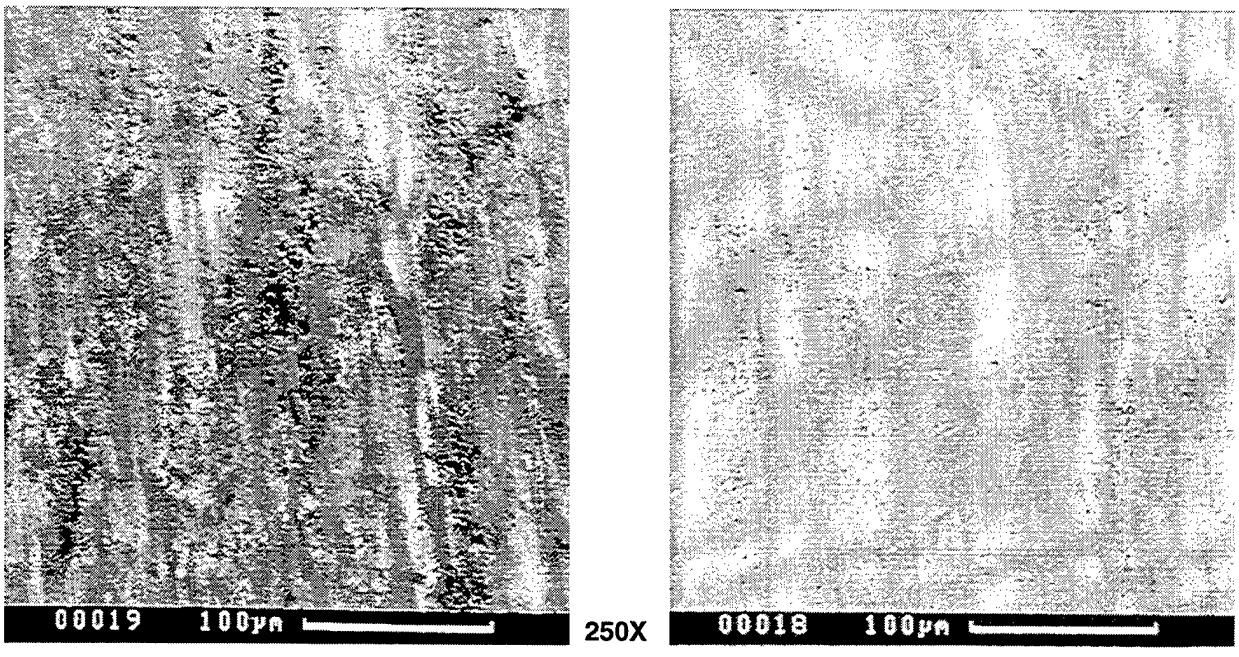
Figure 122. Microphotograph of Skid Damaged Inner Race TDC on Bearing S/N MDACE700. *Light colored areas in the left image highlight the smeared M50 from the balls. Dark areas in the right image indicate partial TDC pull out.*

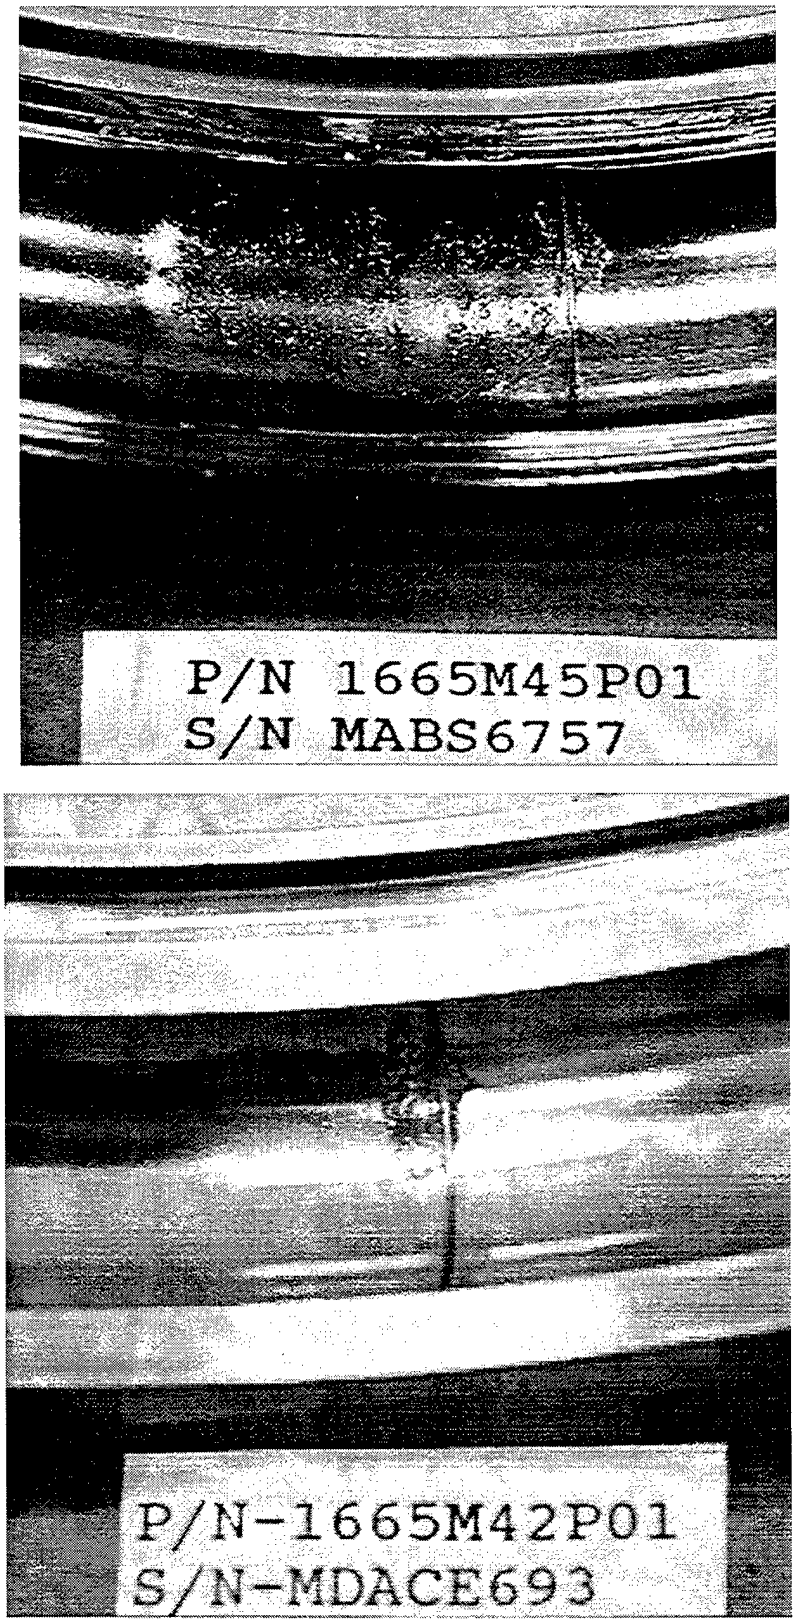
Figures 125 and 126 illustrate the raceway conditions of each bearing after testing. Comparing the postdefect operational damage of the plain bearings (**Figure** 125) with the TDC coated bearings (**Figure** 126) indicates less damage on the TDC coated bearings.

Figure 126. Photos of TDC Coated Bearing Race Damage Evident after Induced Defect Test.
Note reduced level of damage compared to plain bearings Figure 125.

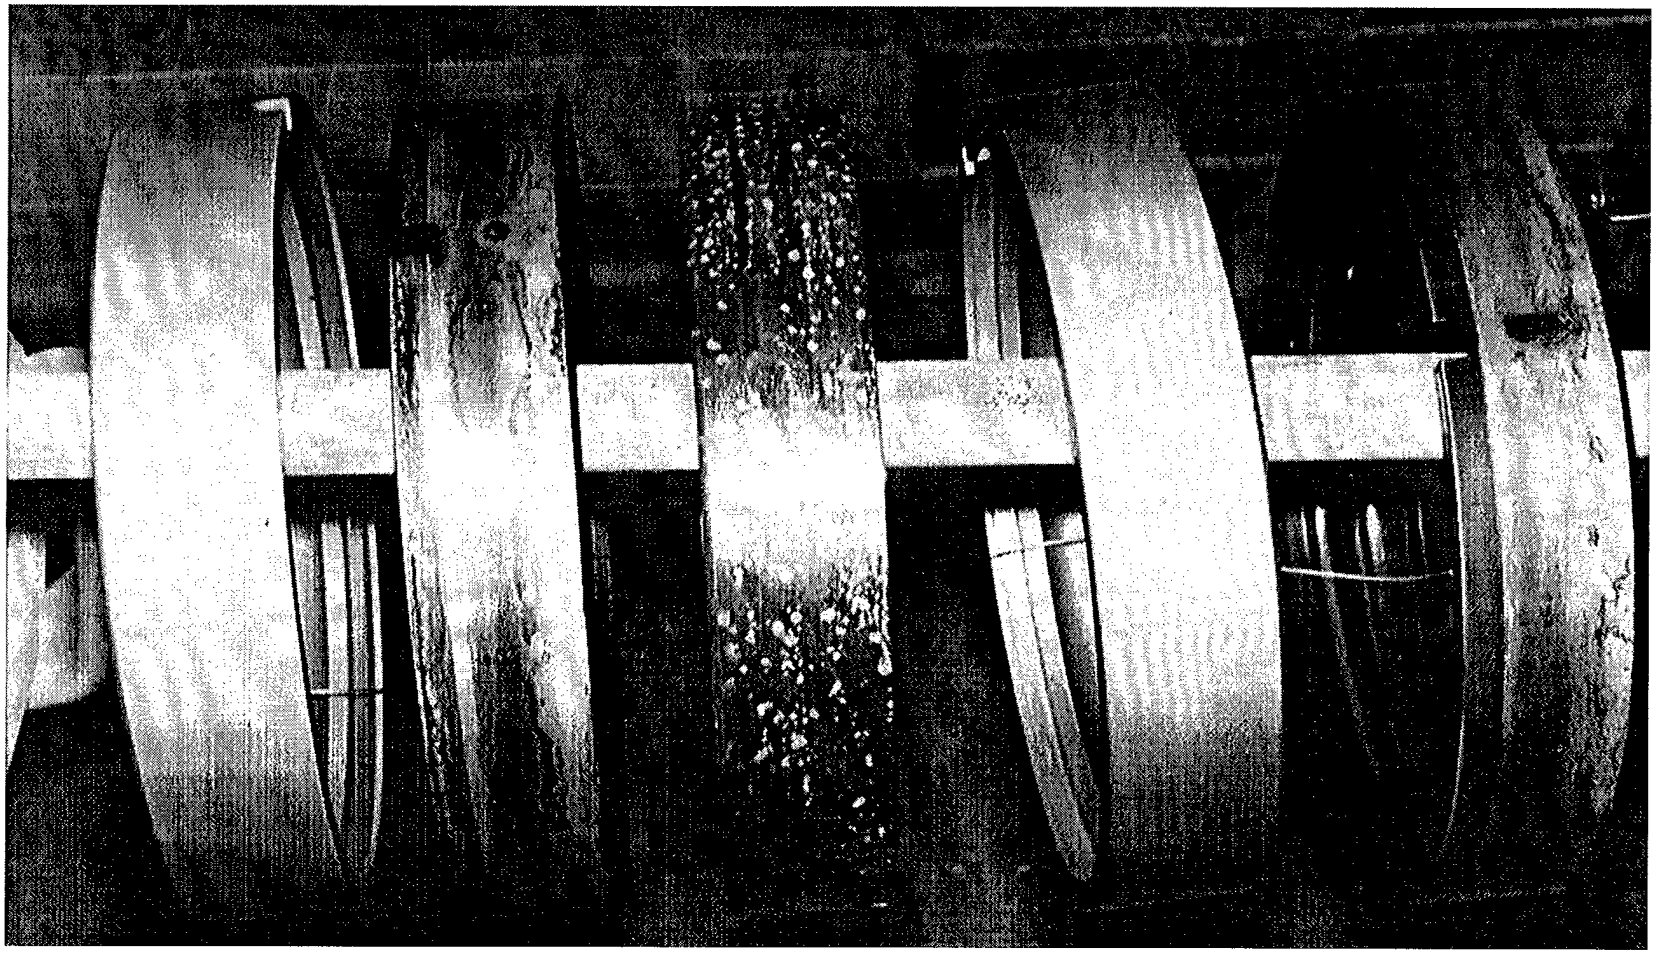
Table 25. Corrosion Resistance Test Results.

OUTER RACE SERIAL NUMBER	RACE MATERIAL/ COATING	PART HISTORY	TEST RESULTS
SNR00173	M50	New Part	Extensive Corrosion
MDA605JV	M50	Induced Defect Tested	Extensive Corrosion
MDACE697	M50/TDC	Thermal Cycle Tested	4 Corrosion Pits on Face
MABS9632	M50/TDC	Op. Endurance Tested	No Corrosion
MABS6867	M50NiL/TDC	Op. Endurance Tested	No Corrosion
X097	M50NiL/TDC	New Part	No Corrosion

Figure 127. Photos of Corrosion Resistance Test Bearings.
TDC coating significantly improved corrosion resistance.

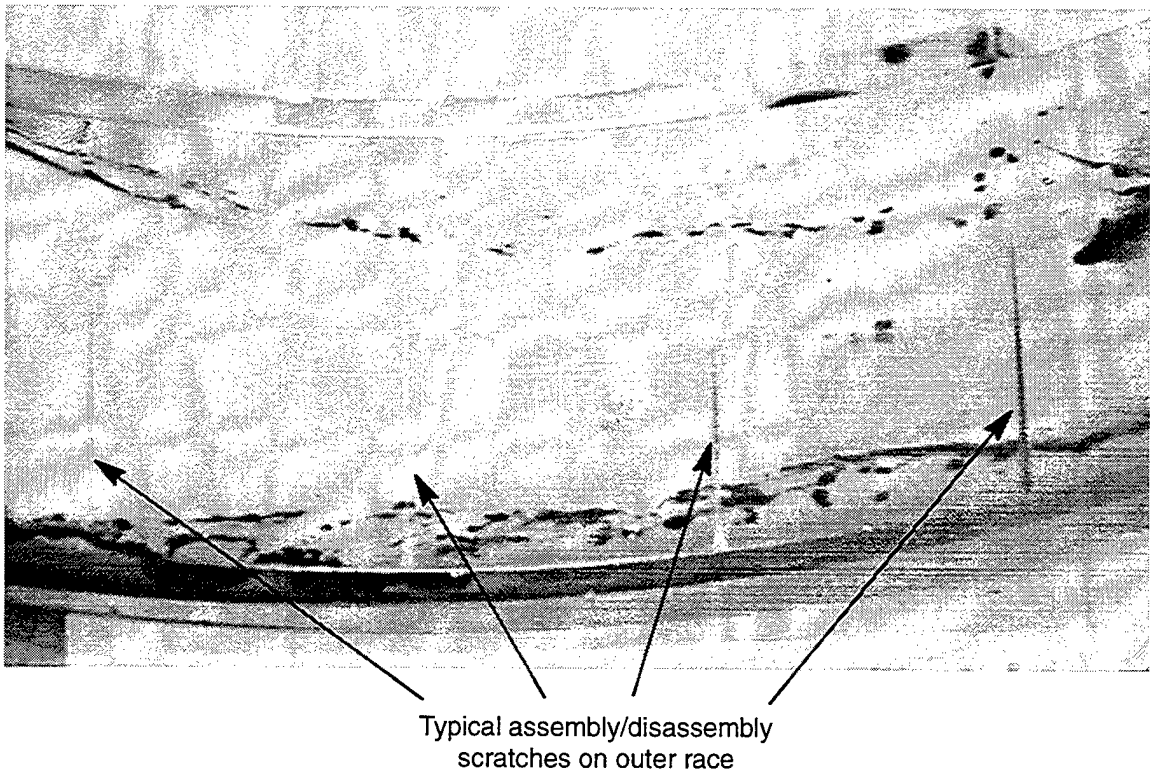
TDC coating of the No. 4R bearing was not recommended due to the increased susceptibility to assembly damage.

Figure 129. Photo of F110 No. 4R Bearing Outer Race TDC Coating Assembly Damage.

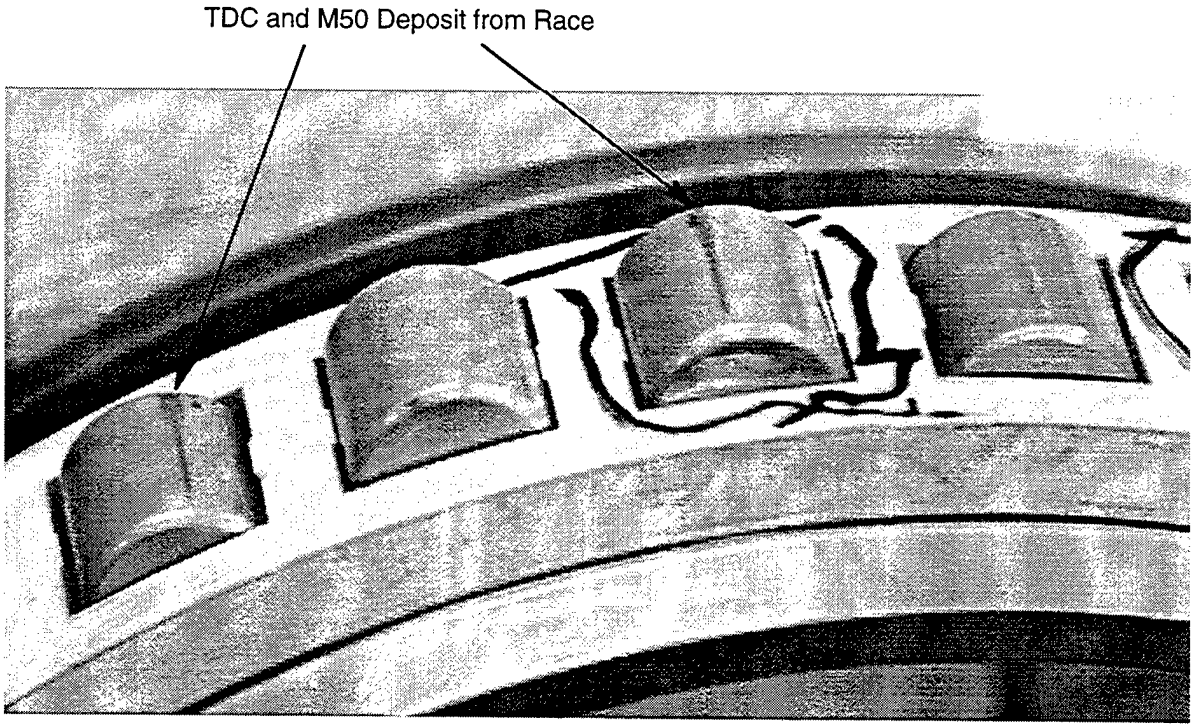
Figure 130. Photo of Assembly Damage to Roller TDC Coating.

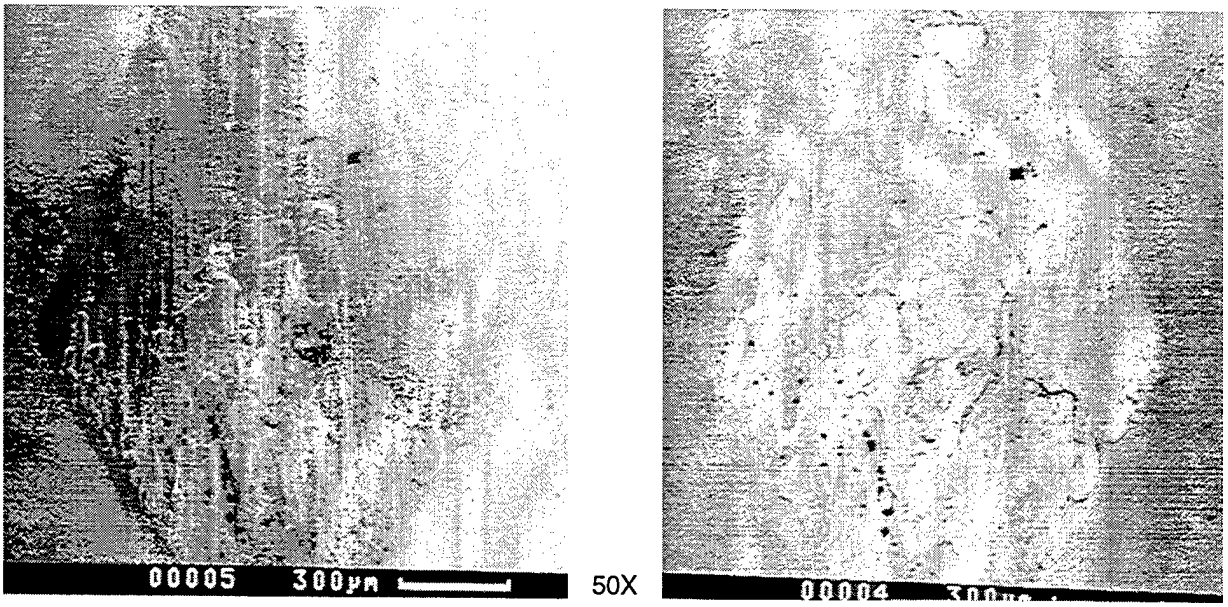
Figure 131. SEM Secondary and Backscatter Photos of Roller Assembly Damage.
Smeared areas indicate M50 material deposited from the race.

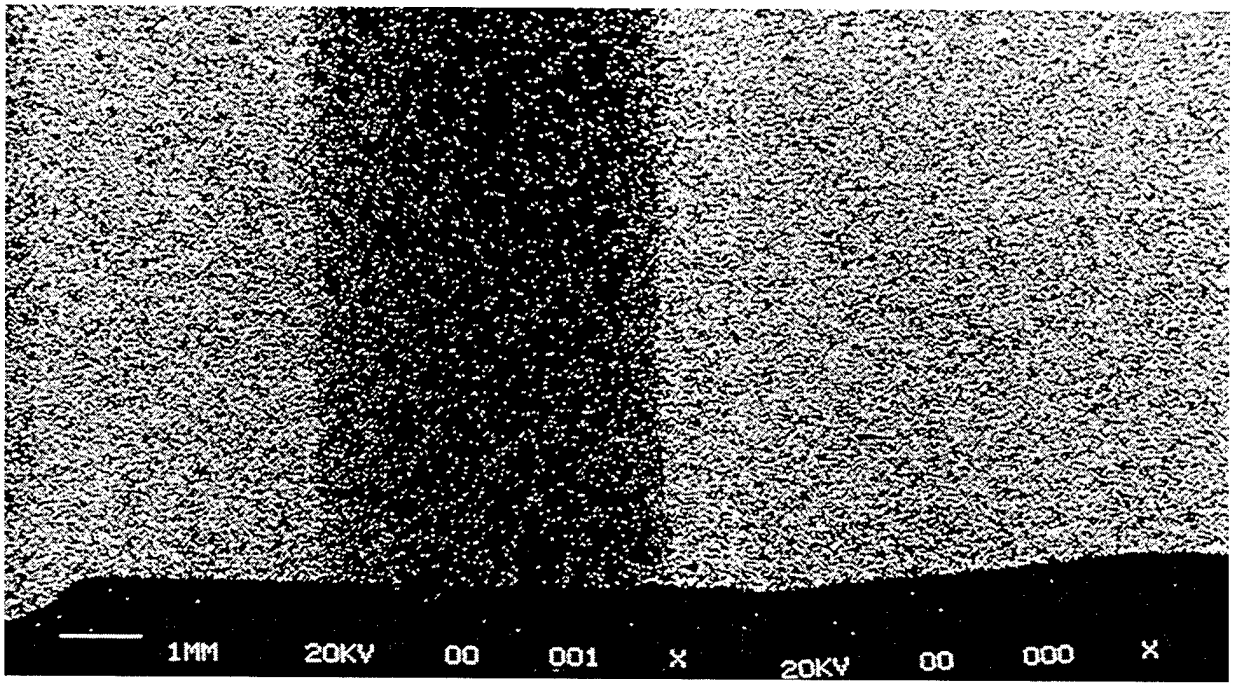
Table 26 summarizes the accumulated test results for the TDC bearings on F110–GE–129 ESN 538–103/4. Bearing inspection results indicated that the No. 1R, 2B, and 4R bearings were in acceptable condition based on in–service engine inspection criteria. The No. 3B and 5R bearing conditions were not acceptable.

The No. 3B bearing experienced skid damage which resulted in removal of the TDC in the skid affected area of the race and spalling of one ball. **Figure** 132 is an energy dispersive spectroscopy dot map of the raceway ball track looking for chromium. TDC had been removed as indicted by the dark band in this photograph. **Figure** 133 is a SEM photograph of the spalled ball. Spalling originated at the surface, probably as a result of the skidding action which damaged the TDC coated race.

Figure 132. Energy Dispersive Spectroscopy of F110–GE–129 ESN 538–103/4 No. 3 Bearing. *Dark band in the center of the dot map indicated the TDC has peeled away. TDC coating is susceptible to operational skid damage.*

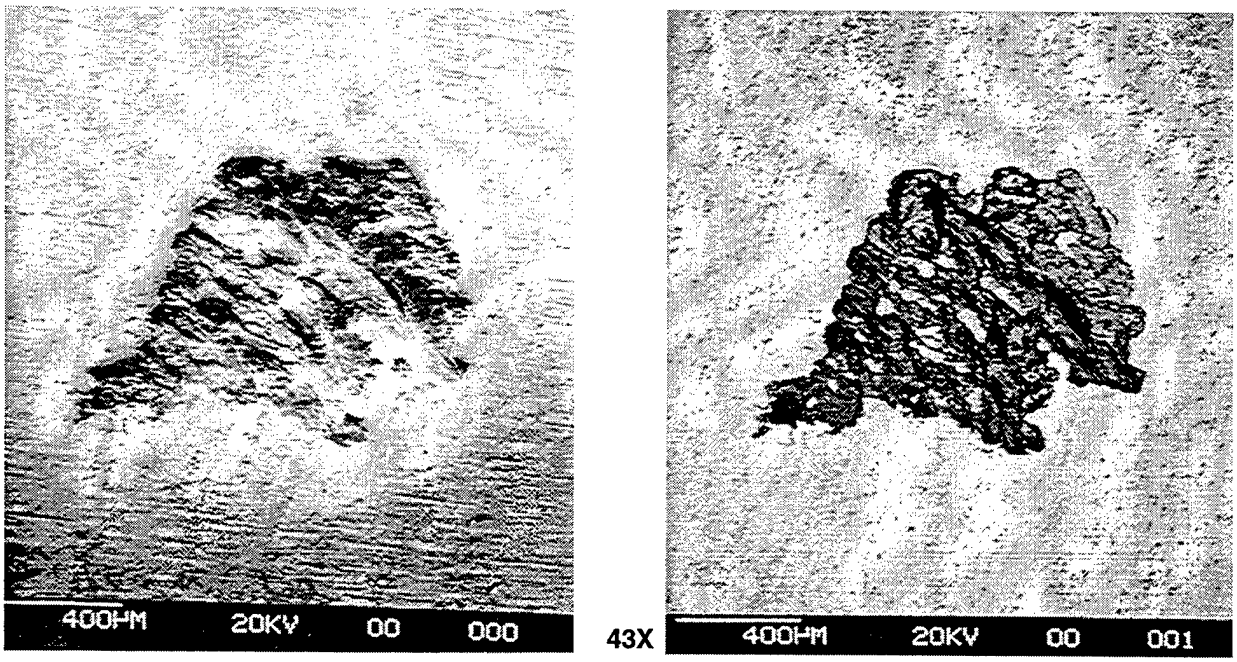
Figure 133. SEM Secondary and Backscatter Photos of Ball Spall. *Skid damaged TDC coating initiated ball spalling in test of ESN 538–103/4 bearing.*

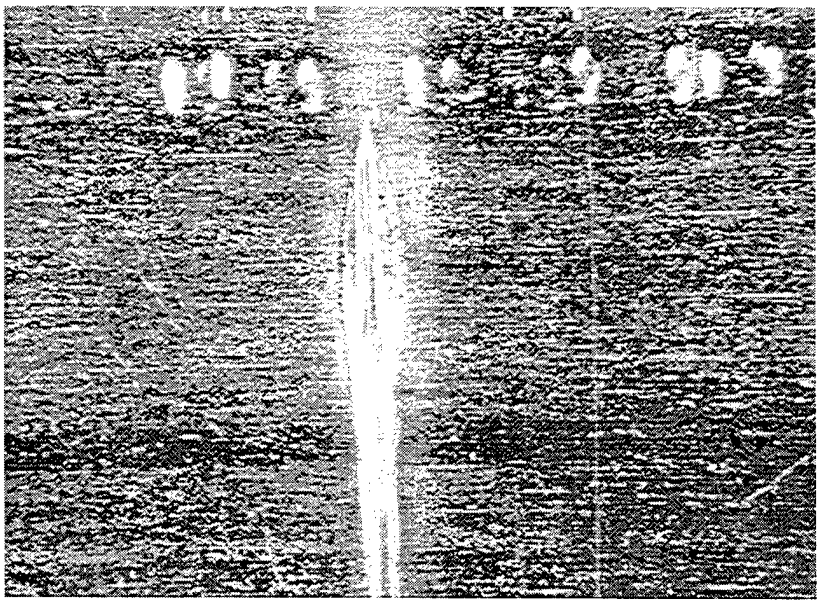
Routine inspection of the No. 1R bearing after 449 hours of engine testing indicated several deep axial scratches on the inner race. In addition, the inner race had a circumferential ring of dents which are aligned with the edge of the scratches and localized partial TDC peeling adjacent to some dents.

The axial scratches breech the TDC coating and extend into the base M50 material. These scratches were caused by damage during engine assembly when the TDC coated rollers axially slide against the TDC coated race. The circumferential ring of dents was probably caused by raised material on the rollers (transferred from race). Localized TDC peeling was considered secondary damage due to continued operational forces at the edges of the dents. **Figure** 135 is a photograph of a typical axial scratch and the adjacent dents.

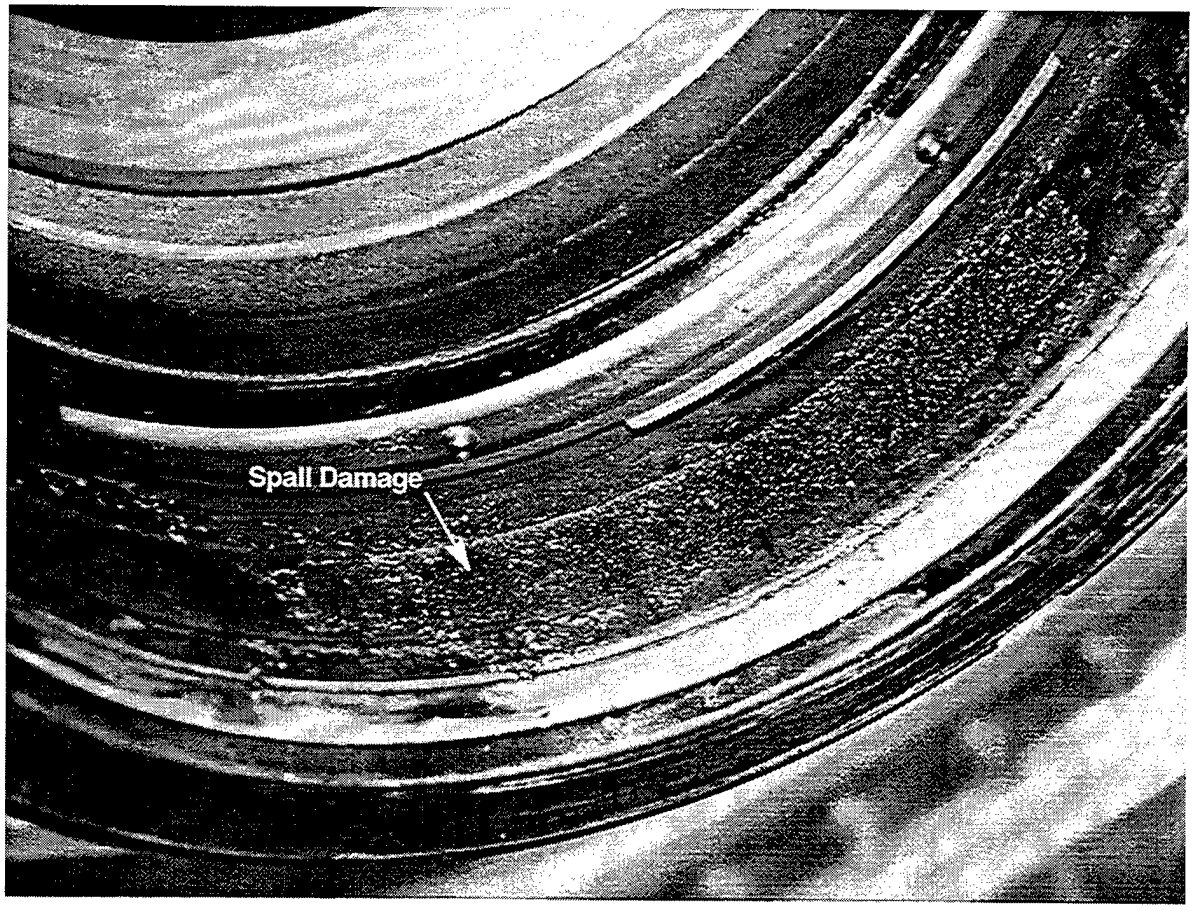
Figure 136. Photo of F110–GE–100 ESN 509–716/5 No. 4R Bearing Outer Race Spall.

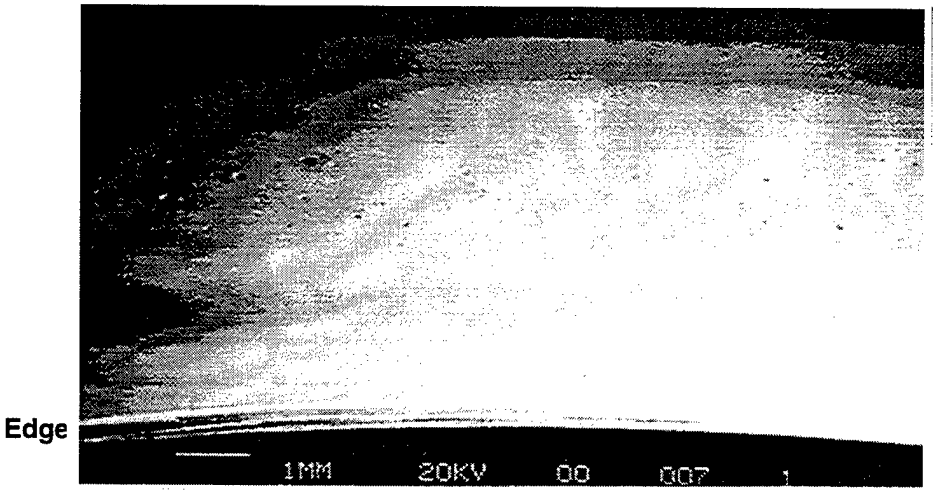
Figure 137. SEM Photo of F110–GE–100 ESN 509–716/5 No. 2B Bearing Inner Race.
Note band of dimples indicating micropeeling.

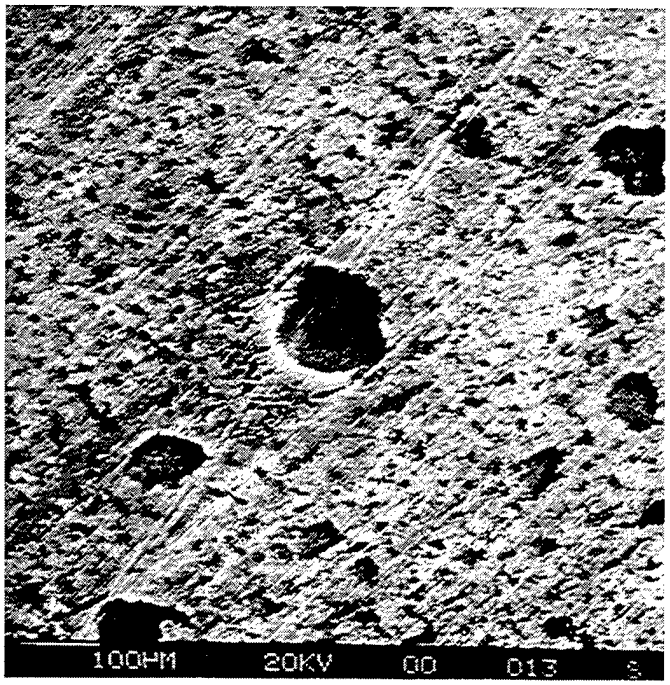
The posttest condition of the No. 2B bearing was considered marginal. Although the condition of the bearing was within inspection limits, there was evidence of undesirable skid damage on the inner race. A circumferential ring of partially peeled TDC areas was present in the location where skidding is likely to occur. **Figures** 137, 138 and 139 are SEM photographs of these areas. **Figure** 139 highlights a typical area adjacent to a location of partially peeled TDC. Secondary polishing and micro–peeling of the TDC has occurred in these areas.

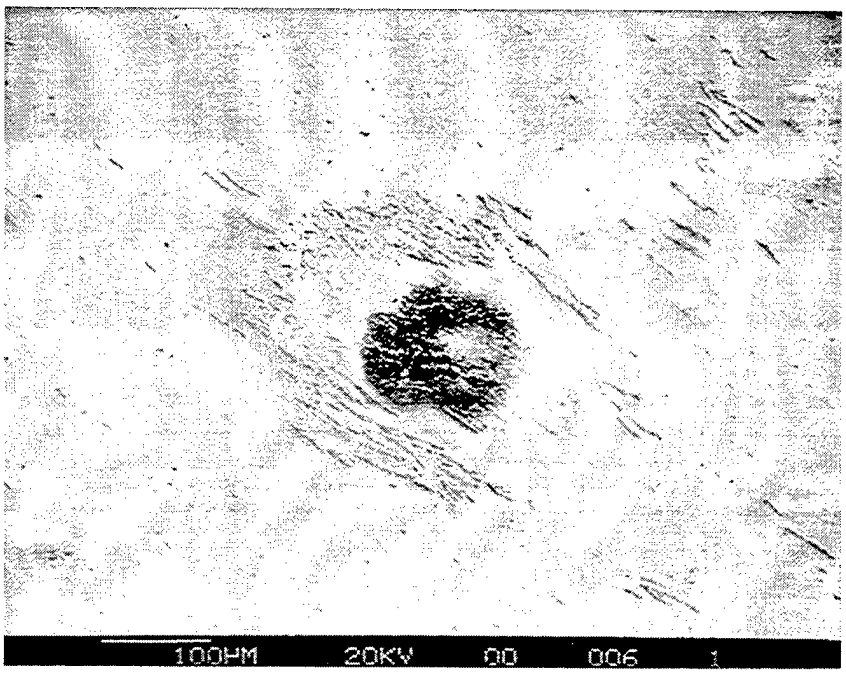
Figure 138. SEM Secondary Photo of F110–GE–100 ESN 509–716/5 No. 2B Bearing Inner Race.

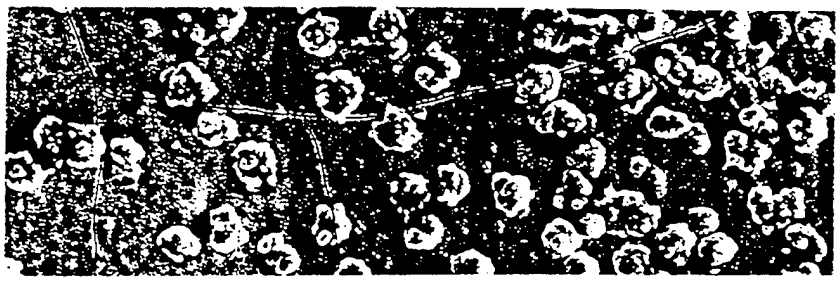
Unacceptable NTDC

Poor Nodularity and Cracking
