ARMY RESEARCH LABORATORY

The Metallurgical Examination and Inspection of Apache Tail Rotor Strap Pack Laminates and Assemblies

ARL-TR-2018 July 1999

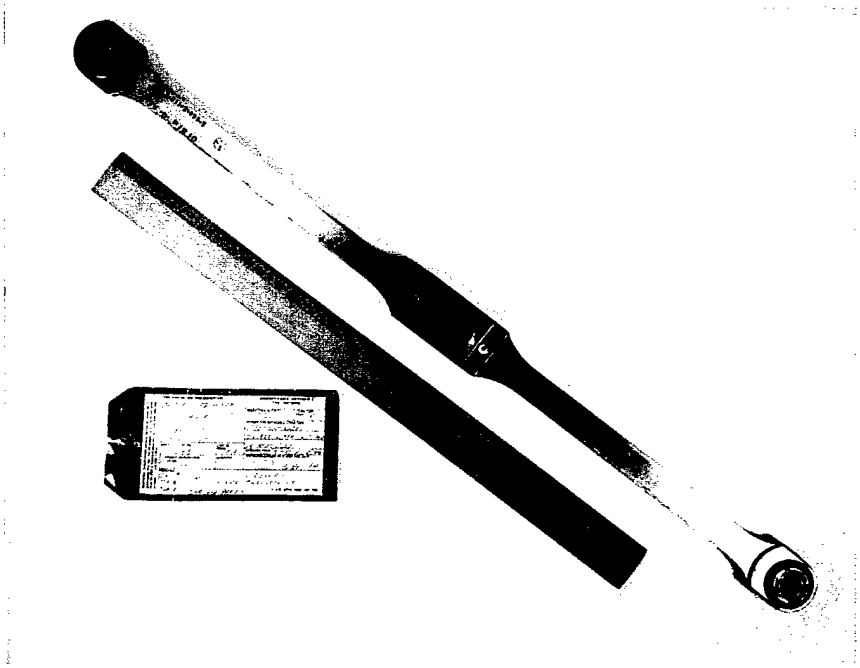
Figure 1. Macrograph of the As-Received Strap Pack 1548 (Top View). (Scale in Inches.)

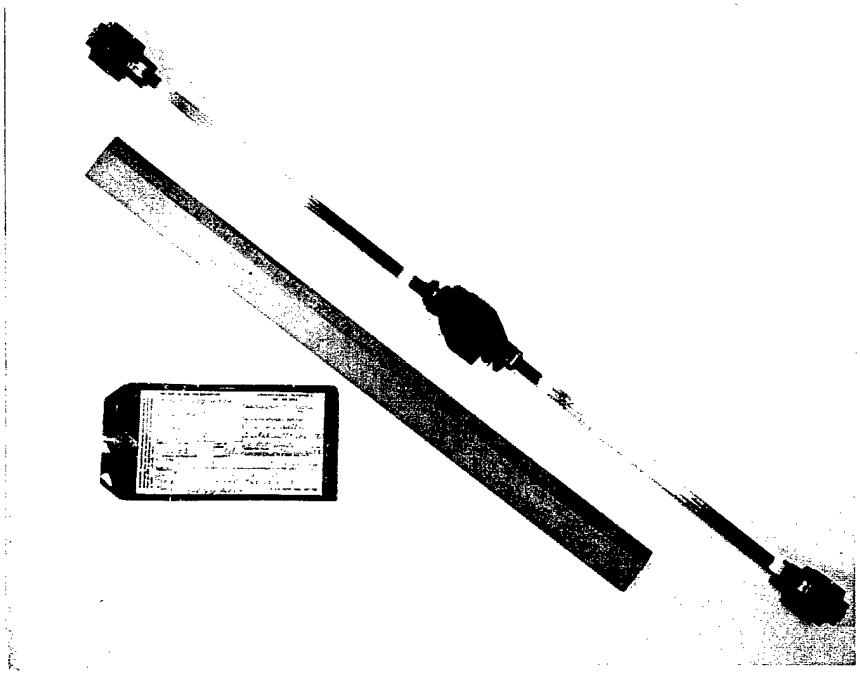
Figure 2. Macrograph of the As-Received Strap Pack 1548 (Side View). (Scale in Inches.)

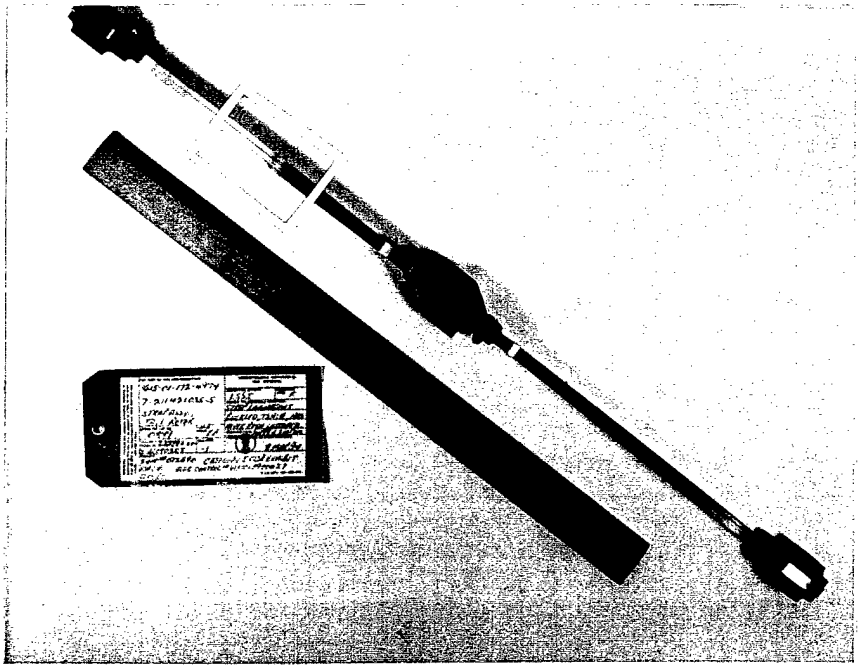
Figure 3. Macrograph of the As-Received Strap Pack 0899 (Top View). (Scale in Inches.)

Figures 3 and 4 show QDR exhibit 003343-0899 (0899) as received by ARL-WMRD. The individual quality deficiency reports designate buckling and/or displacement of the first laminate for exhibit 1548 and the third and eleventh laminate for exhibit 0899. These findings were verified by ARL-WMRD via optical microscopy. The first laminate was visibly buckled on exhibit 1548, as depicted in Figure 5. Closer examination of the white outlined box in Figure 4 reveals the buckling of the third and eleventh laminates on exhibit 0899. The additional nine

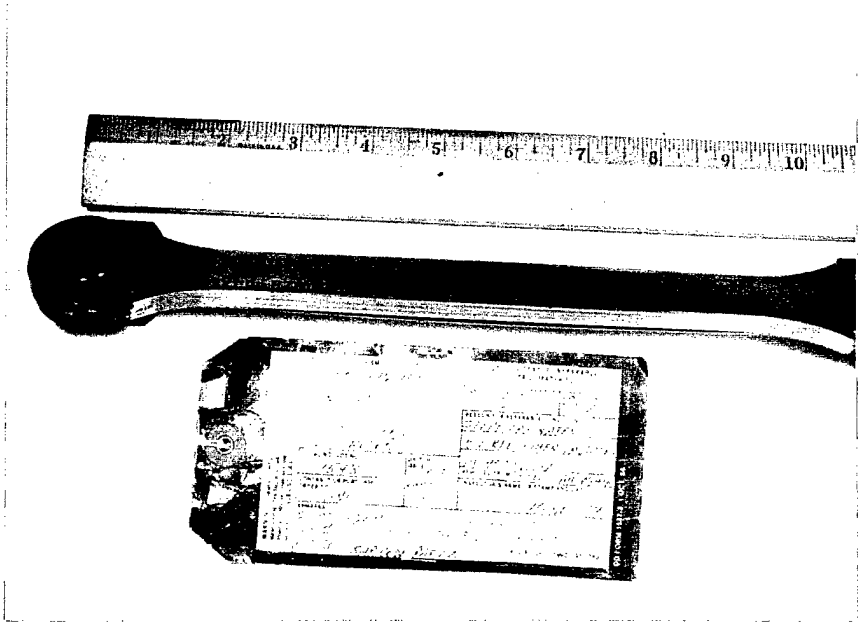
Figure 4. Macrograph of the As-Received Strap Pack 0899 (Side View). (Scale in Inches.)

Further evidence of this scenario is suggested by the displacement/buckling location within the laminate stack as reported previously. The displacement and buckling location matches precisely with the boxed data laminate numbers in Table 1. In strap pack 1548, the first laminate is visibly displaced (refer to Figure 5), and for strap pack 0899, the third and eleventh laminates are displaced (refer to Figure 4).

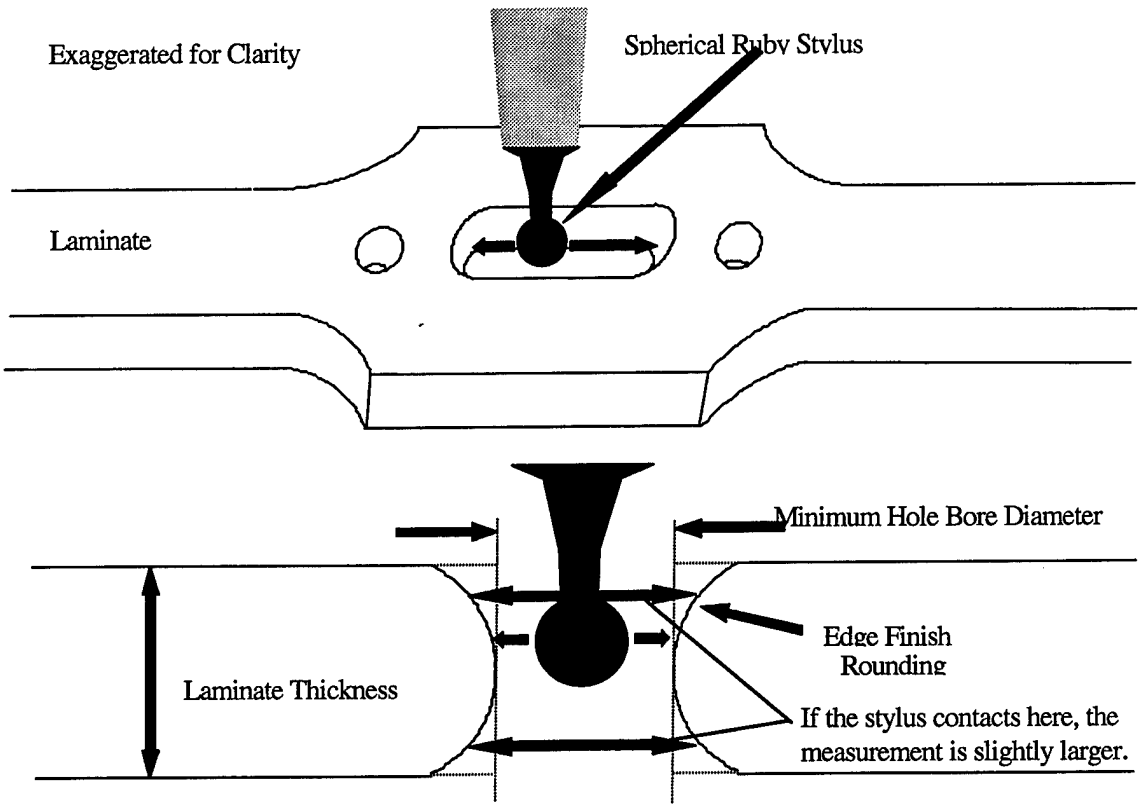
Figure 6. Illustration of the Measurement Inaccuracy Due to Edge Finishing.

3.2 Dimensional Inspection. A three-axis coordinate measuring machine (CMM) was used to check the dimensional conformity of the strap pack laminates. It must be understood in an analysis of the data that the laminates were edge-finished prior to dimensional inspection. This is significant, since the CMM employs a spherical ruby stylus when acquiring measurement data. If the edges of the laminates are also rounded, slight inaccuracies may exist in the measurements obtained due to the extreme thinness of the laminates (approximately 0.014 in). Figure 6 illustrates this phenomenon. However, it is important to note that this small source of error would not account for hole dimensions with measured value smaller than that specified, as the drawing illustrates. If the spherical stylus caused error to be introduced, the dimensions of the holes would be artificially inflated rather than reduced. Therefore, the slight inaccuracy might only explain dimensions that are out of tolerance by being larger than specified. Dimensions found to be smaller than specified cannot be explained away under this argument and are of significant concern. This inaccuracy in measurement due to the edge finishing and spherical stylus is very small, approximately 0.0005 in maximum, and is exaggerated in Figure 6.

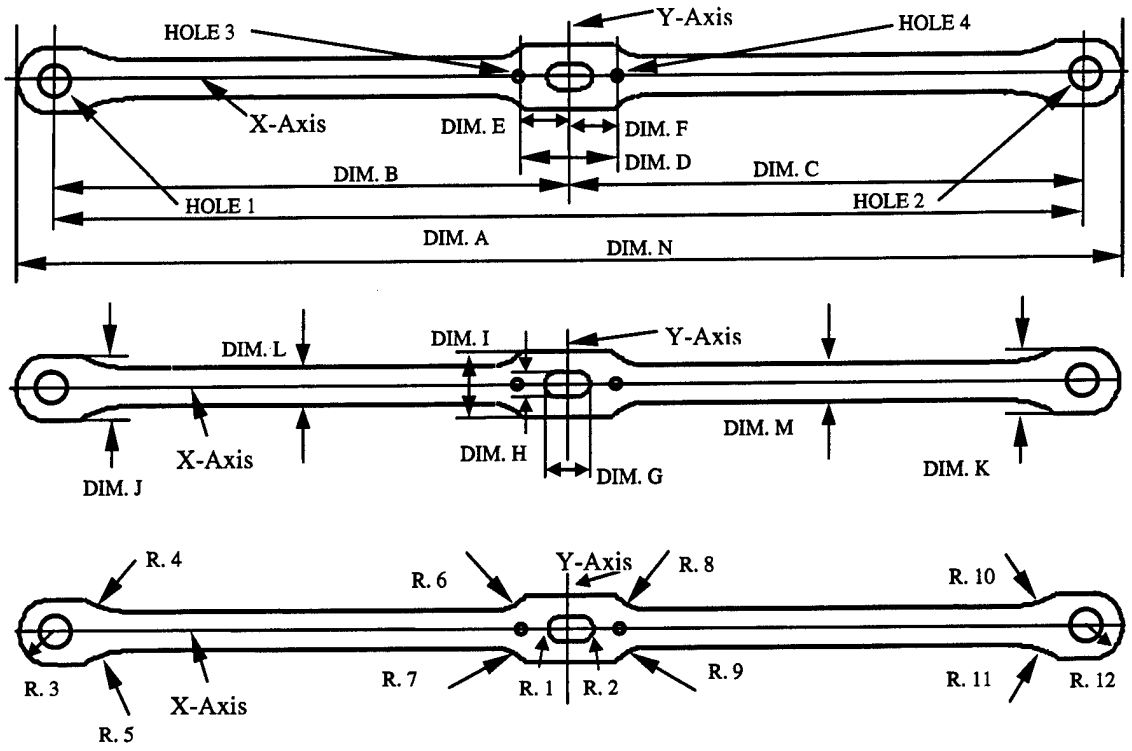
The boxed data in Table 1 indicate the most likely source of the buckling. It can be seen from the data for dimensions E and F that the average value of DIM. E is larger by 0.006 in (average value DIM. E = 1.1294 in and average value DIM. F = 1.1233 in, neglecting the boxed data). The transposition occurs when a laminate is rotated 180° and inserted back into the stack. Therefore, DIM. E becomes DIM. F for the transposed laminate. It can be seen in the data that the transposed laminate's DIM. E values closely resemble the other laminate's DIM. F values.

Figure 7. Illustration of the Defined Laminate Dimensions for Tables 1, 2, 3, and 4.

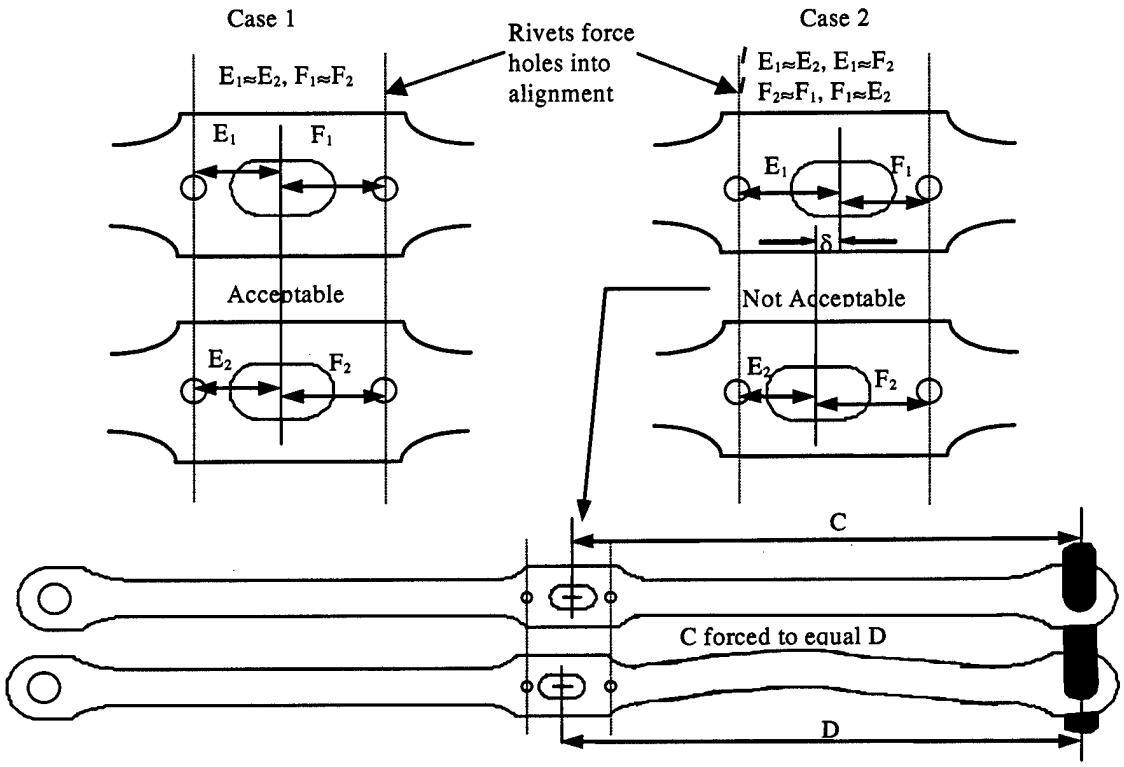
The converse also holds true. Once a 180° transposition about the Y-axis of a laminate has occurred, forcing a rivet through these centrally located rivet holes will cause an offset of the entire laminate. Therefore, the assembly is forced to buckle when the bushings are placed through the ends of the laminate stack. Figure 8 visually depicts the transposition and buckling scenario.

Figure 8. Illustration of the Transposition About the Y-Axis and Buckling Scenario.

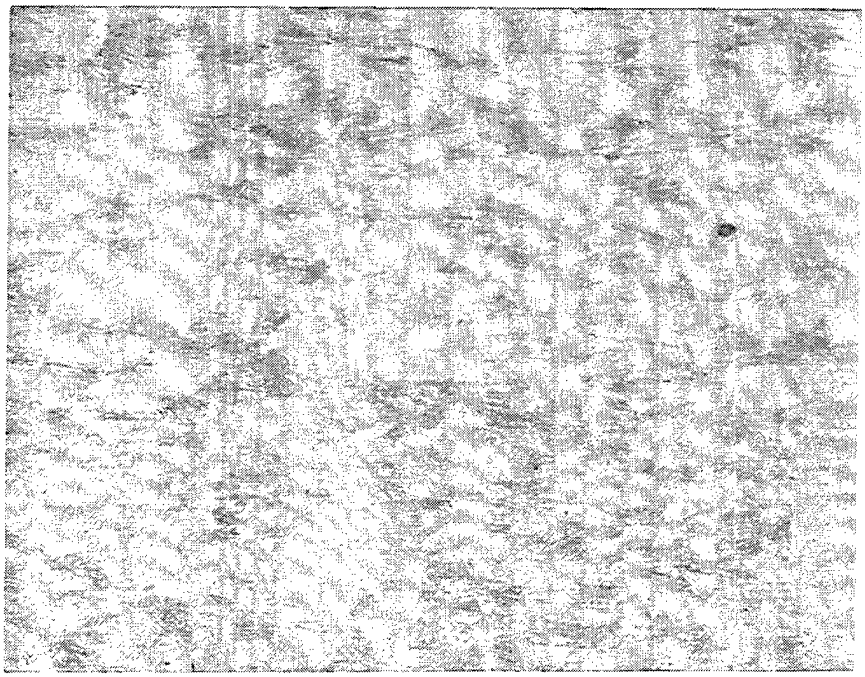
The polished specimens were subsequently etched with Vilella's Reagent to reveal the resultant microstructure. The longitudinal and transverse sections of this semiaustenitic stainless steel exhibited fine carbides uniformly distributed within a tempered martensitic structure as shown in Figures 9–12, respectively, for strap packs 1548 and 0899. The detrimental delta (free ferrite) phase was not apparent to any discernable degree. This structure is consistent with the prior heat treatment, cold rolling, and tempering schedule of the AM-355 precipitation hardenable stainless steel. The material conformed to the governing specification HMS 6-1073.

Figure 9. Micrograph of a Longitudinal Section of 1548. Vilella's Etch. Mag. 500×.
