Durability of Fiber-Reinforced Concrete Under Flexural Stress in a Severe Marine Environment

by   *Edward F. O'Neil, ERDC*
Jack T. Devlin, University of New Brunswick

Final report

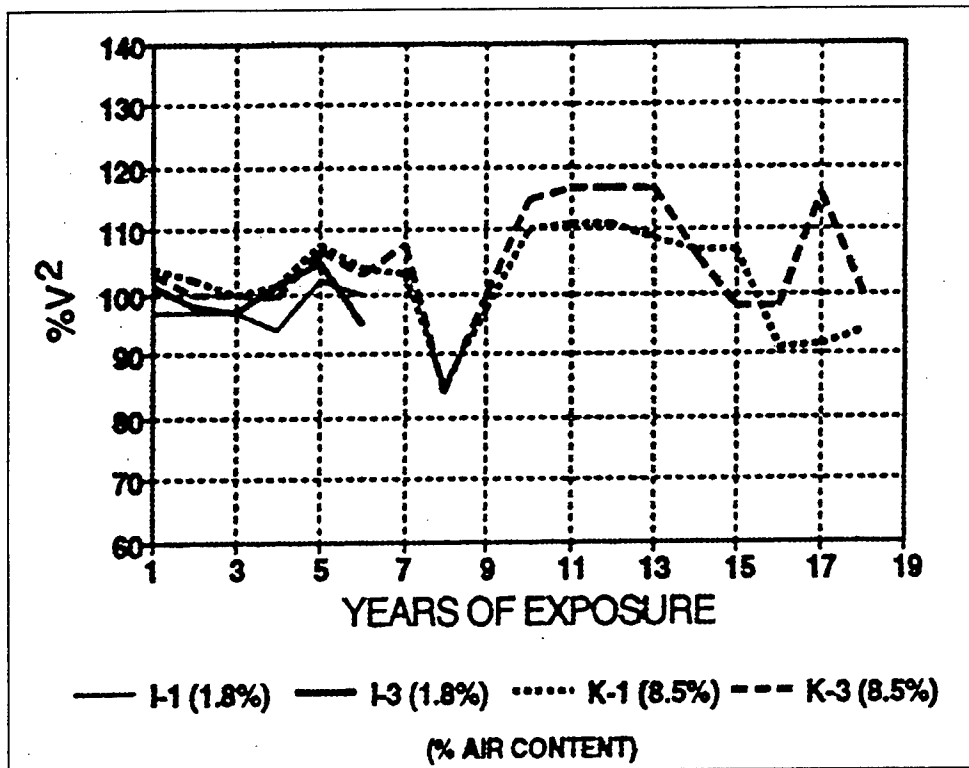
Figure 5. Pulse-velocity results for brass-coated steel-fiber-reinforced beams

Pulse-velocity evaluation. The results of annual pulse-velocity measurements over the exposure life of the beams are plotted in Figures 5 through 8, and tabulated as $\%V^2$ in Appendix D. Deterioration information from these measurements is nonconclusive and tended to be erratic over the life of the beams. The measurements often would indicate an improved condition from 1 year to the next which is contrary to the normal progression of deterioration from freezing and thawing as time progresses. The measurements taken in 1983 appear to be low values in relation to those in other years. No significant difference in performance among fiber type is apparent from these data with the possible exception that the trend for the glass-fiber-reinforced beams (Figure 7) and the nonfiber/stainless-steel fiber beams (Figure 8) appear to show some slight decrease in $\%V^2$ over the years of exposure.

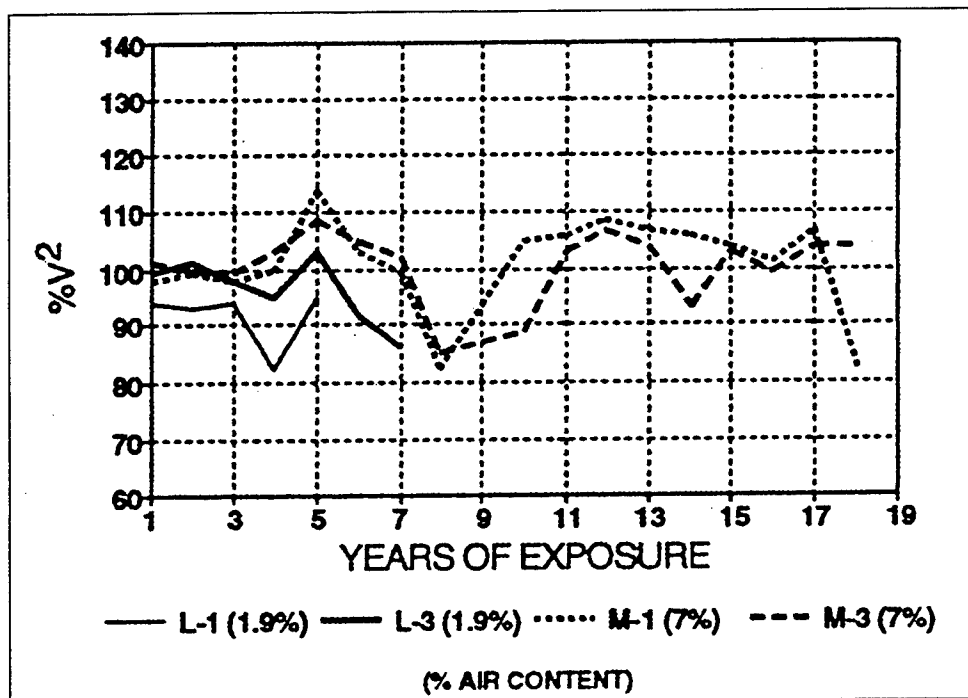
Figure 6. Pulse-velocity results for chopped steel-fiber-reinforced beams

The pulse-velocity data taken over the 18 years of exposure did not produce information that could be used to determine trends in deterioration of the beams with any level of confidence. Figures 5 through 8 show pulse velocities that increase and decrease from year to year. In most cases, at some point in the time-history of the beams the velocities increased rather than decreased, indicating that the condition of the beams was improving rather than deteriorating. Several explanations for the insufficiency of these data can be presented. Over the 18 years that data were collected, different technicians were used to collect the data. Variation in reading technique, placement of the transmitters and receivers on the beams, and differences in temperature and humidity surrounding the beams at the time of reading could have produced great variation in the readings.

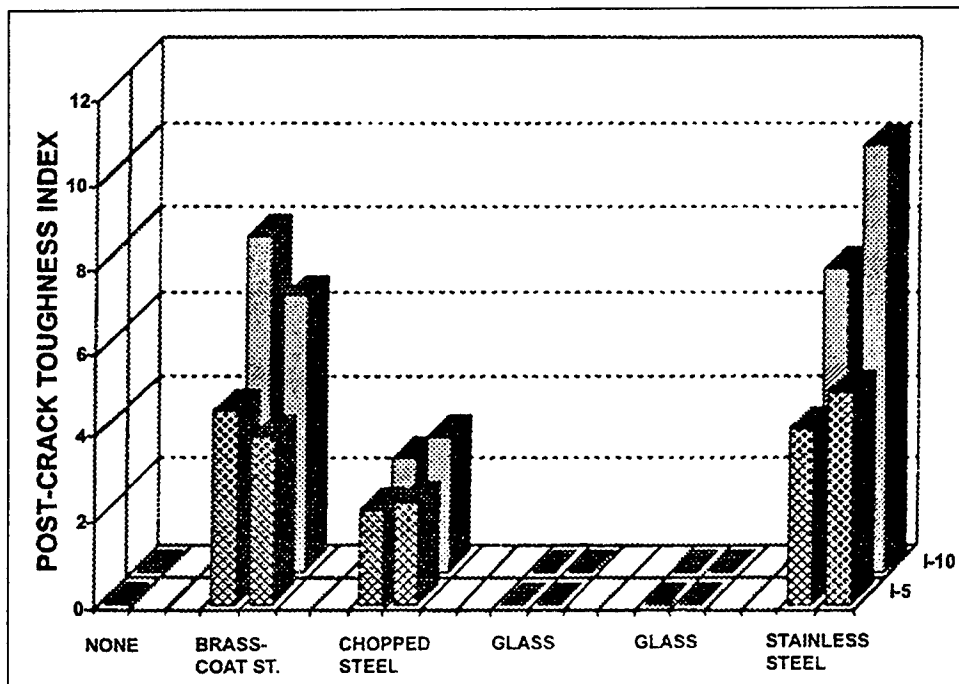
Figure 10.   Postcrack-toughness indices I_5 and I_{10} from flexural measurements

Although the stainless-steel-fiber beams (mixture P) had lower FCS and FCT values than the other carbon-steel-fiber beams, their toughness indices were greater, averaging 4.52, 8.64, and 16.68 for I_5, I_{10}, and I_{20}, respectively. Consequently, the residual-strength factors $R_{5,10}$ and $R_{10,20}$ were greater, averaging 82.5 and 80.5, respectively. The brass-coated 19-mm (3/4-in.) steel-fiber-reinforced beams (mixture K) had greater toughness indices and residual-strength factors than the chopped-steel 25.4-mm (1-in.) fiber-reinforced beams of mixture M. The control beam, mixture J, and both glass-fiber mixtures (mixtures N and O) failed in a brittle manner immediately after first crack and therefore had no postcrack-toughness indices.

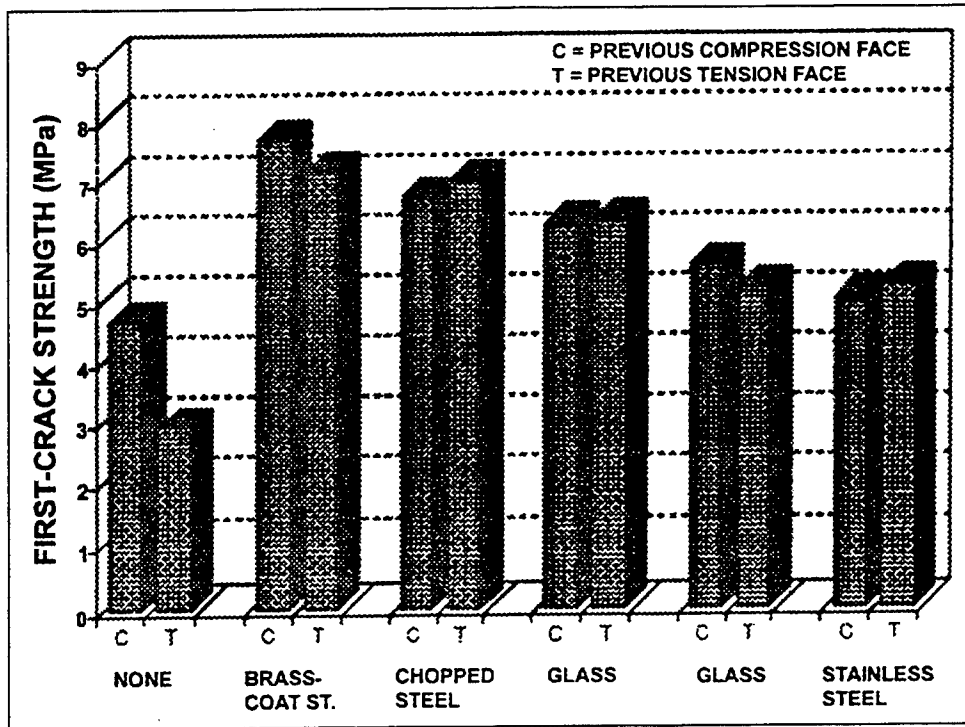
Figure 11. First-crack strength comparison of previous tension and previous

versus previous compression faces when evaluated in flexure in the second series of
failures, i.e., when comparing the two beams within set (A) in Figure 3.

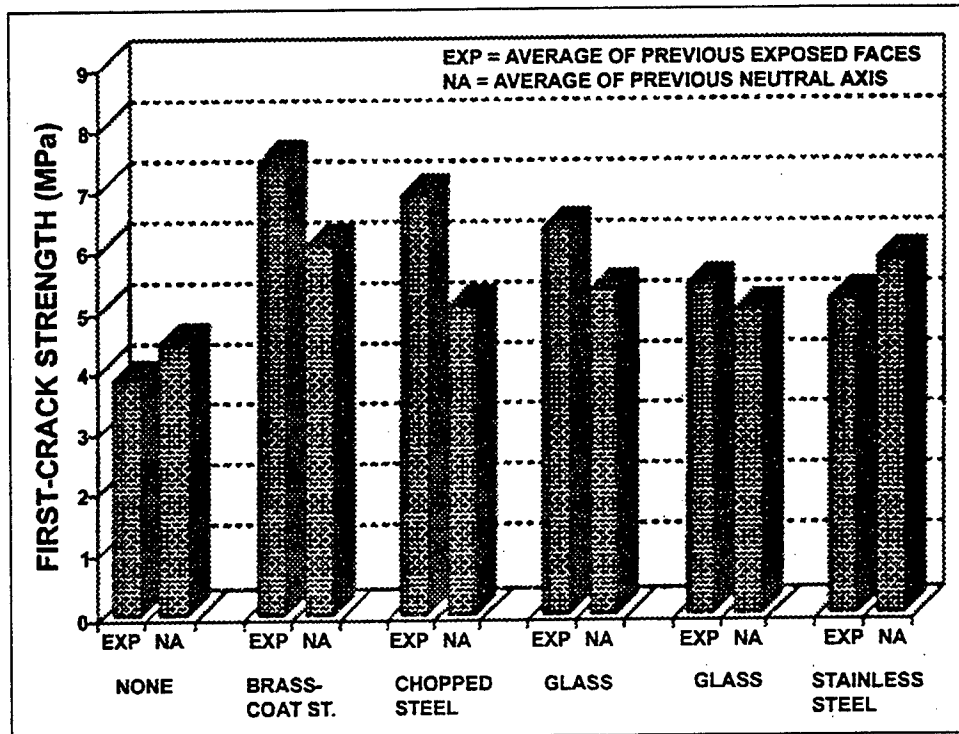
Figure 12. First-crack-strength comparison of previous exposed faces and previous neutral-axis faces

Figure 12 compares the average of the FCS of faces either in tension or
compression during exposure with the average of the FCS of the neutral axis during
exposure as the tensile face, i.e., a comparison of the averages of set A versus set B
in Figure 3. In this comparison, the previous exposed faces were stronger than the
previous neutral axis for the brass-coated steel, chopped-steel, and glass-fiber-
reinforced beams.

The first-crack toughness results of the second series of flexural-toughness
measurements were similar to the first-crack strength results. There was no
difference between previous tension and previous compression zones when placed in
flexural tension. Similarly, there appeared to be some difference between the
previous exposed faces and the previous neutral axis for the brass-coated steel,
chopped steel, and alkali-resistant glass fibers.

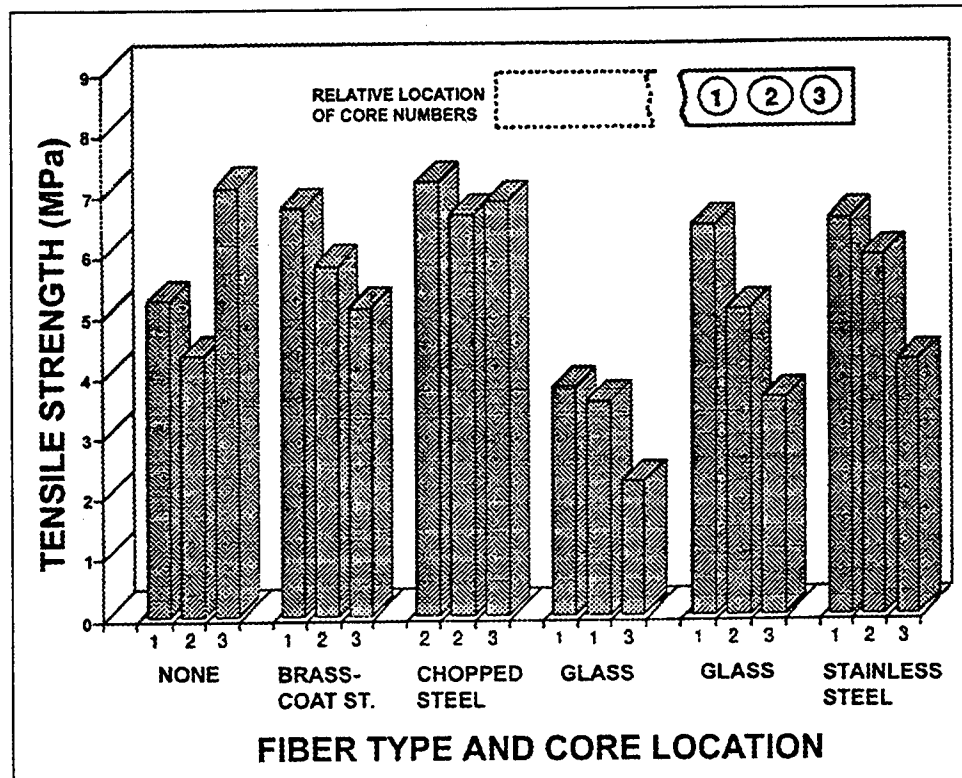
Figure 14. Indirect-tensile strength measurement results

Average tensile strength of the mixtures ranged from 3.16 MPa (459 psi) for mixture N, which was glass-fiber-reinforced, to 6.87 MPa (996 psi) for mixture M, which was reinforced with chopped-steel fibers (Appendix G). The second strongest cores were from the brass-coated carbon-steel fiber-reinforced beams (mixture K) which averaged 5.86 MPa (850 psi).

It was noted that among all the cores which had fiber reinforcement (mixtures K to P), there was a decrease in tensile strength of the individual cores as the drilling location progressed from the center to the end of the beam (Figure 14).

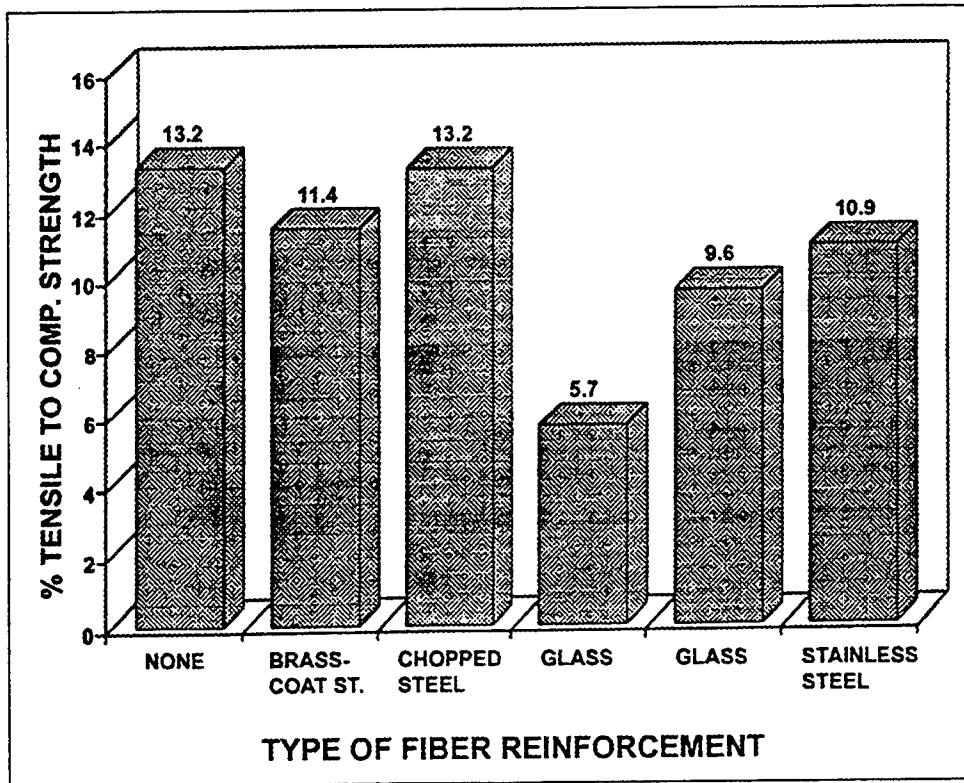
Figure 15. Indirect-tensile strength as a percent of uniaxial-compressive strength

The ratio of indirect-tensile strength to the uniaxial-compressive strength was computed for all mixtures. The carbon-steel-fiber mixtures and the nonreinforced mixture had the greatest ratio (Figure 15). The chopped-steel-fiber mixture and the nonreinforced mixture both measured 13.2 percent while the brass-coated steel fiber cores measured 11.4 percent. The ratios for the two sets of glass-fiber mixtures were lowest at 5.7 percent and 9.6 percent. The overall average ratio of tensile-to-compressive strength for all measurements was 10.7 percent, well within the accepted range of 8 to 12 percent (Kosmatka et al. 1991).

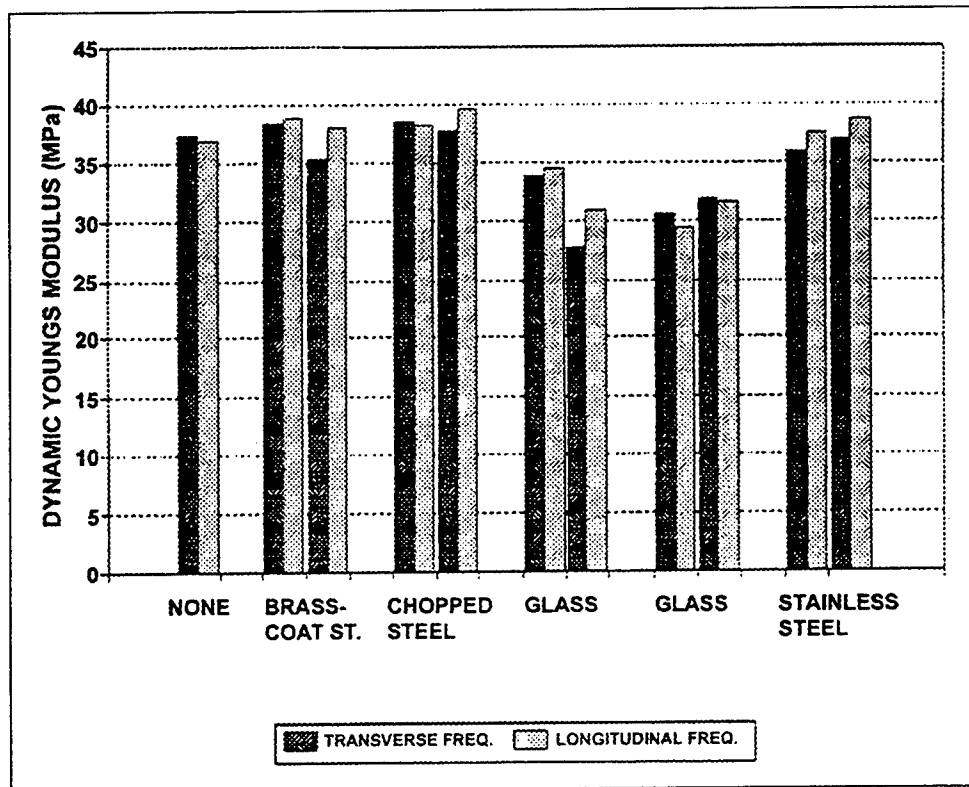
Figure 16. Dynamic Young's modulus of whole beams

The brass-coated-steel- (mixture K) and chopped-steel-fiber beams (mixture M) had the greatest moduli of elasticity averaging 37.6 GPa (5,440 ksi) and 38.5 GPa (5,570 ksi), respectively (Figure 16). Stainless-steel-fiber beam (mixture P) results were slightly greater than the no-fiber beam (mixture J) results. As with the moduli of the glass-fiber-reinforced beams measured under the whole-beam flexural-toughness results, mixtures N & O were lowest in resonant-frequency measurements at 31.8 GPa (4,600 ksi) and 30.9 GPa (4,470 ksi), respectively.

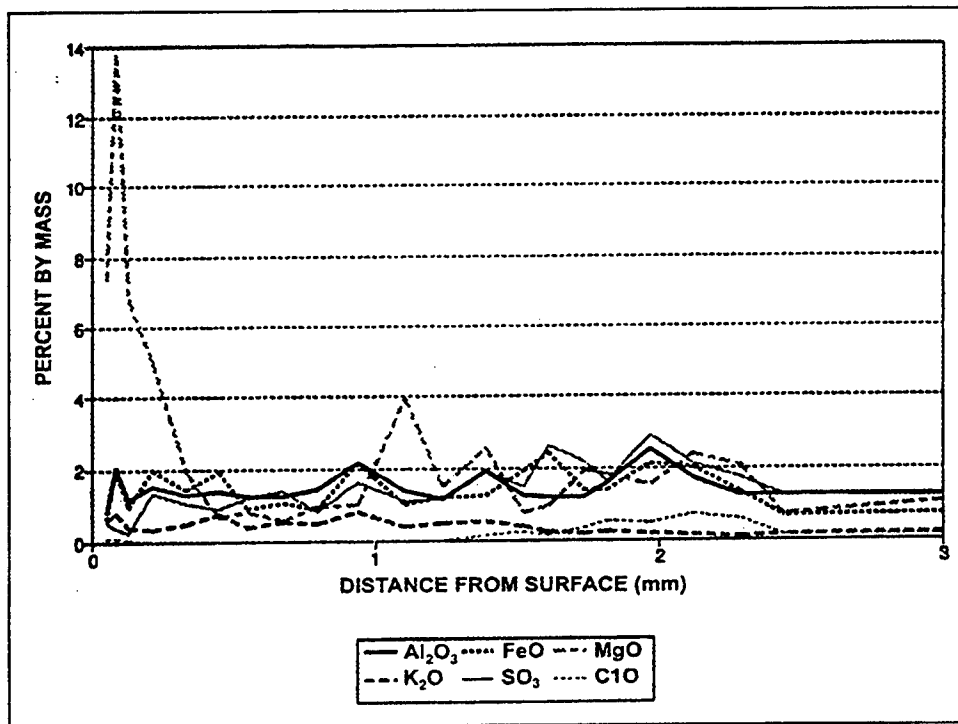
Figure 20. Electron microscope scan results for brass-coated steel-fiber-reinforced beam K-1

All mixtures and fiber types displayed a peak concentration of magnesium (5 to 14 percent weight Mg) at or next to the surface of the beam, which declined quickly to an average of approximately 2 percent, within 1 mm of depth into the beam. A typical plot of scanning results is shown in Figure 20, while all plots are presented in Appendix J. In the figure and the appendix, all elemental concentrations are expressed as oxides.

Mixtures with no fibers (J) as well as the brass-coated and chopped-steel-fiber mixtures (K and M) displayed the greatest surface concentrations of magnesium while the stainless steel-fiber mixture (P) and glass-fiber mixtures (N and O) had lower surface concentrations. All six mixtures displayed a reduction in calcium (Ca) concentration near the surface (Figure 21). Additionally, any change in calcium concentration appeared to be mirrored by an opposite change in silicon (Si) concentration for the chopped-steel-fiber- (mixture M), glass-fiber- (mixtures N and O), and stainless-steel-fiber- (mixture P) reinforced beams.

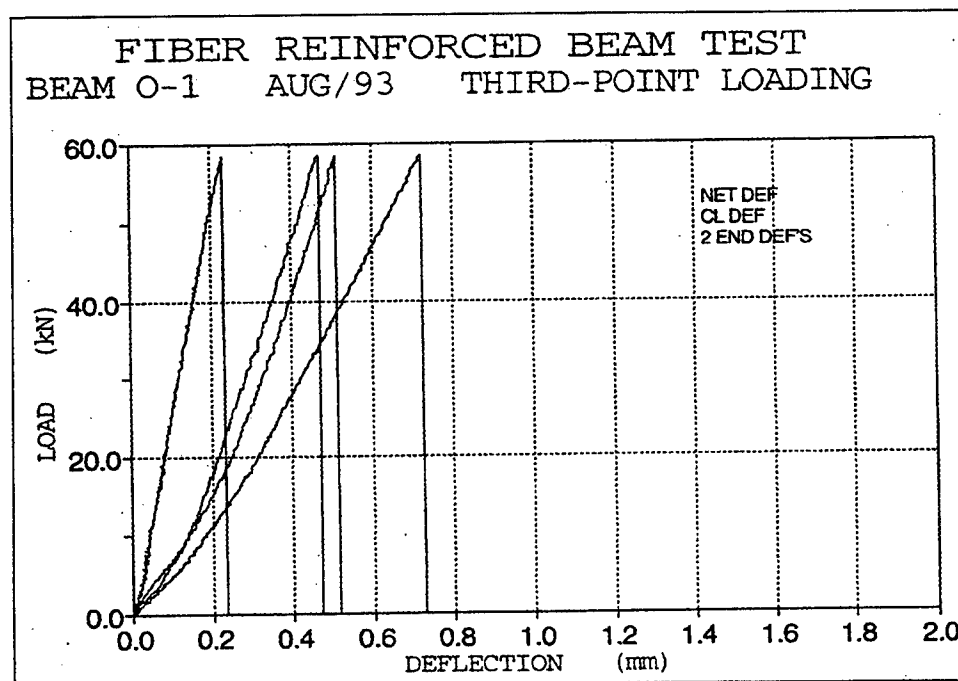
Figure 22. Load-deflection graph of whole-beam third-point flexural failure showing center-line and support-point deflections

The importance of monitoring the deflection of the supports as well as the center line during the flexural loading sequence was noted by the magnitude of the support movement. Figure 22 shows a representative graph of the raw data. This figure shows one of the glass-fiber mixtures which broke in a brittle manner after first crack but illustrates the magnitude of the end deflections. Deflections of the end supports were often on the order of 60 to 70 percent of the measured center-line deflection due to the relatively massive and stiff nature of the beams.

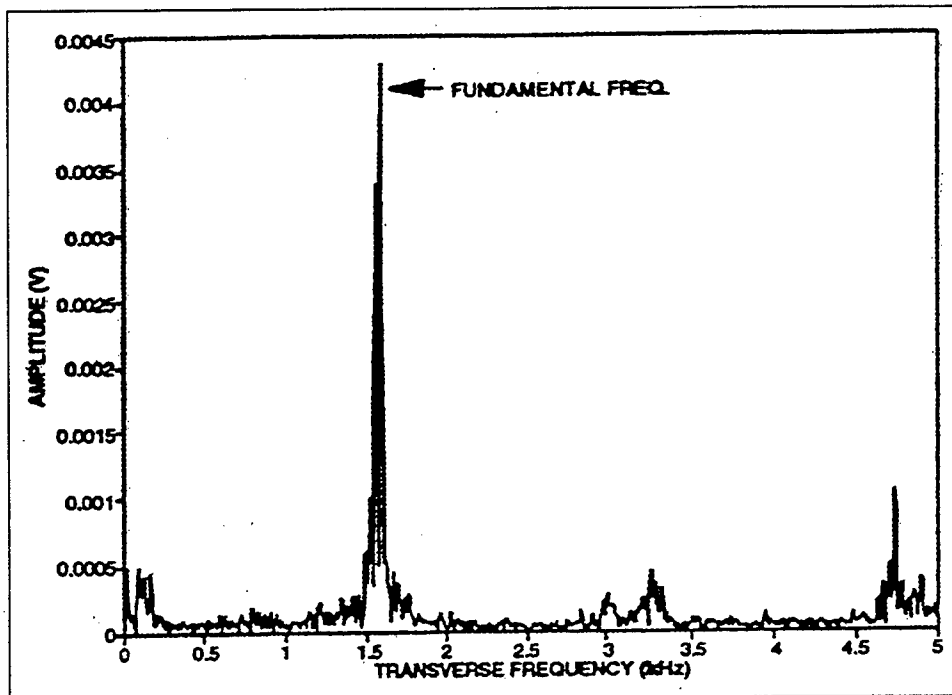
Figure 23. Frequency response of the top/bottom faces of beam K3C which were perpendicular to the direction of bending in flexural-toughness measurements

The transverse resonant-frequency measurements taken on the sawed-beam series clearly showed the effect of stress from the whole-beam flexural-toughness measurements. By using a RION signal analyzer, the response of each beam over a broad spectrum of frequencies was plotted (see Appendix I). These plots enabled a visual comparison to be made between the transverse resonant frequencies taken on the previous tension or compression faces (parallel to the bending stress direction) and the transverse frequencies taken on the top or bottom faces (perpendicular to the bending stress).

The plots of the amplitudes of the transverse vibrations over a wide range of frequencies showed multiple secondary peaks on the T/C-N faces, even if the transverse resonant frequencies were within the expected range. When a comparison was made of the frequency plots of the T-B faces (perpendicular to previous stress) and the T/C-N faces (parallel to the previous stress), in 20 out of 24 cases the T/C-N faces had far more irregular plots containing secondary peaks as a result of the previous stress (compare Figures 23 and 24). Multiple secondary peaks in the frequency data are found, as well as greater background vibrations across the spectrum in relation to fundamental frequency when the readings were taken parallel to the previous stress direction. No visible cracks were found on any of these beams.
