LITTLE DELL LAKE

SALT LAKE CITY STREAMS, UTAH

EMBANKMENT CRITERIA

PERFORMANCE REPORT

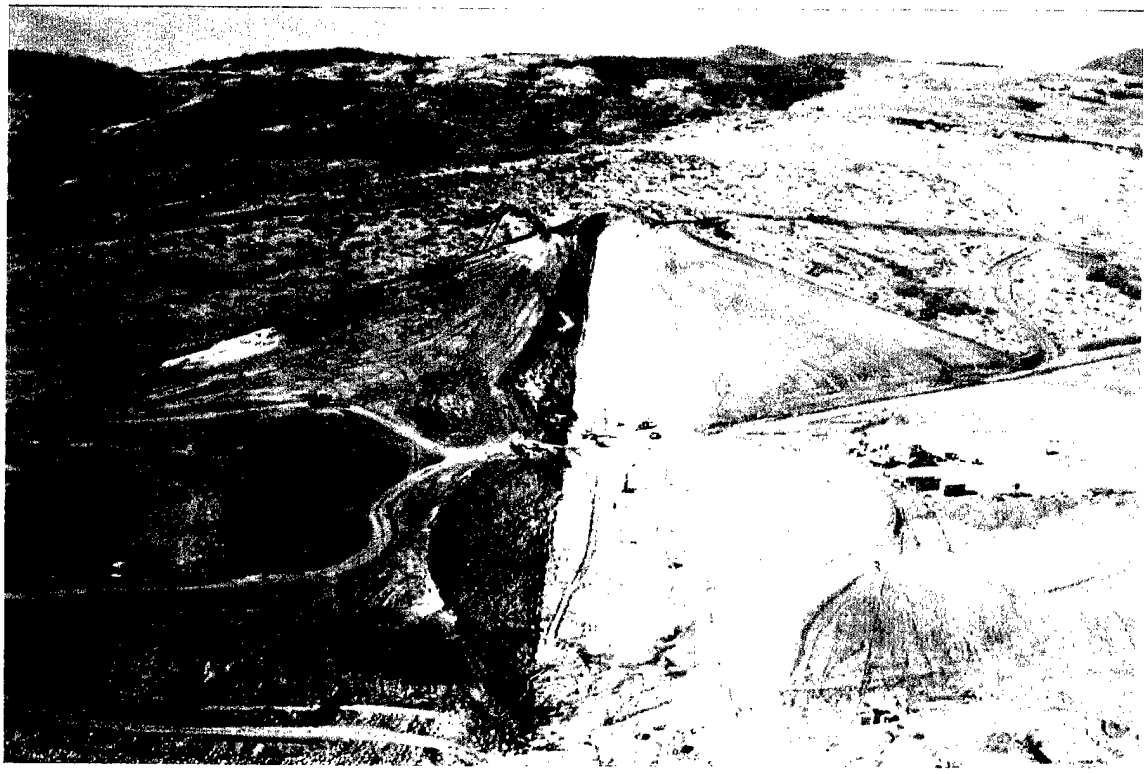
NO. 5 - SEPTEMBER 24, 1989.

Left Abutment from the Right Abutment. Foundation Excavation, Stripping and Core Trench Grouting in Progress.

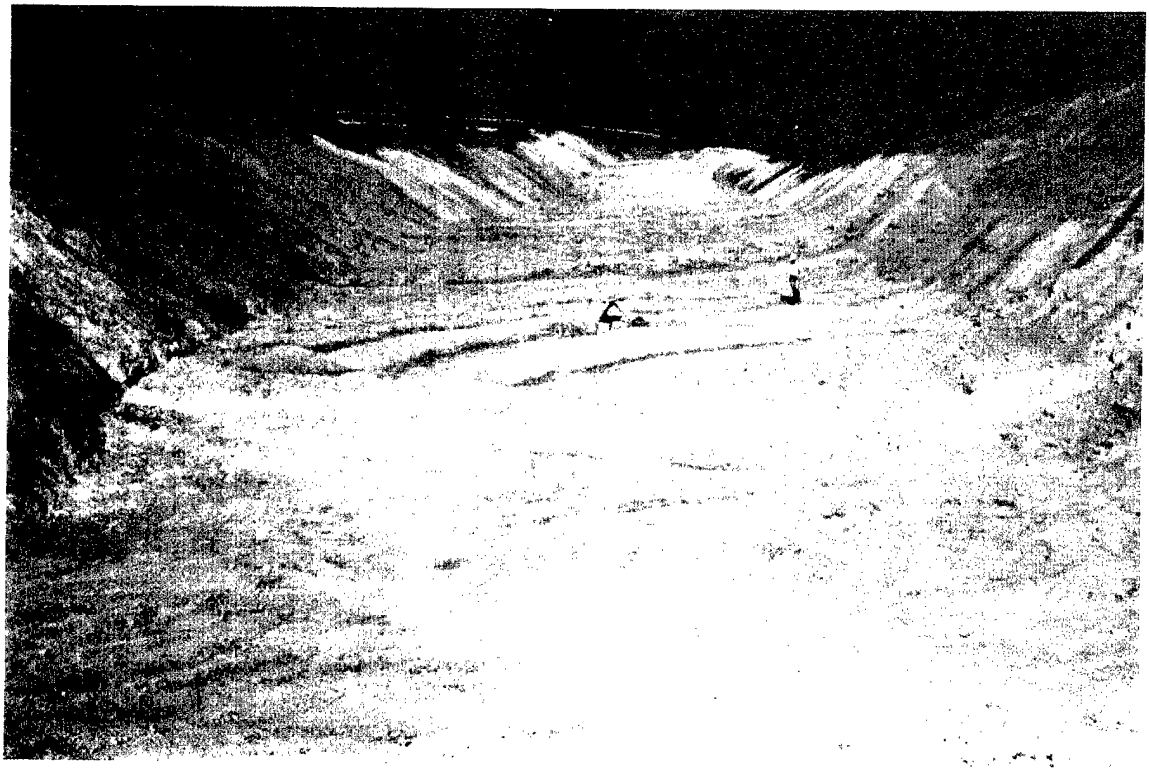
NO. 6 - OCTOBER 23, 1989.

Right Abutment from the Left Abutment. Preliminary Clean-up of the Station 22 Fault in Progress.

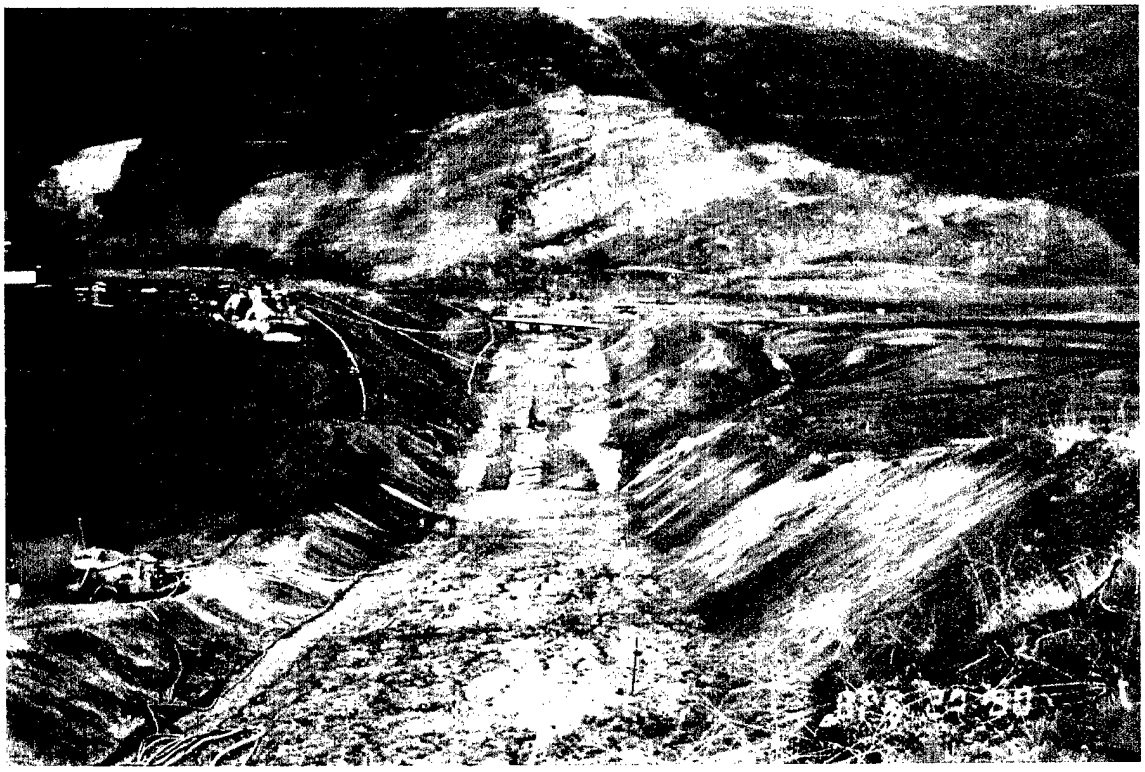
NO. 11 - APRIL 25, 1990.

Right Abutment from the Top of the Left Abutment. Grouting in Progress. Note the Batch Plant Location. Dell Creek "diverted" across the Core Trench in a CMP Flume.

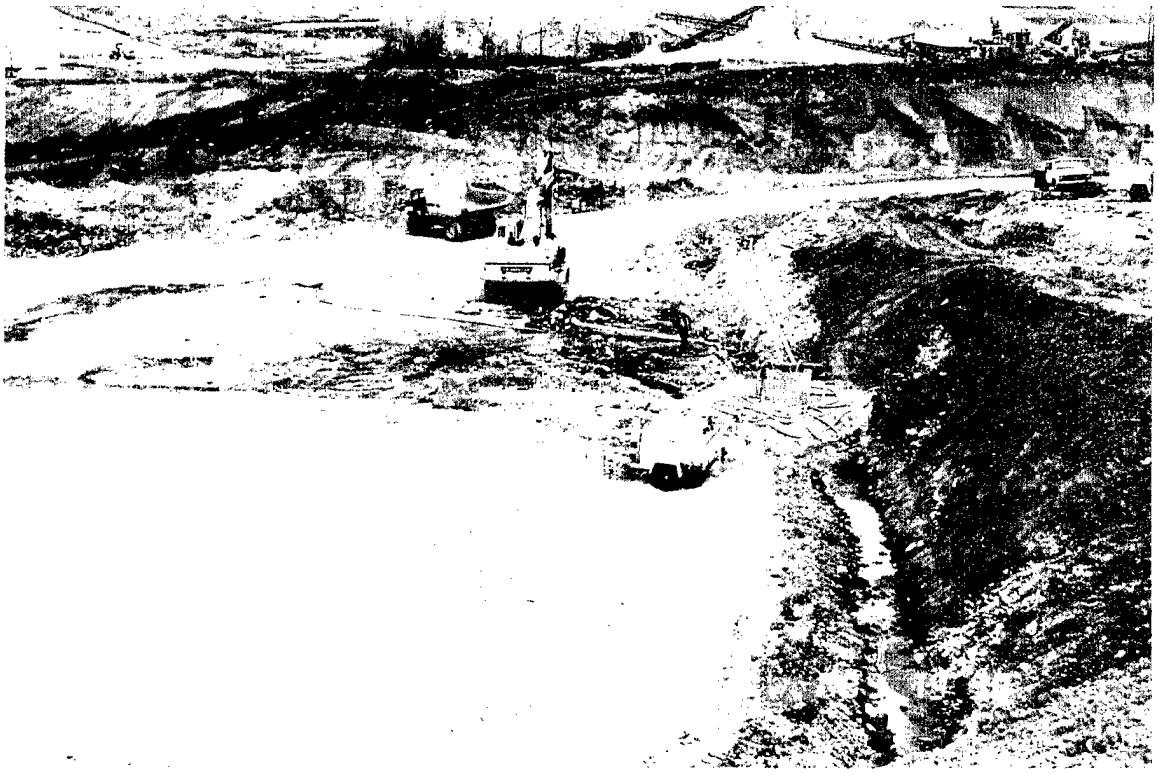
NO. 15 - MAY 19, 1990.

Upstream Streambed Foundation After Proof-rolling, Just Prior to Embankment Placement. (Looking D/S from the U/S Toe)

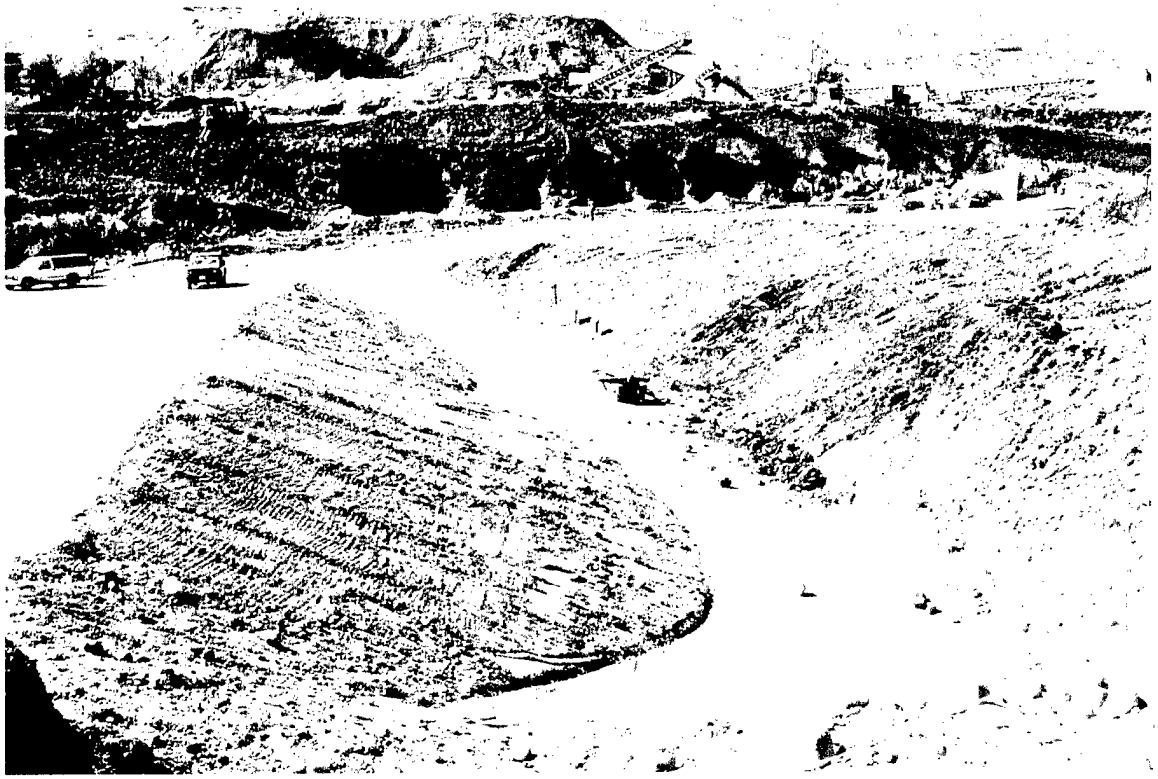
NO. 18 - JUNE 7, 1990.

Work along the Upstream Left Abutment, Random II Zone. Large Stones were Removed from the Abutment Contact. Areas Inaccessible to the Roller were Hand Compacted.

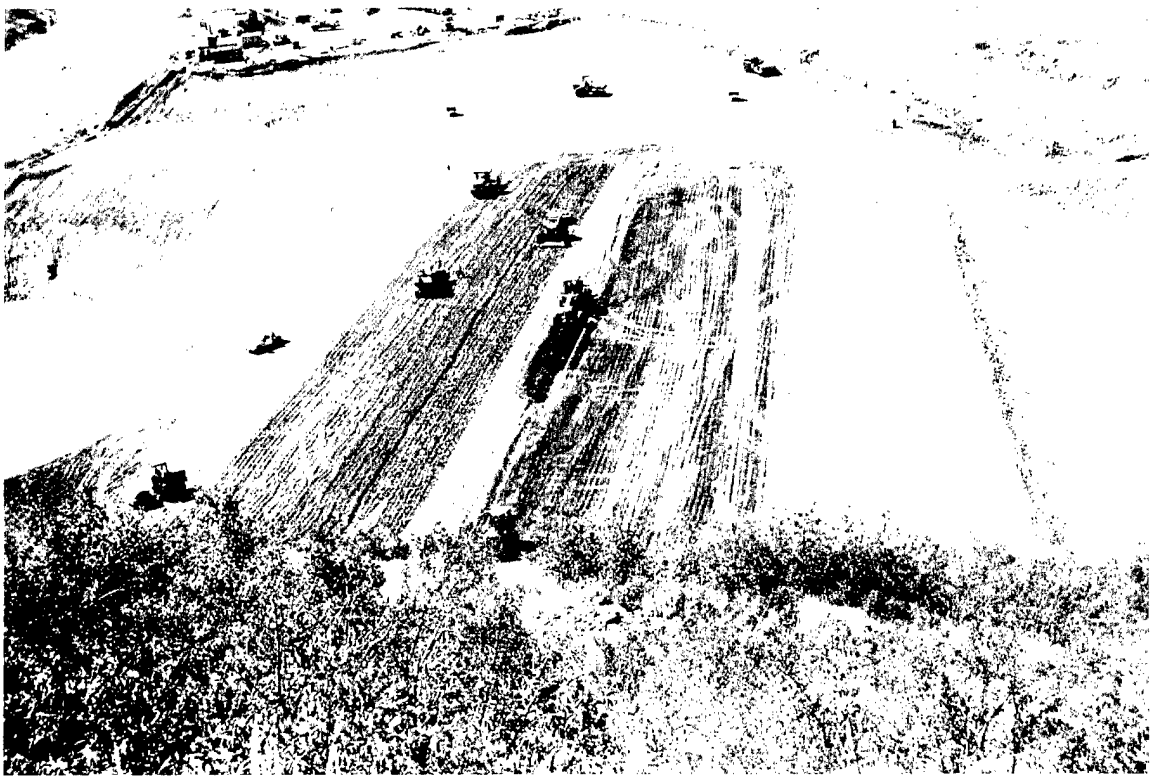
NO. 22 - JULY 16, 1990.

Embankment Processing in the Right Half of the Upstream Streambed Area. Start of "Closure" within the Valley that Resulted in the "Cofferdam". (Looking Downstream from near the Toe)

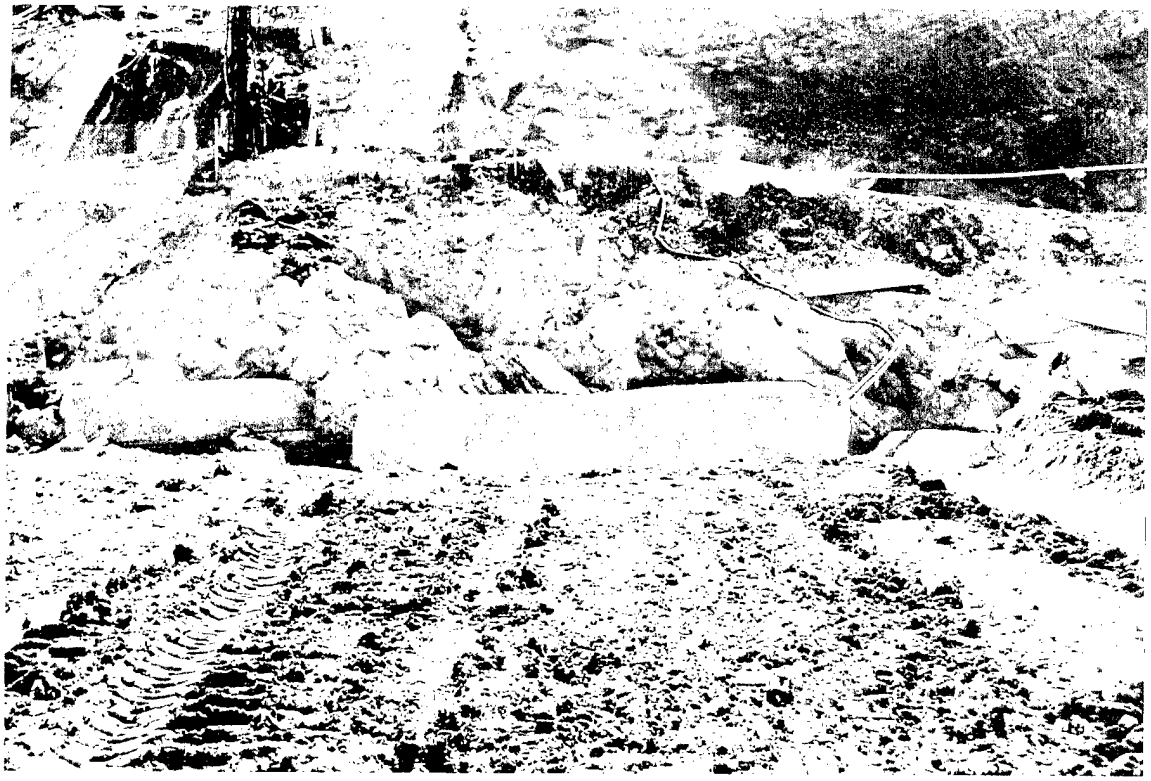
NO. 31 - SEPTEMBER 22, 1990.

Initial Impervious Core Compaction. Wheel Rolling with Cat 980C Rubber Tired Loader.

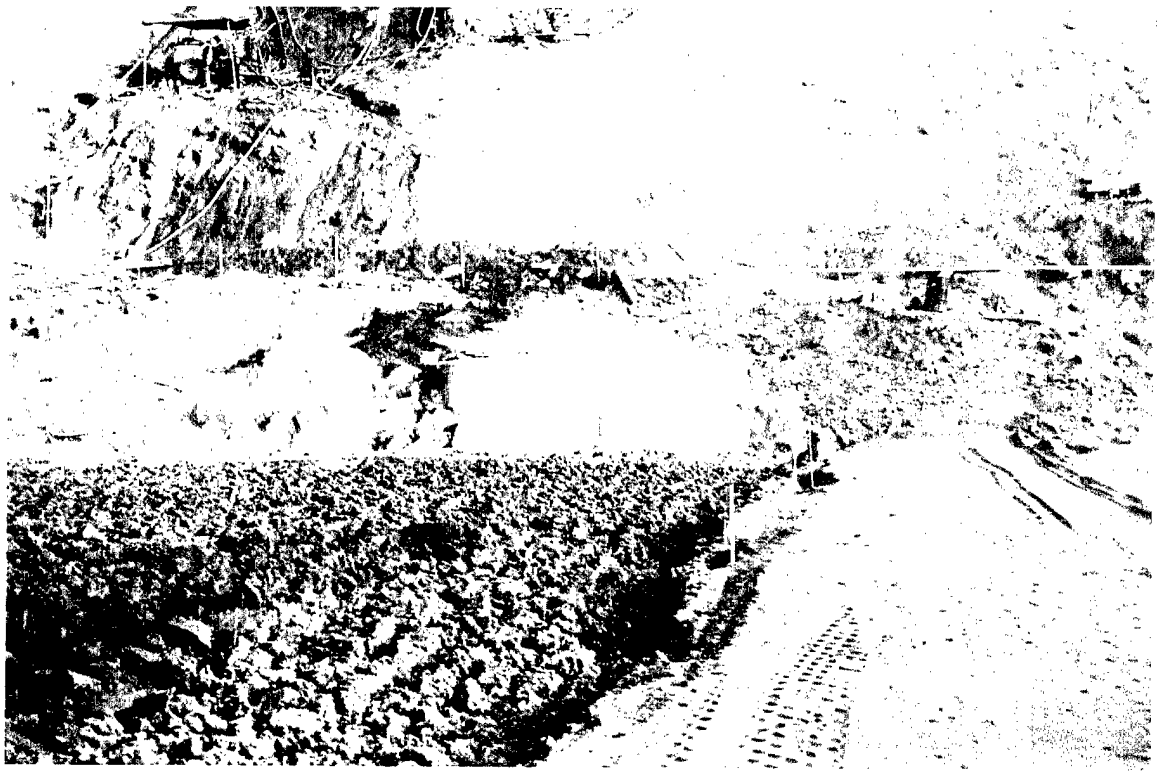
NO. 32 - OCTOBER 4, 1990.
Concrete Fillets at the Base of the Left Abutment, Core Trench Foundation Shaping & Seepage Protection. (Downstream is to the Right in the Photo)

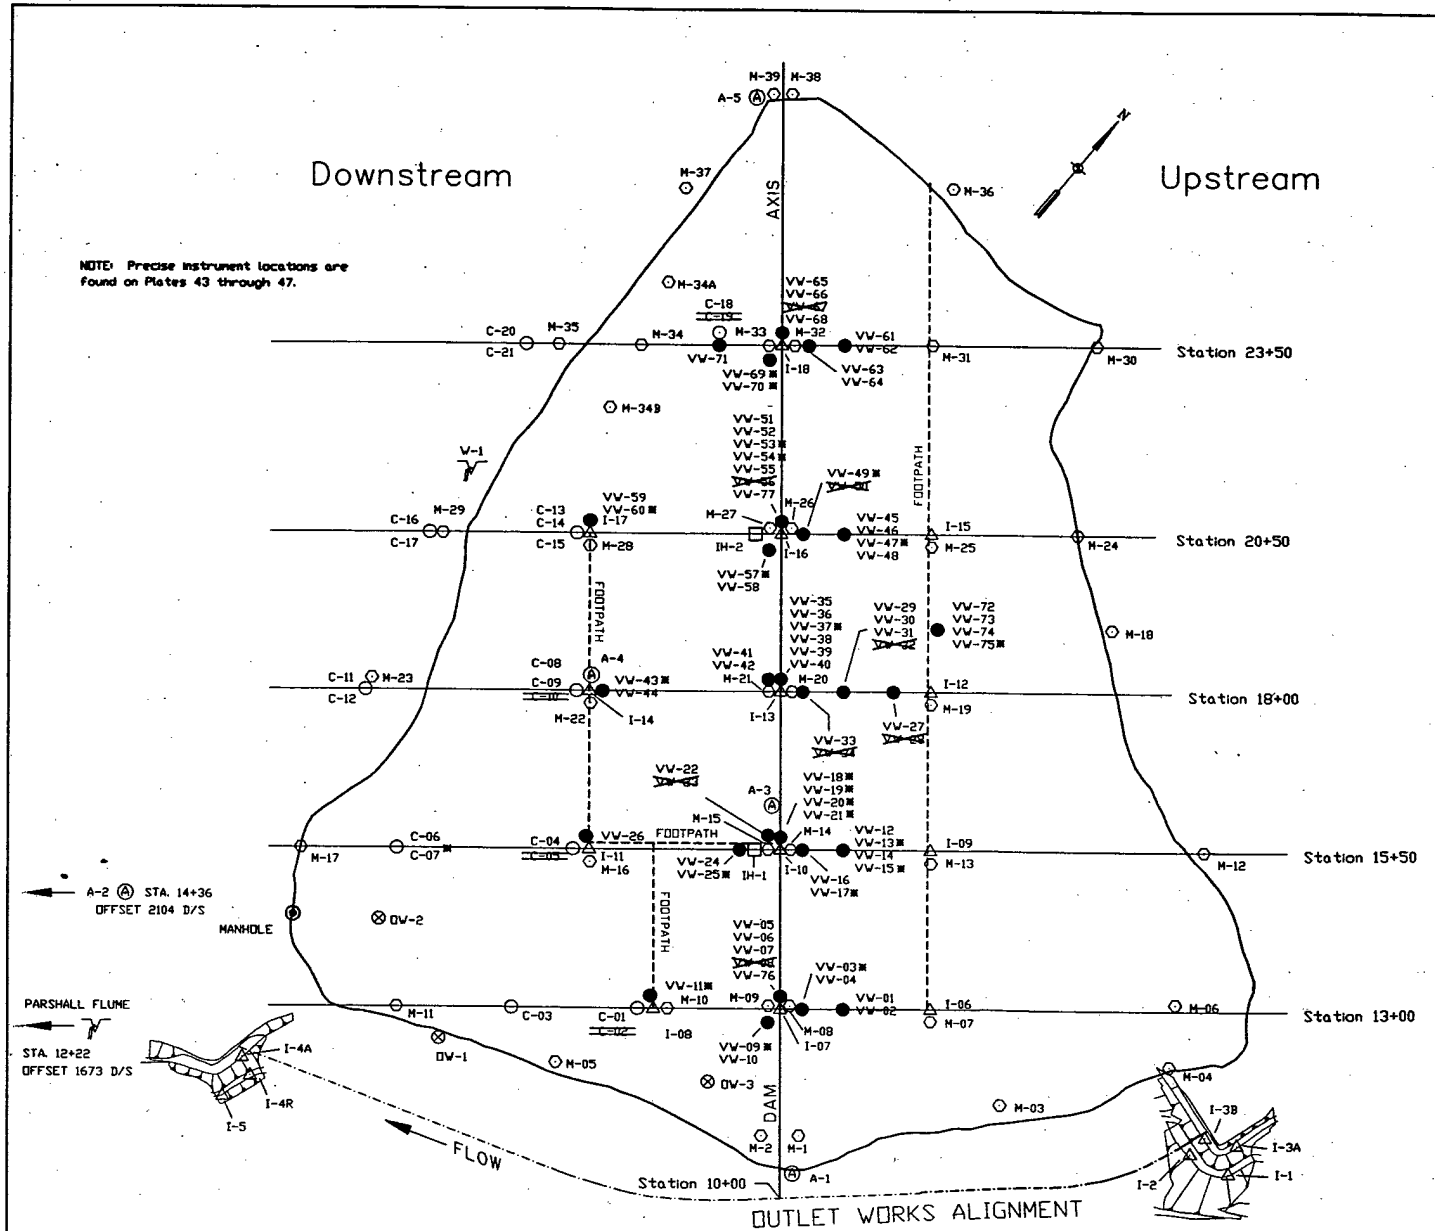
DESIGNED BY	DRAWN BY	CHECKED BY	FILE NO.
JWR	JWR	MDR	PLATE 42

(4) Subsequent to the End-of Construction, lightning destroyed eight (8) and damaged twenty-three (23) vibrating wire piezometers. Plate 42 shows which vibrating wire piezometers (VWP) were destroyed or damaged.

IH-1	INSTRUMENT HOUSE	A-5	ACCELEROGRAPH
I-07	INCLINOMETER	W-1	FLOW MEASUREMENT DEVICE
C-06	OPEN TUBE PIEZOMETER		MANHOLE
VW-1	VIBRATING WIRE PIEZOMETER	VW-75*	LIGHTNING DAMAGED VWP
OW-3	OBSERVATION WELL		LIGHTNING DESTROYED VWP
M-07	SURVEY MONUMENT	C-02	DTP DESTROYED DURING CONSTRUCTION

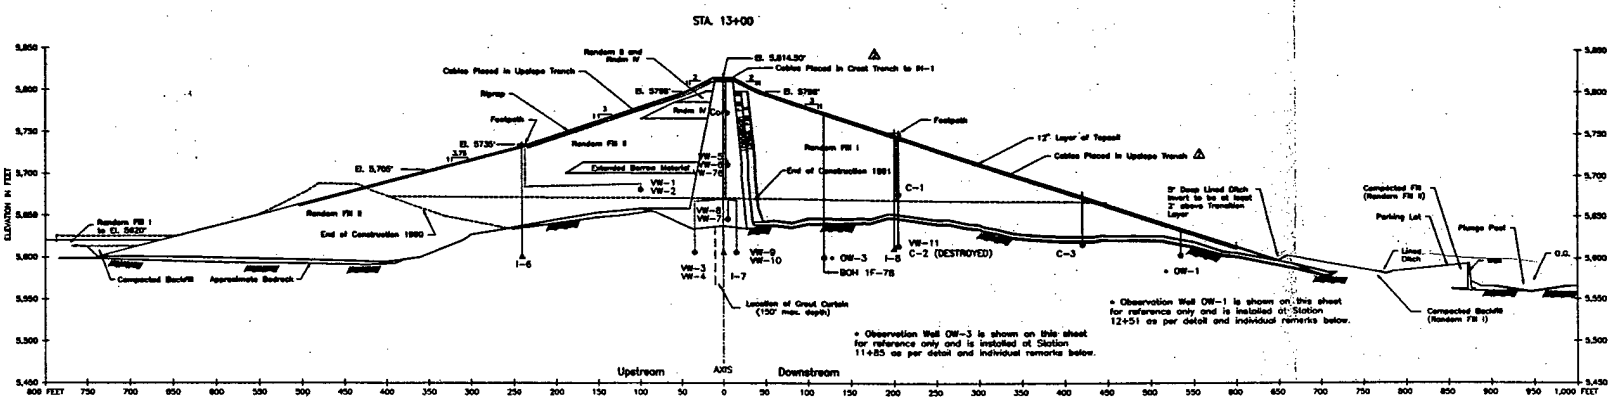
PLATE 43

NAME	TYPE	STATION	DAM AXIS OFFSET	TIP ELEV IN FEET	MATERIAL TYPE	INSTALLATION FILL ELEV.	METHOD OF INSTALLATION	REMARKS
VW-1	VIBRATING WIRE PIEZO	13+00	100 U/S	5681.1	RANDOM FILL II	5686.9	SINGLE PAIR VIBRATING WIRE/EMB.	INSTALLED WITH VW-2. Spliced 10-05-92 @ Sta. 13+11, 38 u/s, 5797 ft.
VW-2	VIBRATING WIRE PIEZO	13+00	100 U/S	5680.3	RANDOM FILL II	5686.9	SINGLE PAIR VIBRATING WIRE/EMB.	INSTALLED WITH VW-1. Spliced 11-21-92 @ Sta. 13+00, 10 d/s, 5810 ft.
VW-3	VIBRATING WIRE PIEZO	13+00	35 U/S	5606.0	BEDROCK, U/S FROM GROUT CURTAIN	5666.4	SINGLE PAIR VIBRATING WIRE/FND.	INSTALLED WITH VW-4.
VW-4	VIBRATING WIRE PIEZO	13+00	35 U/S	5605.4	BEDROCK, U/S FROM GROUT CURTAIN	5666.4	SINGLE PAIR VIBRATING WIRE/FND.	INSTALLED WITH VW-3.
VW-5	VIBRATING WIRE PIEZO	13+00	5 D/S	5710.8	CORE	5714.7	SINGLE PAIR VIBRATING WIRE/CORE	INSTALLED WITH VW-6 AND IN CONJUNCTION WITH VW-7B.
VW-6	VIBRATING WIRE PIEZO	13+00	5 D/S	5710.0	CORE	5714.7	SINGLE PAIR VIBRATING WIRE/CORE	INSTALLED WITH VW-5 AND IN CONJUNCTION WITH VW-7B.

VW-7	VIBRATING WIRE PIEZO	13+00	5 D/S	5644.9	CORE	5667.1	SINGLE PAIR VIBRATING WIRE/CORE	INSTALLED WITH VW-8.
VW-8	VIBRATING WIRE PIEZO	13+00	5 D/S	5645.5	CORE	5667.1	SINGLE PAIR VIBRATING WIRE/CORE	INSTALLED WITH VW-7.
VW-9	VIBRATING WIRE PIEZO	13+00	15 D/S	5610.4	BEDROCK, D/S FROM GROUT CURTAIN	5668.7	SINGLE PAIR VIBRATING WIRE/FND.	INSTALLED WITH VW-10. Note that sand section of installation is 8.1 ft. vs. nominal 5 ft. Sand section extended to cover water loss at el. 5614.7 ft.
VW-10	VIBRATING WIRE PIEZO	13+00	15 D/S	5609.6	BEDROCK, D/S FROM GROUT CURTAIN	5668.7	SINGLE PAIR VIBRATING WIRE/FND.	INSTALLED WITH VW-9. Note that sand section of installation is 8.1 ft. vs. nominal 5 ft. Sand section extended to cover water loss at el. 5614.7 ft.
VW-11	VIBRATING WIRE PIEZO	13+00	205 D/S	5616.2	BEDROCK	5660.2	SINGLE VIBRATING WIRE WITH OPEN TUBE/FND.	INSTALLED WITH C-2. Spliced 11-22-92 @ Back of Instrument House #4-1.

C-1	OPEN TUBE PIEZO	13+00	205 D/S	5676.0	RANDOM FILL I	5681.0	SINGLE OPEN TUBE ADDED IN EMB.	INSTALLED ALONE. Spliced 09-28-91 @ el. 5651.8 ft.
C-2	OPEN TUBE PIEZO	13+00	205 D/S	5615.2	BEDROCK	5660.2	SINGLE VIBRATING WIRE WITH OPEN TUBE/FND.	••• NON FUNCTIONAL ••• - Open Tube was damaged by settlement of the embankment during construction.
C-3	OPEN TUBE PIEZO	13+00	420 D/S	5615.7	BEDROCK	5632.3	SINGLE OPEN TUBE/FND.	INSTALLED ALONE. Open tube spliced at el. 5651.8 ft. C-3 VWP cable spliced 11-12-92 @ Sta. 15+50, Axis, el. 5810 ft.
I-6	INCLINOMETER	13+00	240 U/S	5602.7	BEDROCK	5640.9	INCLINOMETER	INSTALLATION OKAY. The bottom of this installation was grouted twice. NOTE - Bedrock has high permeability
I-7	INCLINOMETER	13+00	0	5594.8	BEDROCK	5666.8	INCLINOMETER	Inclinometer grouted to top of rock due to installation problem. Grouted section 44 ft. Spliced 04-21-92 @ approx. el. 5660 ft.
I-8	INCLINOMETER	13+00	200 D/S	5613.0	BEDROCK	5660.3	INCLINOMETER	INSTALLATION OKAY. Spliced 10-17-91 @ el. 5667.3 ft.

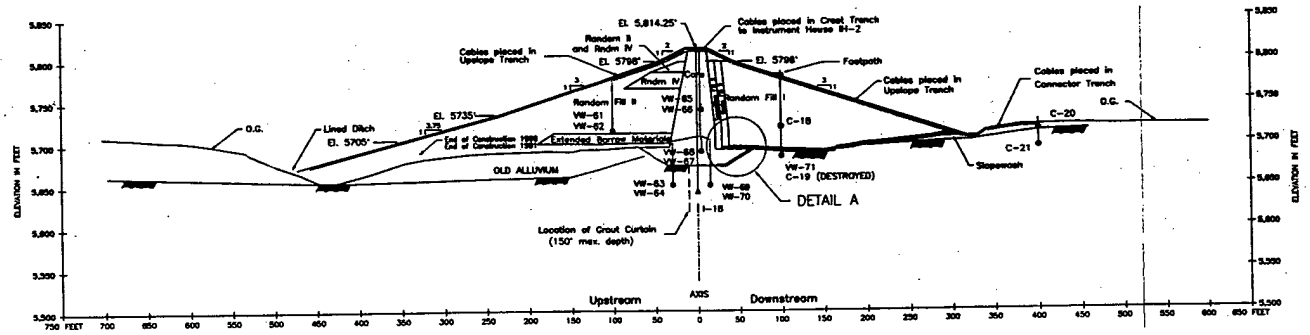
STA. 23+50

VW-68	VIBRATING WIRE PIEZO	23+50	5 D/S	5690.8	CORE	5701.9	SINGLE PAIR VIBRATING WIRE/EMB.	INSTALLED WITH VW-67. Hole was drilled by driving casing through core. This caused extremely high localized pore pressures.
VW-69	VIBRATING WIRE PIEZO	23+50	15 D/S	5650.8	BEDROCK, D/S FROM GROUT CURTAIN	5700.7	SINGLE PAIR VIBRATING WIRE/FND.	INSTALLED WITH VW-70.
VW-70	VIBRATING WIRE PIEZO	23+50	15 D/S	5650.0	BEDROCK, D/S FROM GROUT CURTAIN	5700.7	SINGLE PAIR VIBRATING WIRE/FND.	INSTALLED WITH VW-69.
VW-71	VIBRATING WIRE PIEZO	23+45	95 D/S	5681.0	BEDROCK	5719.2	SINGLE VIBRATING WIRE WITH OPEN TUBE/FND.	INSTALLED WITH C-19. This is the third VW-71 installed. Two installations were abandoned, one @ Sta. 23+50, 100 ft. d/s, and one @ Sta. 23+50, 95 ft. d/s.
C-18	OPEN TUBE PIEZO	23+50	100 D/S	5720.0	RANDOM FILL I	5720.0	OPEN TUBE PIEZO./ADDED IN EMB.	INSTALLED ALONE.
C-19	OPEN TUBE PIEZO	23+45	95 D/S	5679.7	BEDROCK	5719.2	SINGLE VIBRATING WIRE WITH OPEN TUBE/FND.	*** NON FUNCTIONAL *** - Open tube piezometer was damaged by settlement of the embankment during construction.

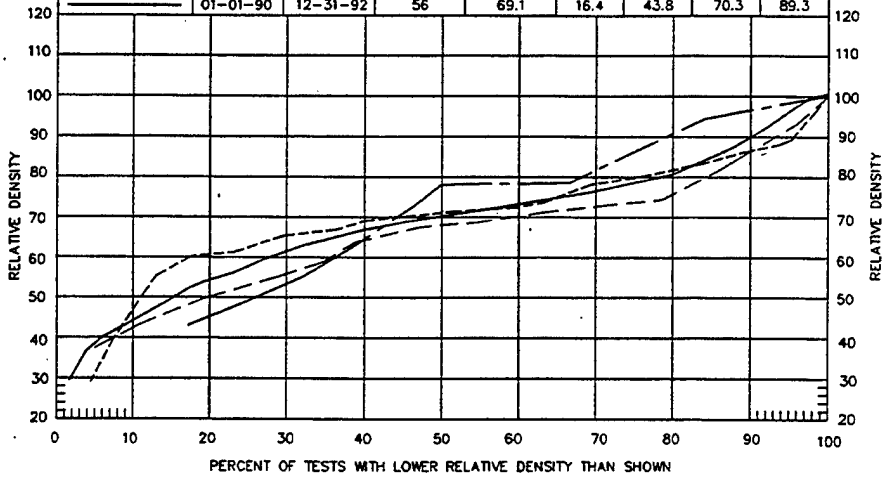
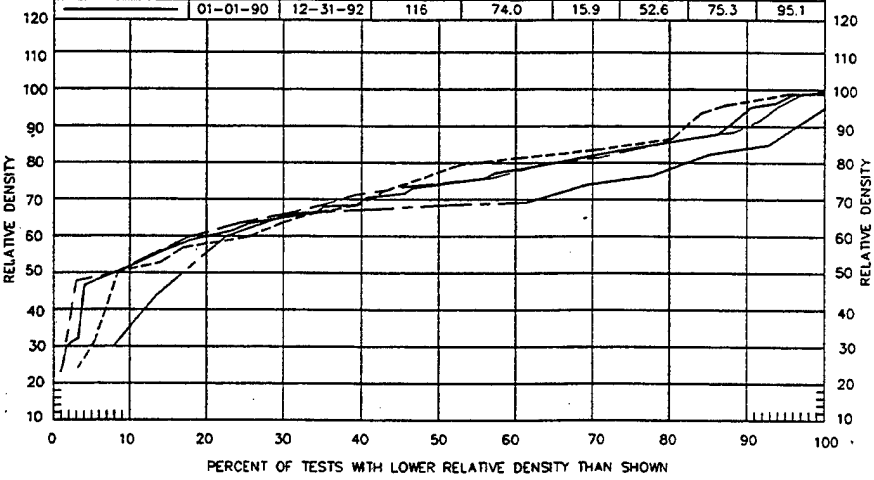
PLATE 34

MATERIAL/ITEM	SPECIFICATION [4] REQUIREMENTS	DISTRICT GUIDANCE [5]	ACCEPTED VARIATIONS
COMPACTION			
Equipment	Sheepsfoot. Rubber tired equipment at the abutments.	--	Except for initial and abutment placements, tamping foot CAT 825 was used. Allowed based on its performance.
Number of Passes	6	--	Numerous extra passes throughout the construction.
Speed	Sheepsfoot, 5.0 MPH, Maximum. Rubber tired equipment speed not stated.	--	Maximum allowed was 4.0 MPH, but because of restricted space speed was generally 1.5 to 2.5 MPH.
TRANSITION I			
SOIL TYPE	SP	--	Almost always SP material placed. Some SP-SC material placed. See Plate 33.
GRADATION			
% Passing 1-1/2"	100%	--	--
% Passing 3/4"	90% to 100%		
% Passing #4	72% to 100%		
% Passing #200	0% to 5%		
COMPACTION	None[3]	--	Relative density determined. 50% relative density considered the minimum with average of 70%. See Plate 34.

MATERIAL/ITEM	SPECIFICATION [4] REQUIREMENTS	DISTRICT GUIDANCE [5]	ACCEPTED VARIATIONS
MOISTURE	-2% to +1% of OMC	--	See Plate 34.
LOOSE LIFT Thickness	12", Maximum	--	Varied. Generally placed in 10" to 14" loose lifts.
COMPACTION			
Equipment	Vibratory Roller (10T)	--	—
Number of Passes	2		At the abutments the three horizontal blanket drain zones, (TI, DI, TII), were rolled concurrently. Speed was generally slower than 1.5 MPH and the number of passes greater than specified because of drum overlap.
Speed	1.5 MPH, Maximum		
TRANSITION II			
SOIL TYPE	SP, SP-SM, SP-SC, SM, SC	--	None. Generally SP, SP-SC material placed that was similar to Transition I. See Plate 33.
GRADATION			
% Passing 1-1/2"	100%	--	--
% Passing 3/4"	90% to 100%		
% Passing #4	72% to 100%		
% Passing #200	0% to 15%		
COMPACTION	None[3]	--	Relative density determined. 50%

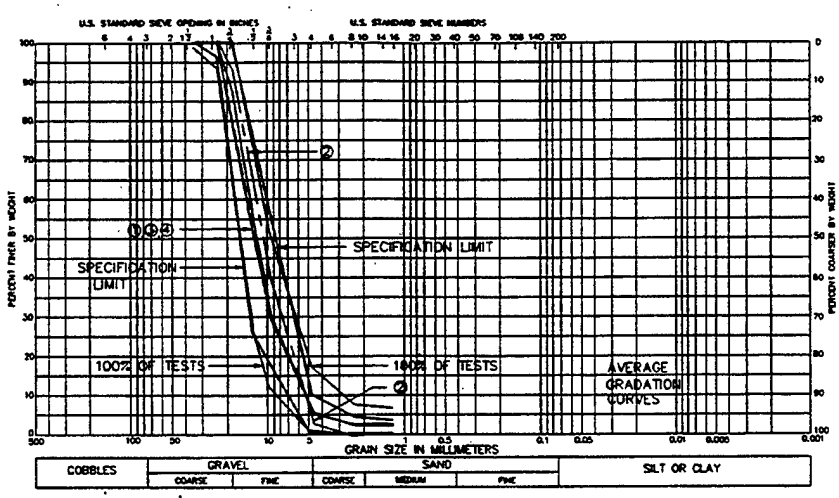
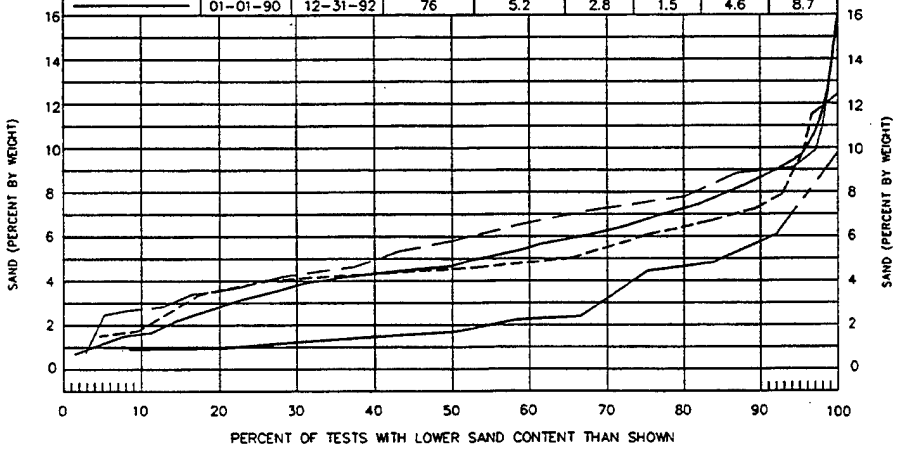
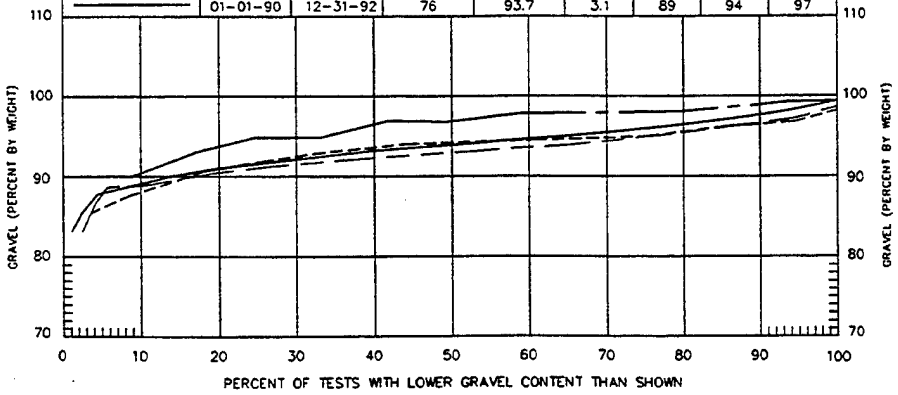
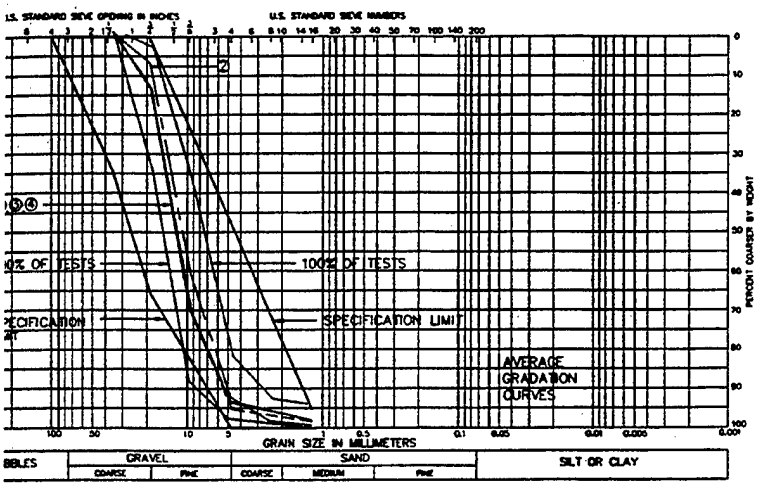
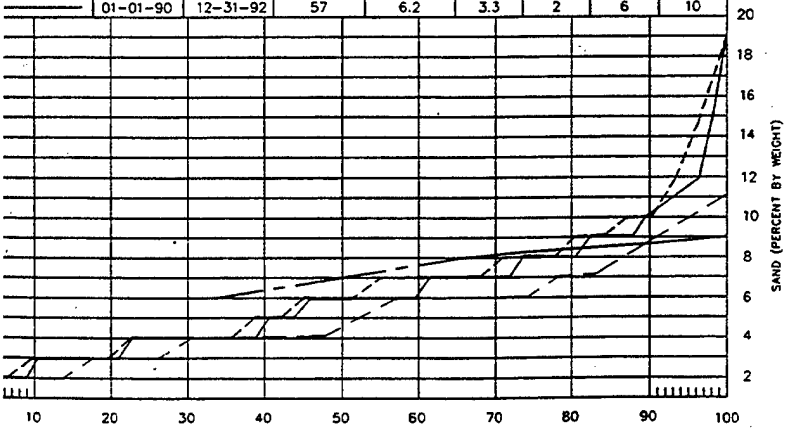
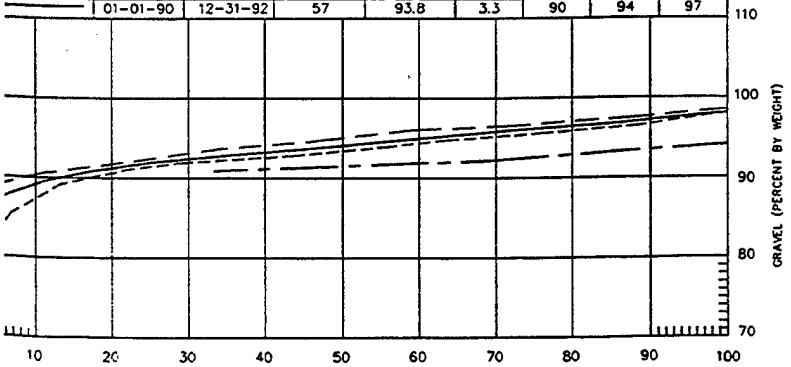
PLATE 35

MATERIAL/ITEM	SPECIFICATION [4] REQUIREMENTS	DISTRICT GUIDANCE [5]	ACCEPTED VARIATIONS
			relative density considered the minimum with average of 70%. See Plate 34.
MOISTURE	-2% to +1% of OMC	--	See Plate 34.
LOOSE LIFT Thickness	12", Maximum	--	Varied. Generally placed in 10" to 14" loose lifts.
COMPACTION Equipment	Vibratory Roller (10T)	--	--
Number of Passes	4	--	At the abutments the three horizontal blanket drain zones, (TI, DI, TII), were rolled concurrently. Speed was generally slower than 1.5 MPH and the number of passes greater than specified because of drum overlap.
Speed	1.5 MPH, Maximum	--	
DRAINAGE FILL I			
SOIL TYPE	GP	--	Generally placed GP. Some stone was not washed clean and particles had clay or silt coatings. See Plate 35.

MATERIAL/ITEM	SPECIFICATION [4] REQUIREMENTS	DISTRICT GUIDANCE [5]	ACCEPTED VARIATIONS
GRADATION			
% Passing 1-1/2"	100%	--	
% Passing 3/4"	60% to 100%		
% Passing #4	0% to 10%		
COMPACTION	None		
MOISTURE	2 Gal/SY/Lift	--	Moisture application never checked. Water applied mostly for dust control.
LOOSE LIFT Thickness	12", Maximum	--	Varied. Generally placed in 10" to 14" loose lifts.
COMPACTION	Static Smooth Drum (10T)	--	Rolled in vibratory mode at the abutments. At the abutments the three horizontal blanket drain zones, (TI, DI, TII), were rolled concurrently. Speed was generally slower than 1.5 MPH and number of passes greater than specified because of drum overlap.
DRAINAGE FILL II			
SOIL TYPE	GP	--	None. Generally placed GP material similar to Drainage Fill I. See Plate 35.

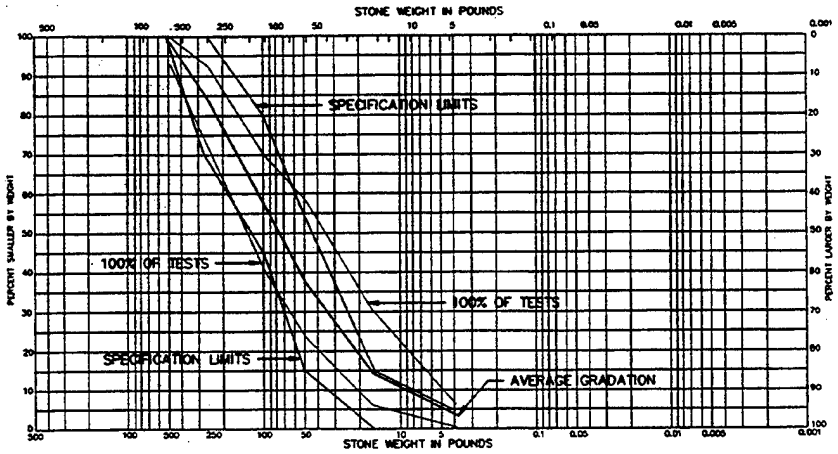
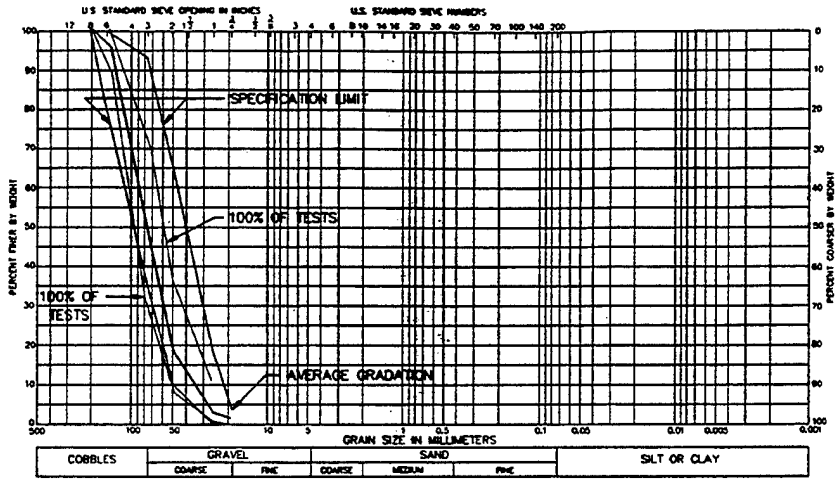
PLATE 36

Riprap and bedding were placed on the upstream face of the dam between late June and December 1992. The rock was obtained from an outcrop of the Nugget Sandstone in Peoa, Utah. The source had been preapproved, but two additional record samples were selected for testing. Gradations tests were also performed on inplace samples obtained at well distributed locations across the face. Material properties and As-Built and design information are presented on Plate 36.

A QUARRY PRE-BID STUDY	PEOA QUARRY AUG 92 SAMPLE	PEOA QUARRY AUG 92 SAMPLE	LITTLE DELL BORROW AREA JUNE 1990 SAMPLES	
			QUARTZITE	SANDSTONE
2.62	2.53	--	2.59	2.54
1.8%	2.0%	--	0.12%	0.66%
PASSED	PASSED	--	PASSED	FAILED
25.6%	46.0%	24.0%	10.8%	10.8%
9.0%	30.2%	--	0.7%	0.7%
PASSED	FAILED	PASSED	PASSED	PASSED

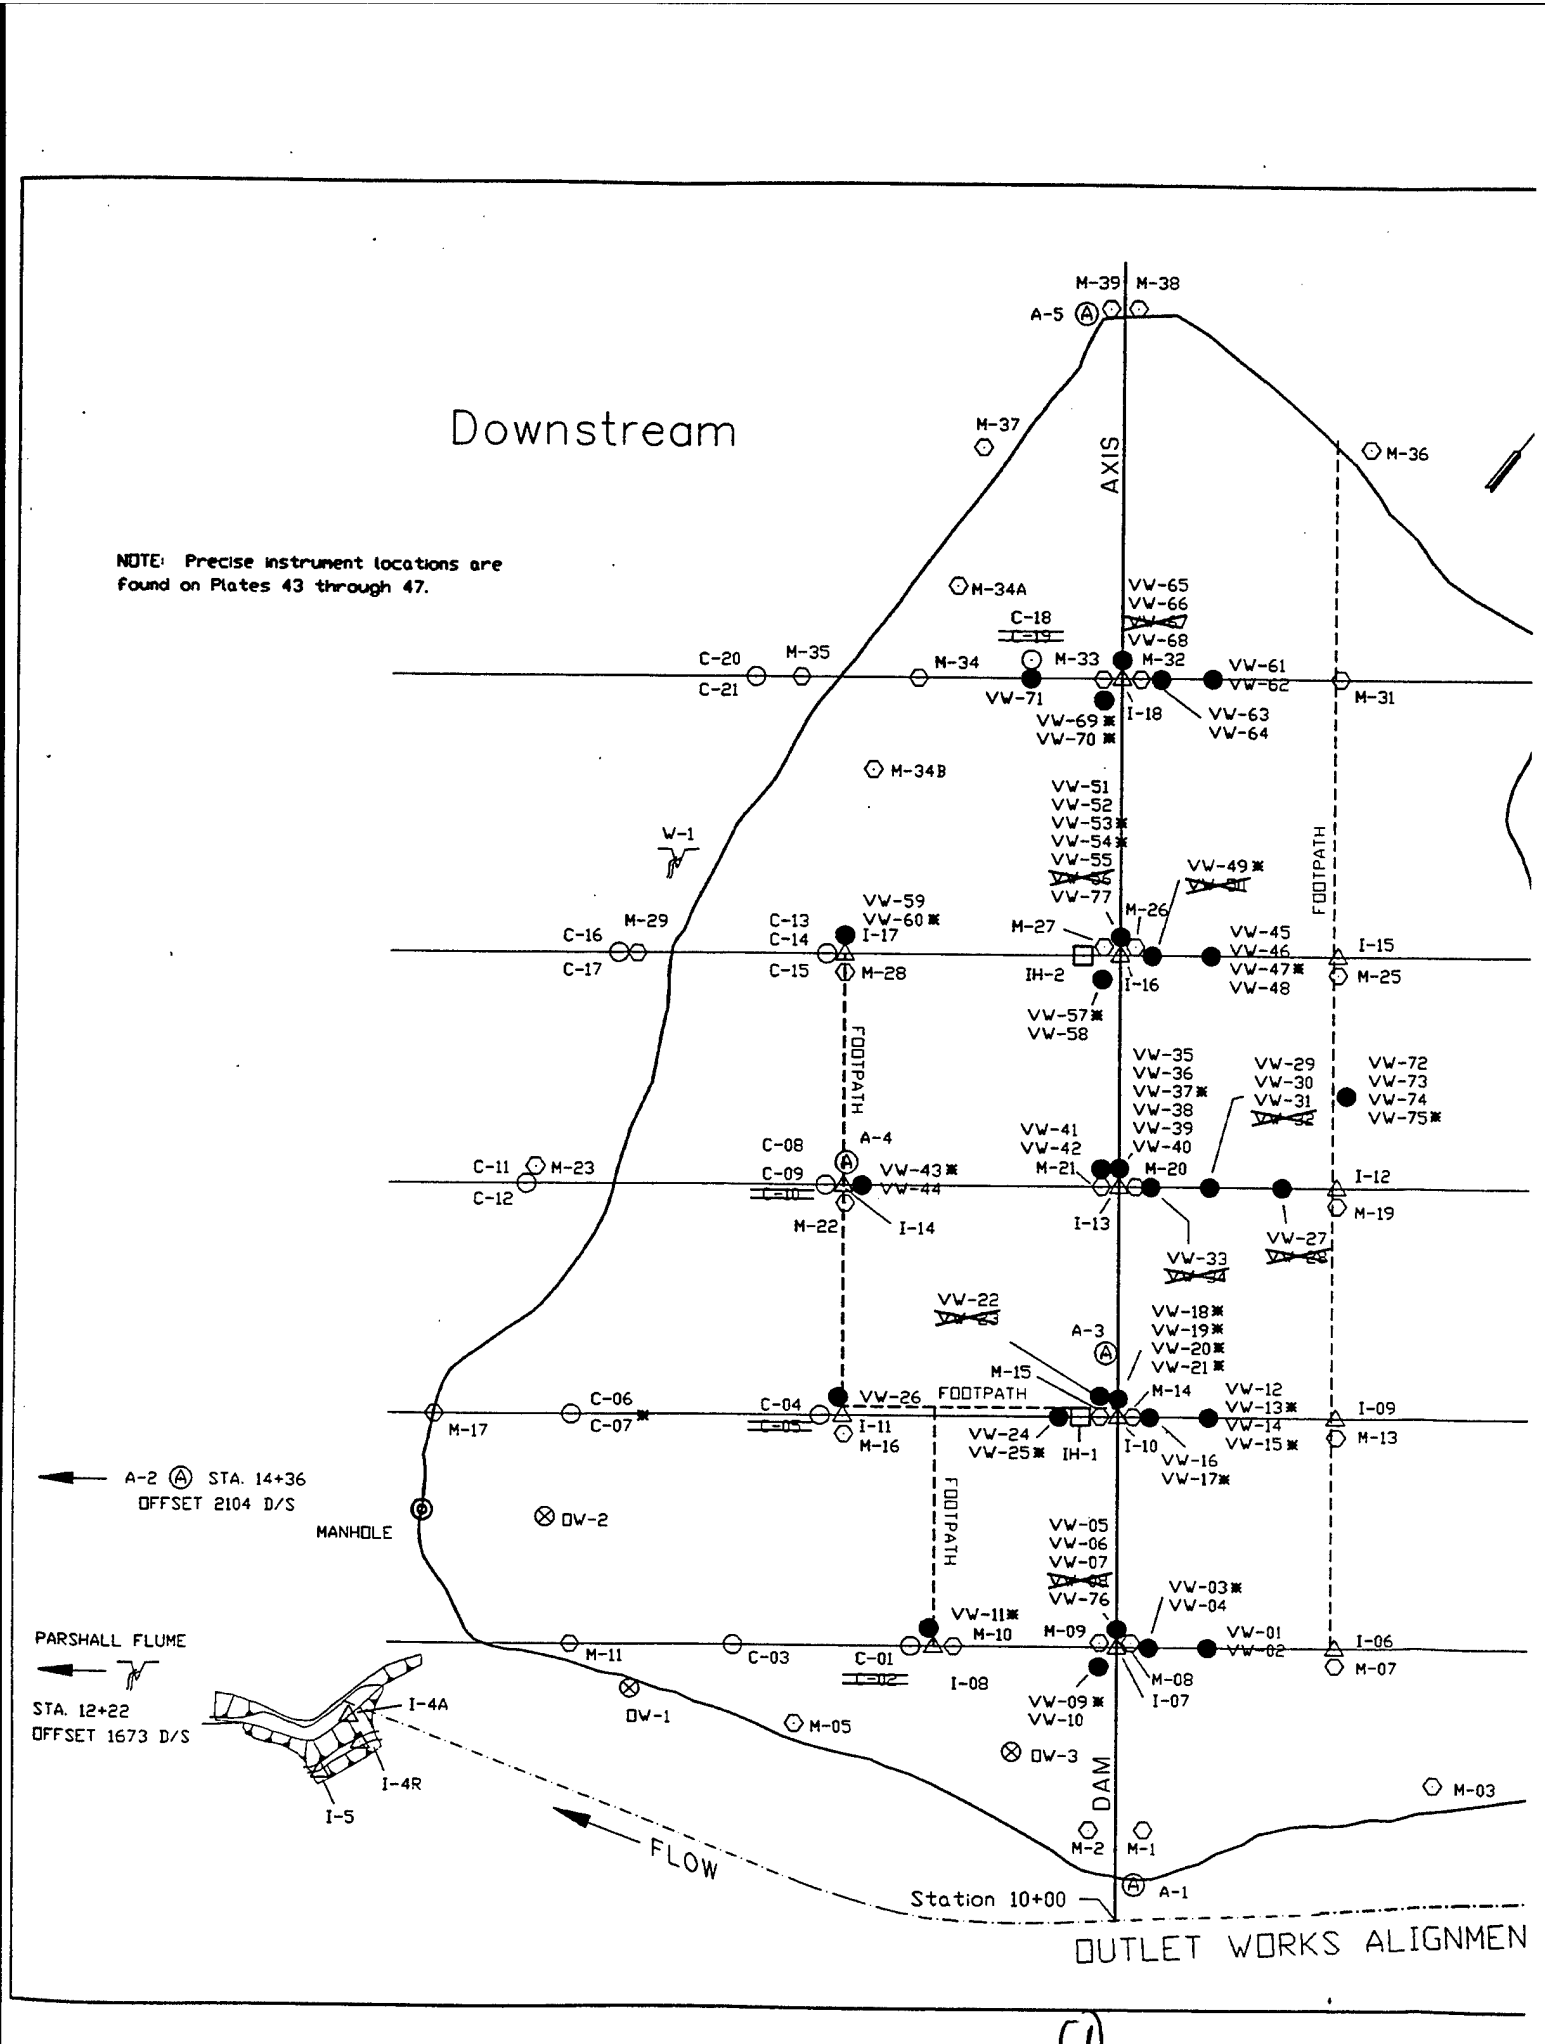
DR BY	CHECKED BY	CHECKED BY	FILE No.
JWR	JWR	MDR	PLATE 42

- IH-1 INSTRUMENT HOUSE
- I-07 INCLINOMETER
- C-06 OPEN TUBE PIEZOMETER
- VW-1 VIBRATING WIRE PIEZOMETER
- OW-3 OBSERVATION WELL
- M-07 SURVEY MONUMENT
- A-5 ACCELEROGRAPH
- W-1 FLOW MEASUREMENT DEVICE
- MANHOLE
- VW-75* LIGHTNING DAMAGED VWP
- ~~VW-82~~ LIGHTNING DESTROYED VWP
- ~~I-02~~ OTP DESTROYED DURING CONSTRUCTION

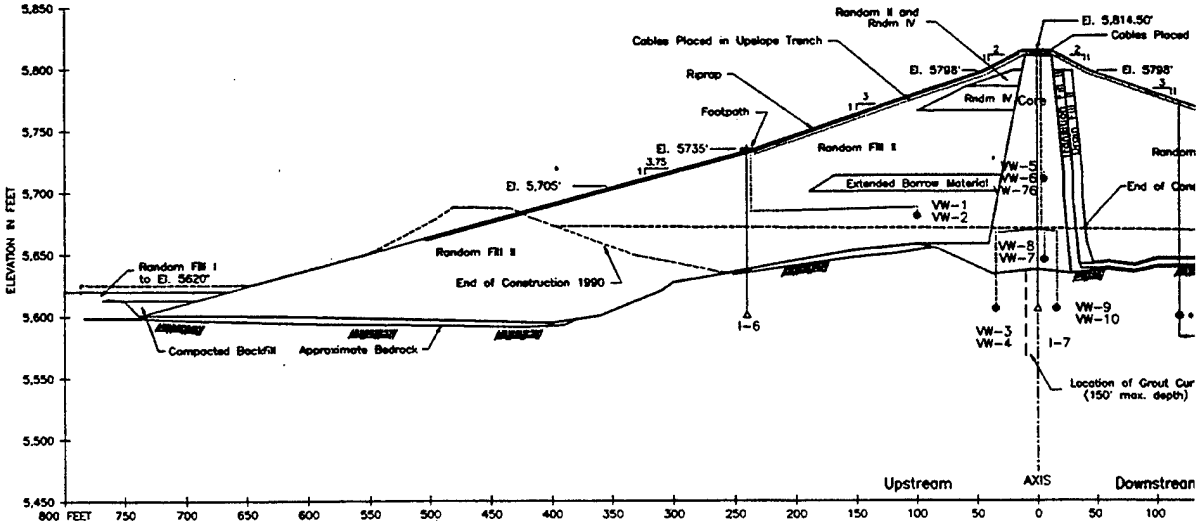
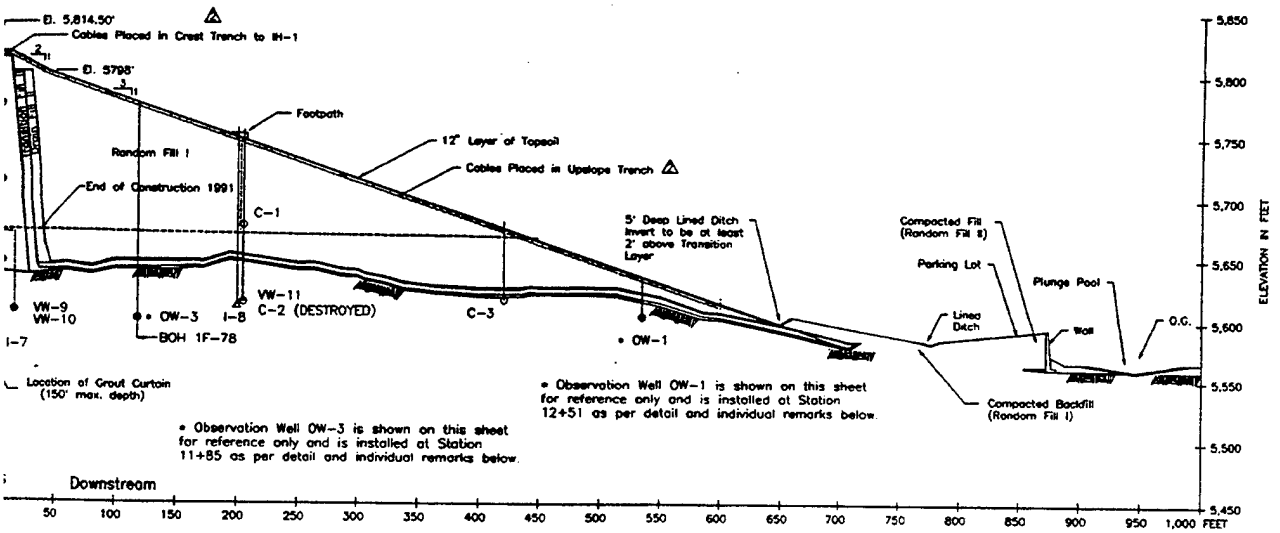
J ROADIFER	M. D. R		PLATE 43

INSTALLED ALONE. Open tube spliced at el. 5651.8 ft. C-3 VWP cable spliced 11-12-92 @ Sta 15+50, Axis, el. 5810 ft.
	INSTALLATION OKAY. The bottom of this installation was grouted twice. NOTE - Bedrock has high permeability
	Inclinometer grouted to top of rock due to installation problem. Grouted section 44 ft. Spliced 04-21-92 @ approx el. 5660 ft.
	INSTALLATION OKAY. Spliced 10-17-91 @ el. 5667.3 ft.
	INSTALLED AT 12+51. Located in a highly fractured sandstone to maximize potential for measuring end around seepage.
	RECOVERED 1F-78 as an observation well. An exploratory hole previously used as a piezometer It will provide useful end around seepage data.
RECT BURIAL VWP	INSTALLED IN CONJUNCTION WITH VW-5,6. Used for comparison of pore pressure measurements between contract installation method and direct burial method.

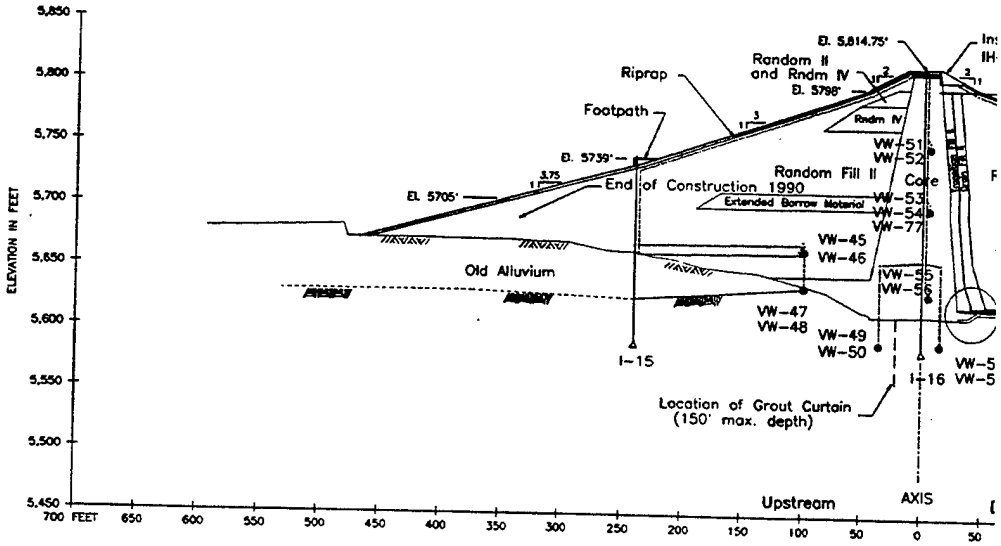
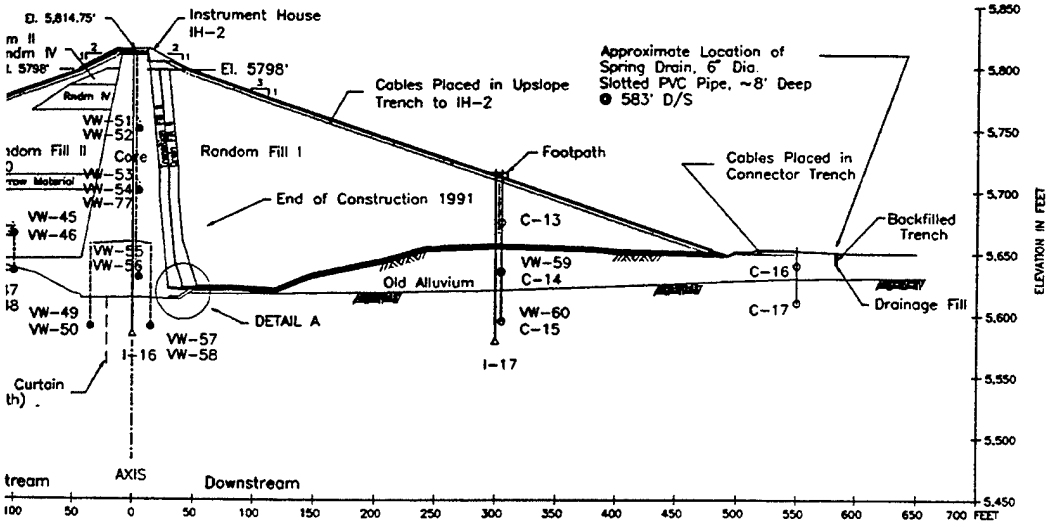
PLATE 46

ATION	REMARKS
WIRE/EMB.	INSTALLED WITH VW-46. Spliced 10-13-92 @ Sta. 20+54, 14 ft. u/s, el. 5808 ft.
WIRE/EMB.	INSTALLED WITH VW-45. Spliced 10-13-92 @ Sta. 20+55, 16 ft. u/s, el. 5808 ft.
WIRE/FND	INSTALLED WITH VW-48.
WIRE/FND	INSTALLED WITH VW-47.
WIRE/FND.	INSTALLED WITH VW-50.
WIRE/FND.	INSTALLED WITH VW-49.
WIRE/EMB.	INSTALLED WITH VW-52.
WIRE/EMB.	INSTALLED WITH VW-51.
WIRE/EMB.	INSTALLED WITH VW-54 AND IN CONJUNCTION WITH VW-77.
WIRE/EMB.	INSTALLED WITH VW-53 AND IN CONJUNCTION WITH VW-77.
WIRE/EMB	INSTALLED WITH VW-56.
WIRE/EMB.	INSTALLED WITH VW-55.
WIRE/FND.	INSTALLED WITH VW-58.
WIRE/FND.	INSTALLED WITH VW-57.
WITH OPEN TUBE/FND.	INSTALLED WITH C-14.
WITH OPEN TUBE/FND.	INSTALLED WITH C-15.
DED IN EMB	INSTALLED ALONE.
WITH OPEN TUBE/FND.	INSTALLED WITH VW-59.
WITH OPEN TUBE/FND.	INSTALLED WITH VW-60. Open tube piezometer damaged by settlement of the embankment. Retro. VWP is still functional but not removable.
