LITTLE DELL LAKE

SALT LAKE CITY STREAMS, UTAH

EMBANKMENT CRITERIA

PERFORMANCE REPORT

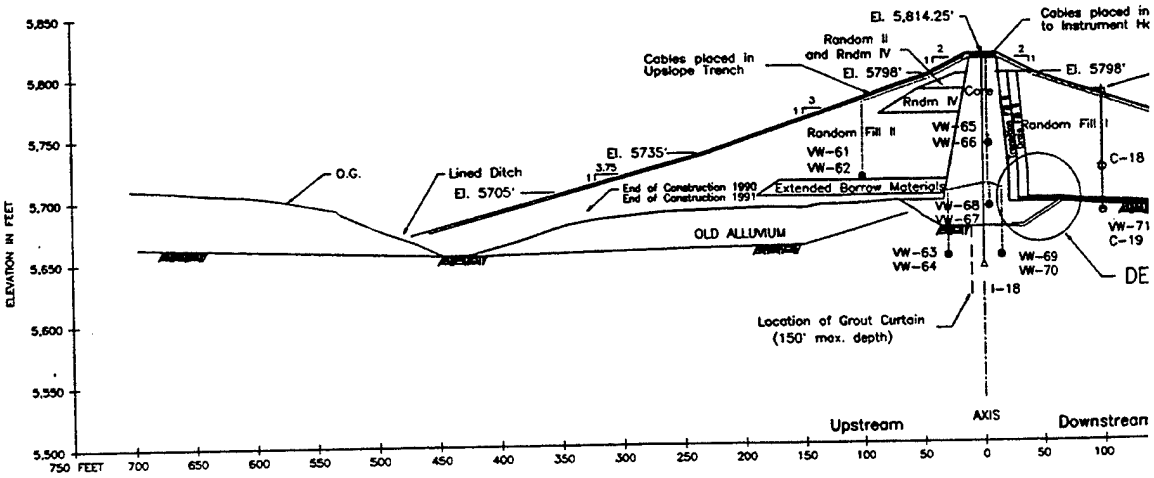
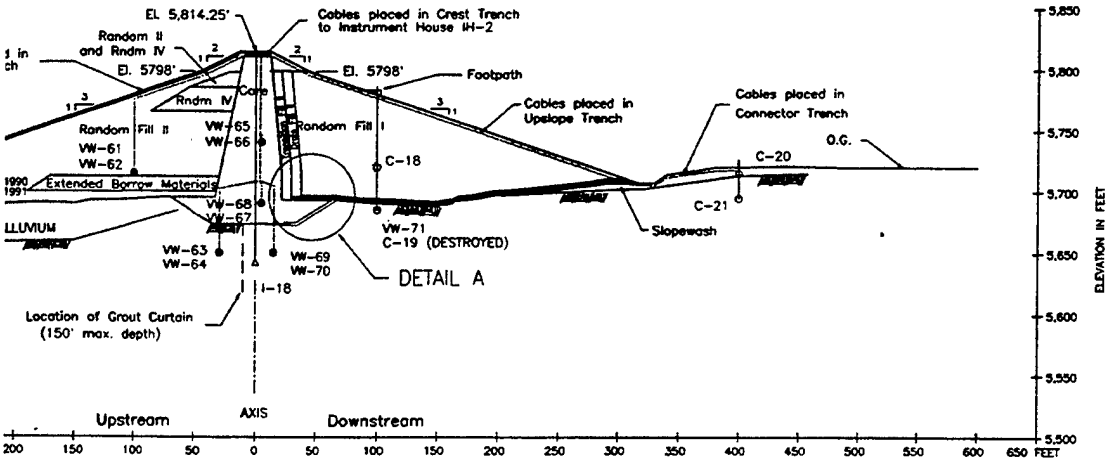
PLATE 47

INSTALLATION (DETAIL)	REMARKS
/IBRATING WIRE/EMB.	INSTALLED WITH VW-62.
/IBRATING WIRE/EMB.	INSTALLED WITH VW-61.
/IBRATING WIRE/FND	INSTALLED WITH VW-64.
/IBRATING WIRE/FND	INSTALLED WITH VW-63.
/IBRATING WIRE/EMB.	INSTALLED WITH VW-66.
/IBRATING WIRE/EMB.	INSTALLED WITH VW-65.
/IBRATING WIRE/EMB.	INSTALLED WITH VW-68. Hole was drilled by driving casing through core. This caused extremely high localized pore pressures.
/IBRATING WIRE/EMB.	INSTALLED WITH VW-67. Hole was drilled by driving casing through core. This caused extremely high localized pore pressures.
/IBRATING WIRE/FND.	INSTALLED WITH VW-70.
/IBRATING WIRE/FND.	INSTALLED WITH VW-69.
ING WIRE WITH OPEN TUBE/FND.	INSTALLED WITH C-19. This is the third VW-71 installed. Two installations were abandoned, one @ Sta. 23+50, 100 ft. d/s. and one @ Sta. 23+50, 95 ft. d/s.
IEZO./ADDED IN EMB	INSTALLED ALONE.
ING WIRE WITH OPEN TUBE/FND.	••• NON FUNCTIONAL ••• – Open tube piezometer was damaged by settlement of the embankment during construction.
