Phase II Site Investigations Report
Volume II of III
Site-Specific Investigations

Fort Devens Sudbury Training Annex, Massachusetts

September 1994
Contract No. DAAA15-90-D-0012
Delivery Order No. 0004
ELIN A009

PHASE II SITE INVESTIGATIONS
FORT DEVENS SUDBURY TRAINING ANNEX
MAYNARD, MASSACHUSETTS

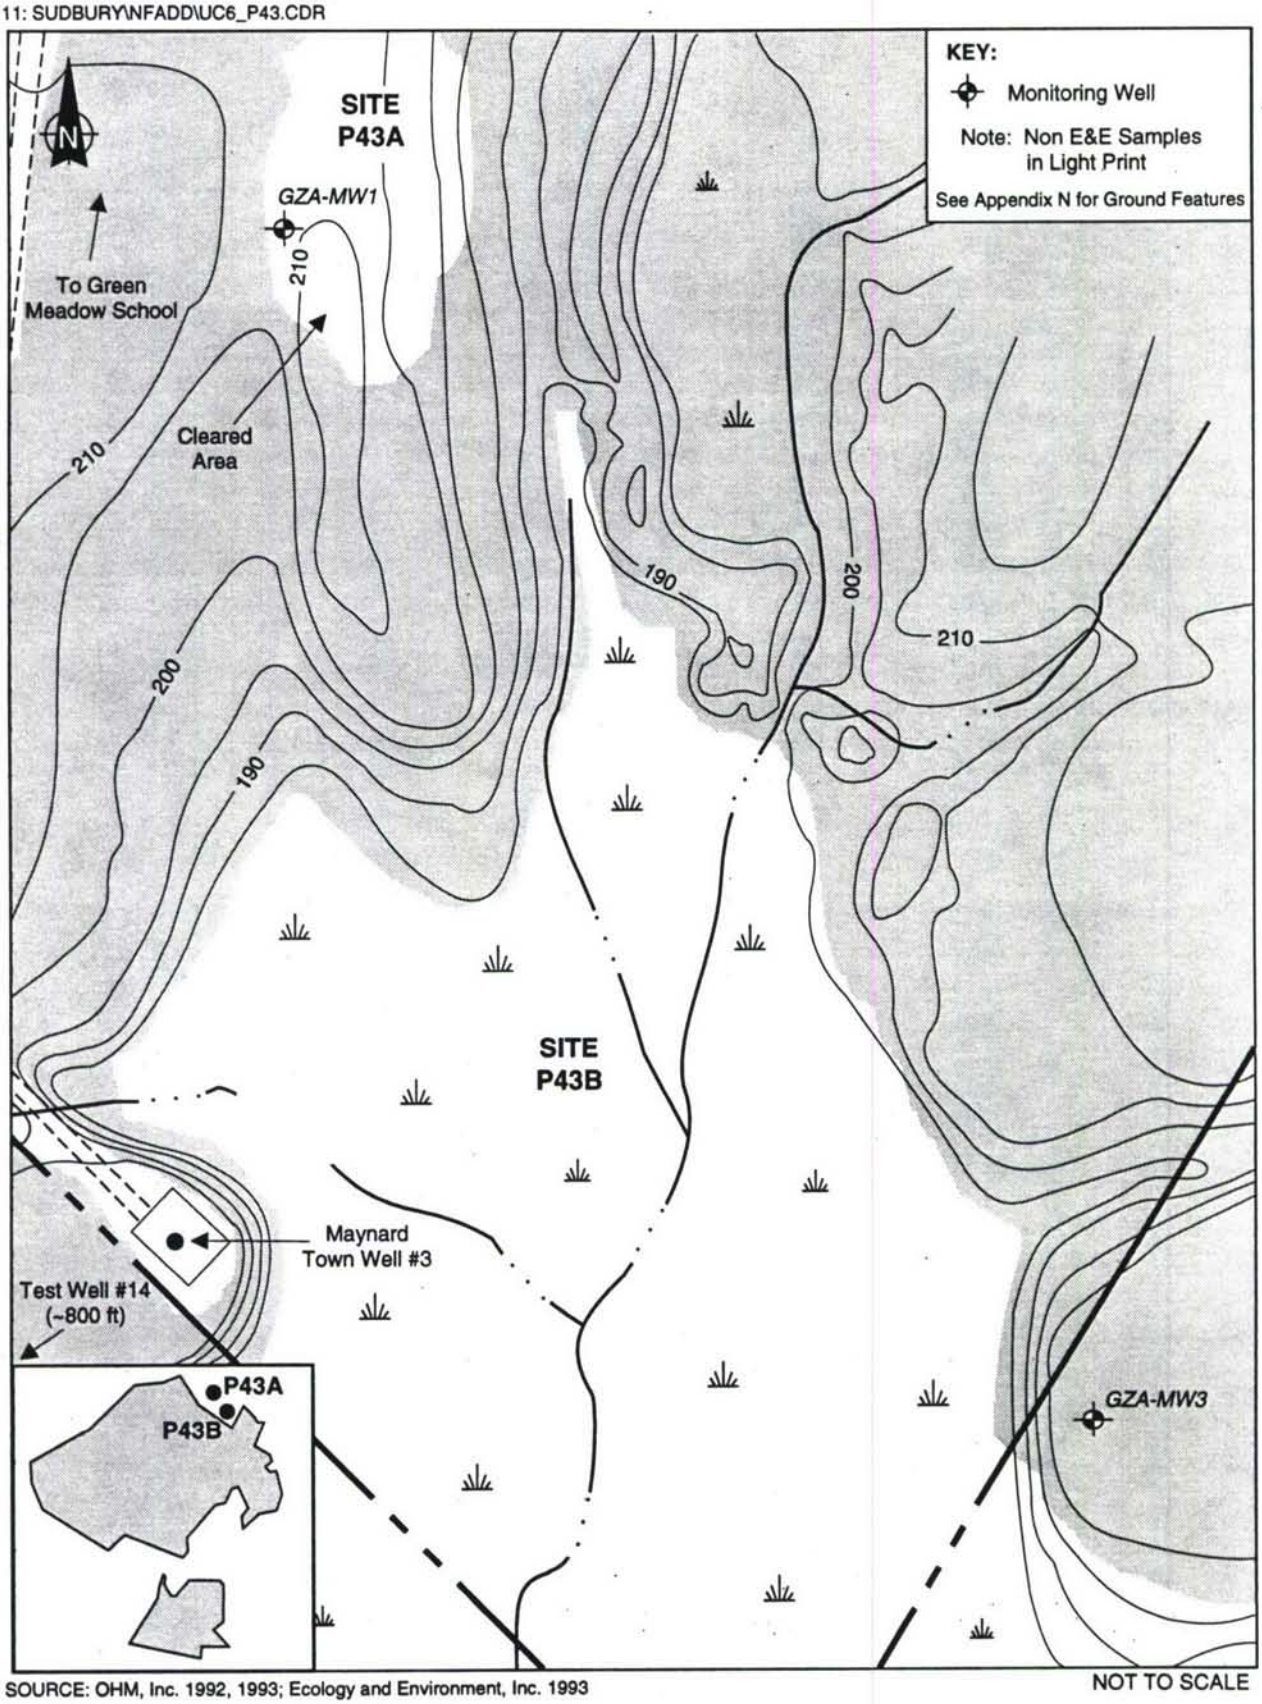
Figure 1-6 MAP OF SITE P43A AND B DISTURBED AREAS/VEGETATION STRESS

These areas were initially identified as zones of stressed vegetation during a study of aerial photographs undertaken by the EPA in 1982. Area features have been illustrated in the area presented as Figure 1-6. The sites are outside the current Annex property boundary.

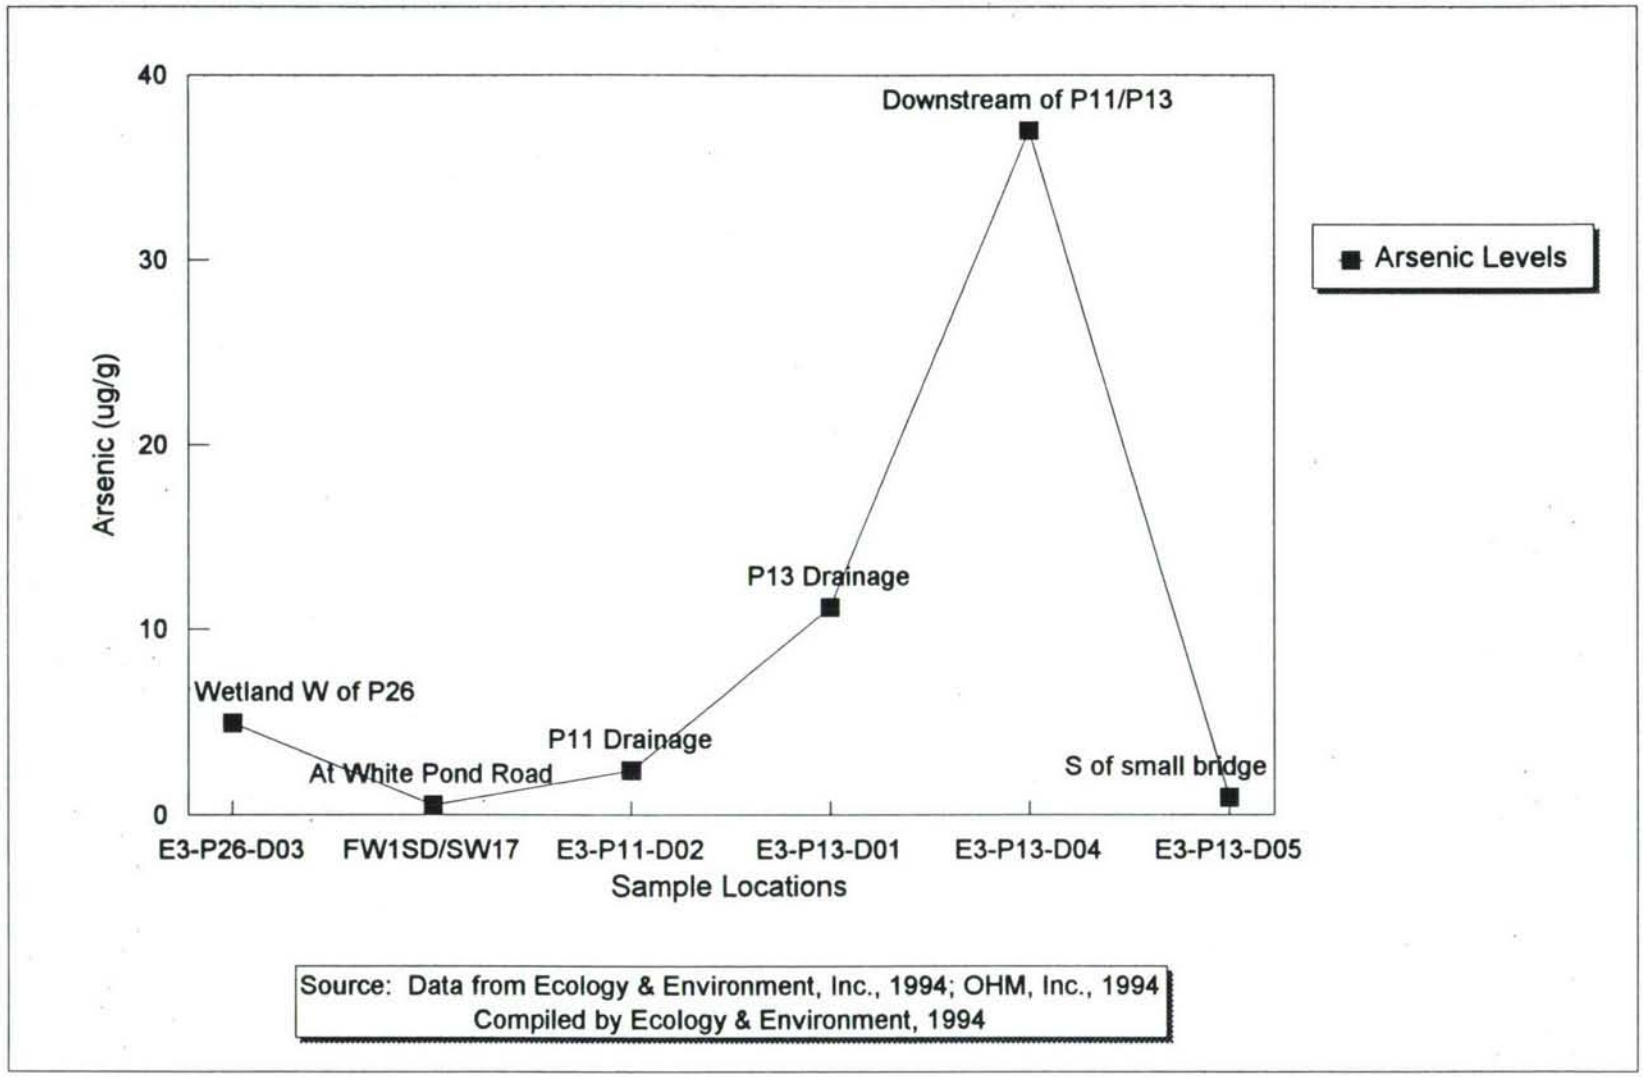
Graph 2-1 Arsenic Concentrations in Sediments in Tributary to Honey Brook

Analysis of sediment samples from Honey Brook also indicated concentrations of arsenic above background and screening levels. However, the concentration of arsenic in sediment increased as one proceeds downstream toward the ponded area at Puffer Pond, with the concentration at the most upstream sample (2.15 μg/g at E3-P26-D04) being only slightly above background, increasing to 8.20 μg/g at E3-P26-D02, and then rising to 35.0 μg/g at E3-P26-D01. The sample at the pond area had a high organic carbon content (46.3 percent), which probably indicates that arsenic is sorbing onto the organic-rich sediments at this point in Honey Brook. At the sediment sample (P4SD1) taken in the drainage from Site P4, arsenic was also found (9.4 μg/g). Arsenic (4.9 μg/g) was found at a lower level further downstream from E3-P26-D01 in the sample FW1SD9 taken below the tributary from Site P11/P13.

Chromium (38.1 μg/g) and copper (16.3 μg/g) were found in the FW1SD9 sample above background and screening levels.

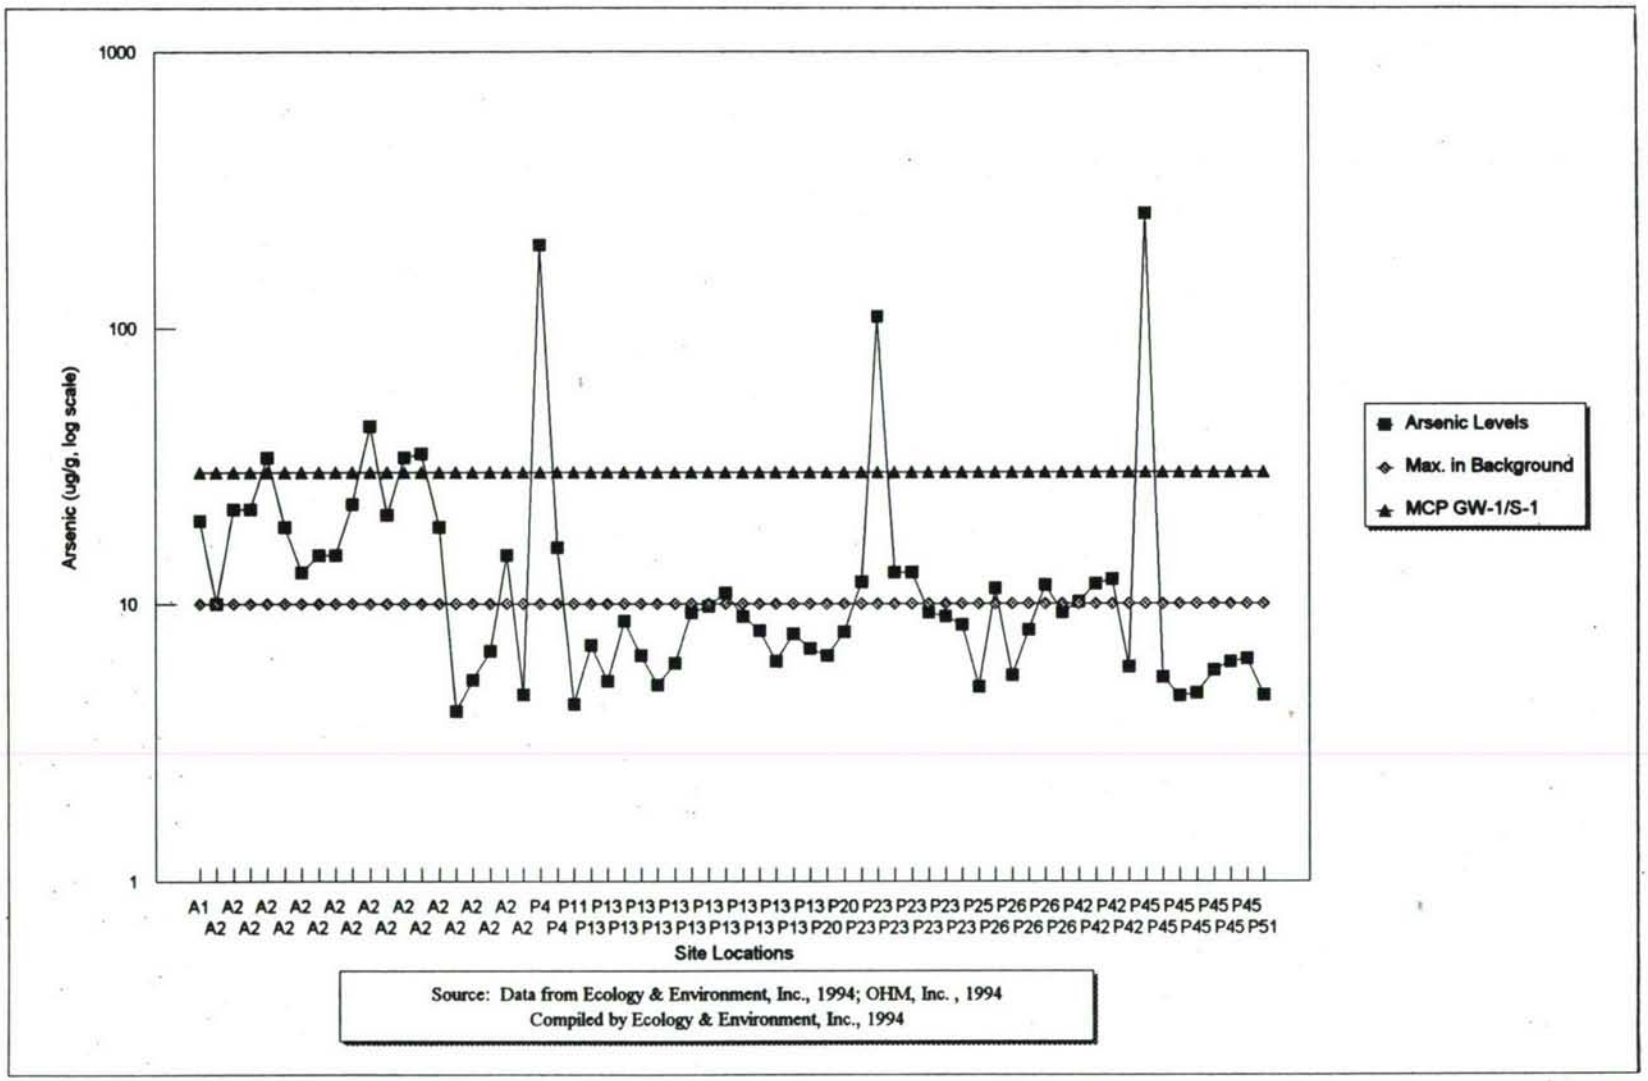
Graph 2-3 Arsenic Concentrations in Soils at Sites in Watershed 1B

Graph 2-3 below shows a profile of arsenic concentrations found in soil samples by site in Watershed 1B. Graph 2–4 is a profile of arsenic concentrations in the drainage from Cutting Pond (in Watershed 1A) to Taylor Brook at Site P42 outside the Annex boundary in Watershed 1B. Tables 2-6 and 2-7 provide a summary of compounds found at concentrations above background and screening levels in surface waters and sediments in Watershed 1B.

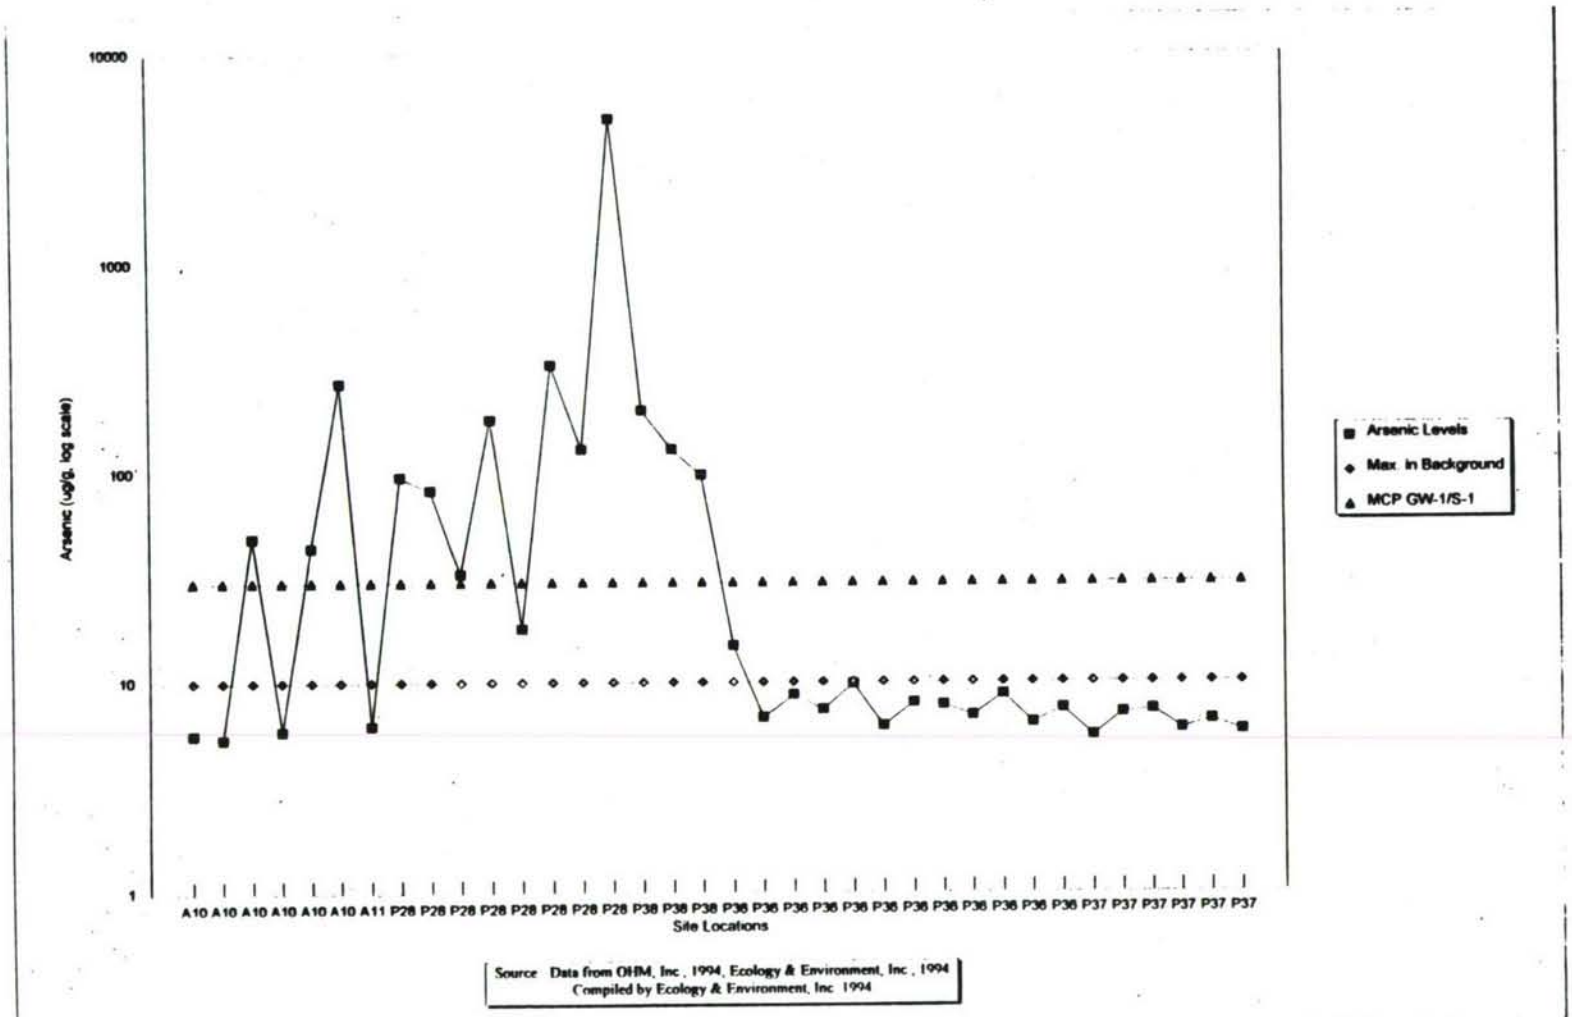
Graph 3-1 Arsenic Concentrations in Soils at Sites in Watershed 2

Graph 3-1 shows the arsenic levels found in soil samples at site in Watershed 2. The sites associated with railway operations (A10, P28, and P38) all have elevated concentrations of arsenic above the screening level, while concentrations of arsenic at other sites are below background levels, reinforcing the possibility that the likely source of arsenic in Marlboro

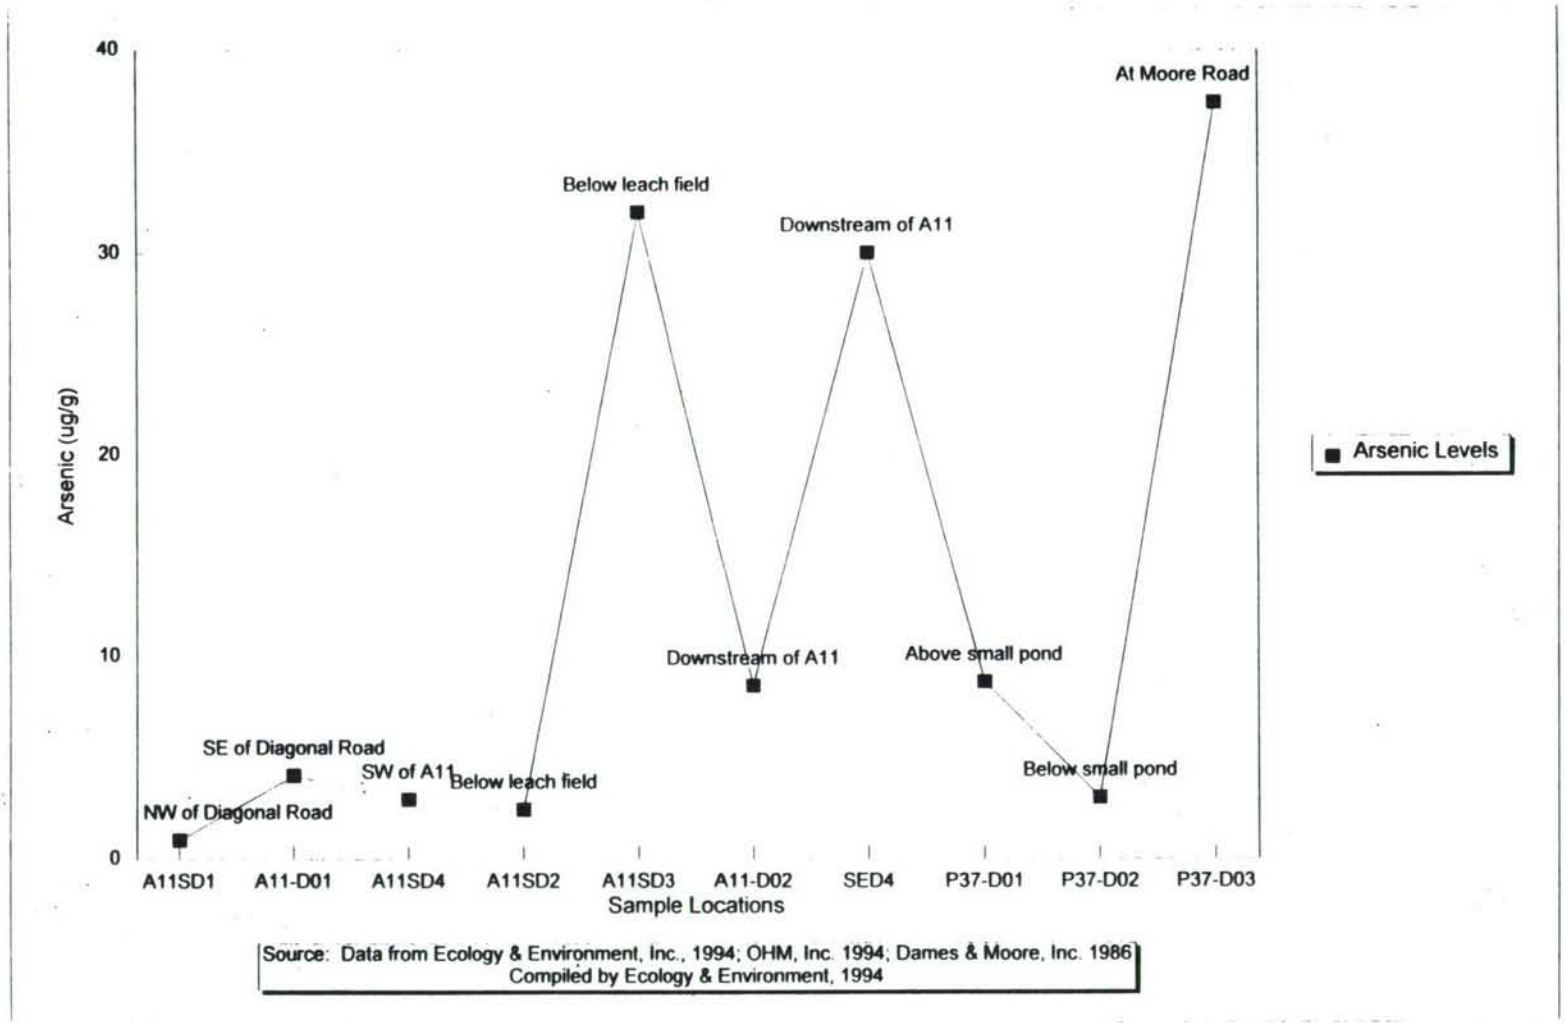
Graph 3-2 Arsenic Concentrations in Sediments in Marlboro Brook

Brook is activity in the Rocket Range/Railroad Classification Yard and surrounding area. One possible activity in this area could be the use of arsenic-based herbicides for weed control in the years of railway operations (1942 to 1964) or the arsenic could come from coal ash or railroad ballasts. Graph 3-2 shows the arsenic levels in Marlboro Brook sediments.

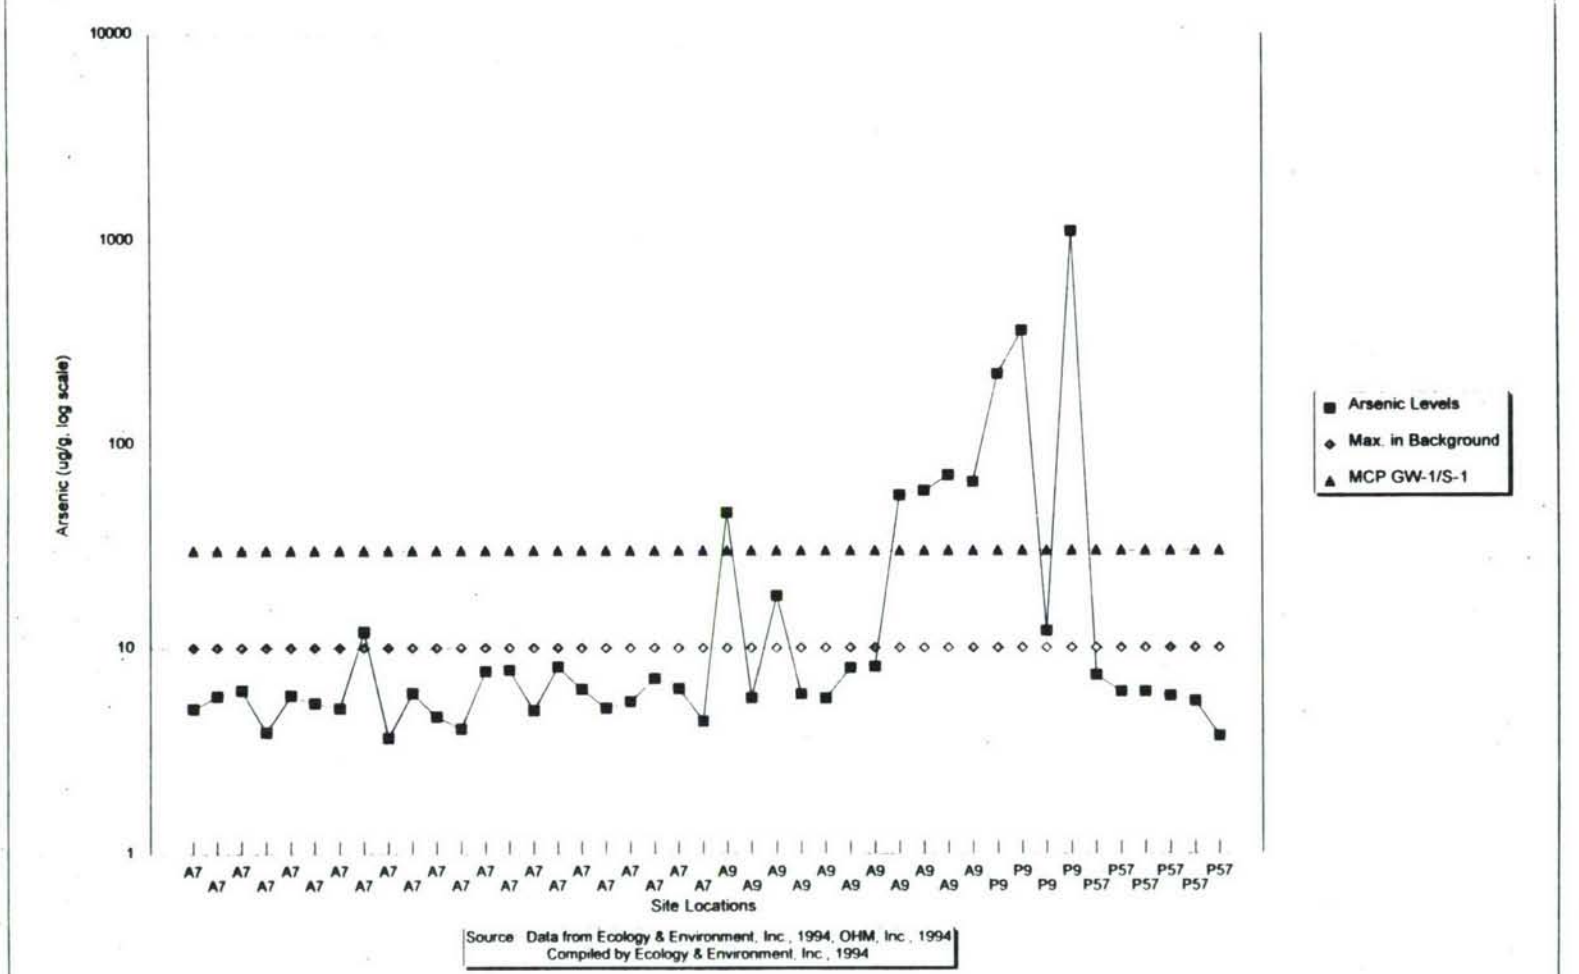
Graph 4-1 Arsenic Concentrations in Soils at Sites in Watershed 3

Graph 4-1 shows a profile of arsenic concentrations found in soil samples in Watershed 3. Graph 4-2 shows a profile of arsenic concentrations in the tributary to the Assabet that drains Watershed 3.
