DEGRADATION, RELIABILITY, AND FAILURE OF SEMICONDUCTOR ELECTRONIC DEVICES

M.A. Derenge, M.H. Ervin, K.W. Kirchner, K.A. Jones*, M.C. Wood, and T.S. Zheleva
Microdevices Branch, Army Research Lab – SEDD, AMSRD-SE-DL, Adelphi, MD

Degradation, Reliability and Failure of Semiconductor Electronic Devices

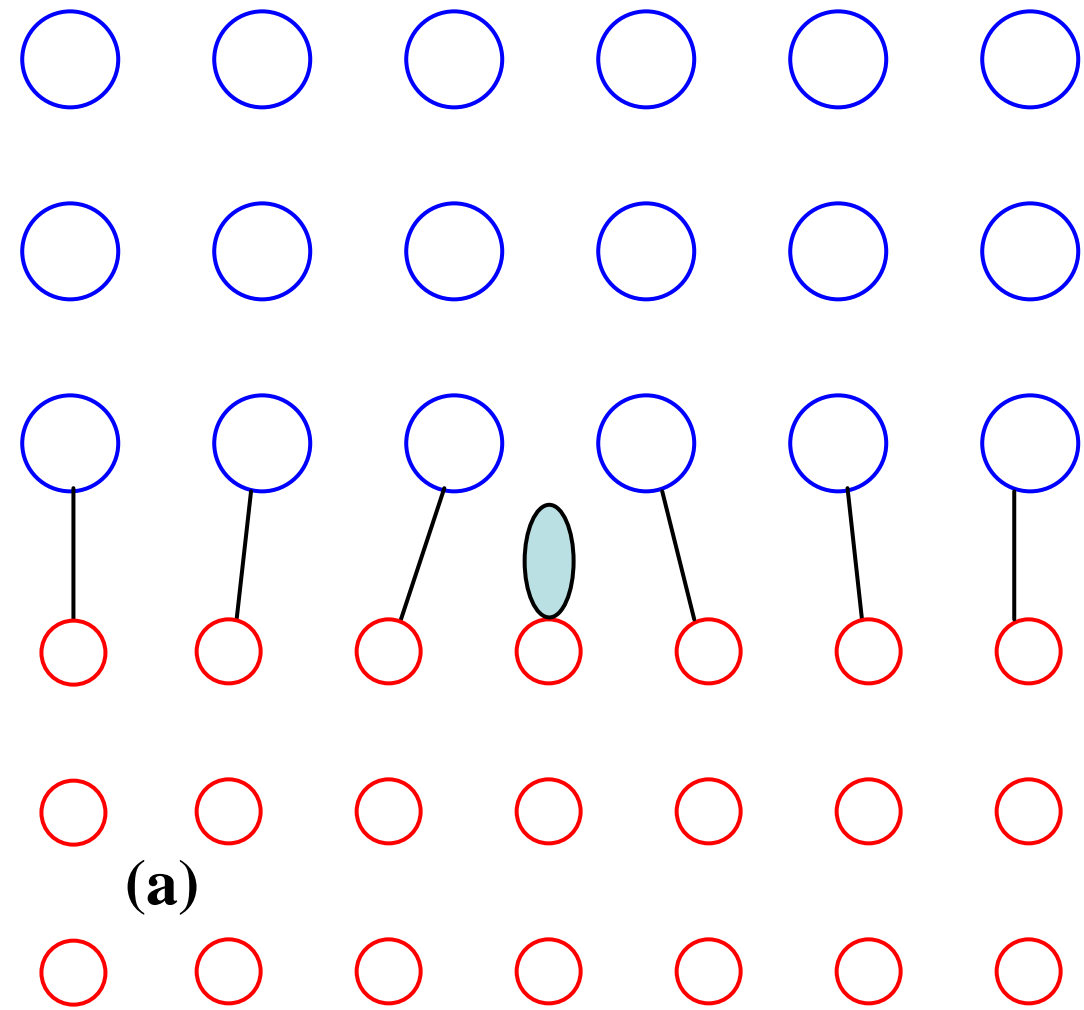
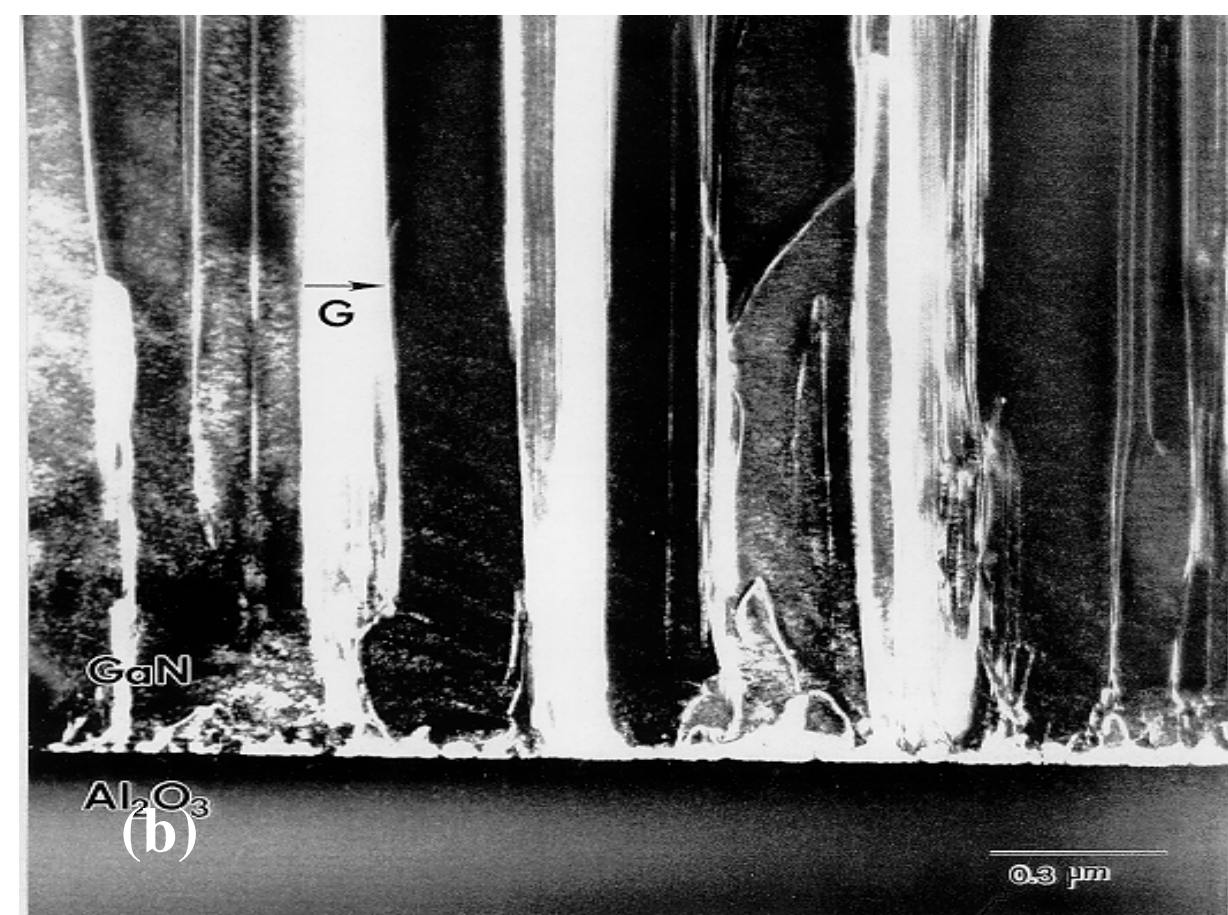
Fig. 3. (a) A schematic on how mismatch dislocations are formed. (b) TEM micrograph of the small angle grain boundaries formed in GaN grown on sapphire (Al_2O_3).

that of the substrate it is grown on. This is demonstrated schematically in Fig. 3a; the consequences of the GaN growing as filaments separated by small angle grain boundaries formed by large numbers of threading dislocations is shown in the TEM micrograph in Fig. 3b. One method for reducing the number of defects is a growth method called pendeo epitaxy. In this method a GaN film is deposited on a substrate such as sapphire or SiC, and then is patterned and etched to form parallel columns and channels with a specific crystallographic orientation. Under very specific MOCVD growth conditions growth occurs laterally from the columns out over the channels where two wings growing out in opposite directions from adjacent columns meet and coalesce. As shown in Fig. 4, these wings have many fewer defects because they are not forced to lattice match with the substrate. We show examples of materials that were grown by pendeo epitaxy (Zheleva et al., 1999), how the film can be processed so that devices are fabricated on the high quality wing regions, and how much better the material is in the winged regions as well as how much better devices fabricated in these regions operate (Zheleva et al., 2008).

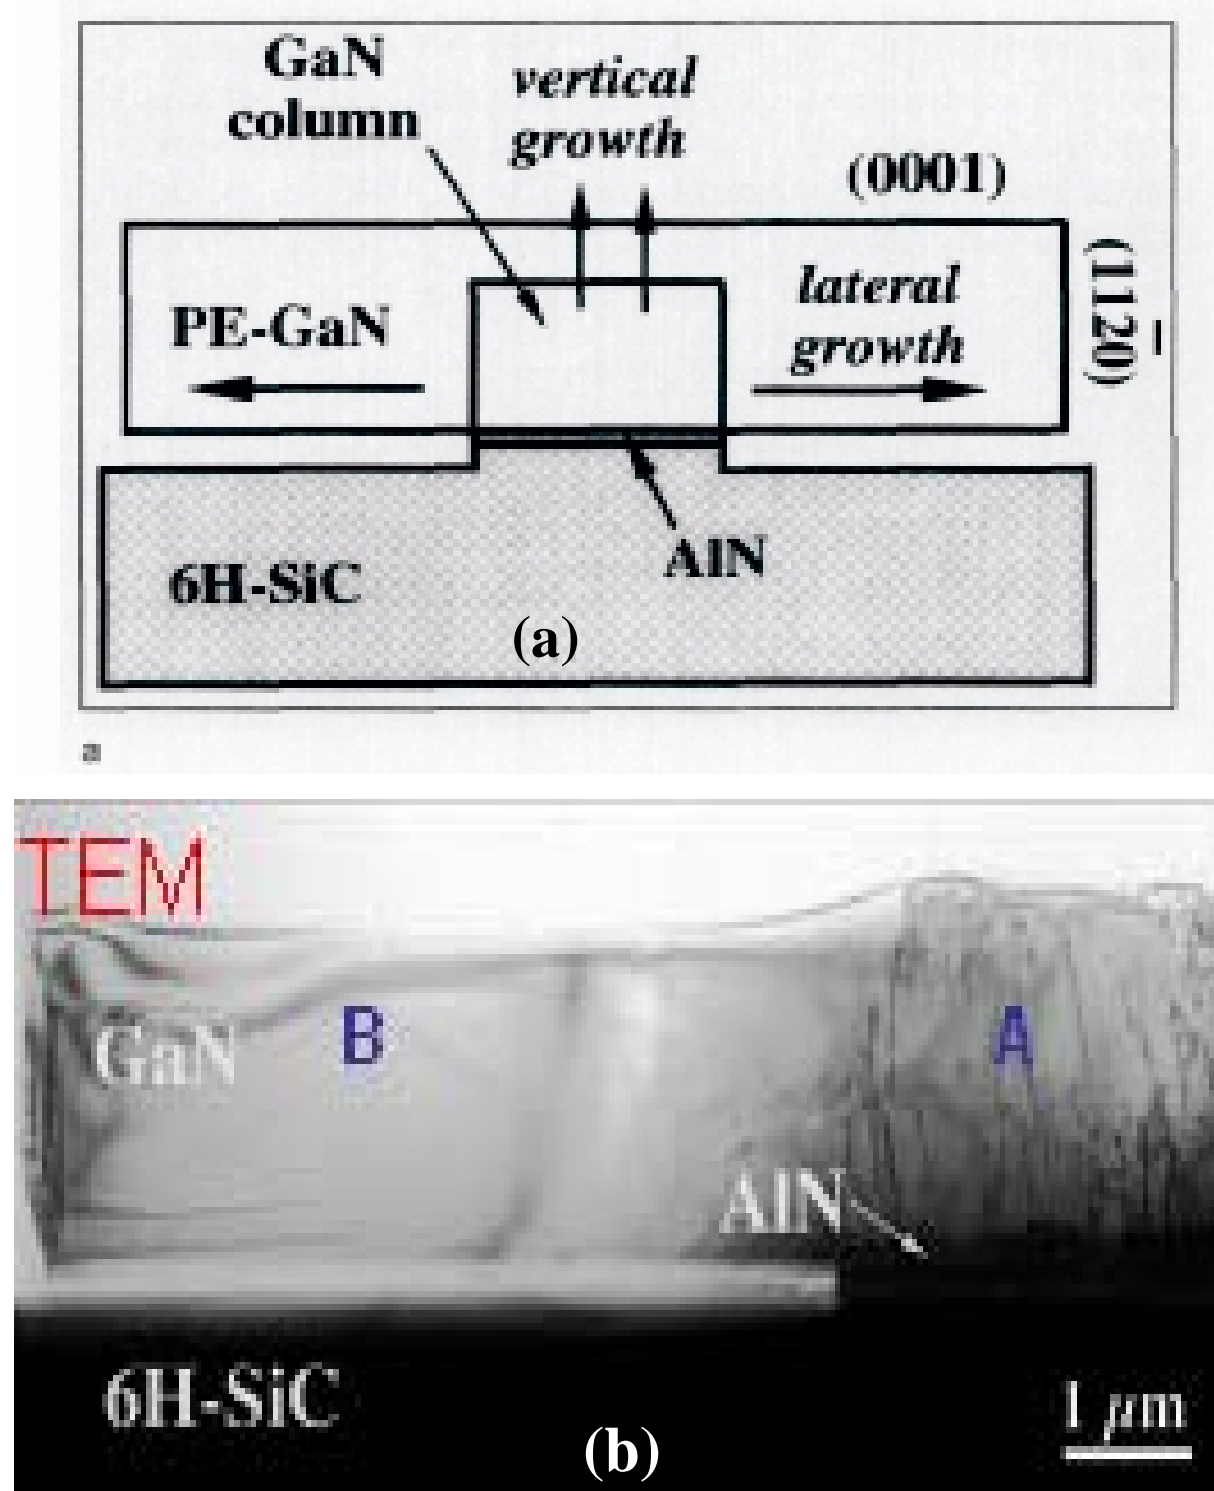
Fig. 4. (a) Schematic diagram demonstrating pendeo-epitaxial growth. (b) TEM micrograph of a pendeo film showing the more defective column **(A)** and more defect free wings **(B)**.

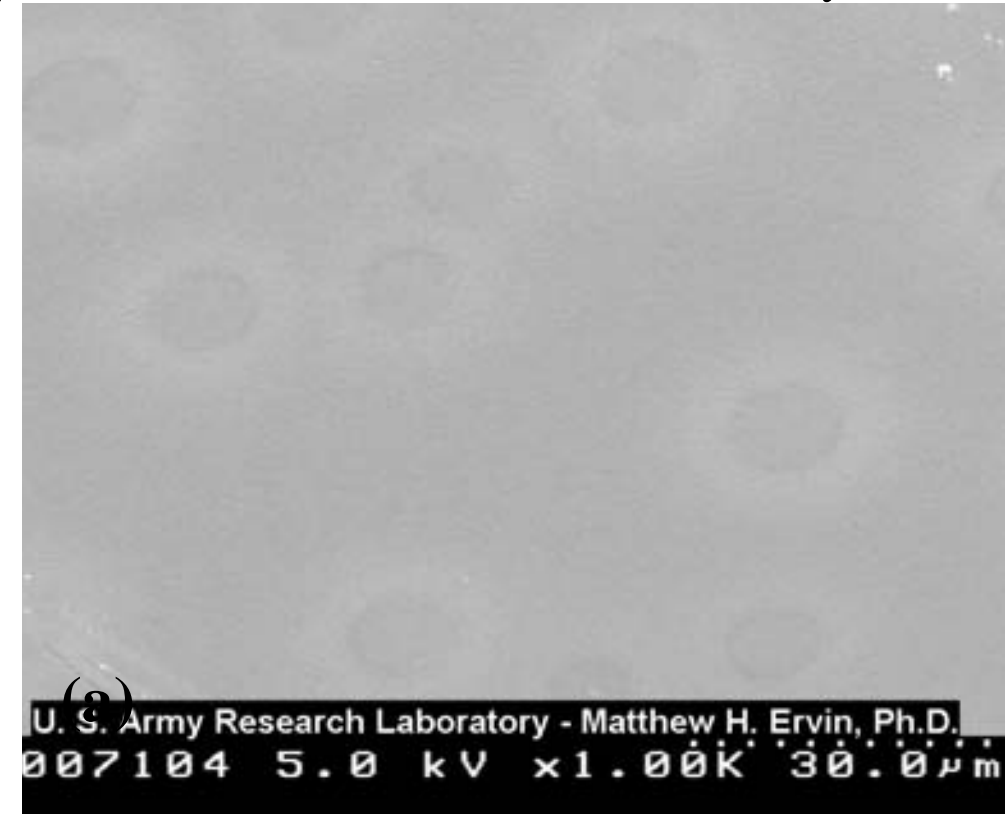
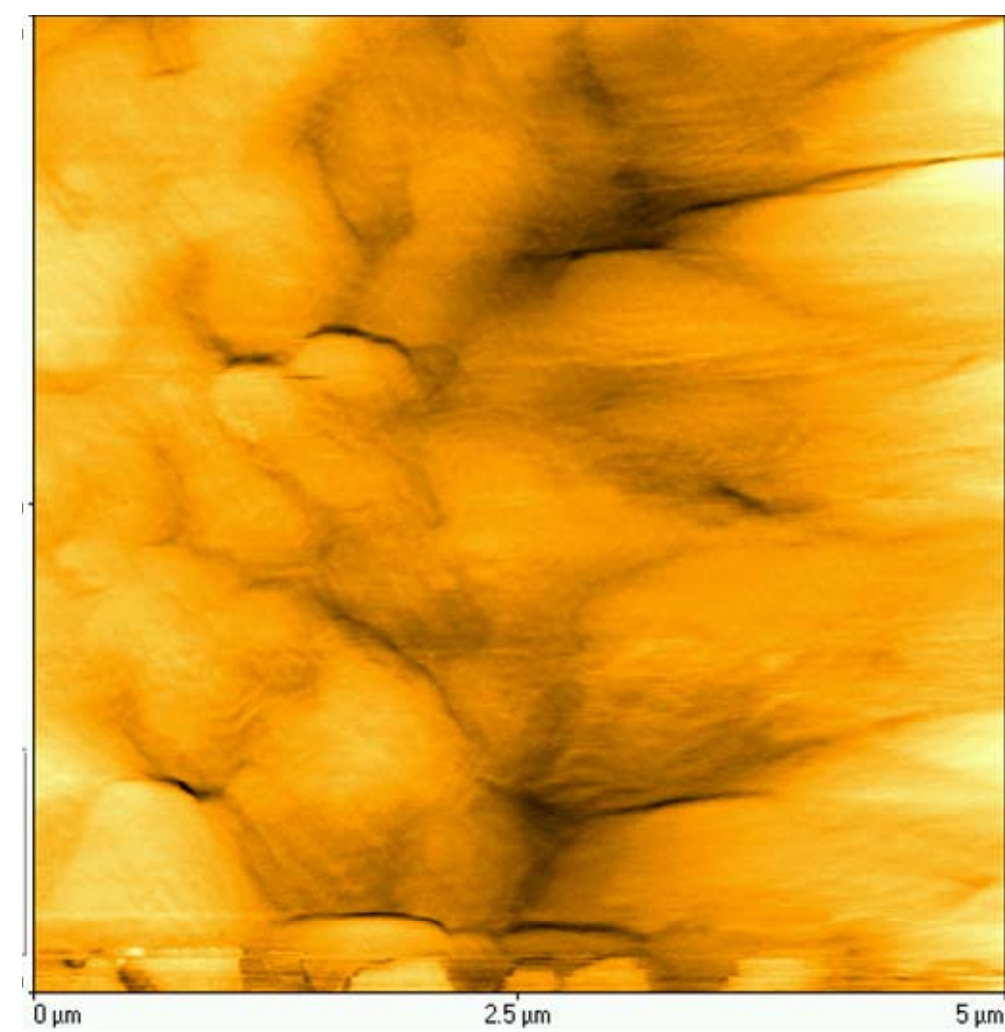
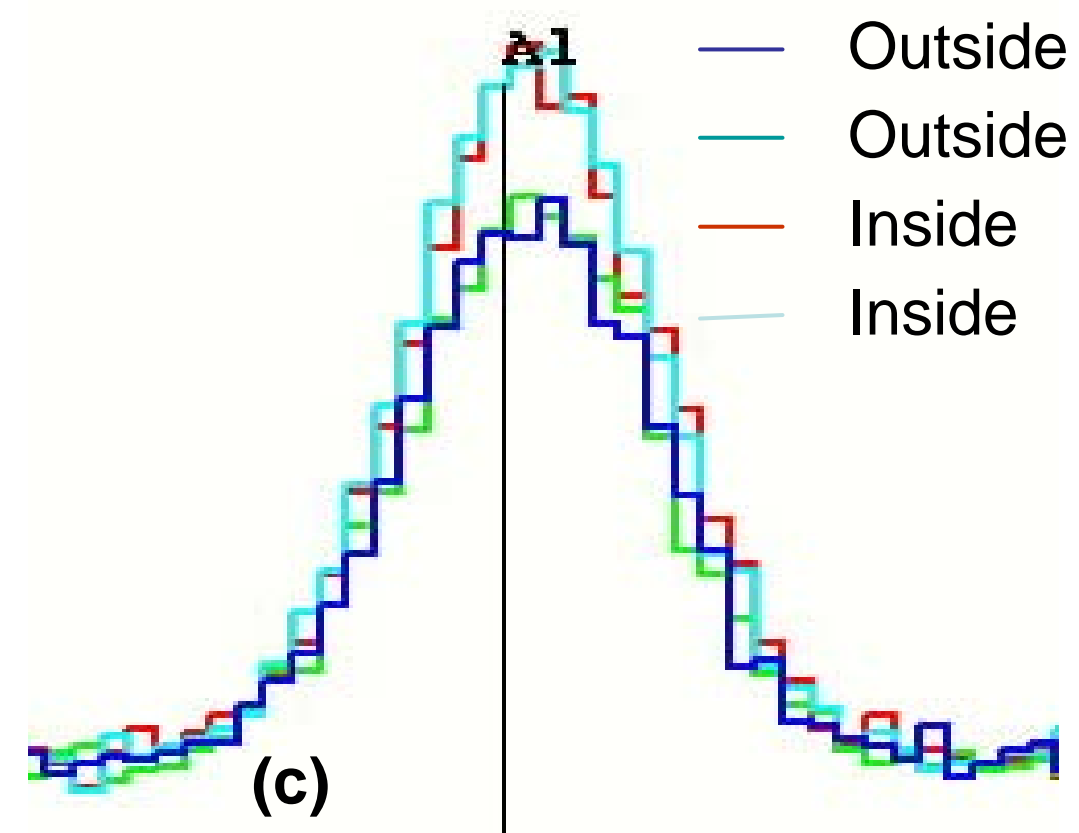
Fig. 5. (a) SEM micrograph of an AlGaN showing circular features. (b) AFM of a region near the edge of a circular region. (c) EDX of a region inside and outside of the circular regions.

appear to be pits, as is seen in the SEM micrograph in Fig. 5a. This result is confirmed in the AFM micrograph in Fig. 5b. Using an energy dispersive x-ray (EDX) attachment to the SEM, we found further that the Al concentration was not

everywhere the same, as it was larger inside the circular region. This is demonstrated in the EDX profiles in Fig. 5c. We concluded that this was a result of the temperature of the substrate in the MBE system was too low so that atoms that struck the surface did not have the energy to surface diffuse to their equilibrium positions. When the growth temperature was raised, the device properties were greatly improved.

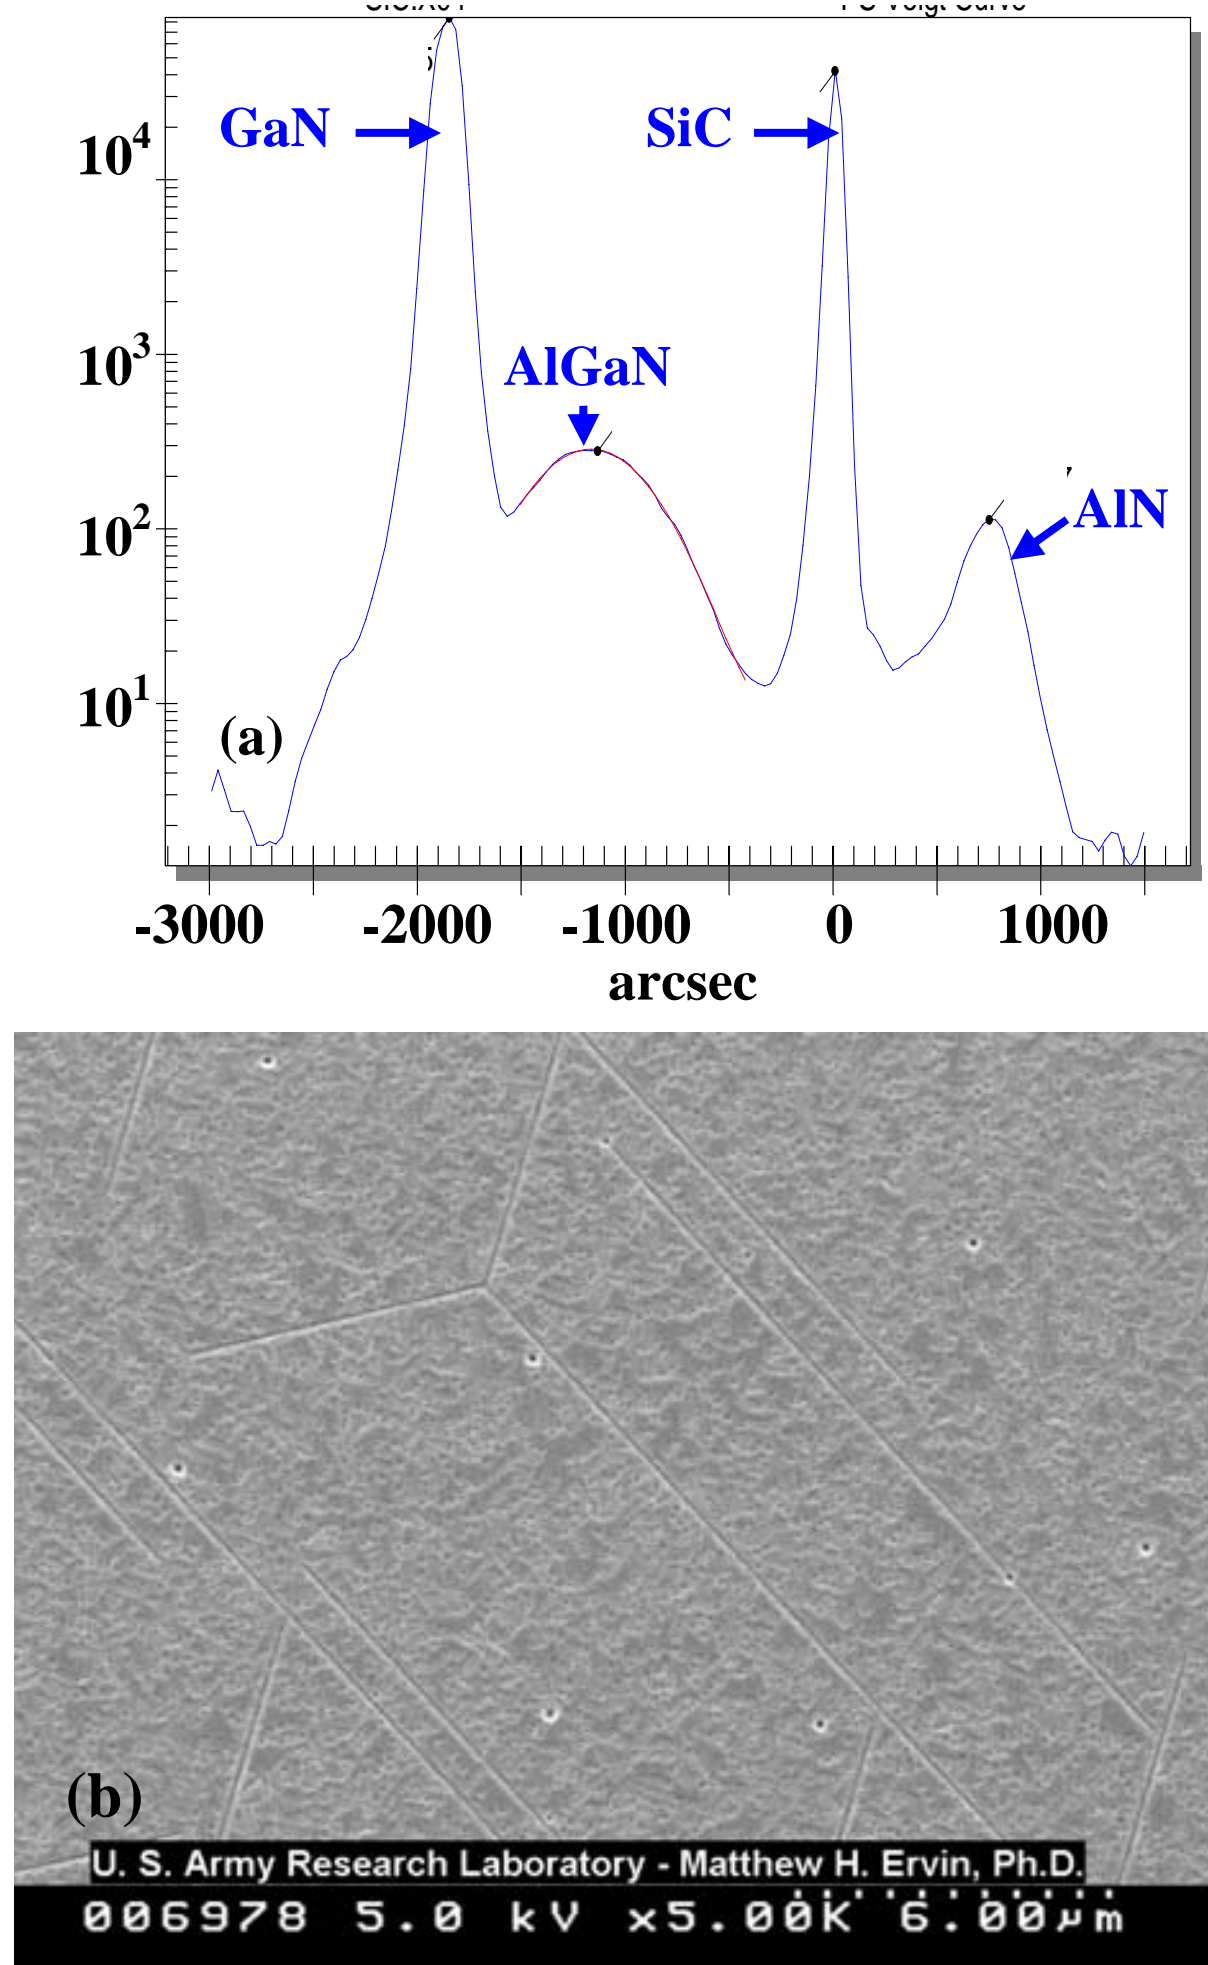
It is generally known that if you can increase the Al content in the AlGaN, you can increase the number of charge carriers in the channel and therefore the peak power output of the device. However, when you increase the Al content, you also increase the mismatch strain between the AlGaN and the GaN, and once you reach the critical thickness limit, cracks will form in the AlGaN. We were able to determine the Al content in the AlGaN, using the θ-2θ x-ray curves like the one shown below in Fig. 6a, from the position of the AlGaN peak relative to the SiC substrate and GaN film peaks.

Fig. 6. (a) X-ray θ-2θ map used to determine the Al content in AlGaN. (b) Cracking in the AlGaN layer due to too much Al in the AlGaN.

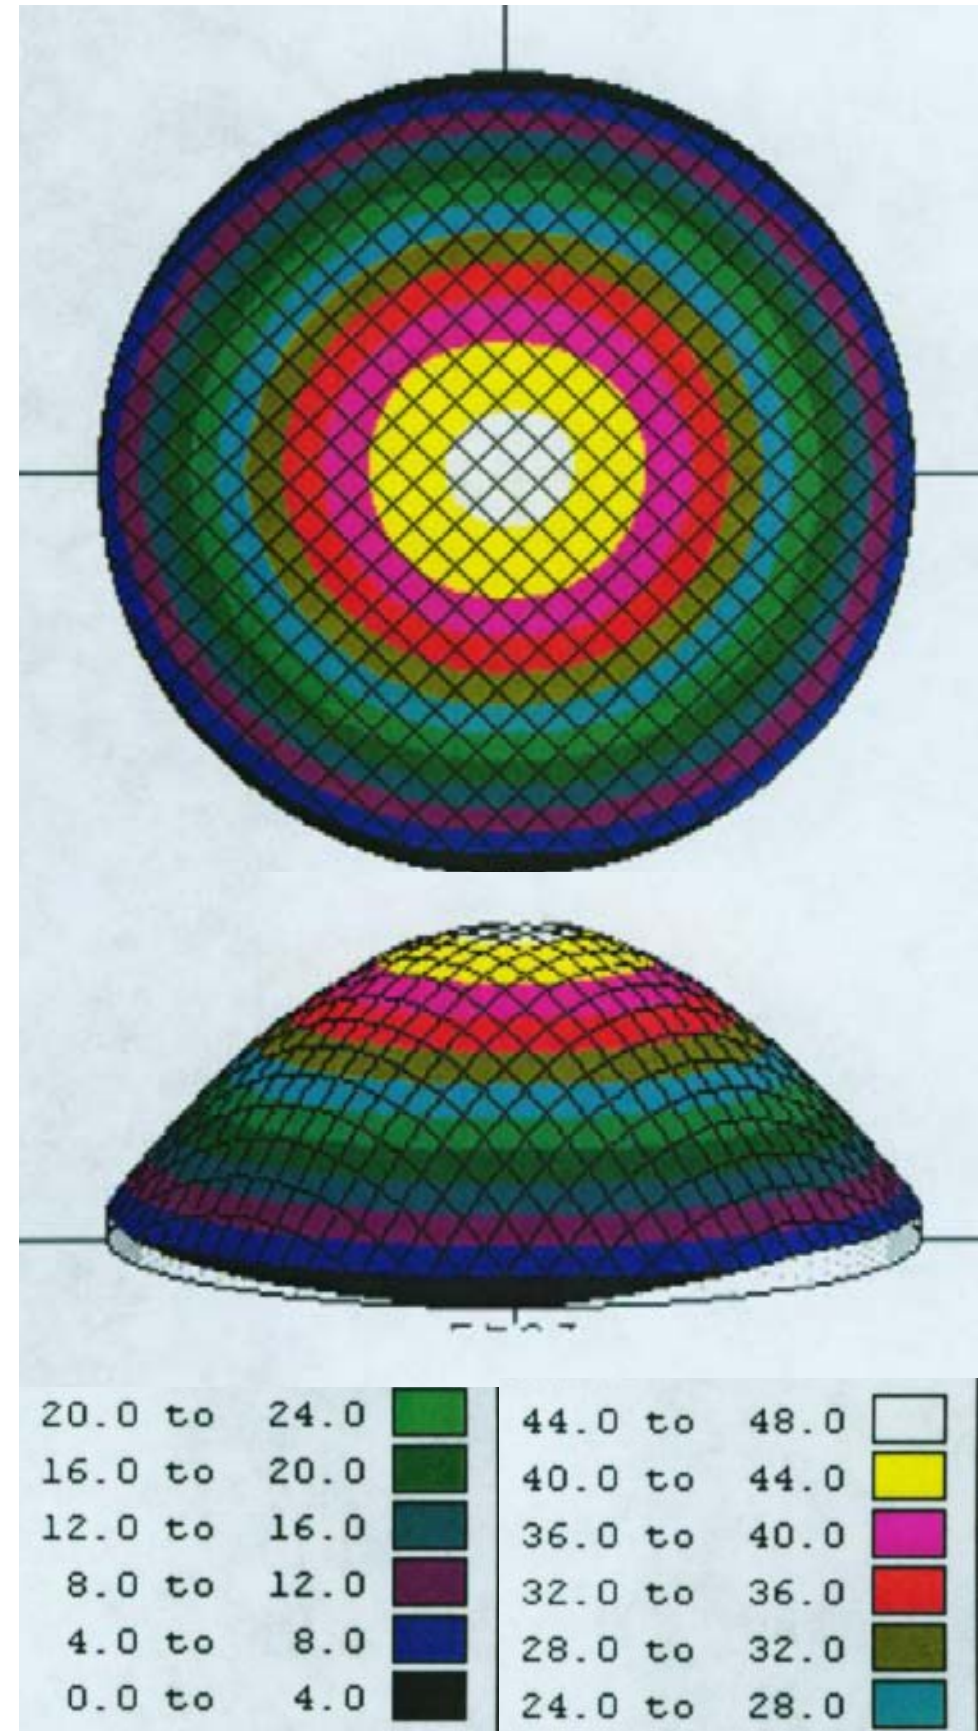
When the films are grown, the surface has to be properly prepared and the sample cannot be cooled done too fast, or there will be a considerable amount of bowing created by the difference in the thermal coefficients of the film and substrate. One DARPA contractor was having problems with breakage and with processing the devices. Using our laser light scanner (LLS), we demonstrated that their wafers were highly bowed; an LLS simply records the reflected beam as a laser is scanned across the diameter of a wafer. As shown in Fig. 7, the wafer was so highly strained, it has a bowl shape with the edges of the bowl being as much as 45 µm lower than the center of the wafer. This is more than 10X the amount of bow we saw in good samples. After being advised of this, the contractor changed the way they deposited the AlN buffer layer in their MBE grown GaN HEMT structure and cooled down the sample more slowly after the growth was complete. The yield and the operation of the devices made from this structure improved significantly after these changes were made.

Fig. 7. Two and three dimensional views of a laser light scan of a highly bowed SiC wafer with an MBE grown GaN HEMT structure grown on it.

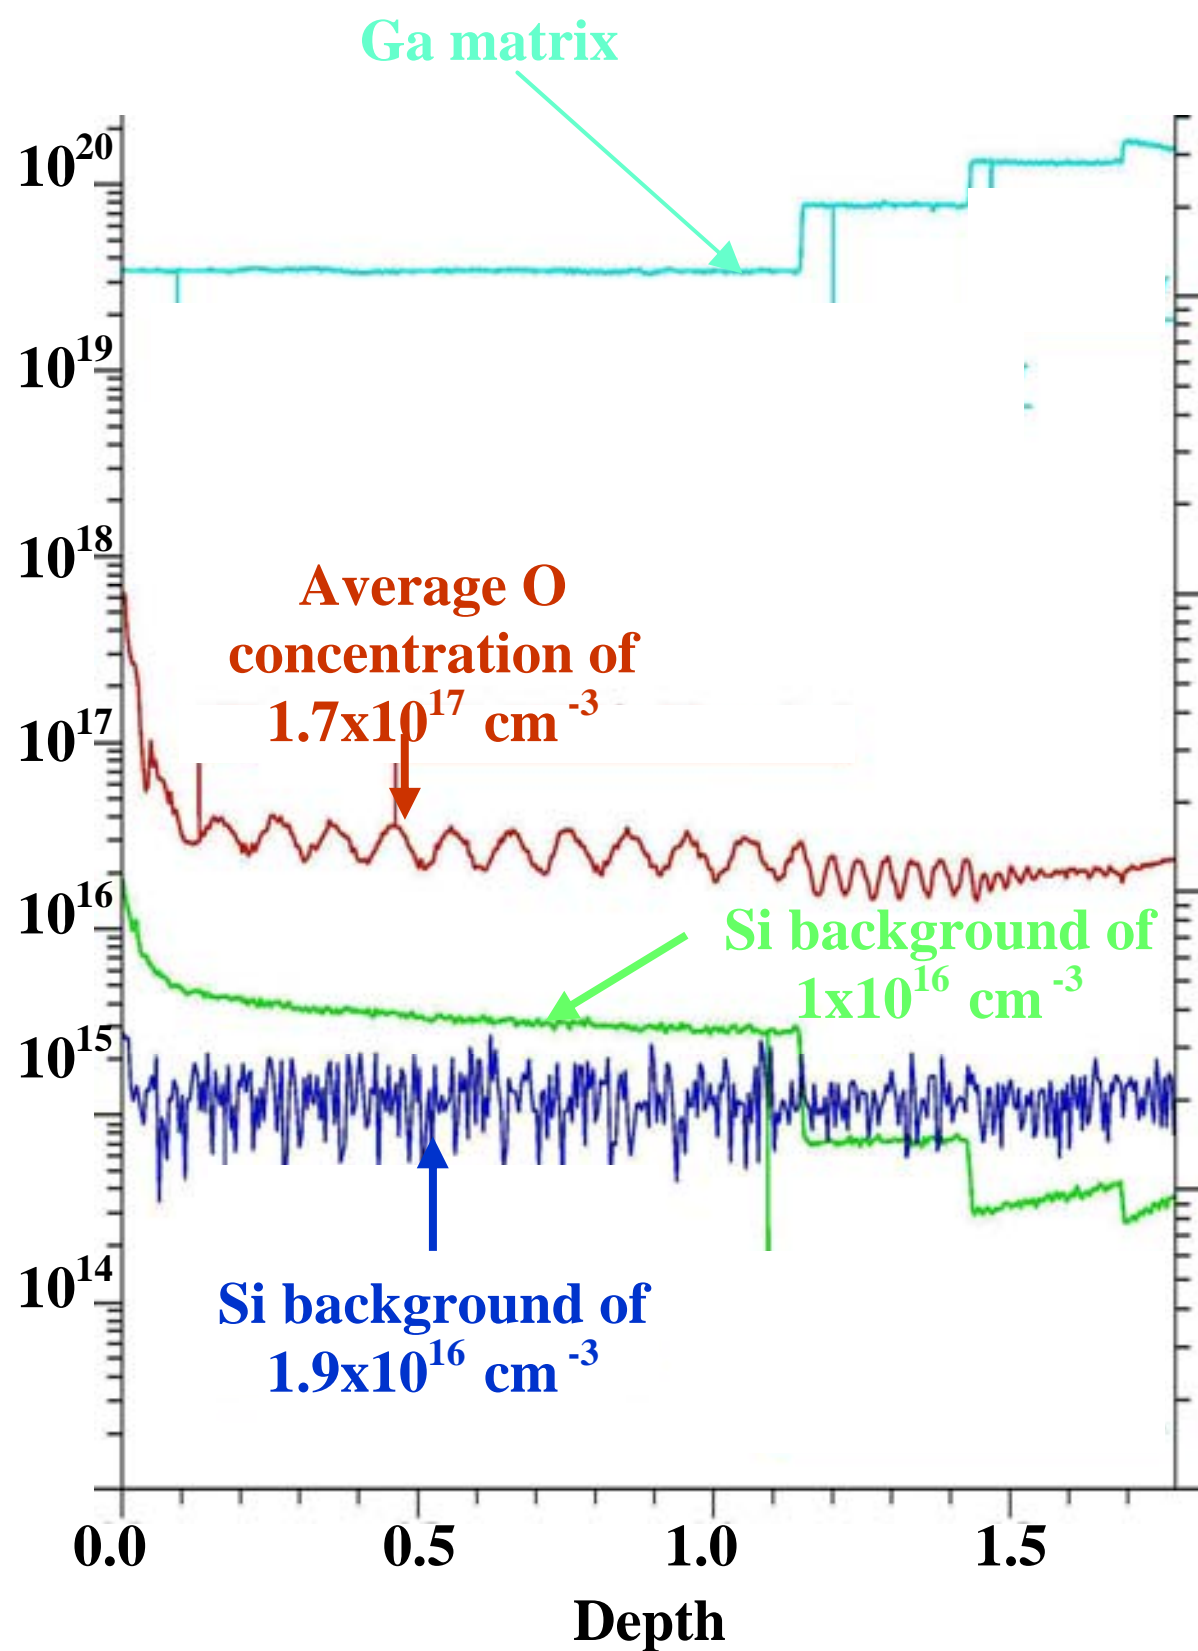
(HVPE), and then etching off the silicon. Although these 'substrates' are quite highly defective, they still have many fewer – about three orders of magnitude – dislocations. However, it is difficult to grow them pure enough so that they can have the required resistivity for operating at RF frequencies. One method to try to overcome this problem is to dope the films with iron, which creates states near the middle of the energy gap that can trap electrons thereby making the GaN 'substrate' more resistive. It is, however, difficult to incorporate the iron and have it be electrically active. Our SIMS profile showed that the Fe concentration oscillated out of phase with the O concentration, which is displayed below in Fig.8, as opposed to being constant. Work is on-going in learning how better to incorporate the Fe, but it is believed this interaction between the Fe and O is playing a critical role.

Fig. 8 SIMS profile of an HVPE GaN 'substrate' showing that the oxygen concentration oscillates as a function of the depth into the 'substrate'.

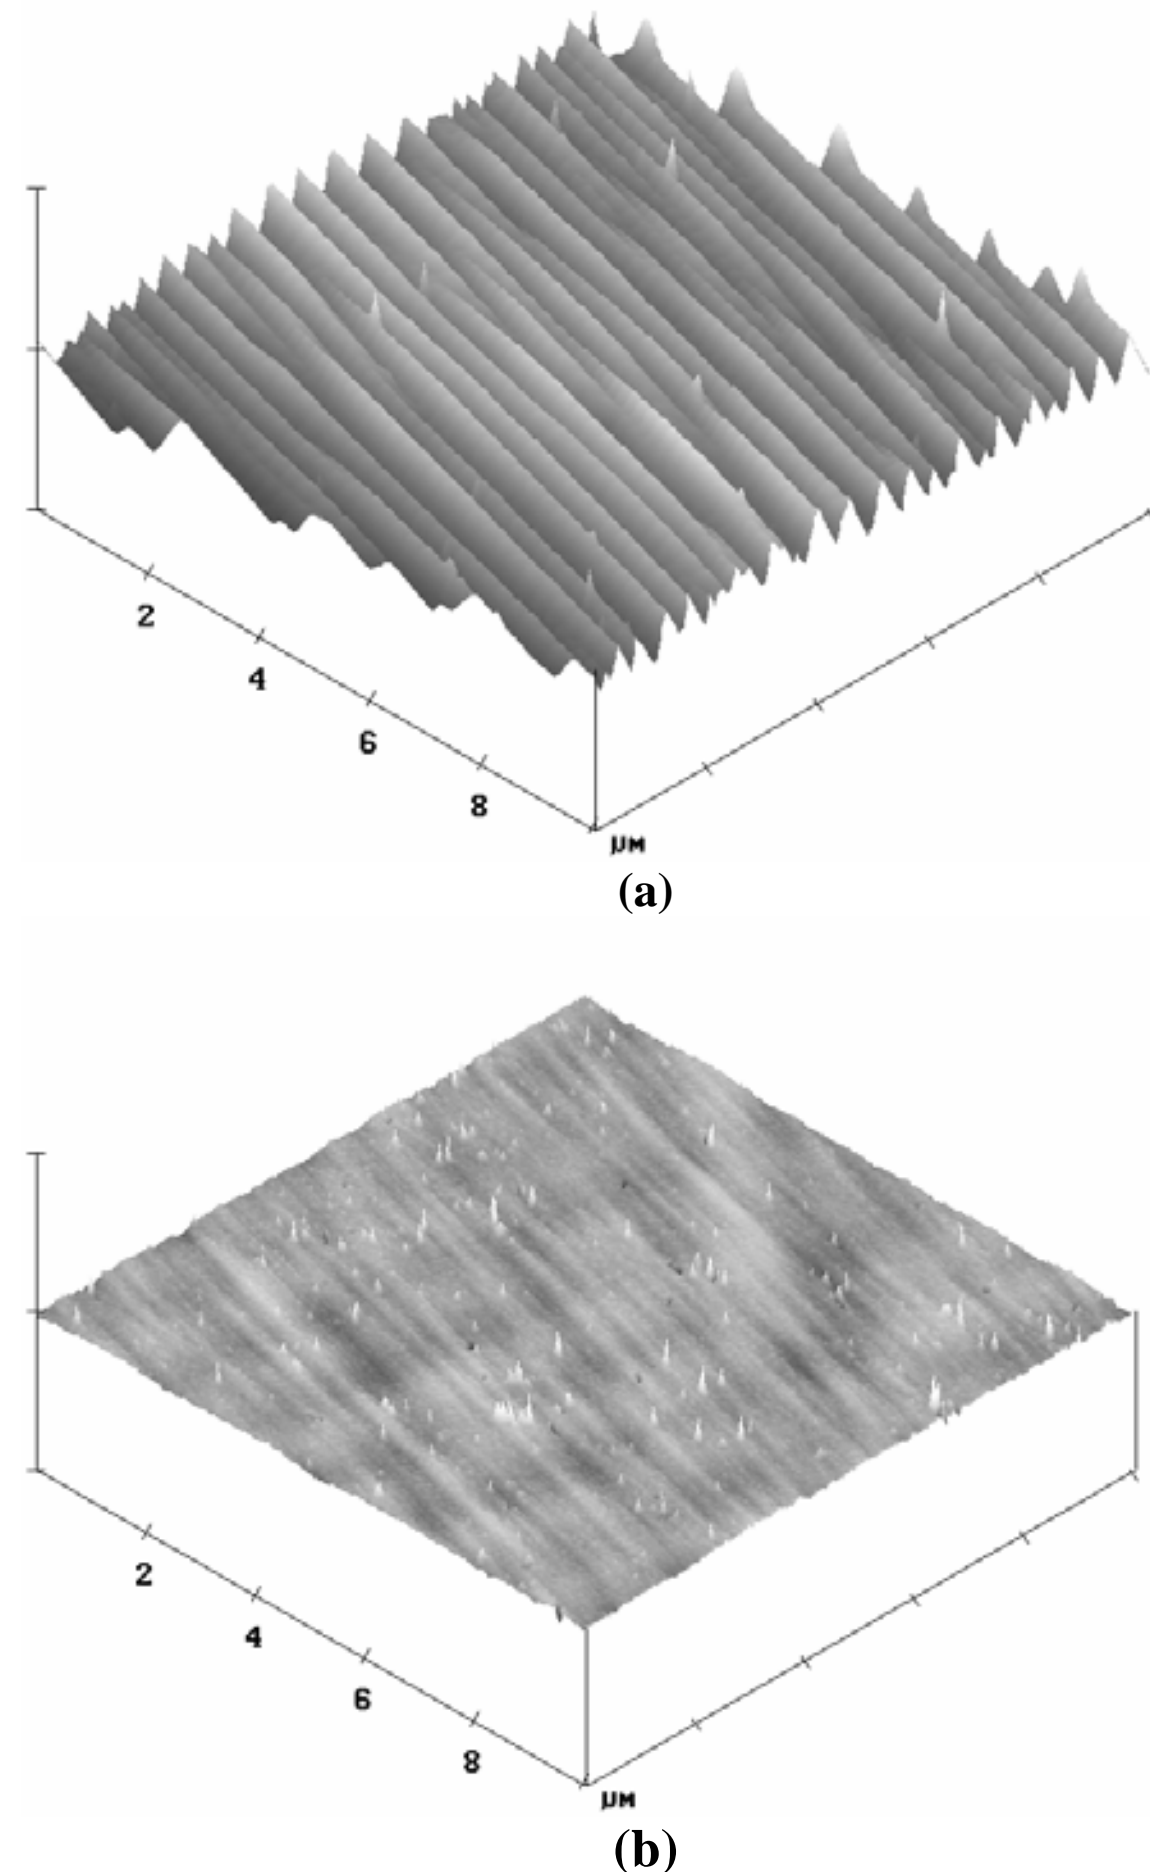
Fig. 9. AFM of the surface of a SiC film annealed at 1600ºC (a) without, and (b) with an AlN cap.

solution (Jones et al., 1999). As shown in Fig. 9, the surface annealed without the cap is much rougher. It is also likely that there are fewer silicon vacancies, which are electrically active, near the surface of the capped sample. This could be particularly important if MOSFETs were going to be fabricated on this sample because the current in these devices is carried near the surface. The rough topography of the unprotected surface would be more prone to scattering the electrons thereby reducing their mobility, and the vacancies could trap out some of the electrons thereby reducing the carrier concentration.

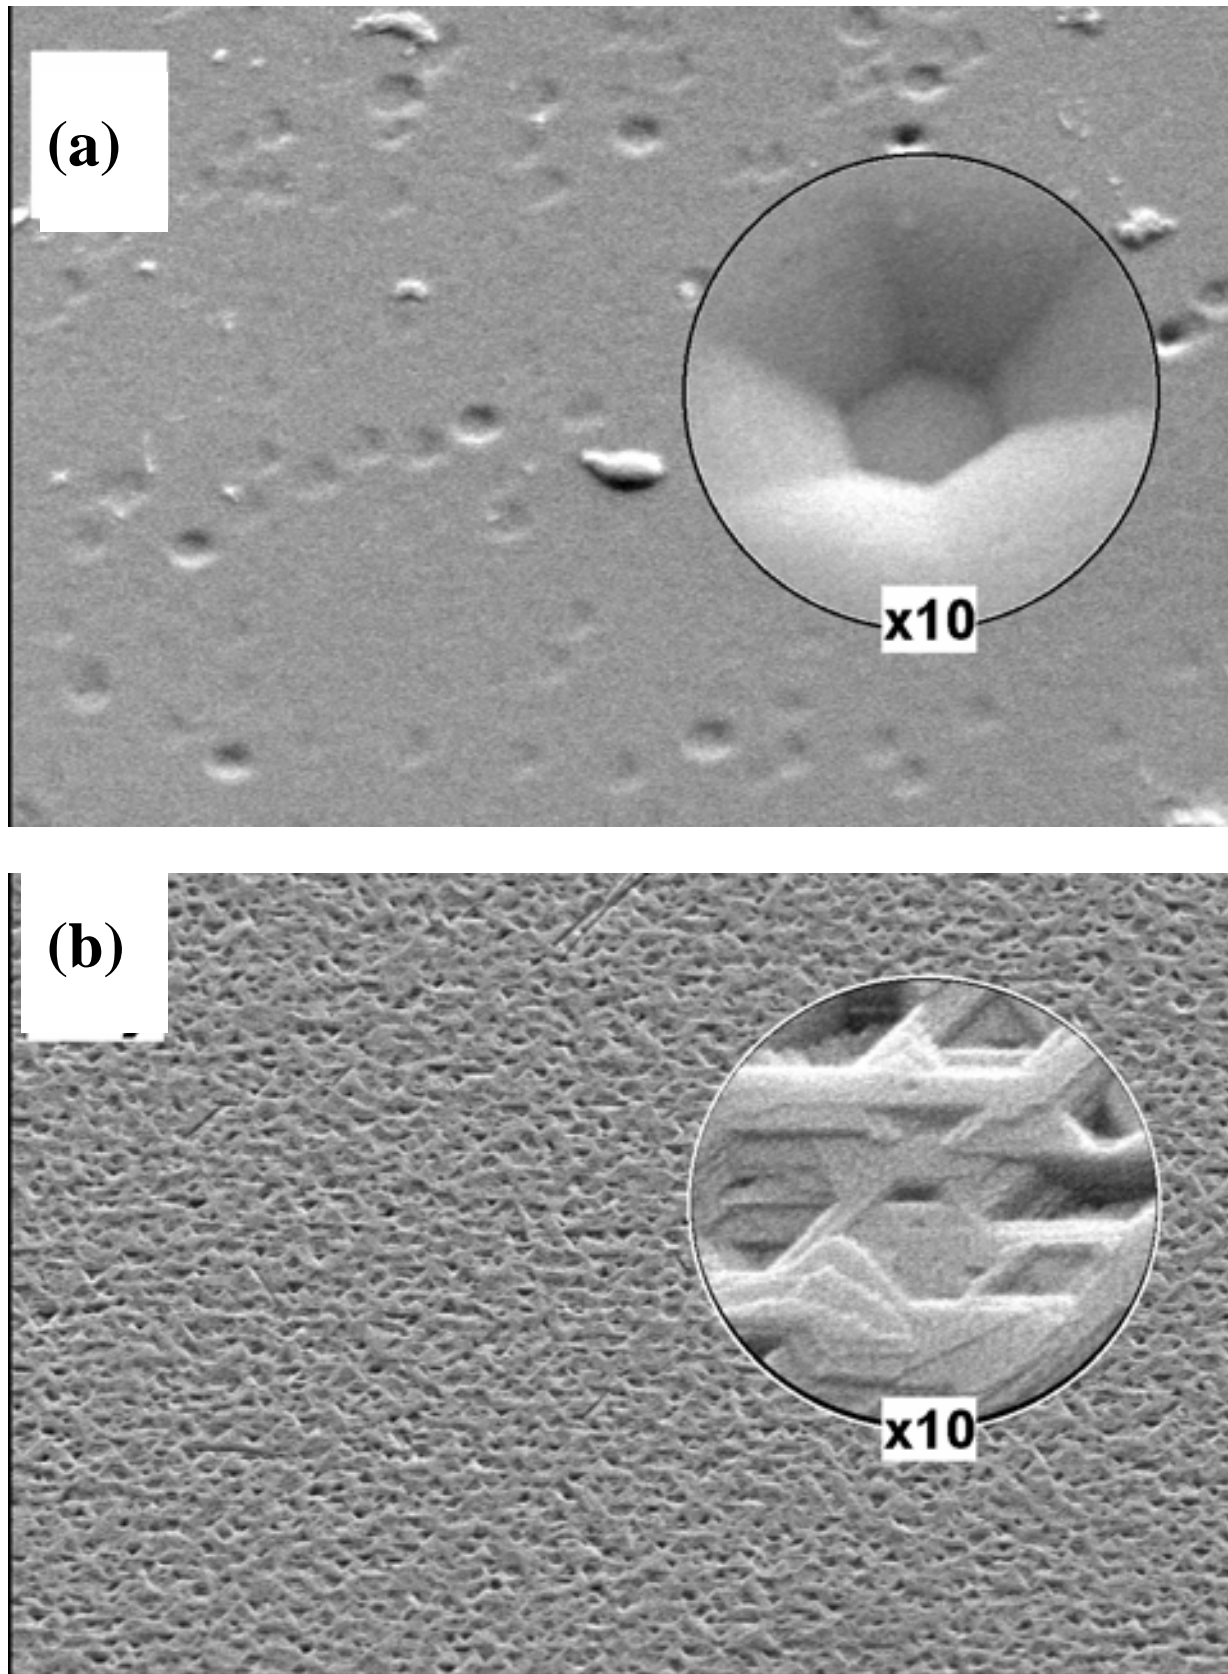
As shown in Fig. 10, the AlN cap has an upper limit, because it begins to noticeably evaporate at temperatures above 1600ºC. As a result, hexagonal etch pits are formed in it that expose the underlying SiC. To enable us to reach higher temperatures – temperatures at which a greater percent of the aluminum acceptors would be activated – we deposited BN on top of the AlN; we essentially capped the

Fig. 10. SEM micrographs of an AlN cap heated to (a) 1650ºC or (b) 1700ºC for 30 min.

cap (Ruppalt et al., 2003), as BN has an even lower vapor pressure than AlN. The BN was then removed by ion milling, and again the AlN was etched off chemically in warm KOH. The BN could not be put directly on top of the SiC because it cannot be chemically removed, and if it were removed by ion milling, the ions would simultaneously damage the SiC surface.

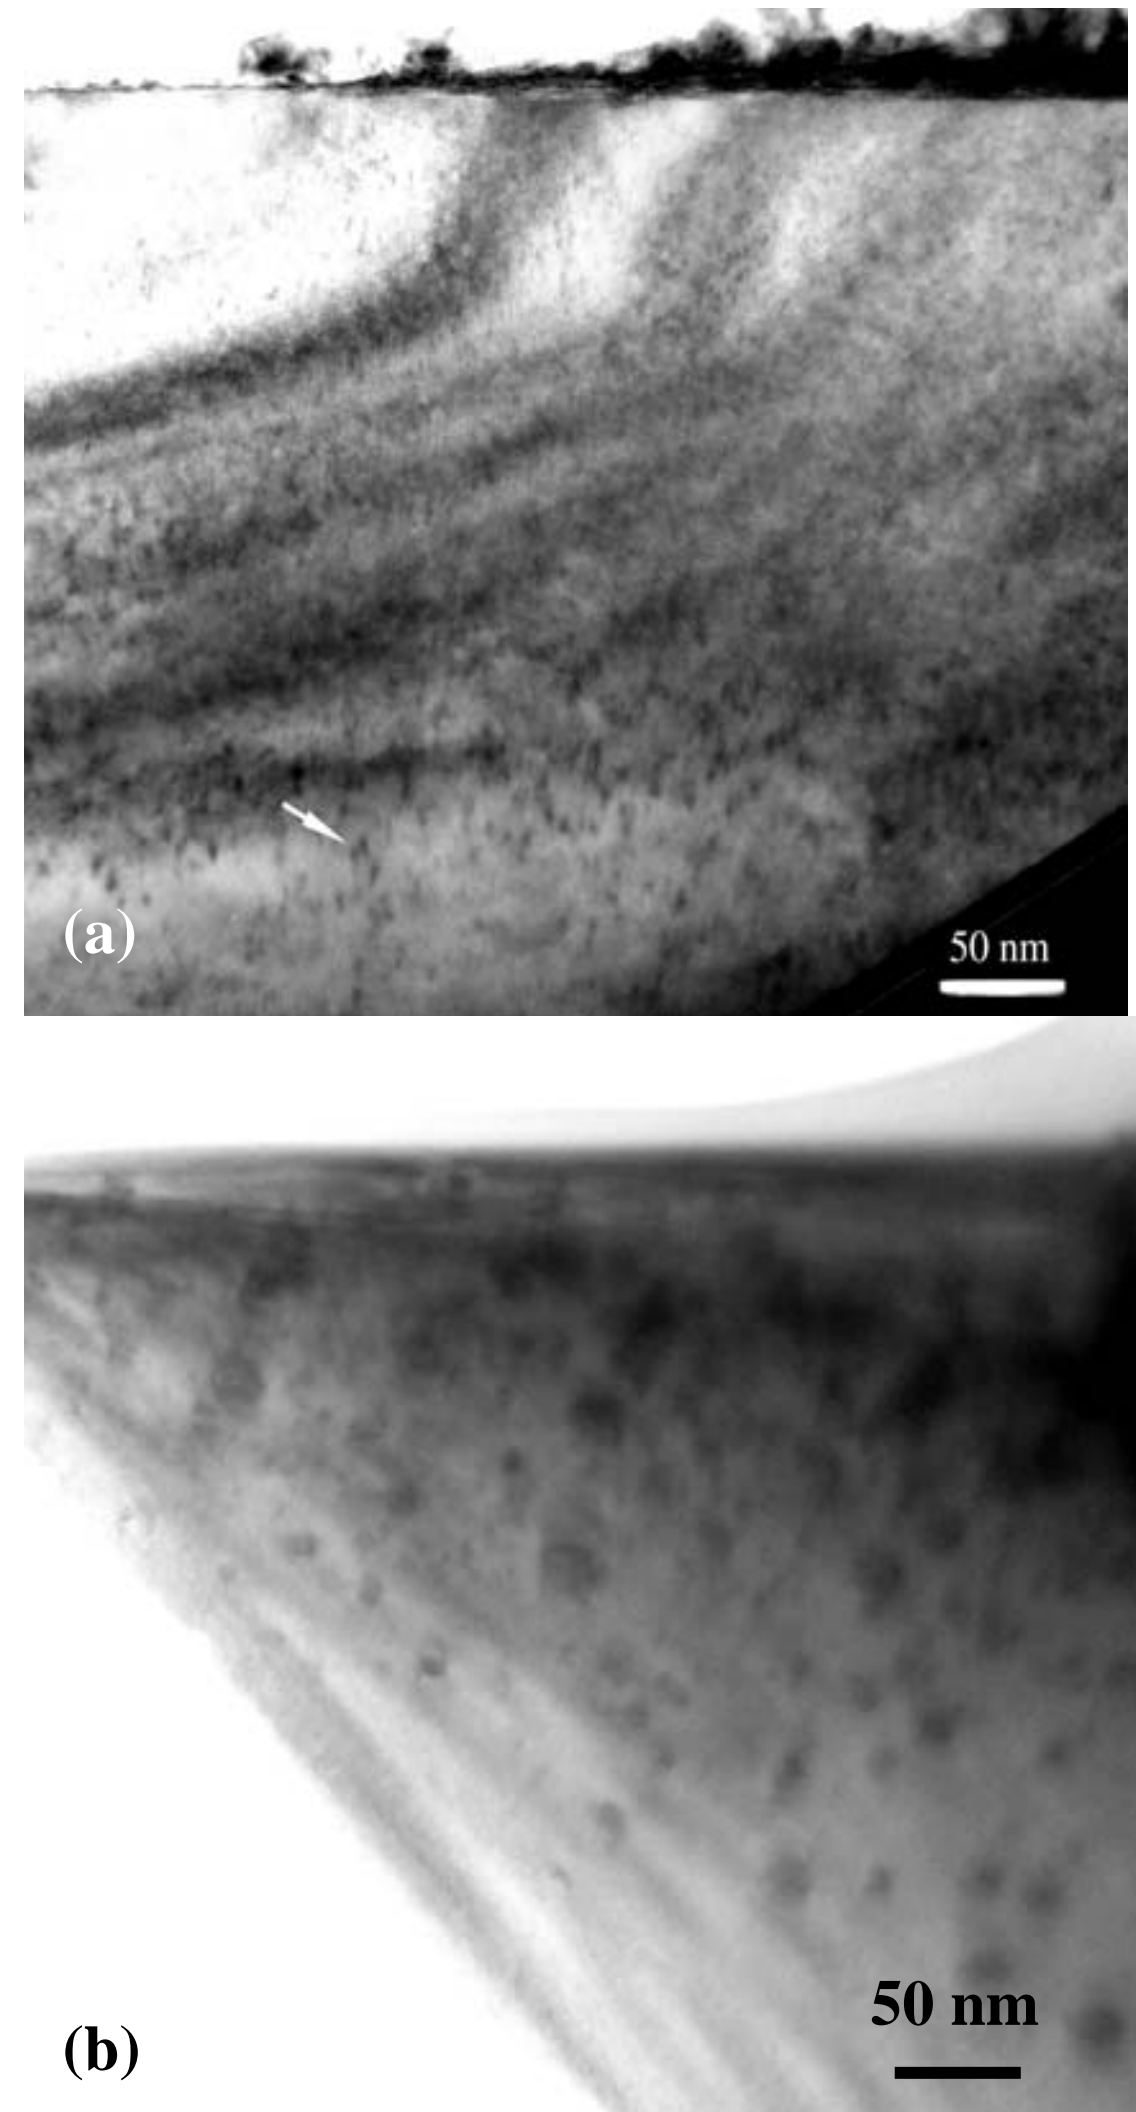
Though we are now able to anneal the implanted SiC up to temperatures as high as 1800ºC, we have determined that even at this high temperature, all of the defects cannot be annealed out. In fact, some defects appear to nucleate and grow. We believe that stacking faults have formed, which means that there are small regions that no longer have the desirable 4H-SiC crystal structure; rather there are small islands of SiC that have the 3C- or 6H-SiC structure. Having different phases present is detrimental because they scatter the electrons thereby increasing the resistance. It is also likely they create states in the energy gap that can act as carrier traps as is represented by the D_I defect that always seems to be present in ion implanted SiC (Jones et al., 2004a, 2004b). (Storasta et al., 2001) believe that this defect is a deep donor capable of trapping out aluminum acceptors. We have suggested that these stacking faults are created by the condensation of silicon – carbon divacancy pairs (V_{Si}-V_C) which form Frank intrinsic stacking faults. As seen in Fig. 11, these stacking faults not only grow in size, but they also appear to migrate towards the surface. This could be detrimental to MOSFETs, which, as stated before, have currents that flow very close to the surface. We are presently looking at ways to overcome this problem by growing a thin epitaxial layer to cover the implanted region thereby keeping the current flow away from the persistent ion implanted defects. Working with RPI, we are also attempting to replace ion implanted regions with regions that are selectively grown. For example, the ion implanted regions of the JBS diode shown in Fig. 12 could be replaced by growing p+ layers in the channel while protecting the columns from being grown on by protecting them with a TaC cap.

Fig. 11. TEM of persistent defects (dark regions) in ion implanted 4H-SiC annealed at (a) 1600 and (b) 1700ºC.

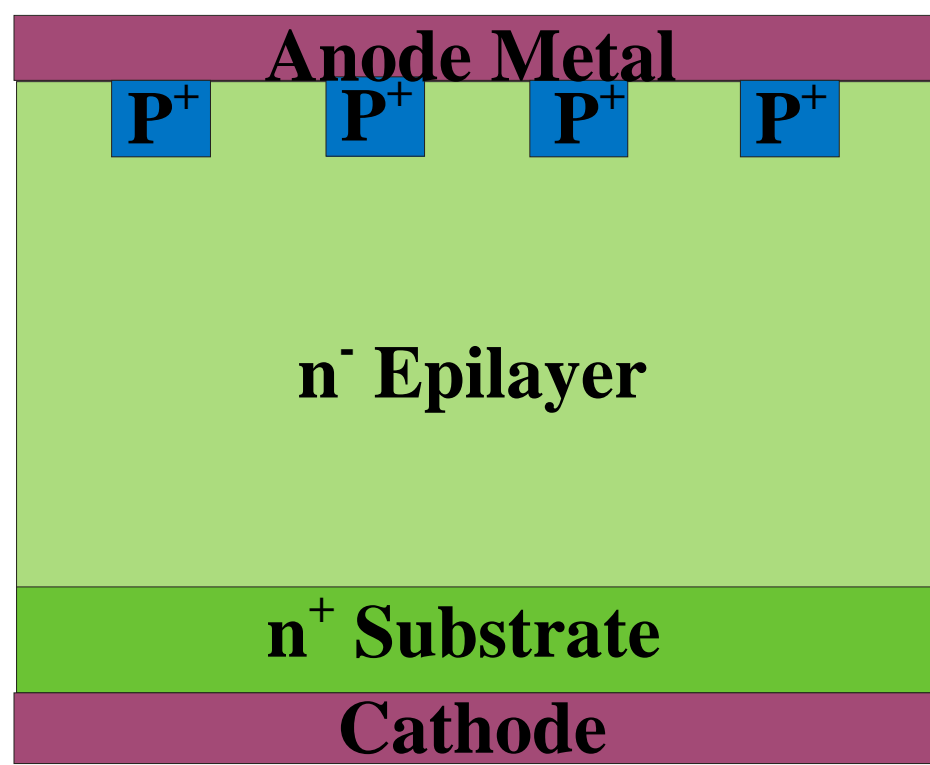
Schottky metal to the n-SiC. The latter has a lower reverse saturation current and a larger breakdown voltage under reverse bias, so the p+ regions are located close enough to each other so that their depletion layers overlap under reverse bias forcing the current to flow from the p+ to the n-SiC. From theoretical considerations, one should dope the p+ regions as heavily as possible. However, because the p+ region was implanted, it contains a number of persistent defects, and these defects do the most damage to the properties of the diode when they are located close to the p-n junction. It is also the case that the more heavily doped material contains the largest number of these defects. Thus, a compromise was made to reduce the concentration of the implanted ions near the p-n junction, but retain the high concentration of implanted ions away from the junction where the higher doping levels outweighed the negative effects of the persistent defects. Thus, as shown in Fig. 12b, the region implanted near the junctions was implanted with 10^{19} cm^{-3} Al, while the region away from the junction was implanted with 10^{20} cm^{-3} Al. Clearly, the more heavily doped region contains more damage.

Fig. 12. (a) Schematic of a JBS diode, and (b) TEM of of an ion implanted p+ channel with the higher concentration, and therefore the damage, being larger in the p+ region. The Ti metal can form a Schottky contact.
