DEGRADATION, RELIABILITY, AND FAILURE OF SEMICONDUCTOR ELECTRONIC DEVICES

M.A. Derenge, M.H. Ervin, K.W. Kirchner, K.A. Jones*, M.C. Wood, and T.S. Zheleva
Microdevices Branch, Army Research Lab – SEDD, AMSRD-SE-DL, Adelphi, MD

Degradation, Reliability and Failure of Semiconductor Electronic Devices

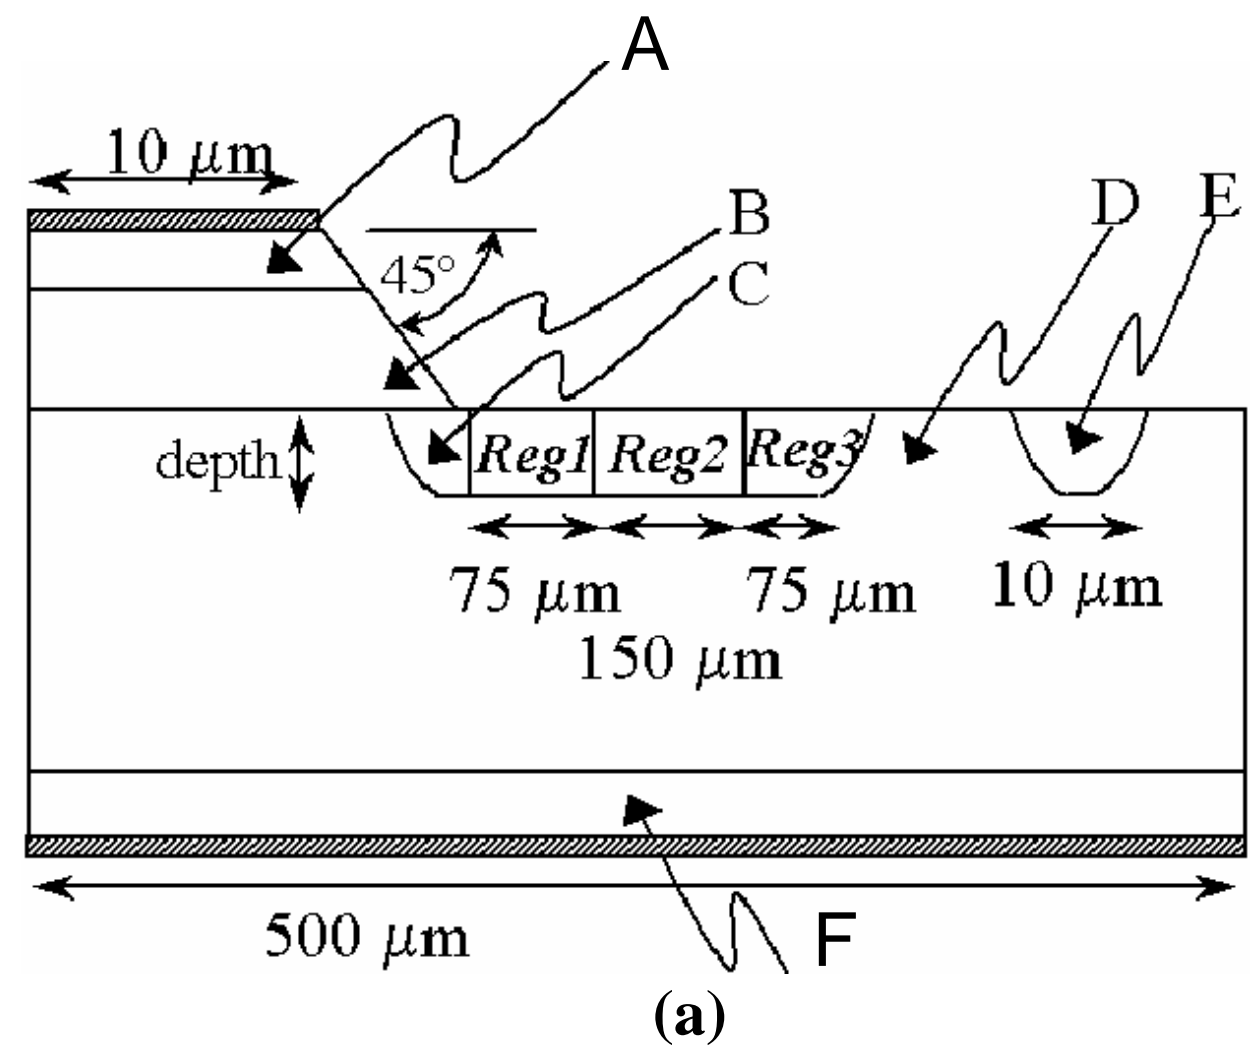
The persistent ion implant damage is not limited to the active device, as it can also affect the ability of guard rings implanted around the device to reduce the electric field at the edges of the device to help prevent premature breakdown. This is displayed in Fig. 13a. One problem we believe this causes is that the implants can themselves contribute to the breakdown. This is suggested by the microplasmas, point sources of light emission, that occur when the diodes breakdown prematurely. We speculate that the light is produced when recombination occurs at the defect sites. We attempted to prove this by using a FIB to cut out parts of the sample in the regions where the microplasmas occurred, and to look for them in the TEM, but currently the results are inconclusive. This is a very difficult challenge, as it is like looking for a needle in a haystack. The samples are a few microns in diameter, whereas the defect we were looking for is probably only a few nm in size.

Fig. 13. (a) Schematic diagram of a JBS diode showing implanted guard rings in regions 1 2 & 3.(b) Microplasmas created during premature breakdown that could be created by recombination of charge carriers at a persistent ion implanted induced defect.

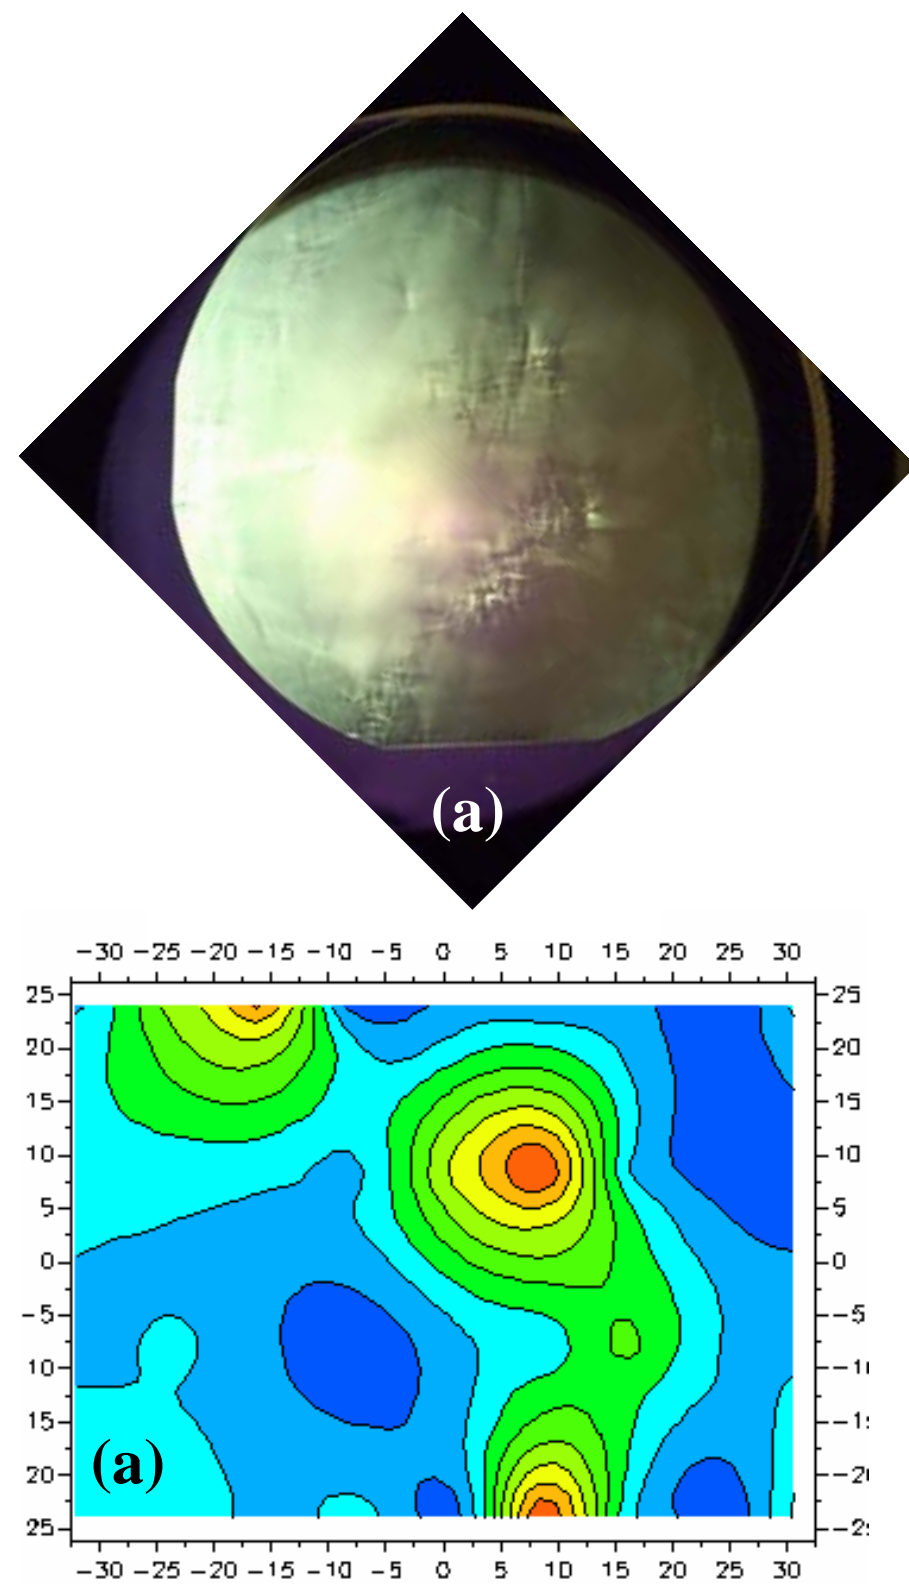
Fig. 14. (a) Cross polar image and (b) x-ray rocking curve map of a SiC wafer showing correlations between the two types of measurements.

Another project we have begun is to attempt to trace the formation of defects in a wafer from the beginning and how they ultimately affect the properties of the devices made from it. A quick method for assessing the quality of a wafer is to examine it in a crossed polar microscope (Fig. 14a). Light passing through the wafer is affected by strains in it thus marking some of its strain fields. One can see there appears to be a line of defects starting to the left of center at the bottom, moving up towards the middle, and veering to the left. A more sophisticated, but more time consuming method for examining these strain fields can be done by plotting the width of an x-ray rocking curve determined at various locations on the wafer and plotting them on a 2D map where the blues represent a narrow rocking curve and the reds represent wider ones (Fig. 14b). One can see that the two figures have similar patterns. Other experiments being done in this effort, but there is not room to describe them here, are x-ray topographs taken with synchrotron radiation that mark out the dislocations and small angle grain boundaries, maps of defects called micropipes, and x-ray peak position maps and LLS's that describe how the crystal planes and wafer are bent. Defects in films grown on these wafers are also being recorded using the same set of techniques, and ultimately PiN diodes will be made on these wafers and the characteristics of devices from different parts of the wafer will be compared with these defect maps.

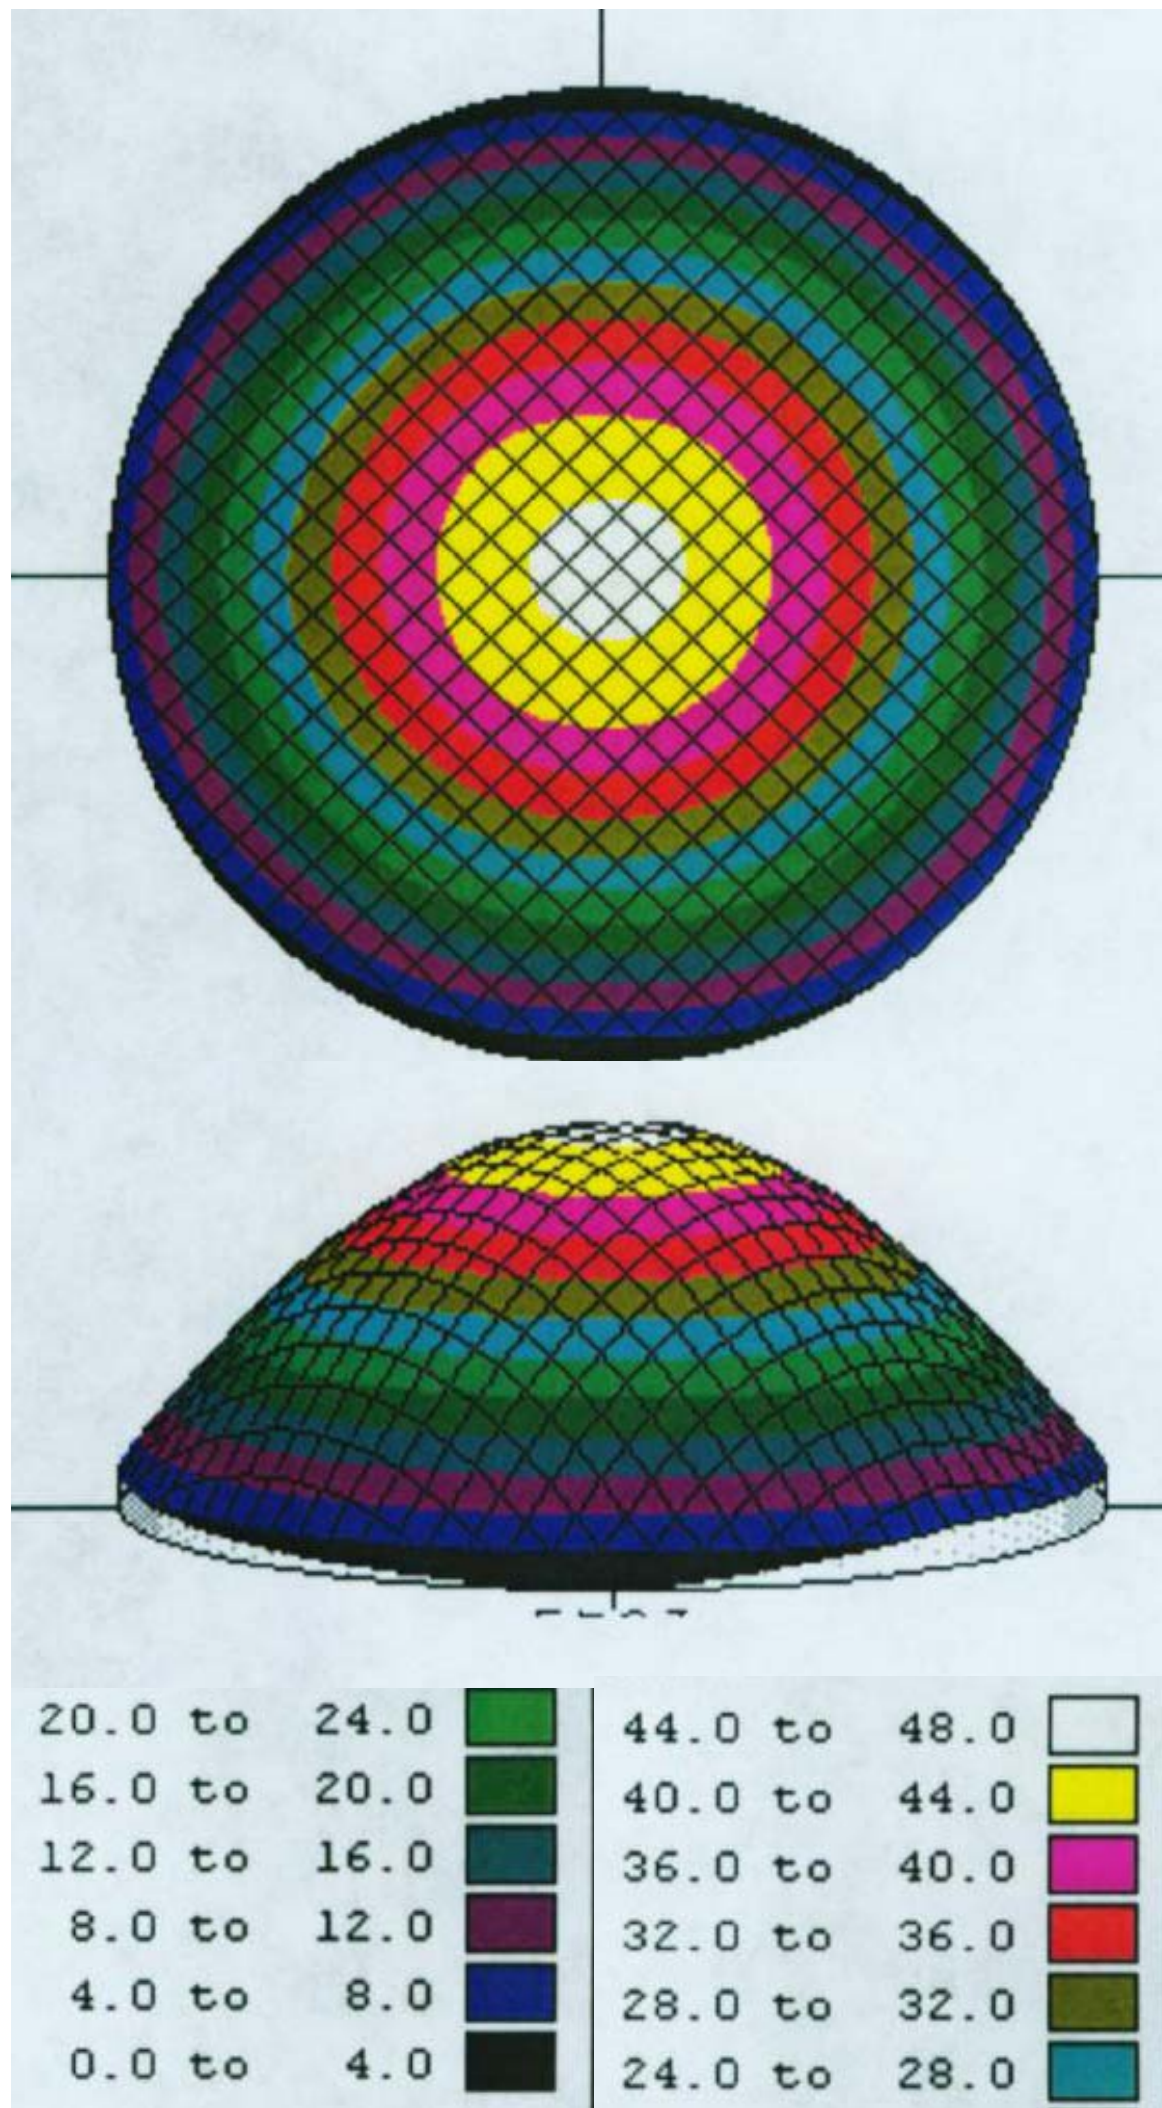
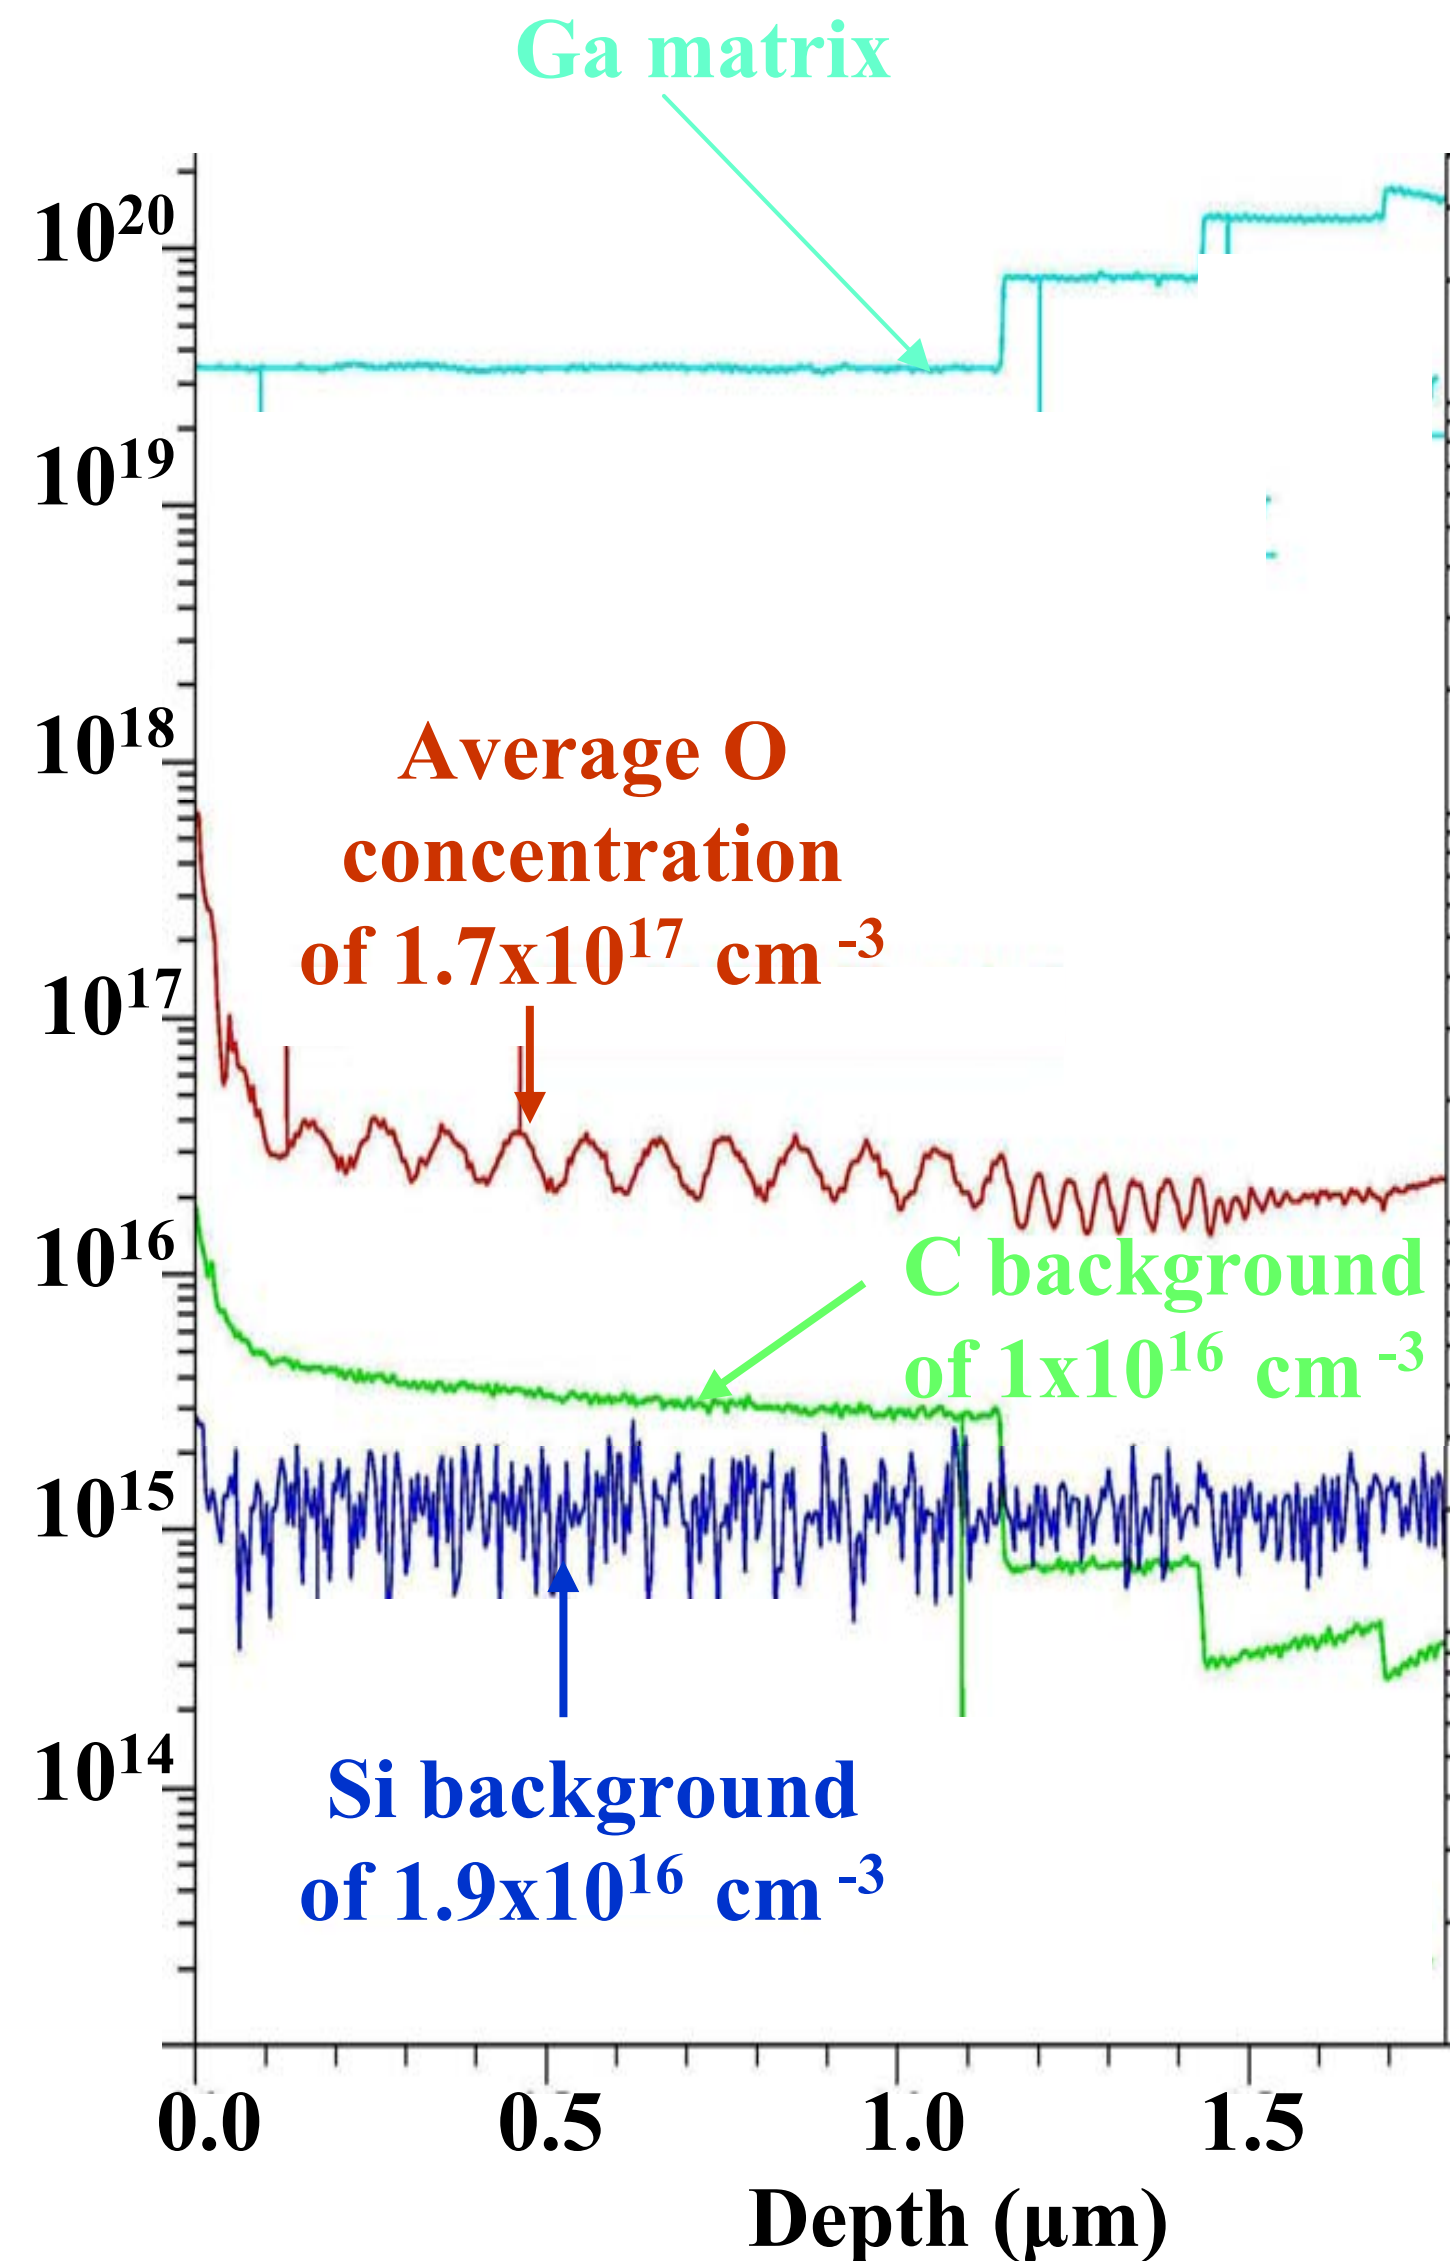
Strained wafer as measured by Laser Light Scan

Oxygen contamination during Fe doping as determined from SIMS

1. Contractor had high breakage in their wafers.
2. Our laser light scan showed that the wafer was highly strained.
3. They grew thicker buffer to accommodate mismatch.
4. Contractor had problem doping buffer with Fe to increase its resistance.
5. Our SIMS measurement showed O impurities.
6. Oscillations in oxygen concentration provided insight into source of contamination.

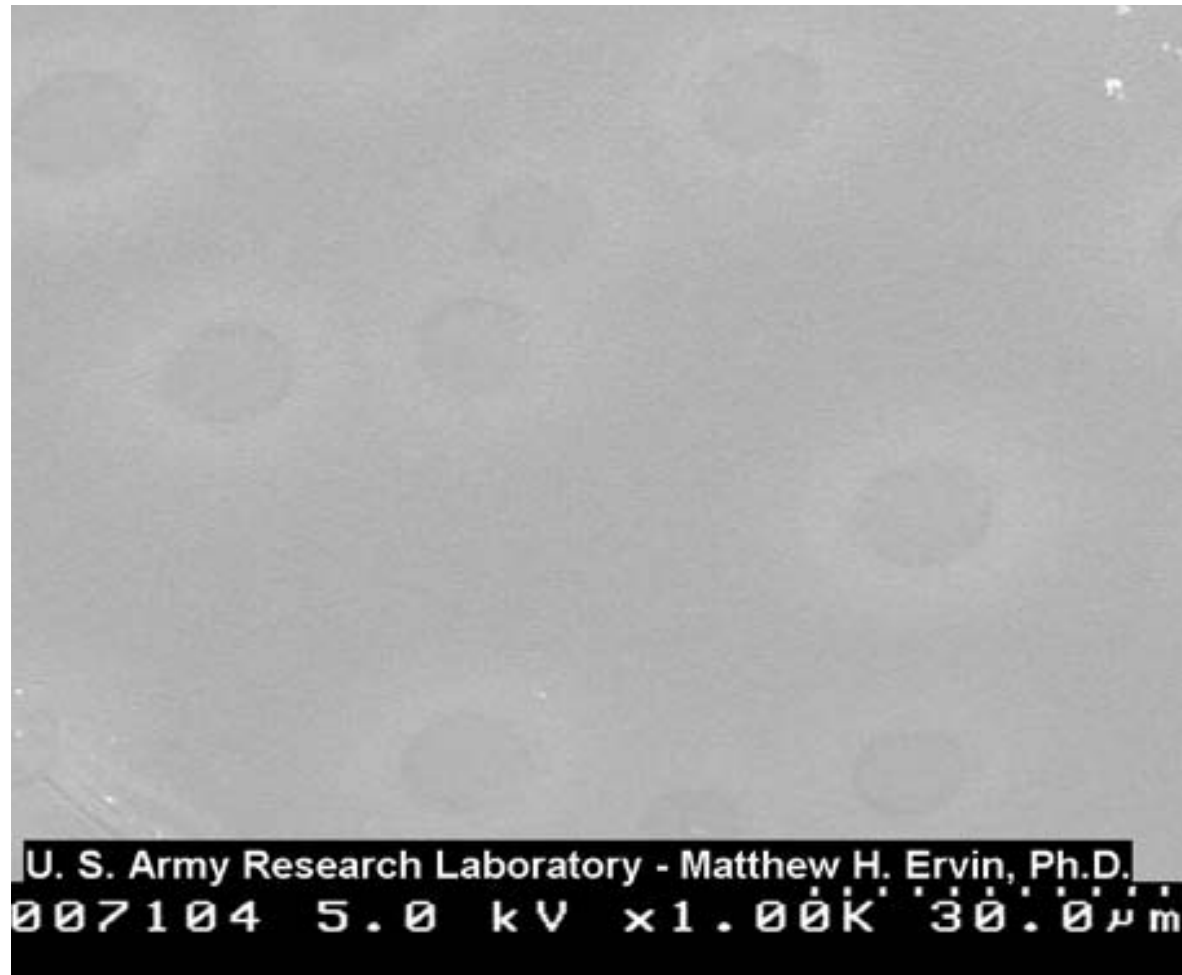
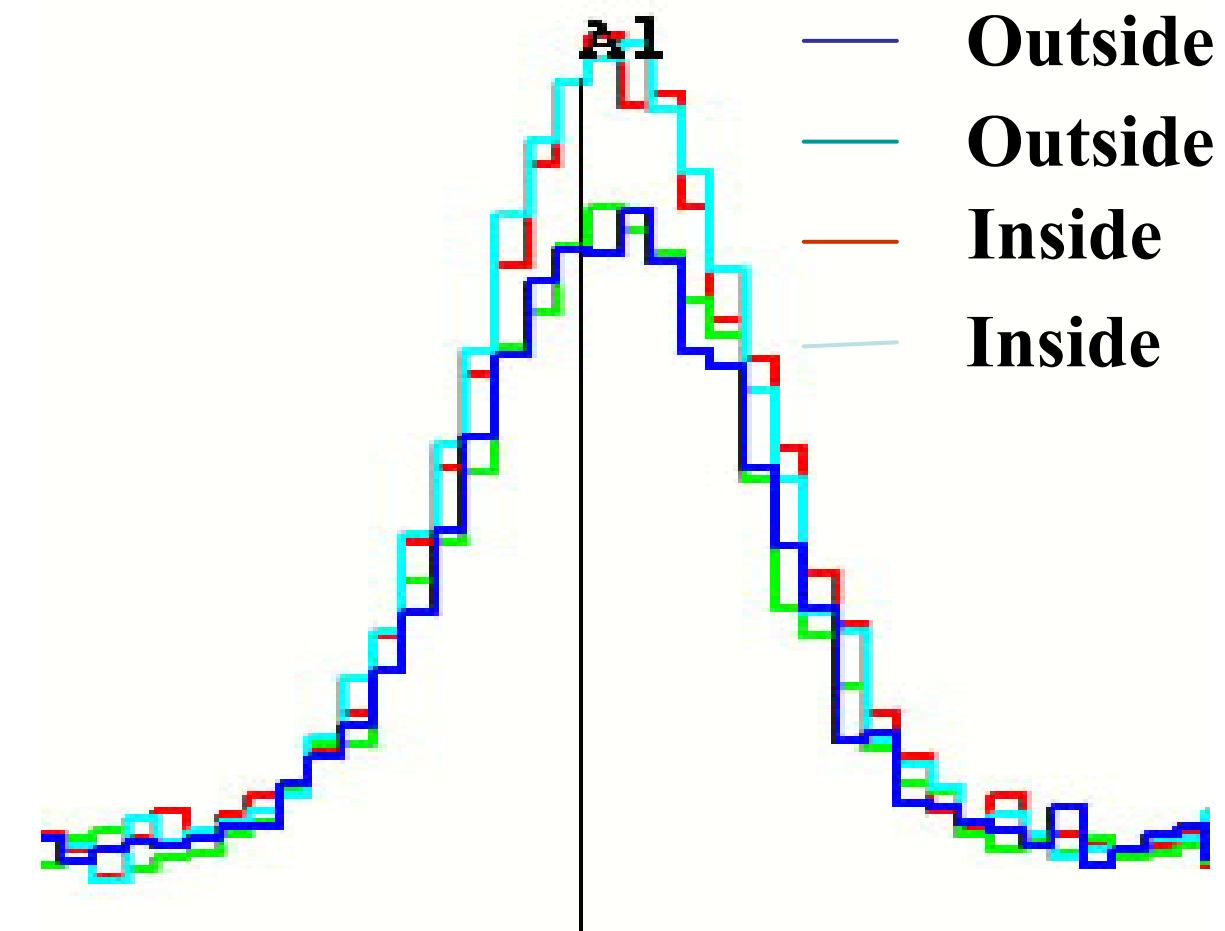
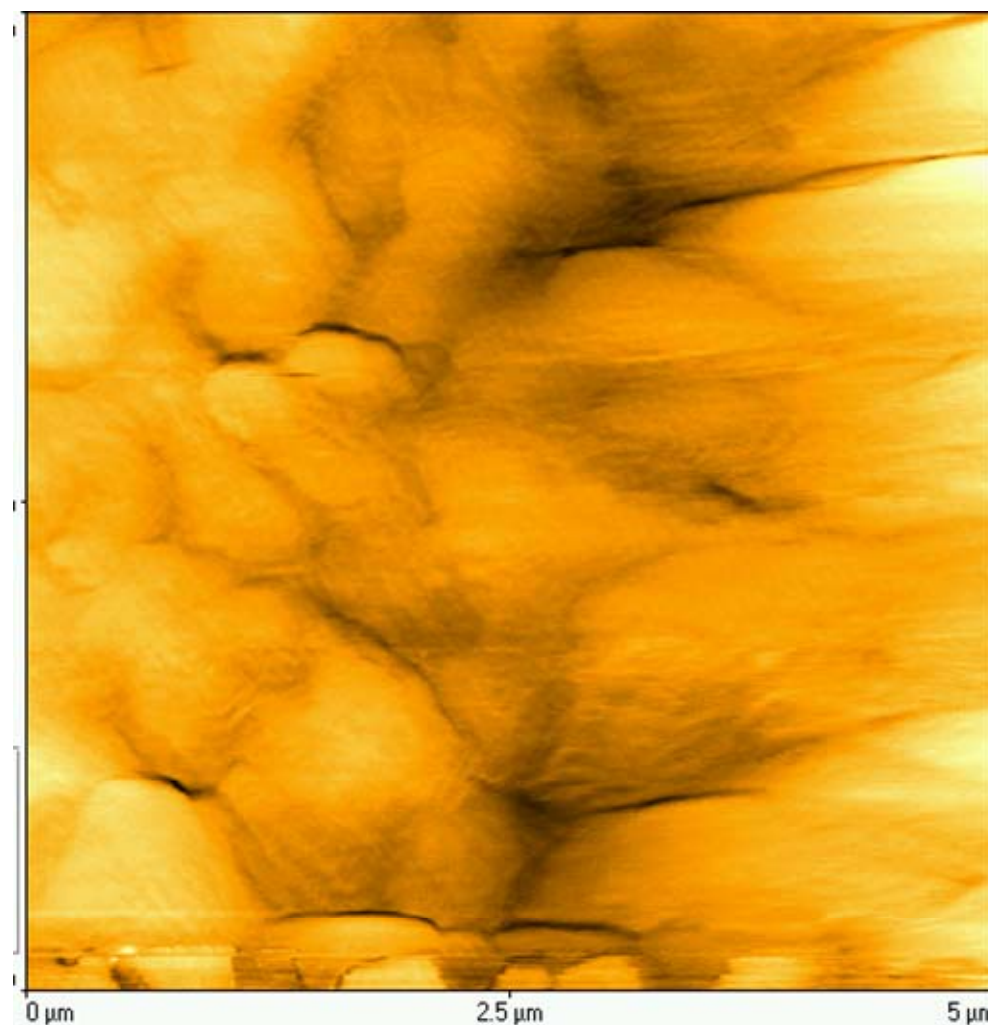
SEM shows 'spots'

EDAX inside and outside of the'spots'

AFM of region surrounding the spots

1. DARPA contractor was having poor device yields.
2. Our SEM analysis of the AlGaN indicated segregation.
3. Our EDAX analysis showed more Al inside than outside of the 'spot'.
4. Our AFM analysis showed three dimensional growth in region outside of 'spot' producing a rough surface.
5. Concluded that growth temperature for AlGaN too low.
6. Contractor fixed thermocouple and increased yield.

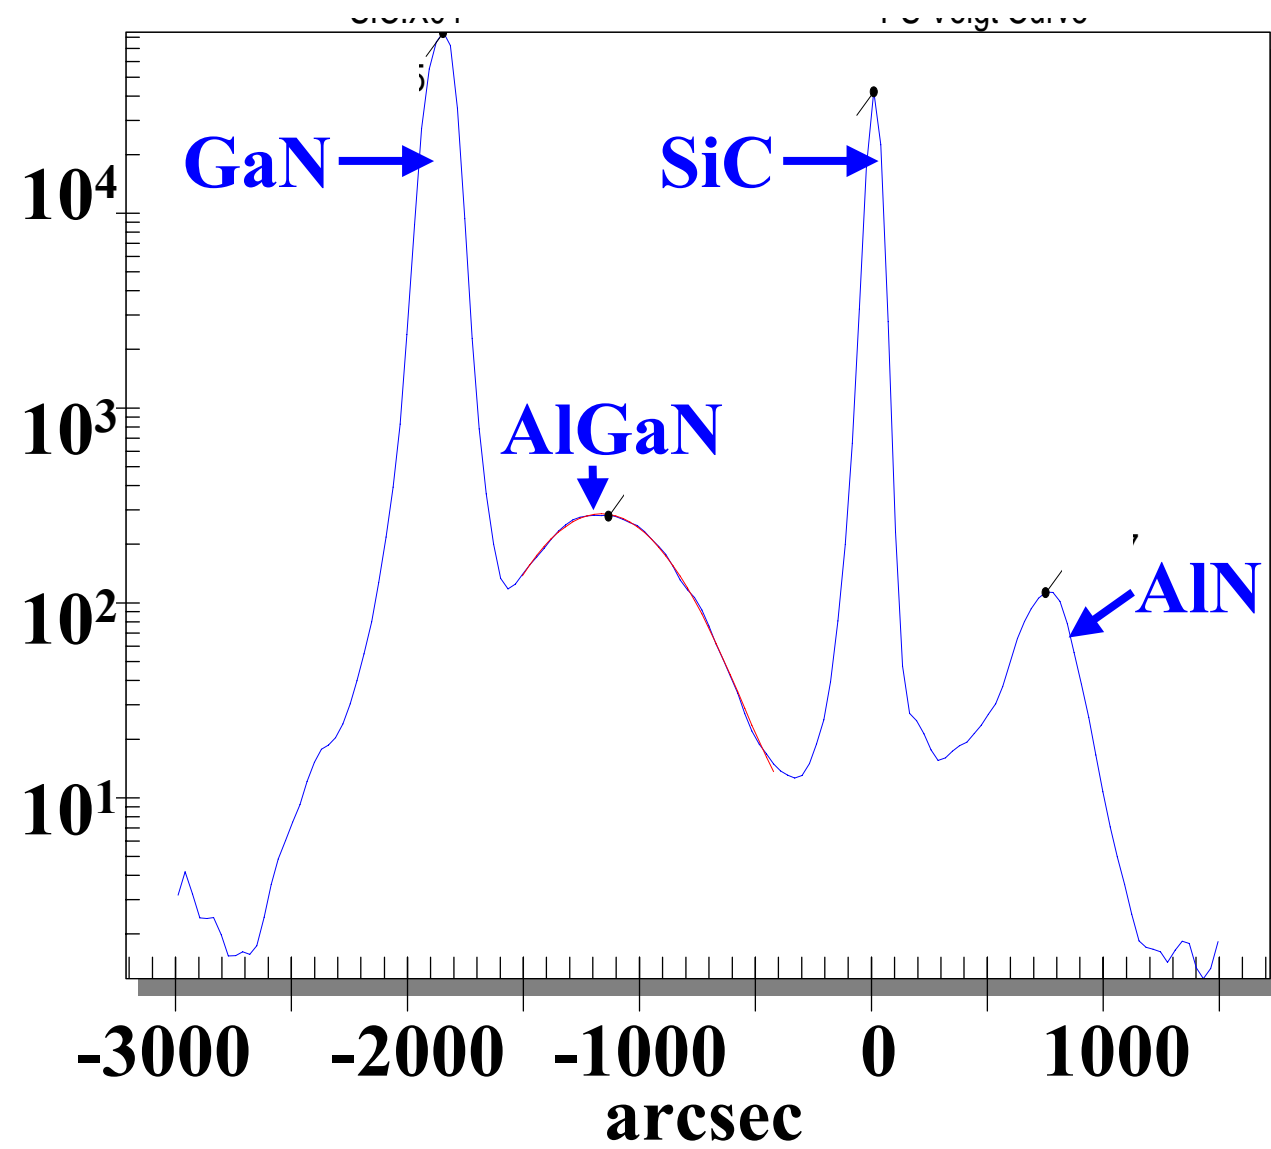
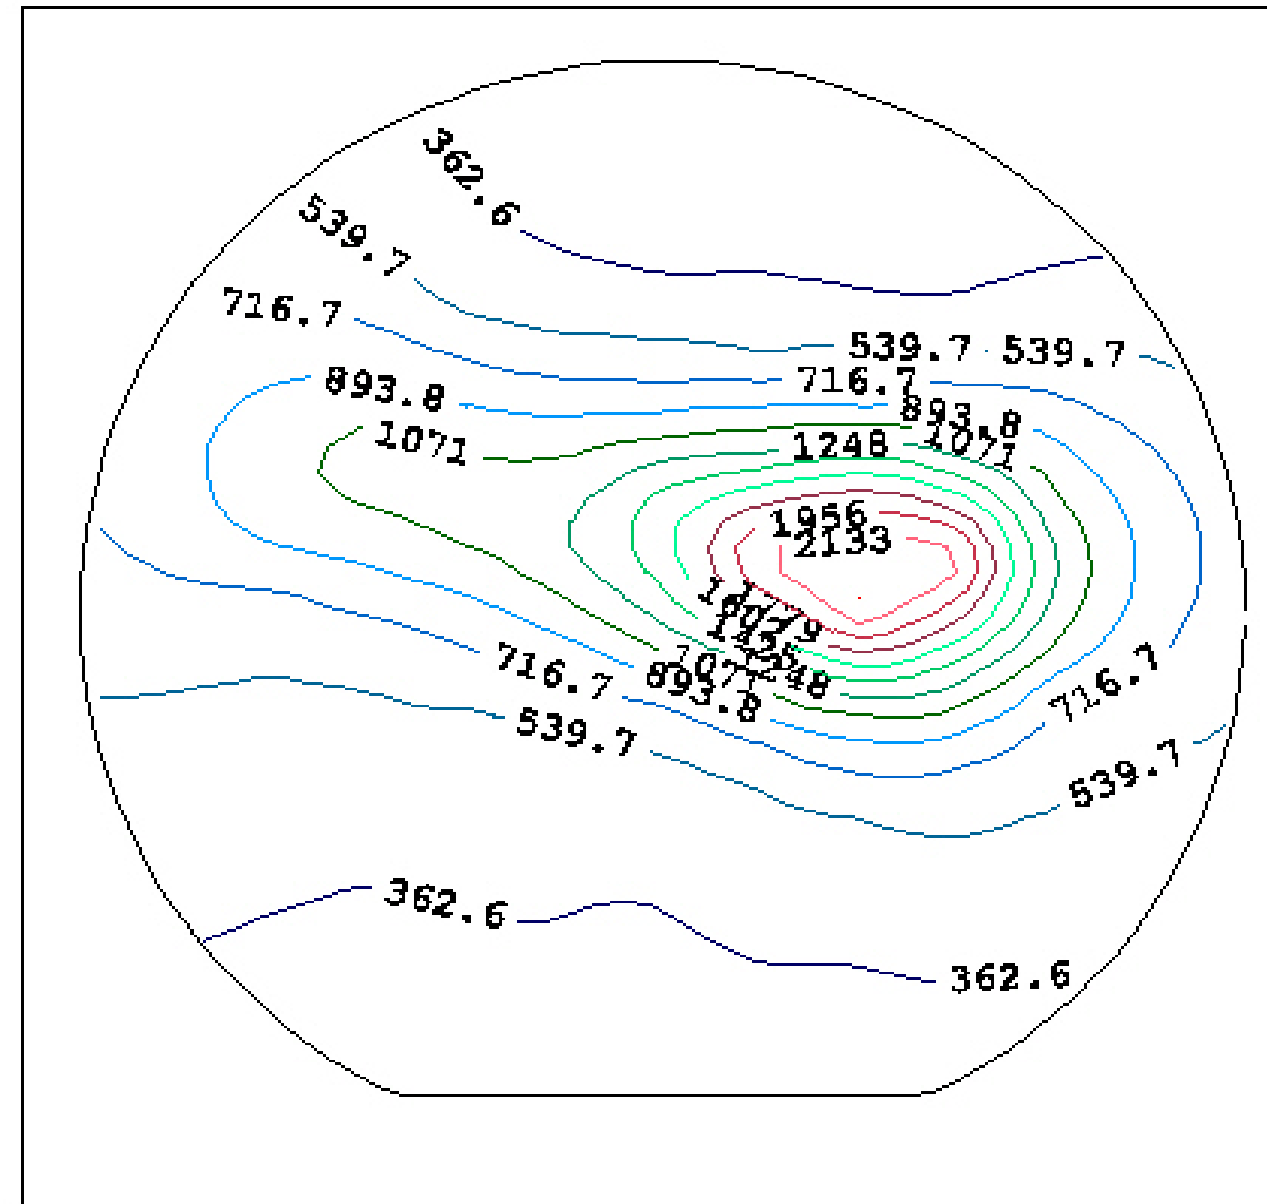
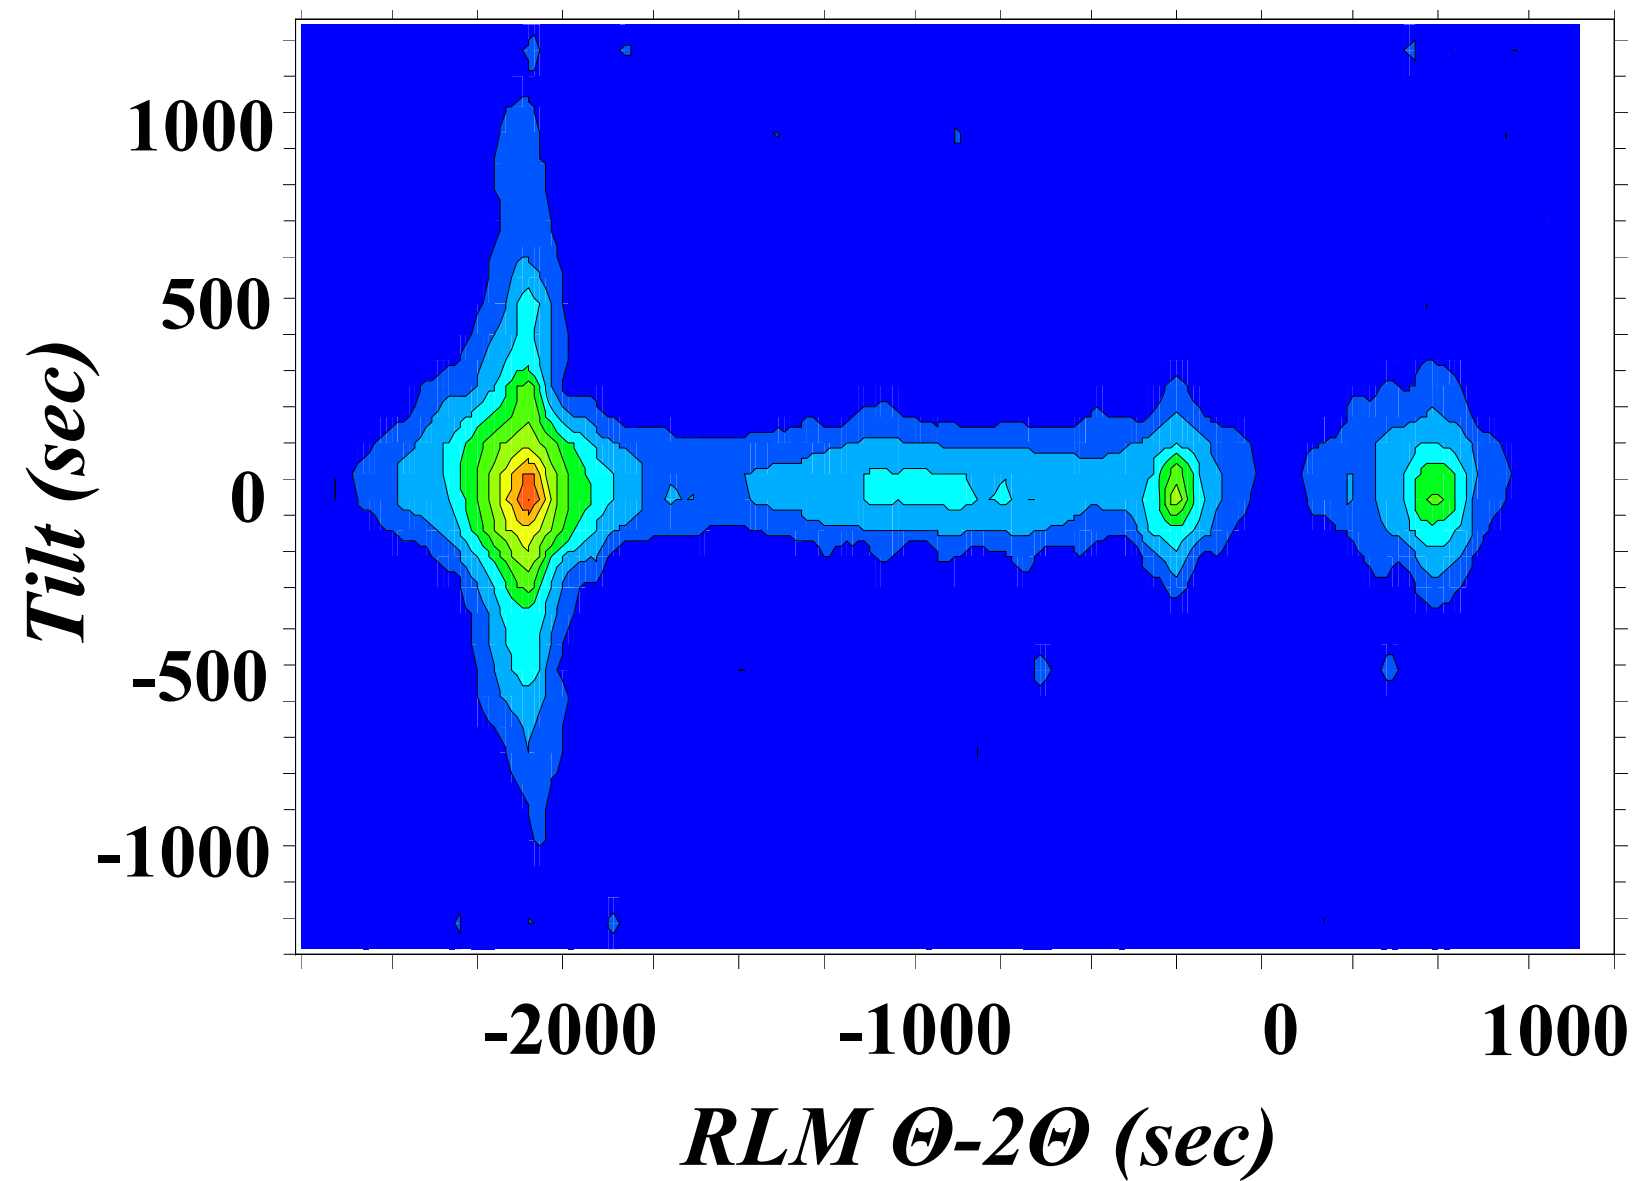
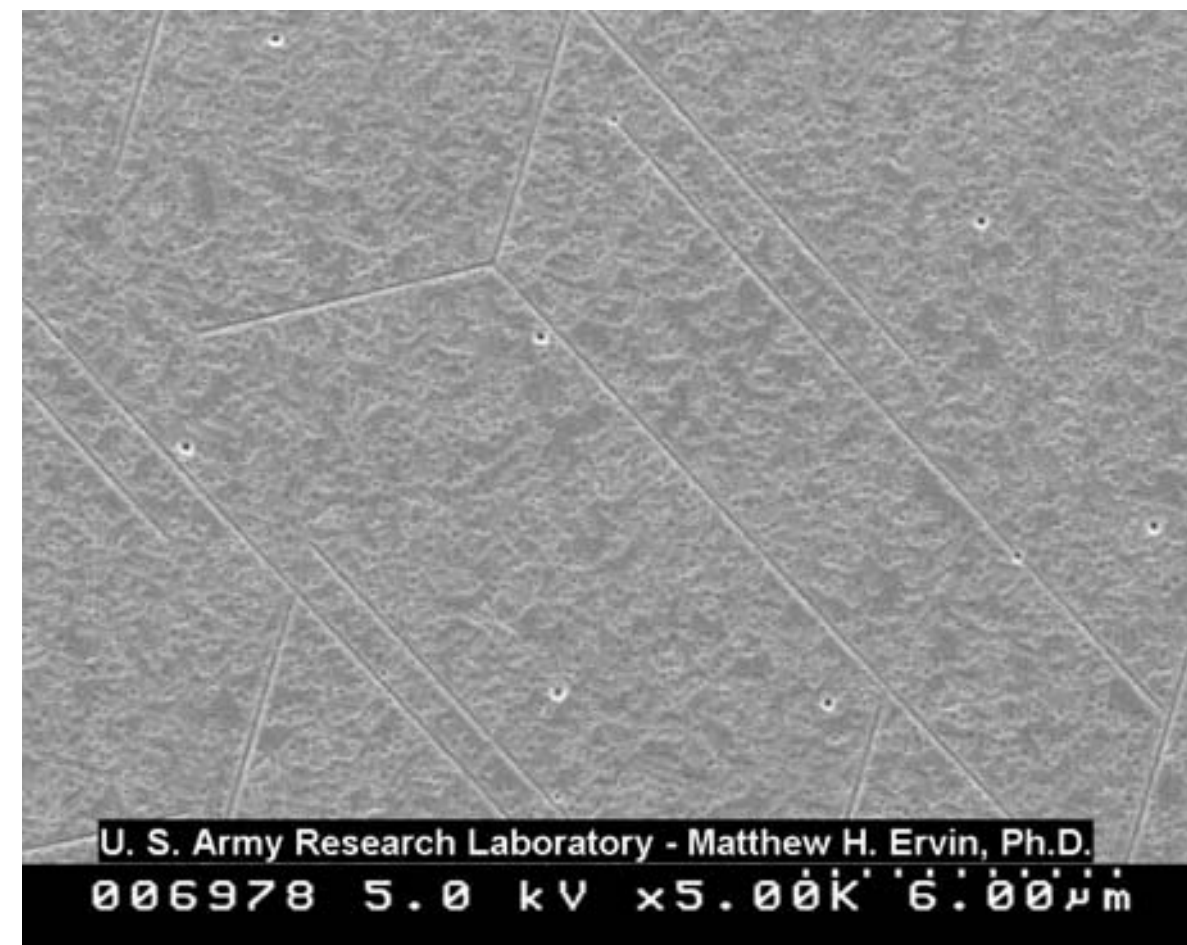
Sheet Resistance Map

SEM of AlGaN Surface

1. Sheet resistance map shows high resistance regions.
2. X-ray Θ-2Θ shows large Al concentration.
3. Reciprocal lattice map confirms high strain.
4. SEM shows cleavage cracks.
5. Recently cracks at gate on drain side detected when larger voltage is applied.
6. Speculate this is due to piezo-strain.
7. Highest electric fields at the gate on the drain side.

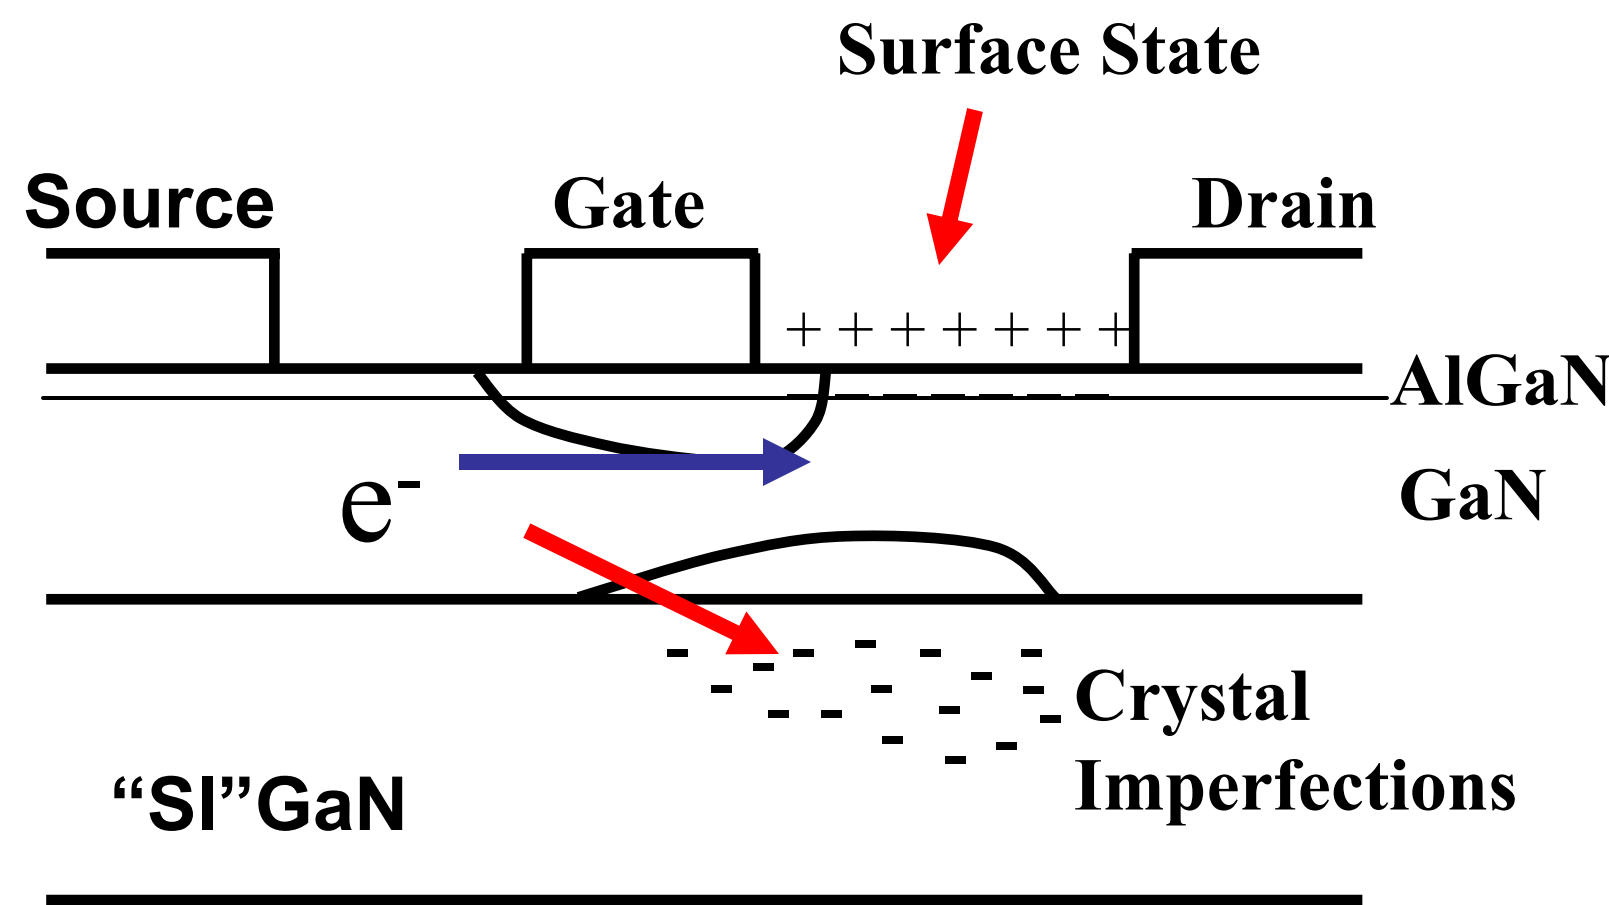
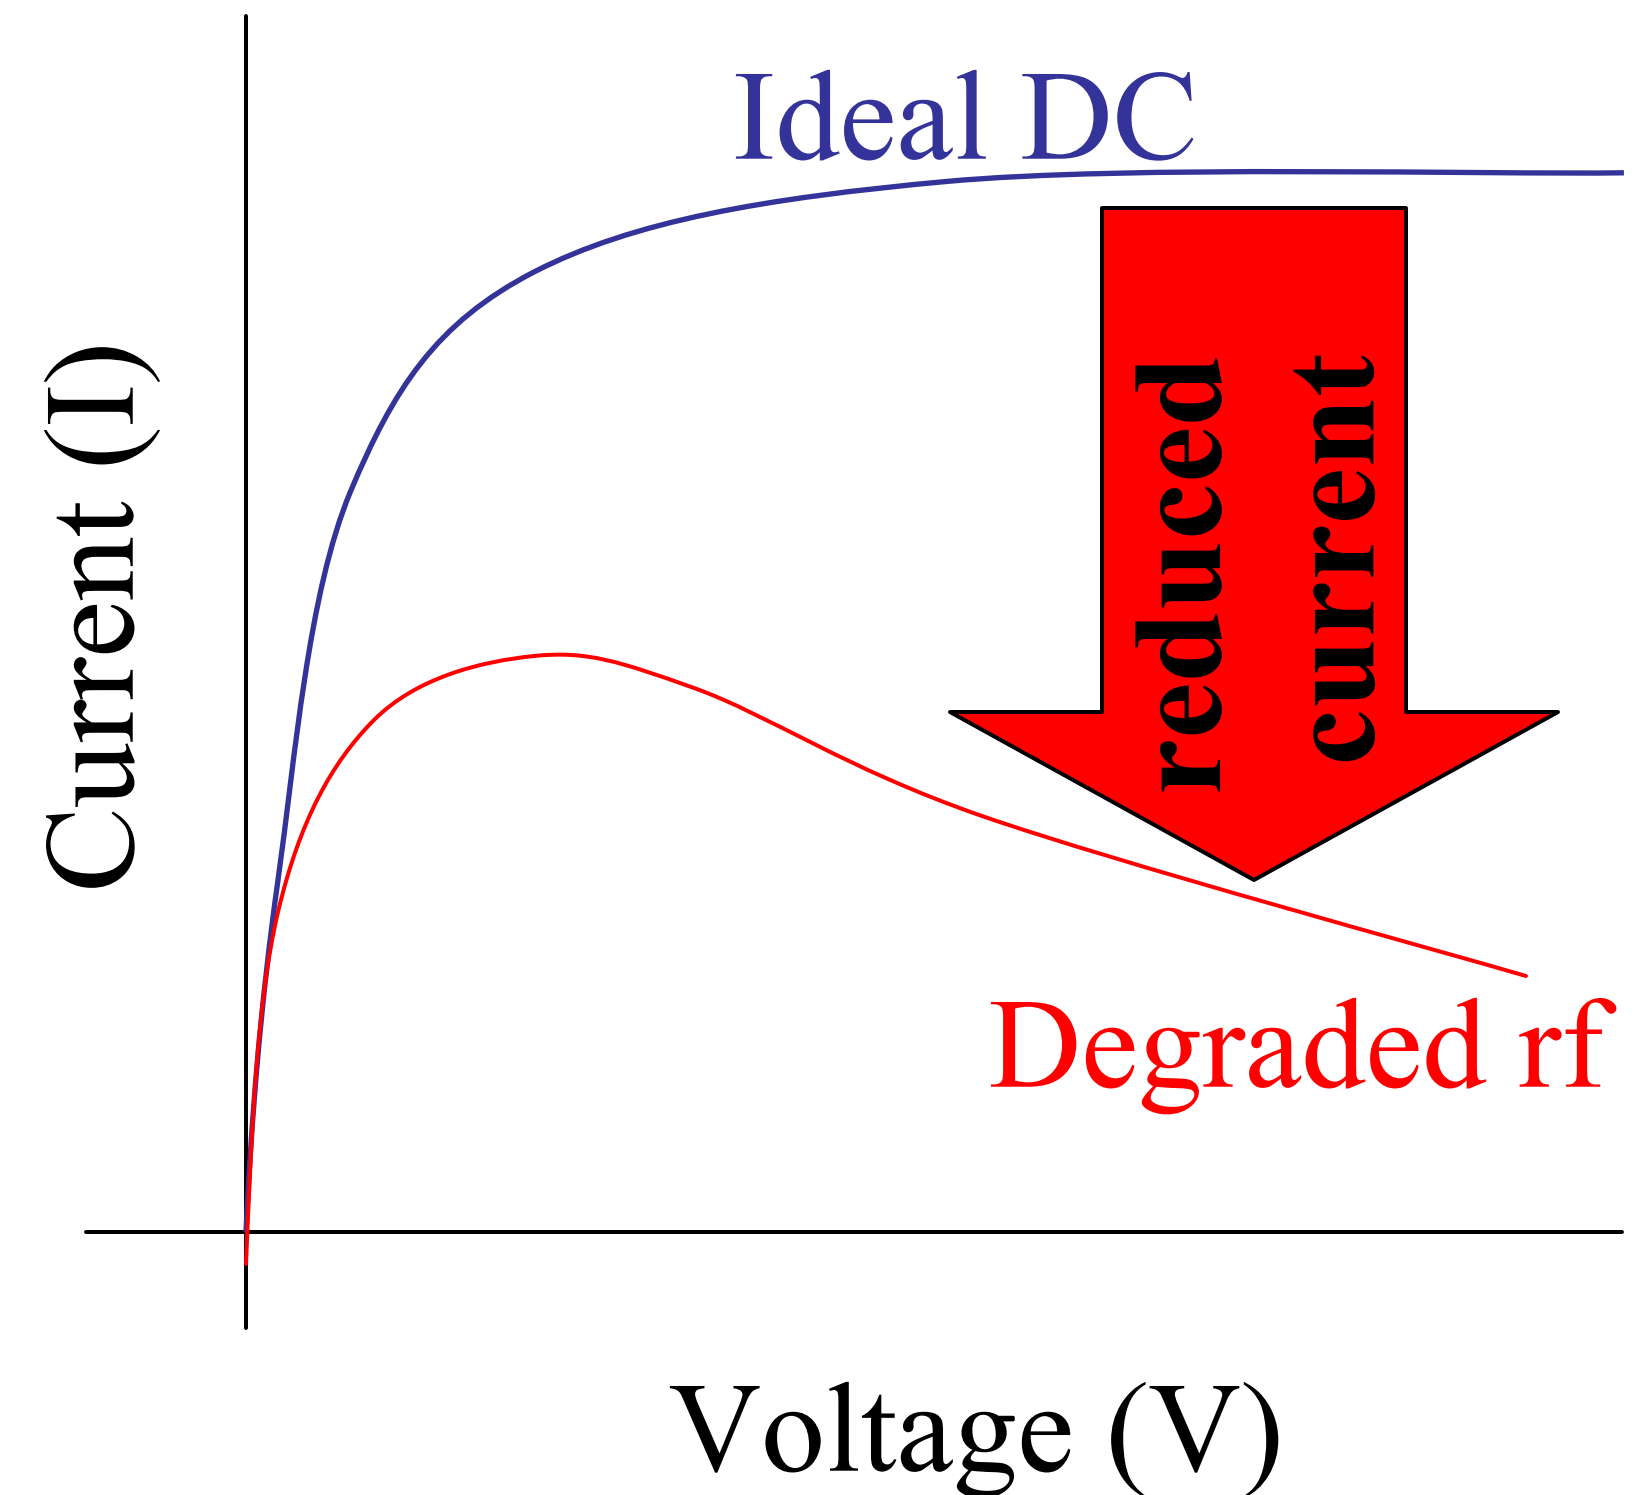
Current Collapse in HEMTs

Crystal imperfections or surface states "trap" electrons and degrade RF current flow

Buffer traps determined by epitaxial growth conditions. Strong polarization induced surface effect is minimized by silicon nitride passivation.
