DEGRADATION, RELIABILITY, AND FAILURE OF SEMICONDUCTOR ELECTRONIC DEVICES

M.A. Derenge, M.H. Ervin, K.W. Kirchner, K.A. Jones*, M.C. Wood, and T.S. Zheleva
Microdevices Branch, Army Research Lab – SEDD, AMSRD-SE-DL, Adelphi, MD

Degradation, Reliability and Failure of Semiconductor Electronic Devices

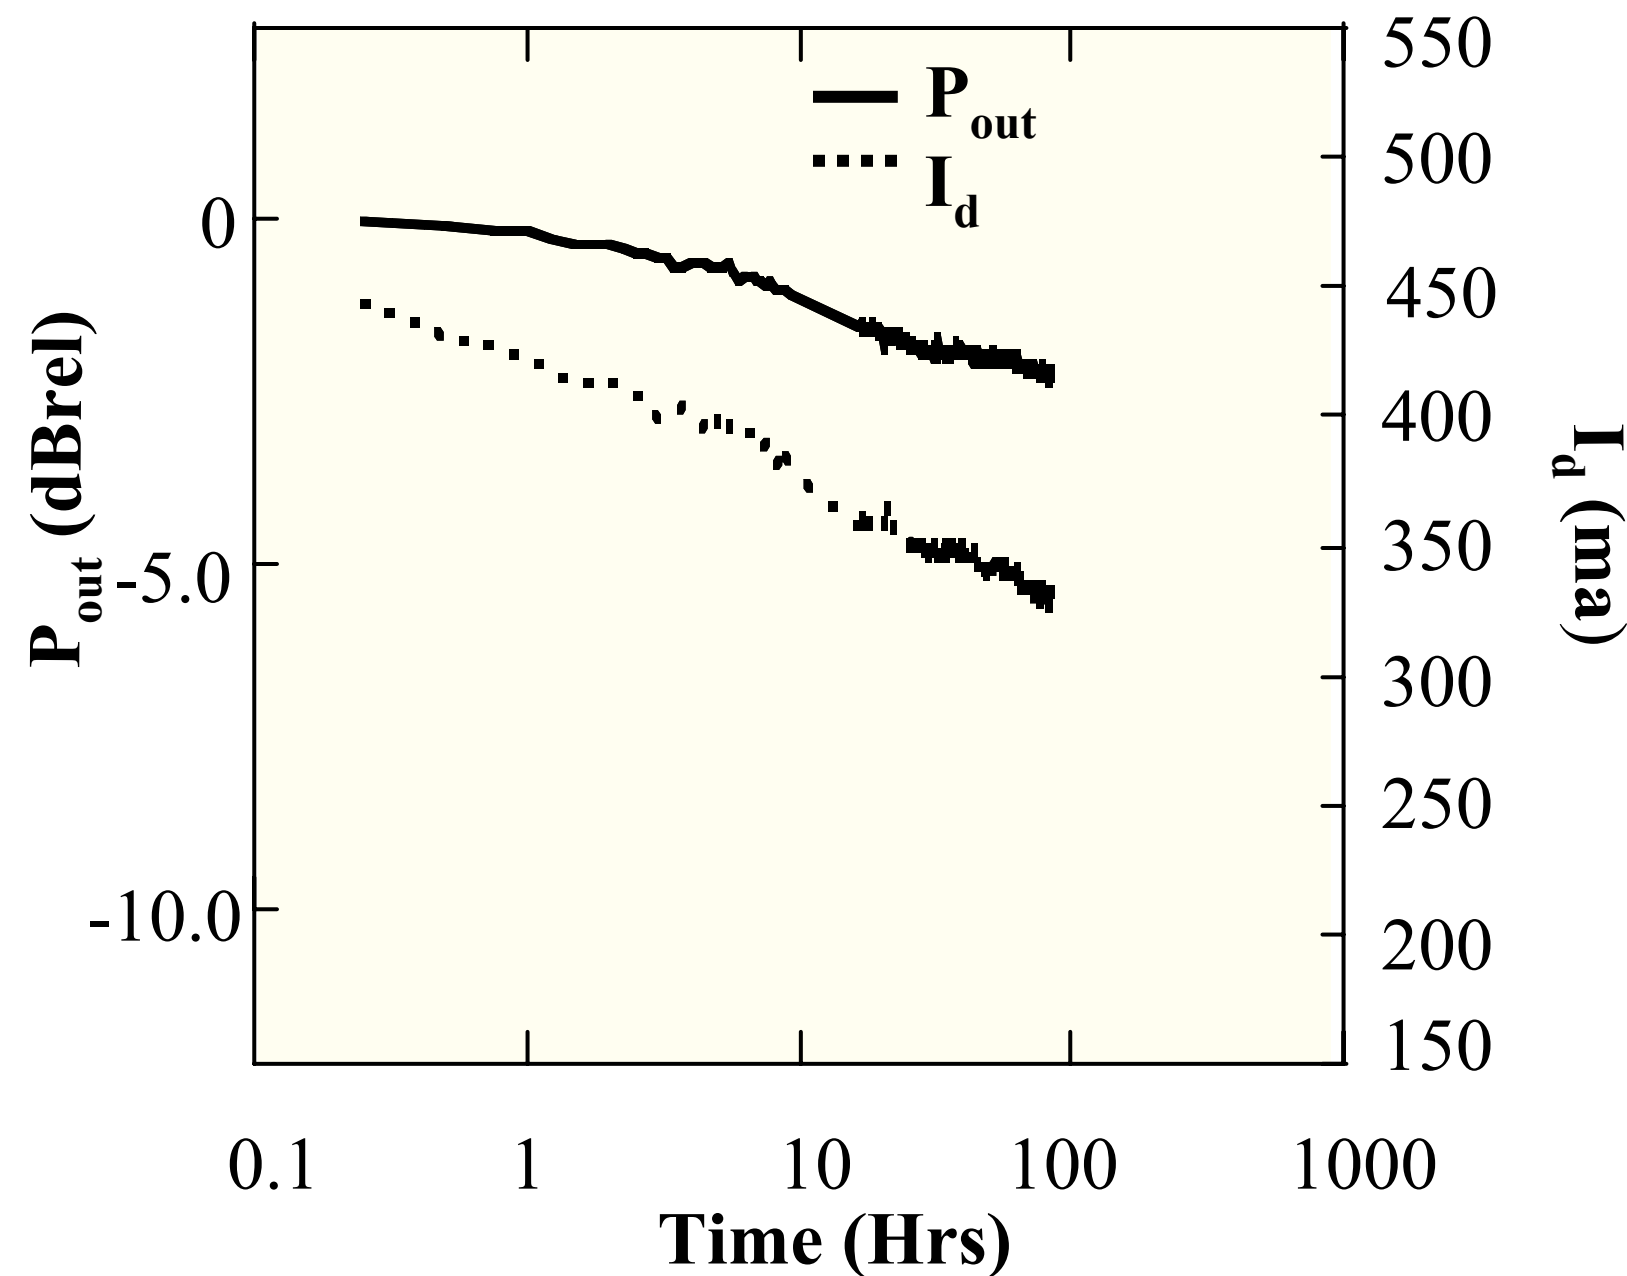
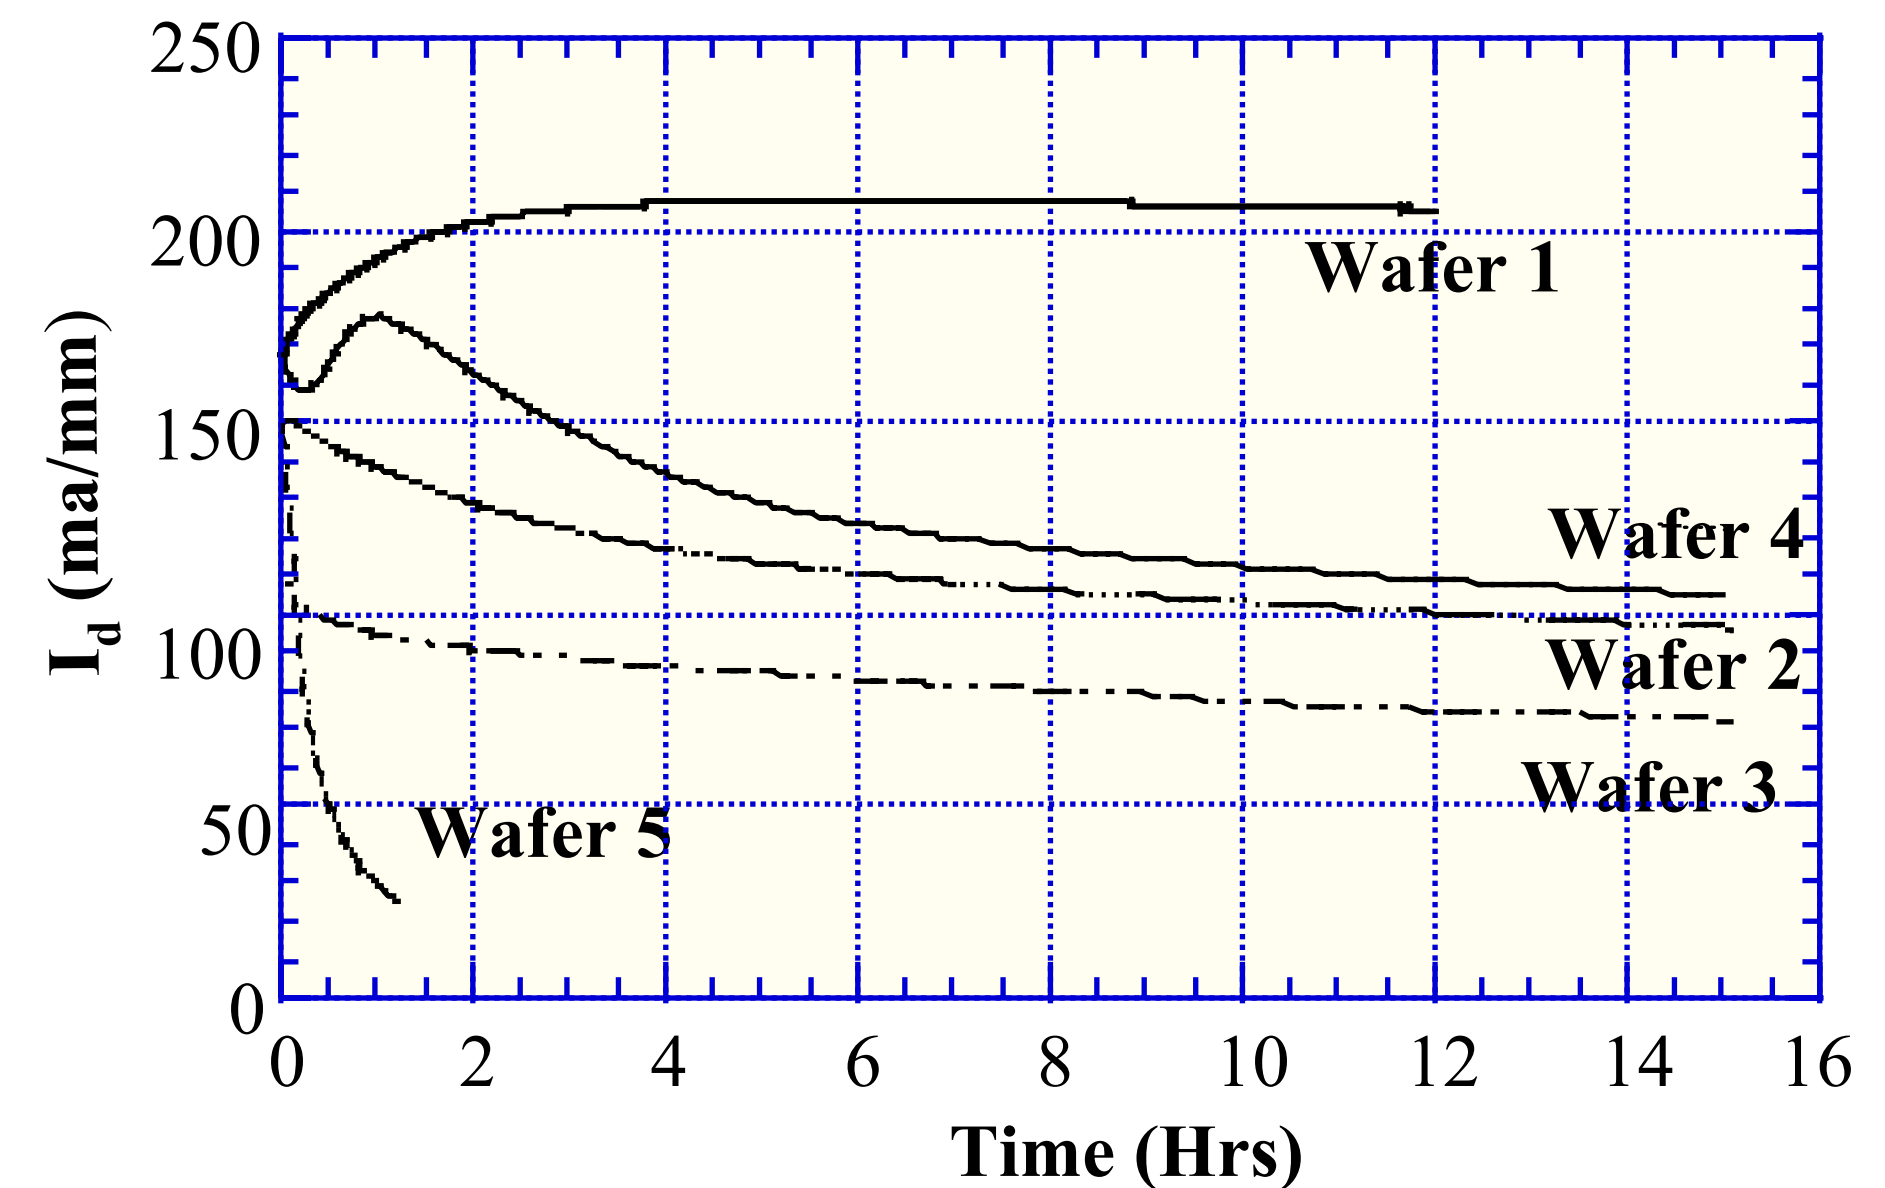
RF reliability
Power (solid) and Drain Current (dashed)

DC stress of multiple wafers

1. Decrease in drain current follows degradation in output power
2. Devices degrade with DC stress as well; degradation varies from wafer to wafer and on same wafer
3. Reliability of device can depend on the method used to grow it.

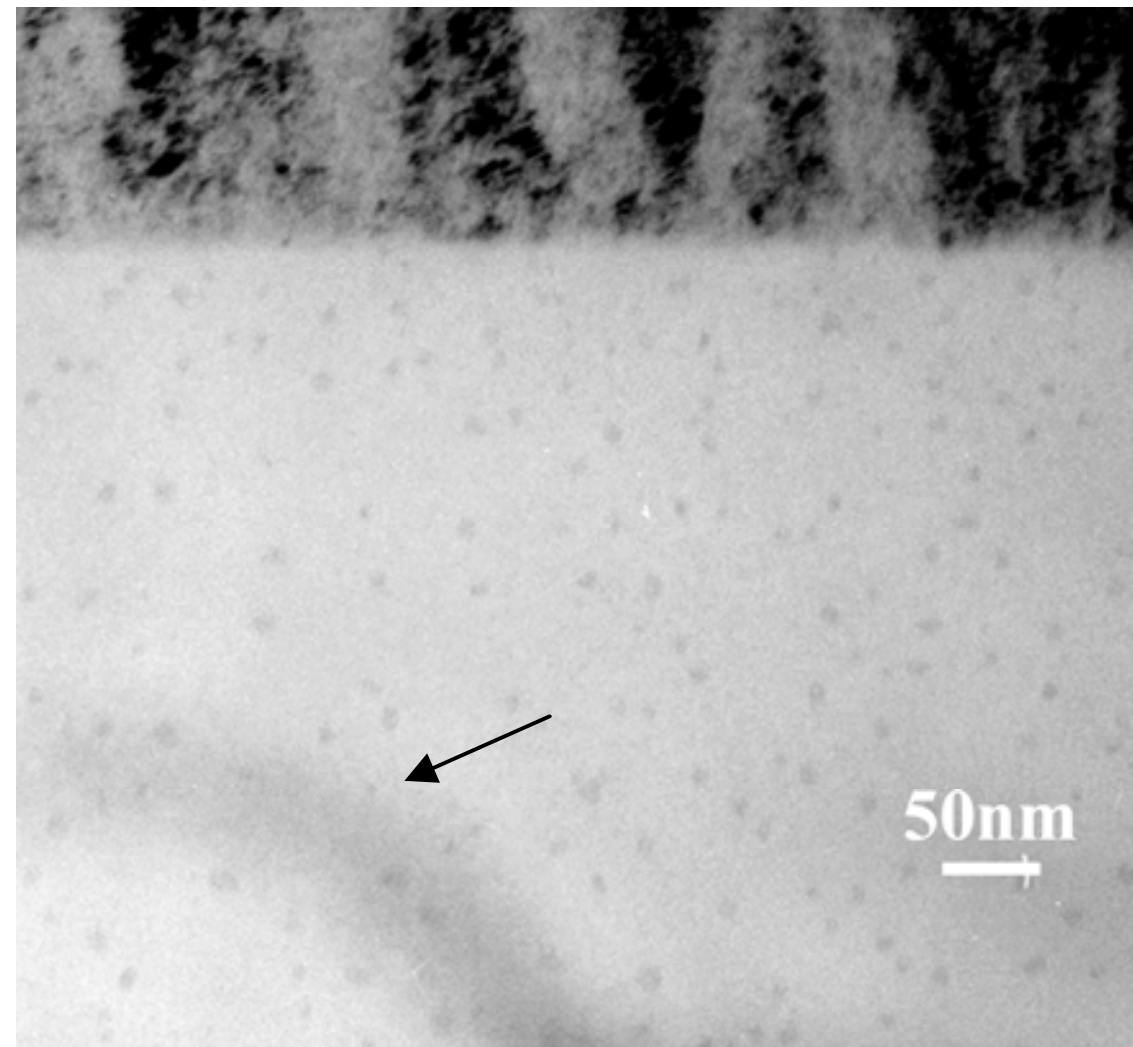
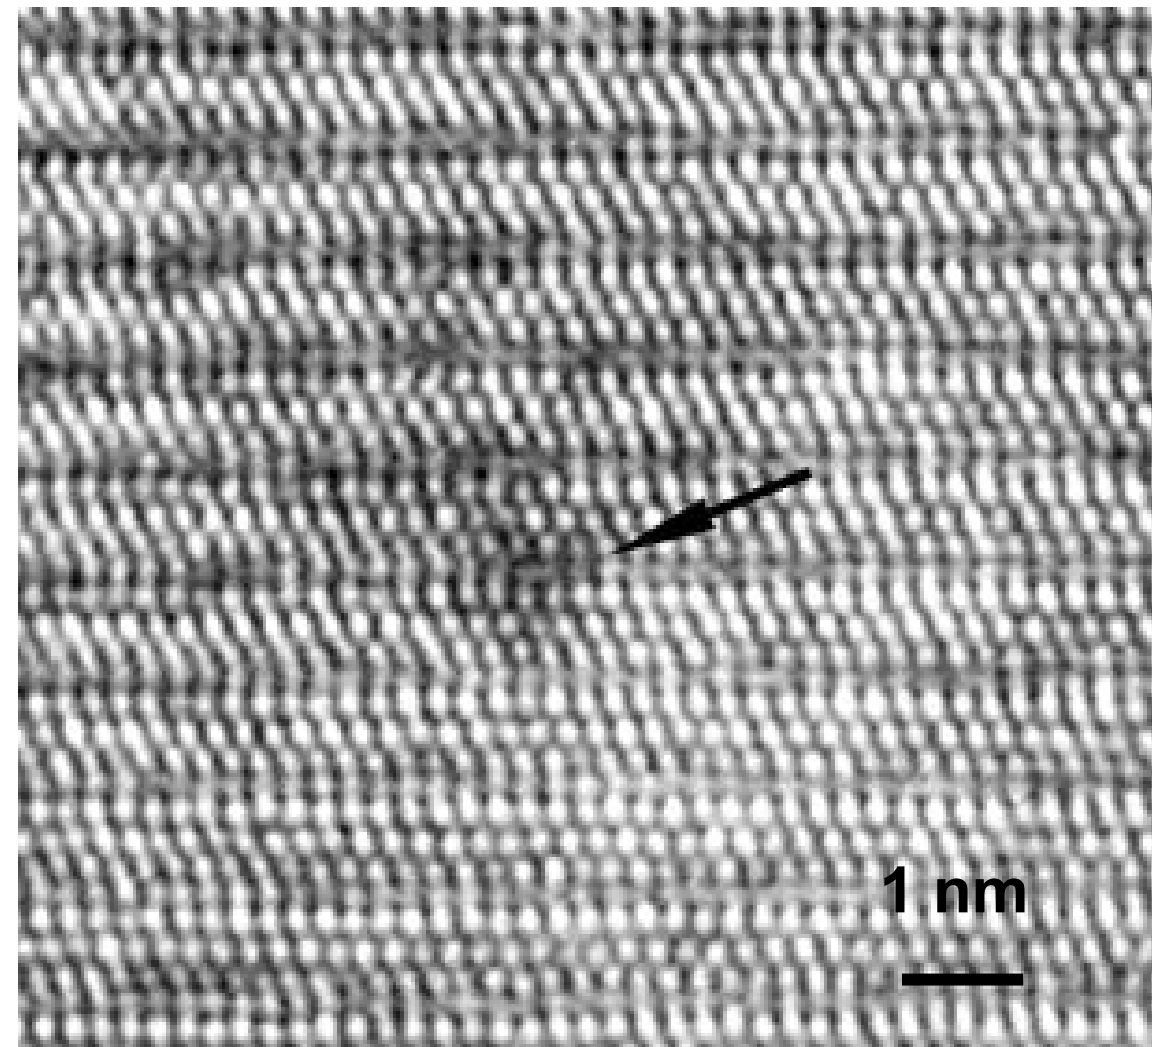
TEM Showing Defects (spots)

HRTEM of Spots Showing SF

1. TEM shows that annealed ion implanted region contains persistent defects; HRTEM show that defects are stacking faults.
2. Defects thought to be a Frank intrinsic stacking fault can be formed by the condensation of divacancies; has energy states in energy gap associated with it.
3. Solution is to reduce implant dose near junction.

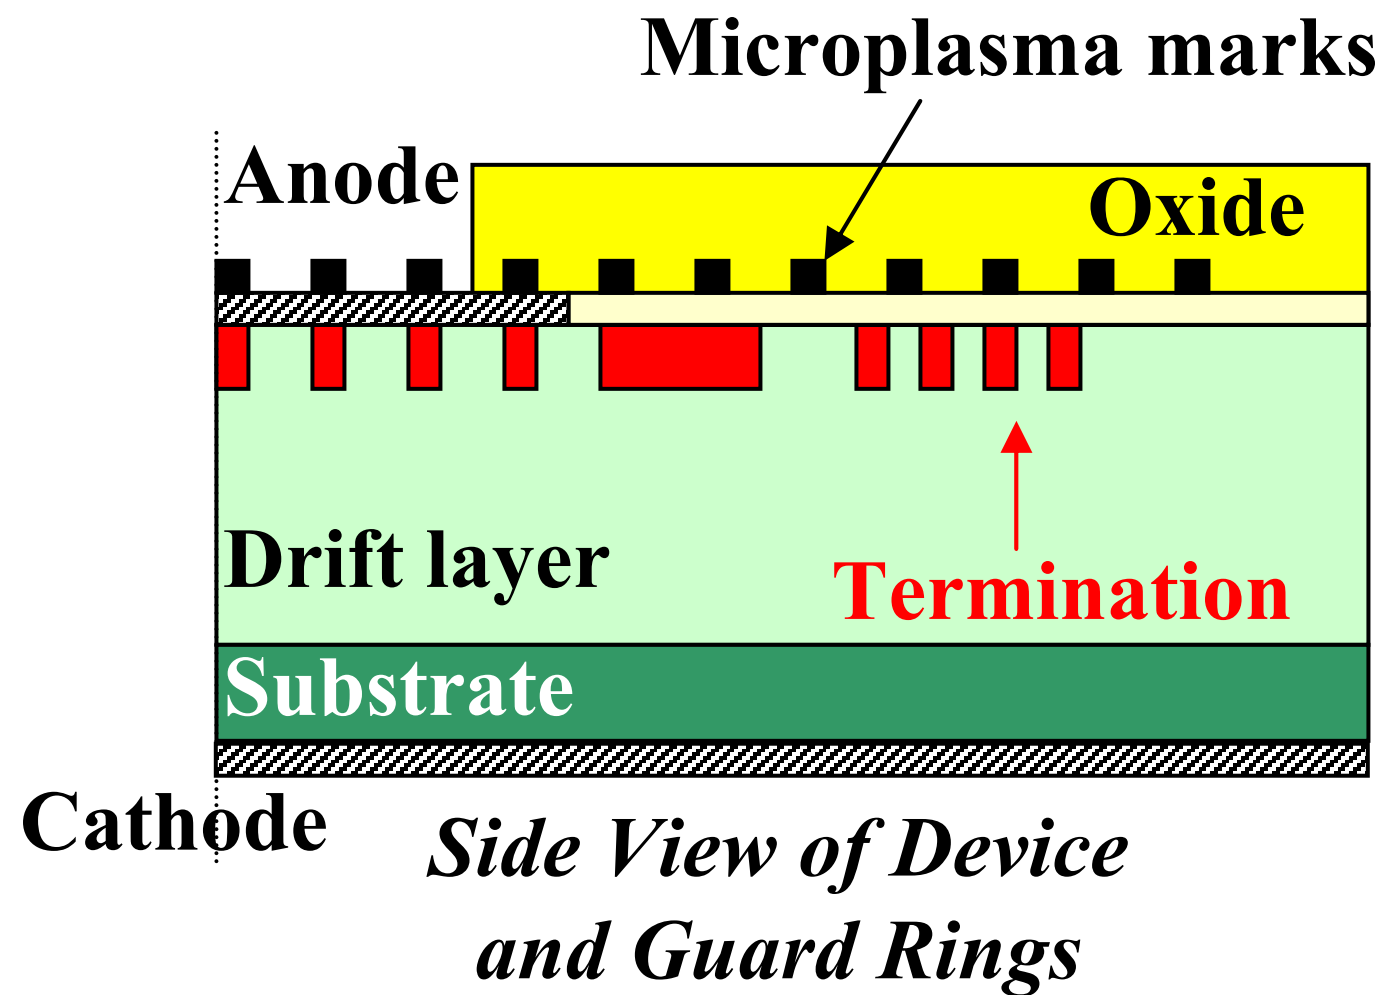
Side View of Device and Guard Rings

1. Guard rings are necessary to prevent premature breakdown at the edges.
2. Guard rings are implanted.
3. There is a possibility of premature breakdown caused by the persistent defects caused by ion implantation.

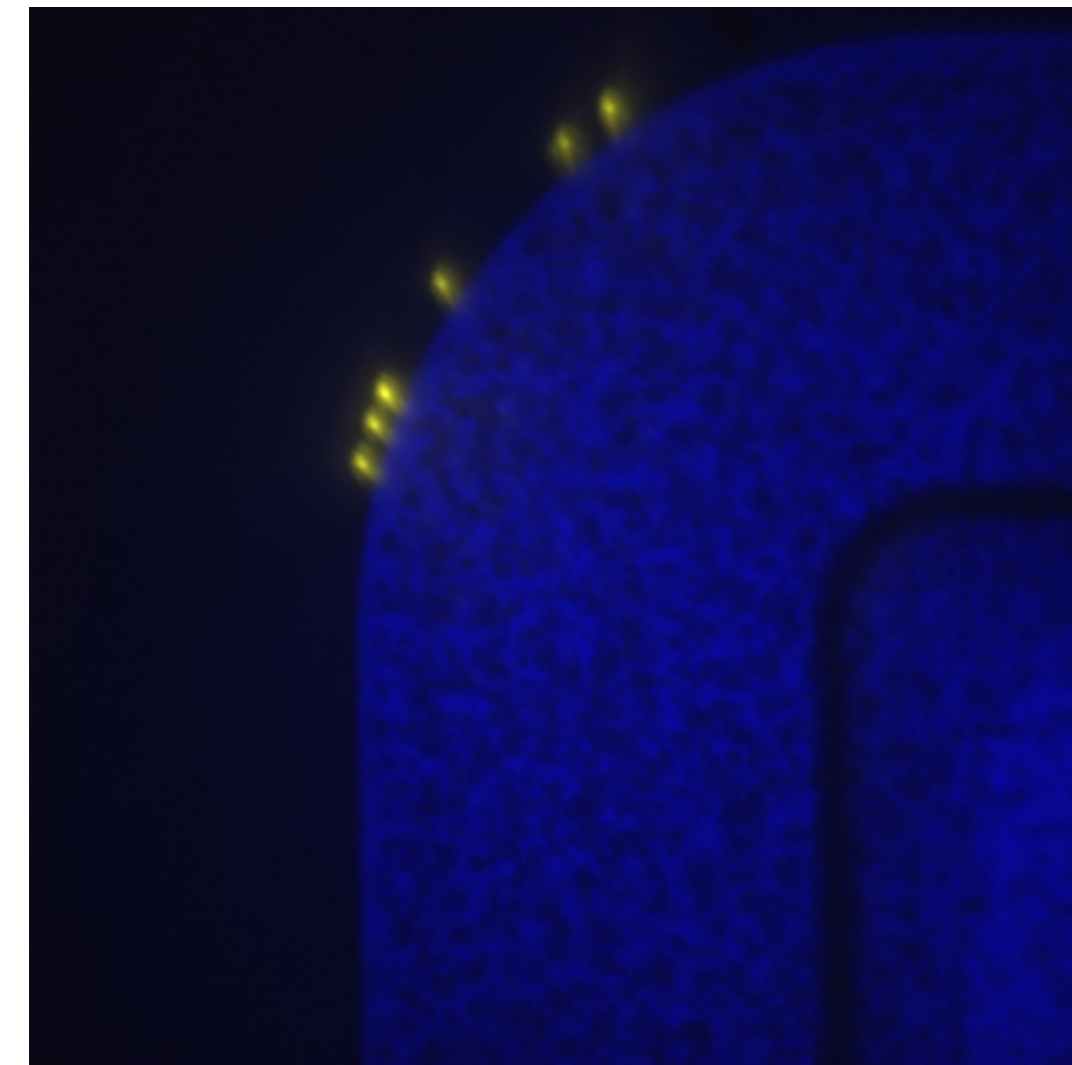
Top View of Device with Microplasmas

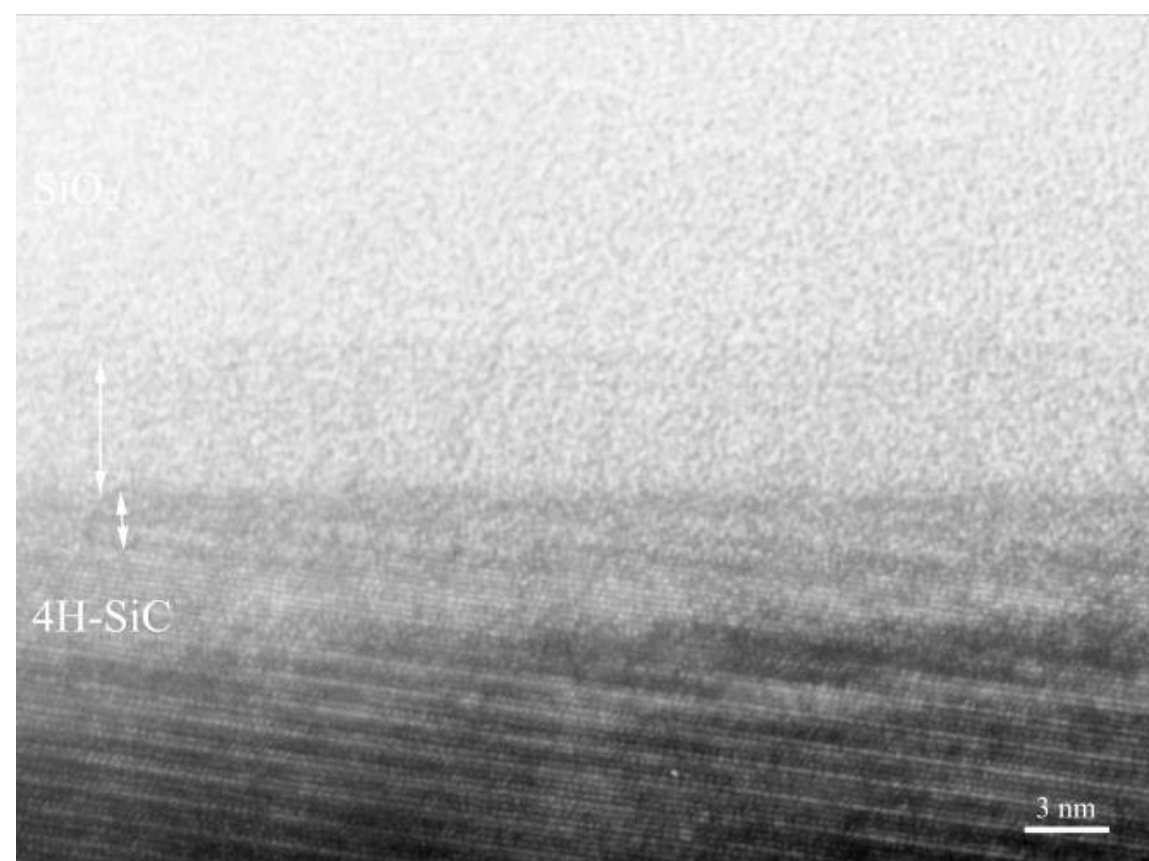
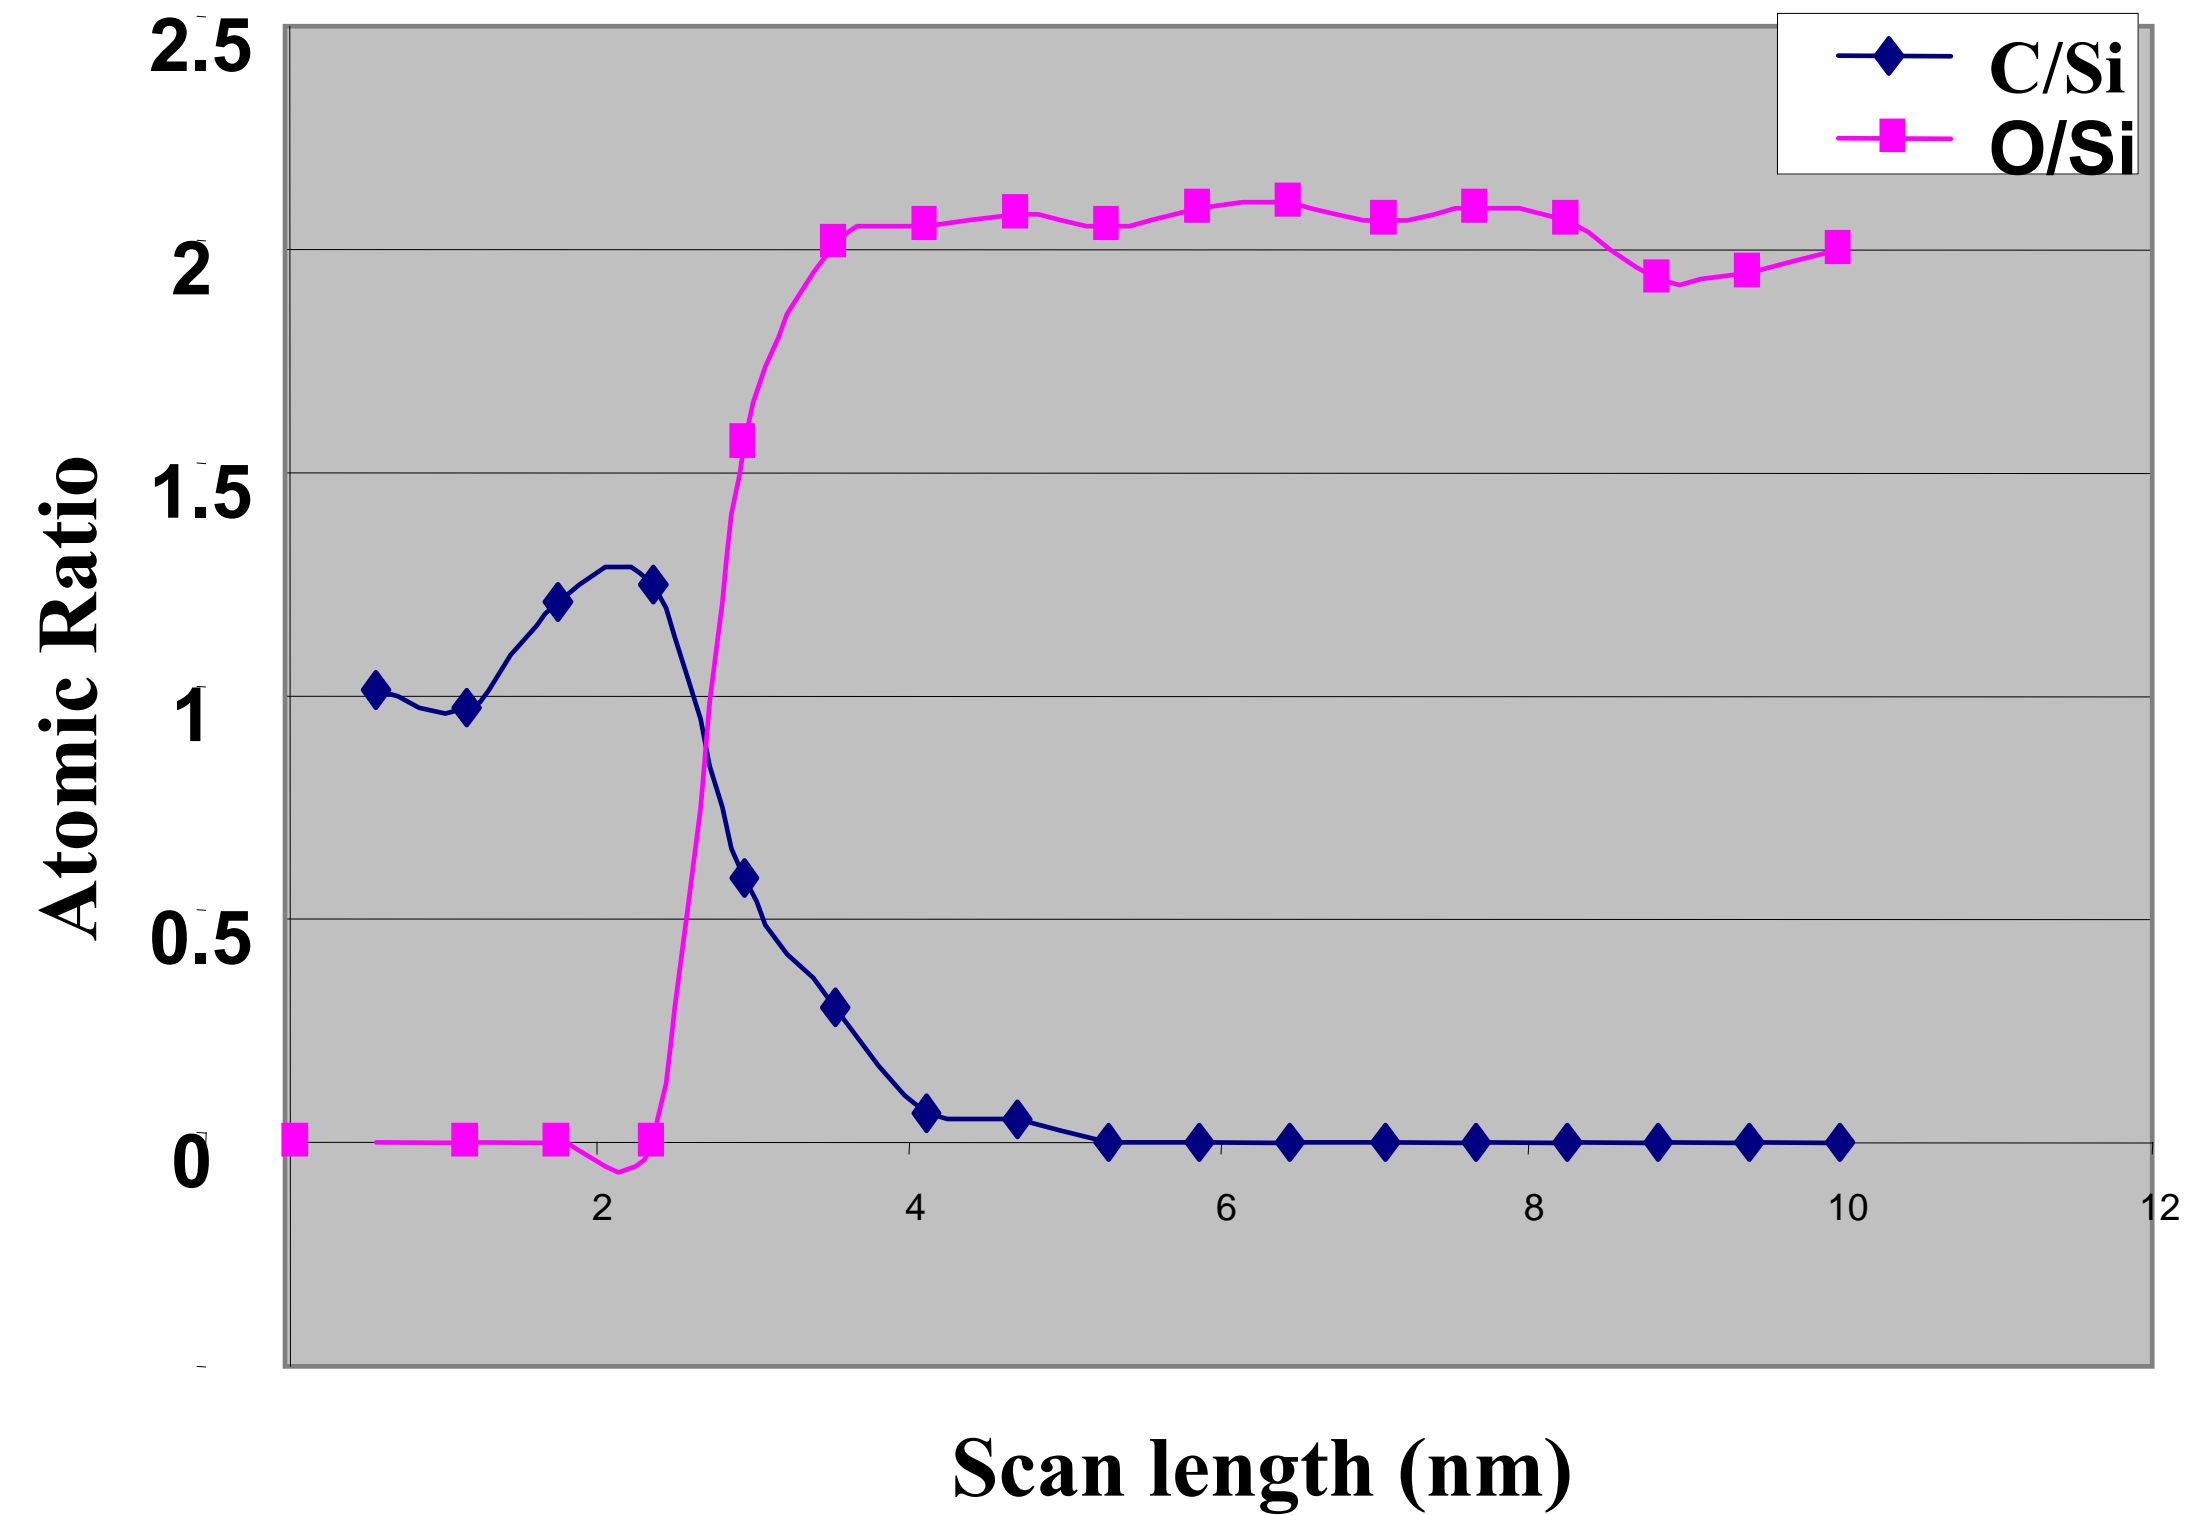
HRTEM of the SiC/SiO_2 Interface

There is evidence from EELs of increased C/Si ratio on both side of the interface consistent with Si vacancies in SiC (SDR studies) and also C incorporation in the oxide transition layer
