RTO AGARDograph **AG-AVT-140**

Corrosion Fatigue and Environmentally Assisted Cracking in Aging Military Vehicles

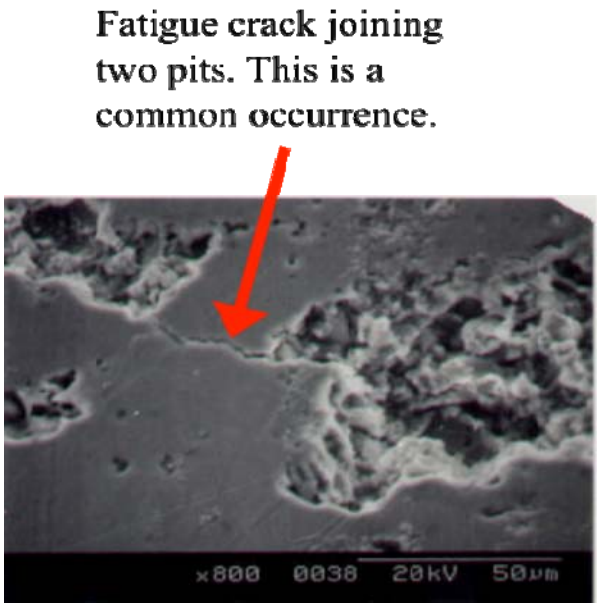
Figure 5-6 and Figure 5-7 above show, respectively, the formation of fatigue cracks at corrosion pits and how fatigue cracks are observed to link pitting. It has been known for some time that both these occur. Thus, corrosion pitting often creates multiple site damage. The characterization studies done recently at the UU QIDEC laboratories have been instrumental in identifying features of pitting that are useful in modeling (see Chapter 7 and references [27]-[49]).

Figure 5-7: View Showing Other Pits with Fatigue Cracks Propagating Between Them.

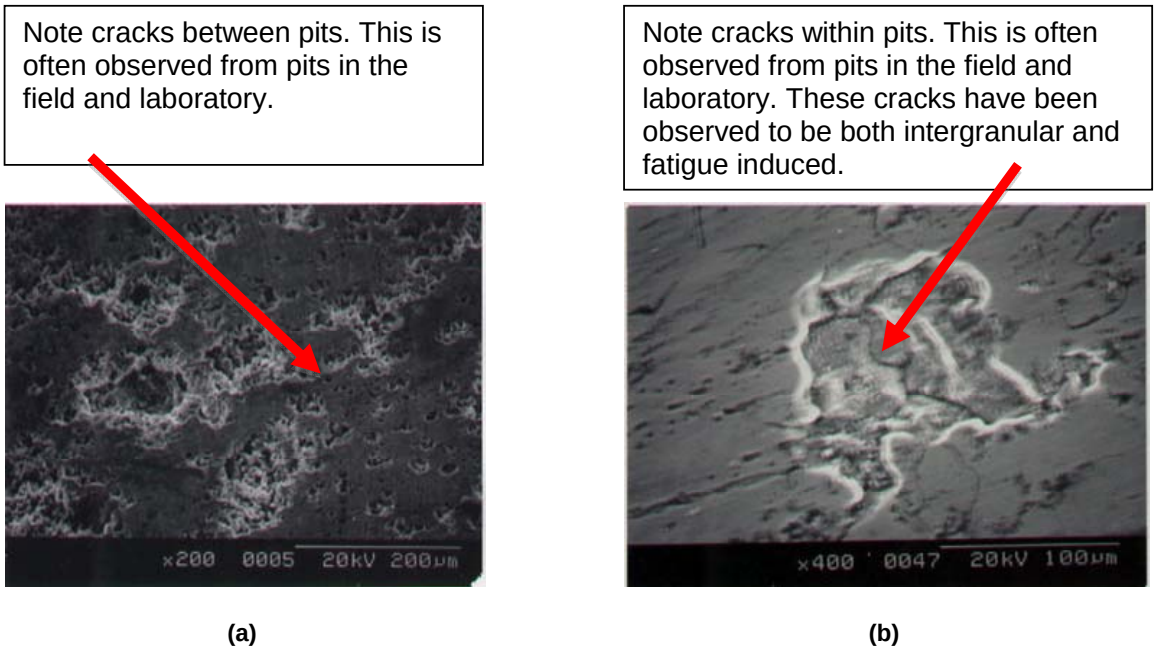
Figure 5-8(a) below shows the frequently observed occurrence of either sustained load or cyclic load induced cracks forming and linking pits. This has significant implications in formulating repair practices and in developing acccurate models to predict corrosion pit growth rates and incorporating them into

models. On the other hand Figure 5-8(b) shows a view of cracks in the bottom of pits. This observation was made quite frequently. (Although not visisble in this photo cracks also were observed in pit walls. This too was frequently observed).

Figure 5-8: Views in the Notch of Corrosion Fatigue Specimens Tested in the QIDEC Laboratory at the University of Utah (2000). Alloy was 7075-T6 tested in 3.5% salt water.

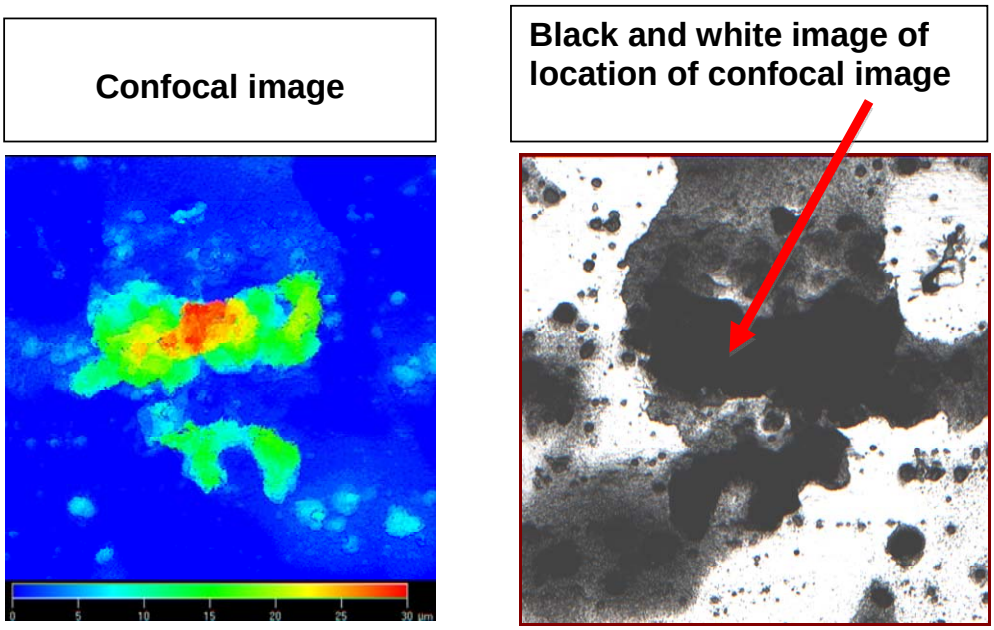
Figure 5-9 below shows an example of an image of pits taken in a confocal microscope. The confocal microscope has been very successful in allowing the determination of pit depth and more clarity on the shape of pits as well (see Ref. [49] for more general descriptions of the use of the confocal microscope to characterize pits. This is in additon to many other references cited herein). Another example of the characterization of pits is shown in Figure 5-10. In this case the confocal microscope was used in conjunction with the SEM (Scanning Electron Microscope) to characterize the depth and shape of corrosion pits developing under corrosion fatigue test conditions. These tools proved invaluable in their ability to assist in characterizing the depth and shape for use in modeling efforts as described in Chapter 7 of this report.

Figure 5-9: Post Corrosion Exposure of 30 Hours, d~0.0012" (30 mm) of Pit: Left image shows typical confocal image with variation in color showing depth – red indicates the deepest area of the pit; Image on right shows area where confocal image was taken.

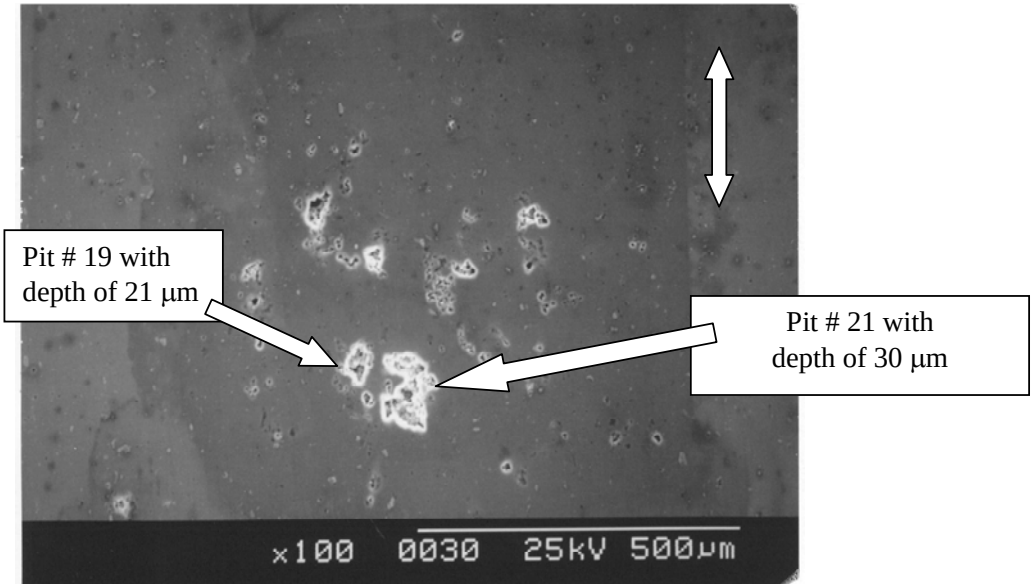
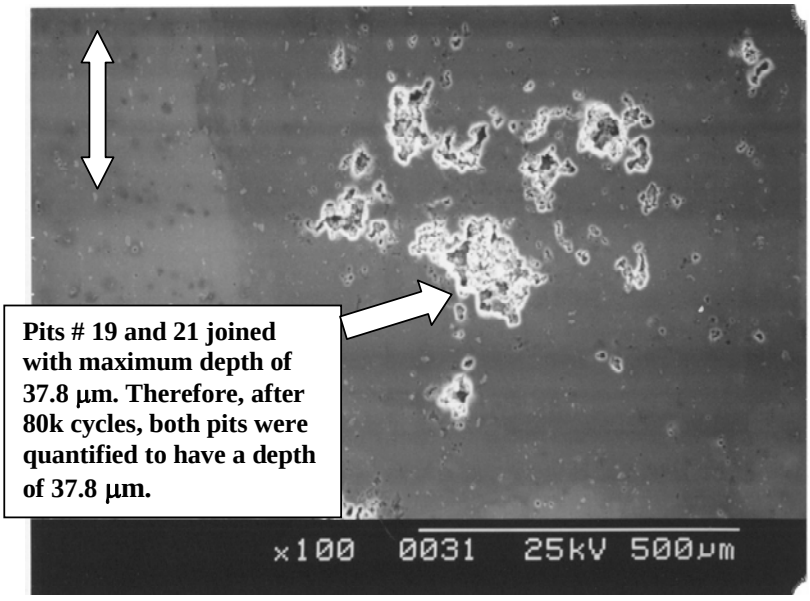
Figure 5-10: SEM Photos Showing Pits Developed Under Corrosion Fatigue Conditions: (a) After 60,000 Cycles; and (b) After 80,000 Cycles. Vertical arrows indicate loading direction. Depth of pits determined by confocal microscopy. (Material was 7075-T6 tested in ASTM 3.5% NaCl solution).

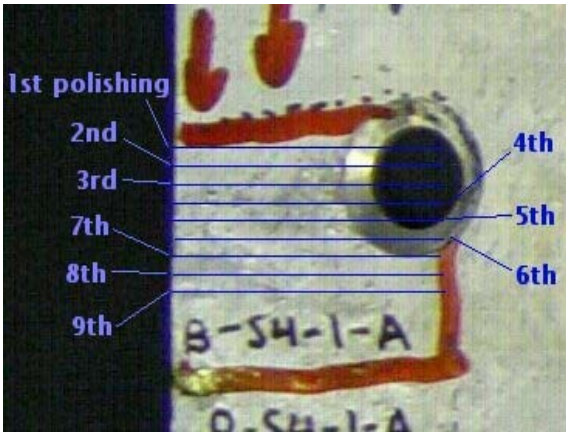
To document the damage caused by exfoliation corrosion, sections were taken from service exposed 7178-T6 upper wing skins from retired Boeing 707 aircraft [3]. As outlined in Chapter 4, these sections were cold mounted and progressively polished to determine the damage state. An image of this section along with the NDI and polishing results are shown in Figure 6-1. It is interesting to note how the damage morphology substantially changed over a small distance, 1.067 mm (0.042 inches), from very little intergranular corrosion to considerable amounts of exfoliation. Although very little intergranular corrosion was present below the observed exfoliation, as can be seen from the arrows in Figure 6-1, the intergranular corrosion that was present was located very close to the maximum exfoliation depth. This suggests that if this area of the wing skin was repaired the intergranular corrosion would probably also be removed.

Figure 6-1: Results from the Progressive Polishing Carried Out on Specimen 362-B-S4-1 that Contained Visible Exfoliation (arrows indicate the location of the deepest intergranular attack).

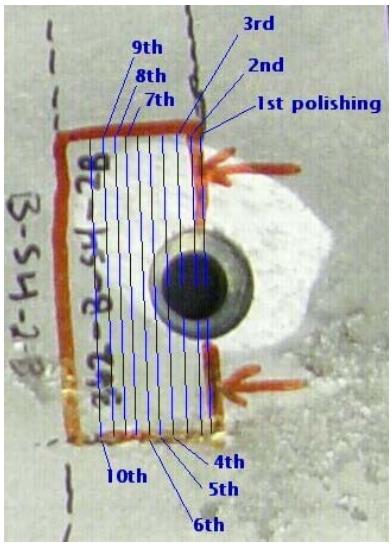
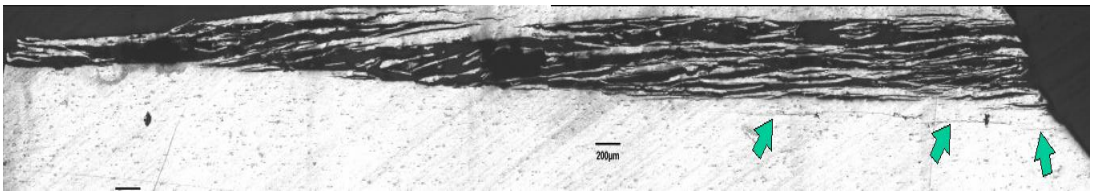
Another section that was taken from an upper wing skin contained both visible exfoliation and a repaired (ground-out) area. An image of this section along with the NDI and polishing results are shown in Figure 6-2. Although visible exfoliation was clearly present outside of the repaired area, no damage was detected within the area. It is interesting to note that as the polishing progressed the severity of the exfoliation decreased to intergranular corrosion, which extended into the repaired area. Whether the intergranular corrosion at this depth was present before the repair process was carried out could not be determined.

Figure 6-2: Results from the Progressive Polishing Carried Out on Specimen 362-B-S4-2 that Contained both Visible Exfoliation and a Repaired (Ground-Out) Area (arrows indicate the location of the deepest intergranular attack).

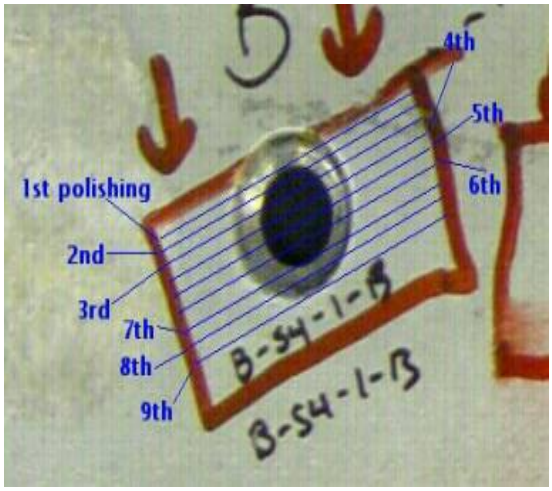
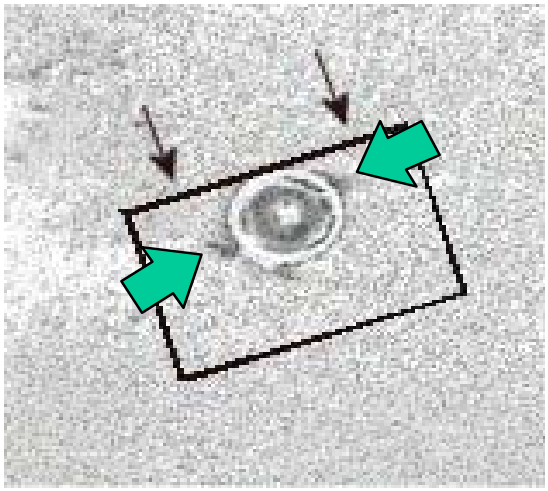
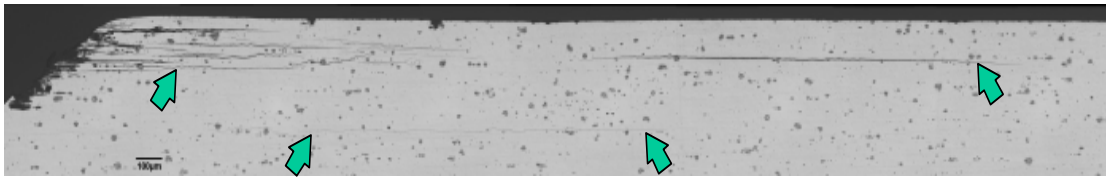
A section was taken from a 7178-T6 upper wing skin that did not contain any visible exfoliation, cold mounted and progressively polished, the results of which are shown in Figure 6-3. As can be seen from this figure, intergranular corrosion was present in the fastener area, which was detected by the ultrasonic inspection technique. This result demonstrated the sensitivity of the ultrasonic techniques to detect small levels of intergranular corrosion. It should also be mentioned that if a repair procedure were to be carried out in this area it is highly unlikely that all the intergranular corrosion would be removed, which is a requirement.

Figure 6-3: Results from the Progressive Polishing Carried Out on Section B Taken from Specimen 362-B-S4-1 that did Not Contain any Visible Exfoliation (arrows in (c) indicate the location of the deepest intergranular attack).

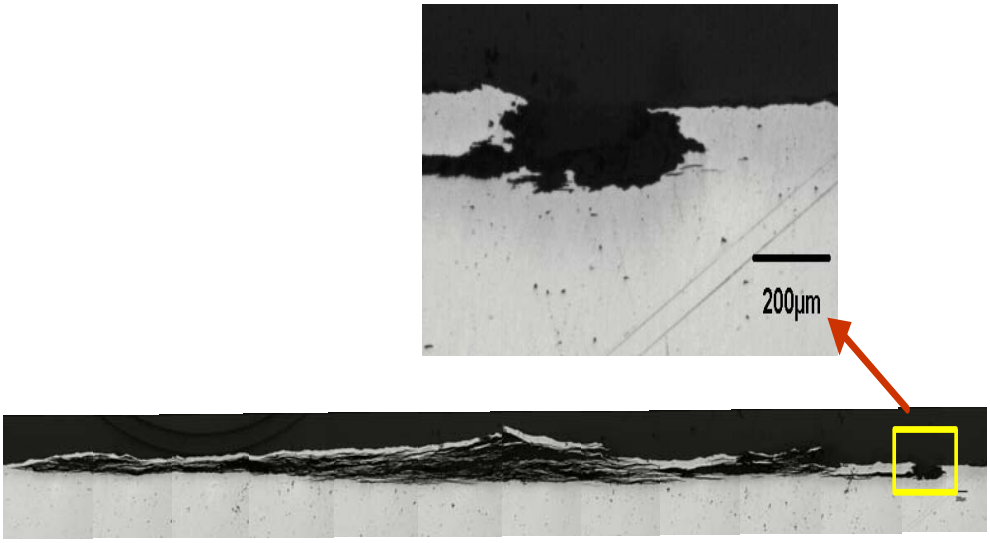
Another study was carried out on exfoliated integrally stiffener extruded 7075-T6511 upper wing skins (that is fasteners were not present) [3]. Wing skins that were accidentally subjected to an age degradation process while in storage were used in this study. However it was determined that the damage sustained from this process was representative of the damage that occurred in service. Sections were taken from exfoliated areas; cold mounted and progressively polished using standard metallurgical techniques to determine the origin of the exfoliation as well as to characterize the damage present. Some of the results are shown in Figure 6-4 and Figure 6-5. From this characterization study it was found that the intergranular corrosion, which developed into exfoliation, originated at a modified discontinuity state (corrosion pit) that evolved from the age degradation process.

(b) Photomicrograph showing exfoliation present in section. Note corrosion pit (square) that was present, which may have started the intergranular corrosion.

Figure 6-4: Exfoliation Present Along S-T Direction 7075-T6 Upper Wing Skin.

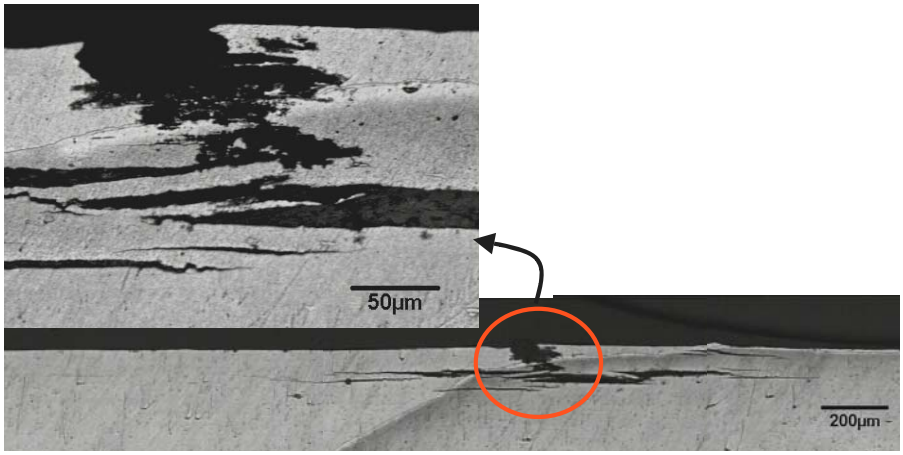
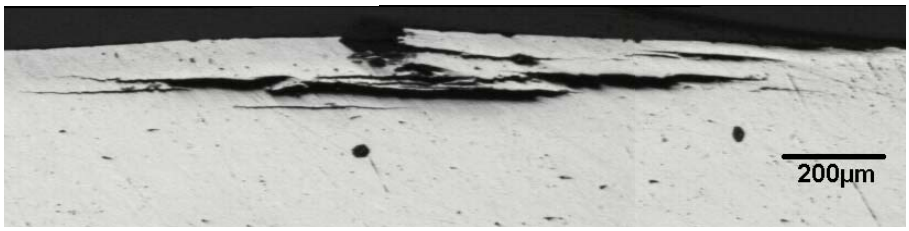
(b) Photomicrograph of exfoliation present in section after first polish. Note presence of corrosion pit (circle).

(c) Photomicrograph of exfoliation present after second polish in same area as (b).

Figure 6-5: Exfoliation Present Along S-T Direction of Section Taken from 7075-T6 Upper Wing Skin.

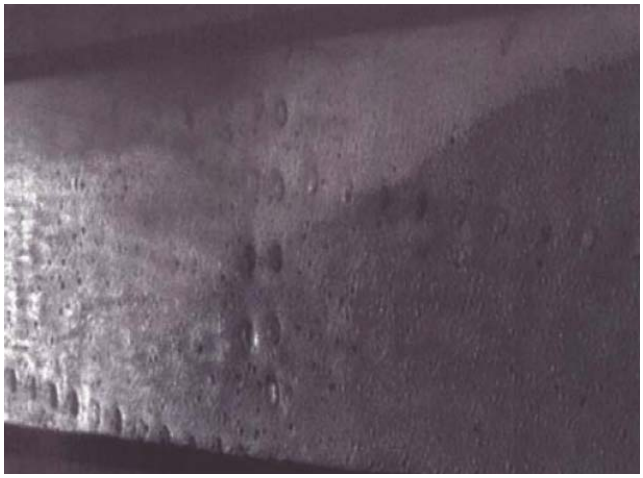
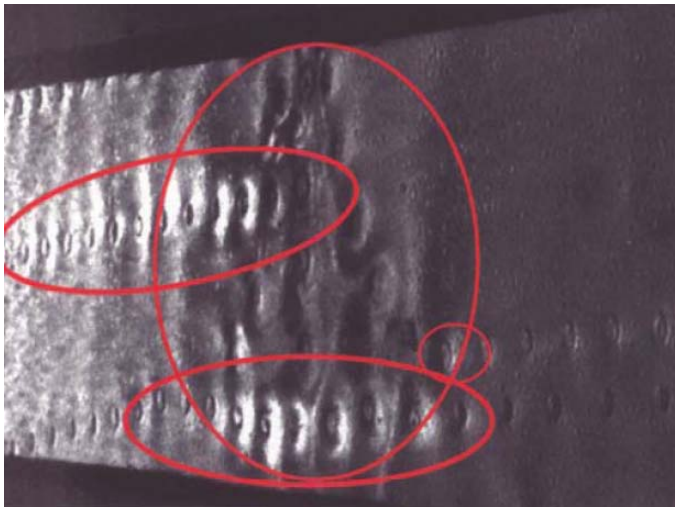
The most common procedure is to inspect the fuselage joints visually from the aircraft exterior. Typically inspectors look at the lap joint surfaces for traces of corrosion products, and for corrosion pillowing deformation, most often with the aid of a flashlight. Figure 7-2, Figure 7-3 and Figure 7-4 show typical images of pillowing obtained using an optical inspection method, known as D-Sight™, designed to enhance the appearance of the surface perturbations. The fundamental assumption is that corrosion is not significant unless the inspector is able to see shadows cast by the deformed surface. Unfortunately, there is no data on the Probability Of Detection (POD) for corrosion pillowing using visual inspection.

(b) Corrosion is present within the joint which is indicated by a bright to dark change in an area of the grayscale image.

Figure 7-2: Enhanced Visual Inspection Results (D-Sight™) of Fuselage Lap Joints.

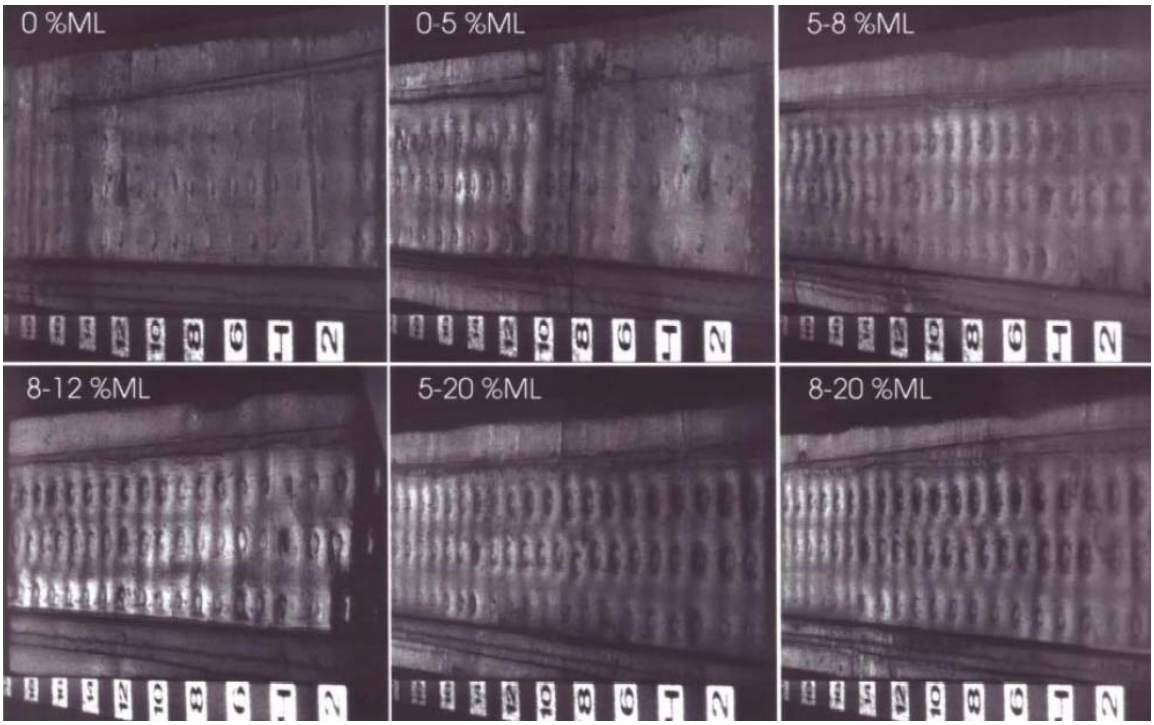
Figure 7-3: Various D-Sight™ Images Showing Degree of Pillowing for Different Level of Material Thickness Loss (ML).

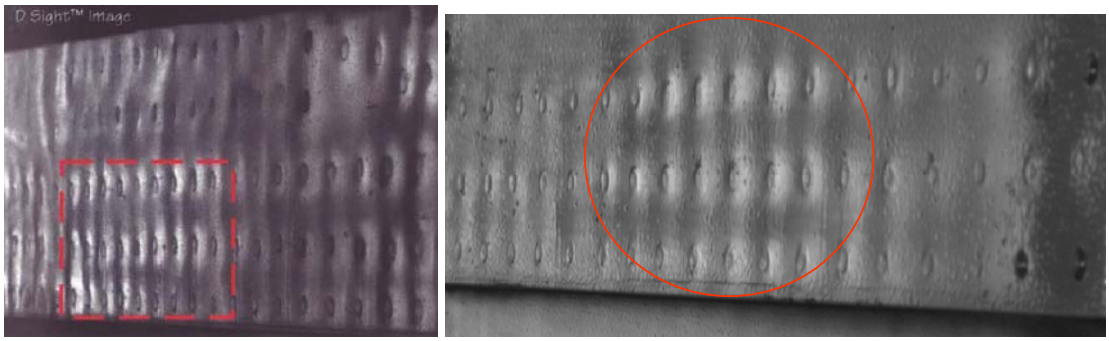
Figure 7-4: D-Sight™ Images Showing Pillowing Caused by Corrosion Products.

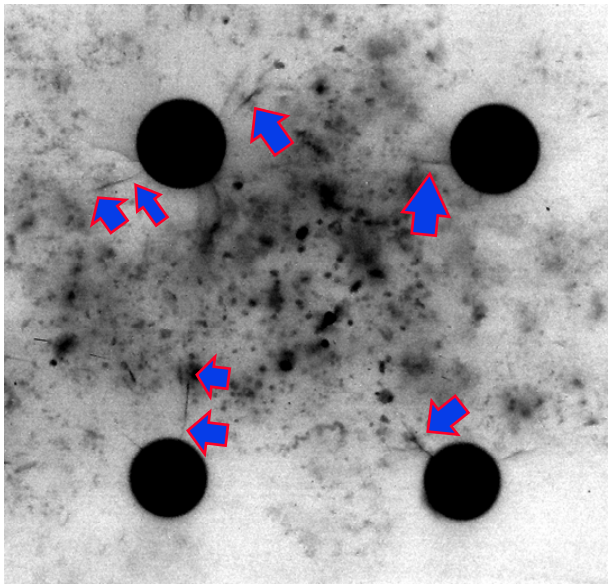
- Pillowing cracks tended to occur in groups (i.e., “star-shape” pattern cracks at more than one rivet hole), which did not normally penetrate through the thickness. The cracks always occurred on the side of the hole that was affected by the increased stress due to the pillowing and tended to propagate into the pillowed region Figure 7-6.
- The crack faces that were pried open contained corrosion products and showed extensive intergranular fracture with numerous secondary cracking, Figure 7-7.
- A number of the cracks had multiple nucleation sites. Although these sites could not be determined, they were evidently based on the different crack planes present, Figure 7-8.

(b) X-ray micrograph showing cracks in L1011 lap joint.

Figure 7-6: Various Images Showing the Typical Star-Shape Pattern Associated with Pillowing Cracks.

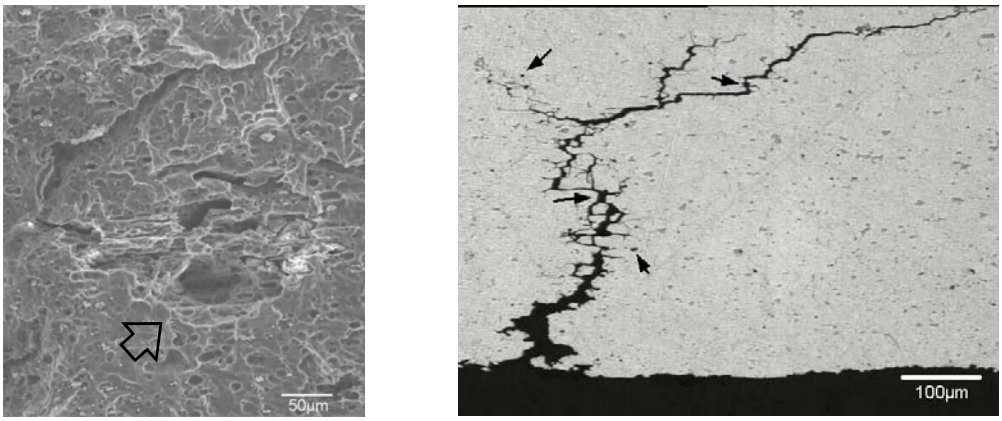
Figure 7-7: Micrographs Showing the Intergranular Cracking with Numerous Secondary Cracks.

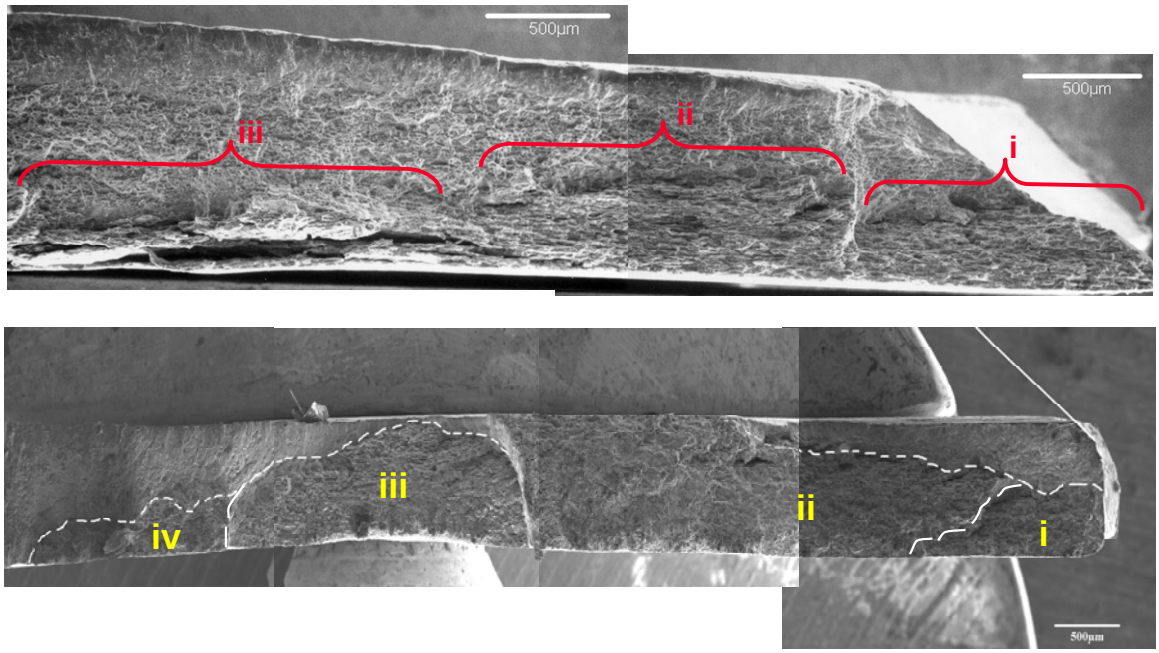
Figure 7-8: Micrographs Showing Multiple Crack Nucleation Sites.

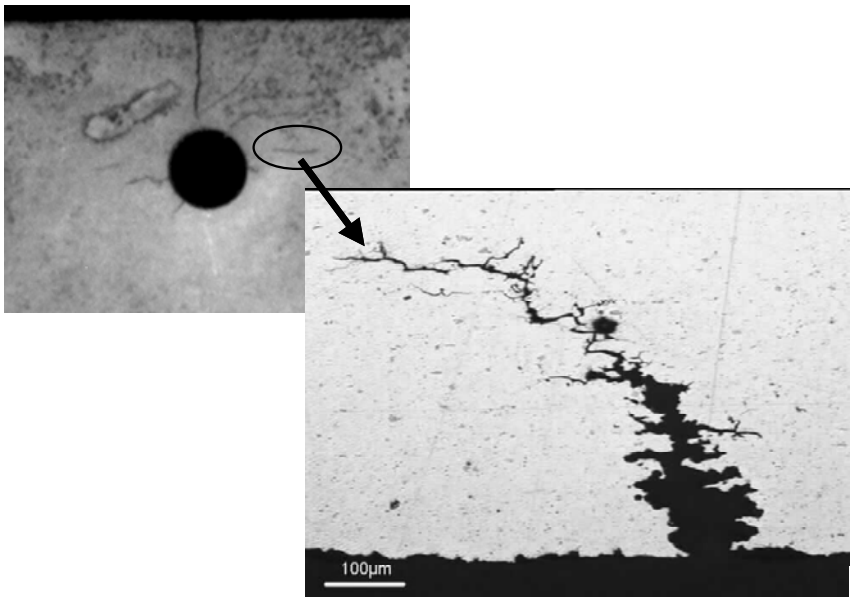
- The crack growth through the thickness was not perpendicular to the faying and outer skin surfaces but occurred at an angle, Figure 7-9.
- Some of the fracture surfaces contained fatigue striations near the crack edge where the corrosion was light, Figure 7-10 and suggests that once these cracks form, they may continue to grow under fatigue loading.

Figure 7-9: Optical Image of Pillowing Crack Showing Angled Crack Growth. (Note that the crack occurred away from the edge of the hole but is still within the highly stressed area caused by the corrosion pillowing.)

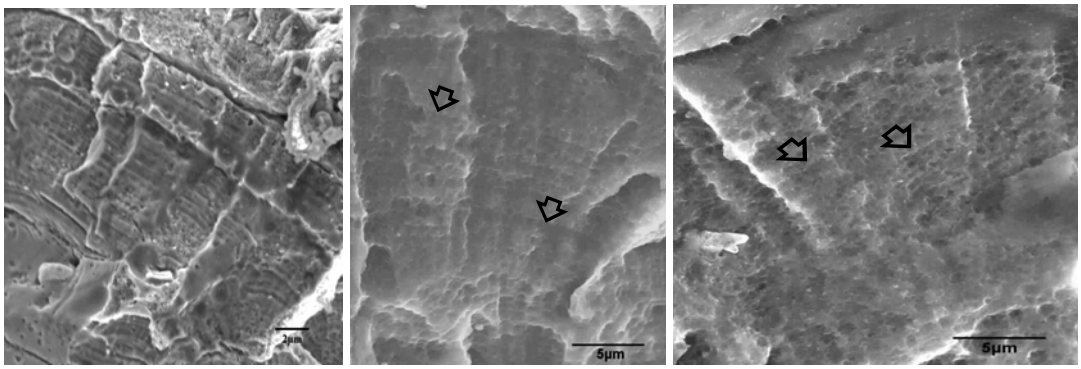
Figure 7-10: Scanning Electron Micrographs Showing Fatigue Striations that were Found on the Fracture Surfaces on Some Pillowing Cracks.

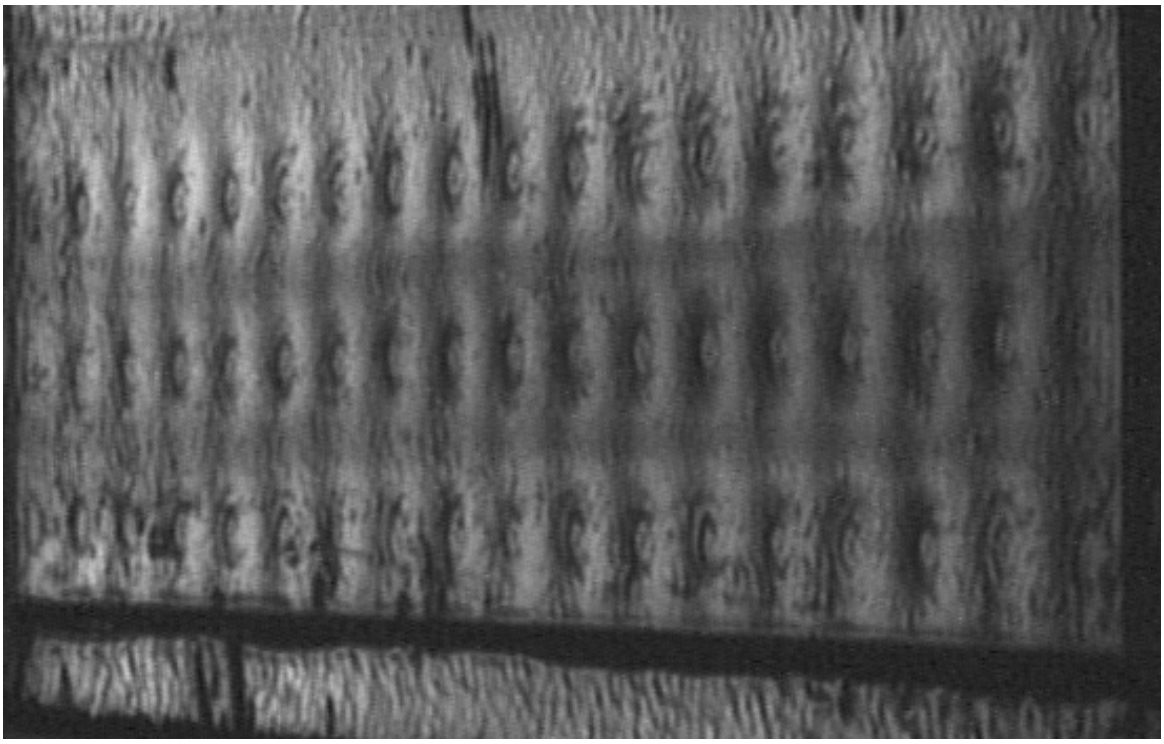
Figure 11-13: DAIS Image of Accelerated Corrosion Pillowing Following 387 Days (9288 Hours) of Salt Fog Exposure.

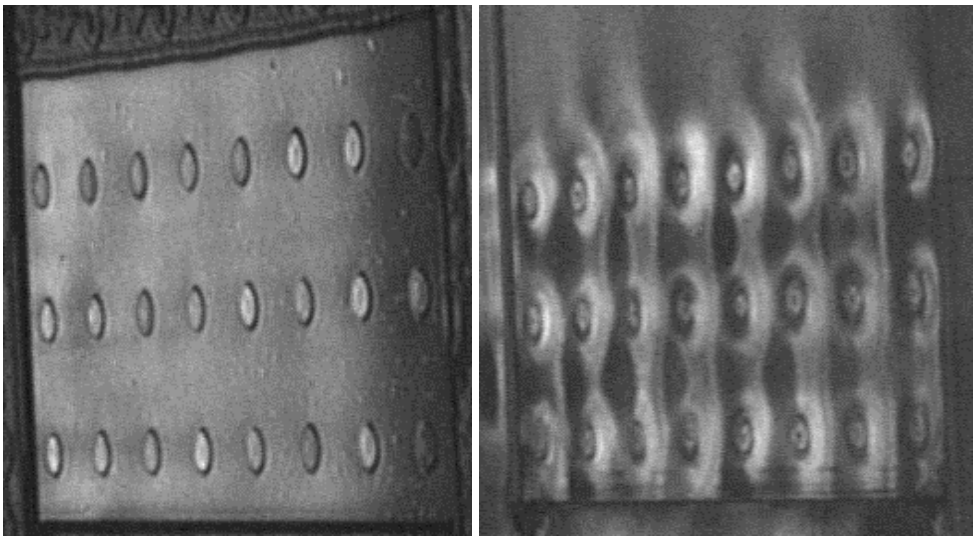
The corrosion build-up inside the splice caused pillowing distortion. This distortion can be seen clearly in comparing the images of corroded and non-corroded specimens in Figure 16-2, which were obtained using the D Sight Aircraft Inspection System (DAIS). The distortion can significantly affect the stress distribution in a splice, and has been modeled in other work at the National Research Council (NRC) Canada [6]. Measurements of pillowing distortion were used to monitor the level of corrosion during the pre-corrosion process.

Figure 16-2: D Sight Aircraft Inspection System (DAIS) Images of a Lap Splice Specimen Before Corrosion (left) and After Corrosion (right).

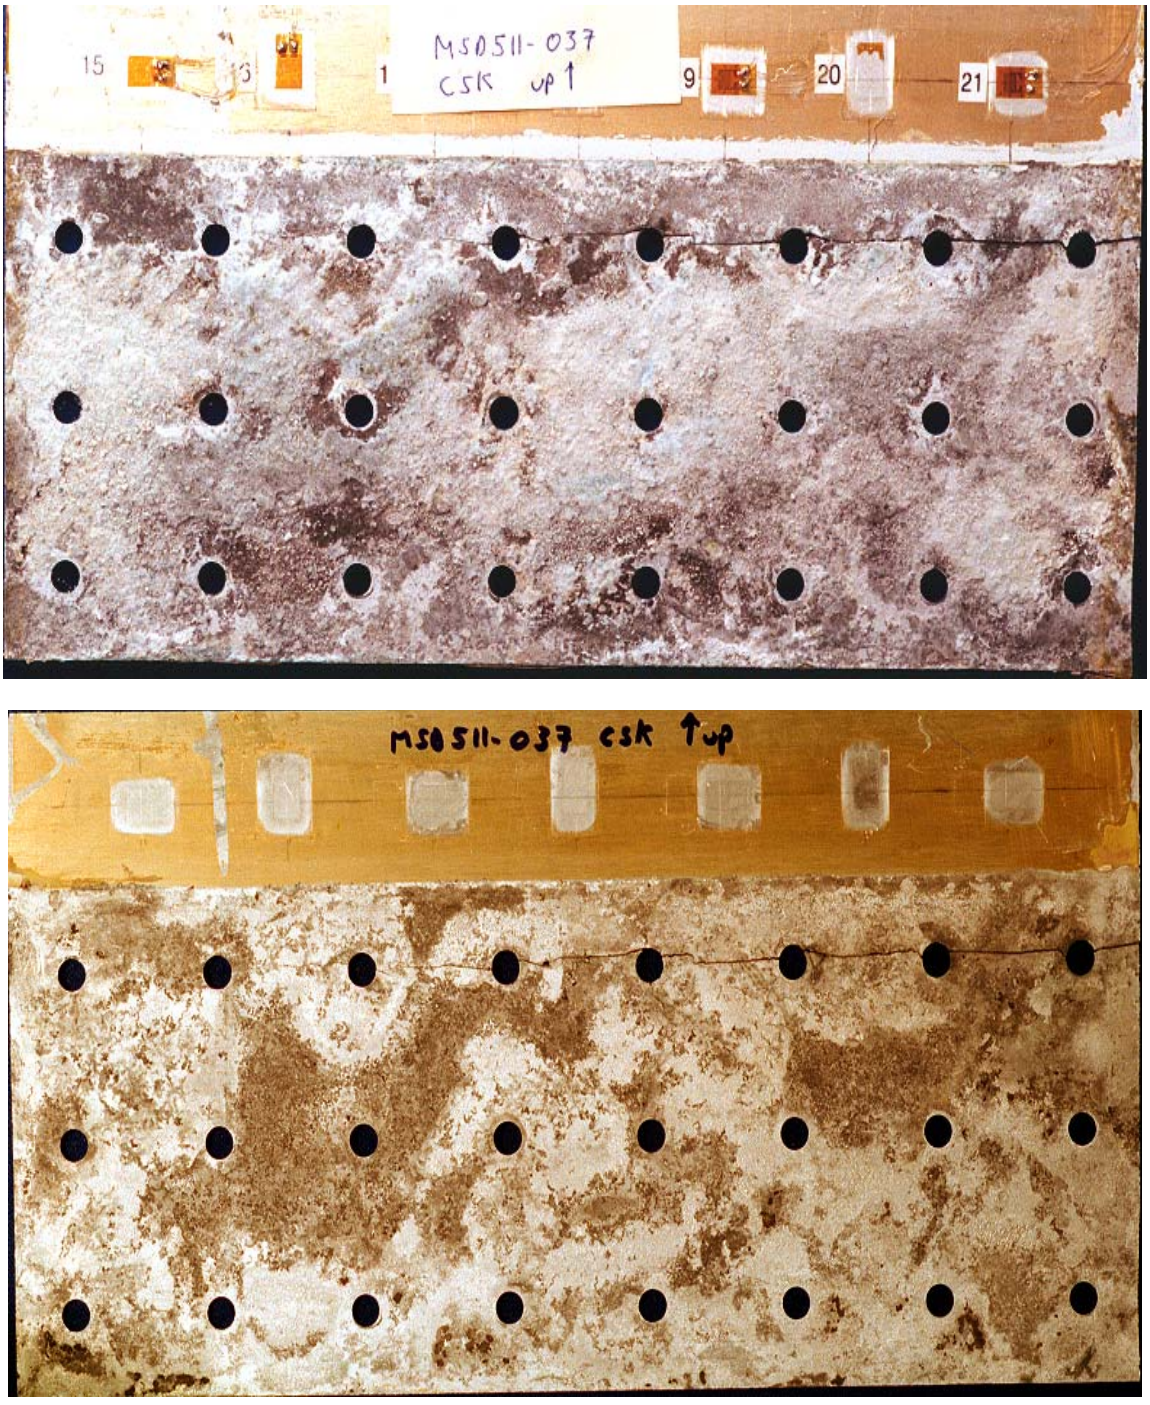
Figure 16-3: Faying Surface of the Countersunk Sheet of Specimen #037 Before and After the Removal of Corrosion Products.

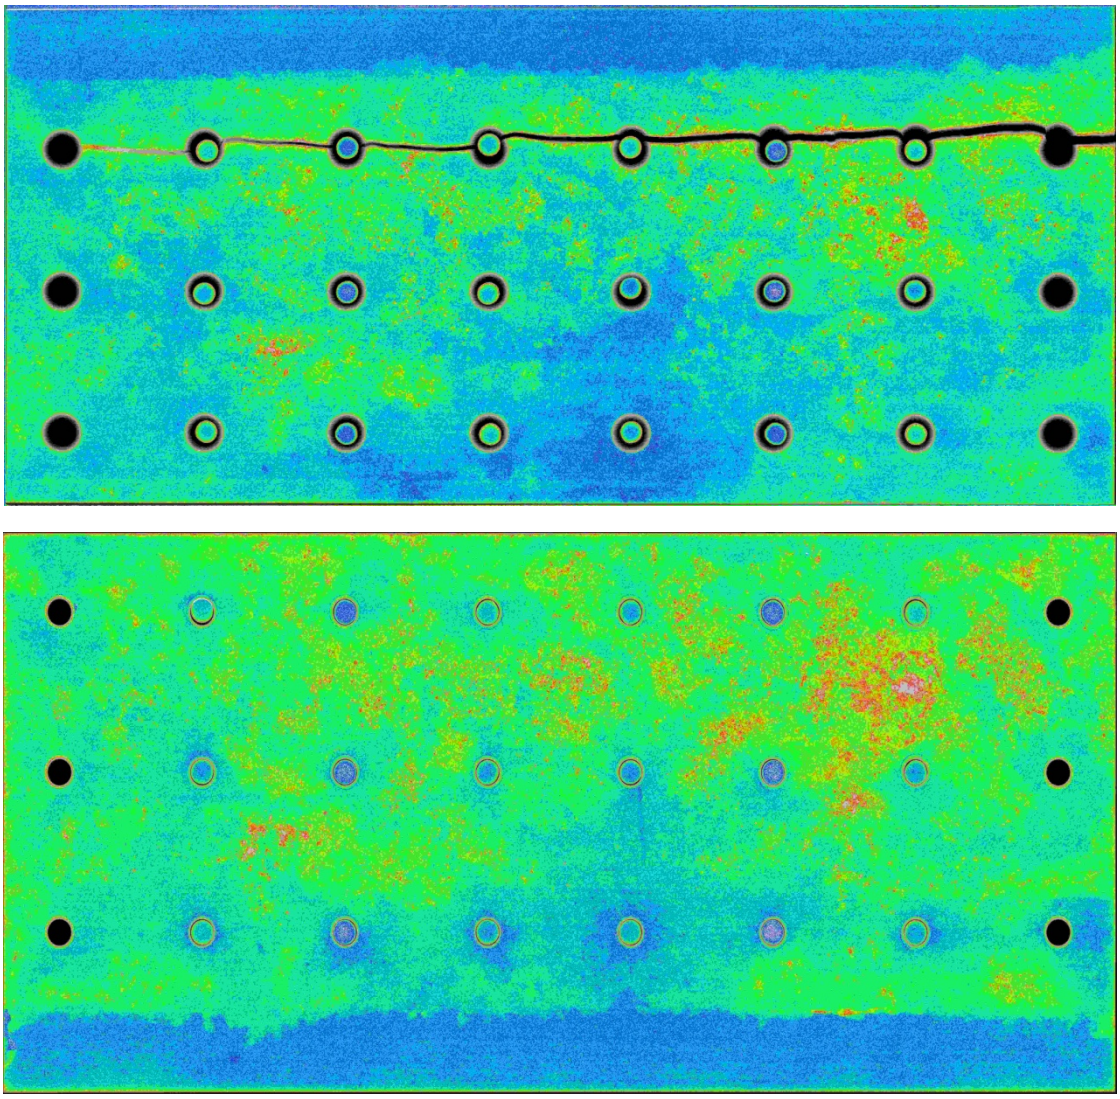
Figure 16-4: Pseudo-Colored Digitized X-Ray (DXR) Thickness Maps Showing Corrosion Distribution in Countersunk (upper image) and Driven (lower image) Sheets of Specimen #035 (higher resolution grey scale images are used for quantitative analysis).

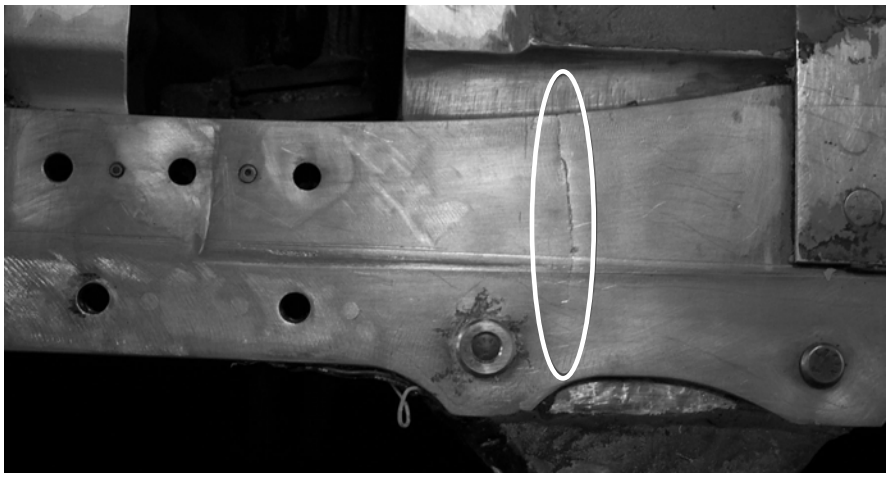
A full scale F-18 wing test (FT245) was conducted at the National Research Council (NRC) Canada under the International Follow-On Structural Test Project (IFOSTP) supported by The Canadian Forces (CF) and The Royal Australian Air Force (RAAF). During the test, a long fatigue crack of 46 mm (1.81 inch) was discovered on the right hand upper Outboard Longeron (UOL) of the centre fuselage at 2932 Simulated Flight Hours (SFH), as shown in Figure 17-1. In this test, the fuselage was used as a transition structure, and was a retired United States Navy (USN) F-18 aircraft that had been in-service for ten years (1984 – 1994), Rutledge et al. [1]. Extensive corrosion was reported on the UOL by the US Navy (USN) during its service life, which was repaired (blended out) [1]. During the full scale wing test, the crack in the component was discovered after a fairing and sealant had been removed to perform a scheduled life enhancement procedure. Corrosion pits were found in the area near the apparent crack nucleation site. Since the full scale wing test was conducted in an environmentally controlled facility, it was reasonable to assume that these pits formed in-service and went undetected after the last maintenance cycle prior to the aircraft being retired. This cracking case was used to demonstrate and validate the applicability of a Holistic Structural Integrity Process (HOLSIP) based corrosion fatigue analysis methodology and tool.

Figure 17-1: Fatigue Crack on the Right UOL of F18 Central Fuselage.

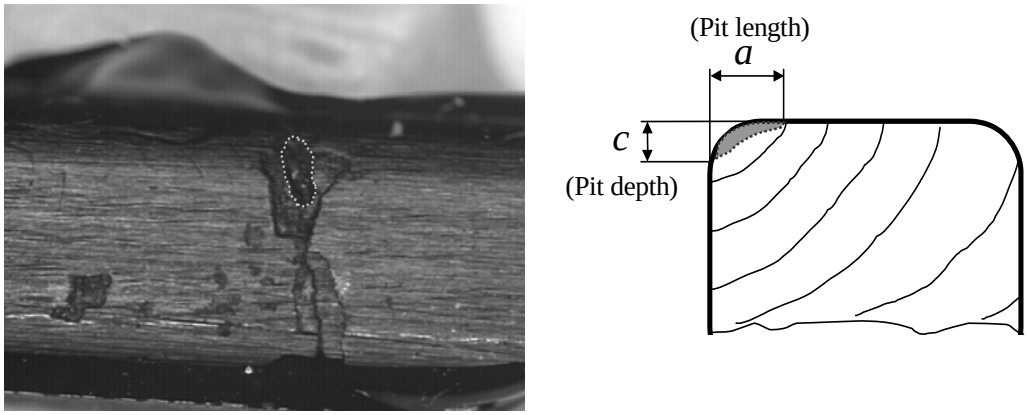
A replica was taken to verify that the crack nucleated from corrosion pits (see the dotted line in Figure 17-3) that were present at the round corner. A corner crack model was thus added to ECLIPSE in order to simulate this cracking scenario. The combined length of the pits along the thickness direction was approximately 0.63 mm (0.0248 inch), and the pit depth (shortest dimension), which occurred in the width direction was approximately 0.44 mm (0.0172 inch).

Figure 17-3: Corrosion Pits and Cracking Scenario.

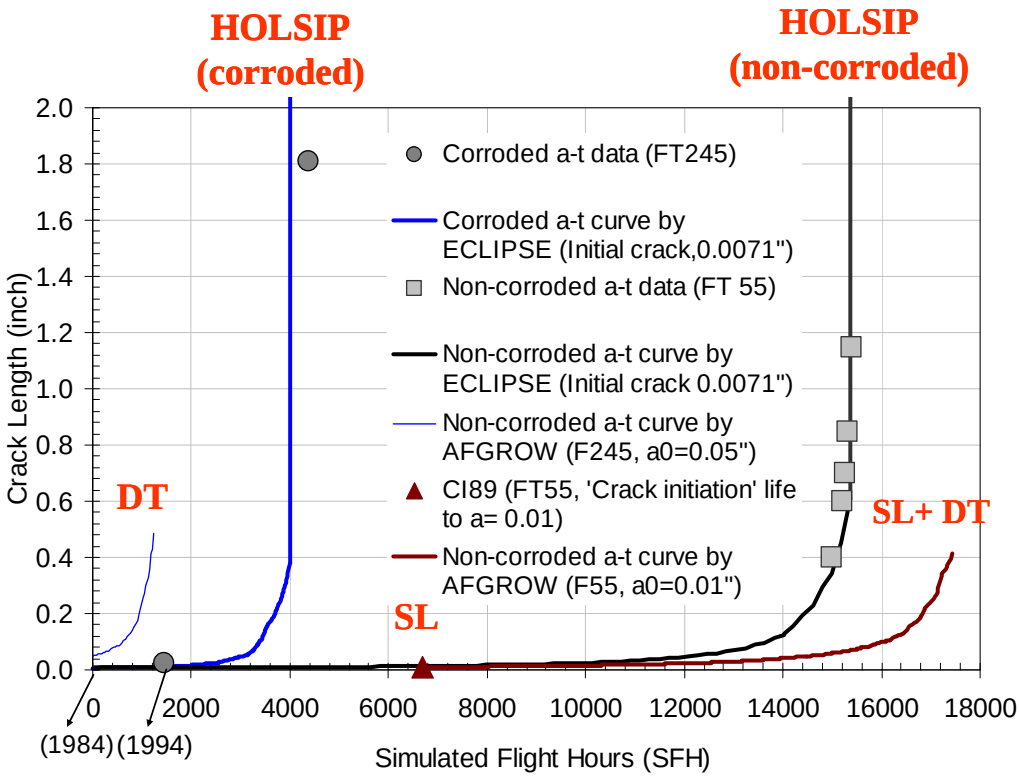
Using the estimated initial crack size (0.18 mm, 0.0071 inches) and other input parameters (corrosion growth, thickness loss, etc.) discussed in the previous section, the corrosion fatigue analysis was carried out for the corroded UOL using ECLIPSE. This analysis was carried out from the start of service life (1984) to when the crack was found during the wing test. It should be noted that this fuselage had previously accumulated 3,644 flight hours with a recorded FLEI (Fatigue Life Evaluation Index) of 0.309 in the USN, Rutledge et al. [1]. This usage converted to the full scale wing test hours is approximately 1,446 SFH. This reduction is due to more aggressive loading spectrum applied to the wing test. The results, labeled as HOLSIP (corroded), from the corrosion and fatigue analysis are shown in Figure 17-7, along with the test results for the corroded and non-corroded UOL. This figure shows that the analytical results for the corroded UOL are in close agreement with the NRC test results.

Figure 17-7: Life Comparison Between Corroded and Non-Corroded UOL.

In Figure 17-7, the result of a Damage Tolerance (DT) analysis is also presented. The DT analysis was carried out using AFGROW, and a typical initial crack size of 1.27 mm (0.050 inches). It is shown that the typical DT analysis clearly underestimated the life of the corroded UOL, without including the corrosion effect.

In summary, both analytical and test results showed that the corrosion pits significantly decreased the life of the UOL. The HOLSIP/ECLIPSE analysis provided most reasonable results for both corroded and non-corroded cases.

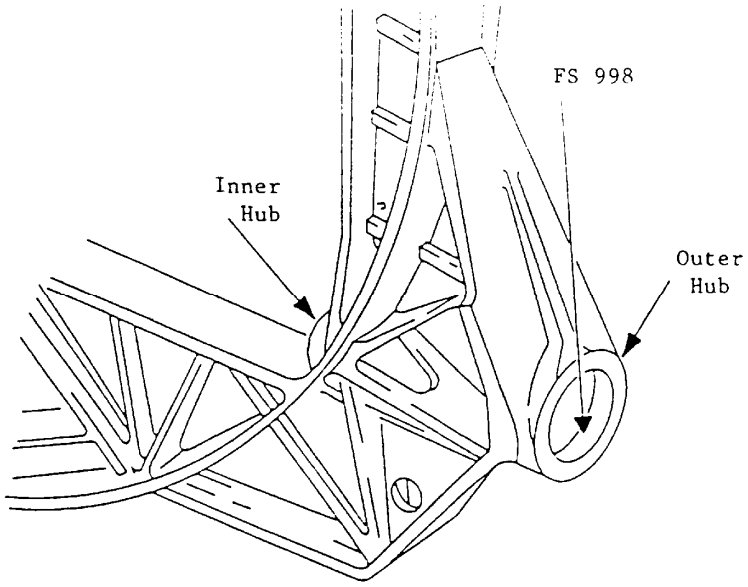
This case study examines the failure of fuselage frames on the now-retired USAF C-141 aircraft. The component experiencing the problem was the frame at Fuselage Station (FS) 998. In particular, cracking was occurring in a hub for a main landing gear attachment point (Figure 18-1). Special concern was placed on this component because it was largely expected to be an 'infinite life' component, at least in the area where cracking was occurring. The discovery of cracks, not explained by any analyses, had the USAF confronting a very likely possibility of wholesale frame replacement throughout the fleet, which would have been a very costly option in terms of both dollars and asset availability. Replacing the FS 998 frame is major surgery.

Figure 18-1: Drawing of Main Frame Landing Gear Hub.

analysis revealed corrosion pitting at the crack nucleation site of the failed frames. Beyond this, very little information was known about the nature of the pitting other than the fact that corrosion up to 250 microns (0.01 inch) deep was found on 20-year old components. This provided a target metric for the holistic structural integrity analyses discussed in the next section.

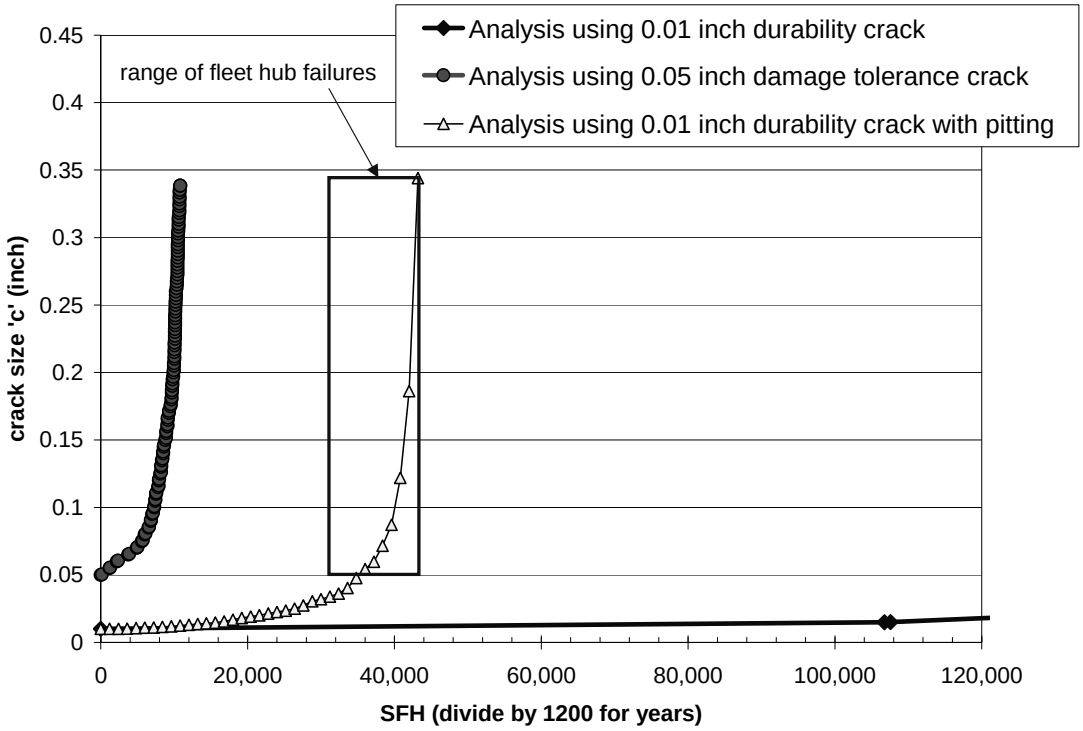
Figure 18-3 shows the results of the demonstration analyses. In practice, the fleet was experiencing failures in the range of 35,000 to 43,000 flight hours. Using traditional analysis techniques and the common durability crack size of 0.25 mm (0.01 inch), the hub showed flat crack growth (practically speaking, infinite life). On the other extreme, by assuming a damage tolerance crack size of 1.25 mm (0.05 inch), the component appeared to have an extremely short service life, which results in a heavy and expensive inspection burden.

Figure 18-3: Crack Growth Analysis of Main Landing Gear Hub Showing Traditional and HOLSIP Analyses.

However, by including corrosion pitting in the traditional durability analysis, the life capability is reduced considerably but accurately (less than with damage tolerance assumptions) and estimates structural capability in the range of the fleet failures. The impact of corrosion is clear and further demonstrates the importance of holistic structural integrity considerations in aircraft maintenance, and also illustrates the power of these methods to identify corrosion-susceptible structure during design.

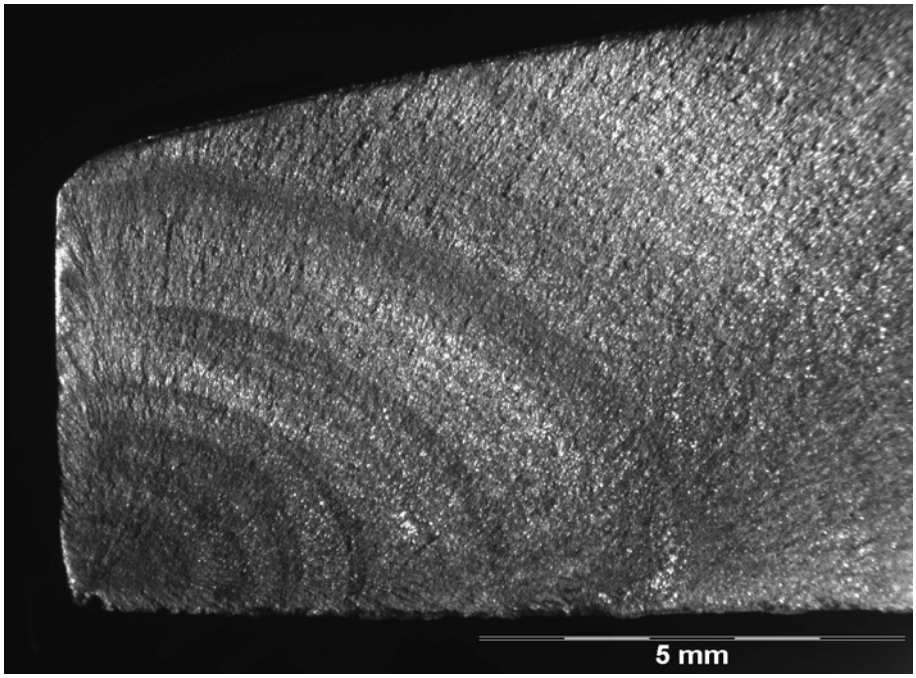
Fracture analysis was conducted using an optical stereoscope and an optical microscope. The fracture face revealed beach marks at lower magnification (Figure 19-1) and striae at higher magnification, which indicated fatigue was the primary crack propagation mechanism.

Figure 19-1: Optical Micrograph of Fracture Face Showing Beach Marks.
